Appendix K: Lower Minnesota River Watershed District: Gully Inventory

Gully Inventory Map
 Area #1
 Lower Minnesota River Watershed District
 Watershed Management Plan

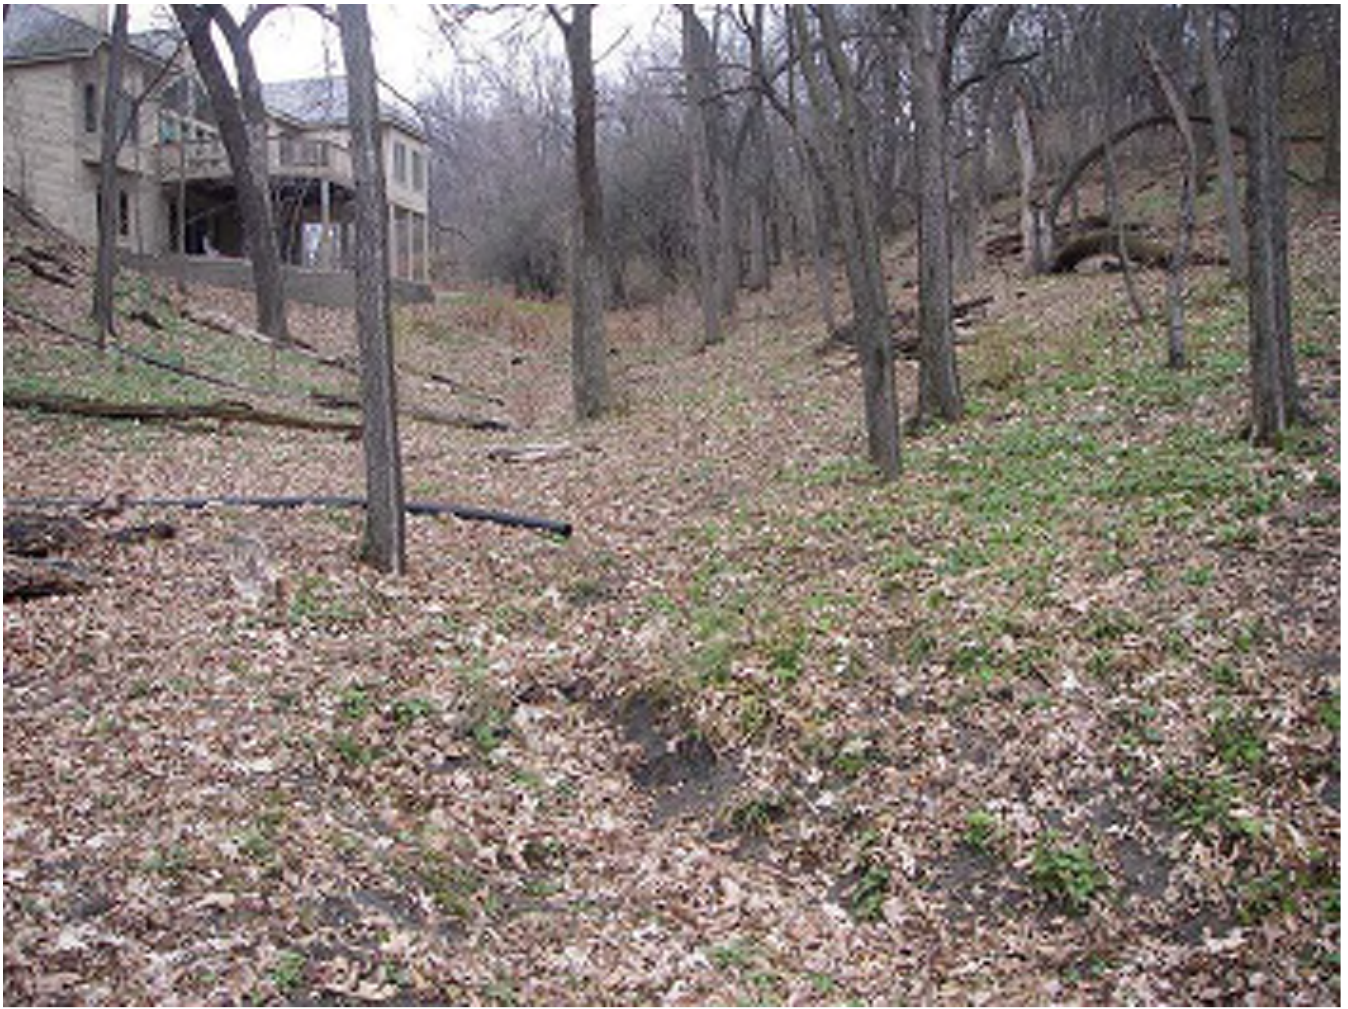
Gully uphill view

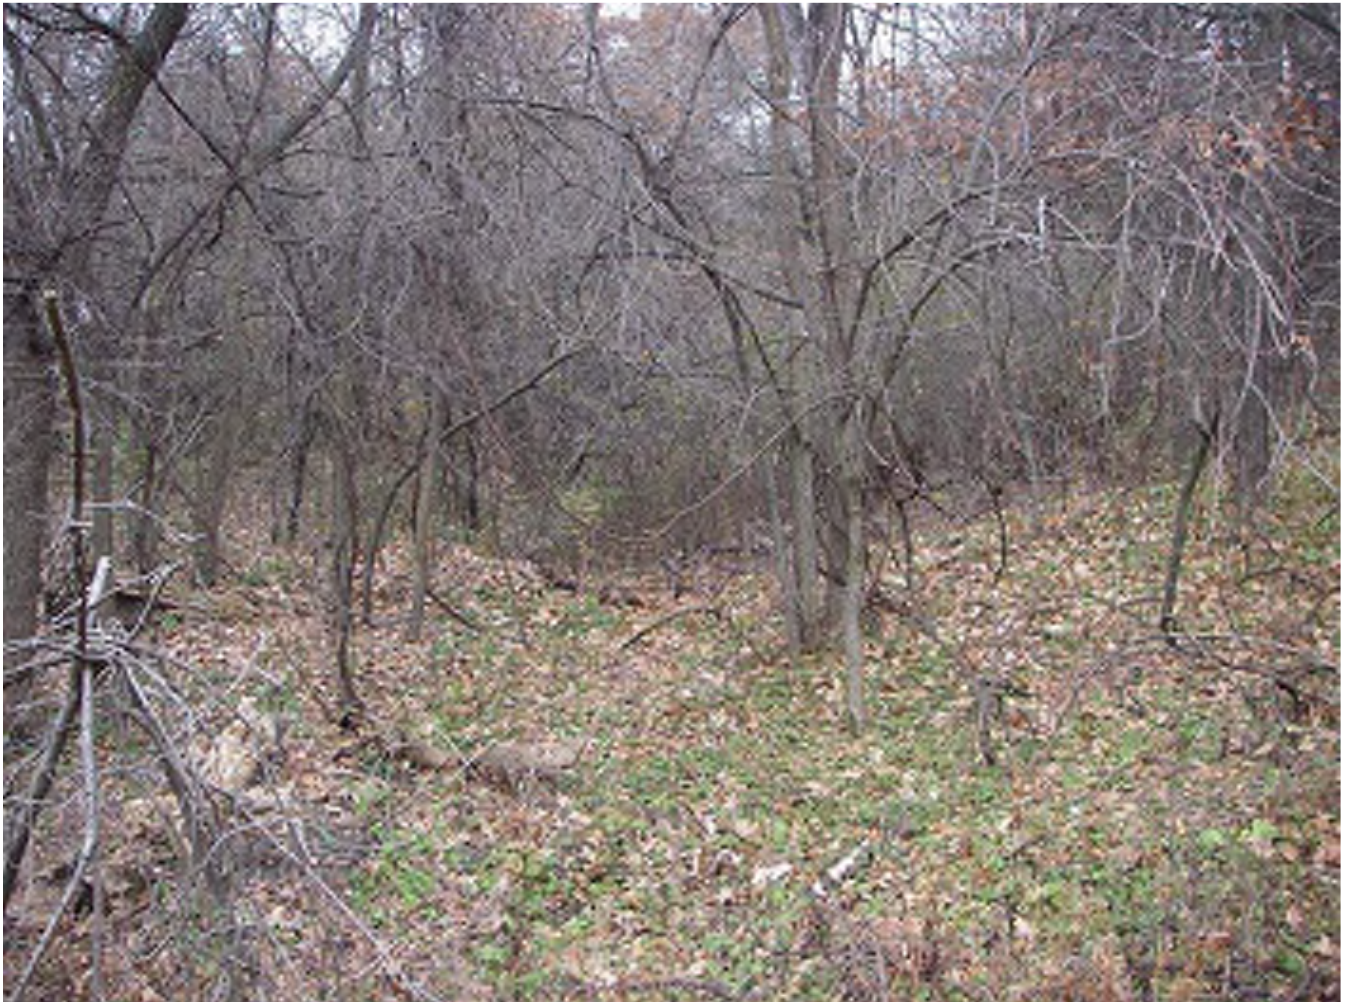
Waypoint 24

Minimal erosion.

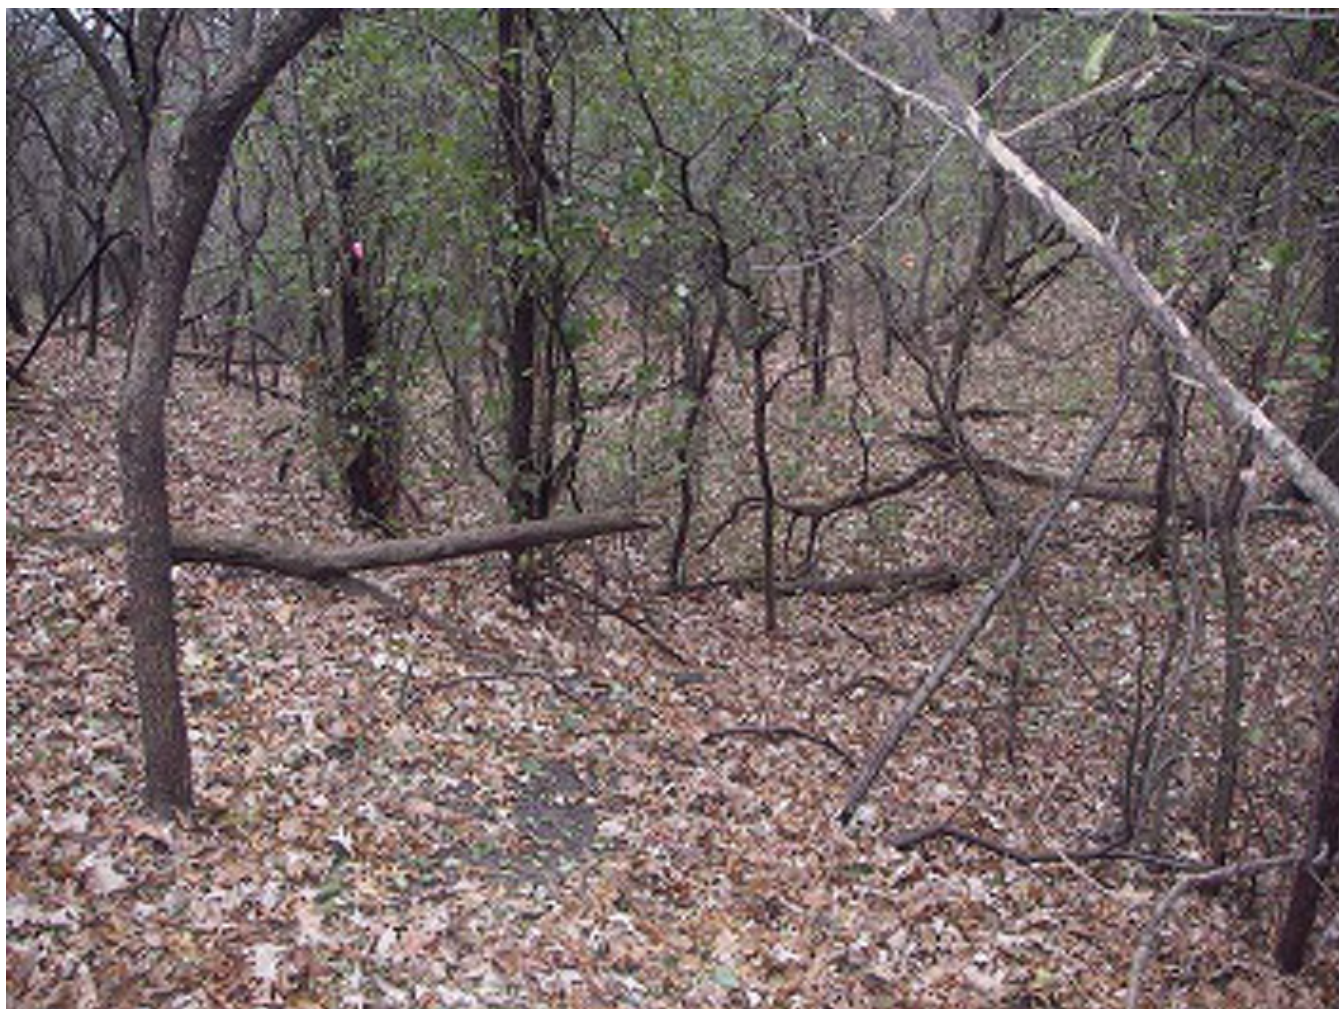
Spring

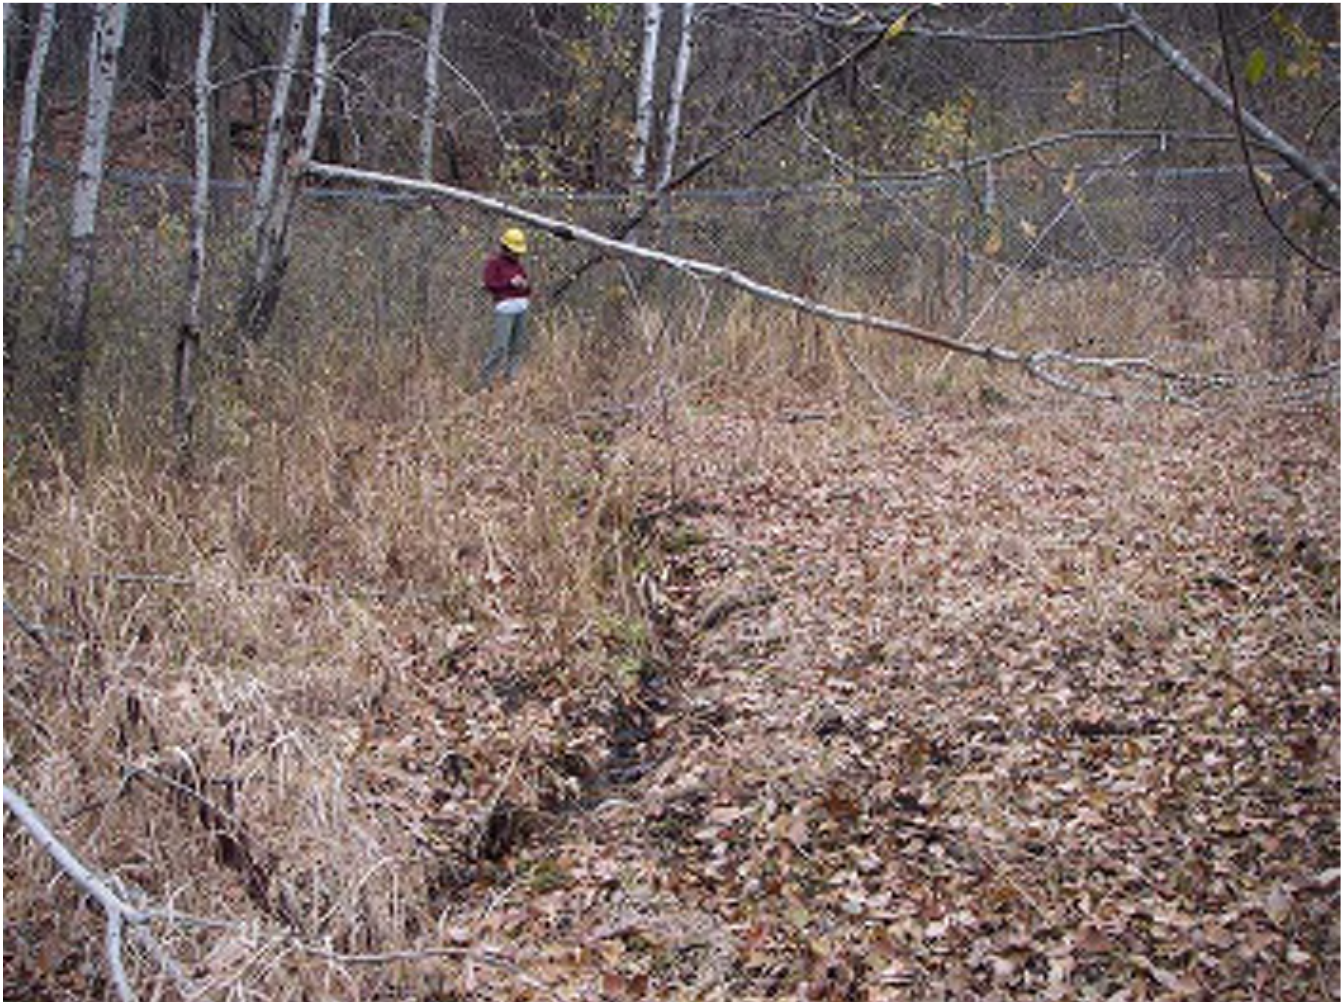
Waypoint 25

Spring & small channel leading to wetland

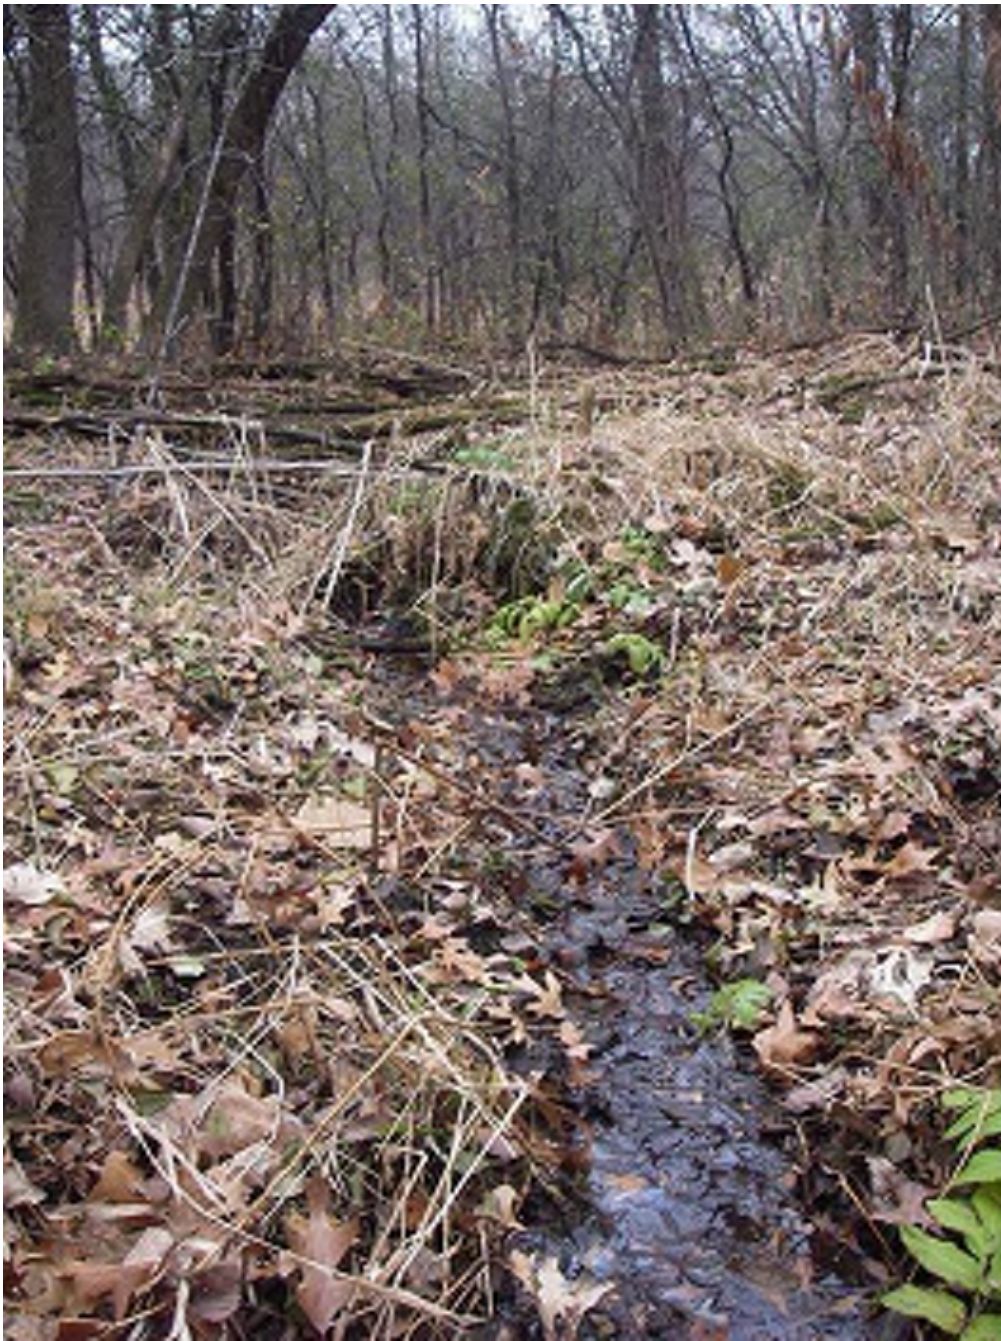
Spring & small channel leading to wetland

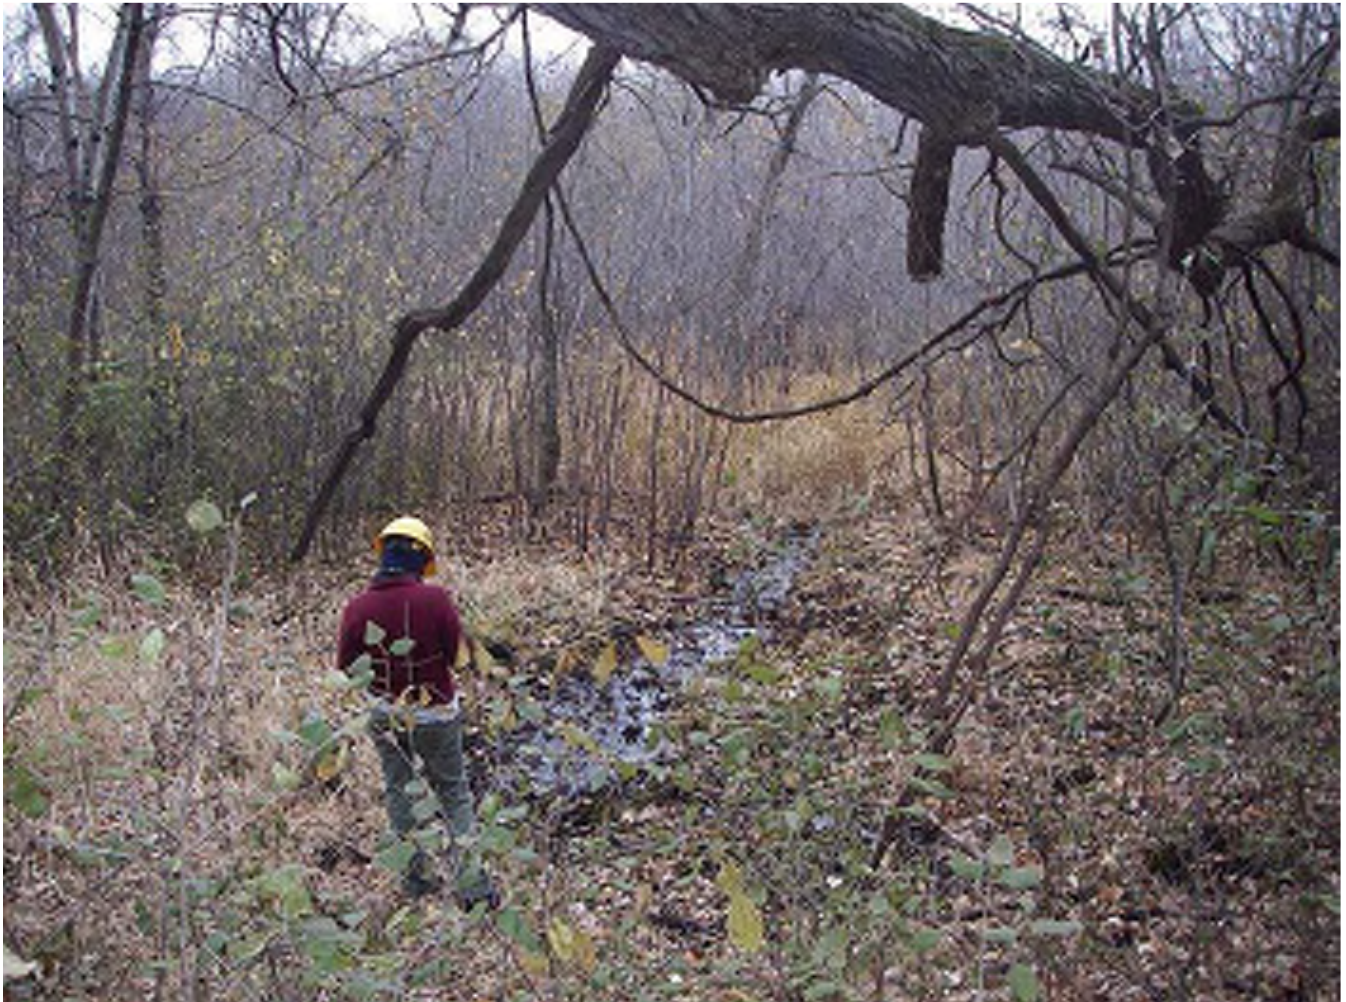
Waypoint 26

Spring & small channel 20 ft. long leading to wetland

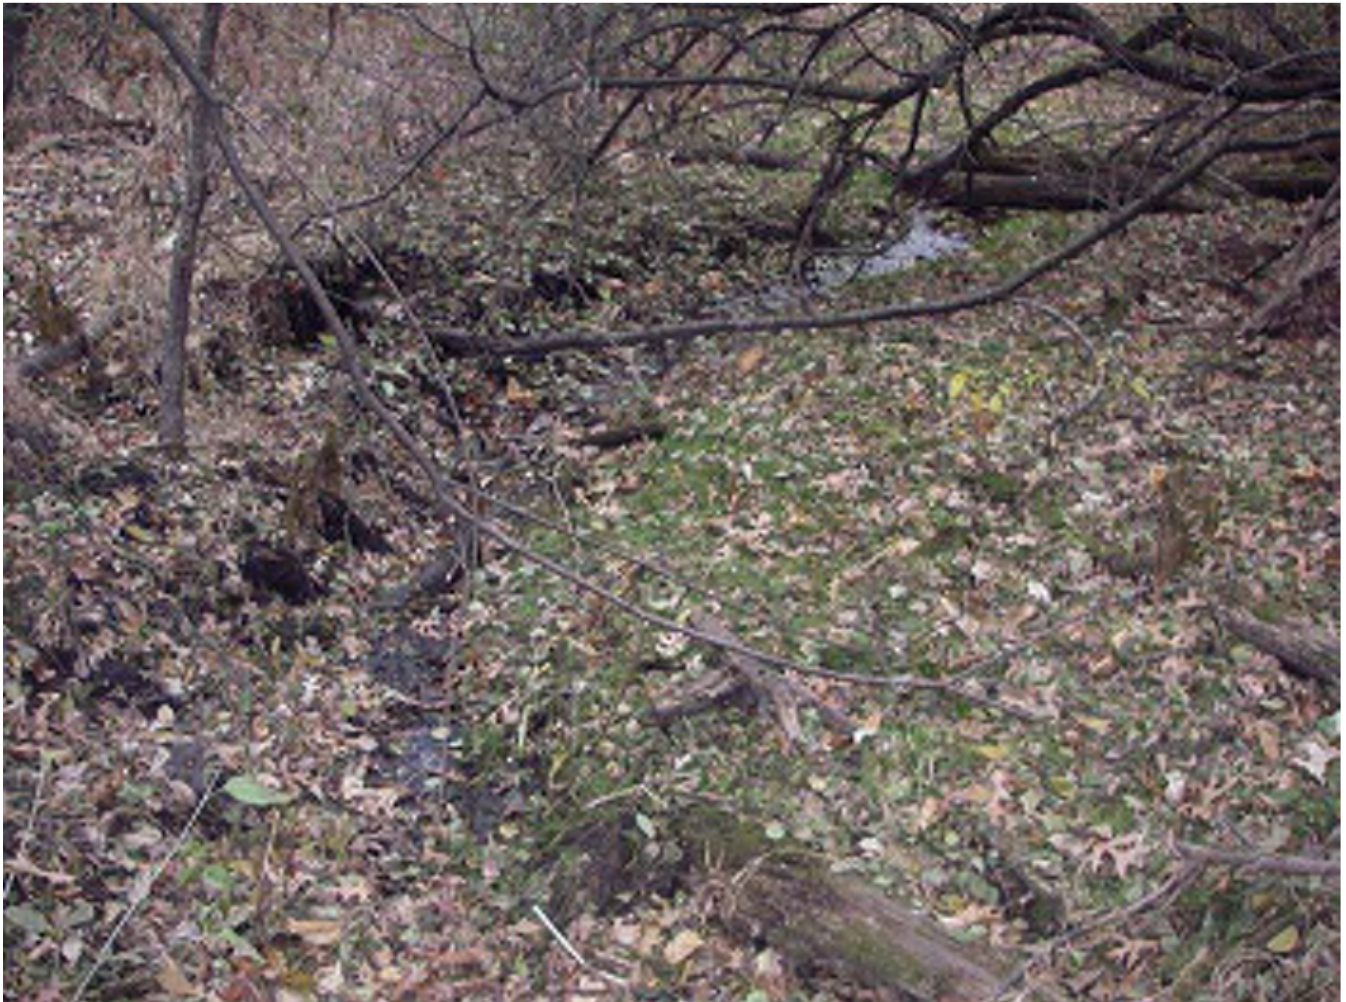
Waypoint 28

Spring & small channel leading to wetland

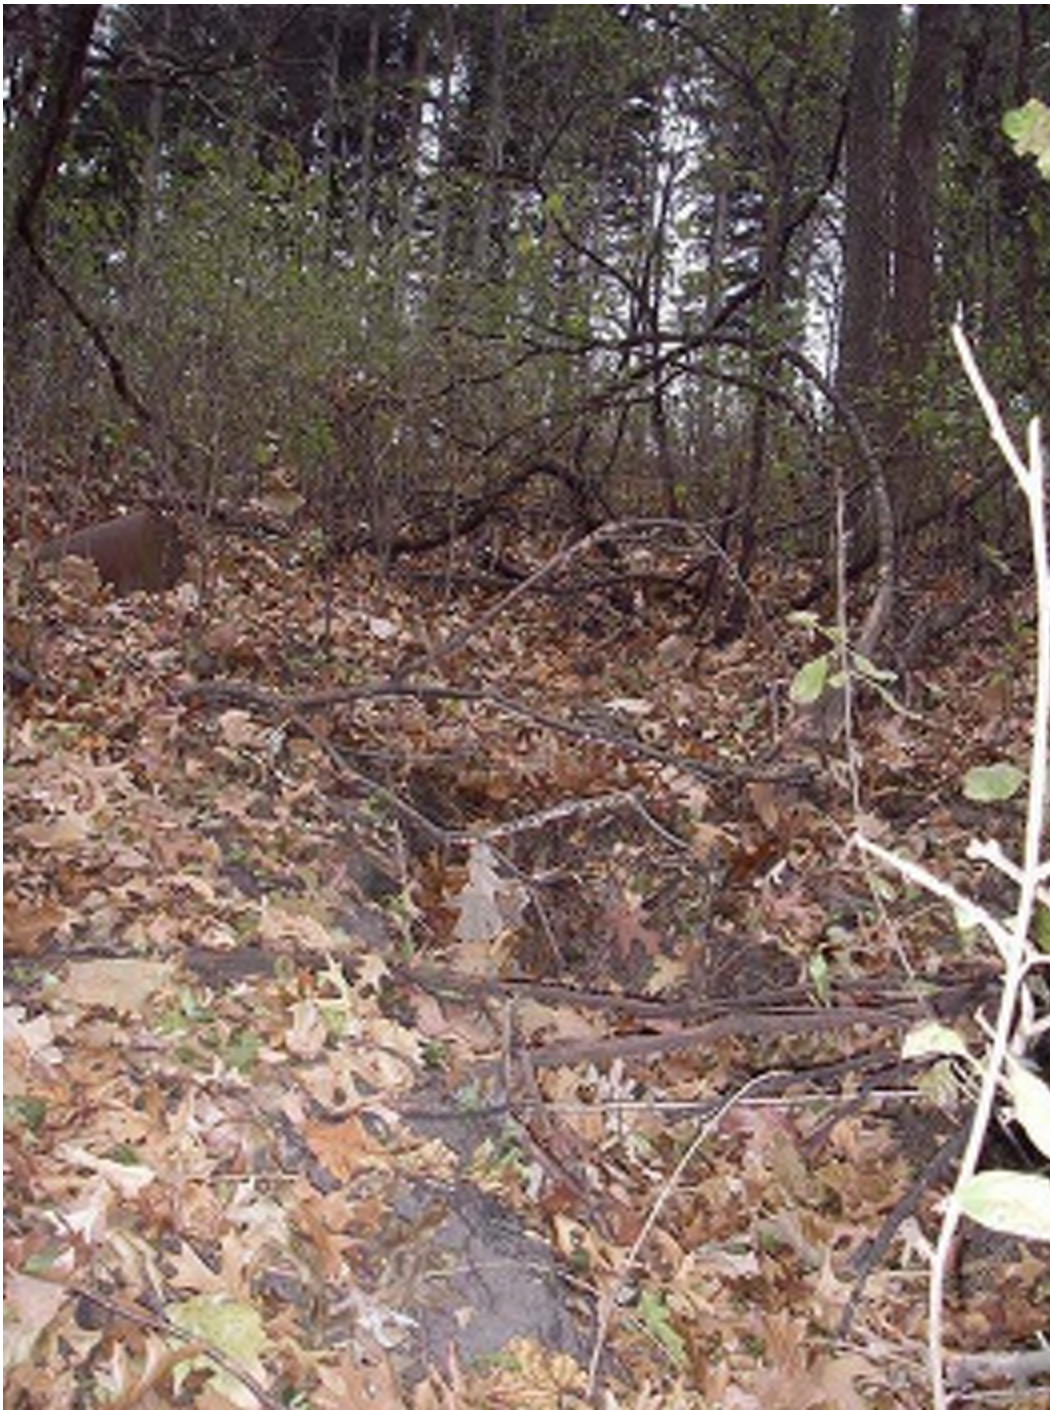
Waypoint 29

Gully bank erosion from parking lot

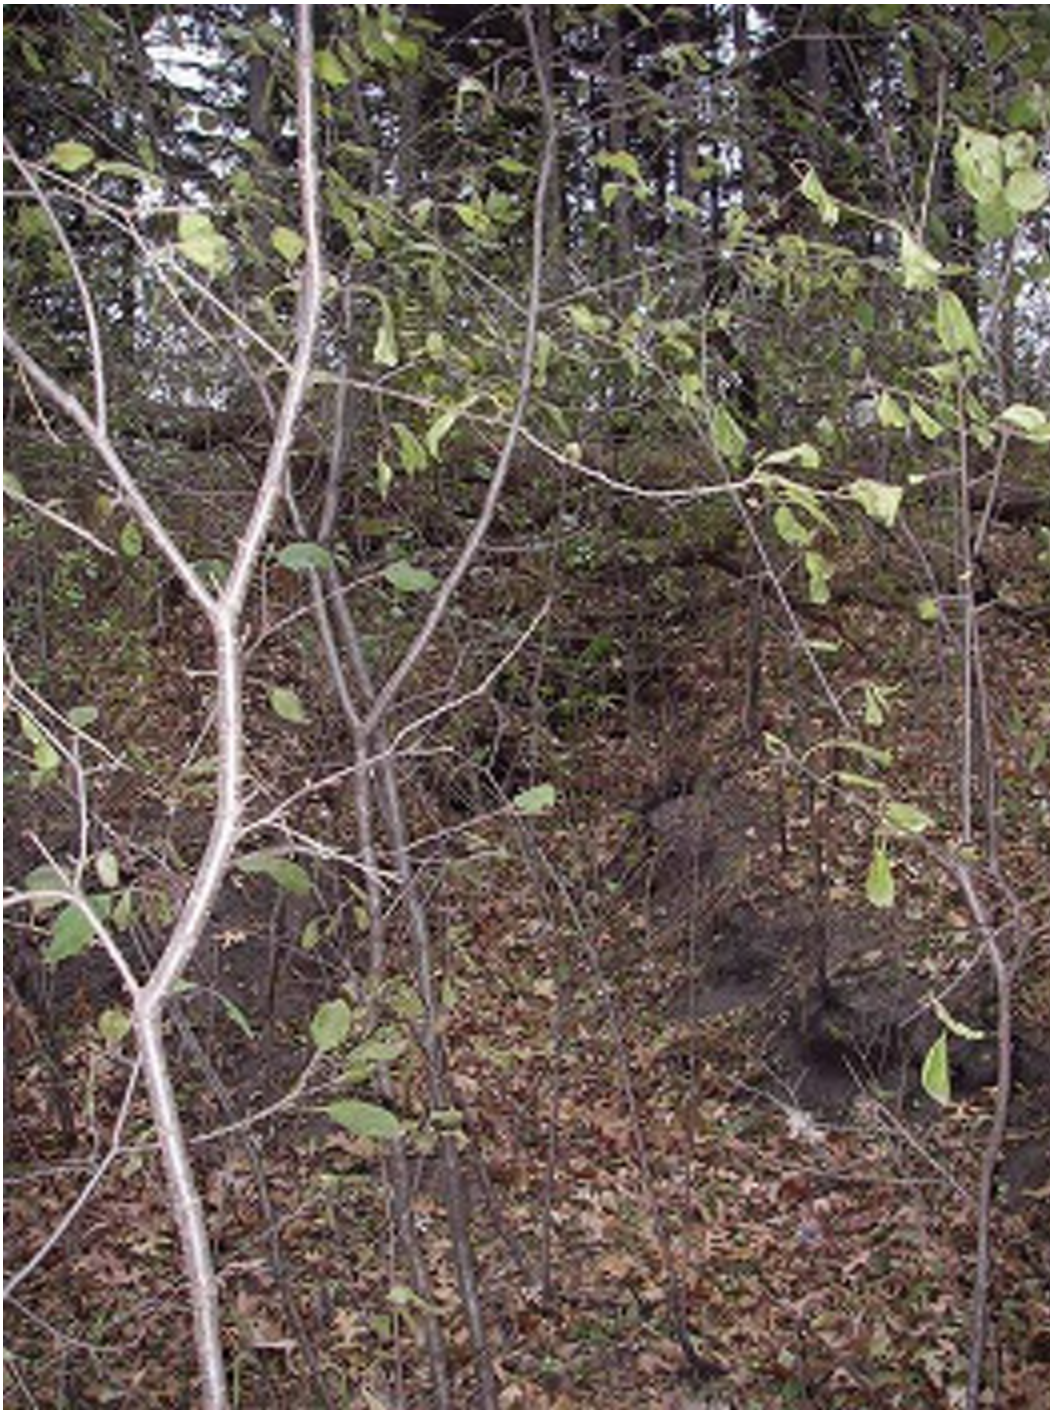
Gully bank erosion from parking lot

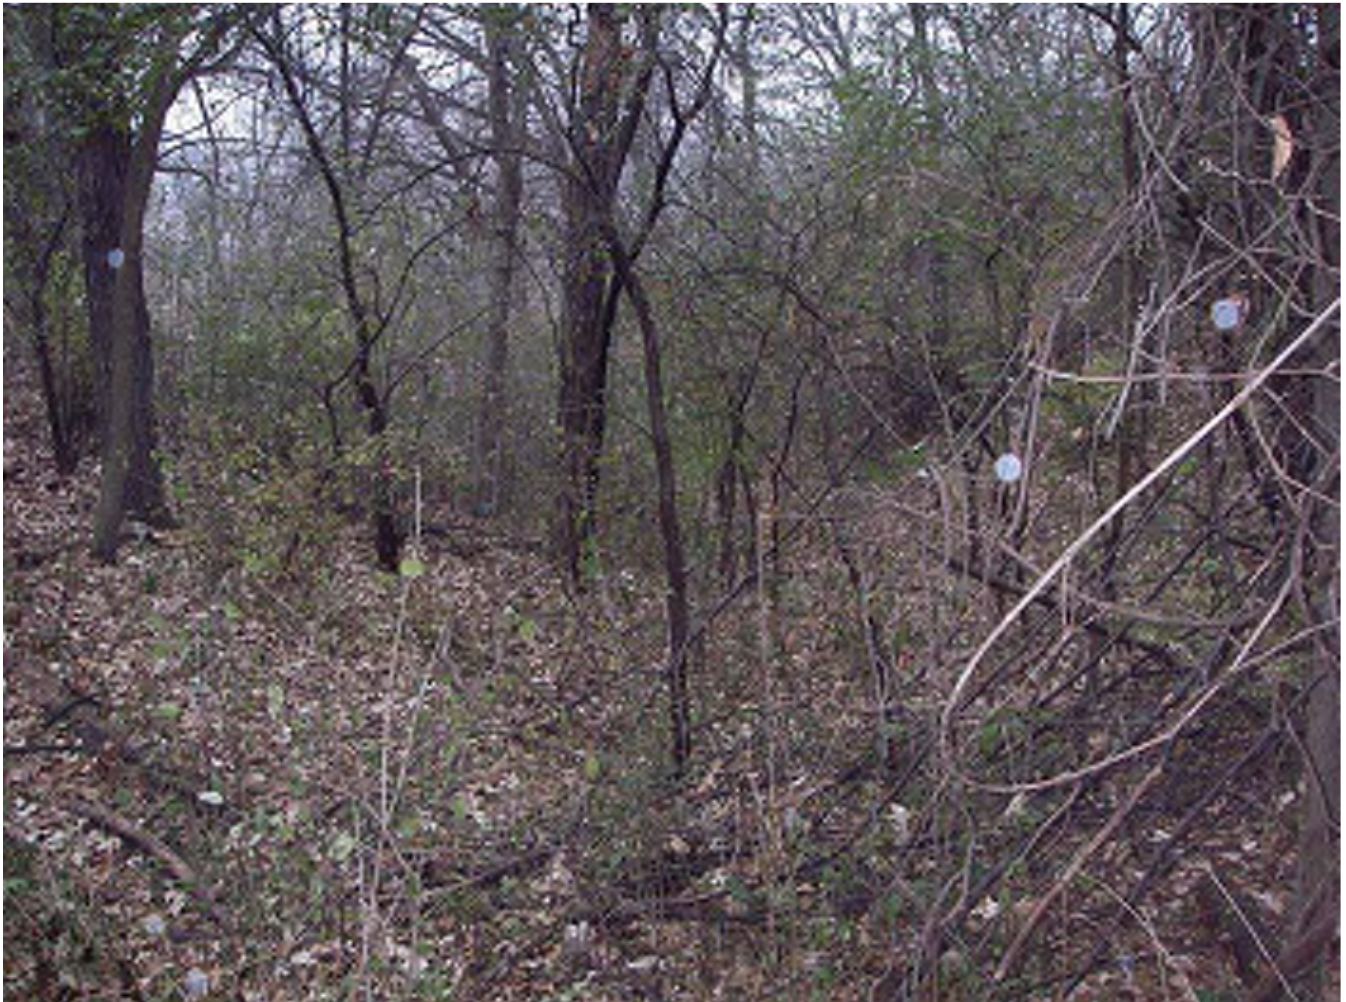
Waypoint 30

Minimal erosion

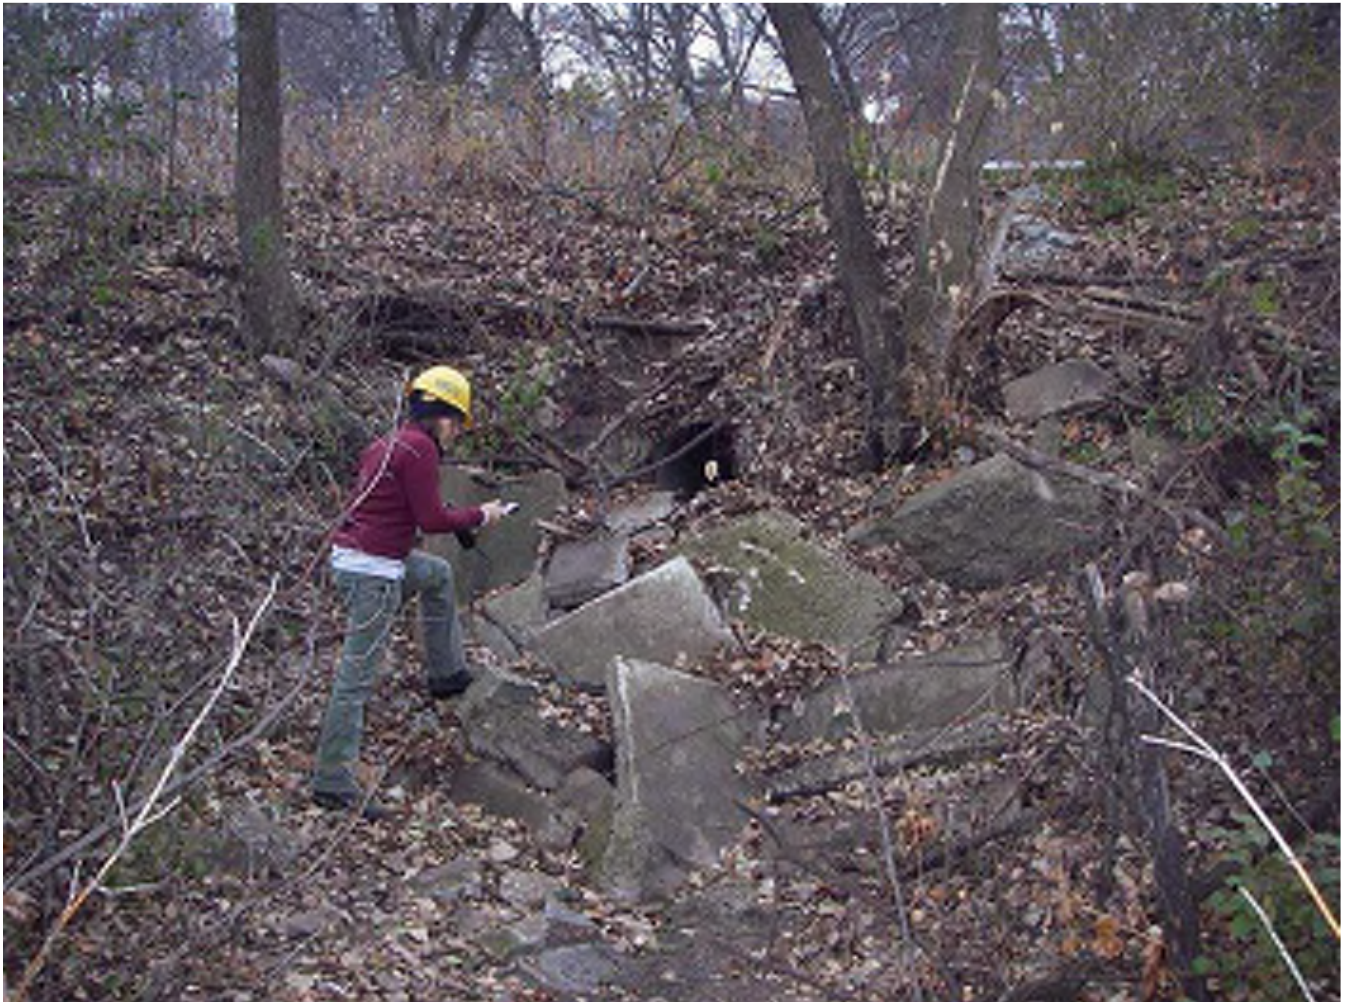
Waypoint 31

Storm sewer drain pipe outlet

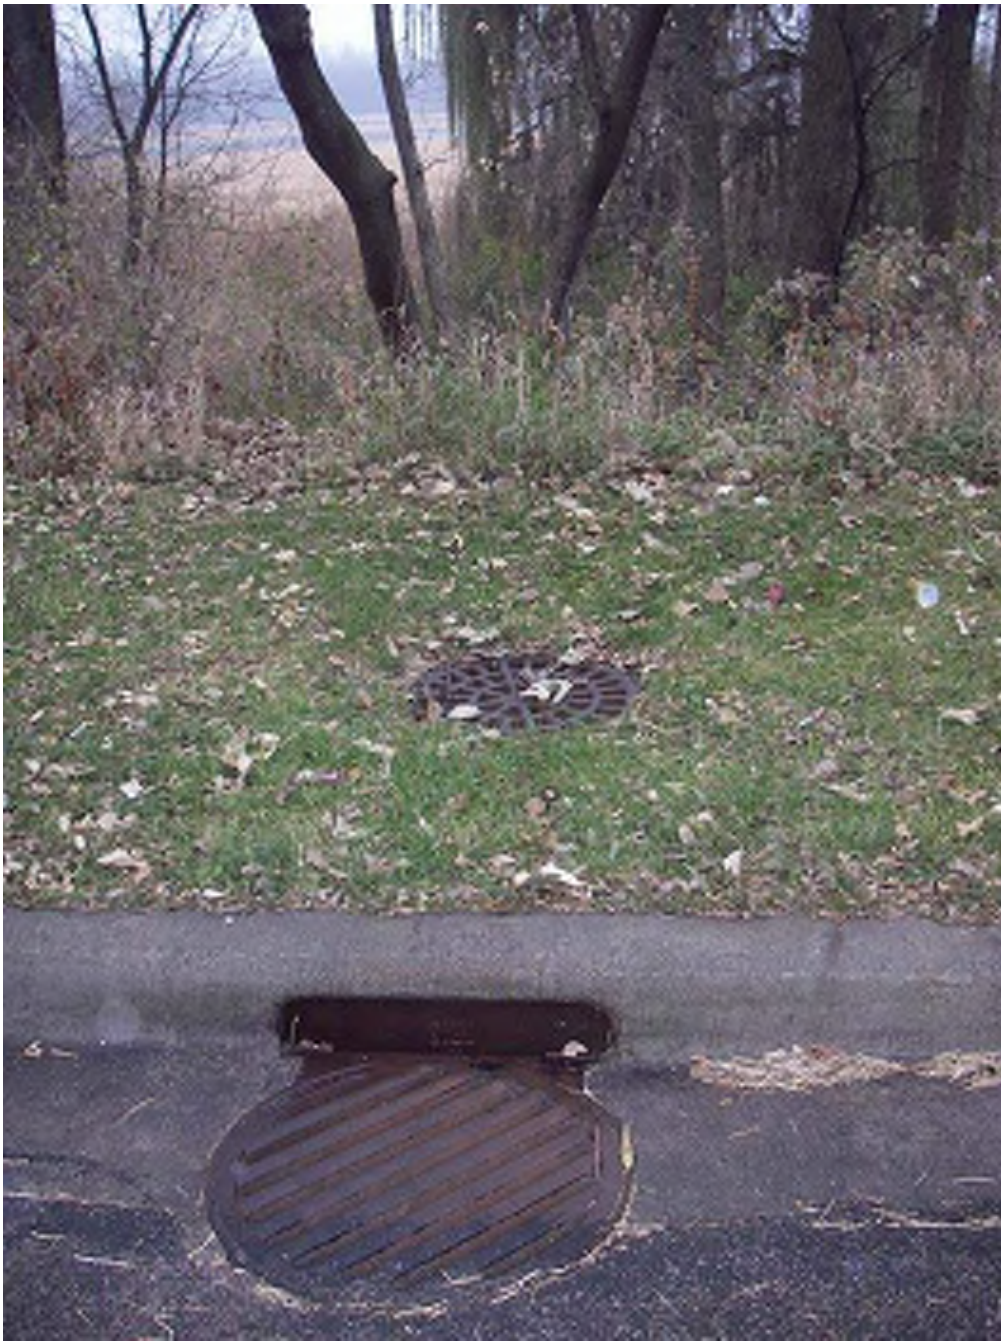
Storm sewer drain pipe outlet from street above

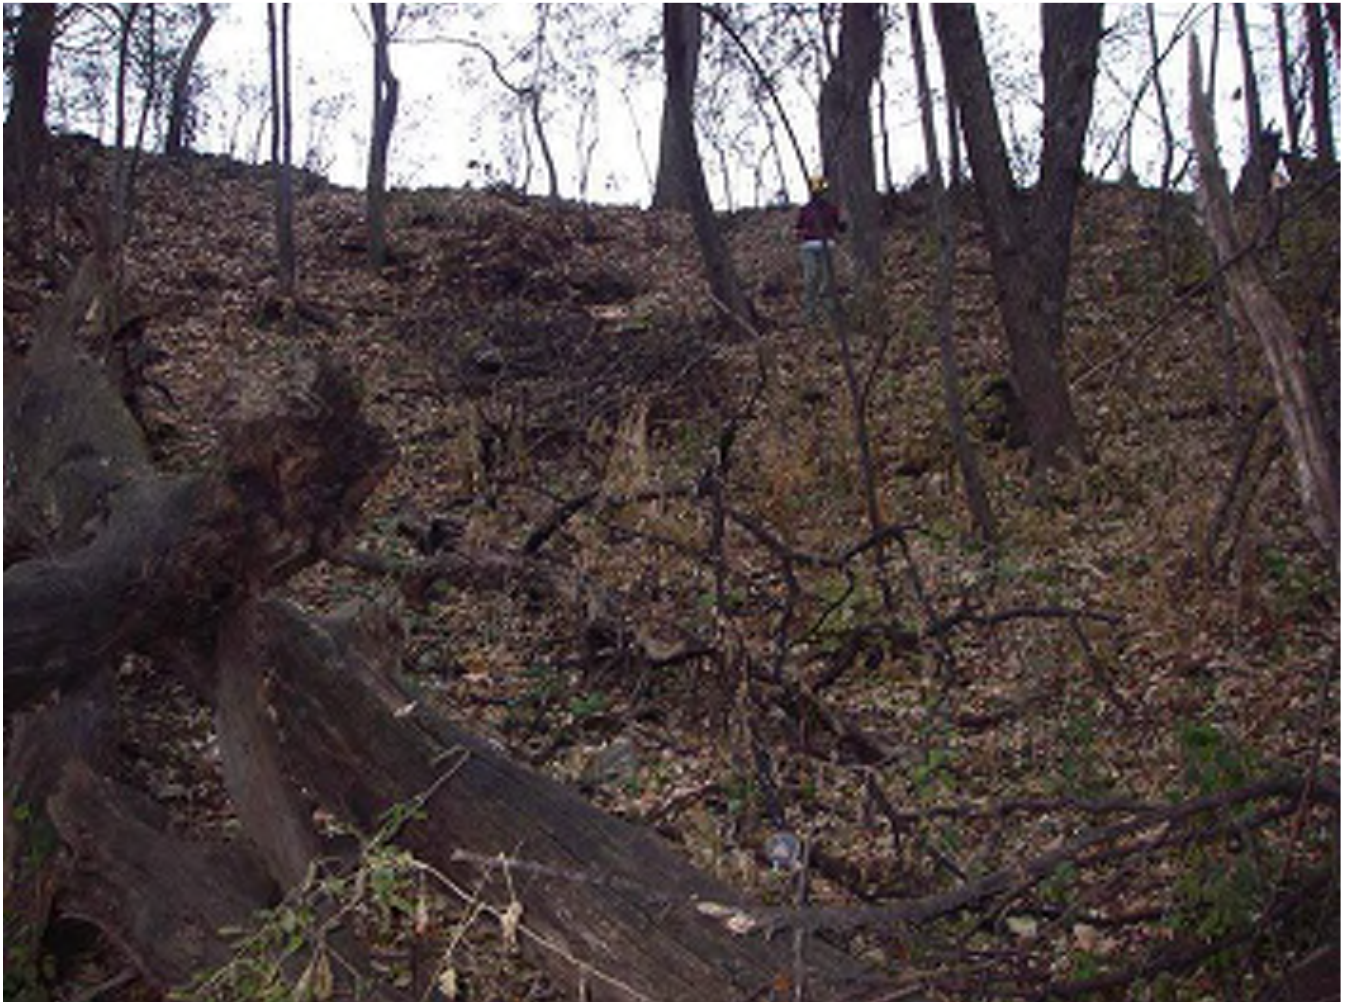
Waypoint 32

Steep bank, minimal erosion visible

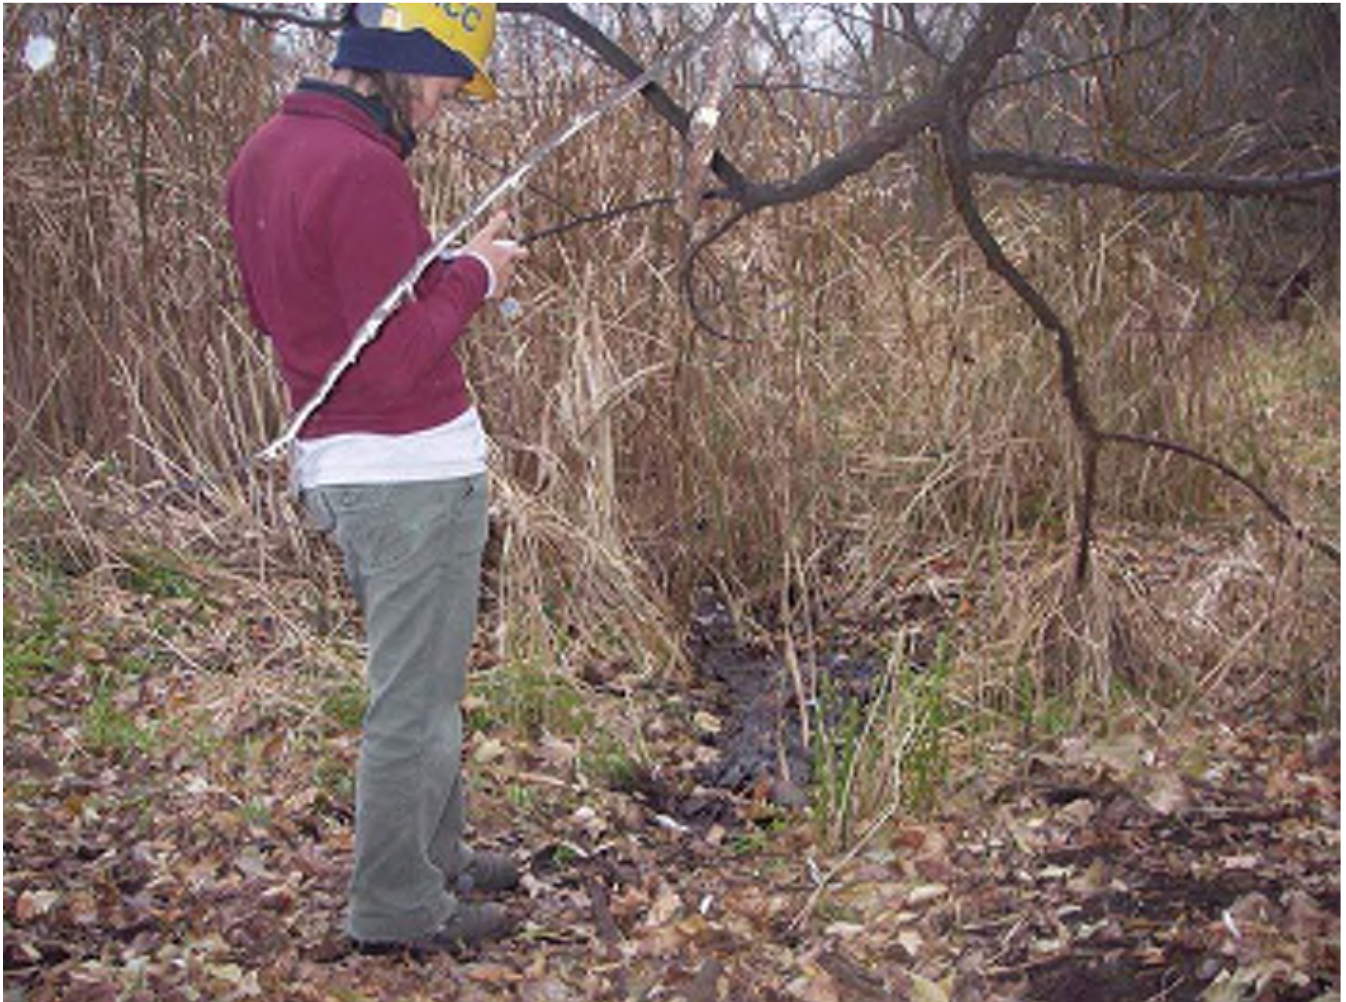
Waypoint 33

Water table, spring seepage

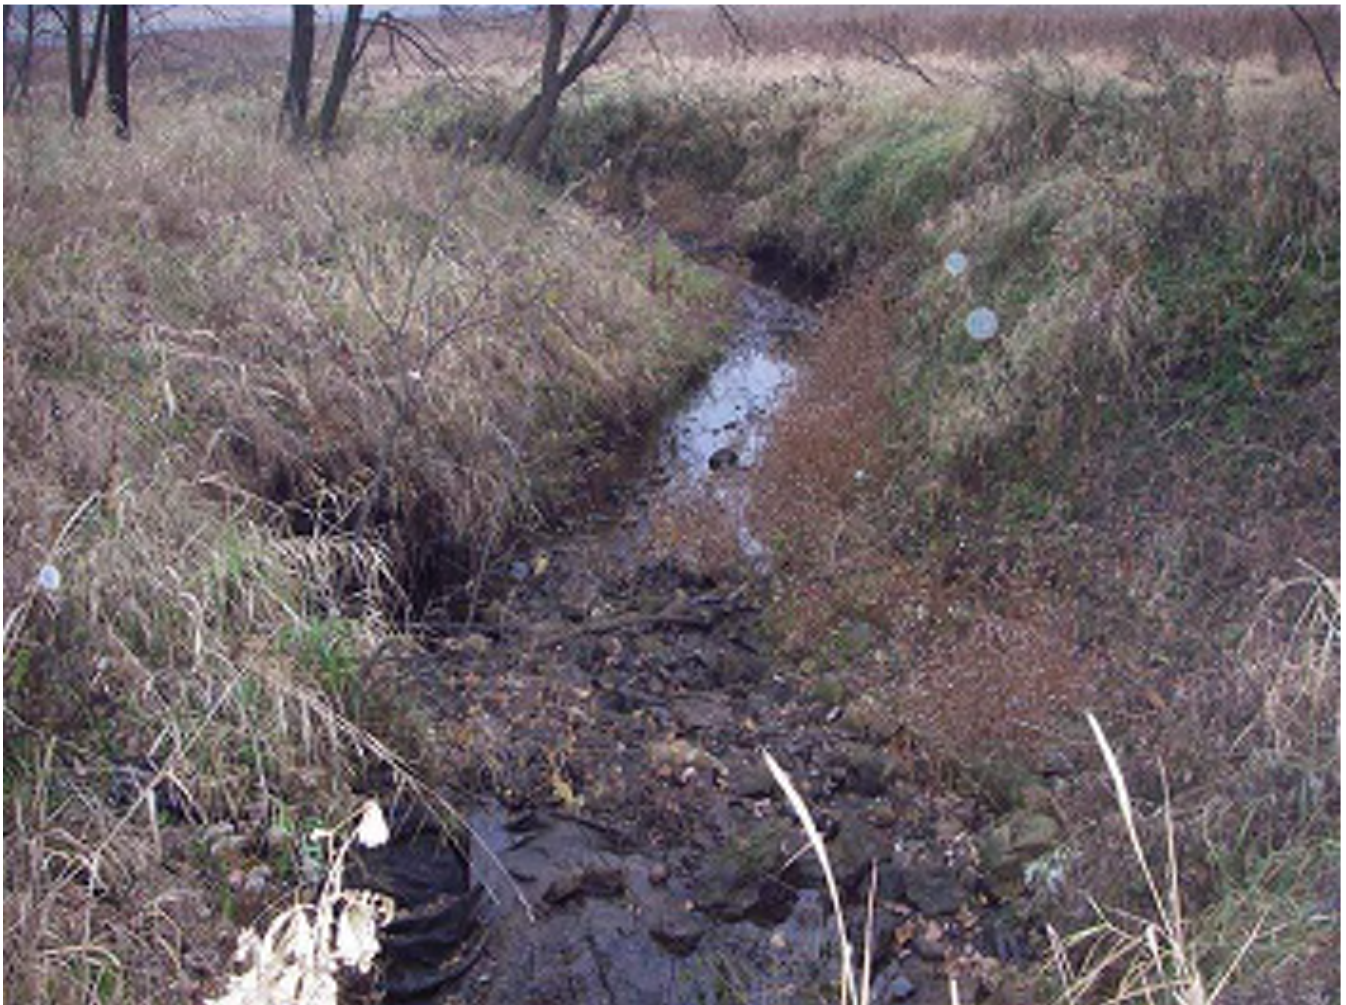
Waypoint 36

Storm pipe outlet from above

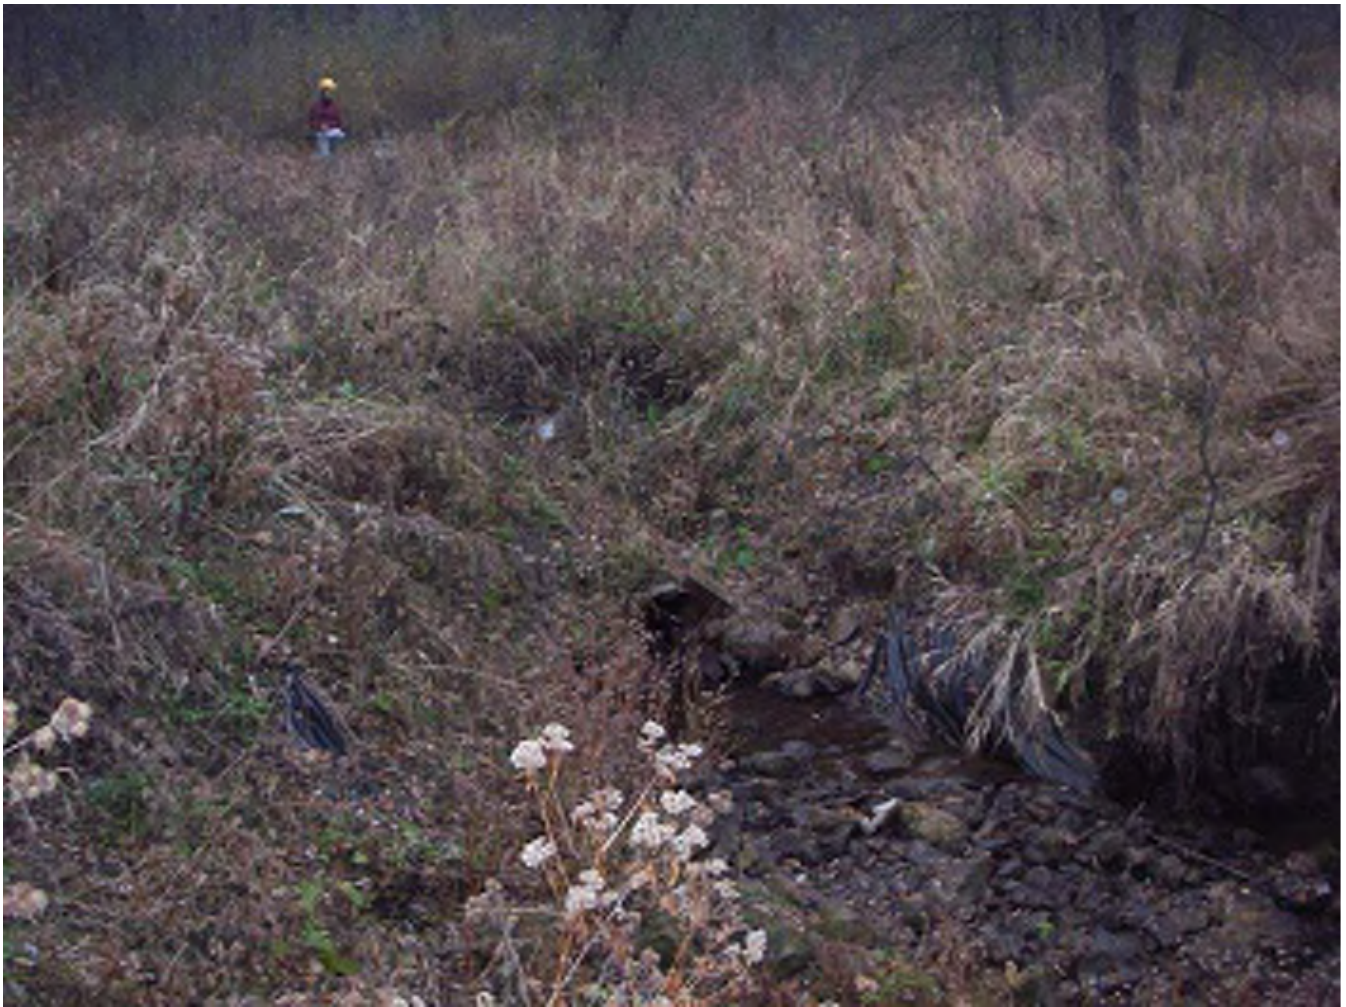
Storm pipe outlet from below

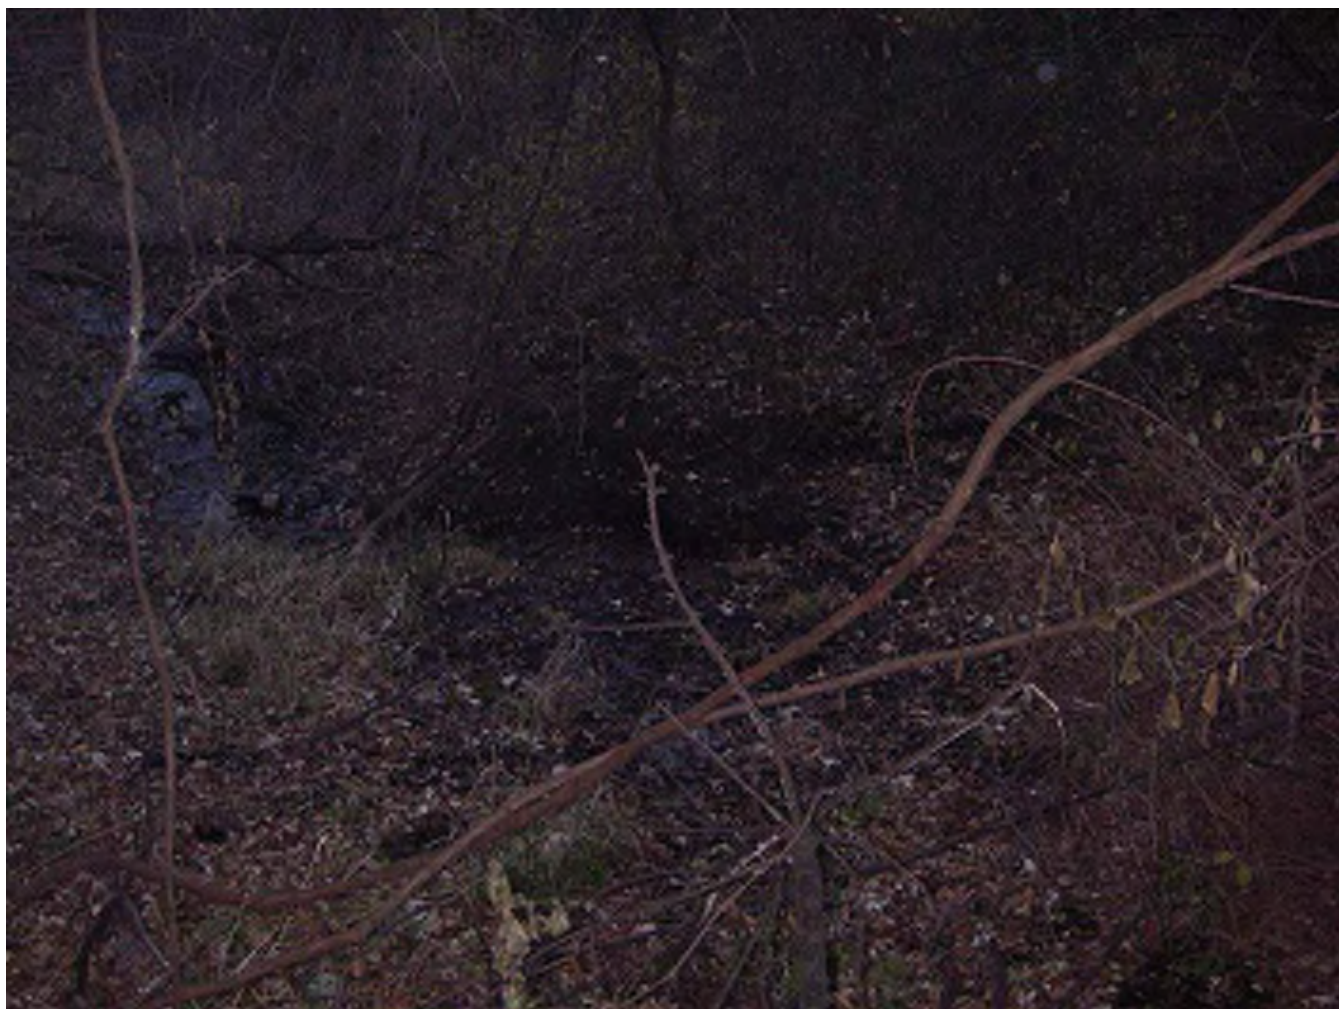
East branch of gully
