Appendix K: Lower Minnesota River Watershed District: Gully Inventory

Gully Inventory Map
 Area #1
 Lower Minnesota River Watershed District
 Watershed Management Plan

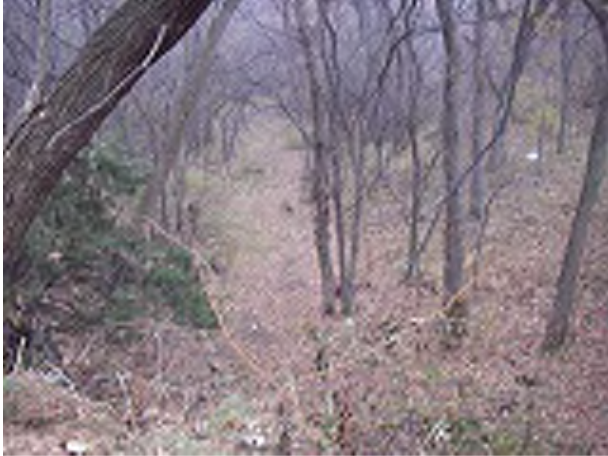
Waypoint 37

Downhill view of gully

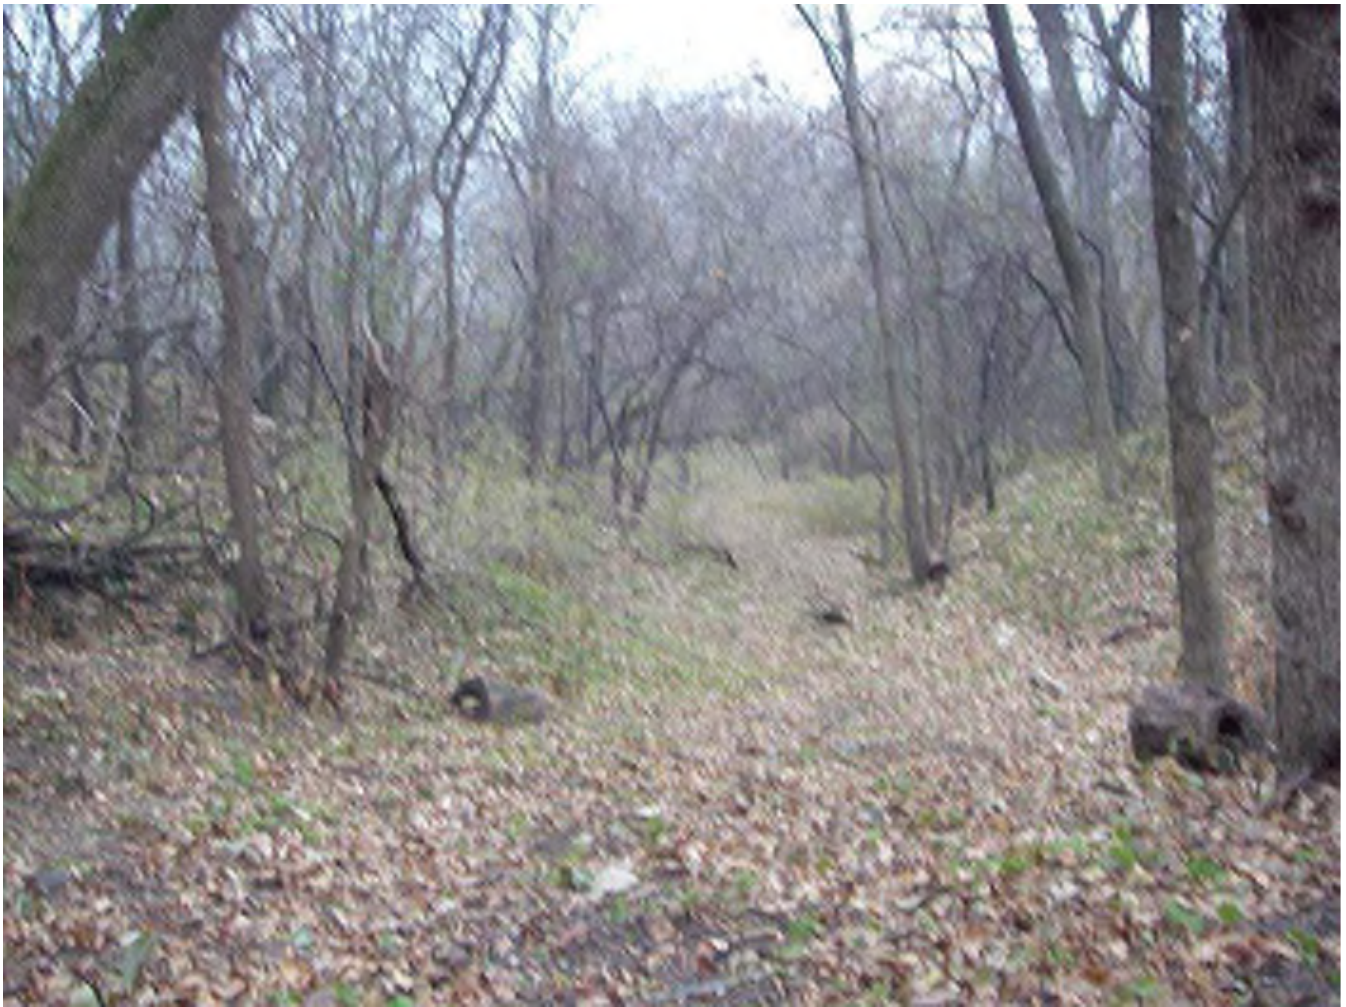
Downhill view of gully

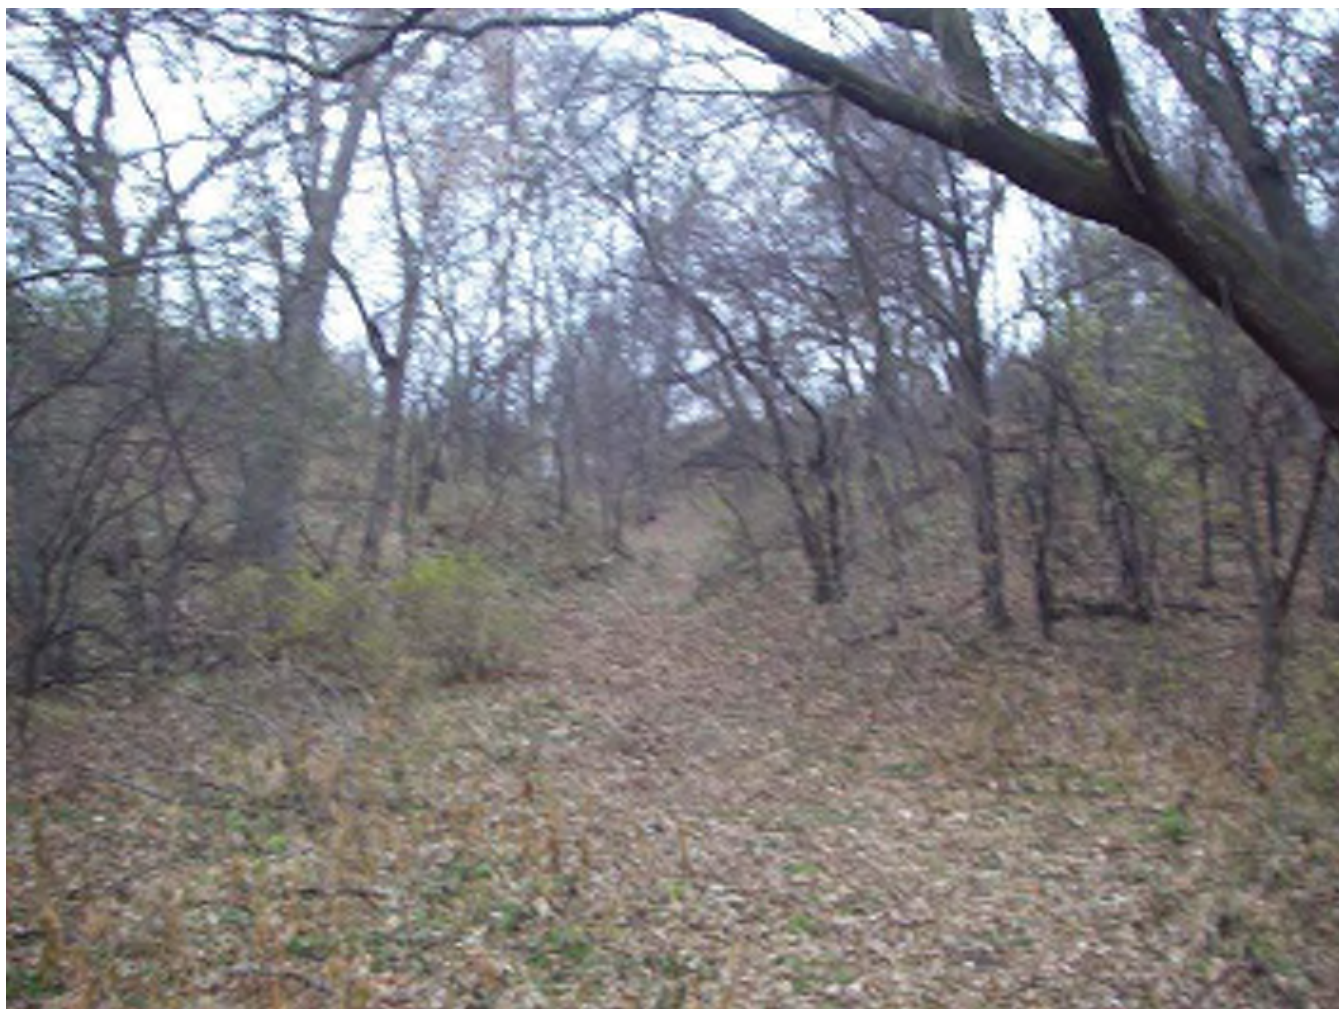
Uphill view of gully

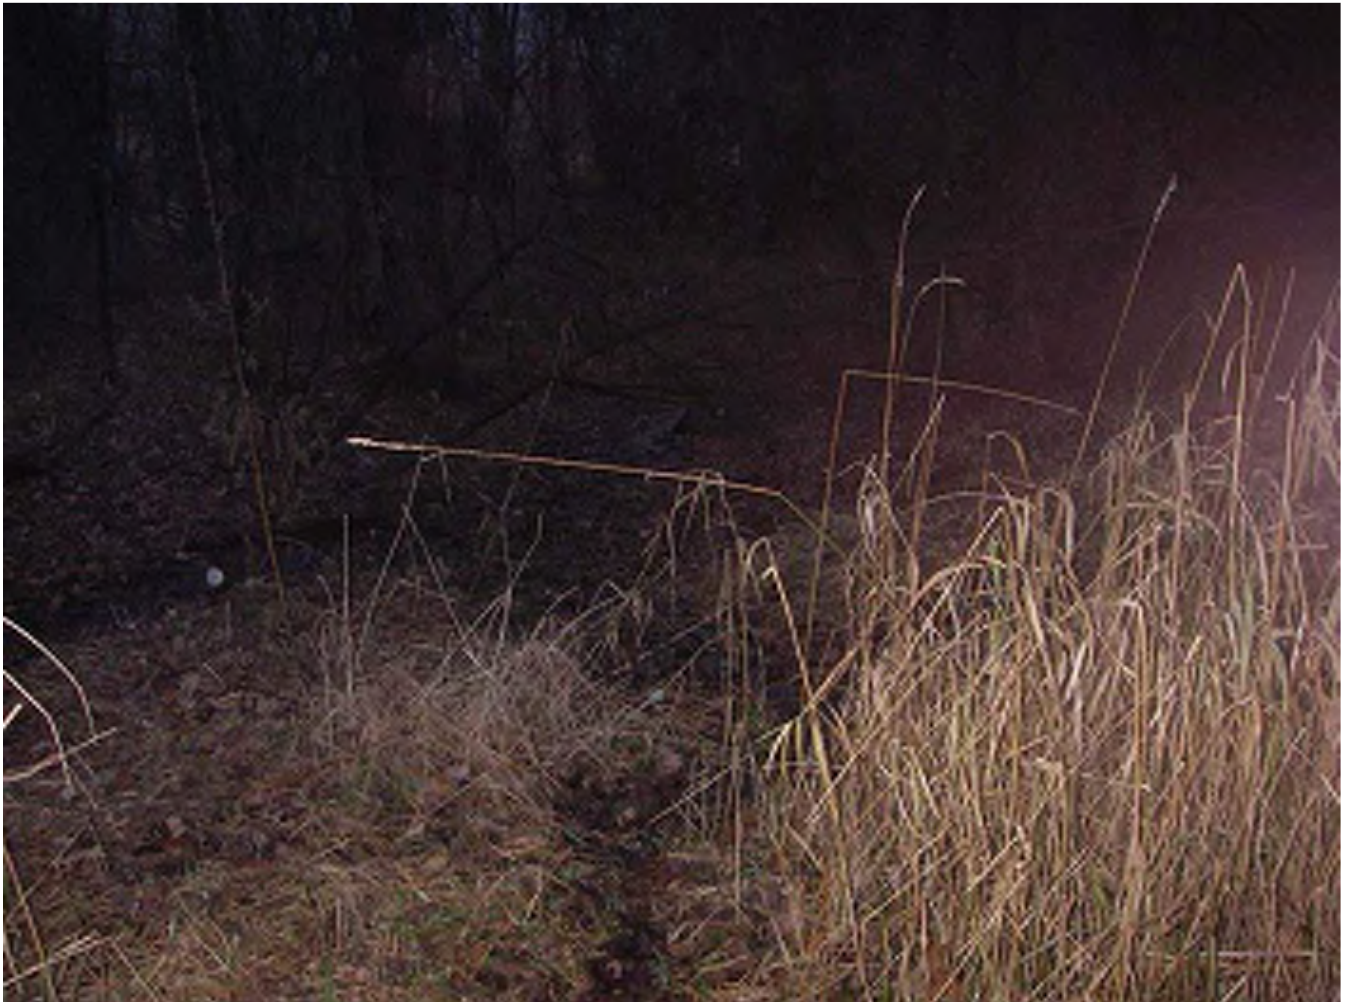
Waypoint 40

Groundwater seepage/spring with watercress around

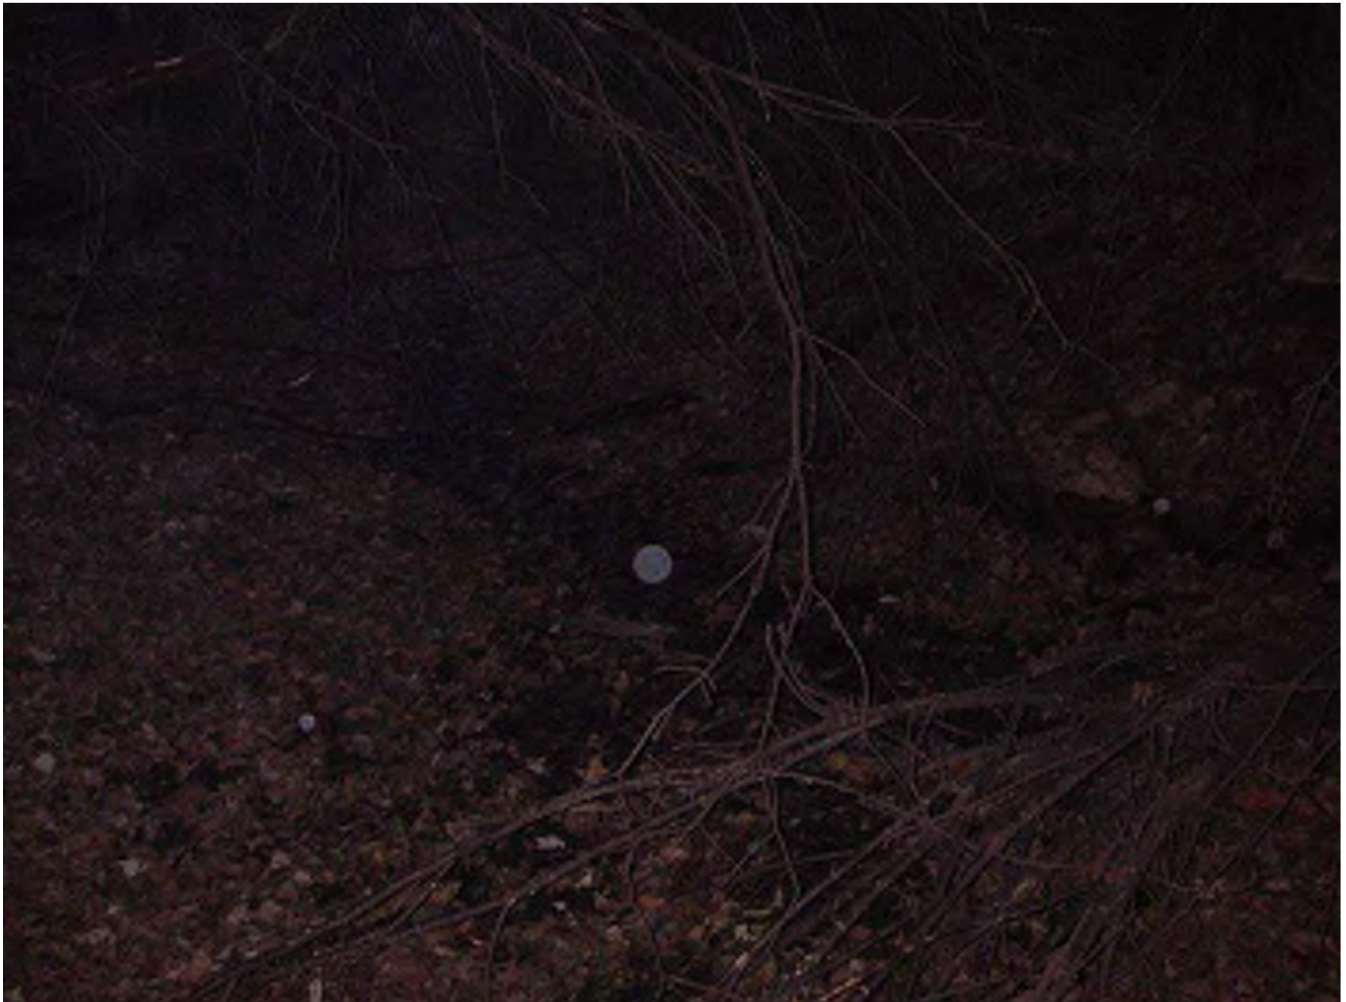
Waypoint 41

crew not sure, said try and look at the picture

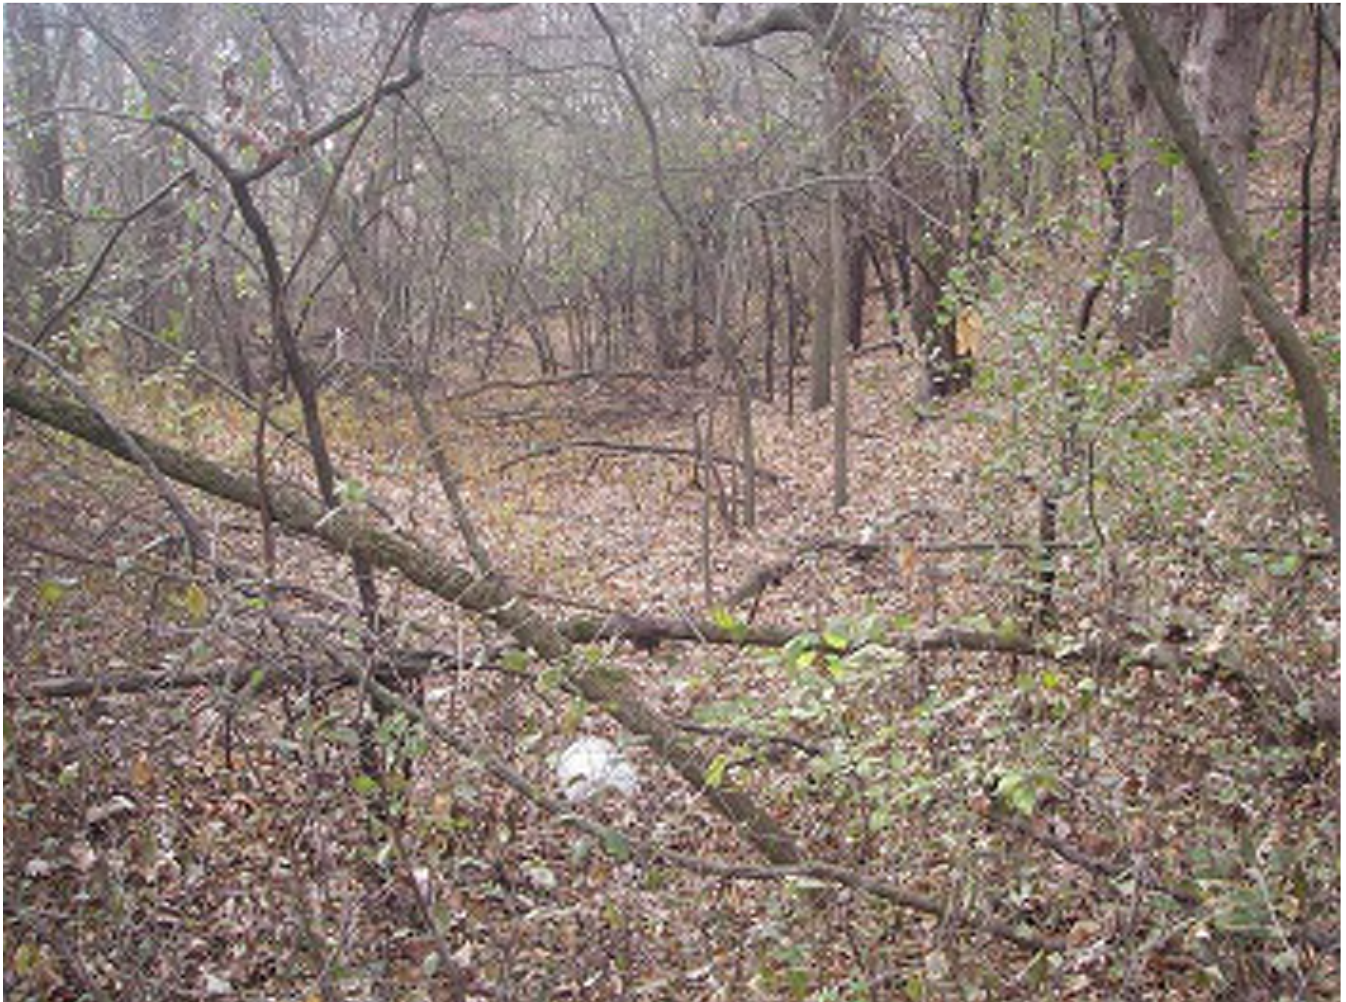
Waypoint 42

Minimal erosion, some tree debris

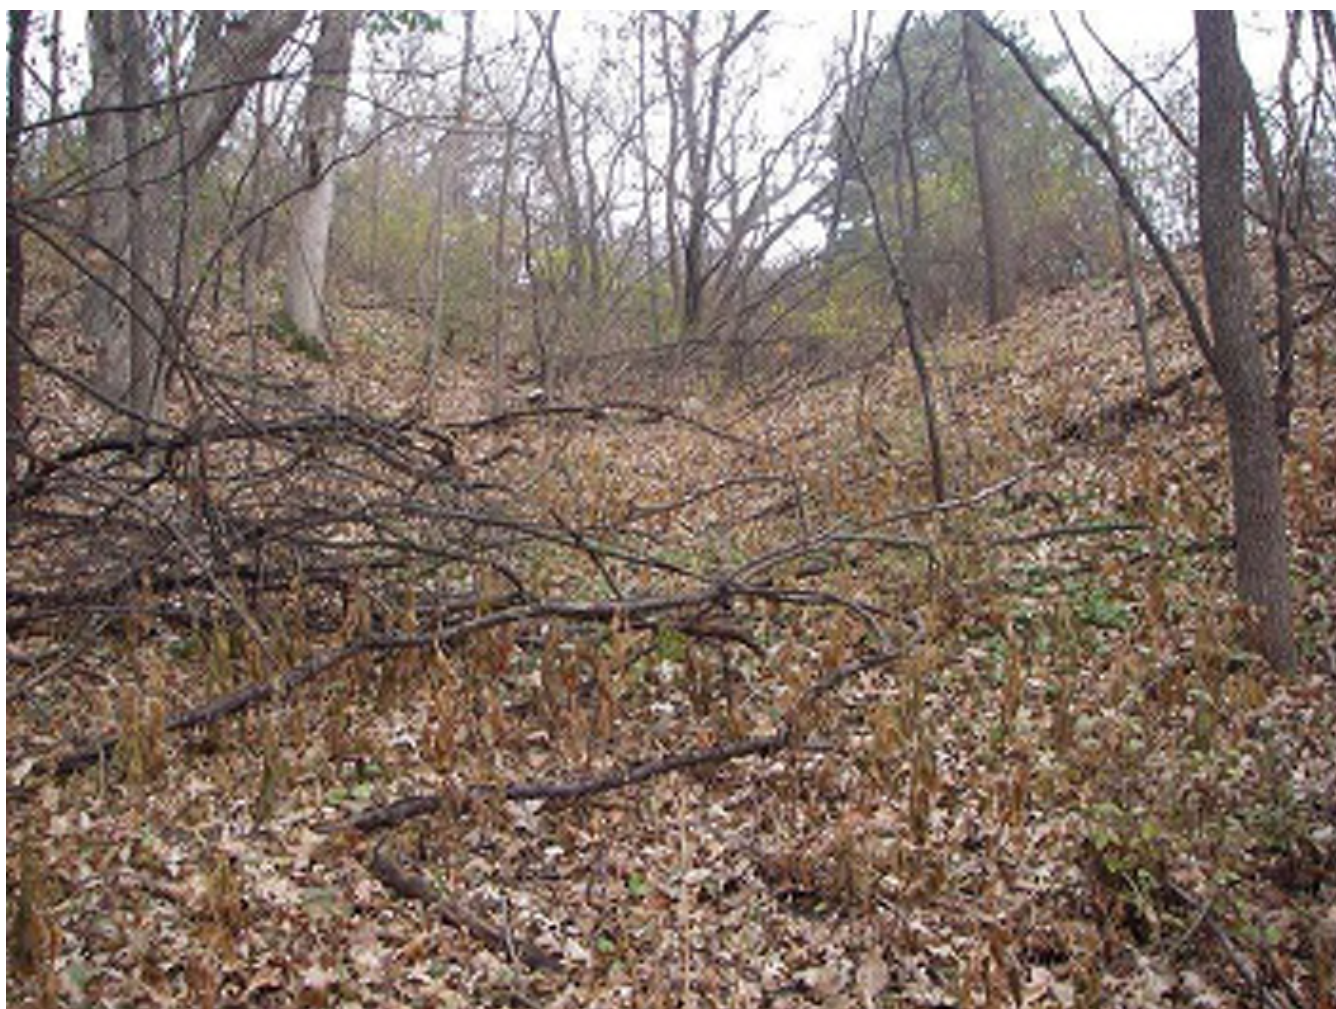
Uphill view

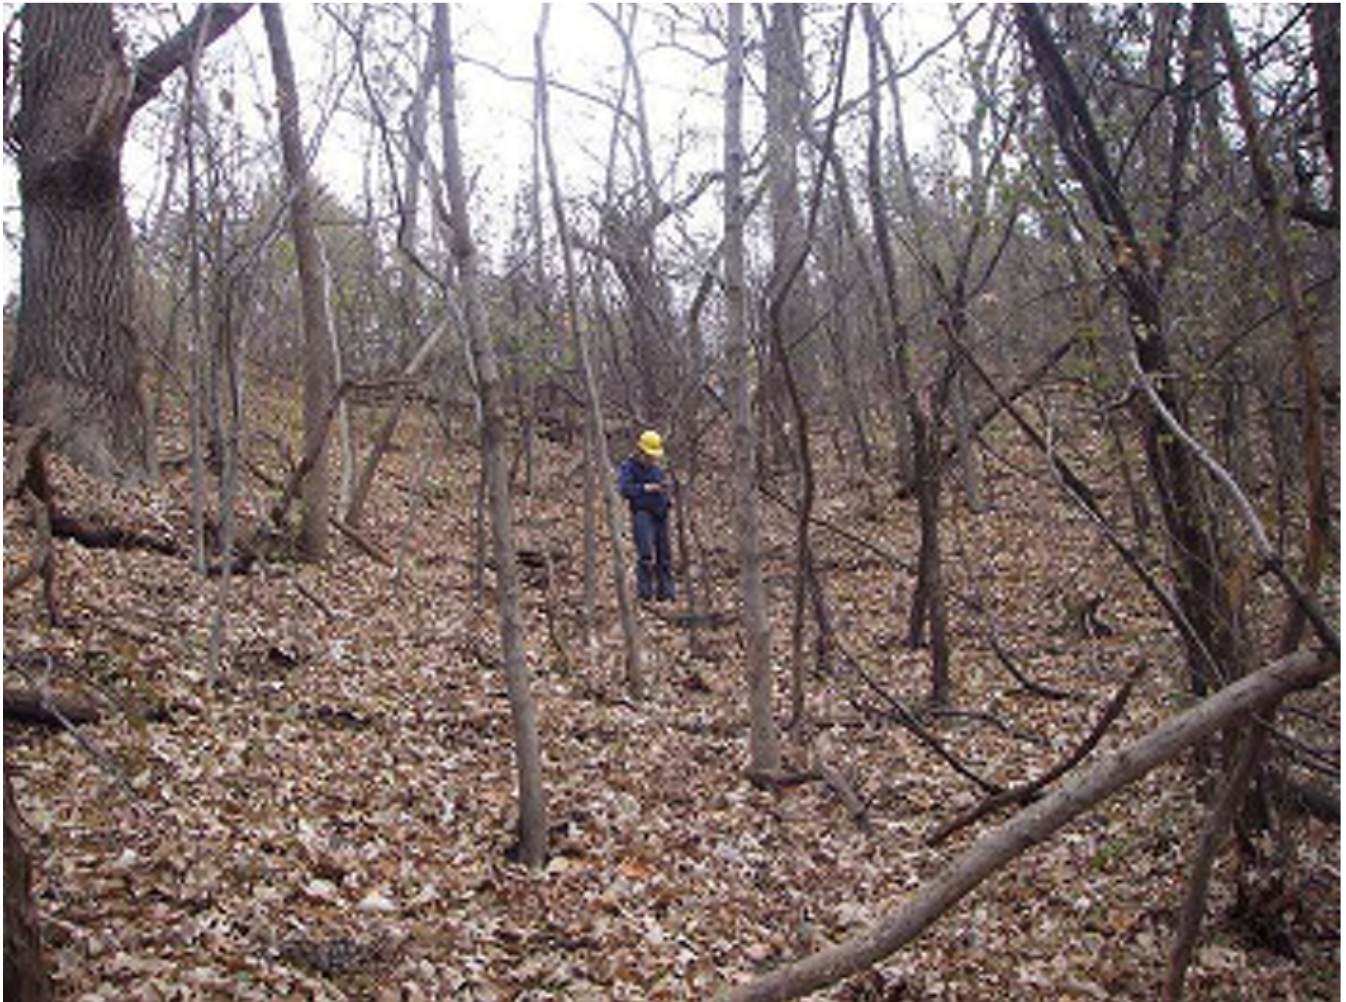
Waypoint 43

Minimal erosion

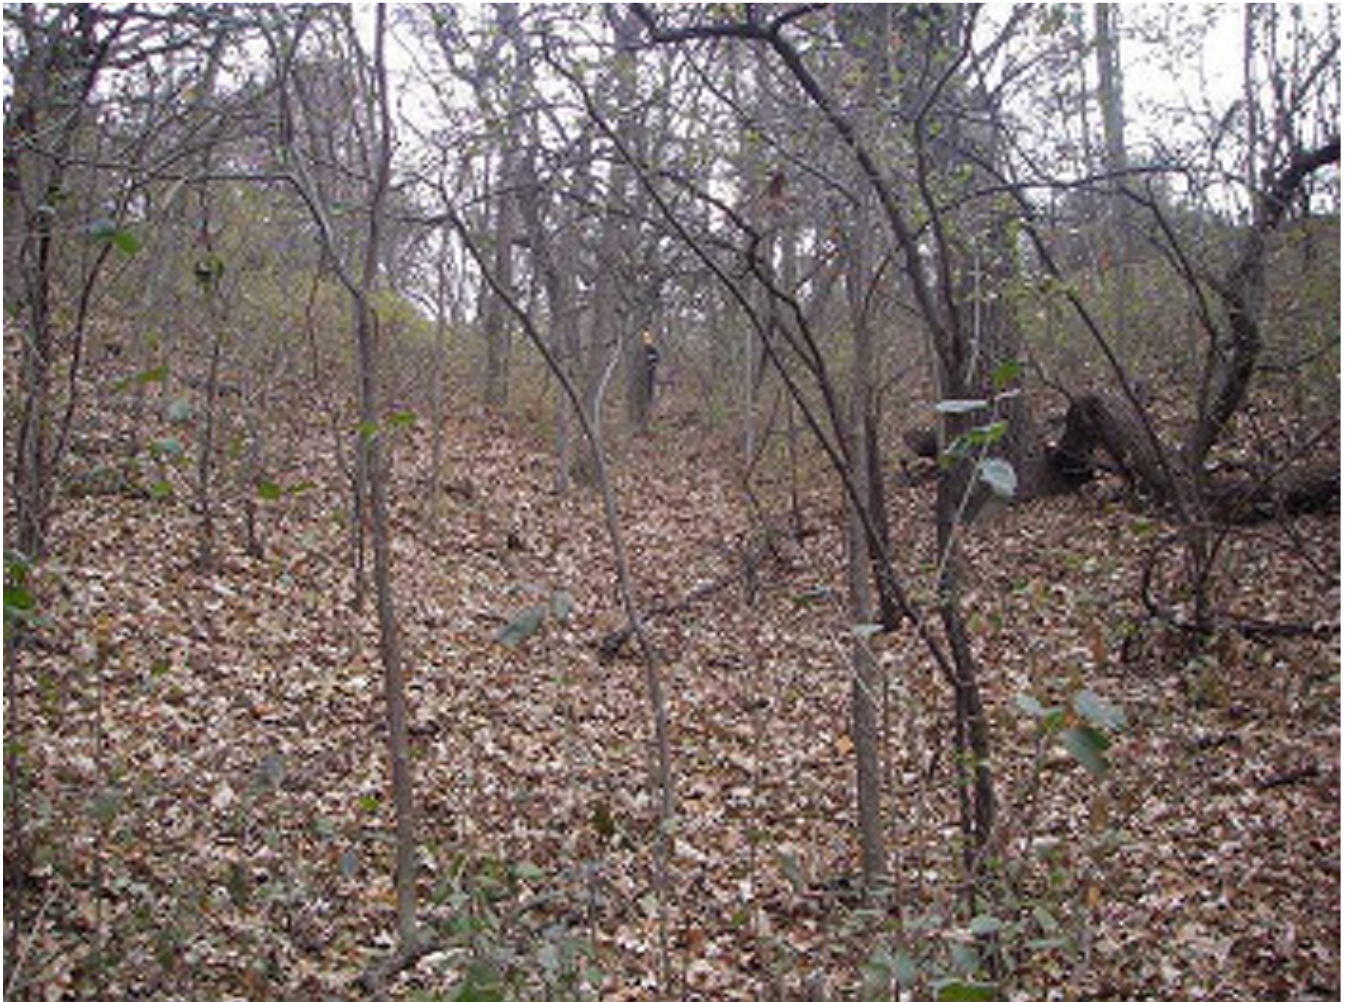
Waypoint 44

Minimal erosion

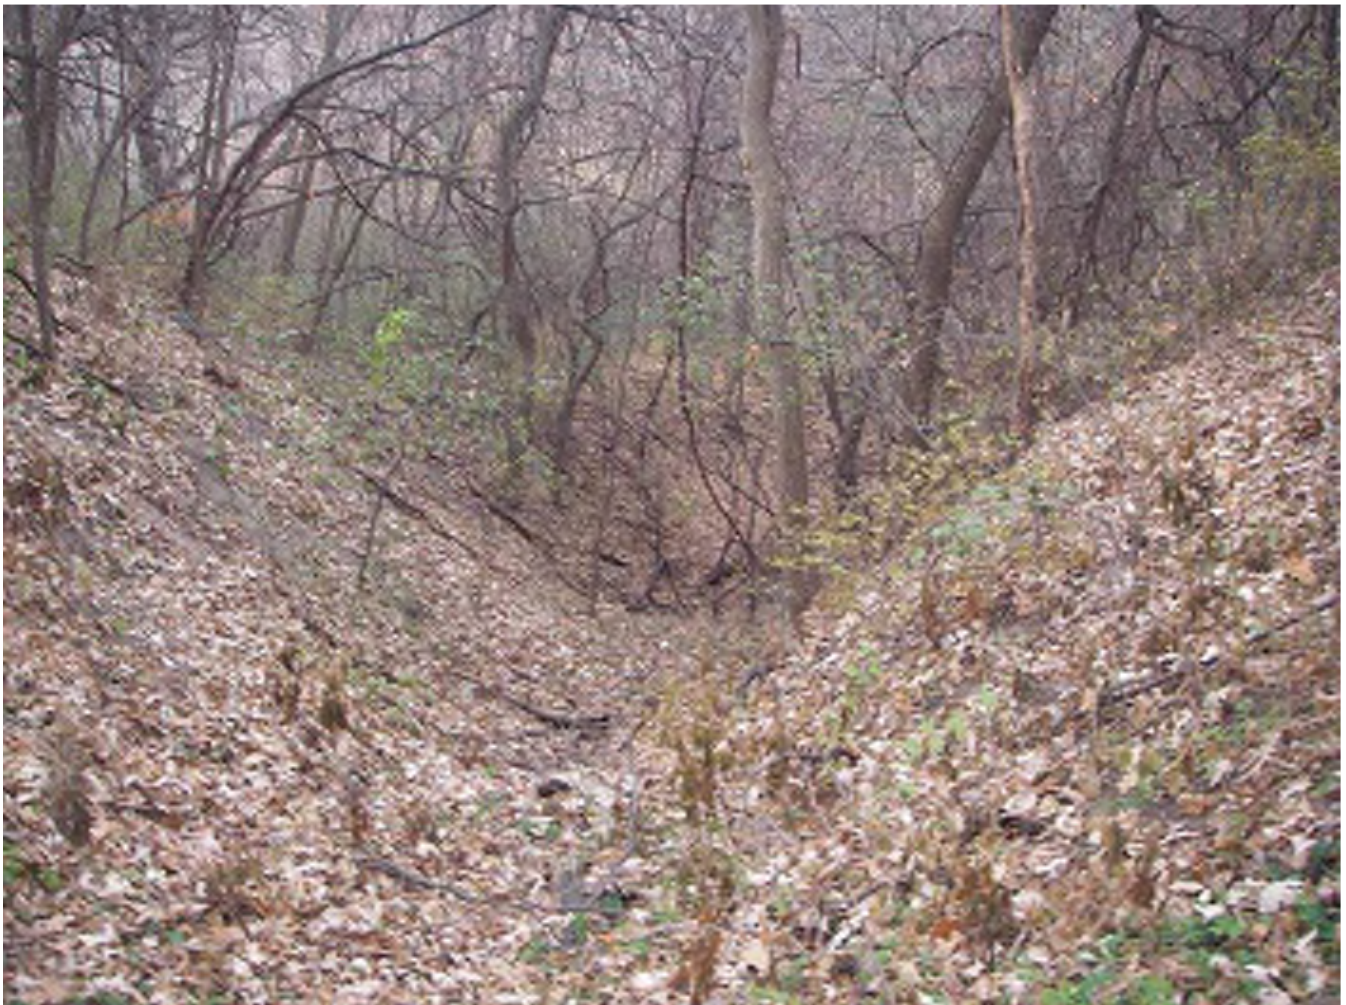
Waypoint 45

Pronounced gully

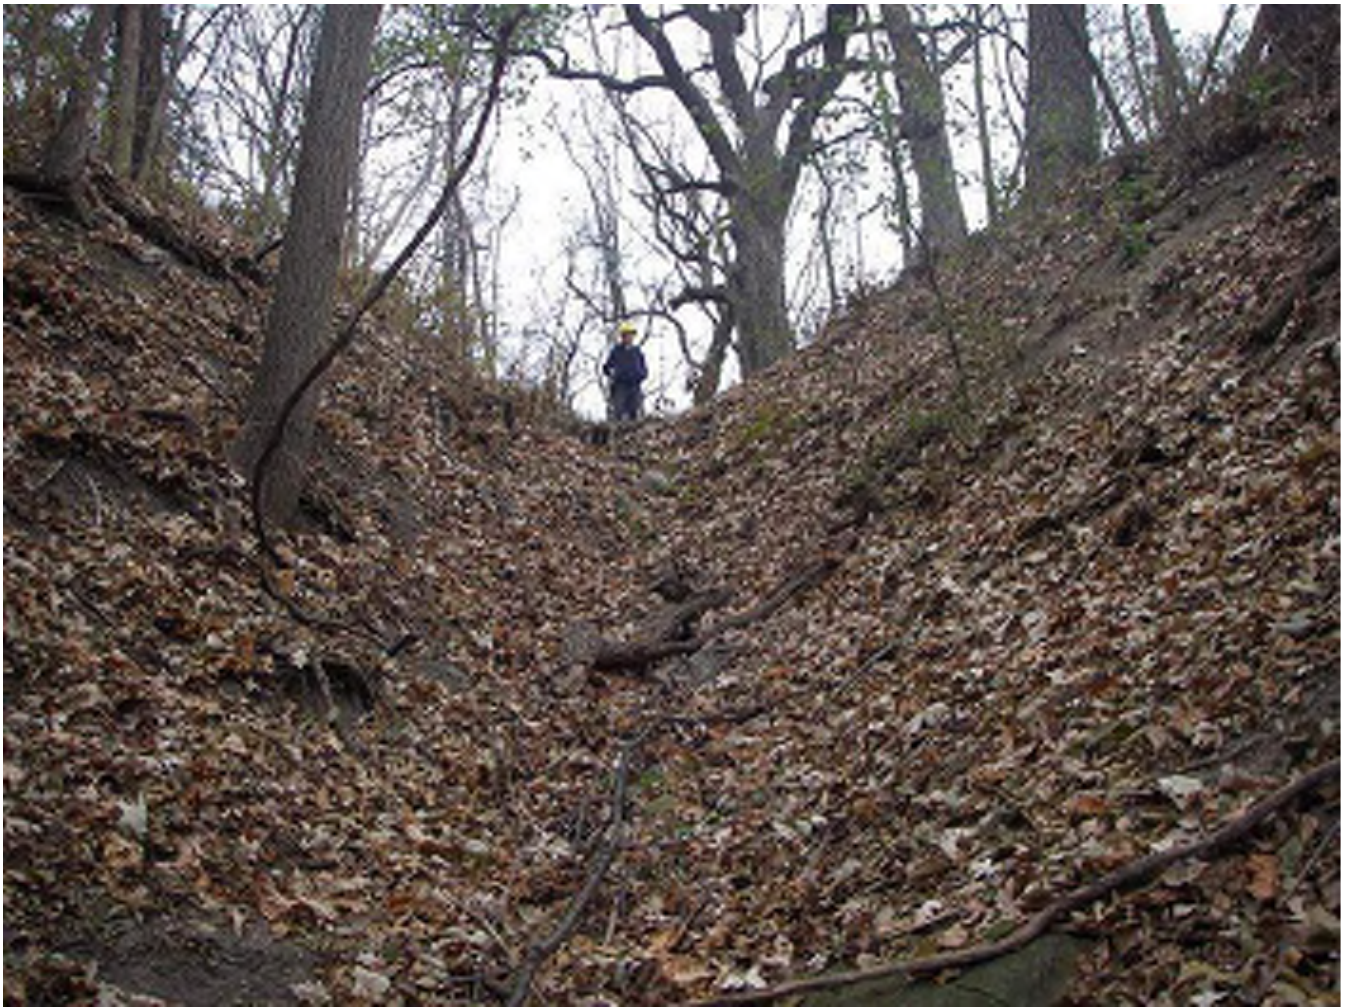
Significant erosion

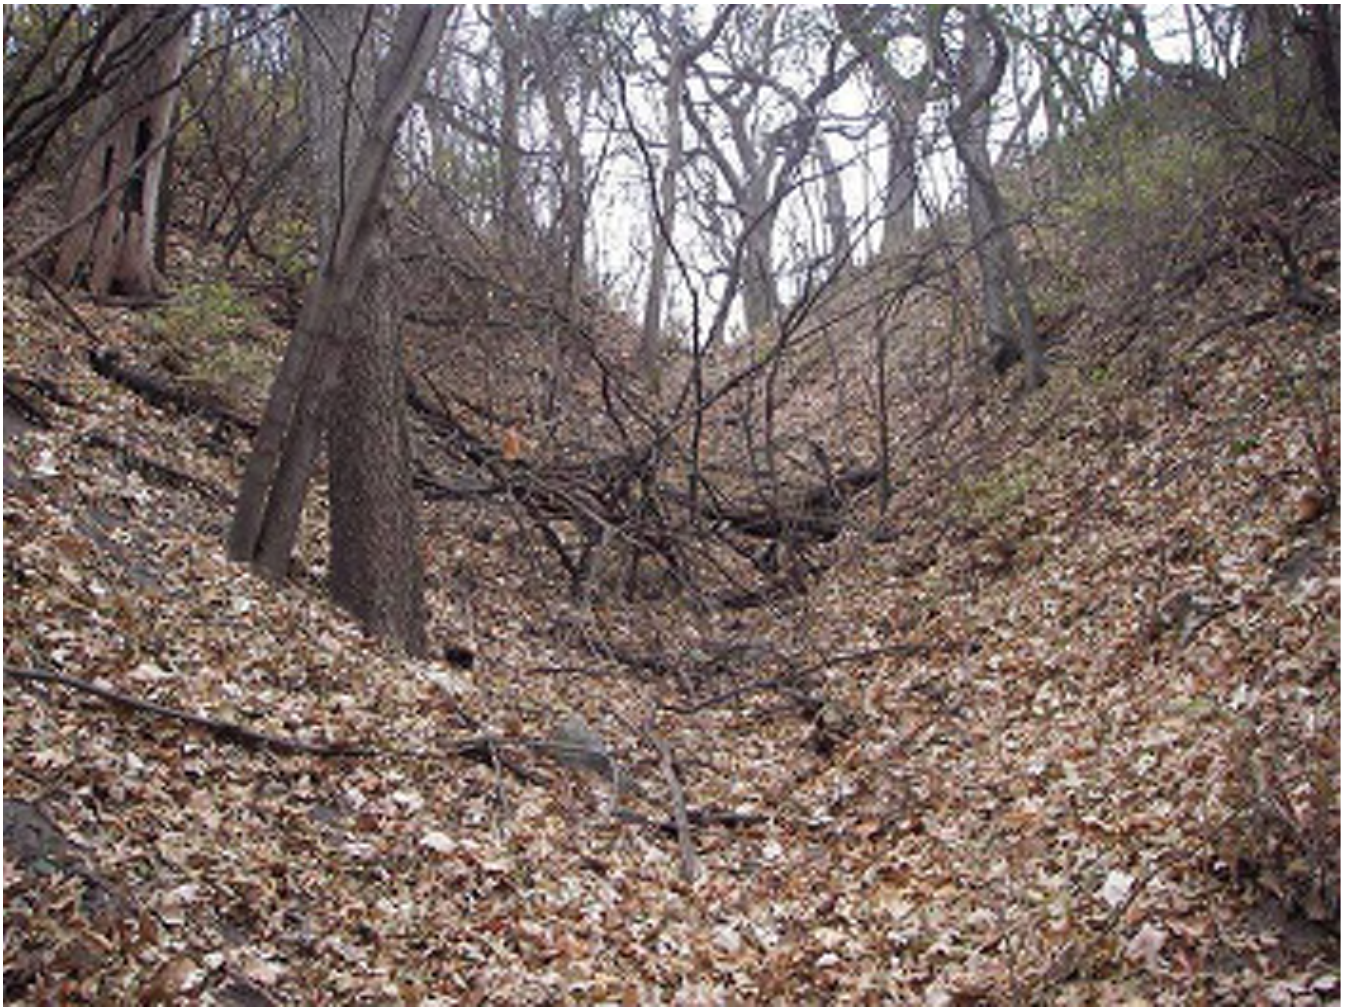
Significant erosion uphill view further down the gully

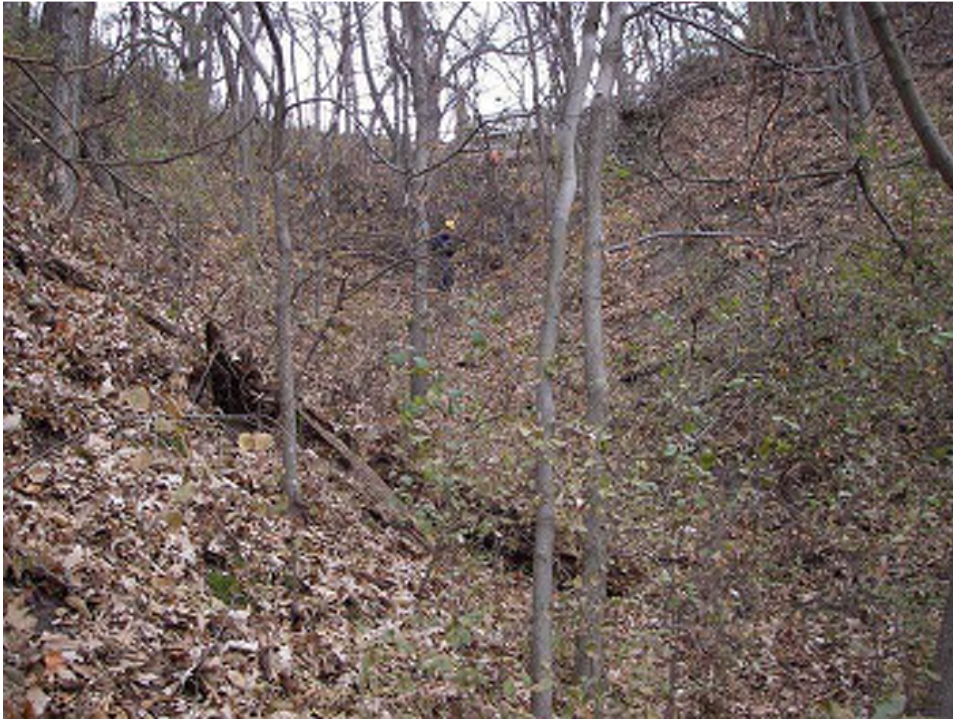
Waypoint 46

bowl-shaped gully, quite steep, large amount of tree debris from homeowner, exposed soil on slopes w/ significant erosion

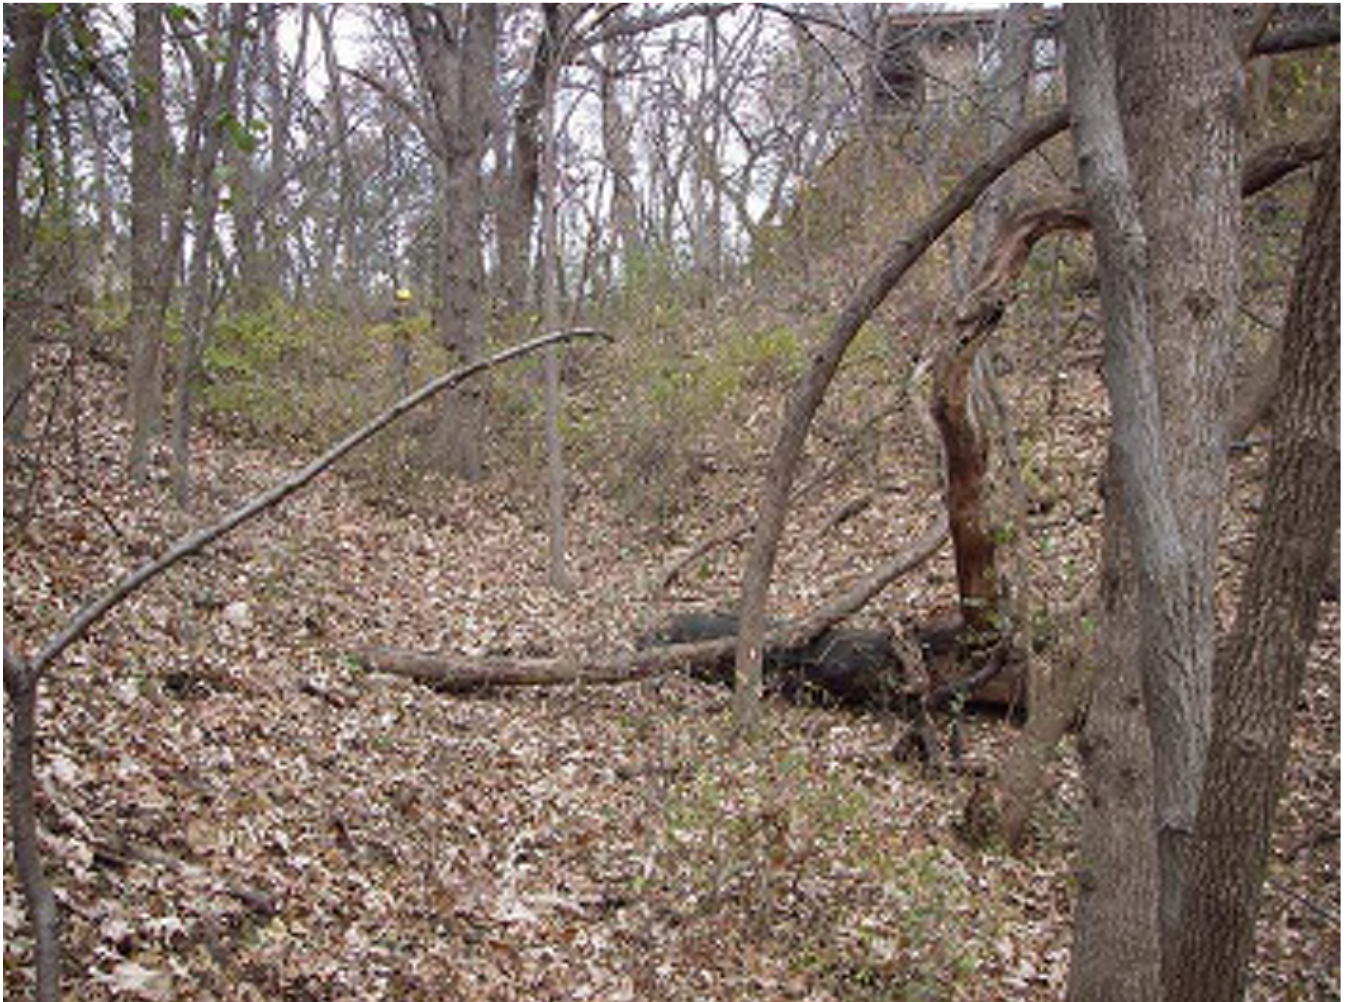
Waypoint 47

Minimal erosion, some tree debris

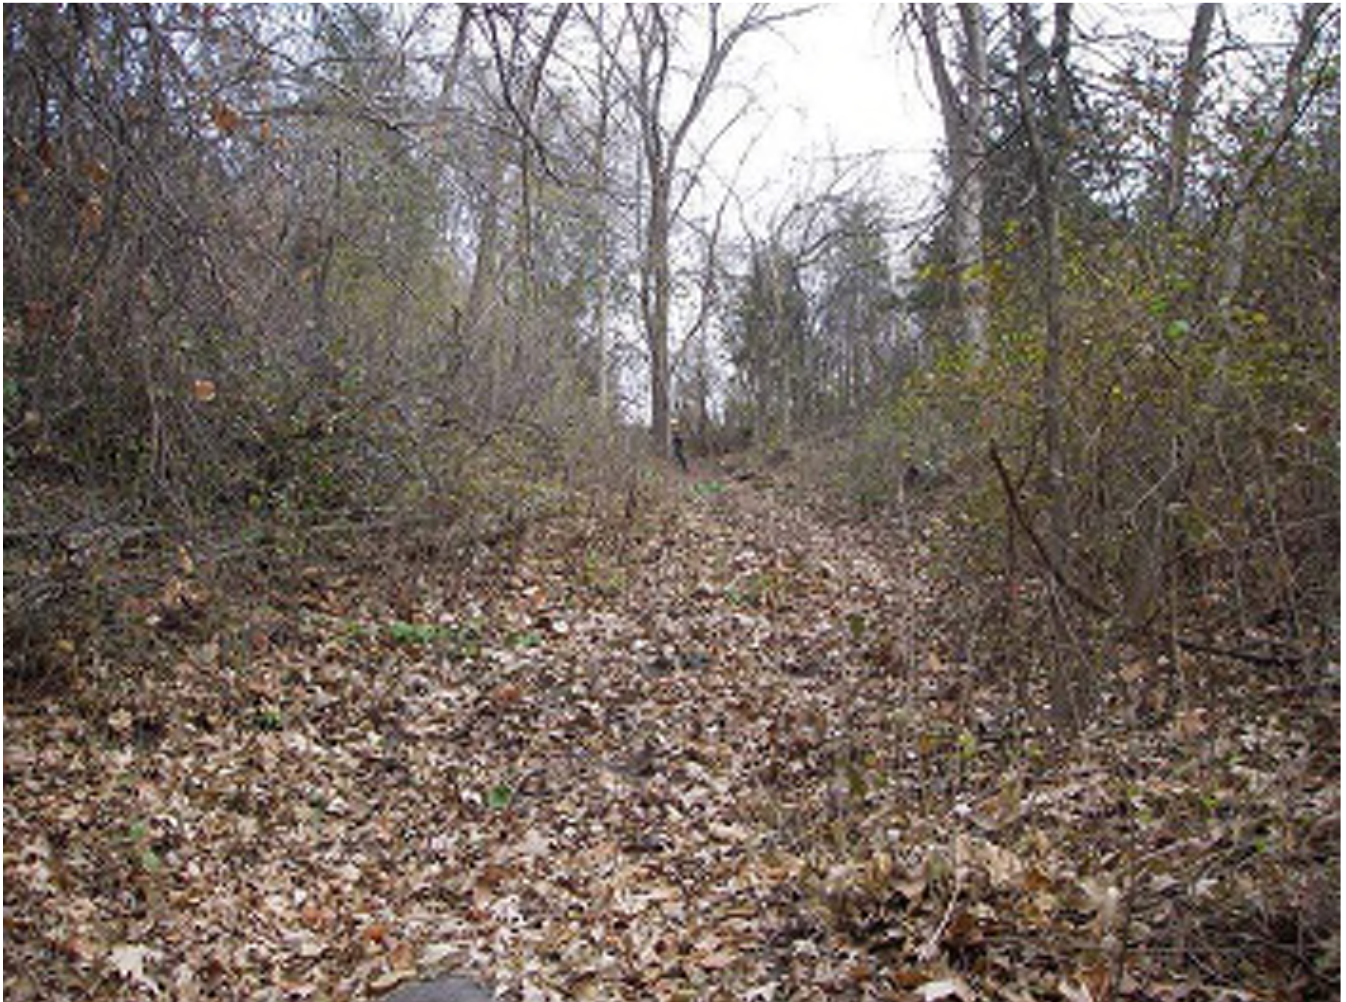
Waypoint 48

Path cleared down the gully, flagging down gully, minimal erosion

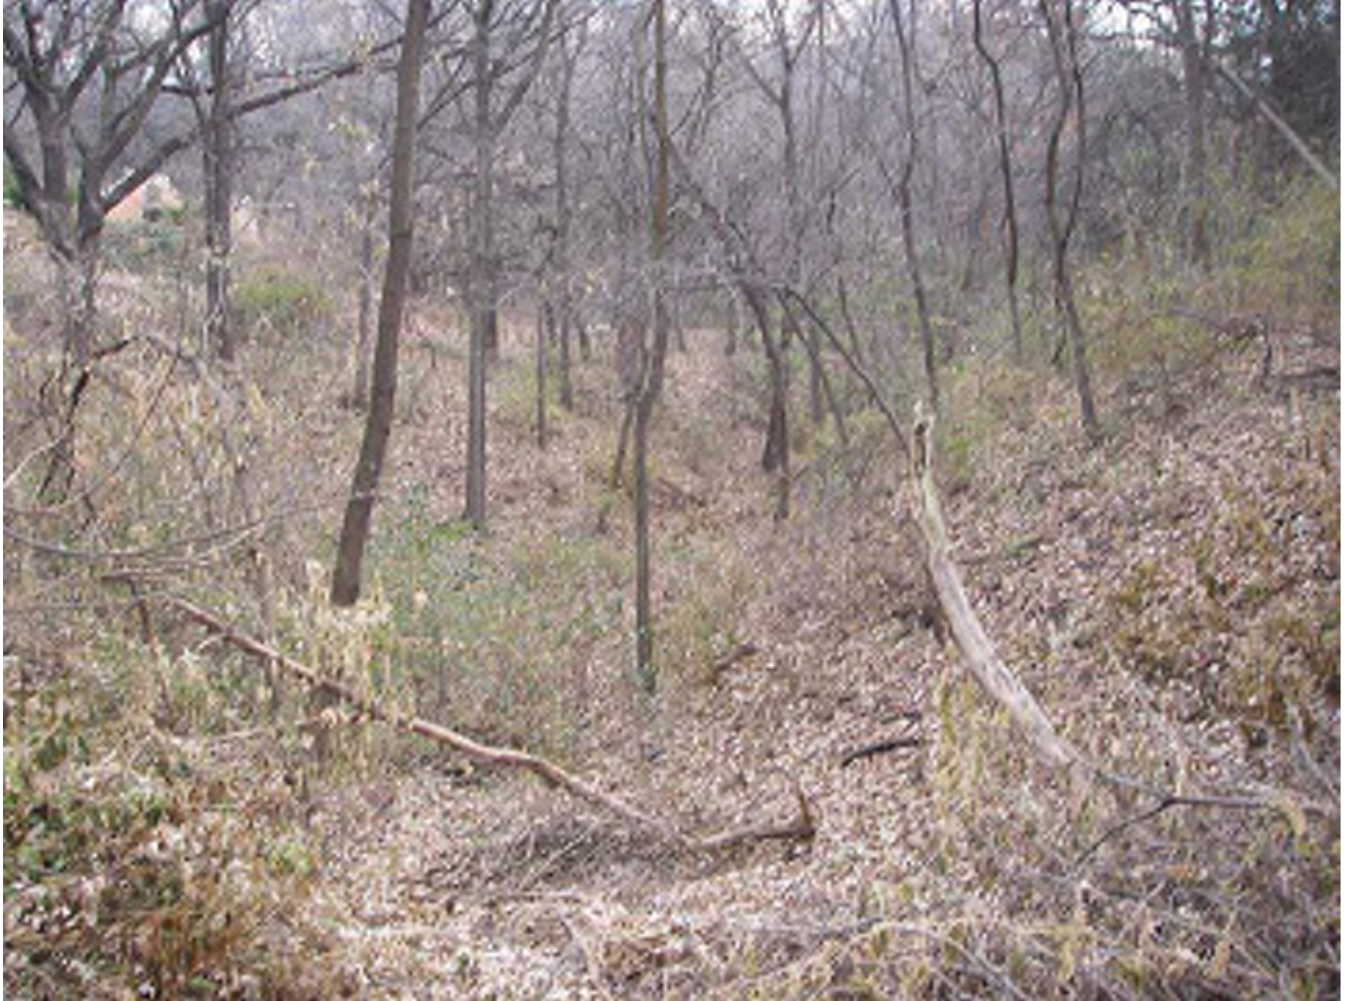
Waypoint 49

Deep gully, some erosion

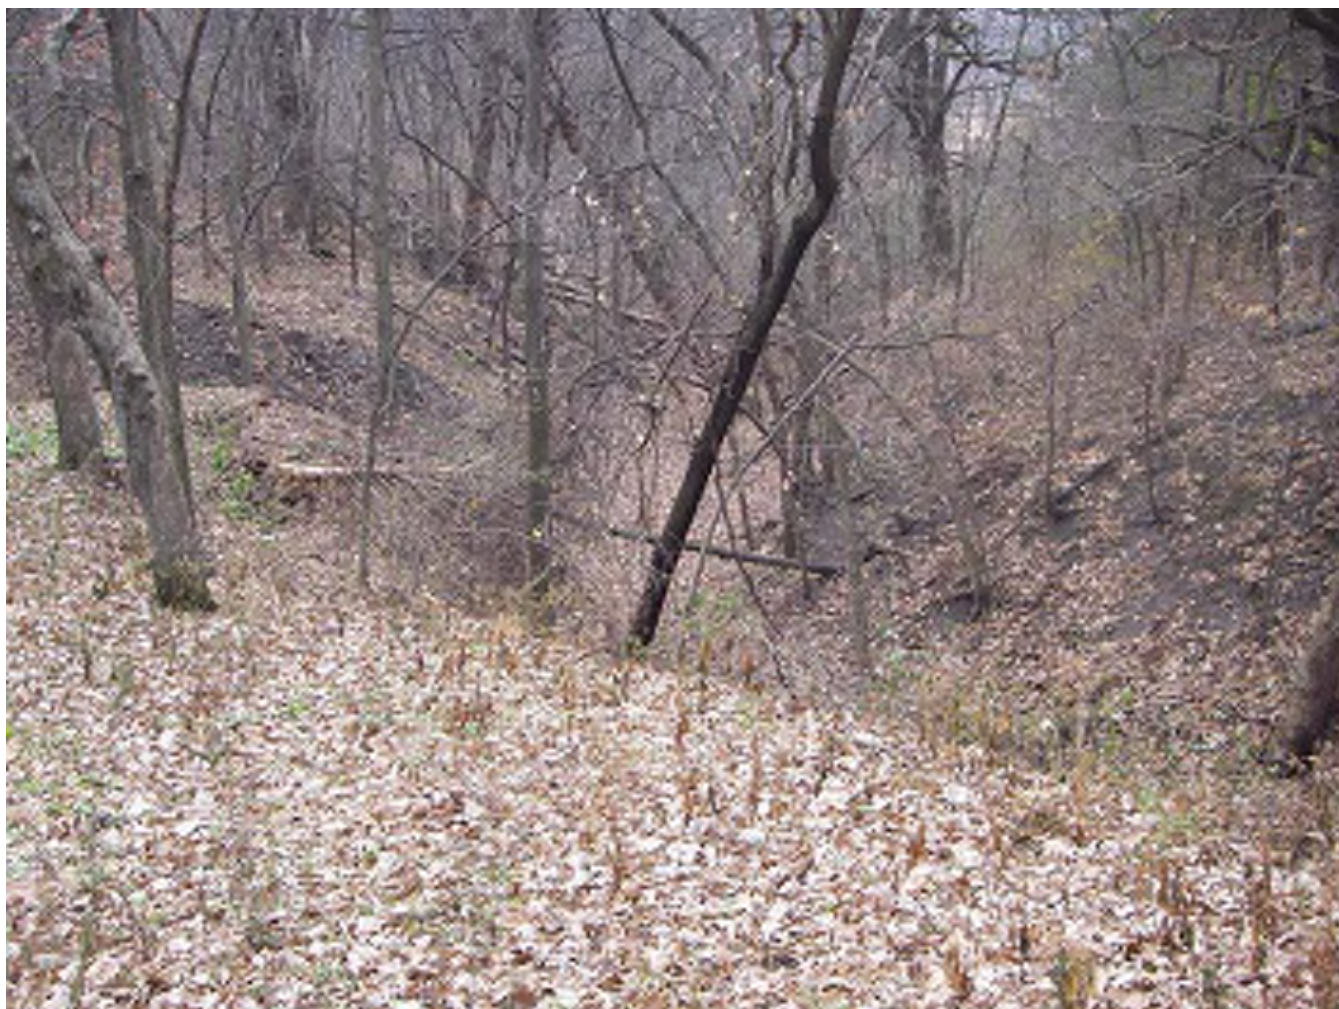
Eroded bank downhill, some large tree debris

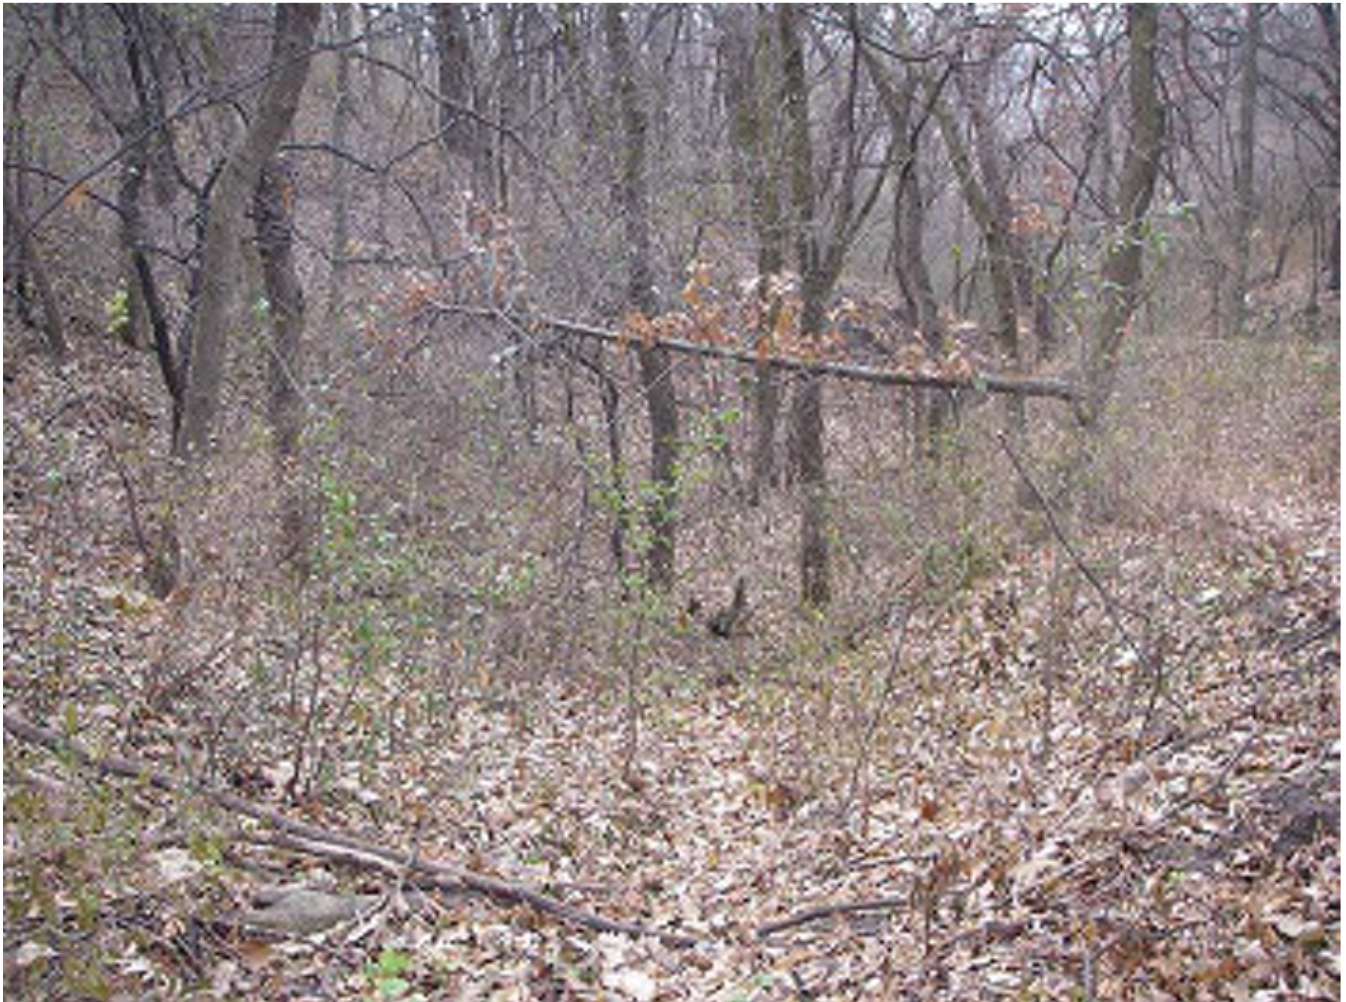
Waypoint 50

East branch of gully
