Appendix K: Lower Minnesota River Watershed District: Gully Inventory

Gully Inventory Map
 Area #1
 Lower Minnesota River Watershed District
 Watershed Management Plan

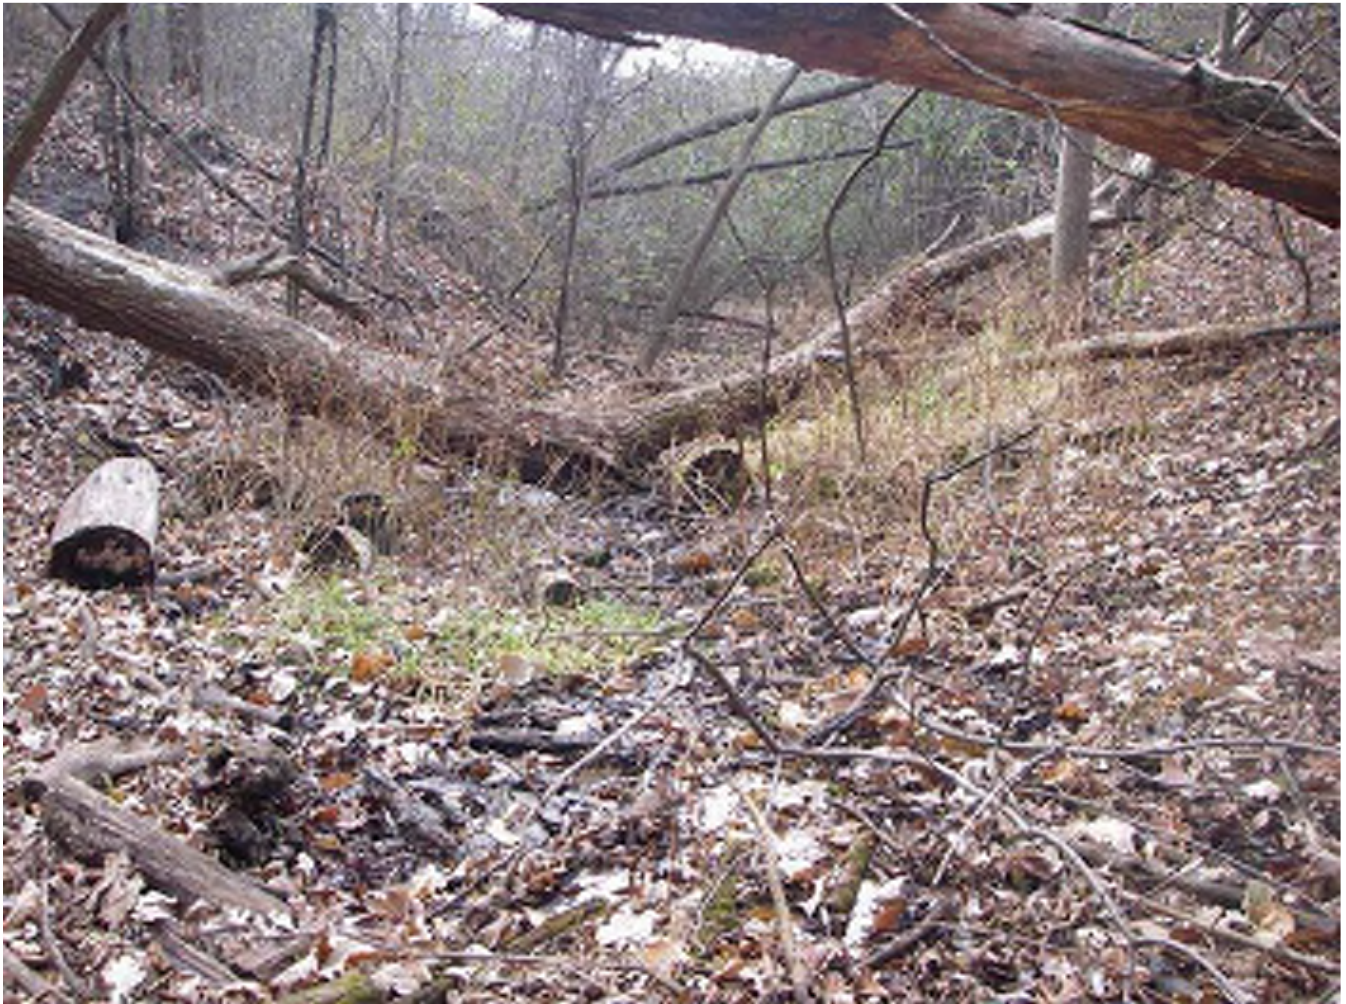
Waypoint 51

Spring/groundwater seepage and channel feeding to marsh

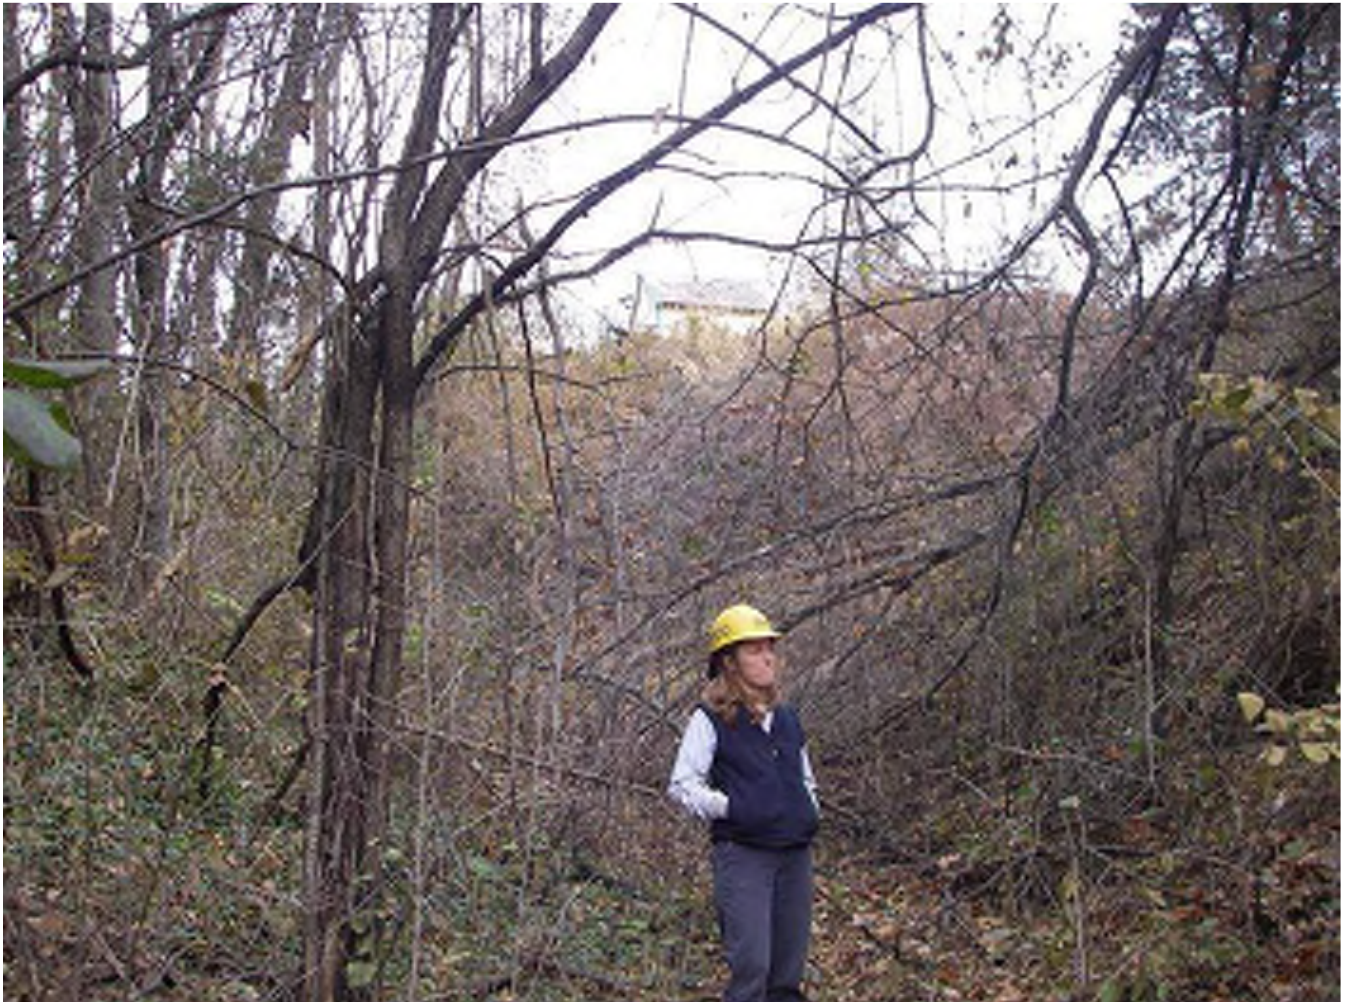
Waypoint 52

Deep gully w/some erosion & some tree debris

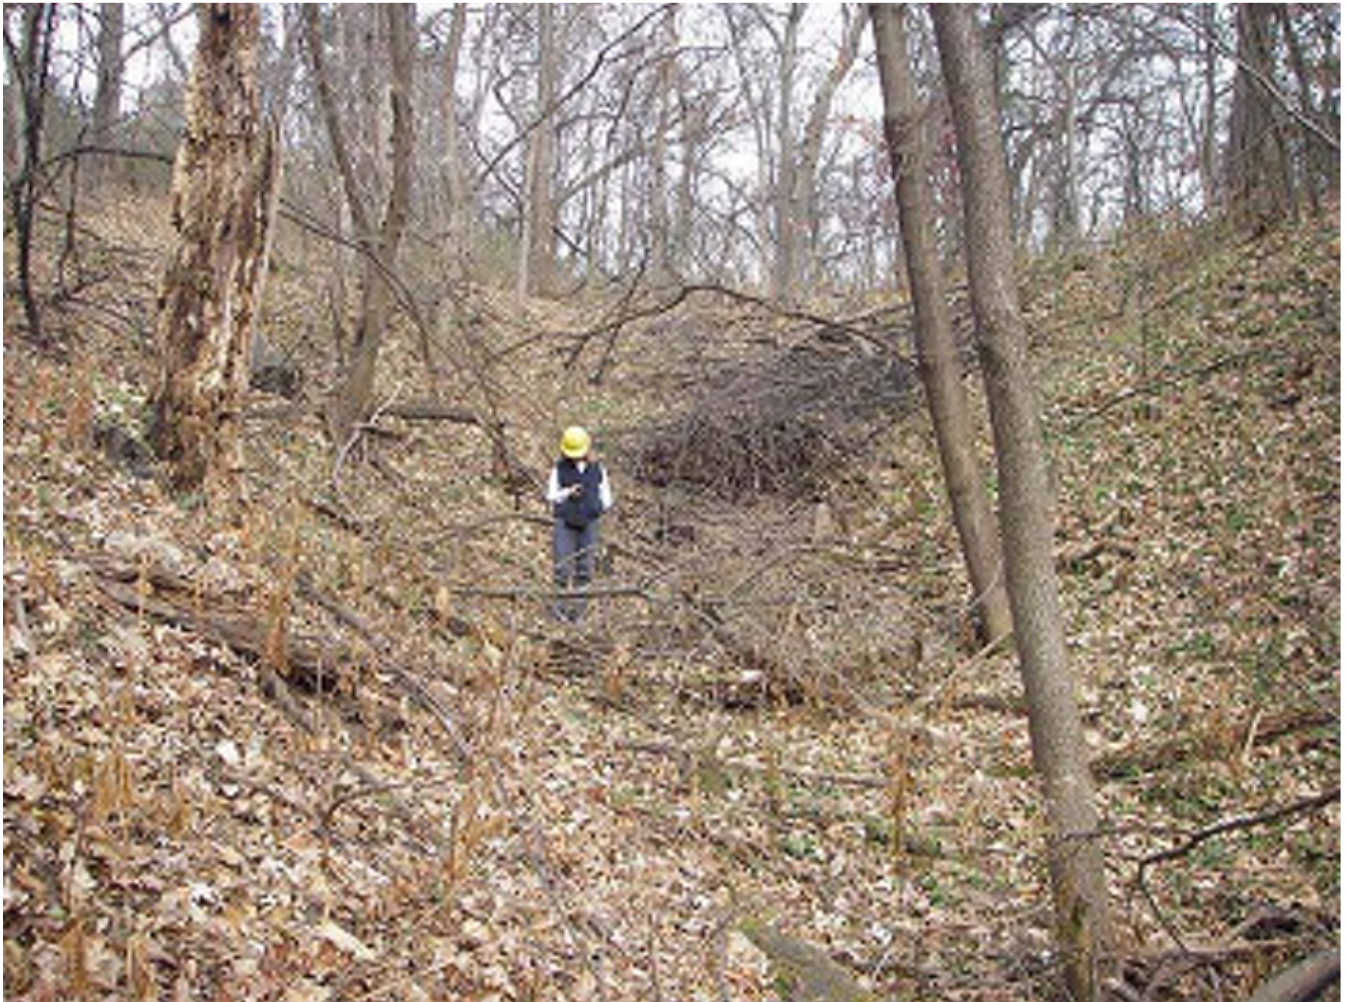
Waypoint 53

Gully w/lots of tree debris

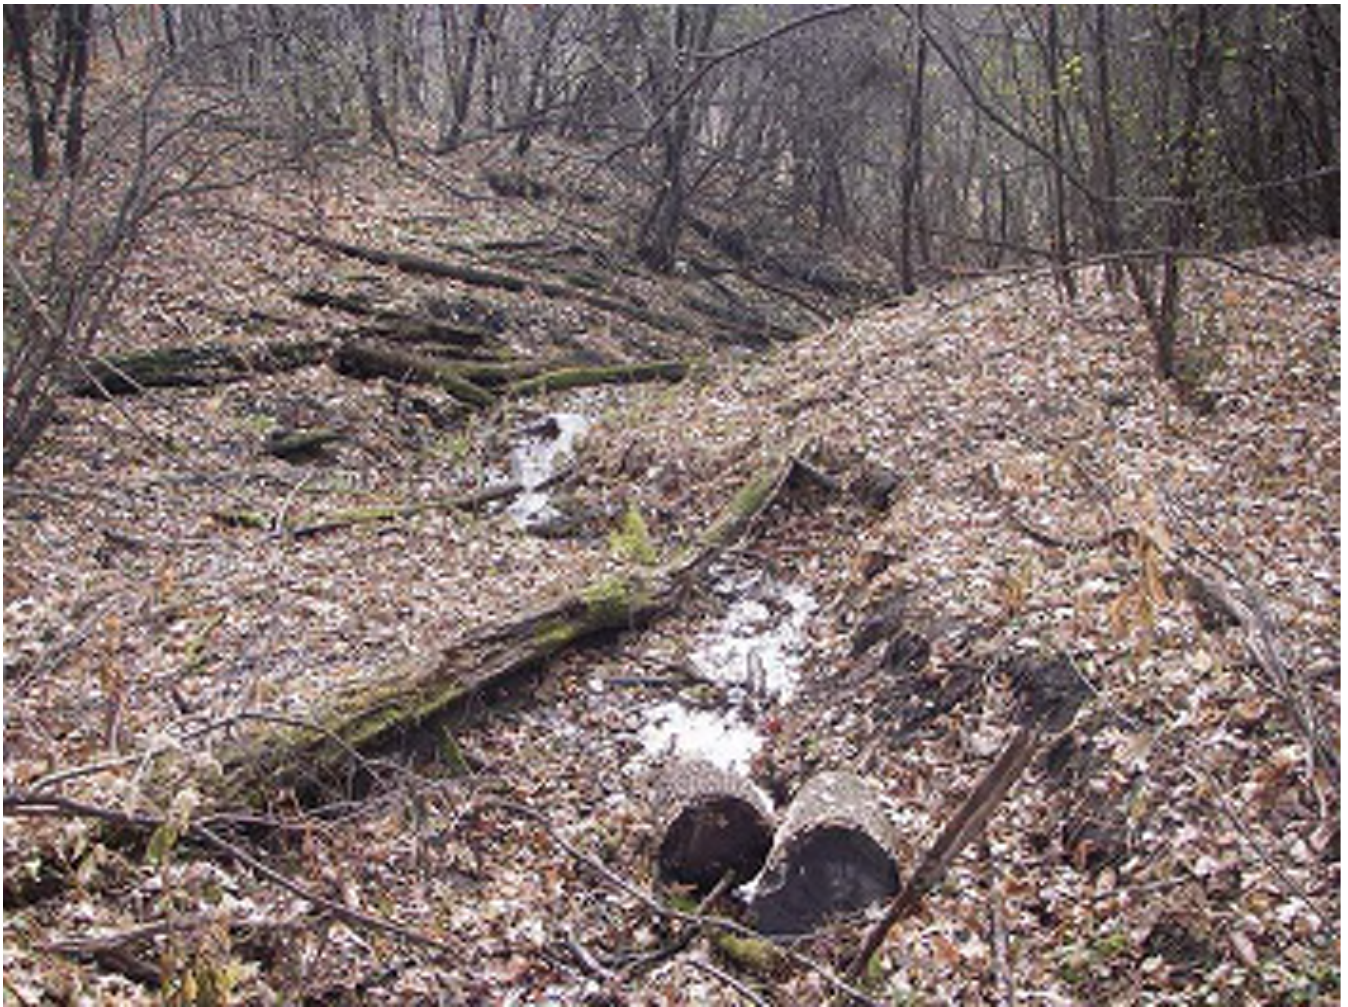
Good spring 10 ft. from WP053 GPS point forming deep channel & stream, some metal trash

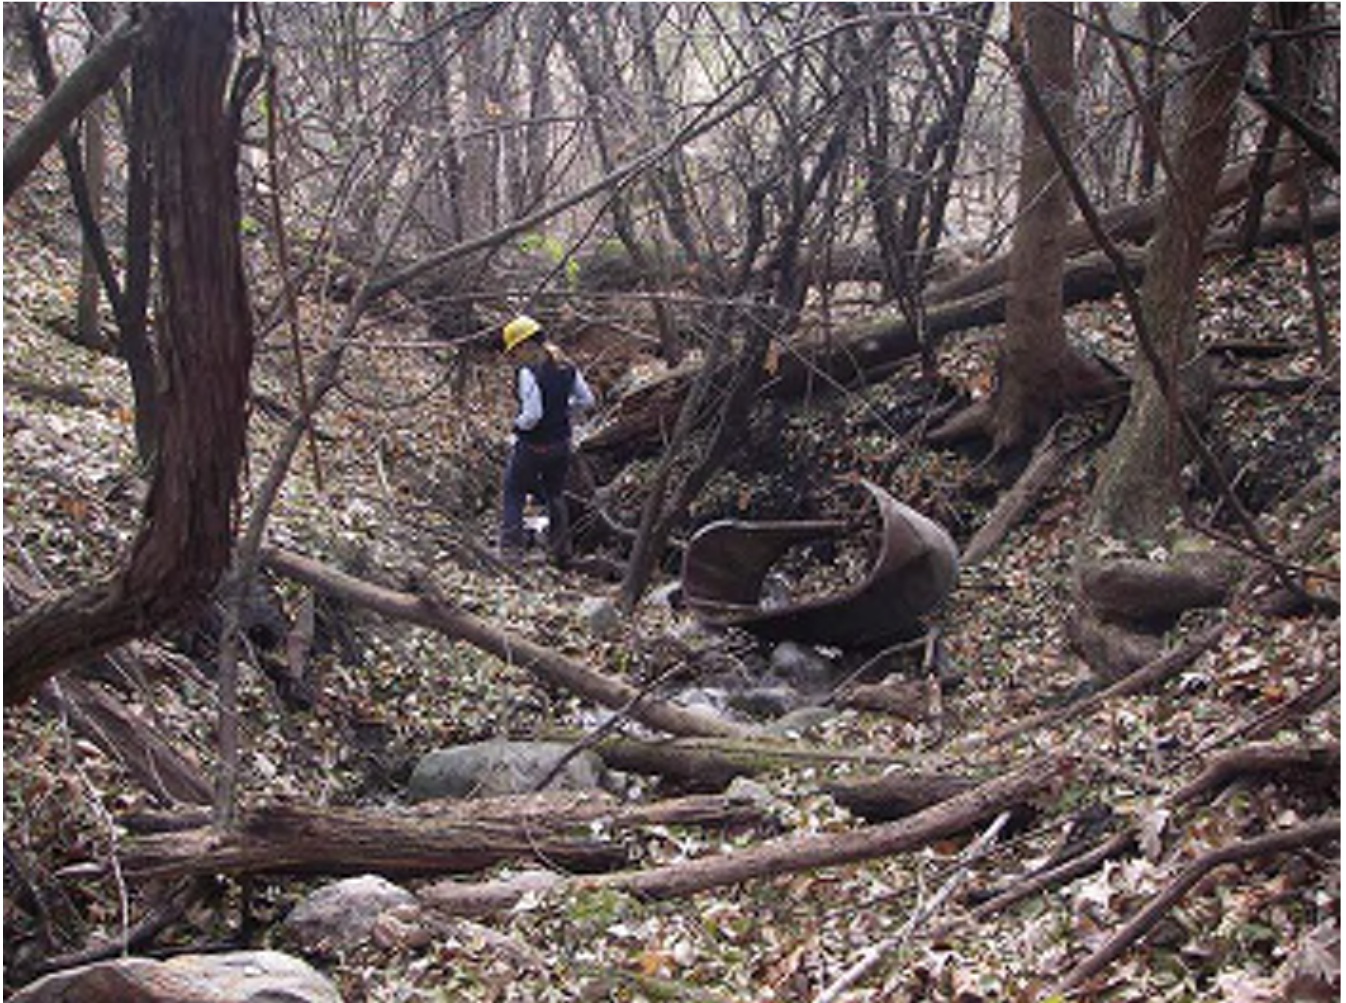
Waypoint 54

Pronounced erosion

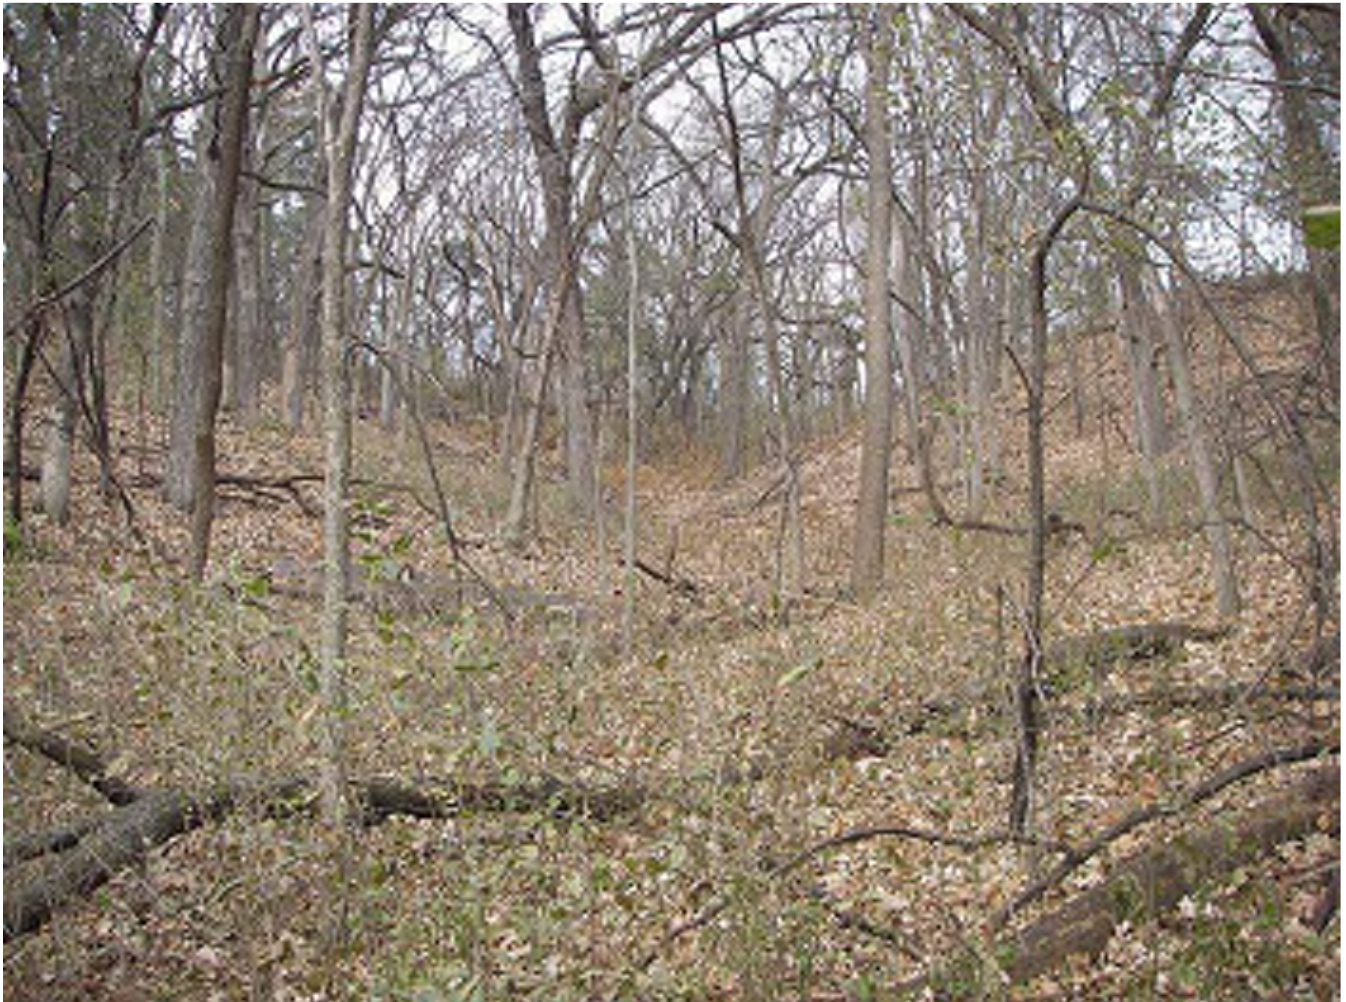
Waypoint 55

Minimal erosion

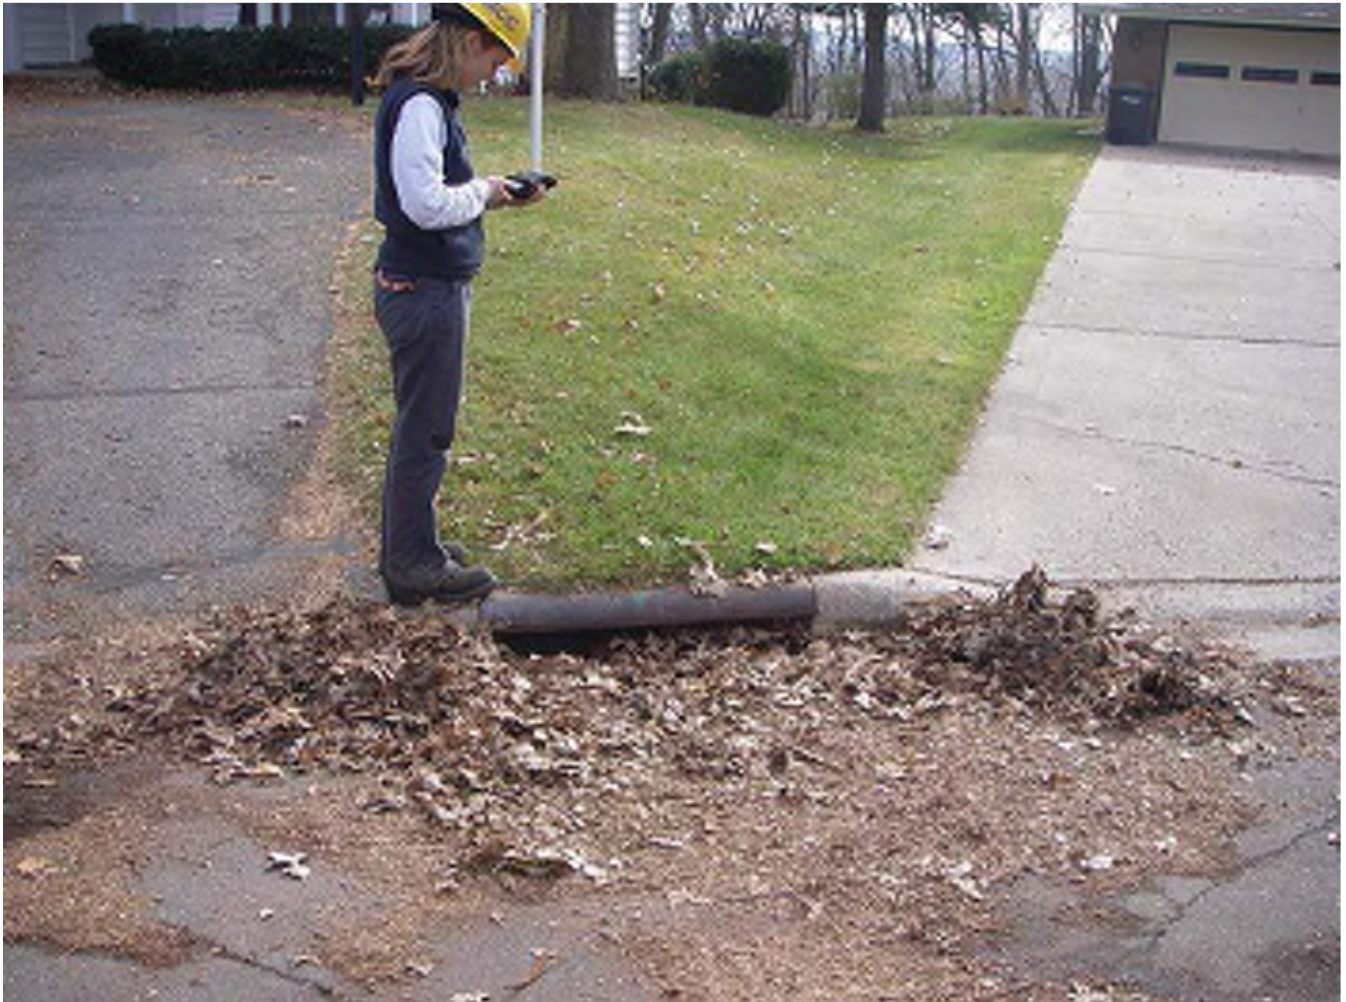
Waypoint 56

Storm drain

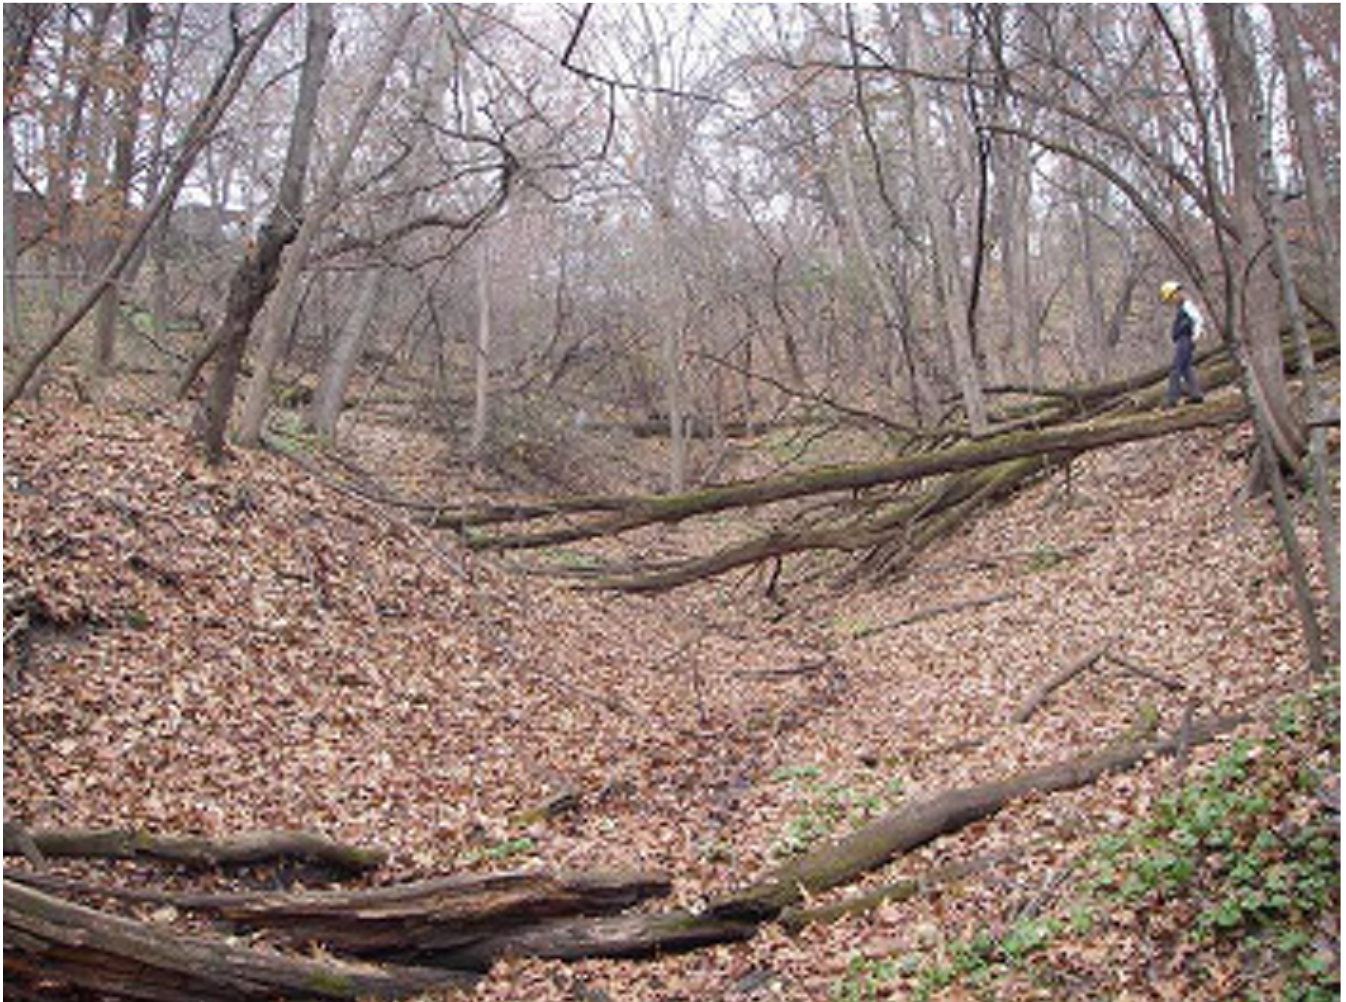
Uphill shot of point 058

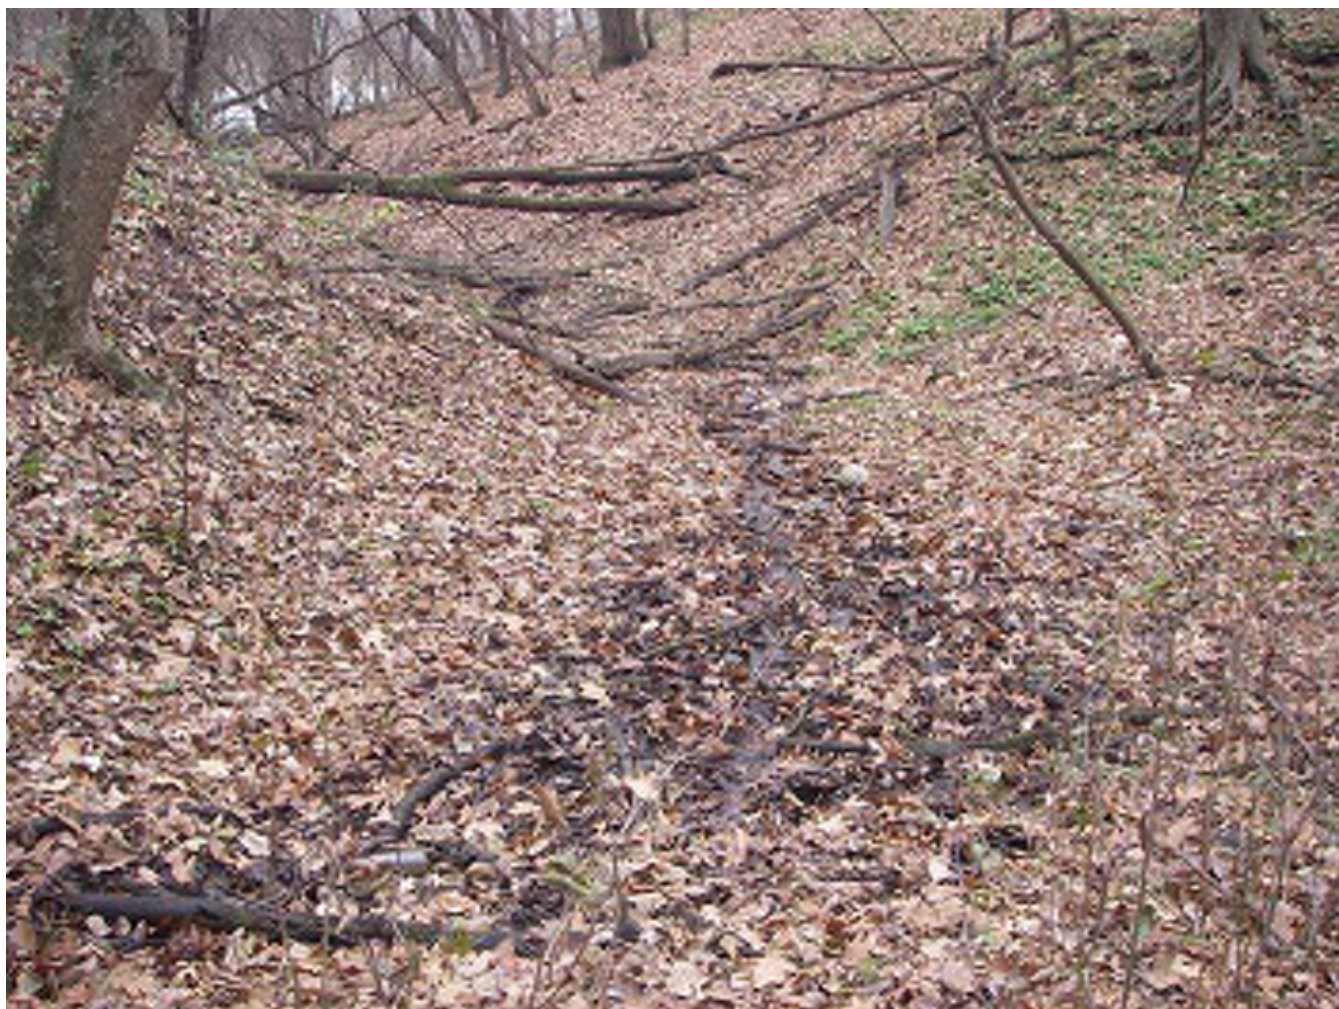
Water table/spring from point 058

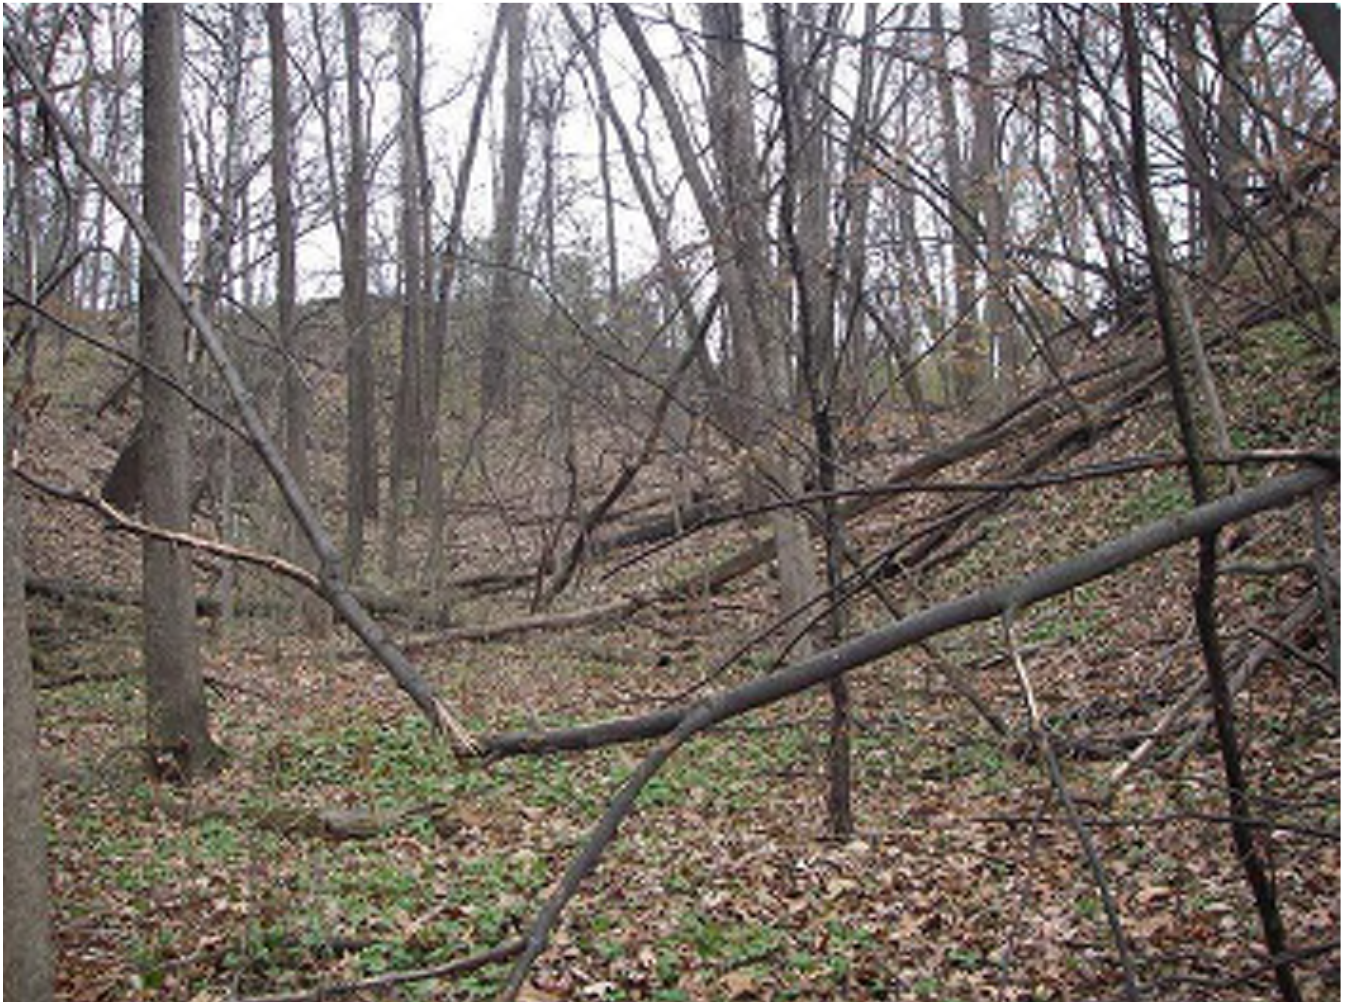
Waypoint 59

E. branch uphill shot from point 058, min. erosion

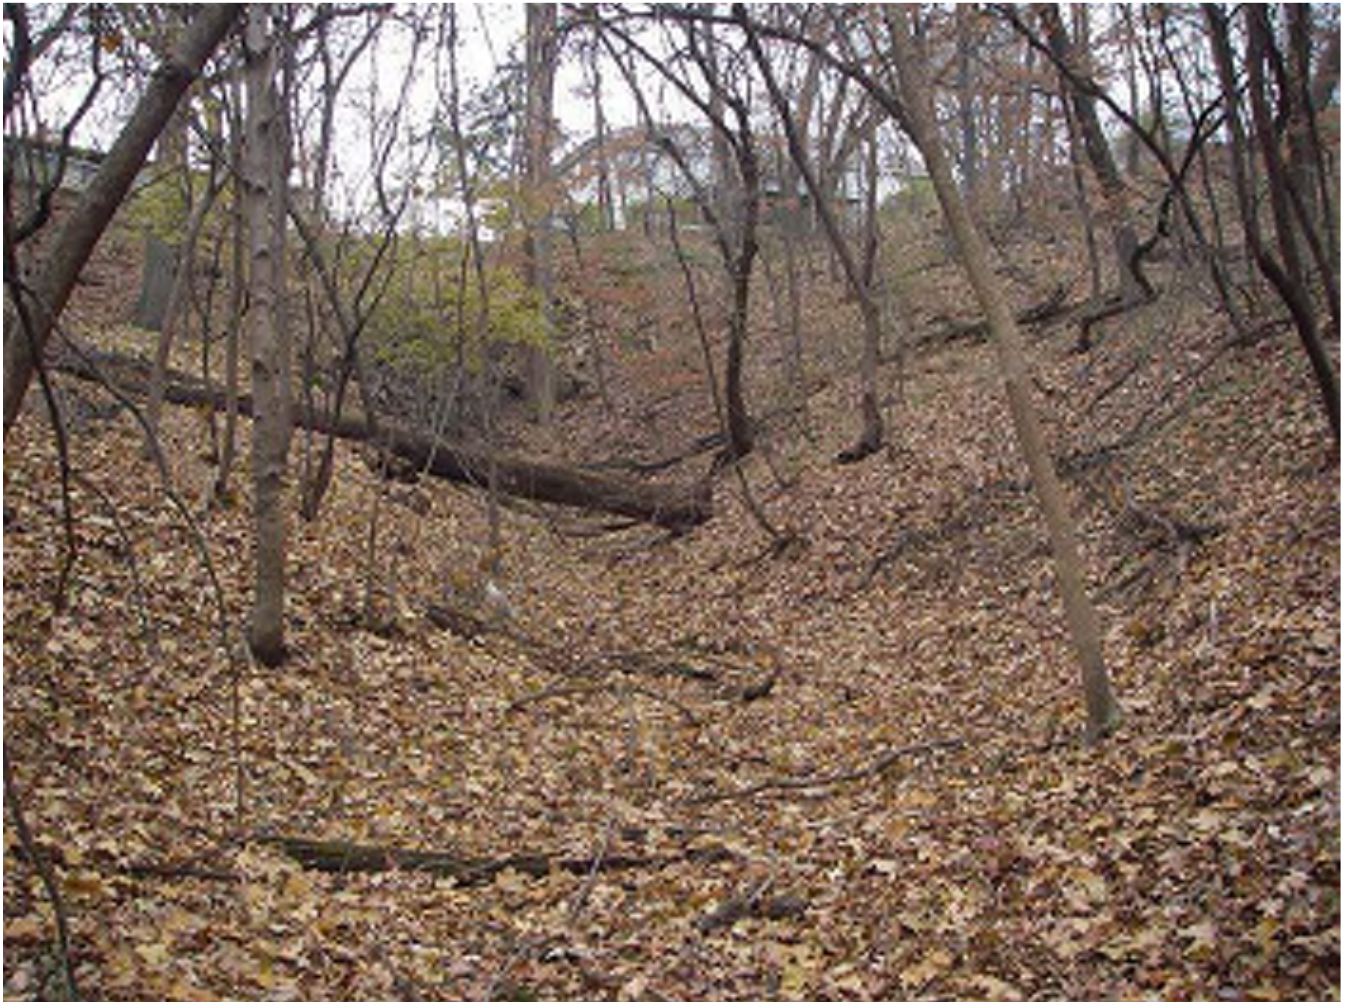
Waypoint 60

W. branch: uphill, some tree debris in gully

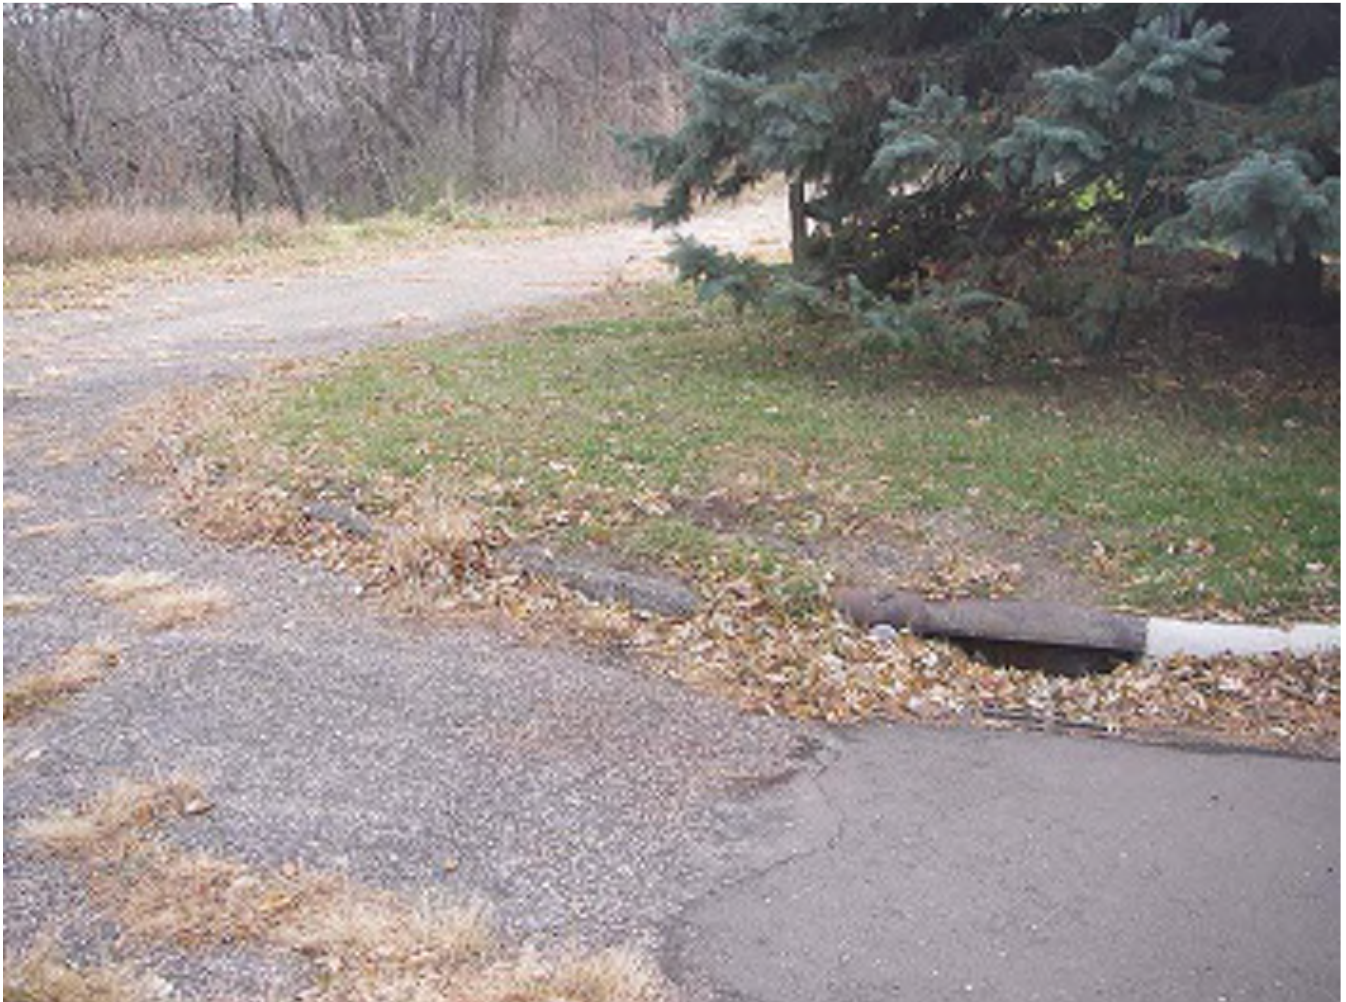
Waypoint 61

Storm sewer*

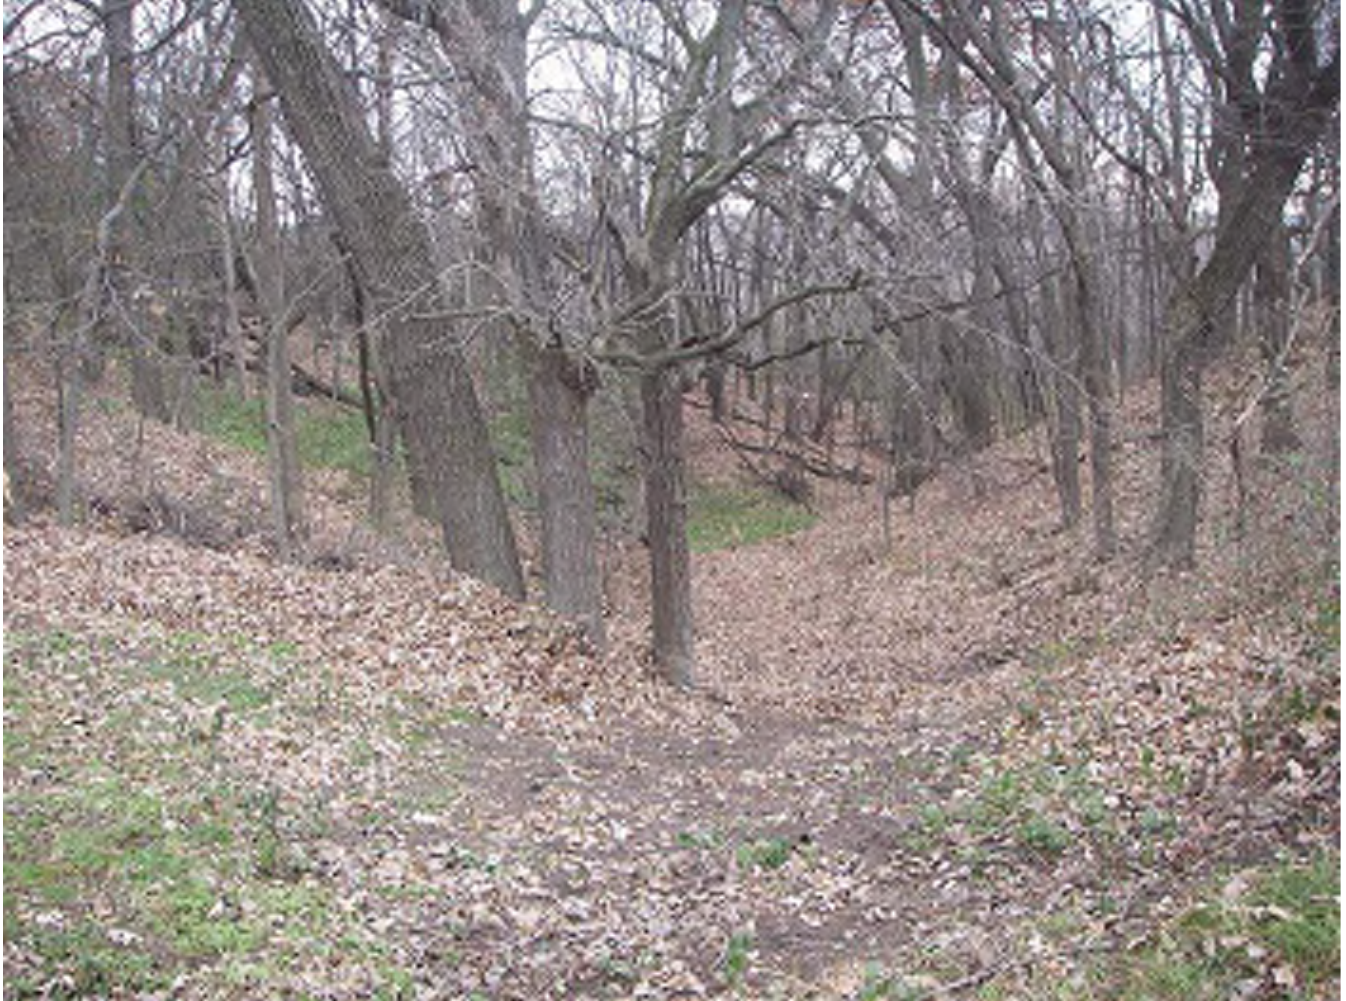
Waypoint 62

Minimal erosion

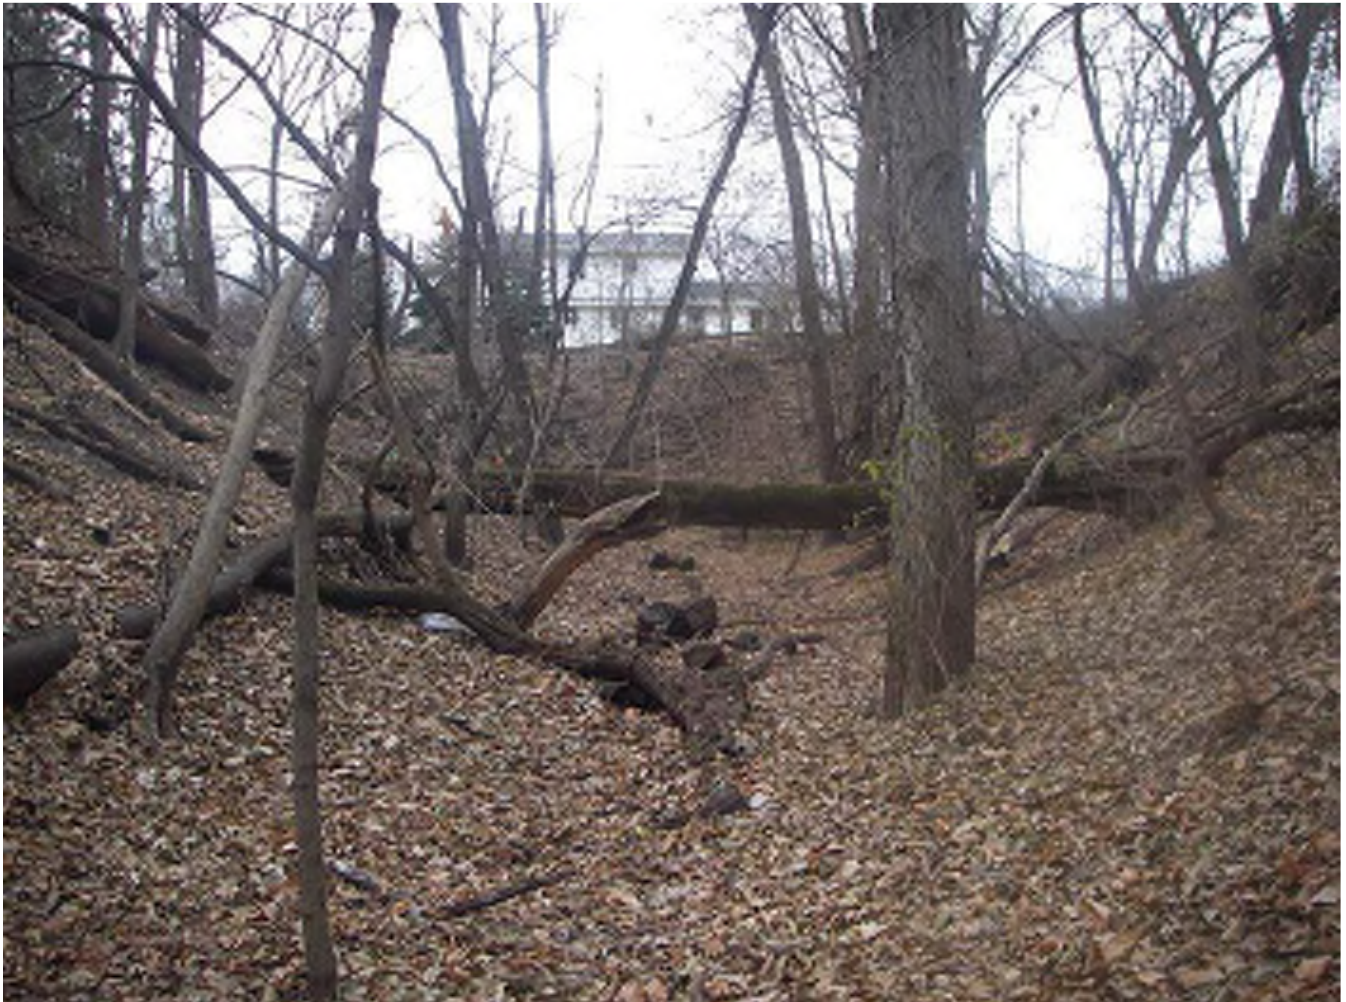
Waypoint 63

Drainage pit, erosion very evident, bare soil on all sides of slopes

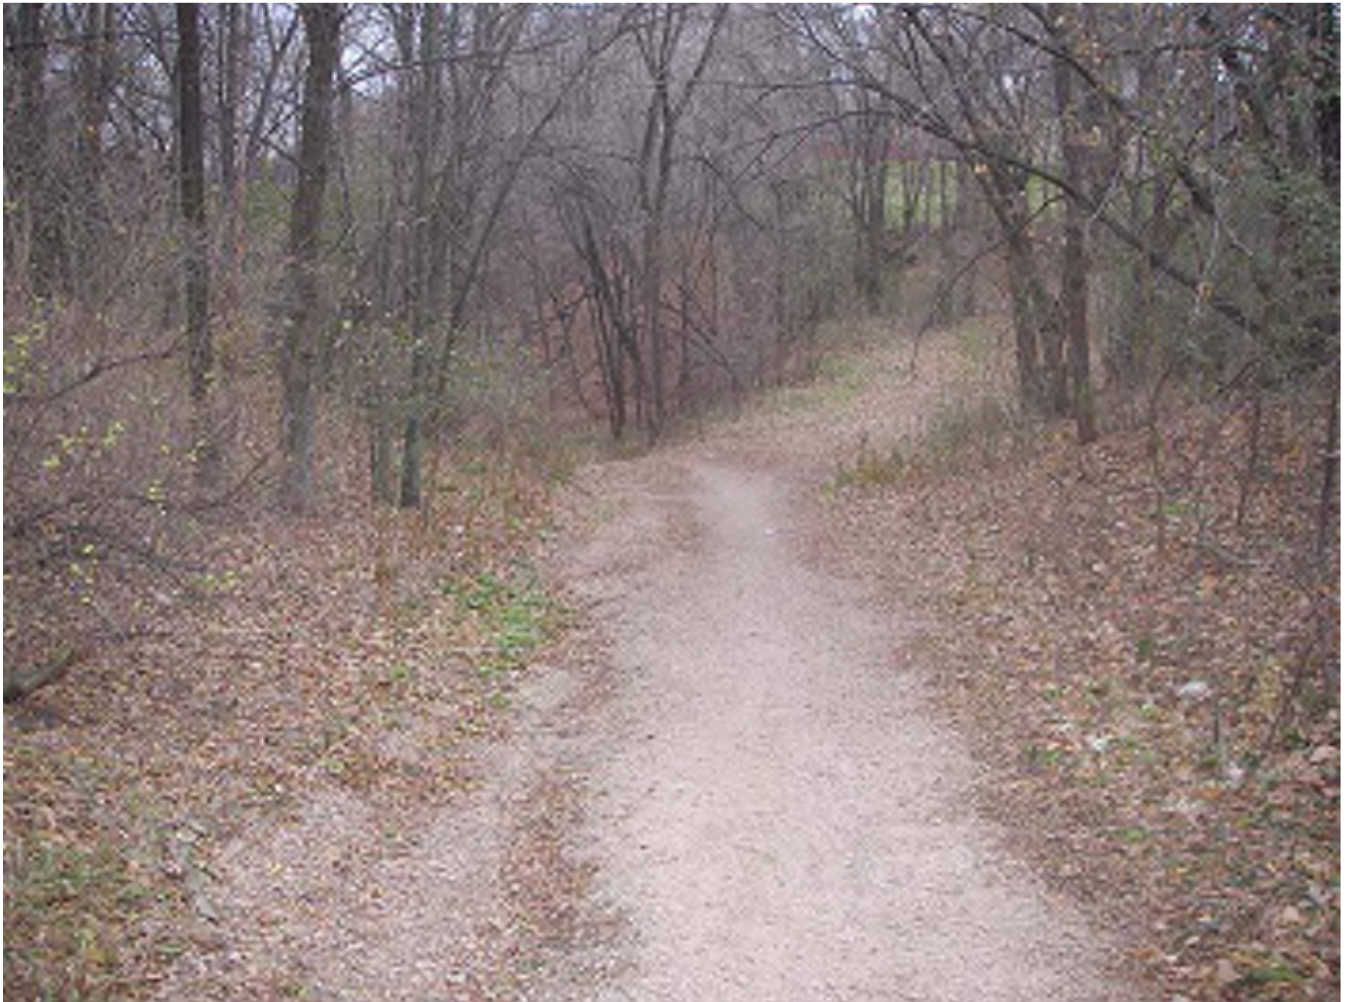
Waypoint 64

Path - some erosion down center of trail

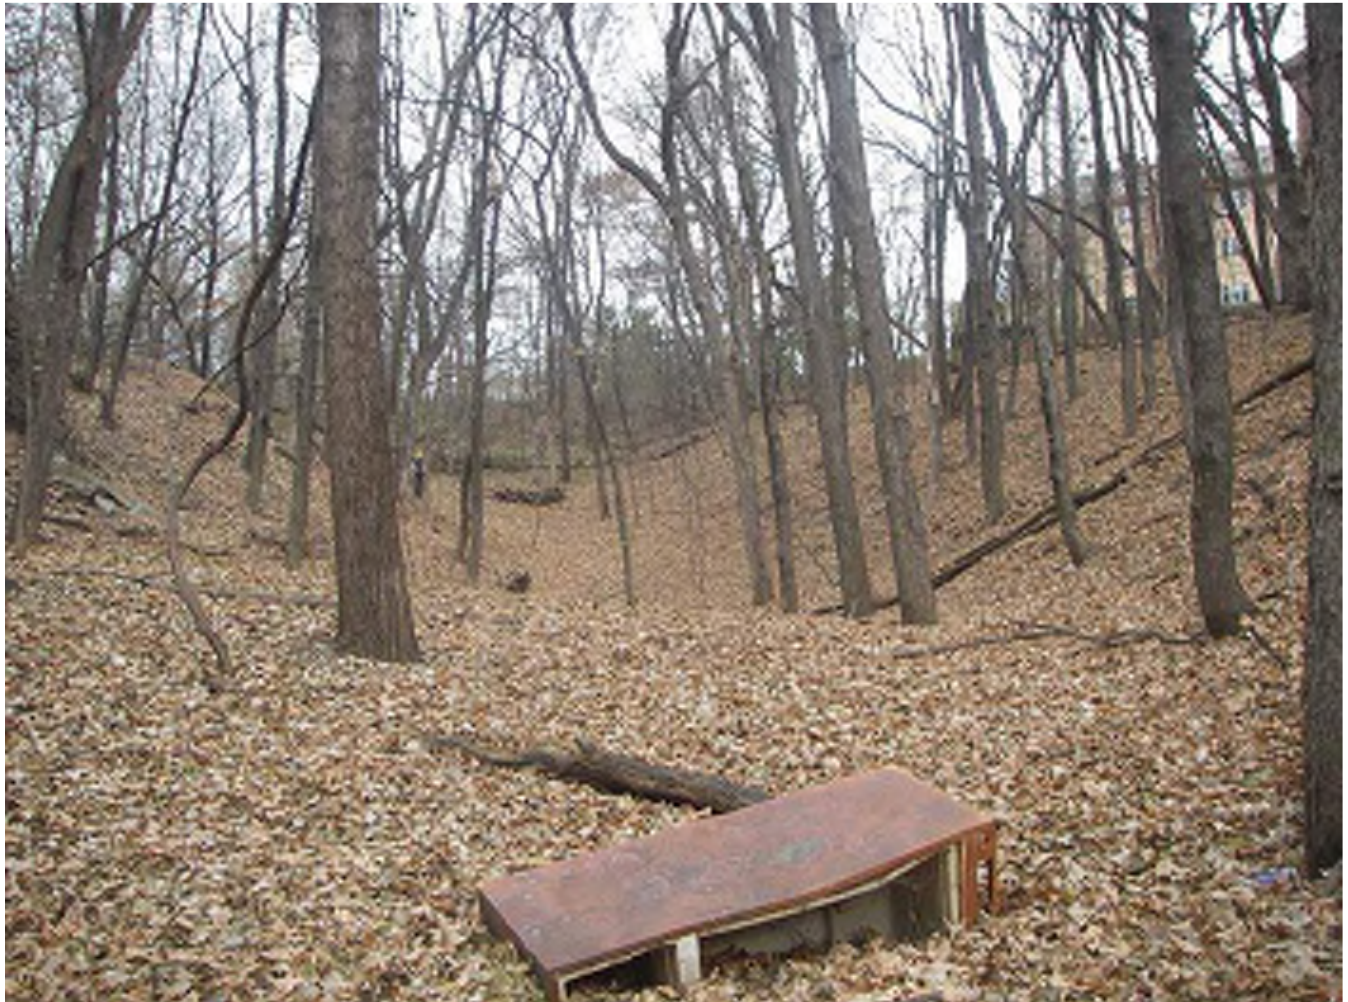
Waypoint 65

NE branch of gully, some erosion apparent

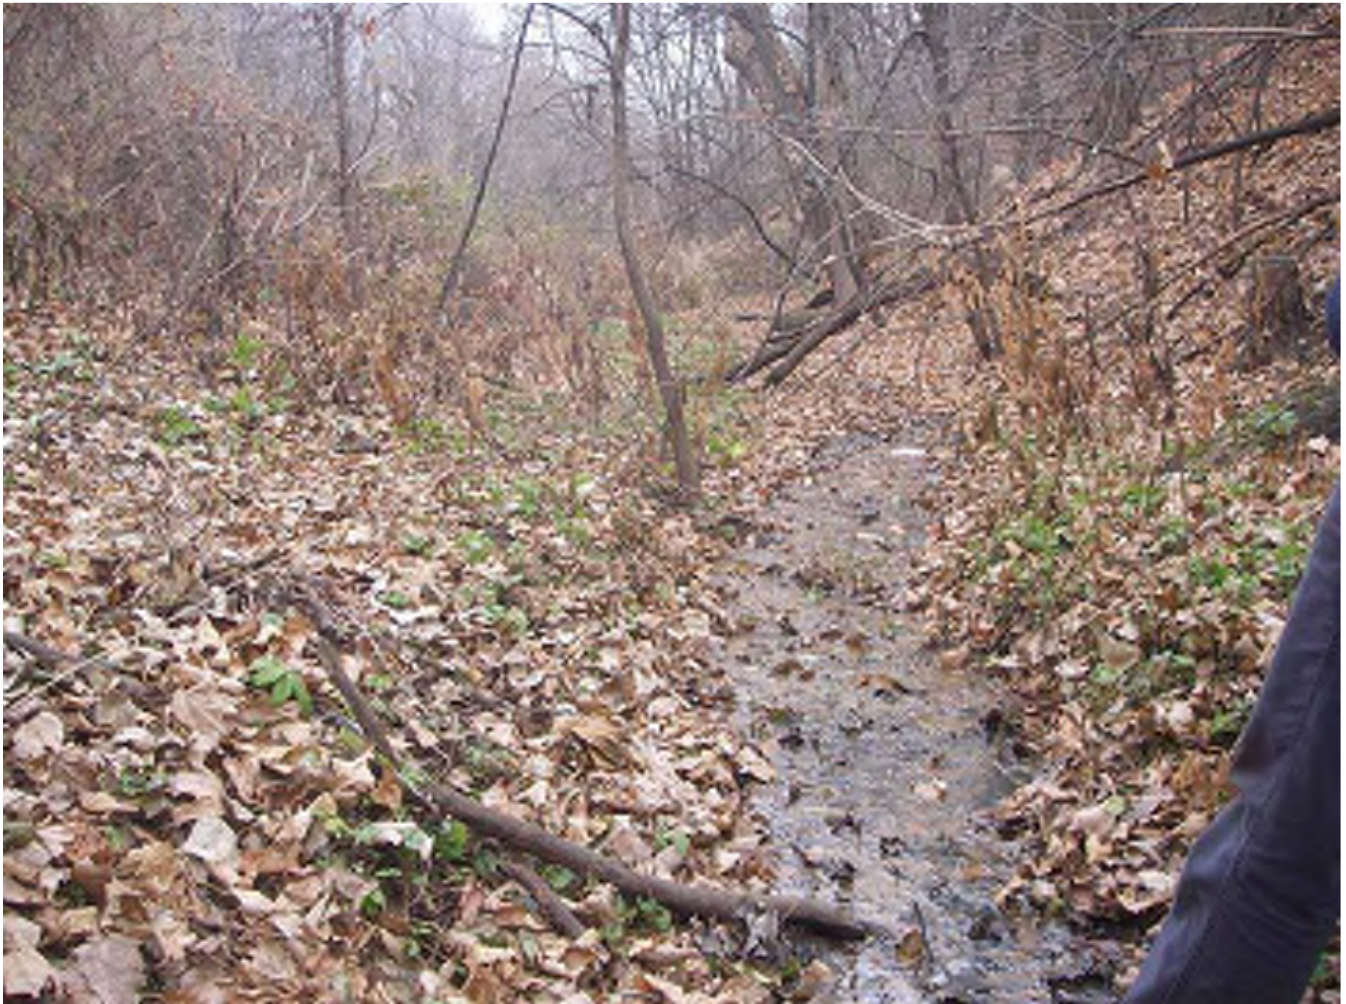
Waypoint 66

Spring on west edge of path
