Appendix K: Lower Minnesota River Watershed District: Gully Inventory

Gully Inventory Map
 Area #1
 Lower Minnesota River Watershed District
 Watershed Management Plan

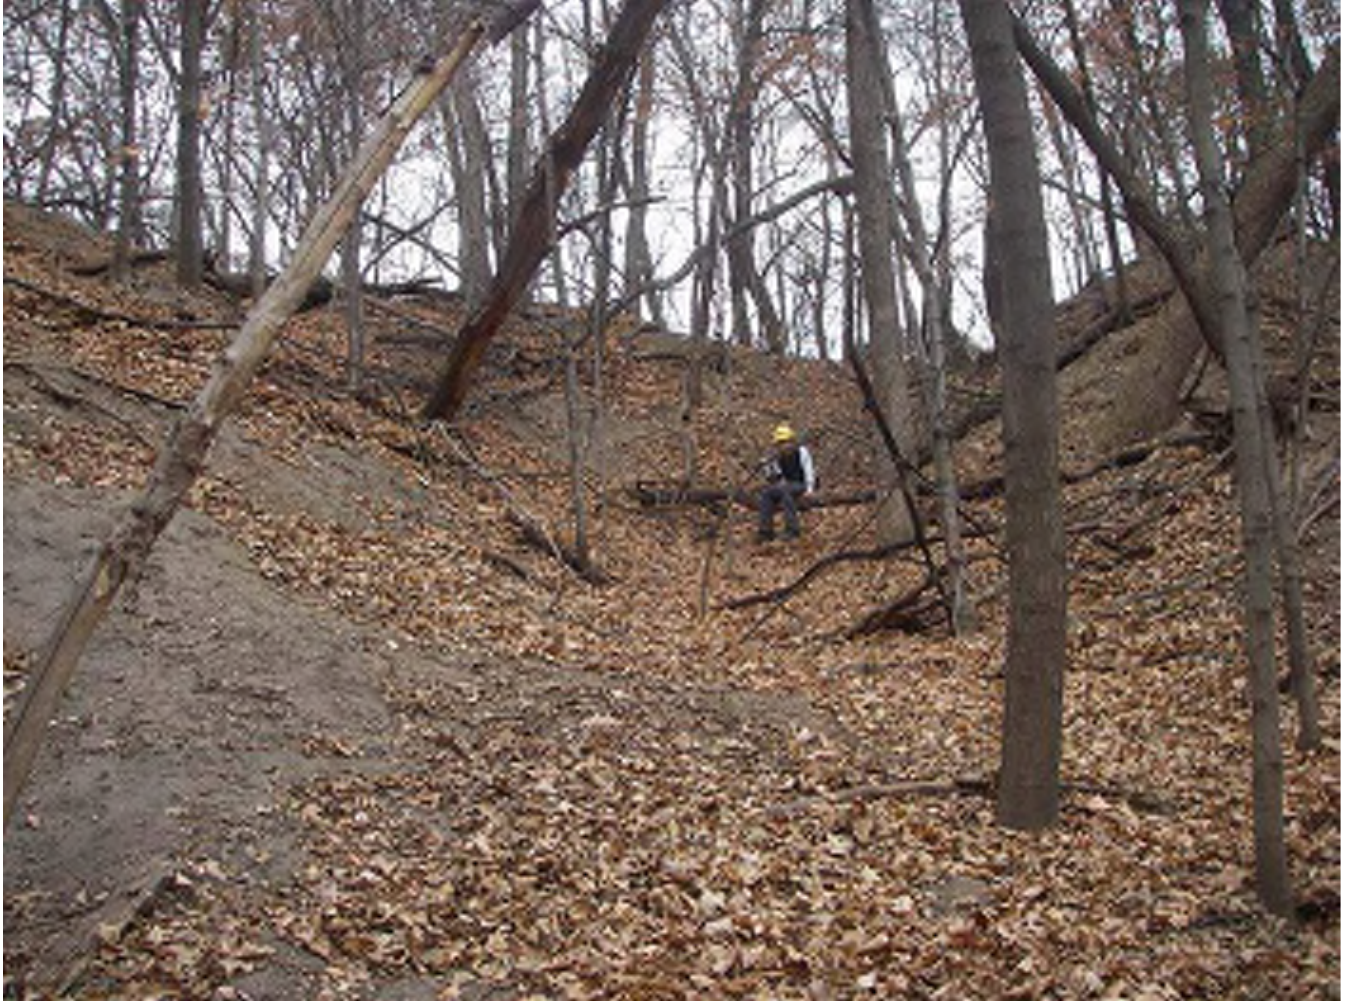
Waypoint 67

Branch off main gully

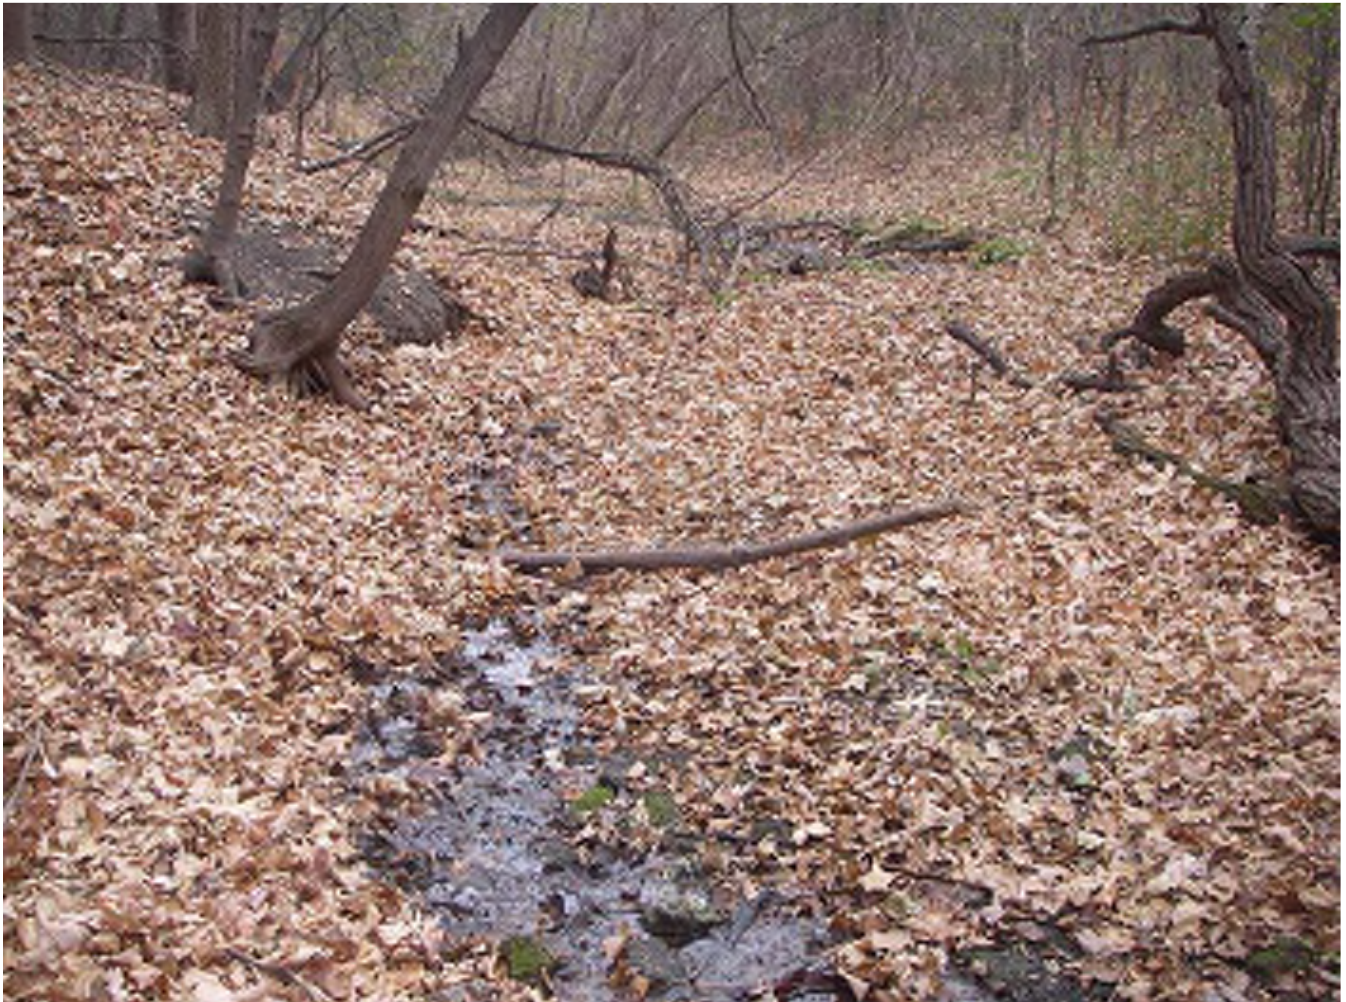
Waypoint 68

Spring on east edge of path

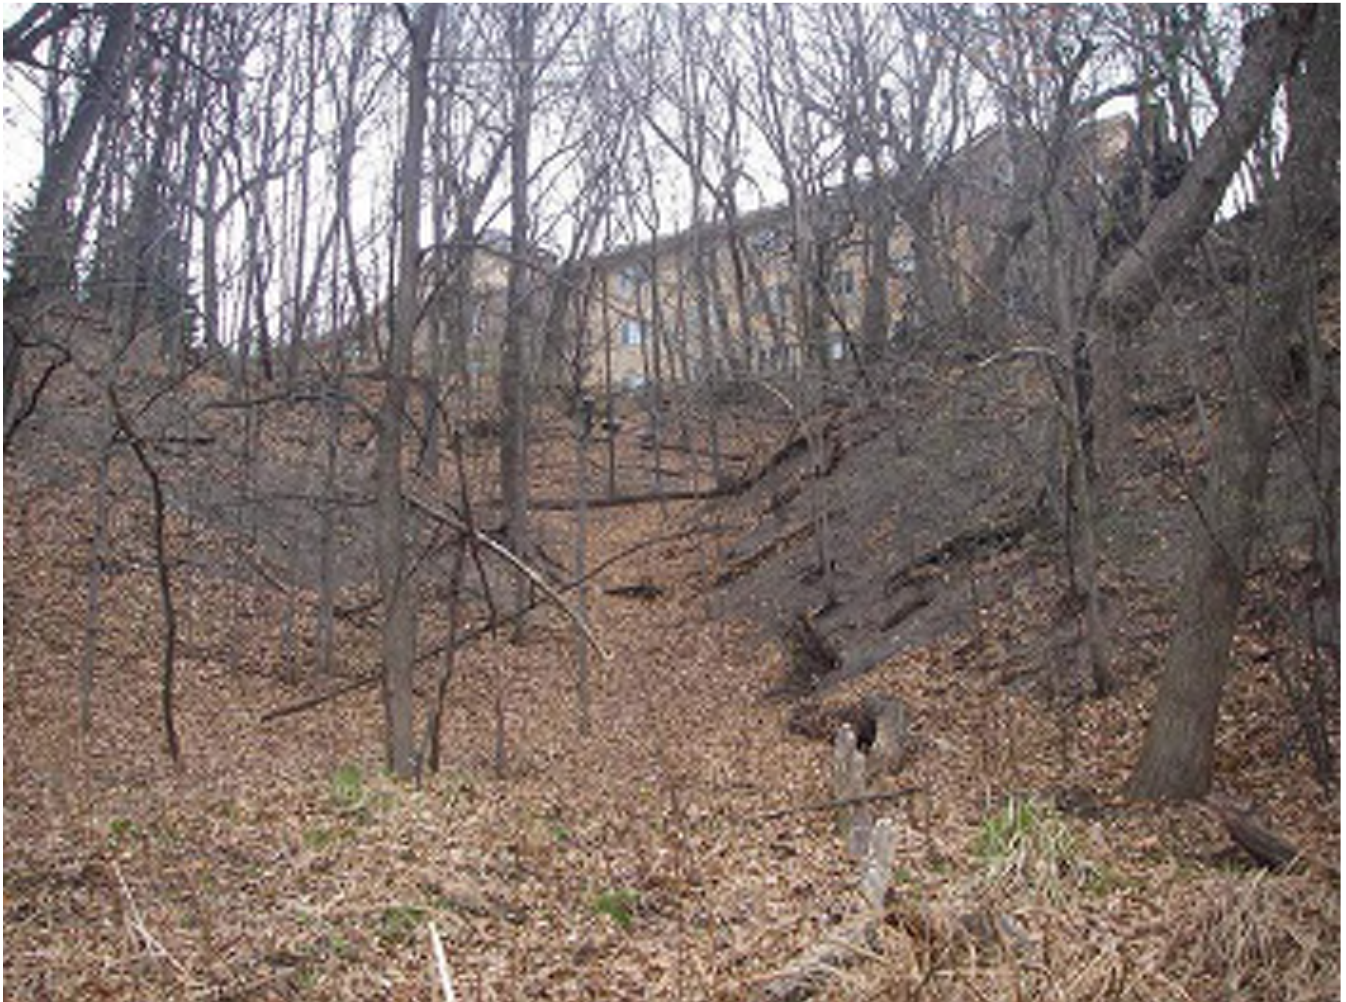
Waypoint 69

Branch and outlet pipe off main gully, severe erosion

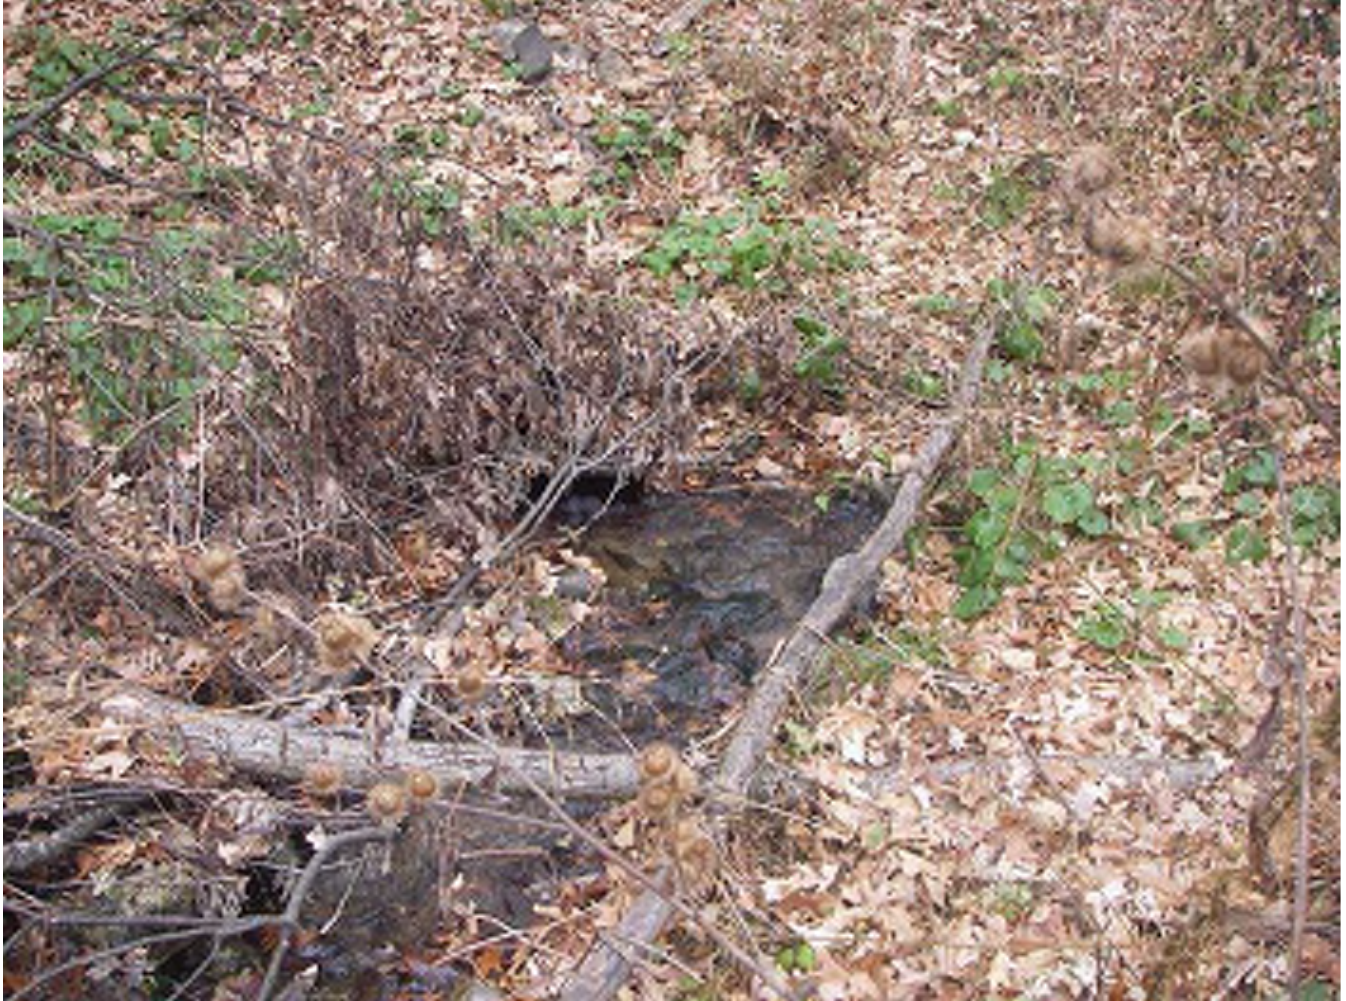
Waypoint 70

Pipe outfall

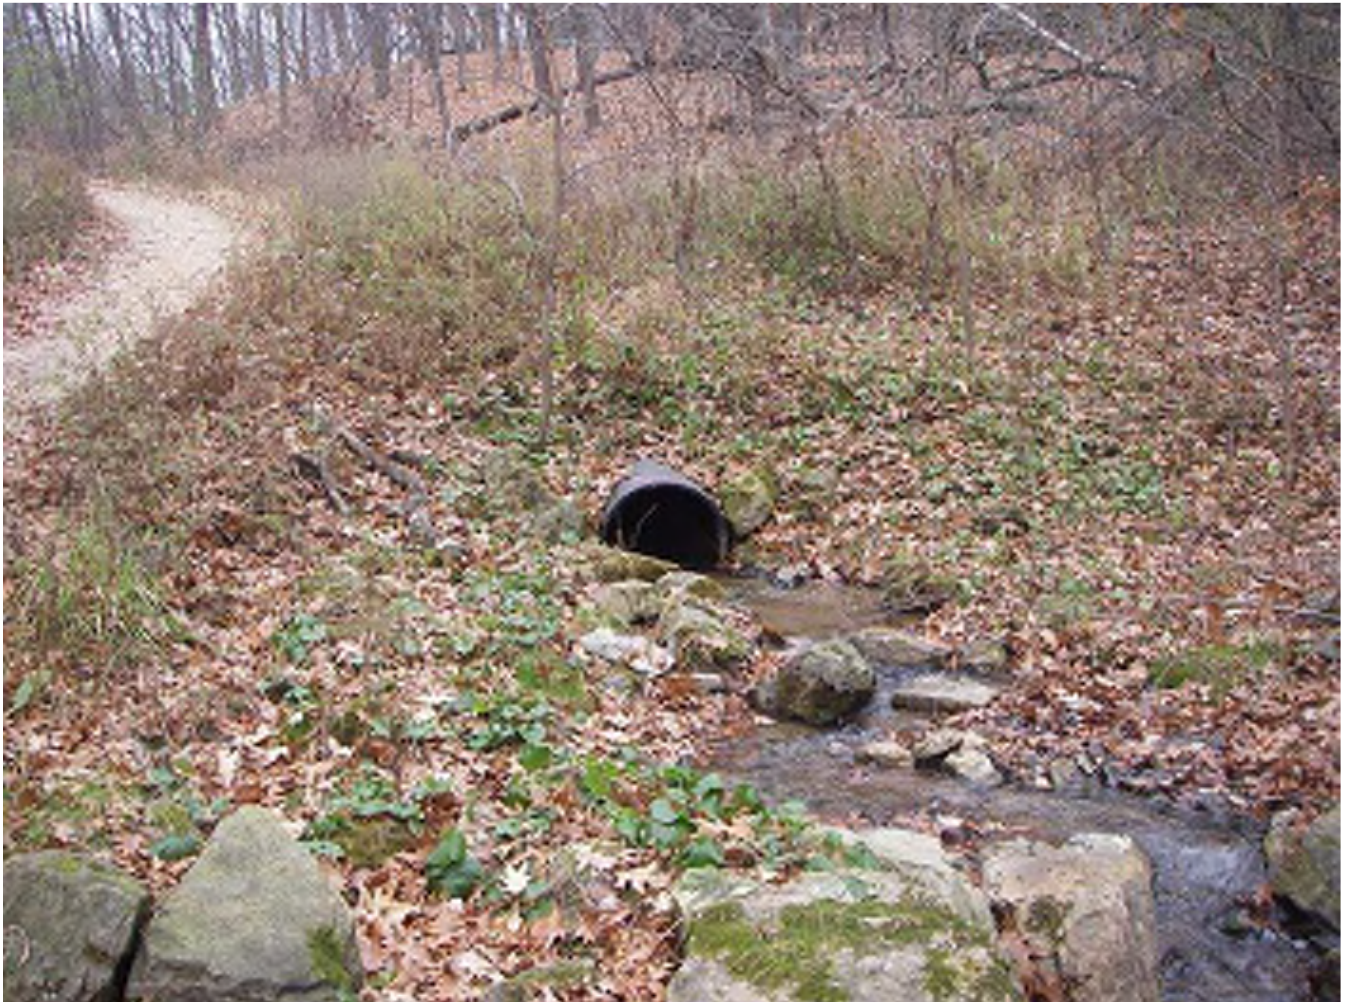
Waypoint 71

Outlet of pipe

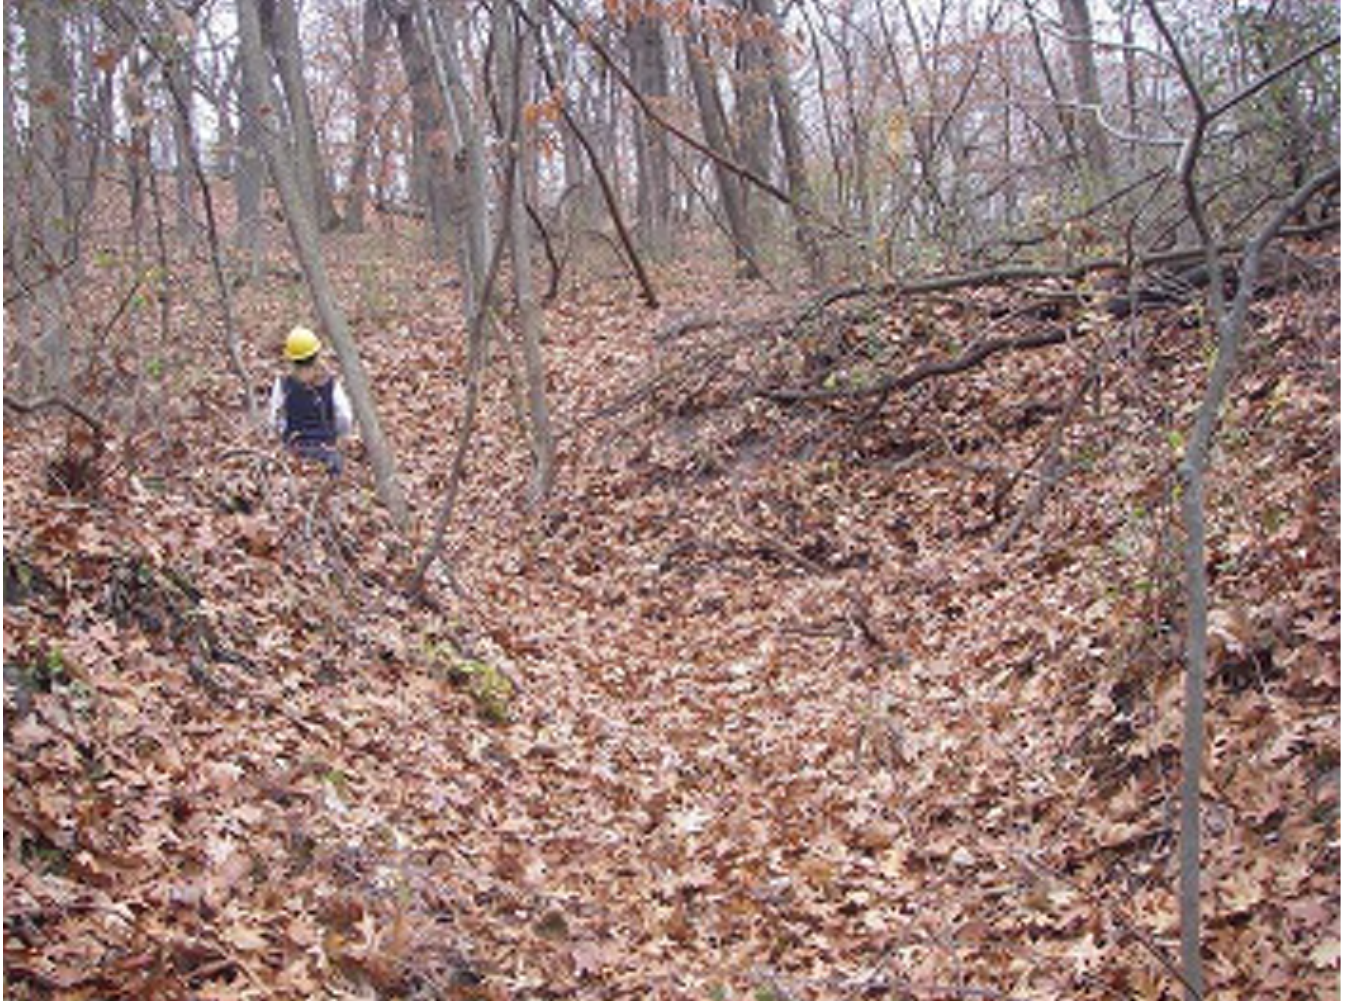
Waypoint 72

Minimal erosion and some tree debris

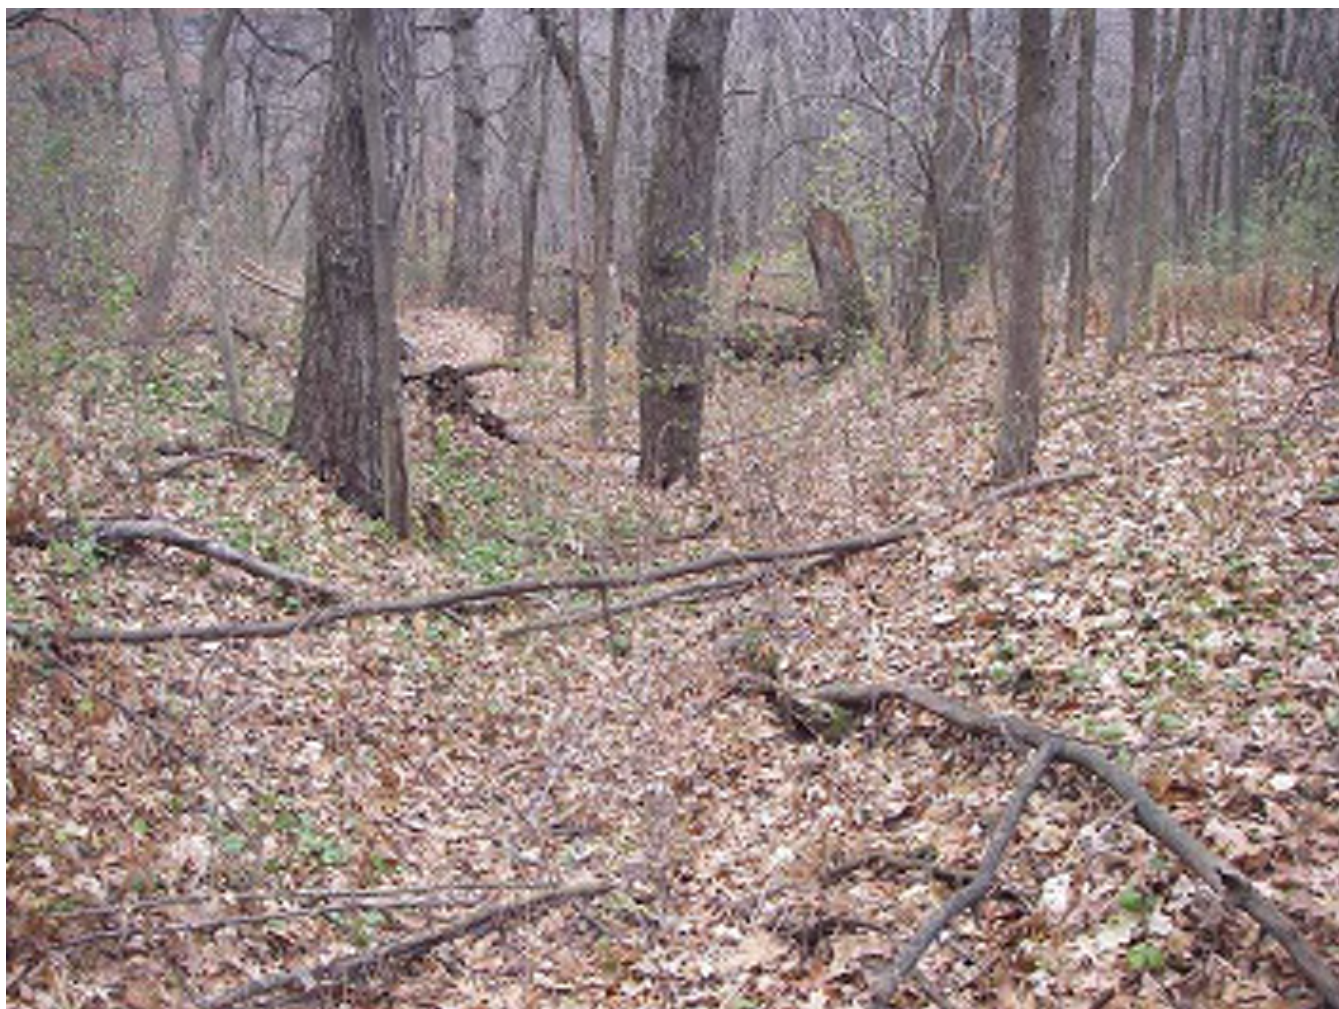
Minimal erosion and some tree debris

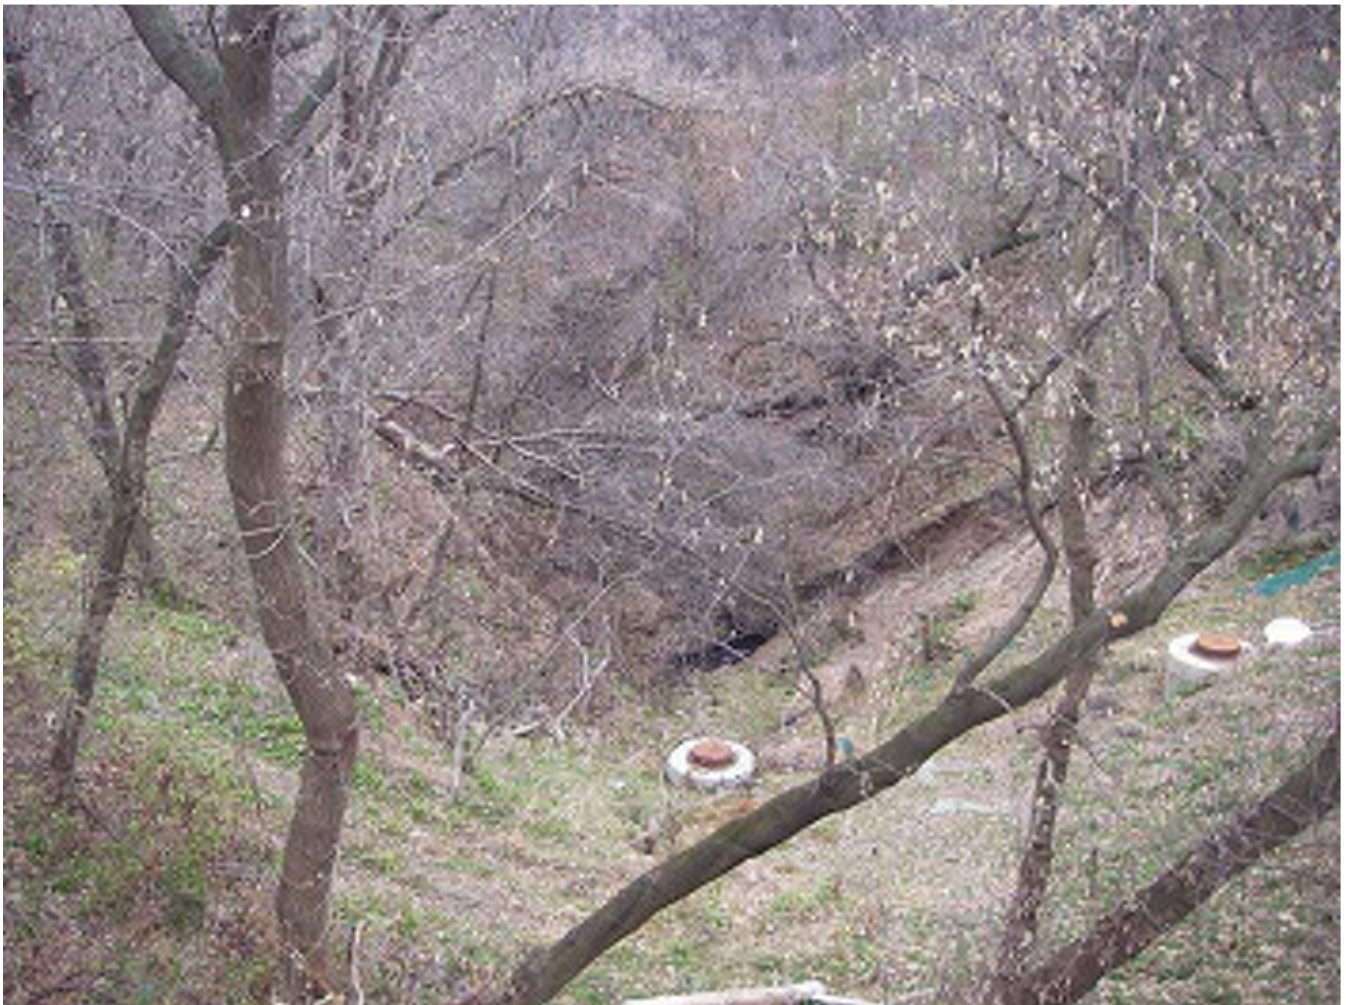
Waypoint 73

Deep gully with severe erosion

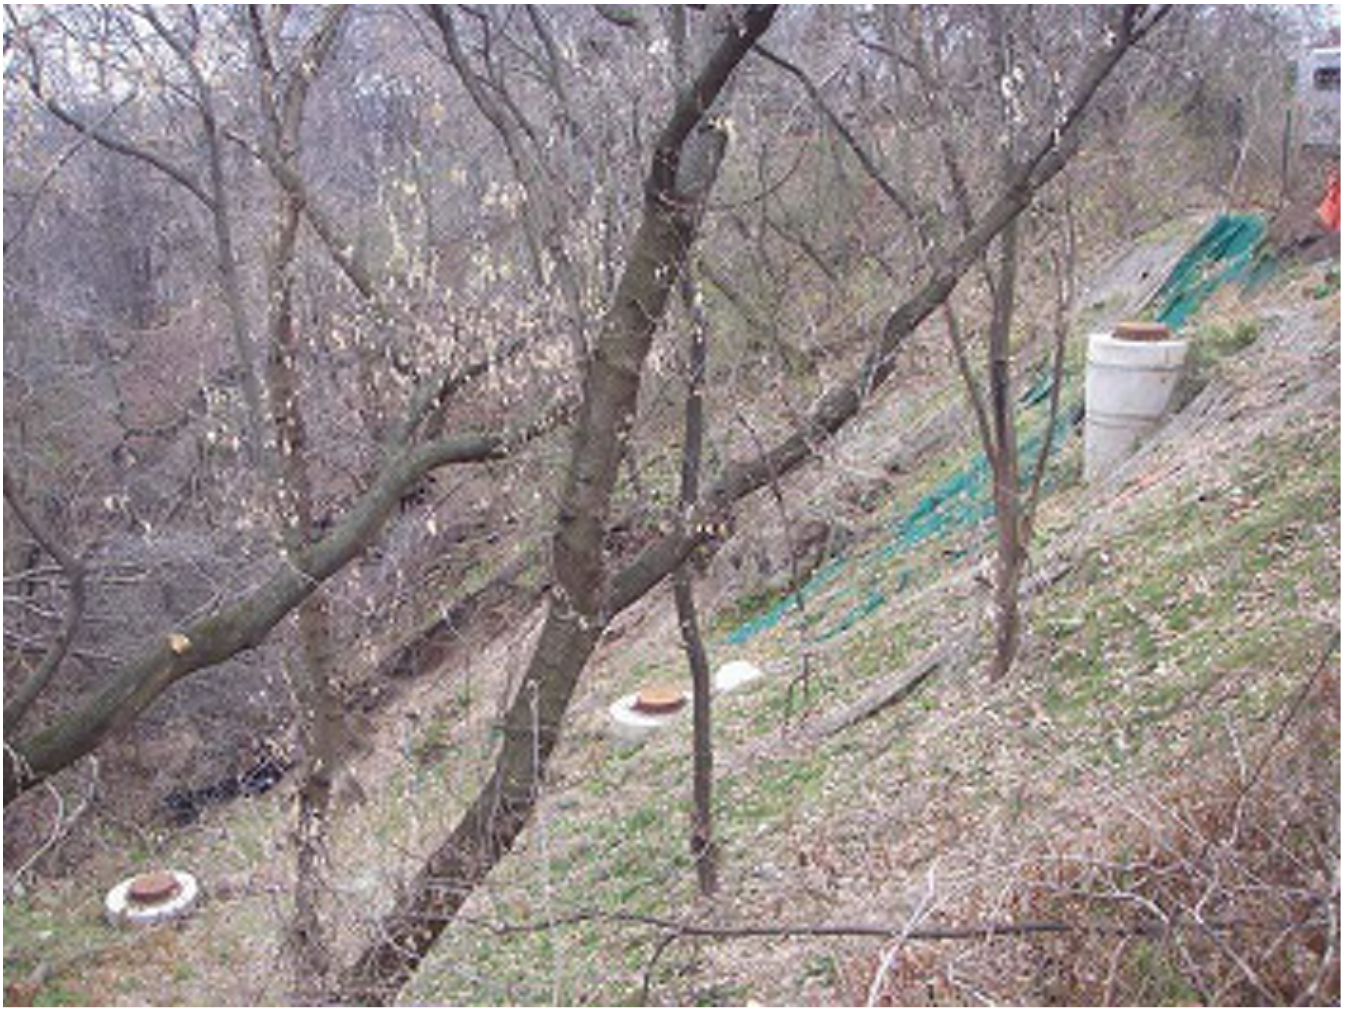
Some erosion control in place

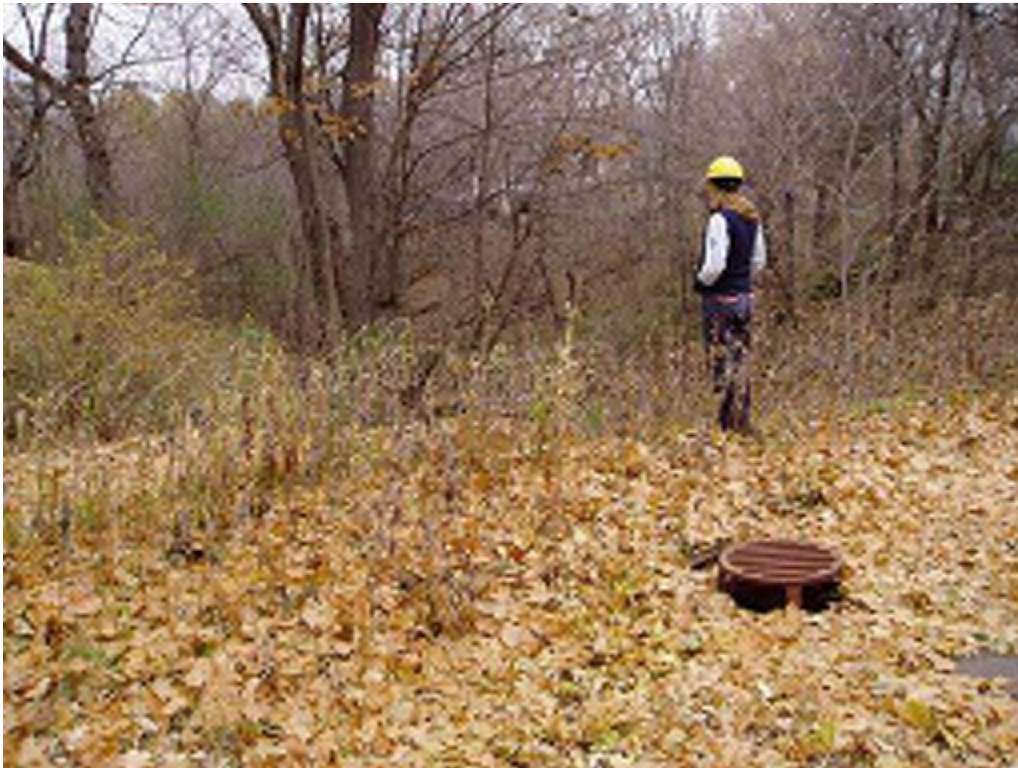
Waypoint 74

Storm drain

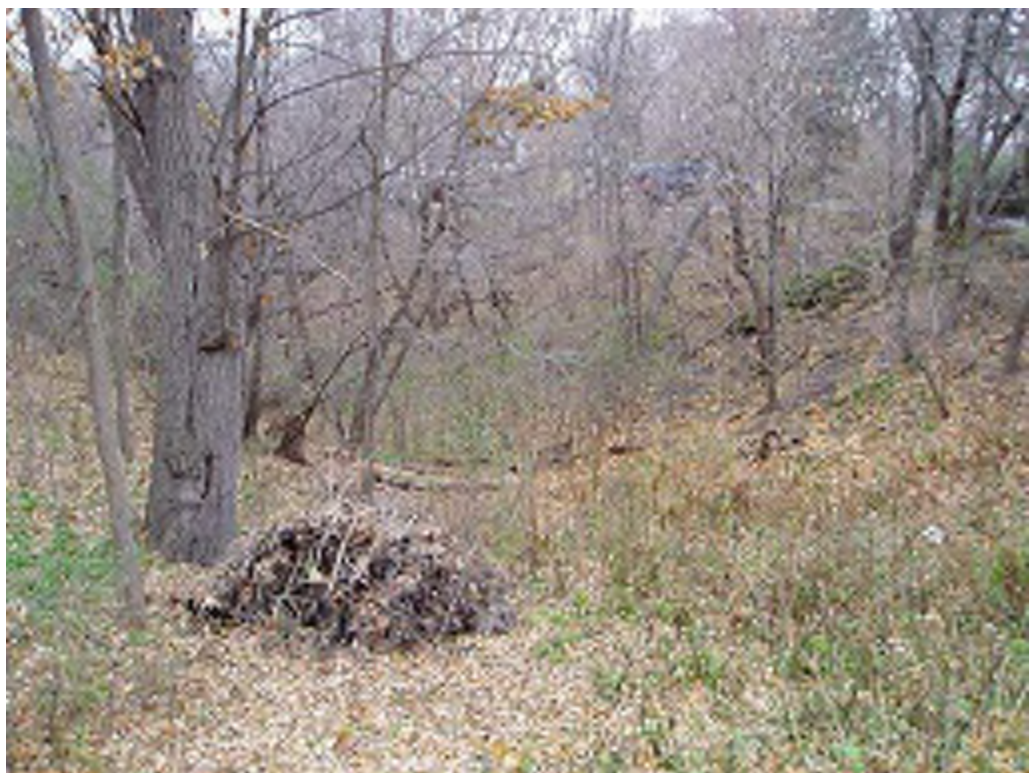
Beginning of gully erosion

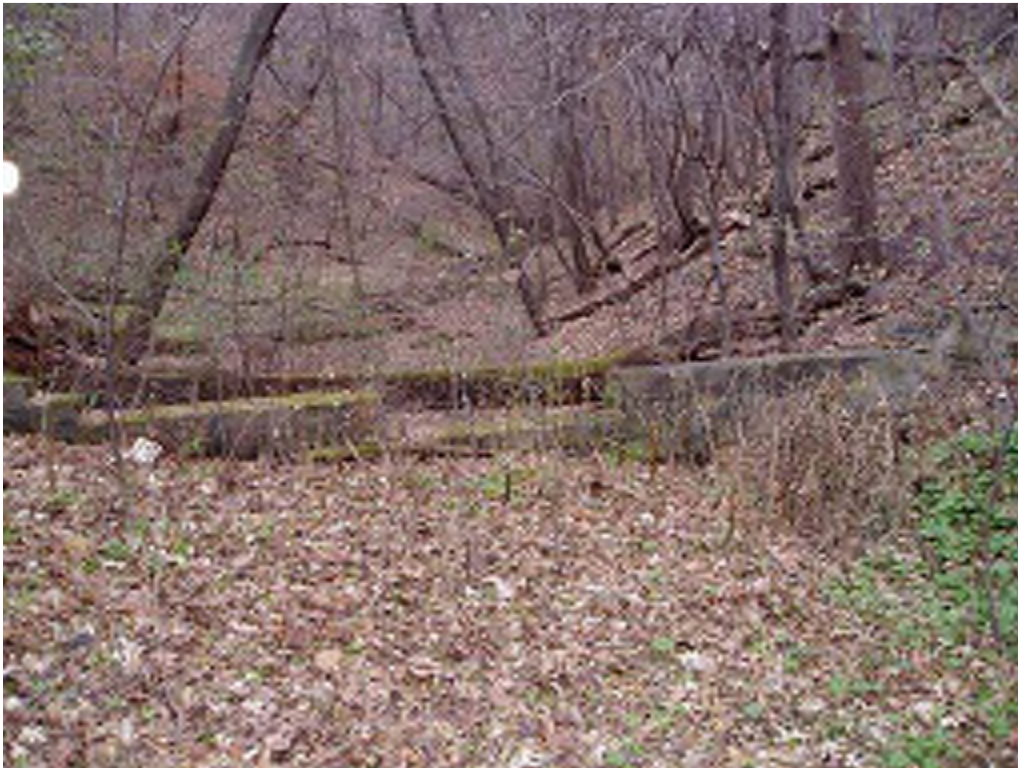
Waypoint 75

Retaining wall in gully, erosion apparent, bare soil

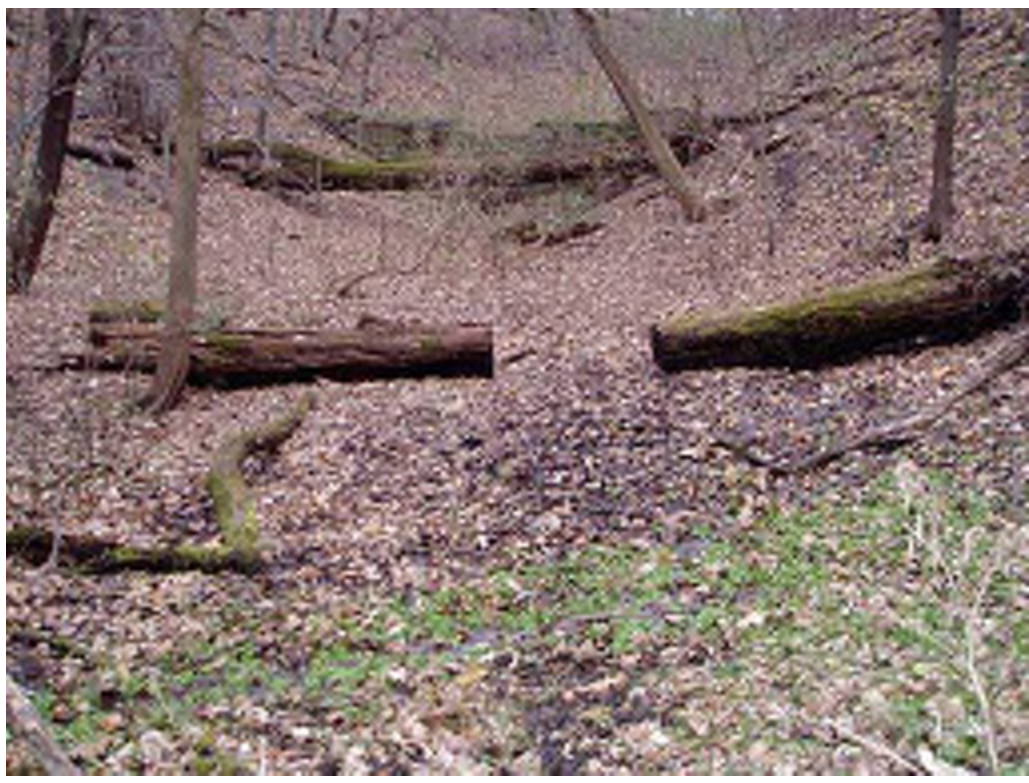
Spring by retaining wall

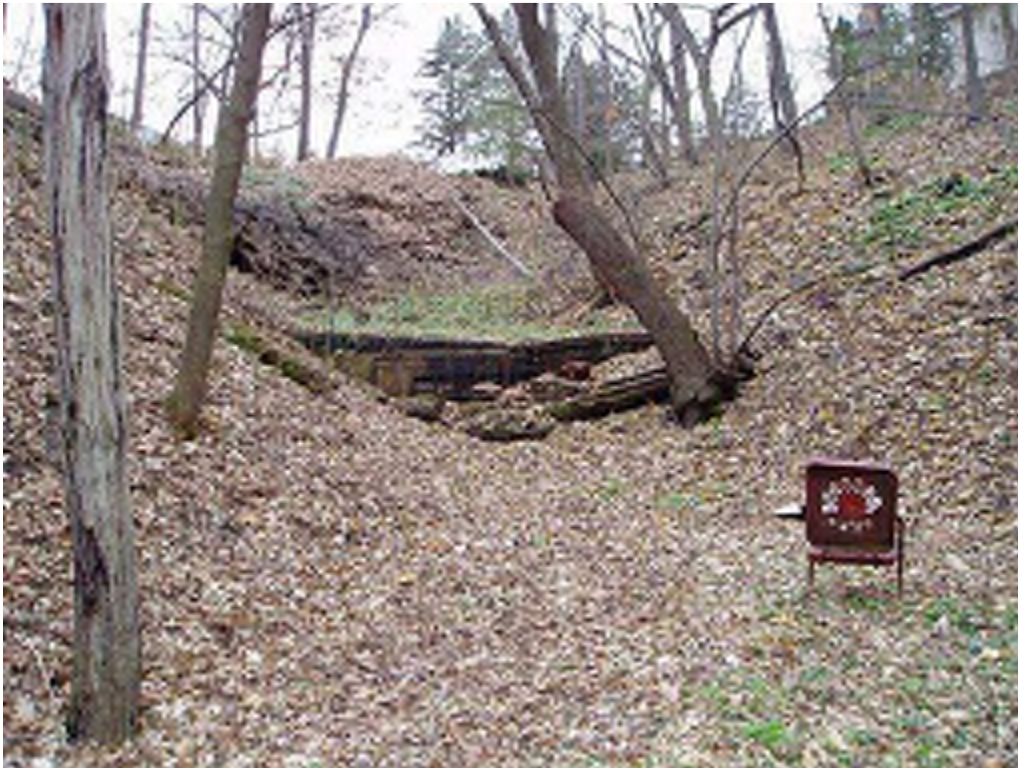
Waypoint 76

Branch and retaining wall, erosion apparent

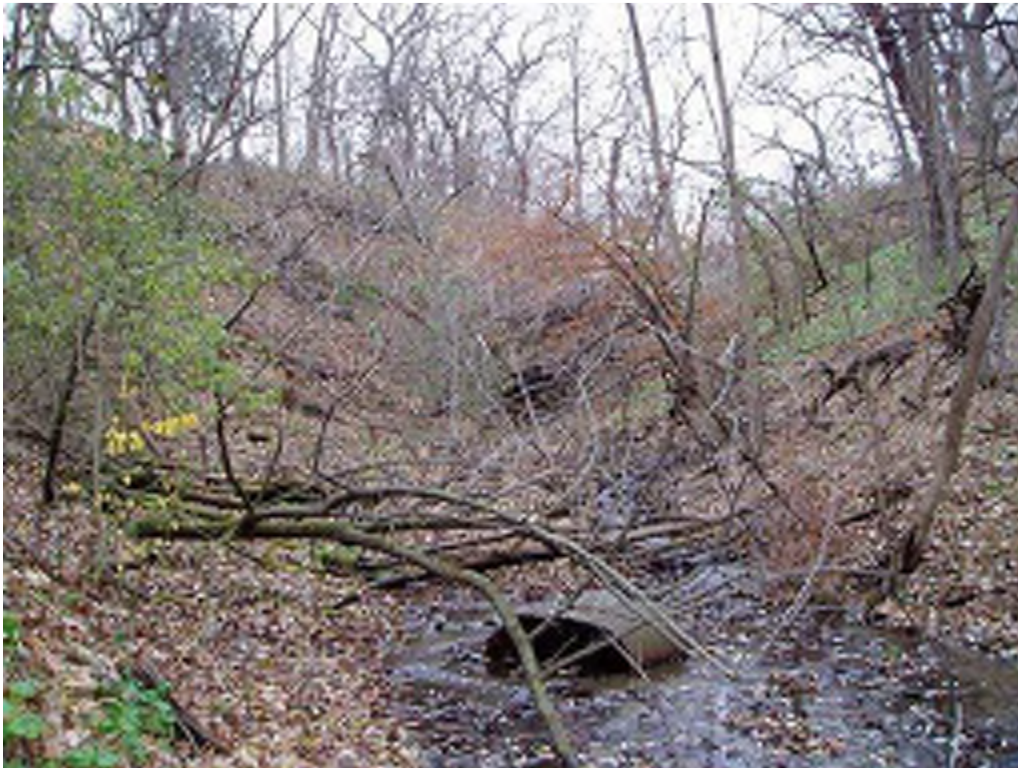
Waypoint 77

Gully with a lot of tree debris

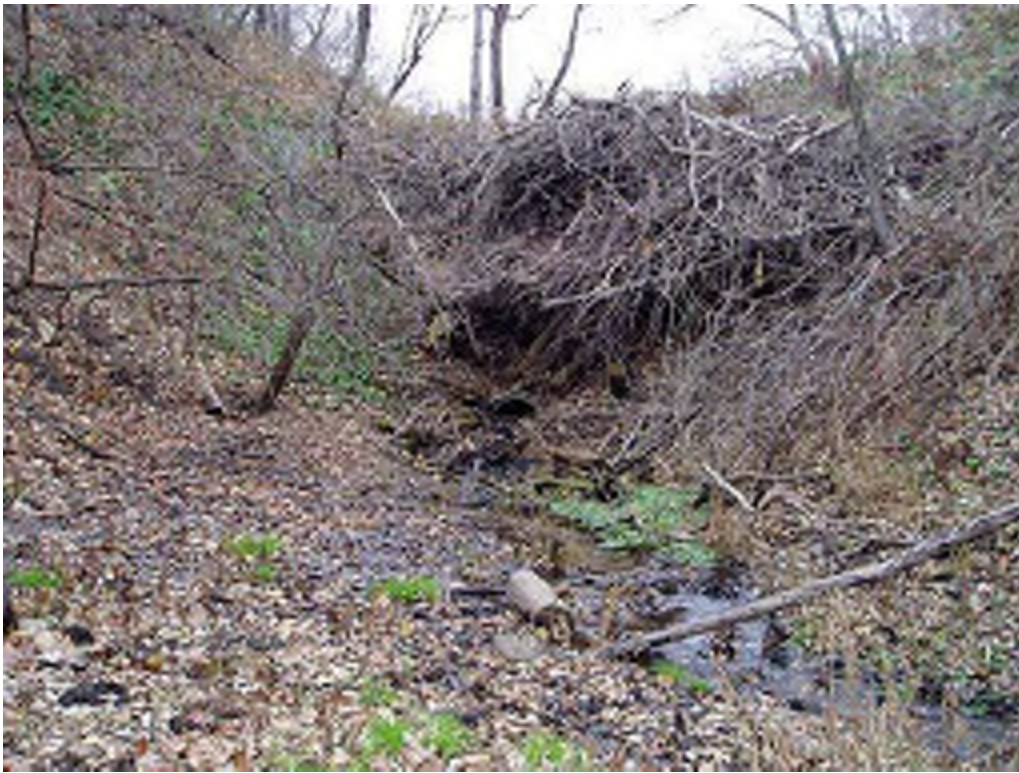
Culvert under dam

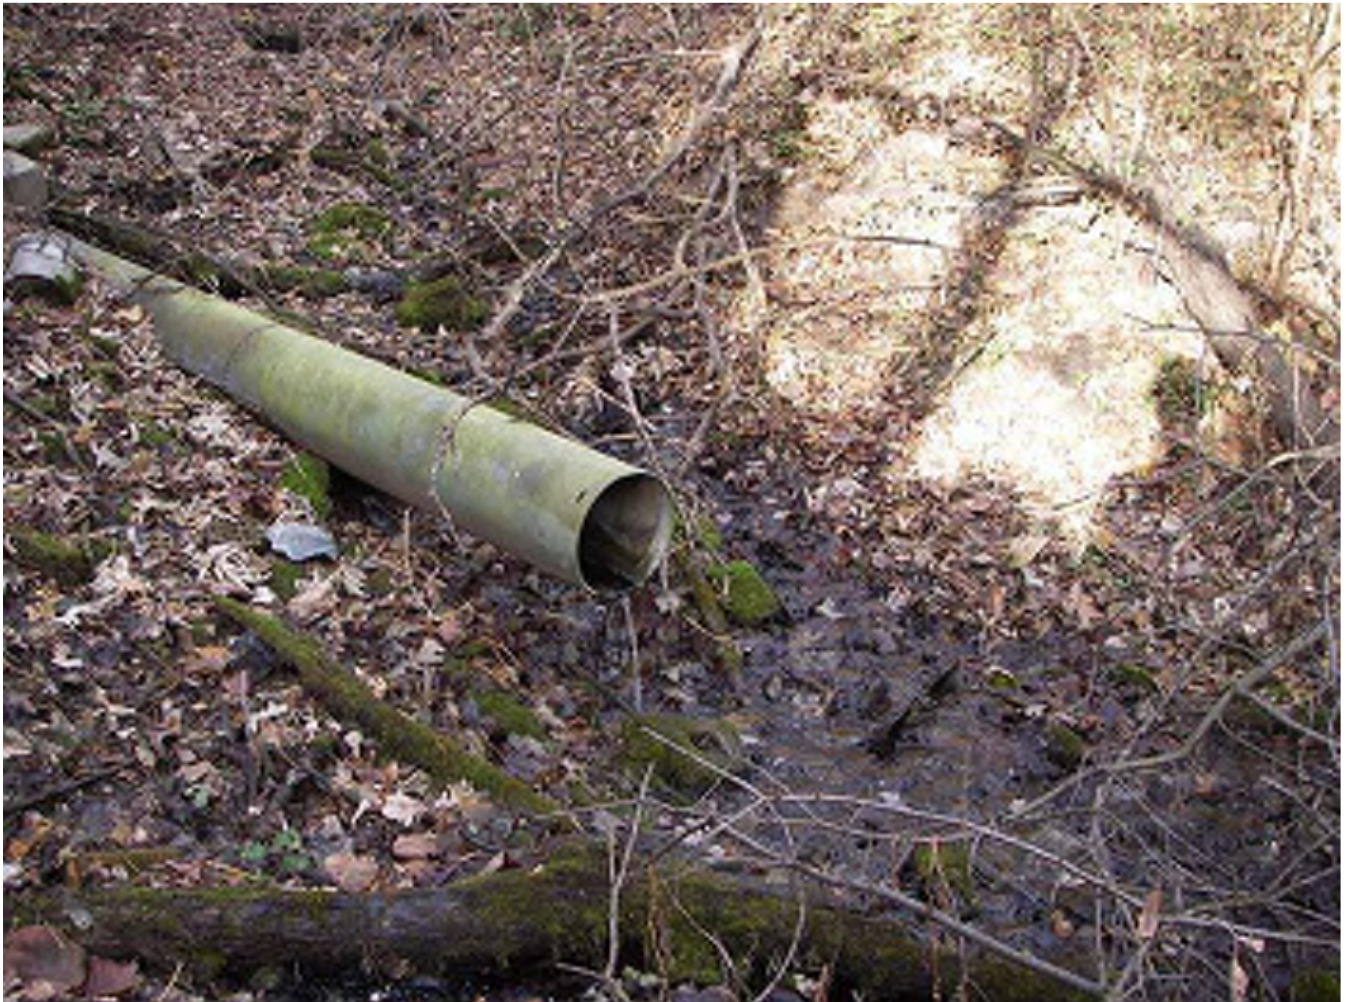
Waypoint 79

Pipe outlet and spring

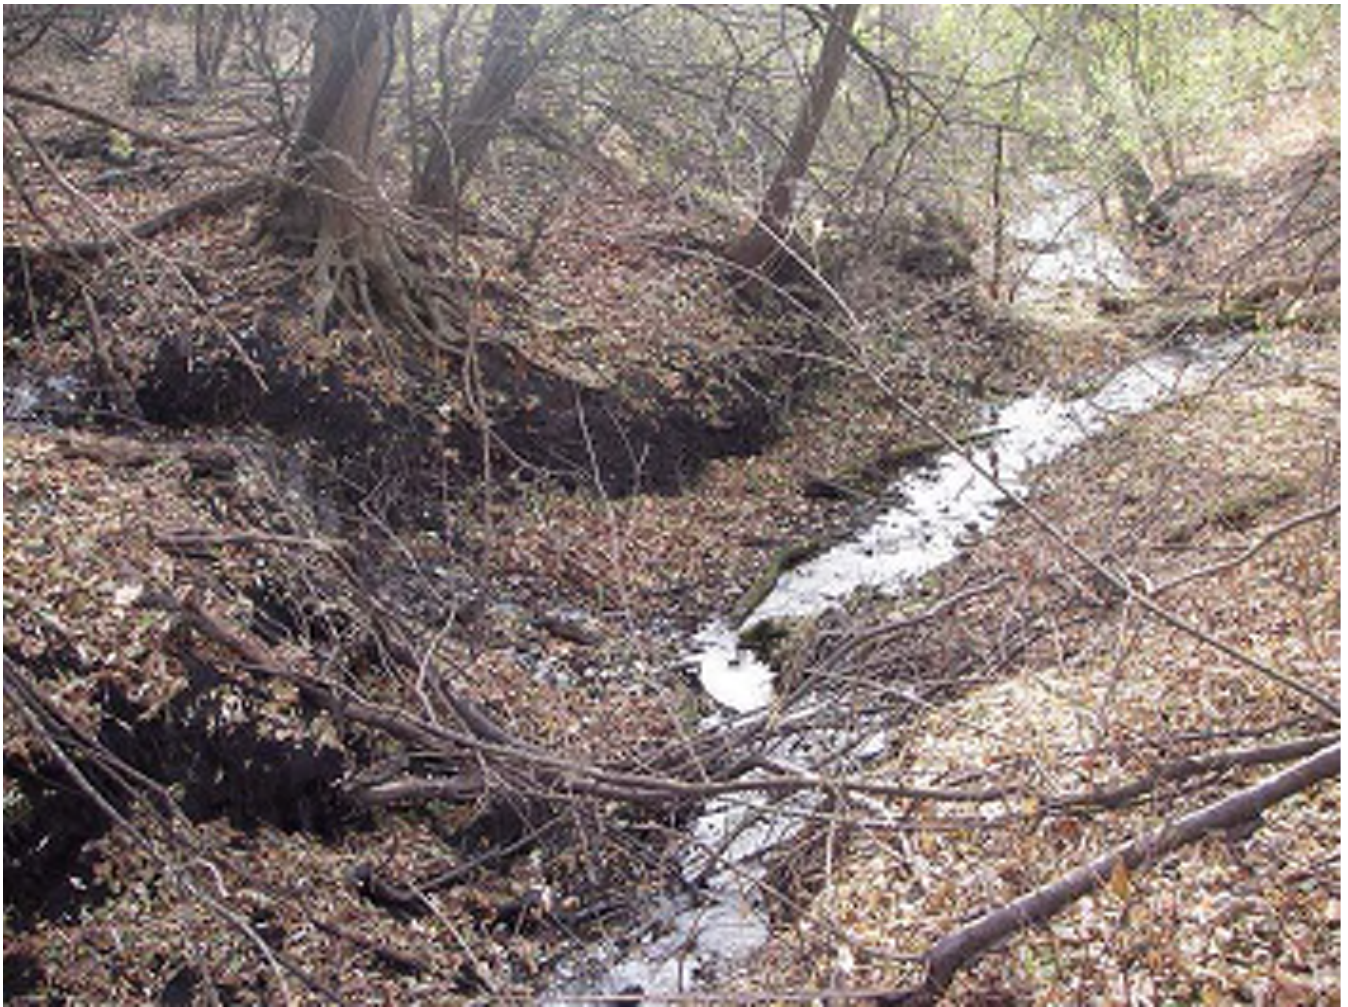
Some severe erosion throughout gully

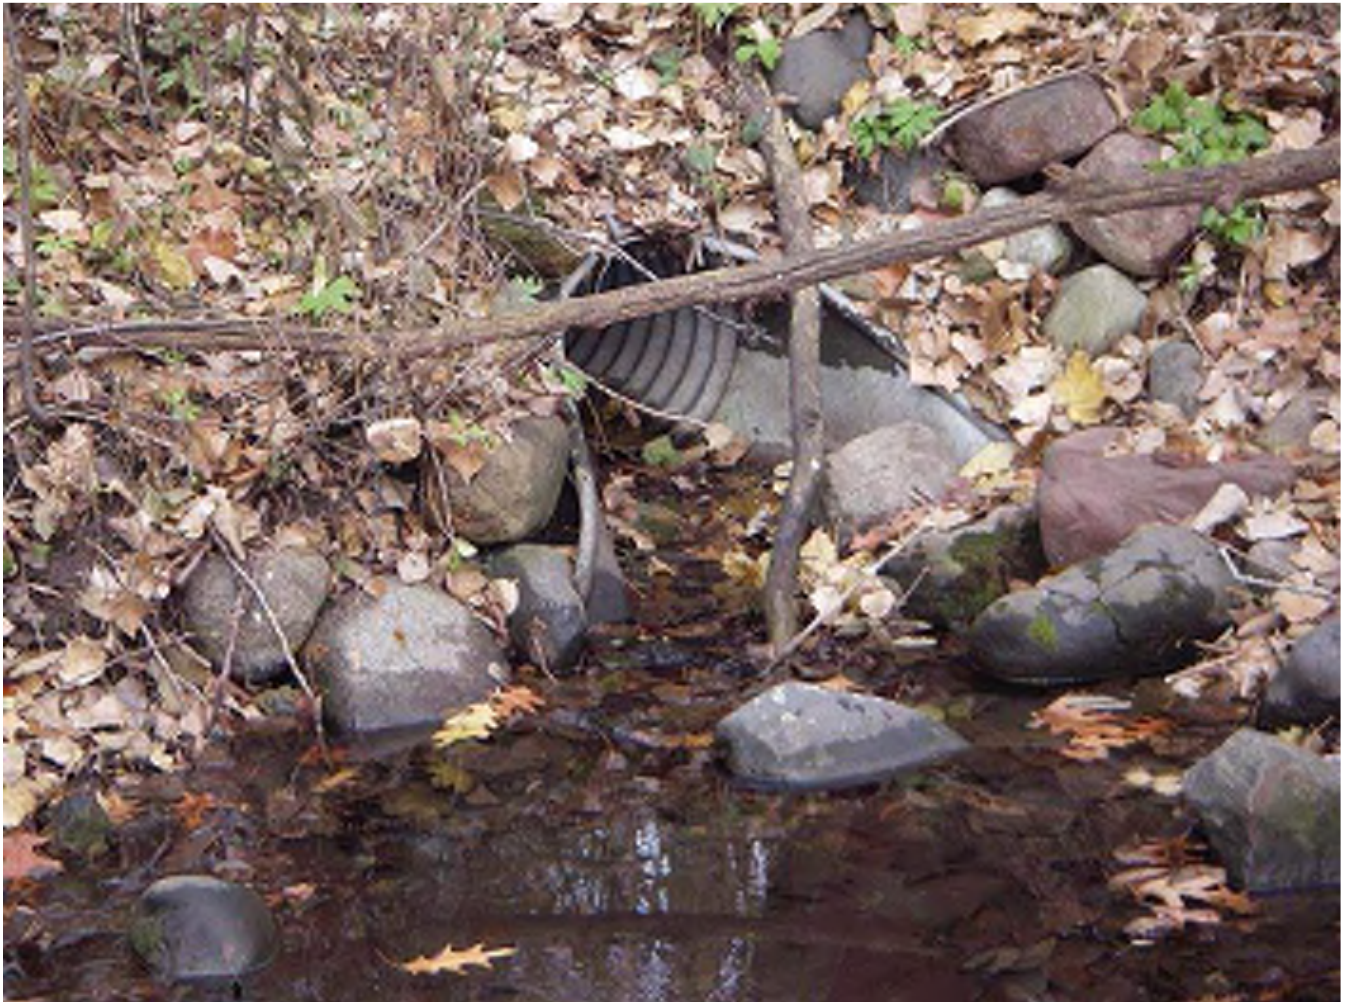
Waypoint 80

Pipe outfall

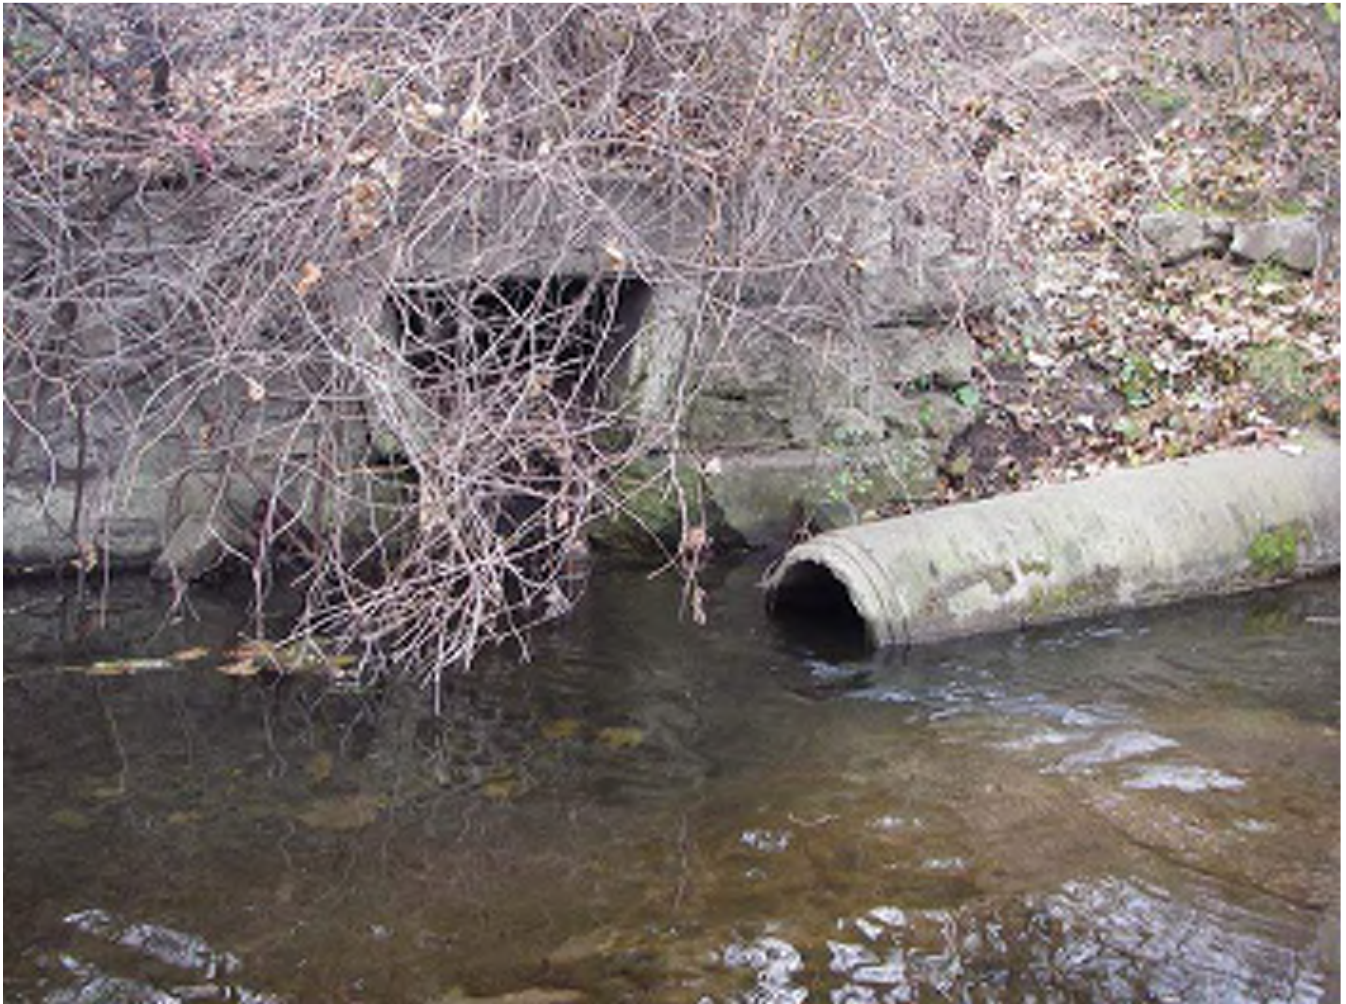
Waypoint 81

Pipe outfall
