Appendix K: Lower Minnesota River Watershed District: Gully Inventory

Gully Inventory Map
 Area #1
 Lower Minnesota River Watershed District
 Watershed Management Plan

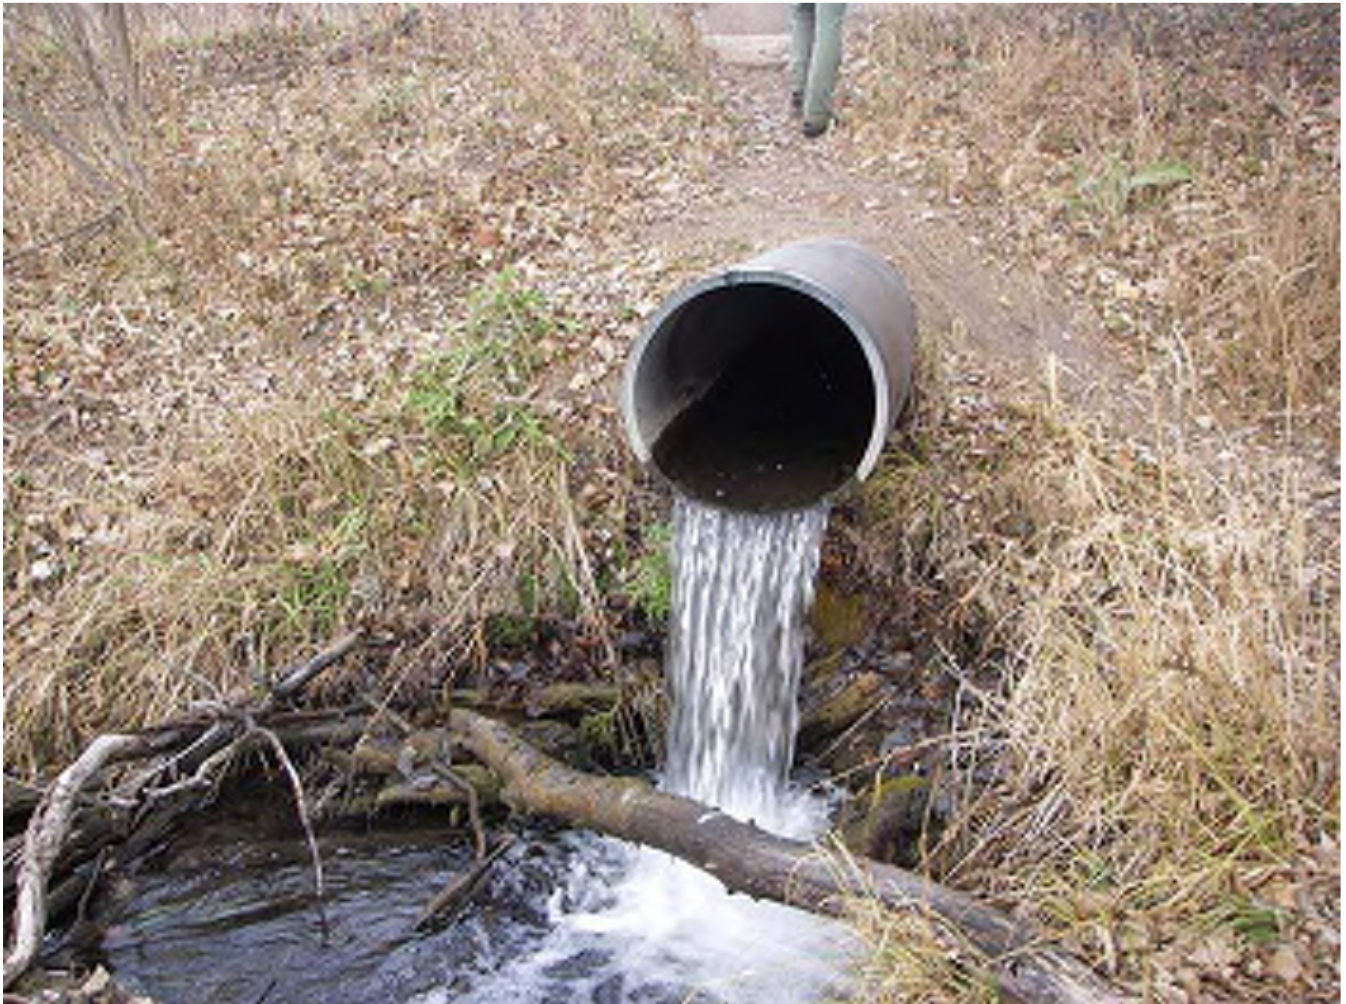
Waypoint 83

Pipe outfall

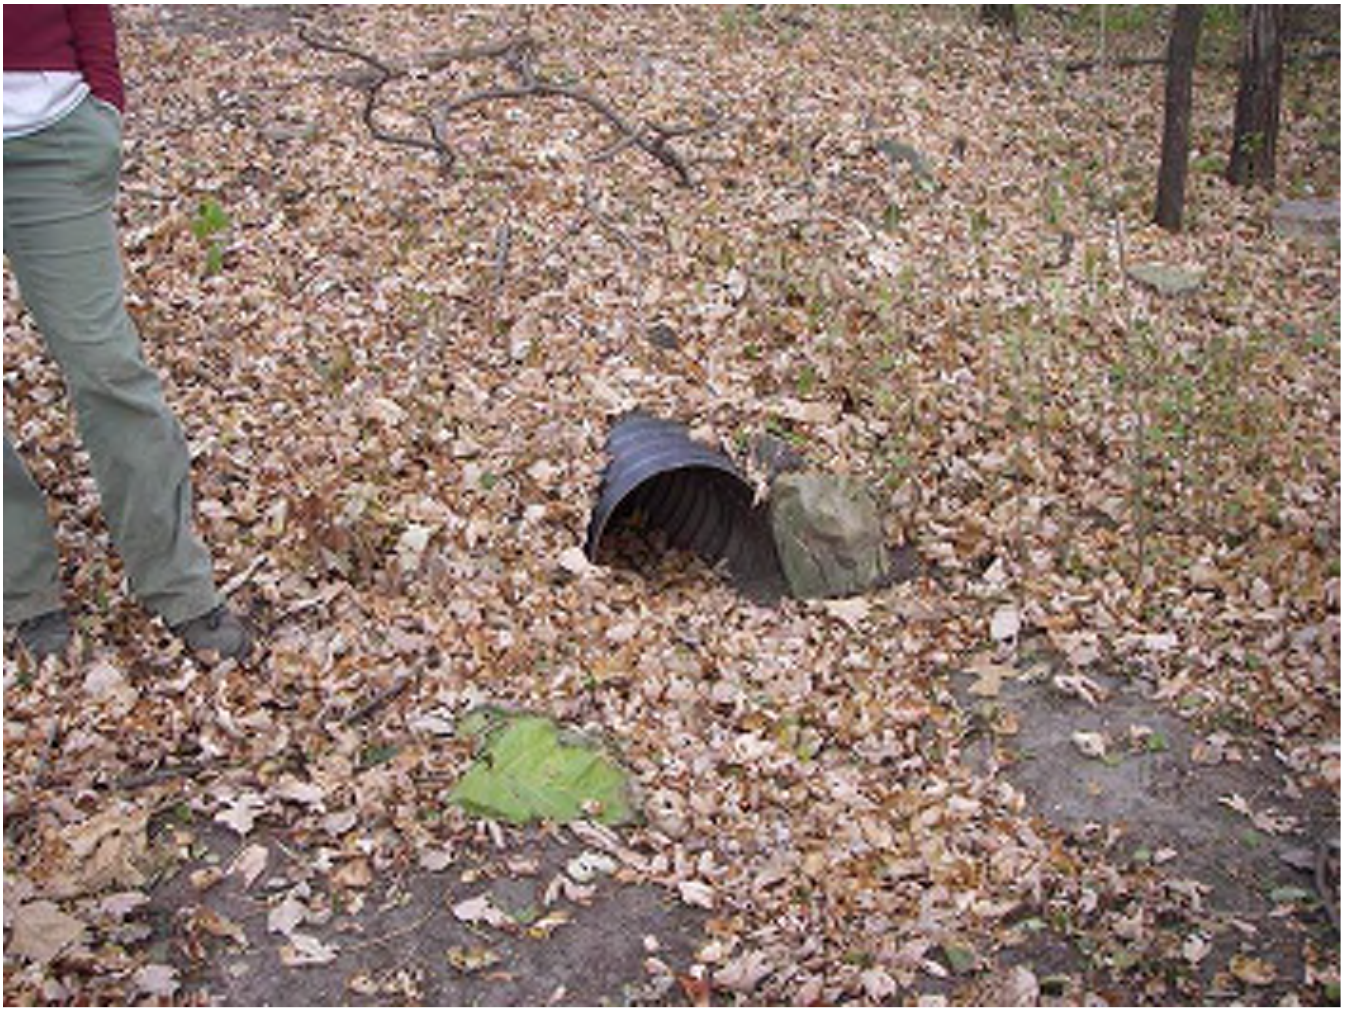
Pipe outfall

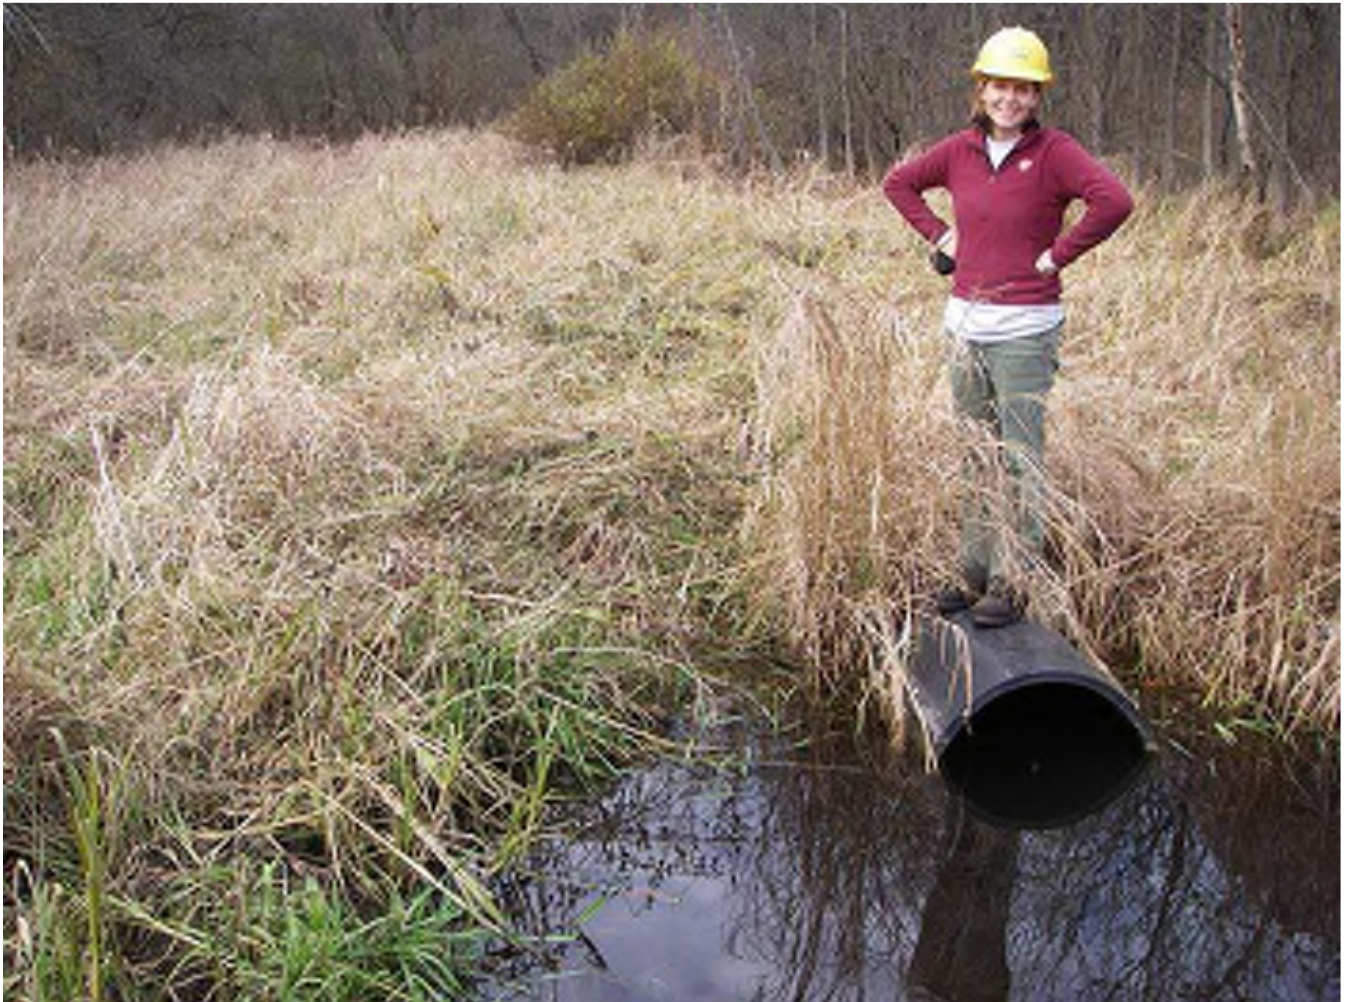
Waypoint 85

Pipe outfall

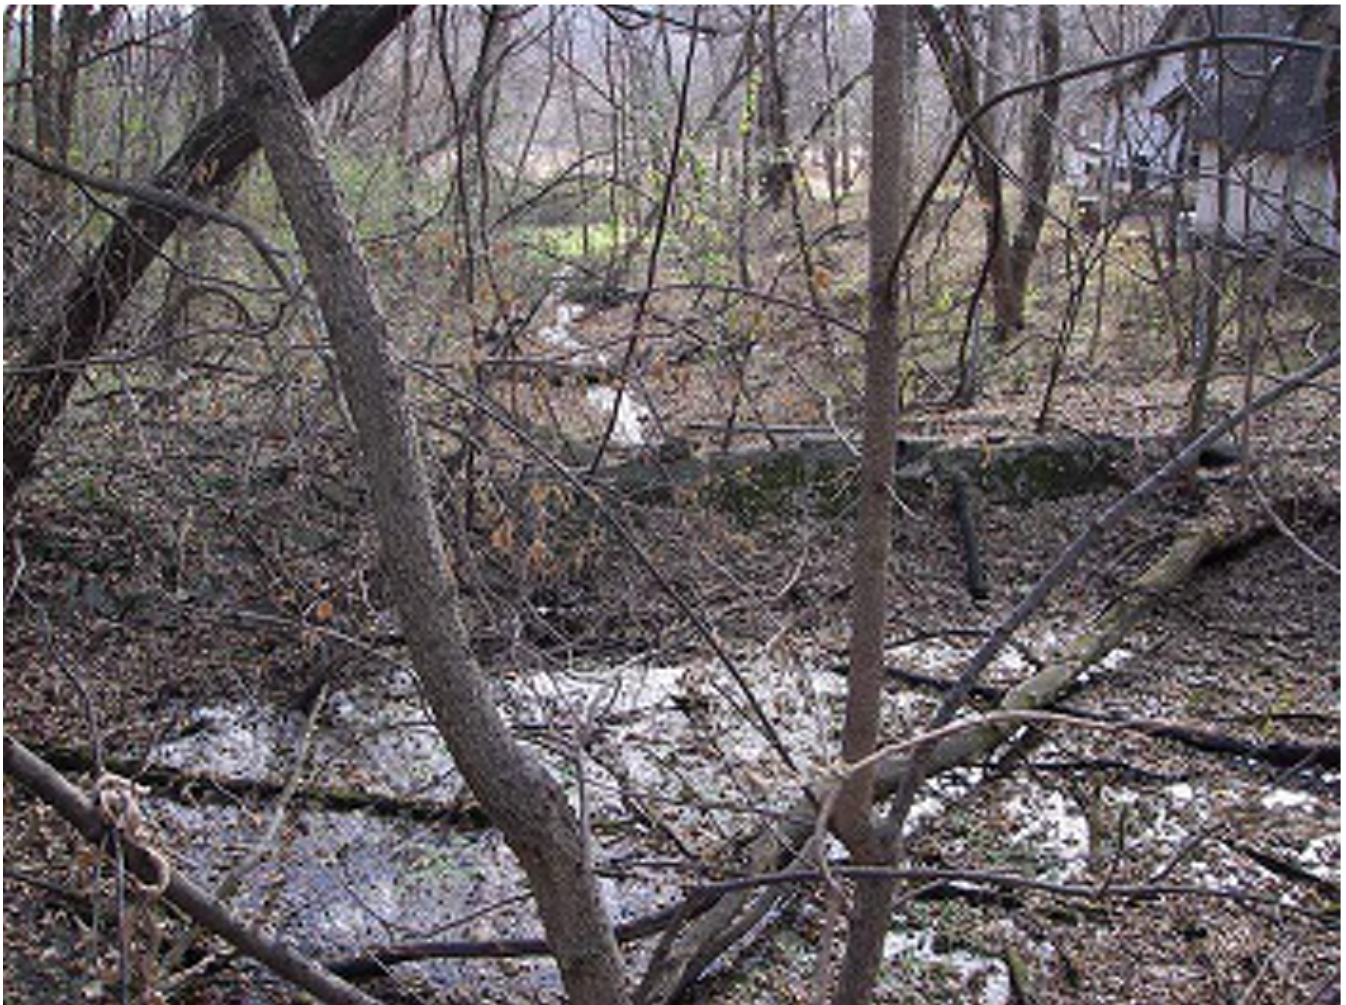
Waypoint 86

Spring w/retaining wall and outlet pipe on top of wall, minimal erosion

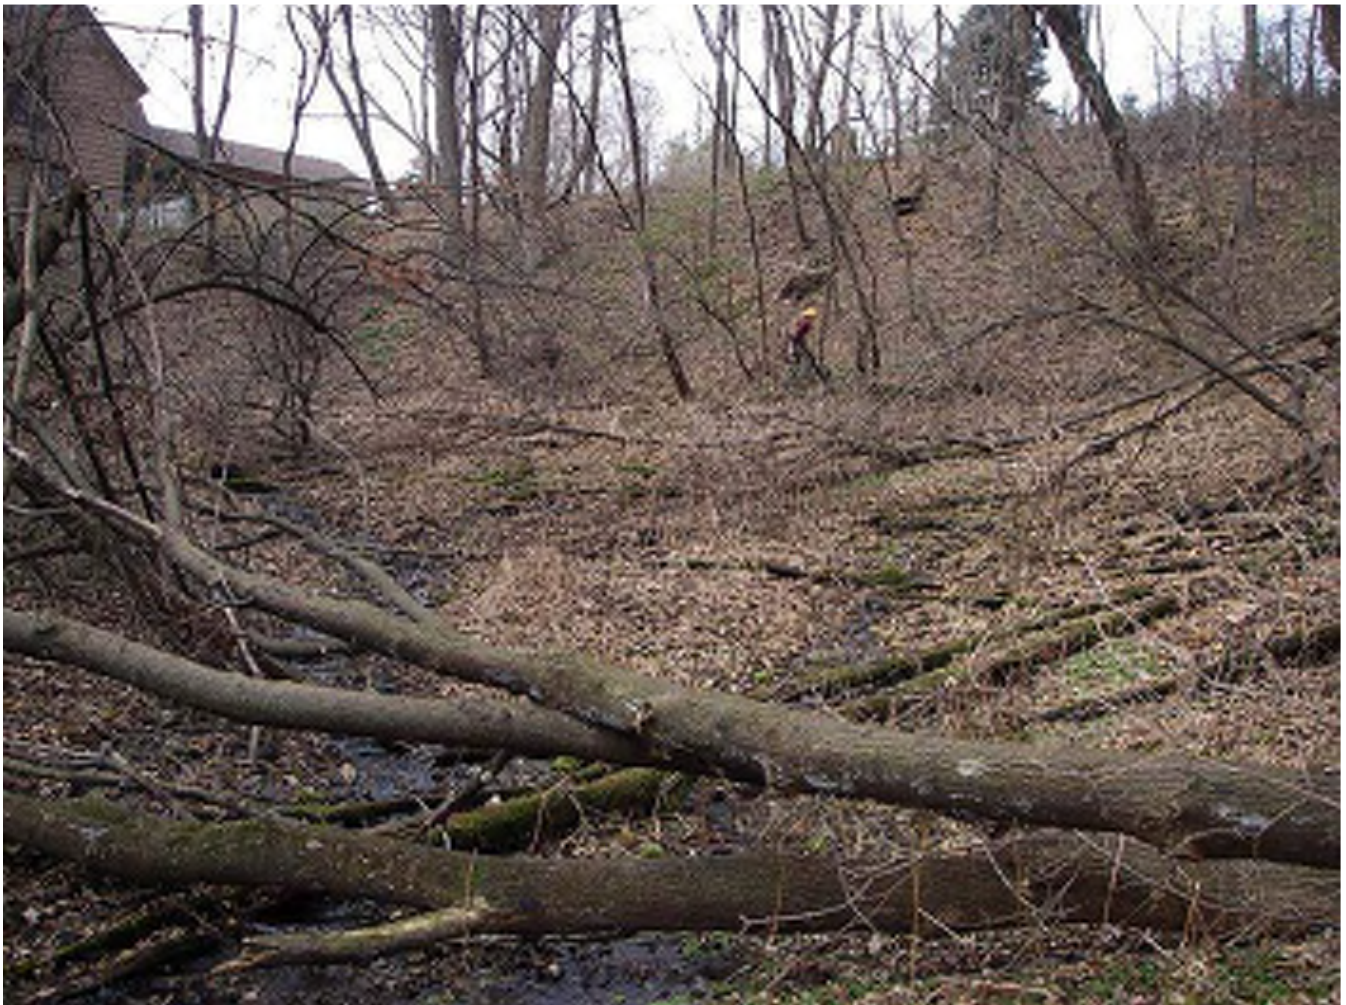
Waypoint 87

Some erosion present/spring-S. Branch

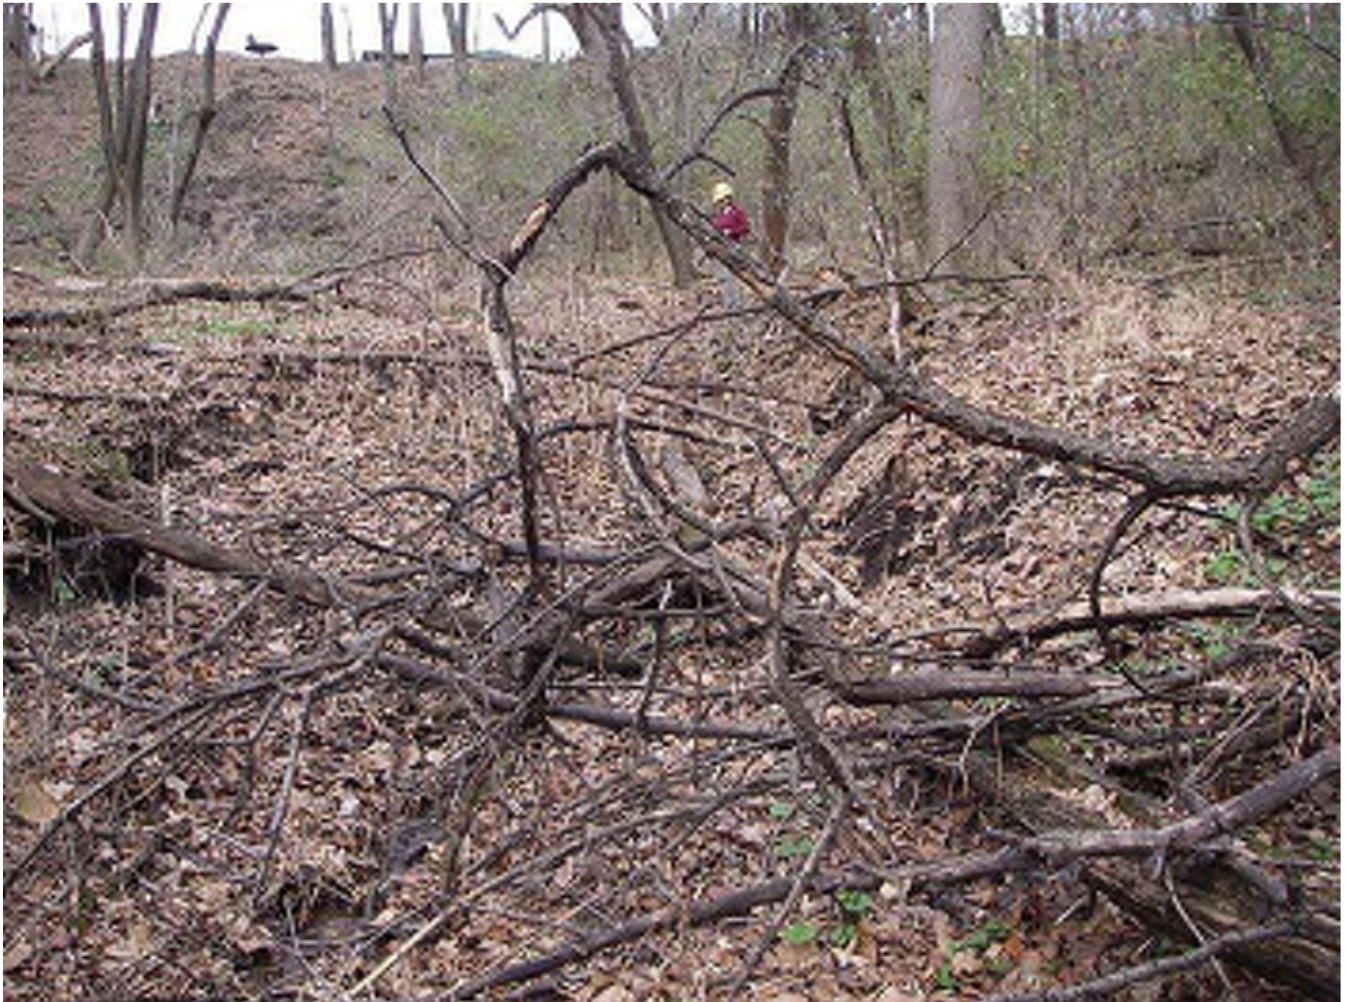
Waypoint 88

N. branch of spring, tree litter

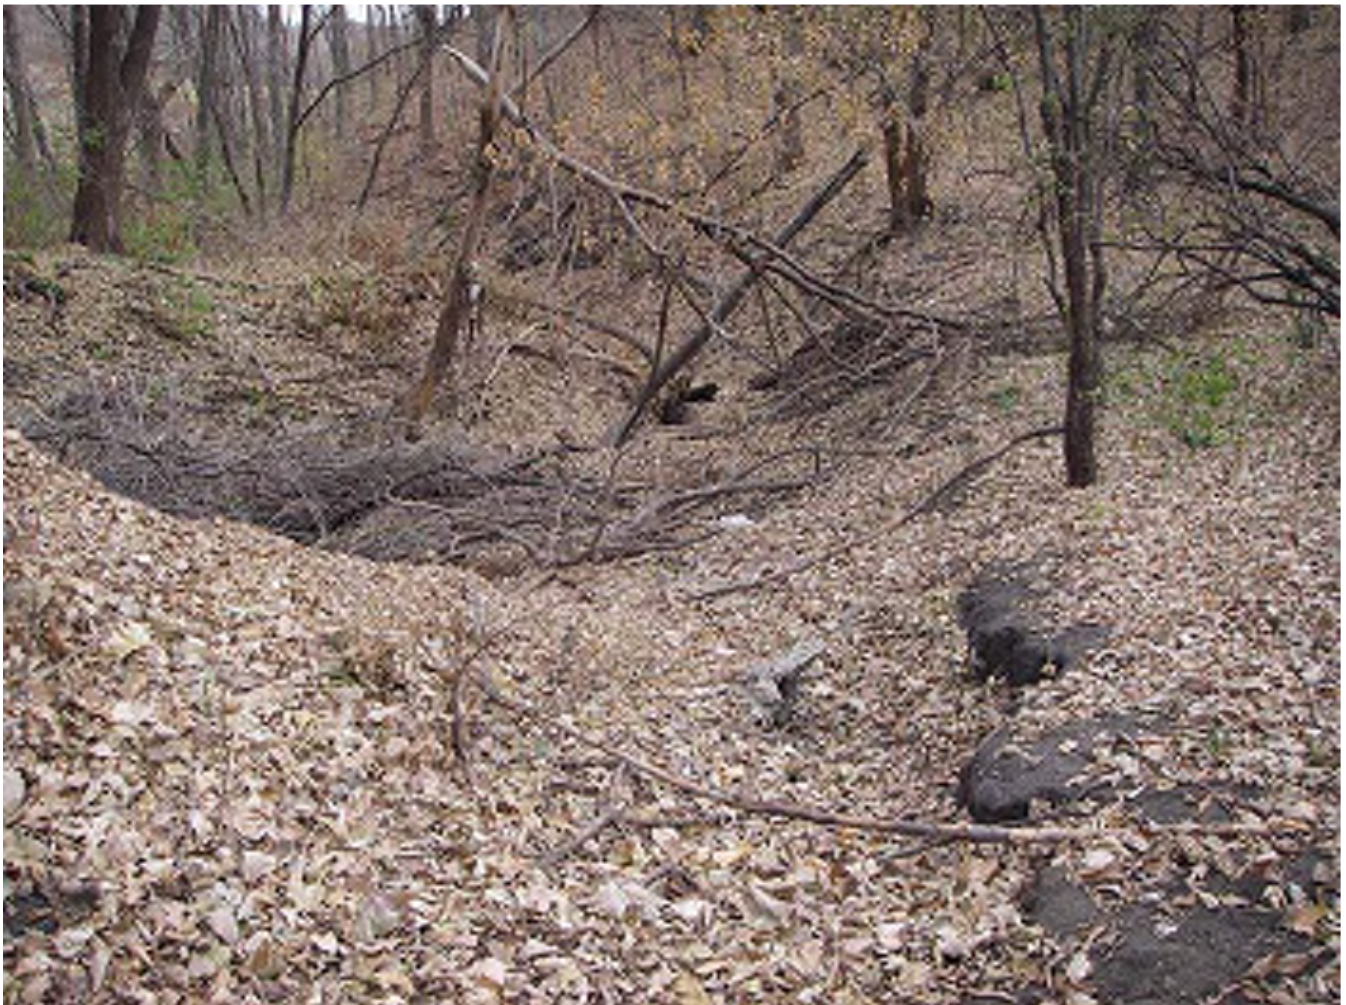
Waypoint 89

Severe erosion on banks and spring

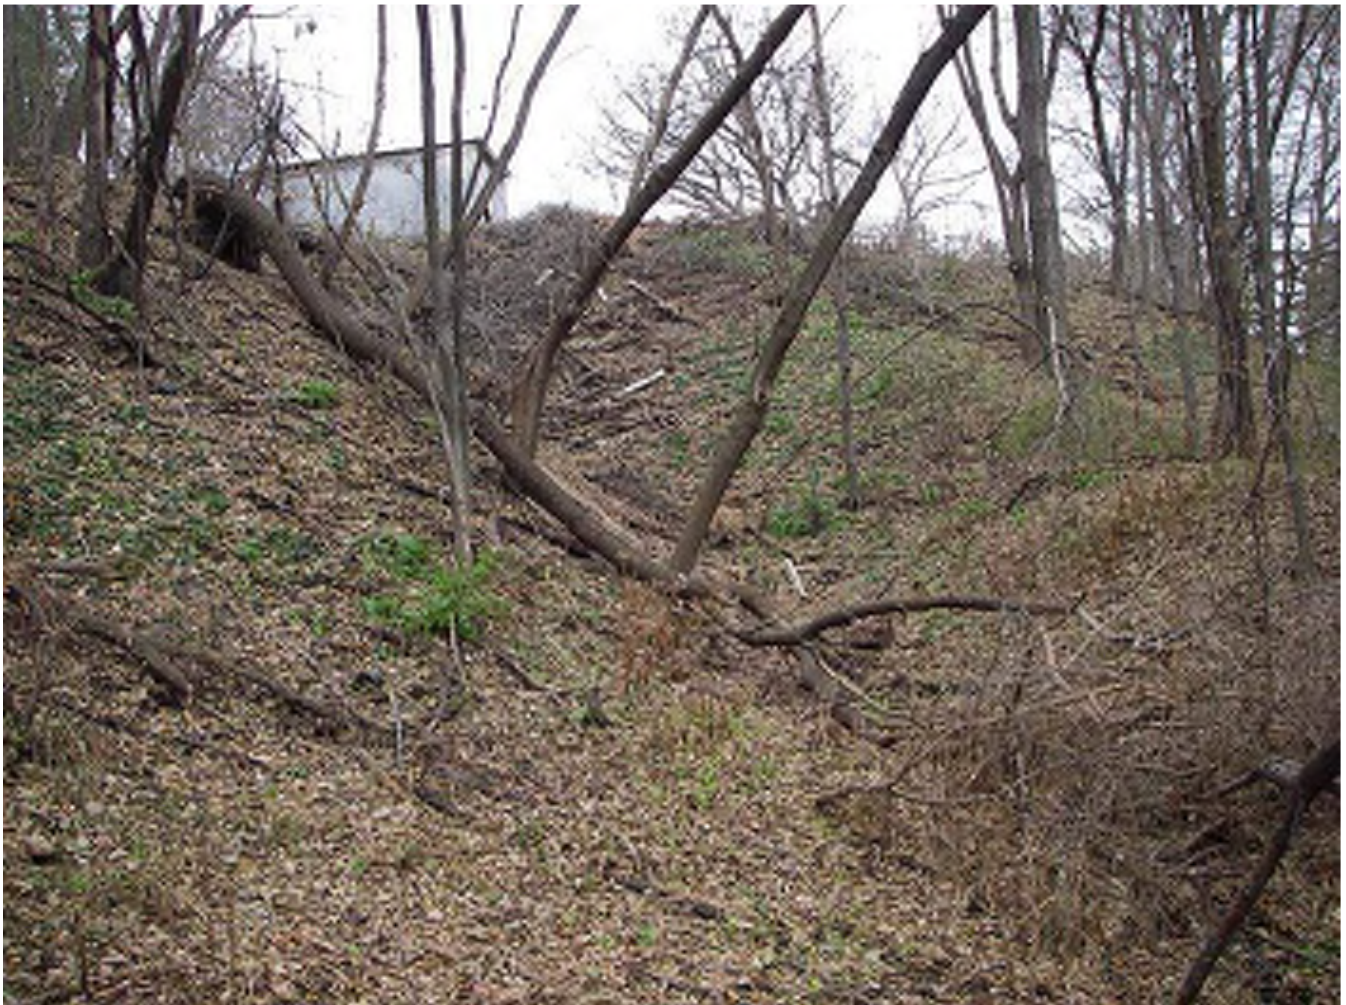
Waypoint 90

Spring on N. branch, much tree debris

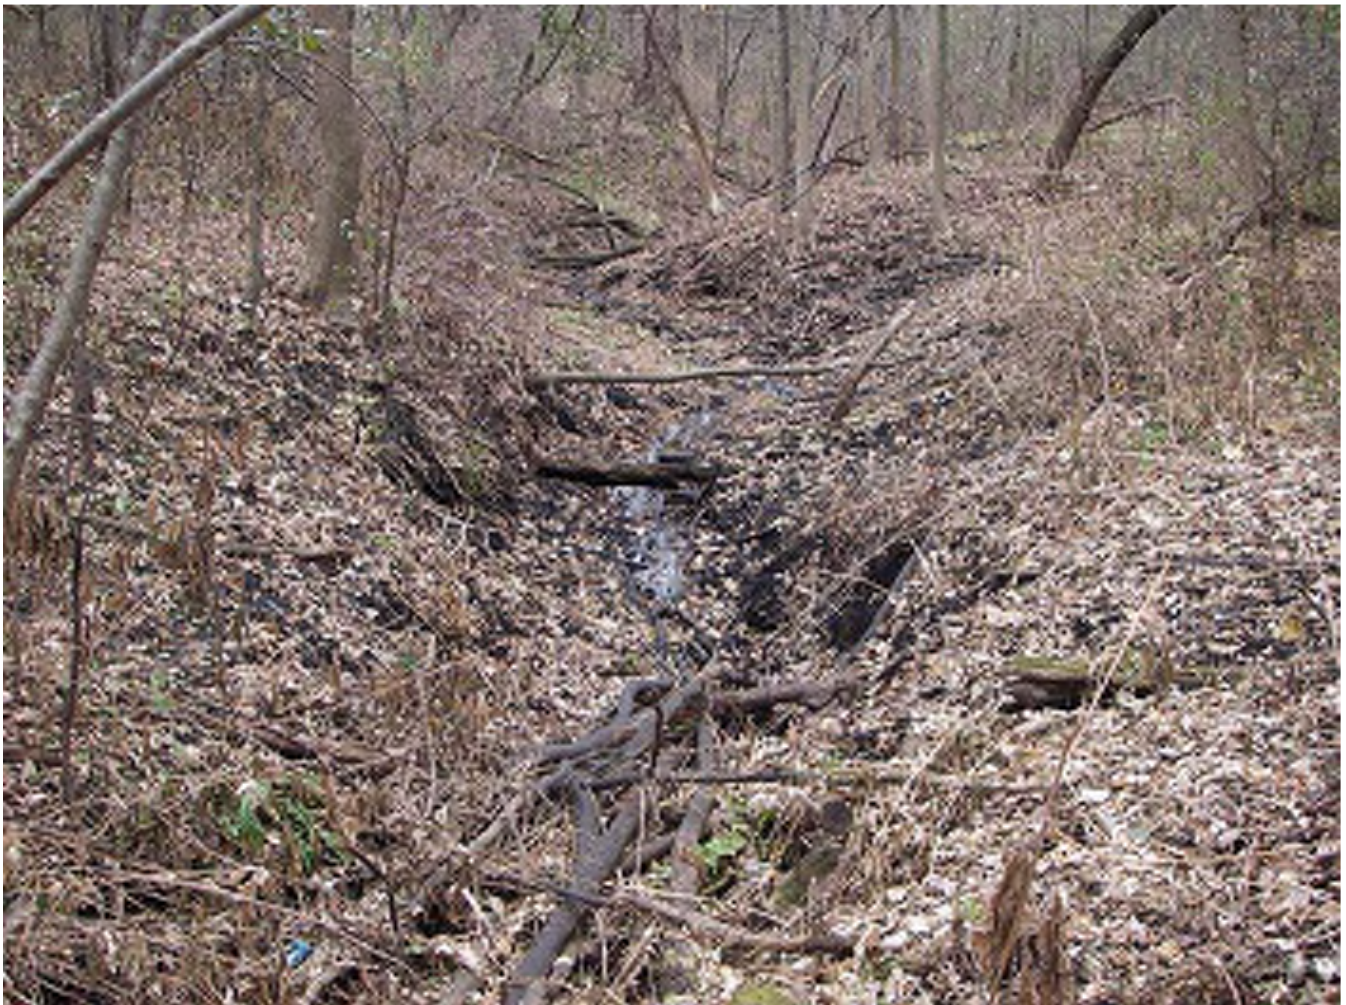
Waypoint 91

Spring, some severe erosion and tree debris

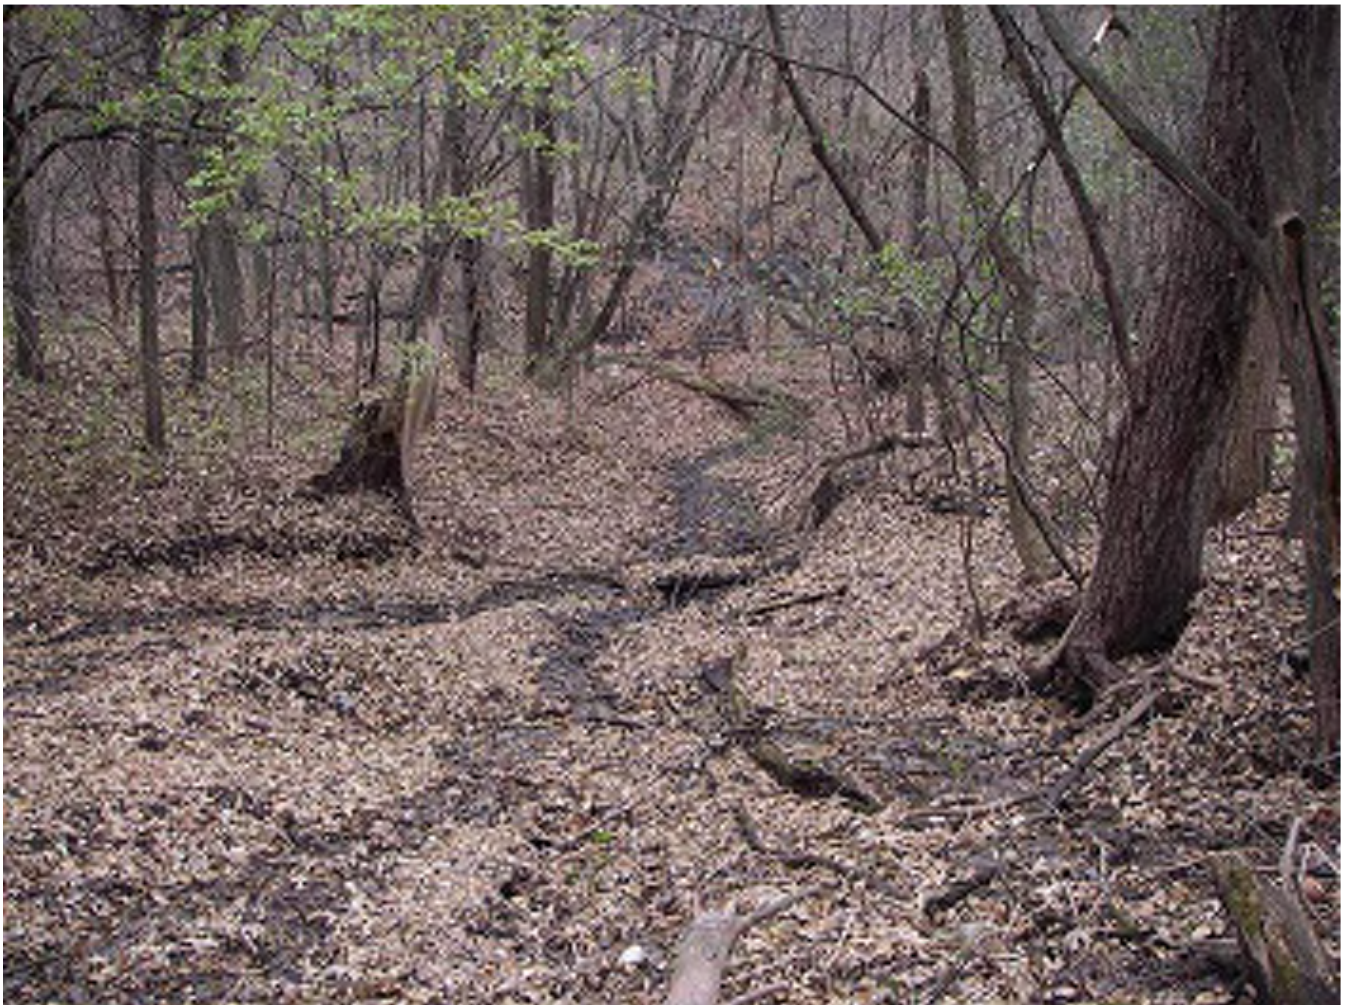
S. branch, spring, moderate erosion

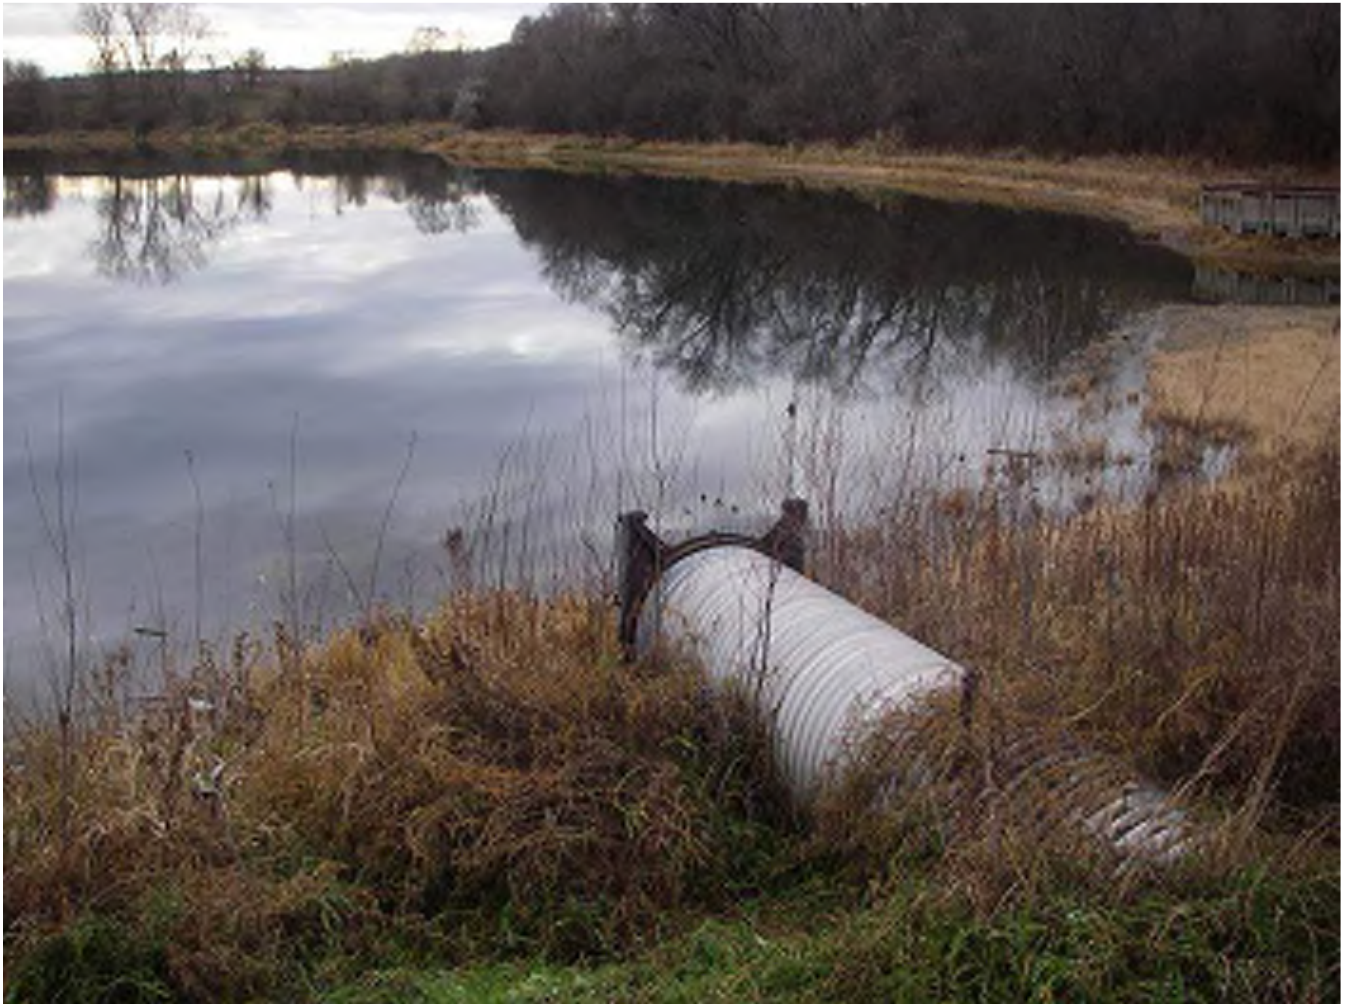
Waypoint 93

No erosion, pipe outlet

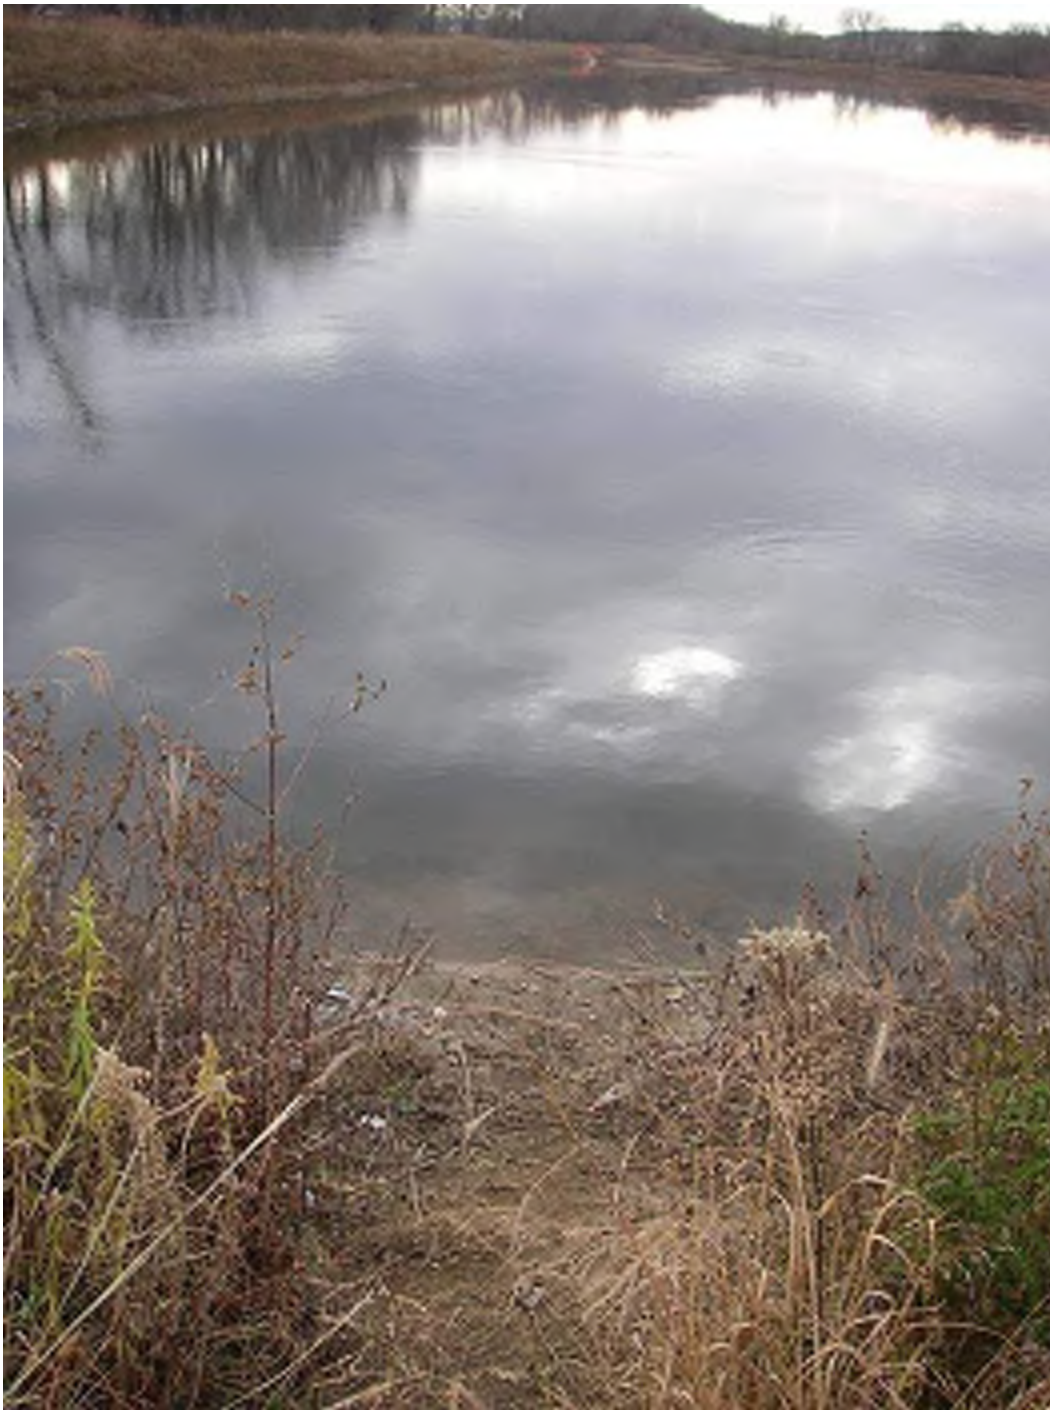
Waypoint 94

Pipe underwater

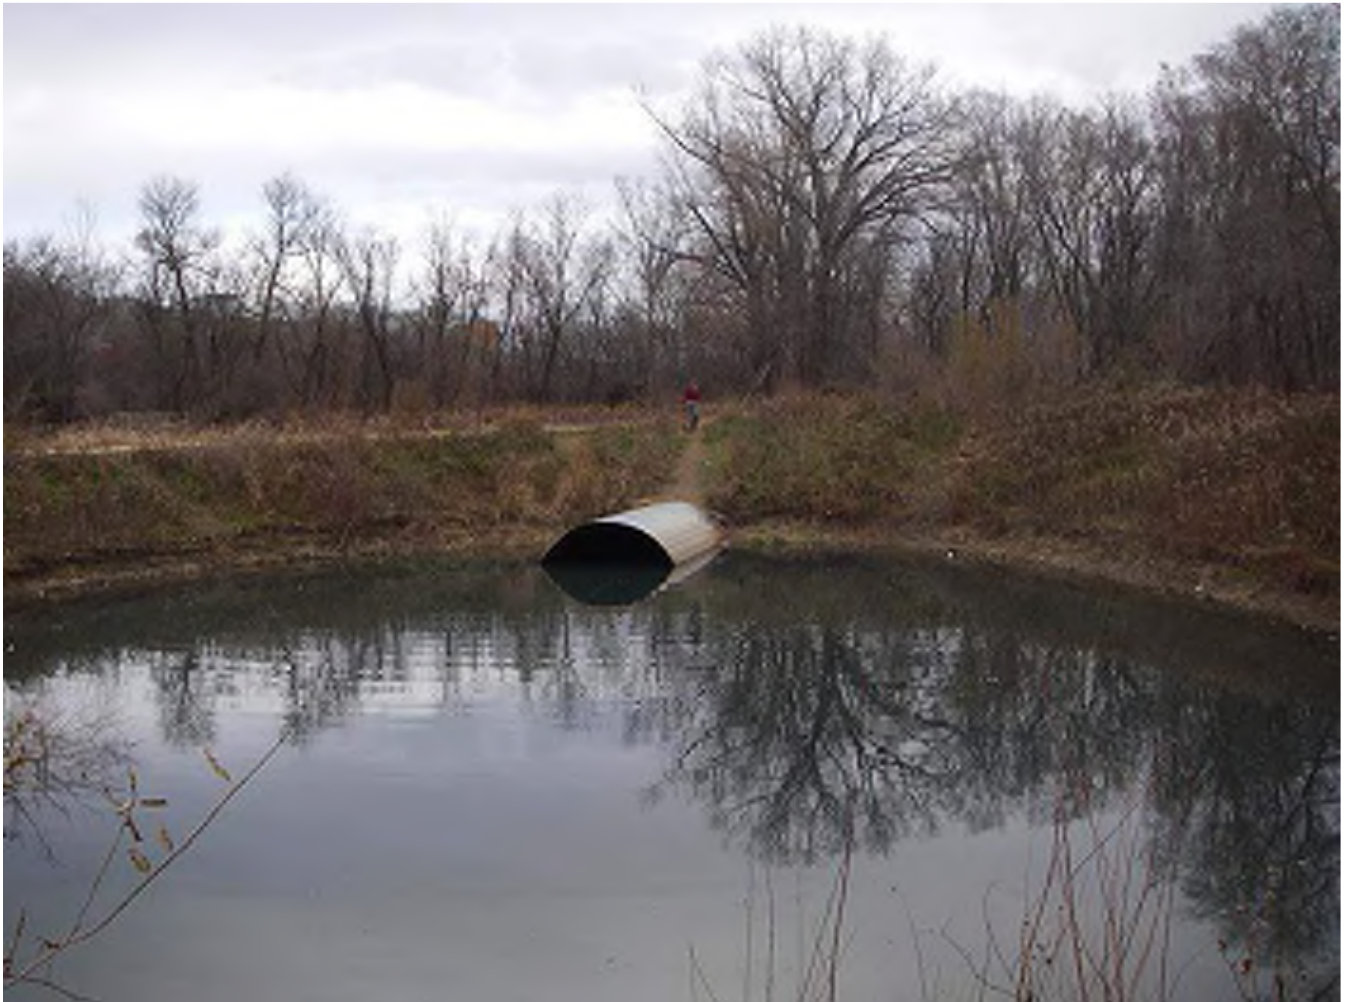
Waypoint 95

Outlet pipe

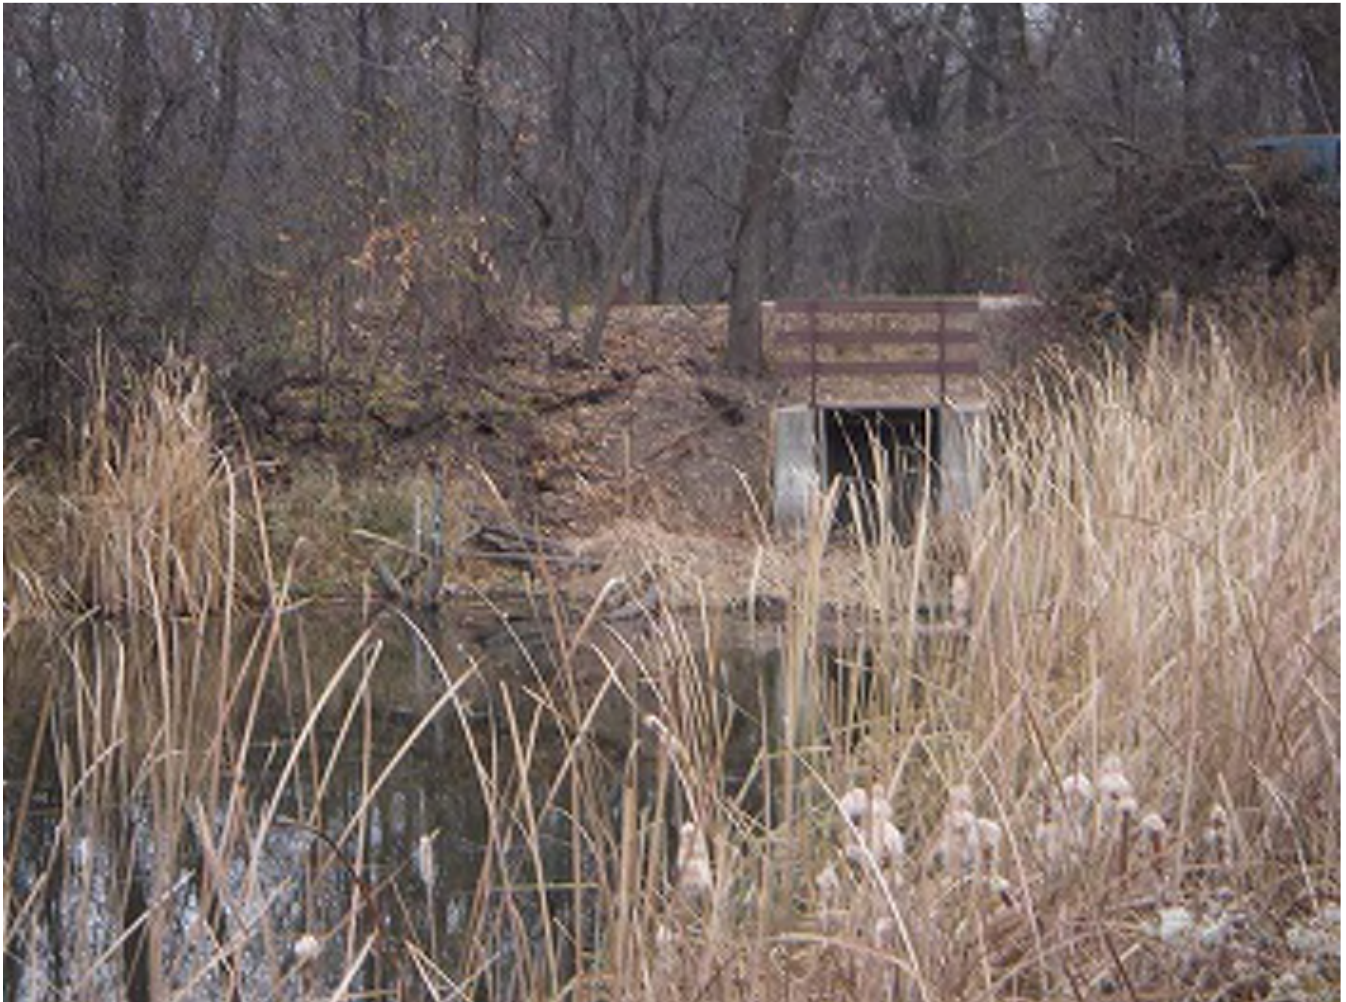
Waypoint 96

Outlet pipe

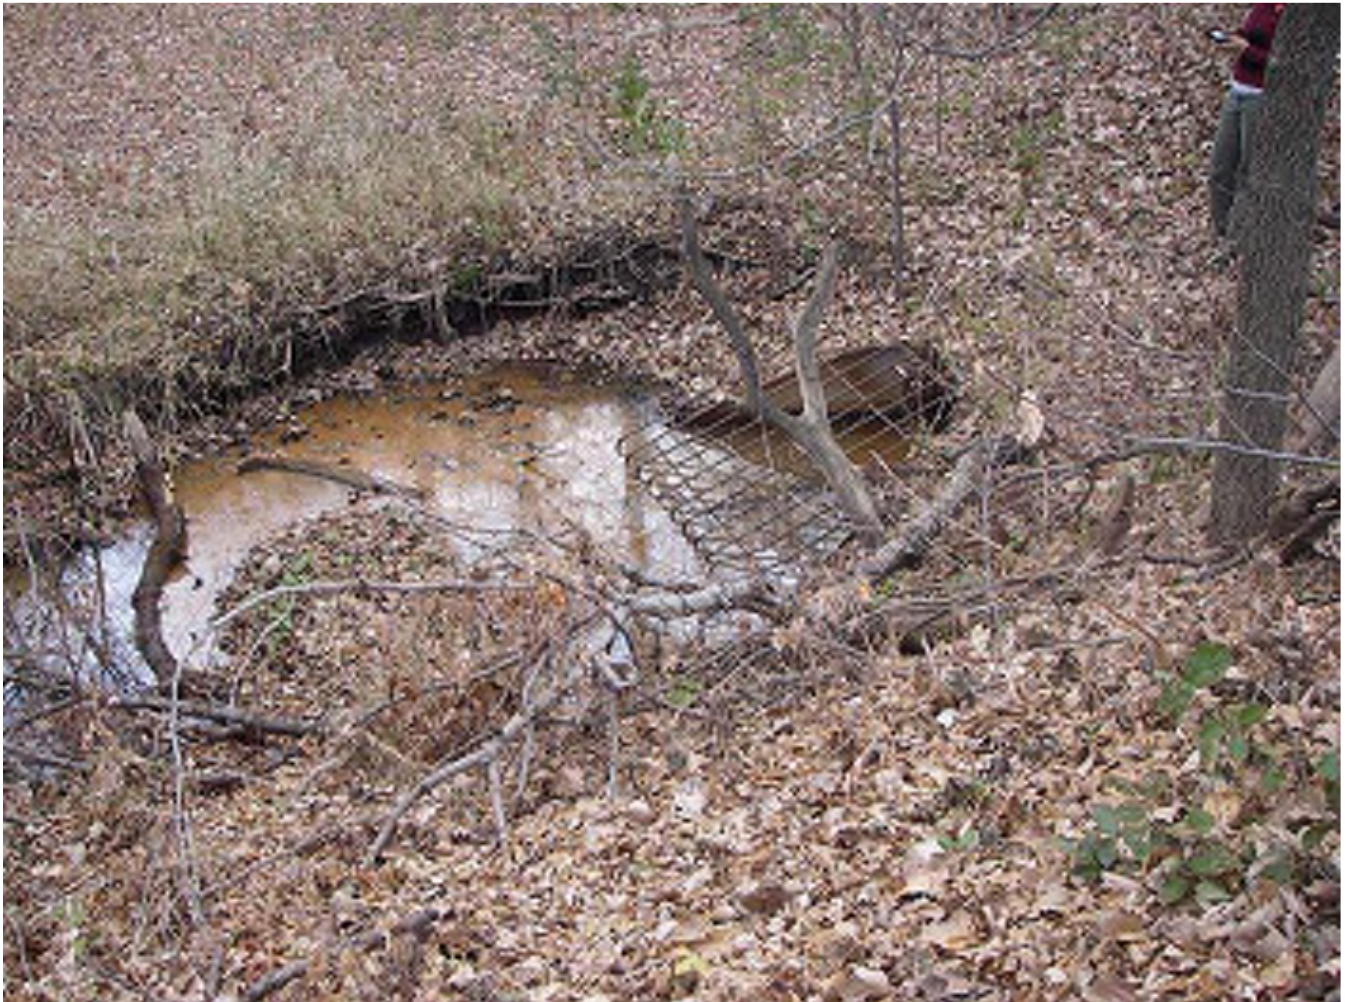
Waypoint 97

Culvert

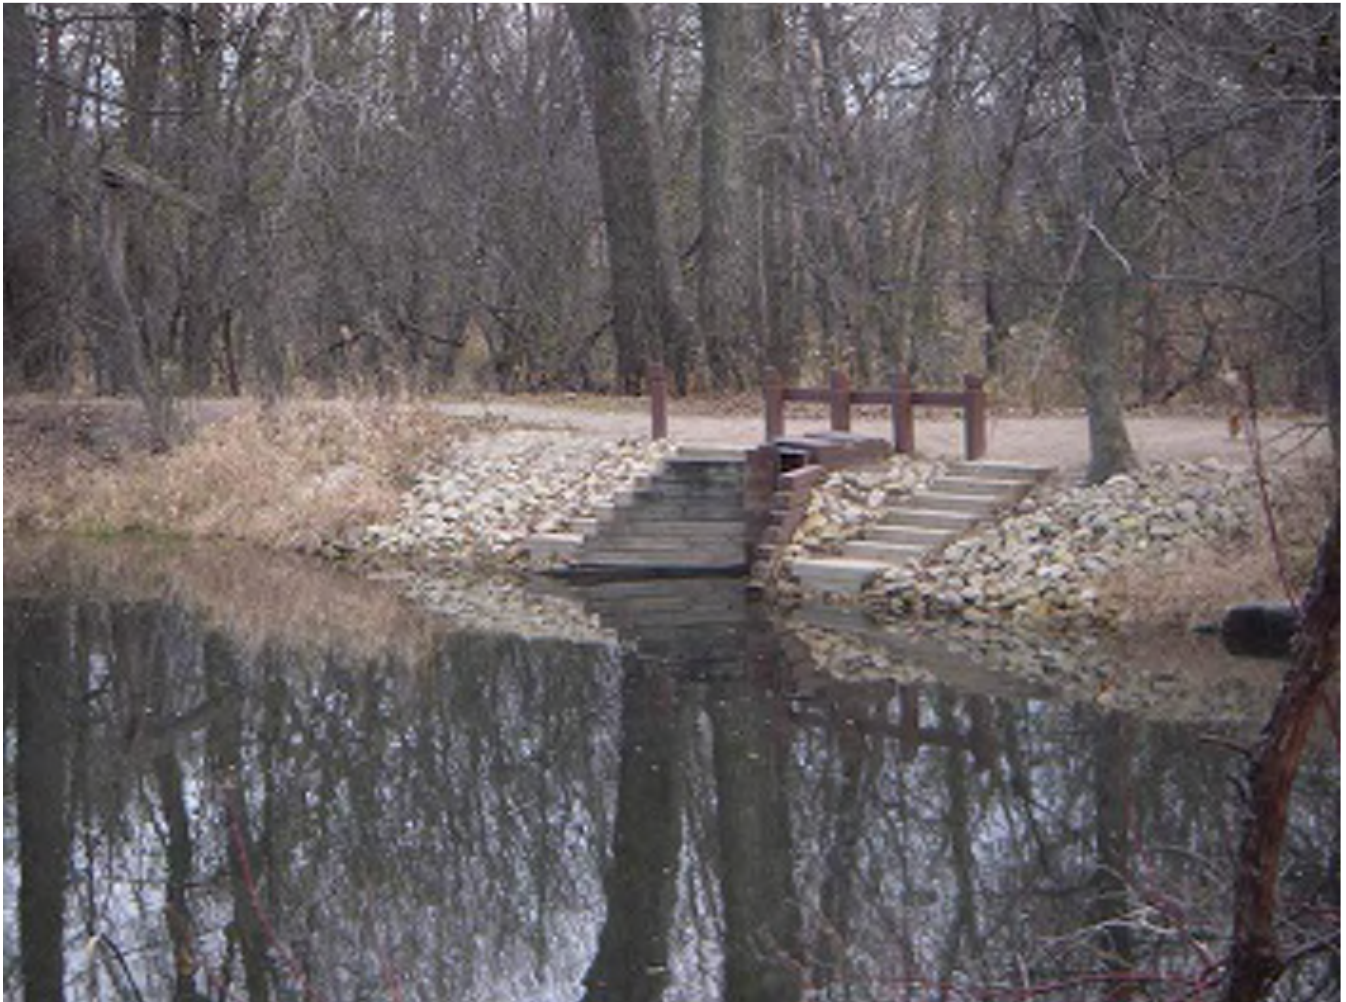
Waypoint 98

Culvert

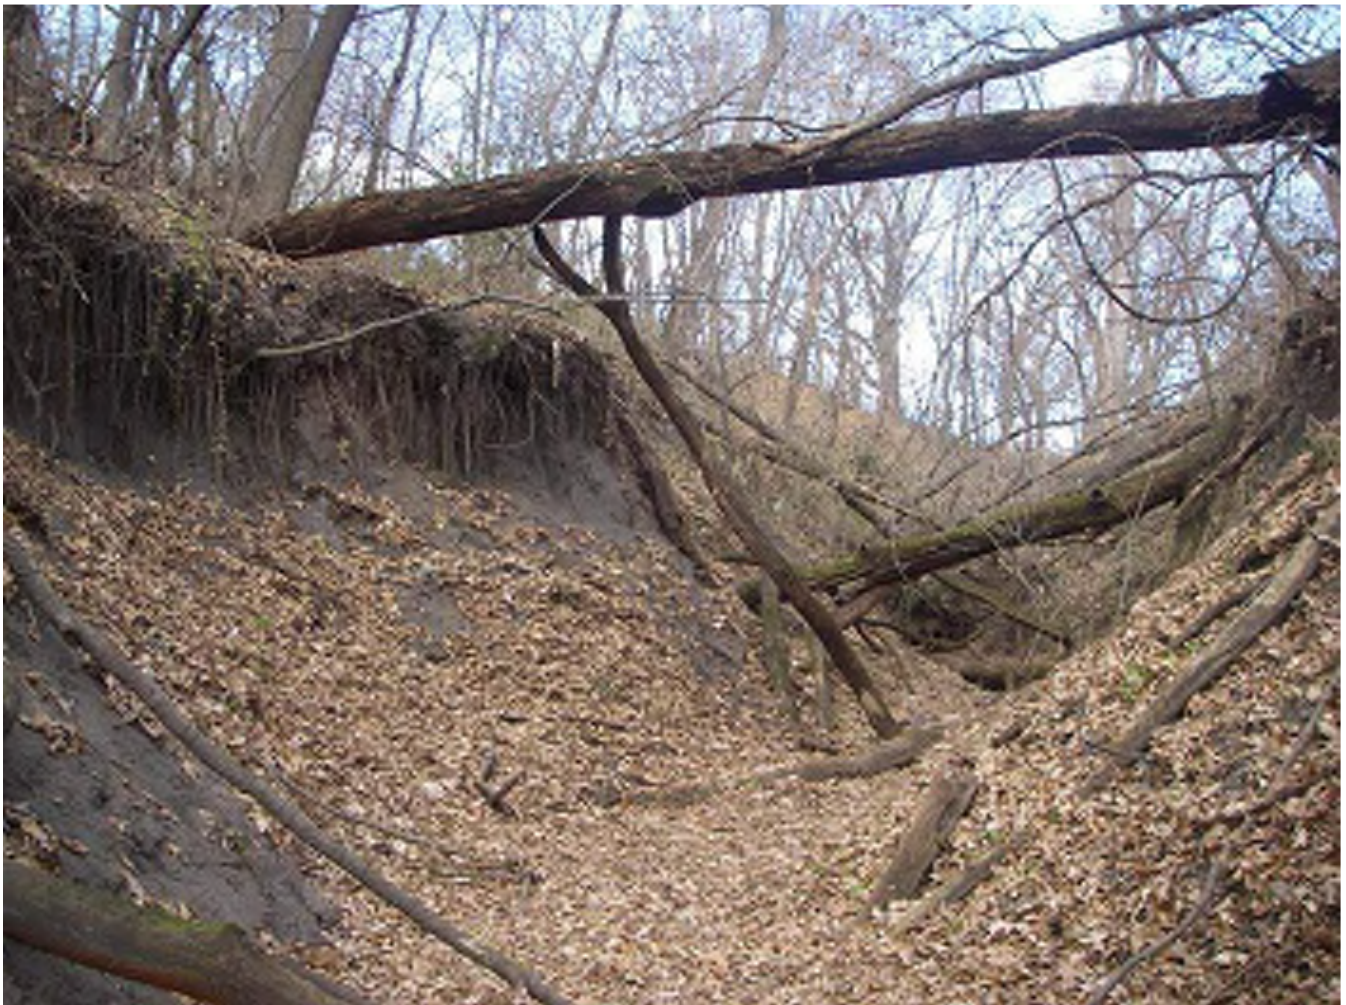
Waypoint 99

Extreme erosion
