Appendix K: Lower Minnesota River Watershed District: Gully Inventory

Gully Inventory Map
 Area #1
 Lower Minnesota River Watershed District
 Watershed Management Plan

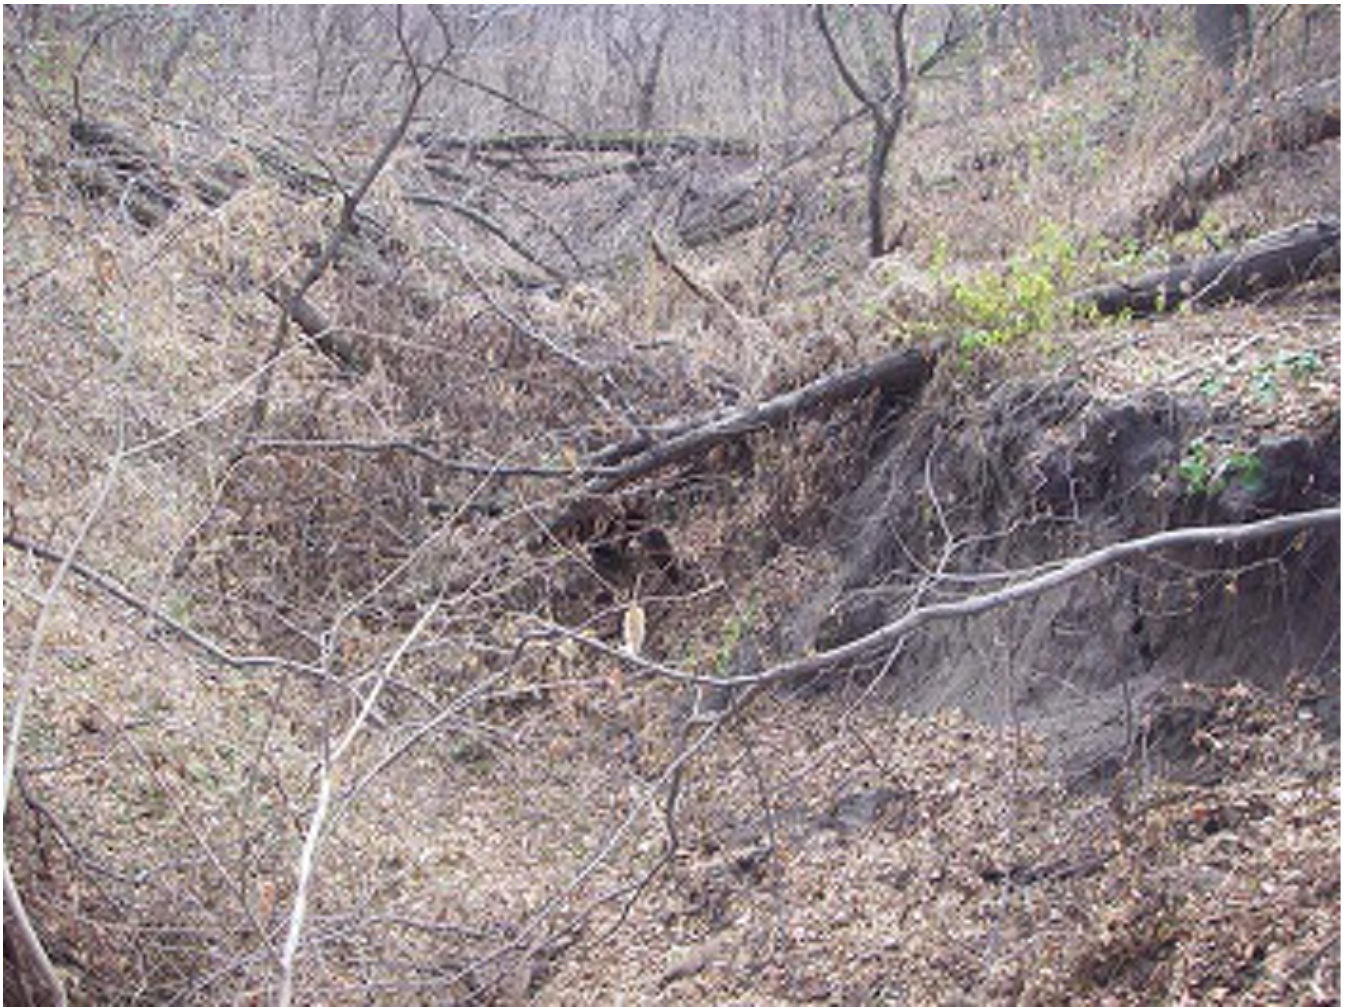
Extreme erosion

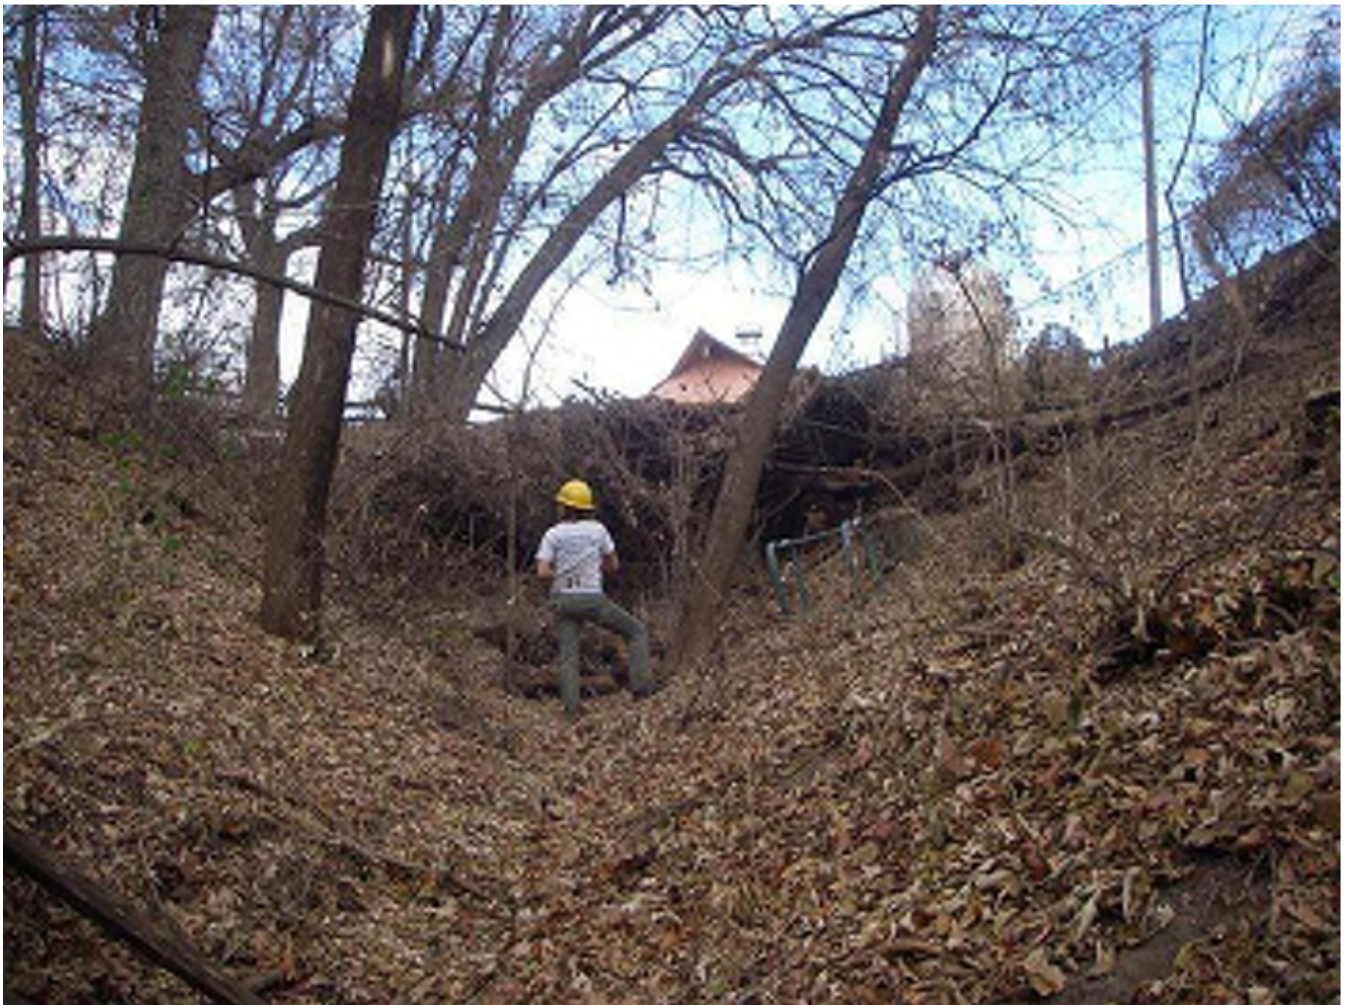
Waypoint 100

Lots of tree litter

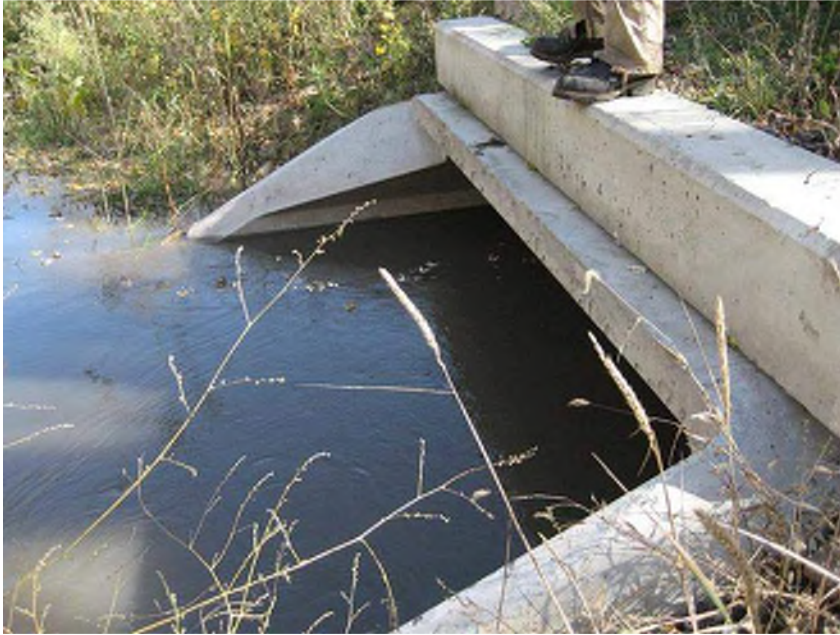
Waypoint 100A

Concrete culvert along paved trail on river side; culvert goes under paved trail; high water; little erosion; couldn't get to river shore cu

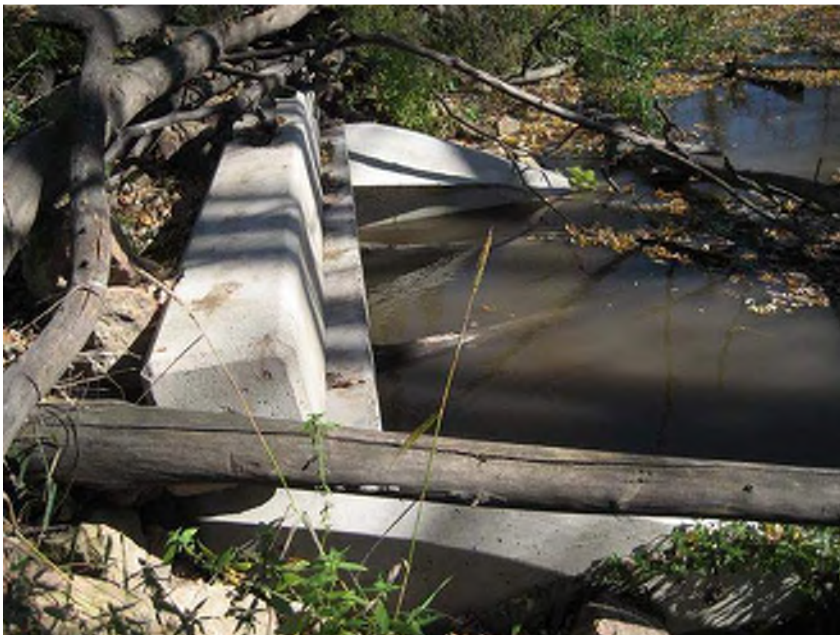
Concrete culvert on other side of paved trail; culvert goes under paved trail; high water; little erosion; couldn't get to river shore cue t

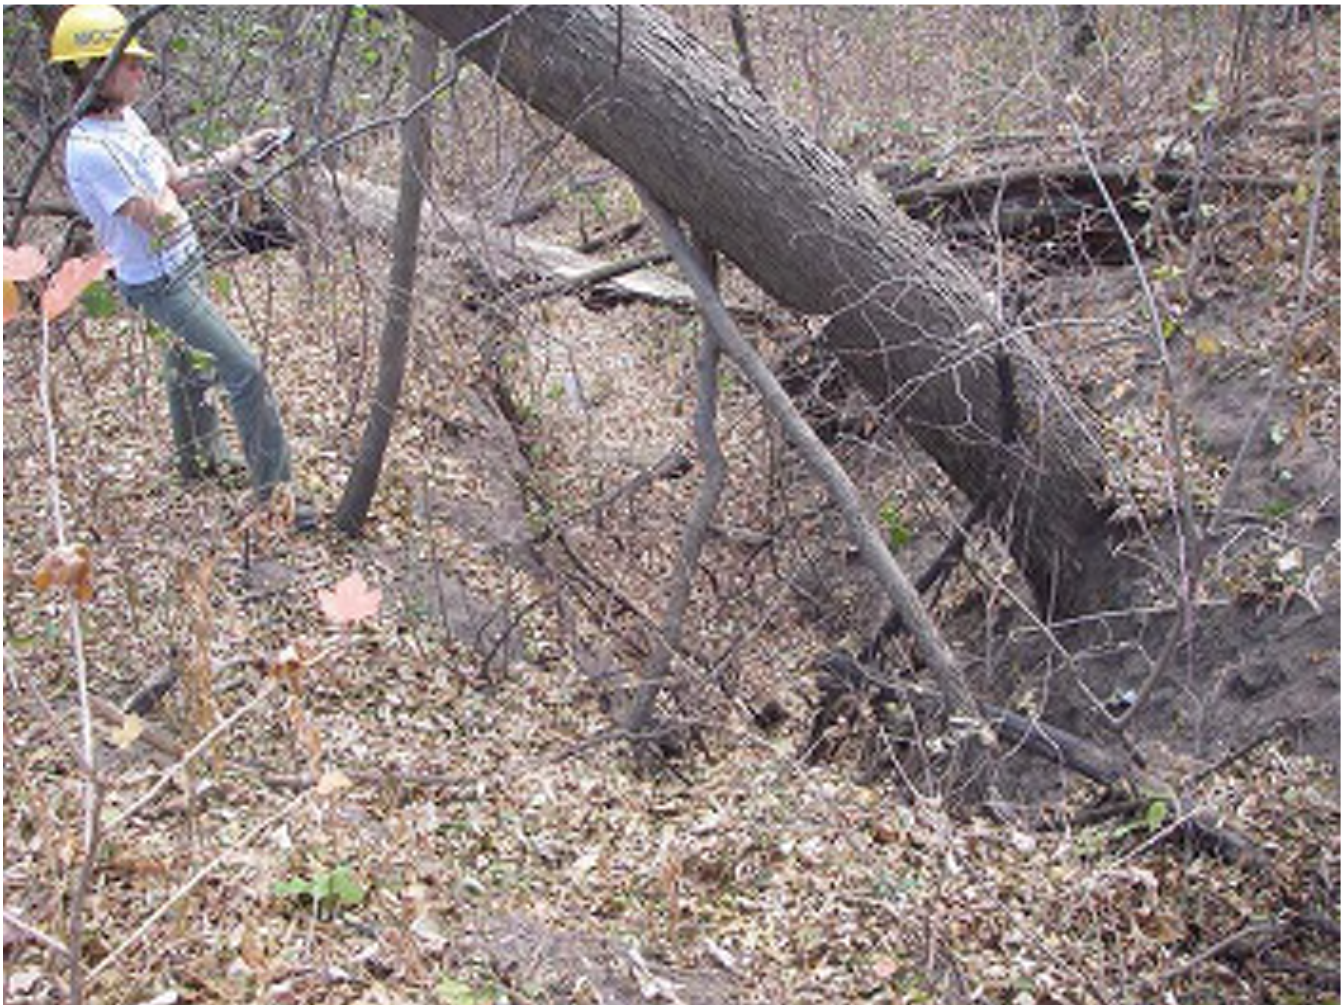
Waypoint 101

Deeply eroded gully/tributary

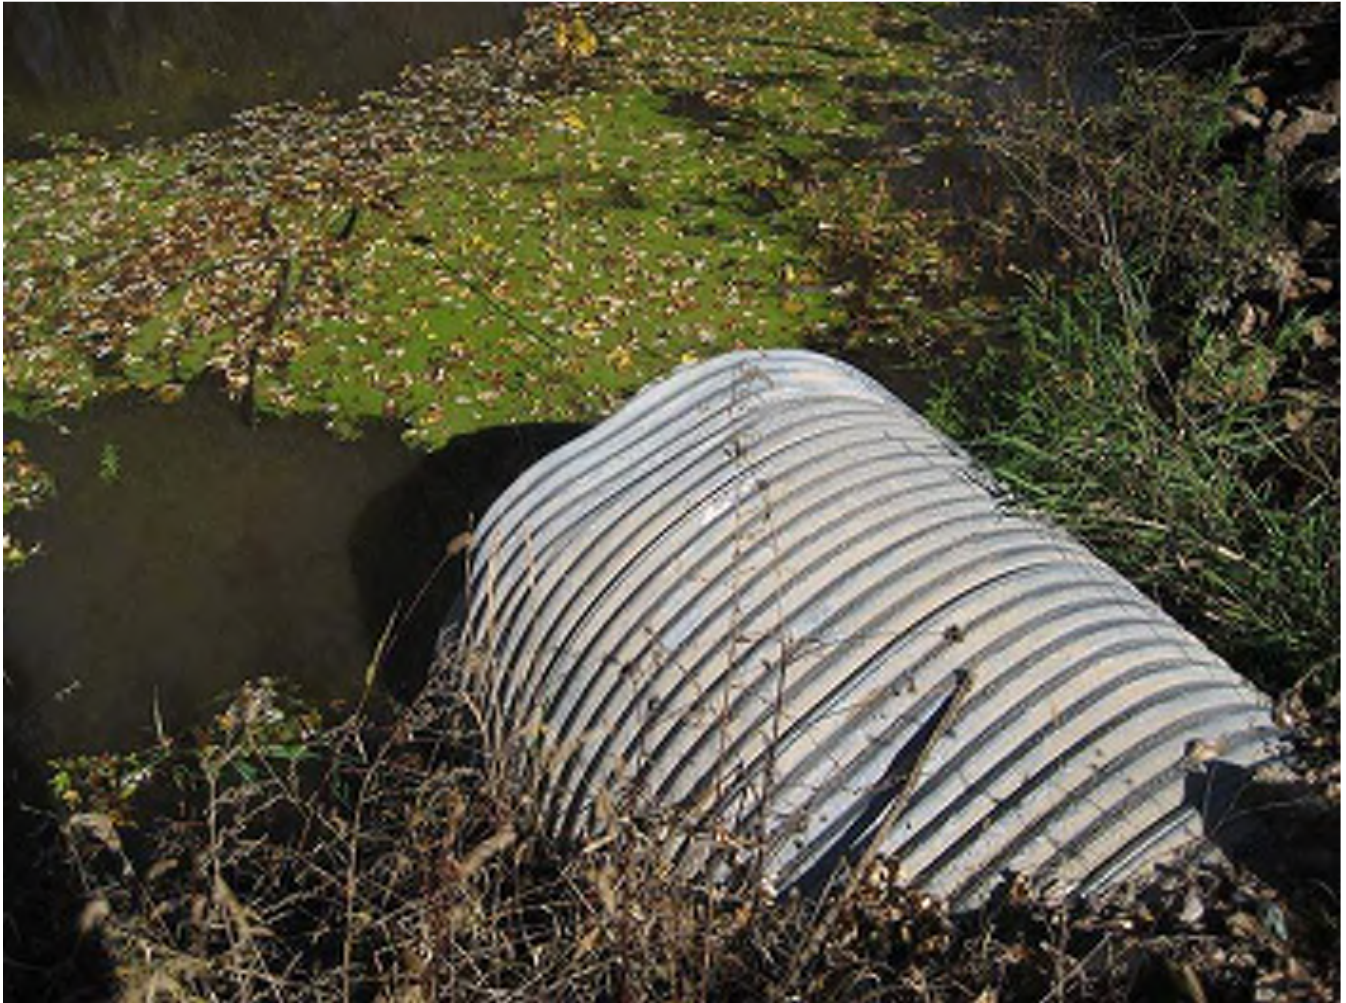
Waypoint 101A

Metal culvert piping going under paved trail - river side.

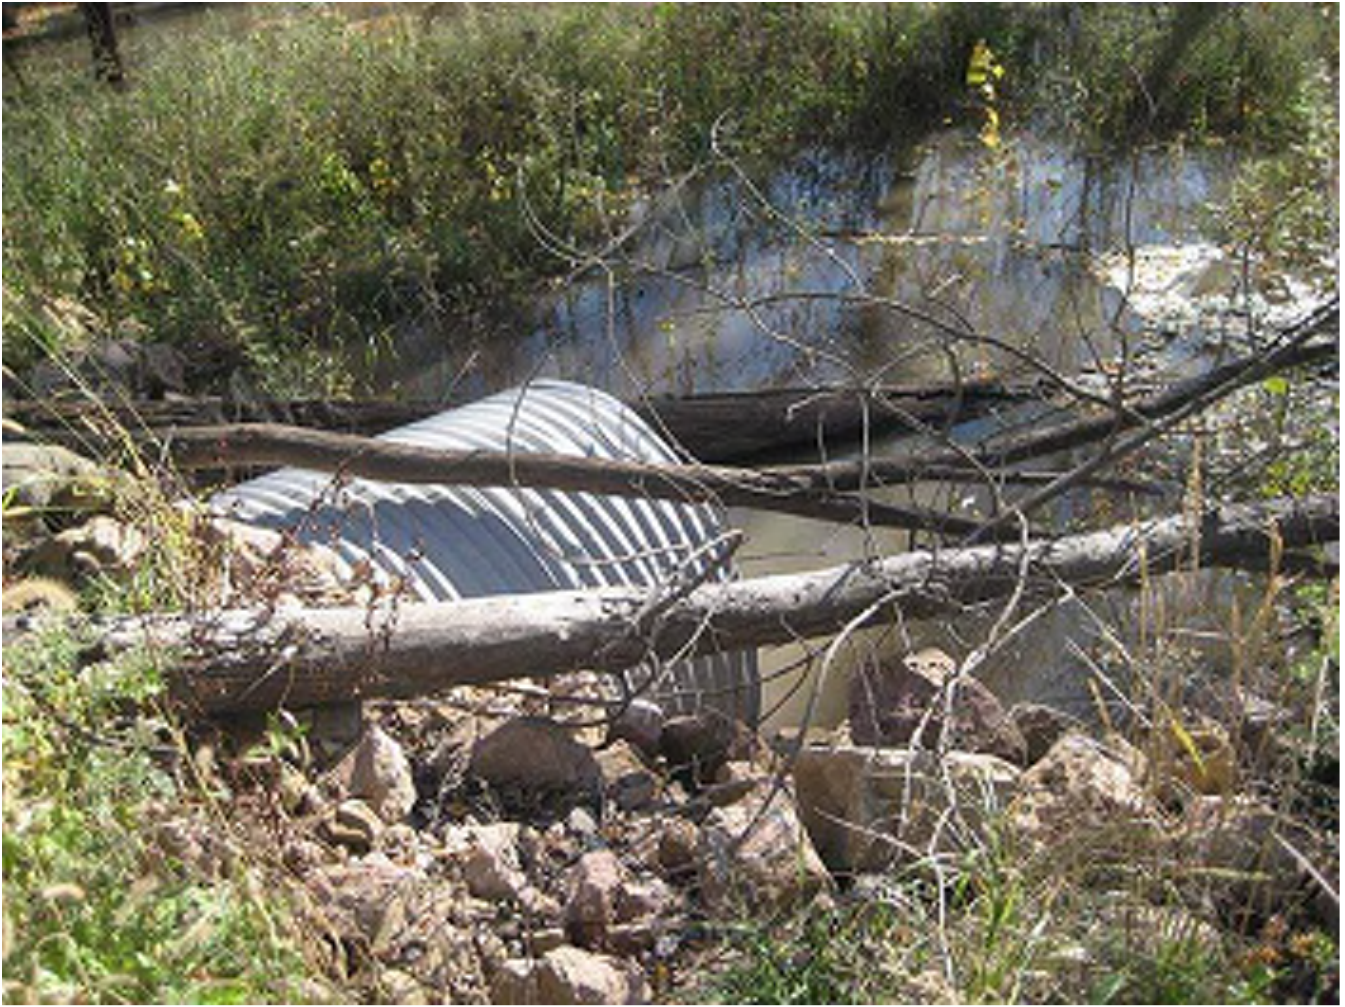
Metal culvert piping going under paved trail - opposite side of trail.

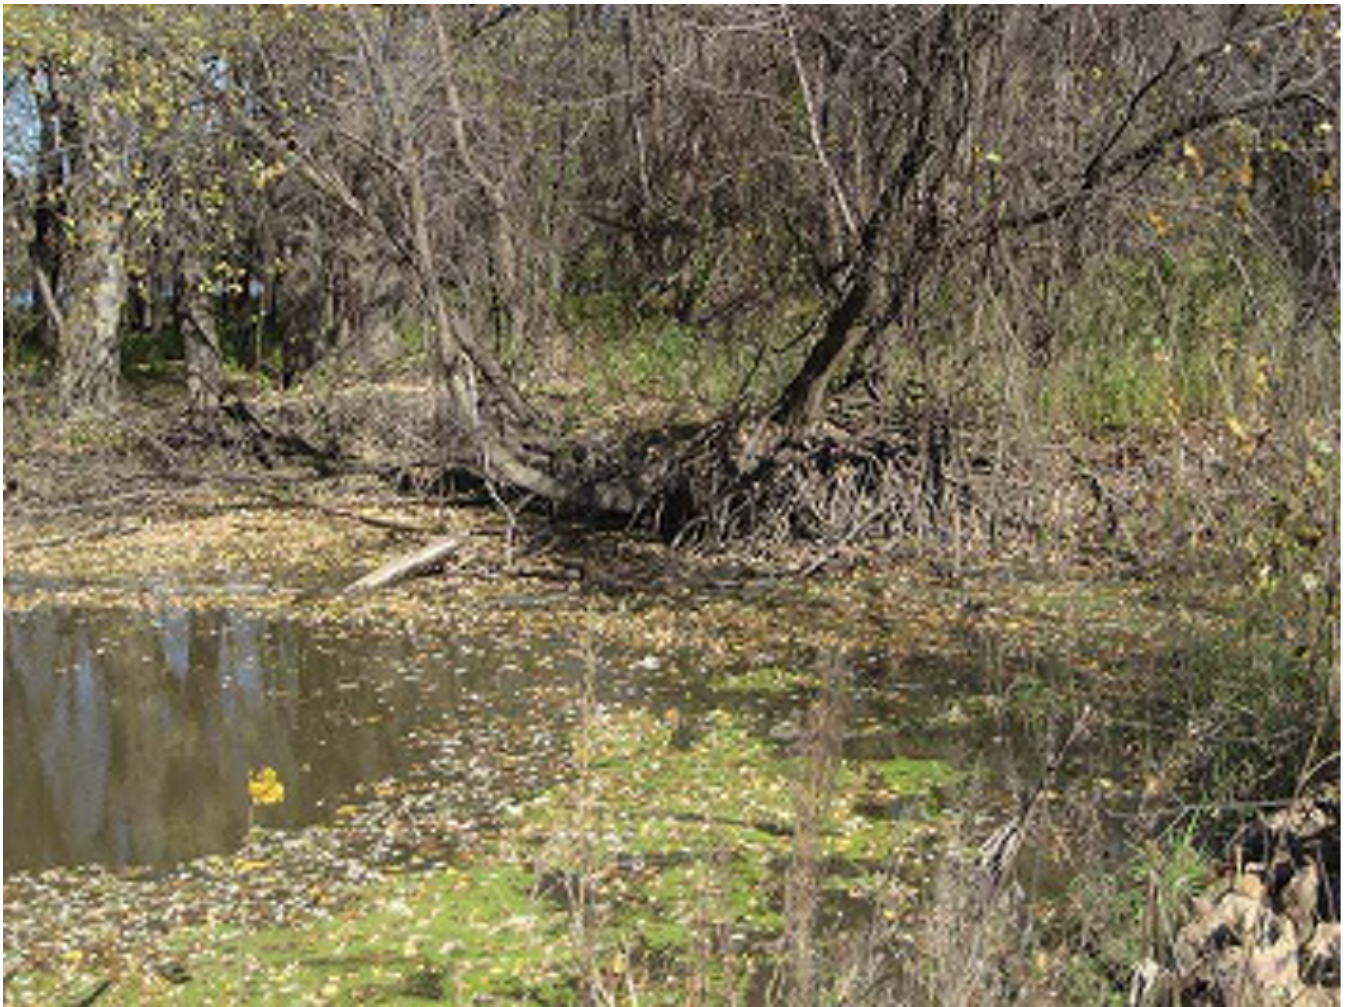
Small amount of erosion on riverside of trail at metal culvert.

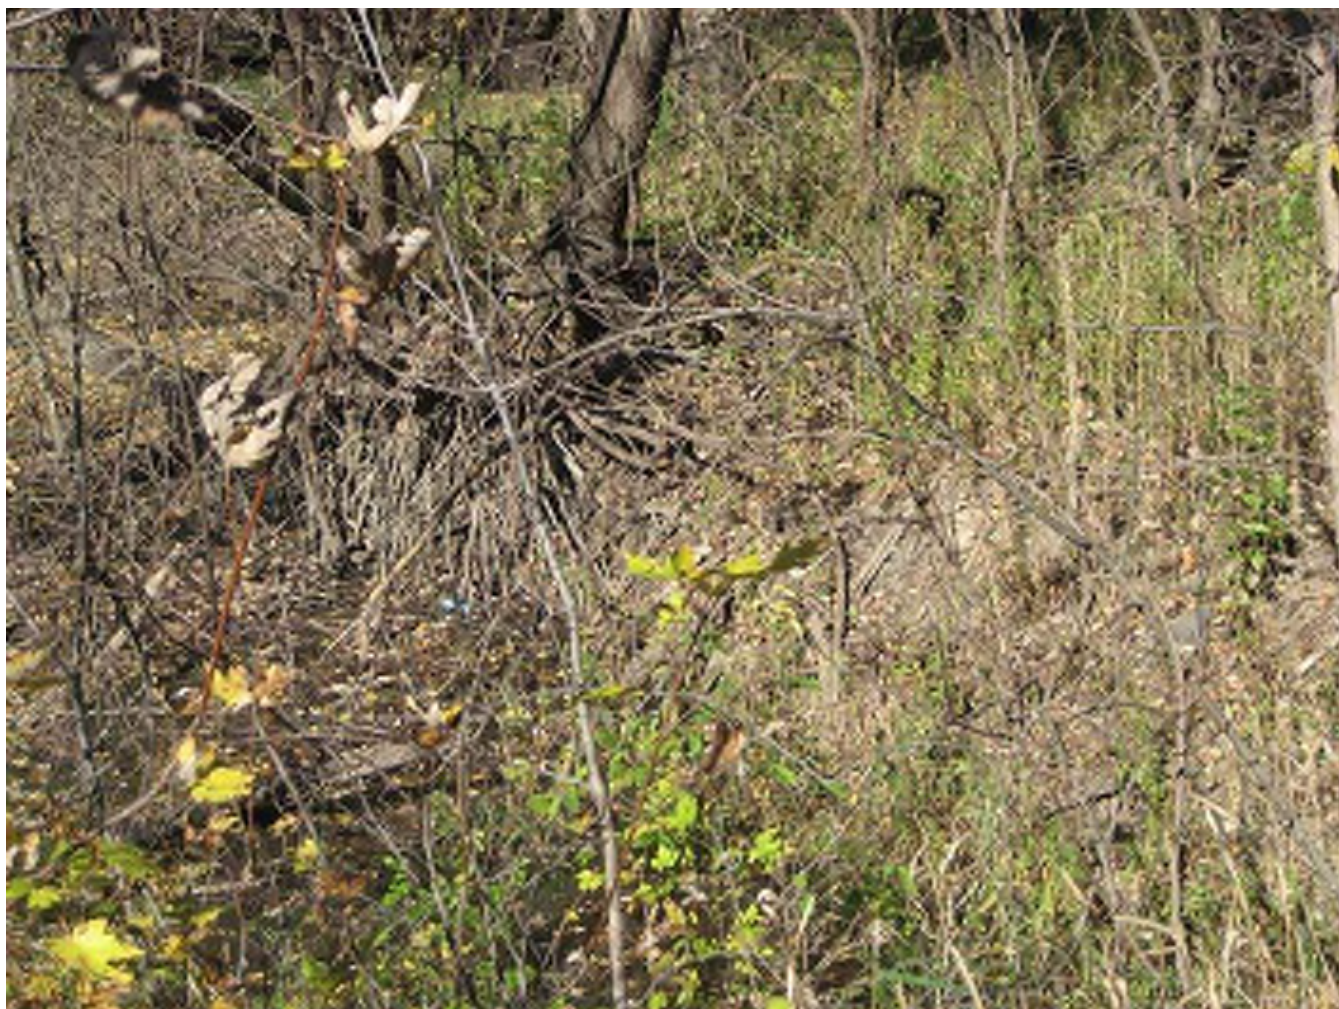
Closer picture of erosion.

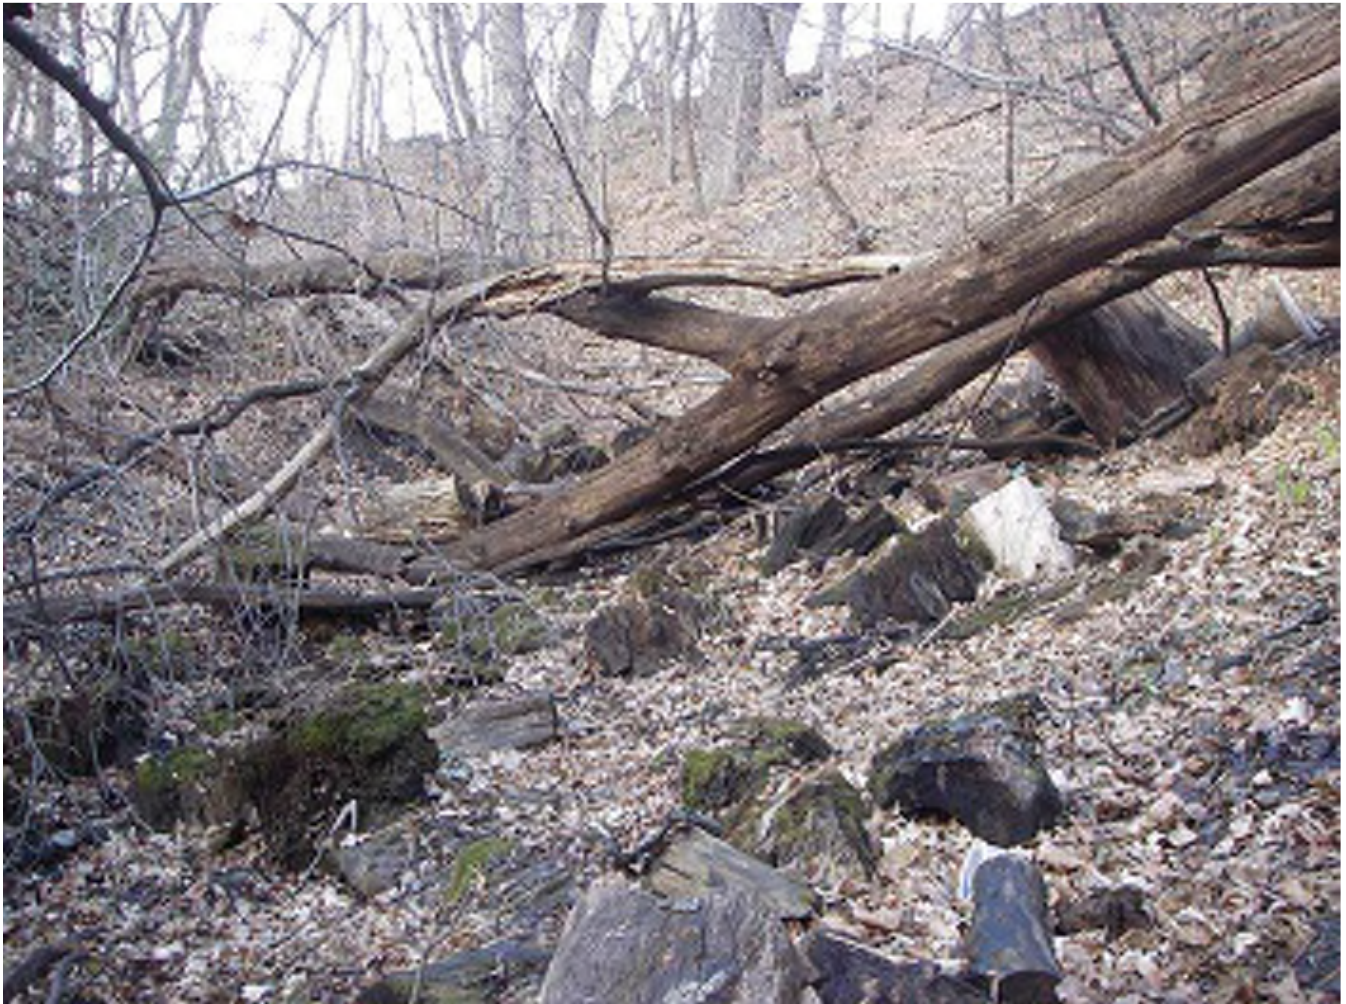
Waypoint 102

Some trash and some erosion at spring

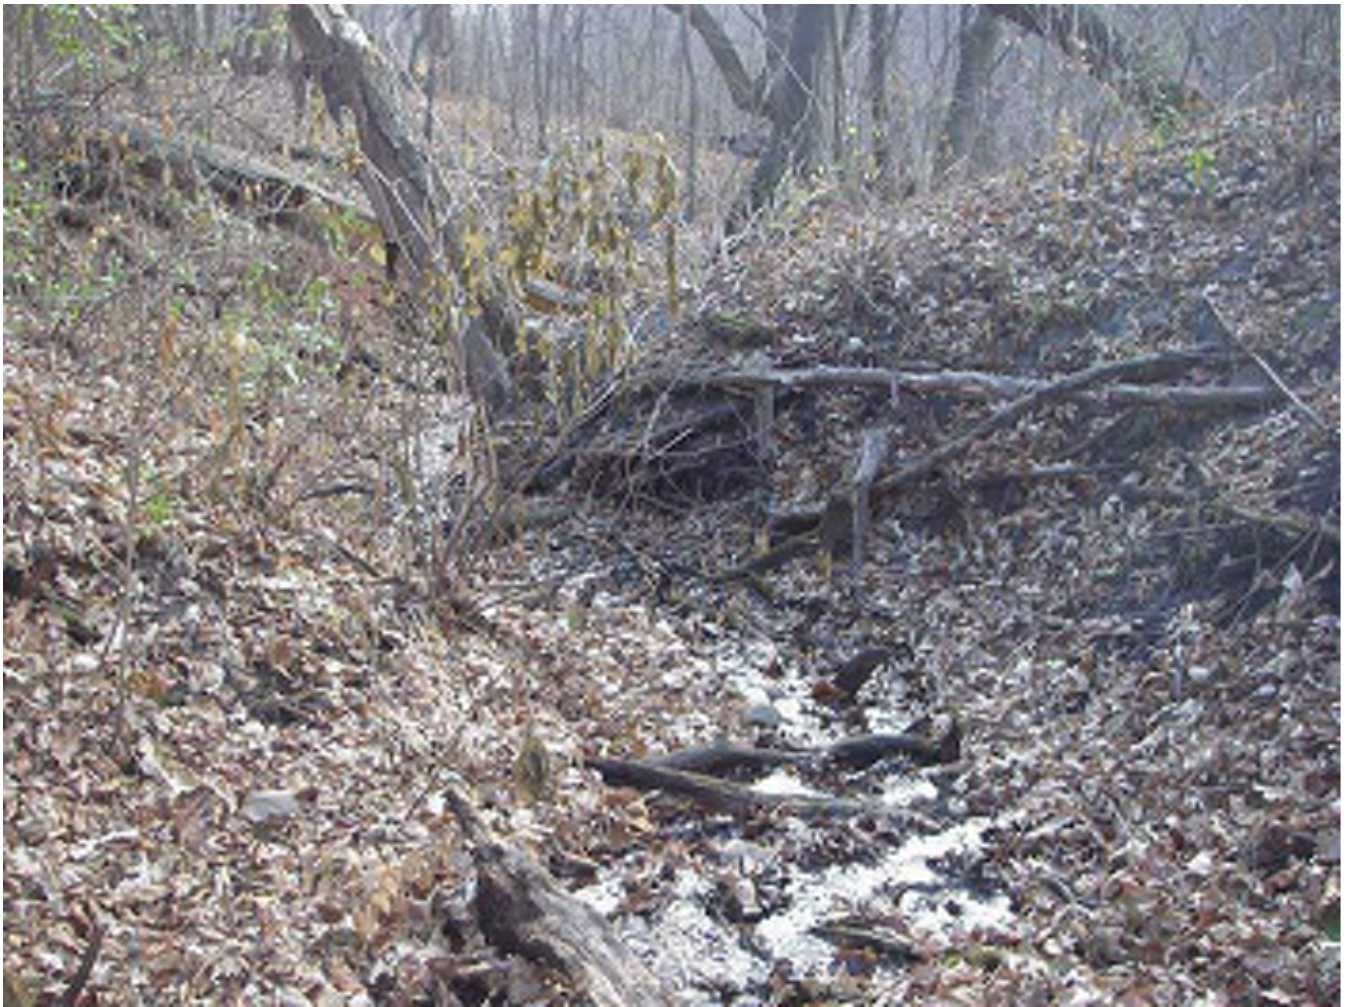
Erosion

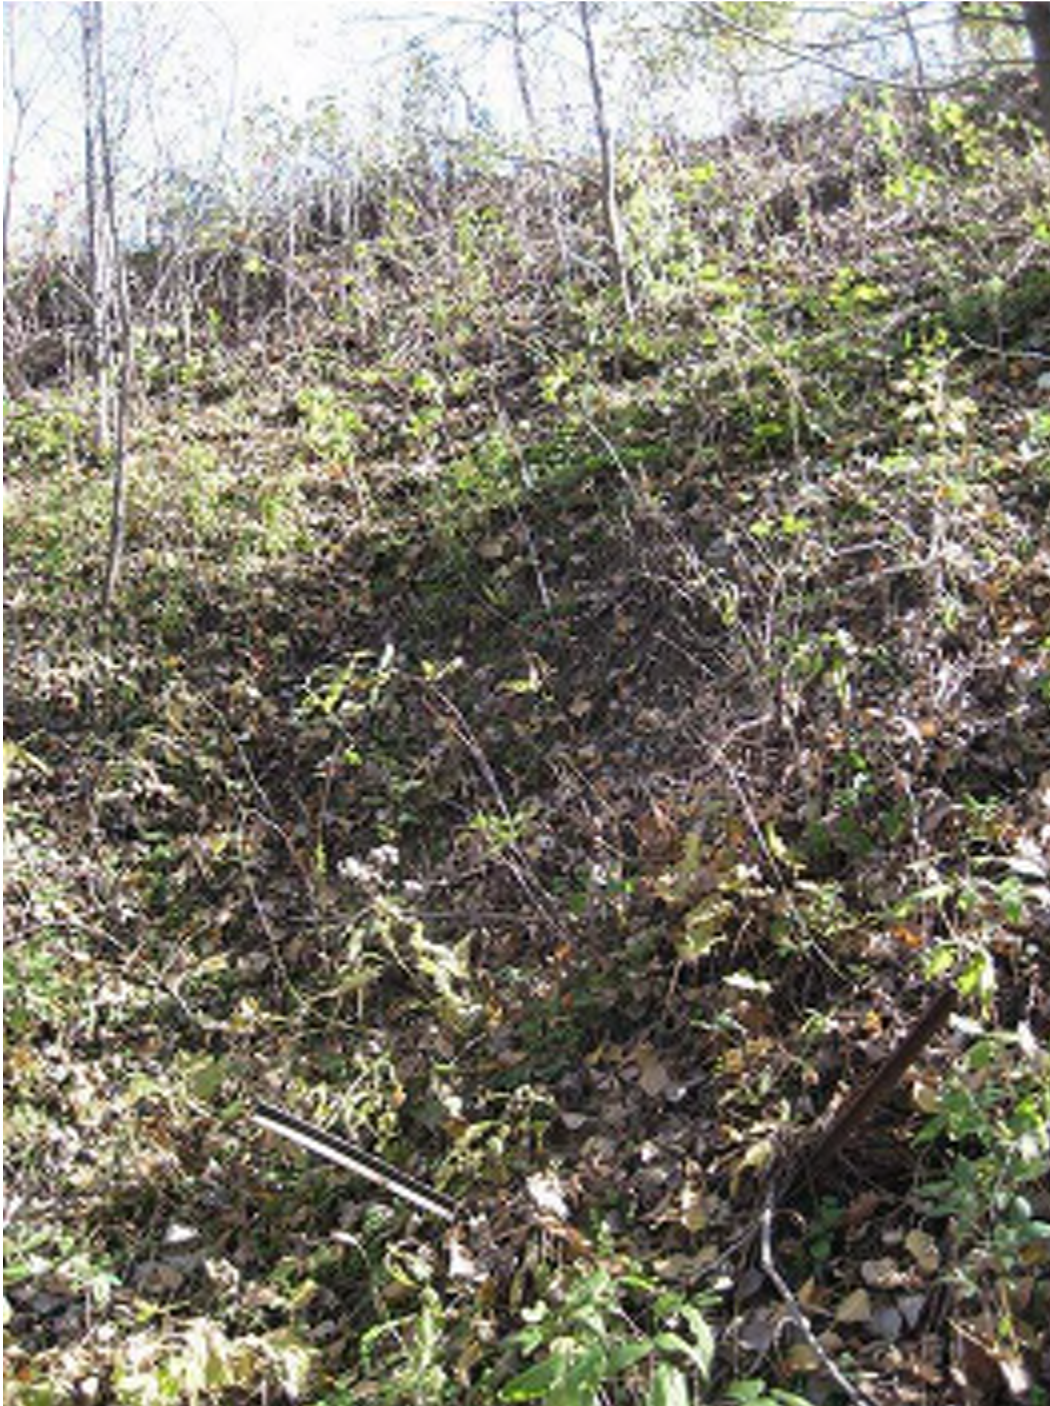
Waypoint 102A

Between trail and quarry; steep hillside slope with slight erosion.

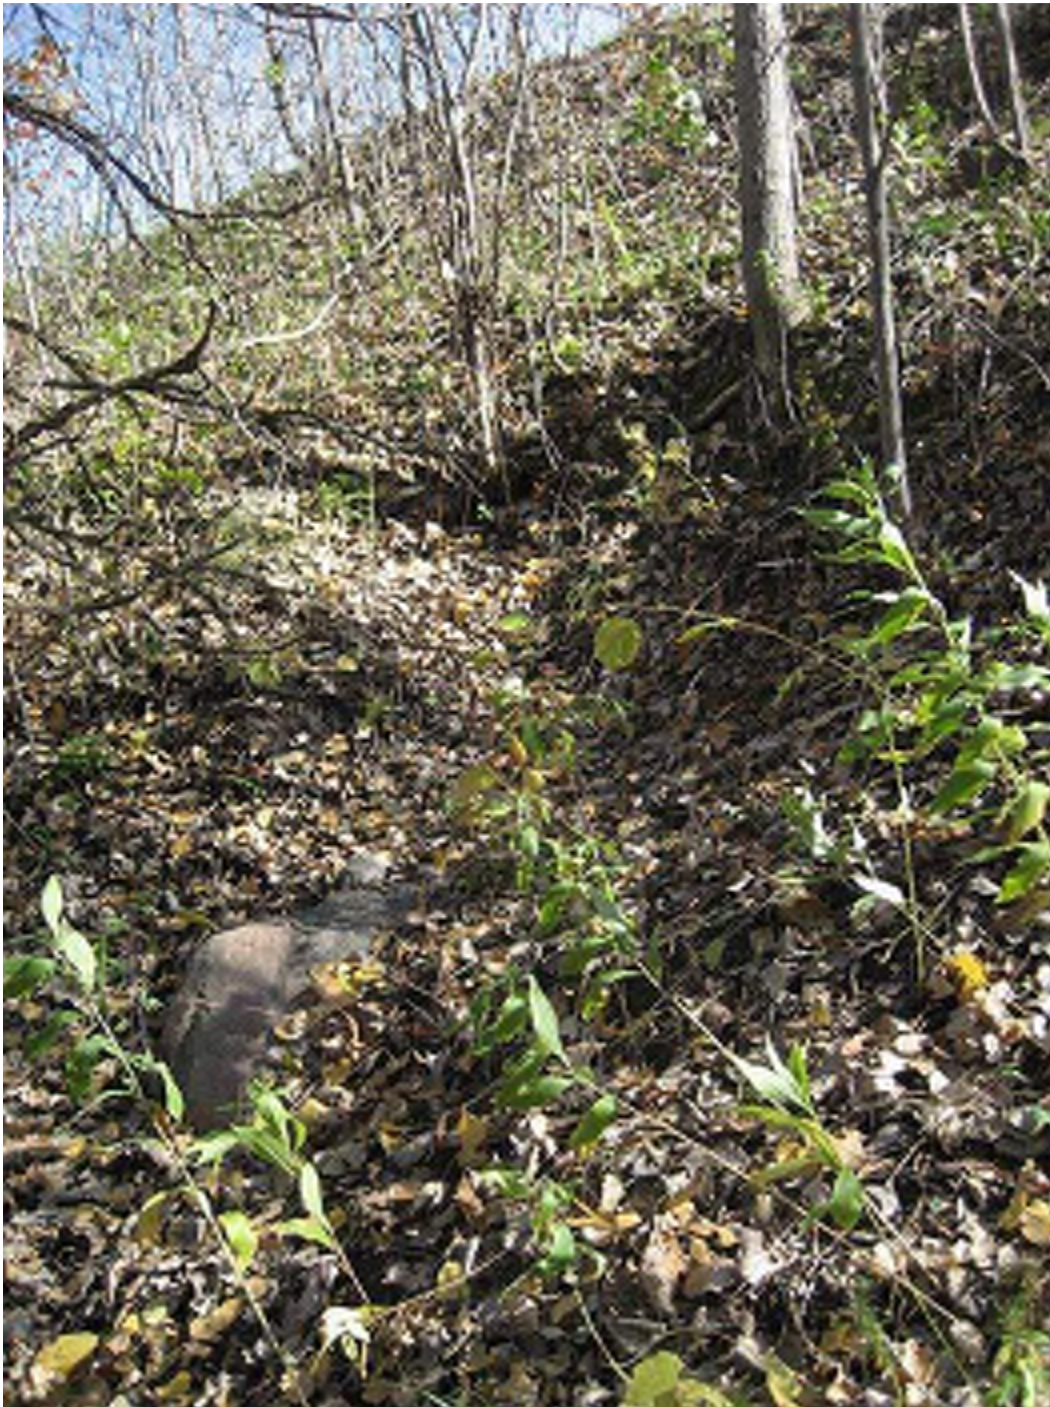
To the left of previous picture; slight erosion.

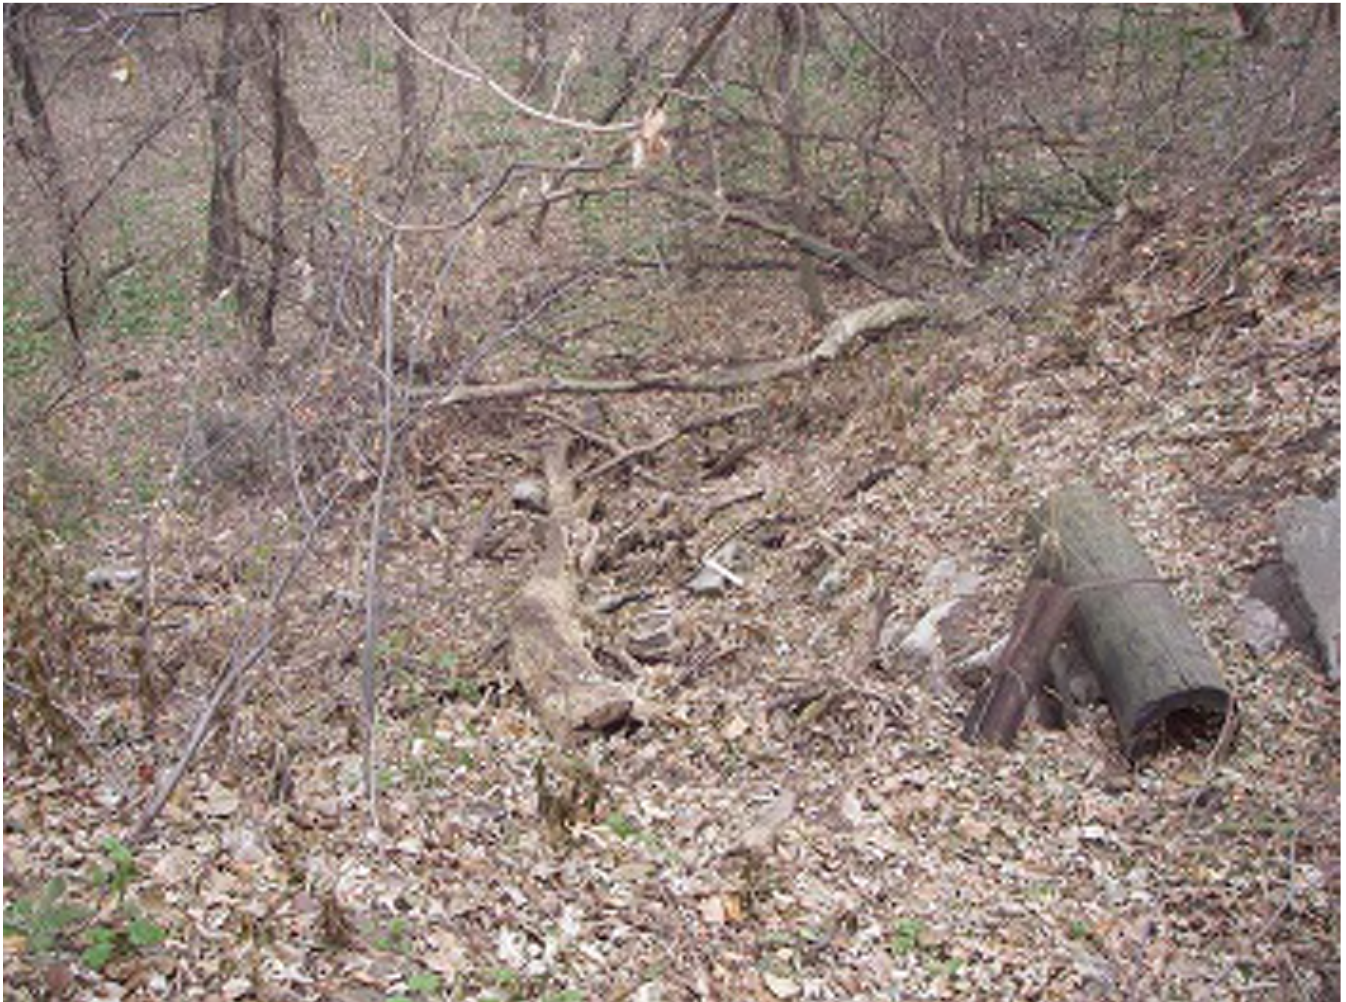
Waypoint 103

Erosion and trash heap

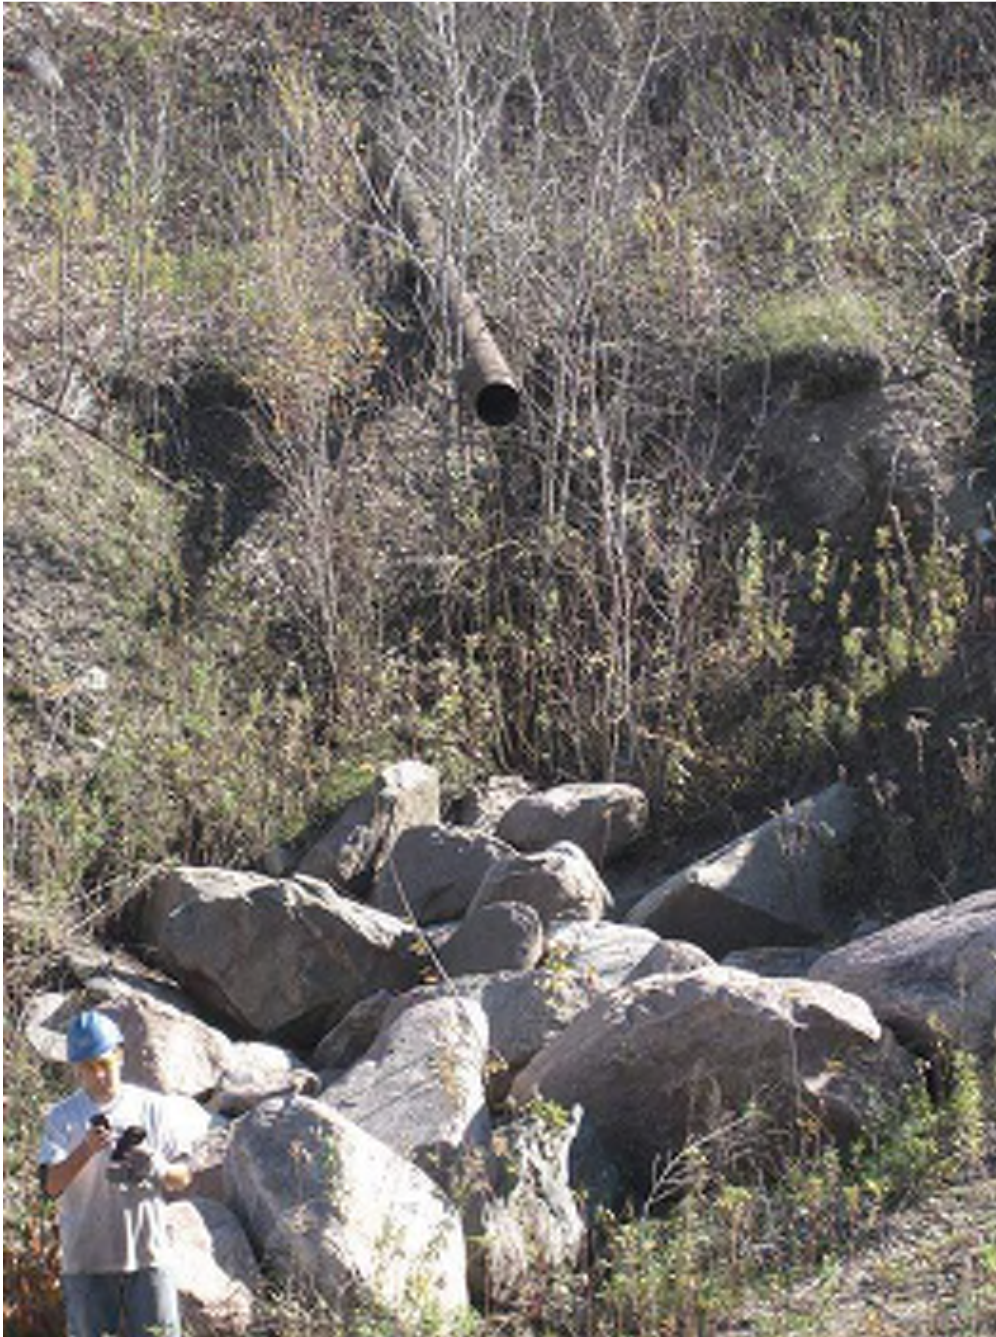
Waypoint 103A

Long metal piping coming down from quarry onto large boulders; major erosion.

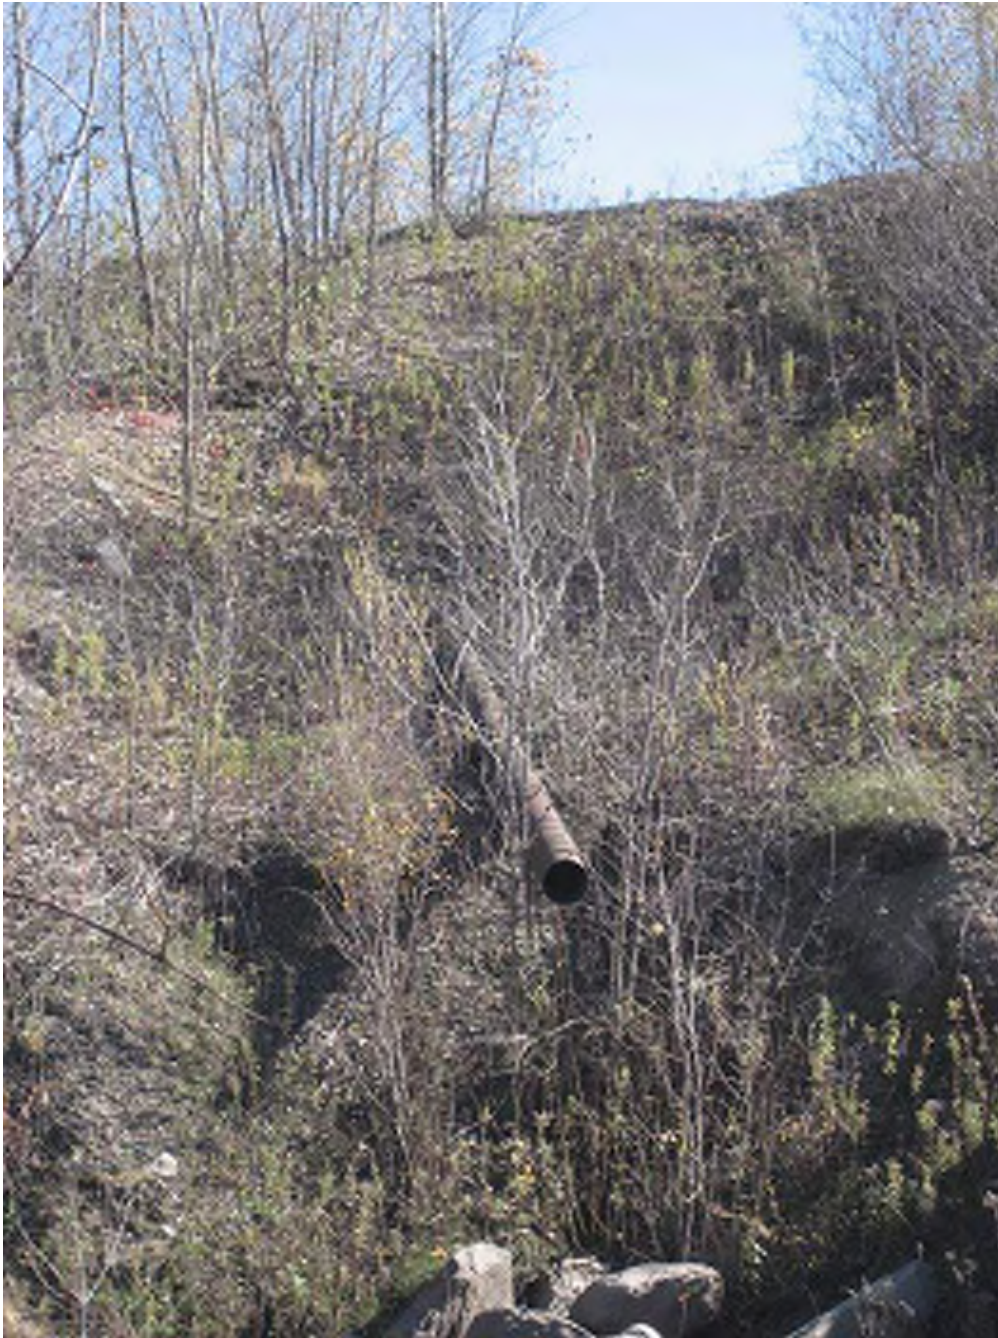
Long metal piping coming down from quarry onto large boulders; major erosion.

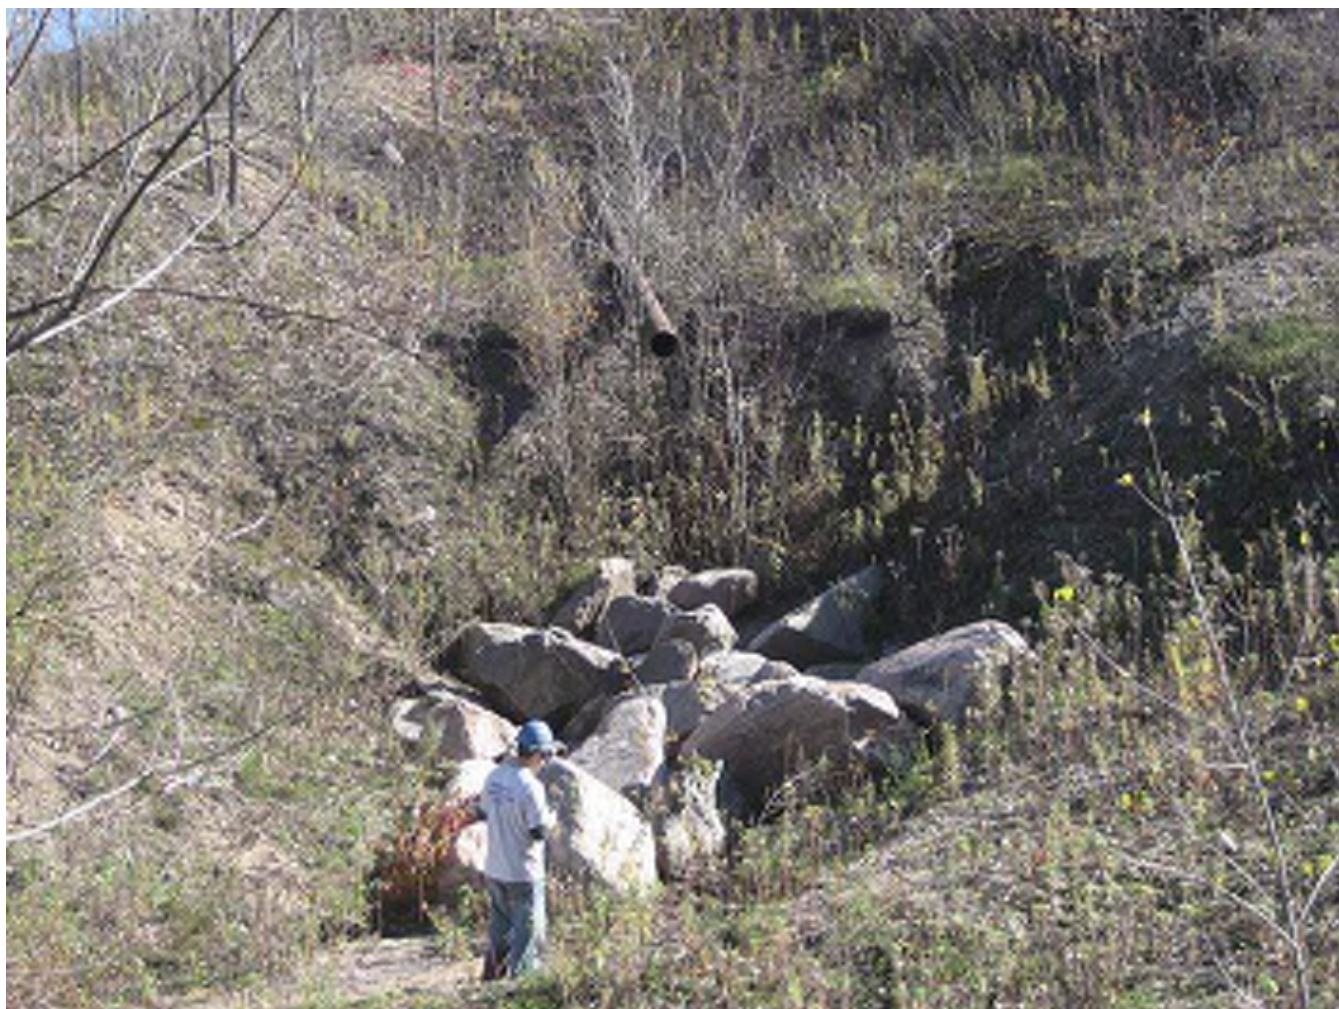
Long metal piping coming down from quarry onto large boulders; major erosion.

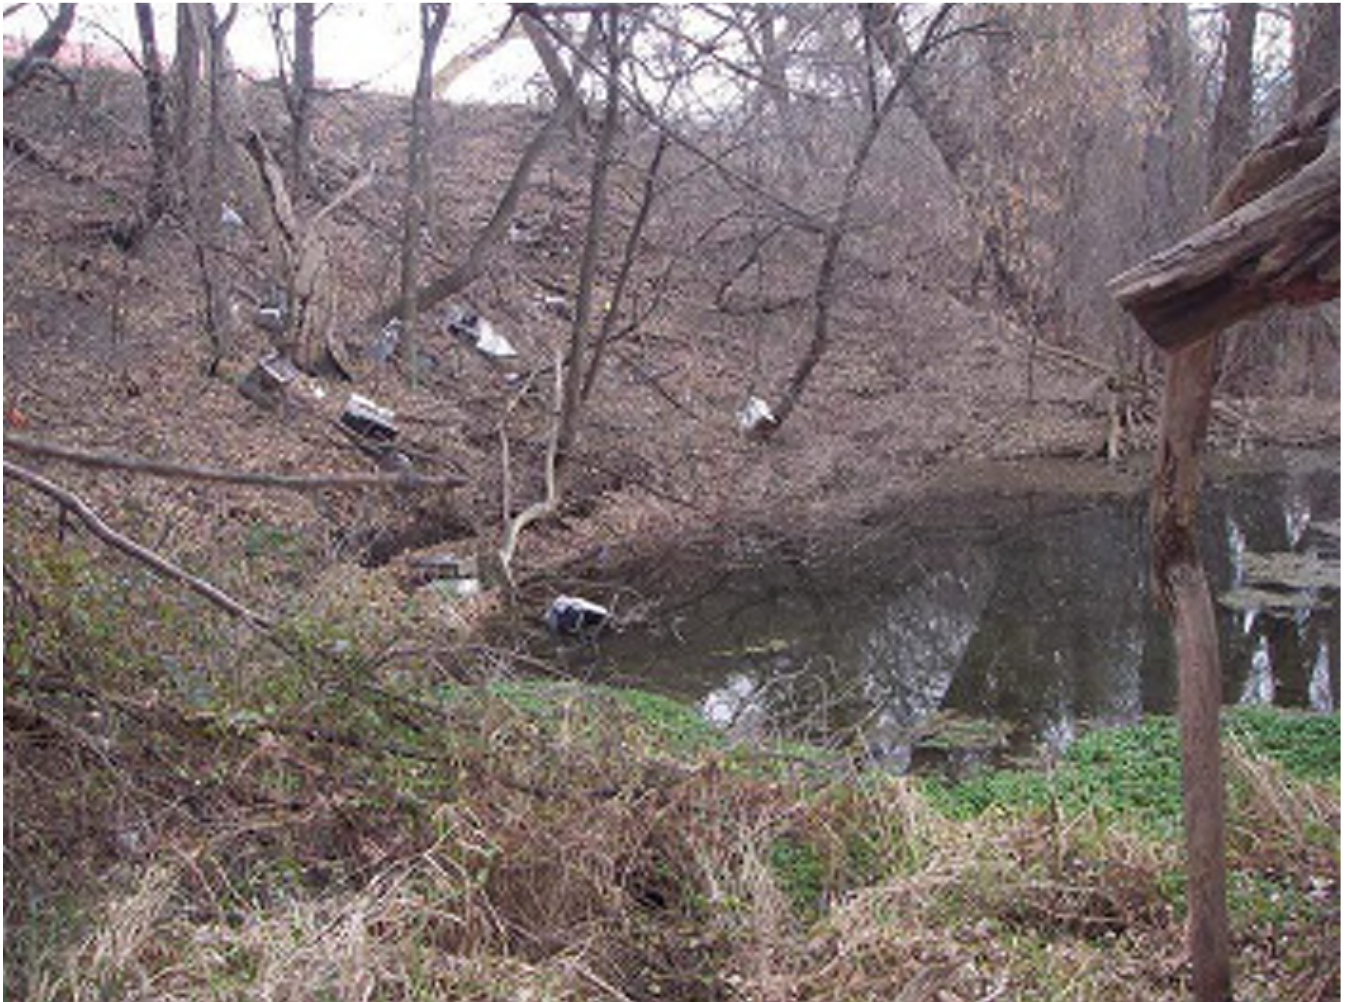
Waypoint 104

Bass ponds stream source/spring
