Appendix K: Lower Minnesota River Watershed District: Gully Inventory

Gully Inventory Map
 Area #1
 Lower Minnesota River Watershed District
 Watershed Management Plan

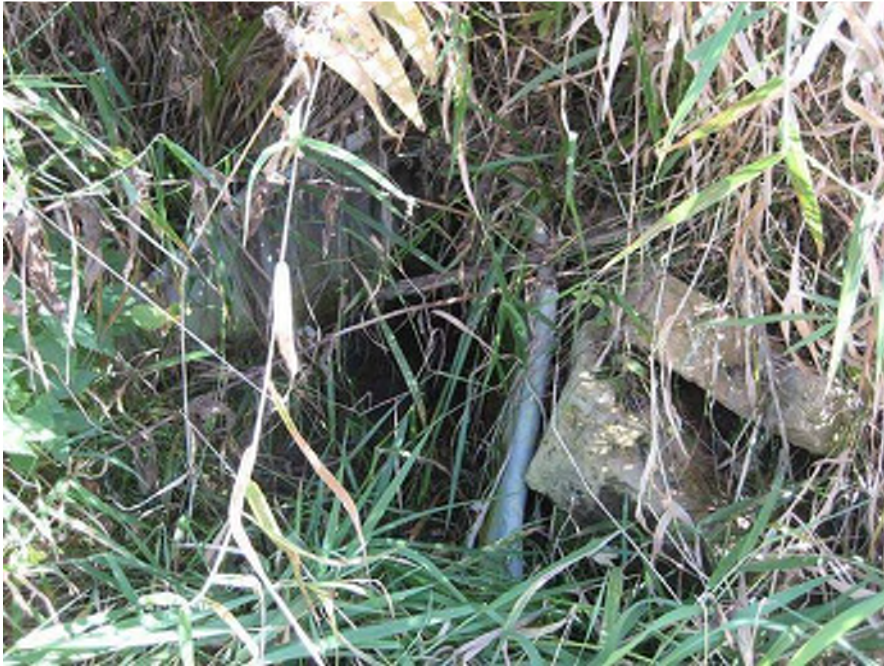
Waypoint 104A

Small culvert going under paved trail; little or no erosion

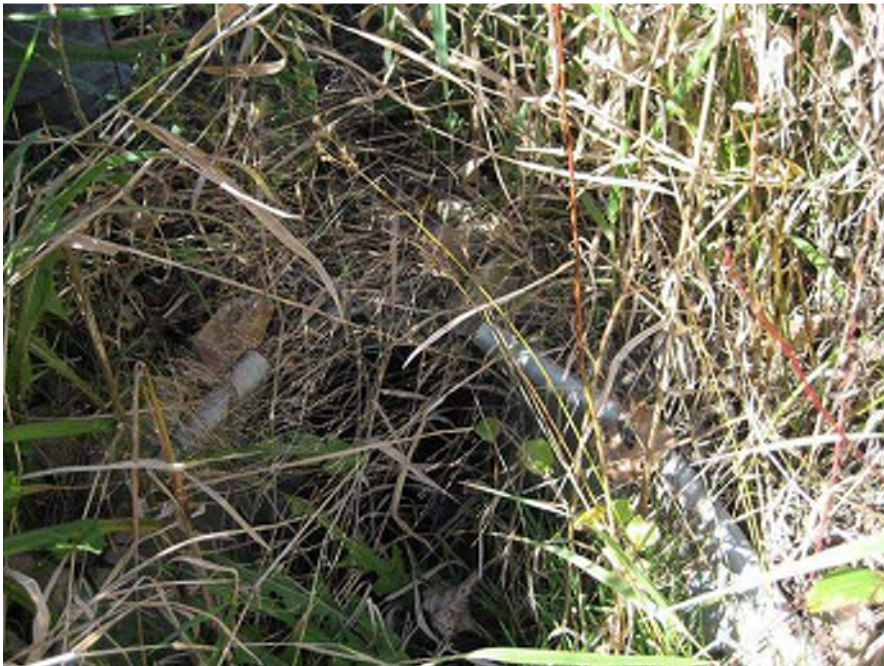
Small culvert going under paved trail; little or no erosion

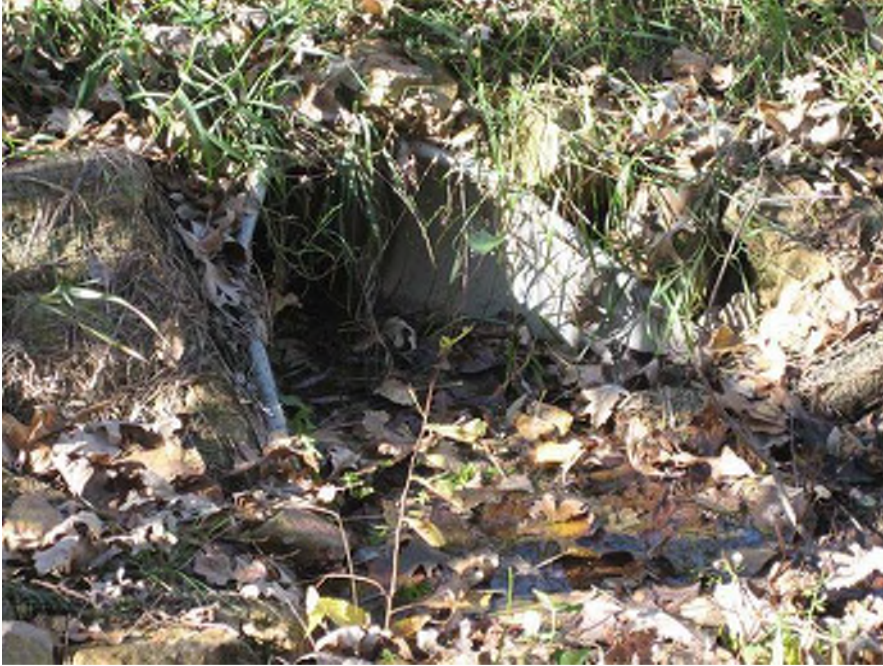
Opposite side of path from river; culvert going under path; erosion matting/rock placed under culvert; pooling water around culvert.

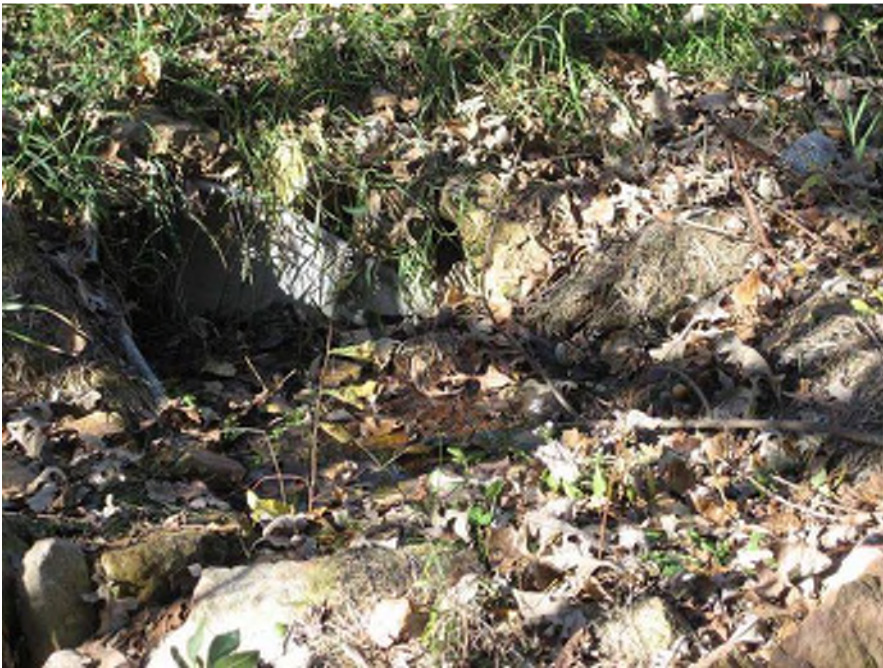
Opposite side of path from river; culvert going under path; erosion matting/rock placed under culvert; pooling water around culvert.

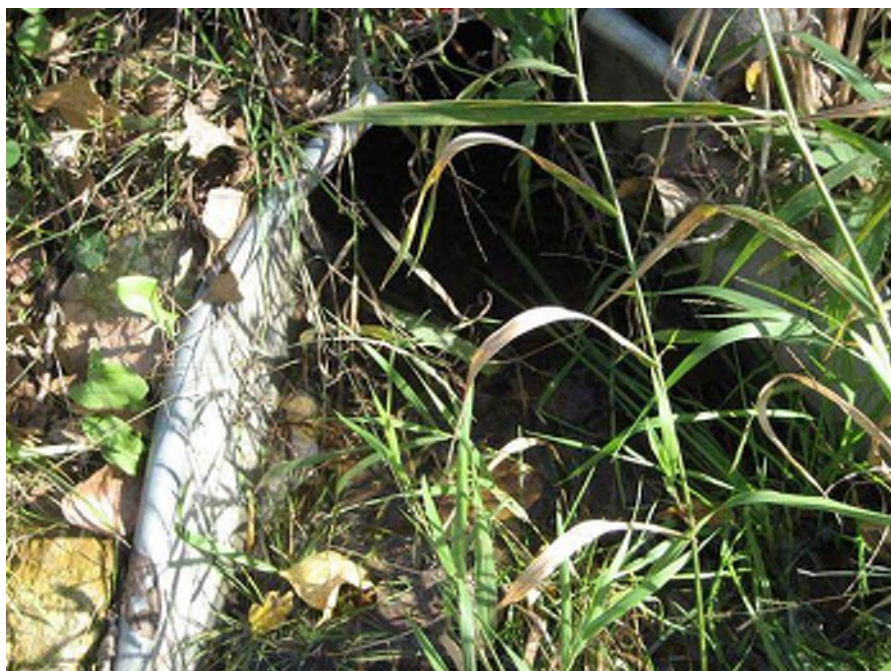
River side of trail; matting/rock layer; pooling water.

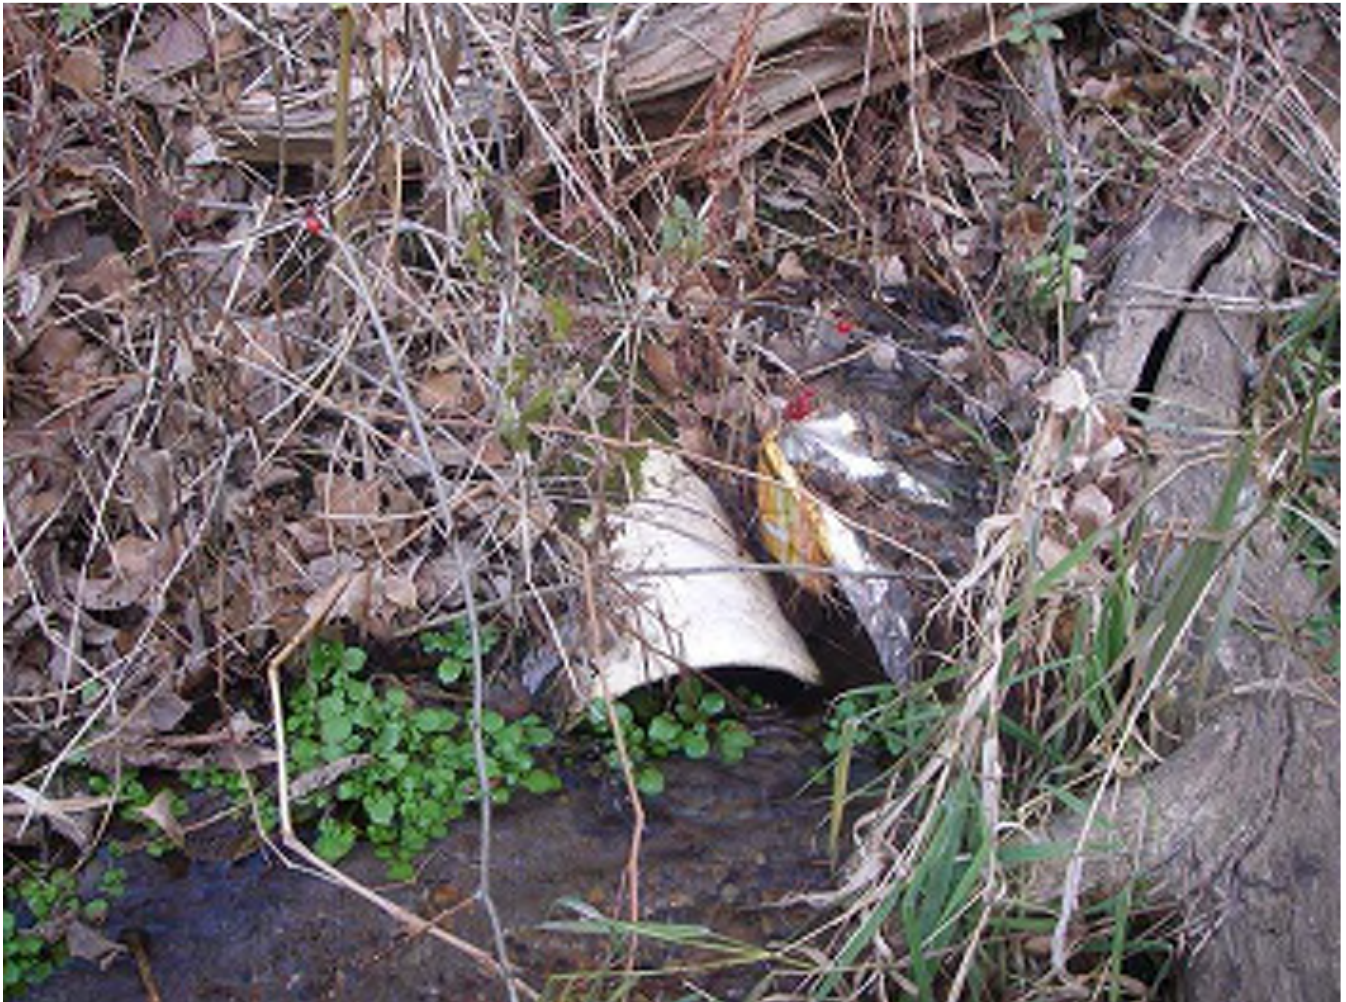
Waypoint 105

Pipe outfall at spring/somewhat buried

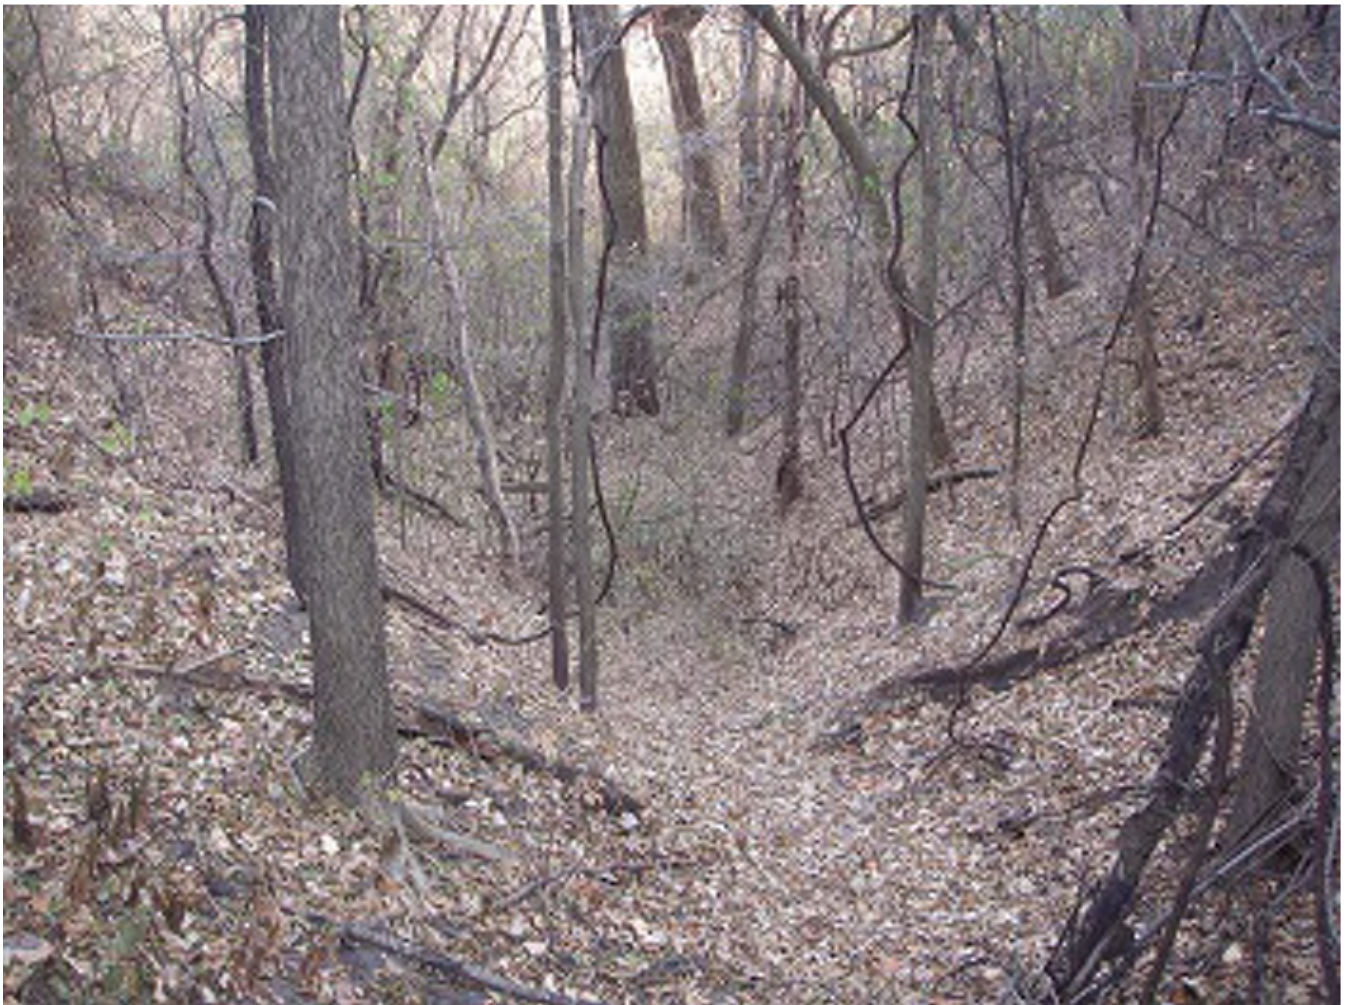
Waypoint 106

Deep erosion

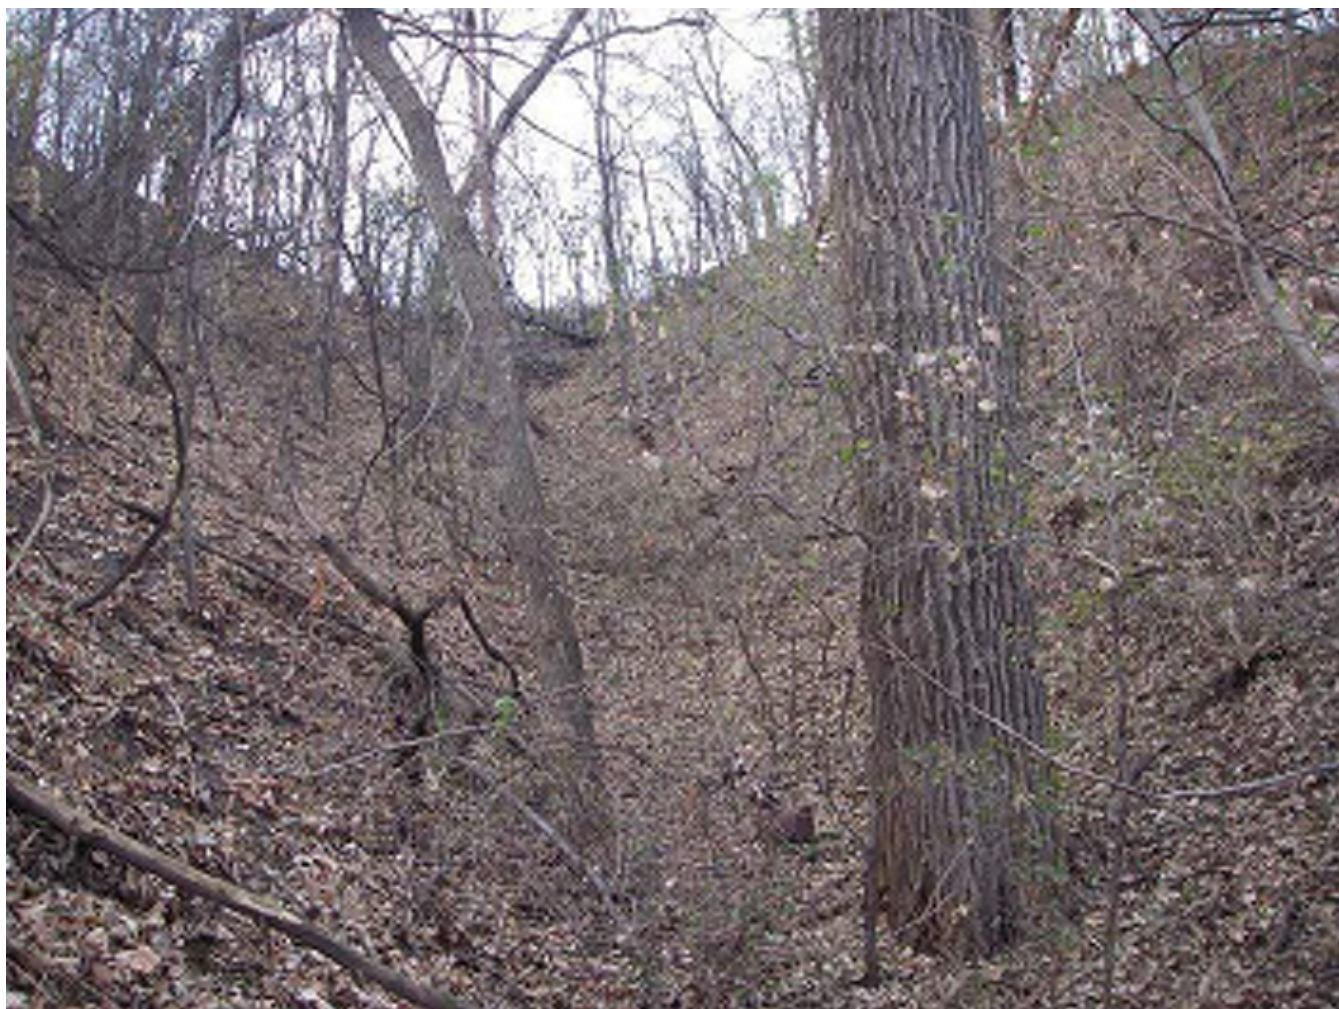
Deep erosion

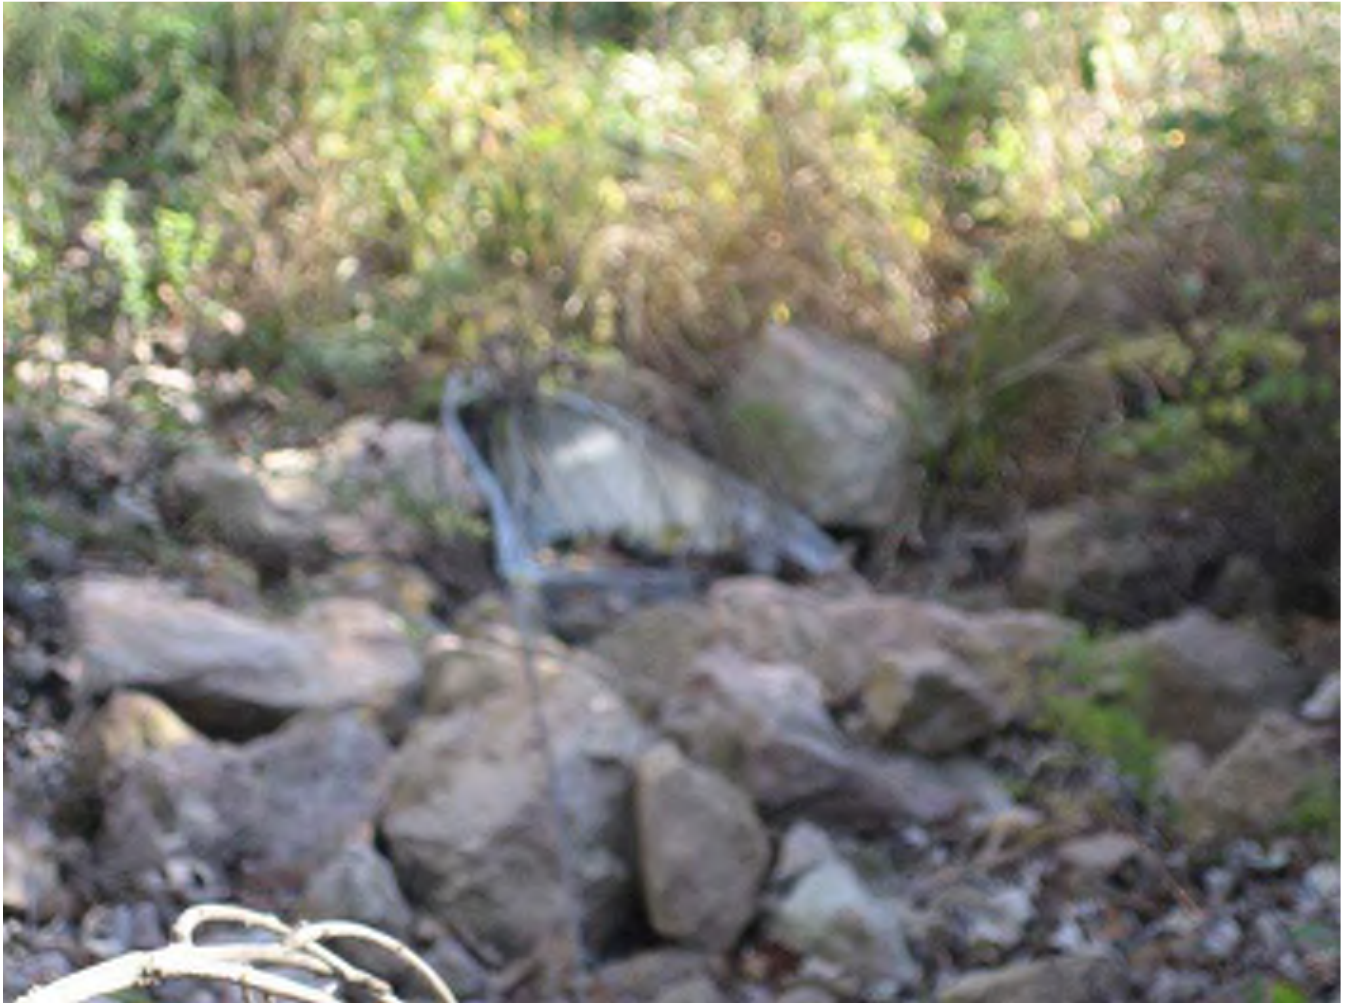
Waypoint 106A

Riverside metal culvert going under trail; large rocks around culvert.

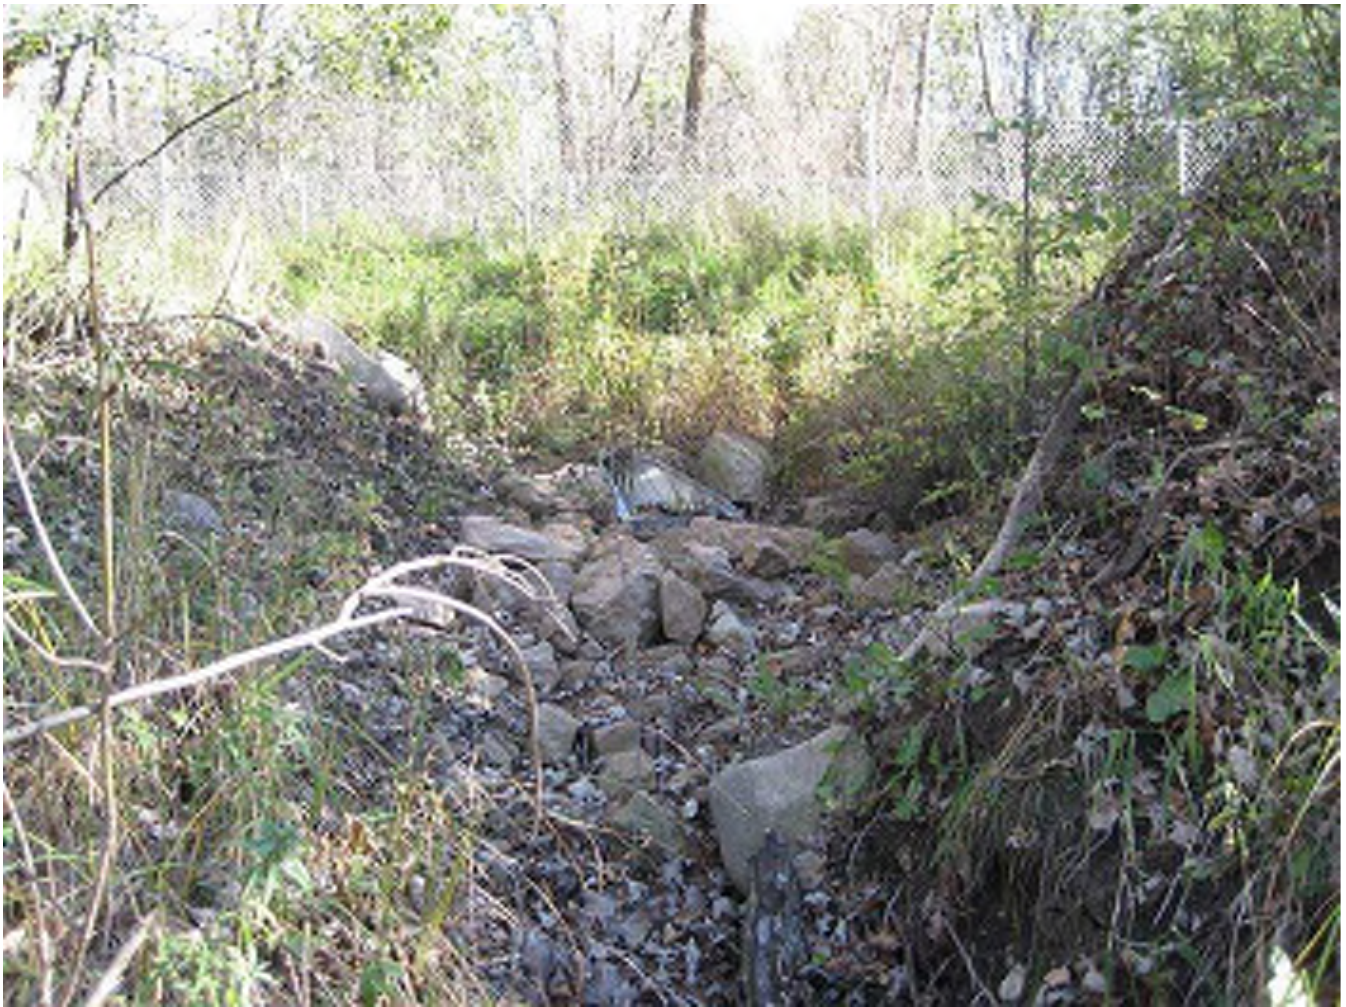
Major erosion

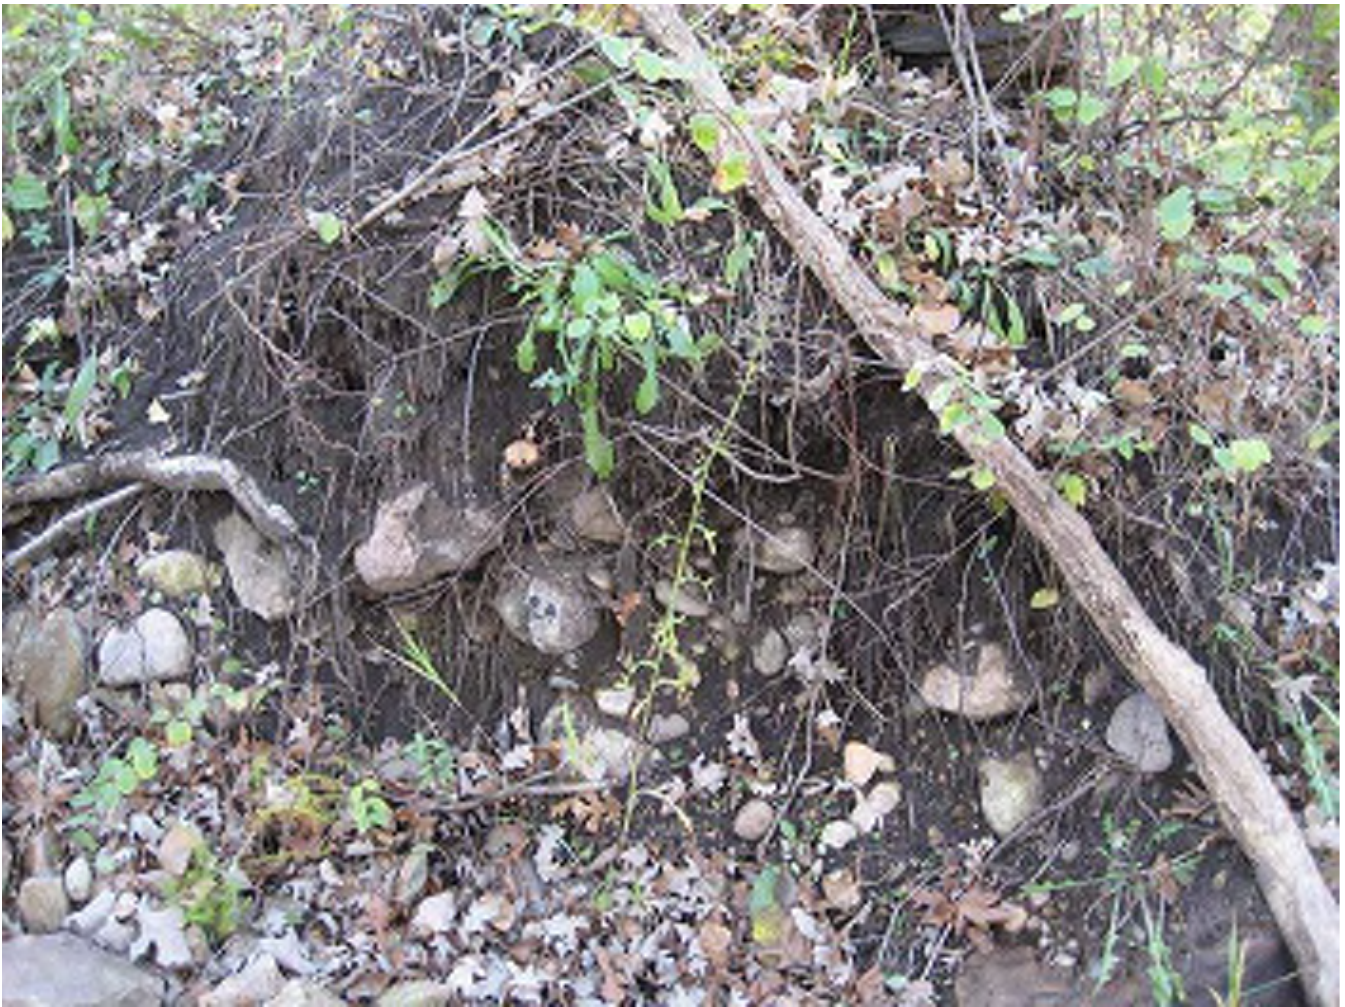
Severe erosion

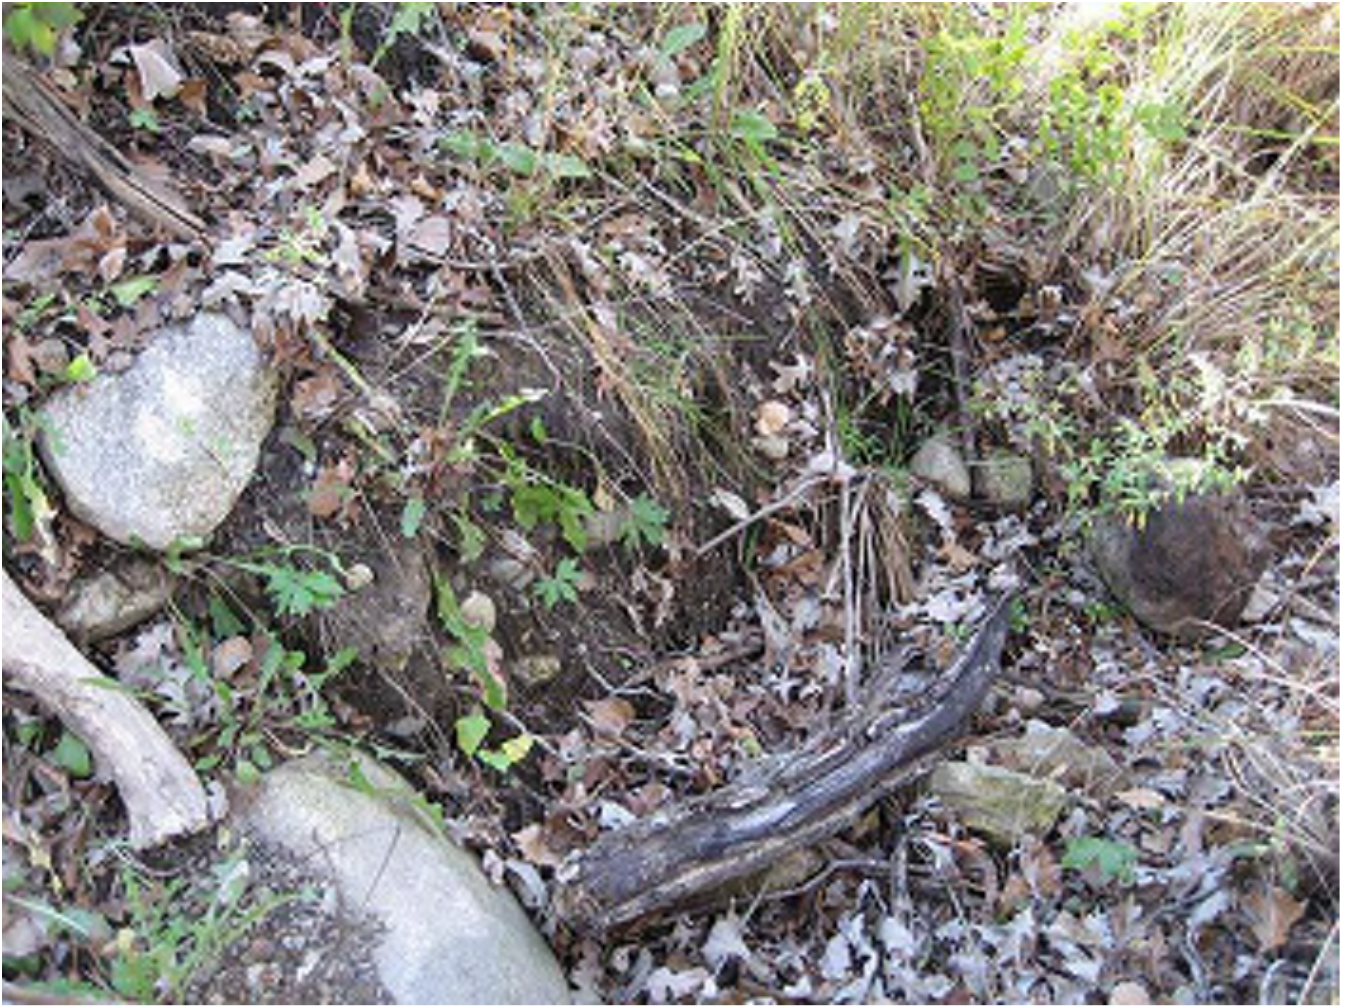
Severe erosion

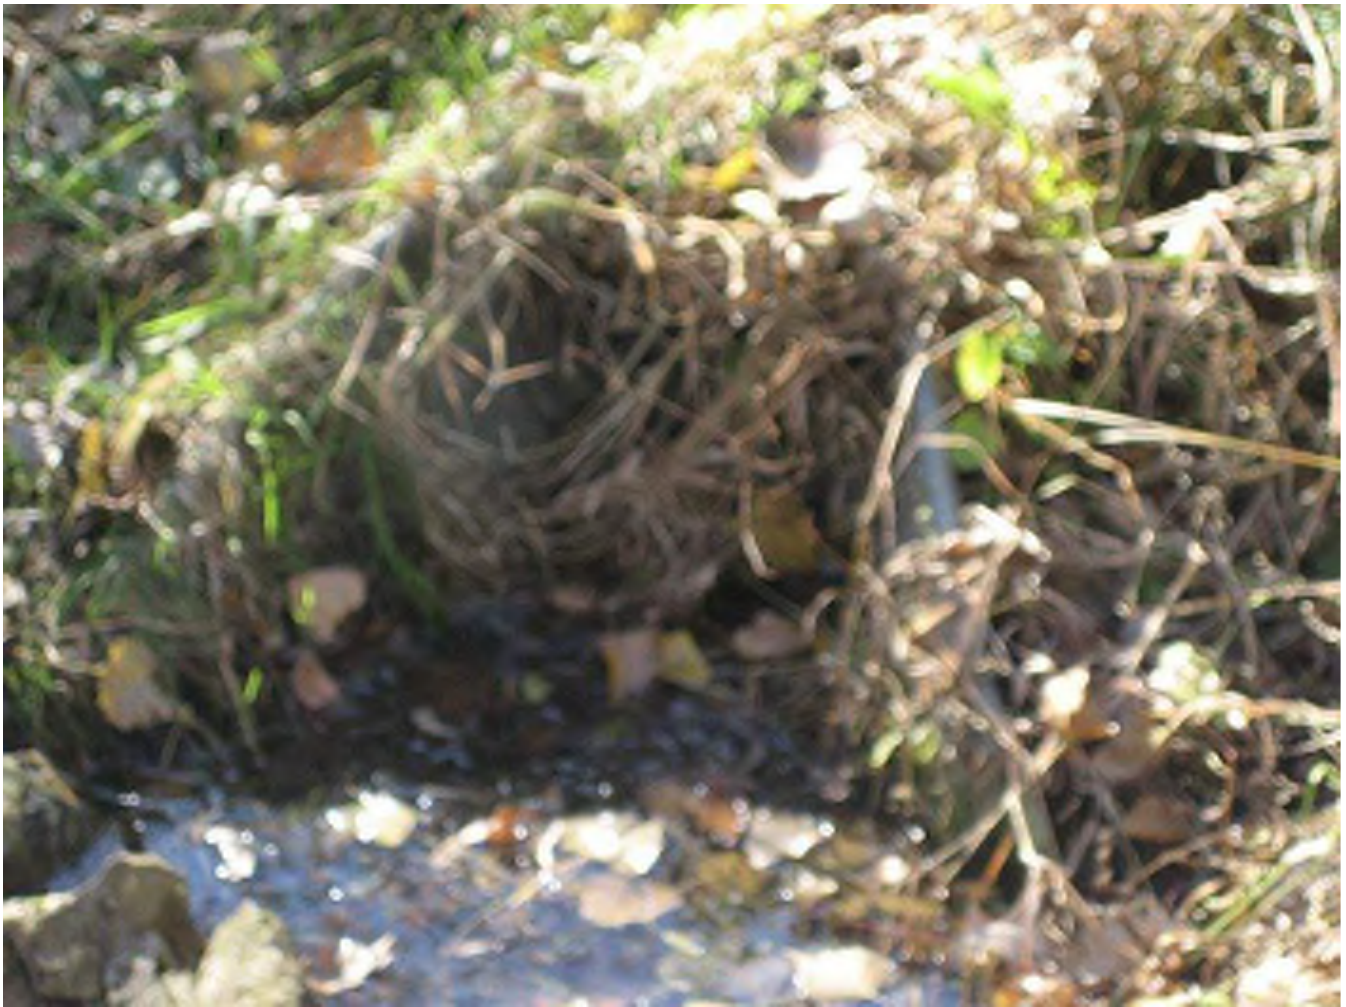
Other end of culvert; rock and erosion blanket.

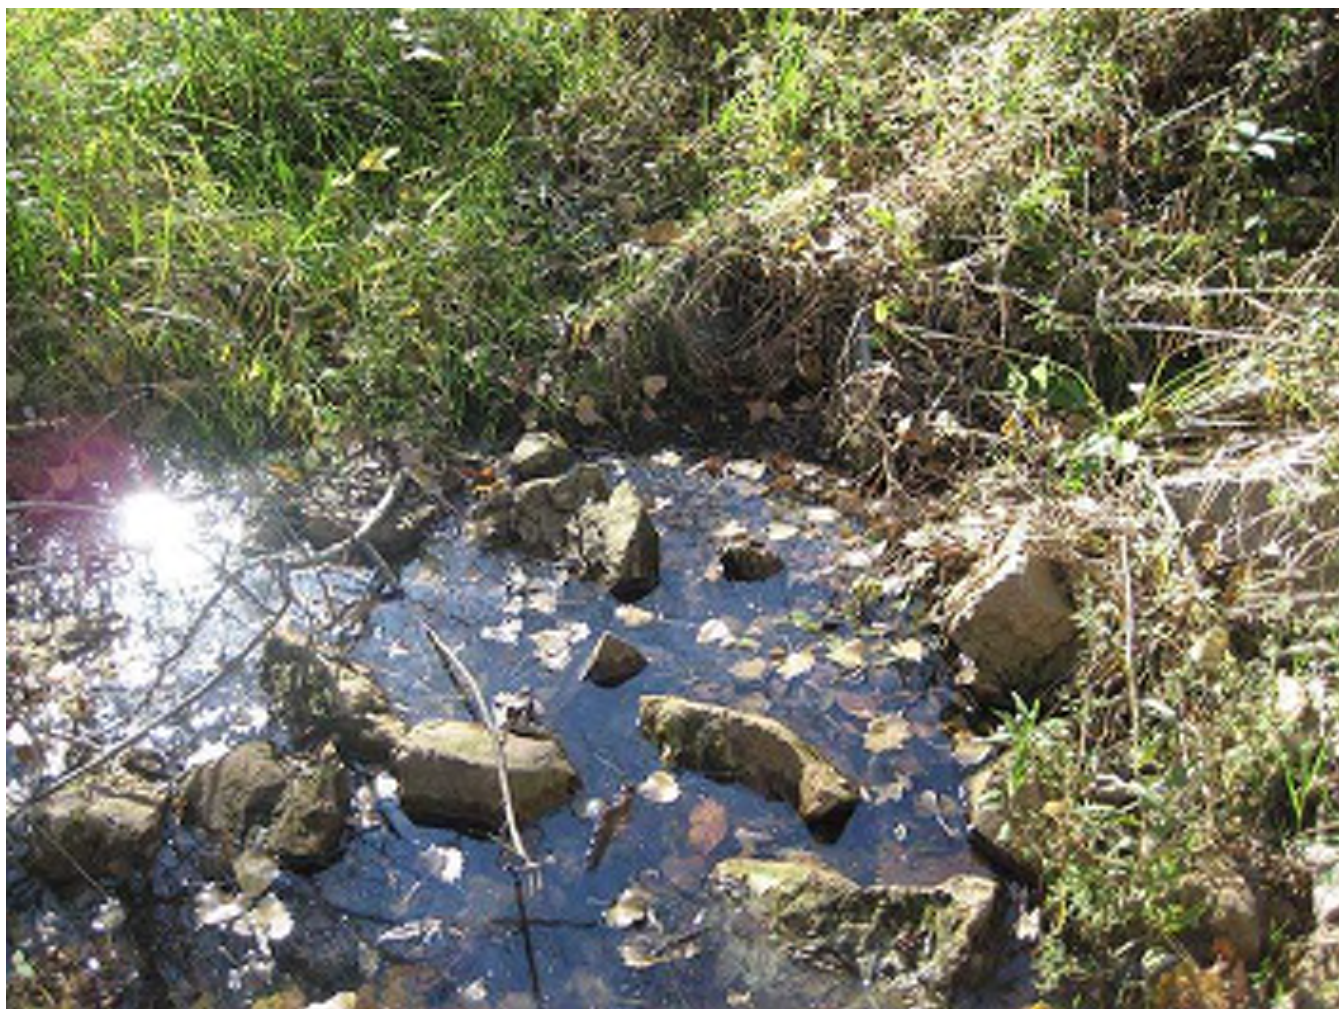
Pooling water around culvert.

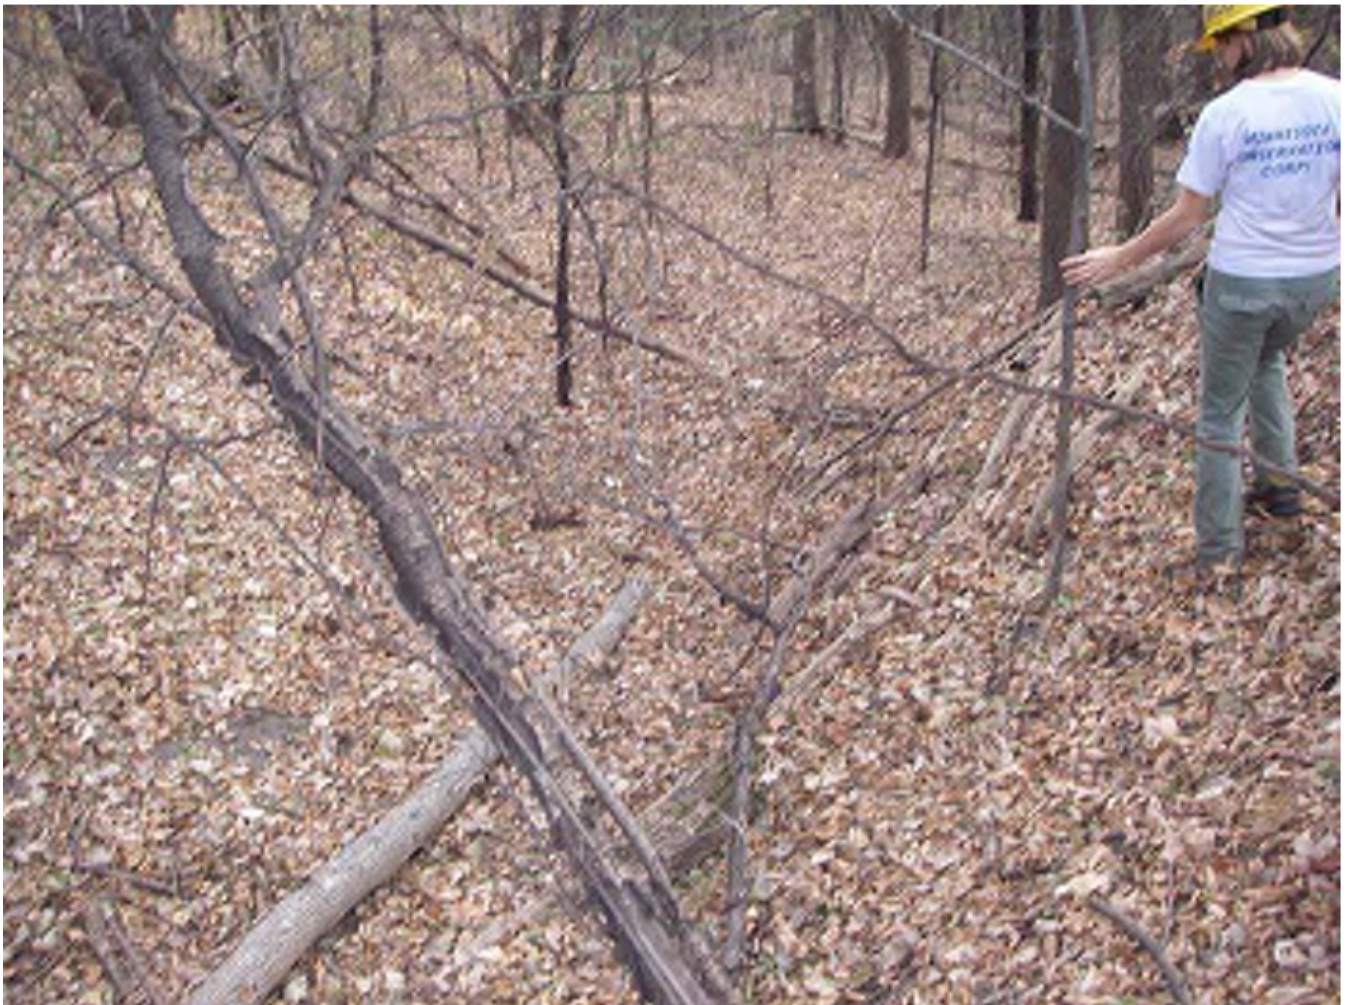
Some erosion; Multiple 111

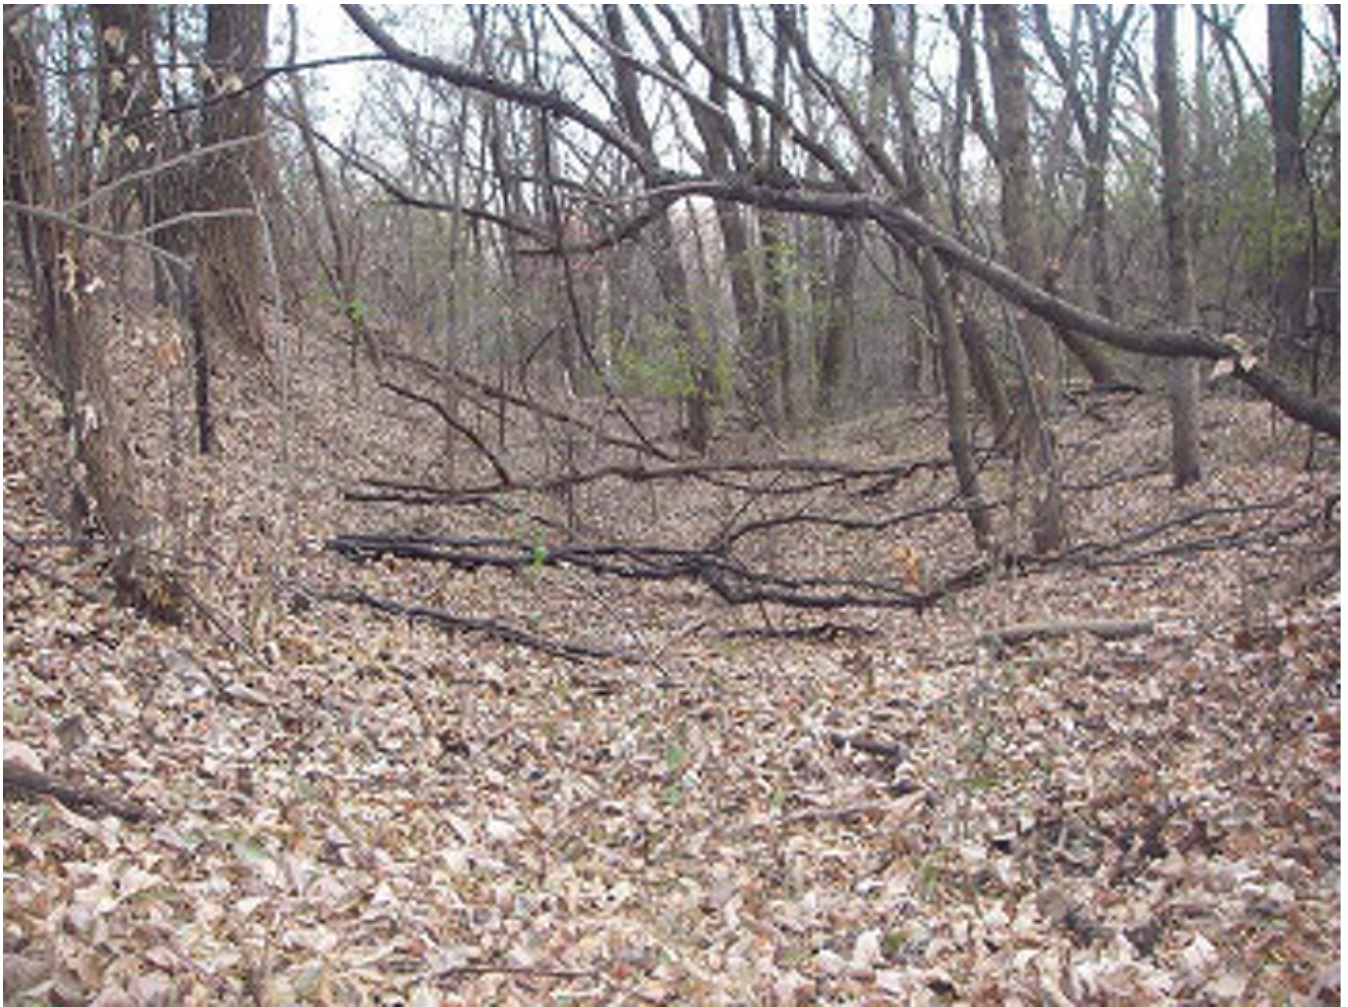
Gully with tree litter;

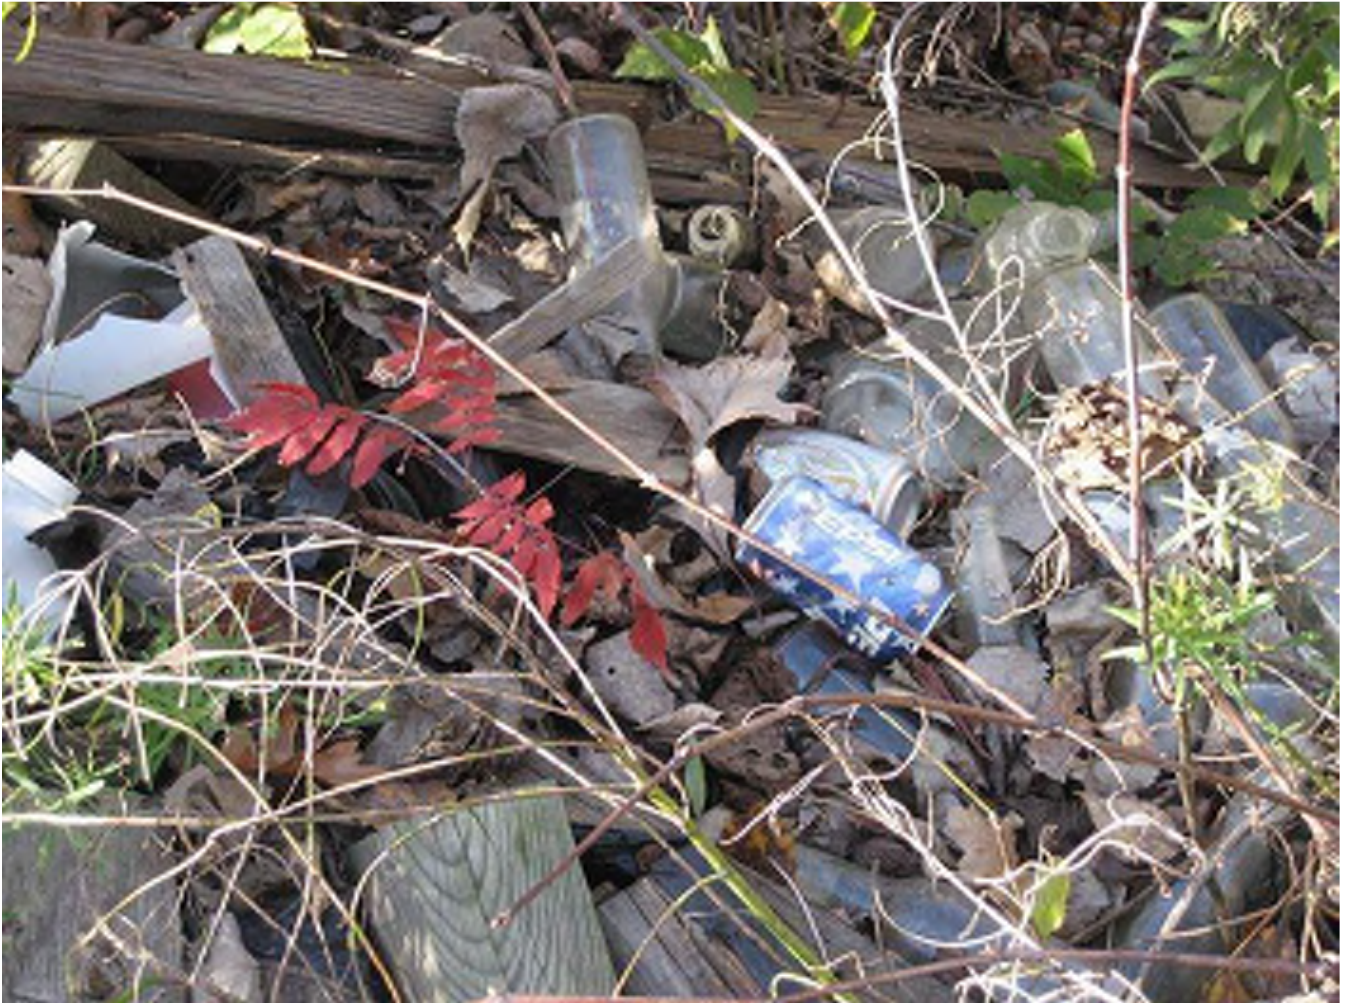
Waypoint 107A

Top of gully; lots of litter, cans, bottles, refrigerator, mattress, rugs, tires, etc.

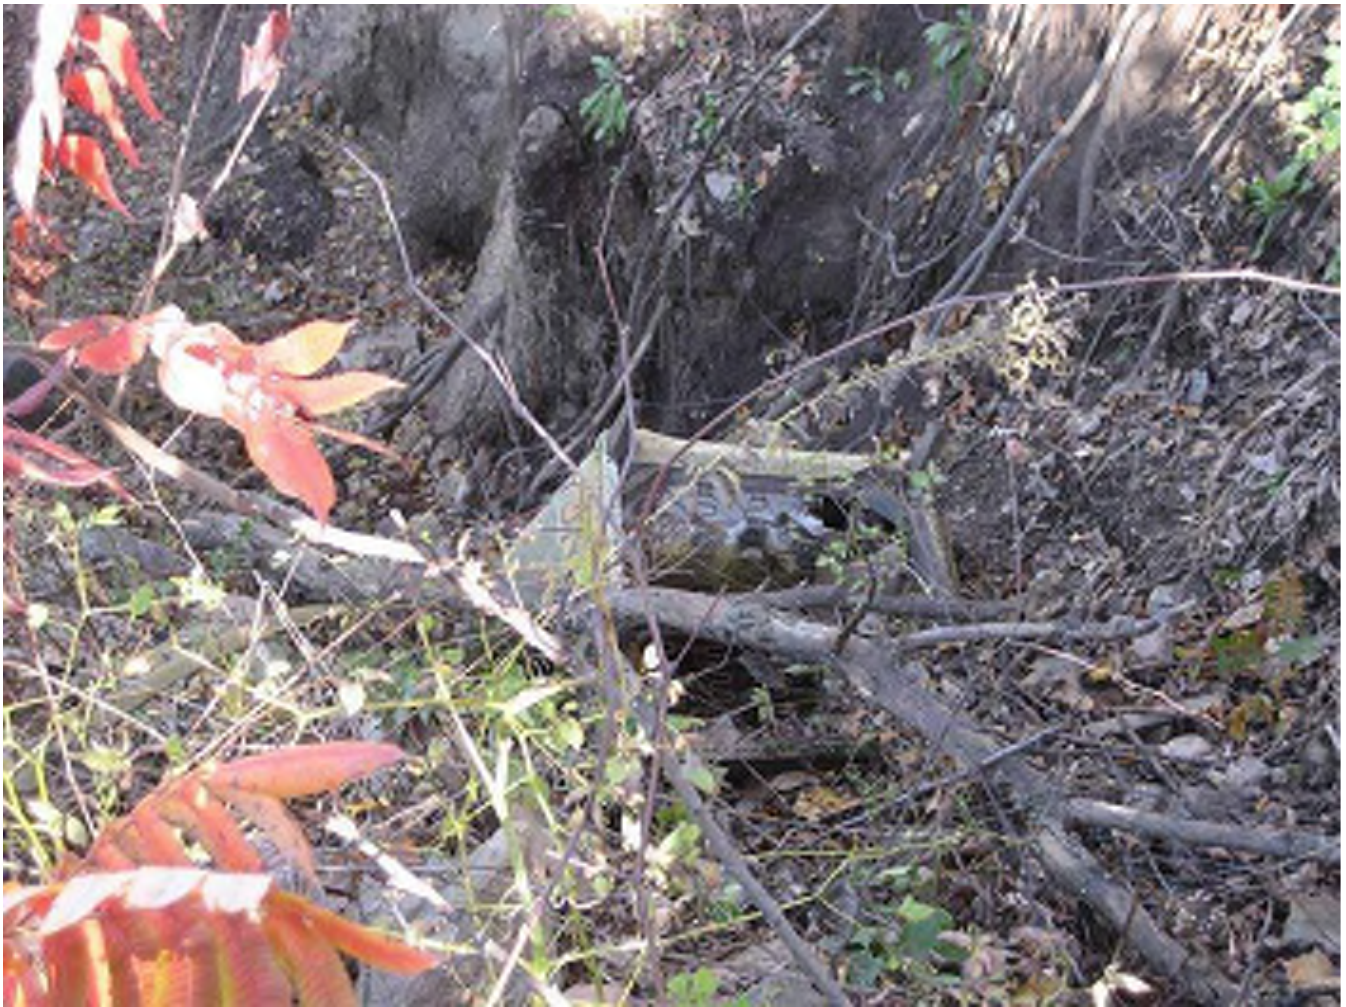
Major erosion.

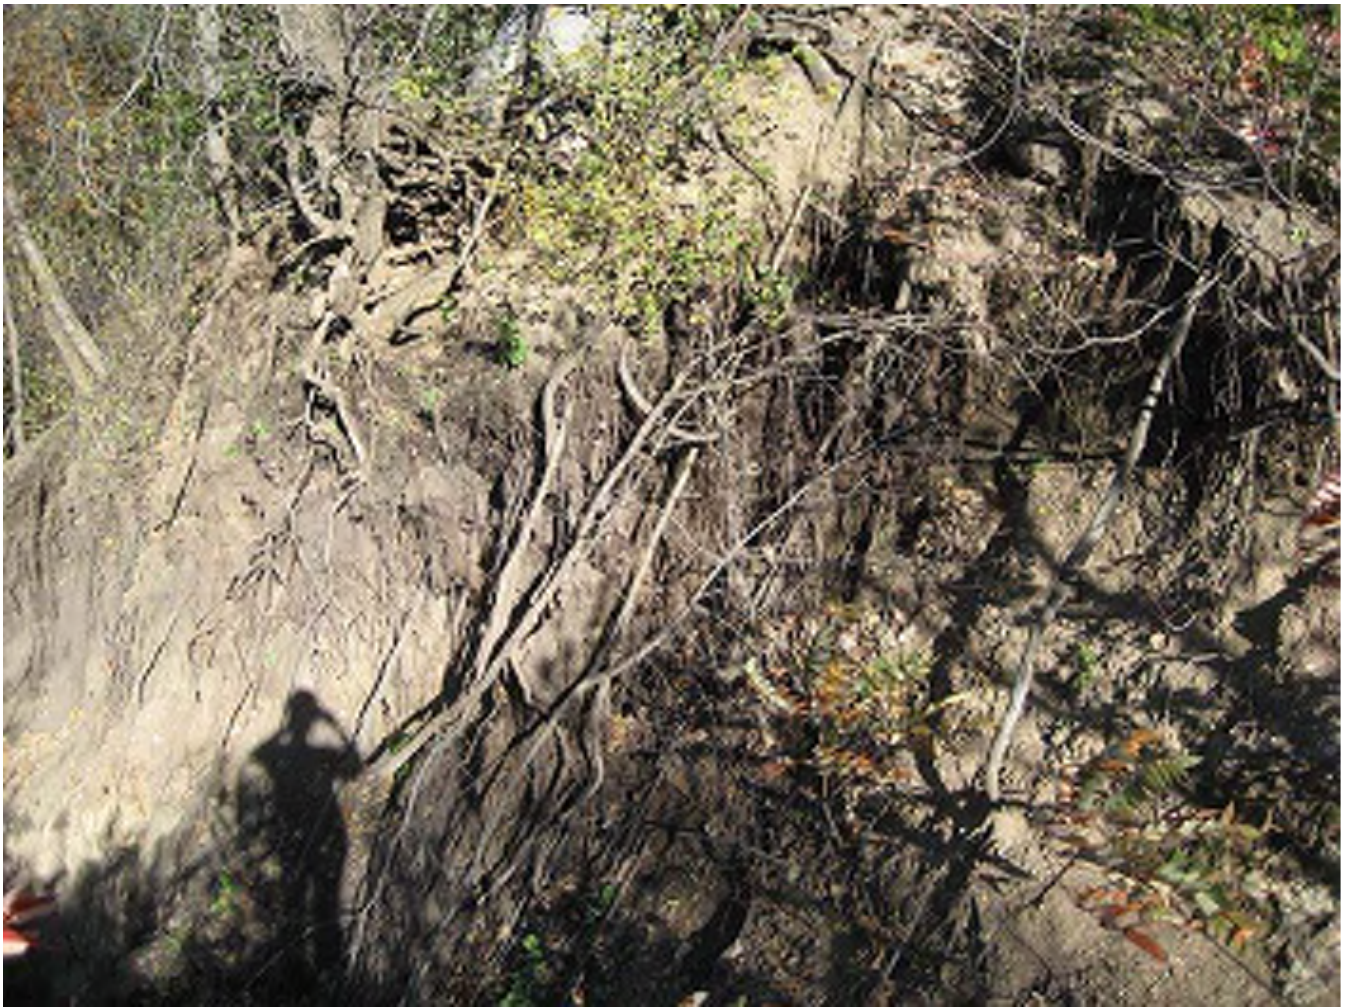
Major erosion.
