Appendix K: Lower Minnesota River Watershed District: Gully Inventory

Gully Inventory Map
 Area #1
 Lower Minnesota River Watershed District
 Watershed Management Plan

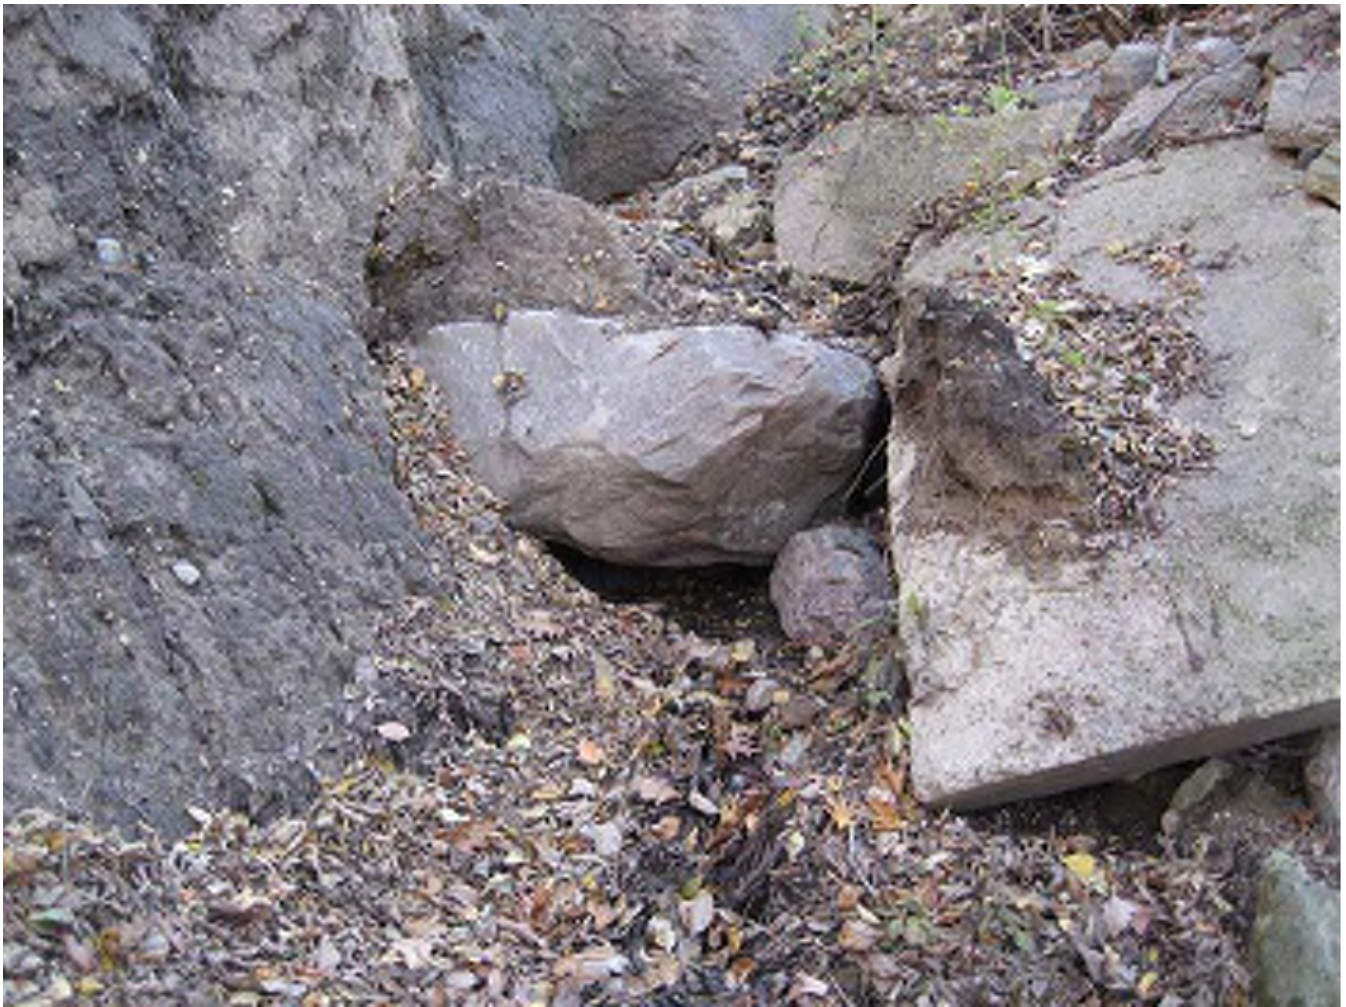
Natural water springs; large boulders.

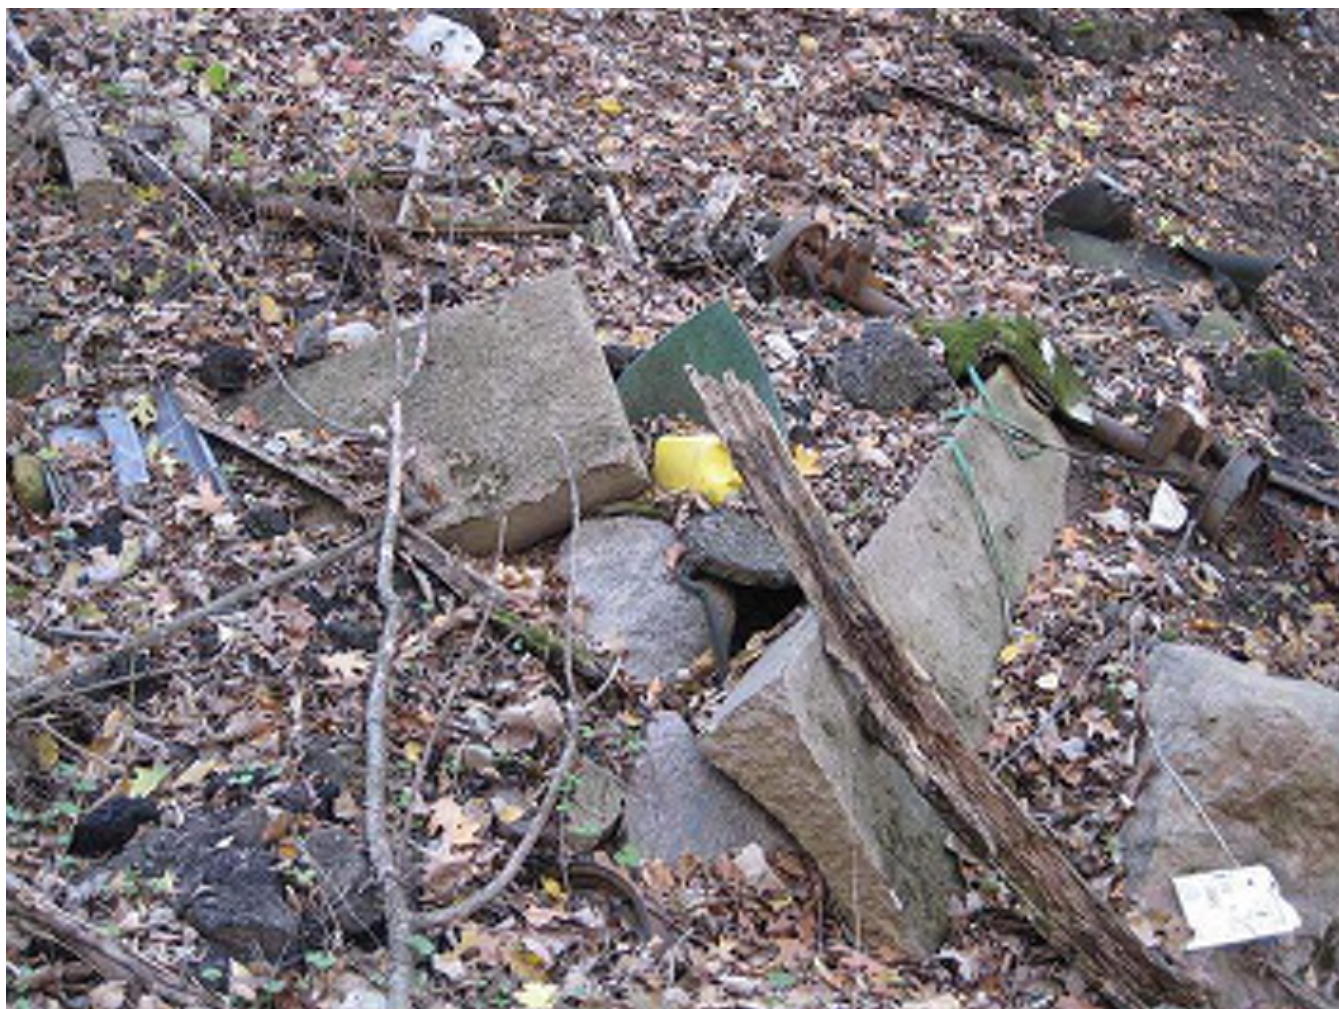
Litter.

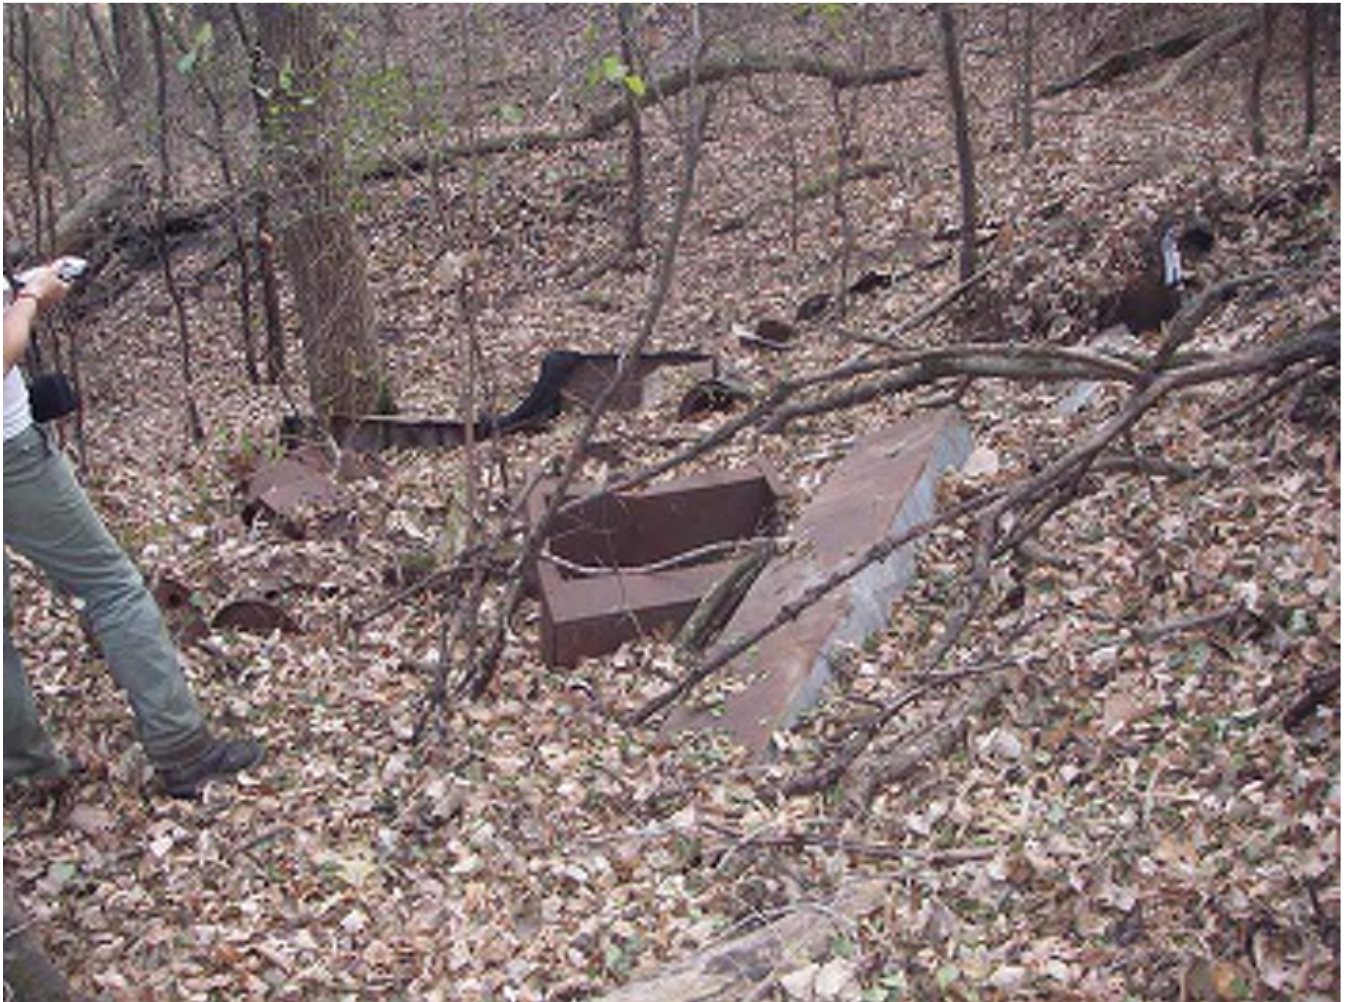
Waypoint 108

Trash, Multiple 112

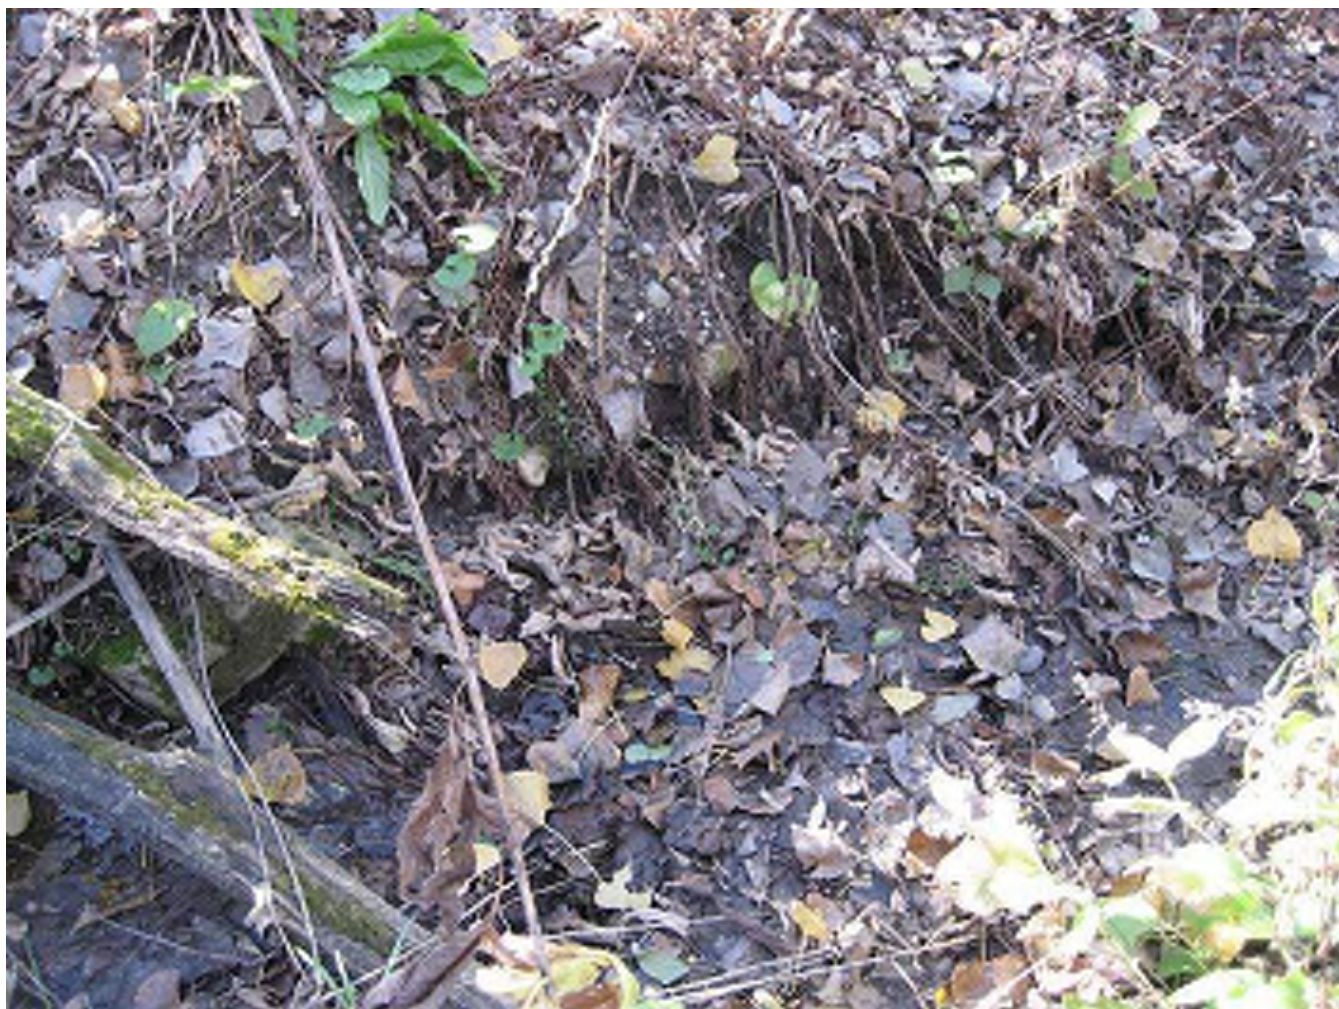
Slight erosion coming out of culvert.

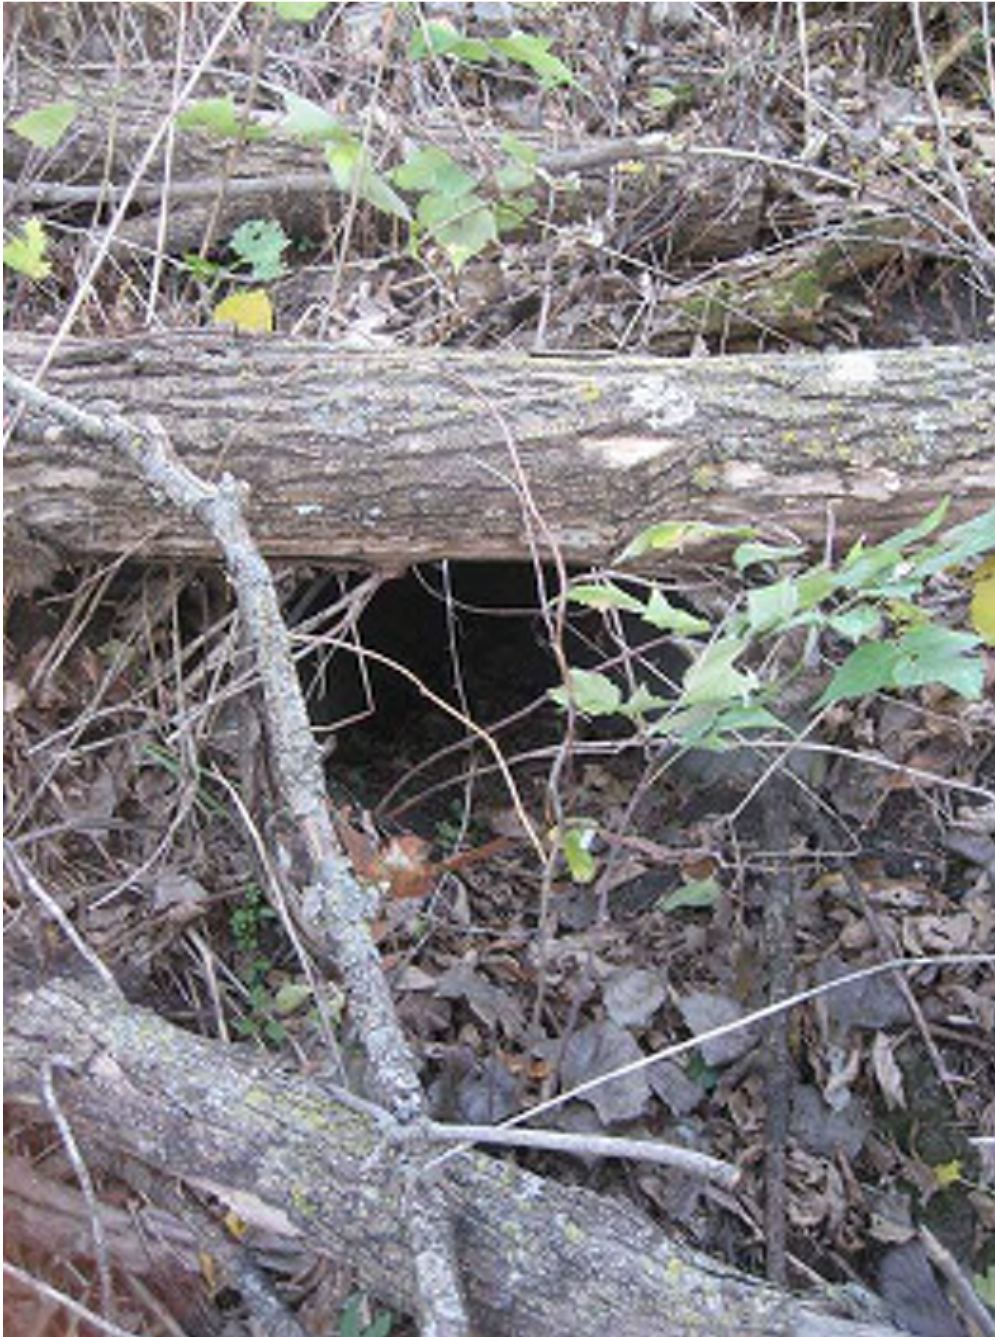
Waypoint 109A

Small culvert on river side of trail; small amount of erosion.

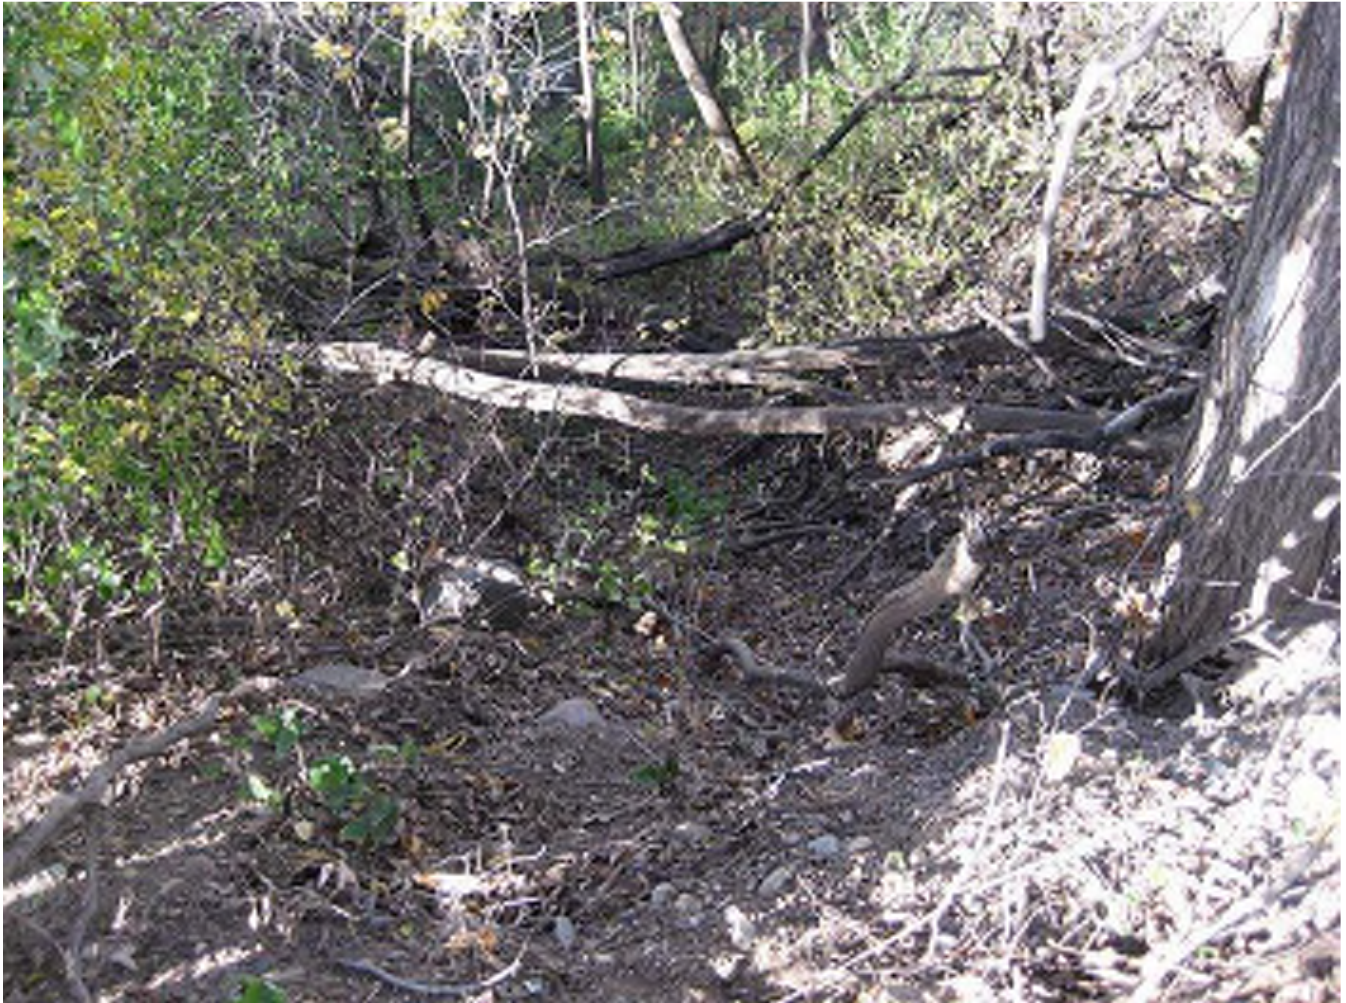
Waypoint 110A

Looking down gully; moderate erosion.

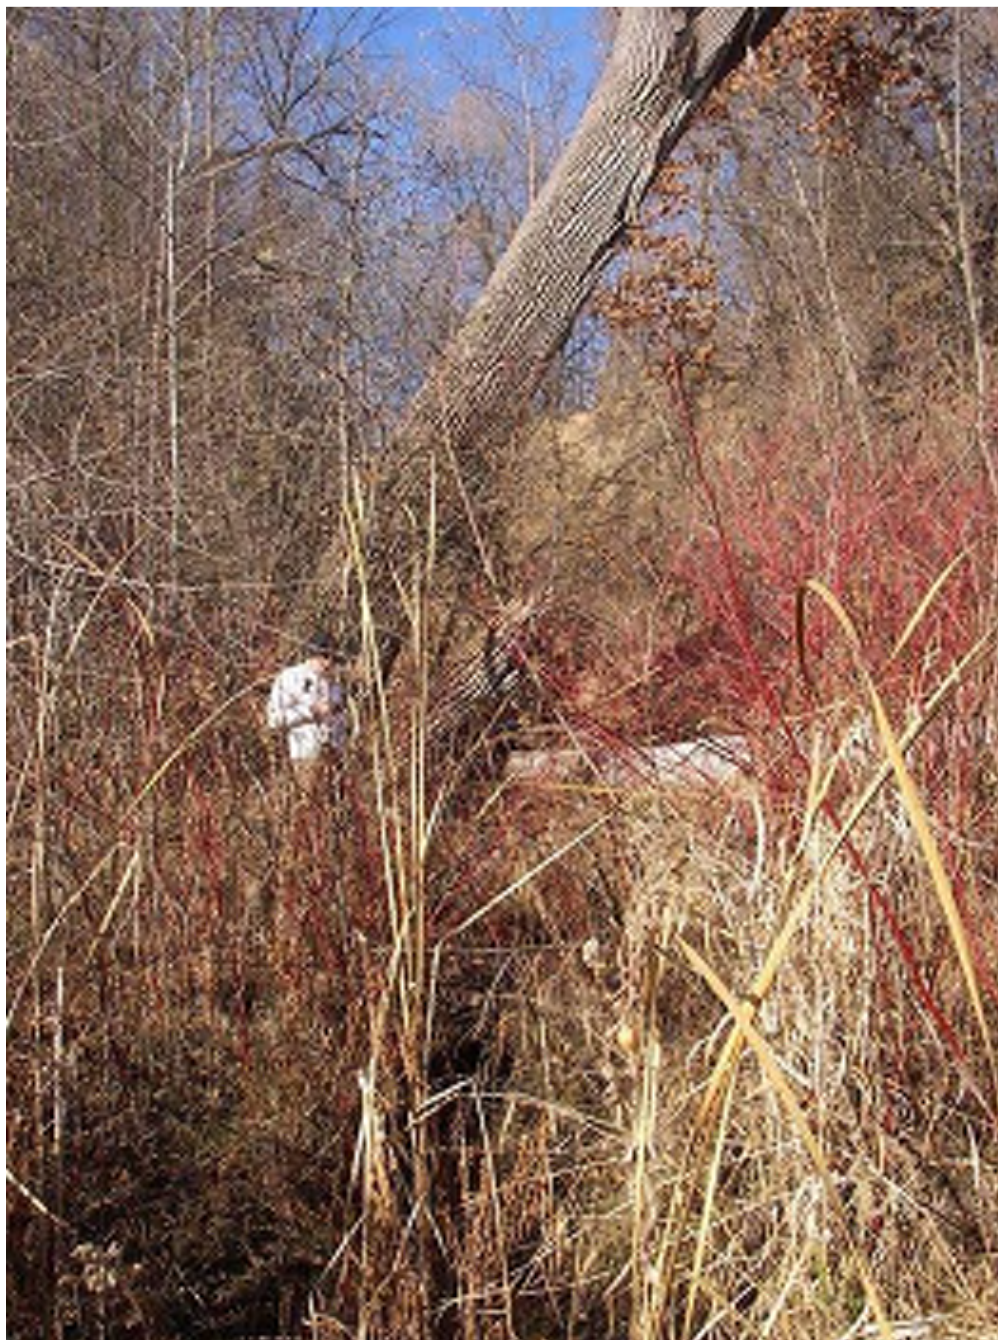
Waypoint 111

Delta/end of water flow into lake

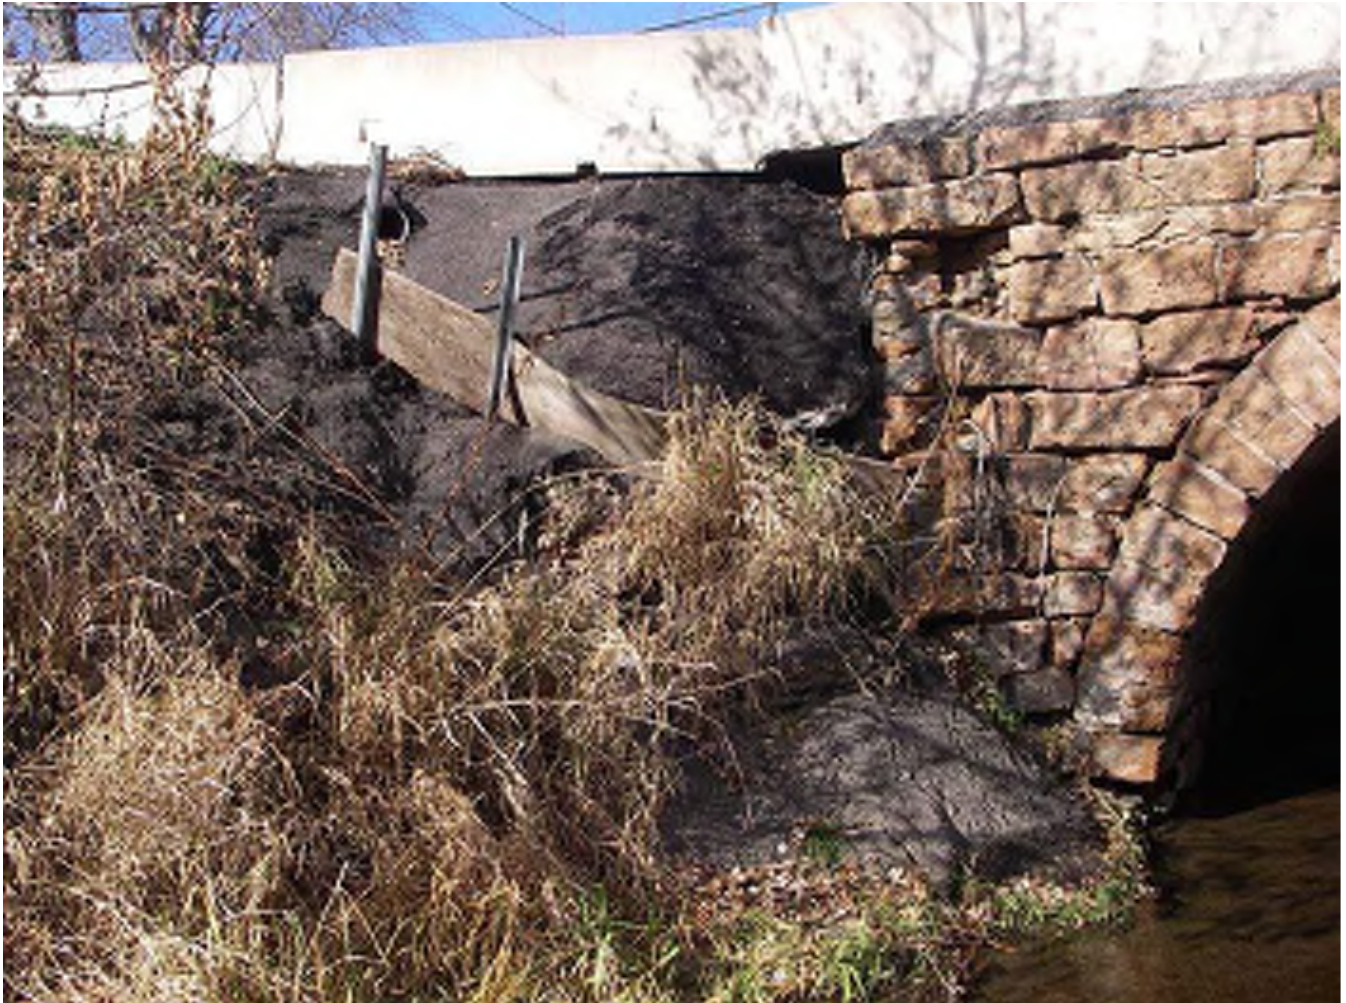
cement erosion control

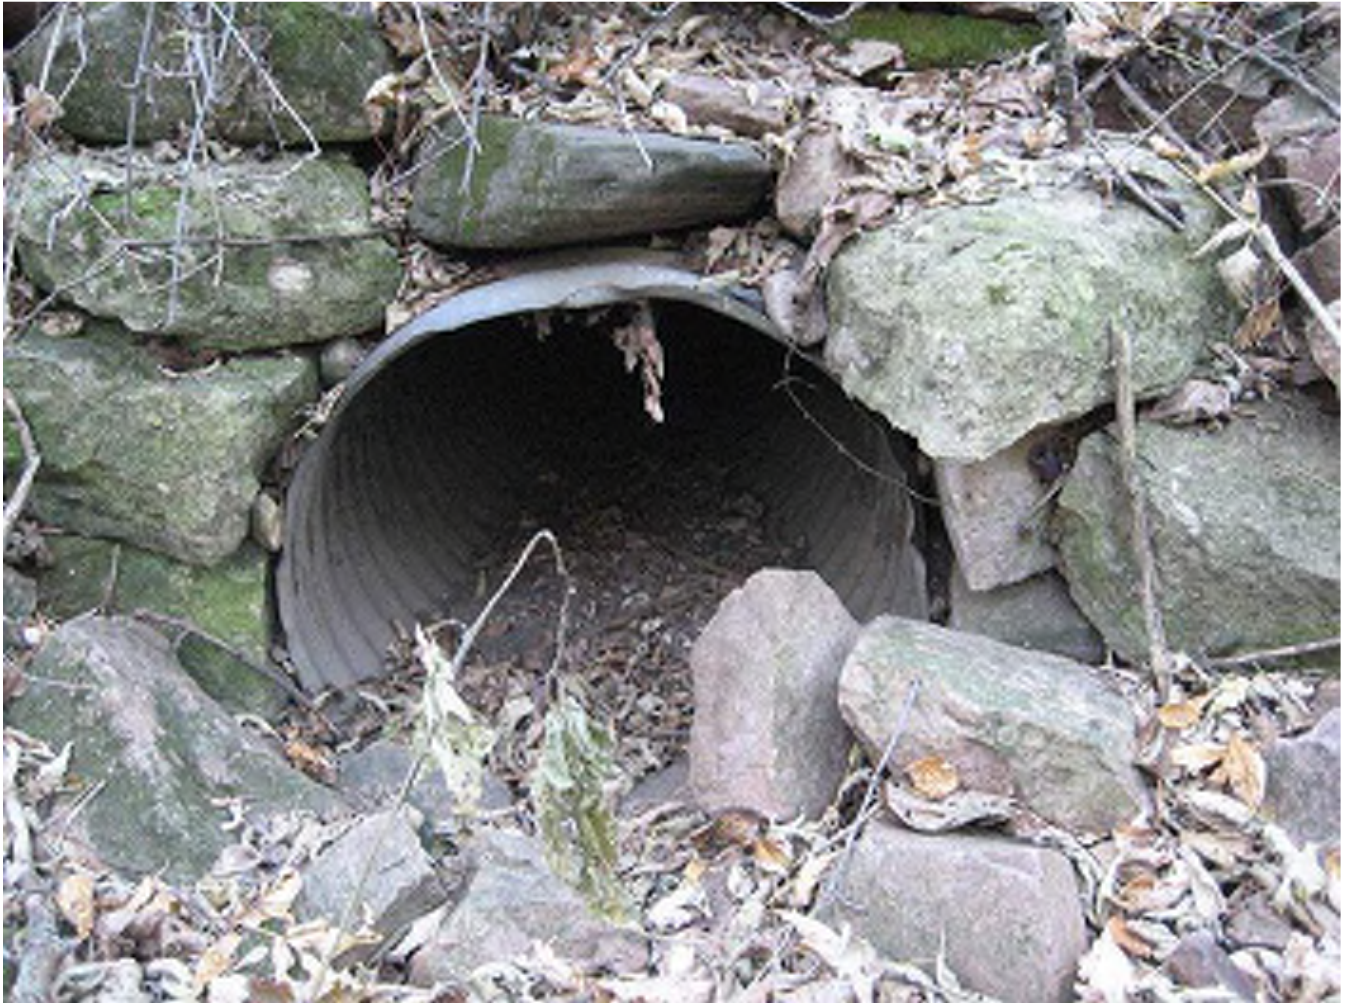
Waypoint 111A

Culvert going under trail opposite of river side; little erosion.

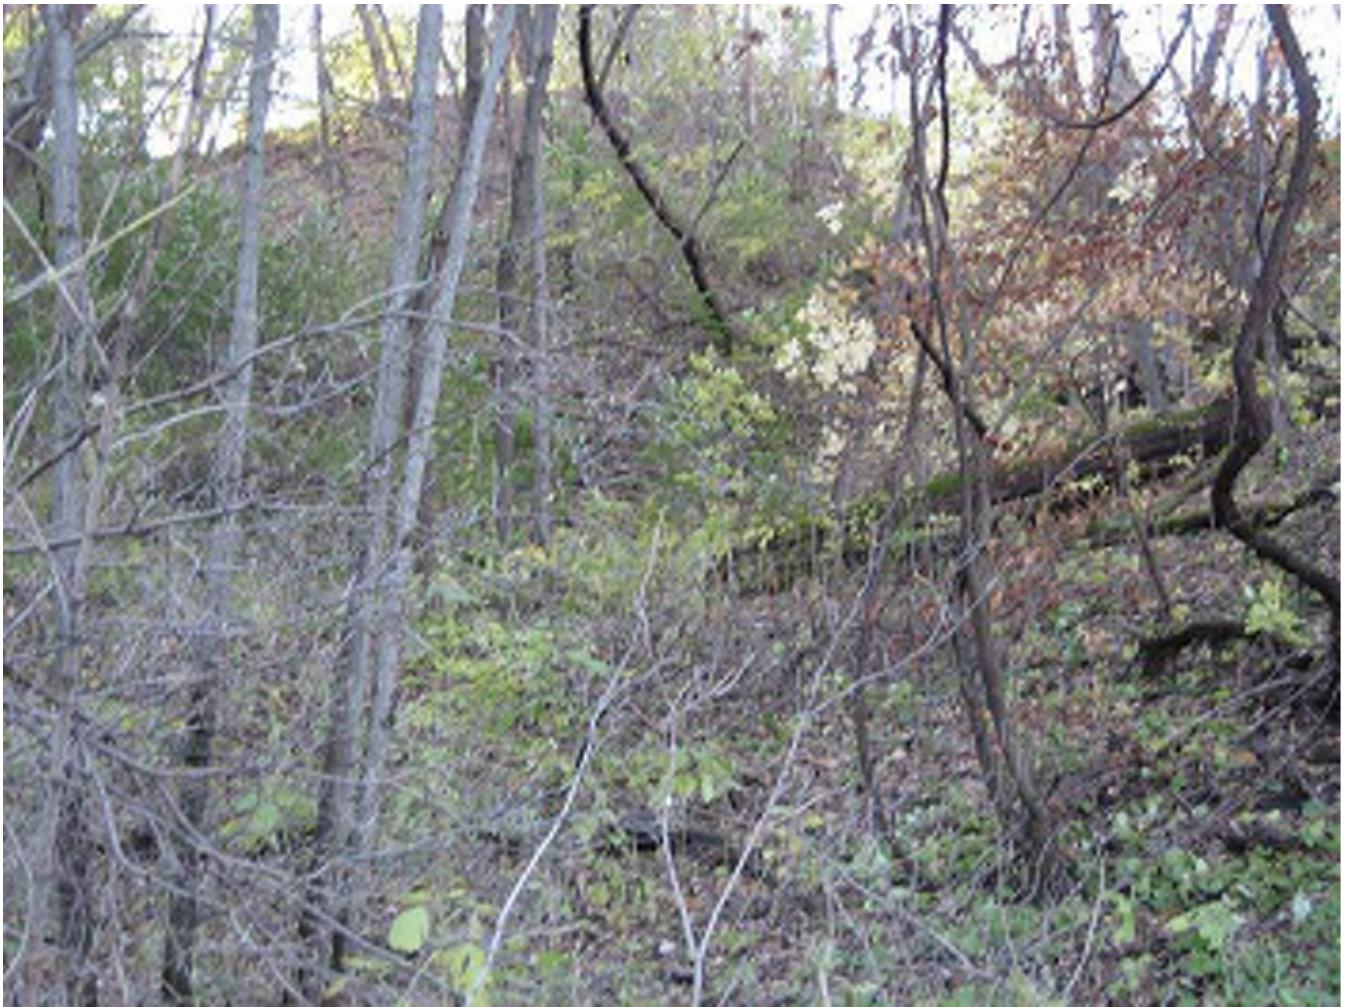
Looking up at gully above previous picture; very little erosion.

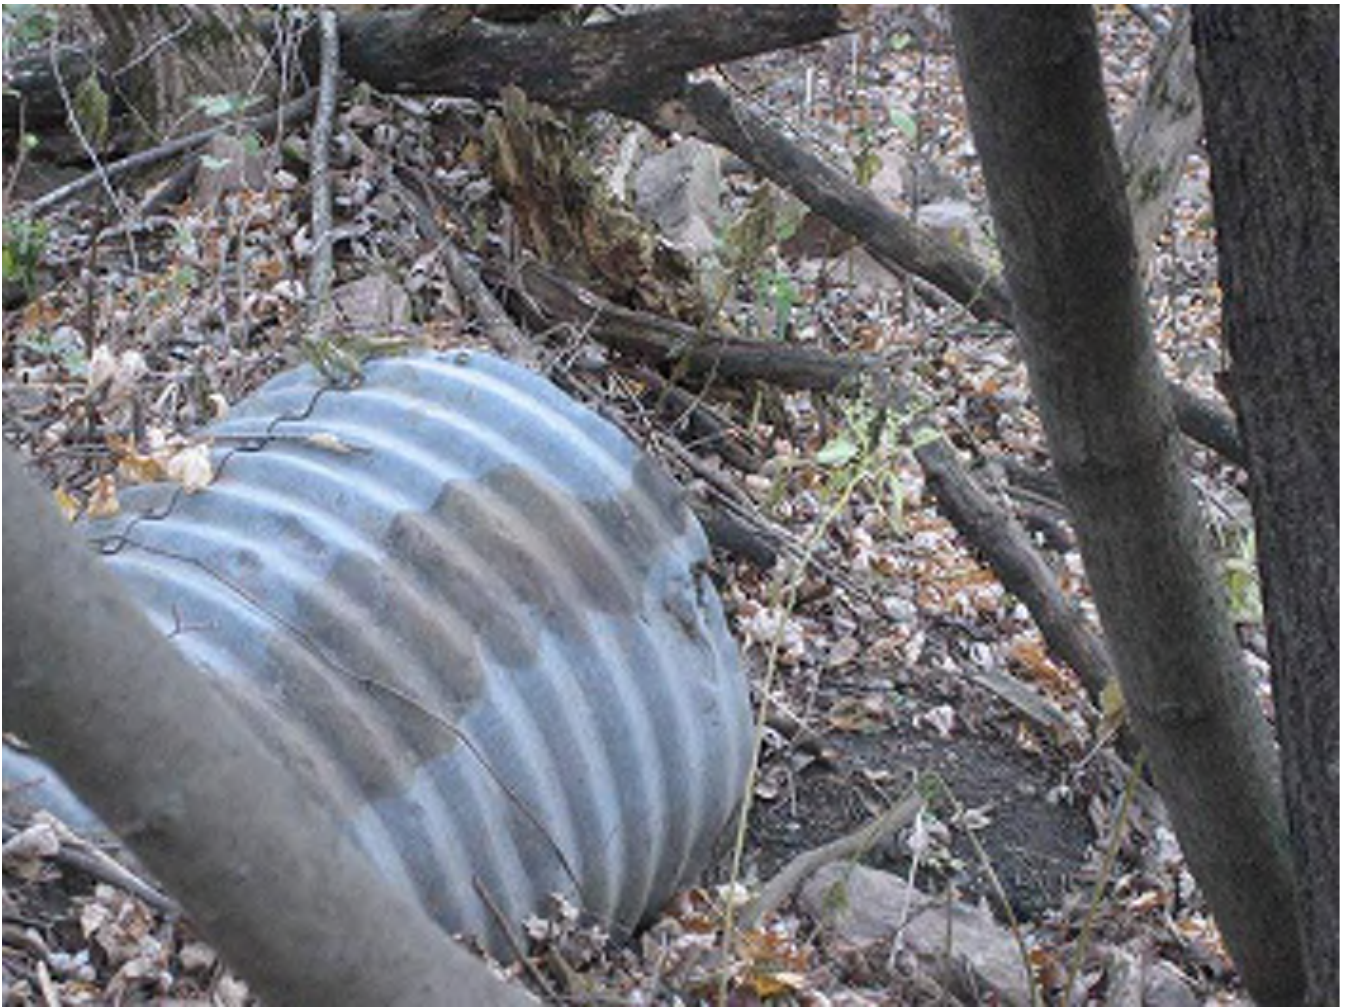
Culvert on river side; small amount of erosion.

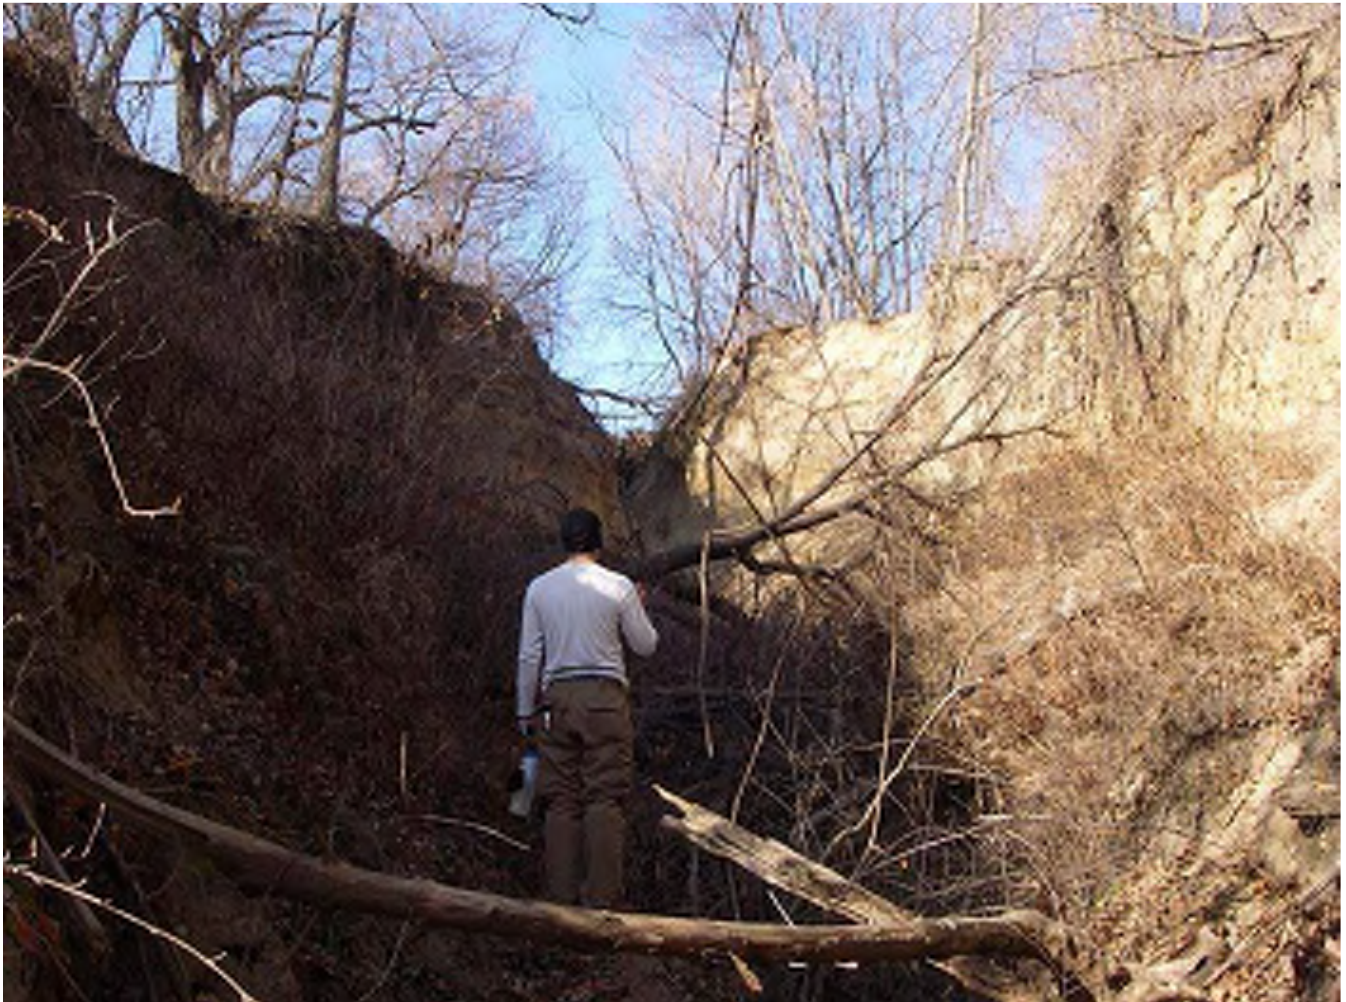
Waypoint 112

Heavy erosion middle short & short of finger tip

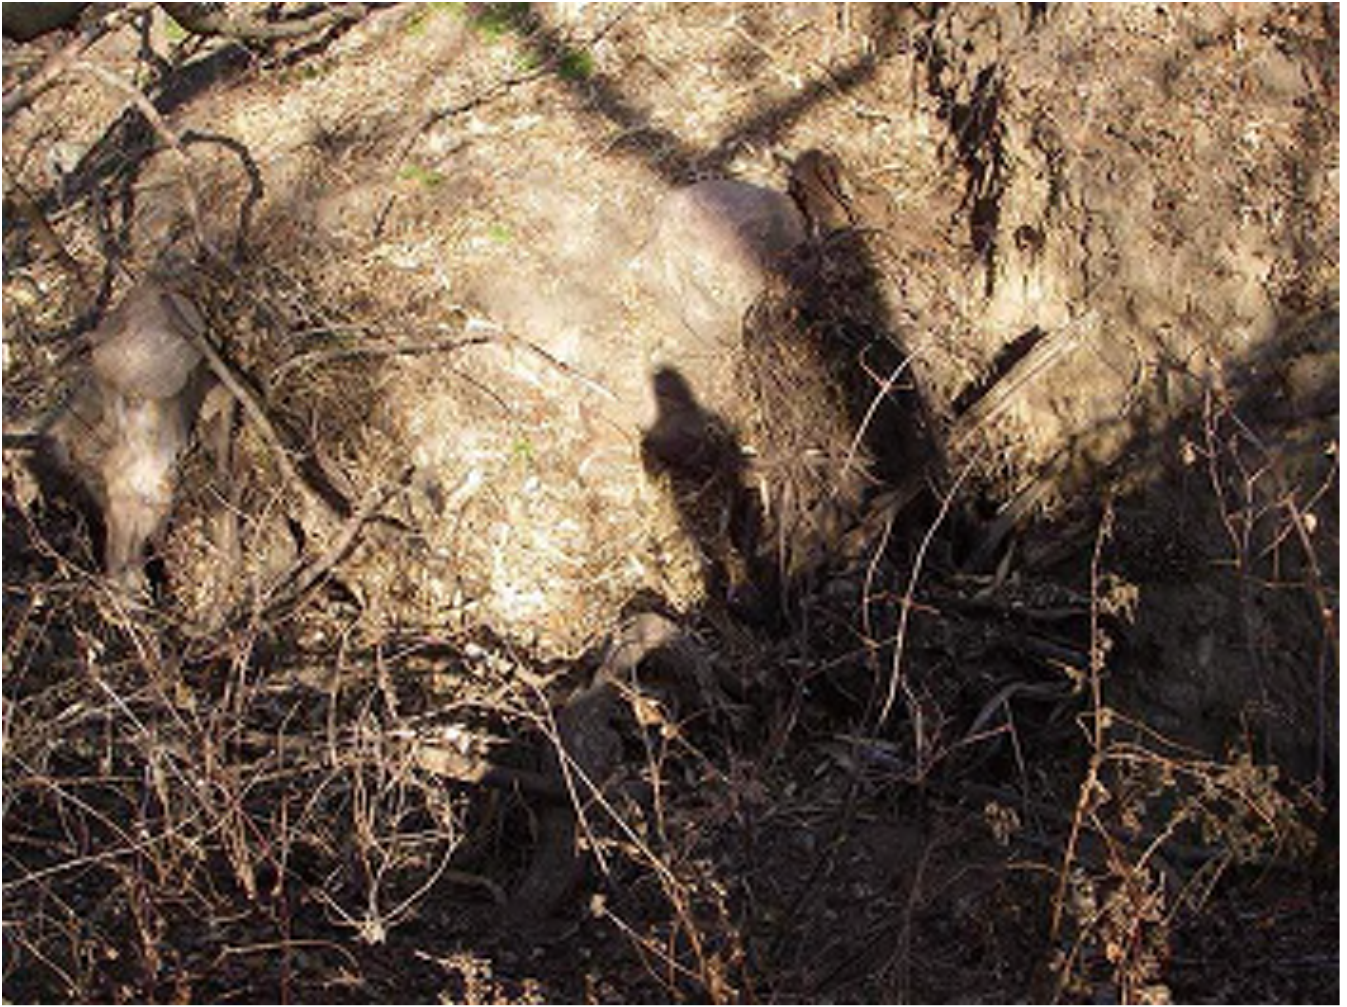
Heavy erosion middle short & short of finger tip

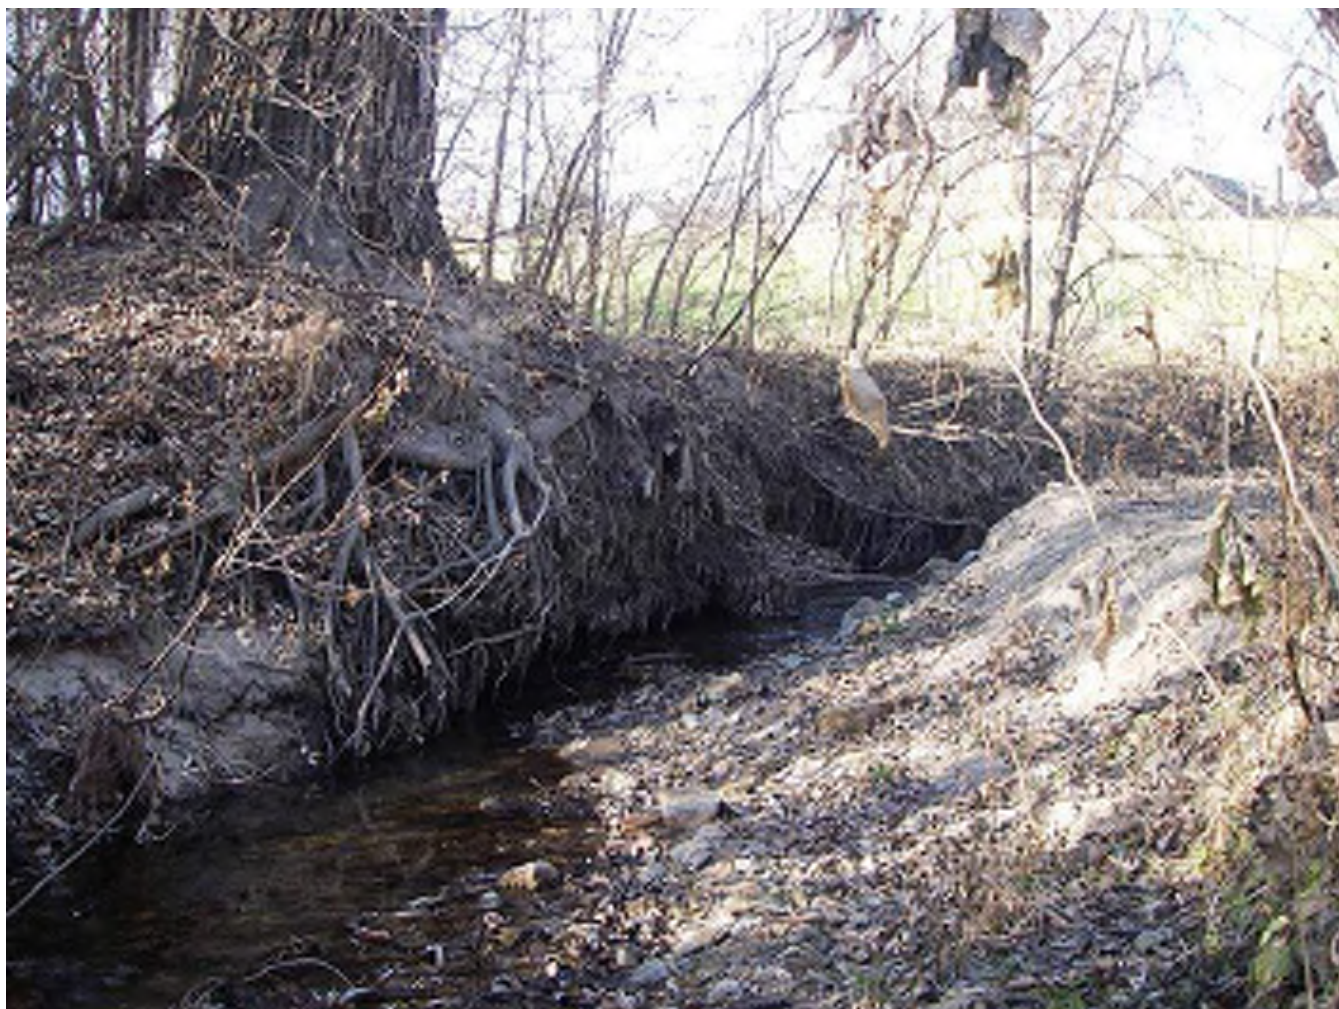
Eroded stream bank

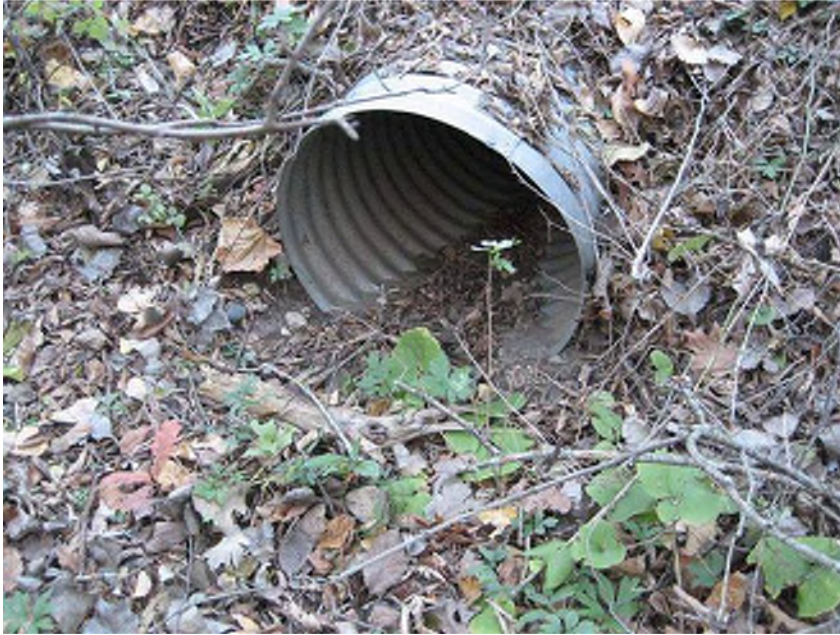
Waypoint 112A

Culvert opposite side of river going under trail; very little erosion.

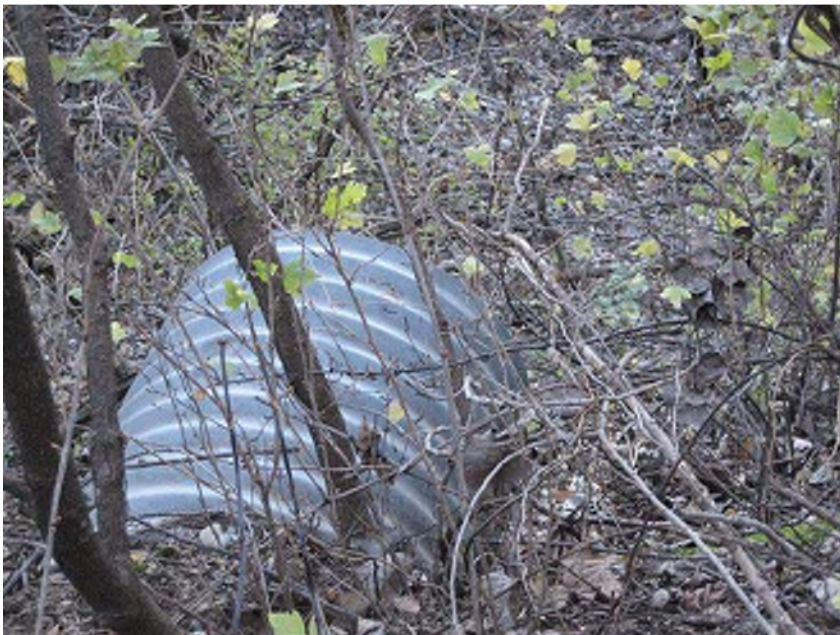
Culvert on river side of trail; large drop-off under culvert; probably some erosion but could not see due to leaves/ground cover; too hard t

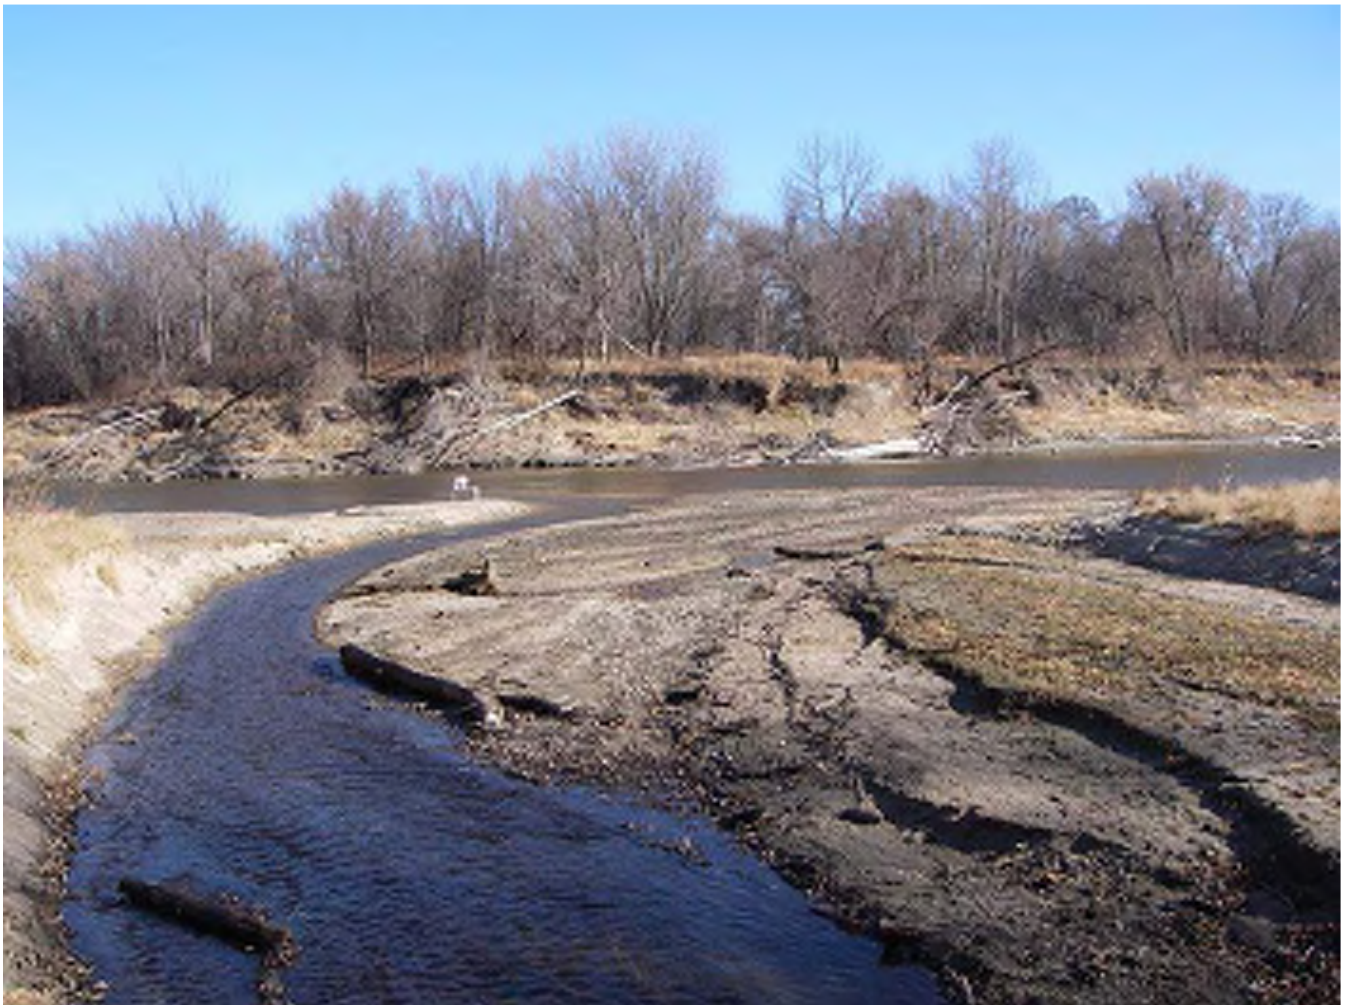
Waypoint 113

View of sediment out-wash into river

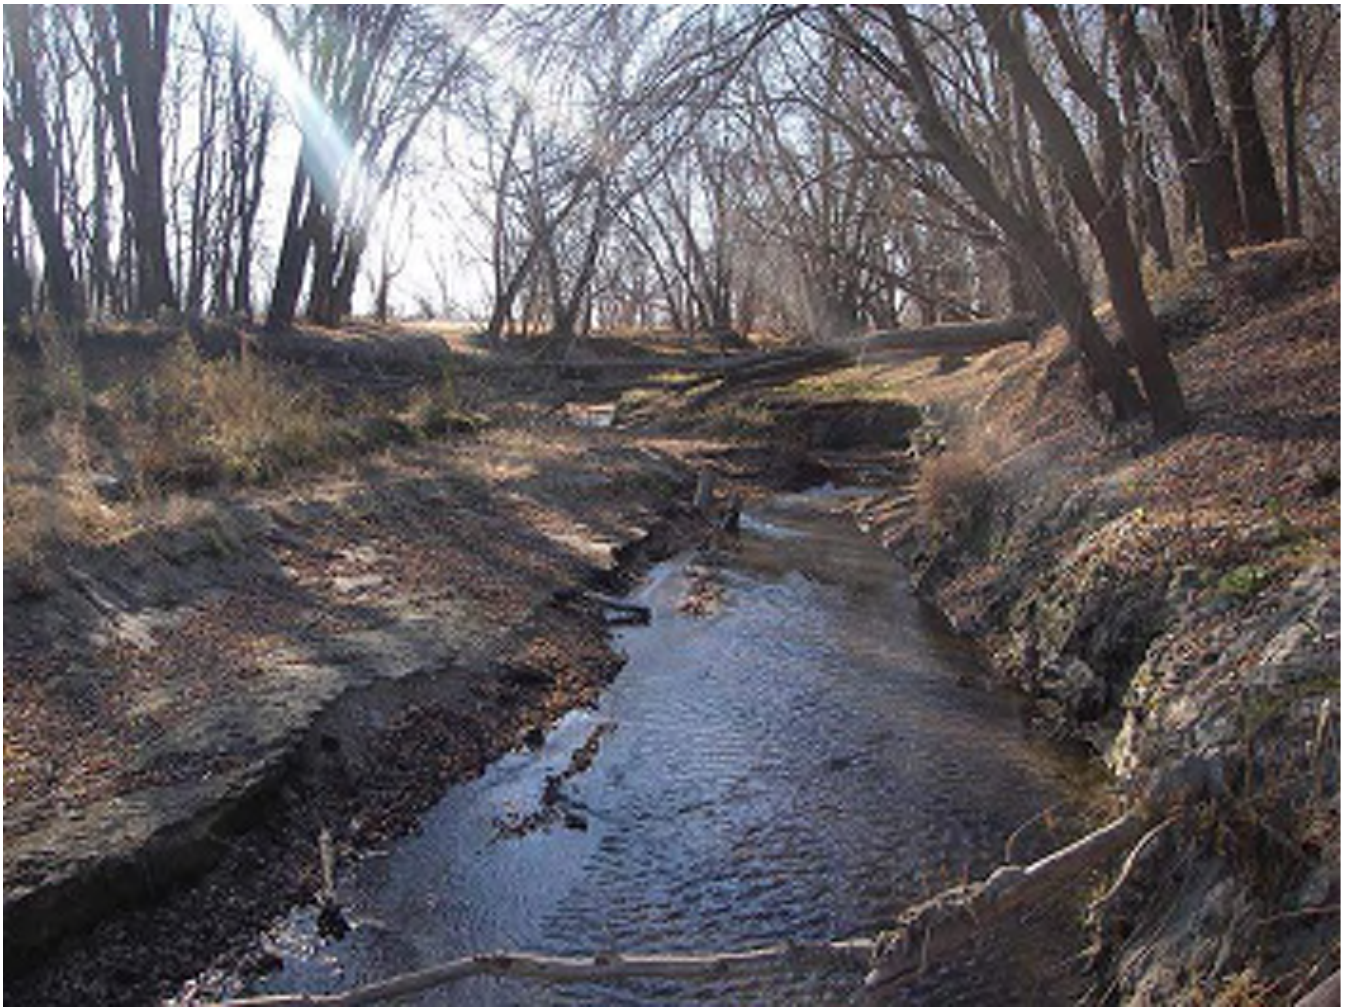
Eroded banks of stream
