Appendix K: Lower Minnesota River Watershed District: Gully Inventory

Gully Inventory Map
 Area #1
 Lower Minnesota River Watershed District
 Watershed Management Plan

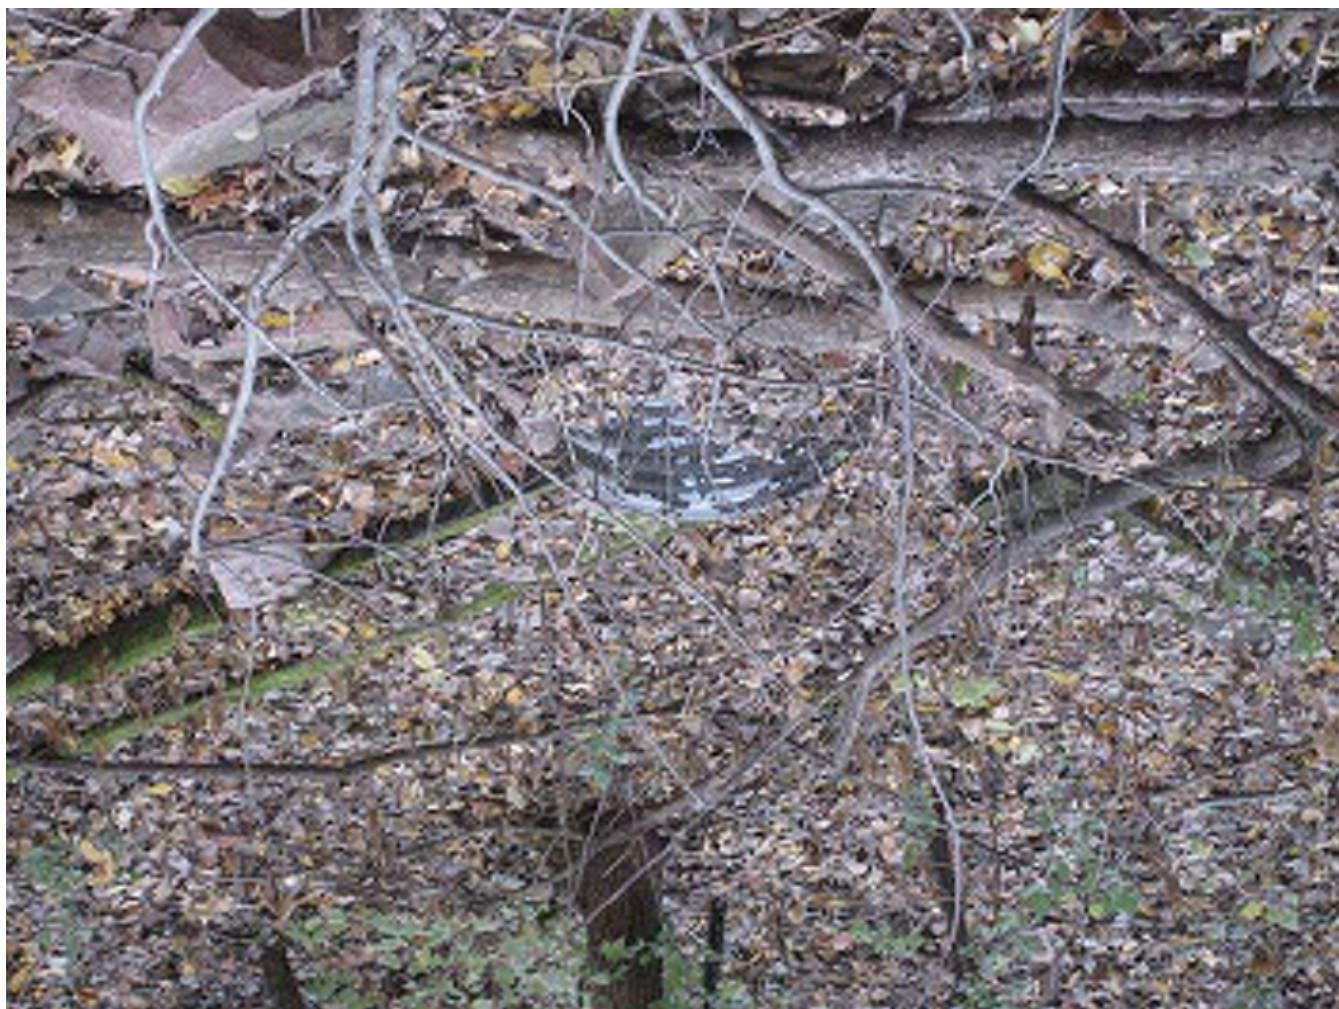
Culvert on river side; large rocks around it; small amount of erosion.

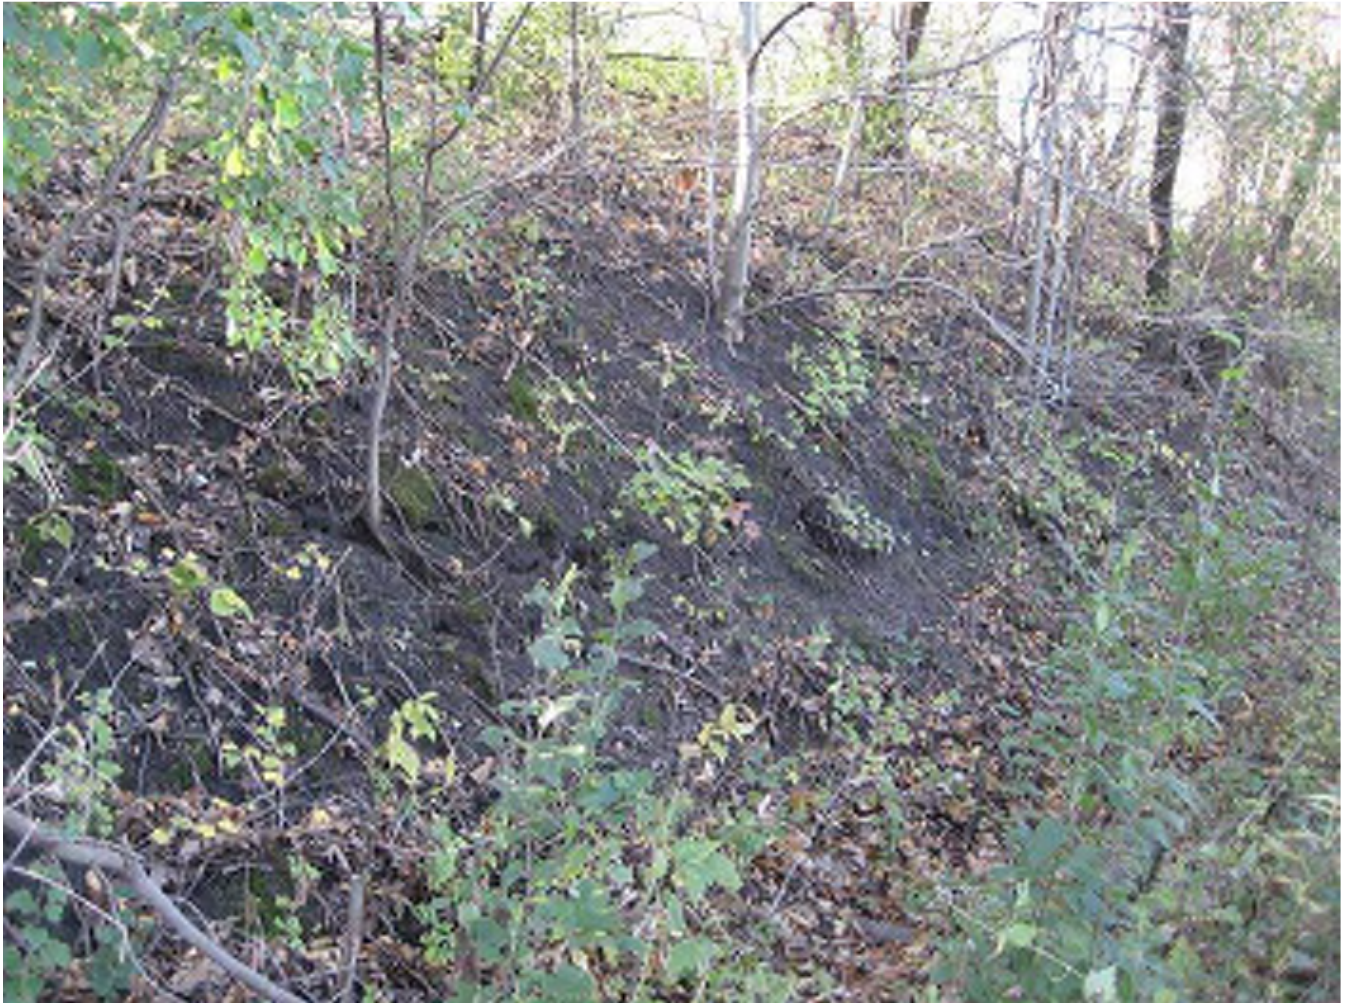
Waypoint 114A

Opposite side of river on trail; moderate erosion.

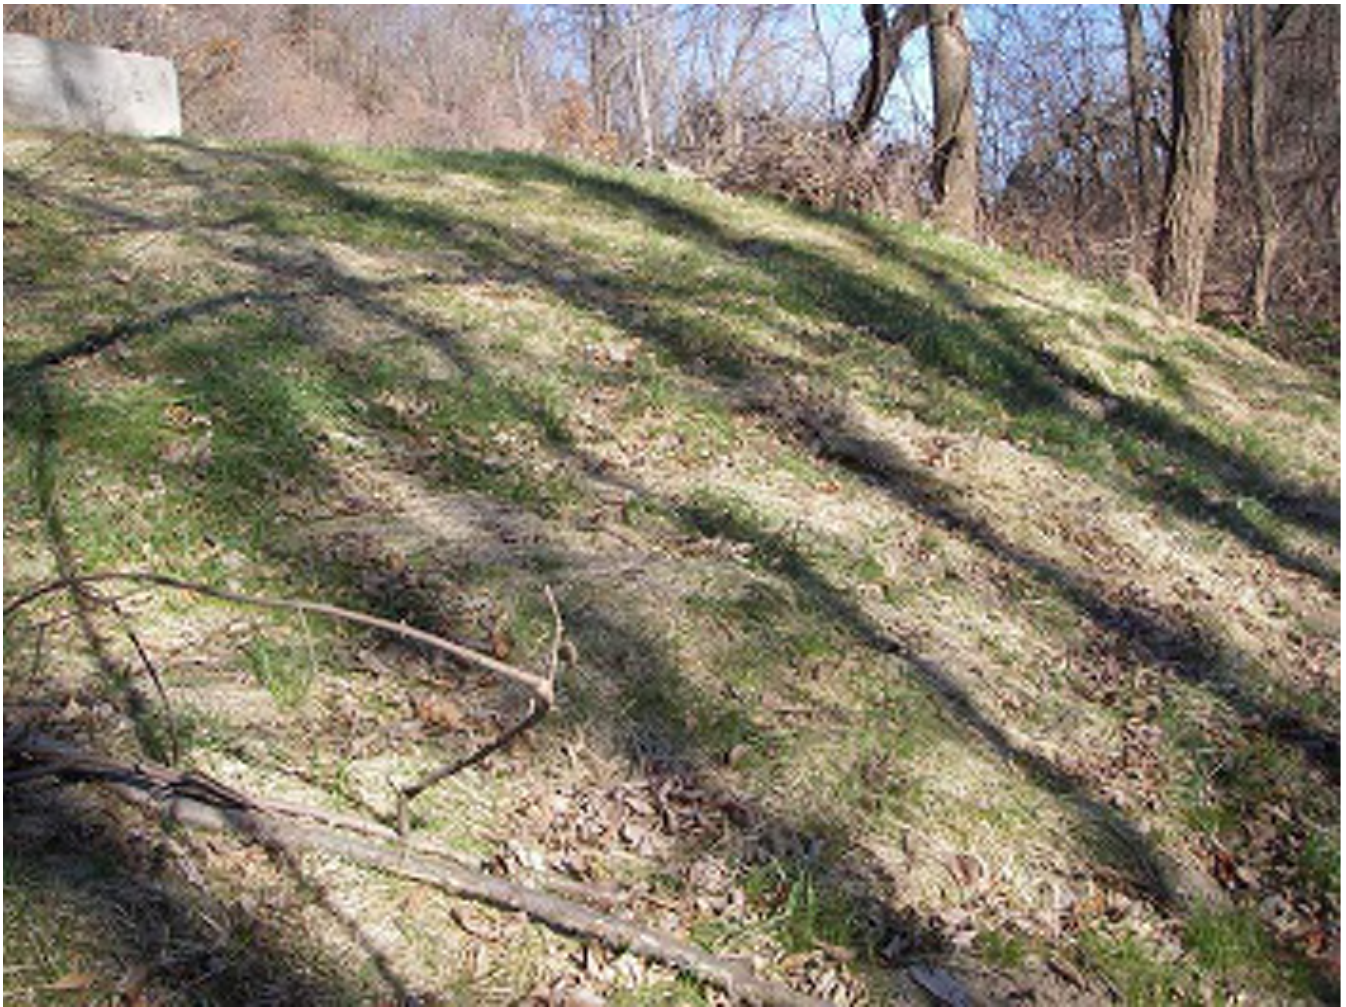
Erosion control matting

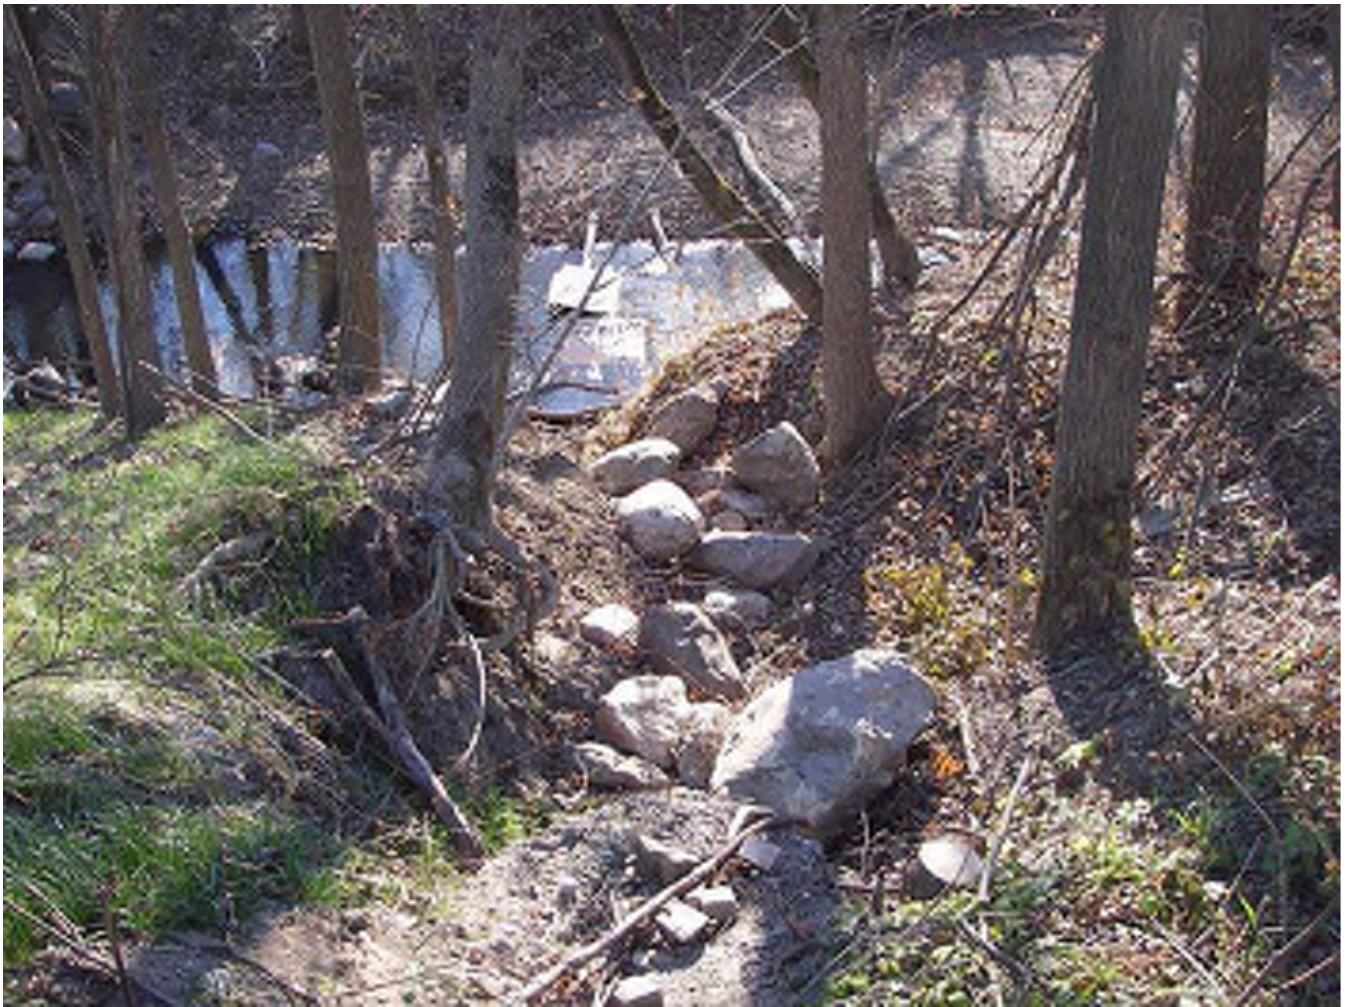
Gully from WP1716 drain pipe

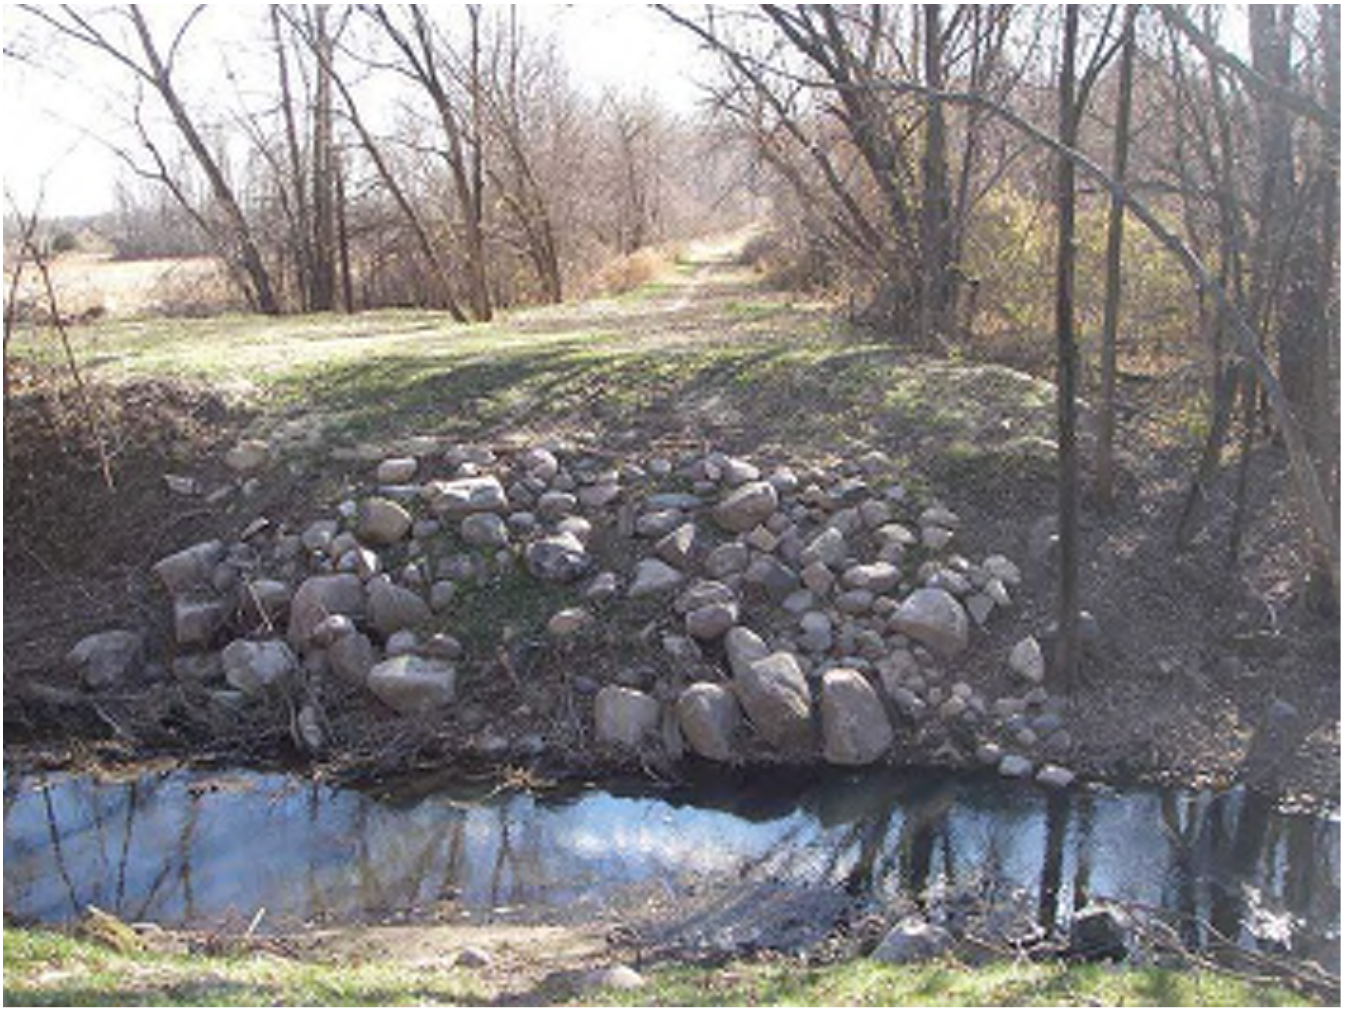
Erosion control along bank of river

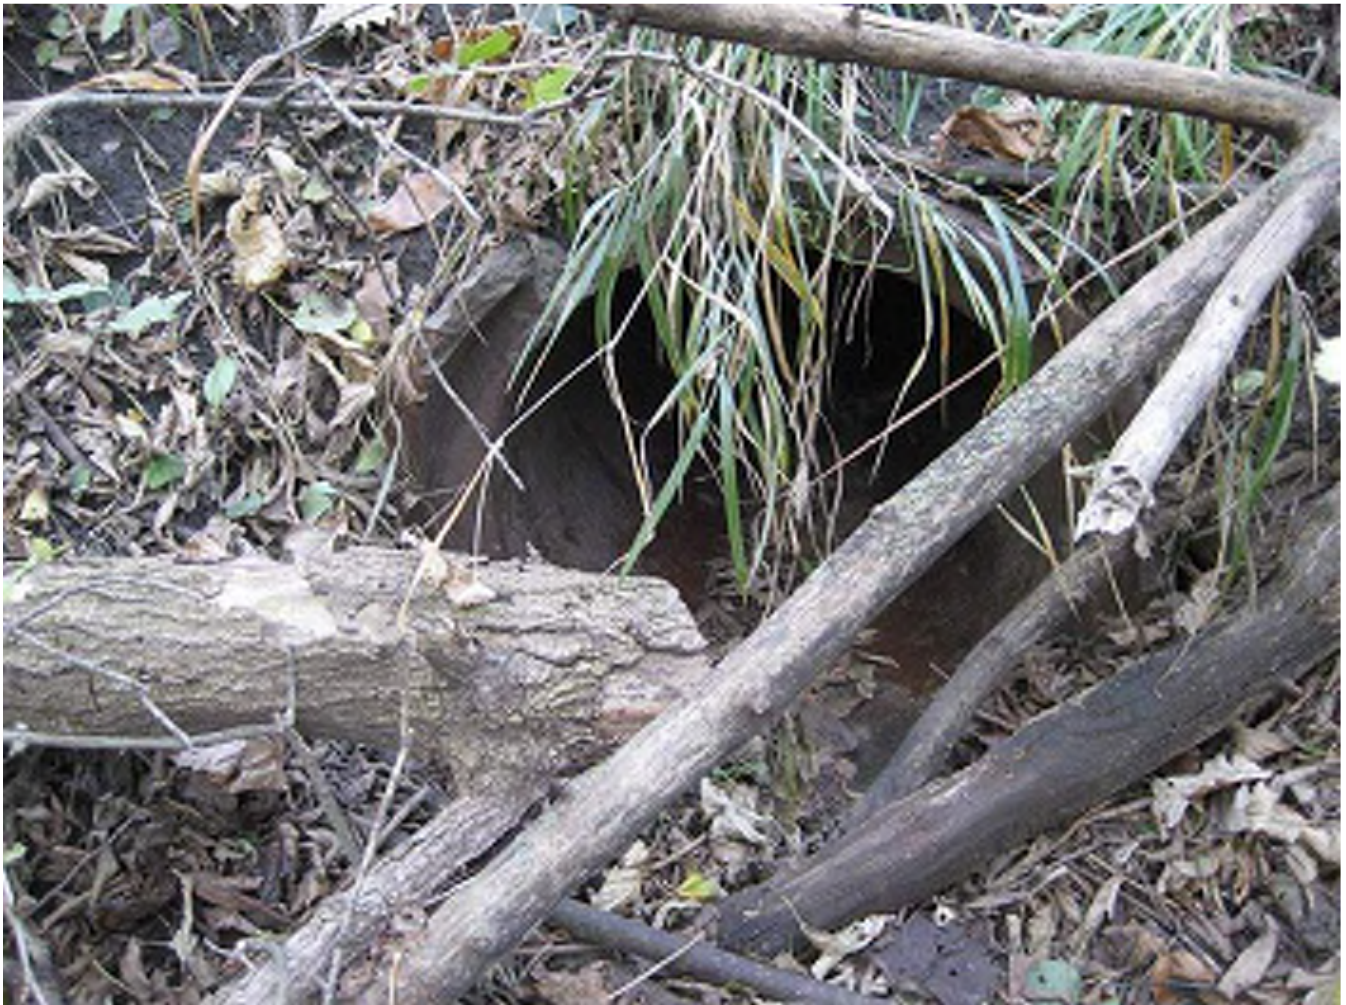
Culvert going under trail opposite river side.

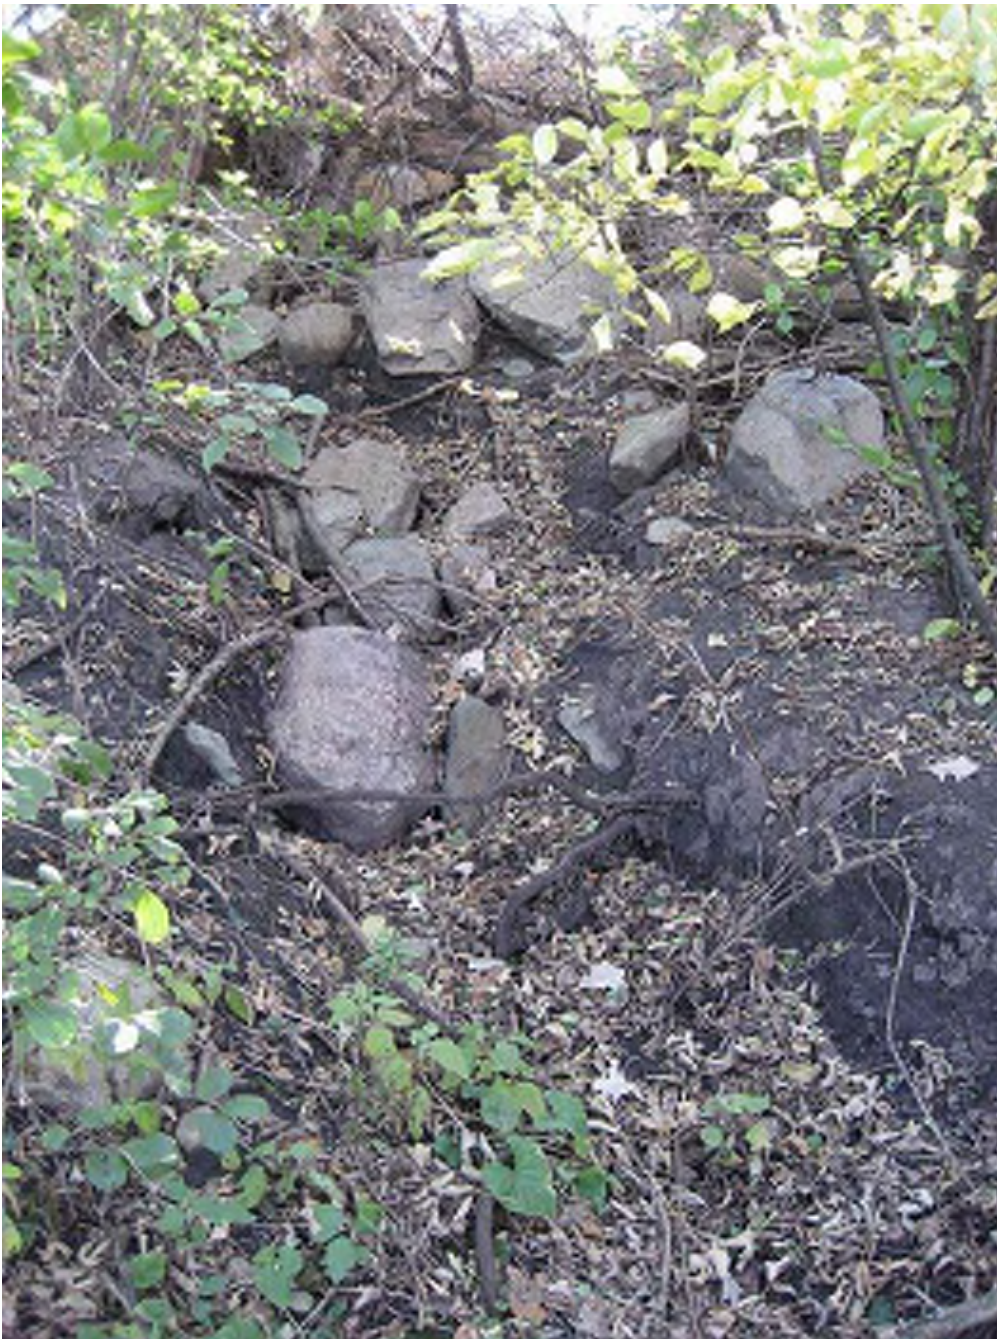
Above culvert; moderate erosion.

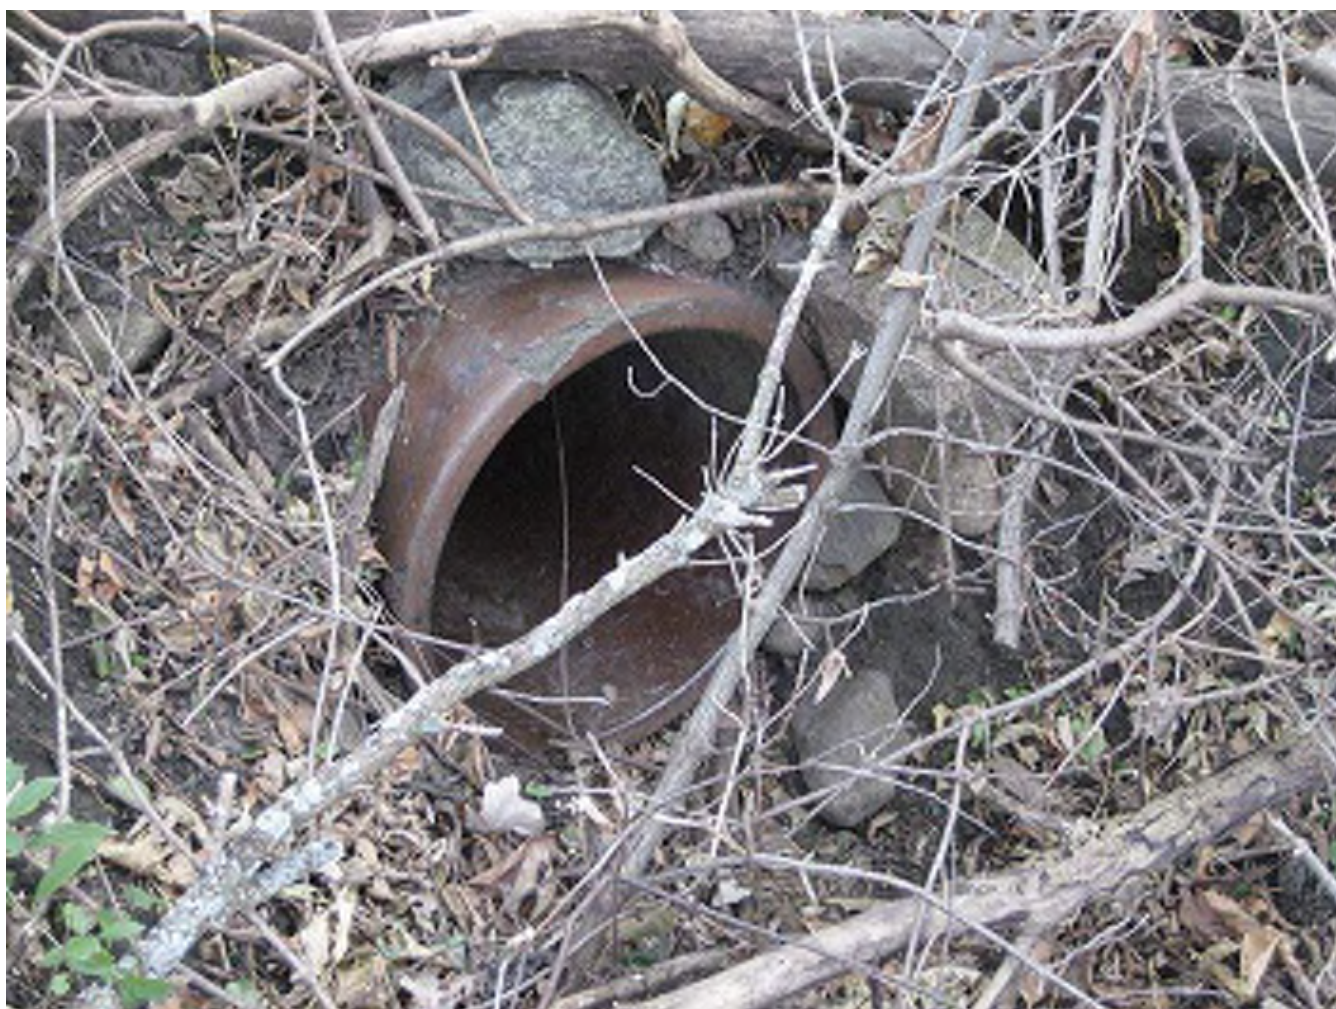
Culvert on river side of trail; cement culvert; minor erosion.

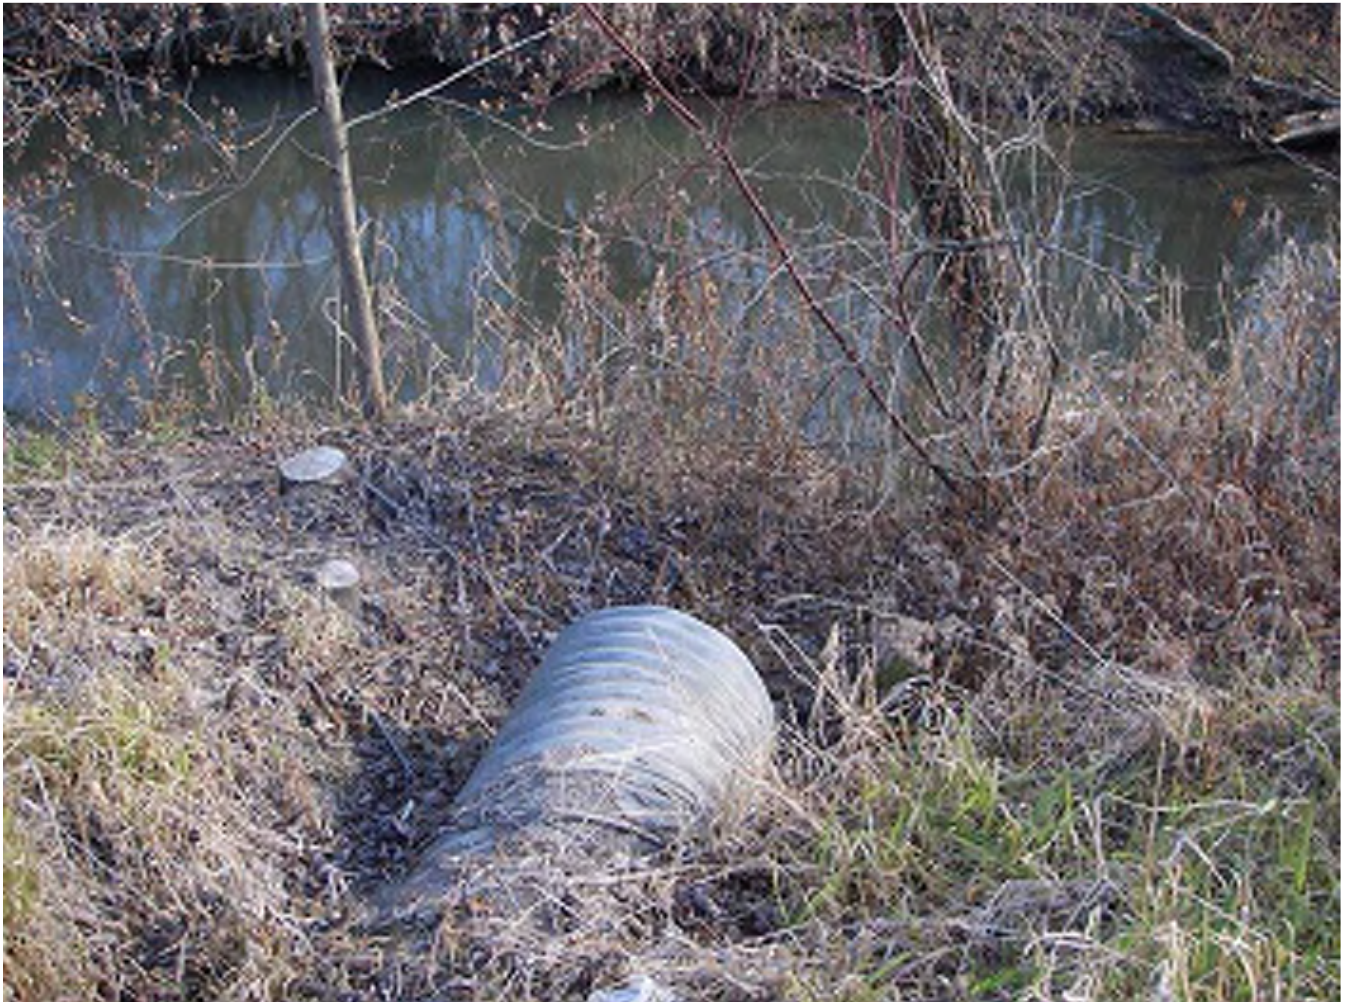
Waypoint 116

Drain pipe exit

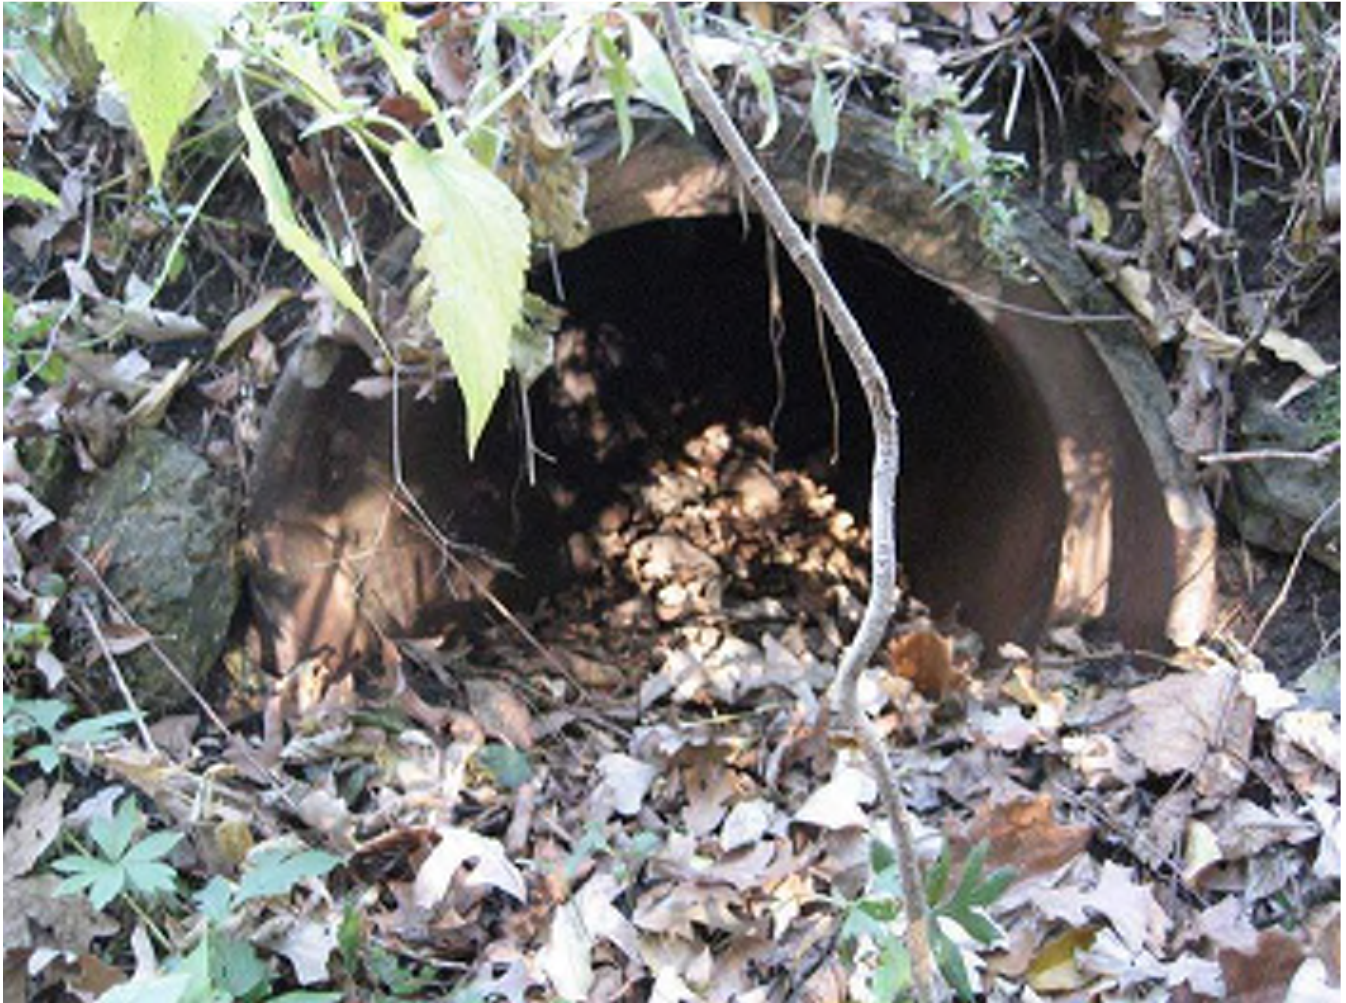
Waypoint 116A

Cement culvert opposite river side of trail; minor erosion.

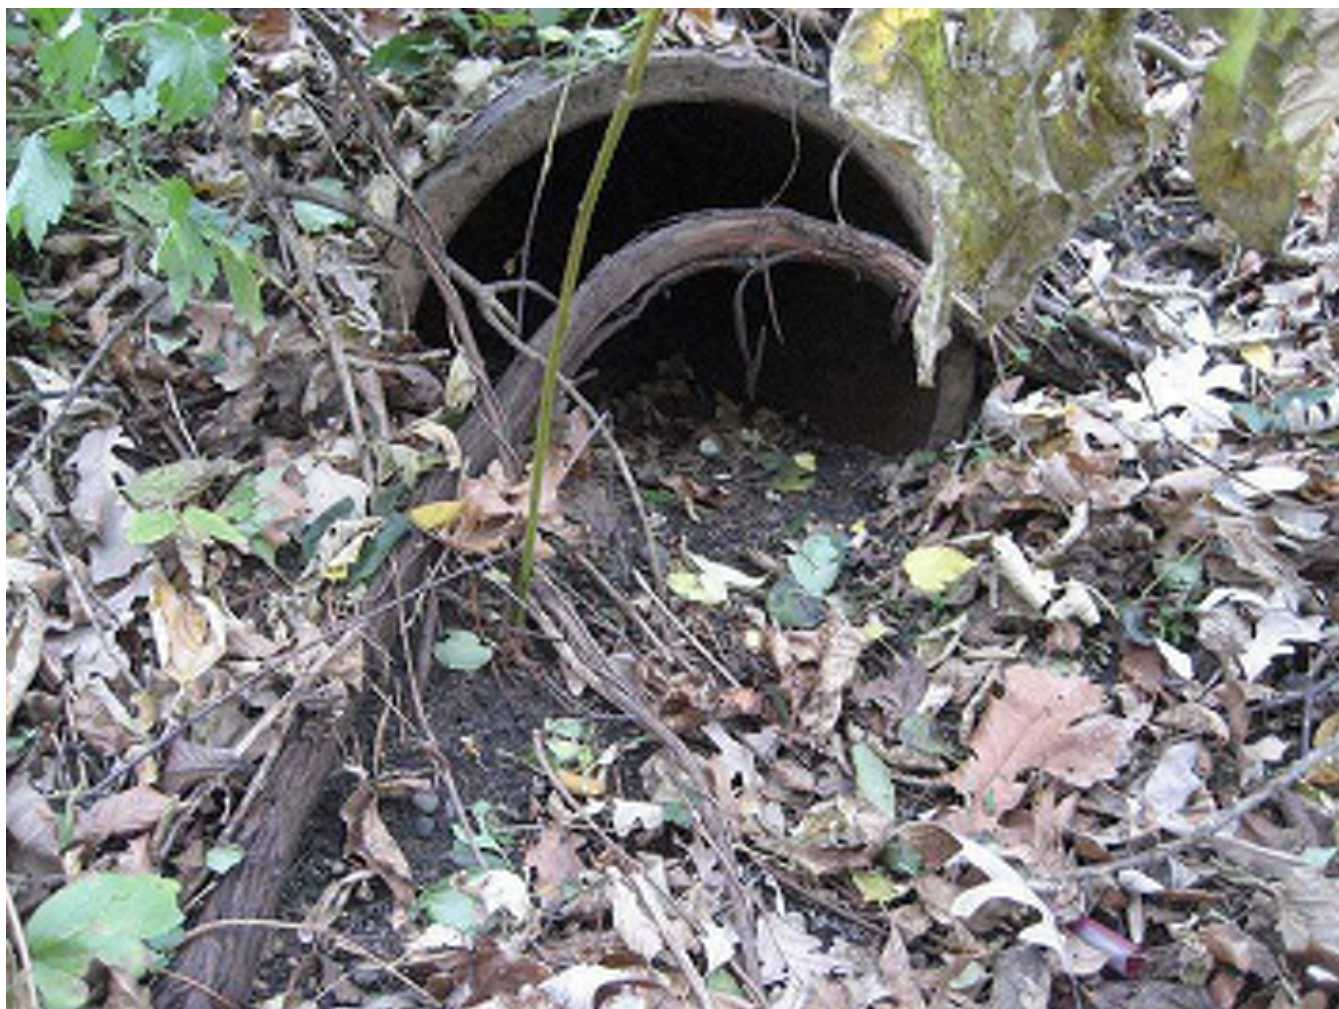
Culvert on river side of trail; minor erosion.

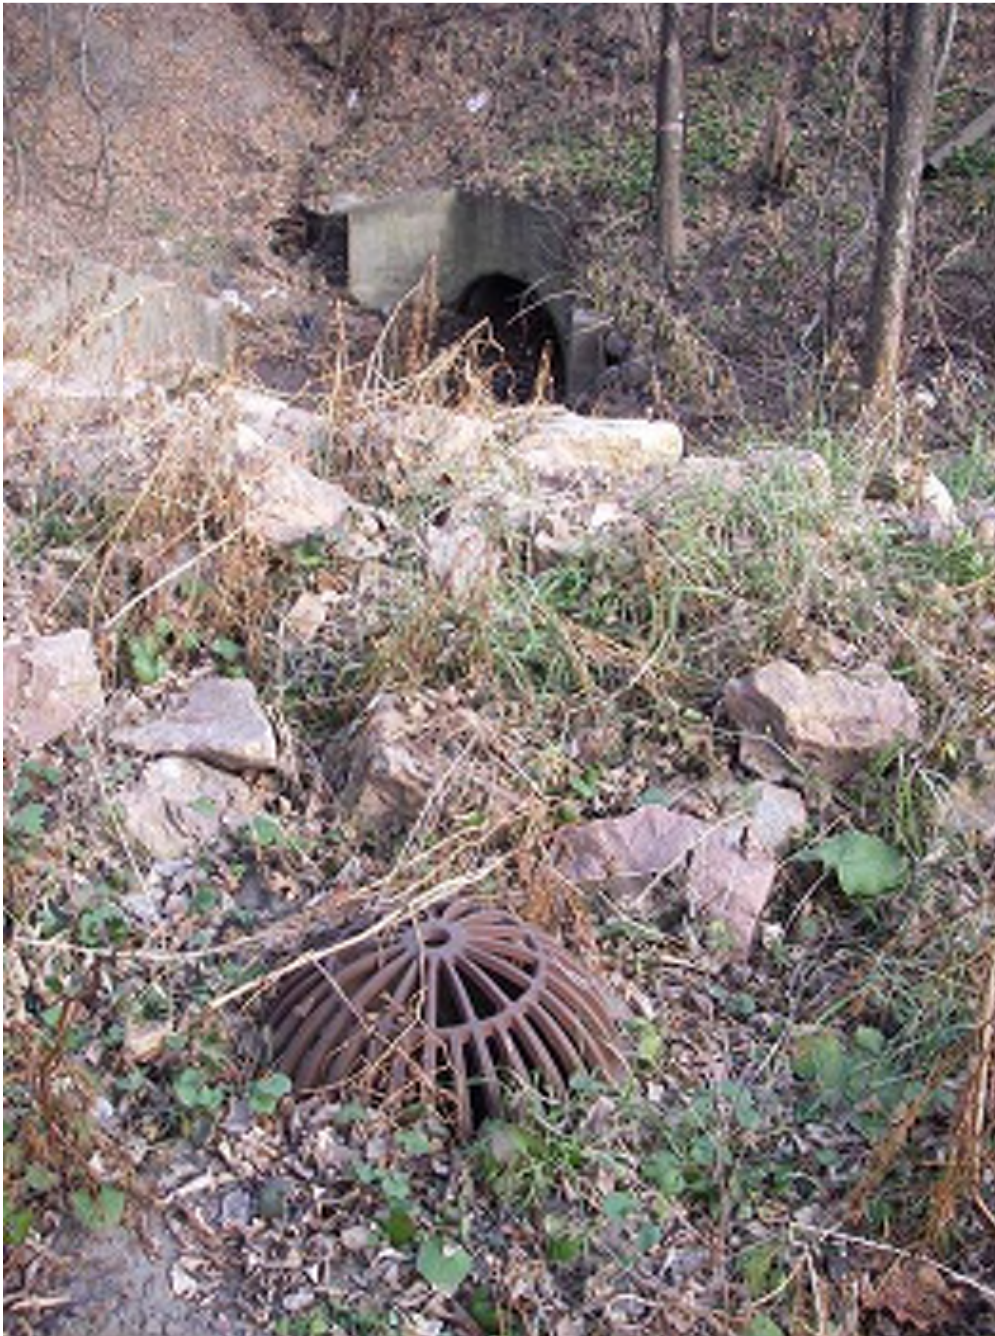
Waypoint 117

Sewer grate

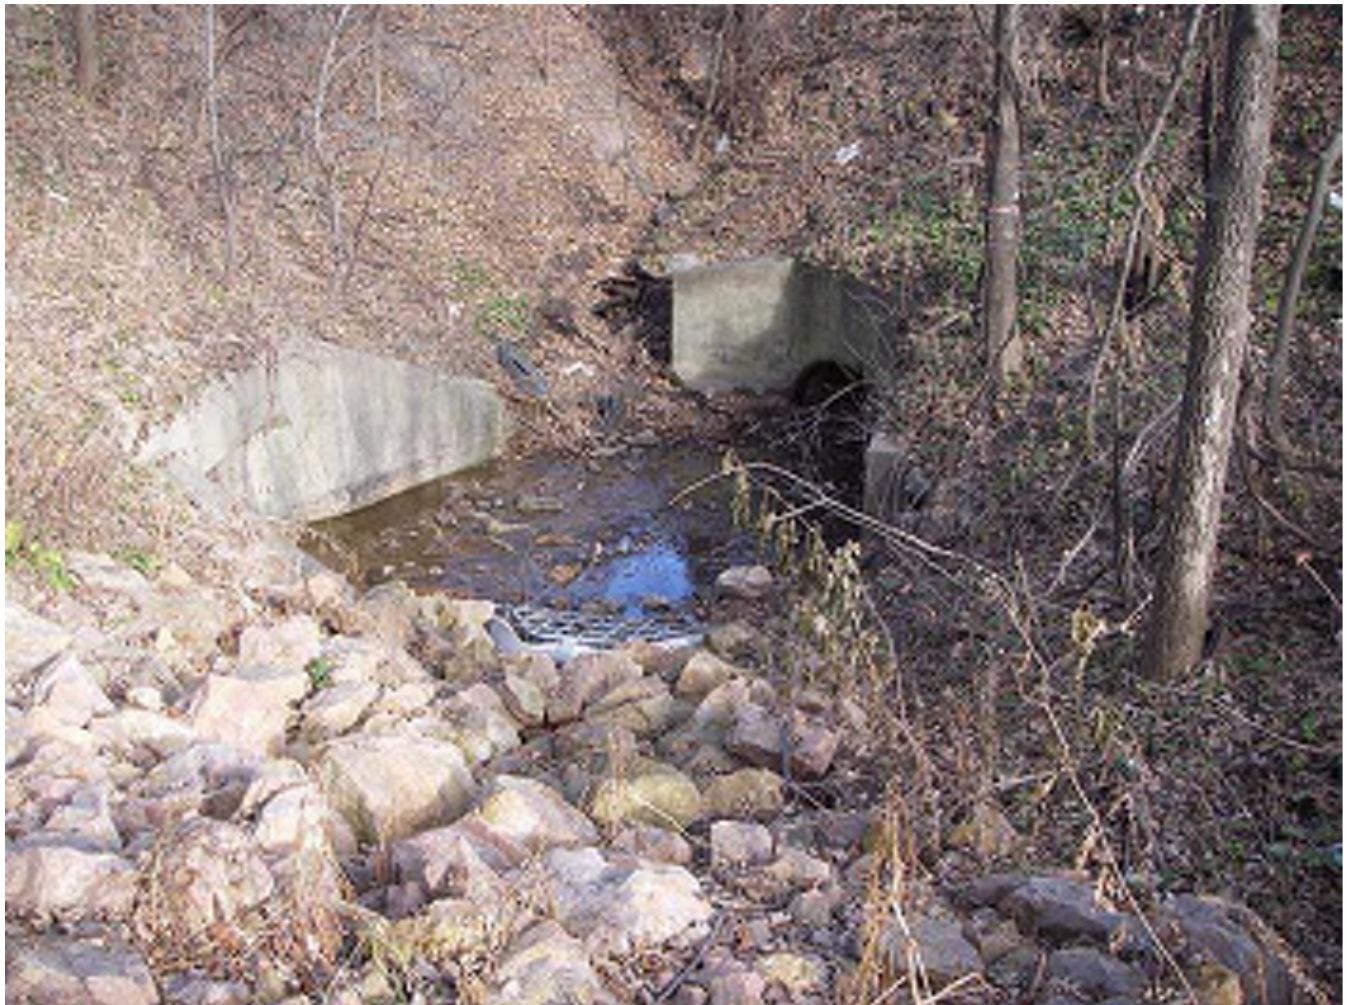
Erosion control/culvert/tunnel

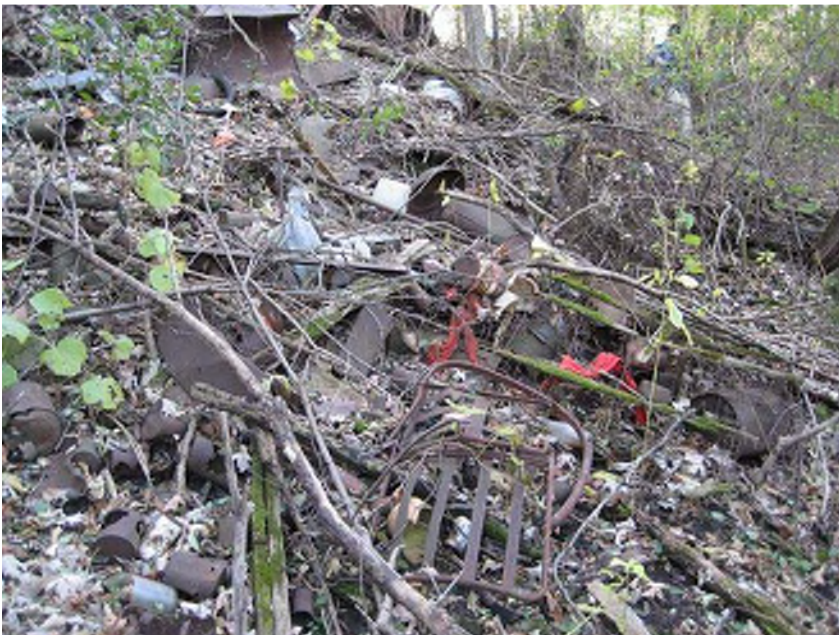
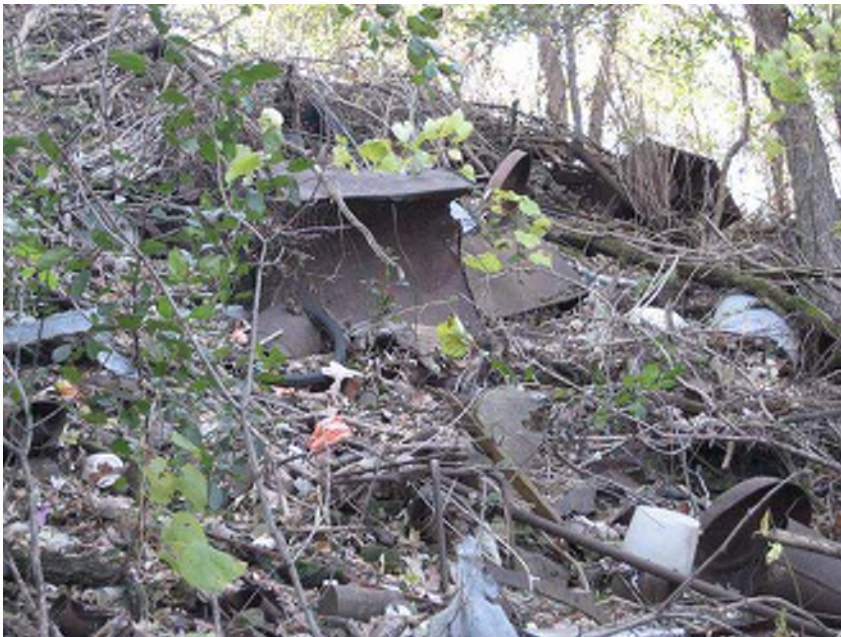
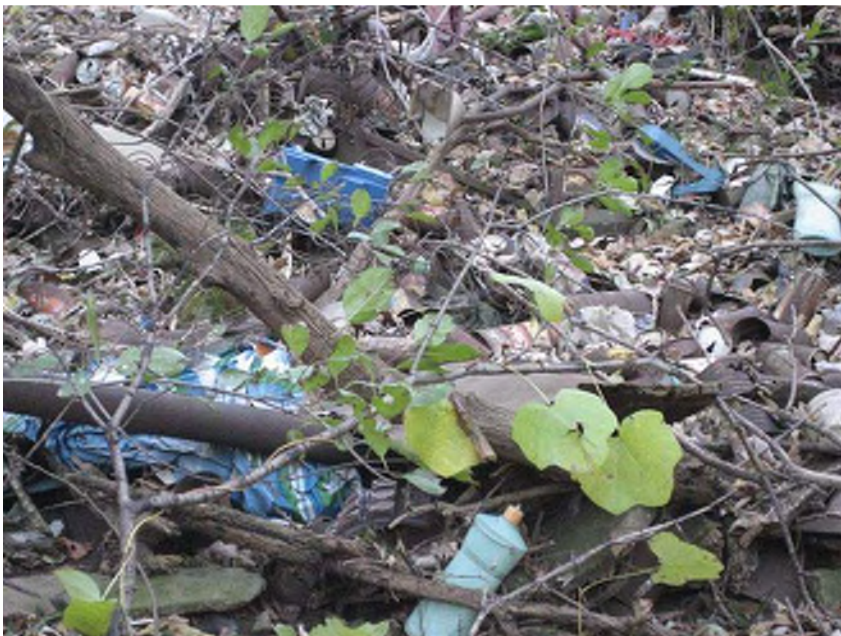
Waypoint 117A

All pictures - Large dump site; lots of bottles, cans, metal containers, misc. metals (rusted); old style of cans indicate they've been here

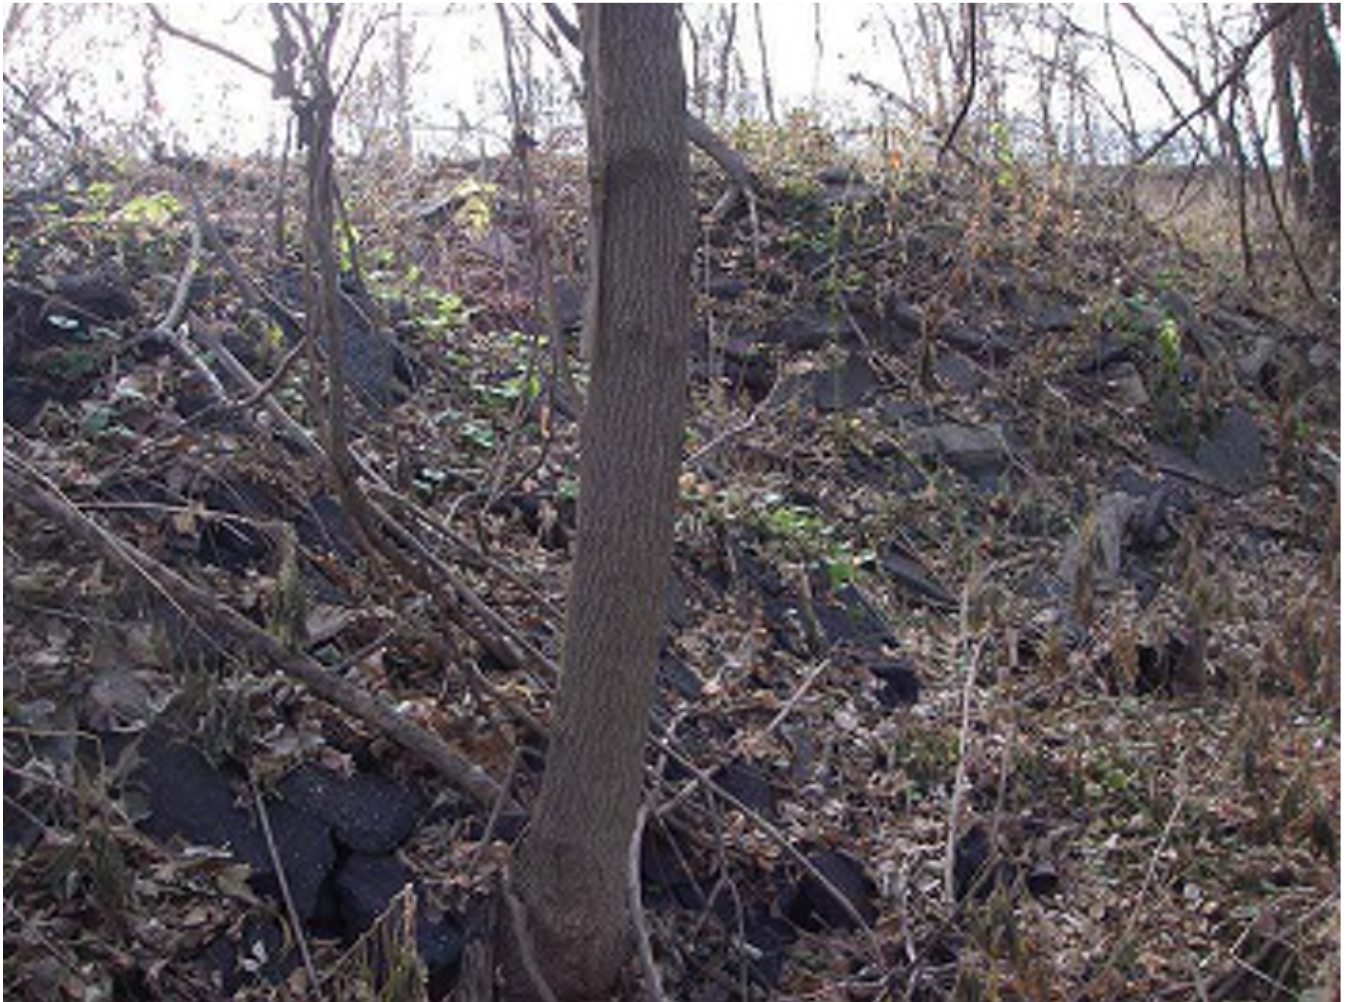
Waypoint 118

Blacktop/cement rubble piles and trash

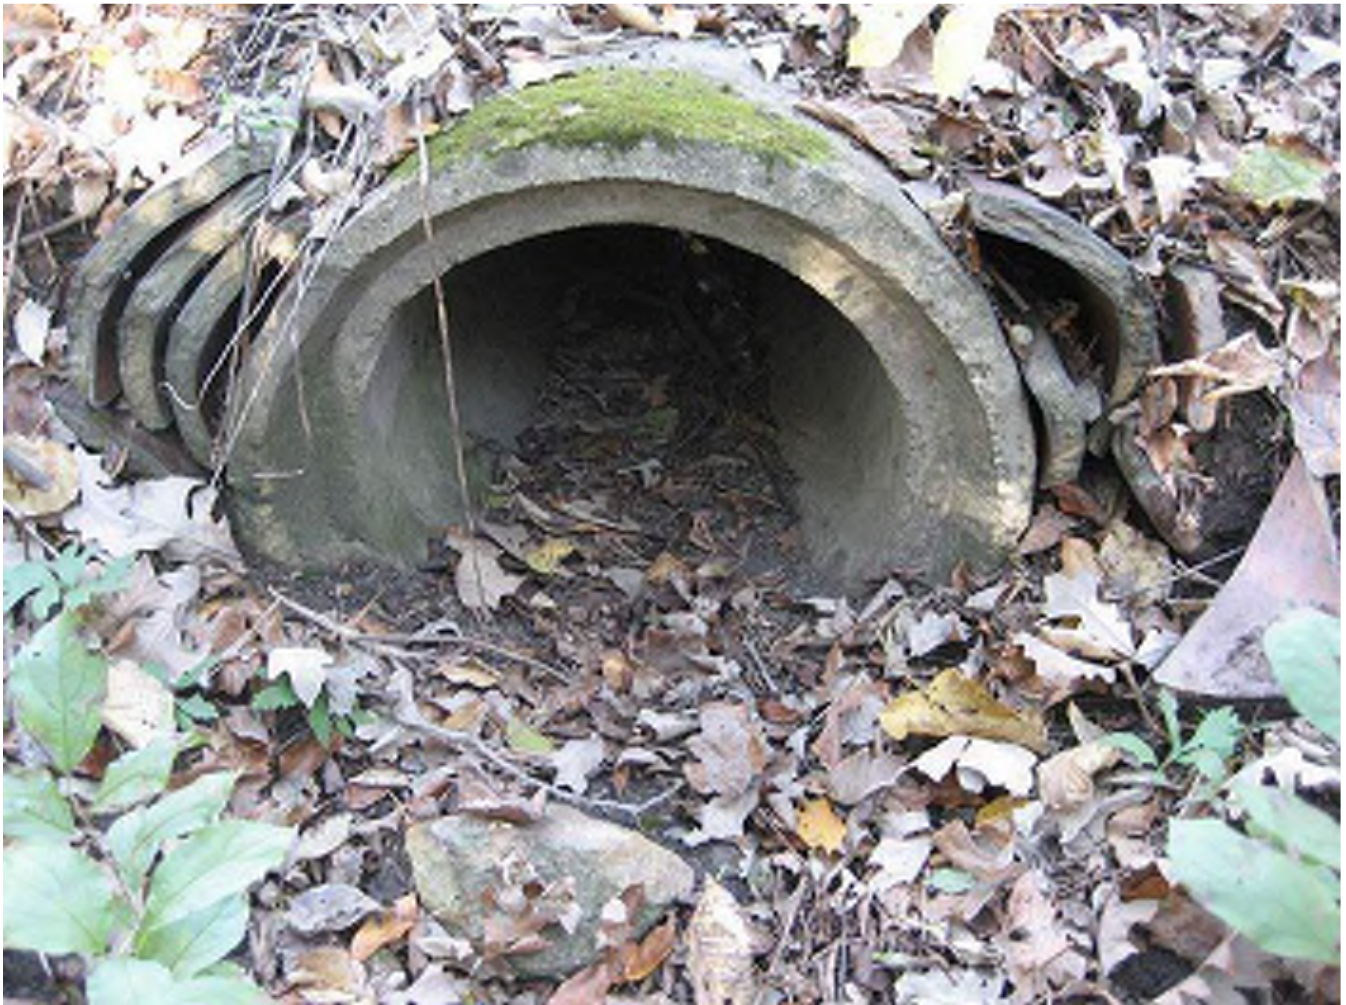
Waypoint 118A

Cement culvert opposite river side; minor erosion.
