Appendix K: Lower Minnesota River Watershed District: Gully Inventory

Gully Inventory Map
 Area #1
 Lower Minnesota River Watershed District
 Watershed Management Plan

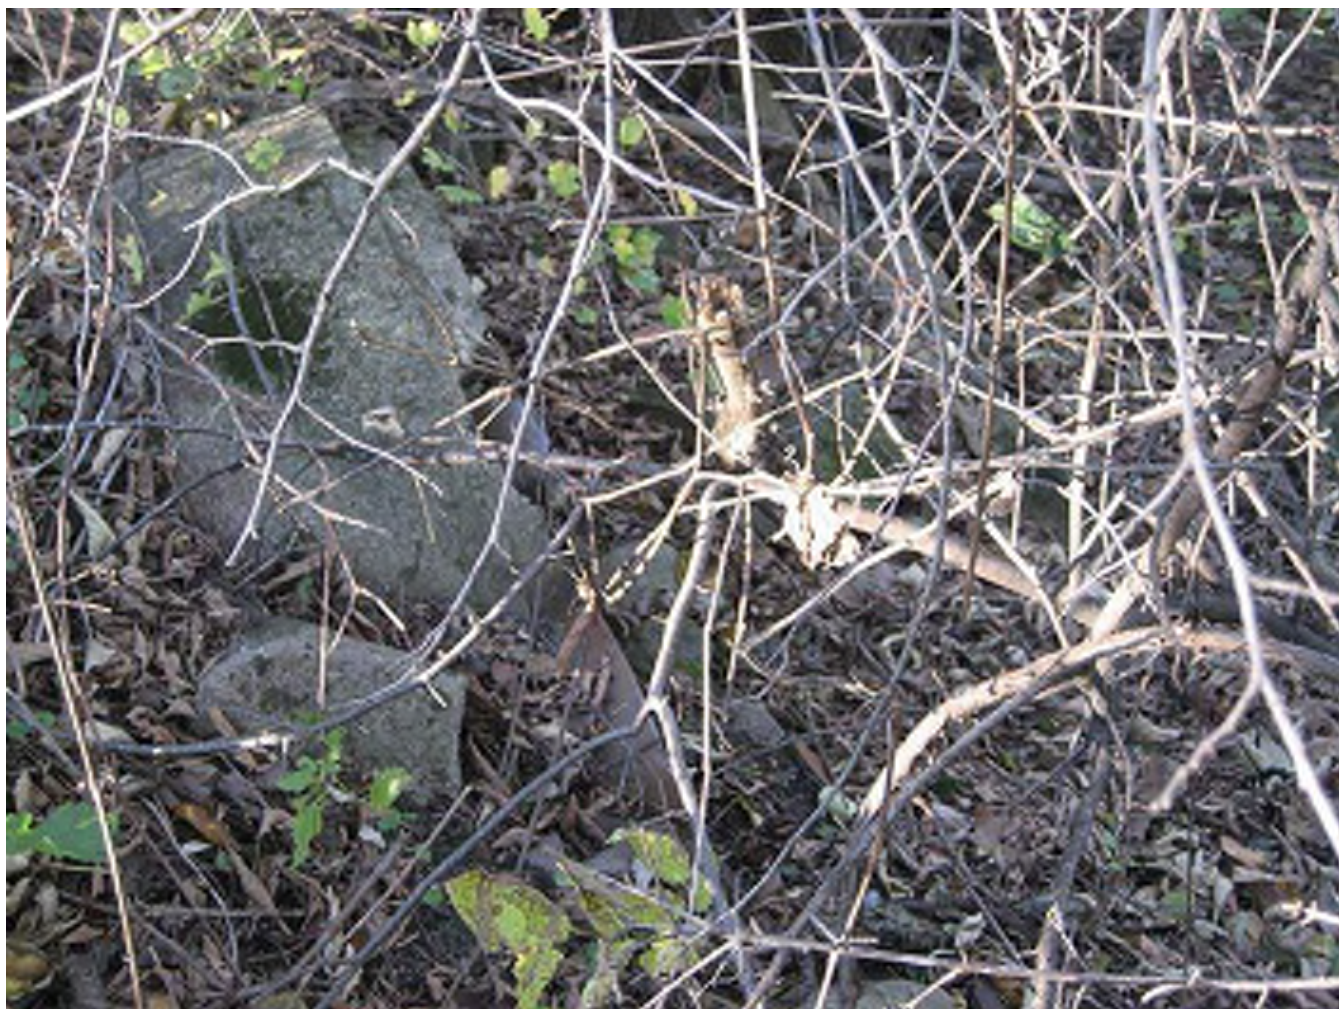
Culvert on river side of trail; minor erosion.

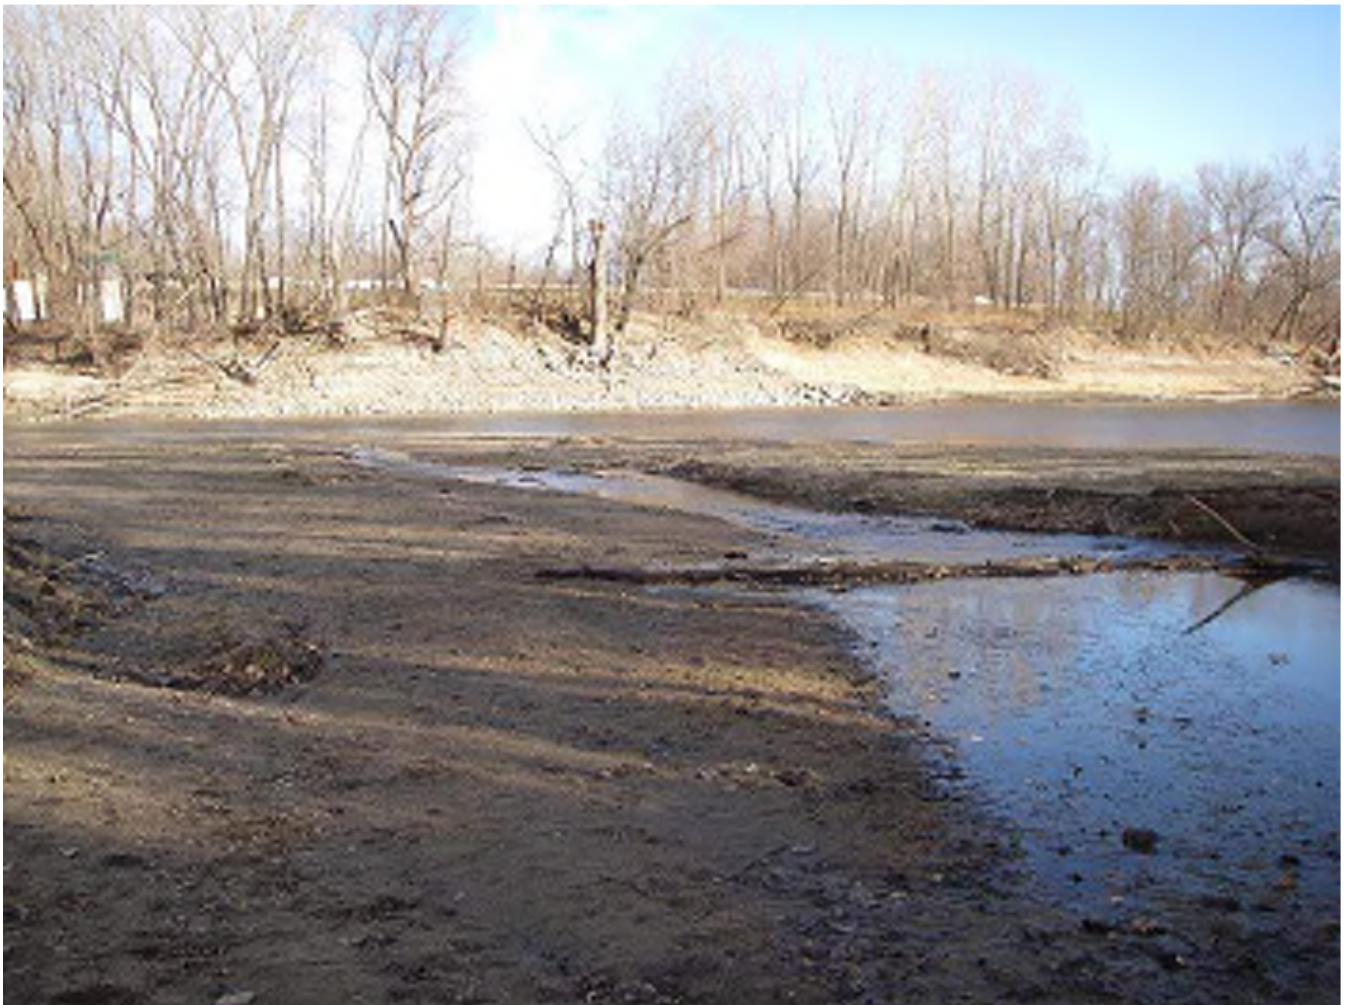
Waypoint 119

Outlet of stream into river

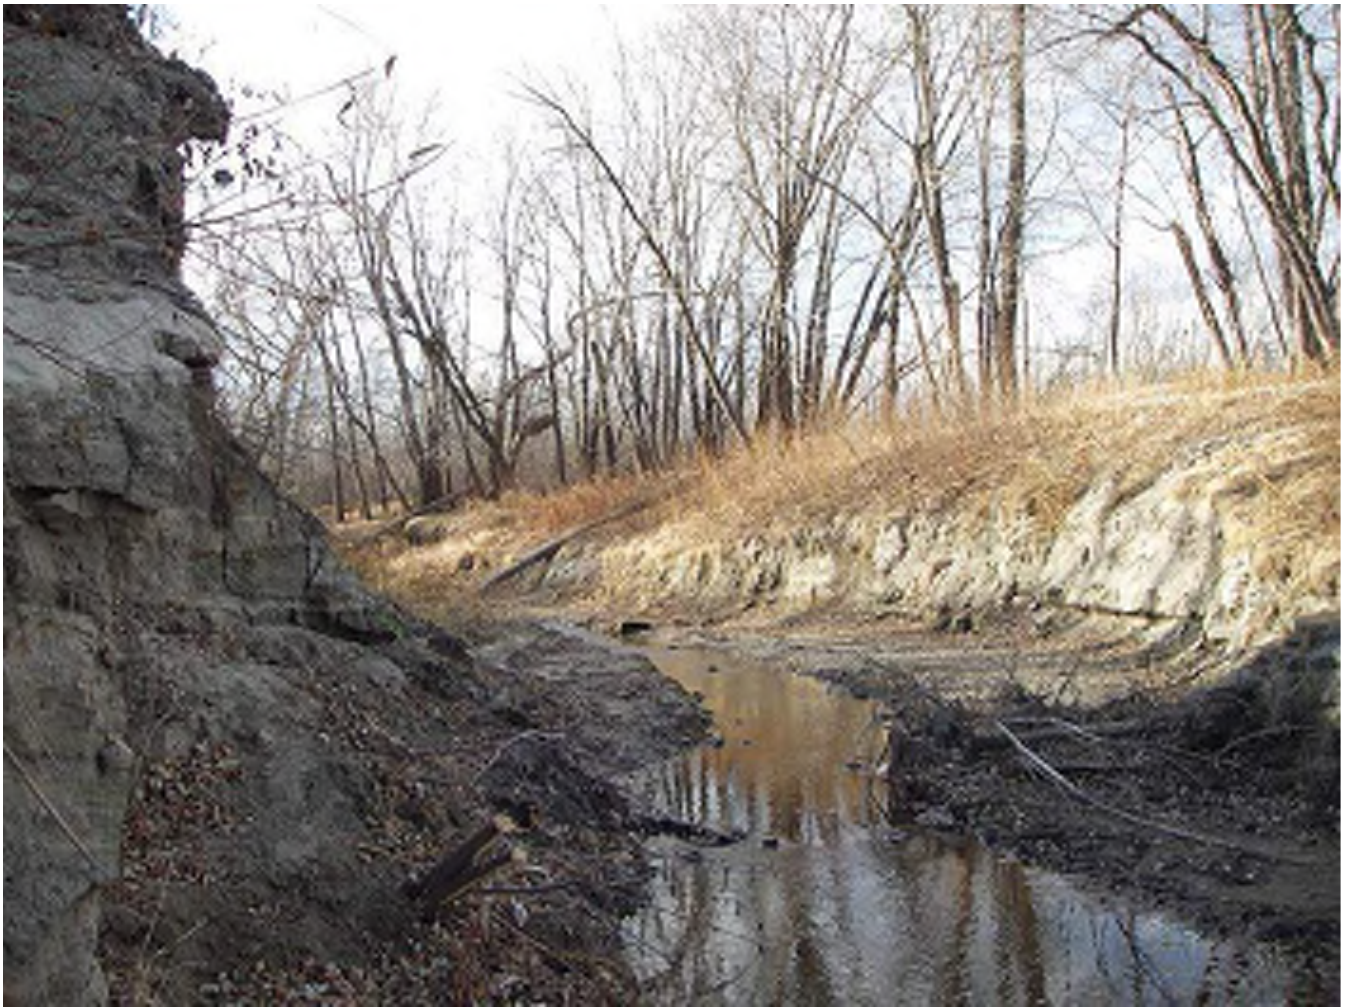
Erosion of banks

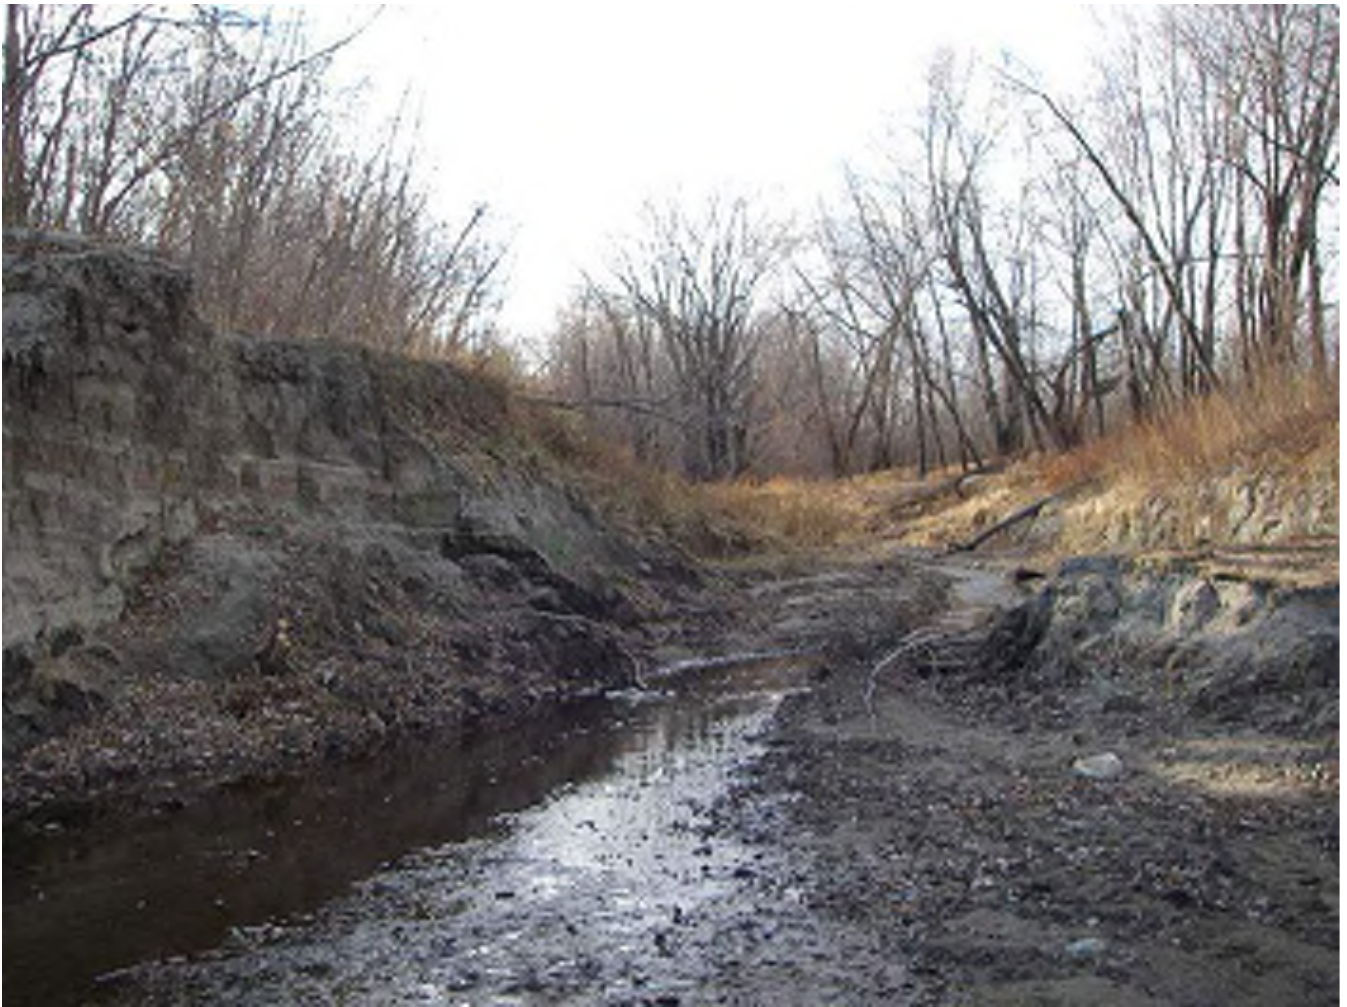
Erosion of banks

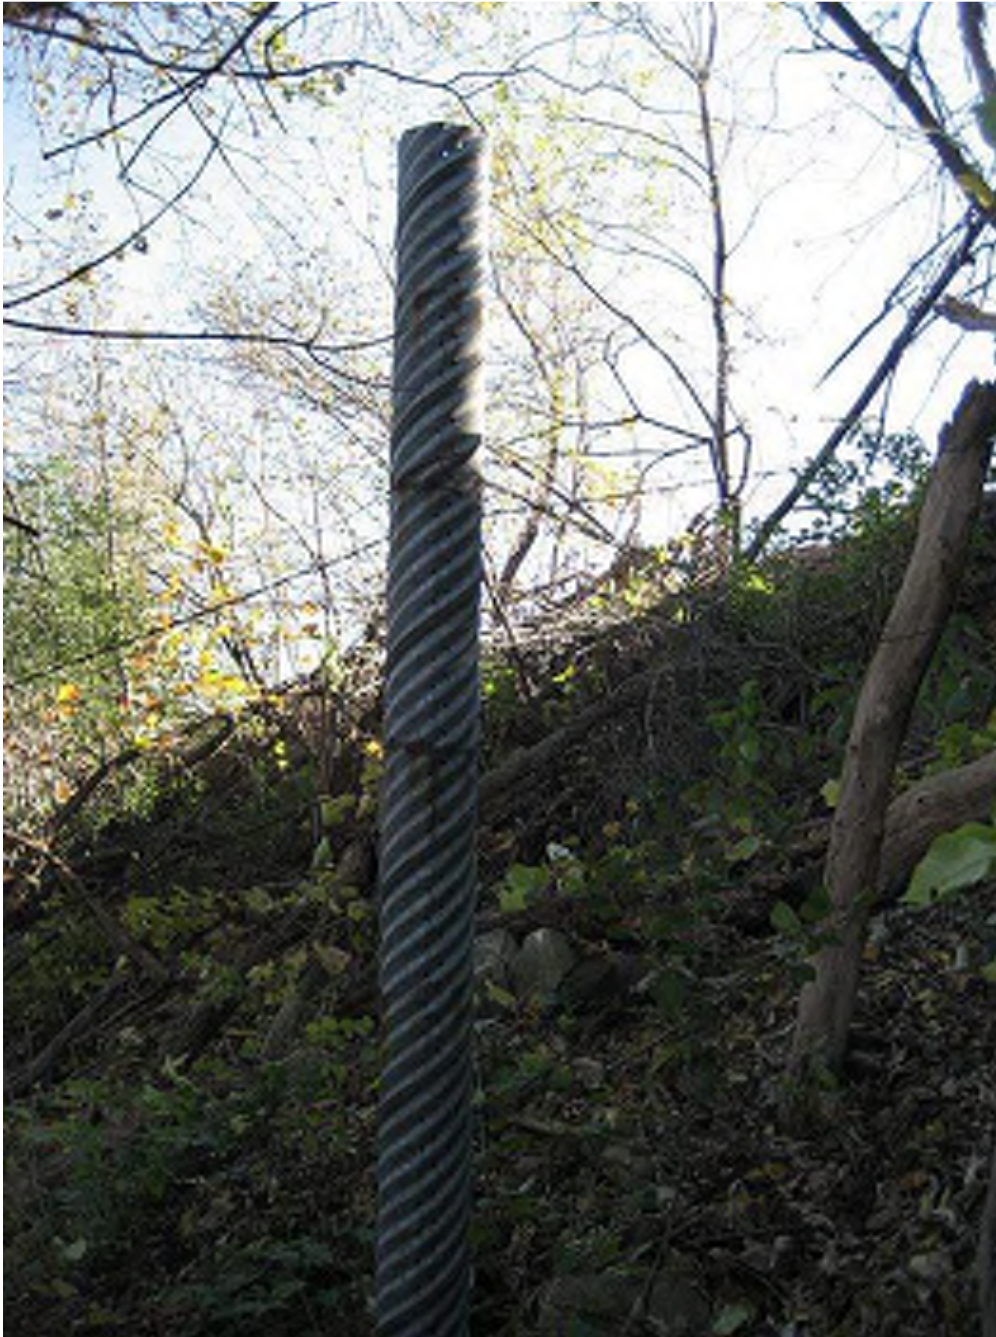
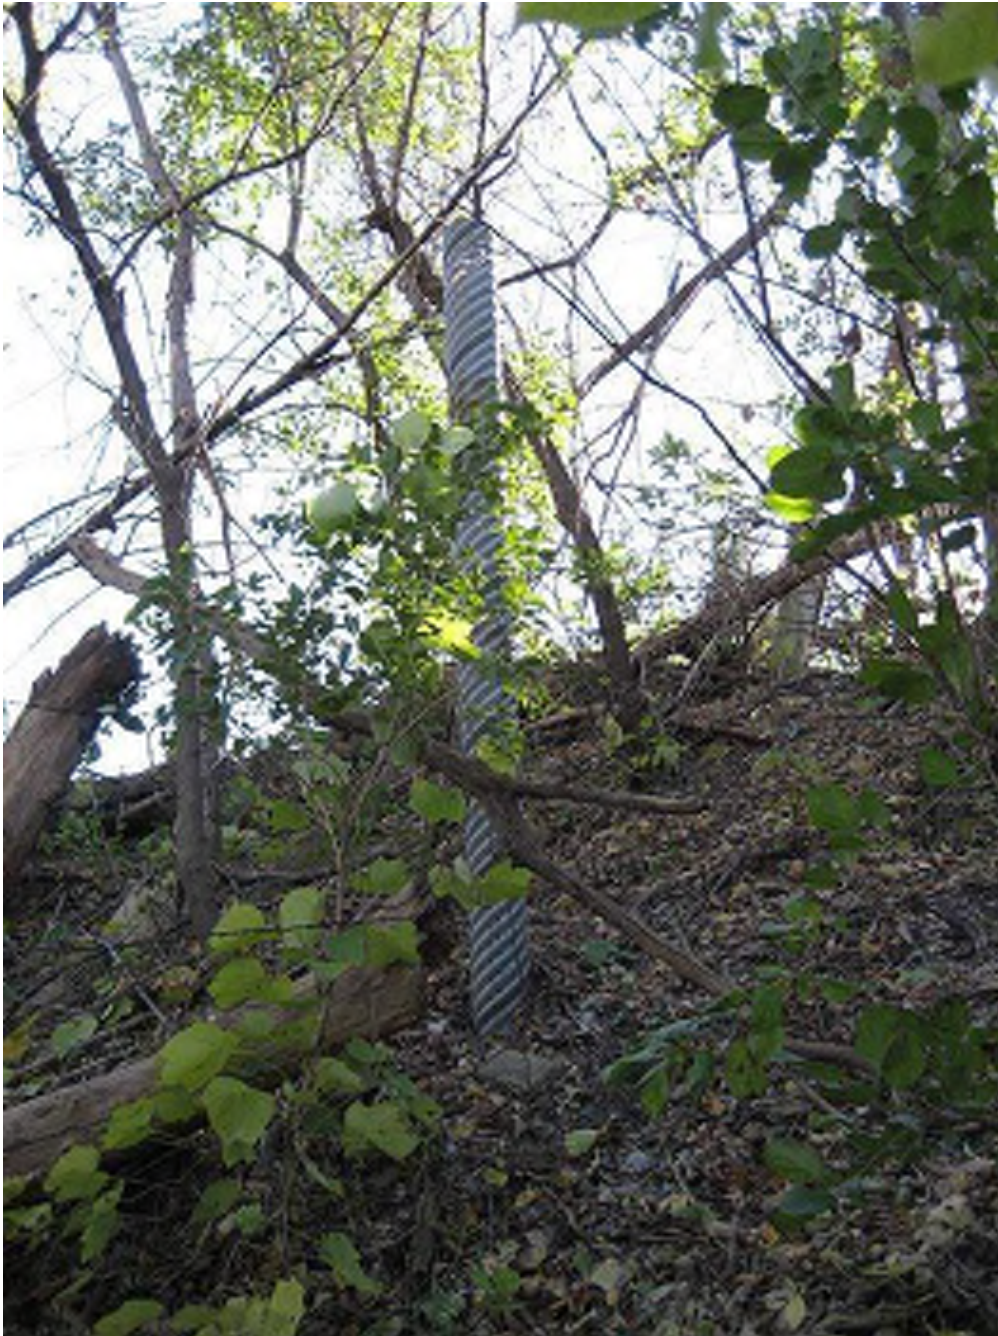
Waypoint 119A

Large pipe coming out of ground; seems to be holding up barbed wire fence.

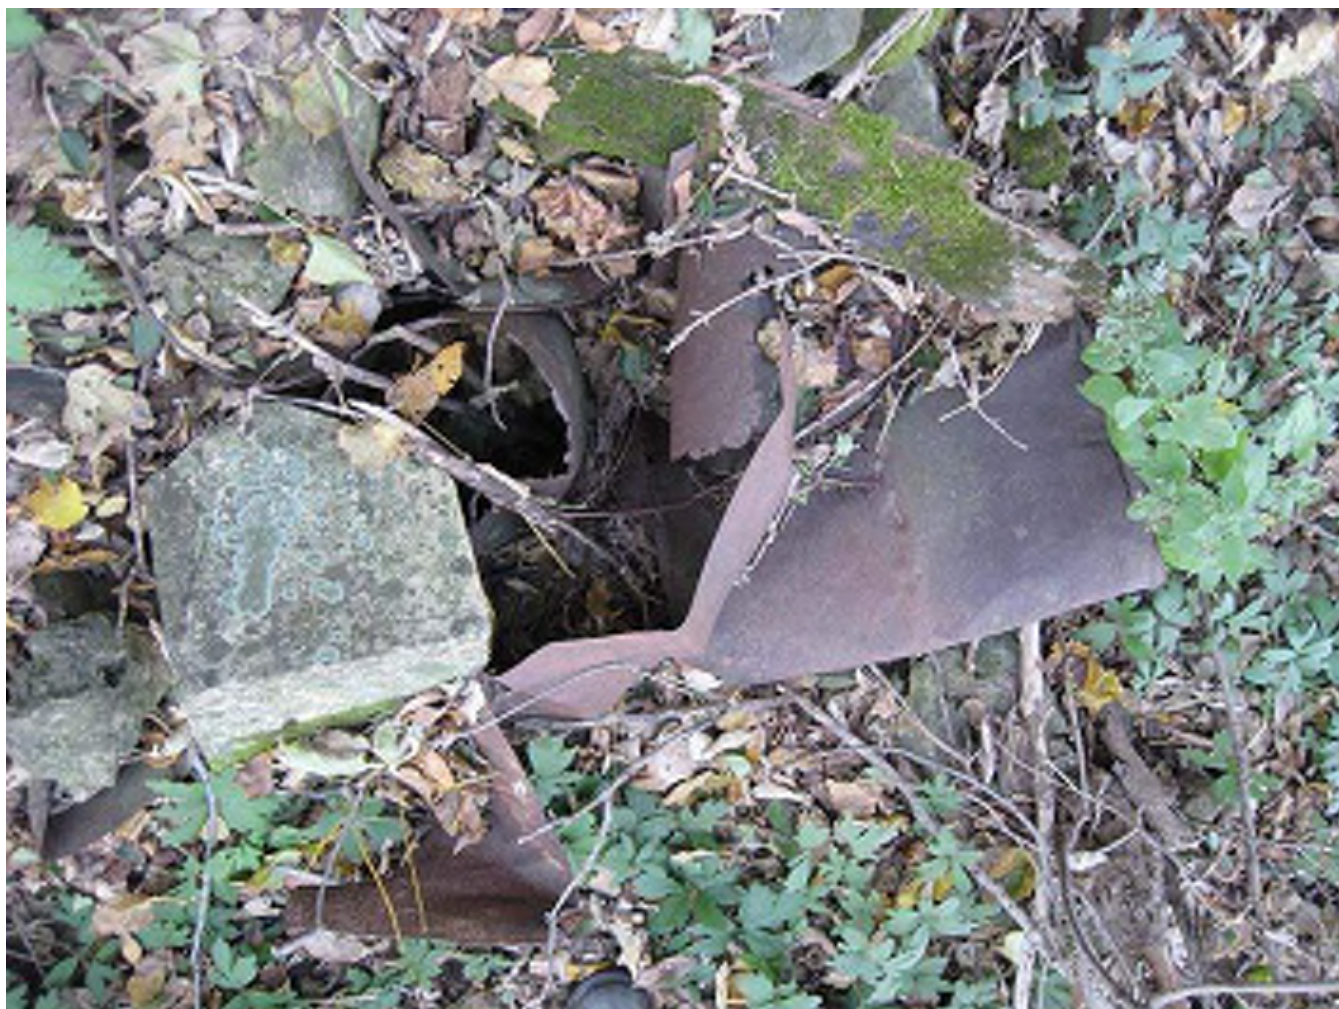
Scrap metal dumping.

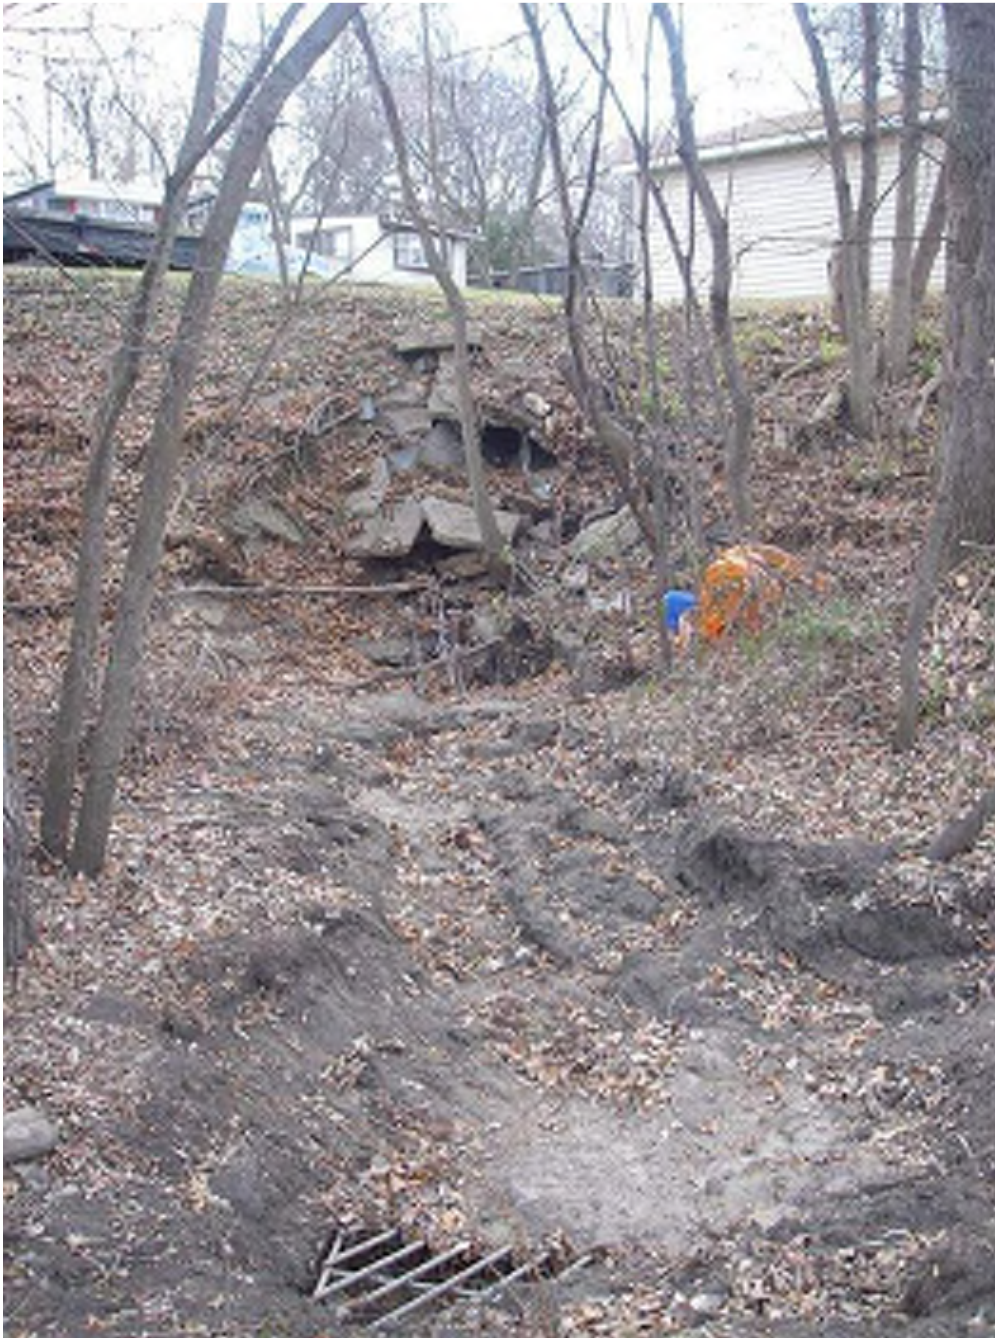
Waypoint 120

Drain pipe from trailer park & erosion

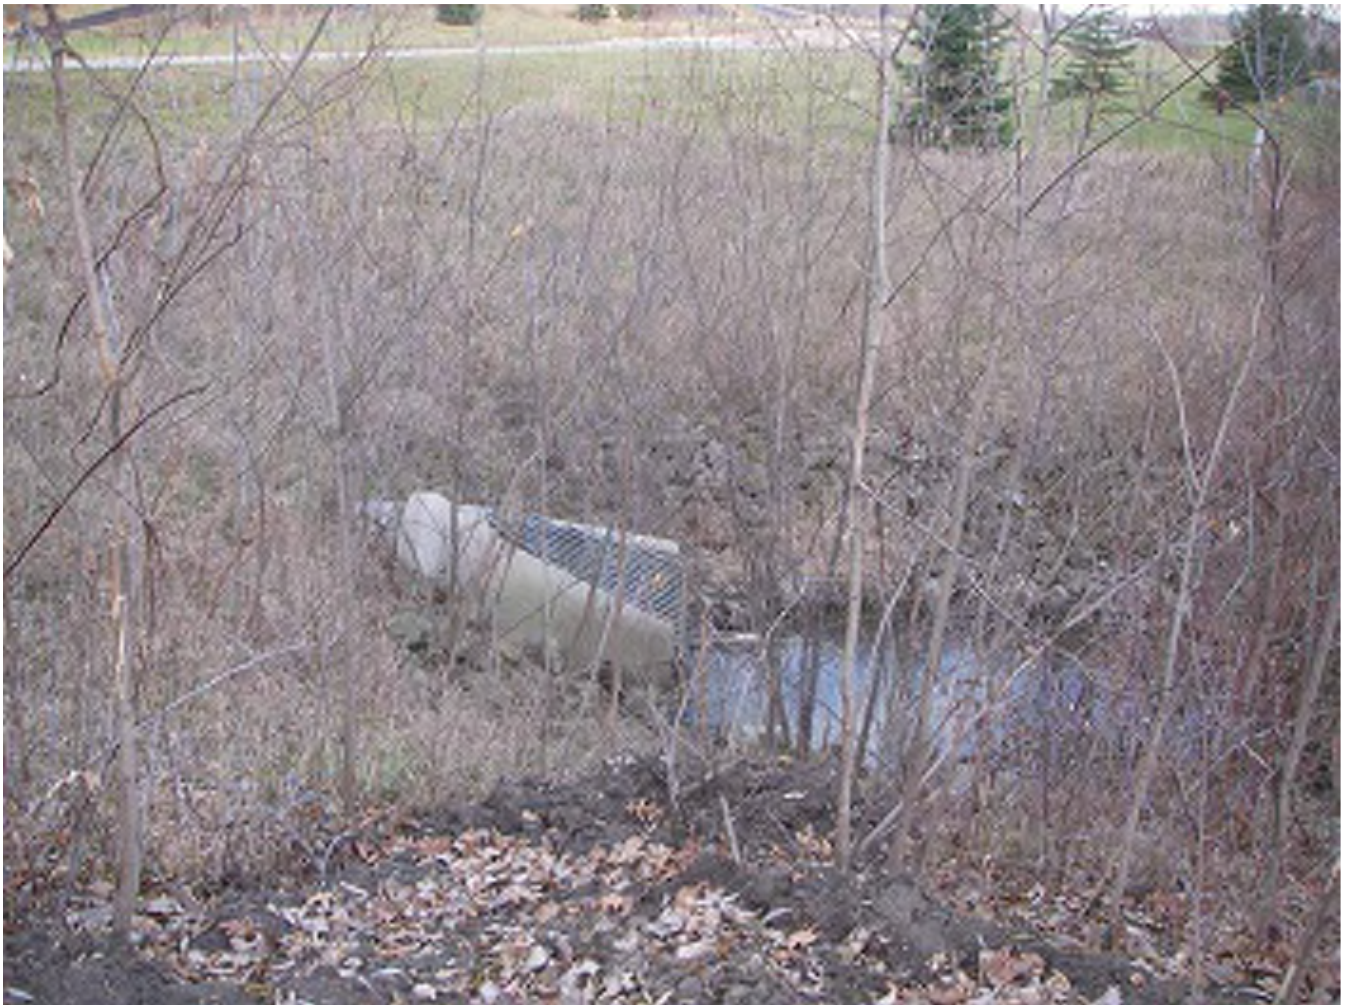
Culvert on other side

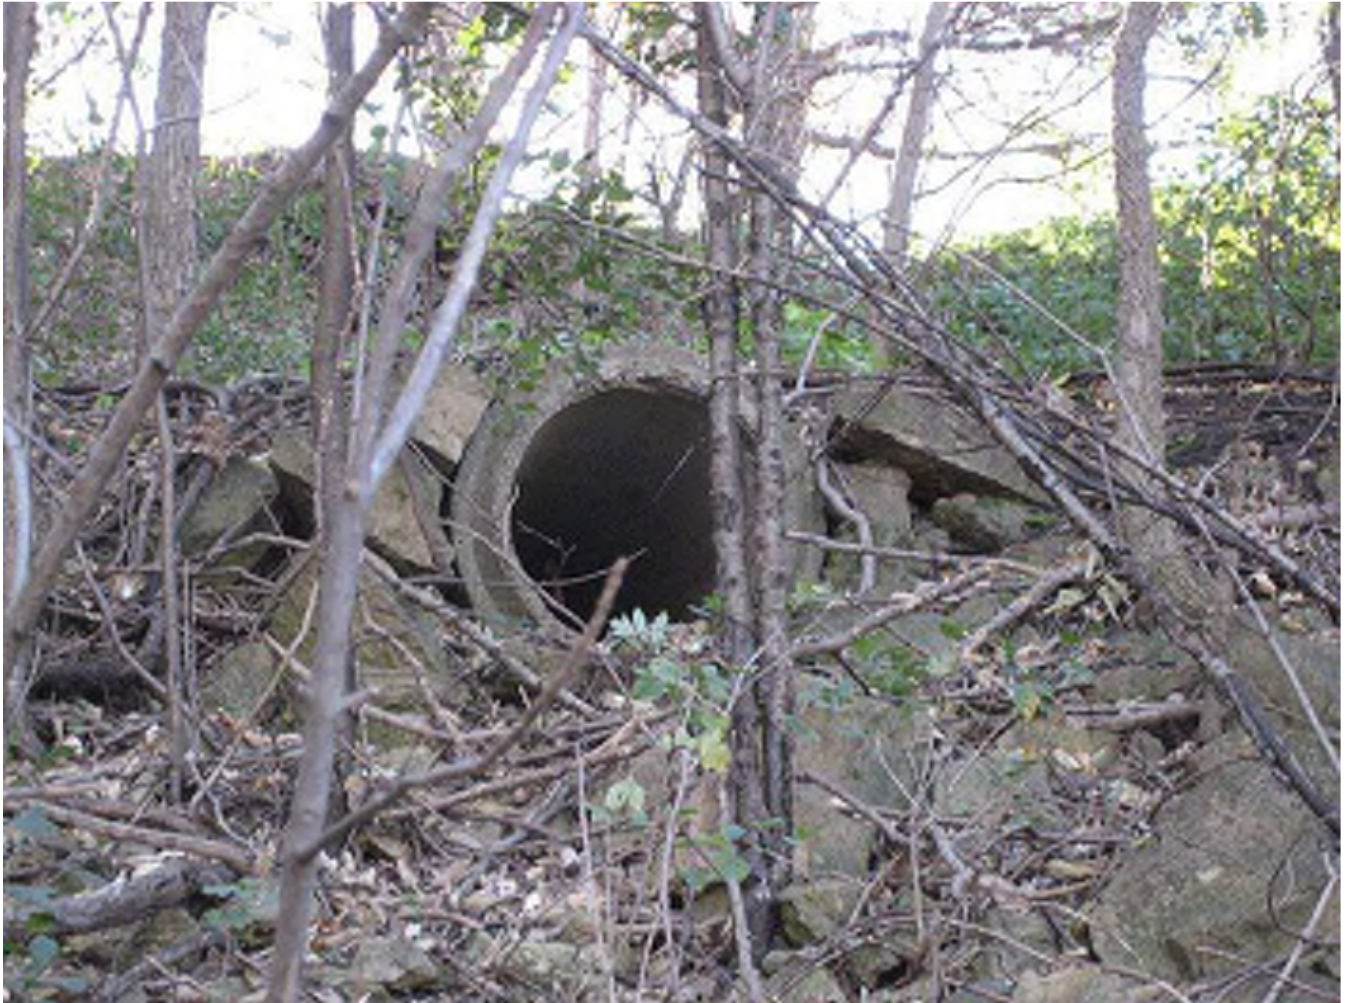
Waypoint 120A

Culvert coming out of side of slope; minor erosion.

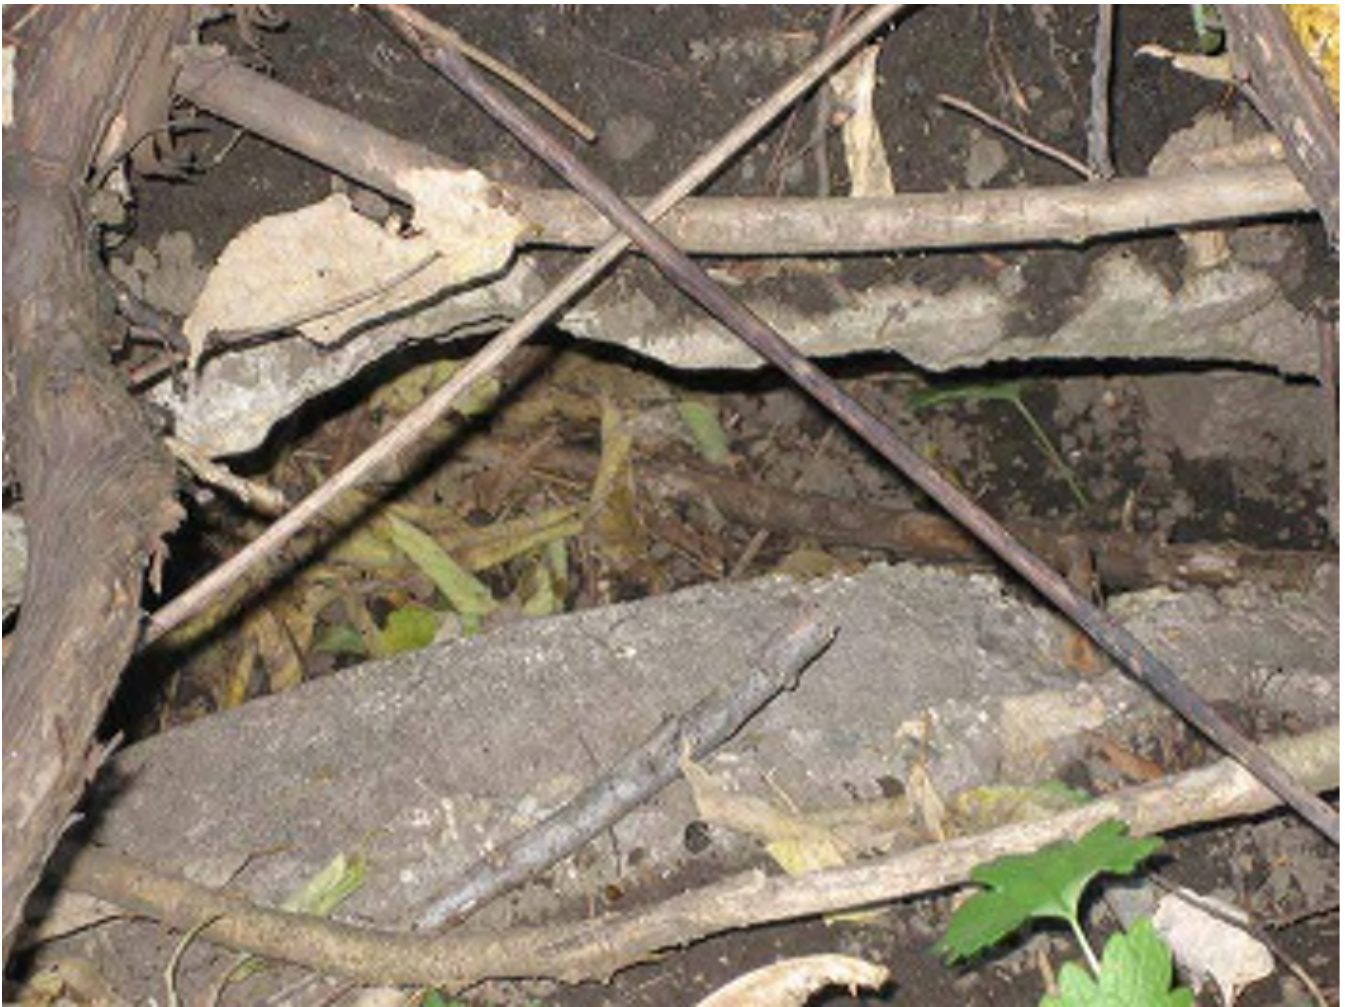
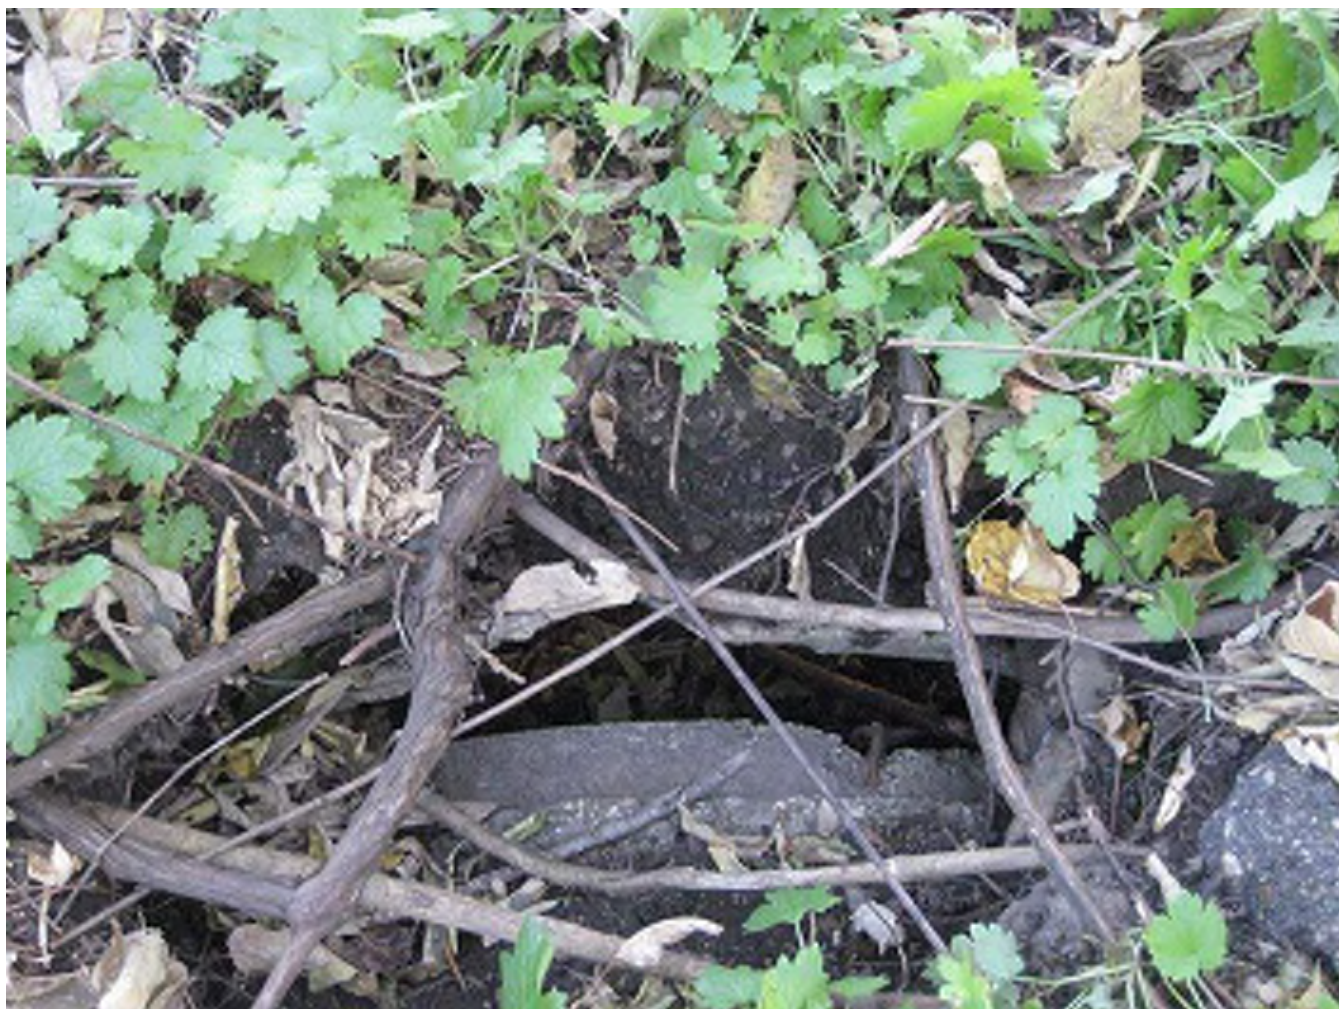
Large gap between two culverts.

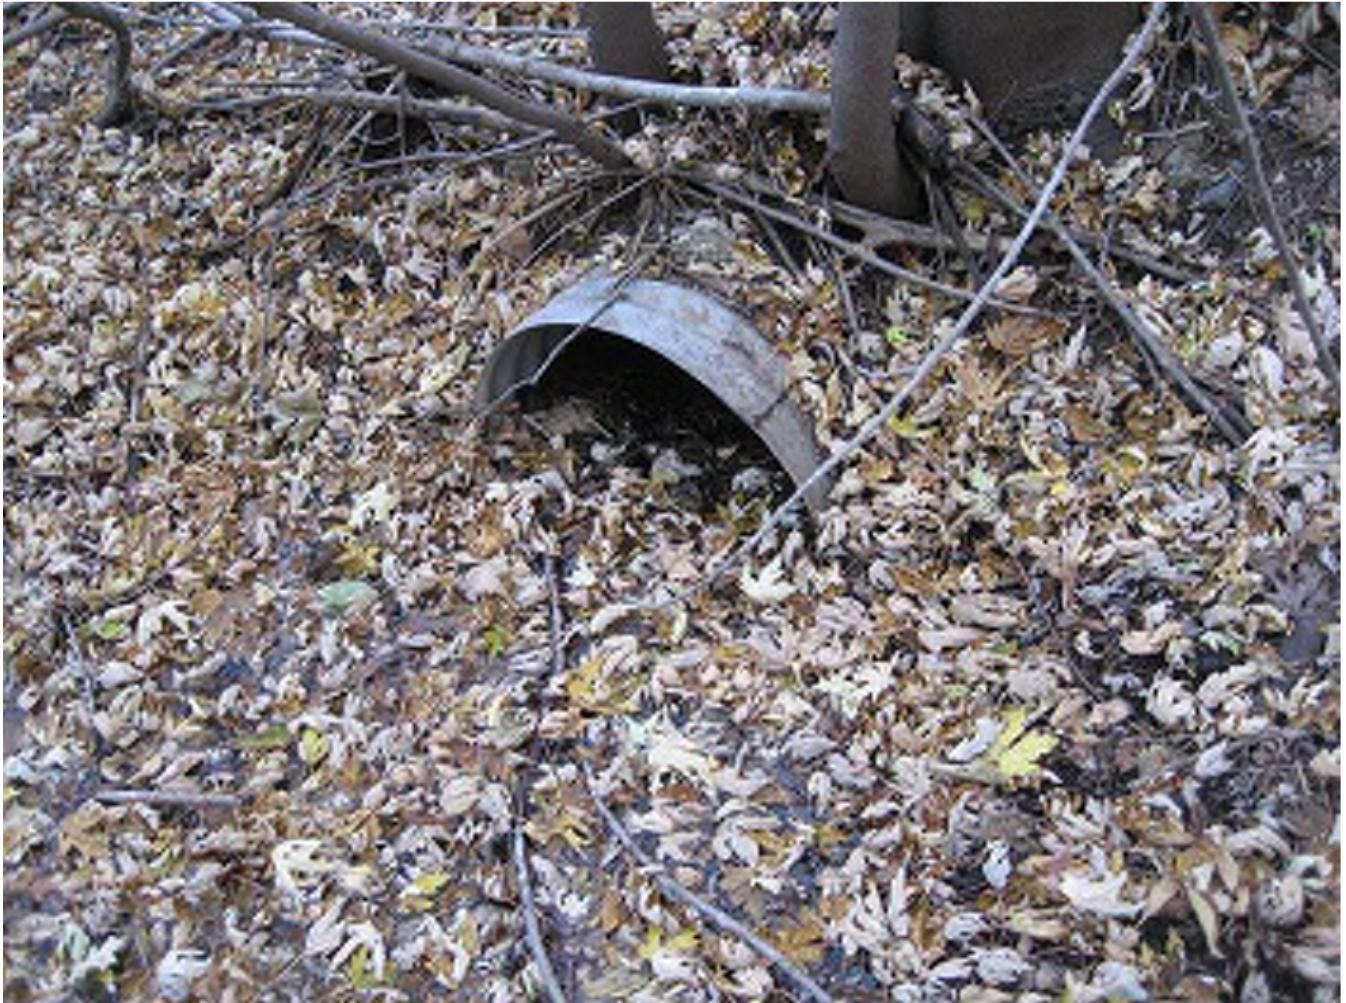
Waypoint 121A

Culvert opposite river side halfway under water; possibly clogged.

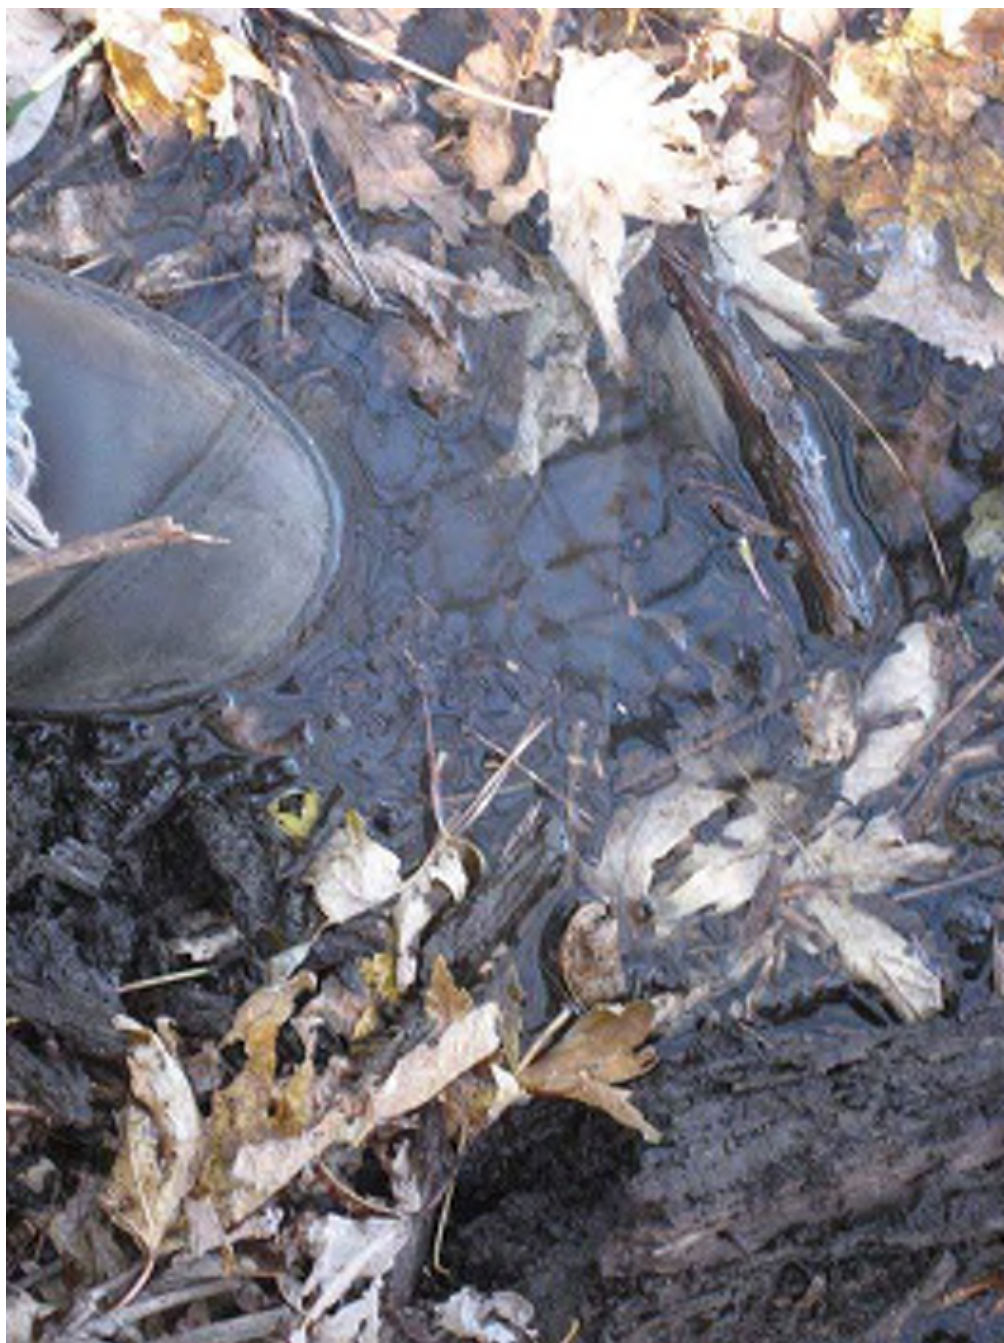
Culvert on river side completely under water

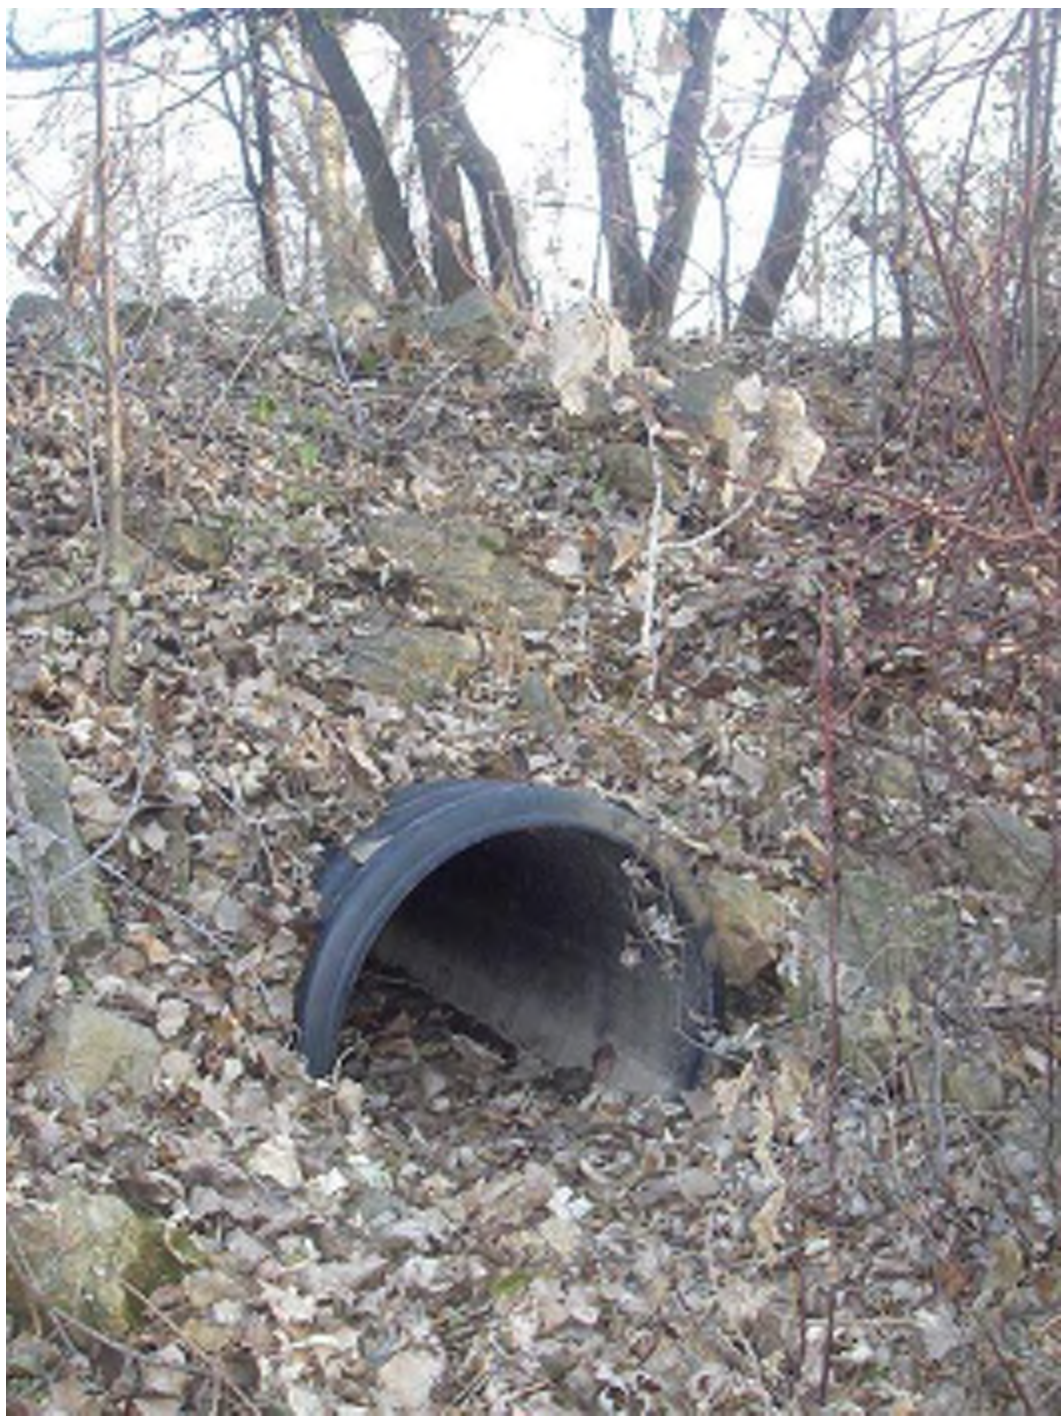
Waypoint 122

Drain pipe

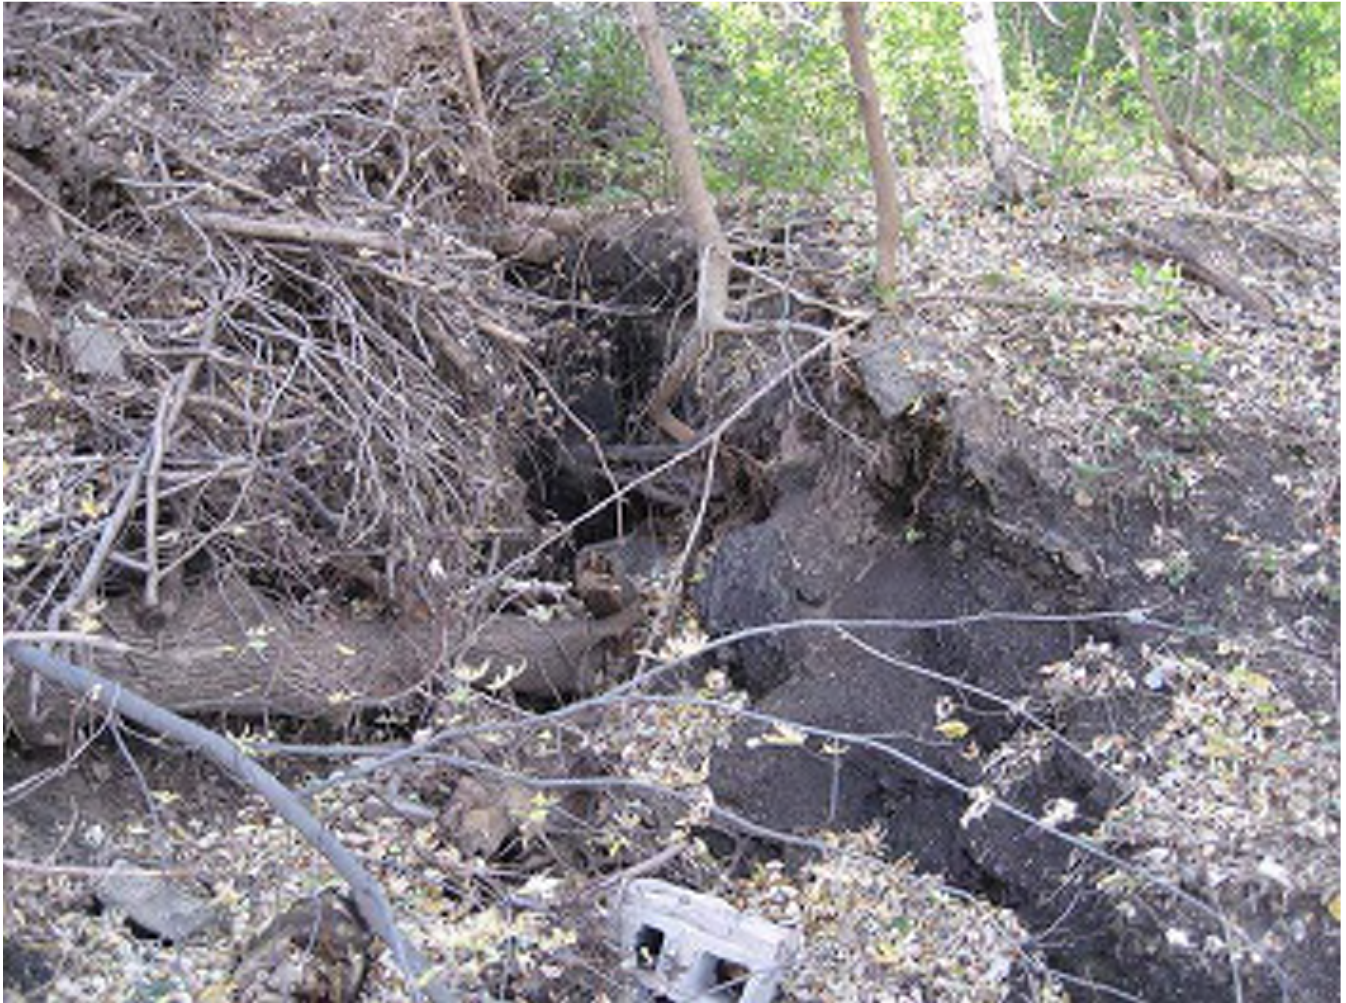
Waypoint 122A

Large amount of erosion cut 3-5 feet into the ground.

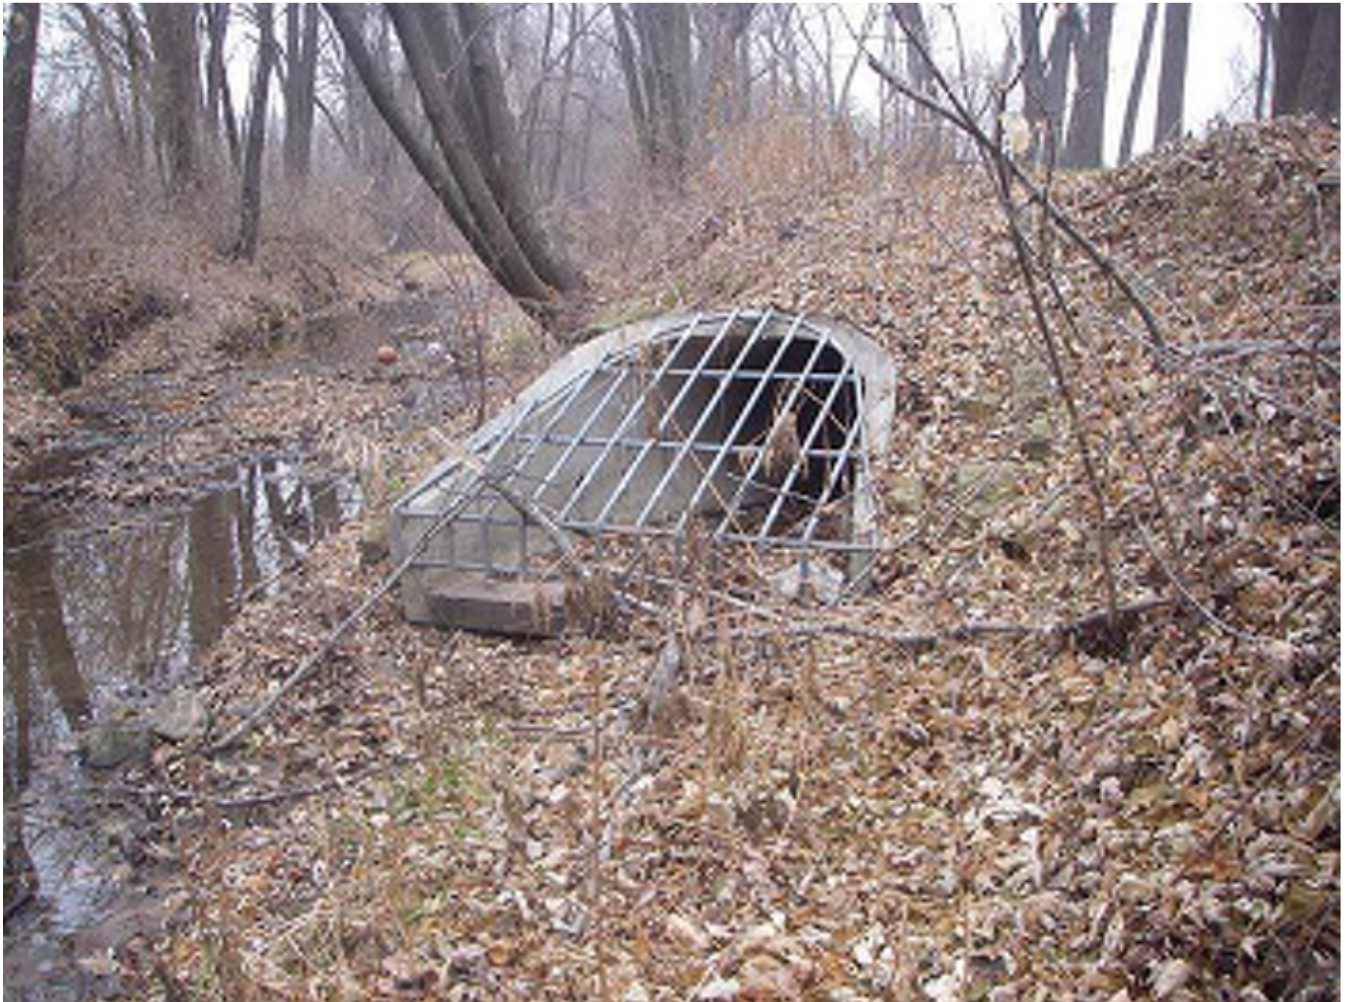
Waypoint 123

Drain pipe
