Appendix K: Lower Minnesota River Watershed District: Gully Inventory

Gully Inventory Map
 Area #1
 Lower Minnesota River Watershed District
 Watershed Management Plan

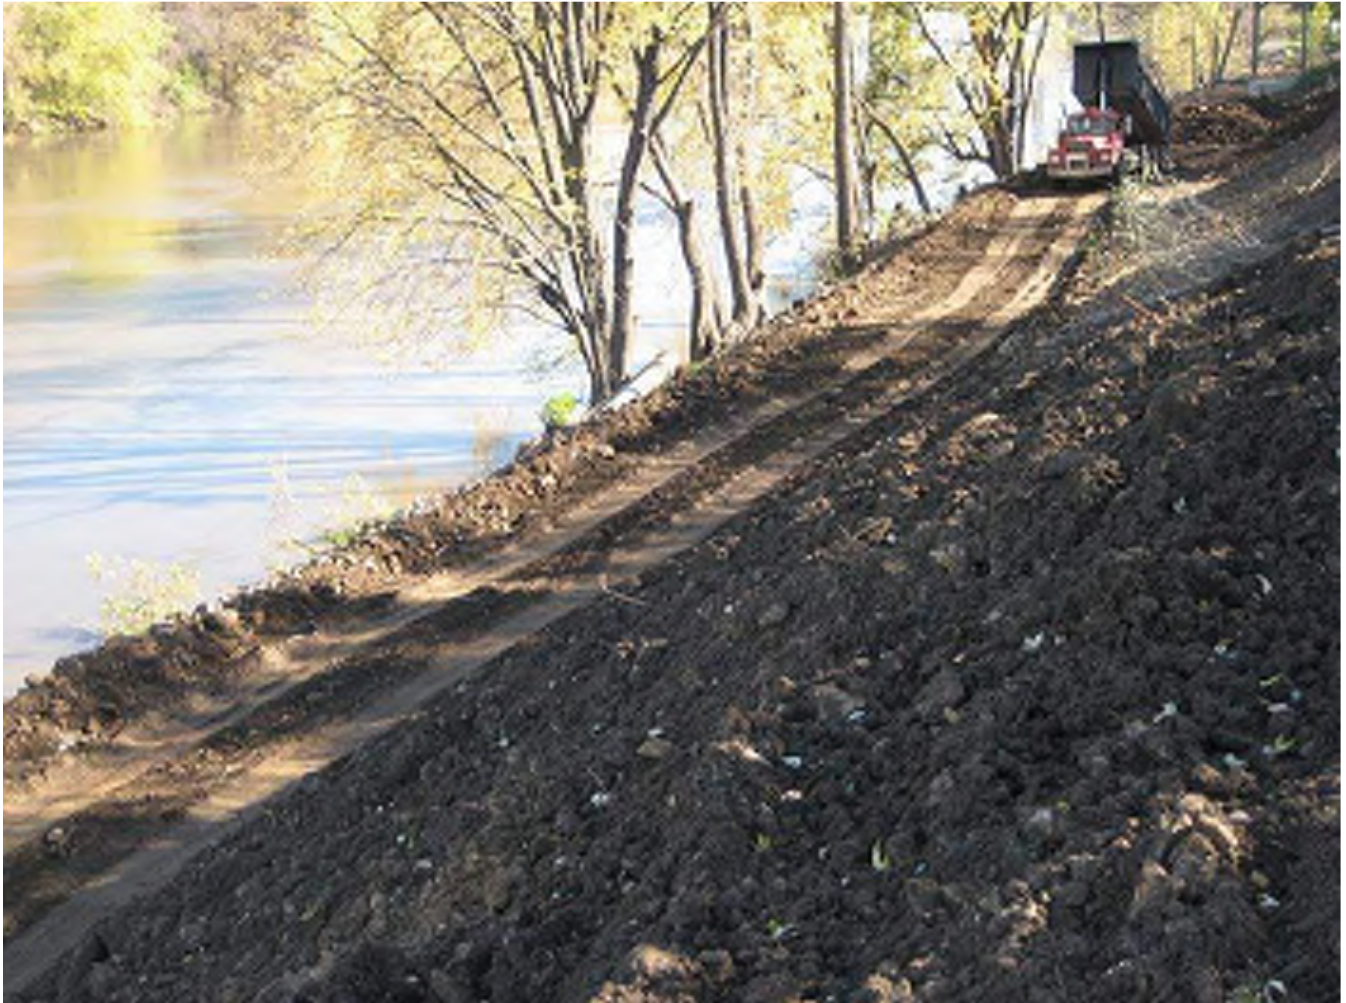
Waypoint 123A

Trail construction along river; couldn't access river side (downtown Shakopee).

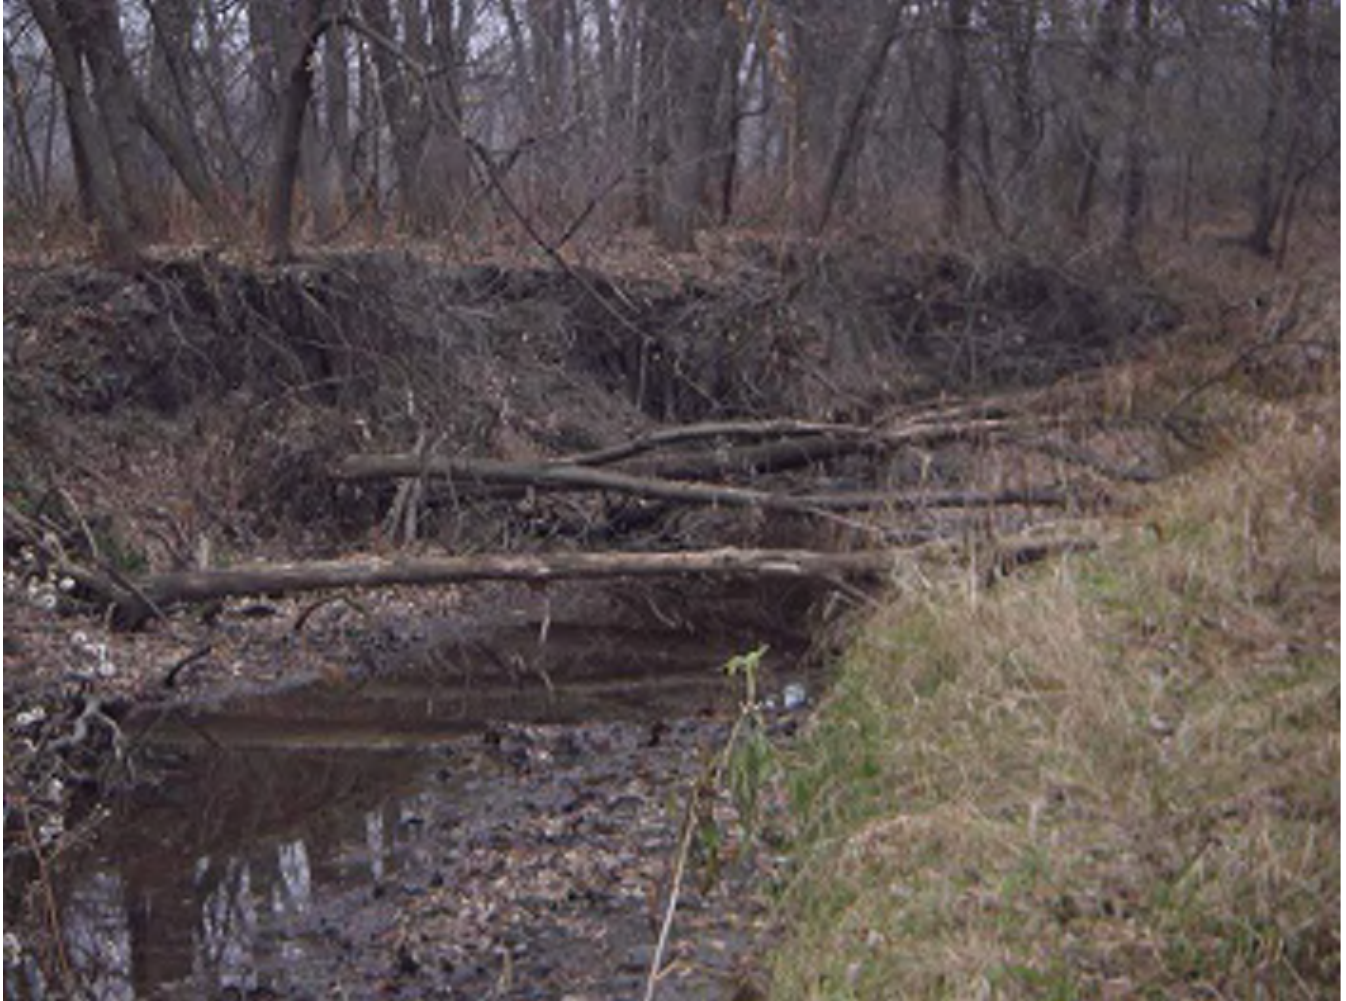
Waypoint 124

Heavy erosion on stream bank

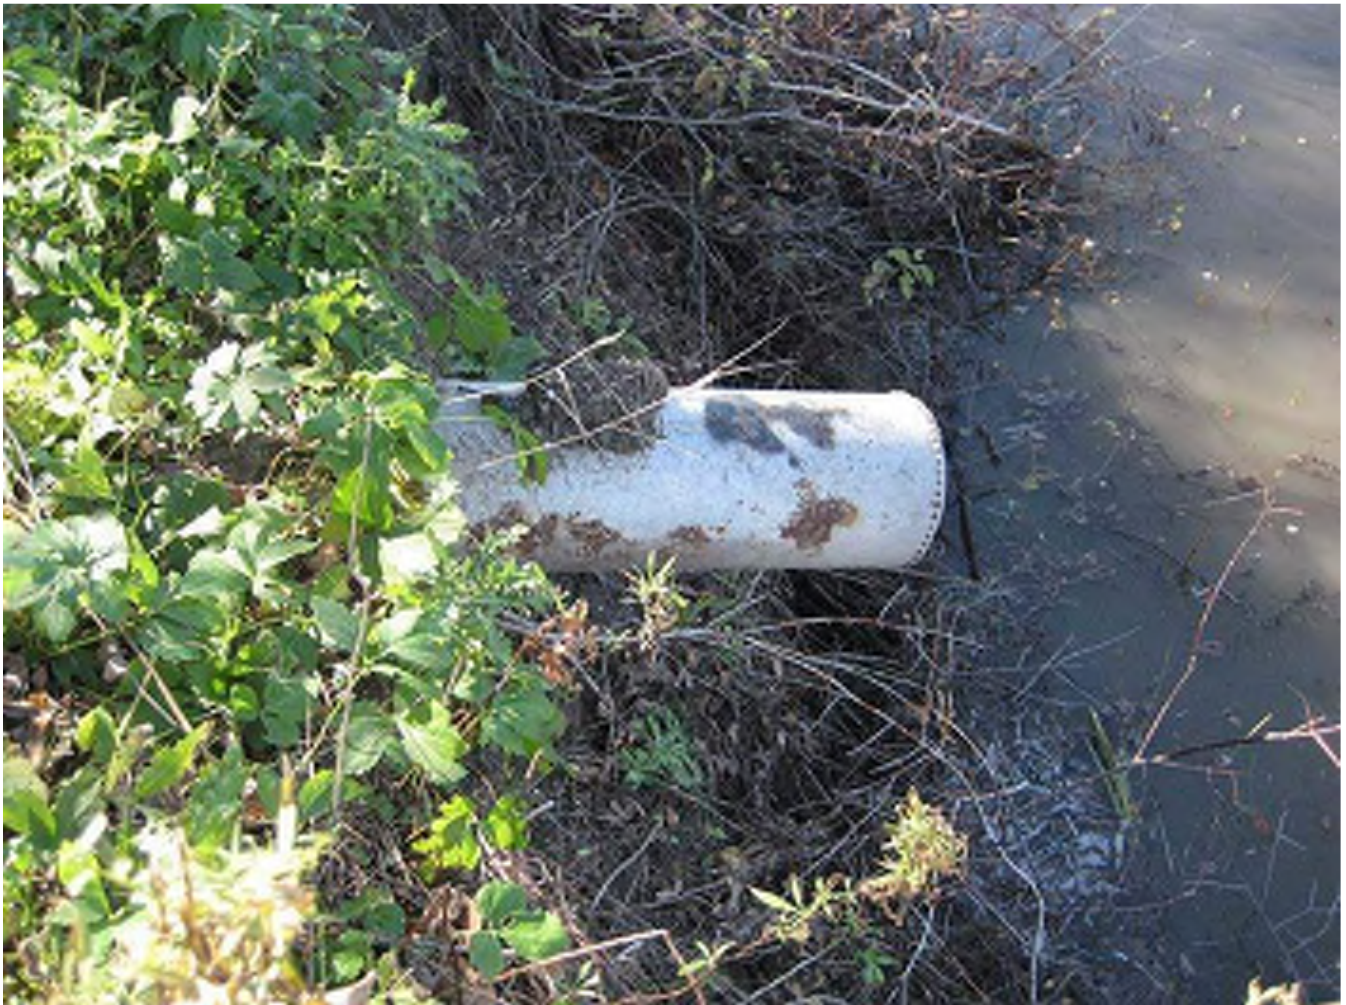
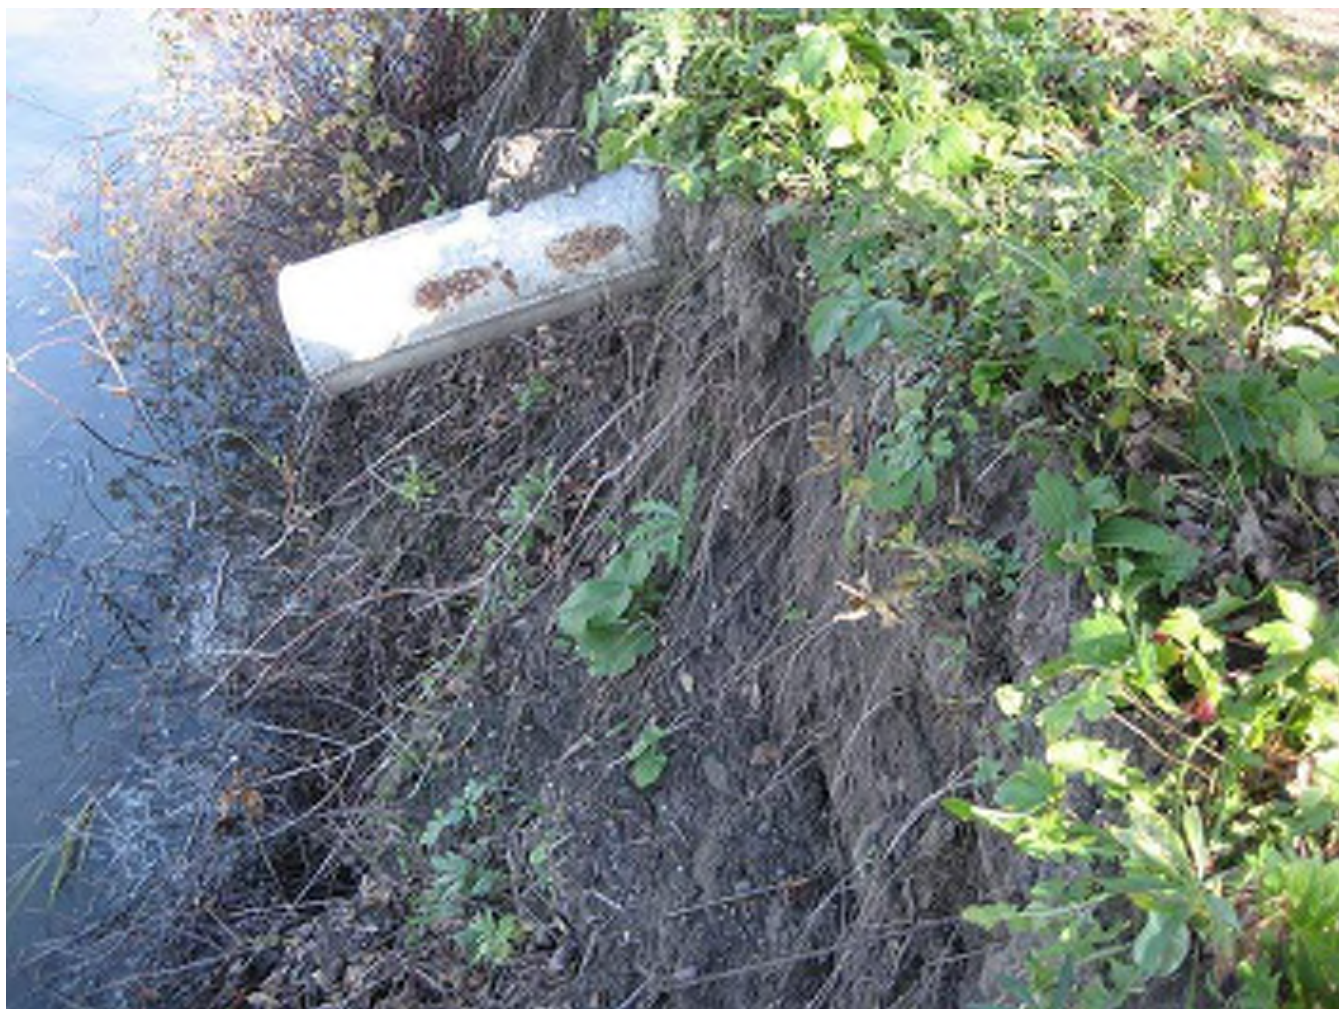
Waypoint 124A

Culvert coming from underneath path to river.

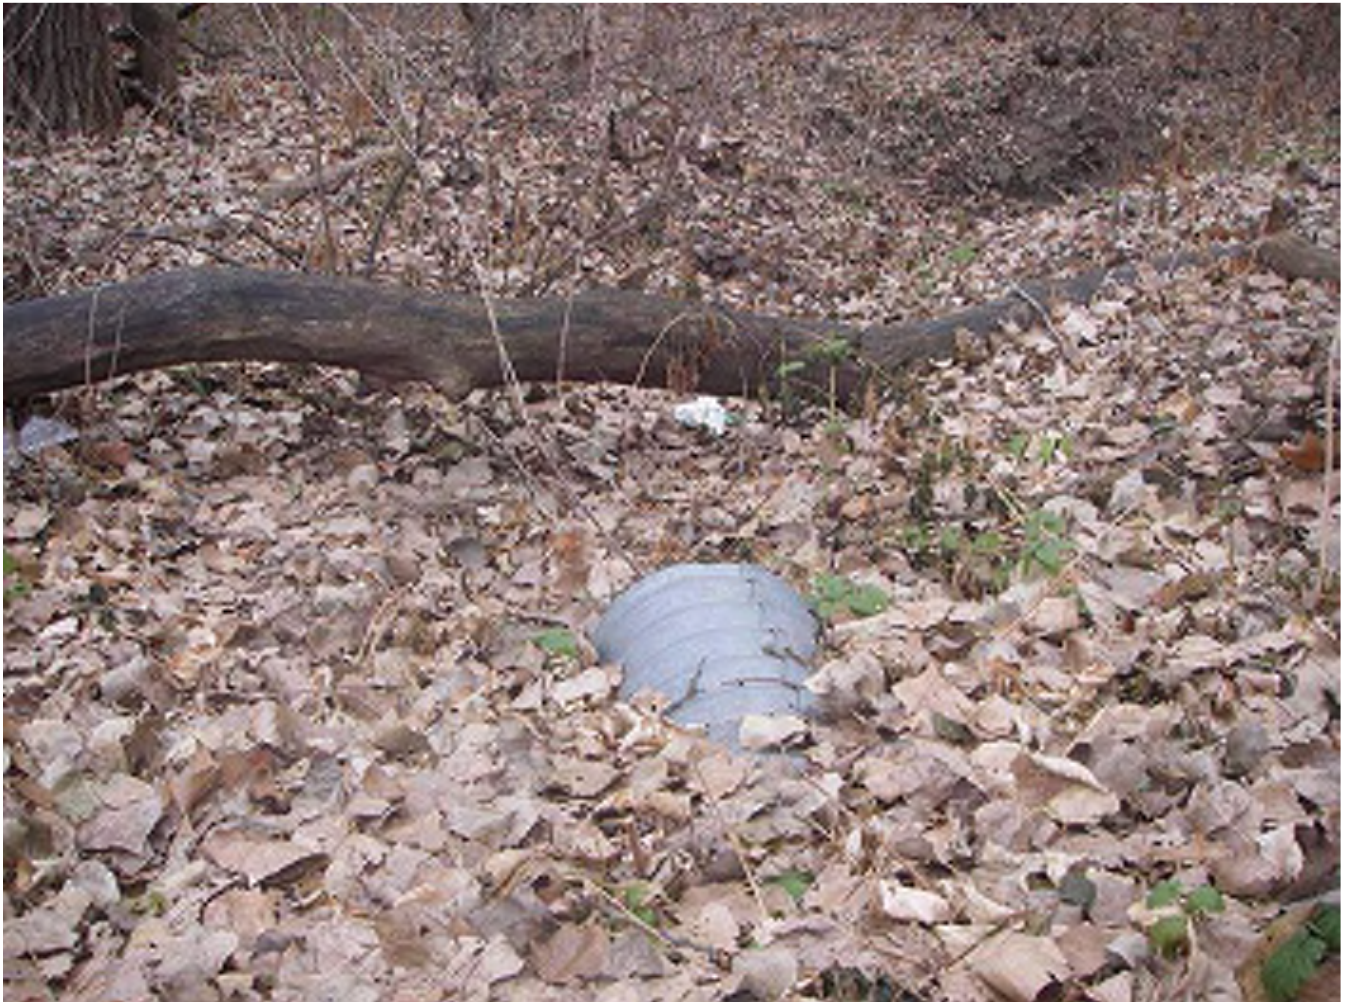
Waypoint 125

Drain pipe

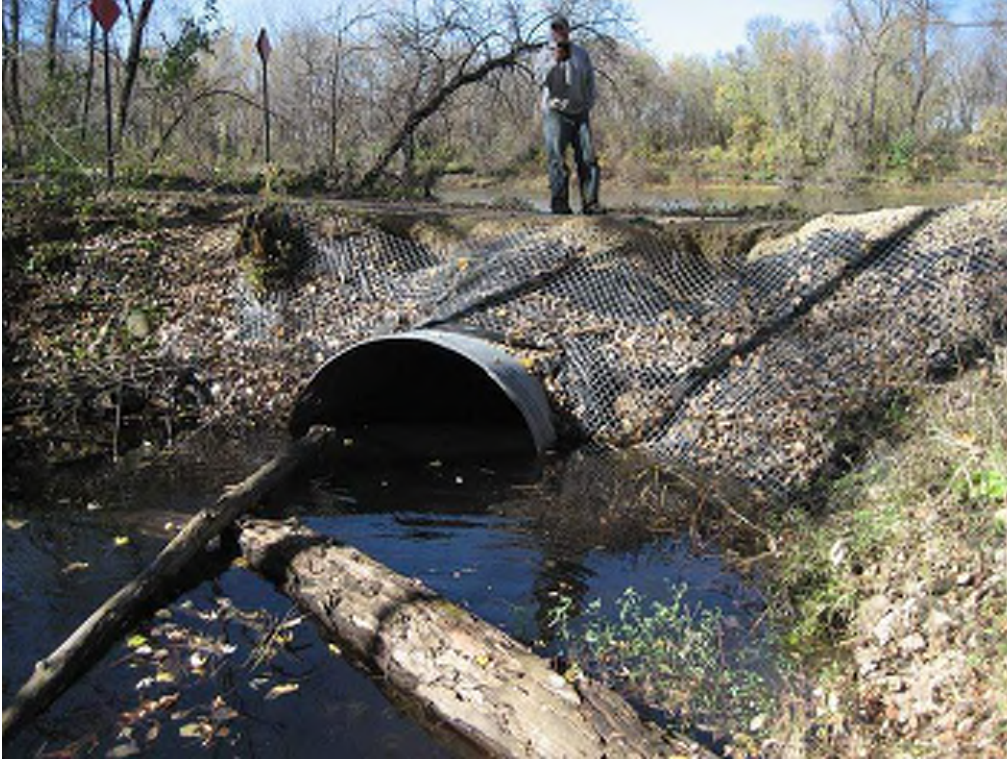
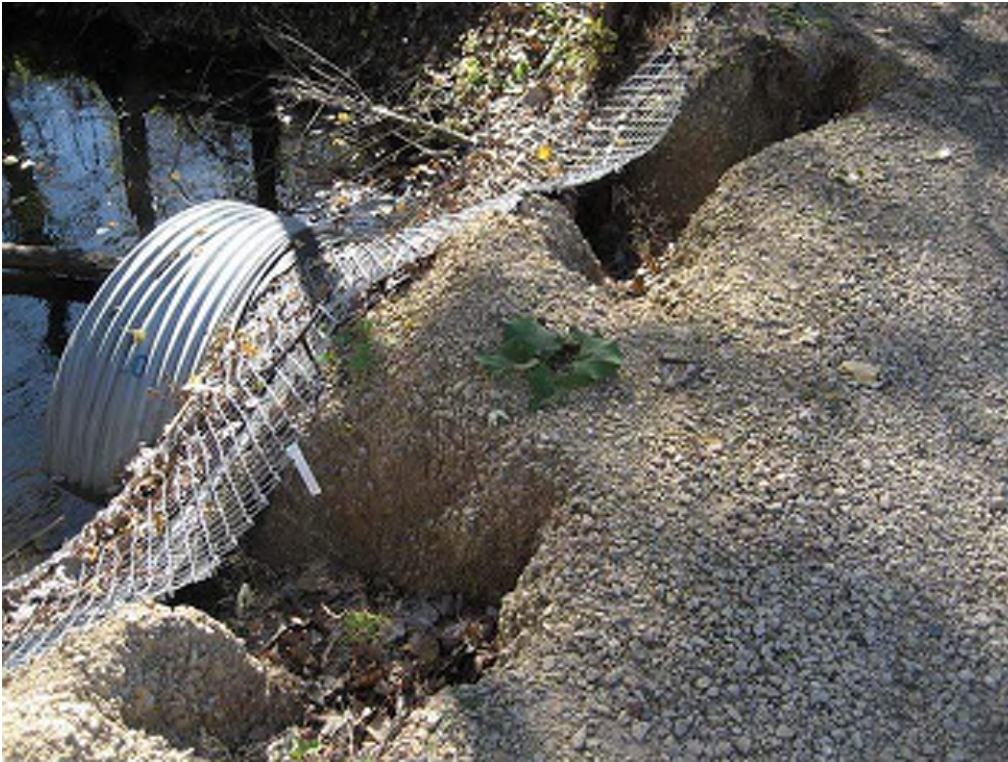
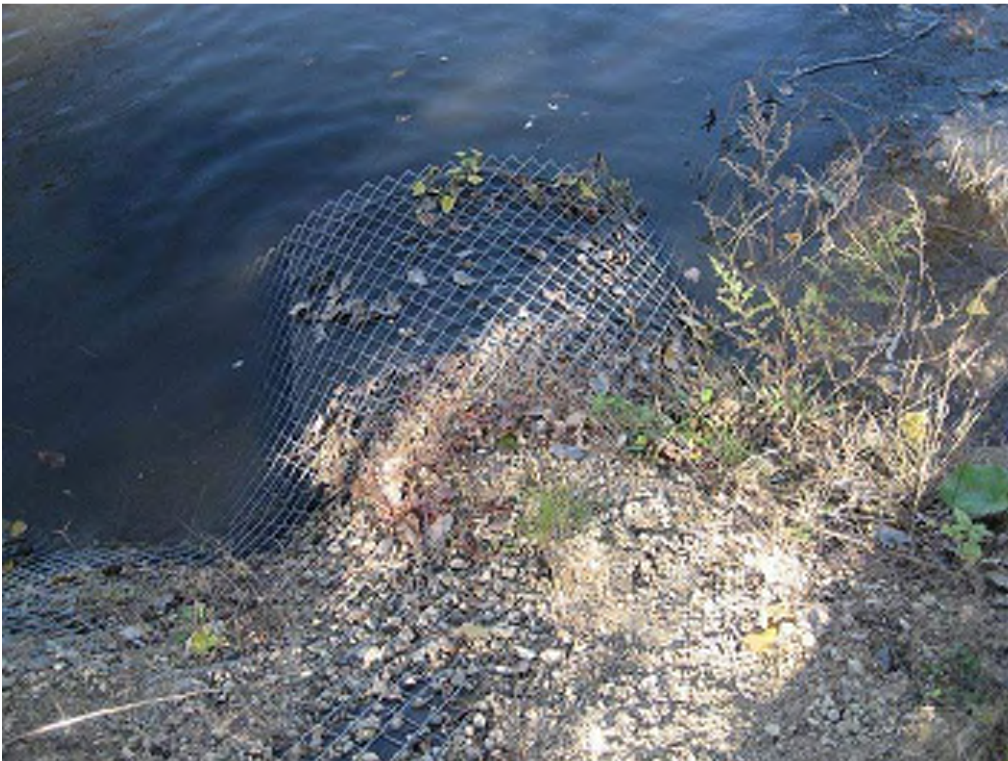
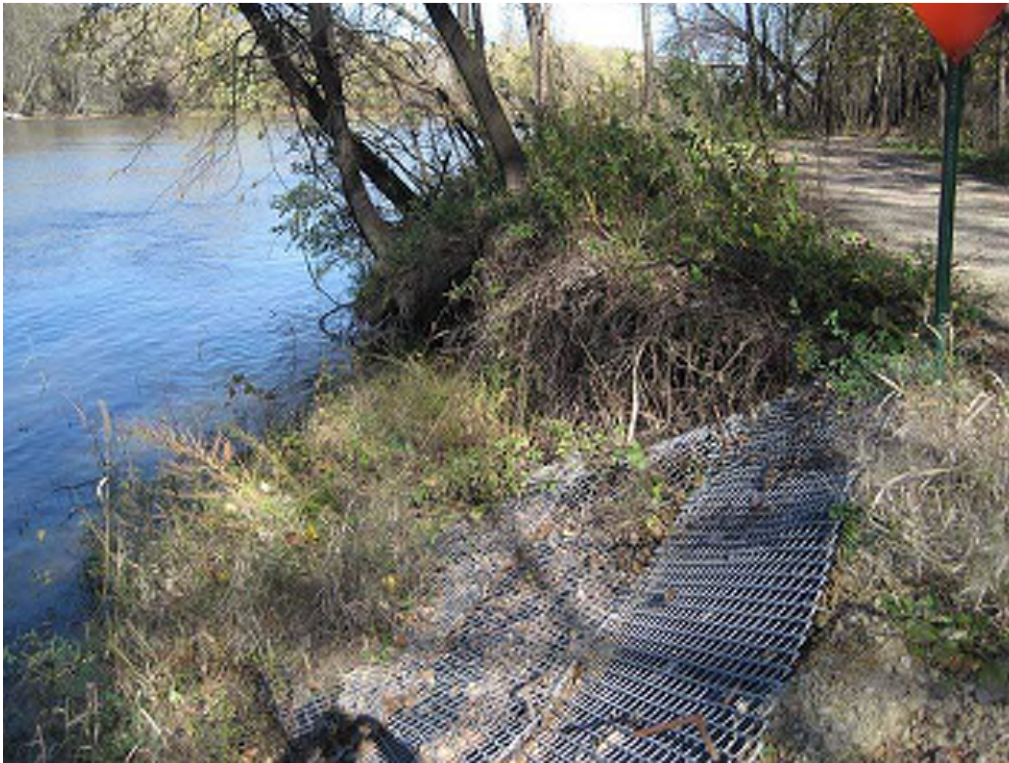
Waypoint 125A

Newly installed metal culvert, matting and fencing laid over slope to control erosion; some major erosion on trail.

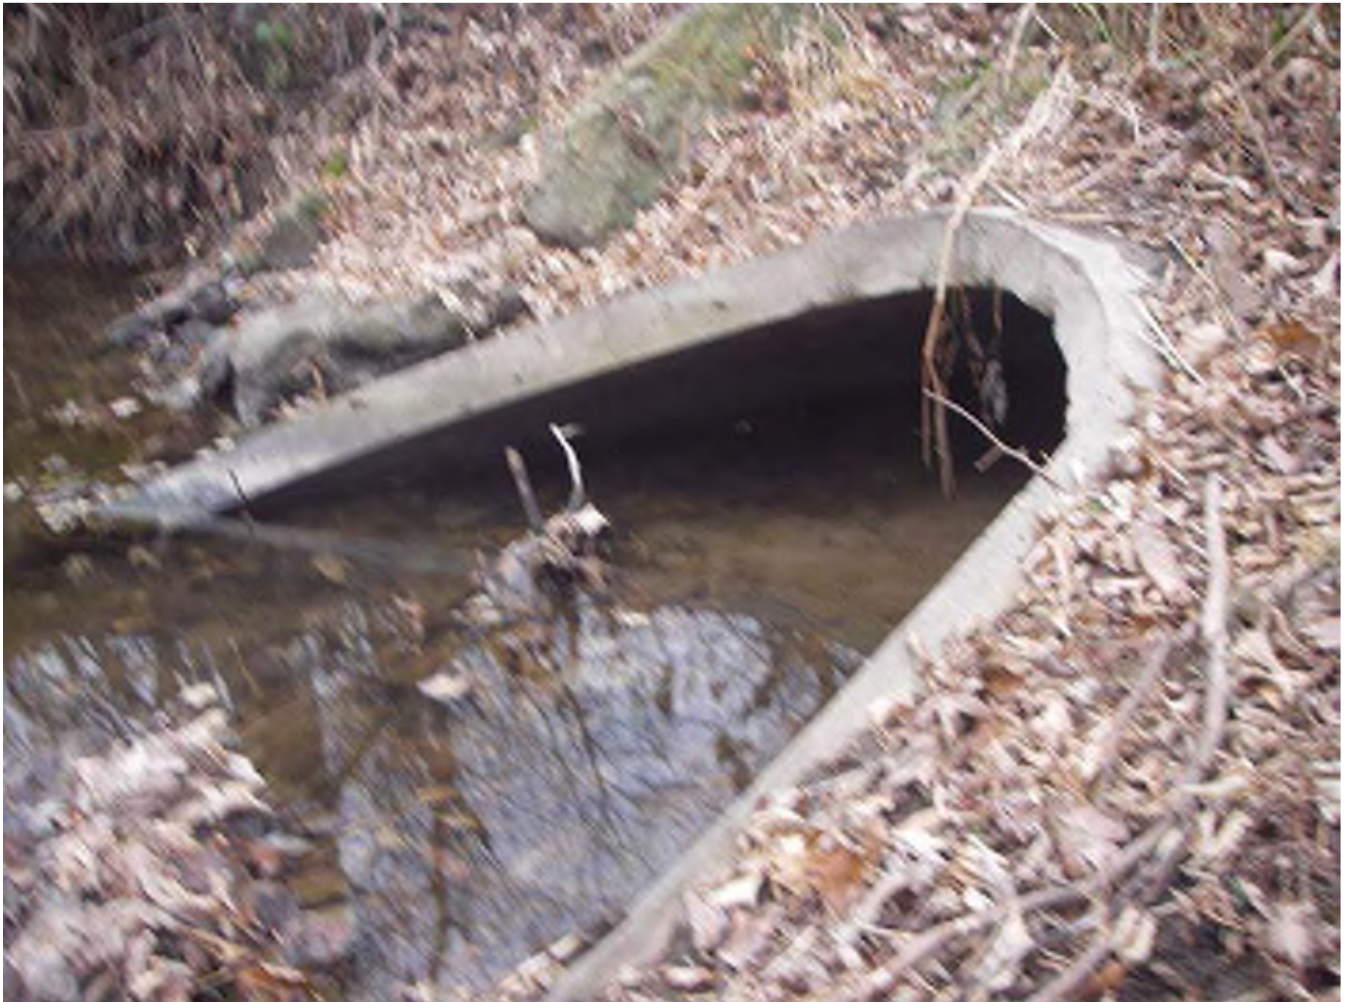
Waypoint 126

Drain pipe and bank erosion

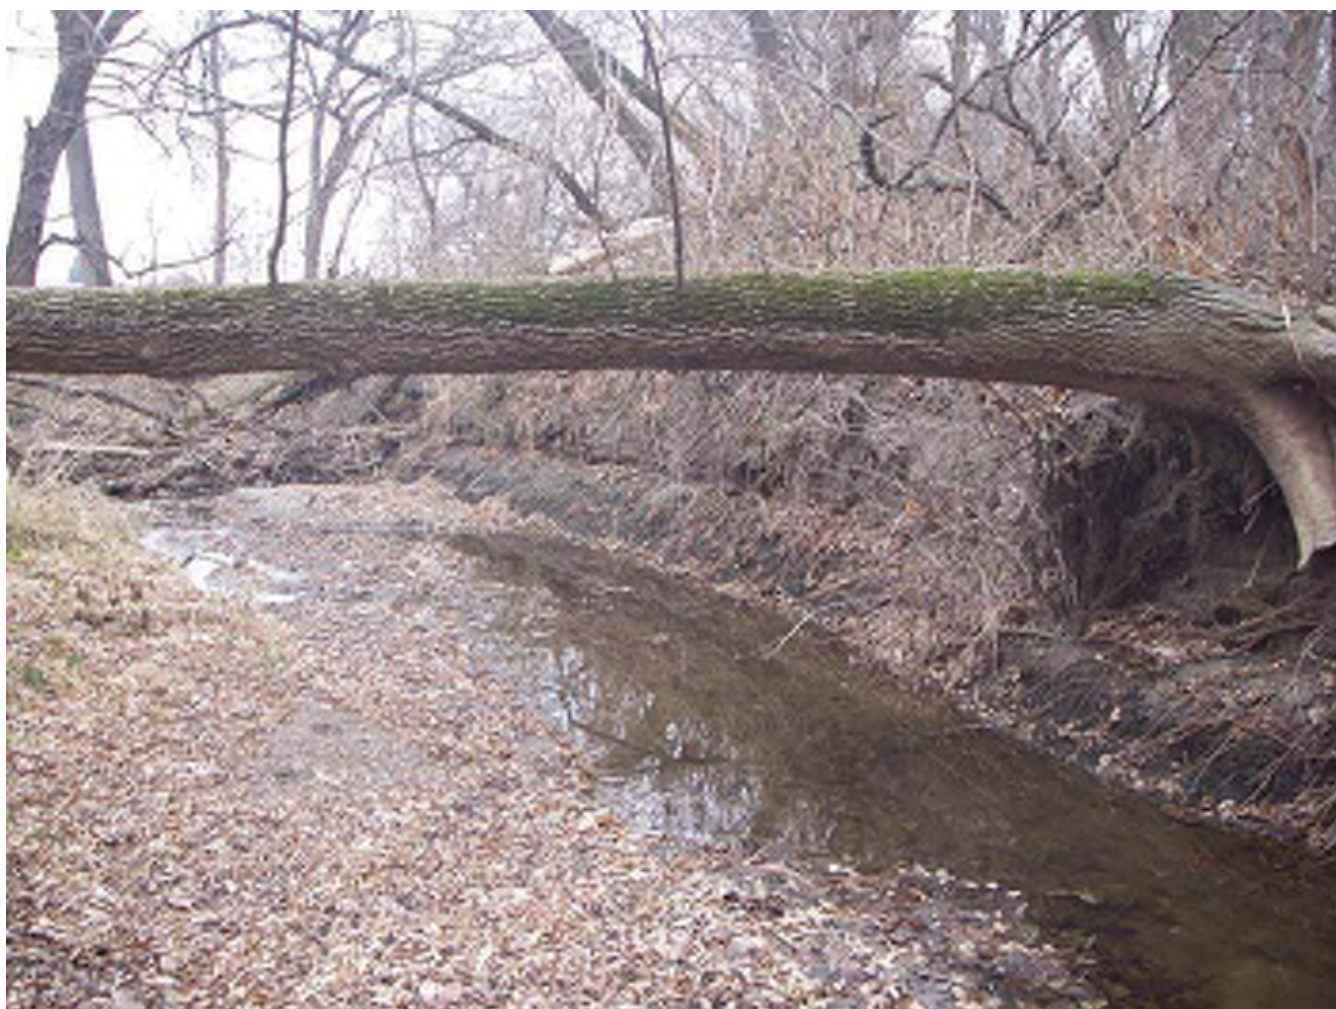
Drain pipe and bank erosion

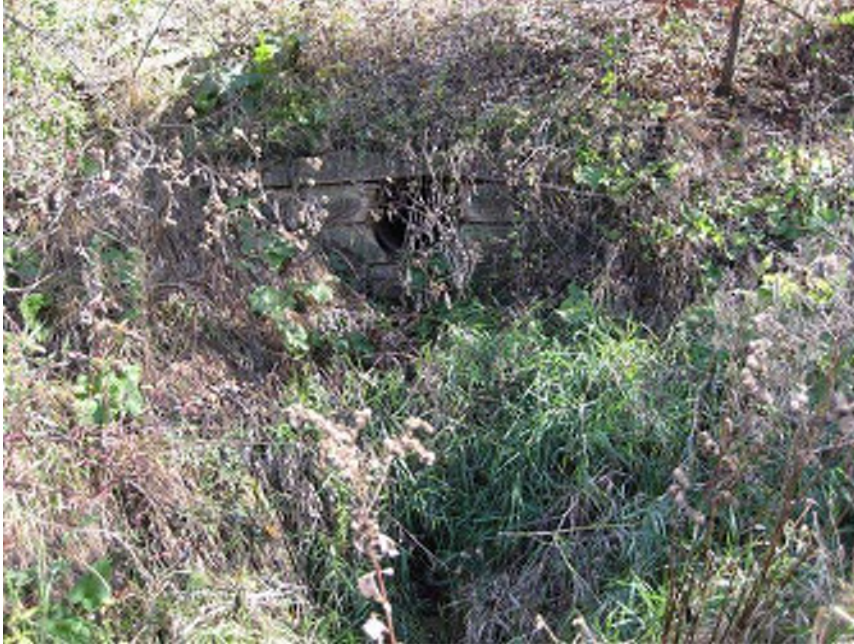
Waypoint 126A

Culvert coming from underneath railroad tracks; little erosion.

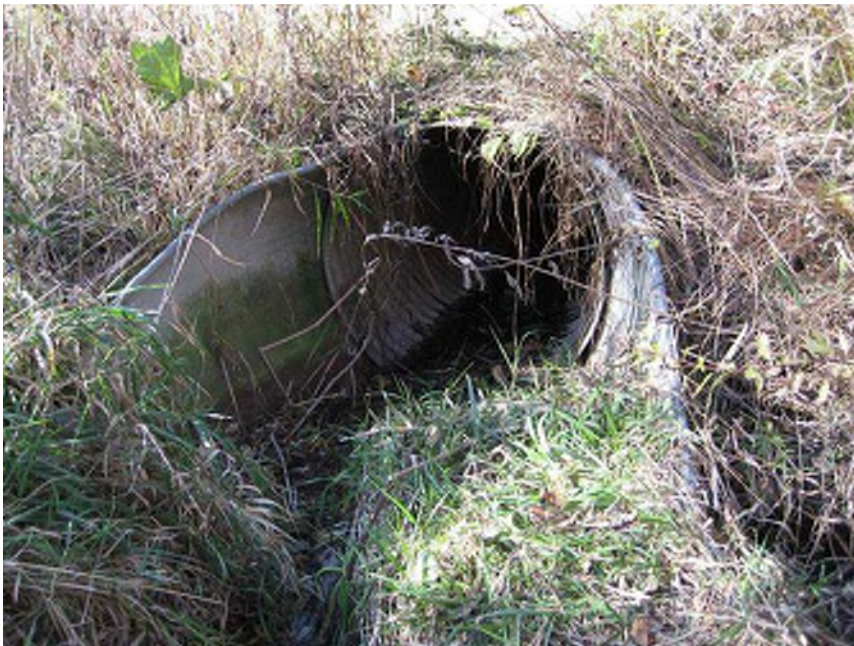
Culvert going under path; minor erosion.

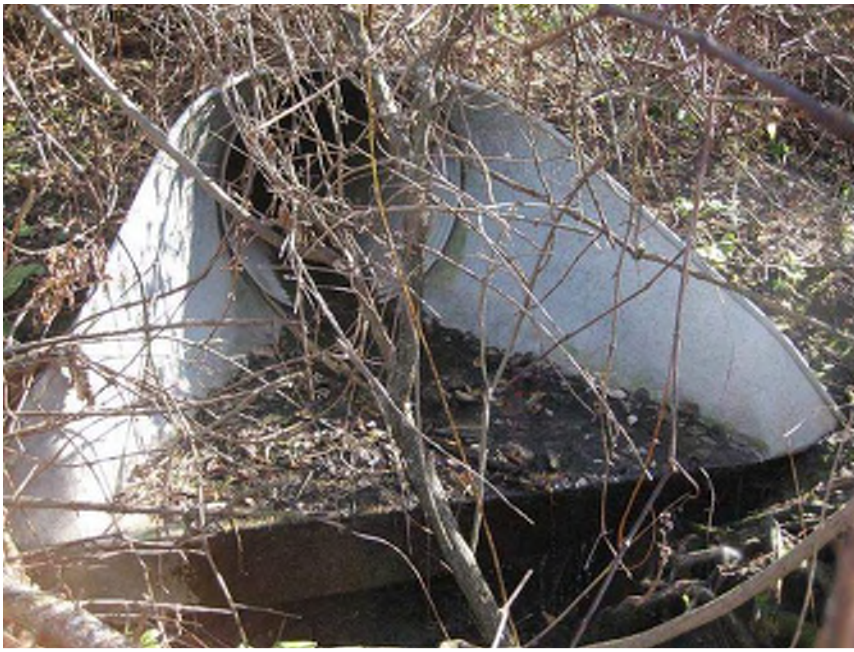
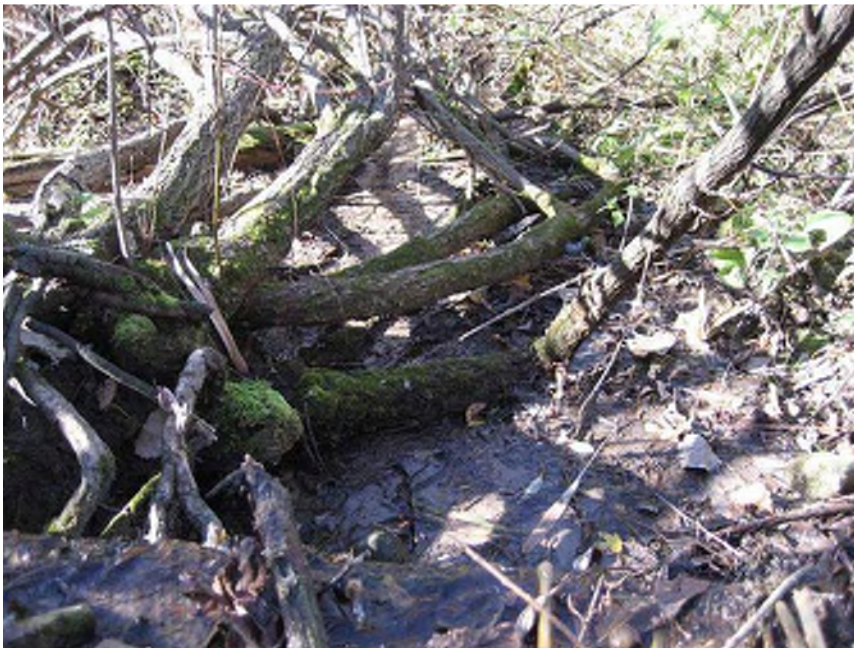
Culvert on river side of trail; cement slab under lip of culvert then approx. 6" drop-off to ground; lots of logs and debris at bottom.

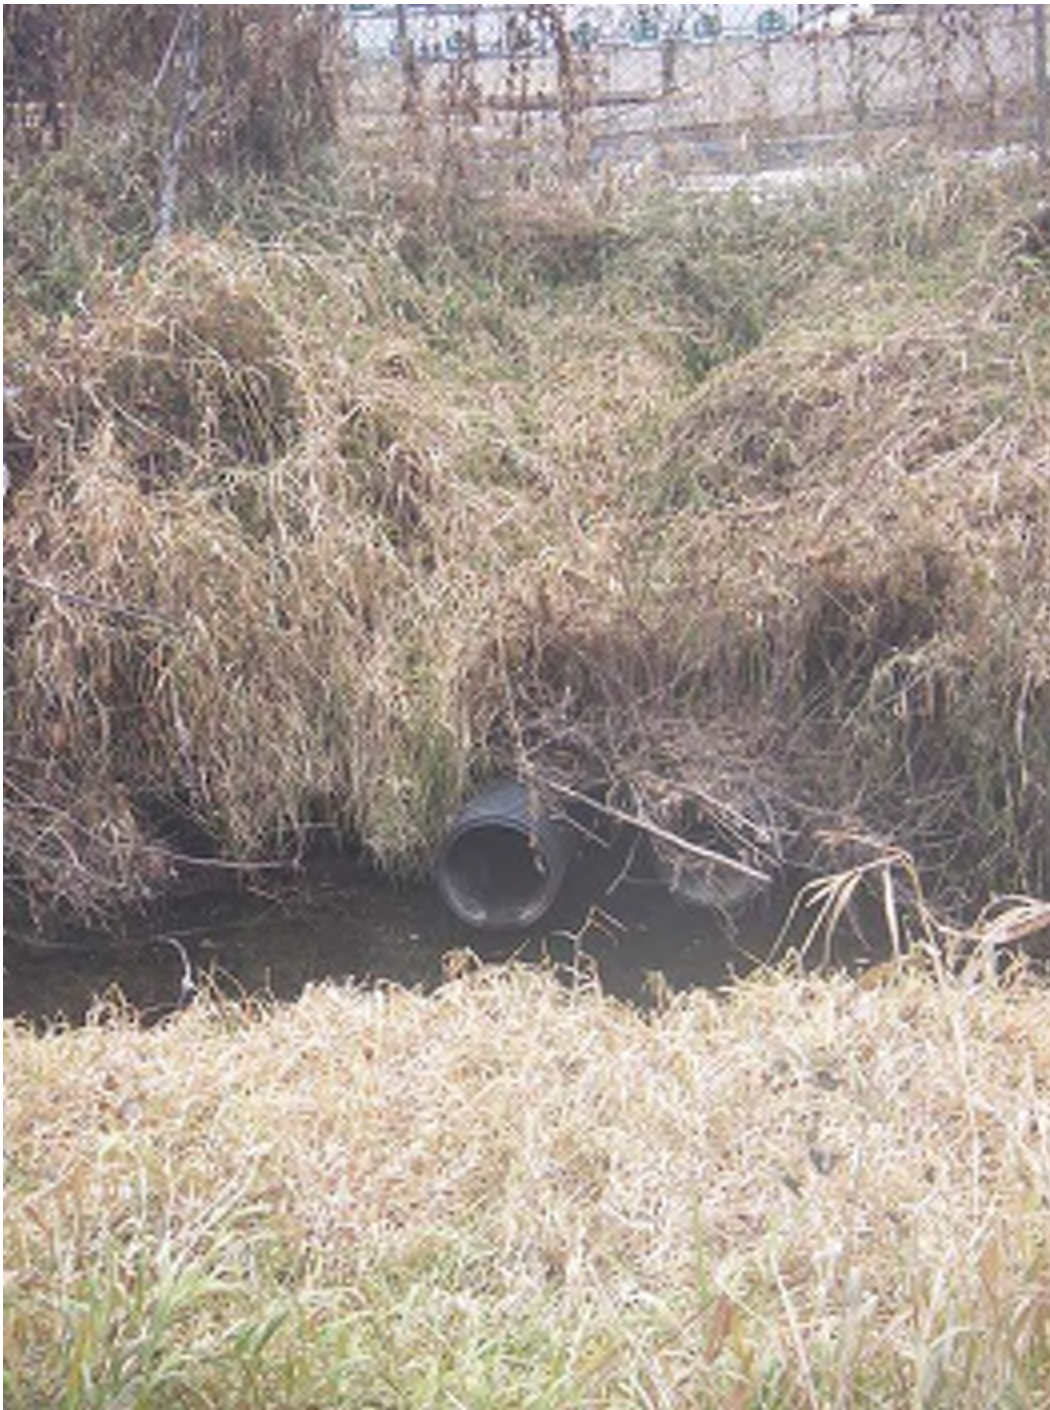
Waypoint 127

Drain pipe

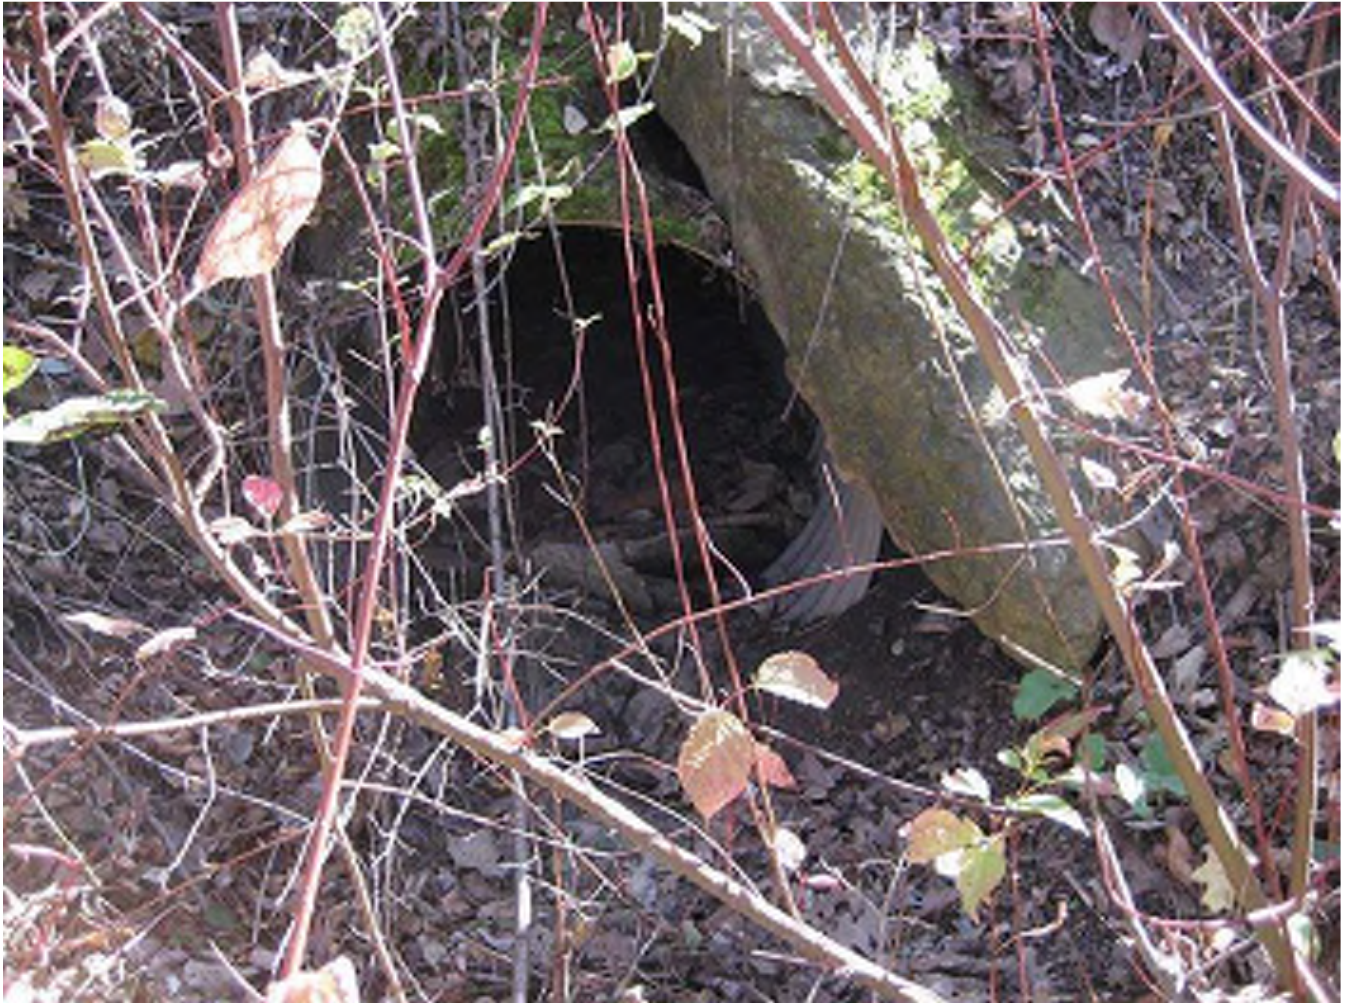
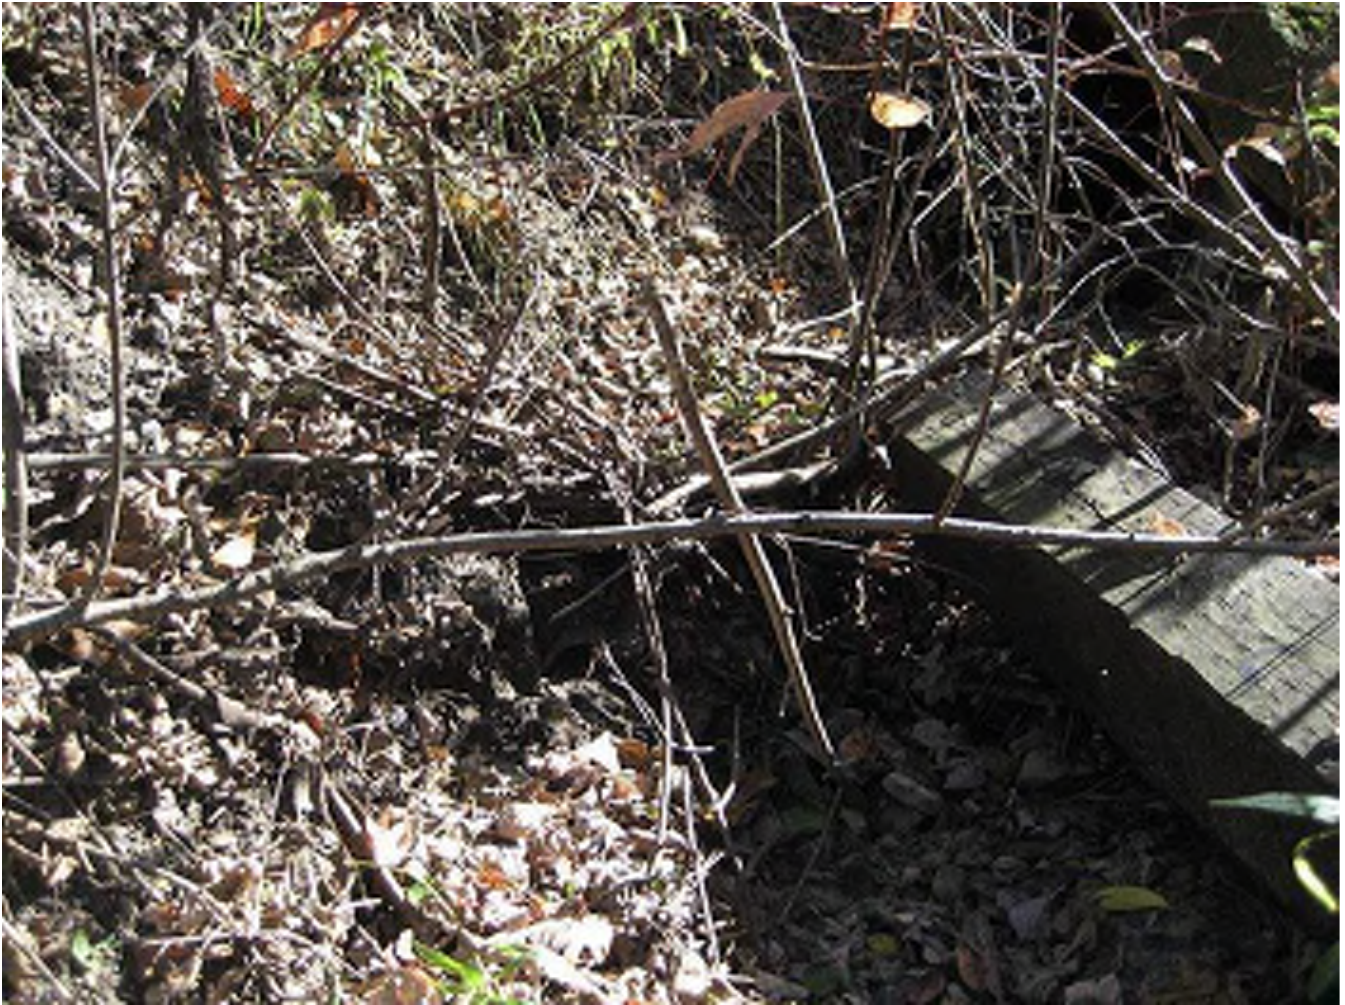
Waypoint 127A

Culvert outlet from under railroad tracks; moderate erosion.

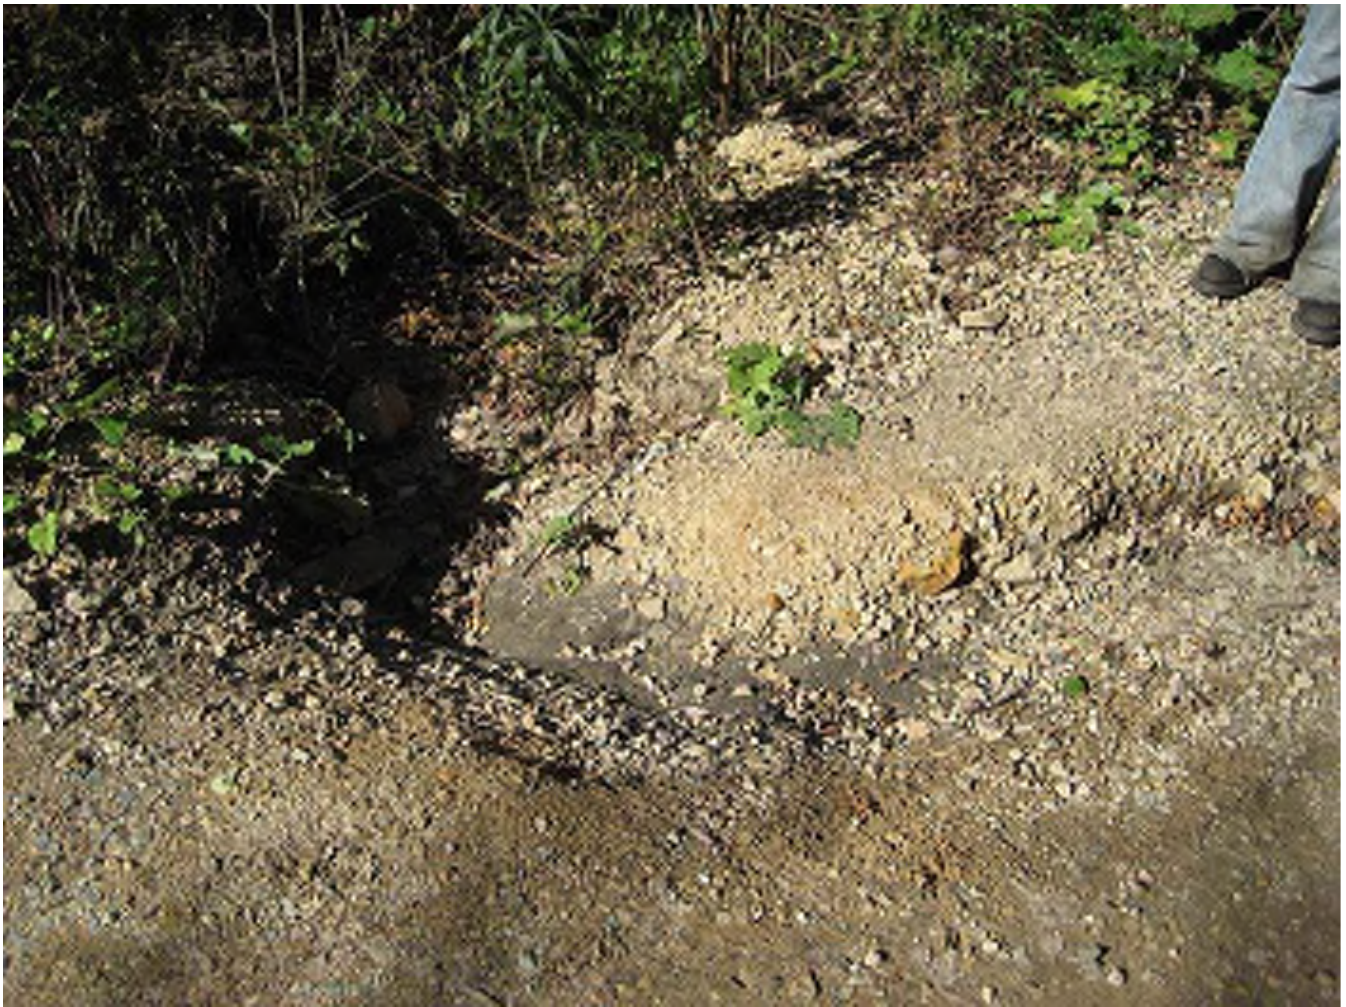
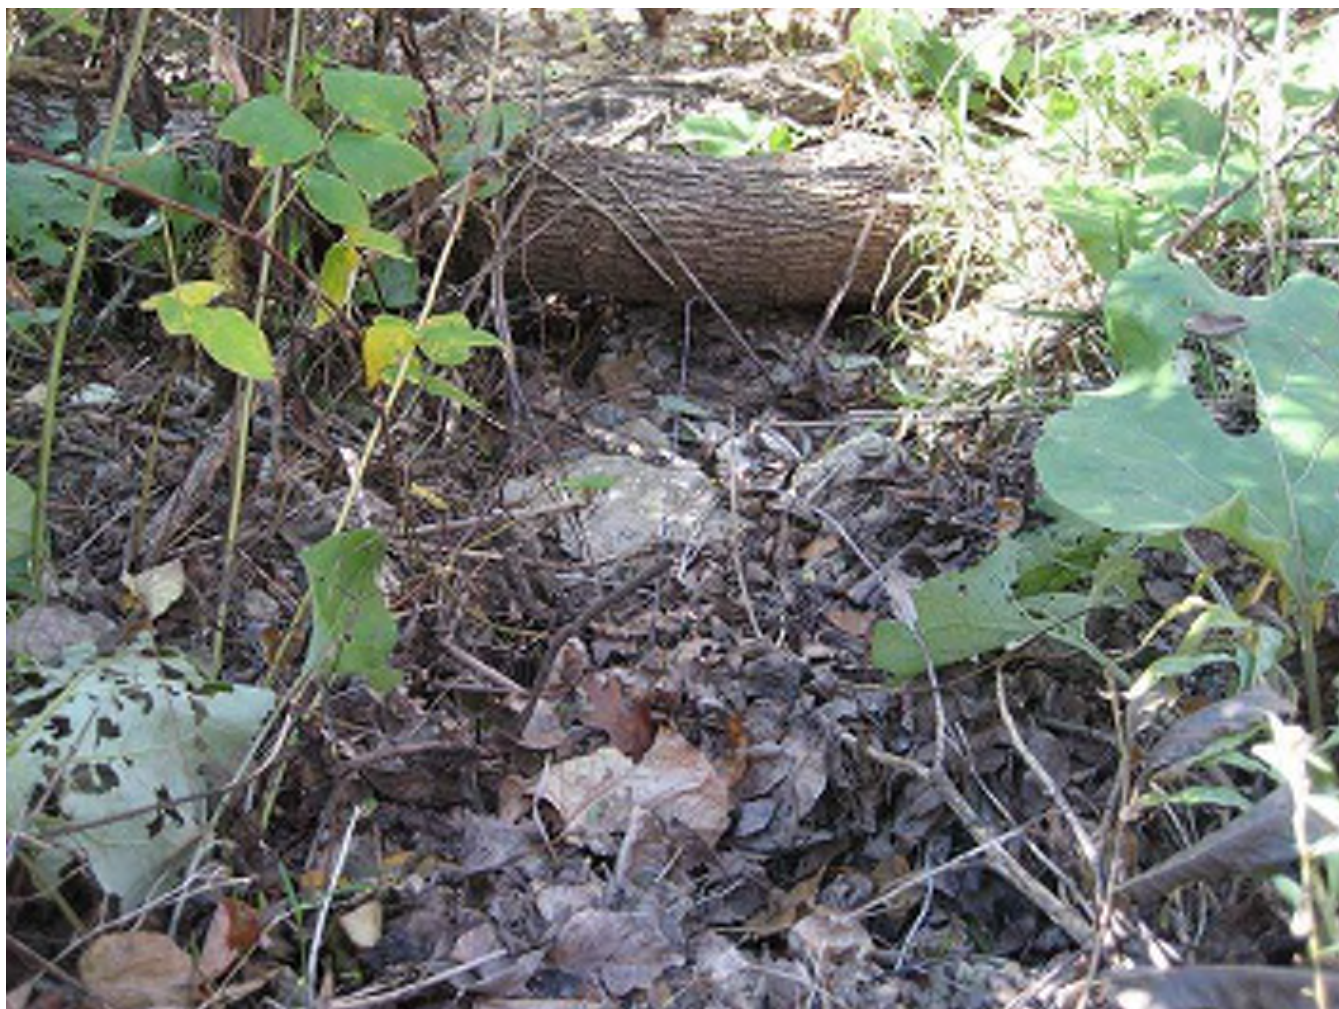
Erosion of trail due to no culvert going under trail; major erosion.
