Appendix K: Lower Minnesota River Watershed District: Gully Inventory

Gully Inventory Map
 Area #1
 Lower Minnesota River Watershed District
 Watershed Management Plan

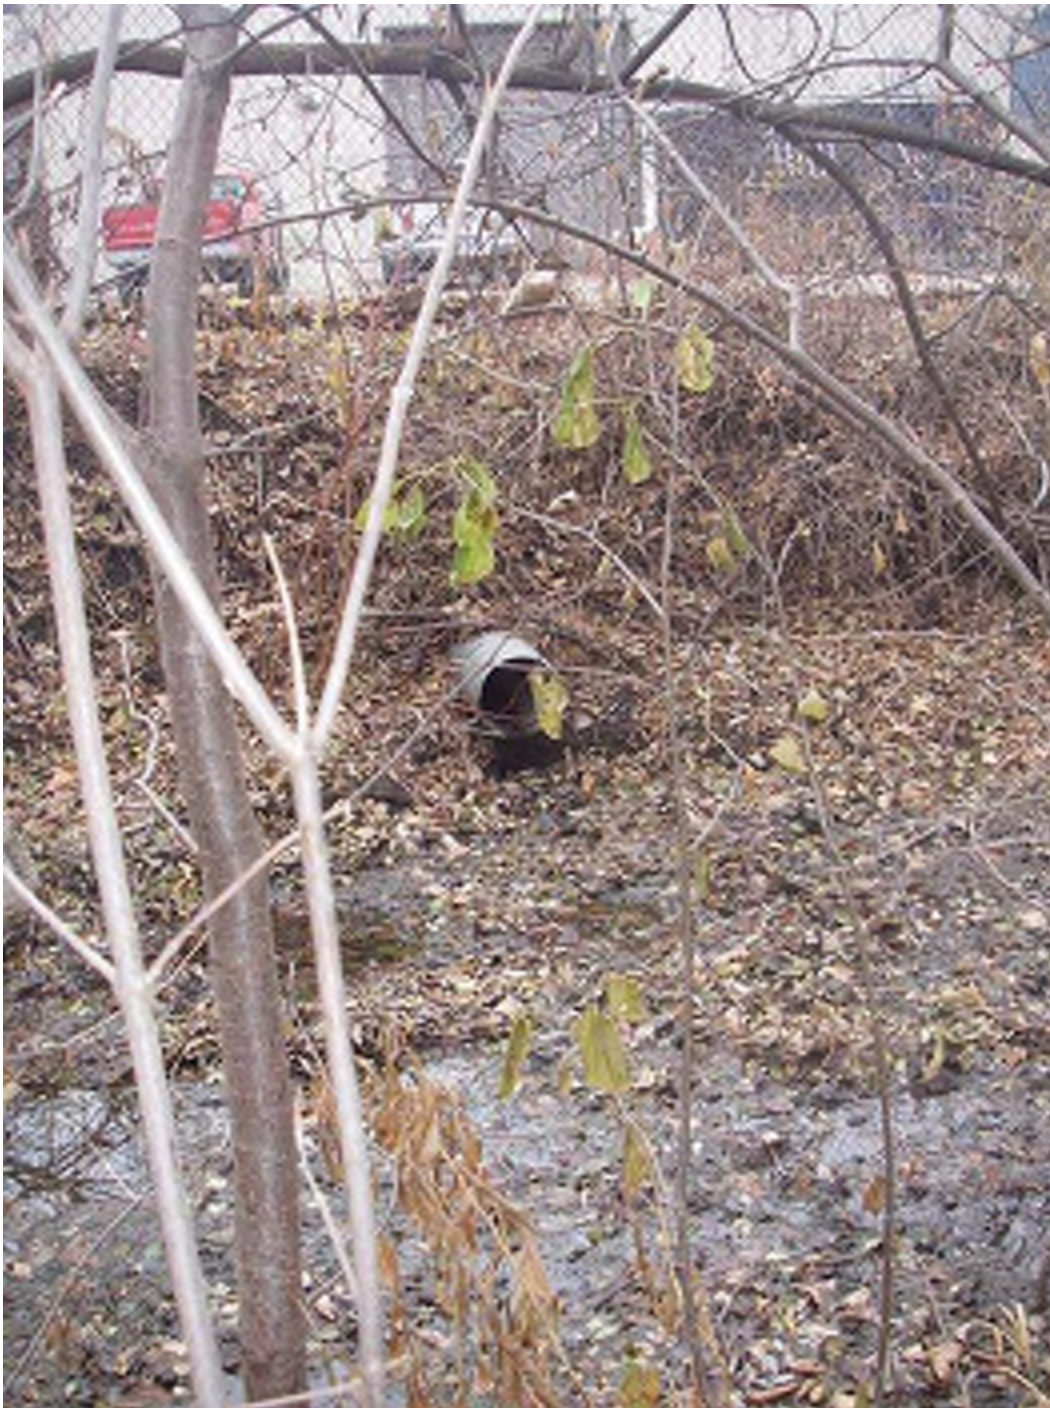
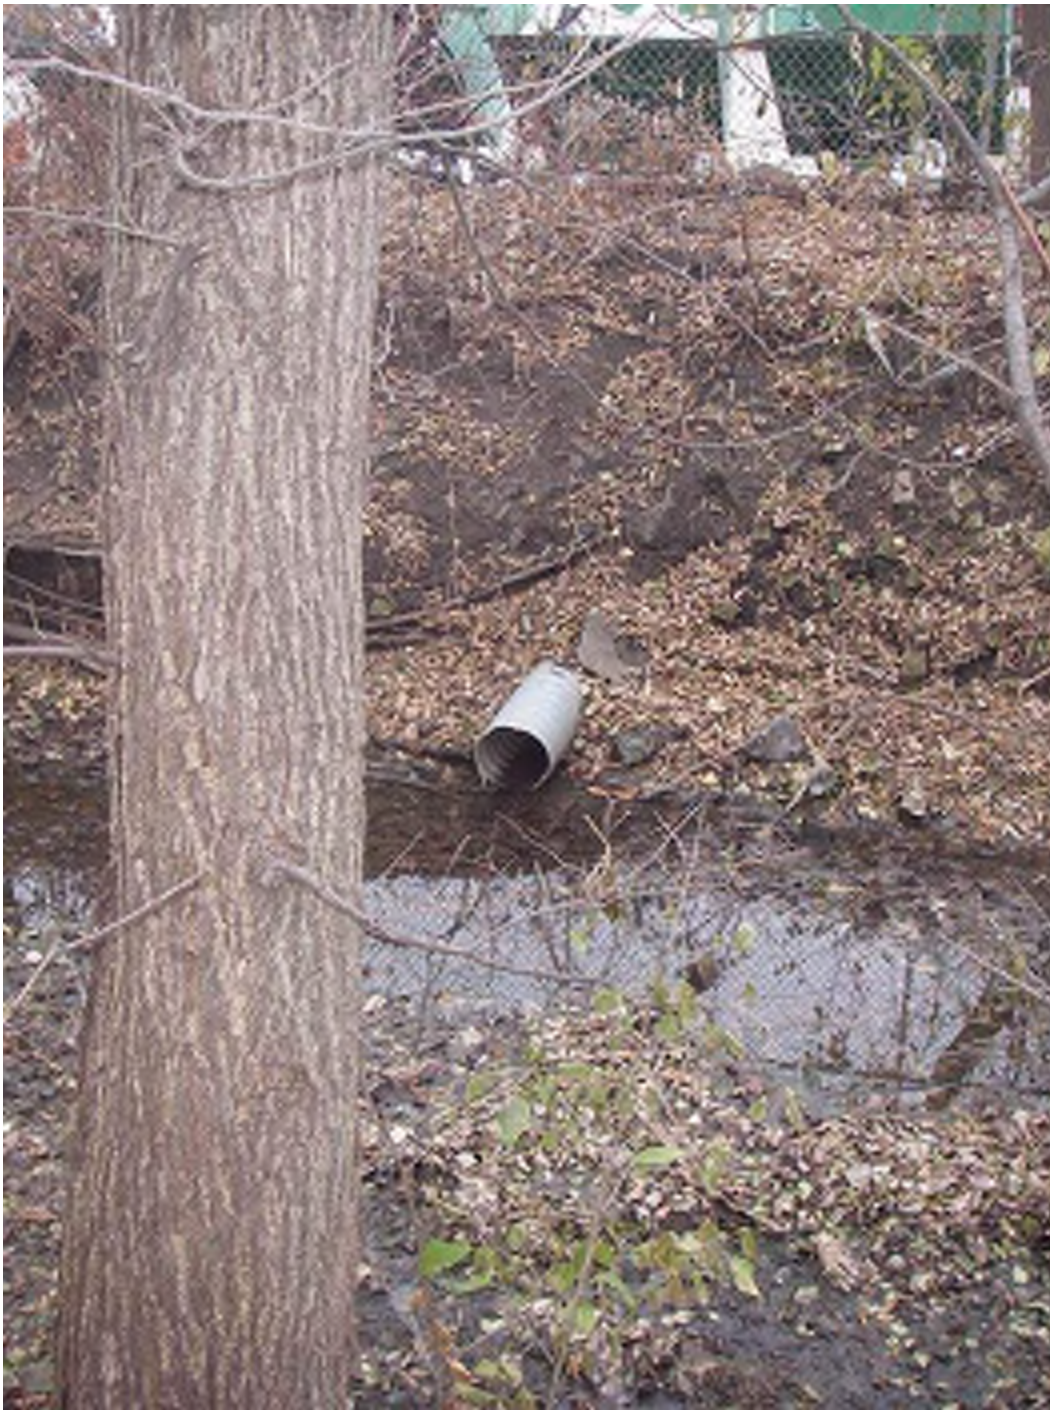
Waypoint 128

Drain pipe

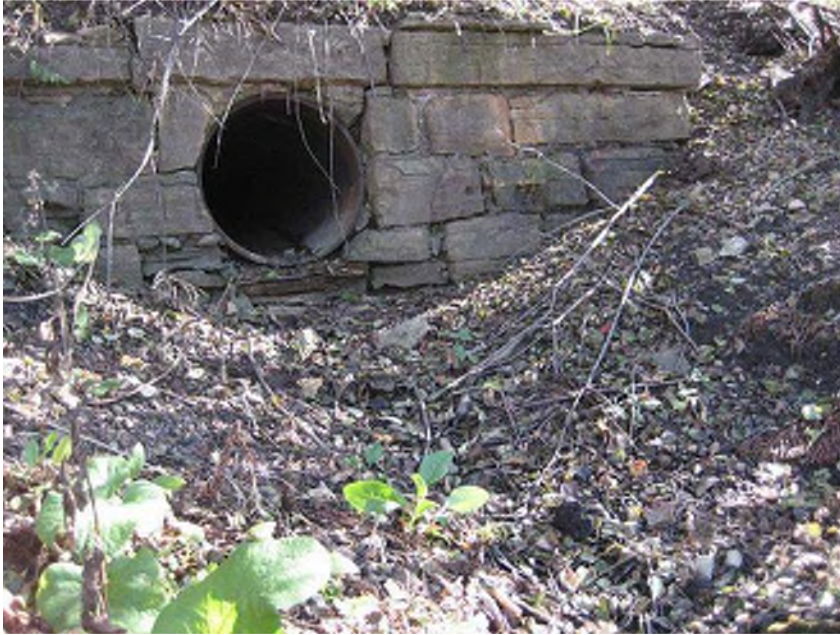
Waypoint 128A

Culvert going under railroad; moderate erosion.

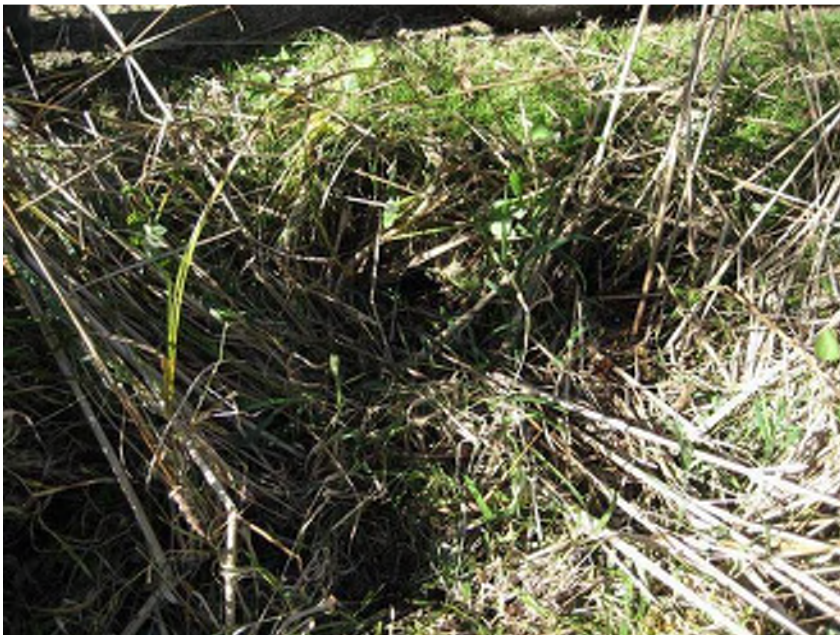
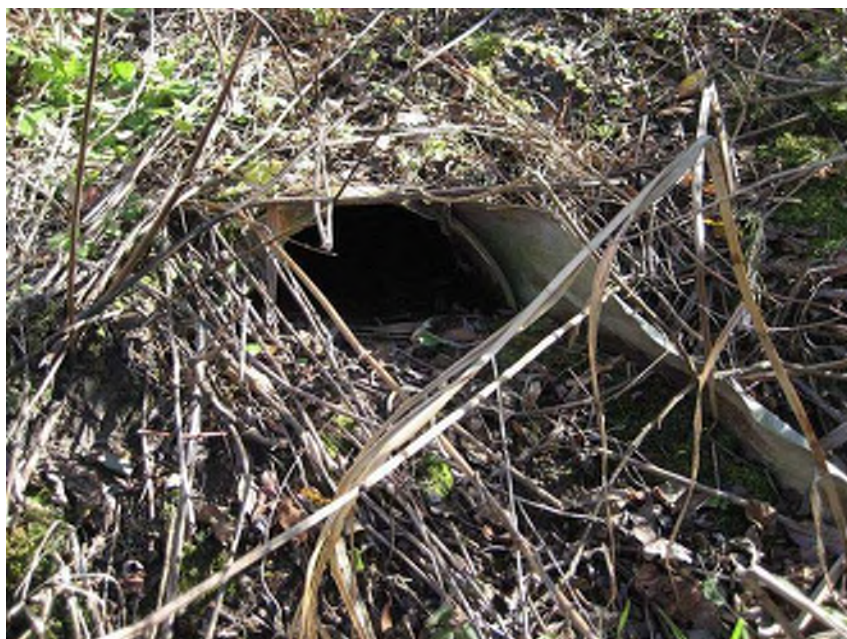
Culvert going under trail below picture #1; culvert is buried and very hard to see; lots of grass and reeds covering both inlet and outlet o

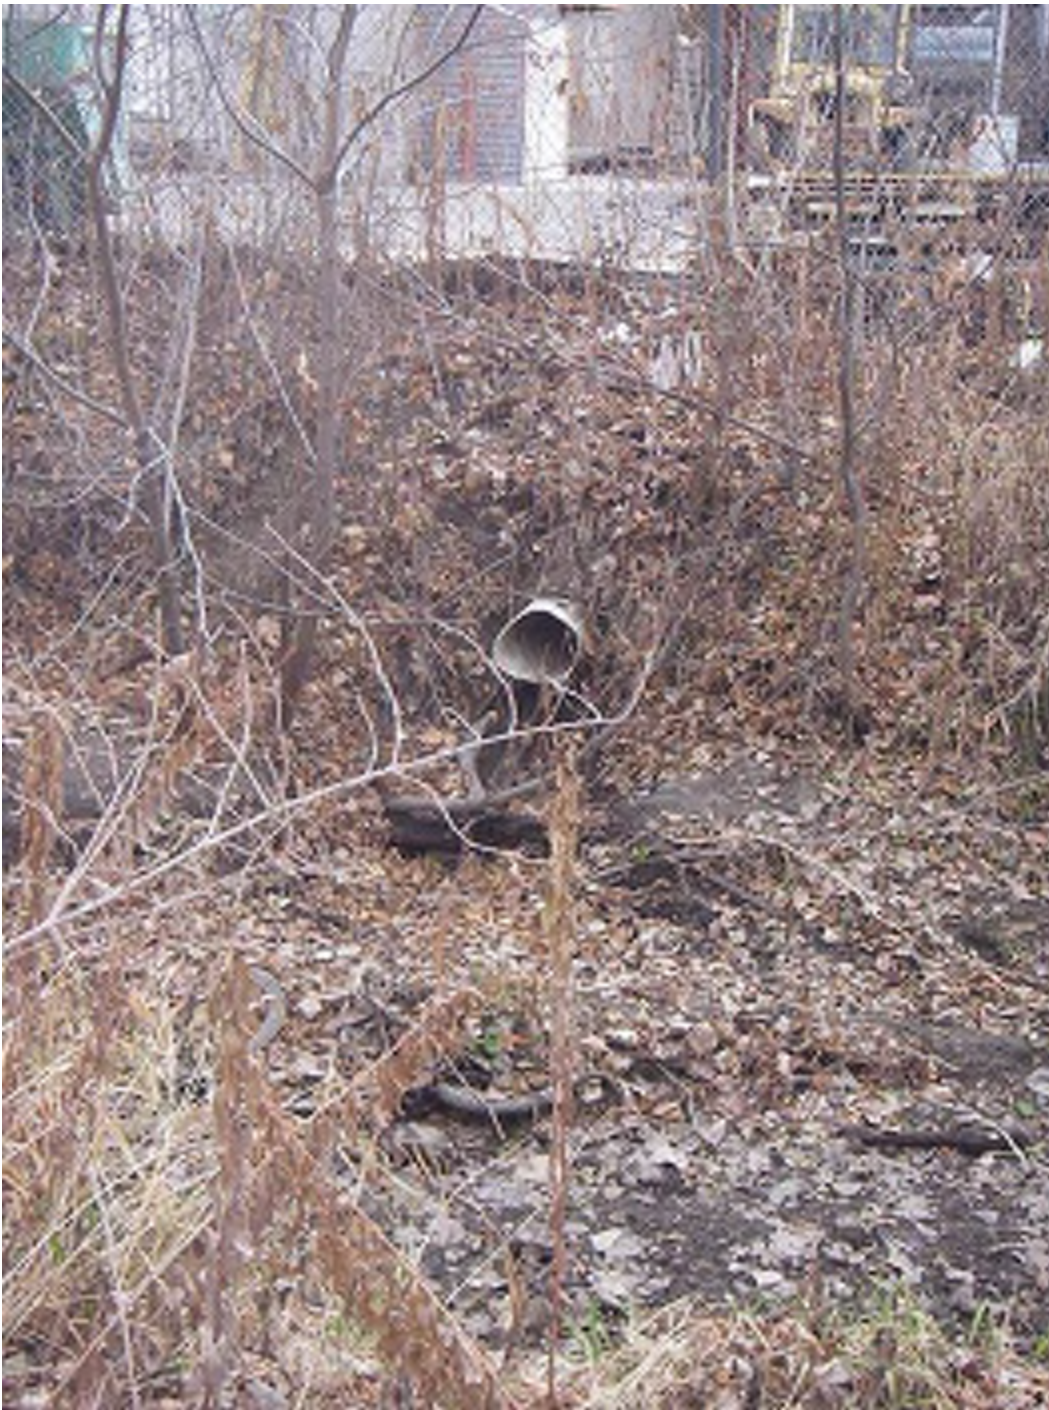
Waypoint 129

Drain pipe

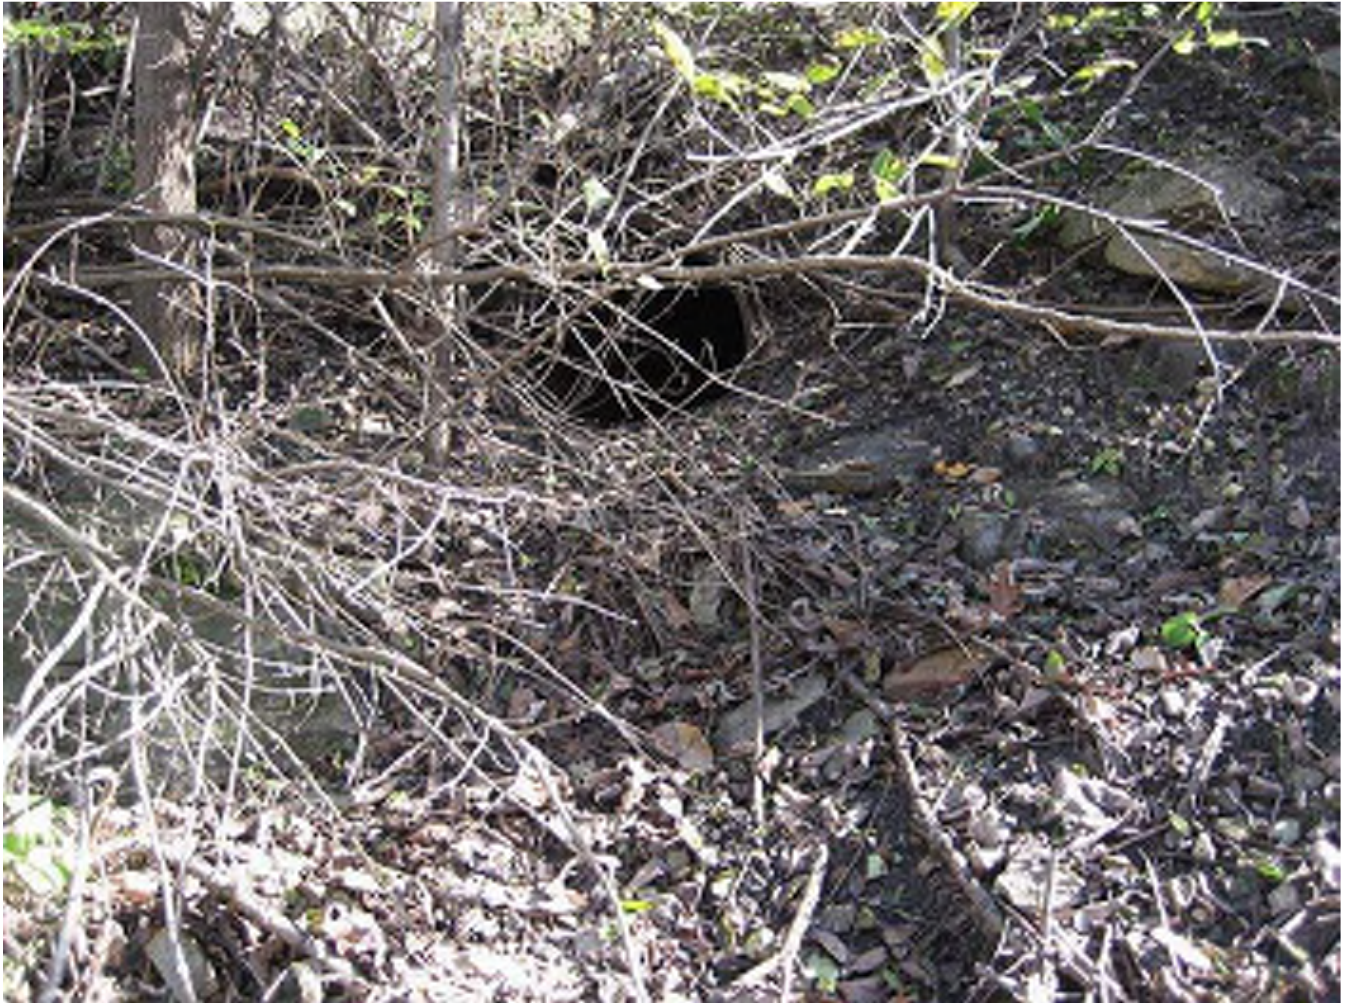
Waypoint 129A

Culvert coming out from railroad.

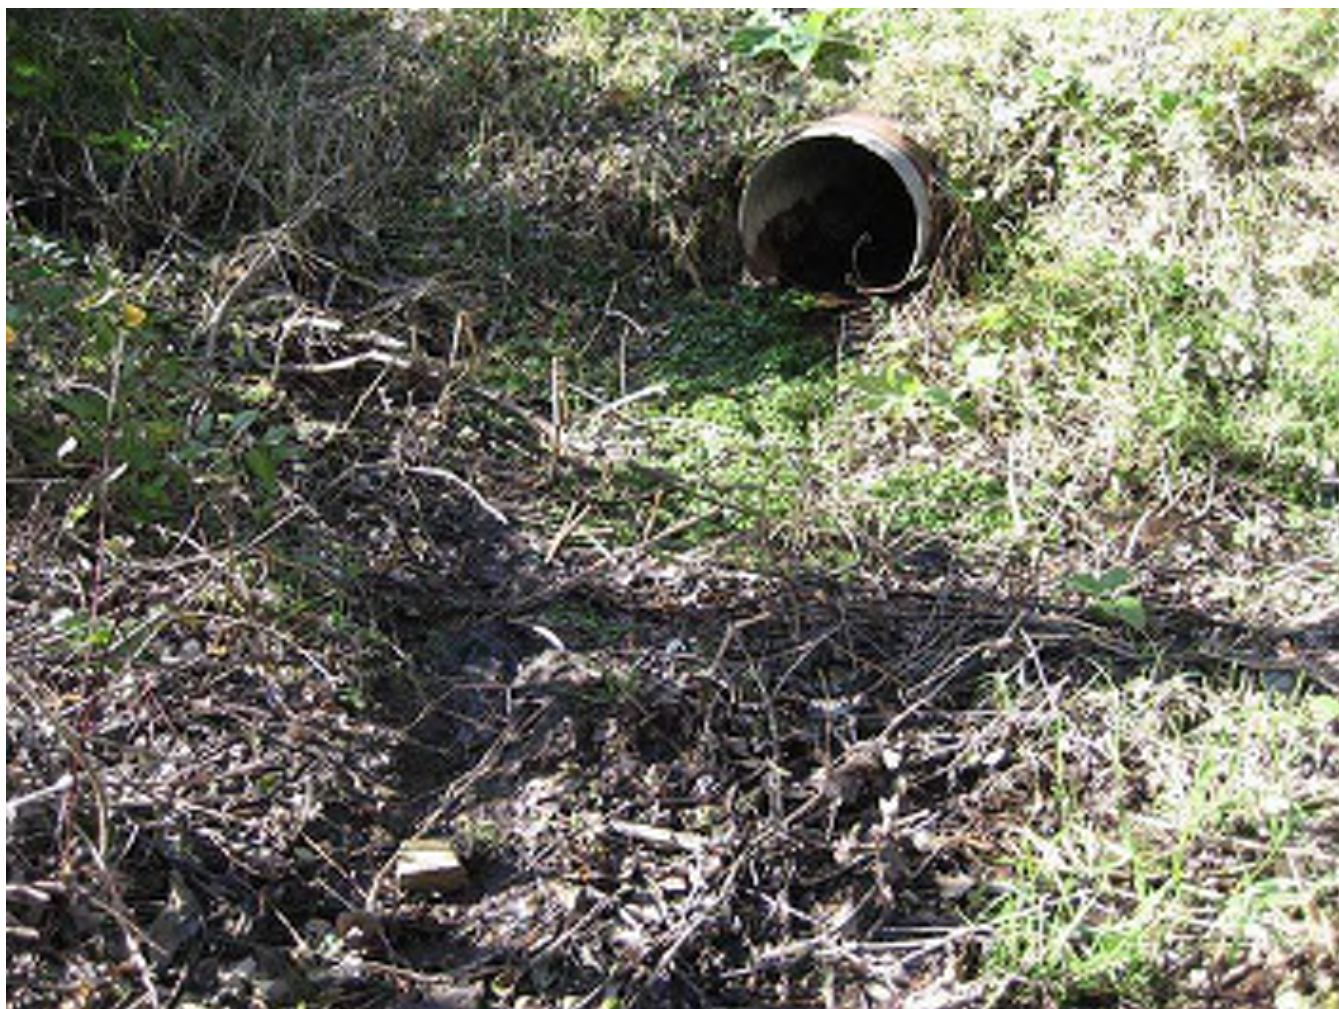
Culvert going under trail below picture #1; moderate erosion on both sides on culvert.

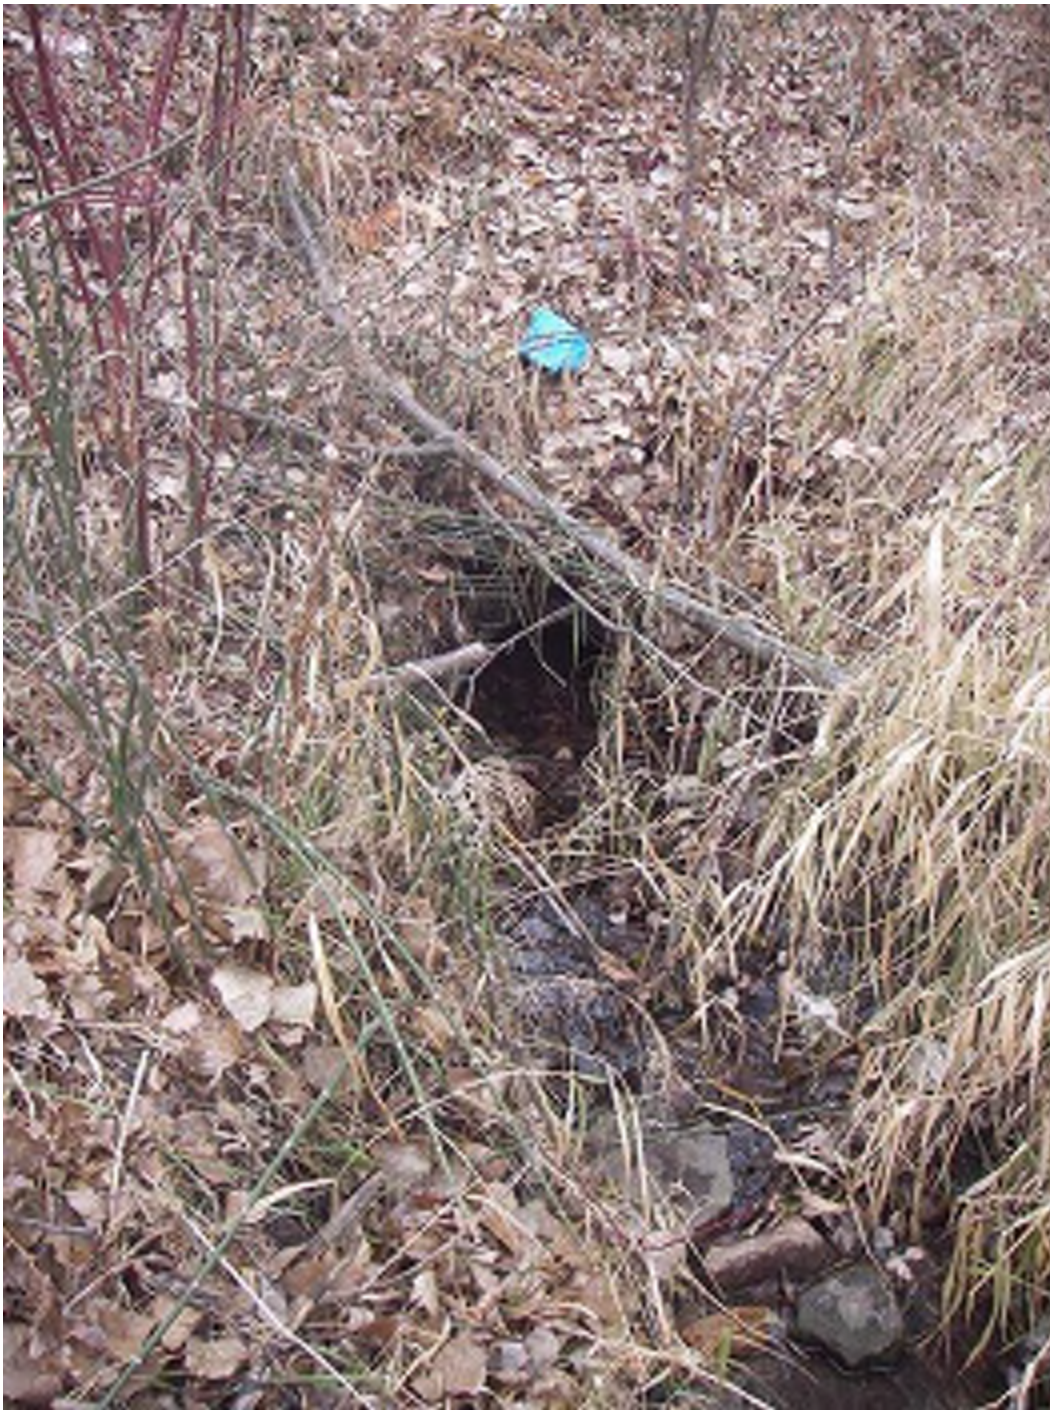
Waypoint 130

Drain pipe

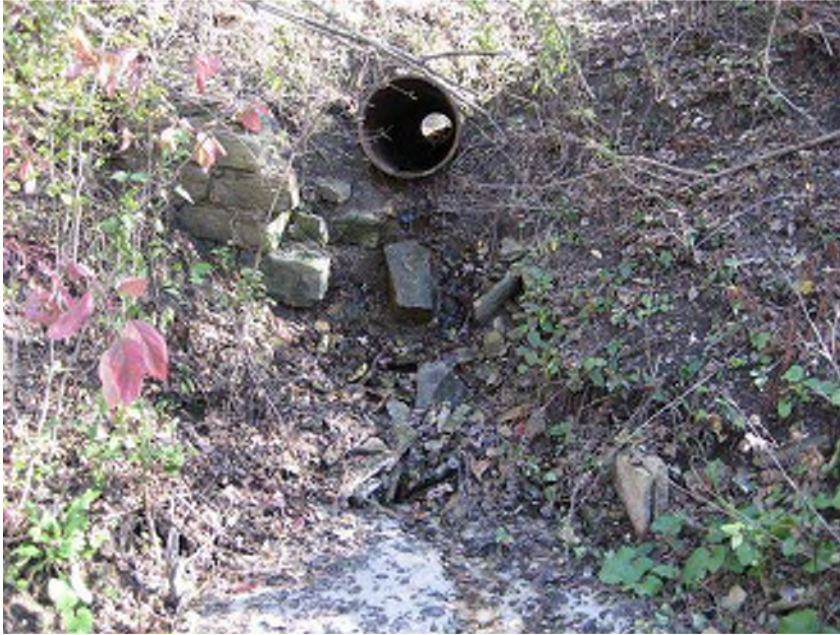
Waypoint 130A

Culvert going under trail below picture #1; culvert is buried and very hard to see; lots of grass and reeds covering both inlet and outlet o

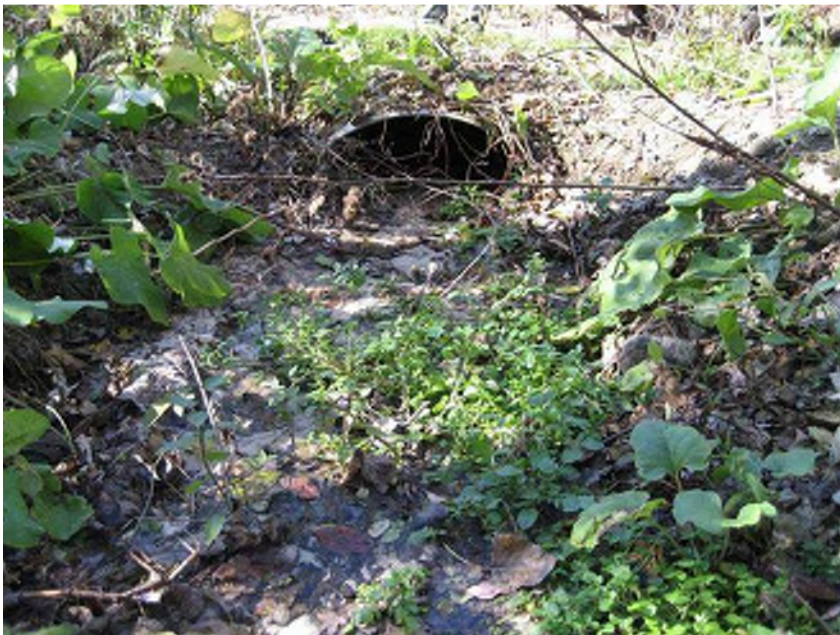
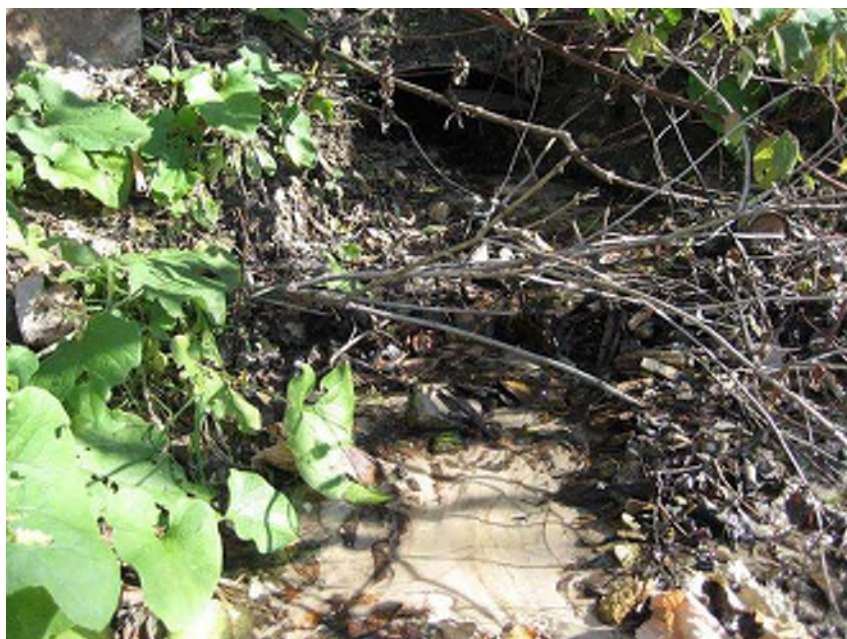
Culvert going under trail; lots of washed out sand and moderate erosion.

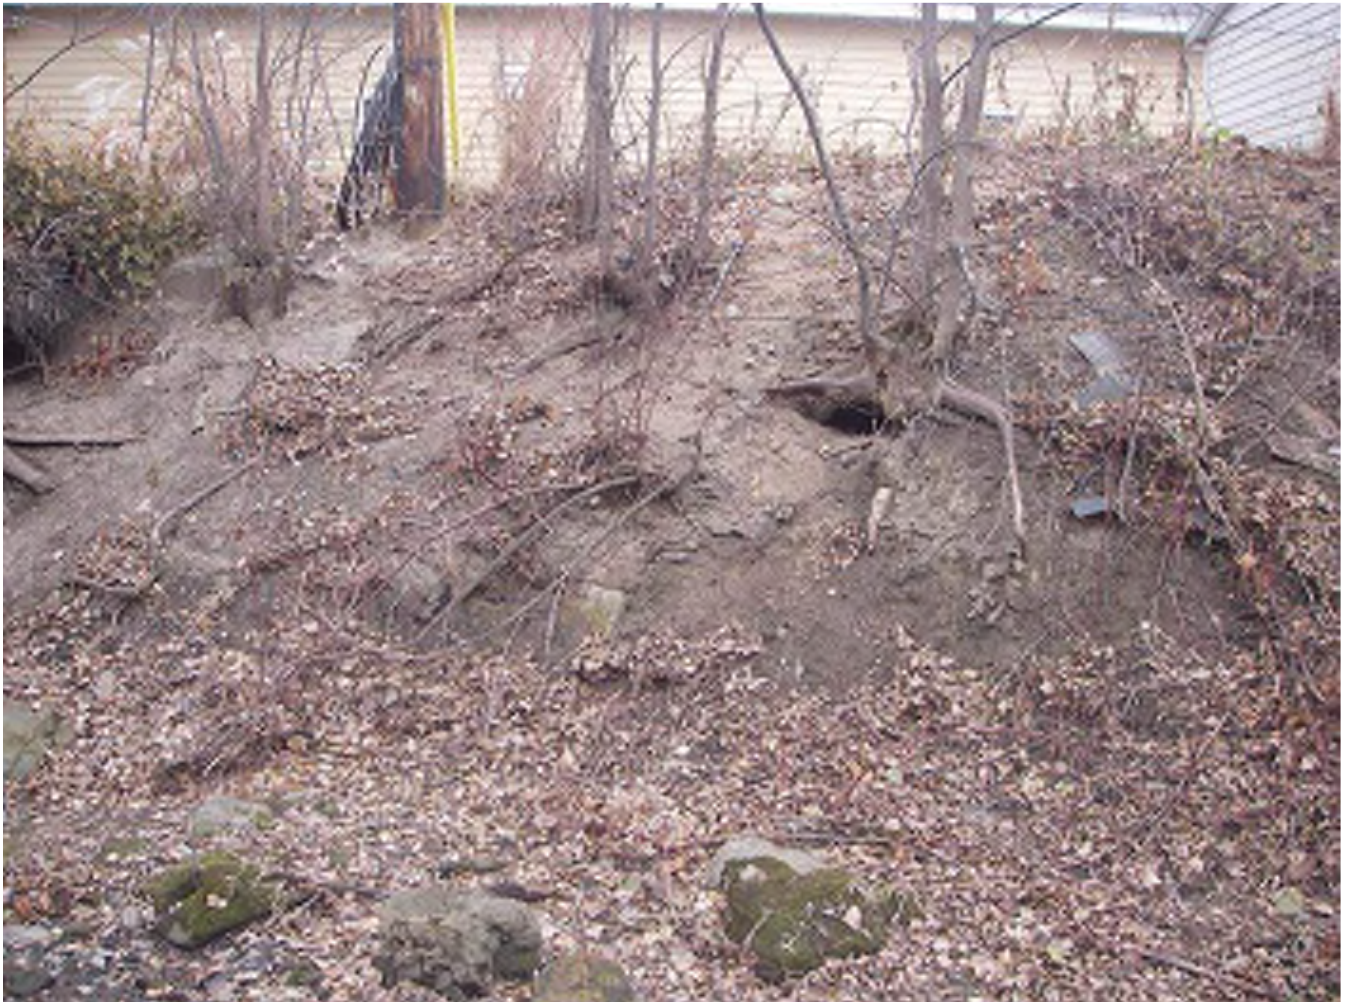
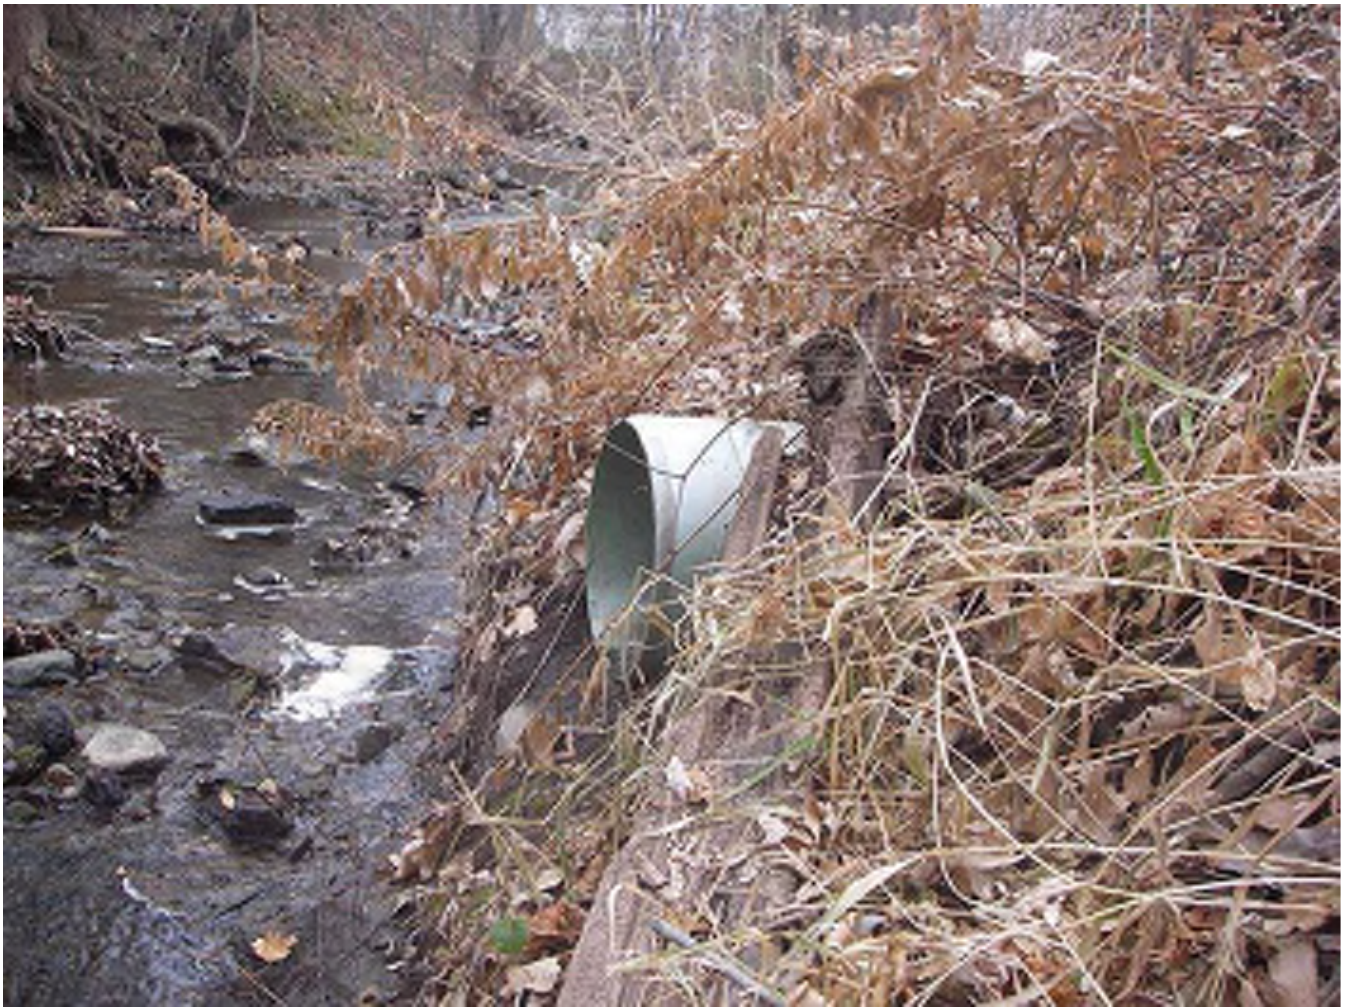
Waypoint 131

Drain pipe and erosion

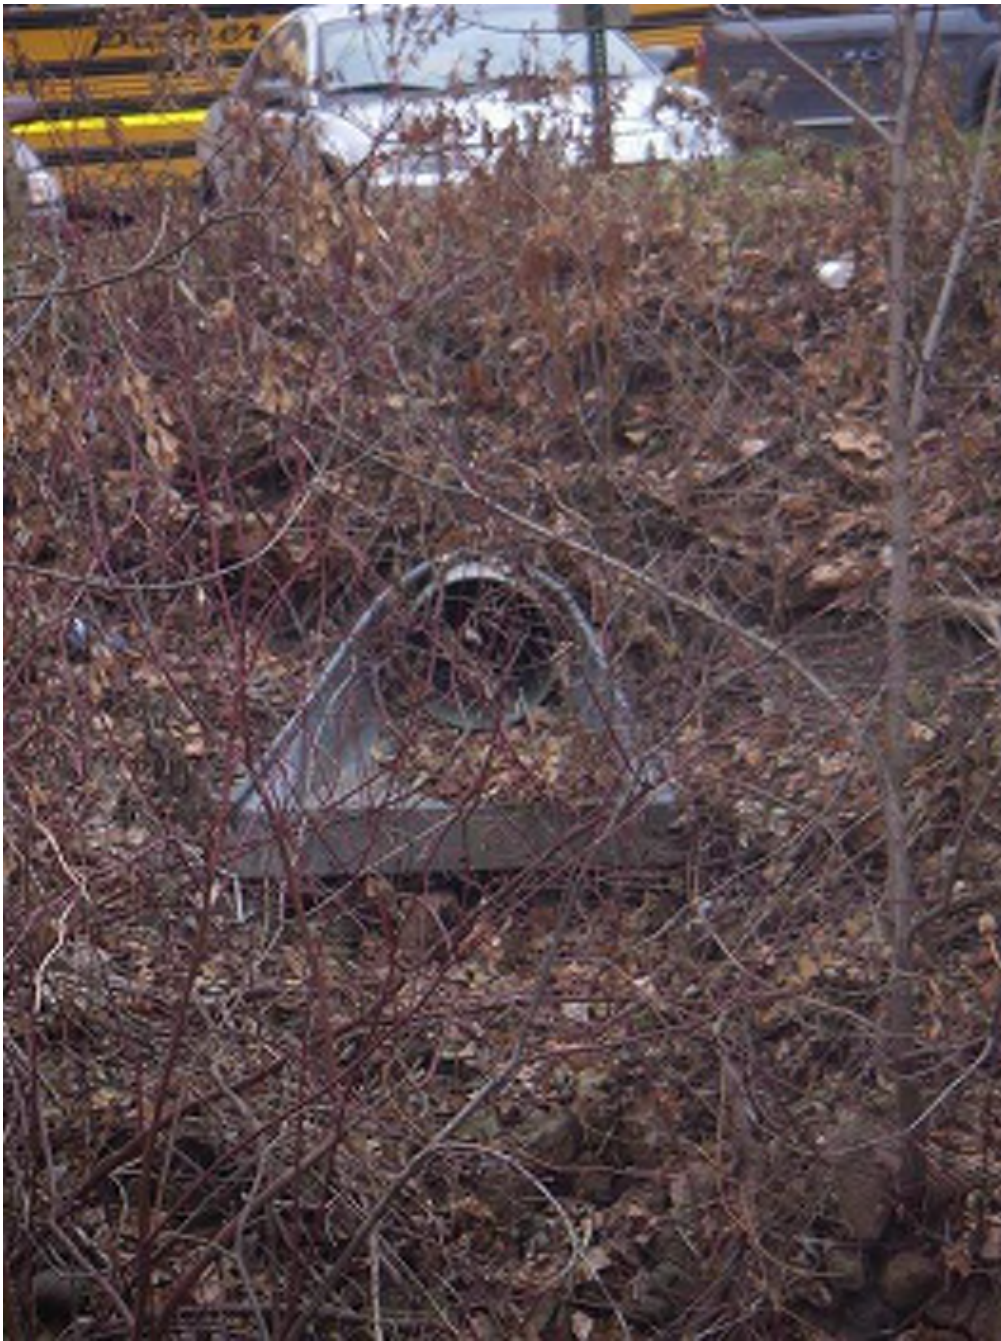
Drain pipe 40 years downstream

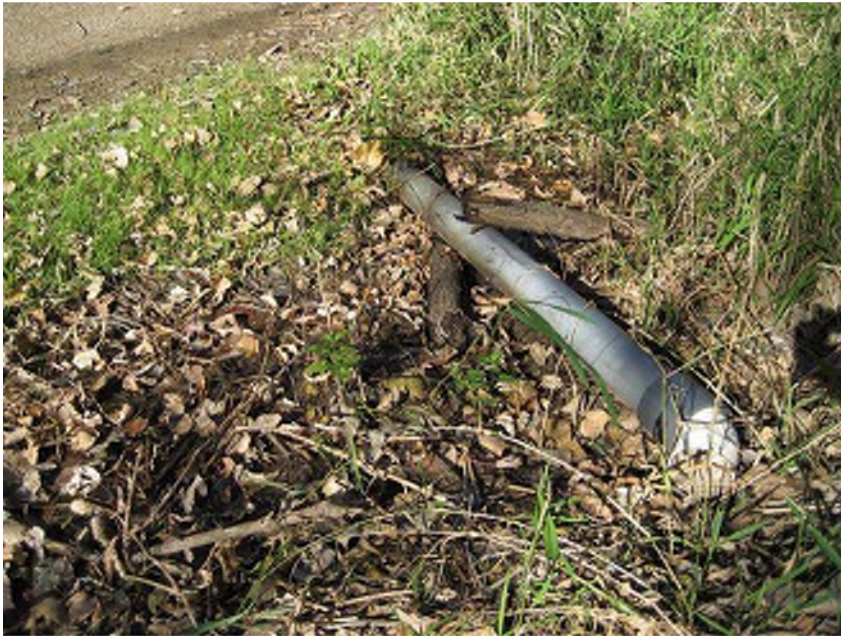
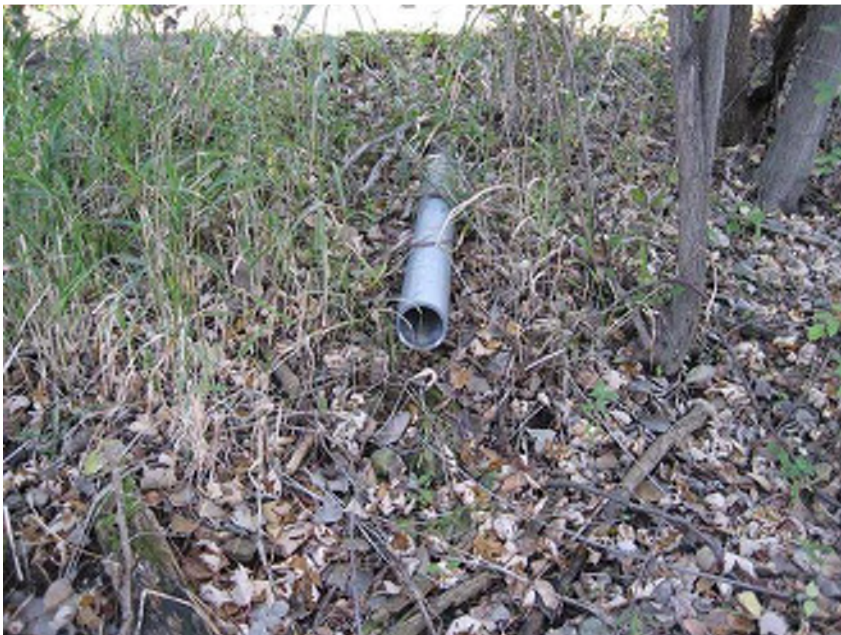
Waypoint 131A

PVC pipe going under trail; not effective due to pipe being too high; water is not able to go through pipe.

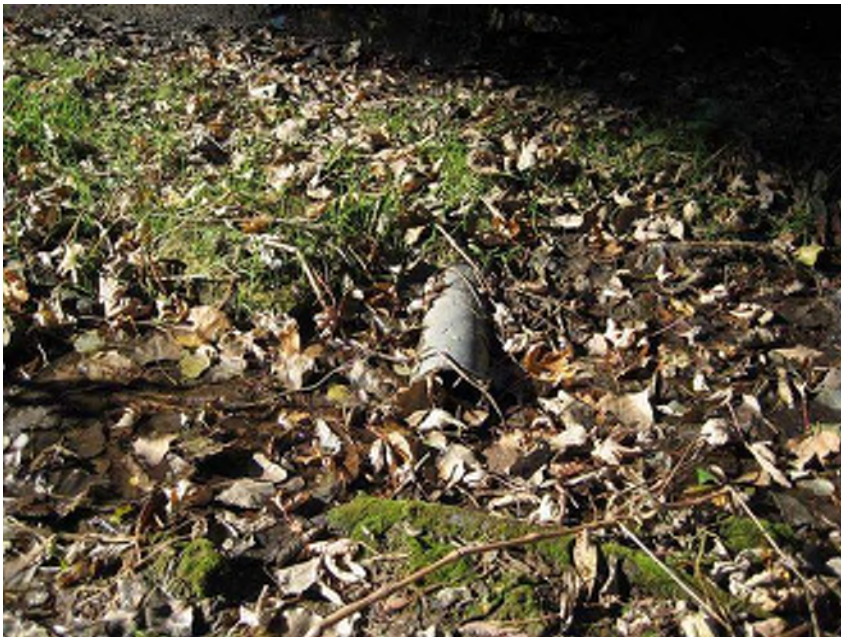
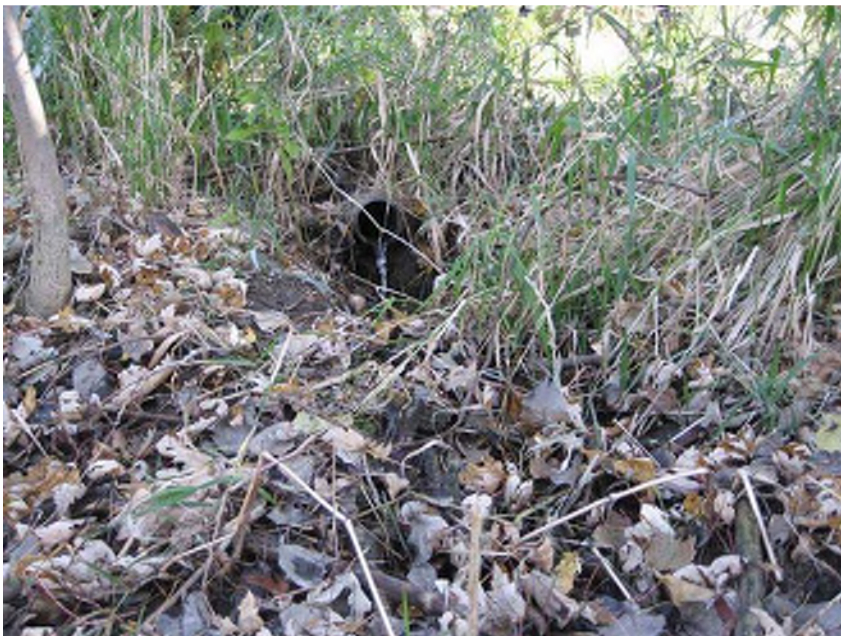
PVC pipe going under trail; pooling water at top part of pipe; possibly clogged; minor erosion; approx. 20-feet between pipe shown in pictu

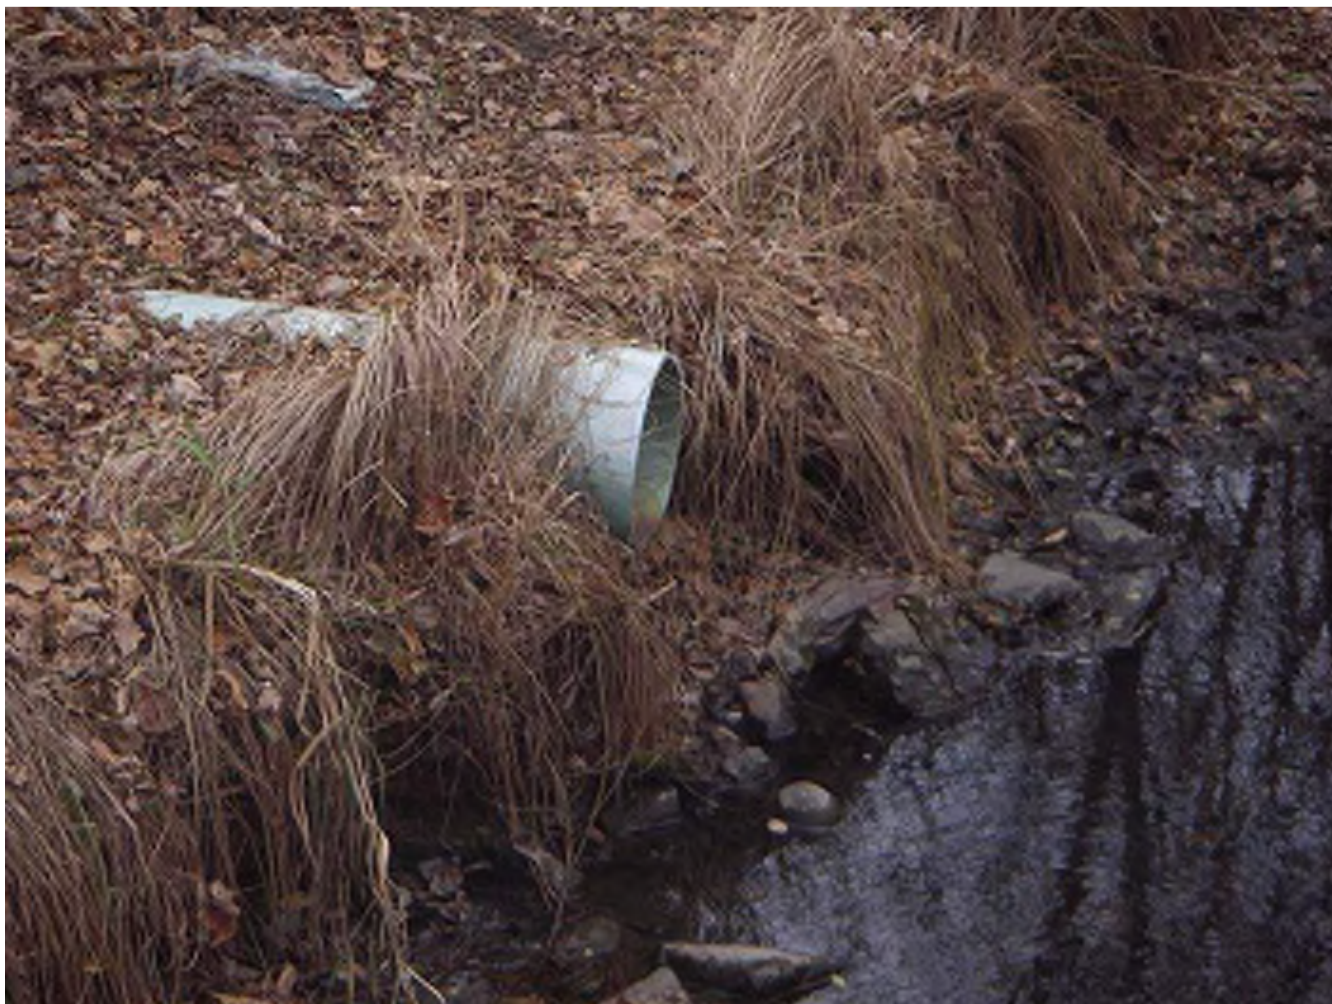
Waypoint 132

Drain pipe

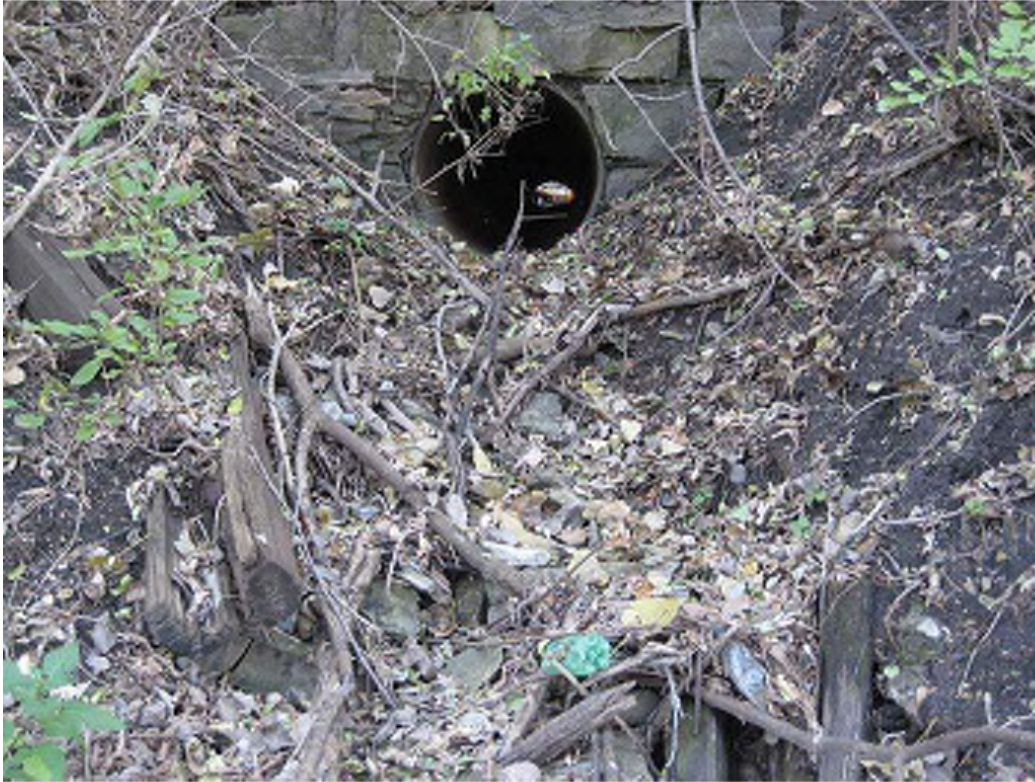
Waypoint 132A

Pipe coming from under railroad tracks; moderate erosion; lots of leaves, rock and branches.

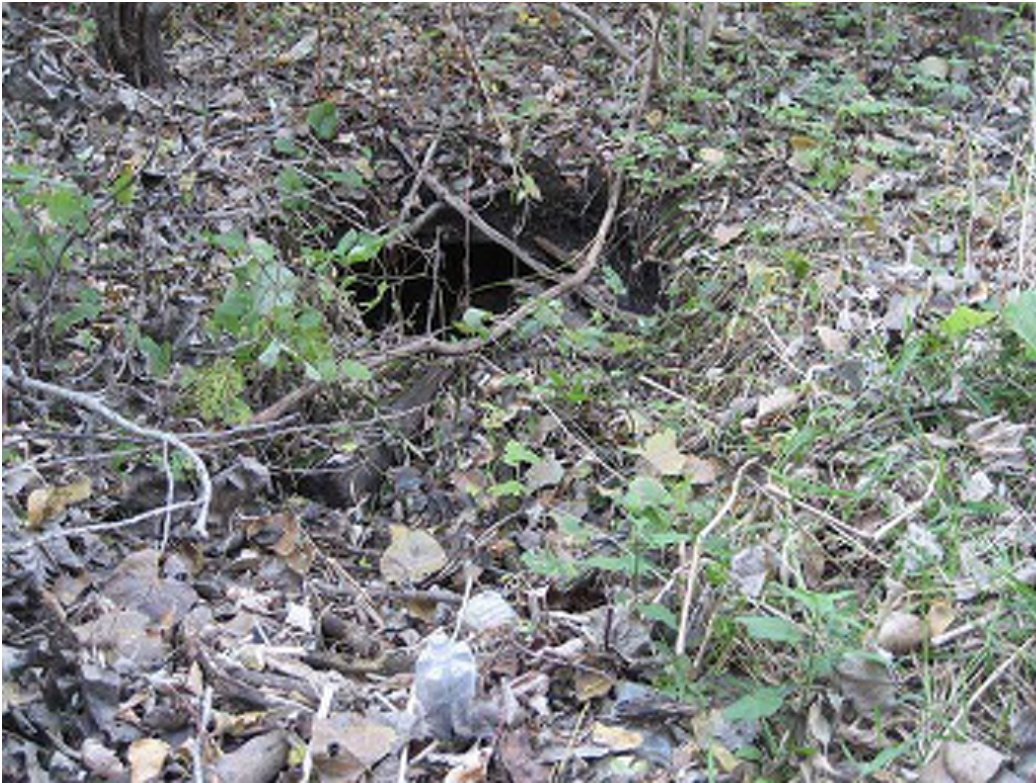
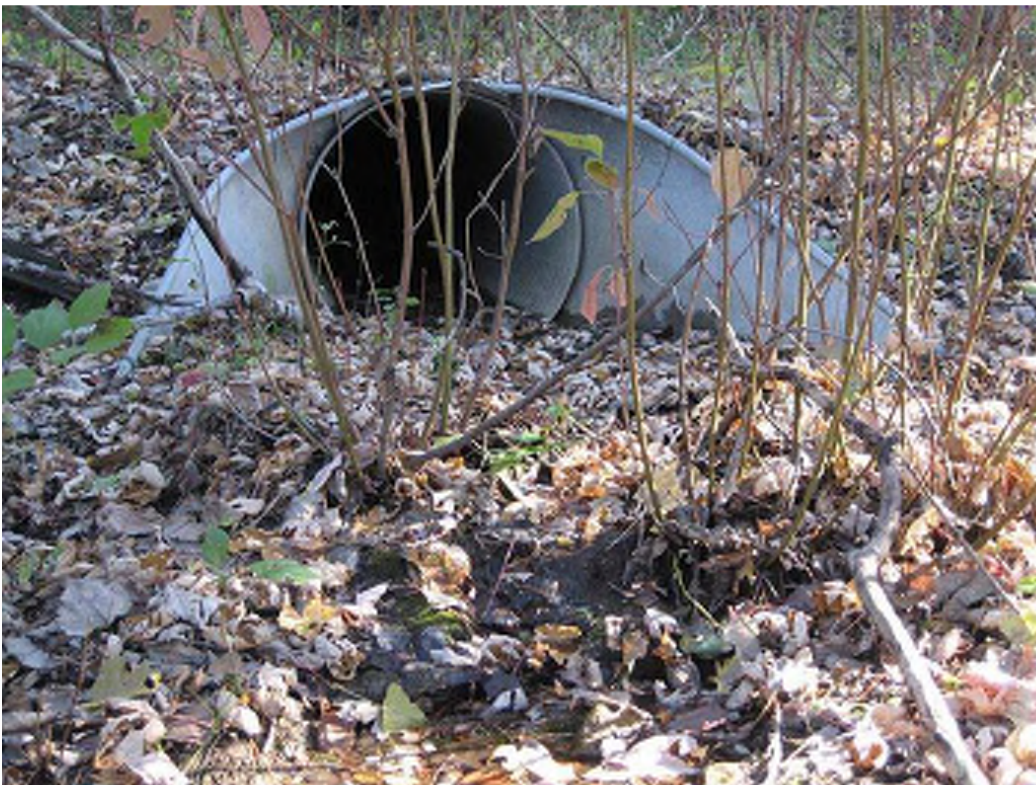
Culvert going under path; minimum erosion; lots of rocks, leaves and branches; area below culvert in picture #1.
