Appendix K: Lower Minnesota River Watershed District: Gully Inventory

Gully Inventory Map
 Area #1
 Lower Minnesota River Watershed District
 Watershed Management Plan

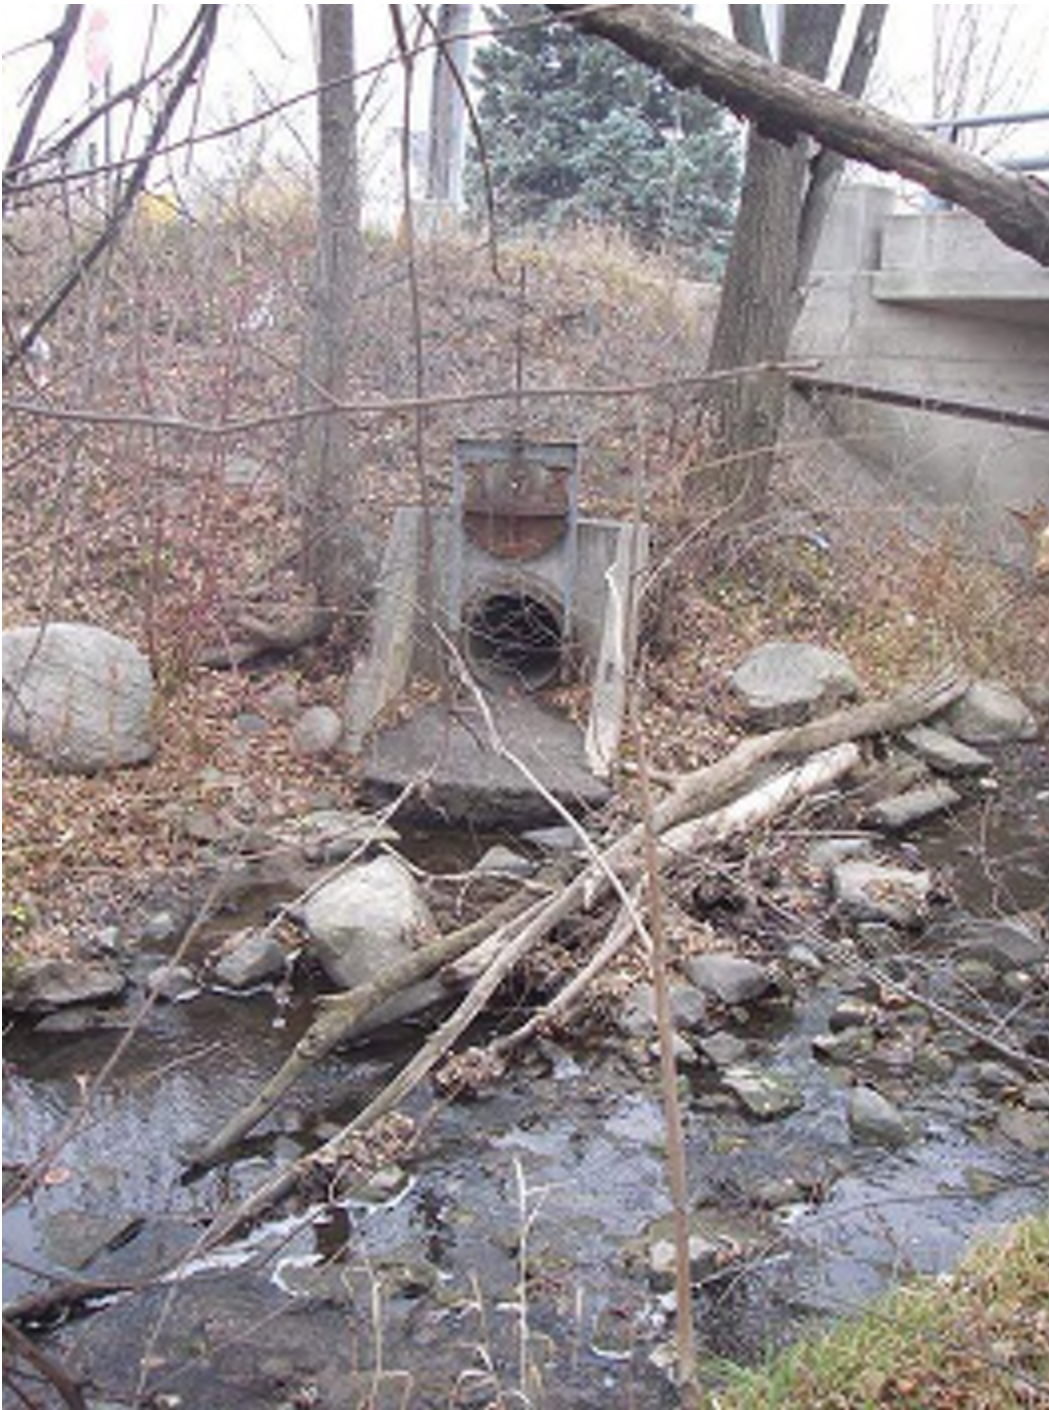
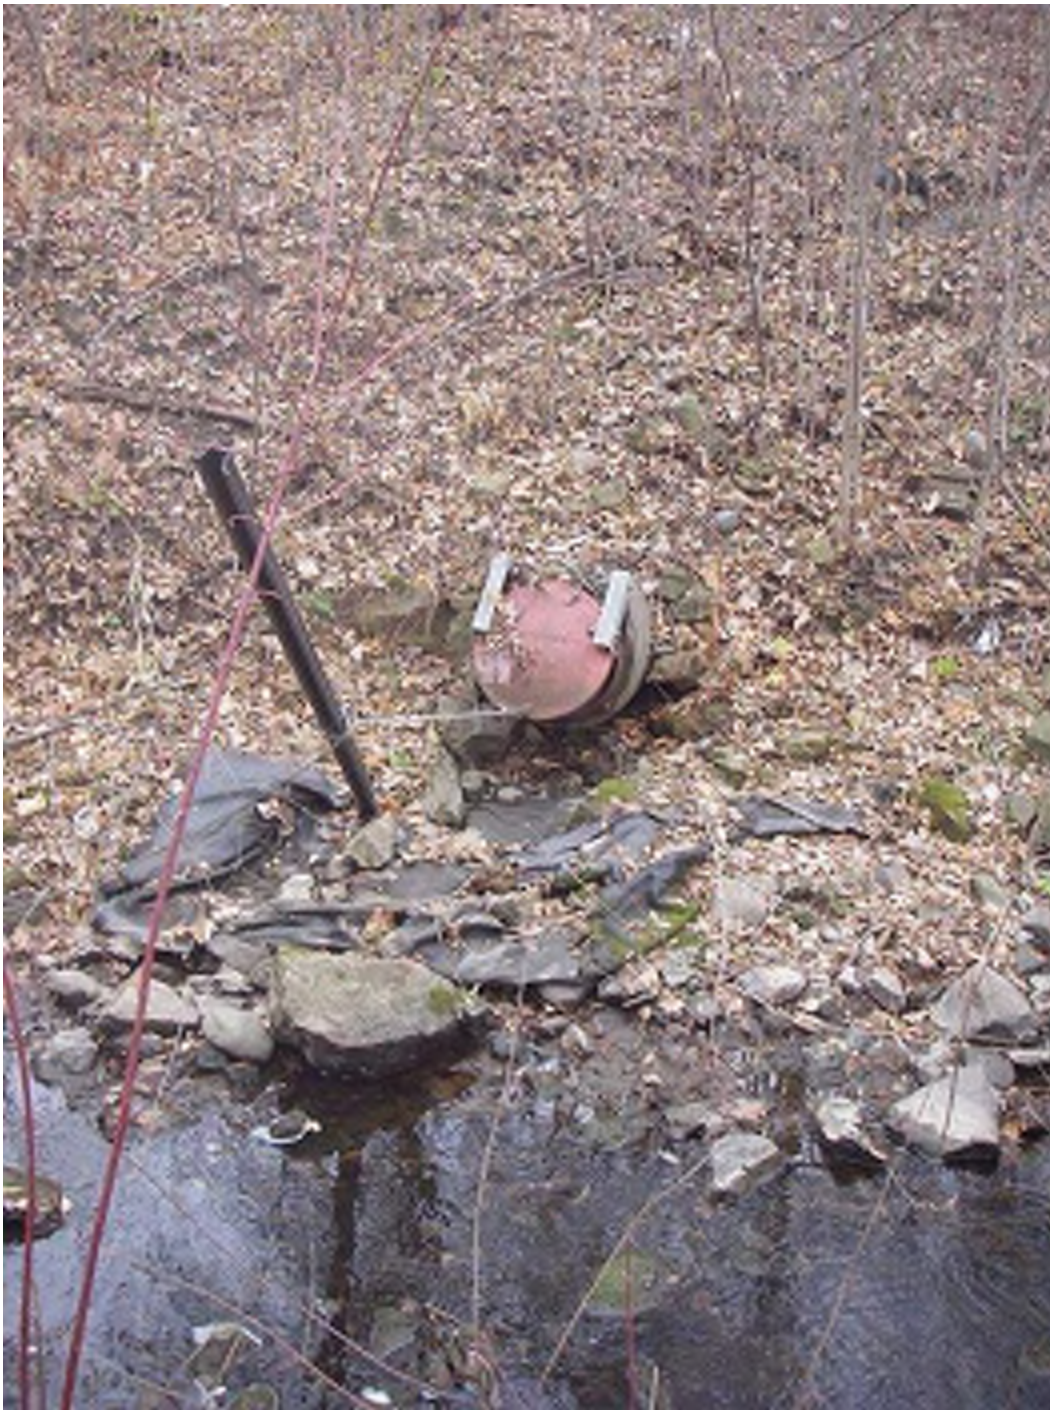
Waypoint 133

Two drain pipes

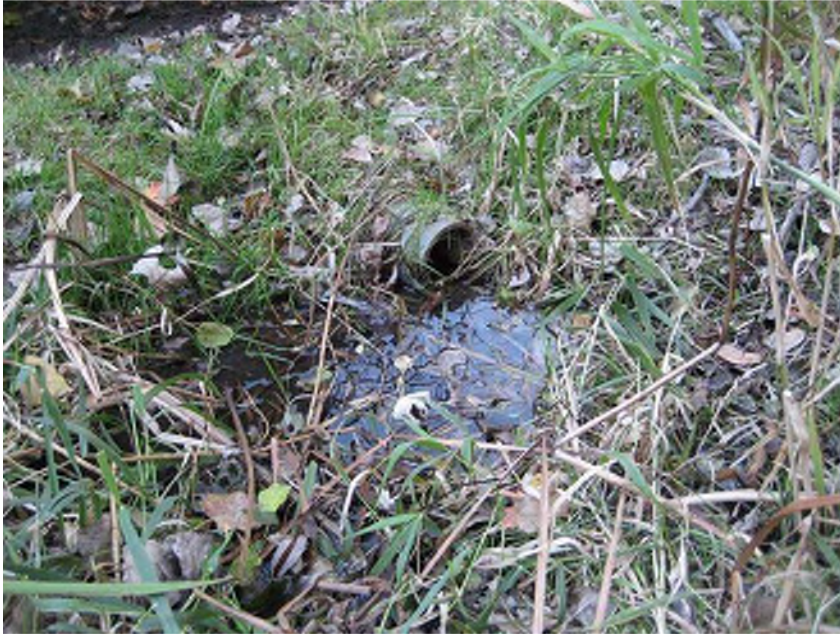
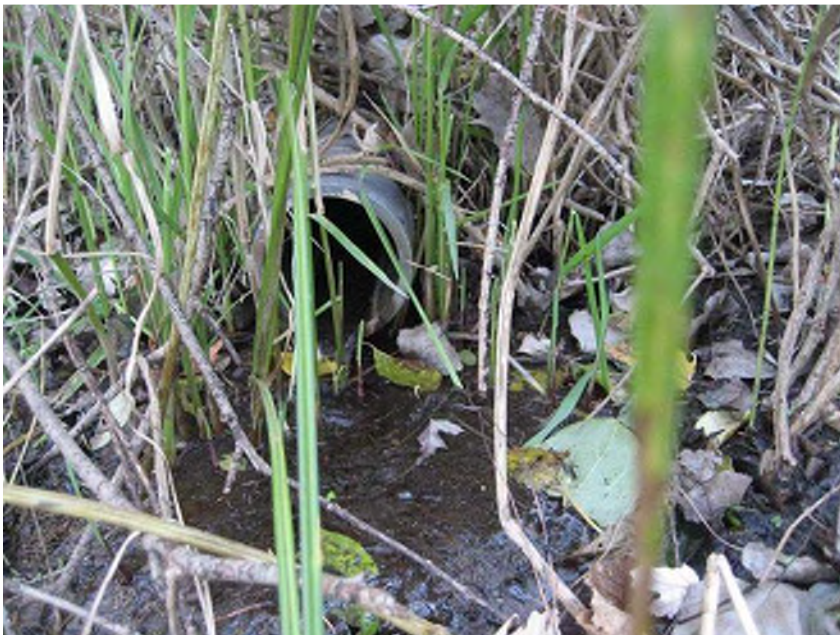
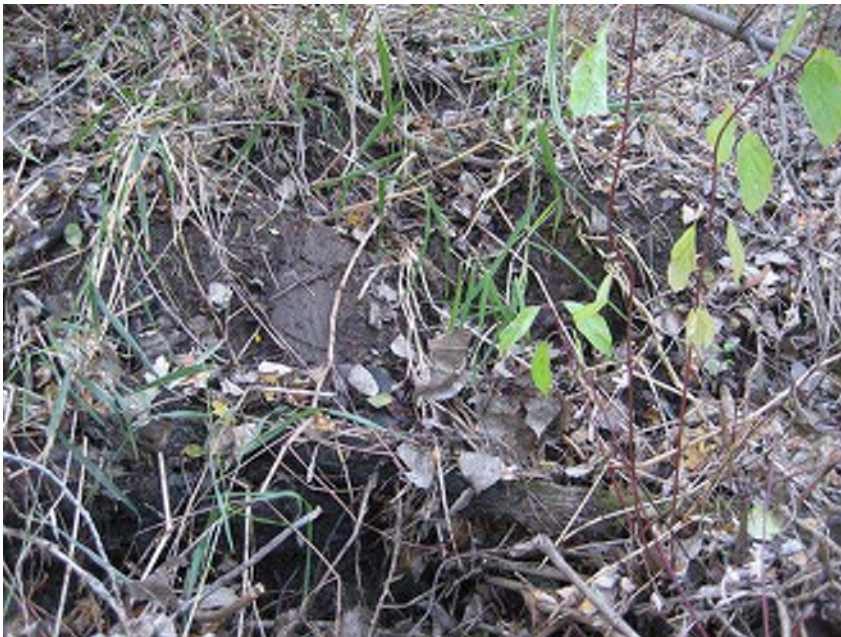
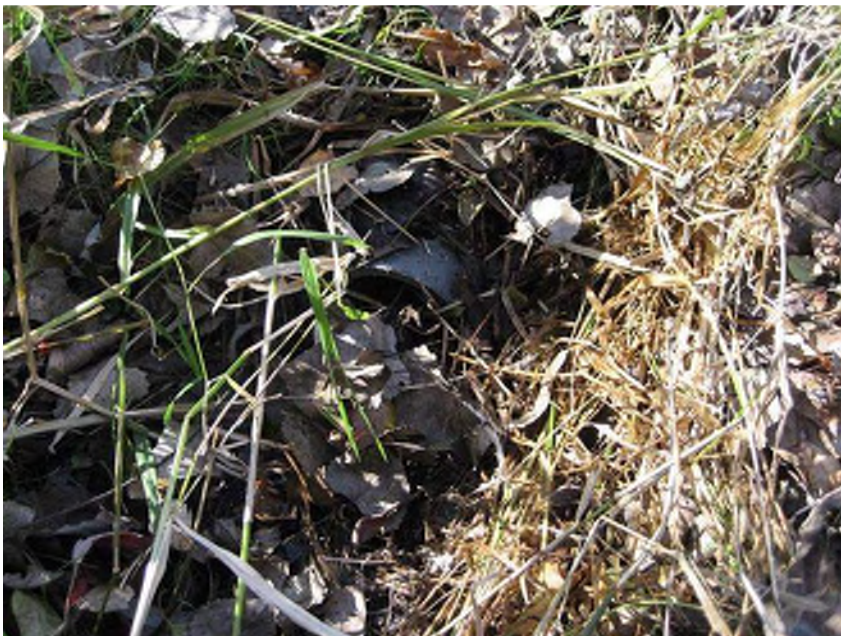
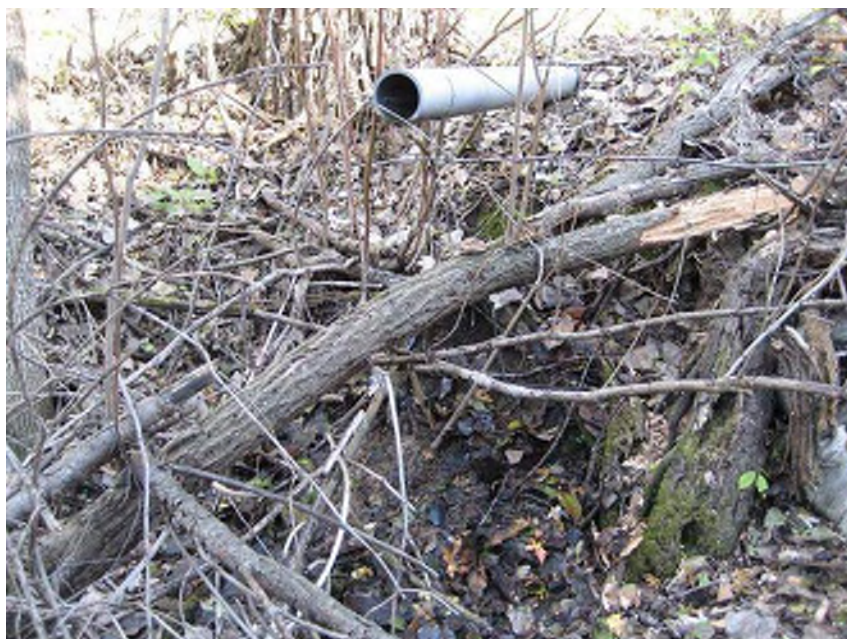
Waypoint 133A

PVC pipe going under trail; very little erosion; pooling water at inlet side; covered by tall grass; 2 sets of pipes approx. 20-feet apart;

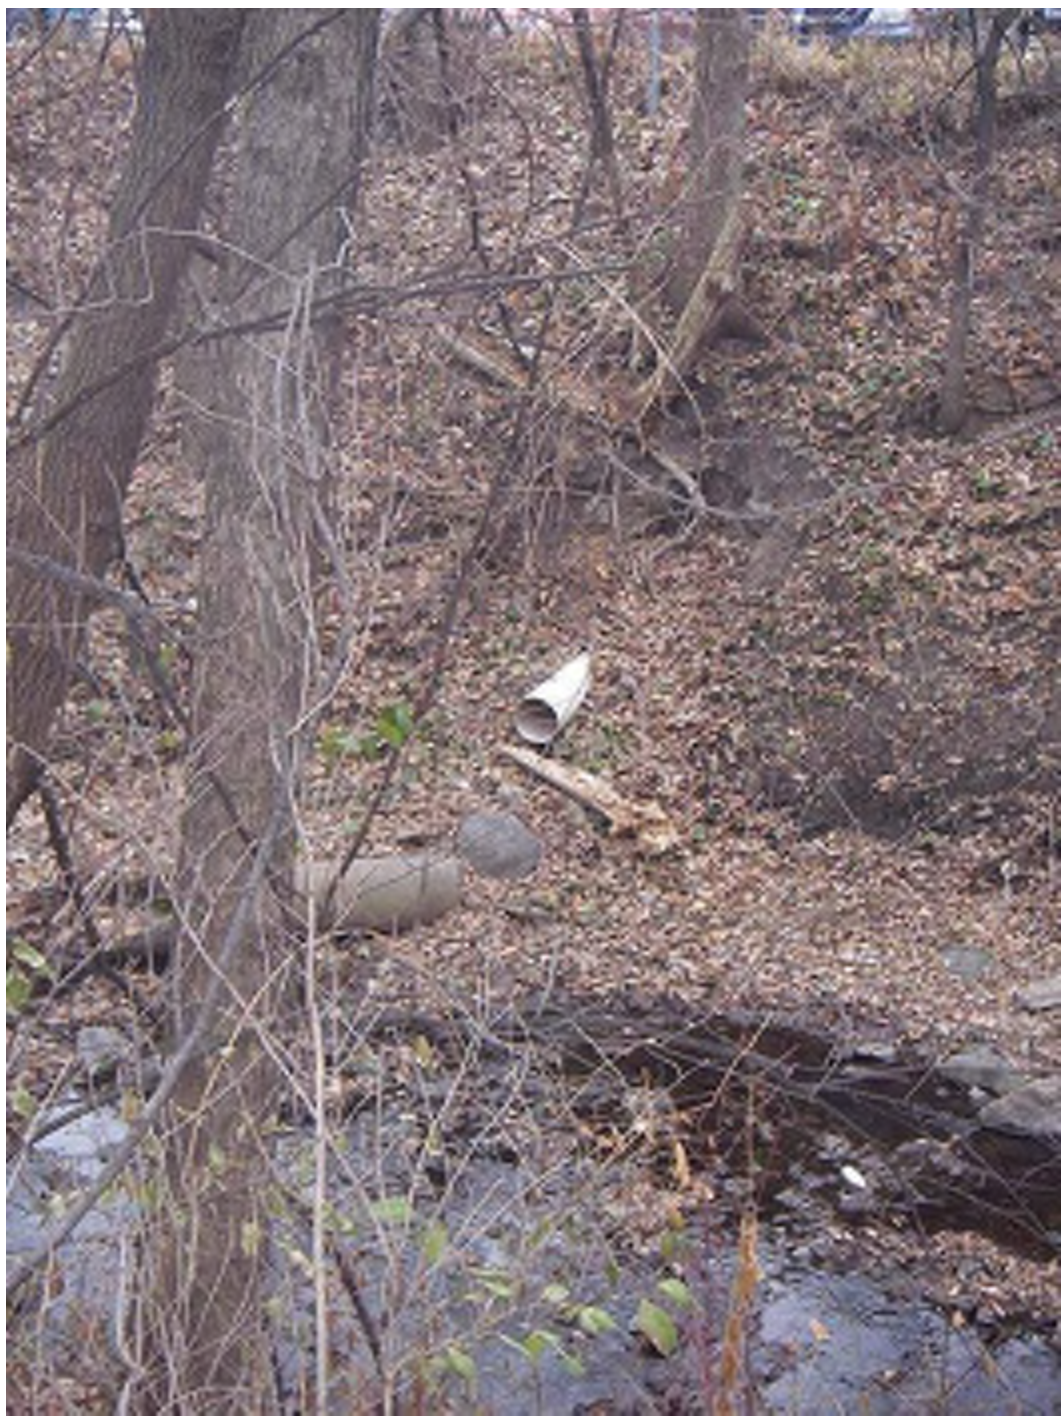
Drain pipe

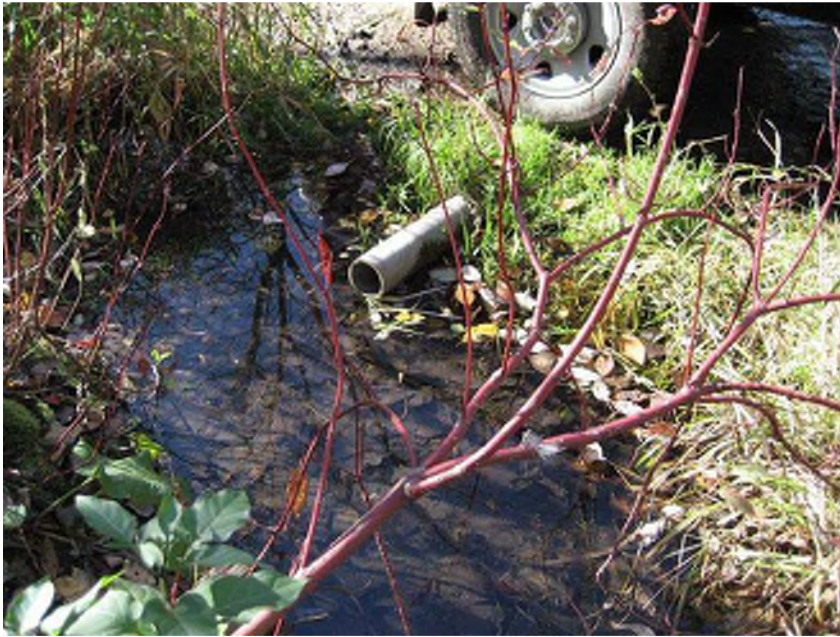
Waypoint 134A

PVC pipe going under trail; pipe is not low enough to ground for water to flow through pipe; instead water flows around the pipe and over th

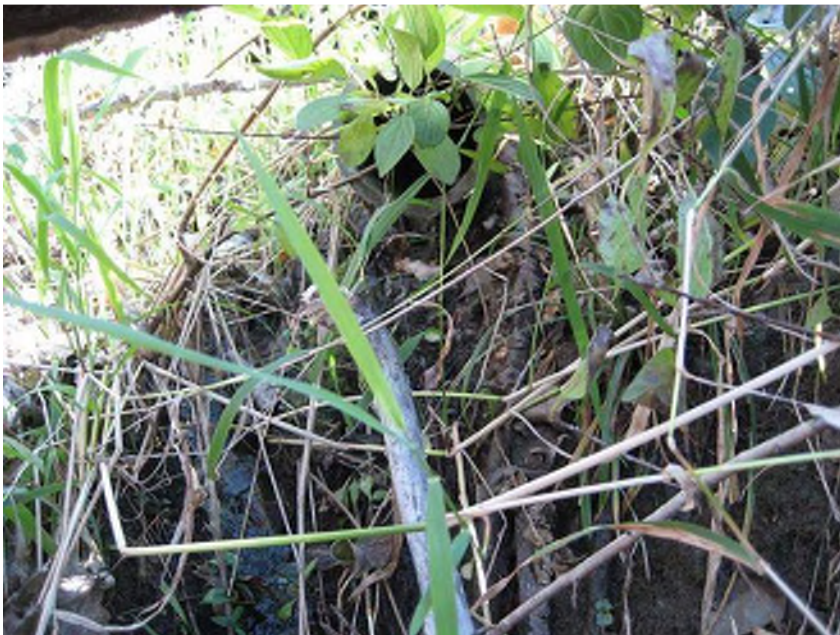
Eroding under pipe due to water going over trail.

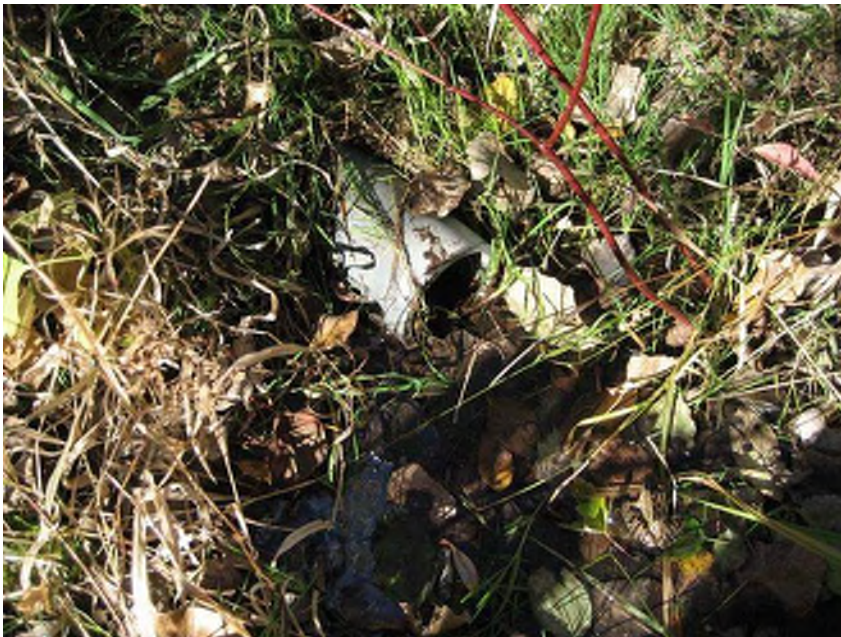
PVC pipe going under trail.

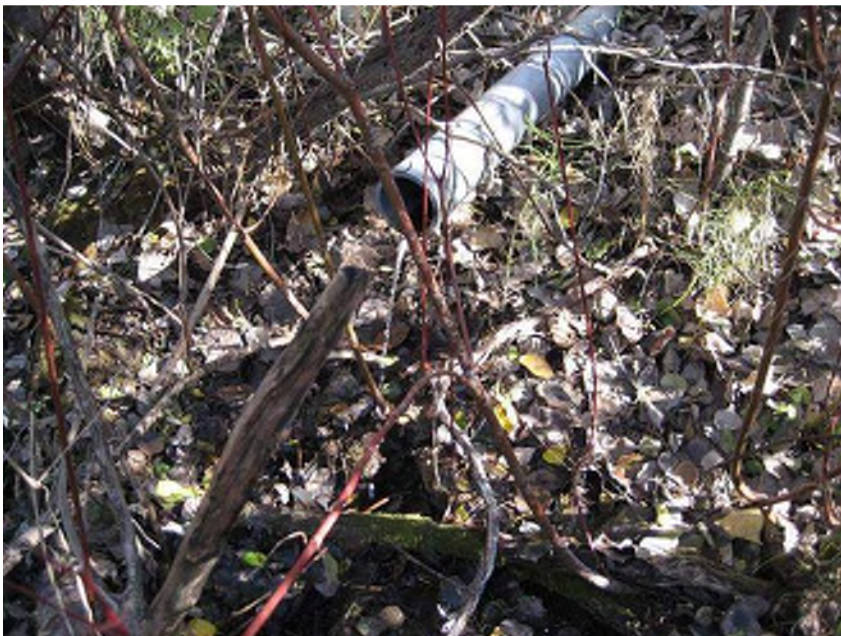
Minimal erosion due to logs under the flow of the piping.

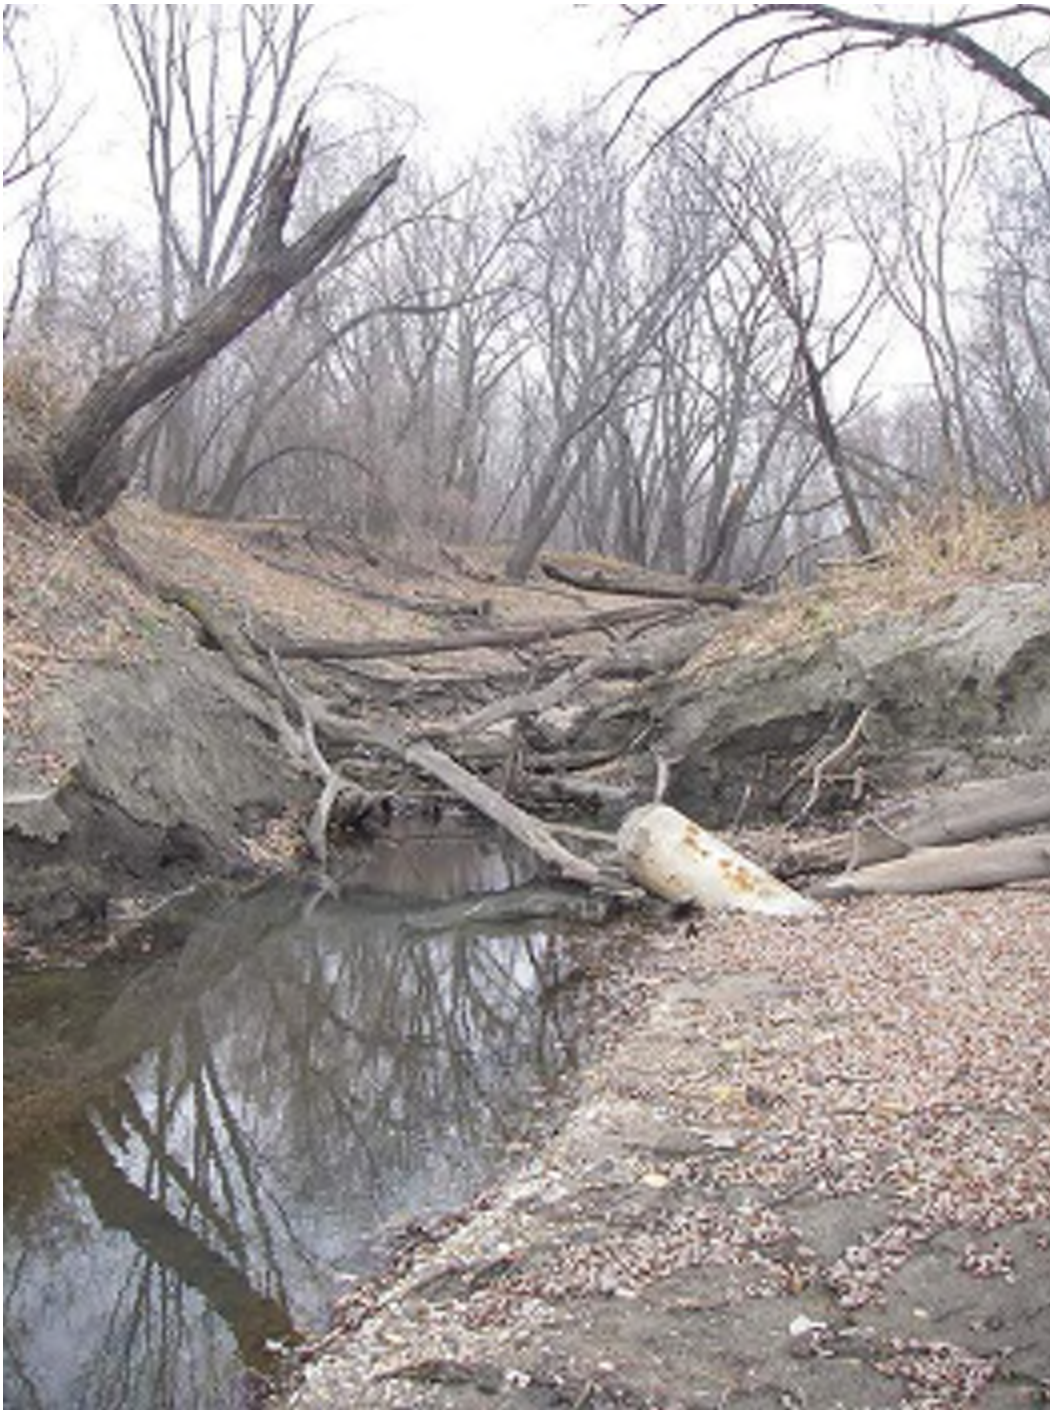
Waypoint 135

Mouth of creek at river, moderate soil erosion

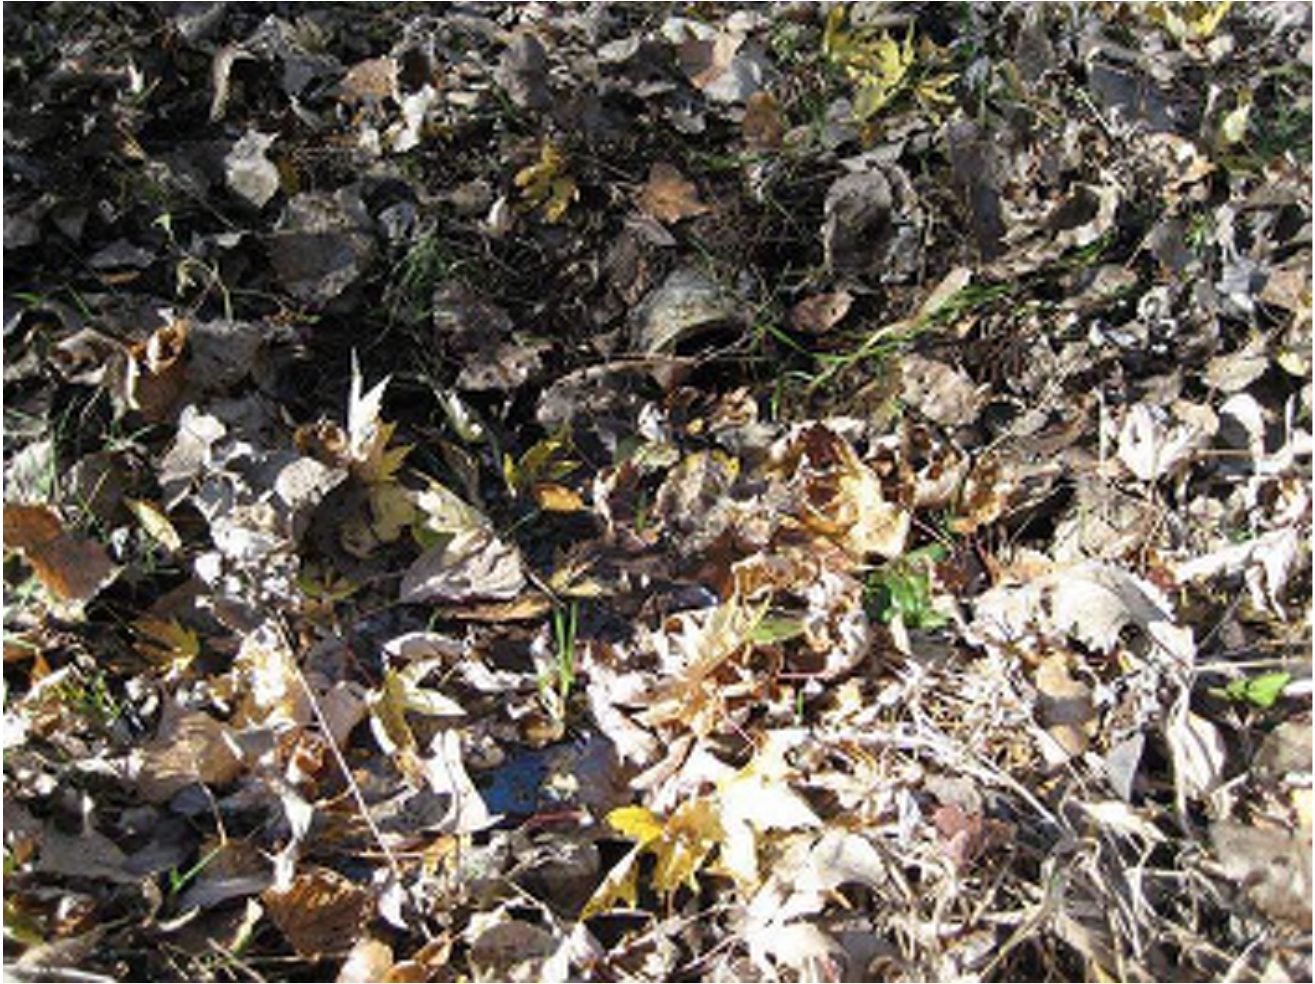
Waypoint 135A

PVC pipe going under trail; pooling water with lots of leaf litter; slow output of water.

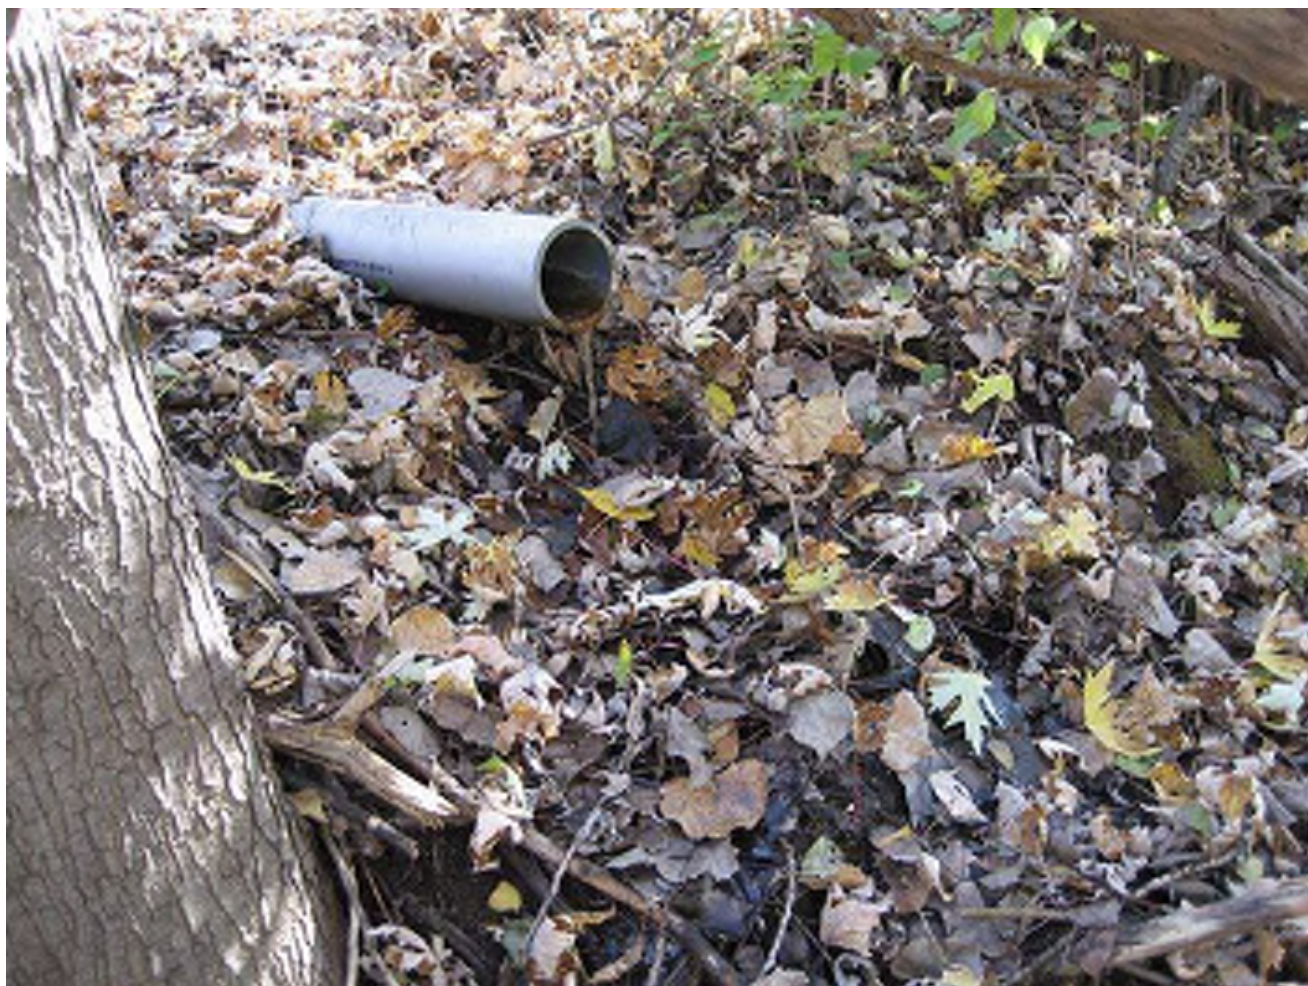
PVC pipe outlet; minimum erosion.

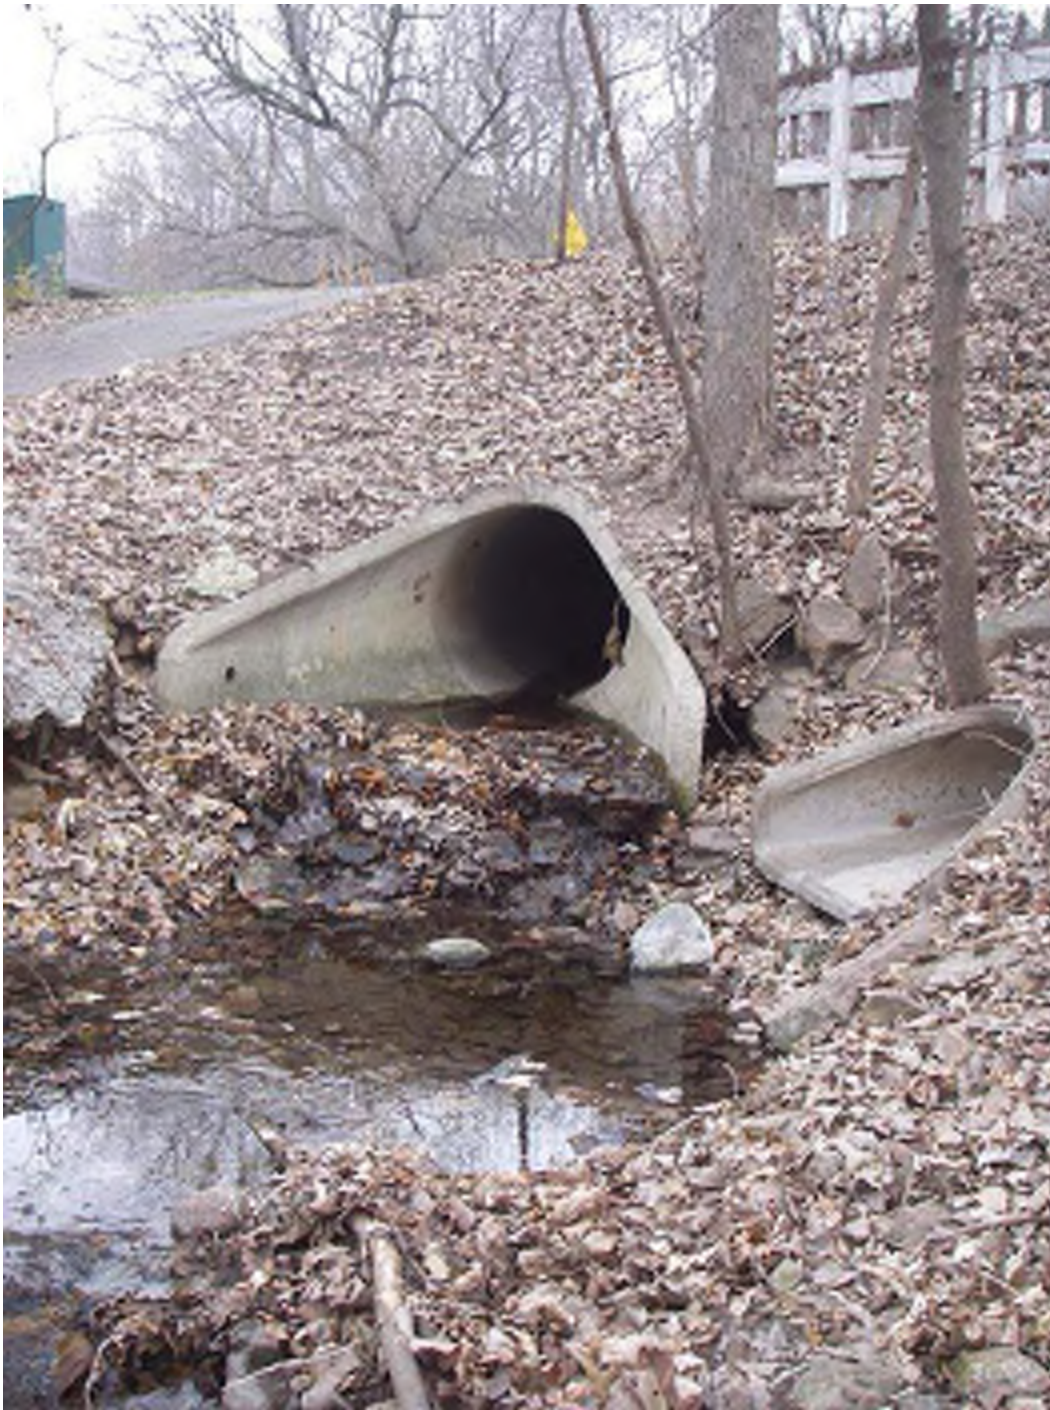
Waypoint 136

Culvert at Engler Blvd.

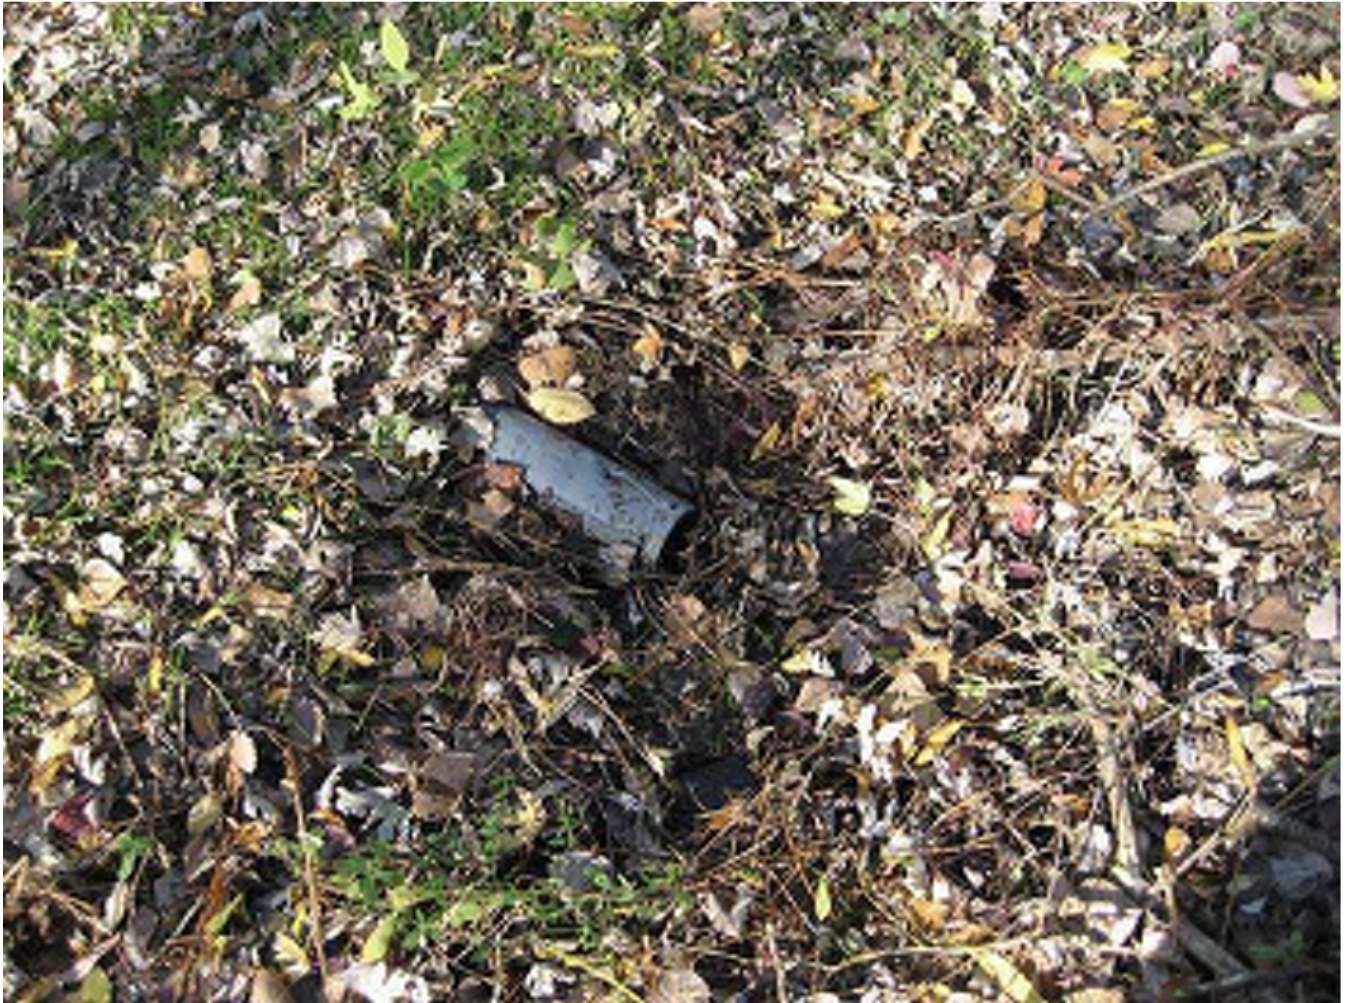
Waypoint 136A

PVC piping going under trail.

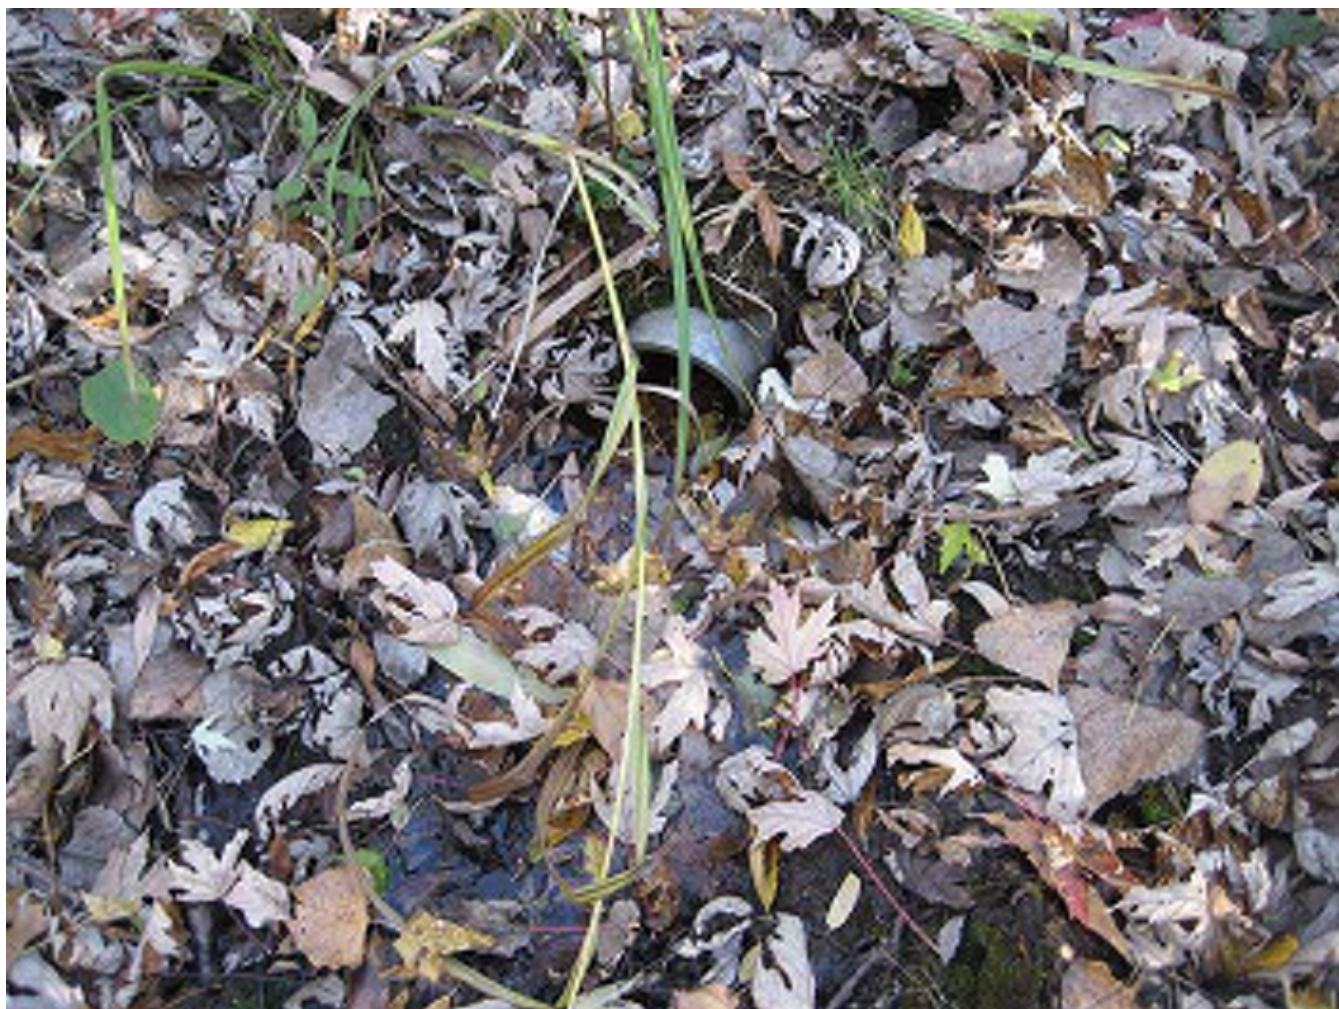
Pooling water at outflow end of pipe; minimum erosion.

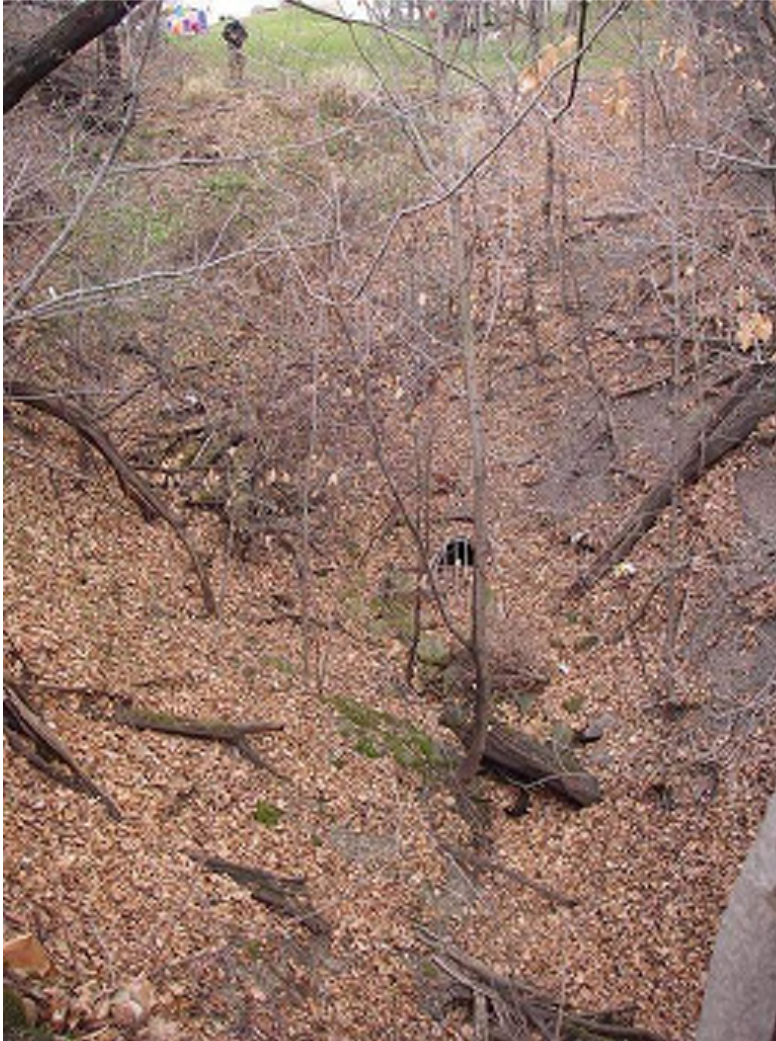
Waypoint 137

Start of gully

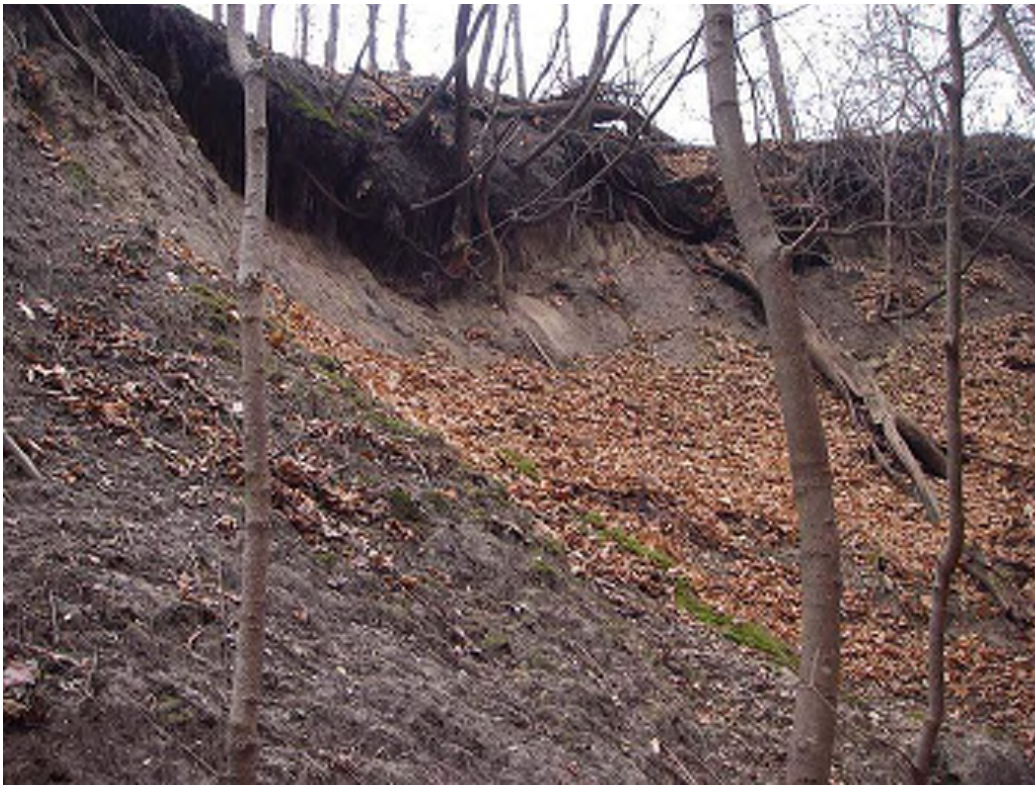
Extreme soil erosion

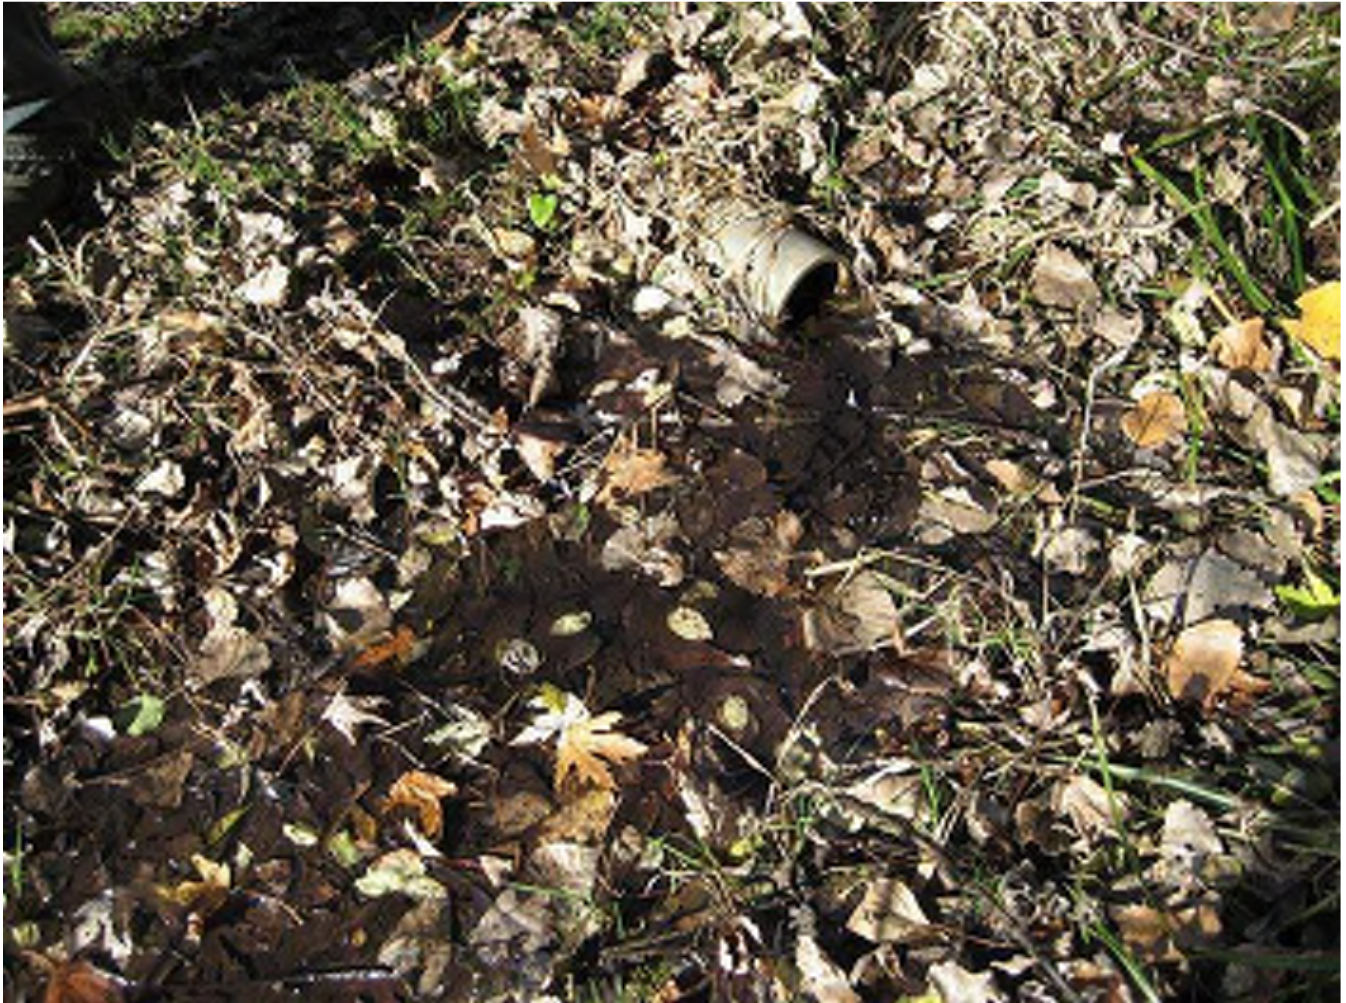
Waypoint 137A

PVC pipe going under trail; pooling water at intake end of pipe.

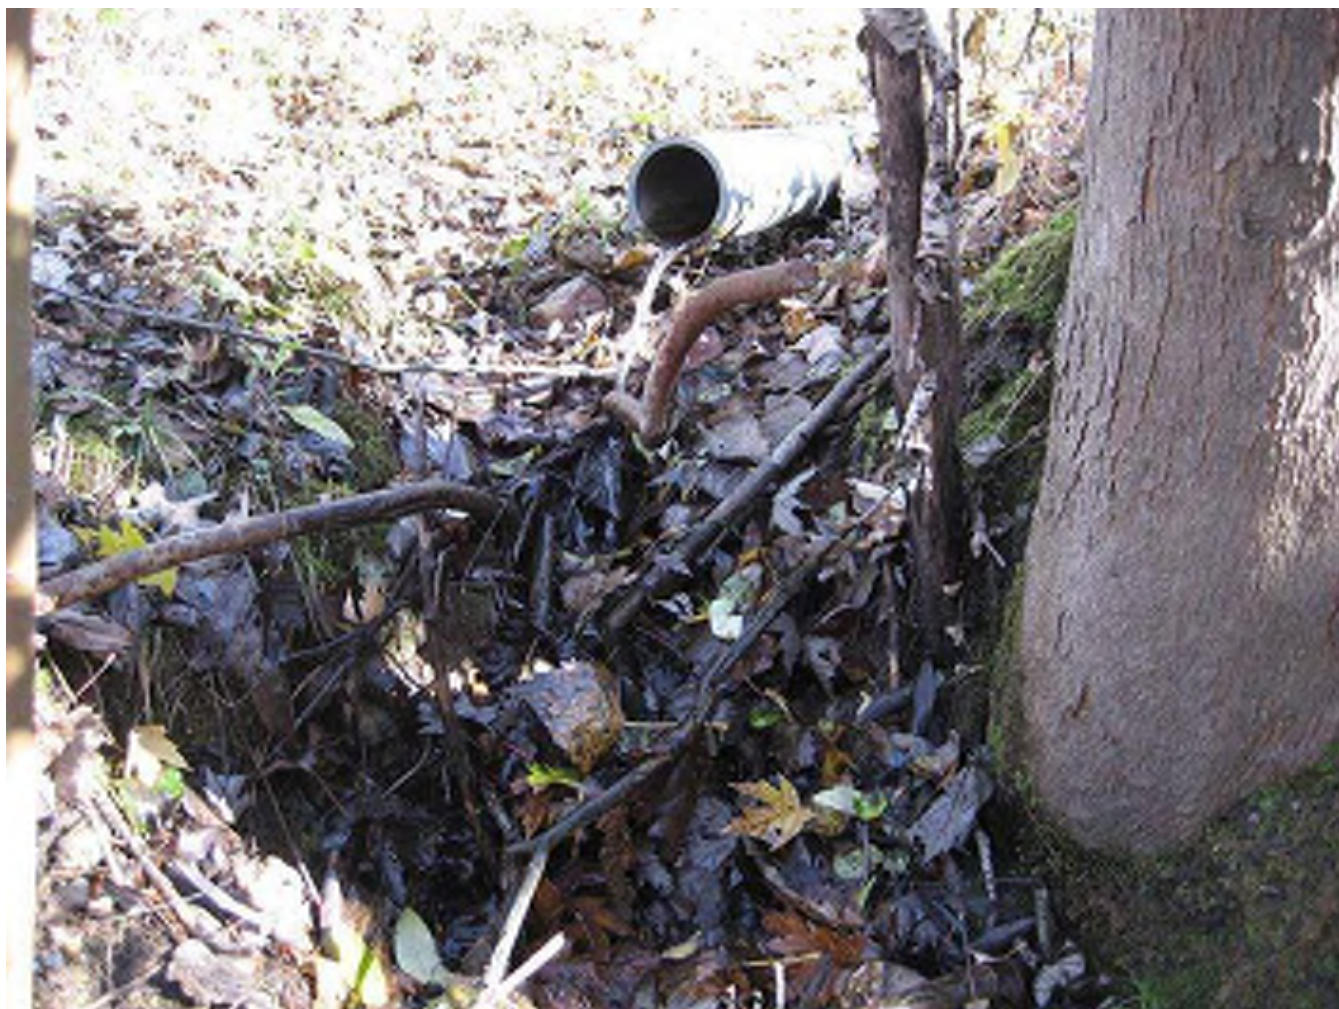
PVC outlet; moderate to major erosion.
