Appendix K: Lower Minnesota River Watershed District: Gully Inventory

Gully Inventory Map
 Area #1
 Lower Minnesota River Watershed District
 Watershed Management Plan

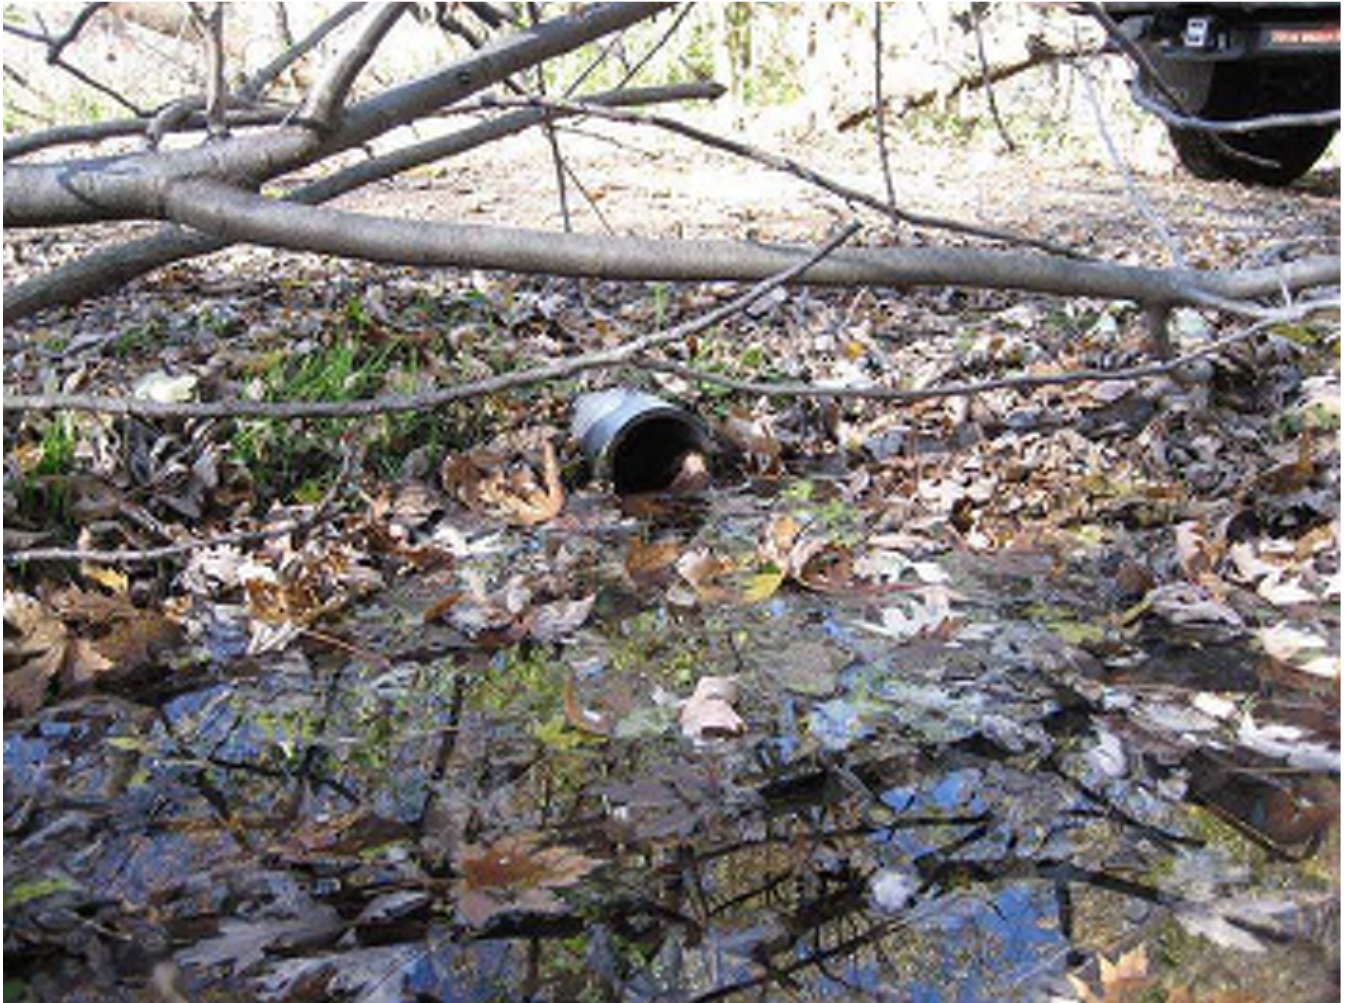
Waypoint 138A

PVC pipe going under trail; pooling water.

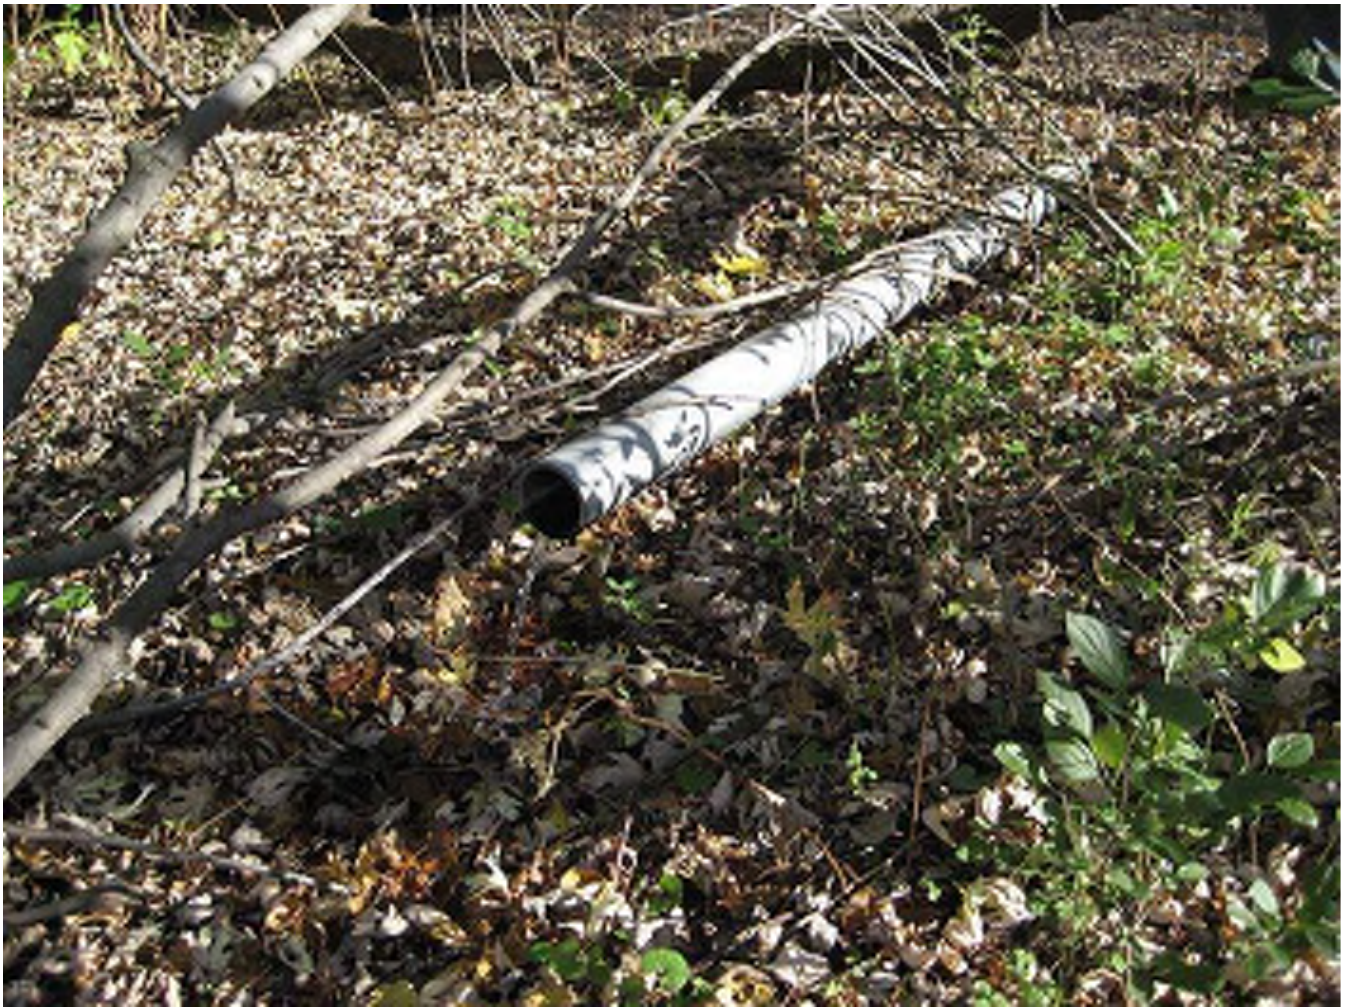
PVC outlet.

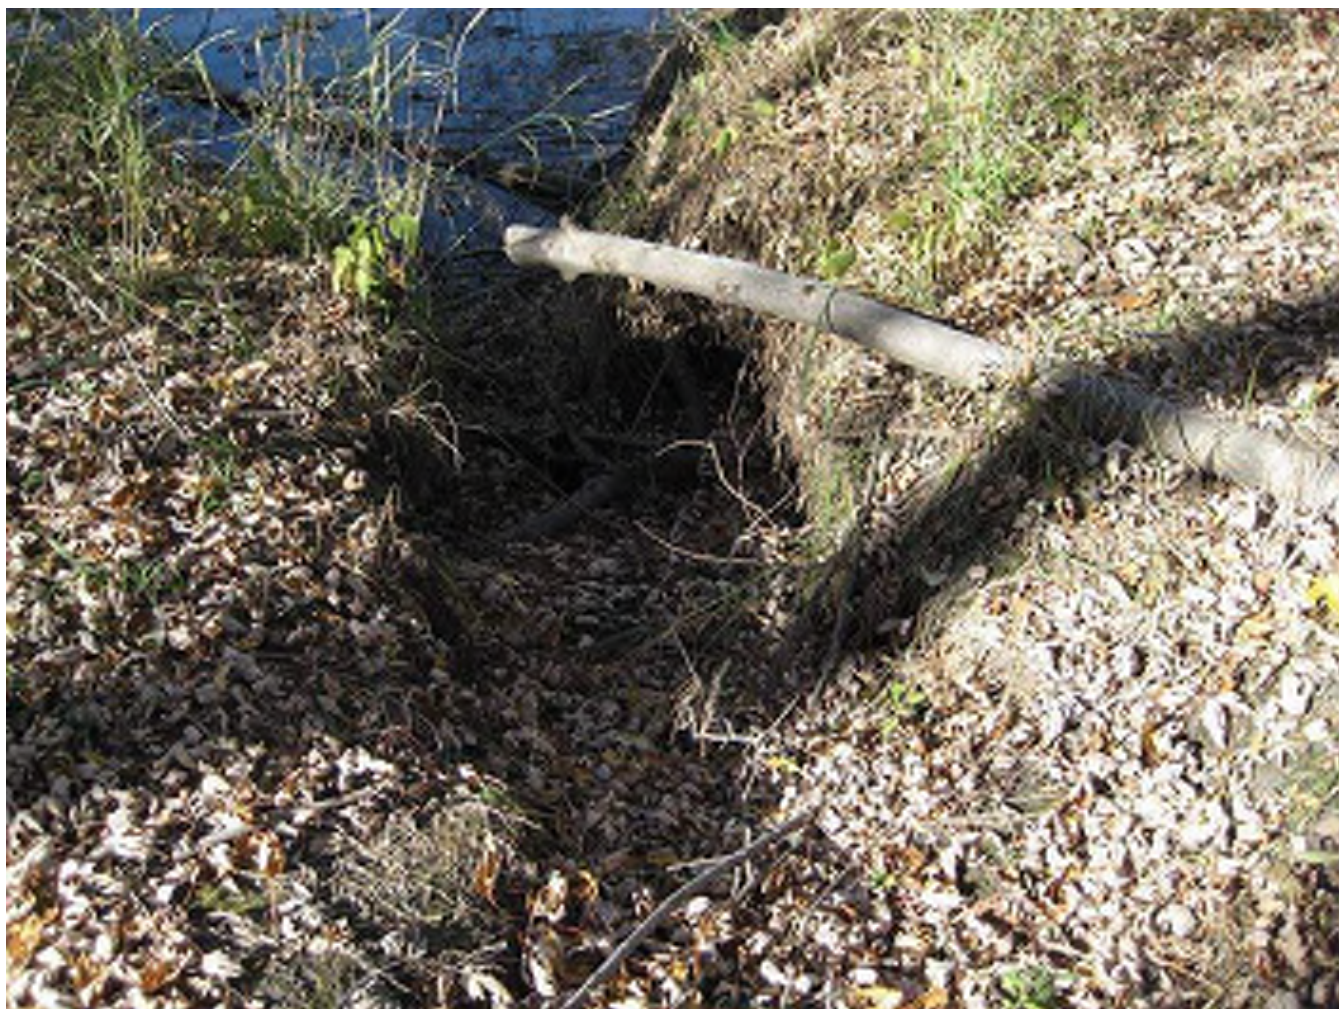
Major erosion due to outlet of PVC pipe.

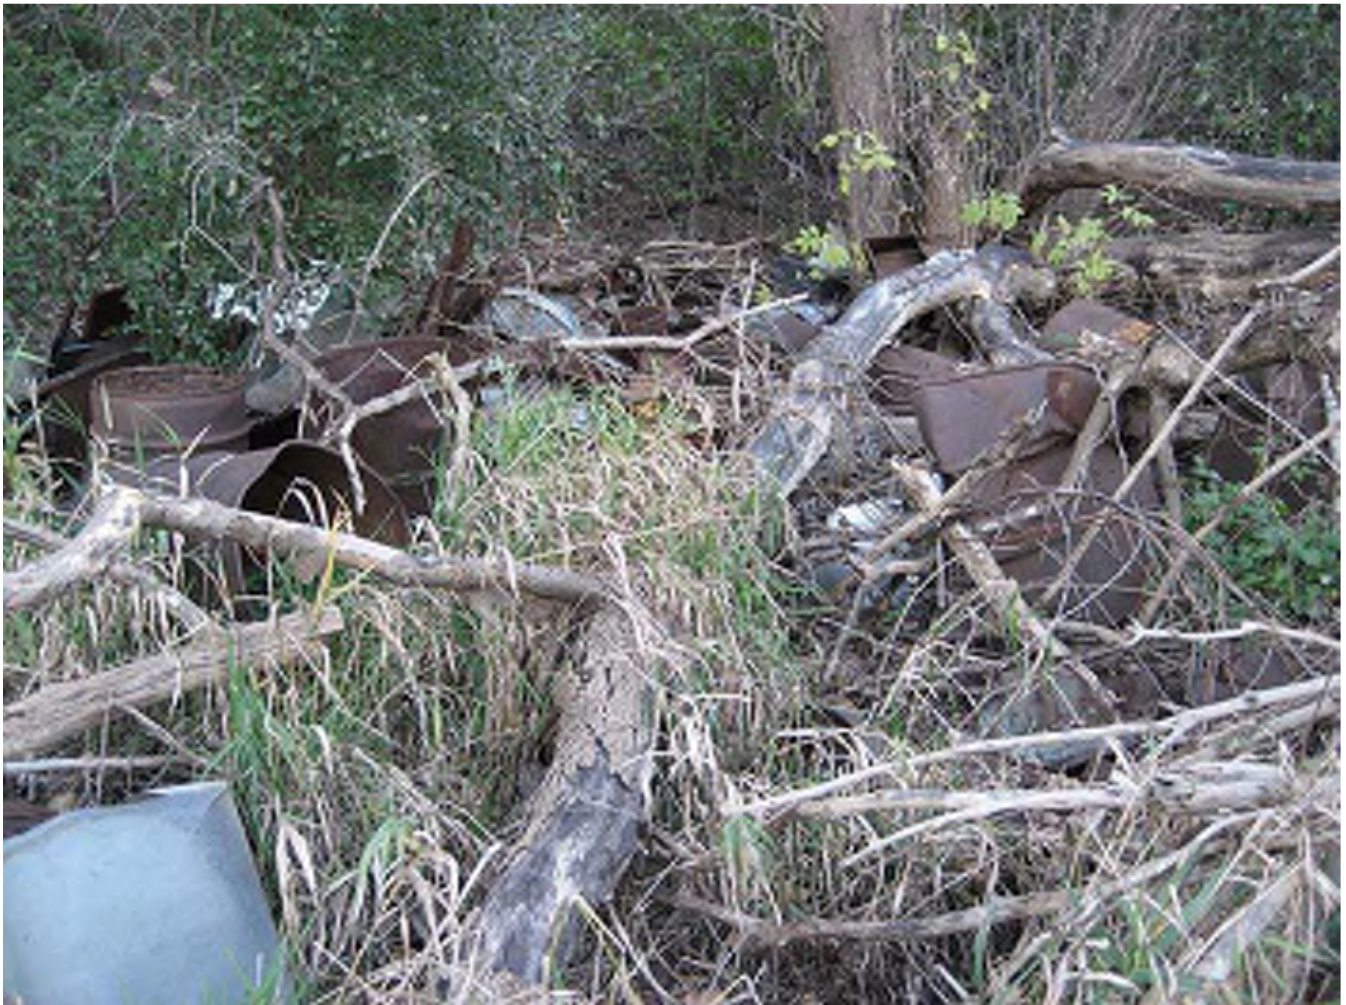
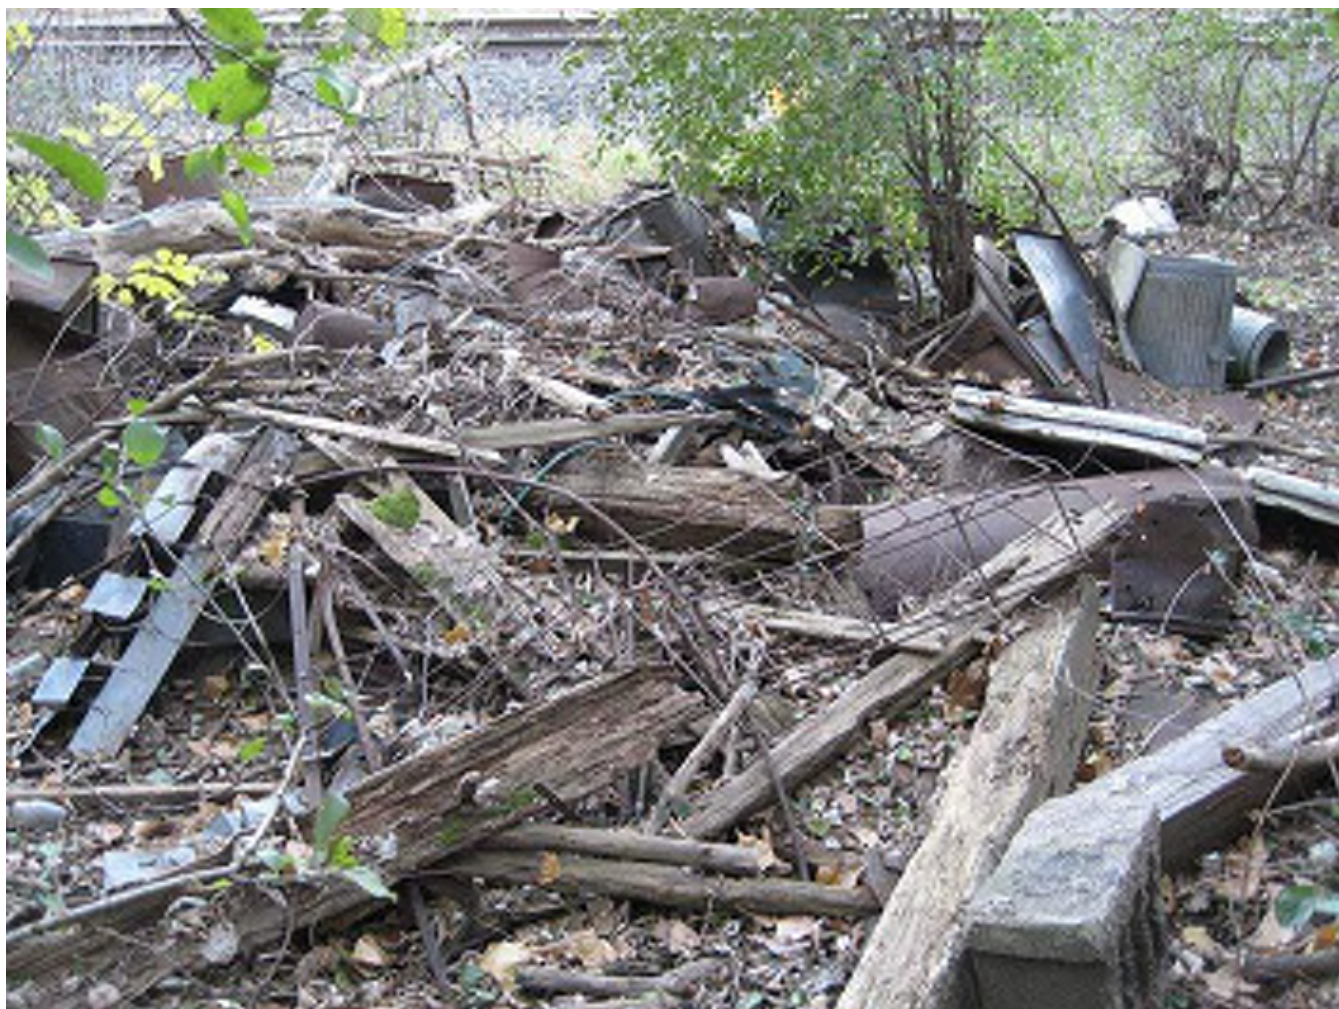
Waypoint 139A

Dump side; lots of old barrels and metal scraps.

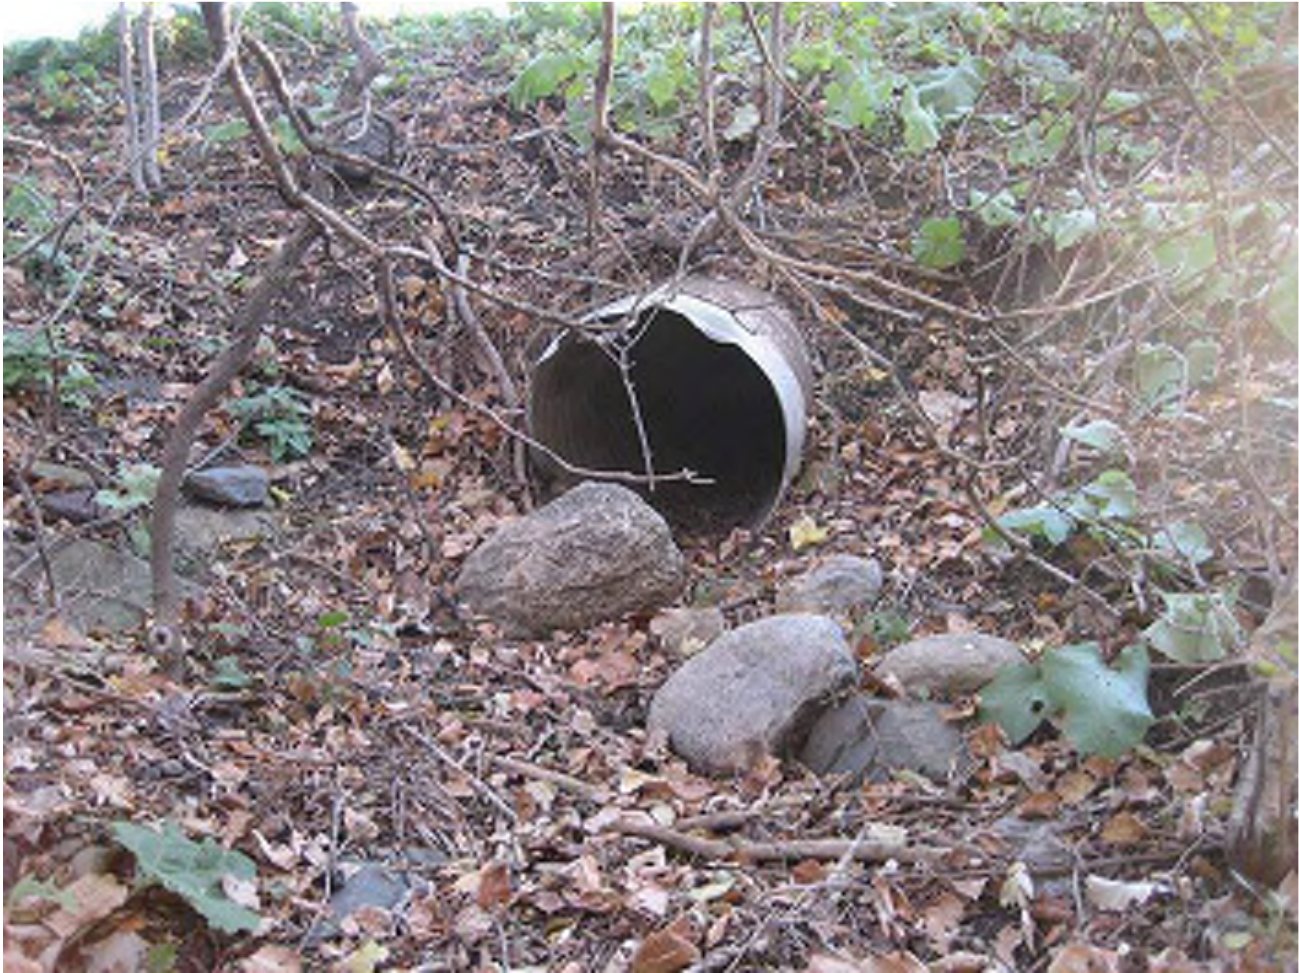
Waypoint 140A

Culvert output coming from under trail; minor erosion.

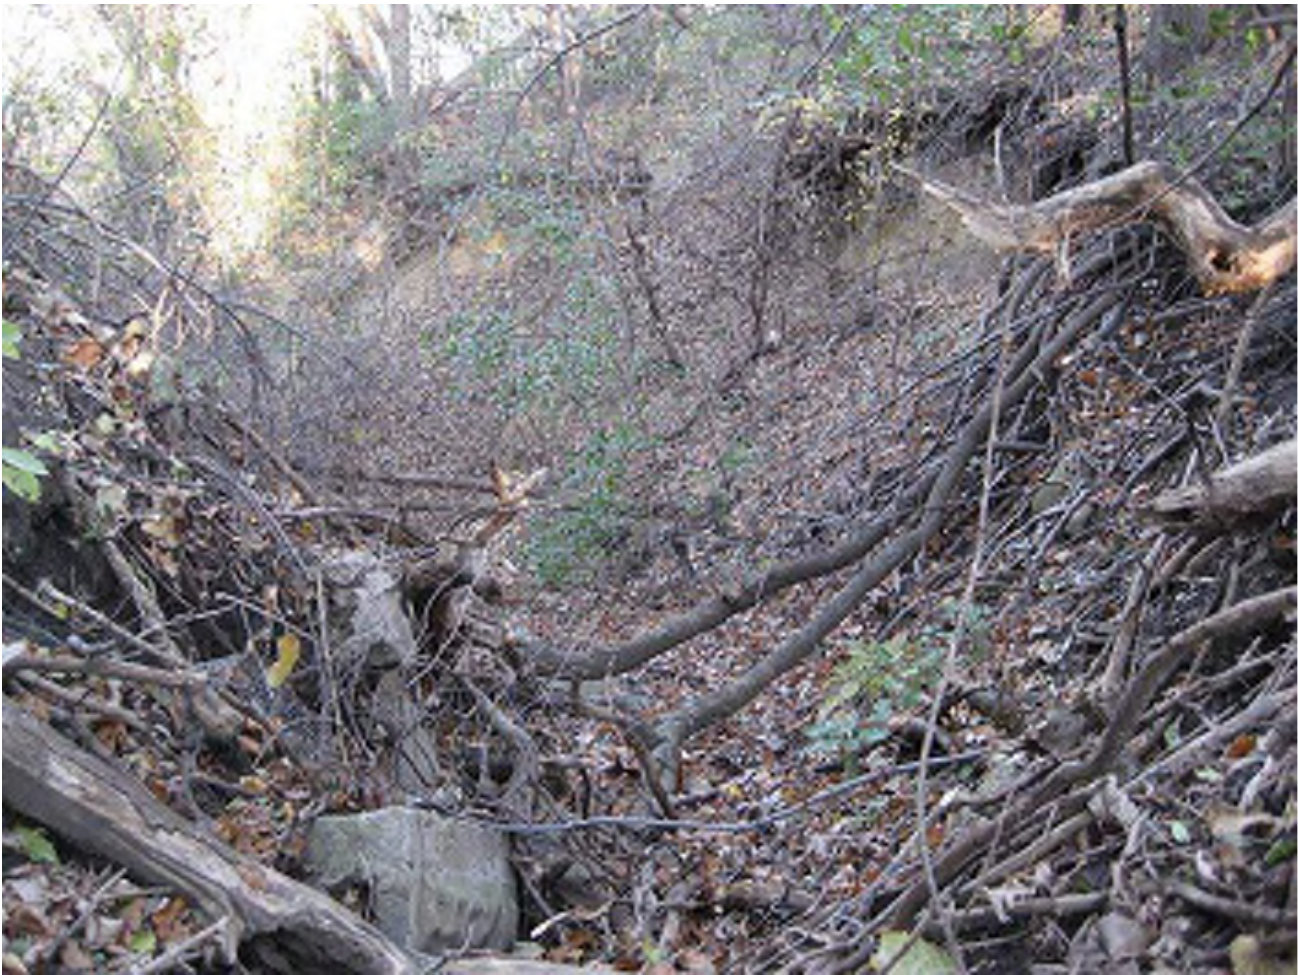
Major erosion; gully further below culvert in picture #1; some litter; looking down gully.

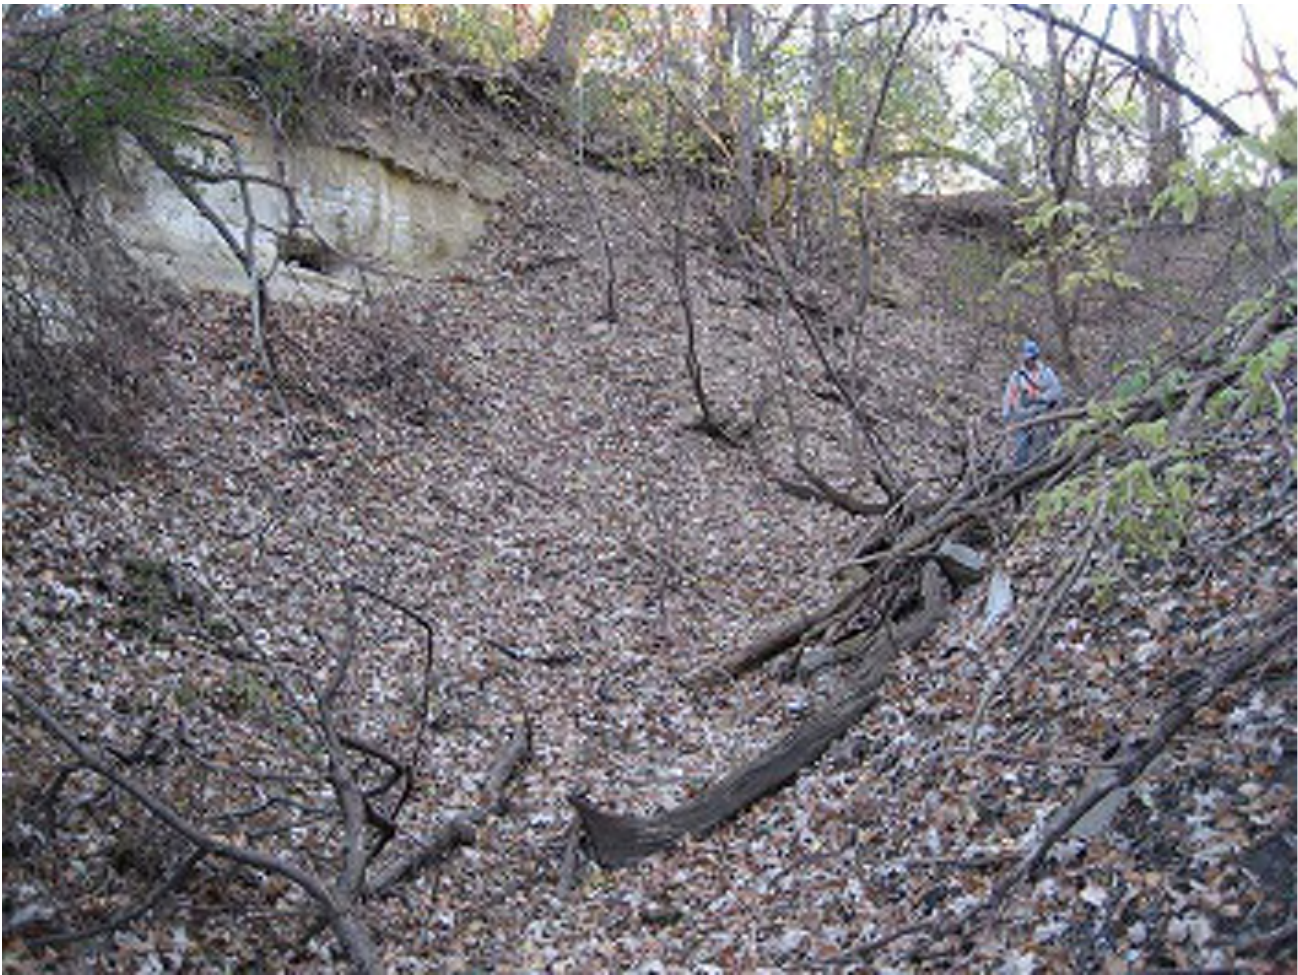
Looking up at gully; major erosion.

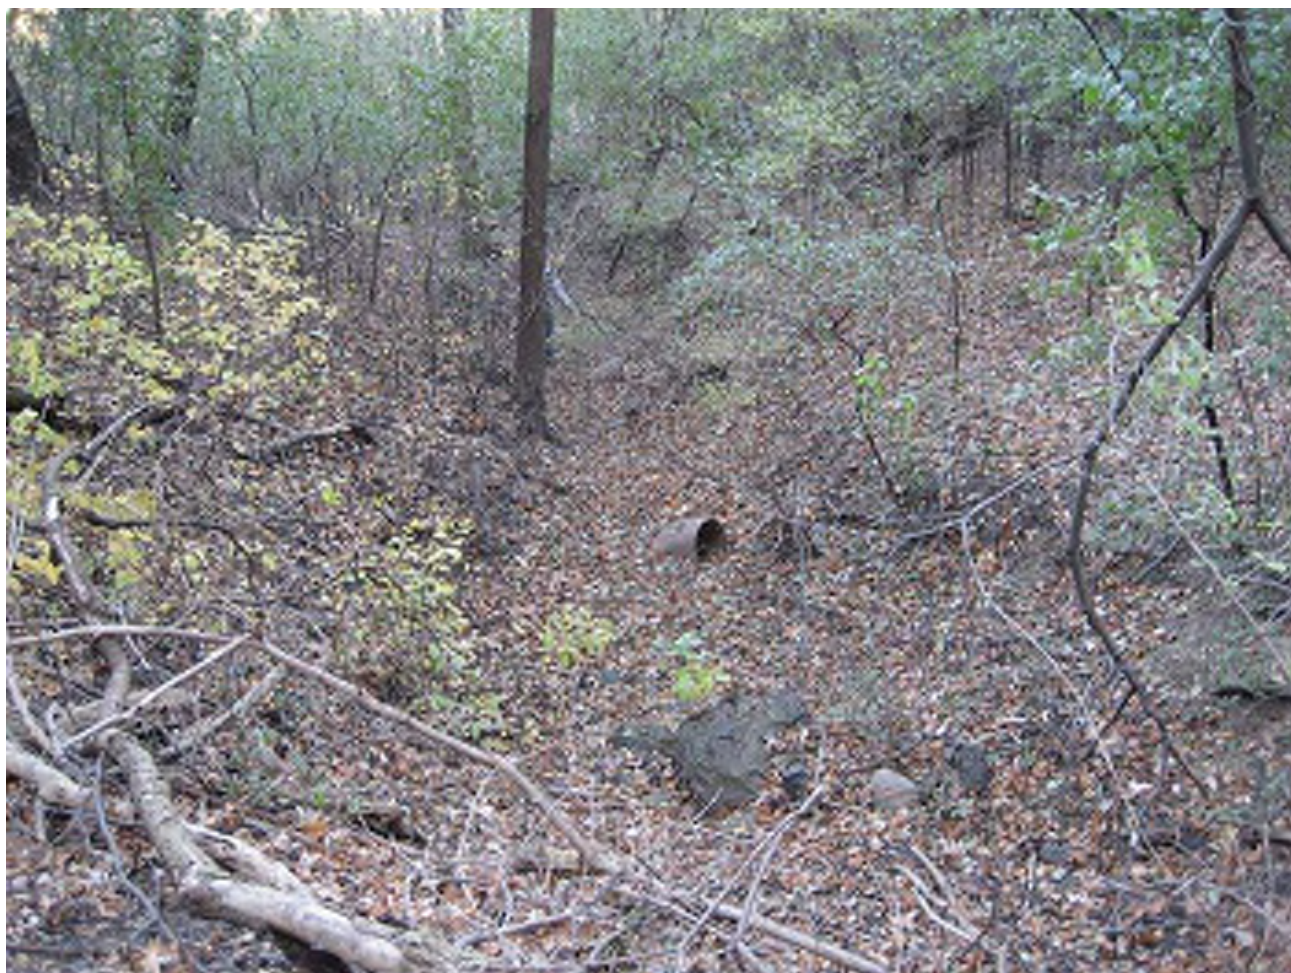
Looking down at gully; major erosion.

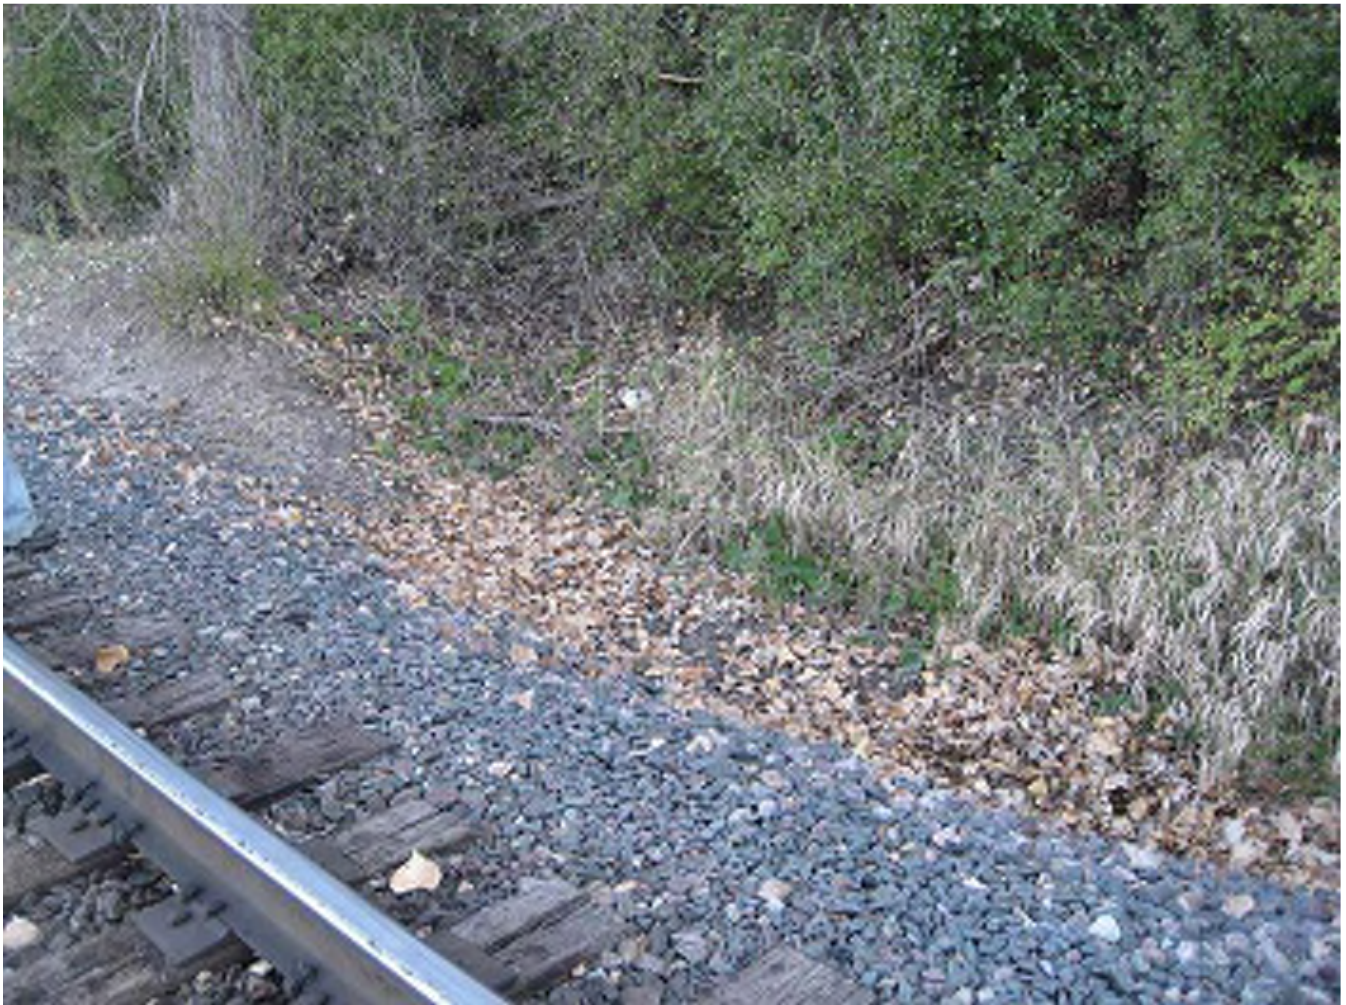
Waypoint 141A

Bottom of gully from waypoint 140A; looking up at gully.

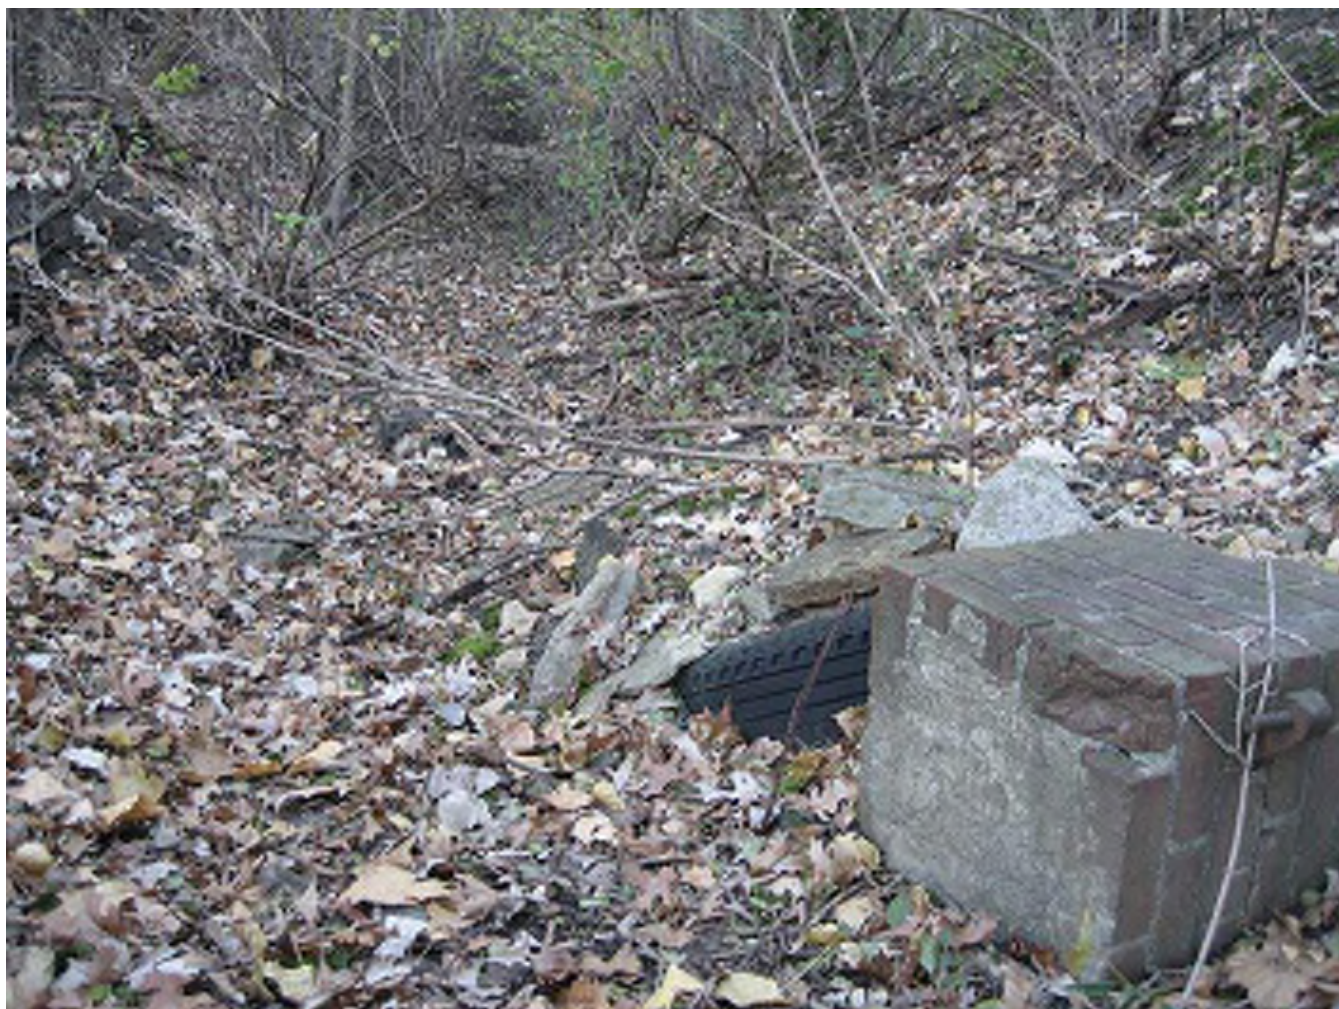
Looking up gully; moderate erosion heading towards major erosion in near future.

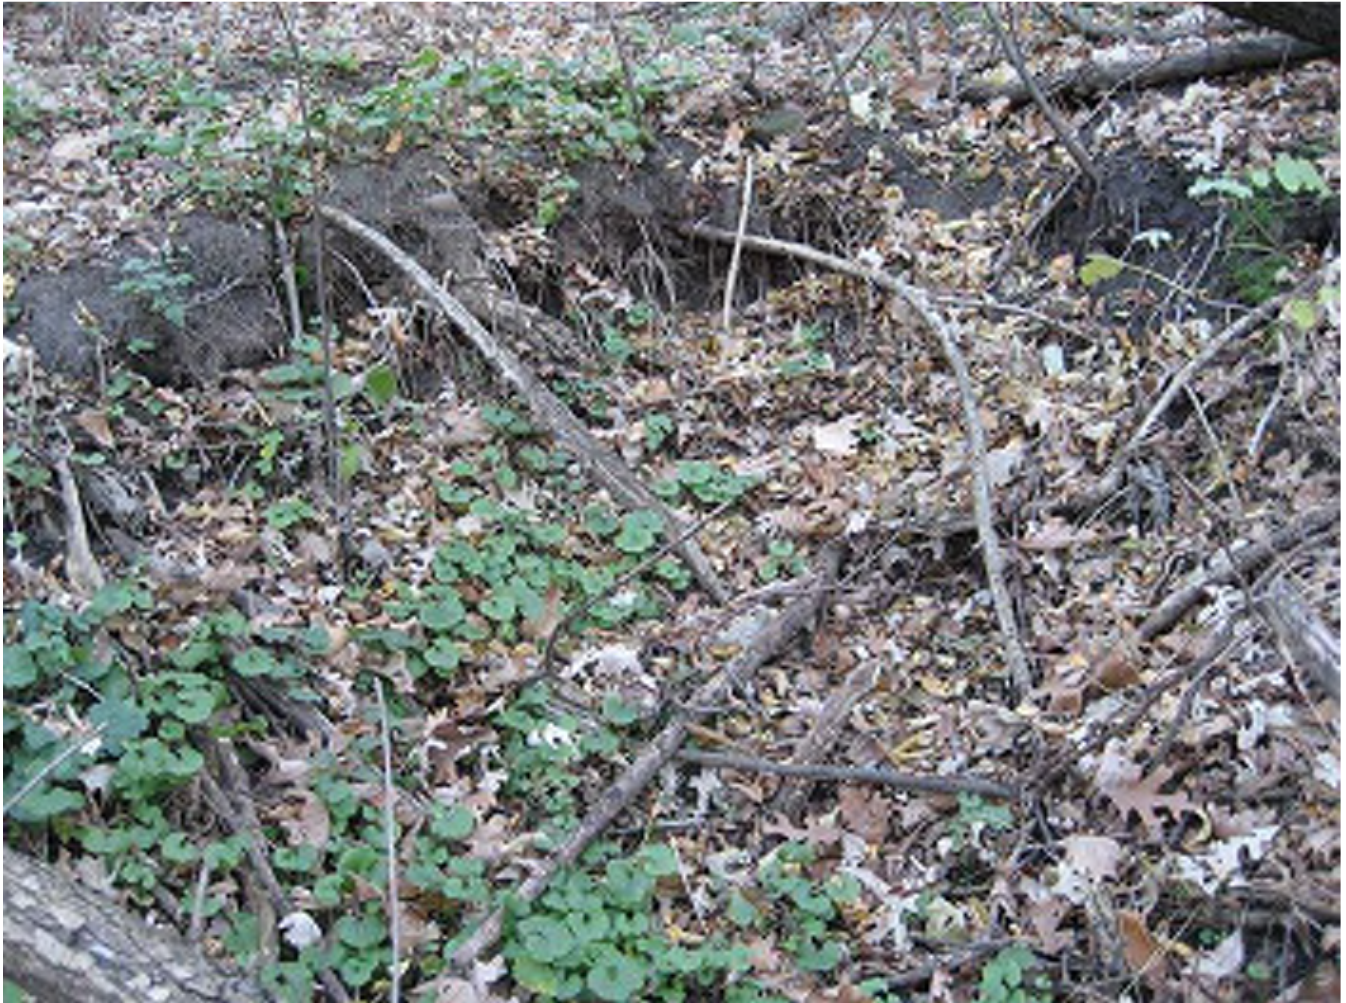
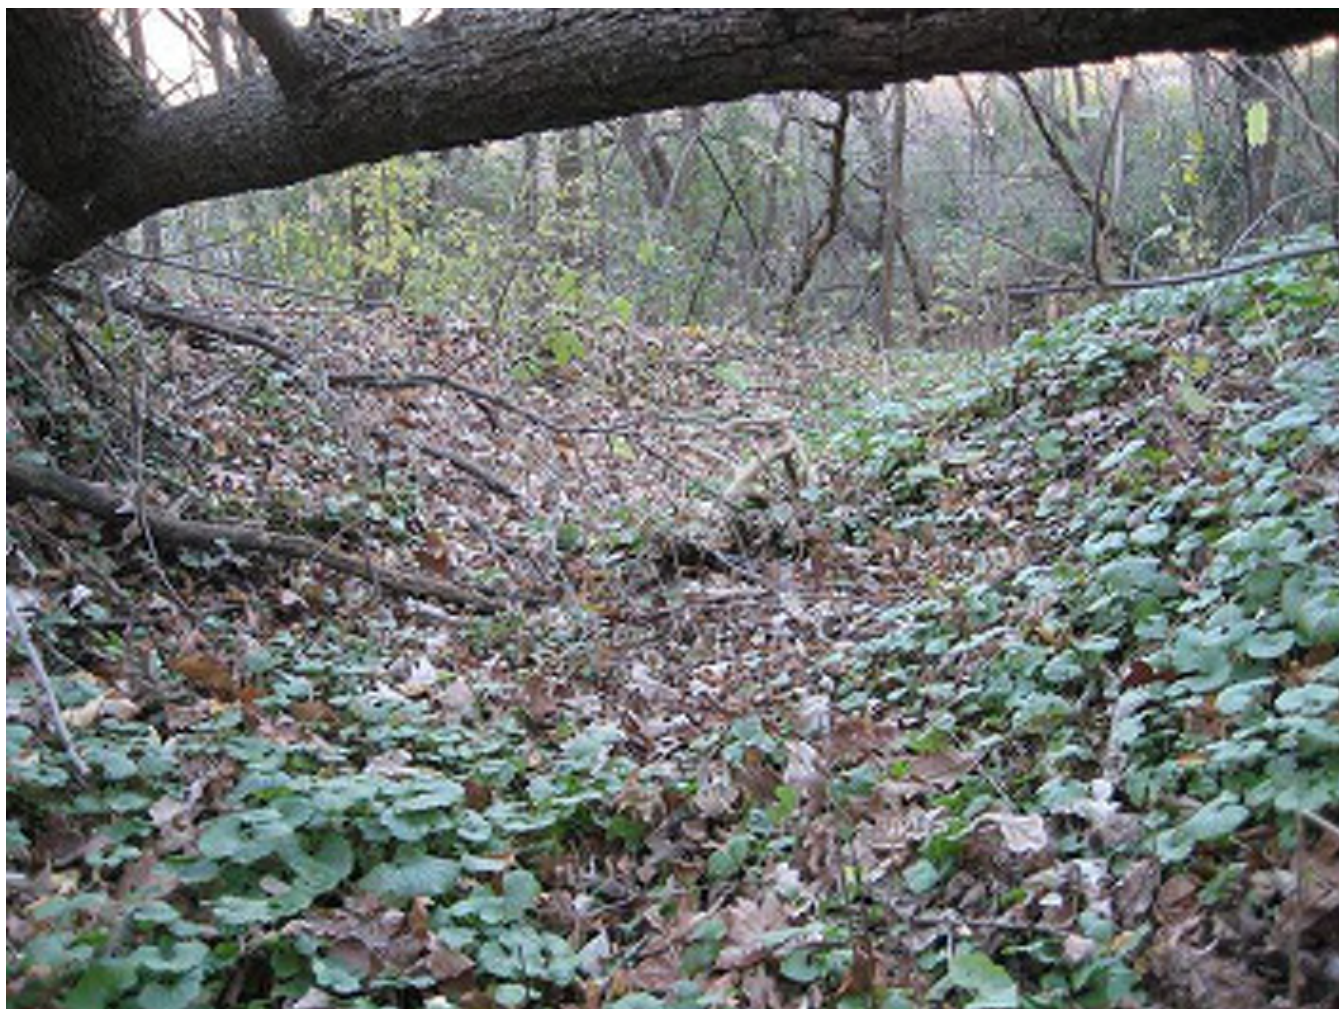
Waypoint 142A

Beginning of erosion; minimal erosion; could potentially turn into a large gully.

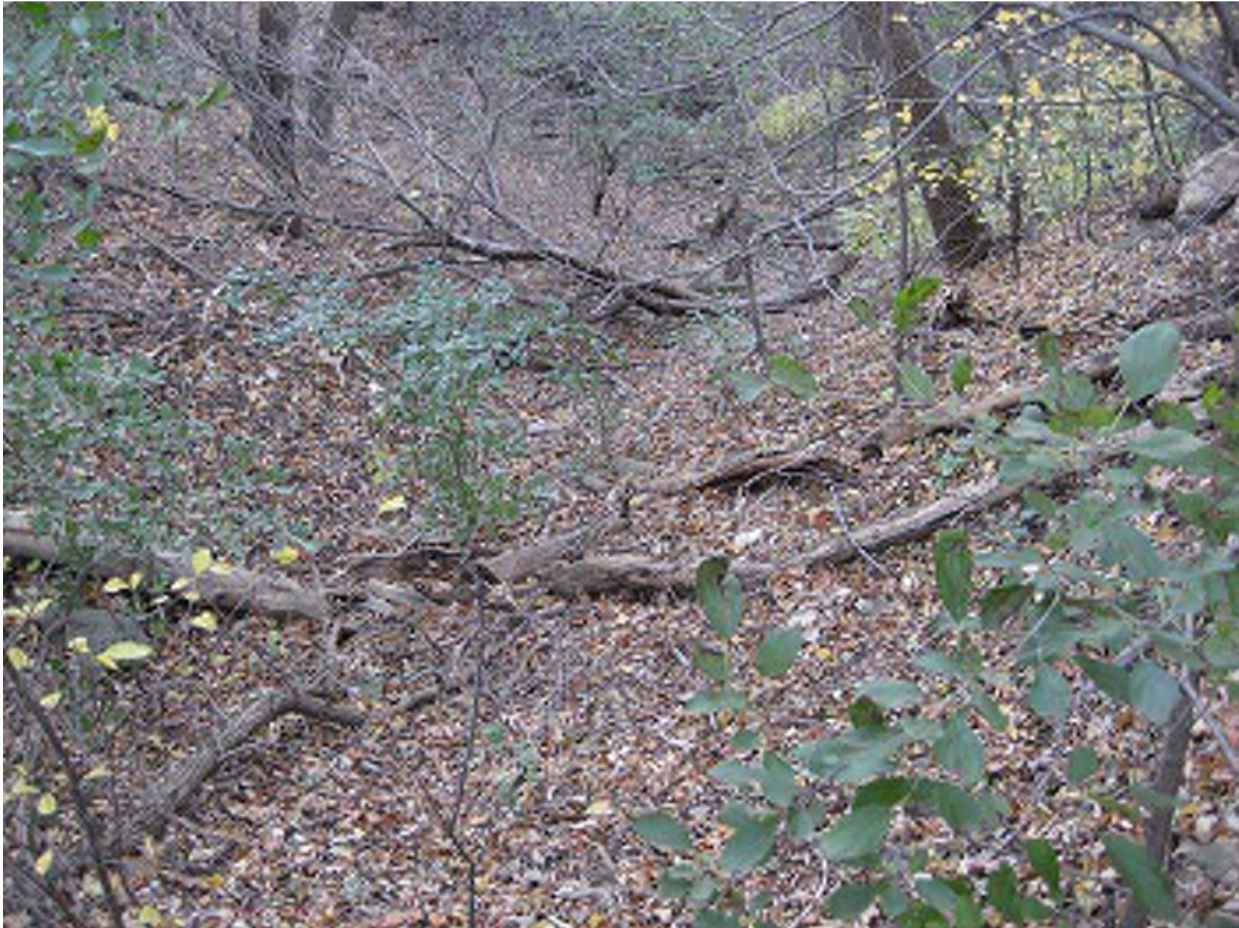
Waypoint 143A

Very large gully off of trail; minor erosion but hard to tell due to leaf litter; no culverts.

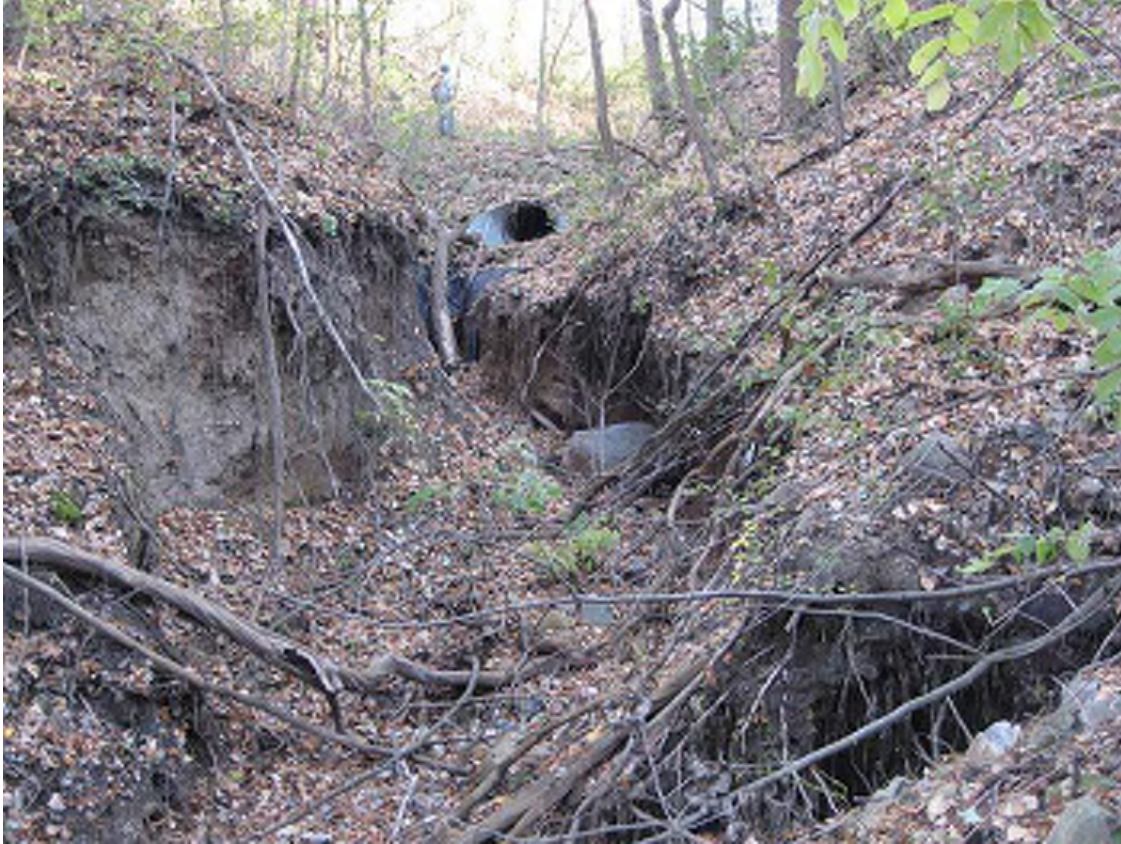
Waypoint 144A

Looking up gully at culvert with black matting underneath; major erosion; large cuts going into ground.

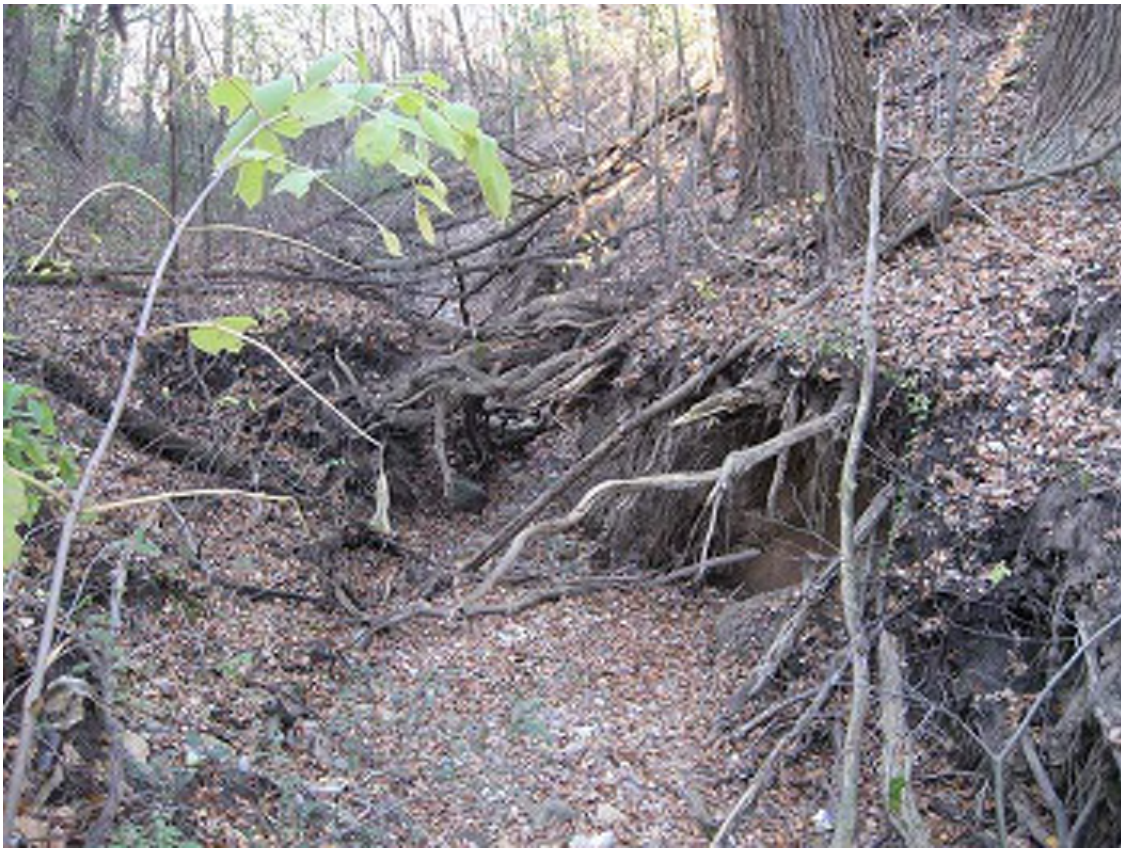
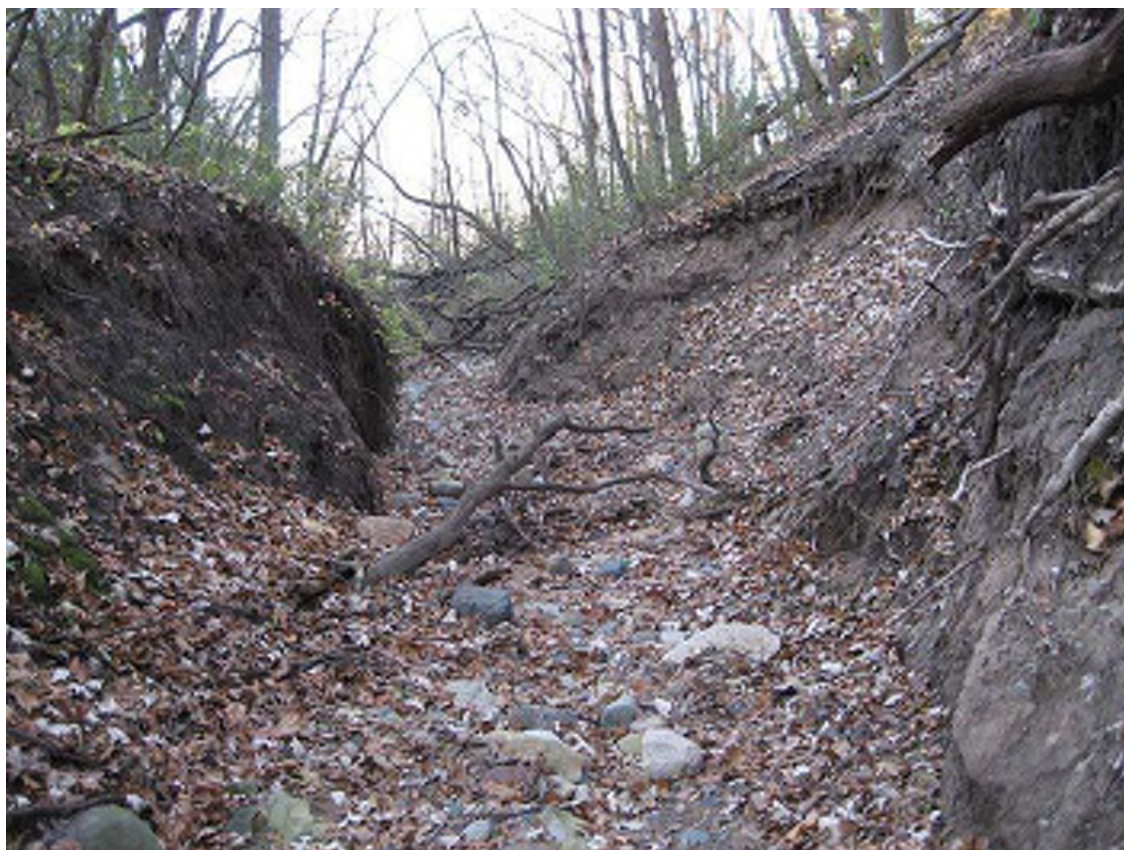
Looking down gully; large boulders at bottom of gully with lots of sand deposits.

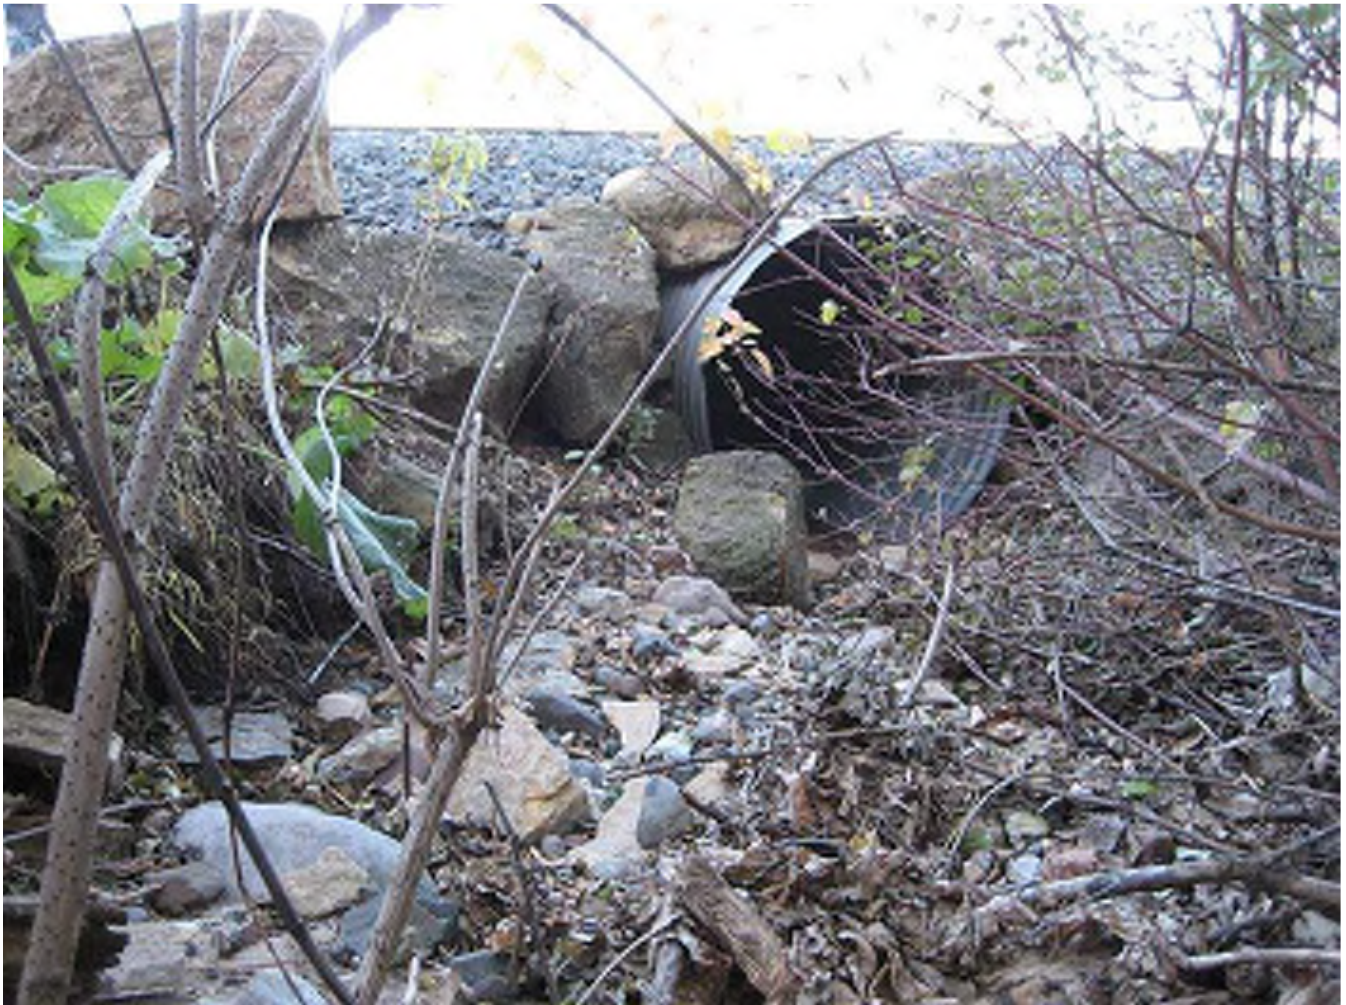
Waypoint 145A

Culvert at bottom of gully; major erosion.
