Appendix K: Lower Minnesota River Watershed District: Gully Inventory

Gully Inventory Map
 Area #1
 Lower Minnesota River Watershed District
 Watershed Management Plan

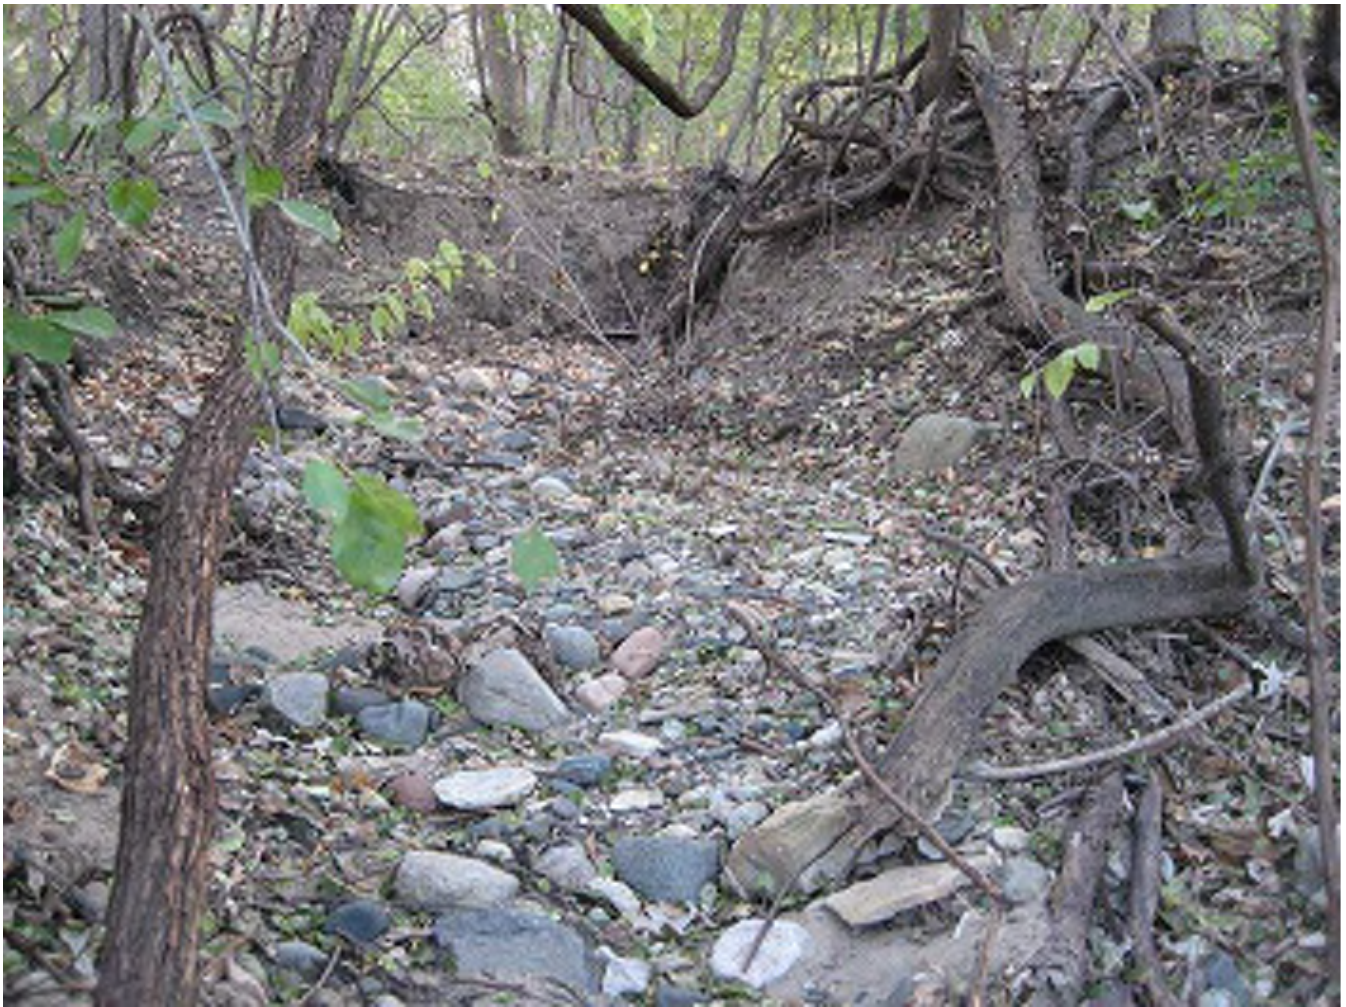
Further up in gully; major erosion.

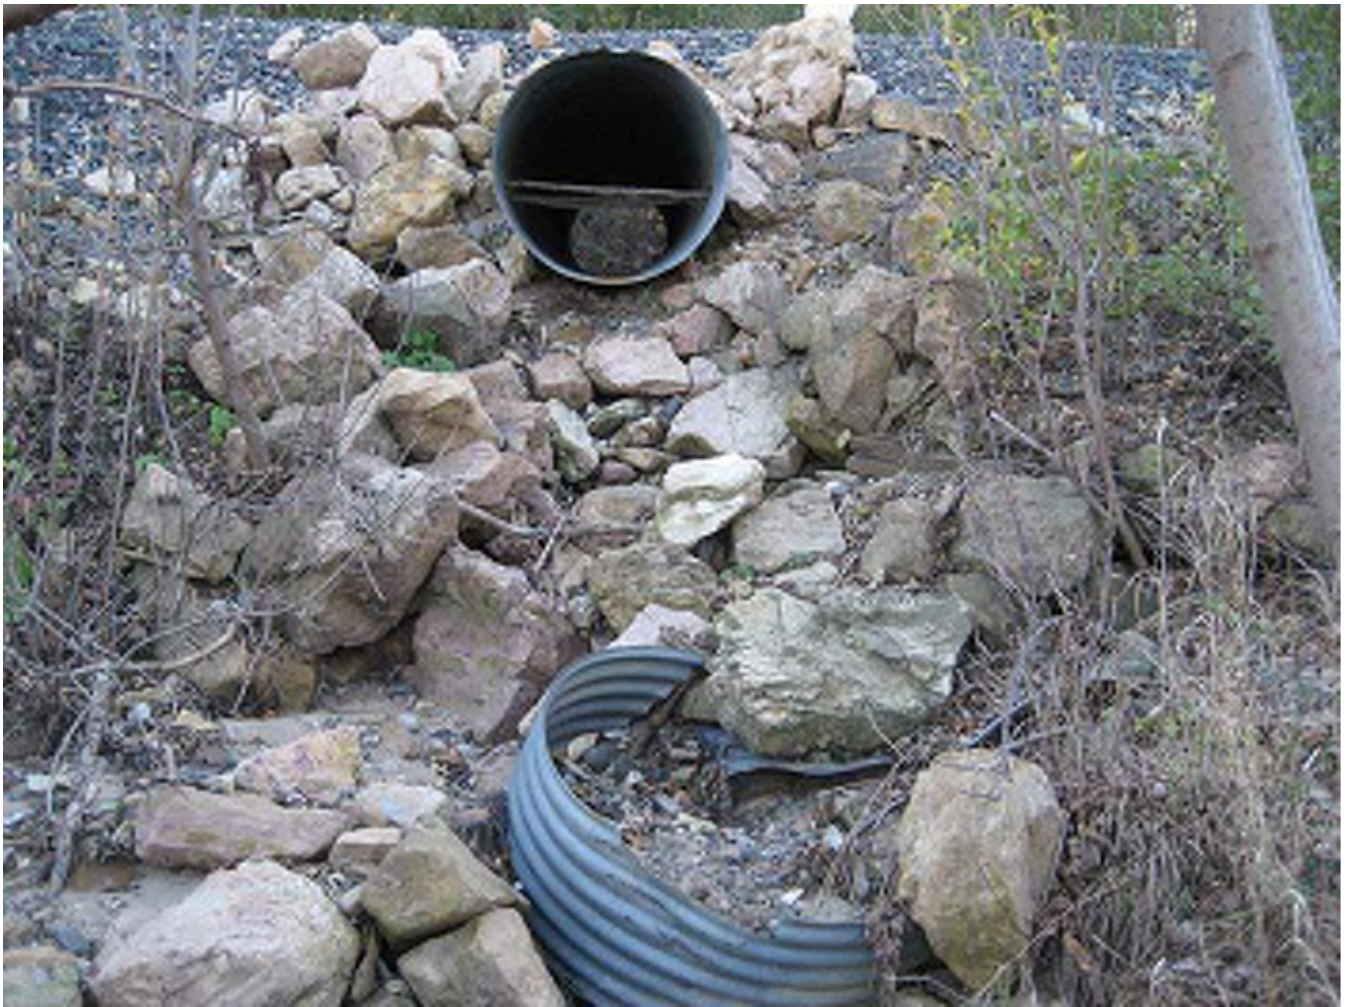
Other side of culvert; minimal erosion.

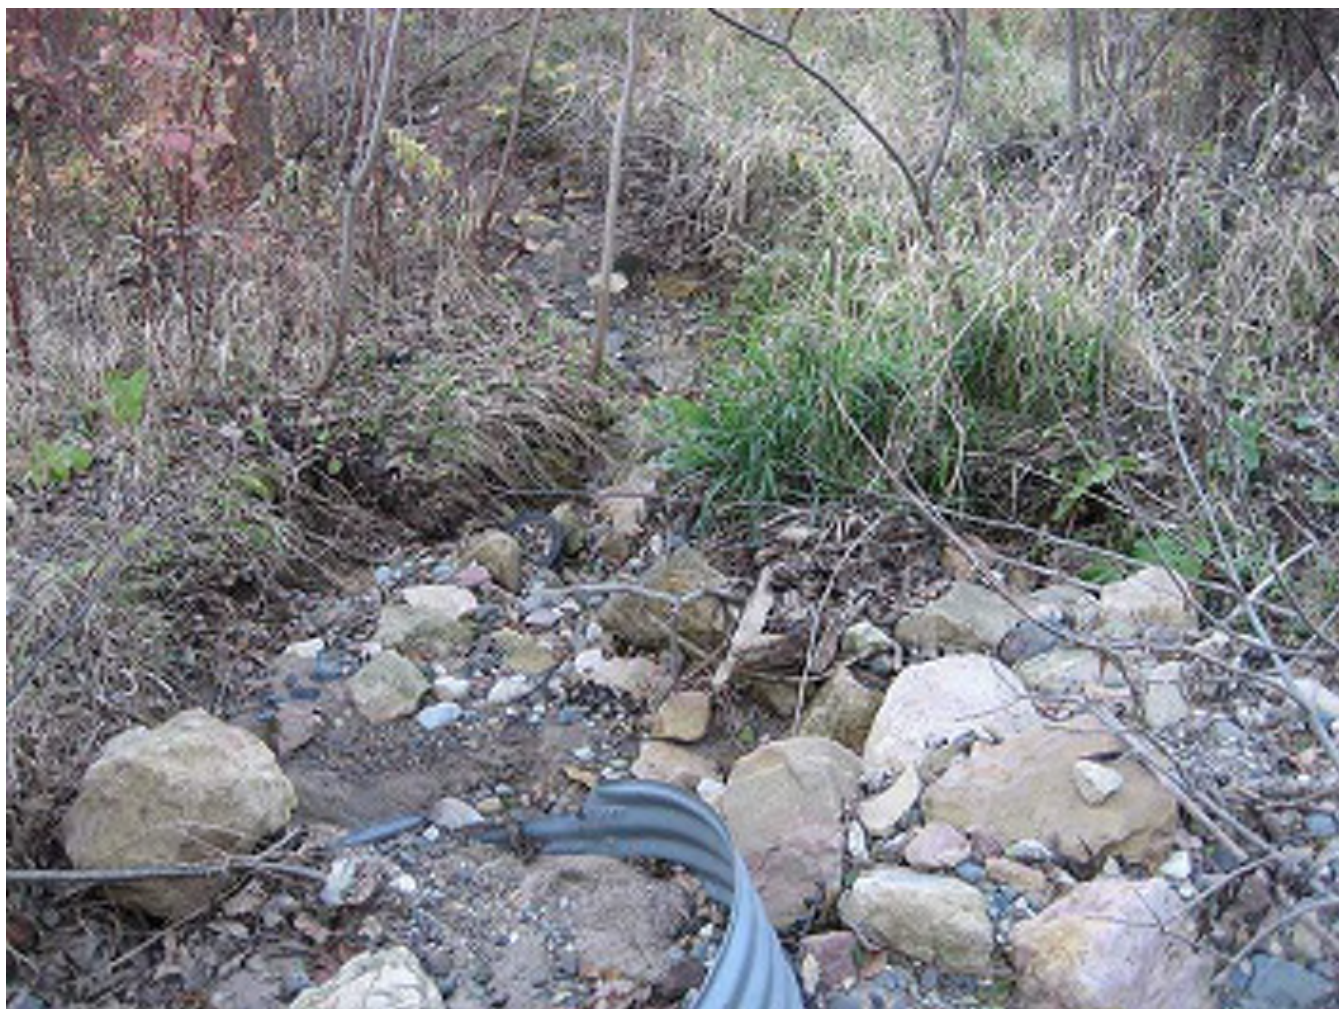
Bottom of culvert; minimal erosion.

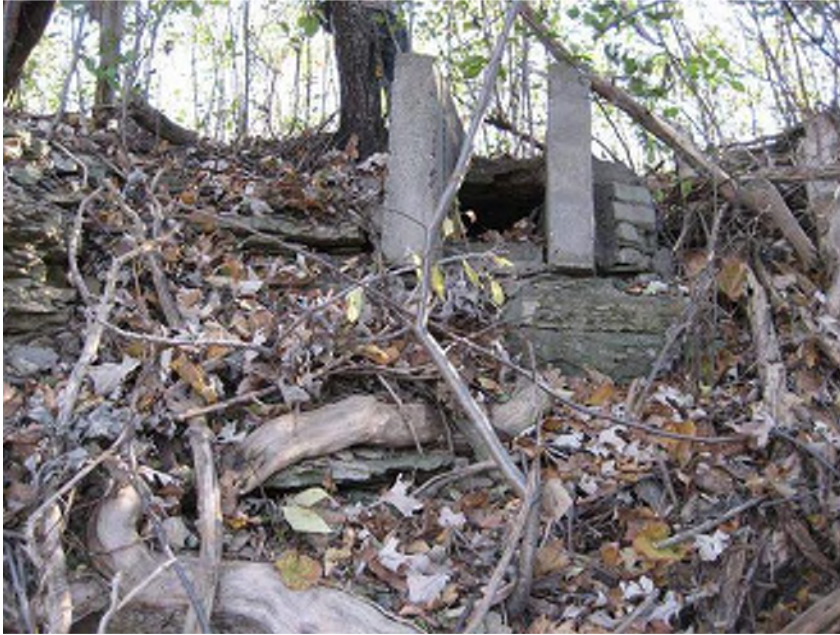
Waypoint 146A

Make-shift culvert made out of concrete; overall looks good.

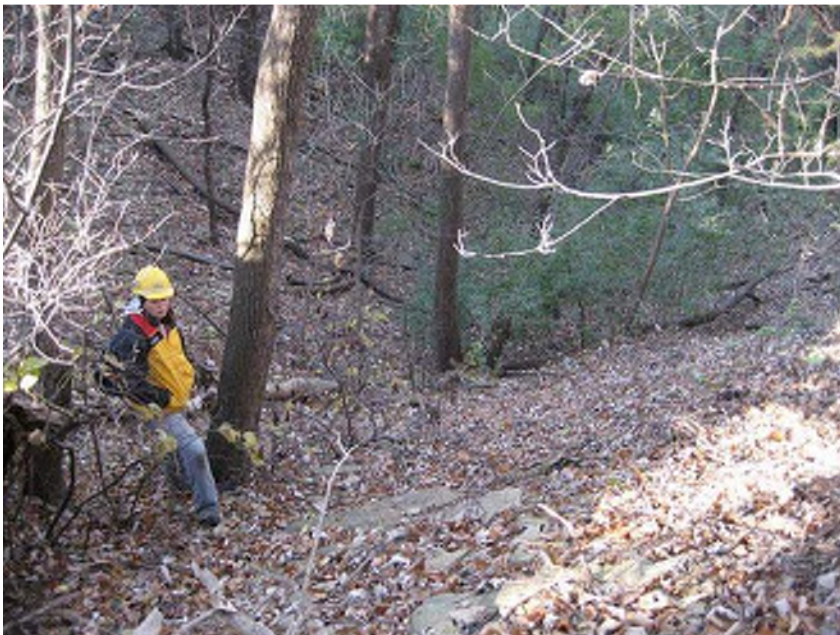
Looking down gully; flat rocks placed below culvert to slow down speed of water; very minor erosion; lots of cans, glass bottles, old metal

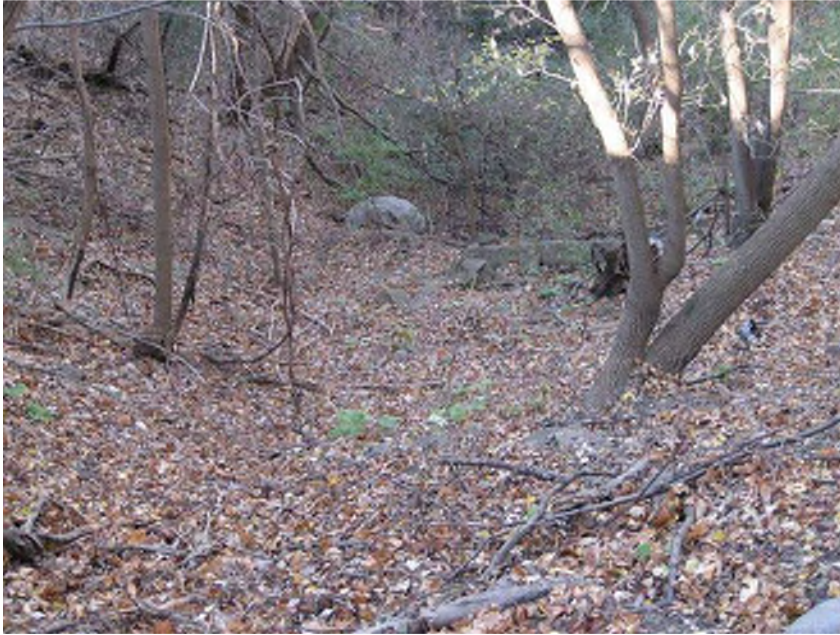
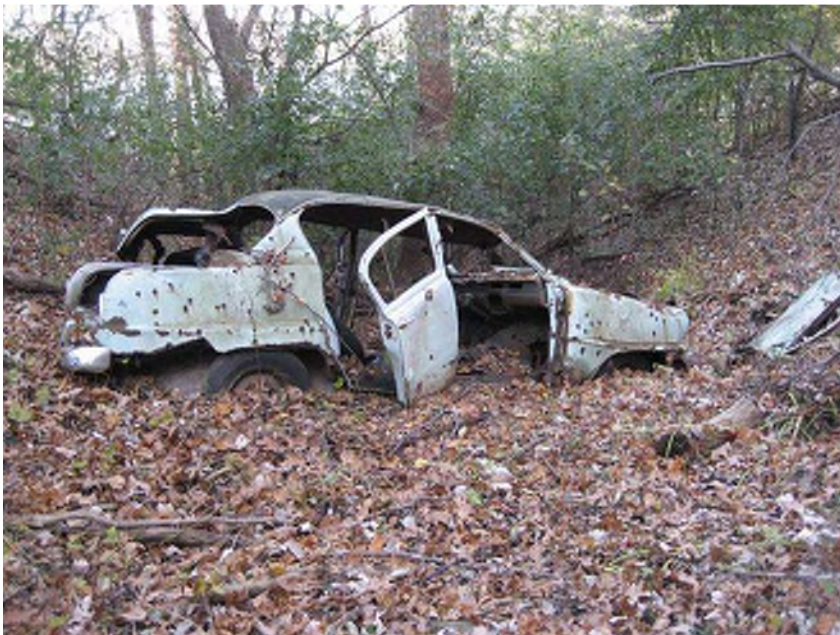
Waypoint 147A

Looking down gully; minimal erosion; some erosion due to uprooted tree; lots of old metal, cans, bottles and old are; at top there is a thic

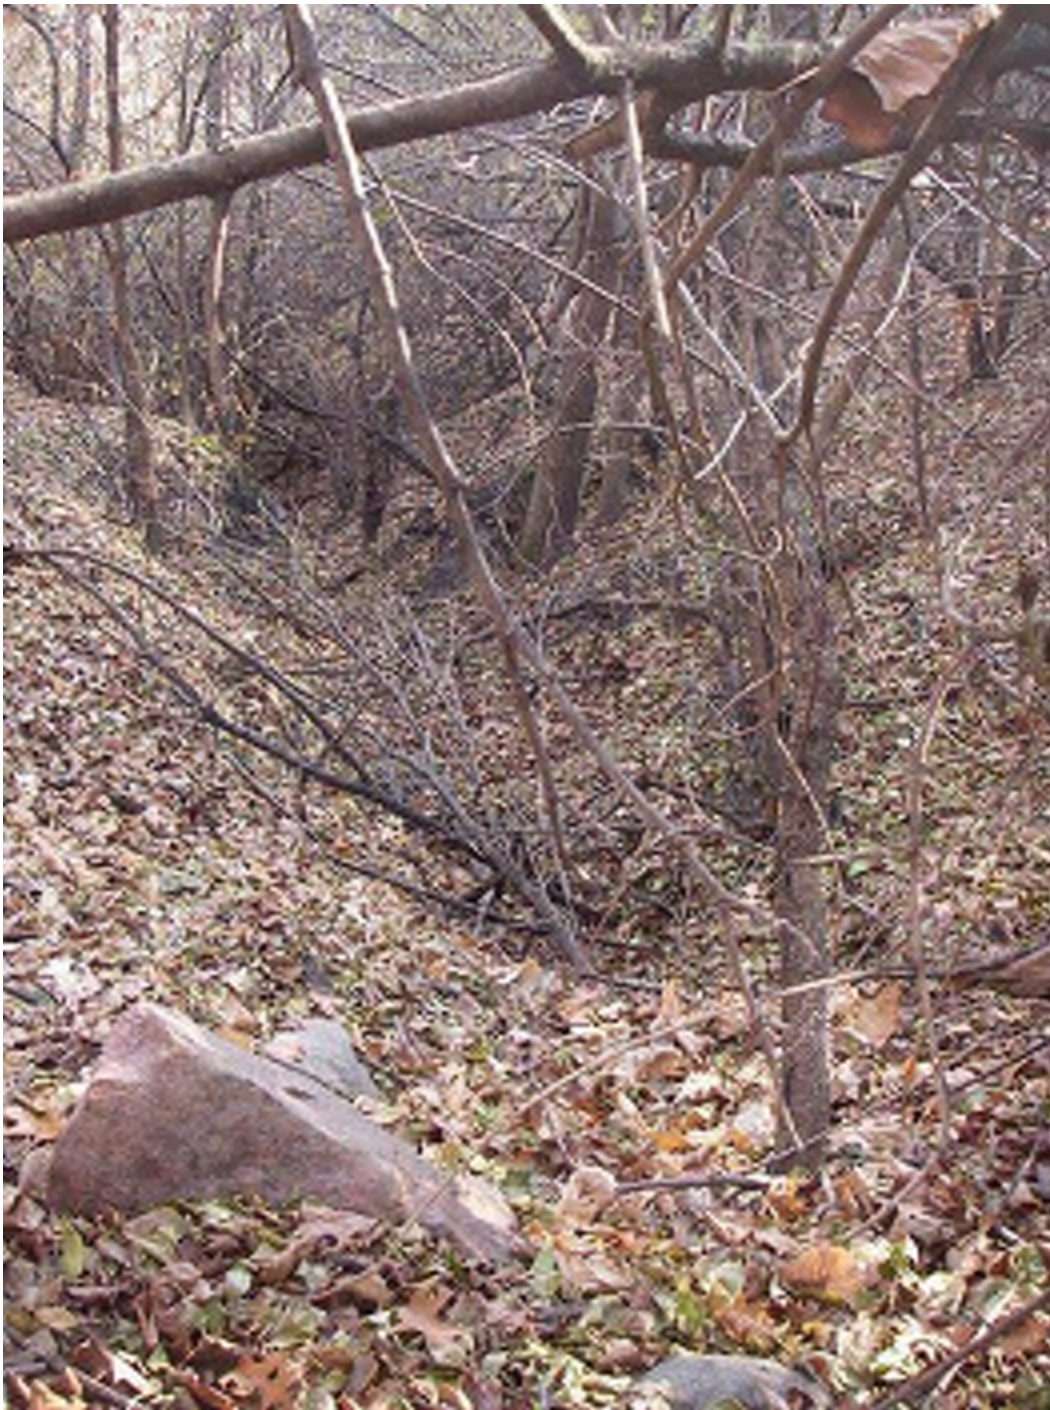
Start of gully

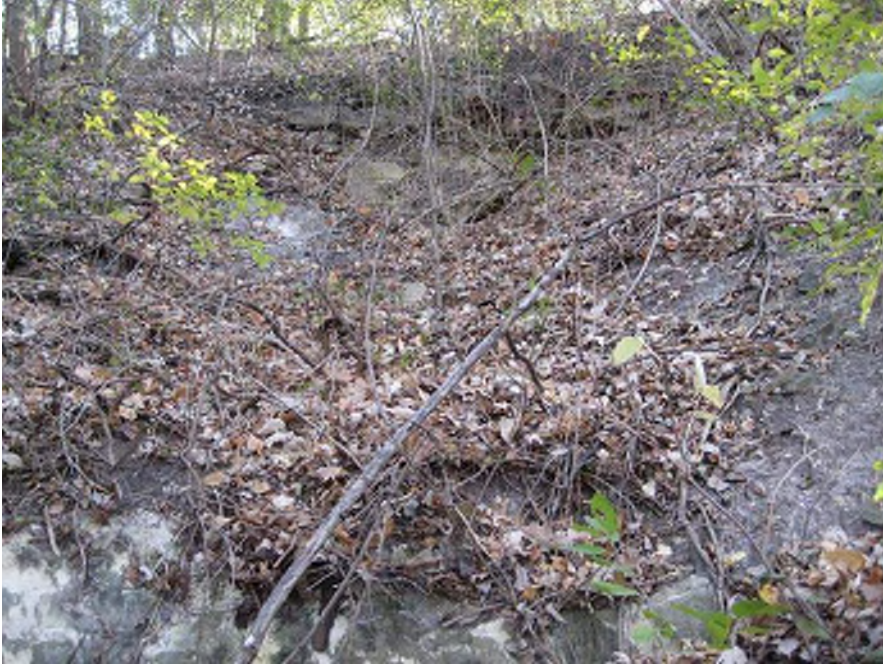
Waypoint 148A

Drop-off about 8-feet; major erosion at top then merges into a gully which has minimal erosion; looking up at beginning of drop-off.

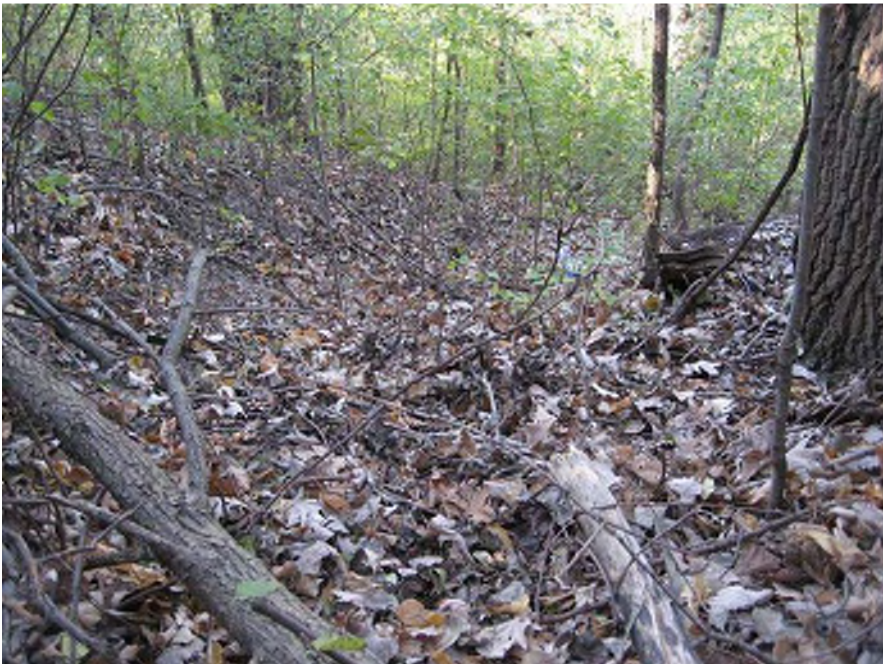
Looking down gully; small drop-off about 3-feet.

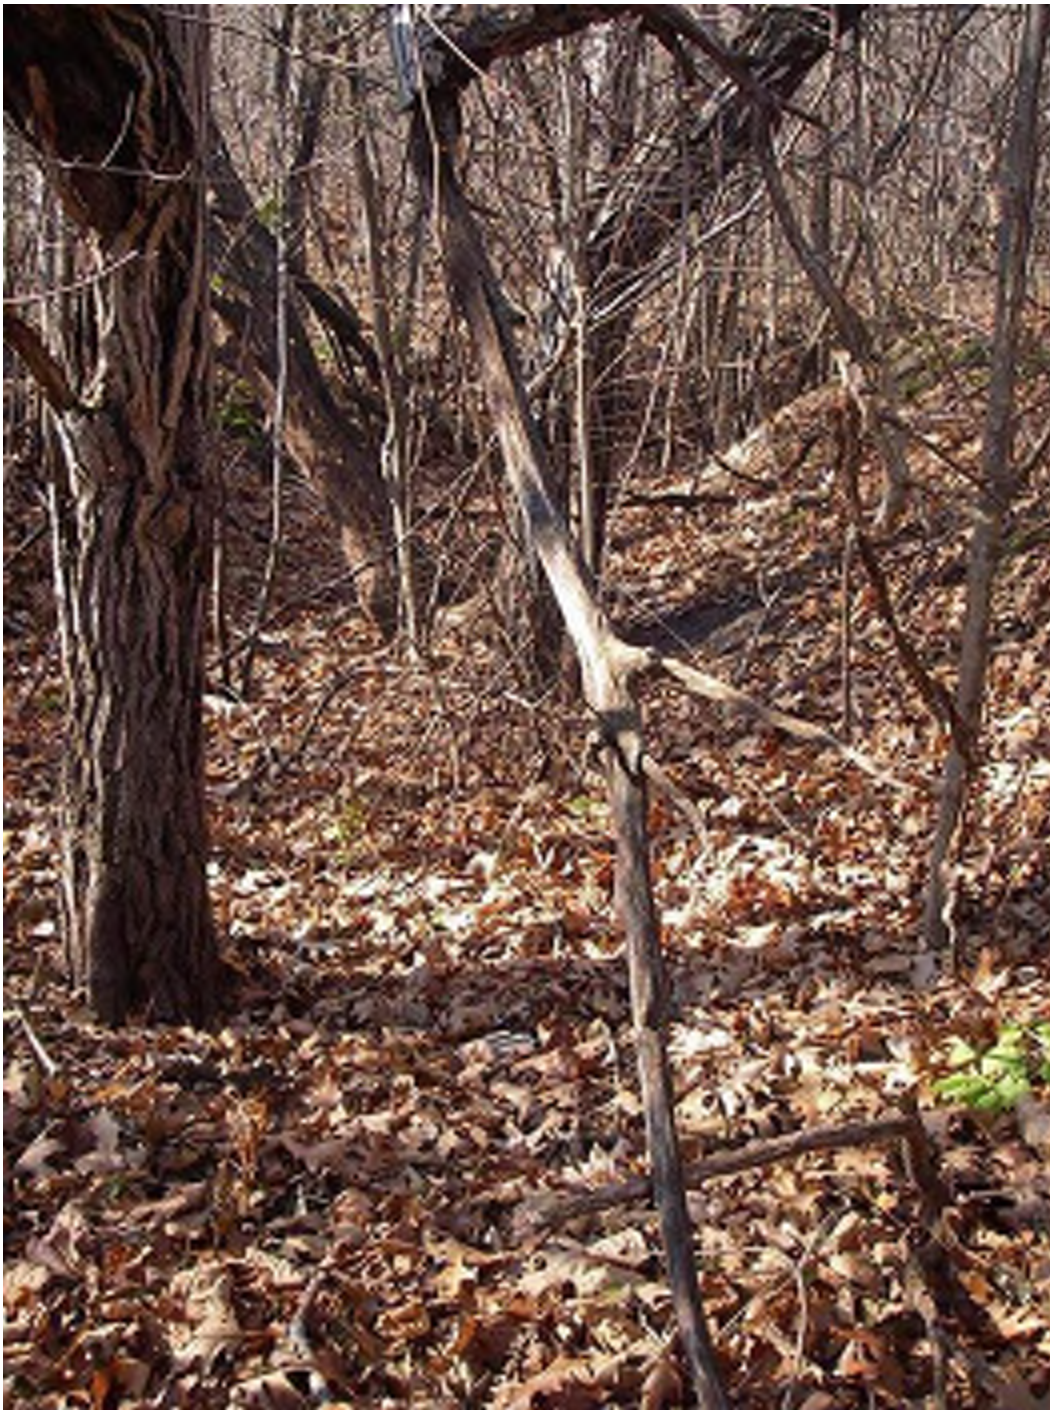
Waypoint 149

End of gully-mild to moderate erosion

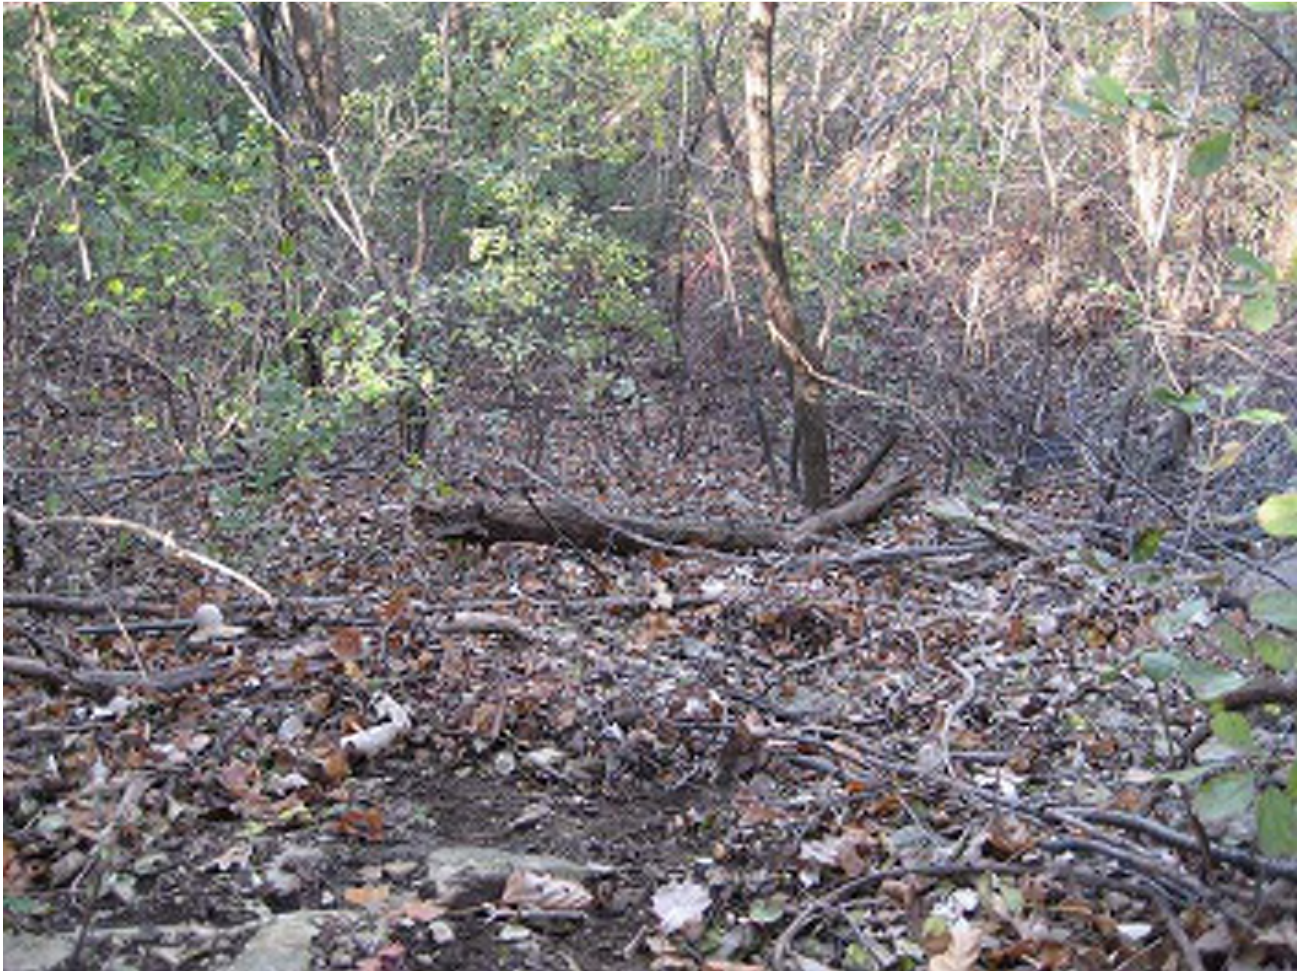
Waypoint 149A

Large gully with moderate to major erosion; hard to see sides of gully due to leaf litter.

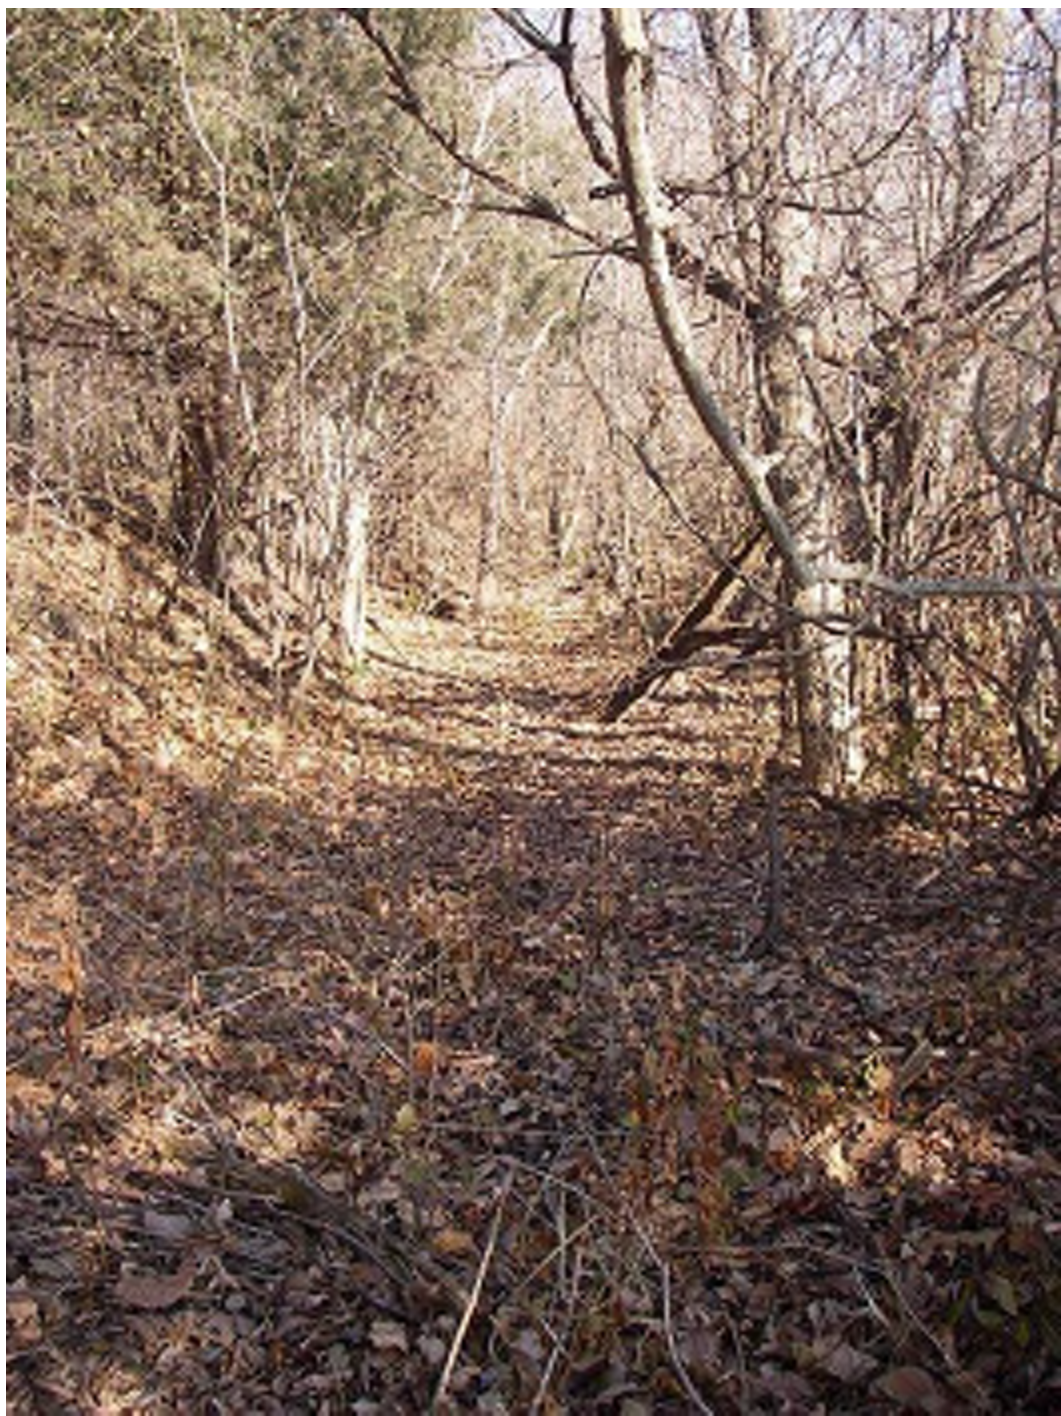
Waypoint 150

End -no major concerns

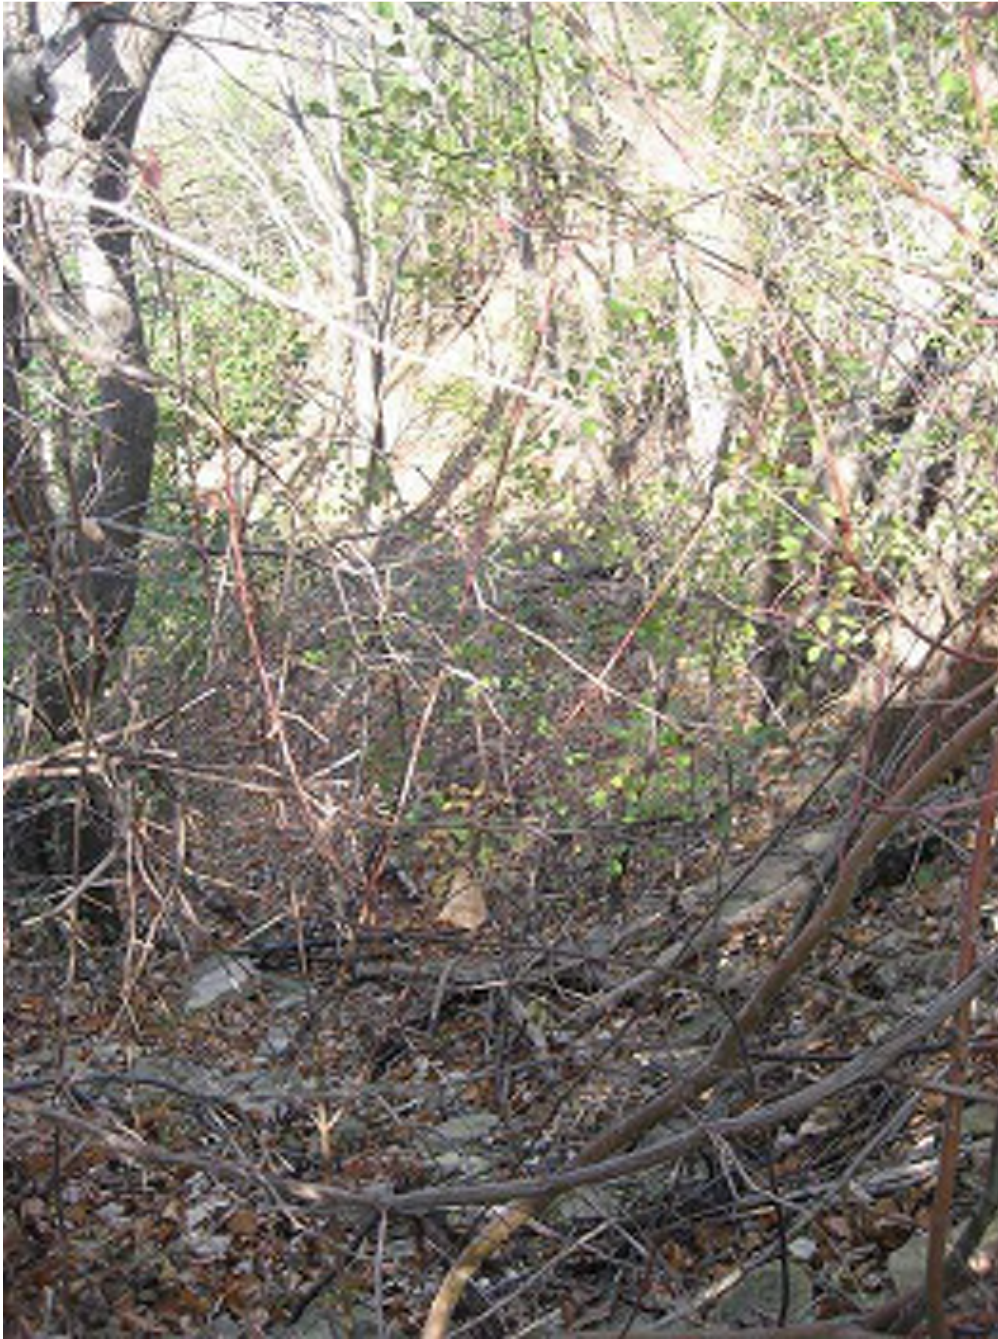
Waypoint 150A

Looking down gully; lots of rock at top of gully; minimal erosion.

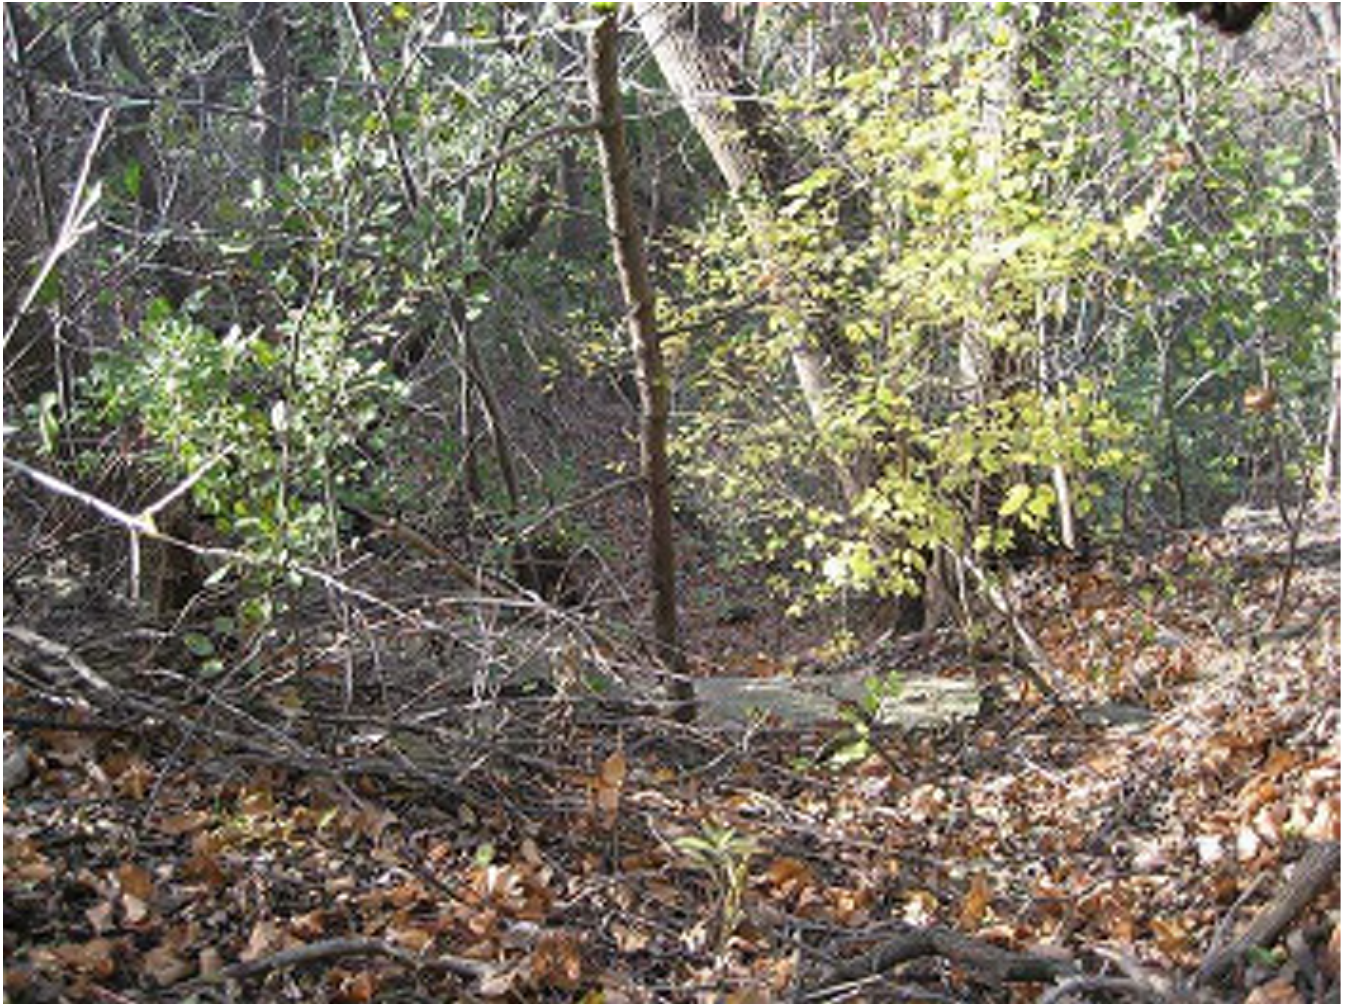
Looking down gully; lots of rock at top of gully; minimal erosion.

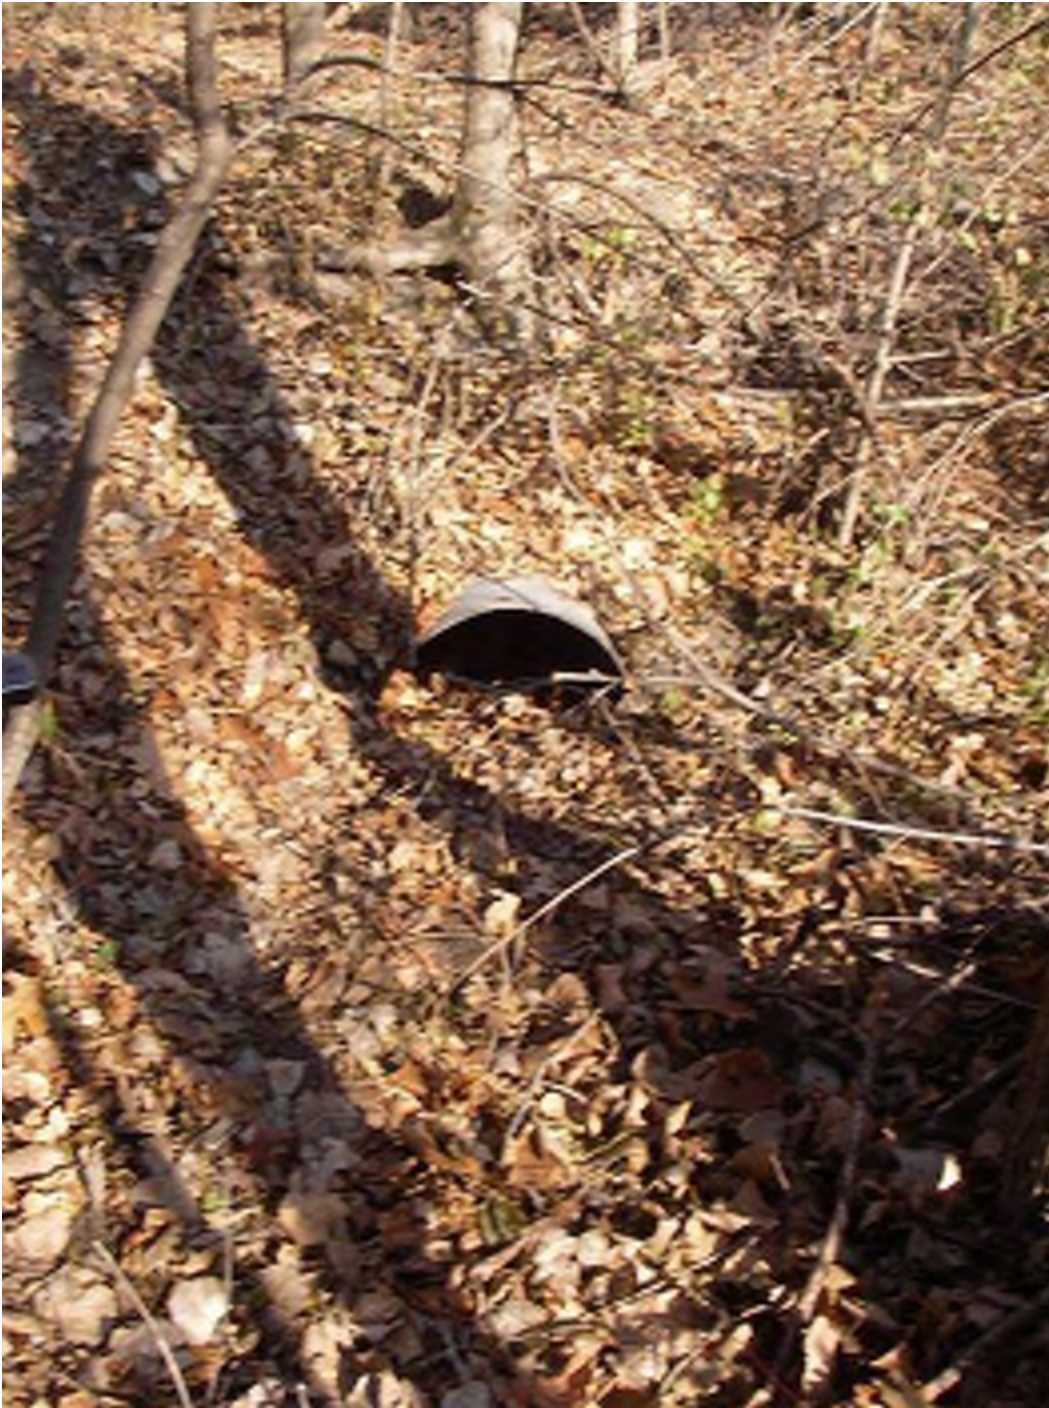
Waypoint 151

Drain pipe

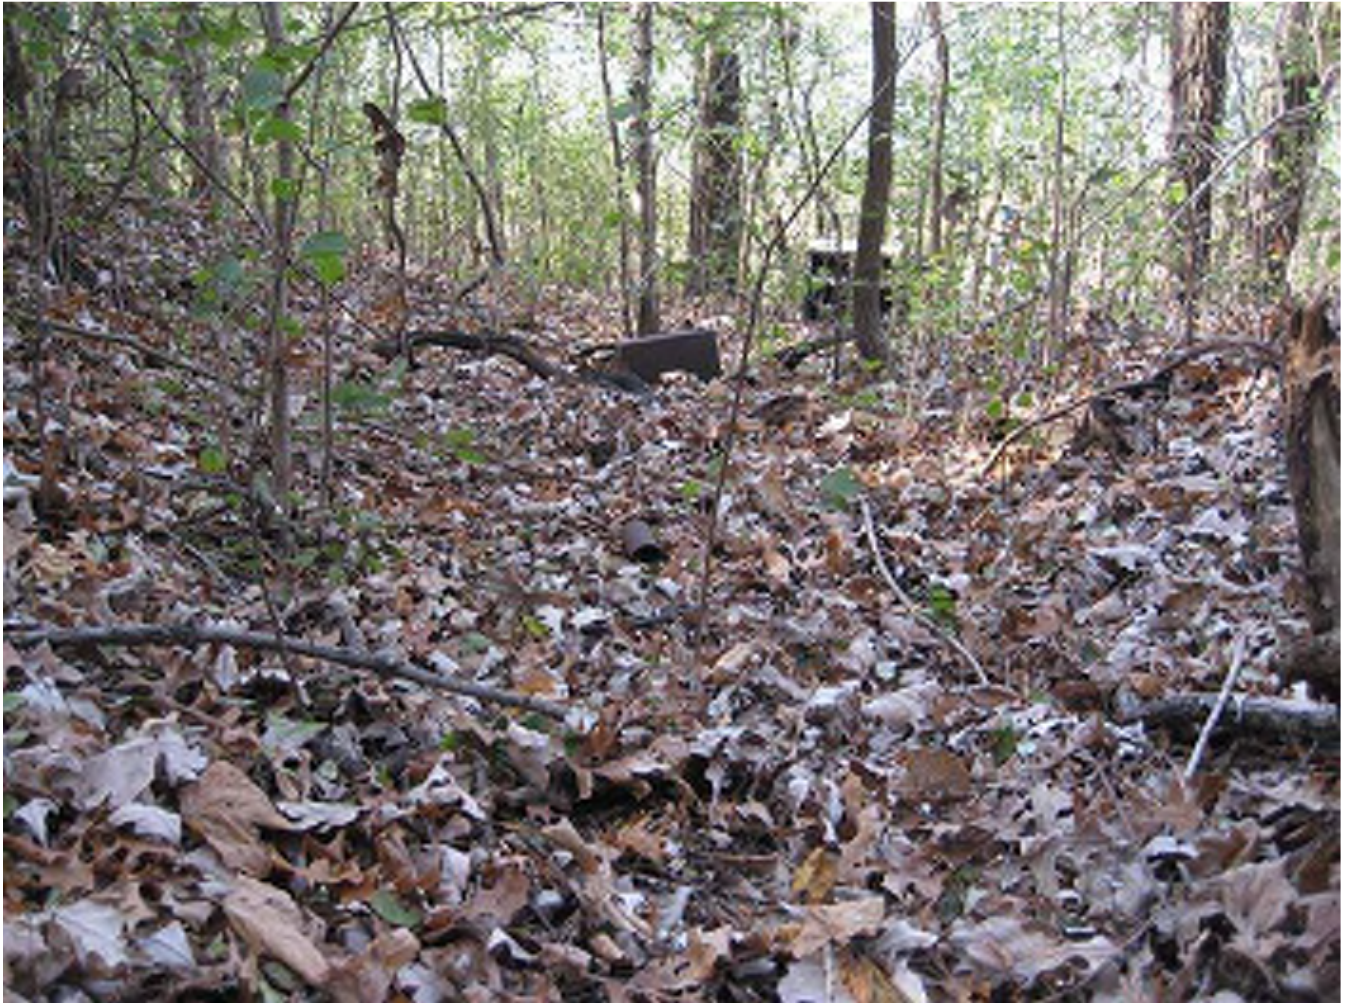
Waypoint 151A

Bottom of gully of waypoint 150A; minimal erosion.

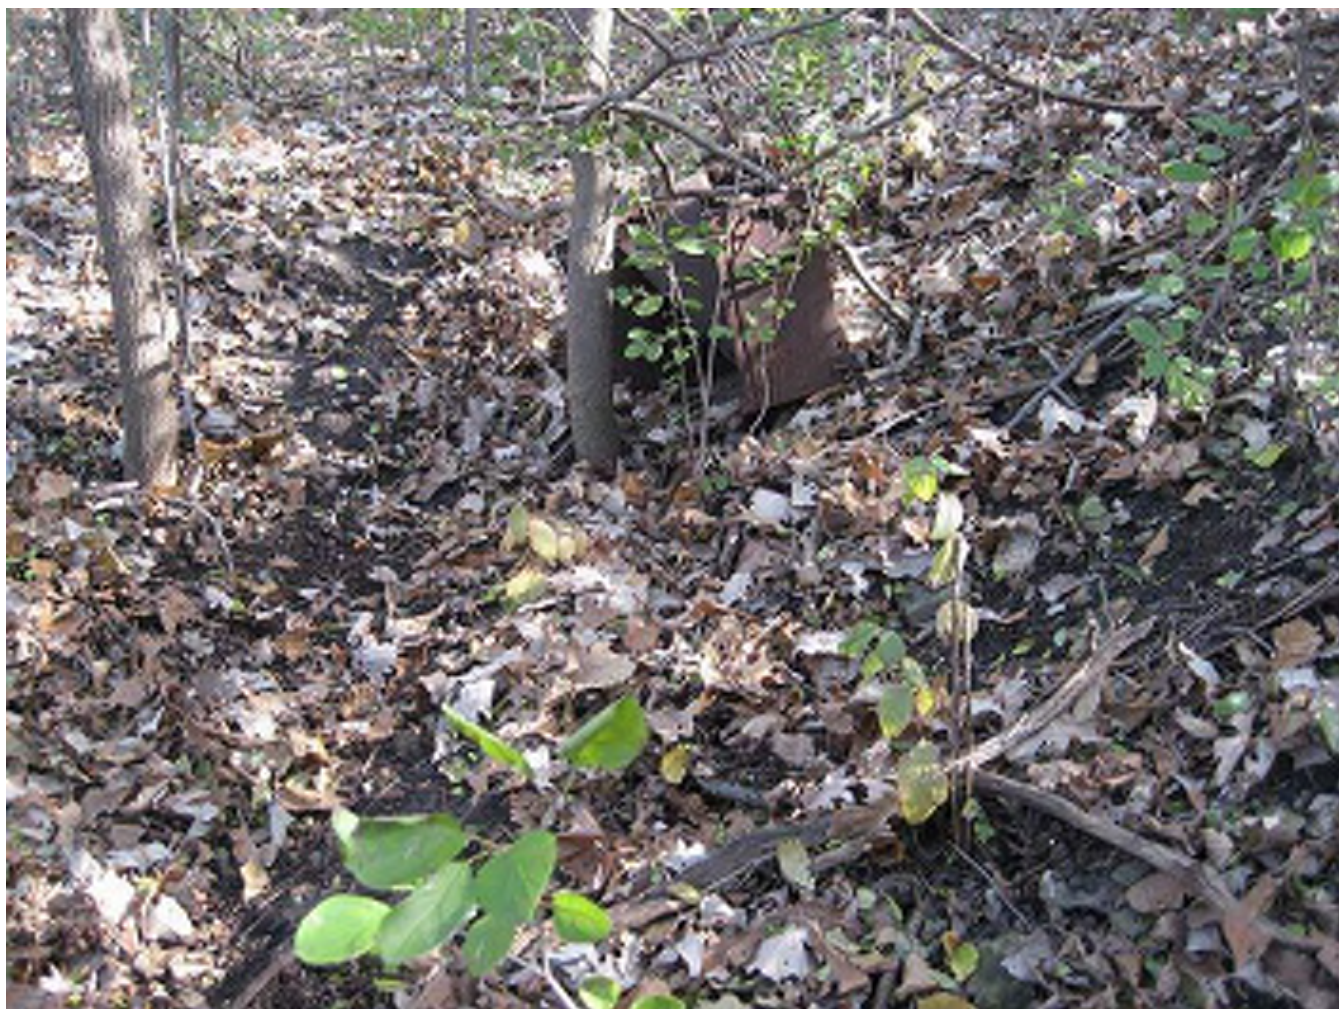
Bottom of gully of waypoint 150A; minimal erosion.

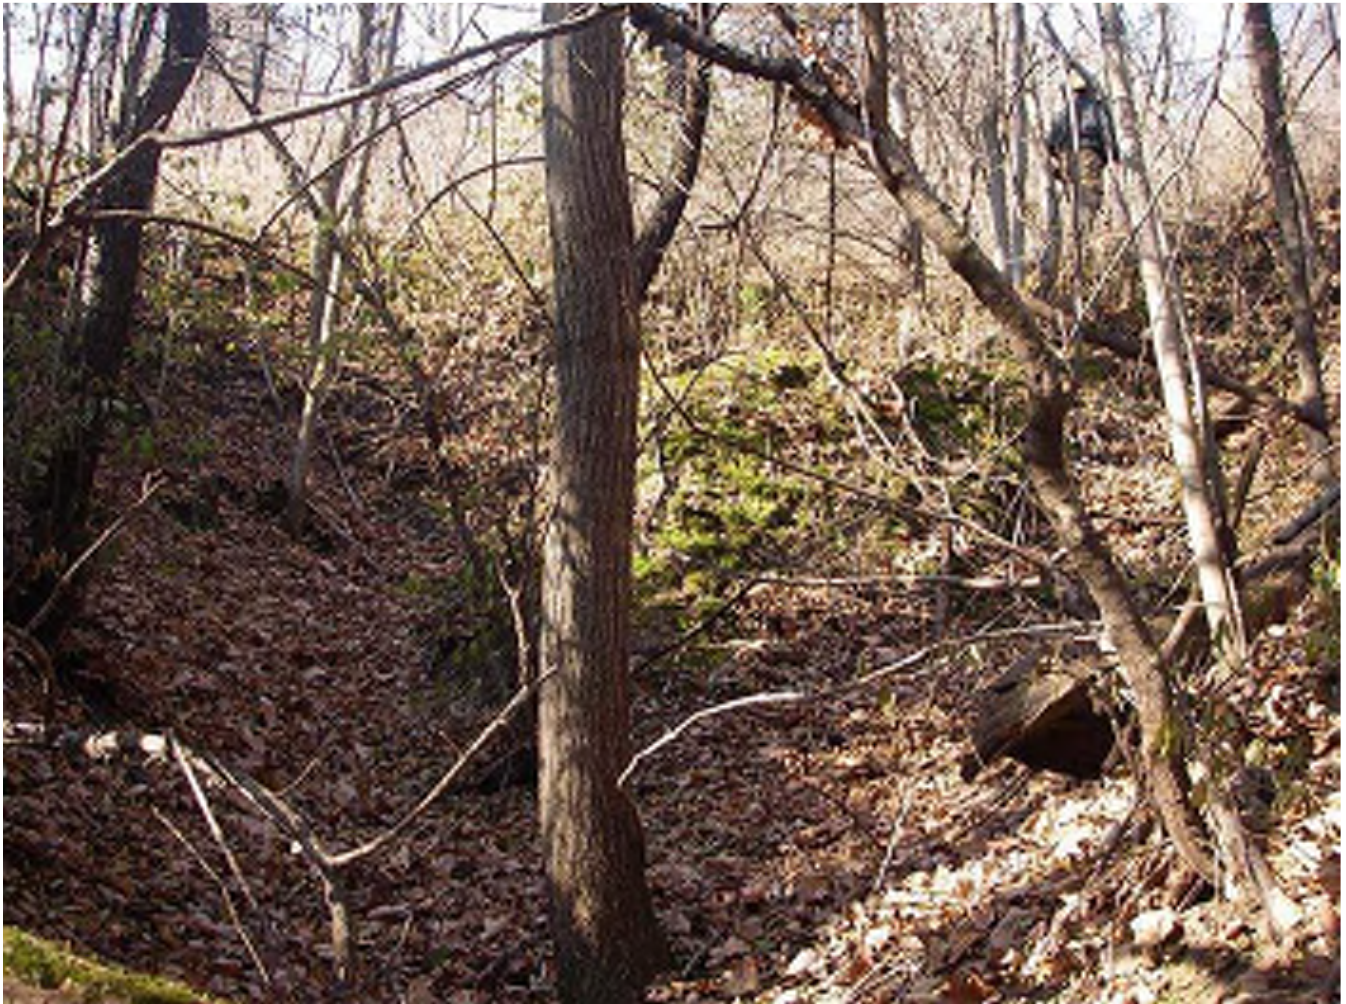
Waypoint 152

Branch

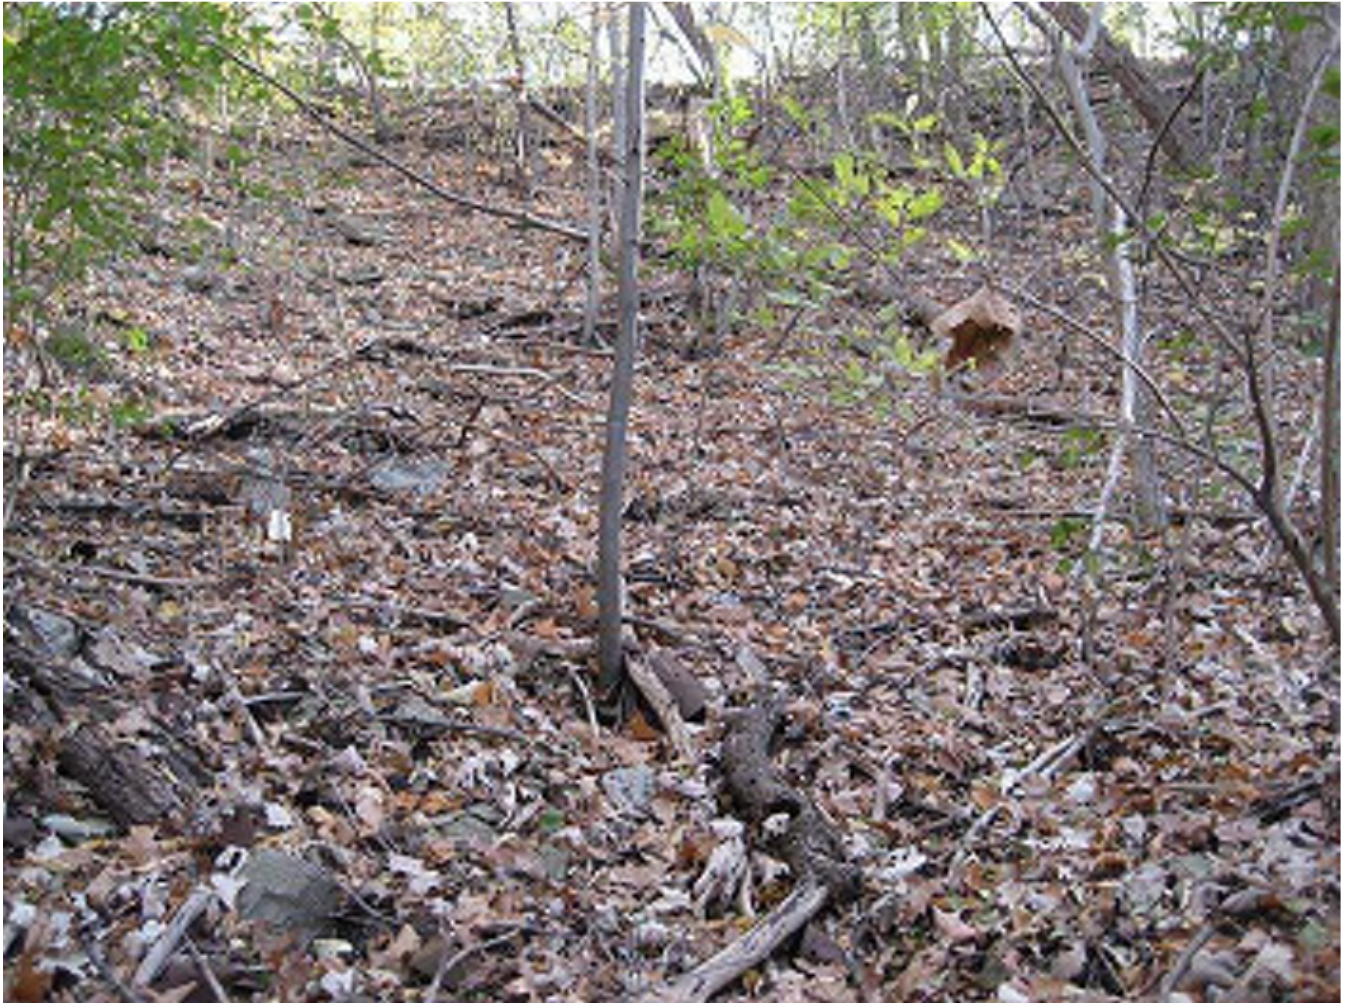
Waypoint 152A

Looking up at gully; minimal erosion.
