Appendix K: Lower Minnesota River Watershed District: Gully Inventory

Gully Inventory Map
 Area #1
 Lower Minnesota River Watershed District
 Watershed Management Plan

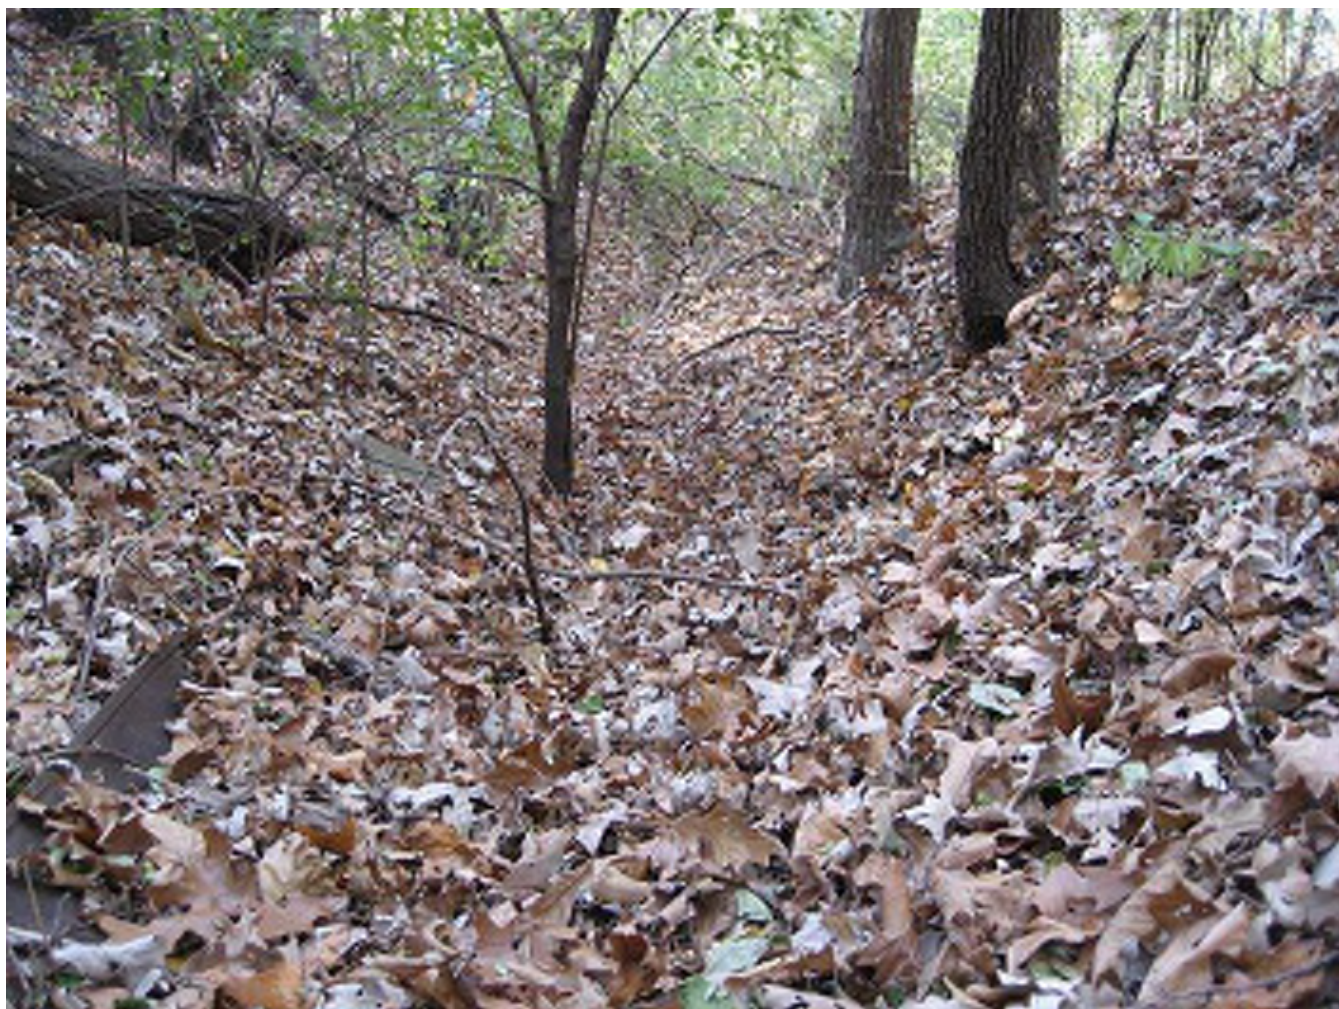
Looking downhill at gully; minimal erosion.

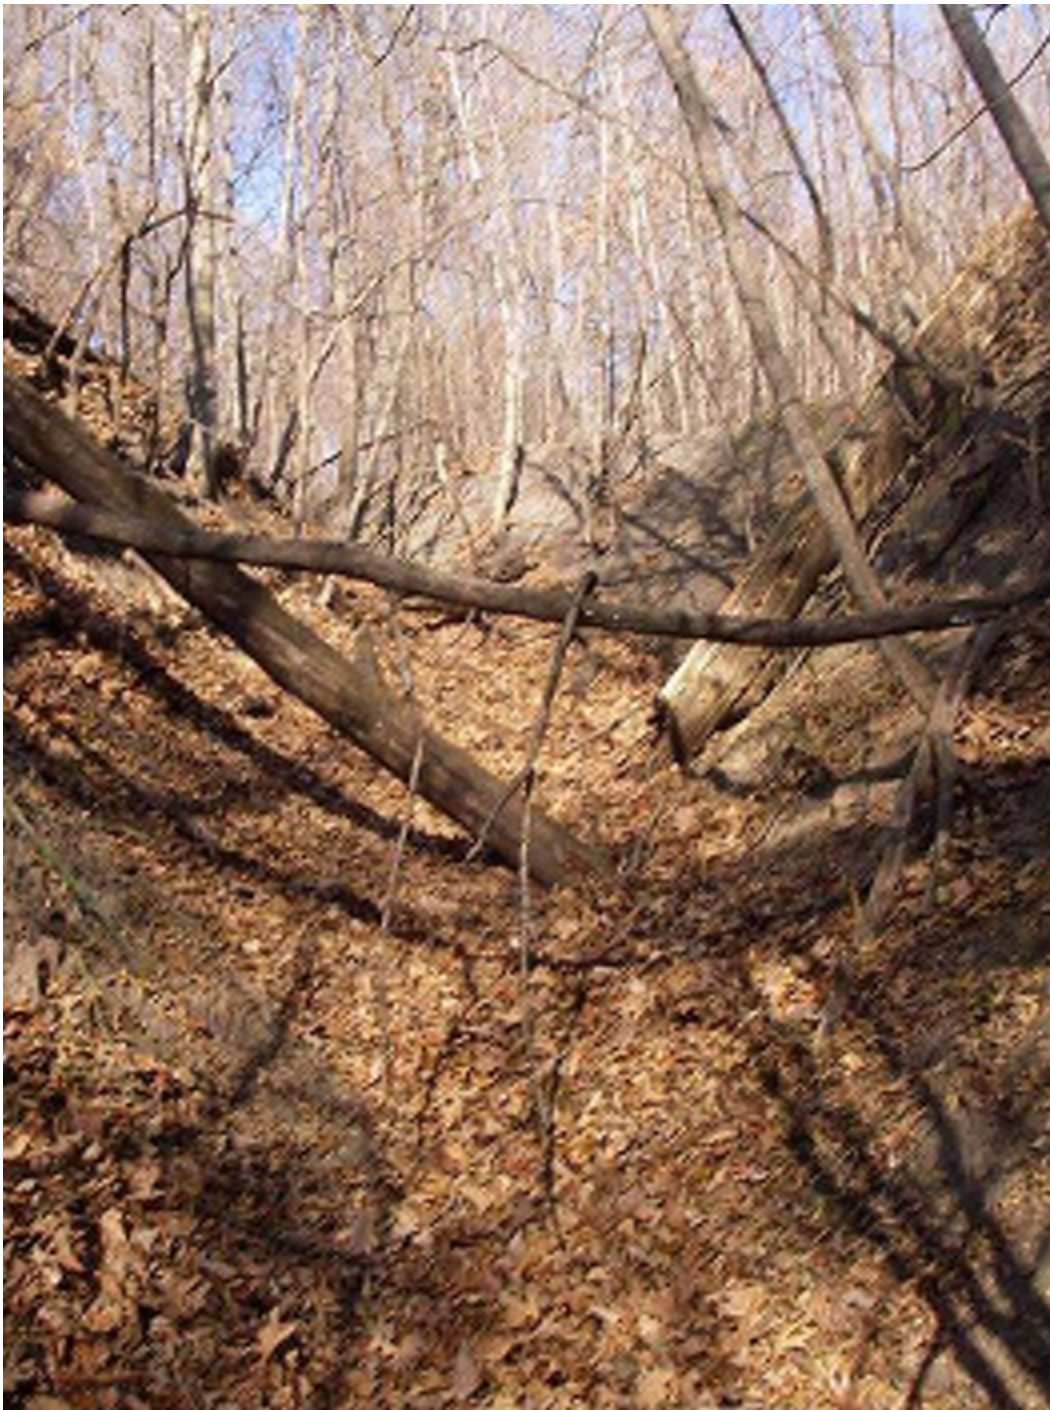
Waypoint 153

Branch w/moderate to severe erosion

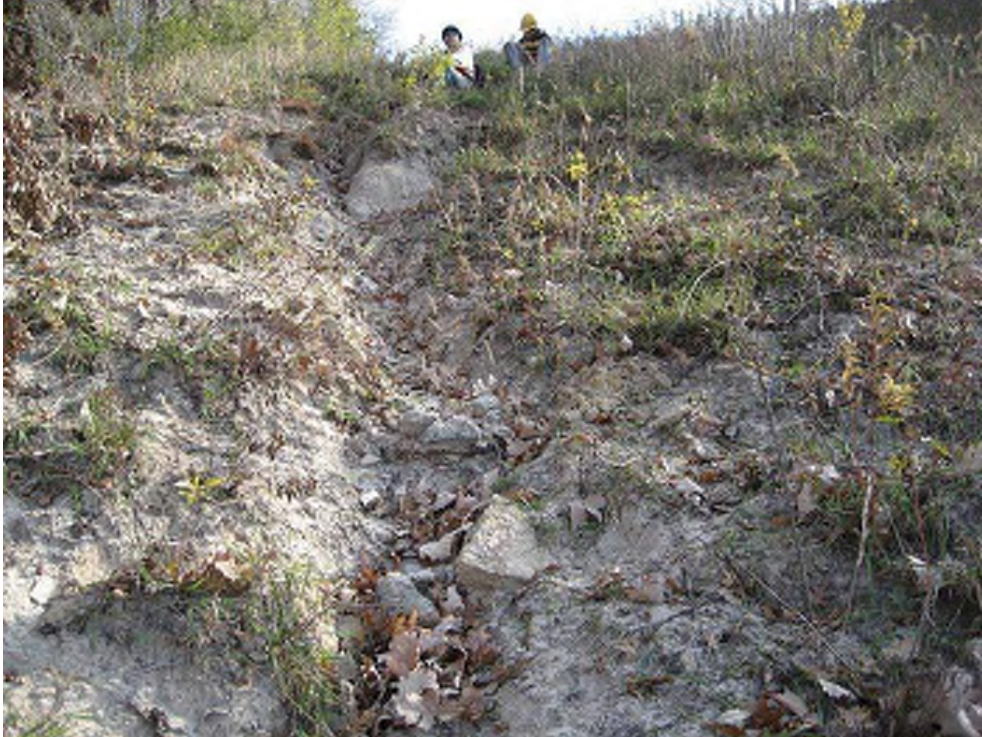
Waypoint 153A

Looking up at some moderate erosion; looks like water coming down a deer trail and starting to erode part of the slope.

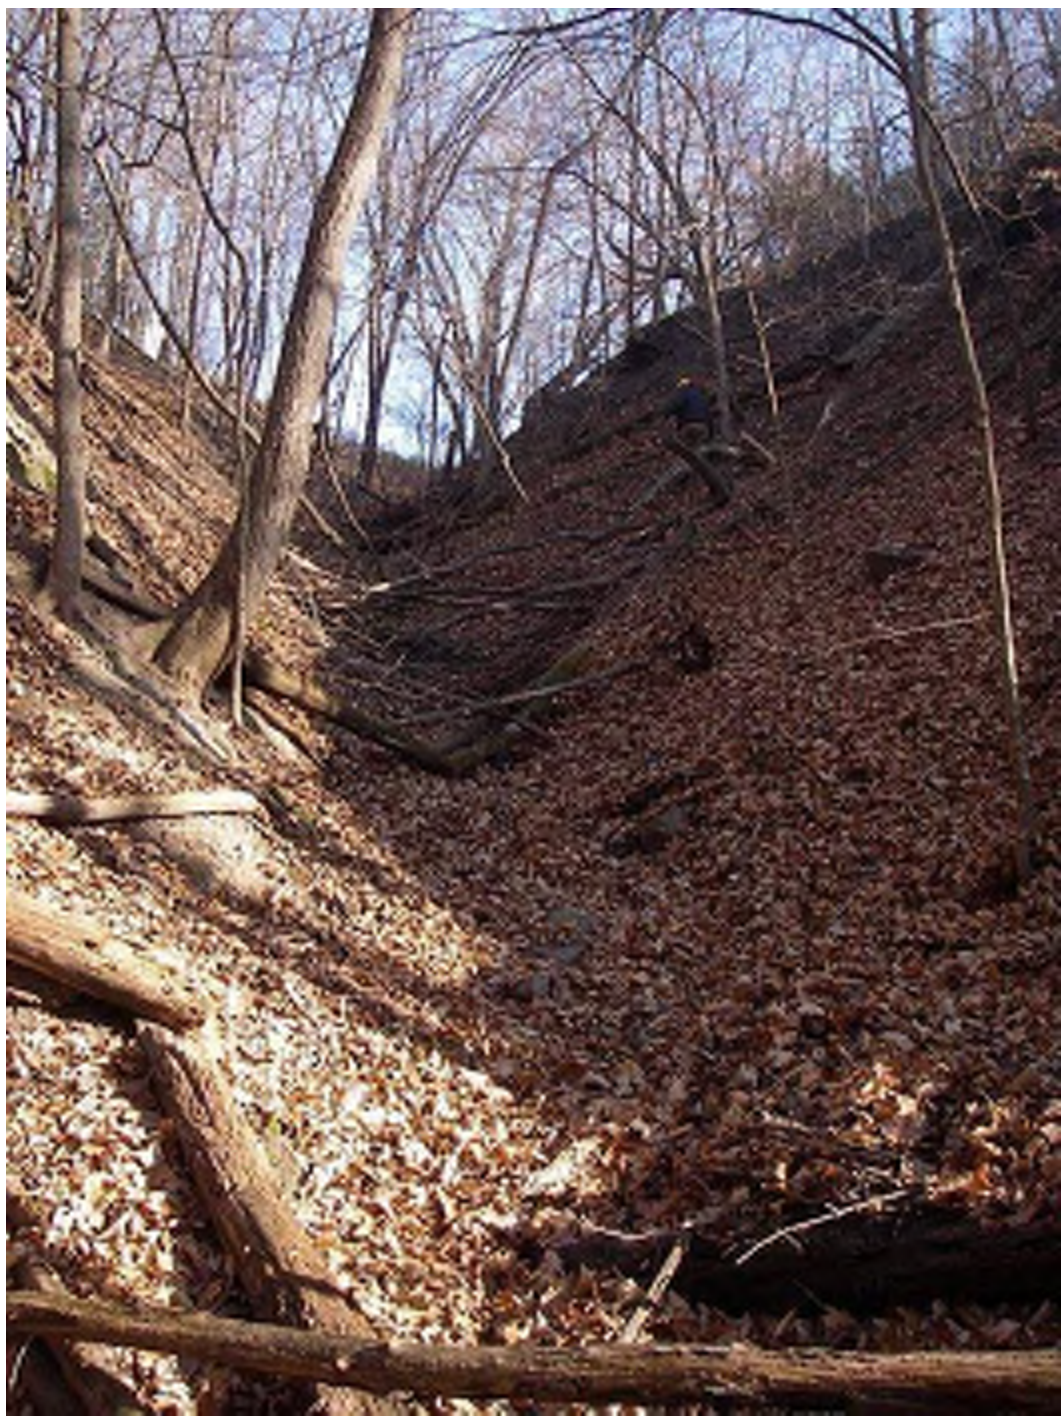
Waypoint 154

Branch

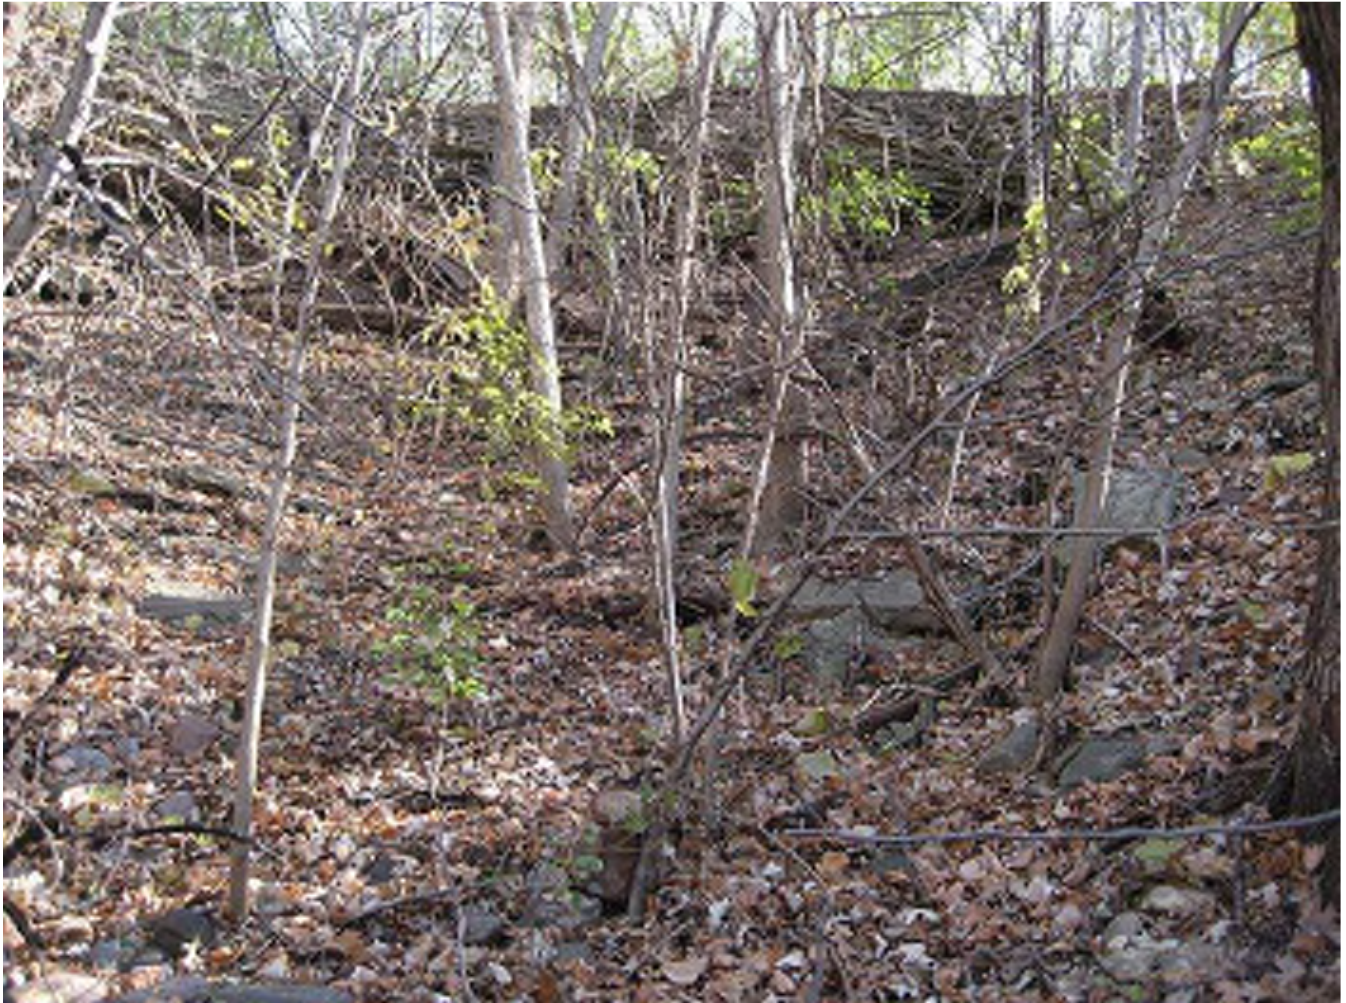
Waypoint 154A

Looking up at gully; top of gully about a 10-foot layer of rock.

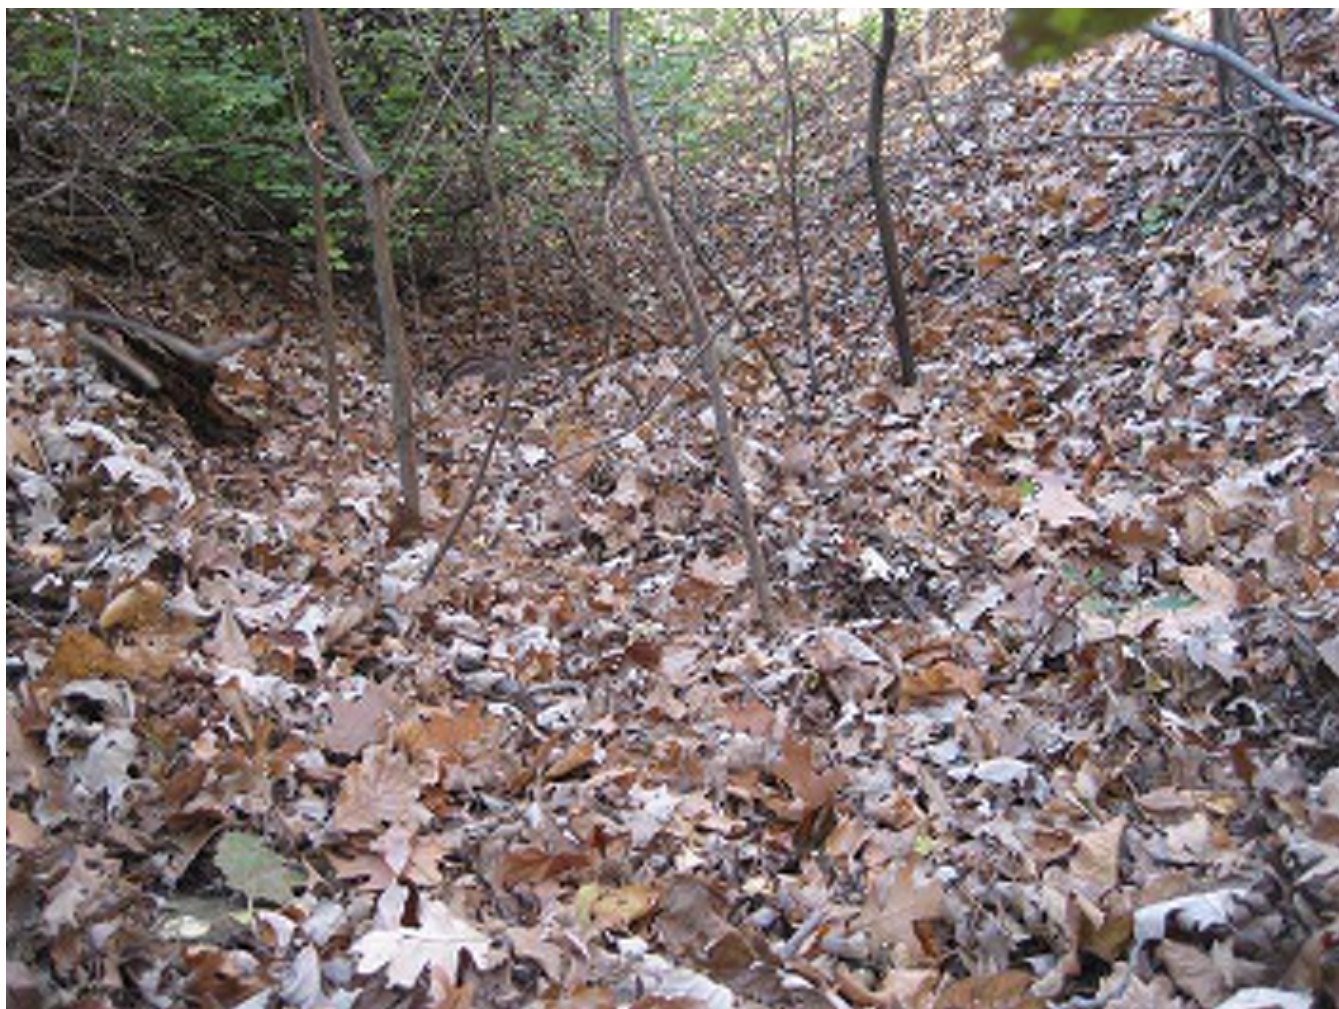
Looking down gully; some sides of gully have moderate erosion.

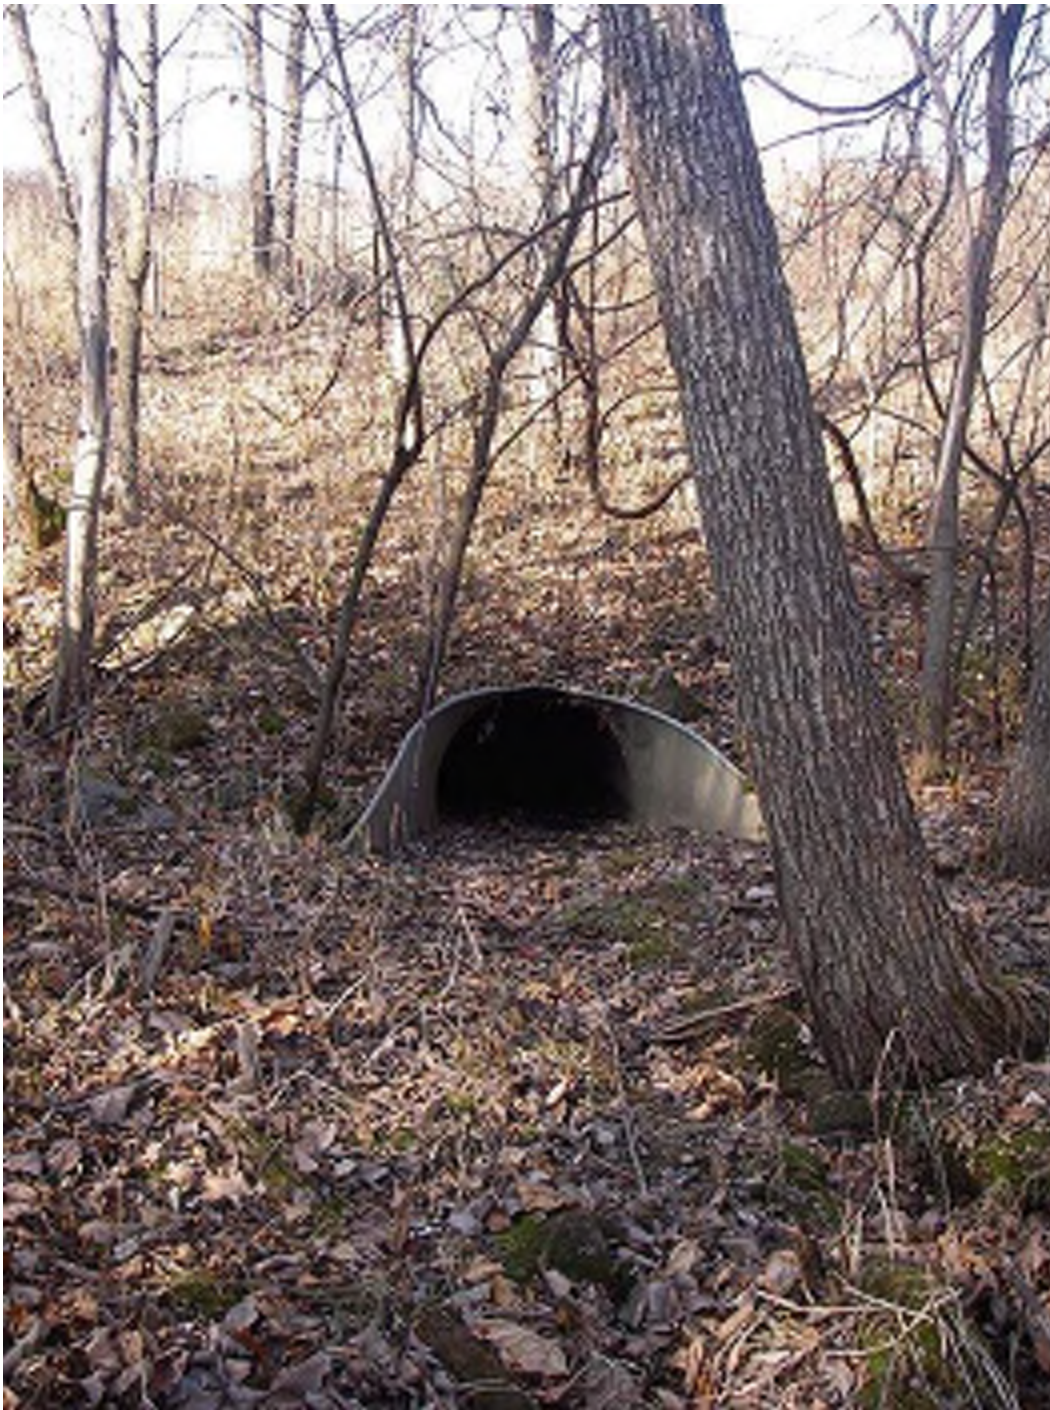
Waypoint 155

Start and drain pipe

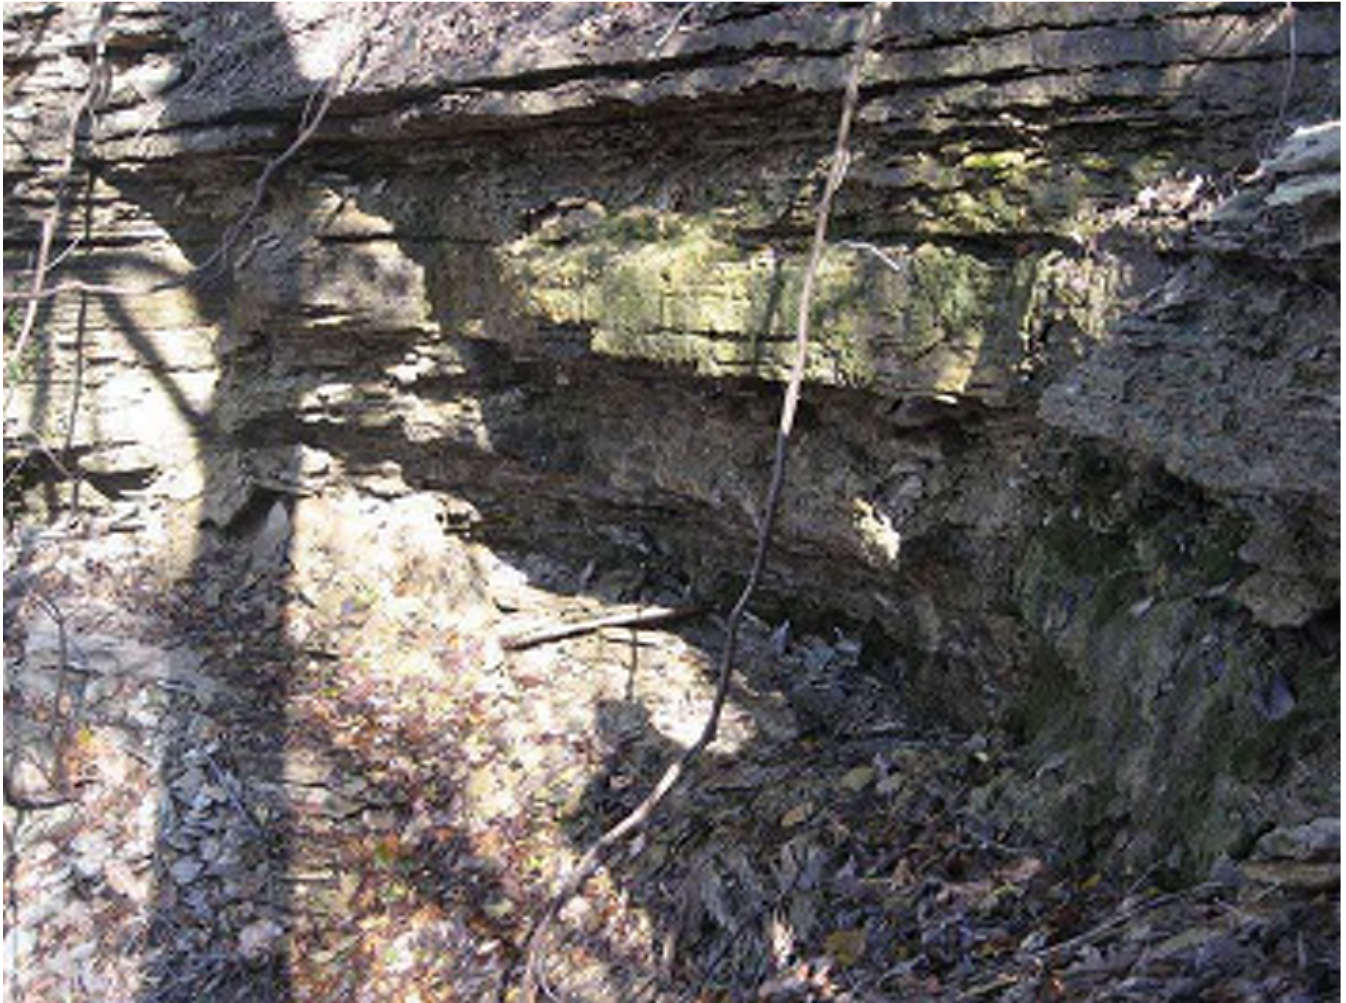
Waypoint 155A

Large rock shelf at top of gully with water coming out of rock layer.

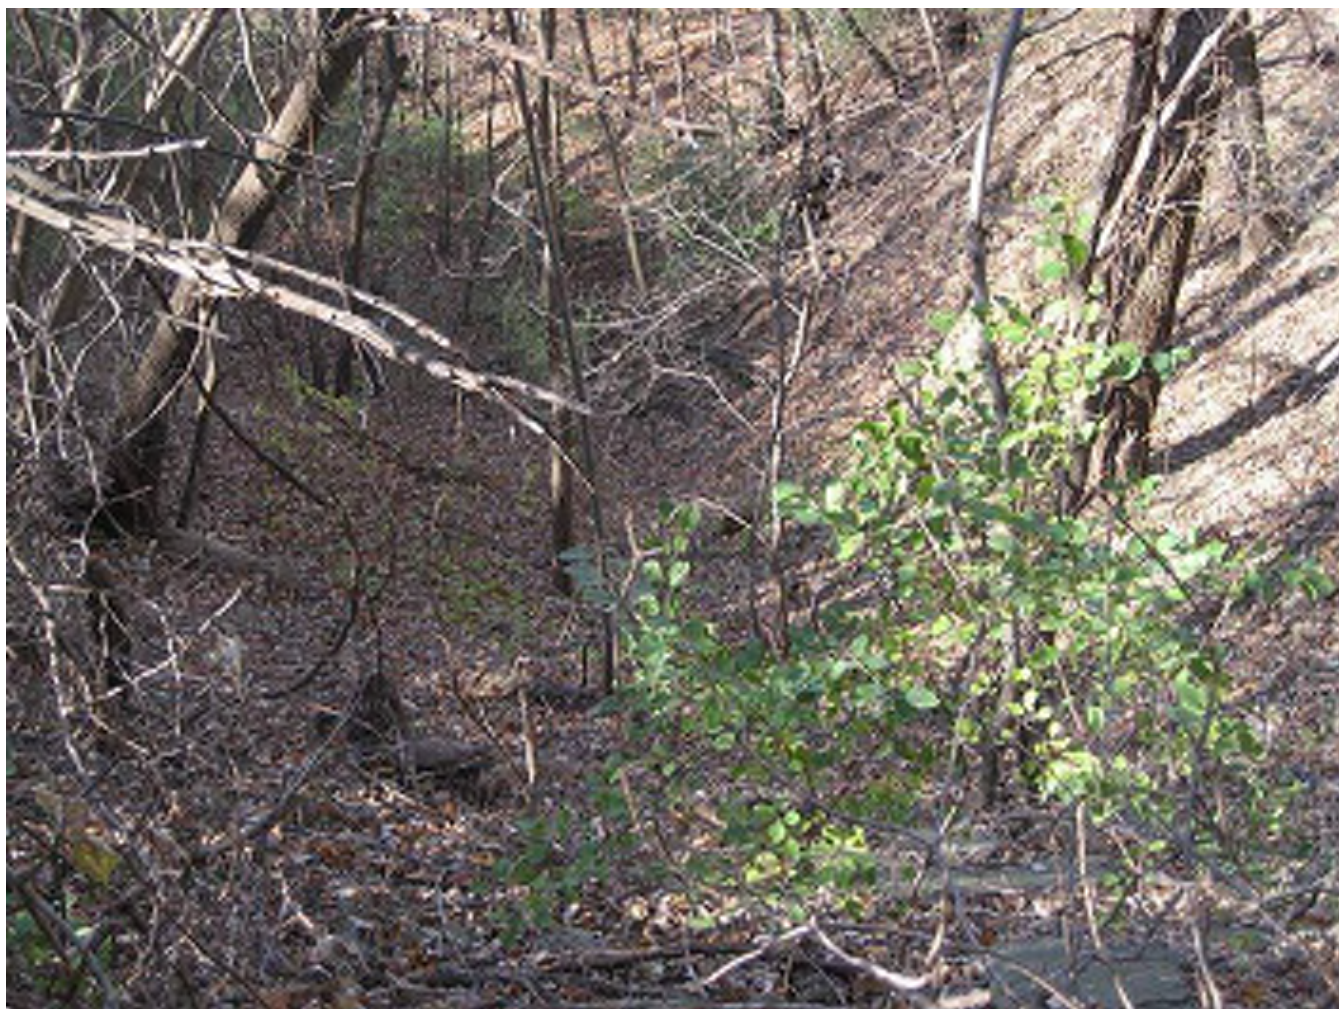
Looking down gully; minor to moderate erosion.

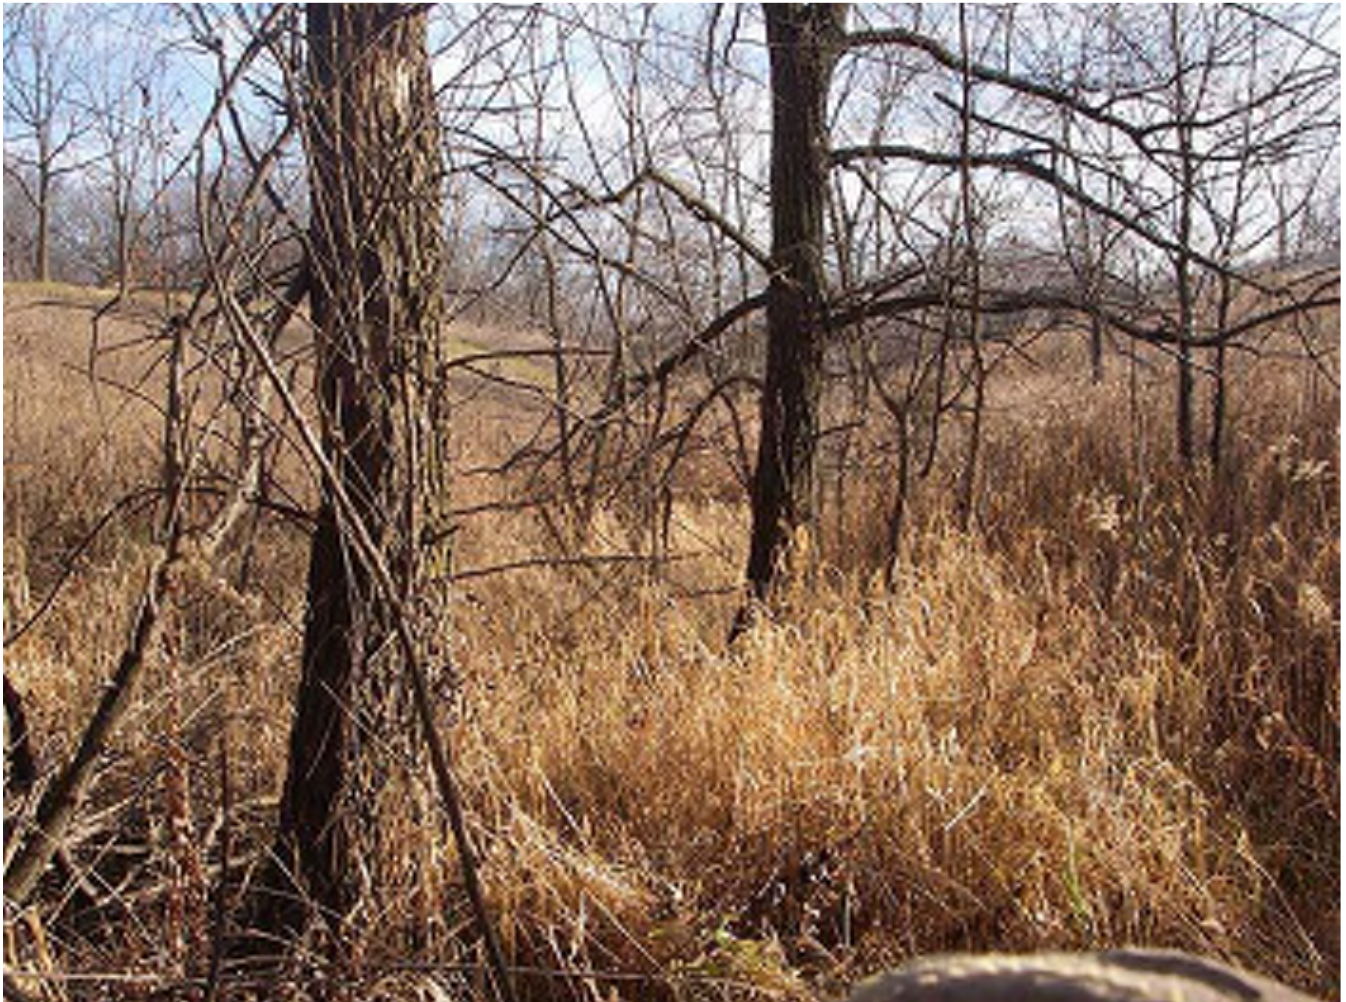
Waypoint 156

Start

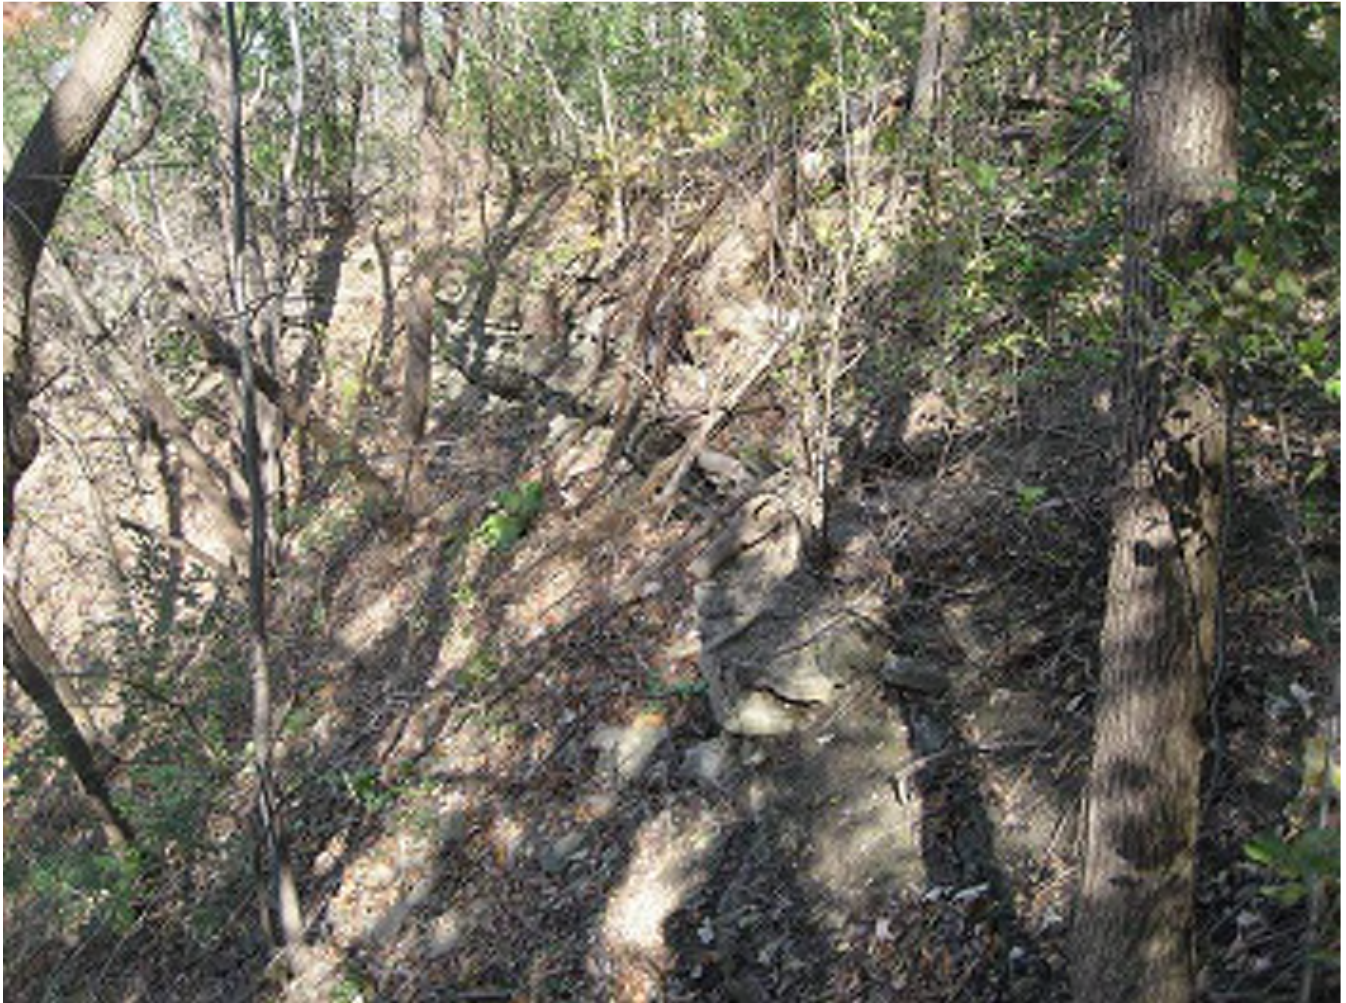
Waypoint 156A

Large rock shelf at top of gully with an approx. 6-foot drop off.

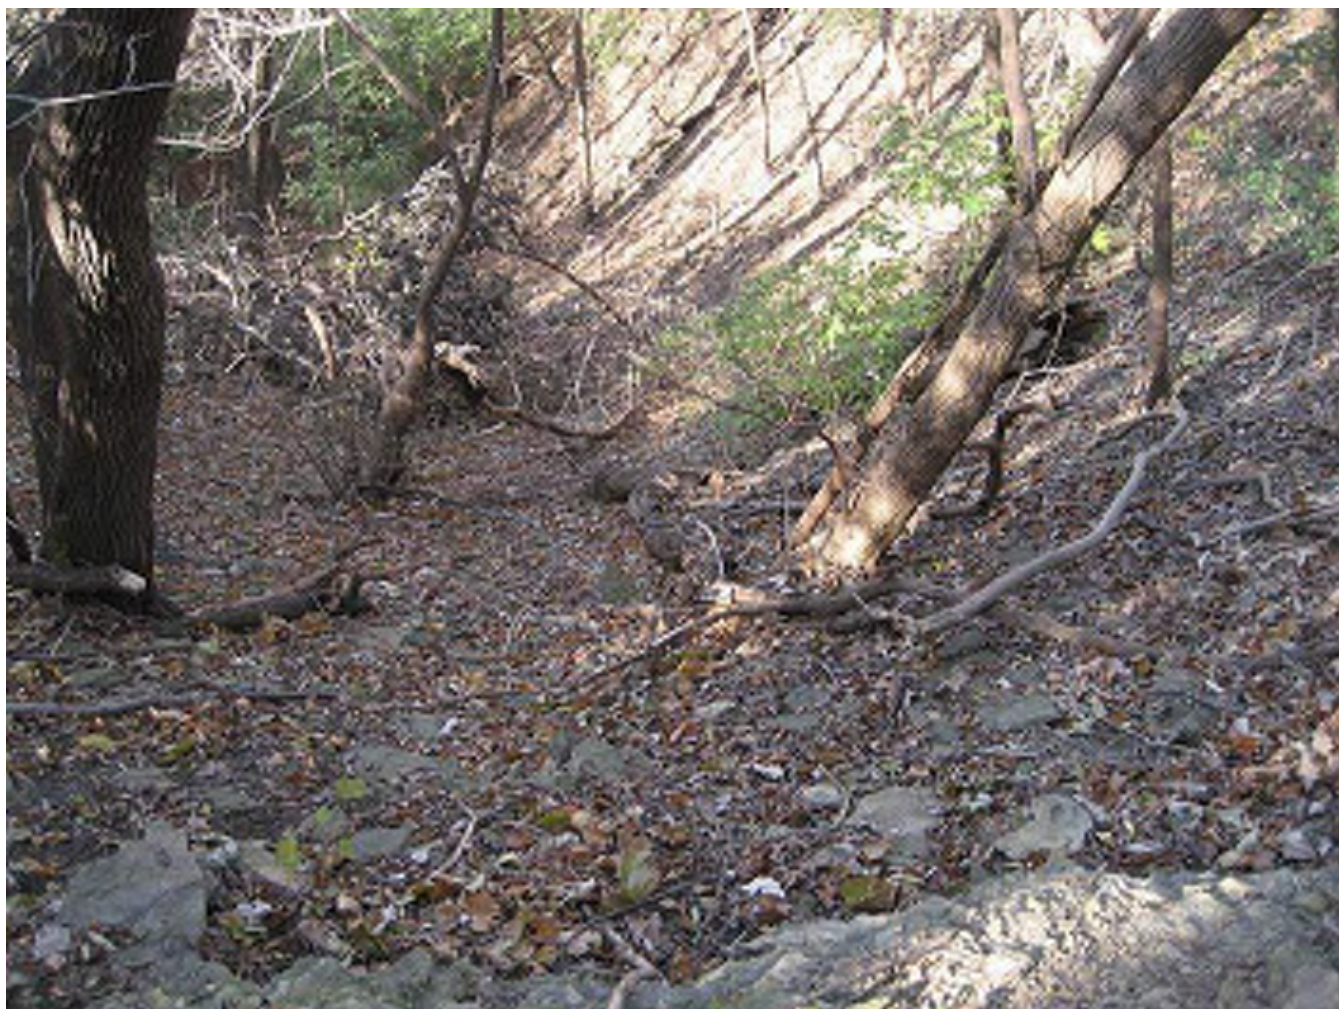
Looking down gully; minimal to moderate erosion.

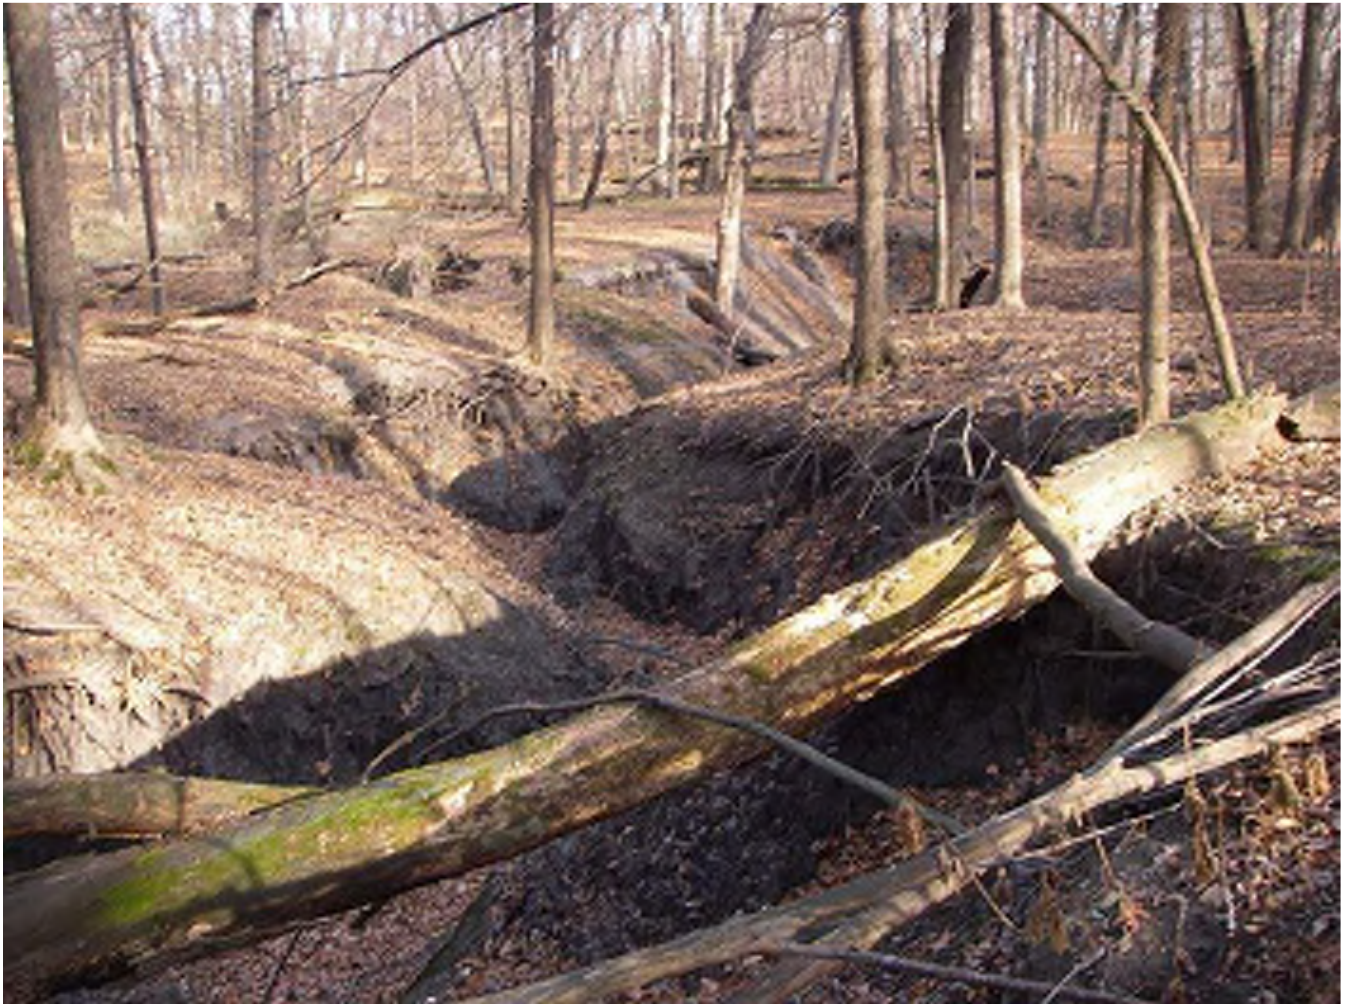
Waypoint 157

Garbage and erosion

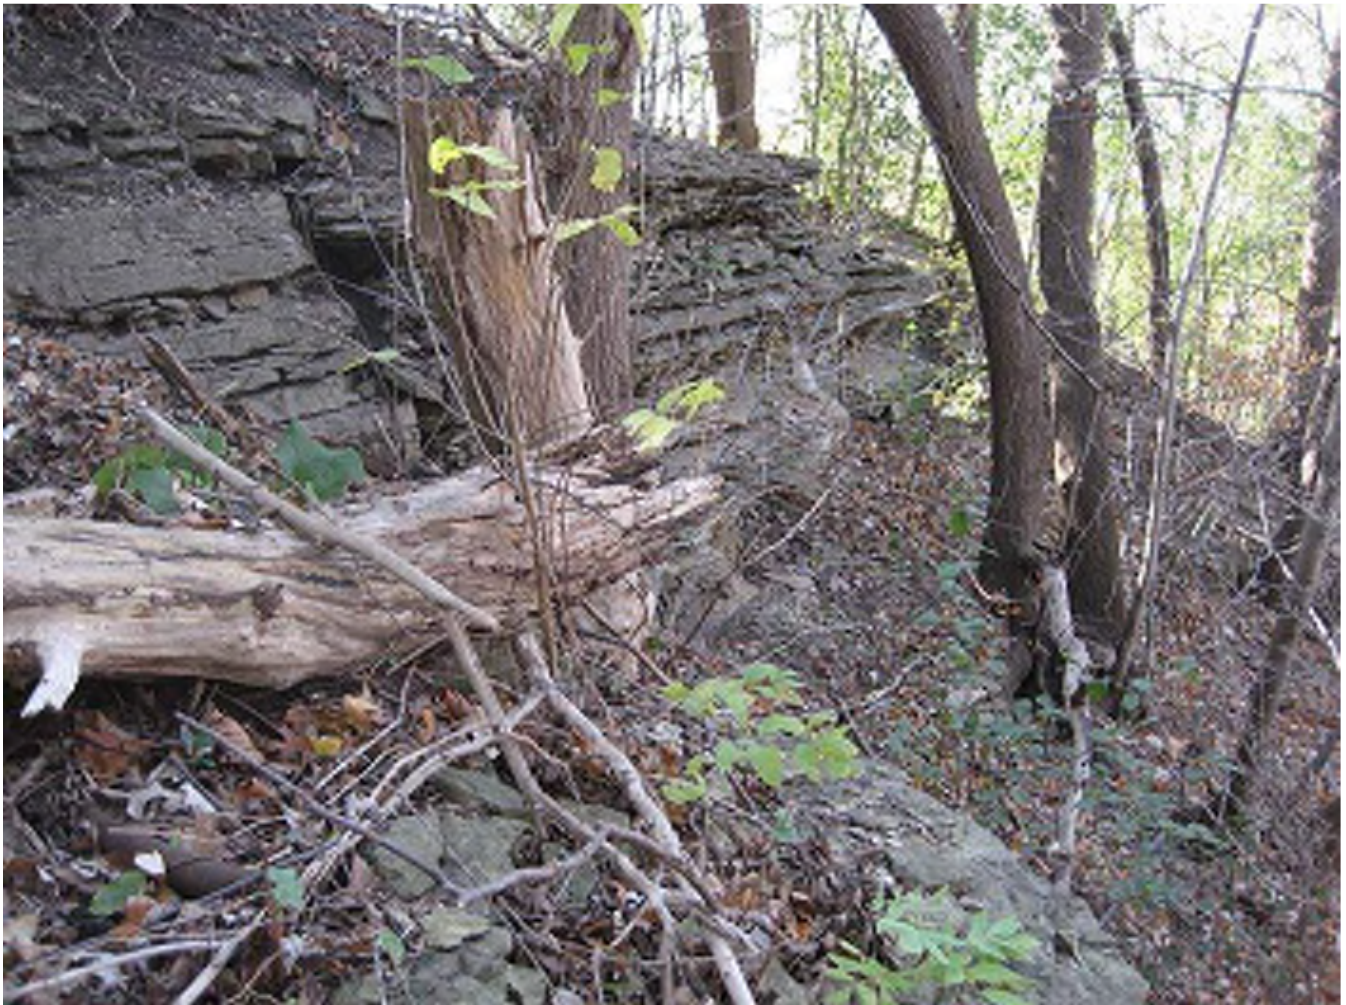
Waypoint 157A

Rock shelf at top of gully approx. 8-feet.

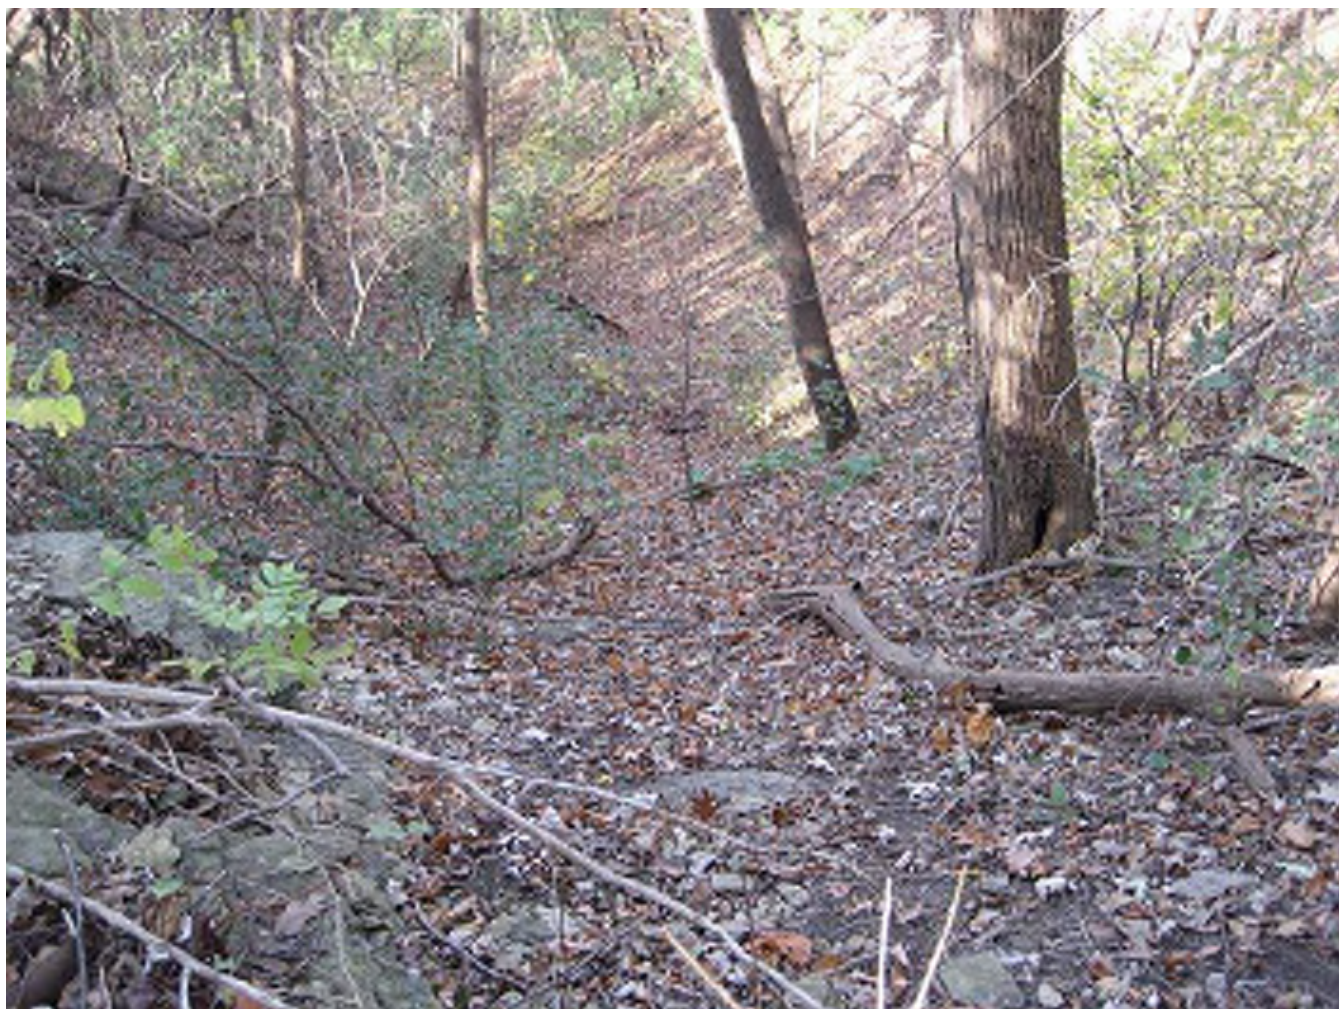
Looking down gully; minimal erosion.

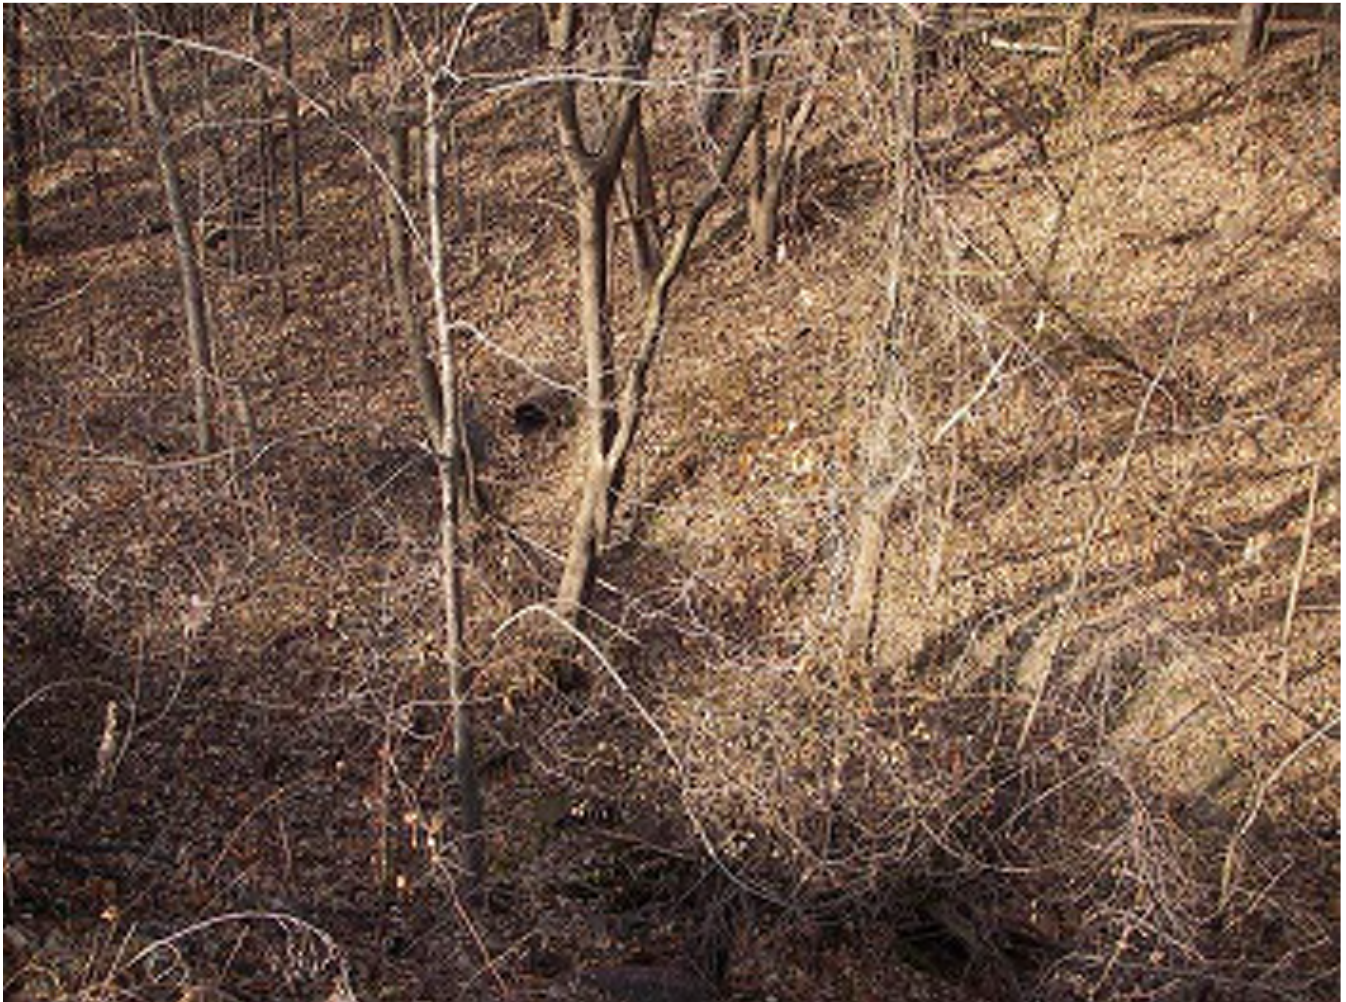
Waypoint 158

Severe erosion

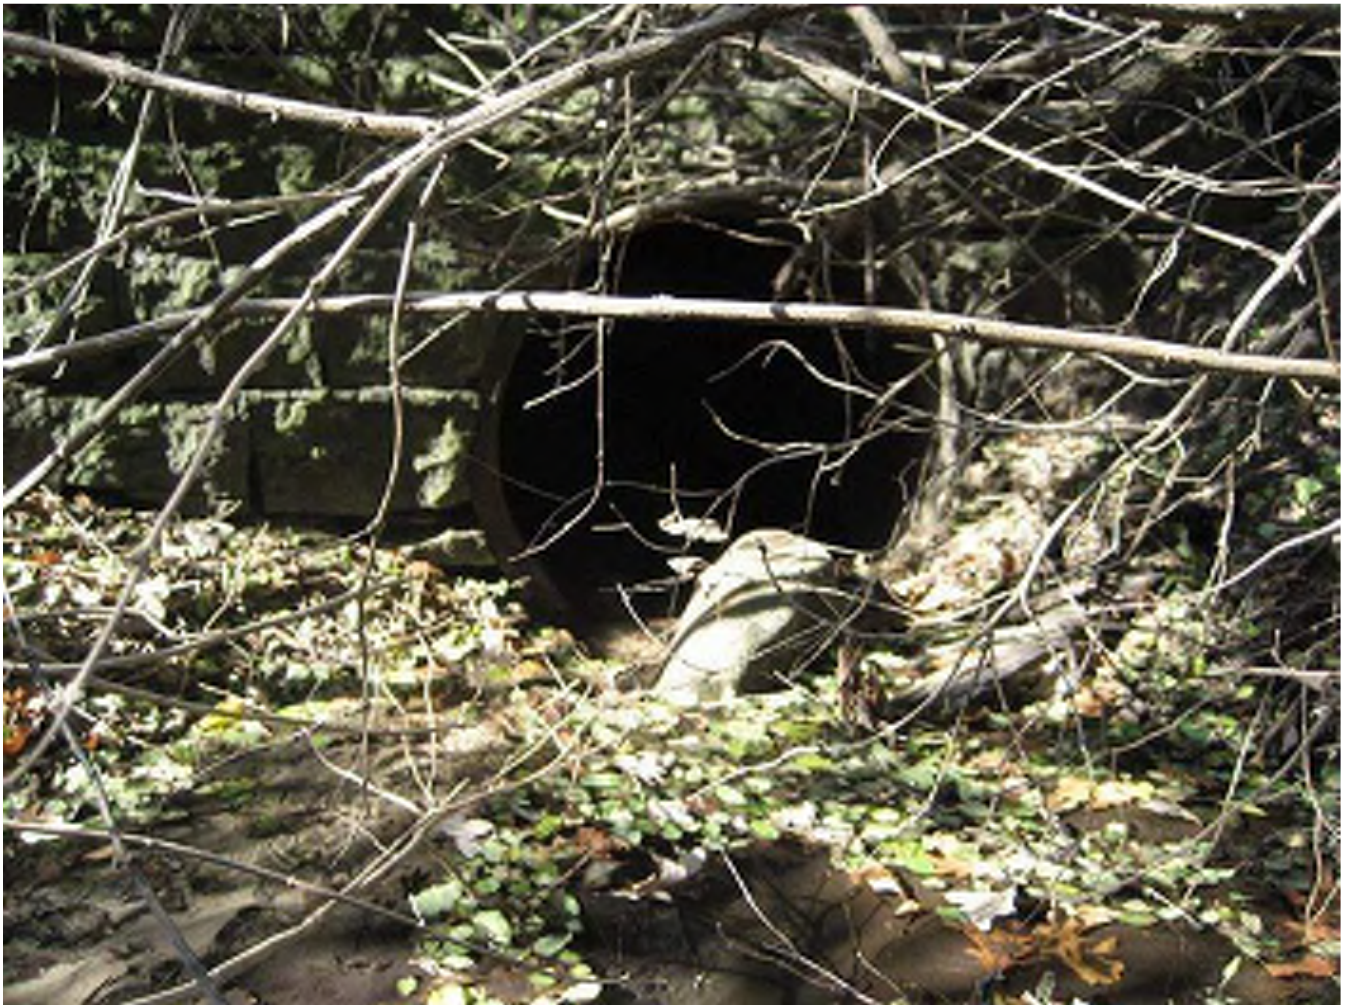
Waypoint 158A

Culvert on slope side going under railroad tracks.
