Appendix K: Lower Minnesota River Watershed District: Gully Inventory

Gully Inventory Map
 Area #1
 Lower Minnesota River Watershed District
 Watershed Management Plan

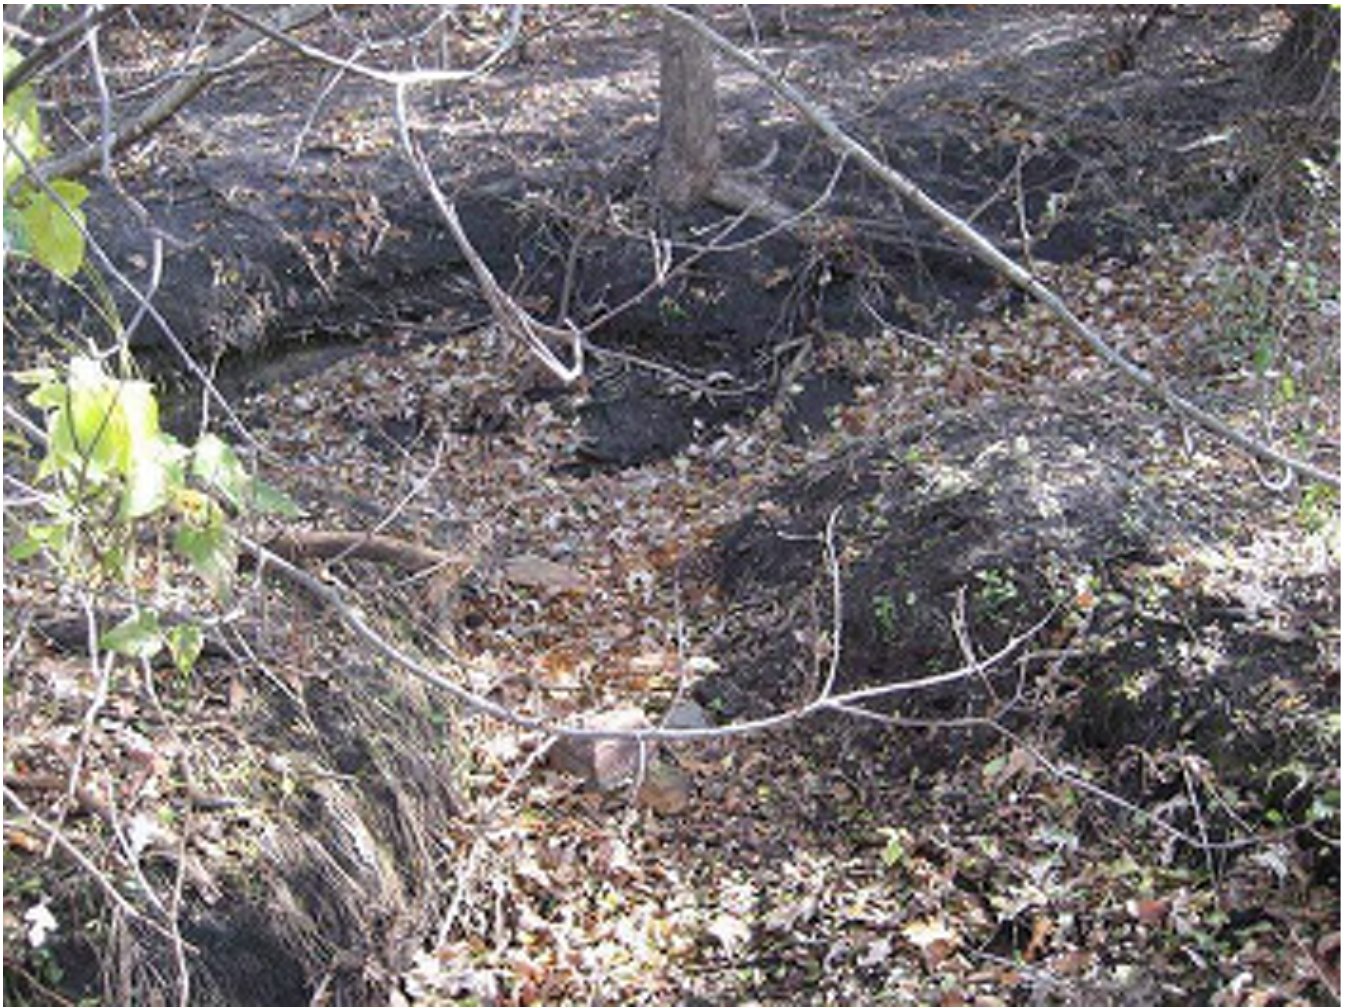
Erosion above culvert in picture #1; major erosion.

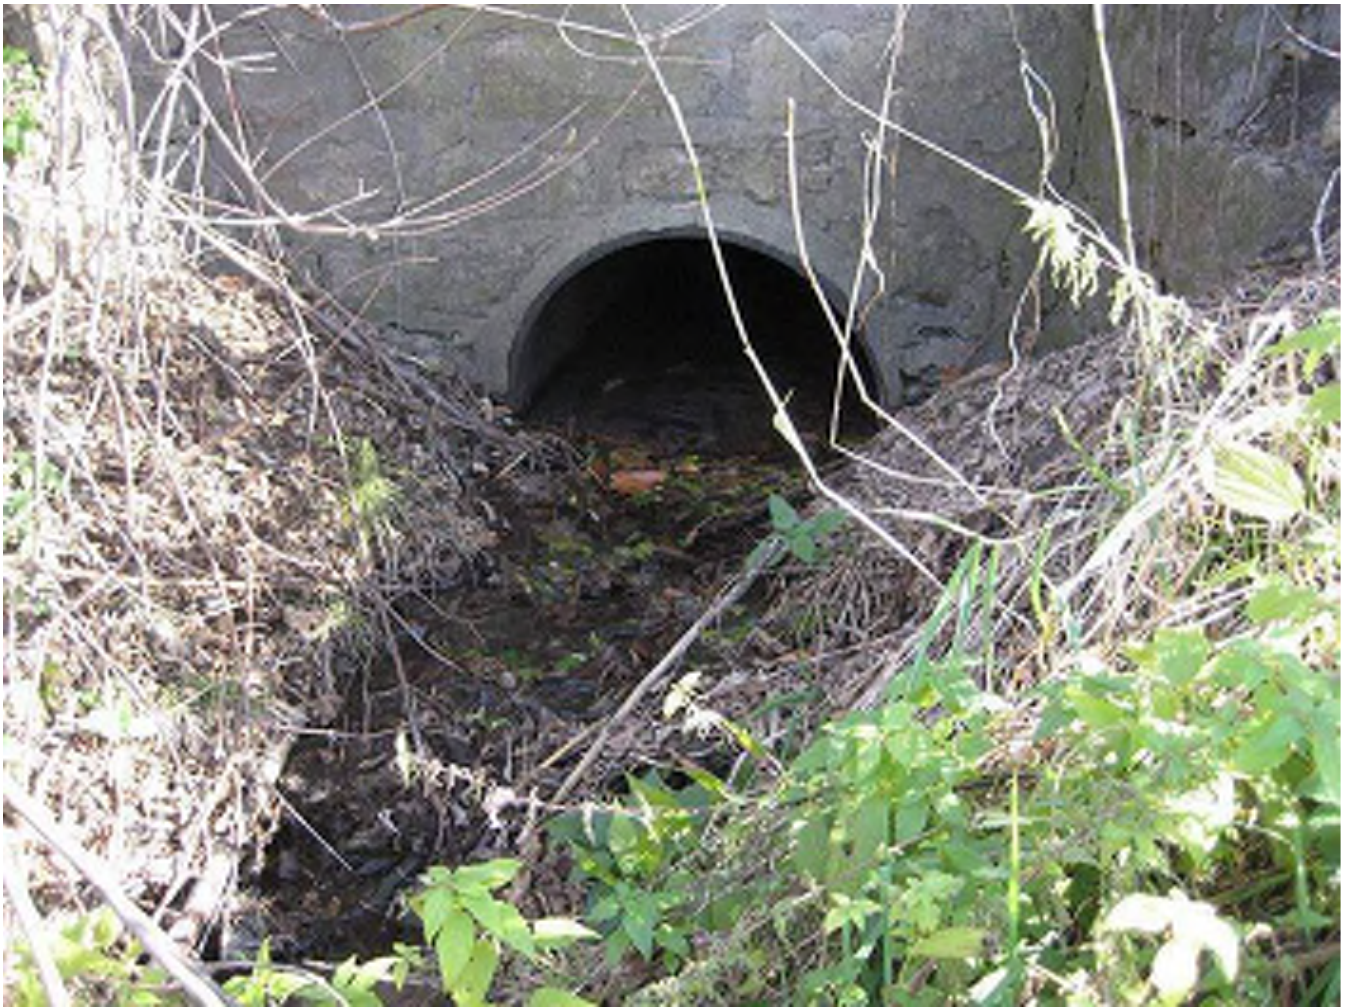
Culvert on lower side of railroad tracks.

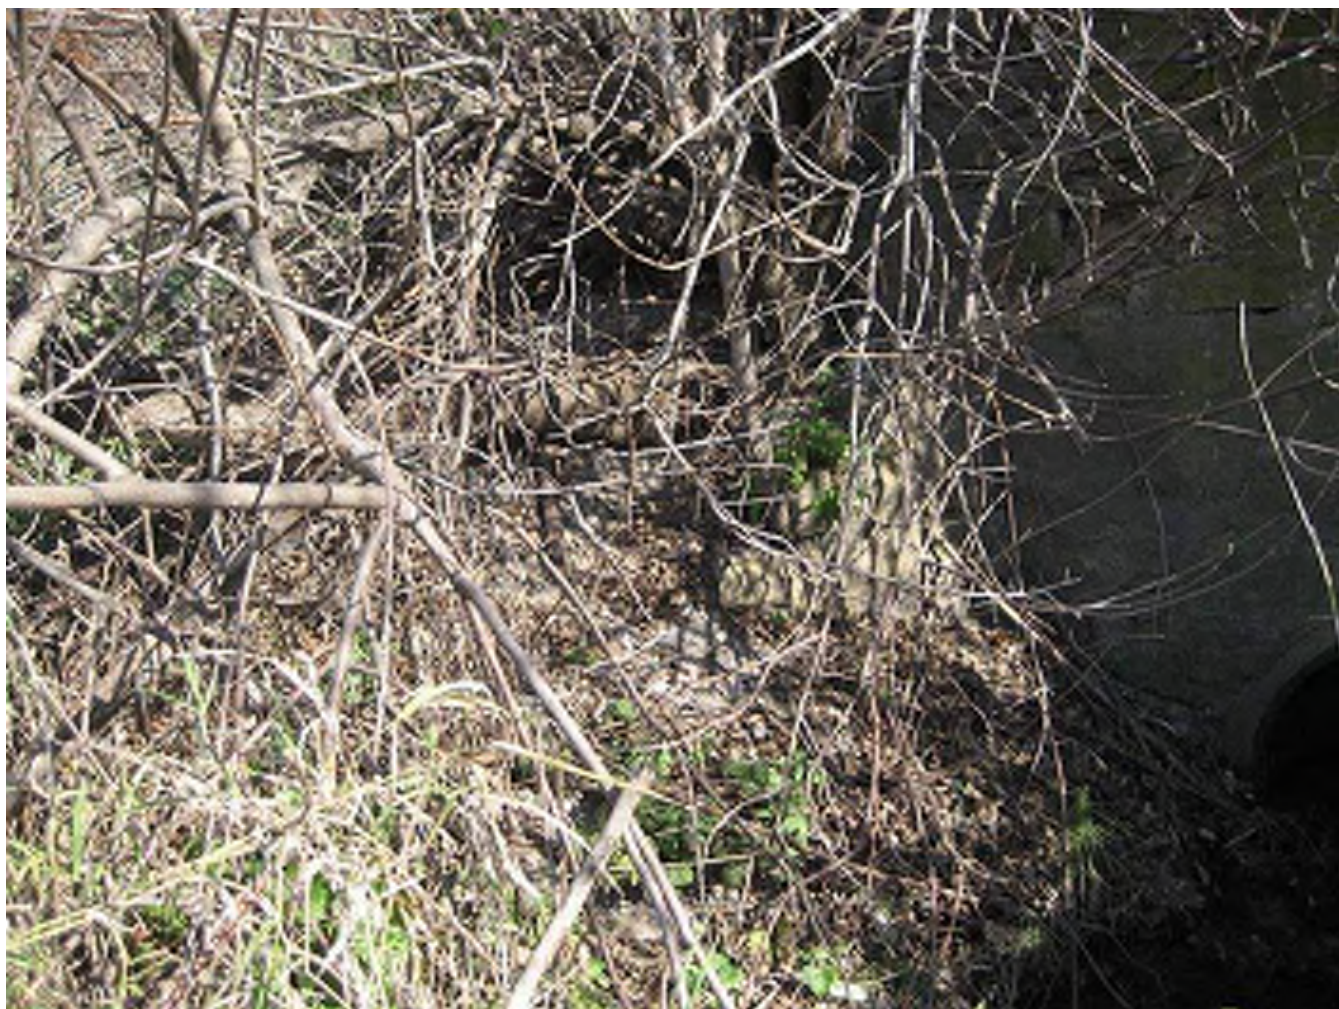
Moderate erosion on sides of culvert.

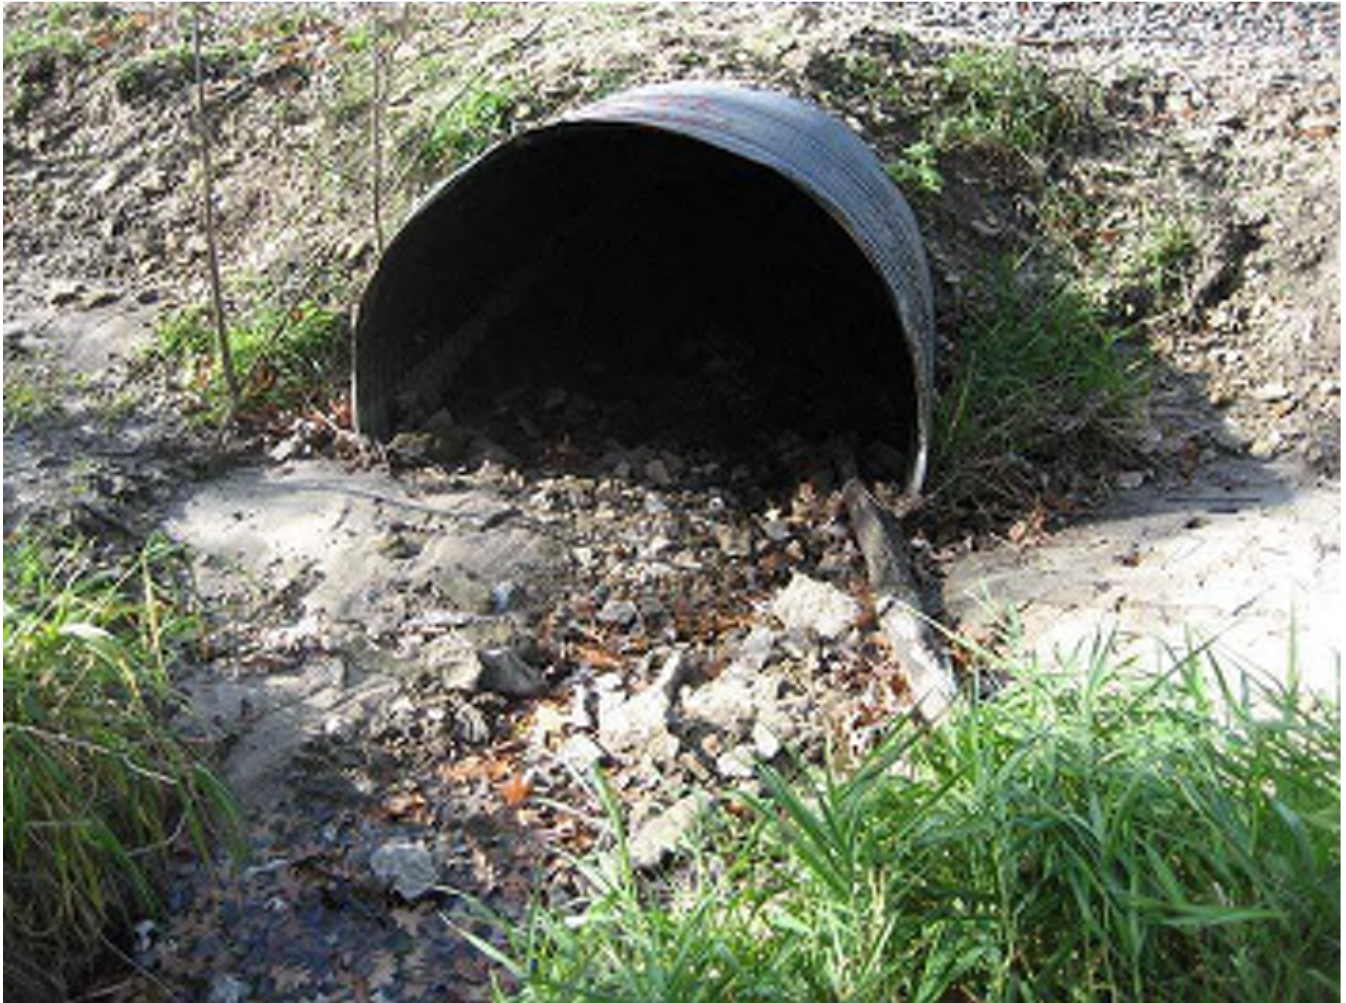
Waypoint 159A

Culvert on slope side.

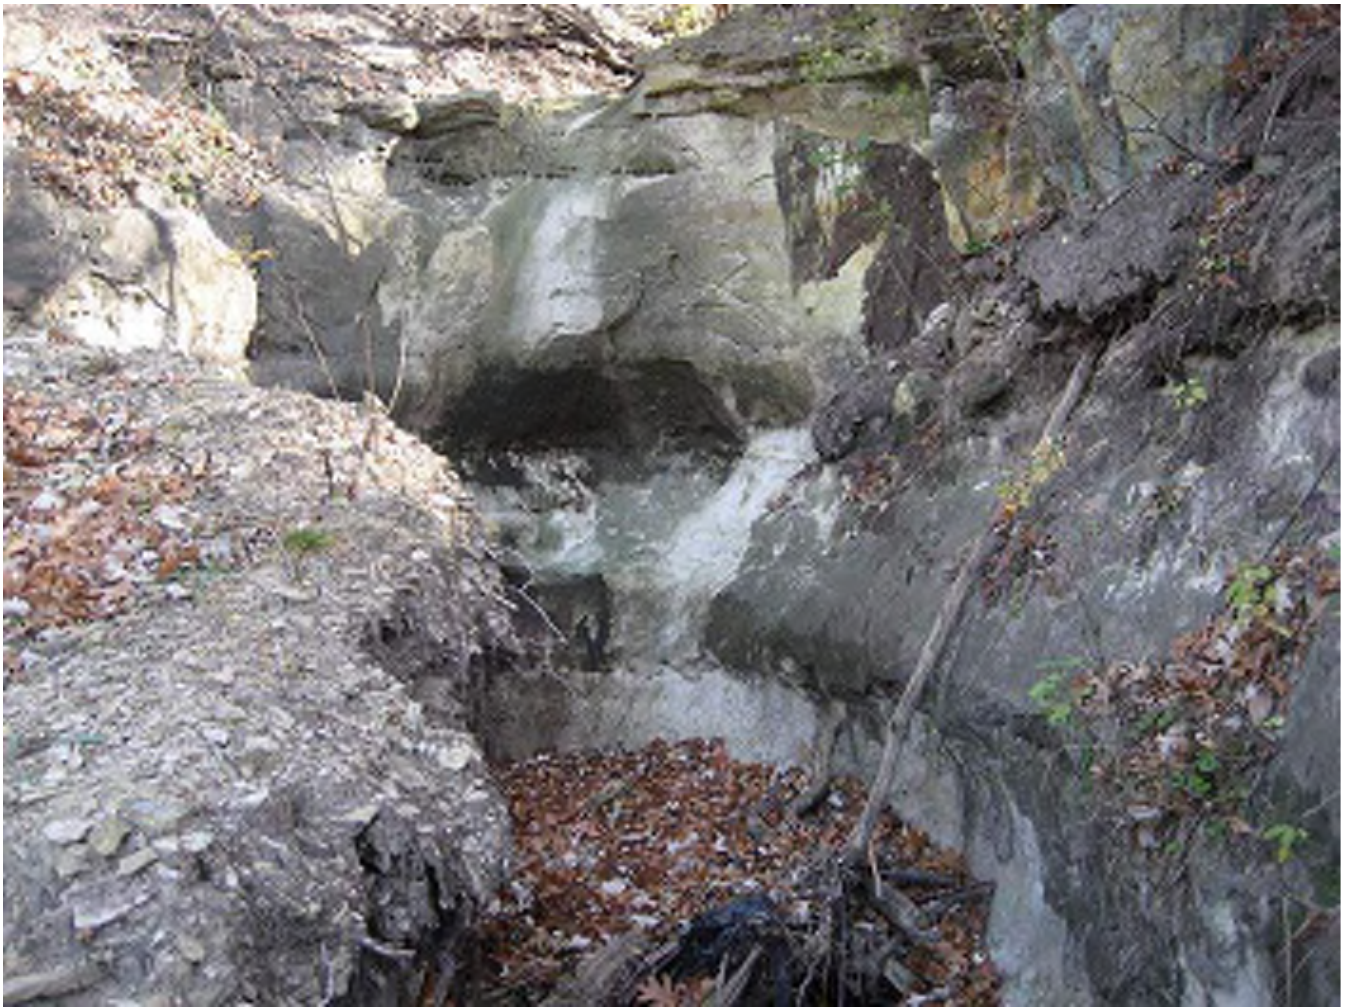
Waterfall? Major erosion above culvert in picture #1.

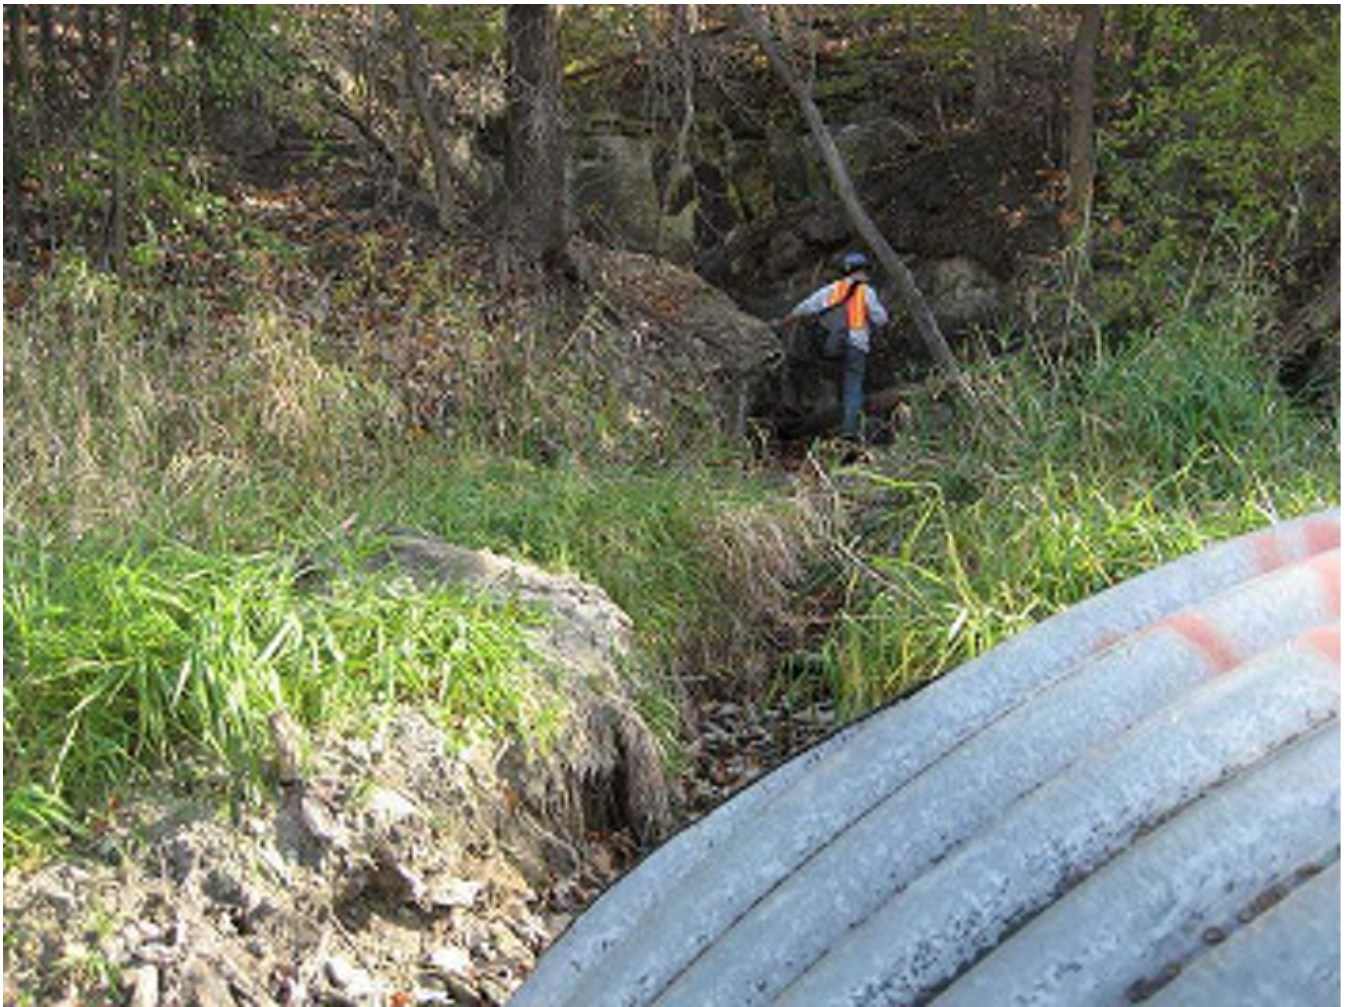
Looking up towards picture #2; major erosion.

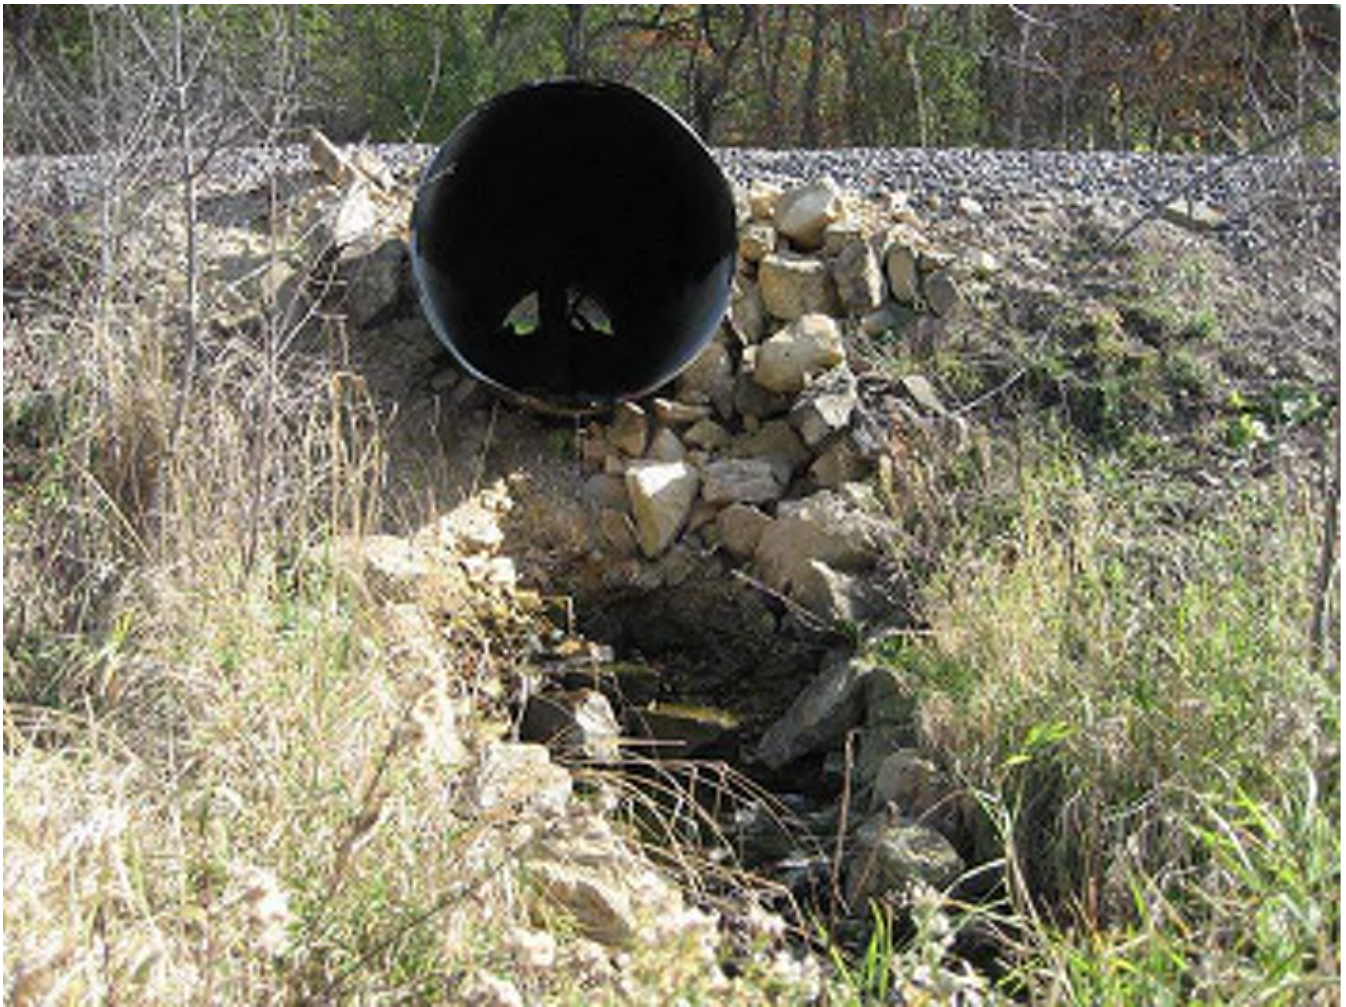
Down slope side of culvert in picture #1; starting to erode.

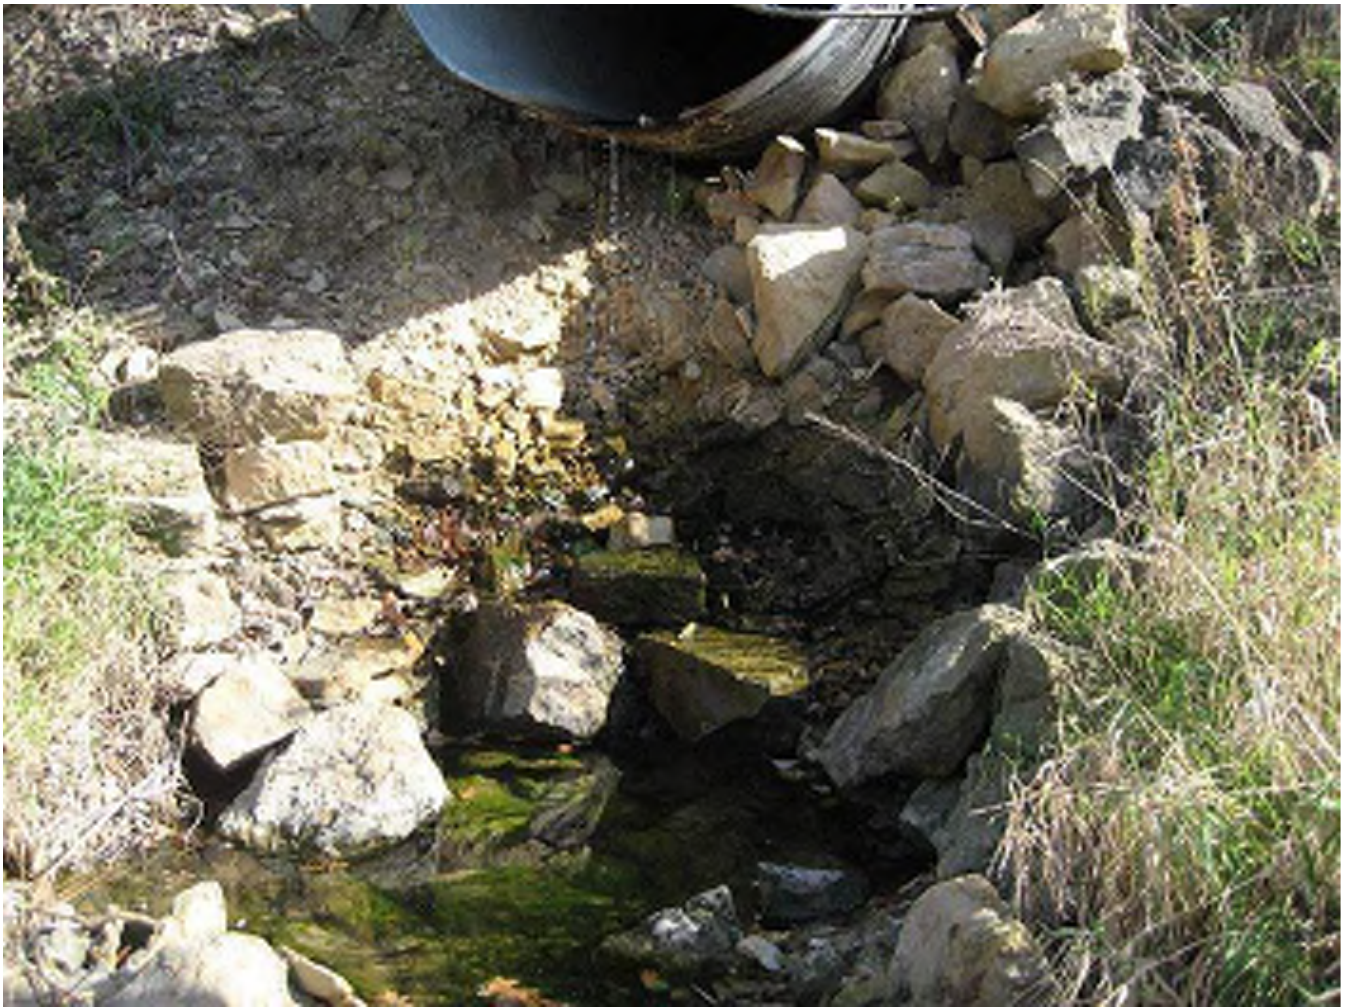
Down slope side of culvert in picture #1; starting to erode.

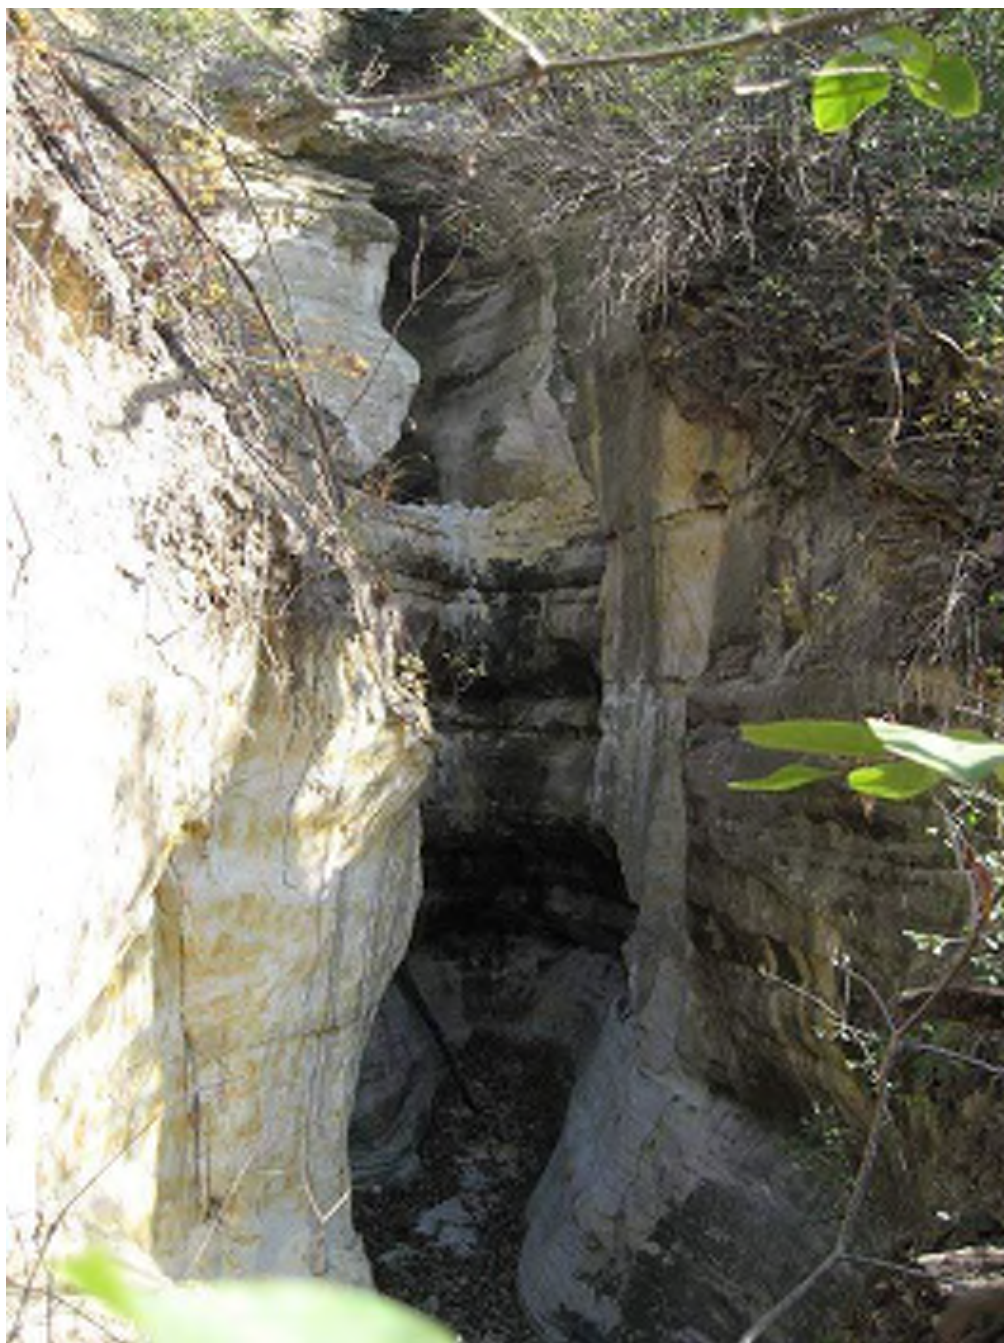
Waypoint 160

Site comments:

Severe erosion

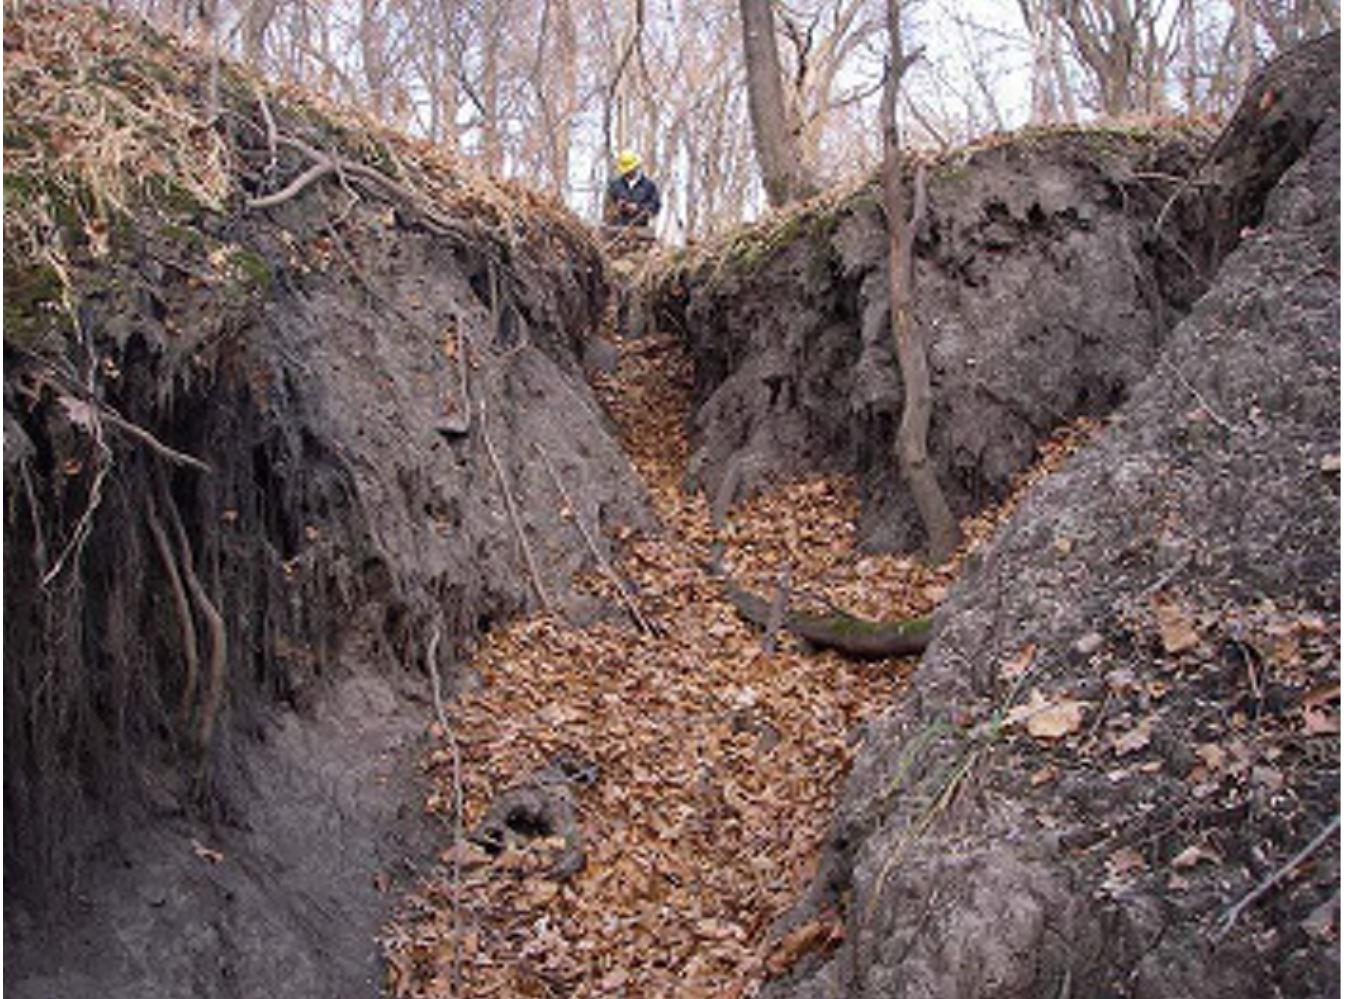
Waypoint 160A

Culvert coming from under road.

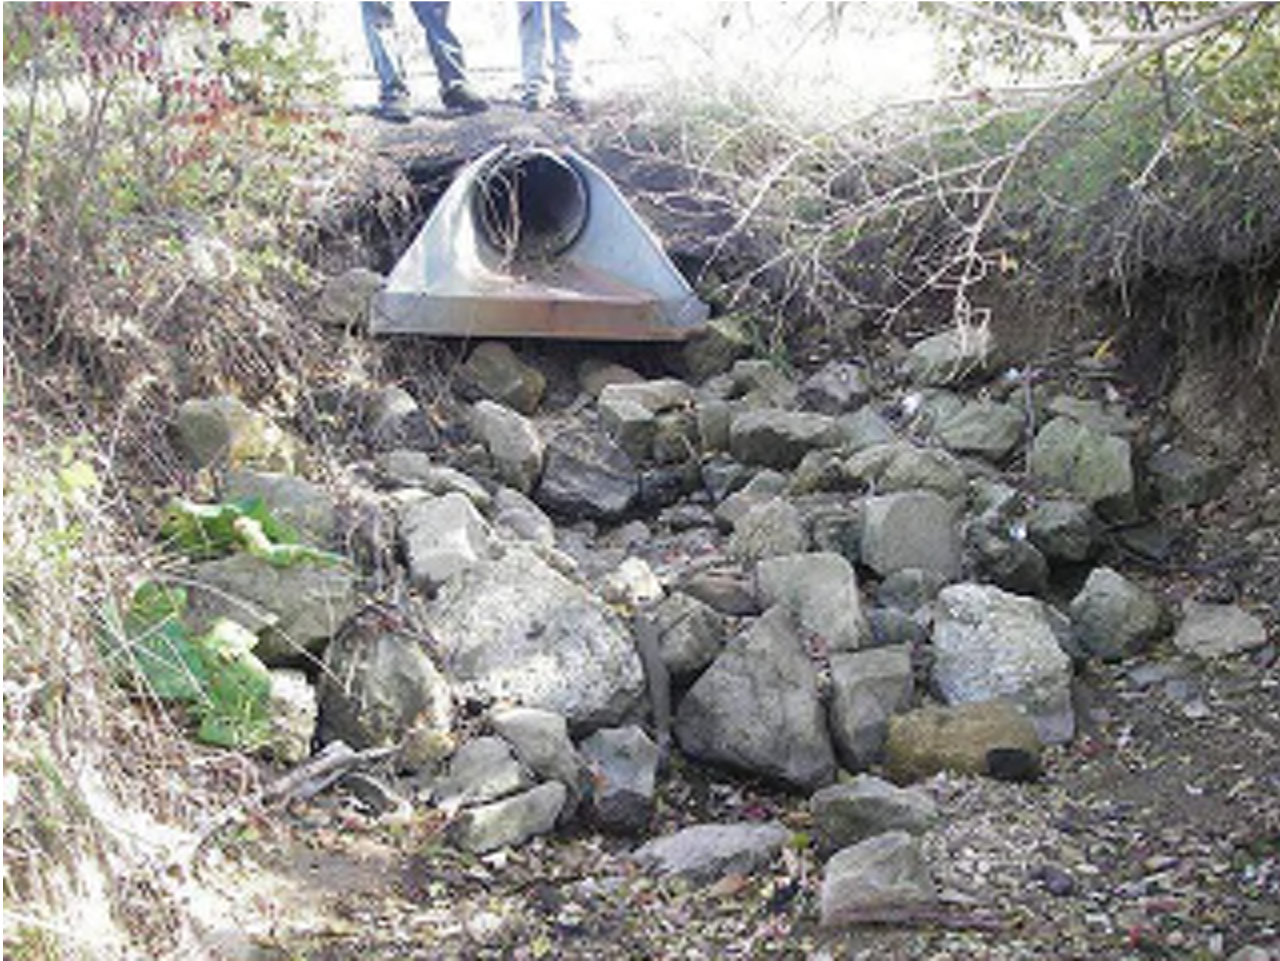
Erosion due to the culvert; 3-4 foot cut.

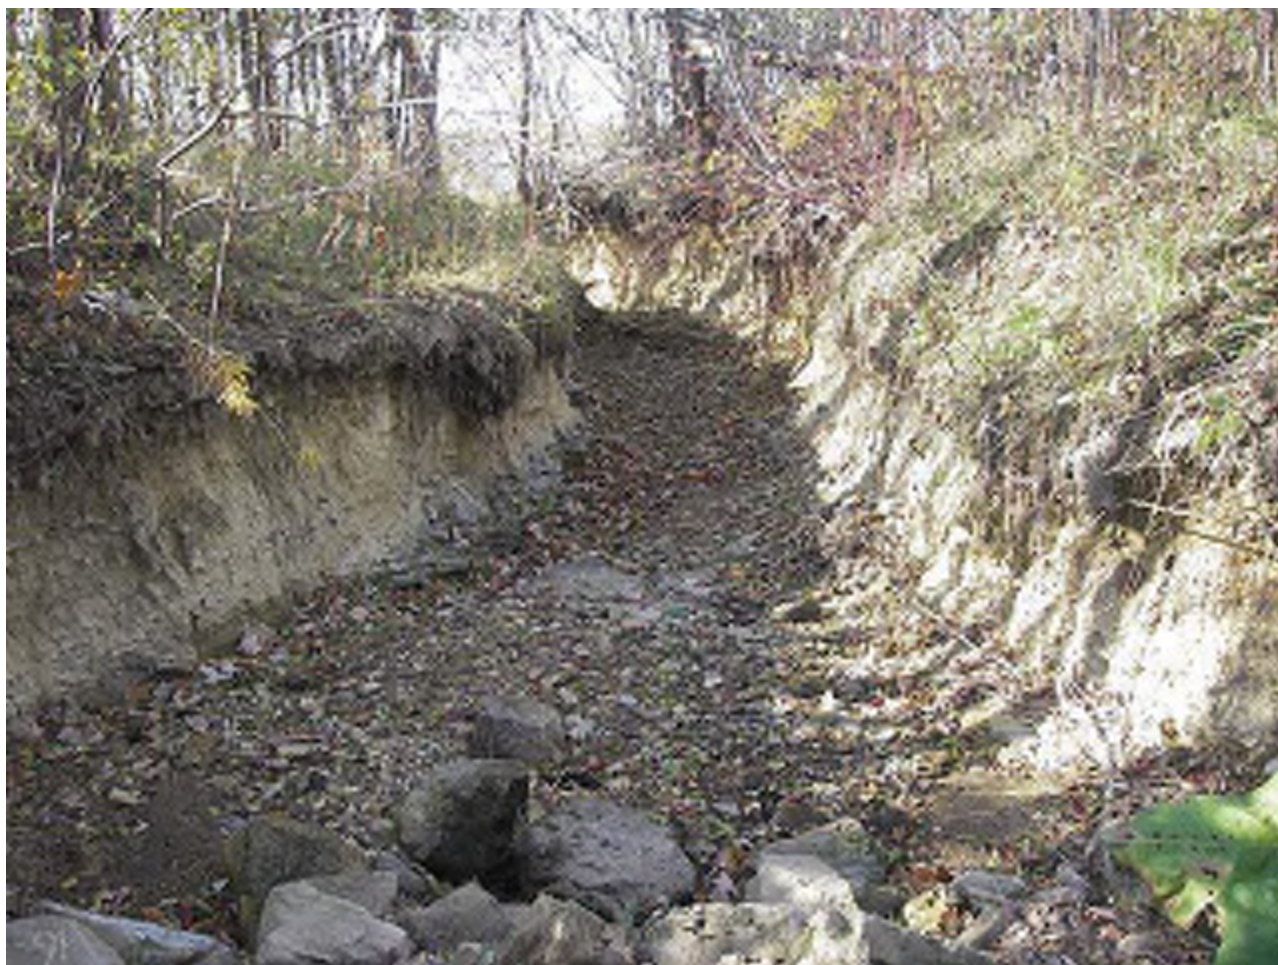
Waypoint 161

Branch/erosion

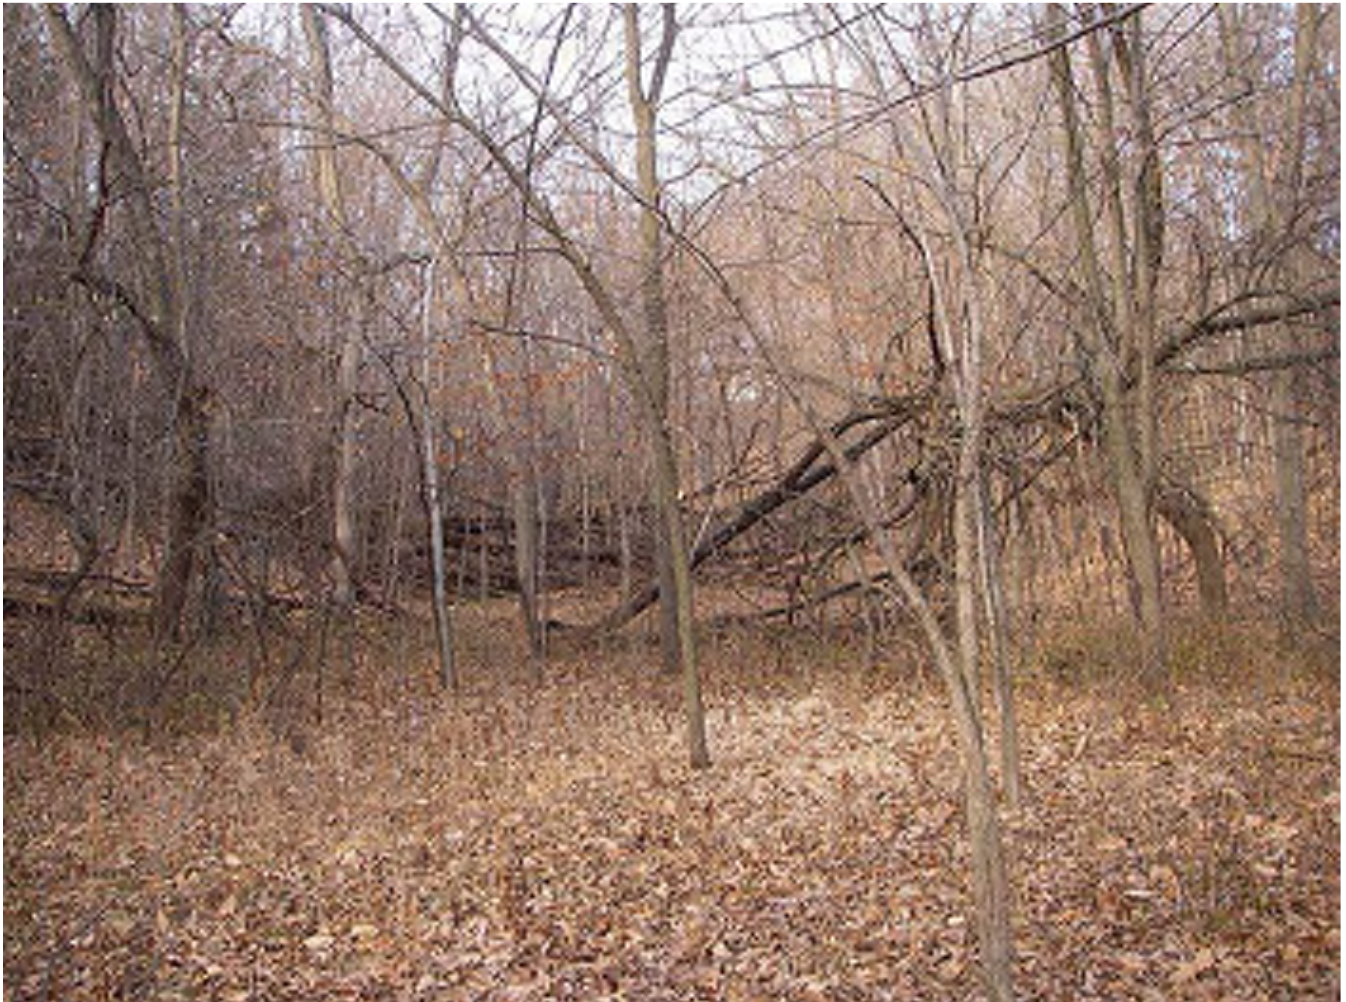
Waypoint 161A

Looking down gully; lots of rock and erosion; hard to access due to rough terrain.

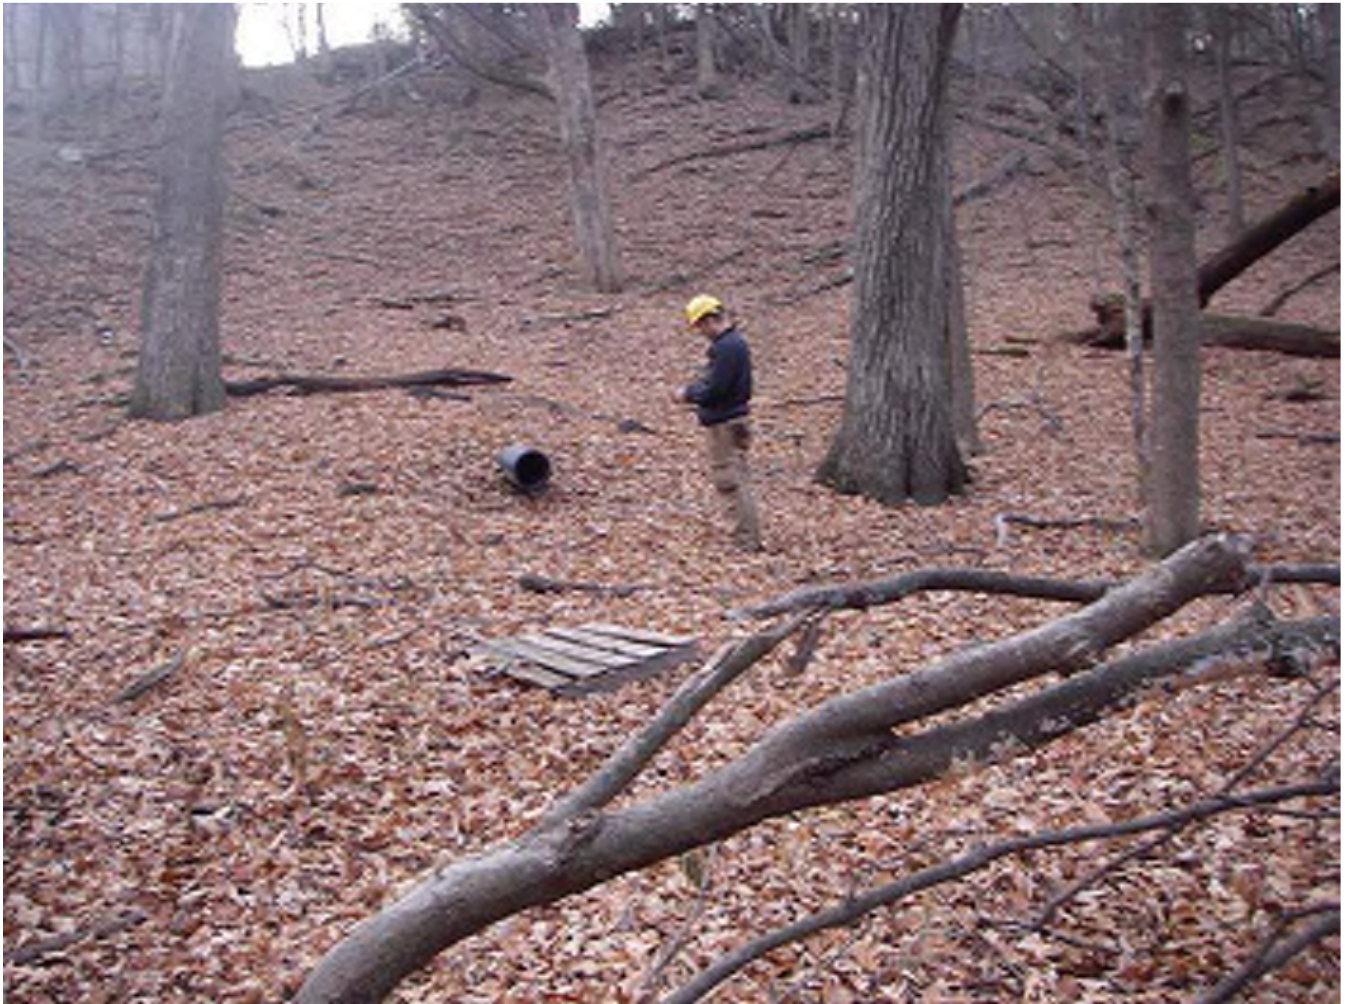
Waypoint 162A

Very large gully with large rock ledge.

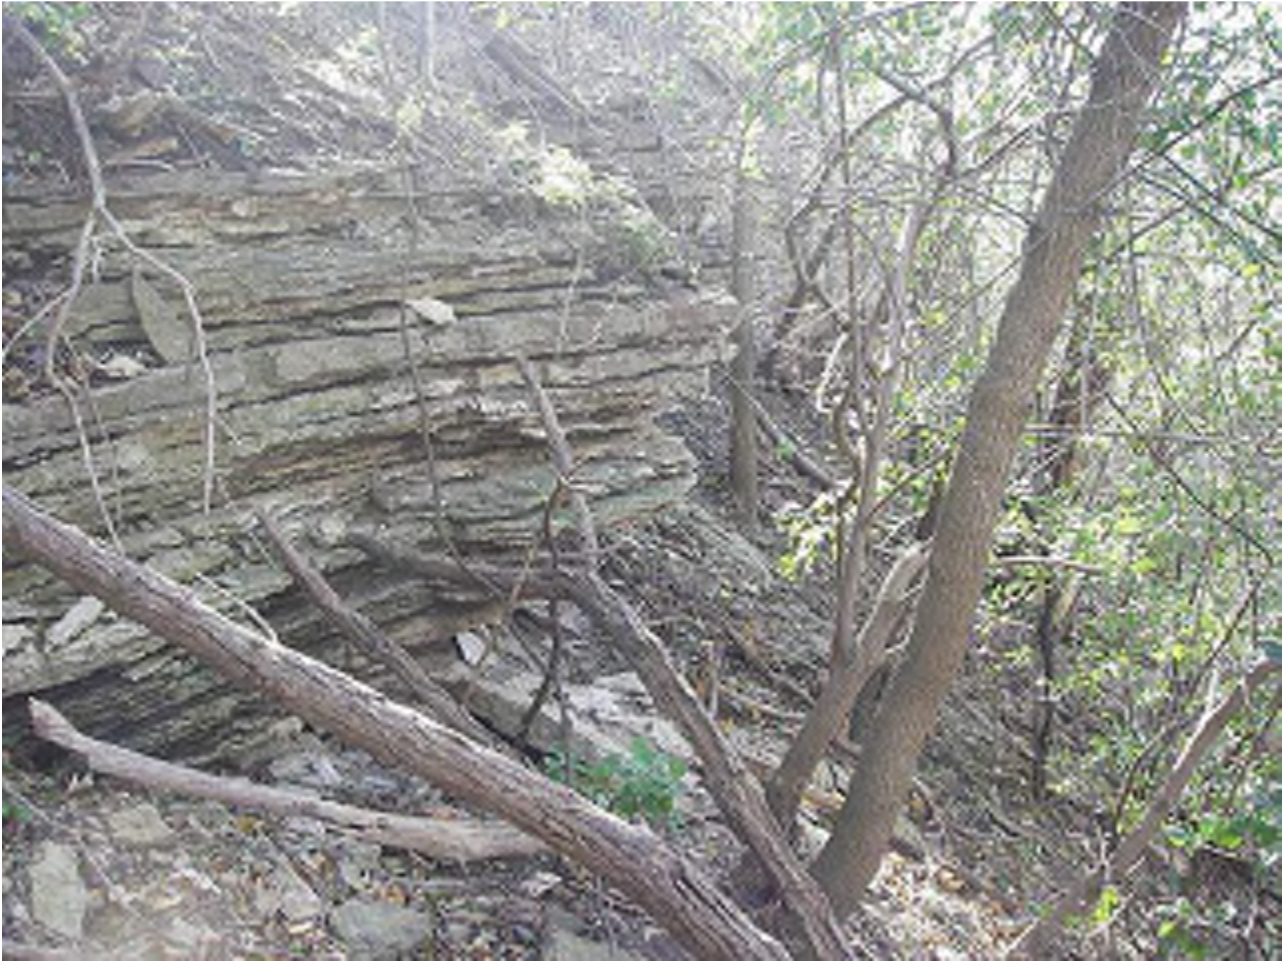
Looking down gully; large blue barrels midway down.

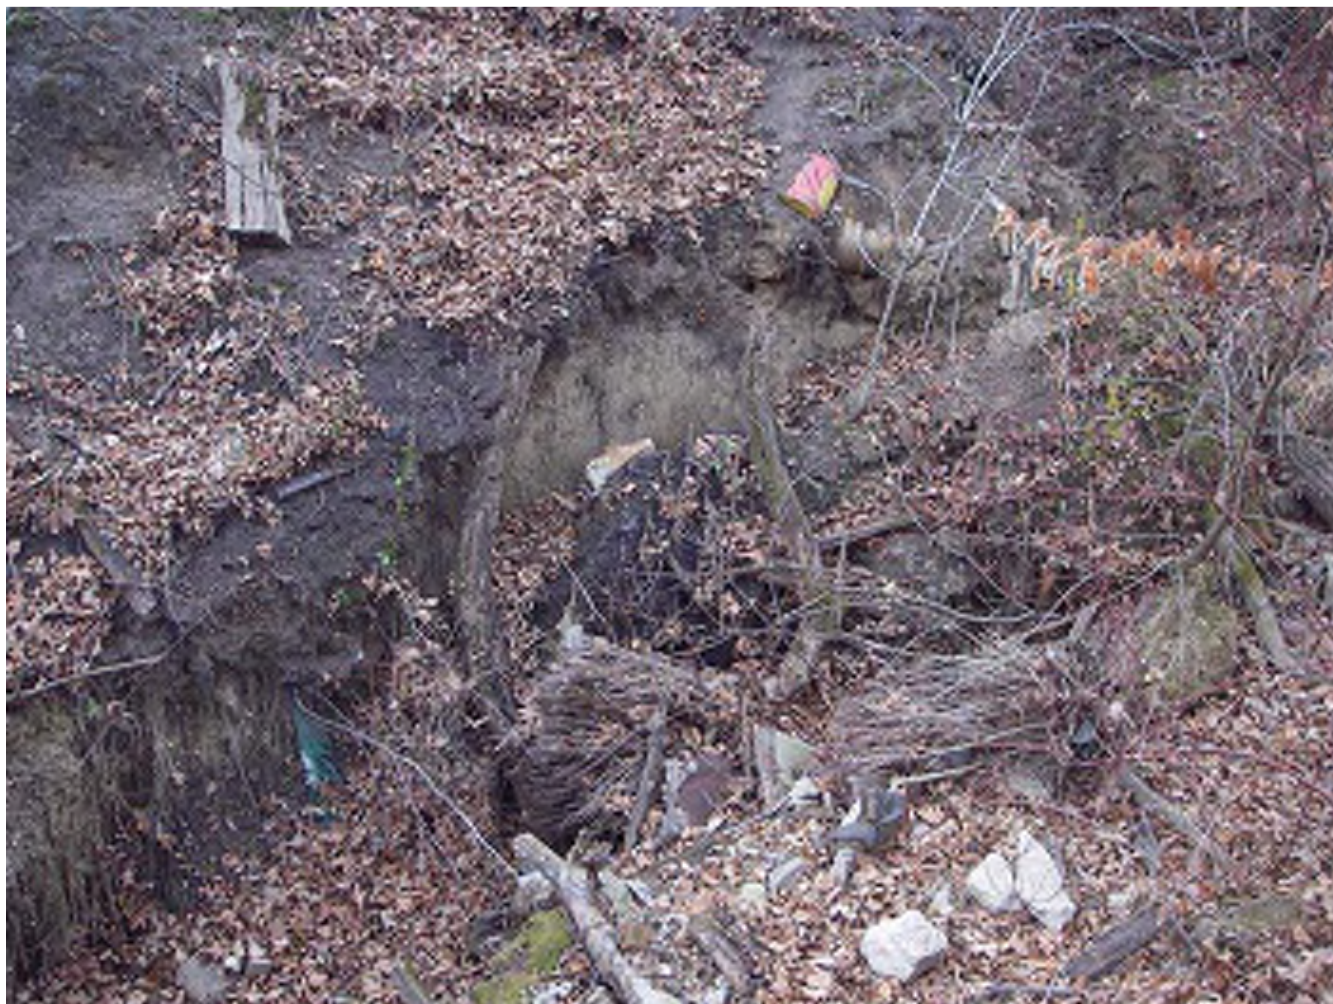
Waypoint 163A

Large gully with moderate erosion.

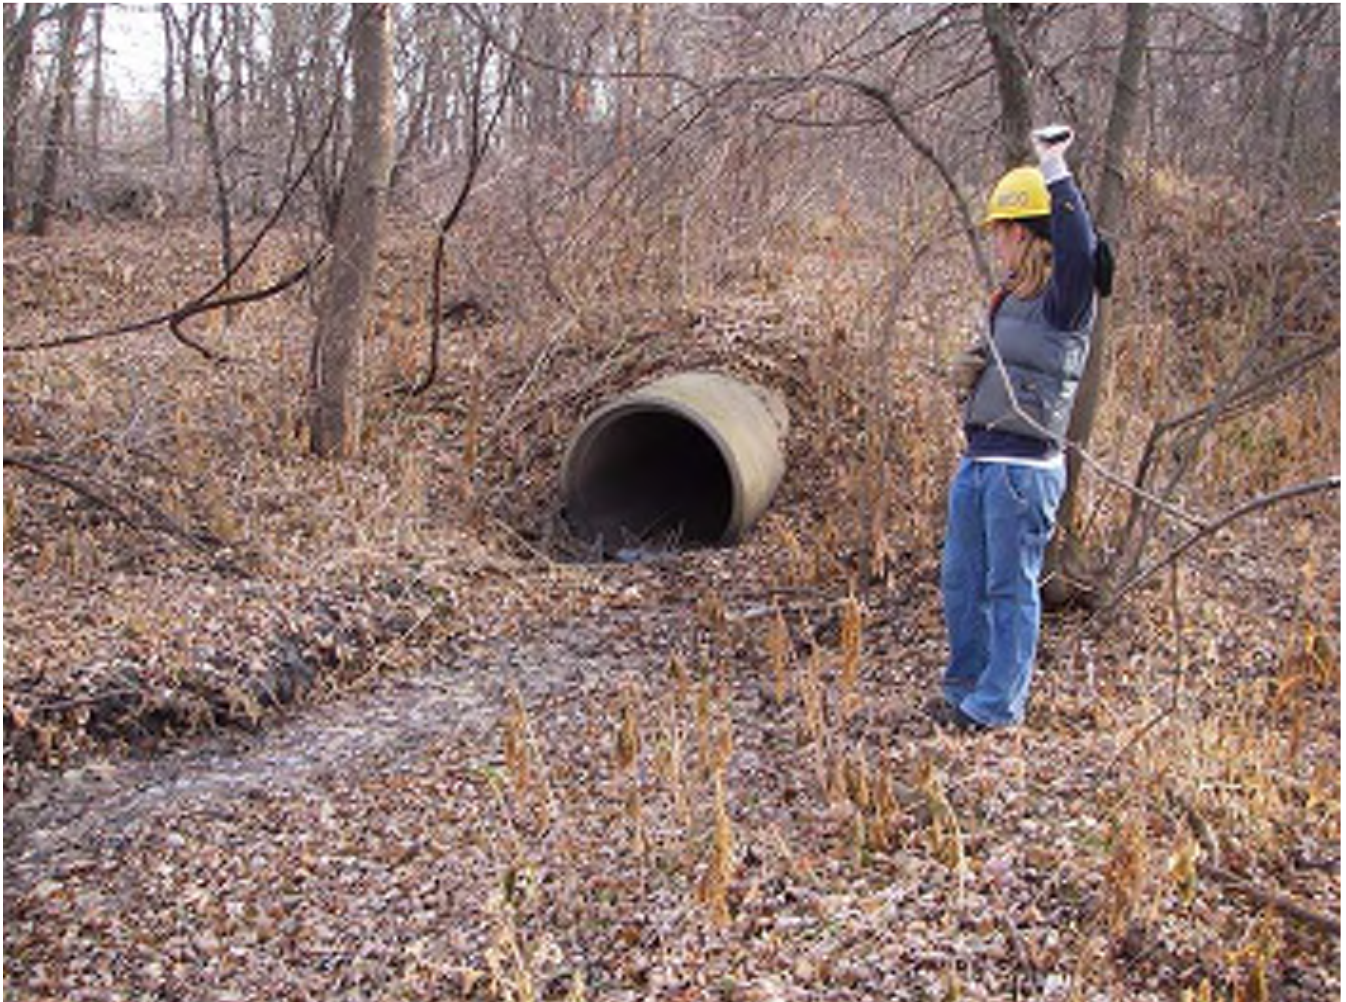
Waypoint 164A

Culvert coming from under road.
