Appendix K: Lower Minnesota River Watershed District: Gully Inventory

Gully Inventory Map
 Area #1
 Lower Minnesota River Watershed District
 Watershed Management Plan

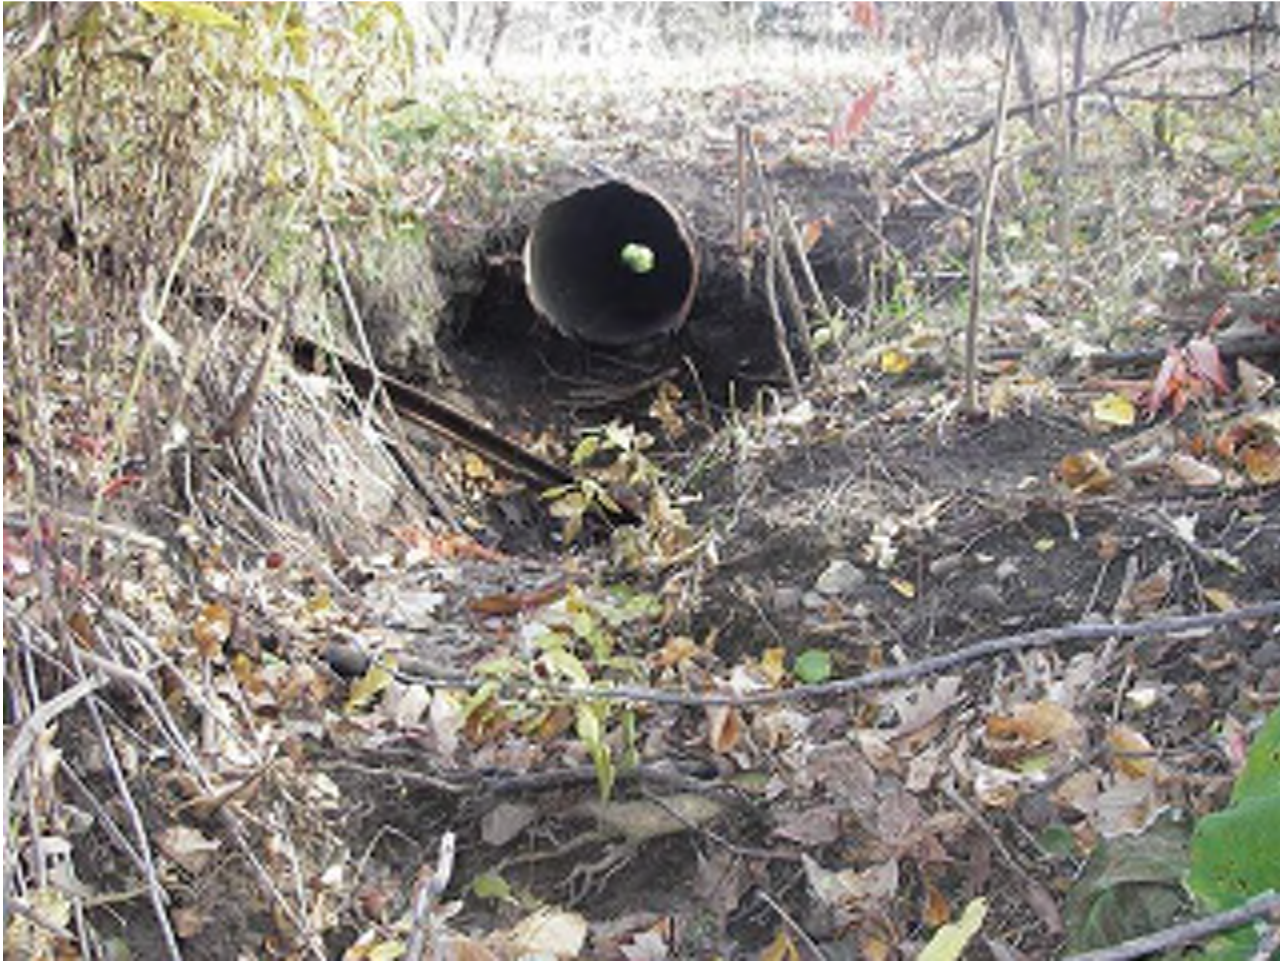
Looking down from culvert; moderate to major erosion.

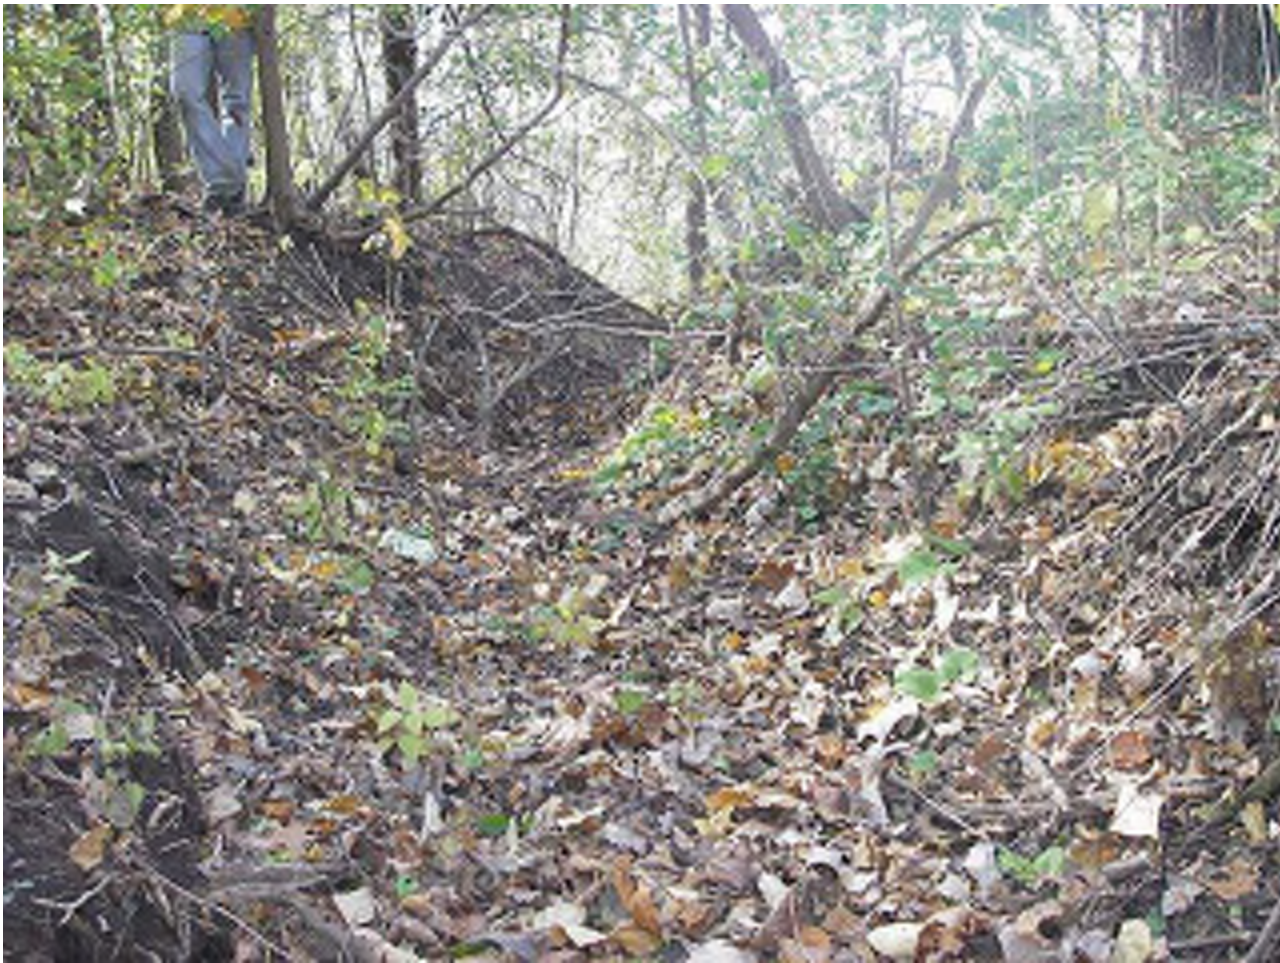
10-foot drop-off into large ravine.

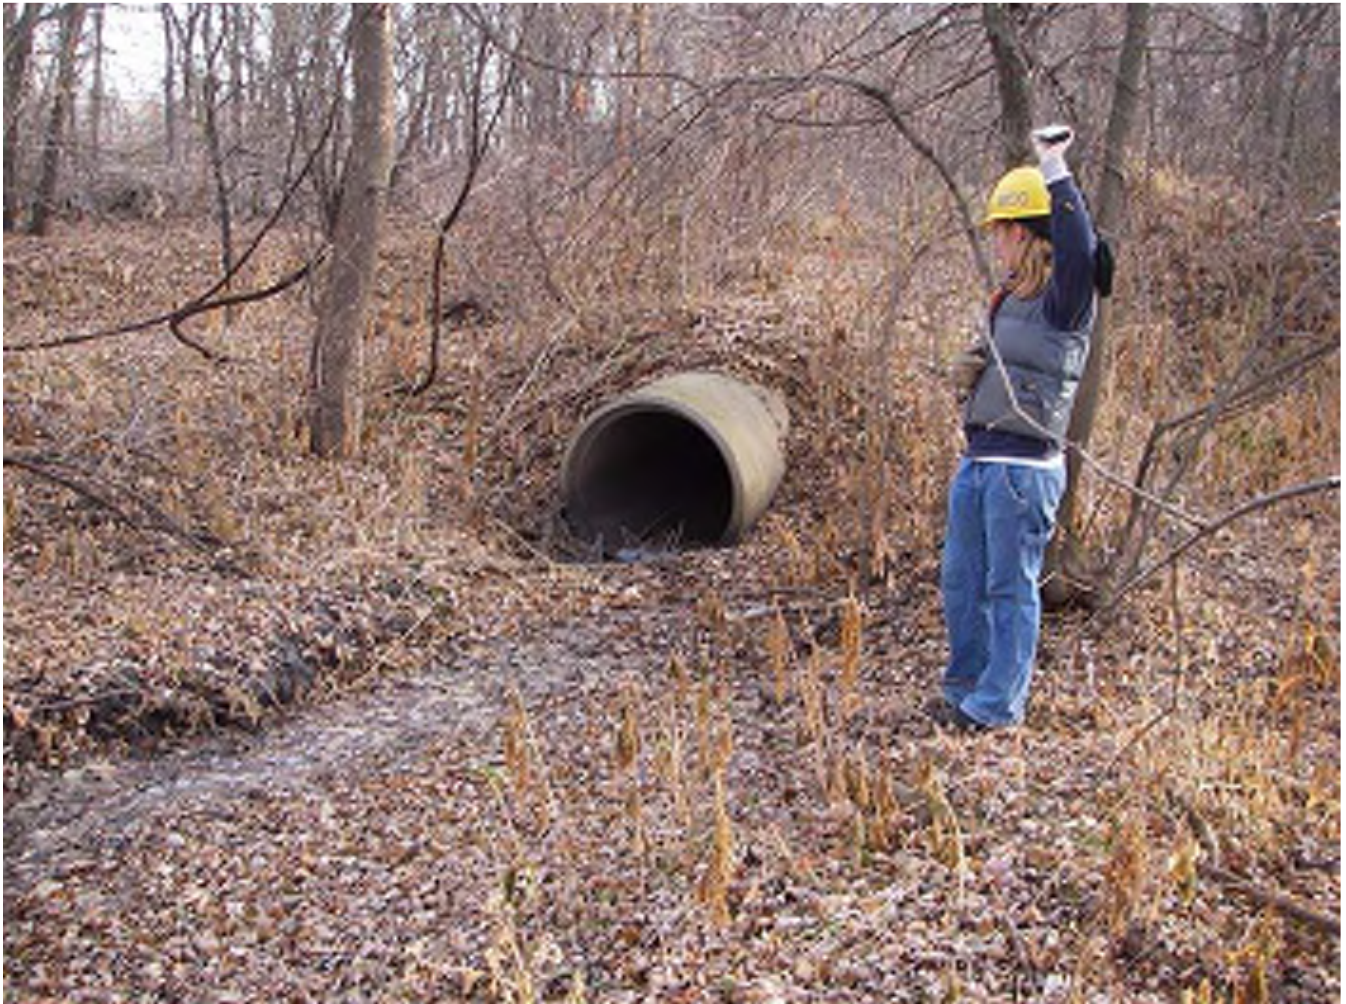
Waypoint 165A

Large rock ledge at top of gully.

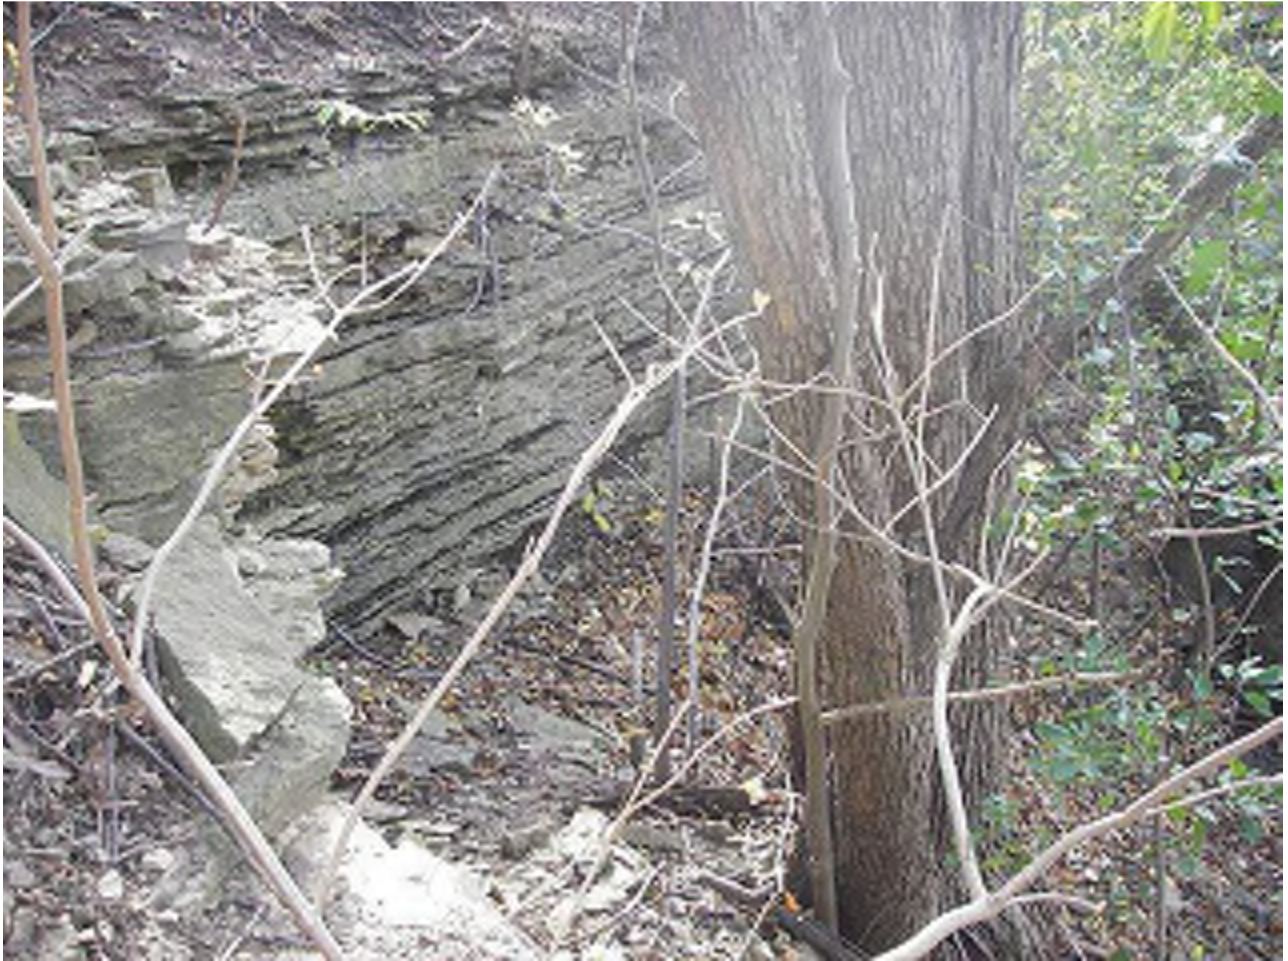
Looking down gully; steep sides with moderate erosion.

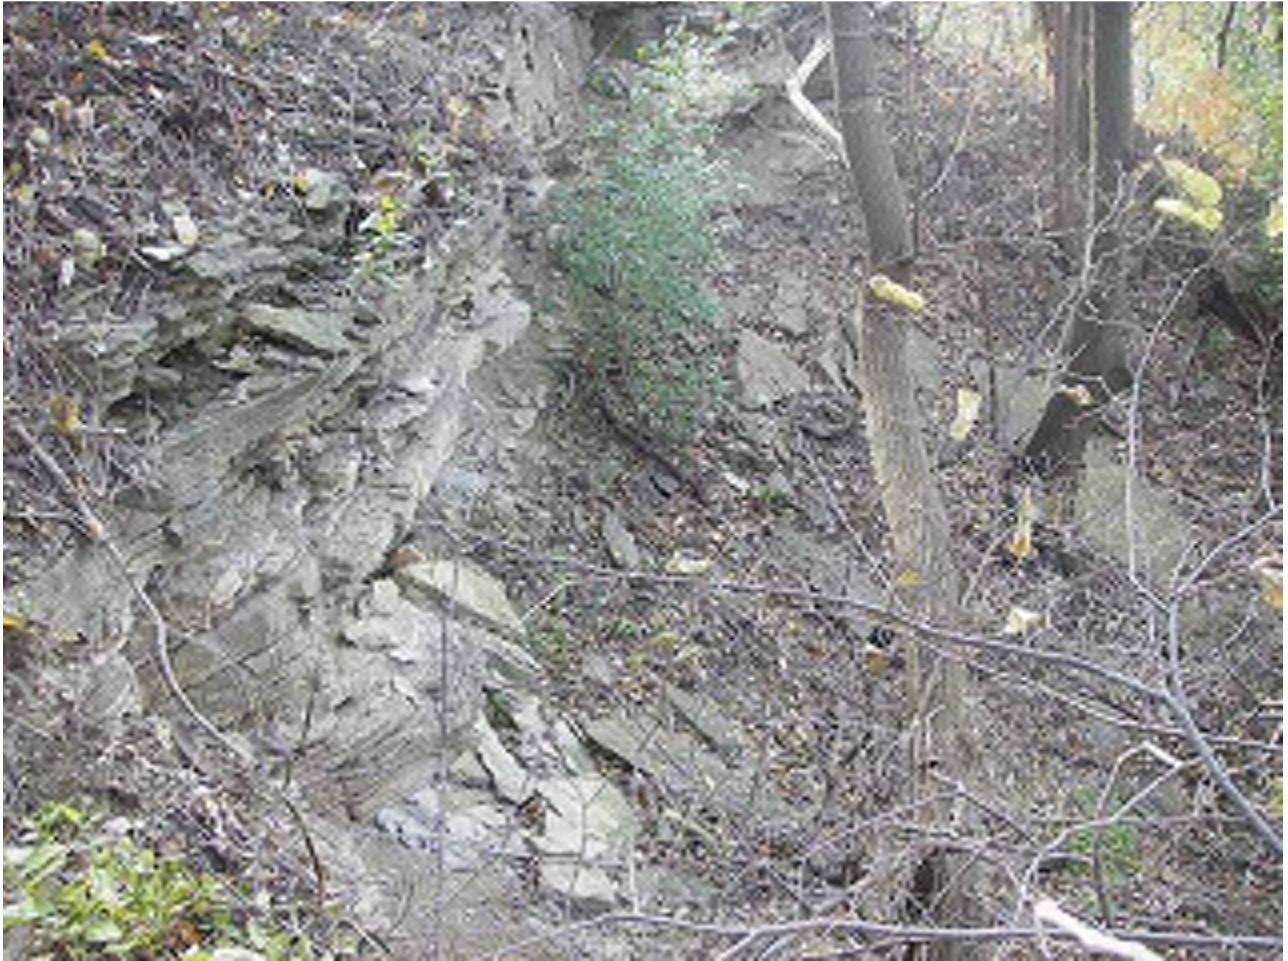
Culvert at bottom of gully going under railroad tracks; minor erosion.

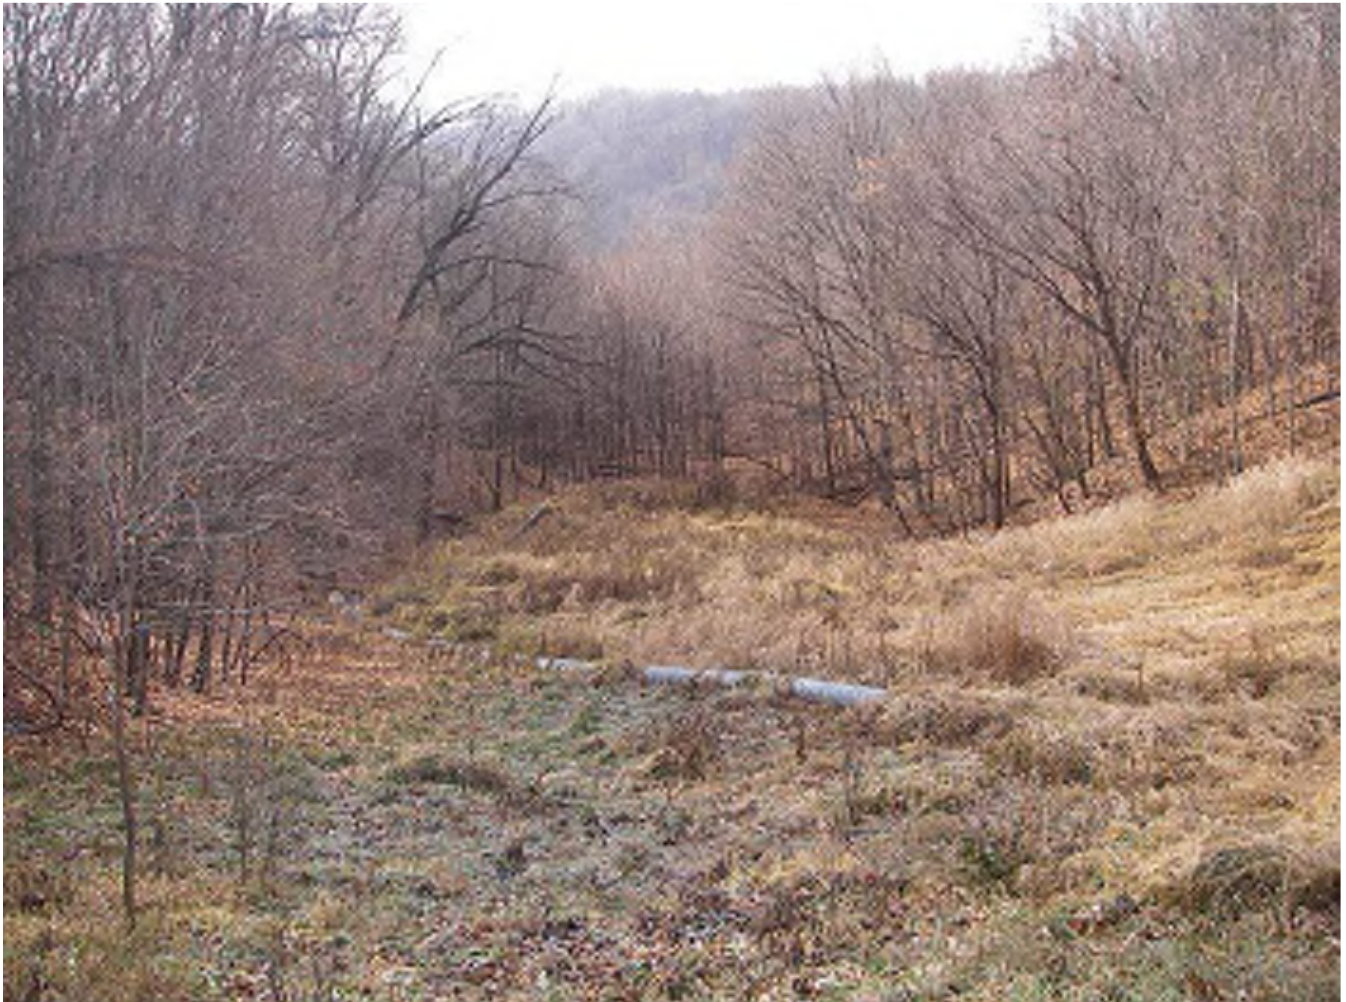
Waypoint 169A

Large gully with large rock shelf at top of gully; moderate erosion.

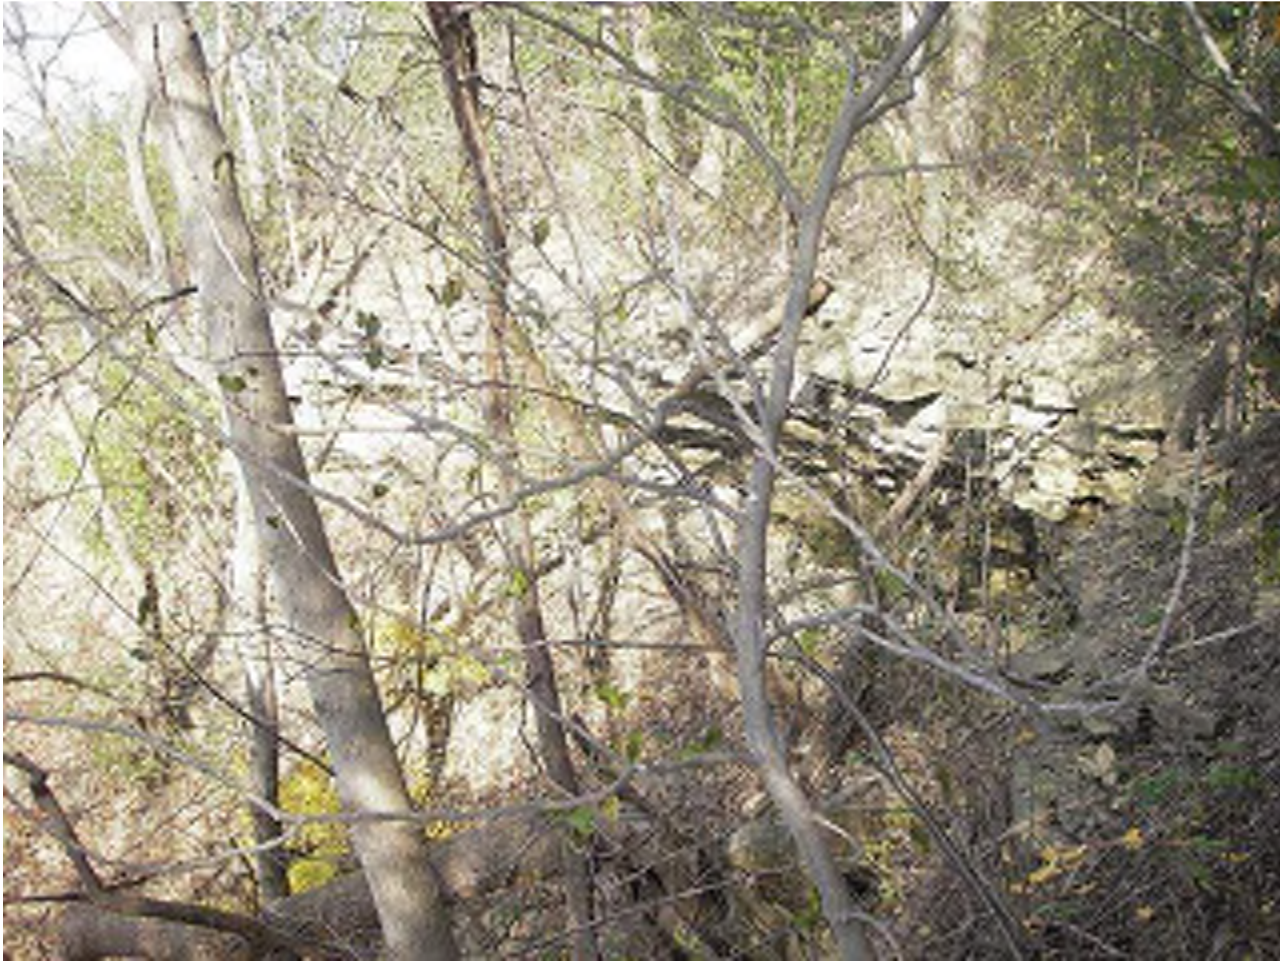
Culvert at bottom of gully going under railroad tracks; minor erosion.

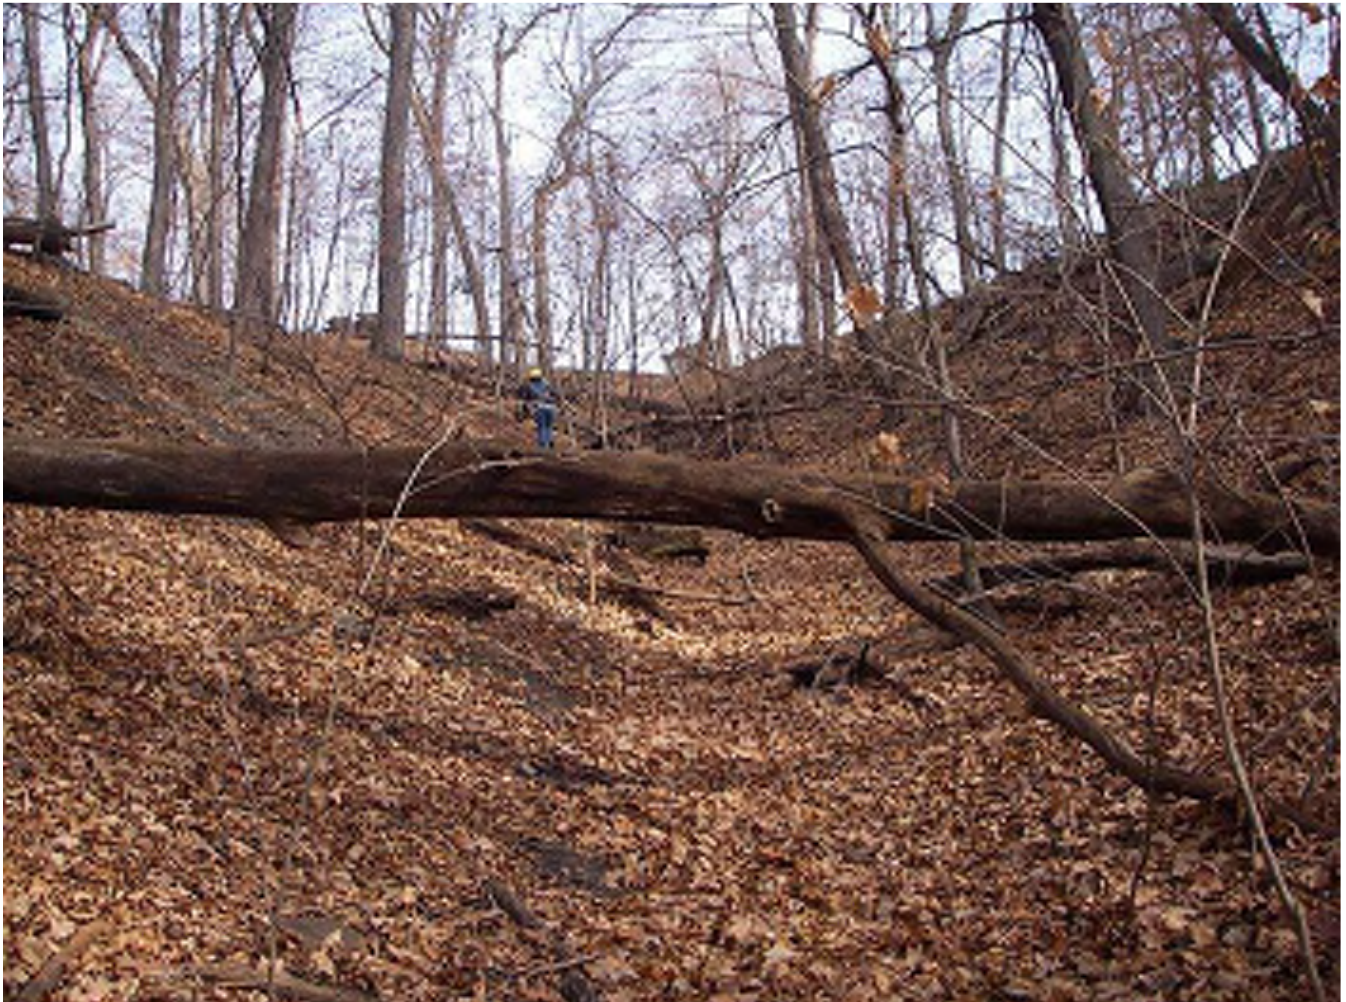
Waypoint 170A

Large gully with large rock shelf at top; moderate erosion; culvert at bottom of gully going under railroad tracks; moderate erosion.

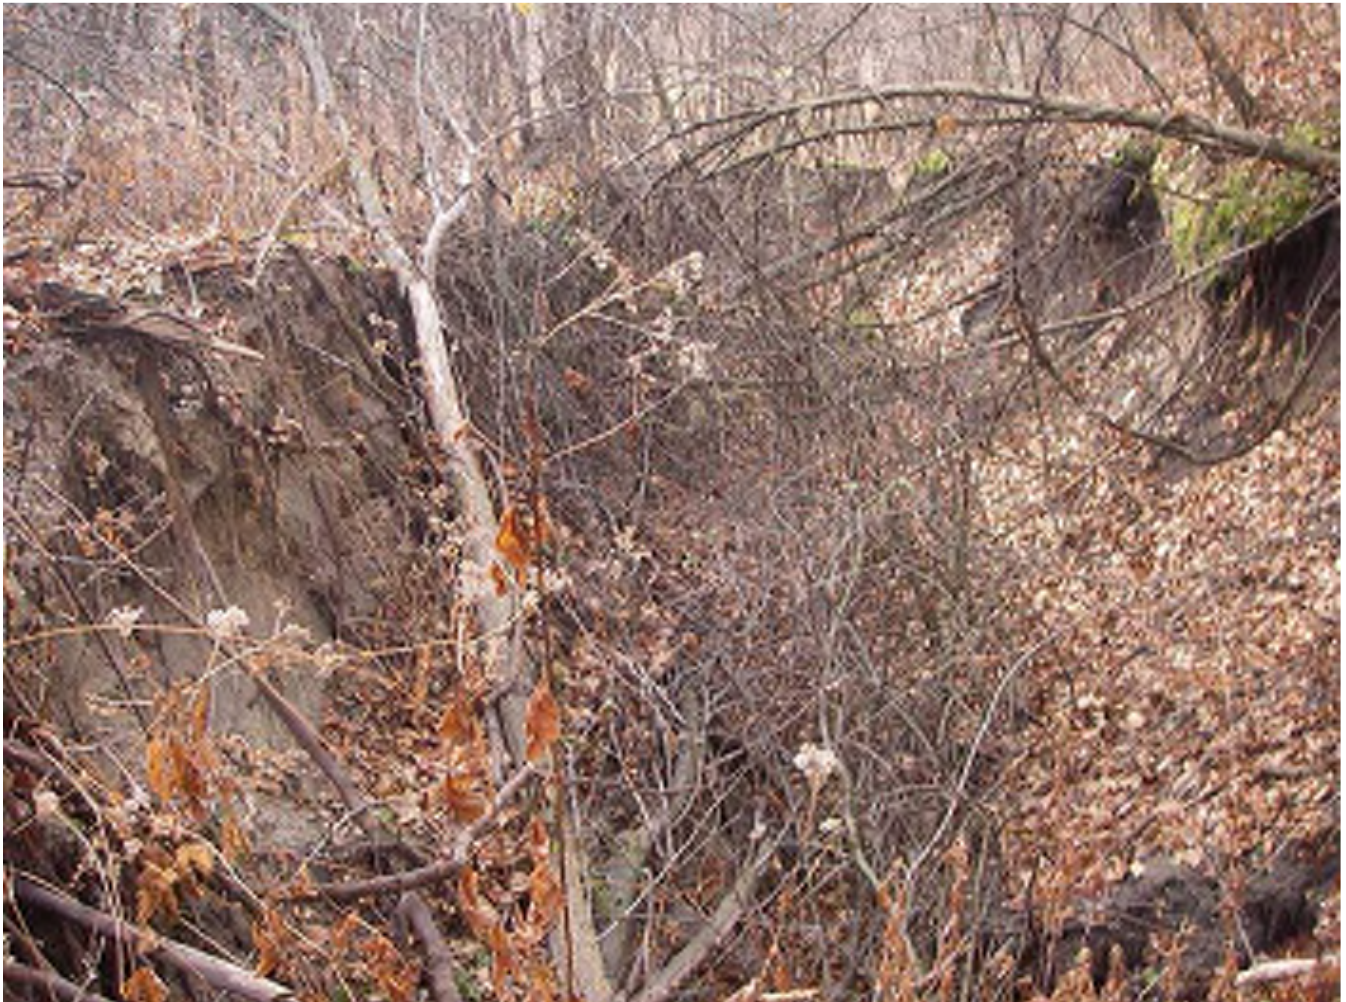
Waypoint 171A

Large gully with large rock shelf at top; moderate erosion; culvert at bottom of gully going under railroad tracks; moderate erosion.

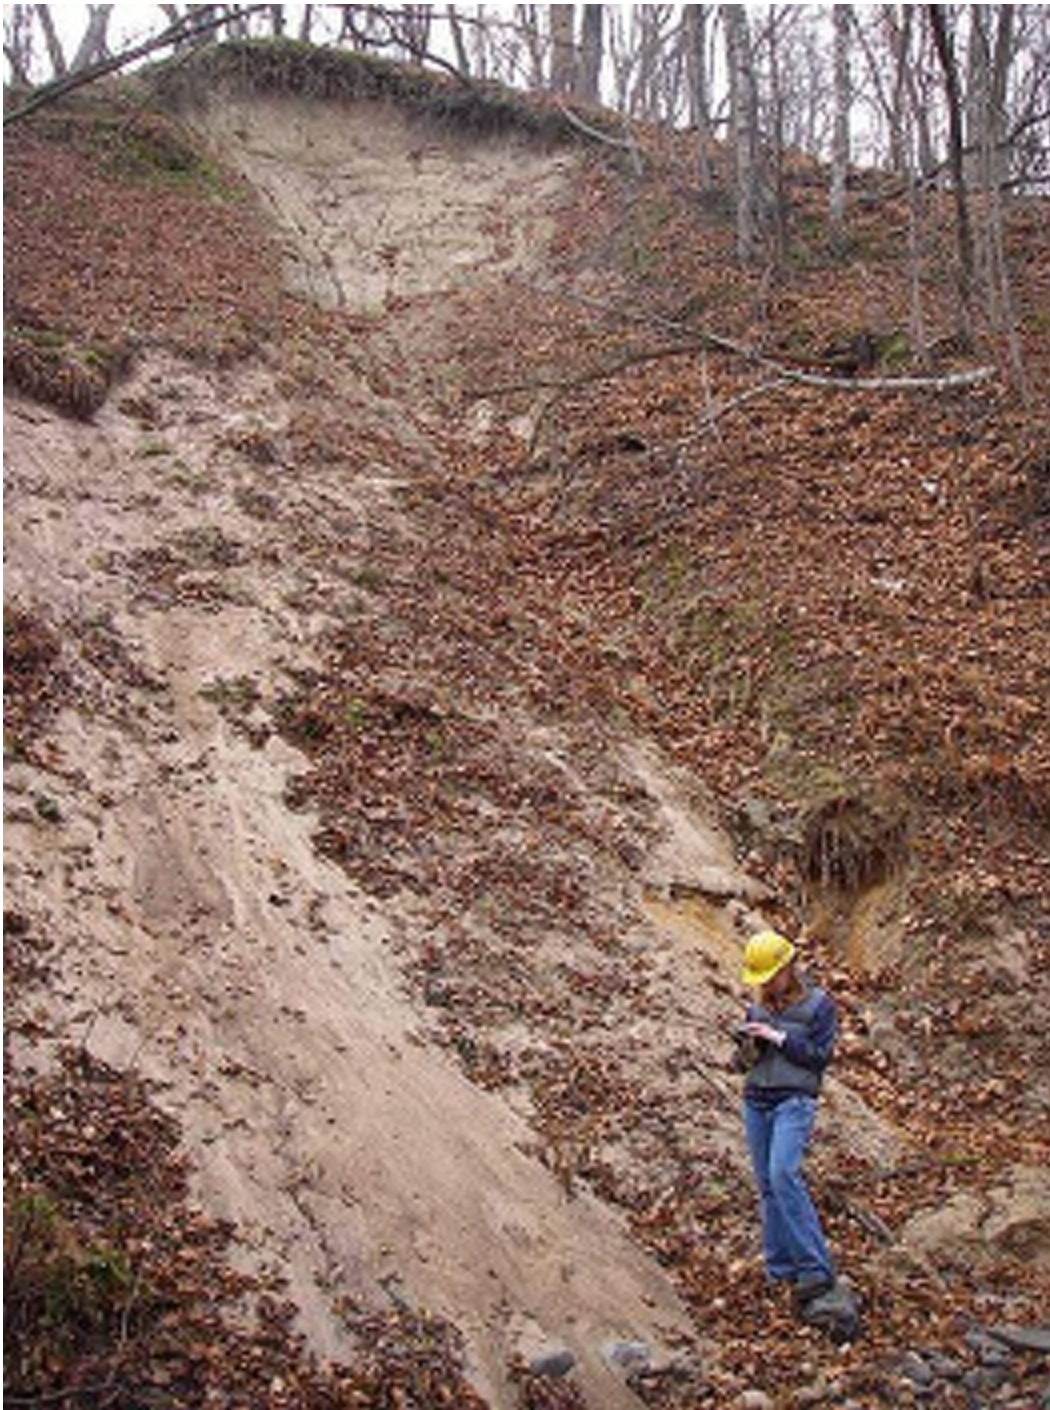
Waypoint 172A

Large gully with large rock ledge at top; major erosion.

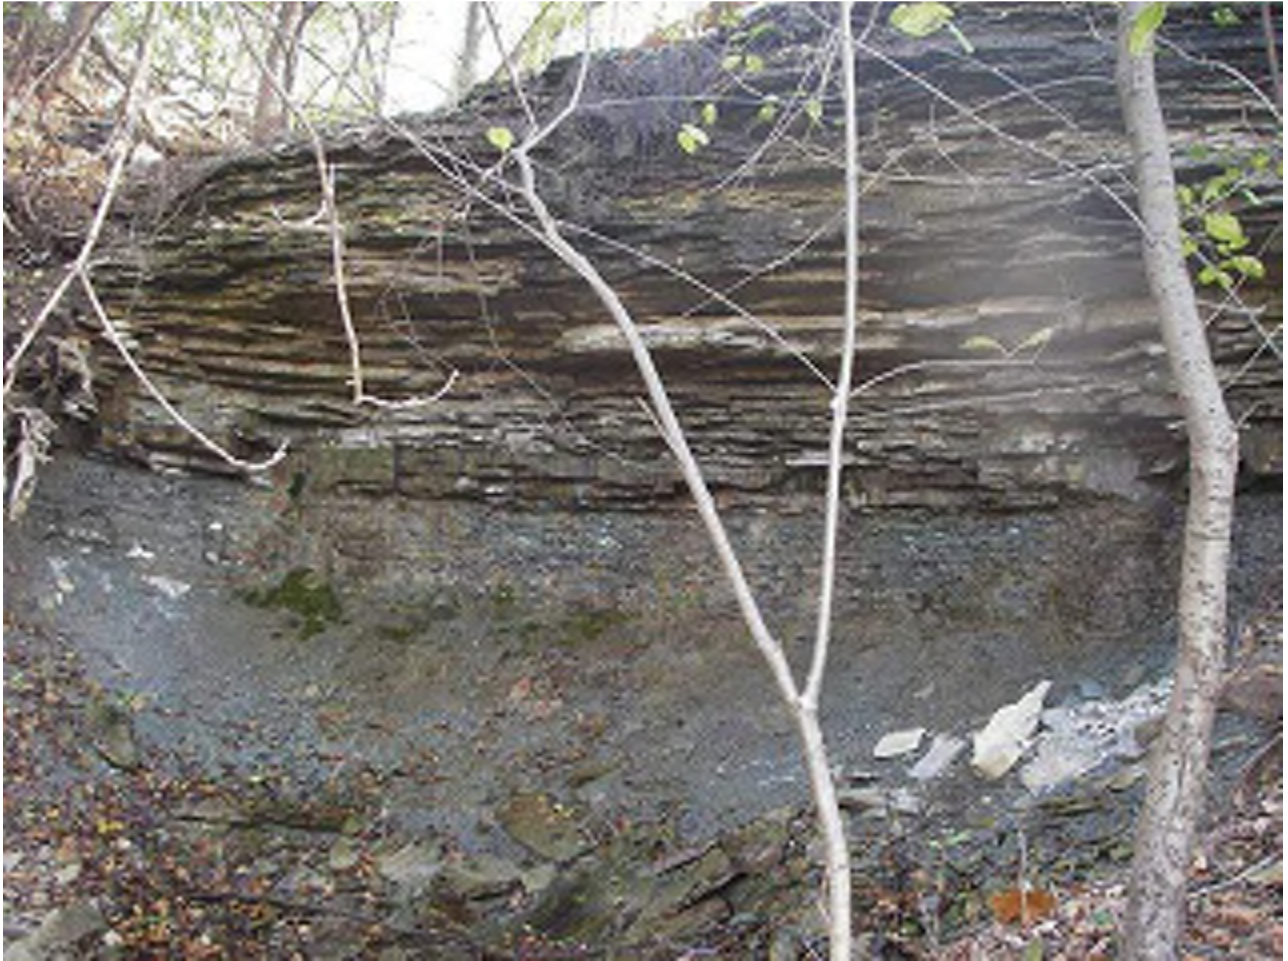
Large gully with large rock ledge at top; major erosion.

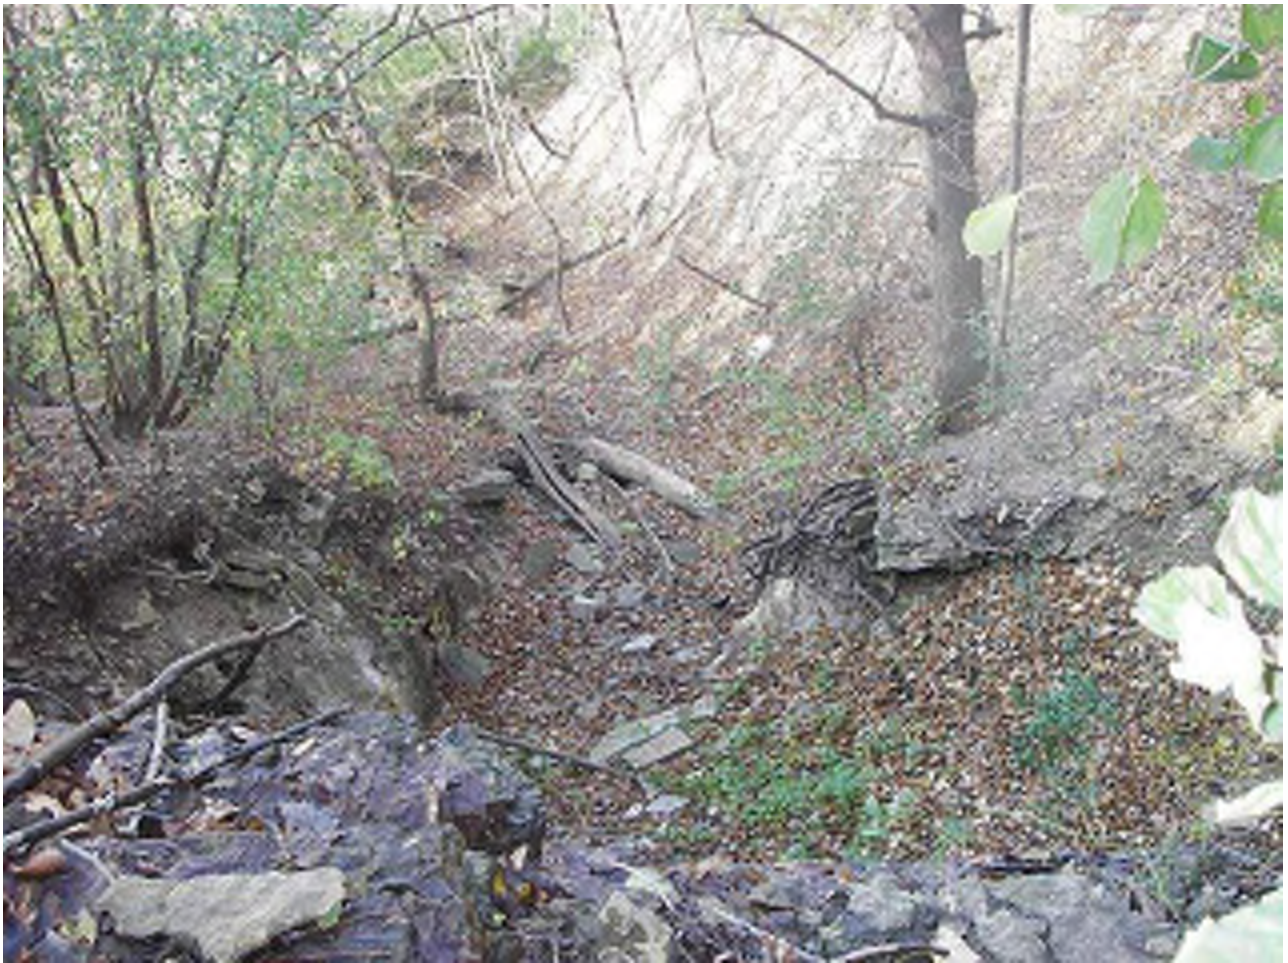
Culvert at top of gully coming from under road.

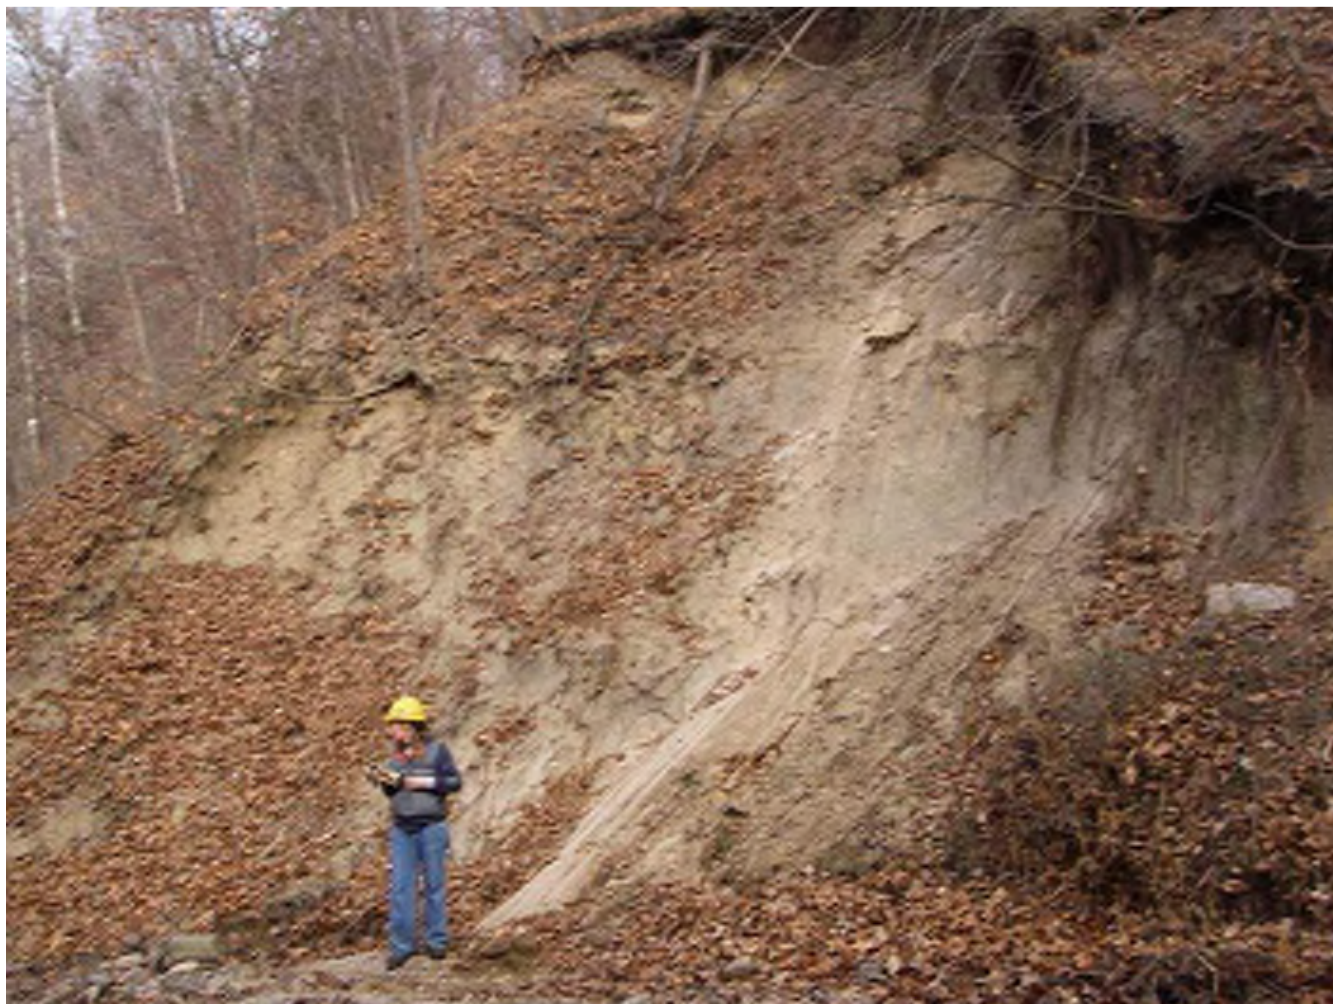
Waypoint 173A

Large gully with two arms going down and connecting midway down gully; arm #1 has moderate erosion.

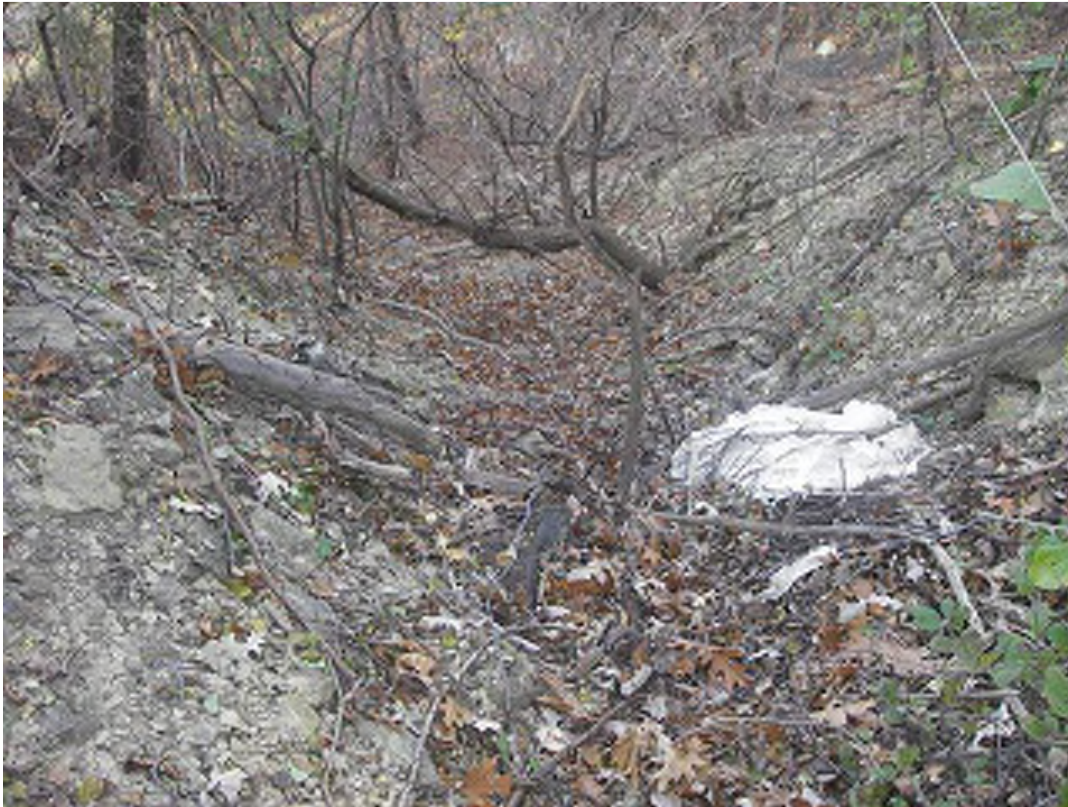
Arm #2 has major erosion.

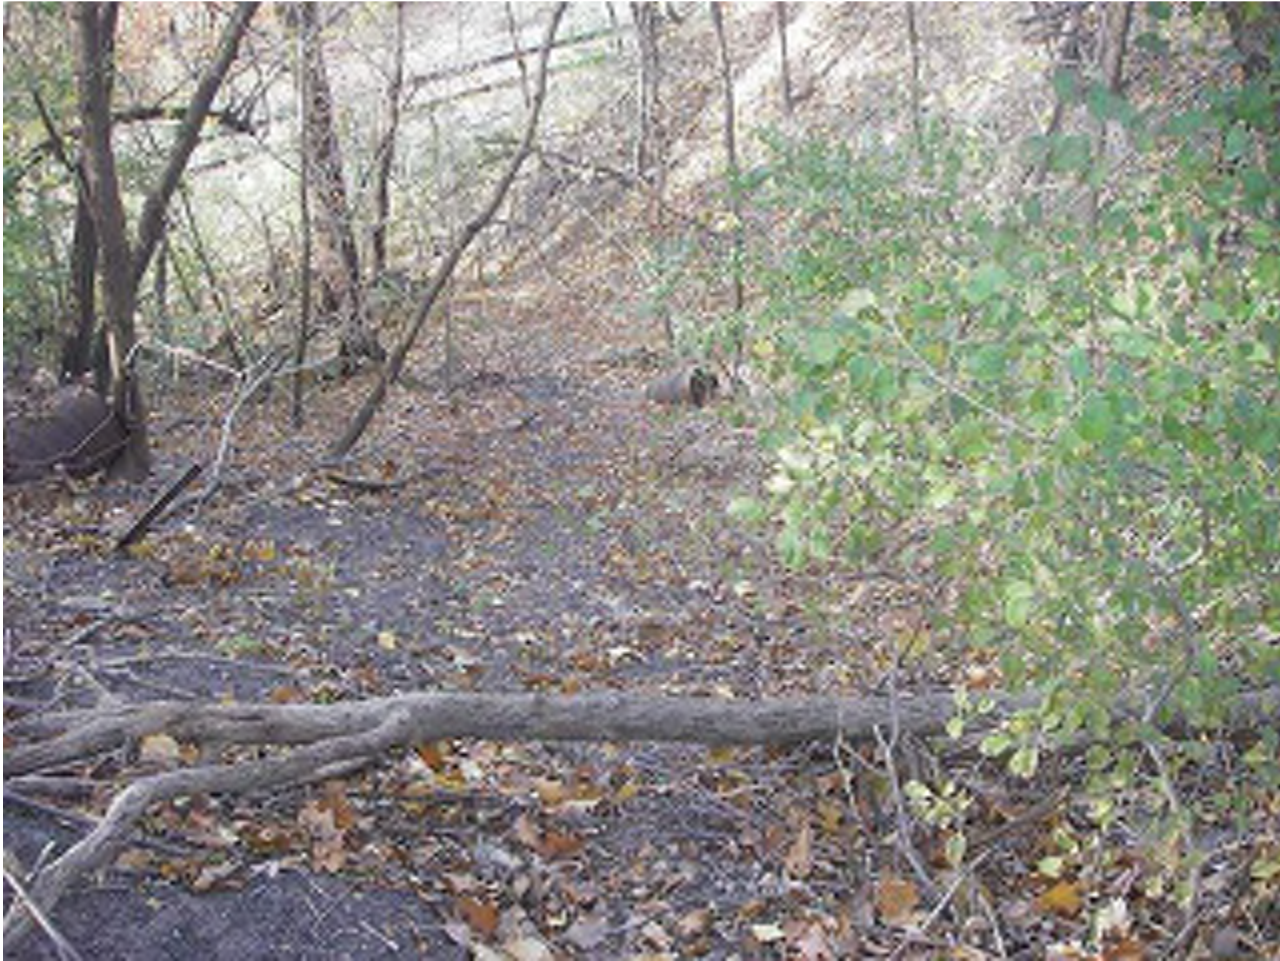
Looking down at large gully; moderate erosion.

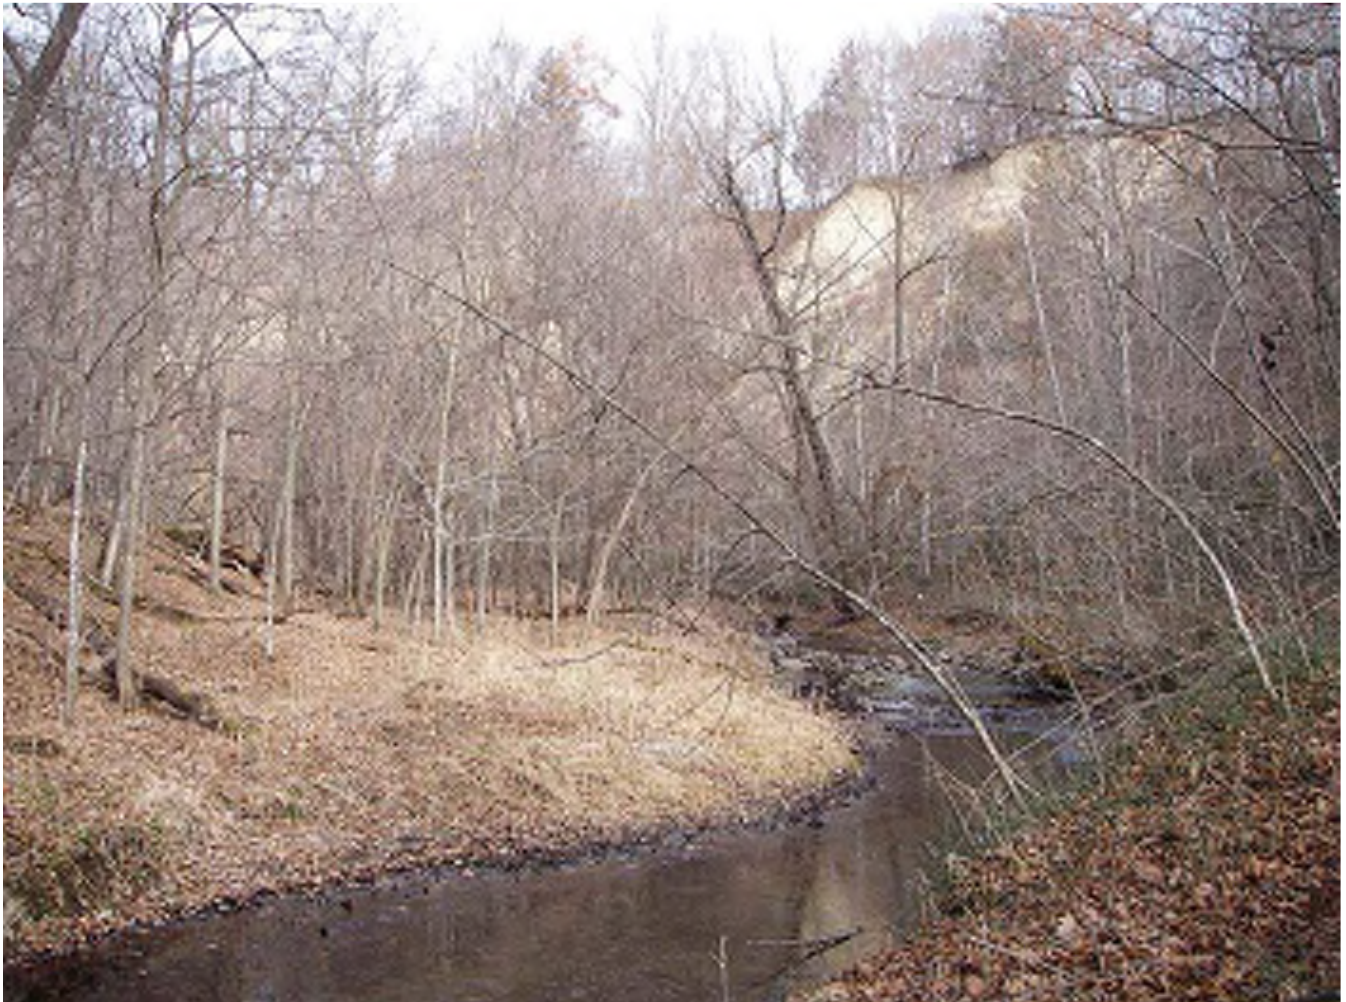
Waypoint 175

Severe erosion

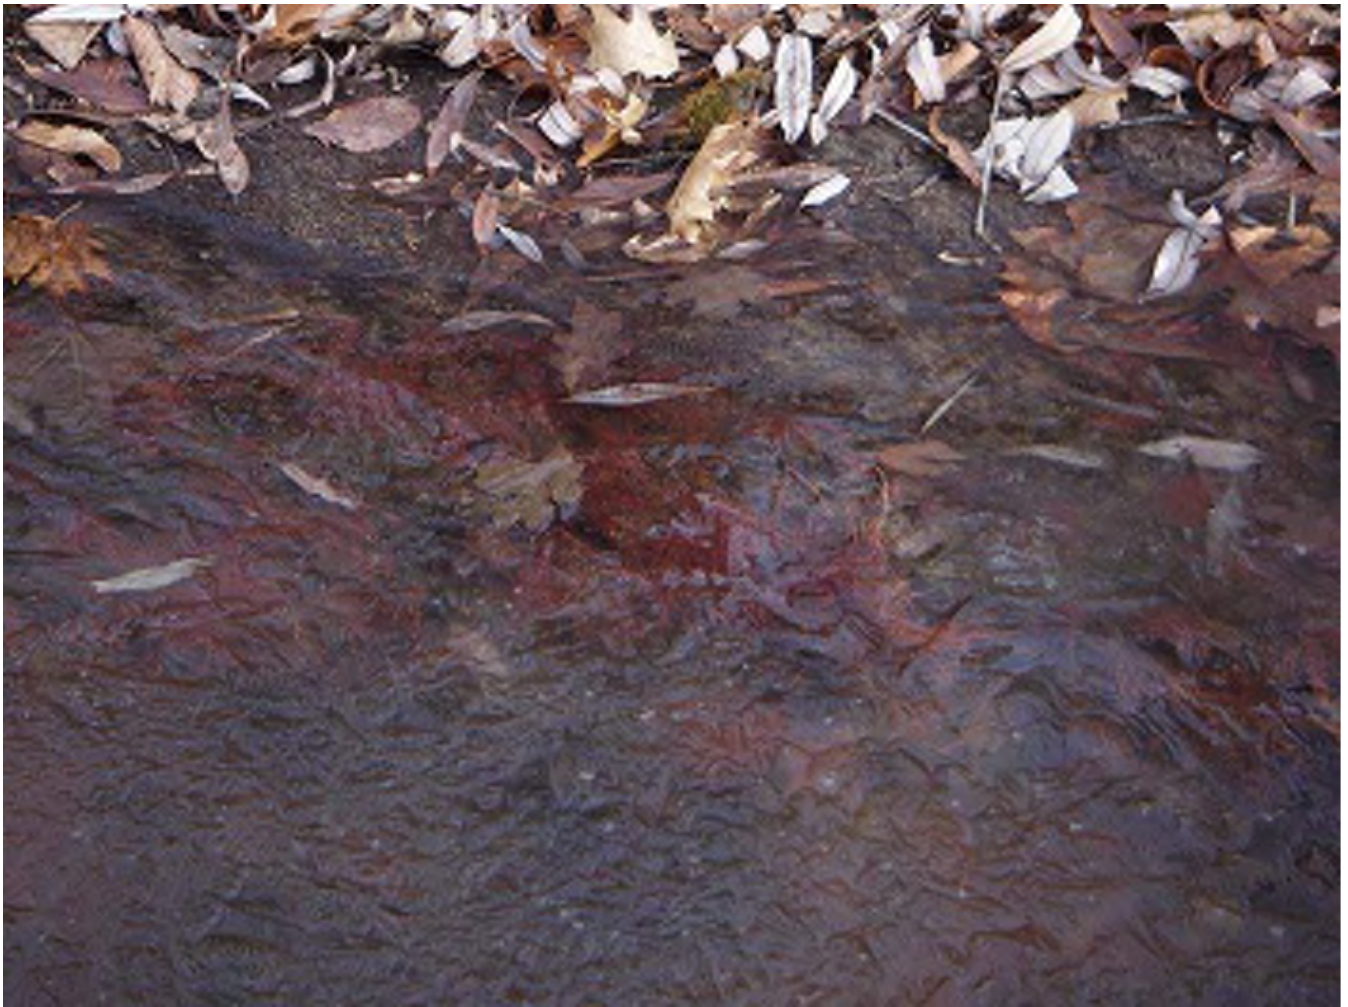
Fresh water sponges

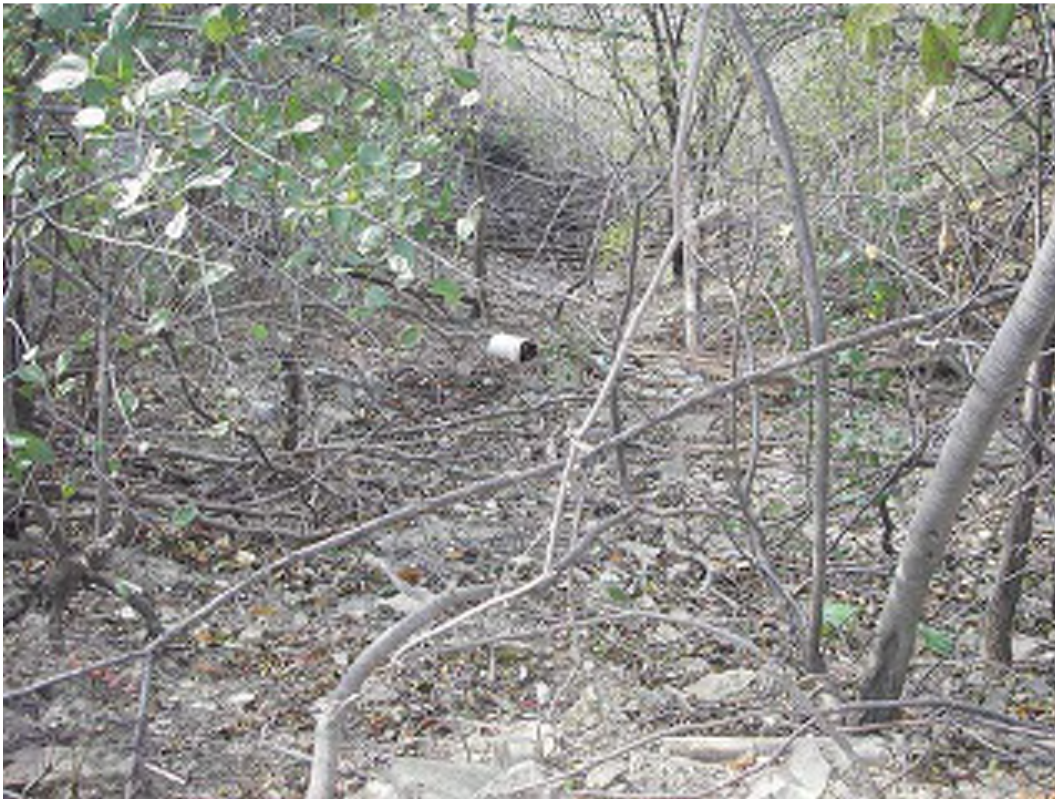
Waypoint 175A

Looking down at gully; moderate to major erosion; looks like large amounts of water flow down gully.
