Appendix K: Lower Minnesota River Watershed District: Gully Inventory

Gully Inventory Map
 Area #1
 Lower Minnesota River Watershed District
 Watershed Management Plan

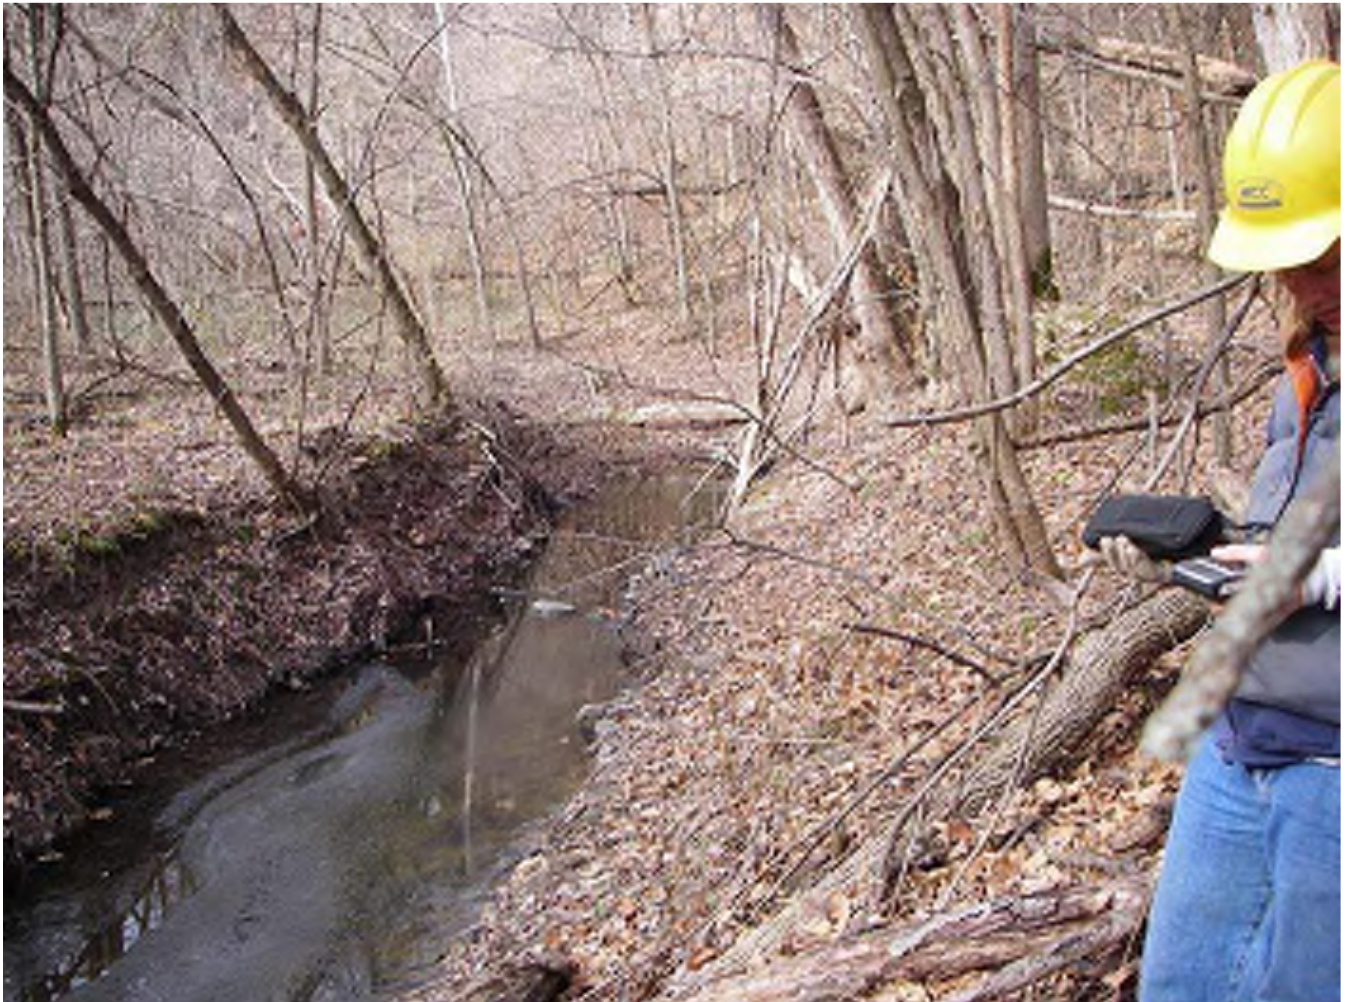
Waypoint 176

End

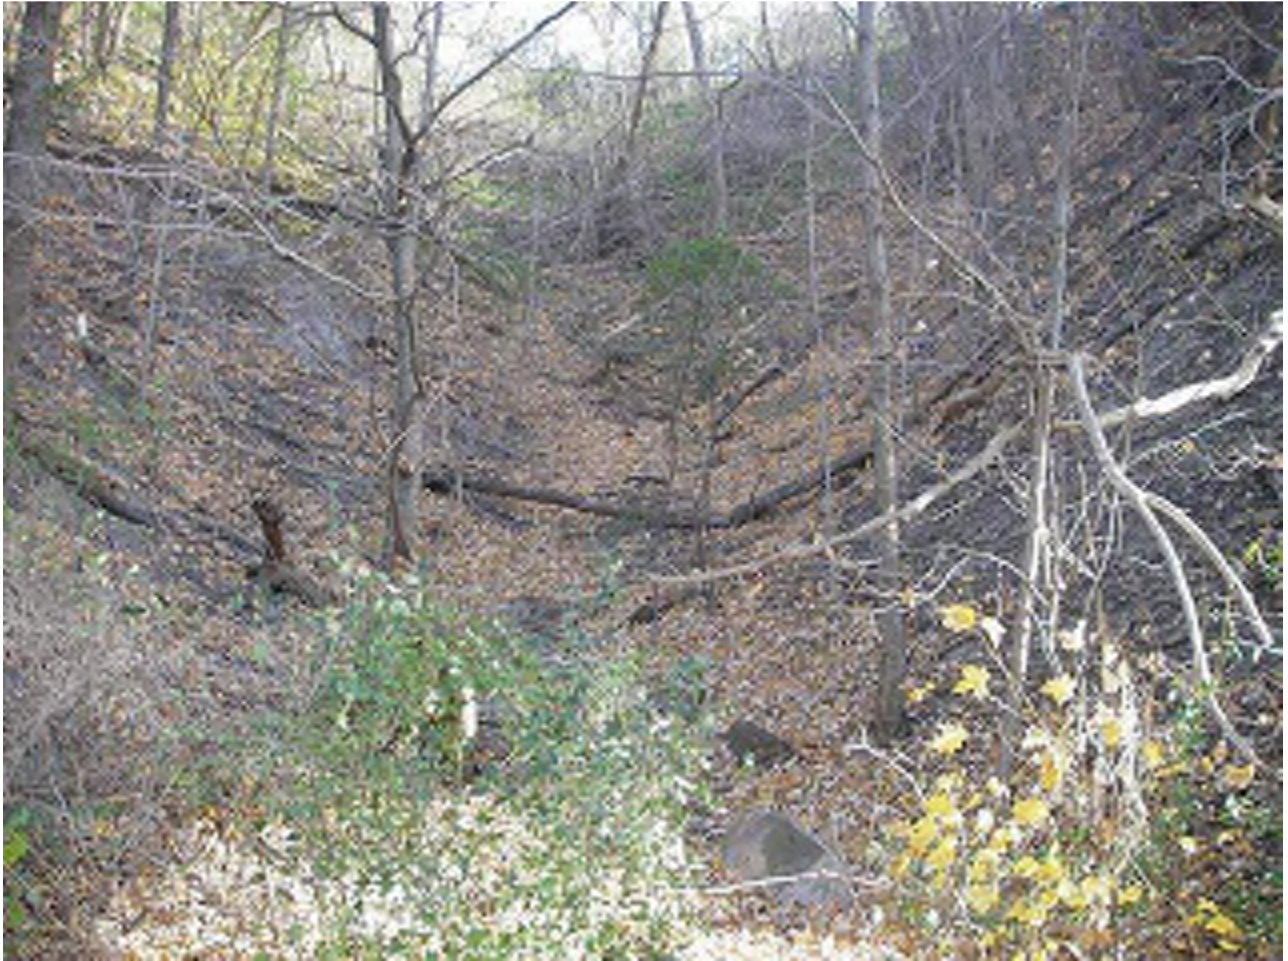
Waypoint 176A

Looking up at gully from railroad tracks; moderate to major erosion.

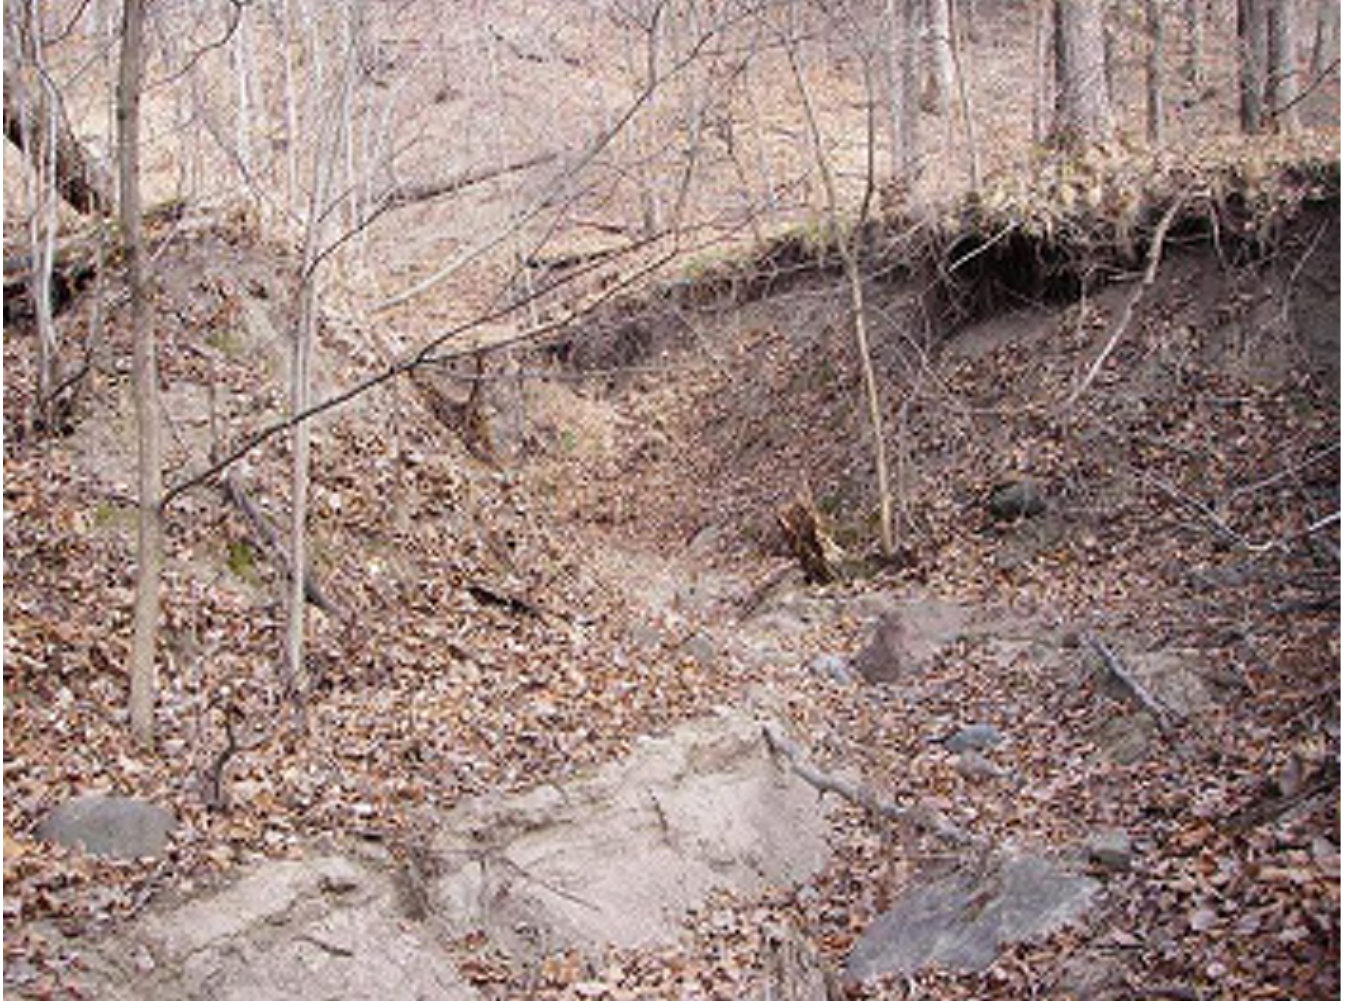
Waypoint 177

Branch

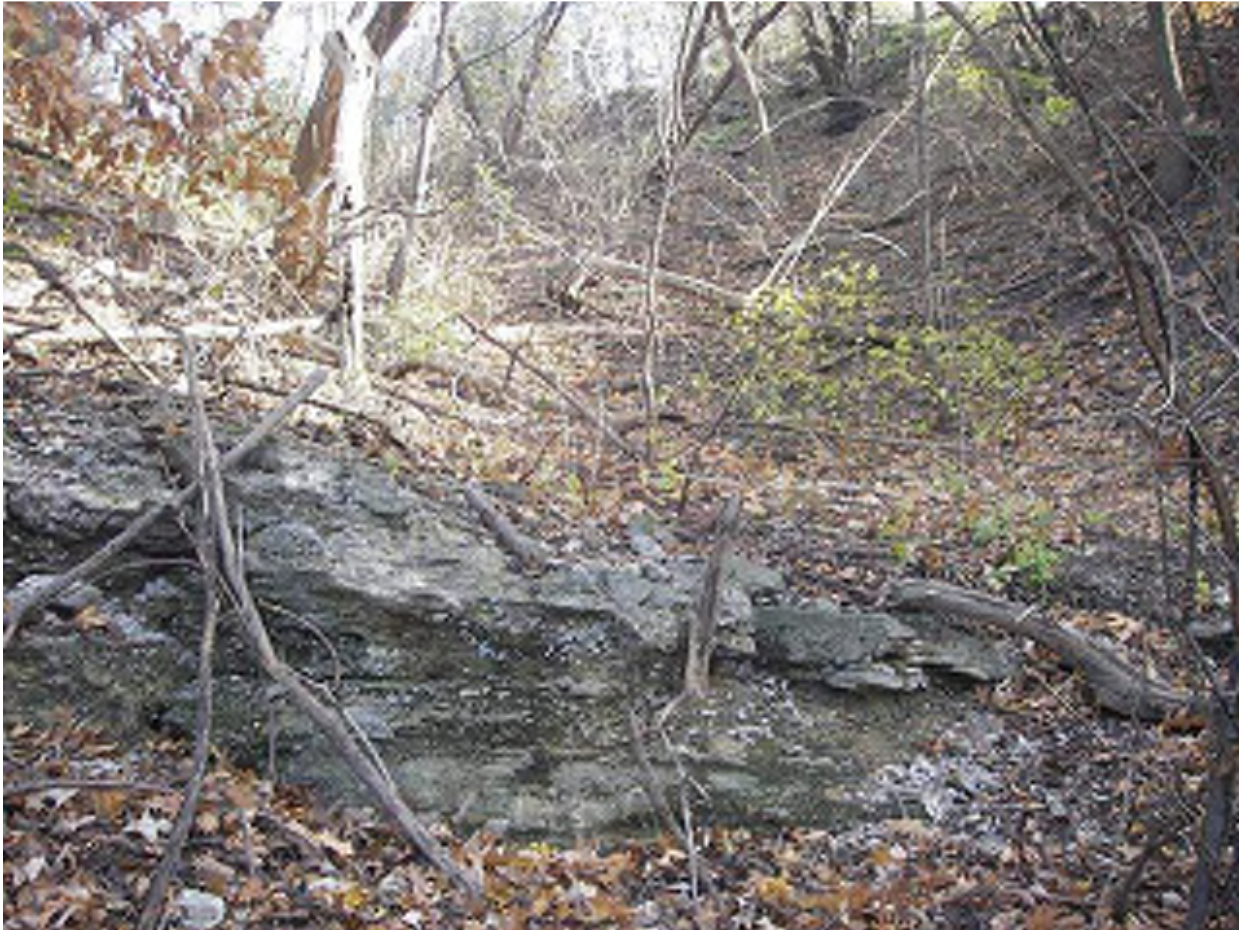
Waypoint 177A

Looking up at large gully from railroad tracks; lots of rock ledges; minimal erosion.

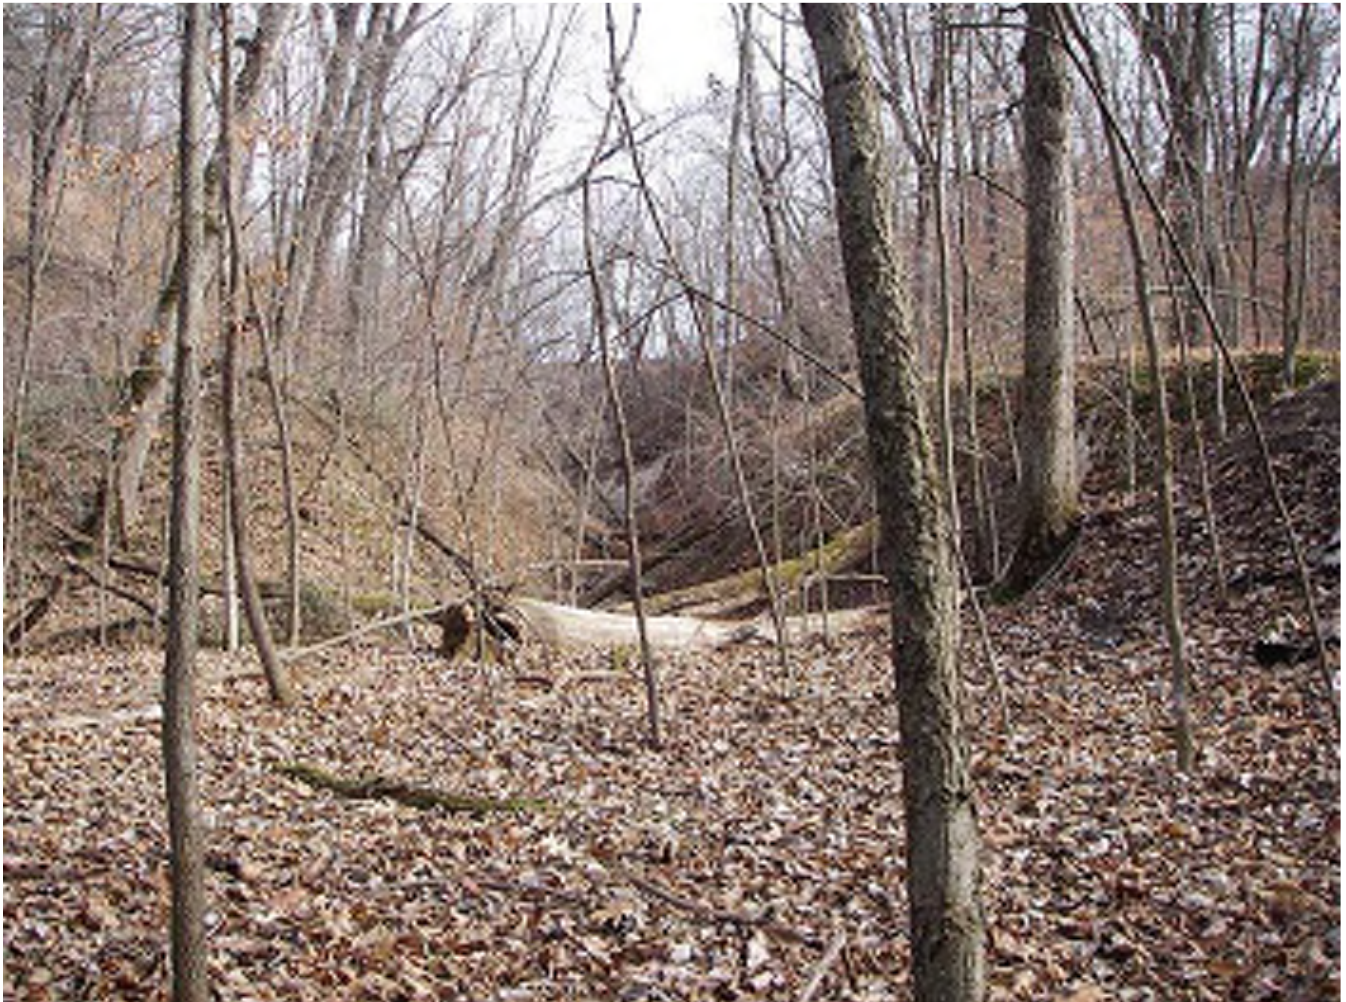
Waypoint 178

Branch

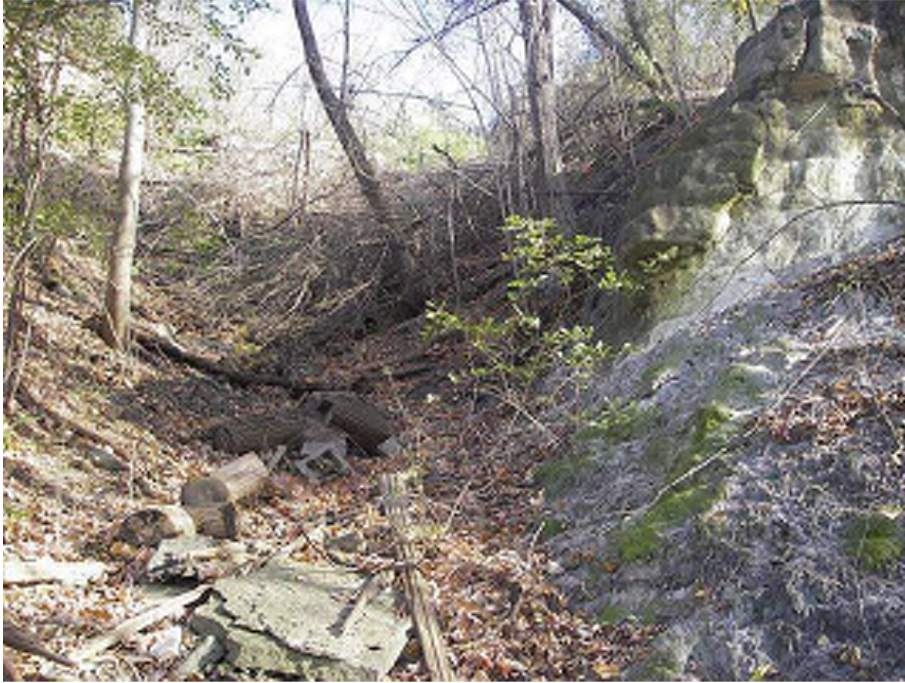
Waypoint 178A

Medium gully with moderate erosion on sides; lots of down trees and brush; looking up at gully from railroad tracks.

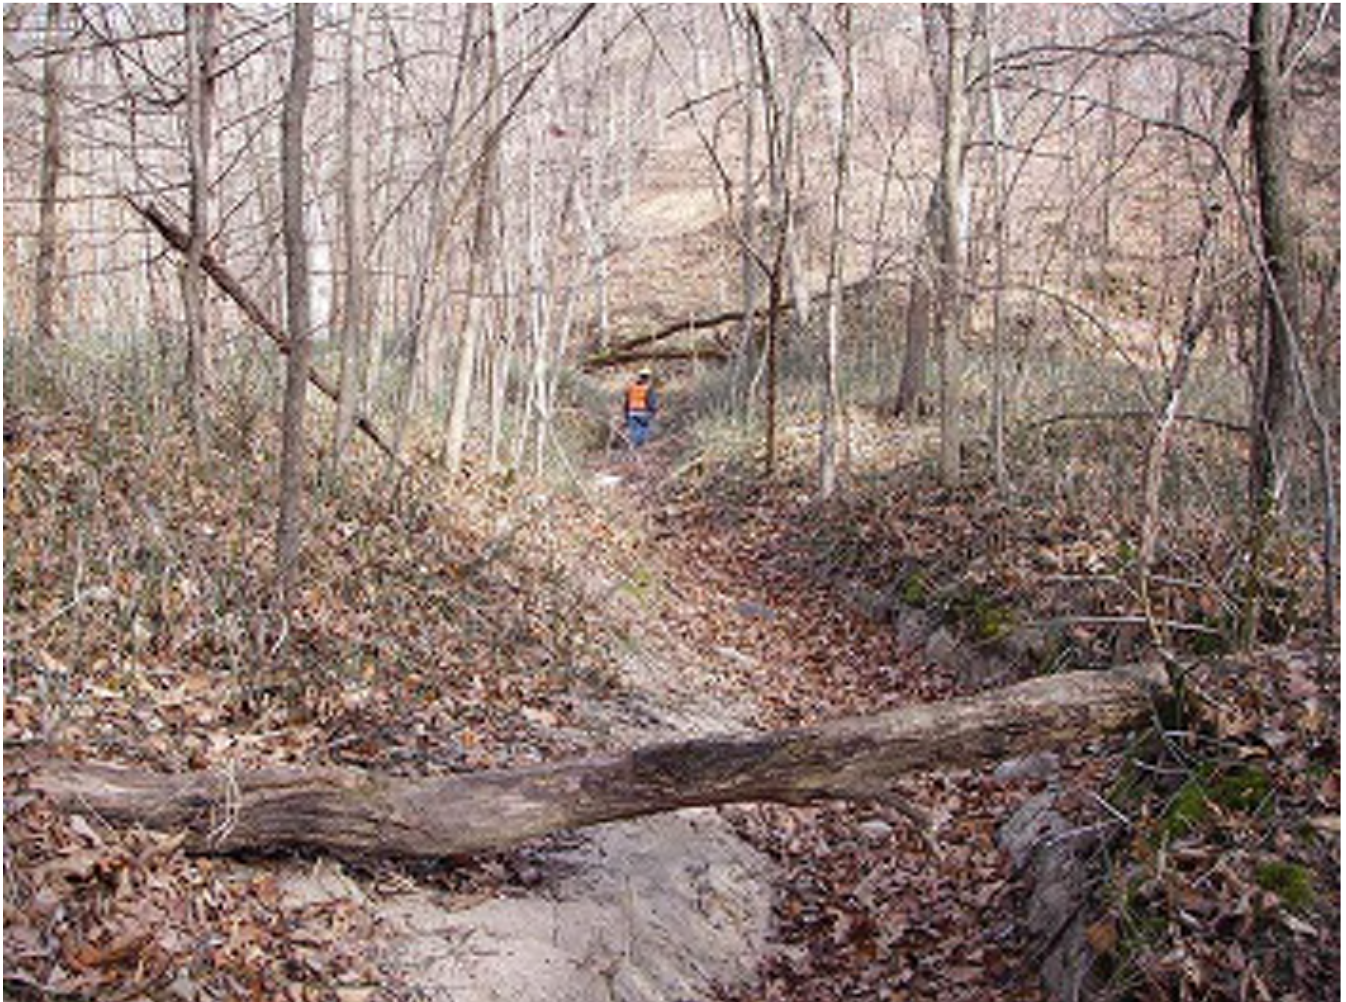
Waypoint 179

Branch

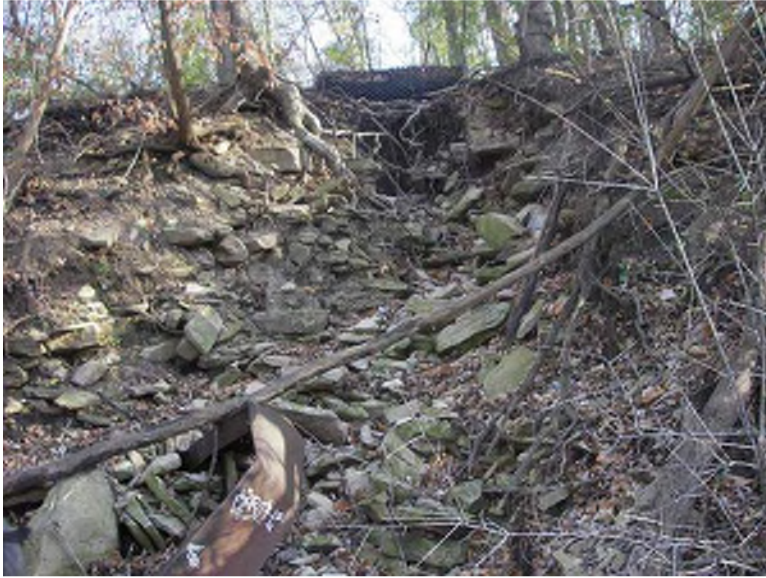
Waypoint 179A

Looking up at small gully from railroad tracks; lots of small rock and some sort of erosion control method at top; looks like a fence laying

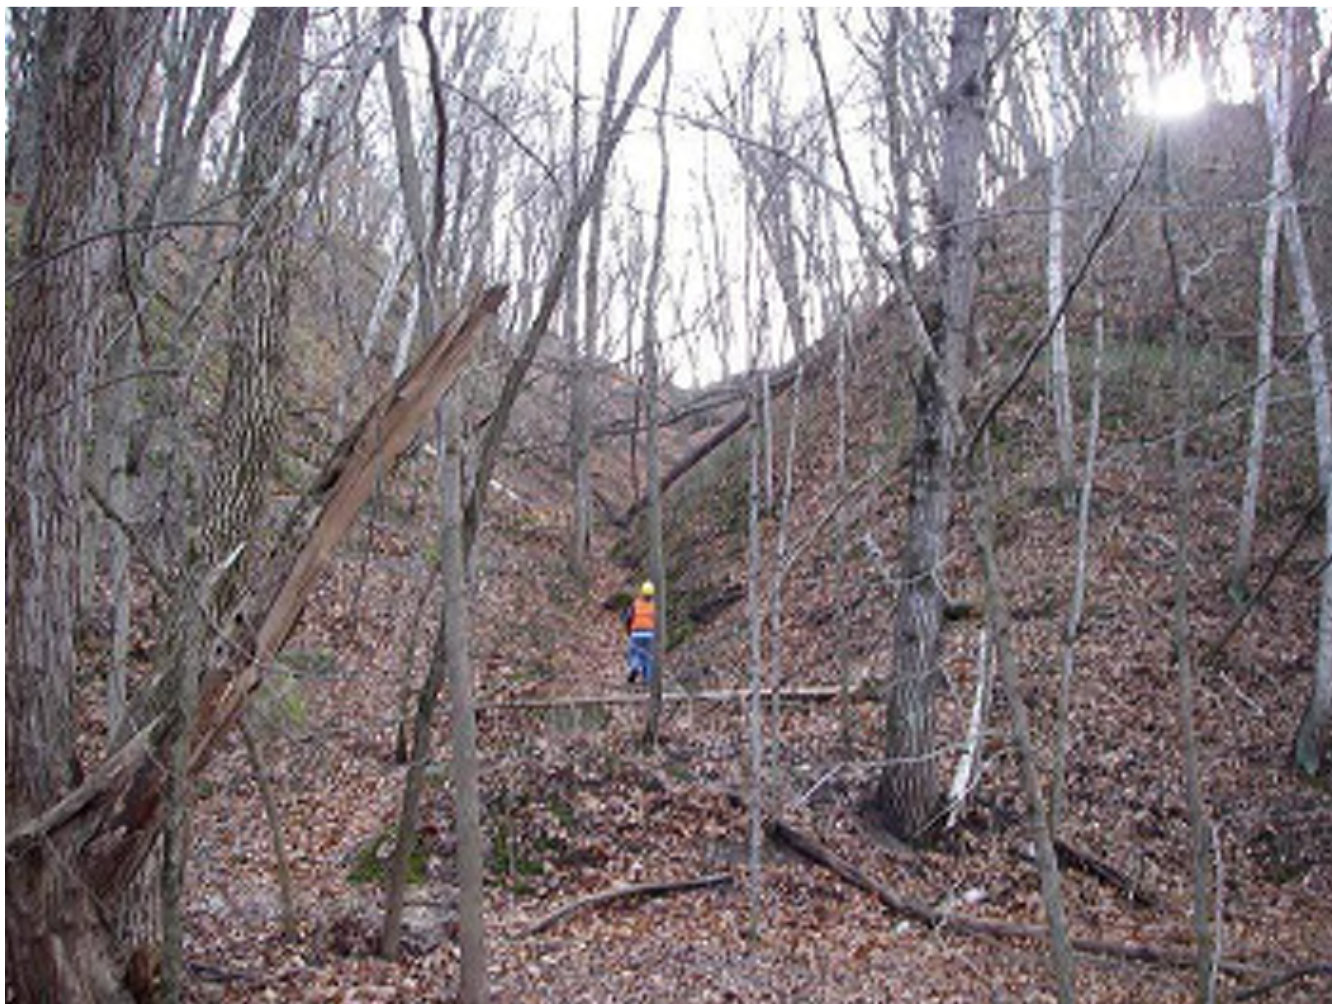
Waypoint 180

Branch

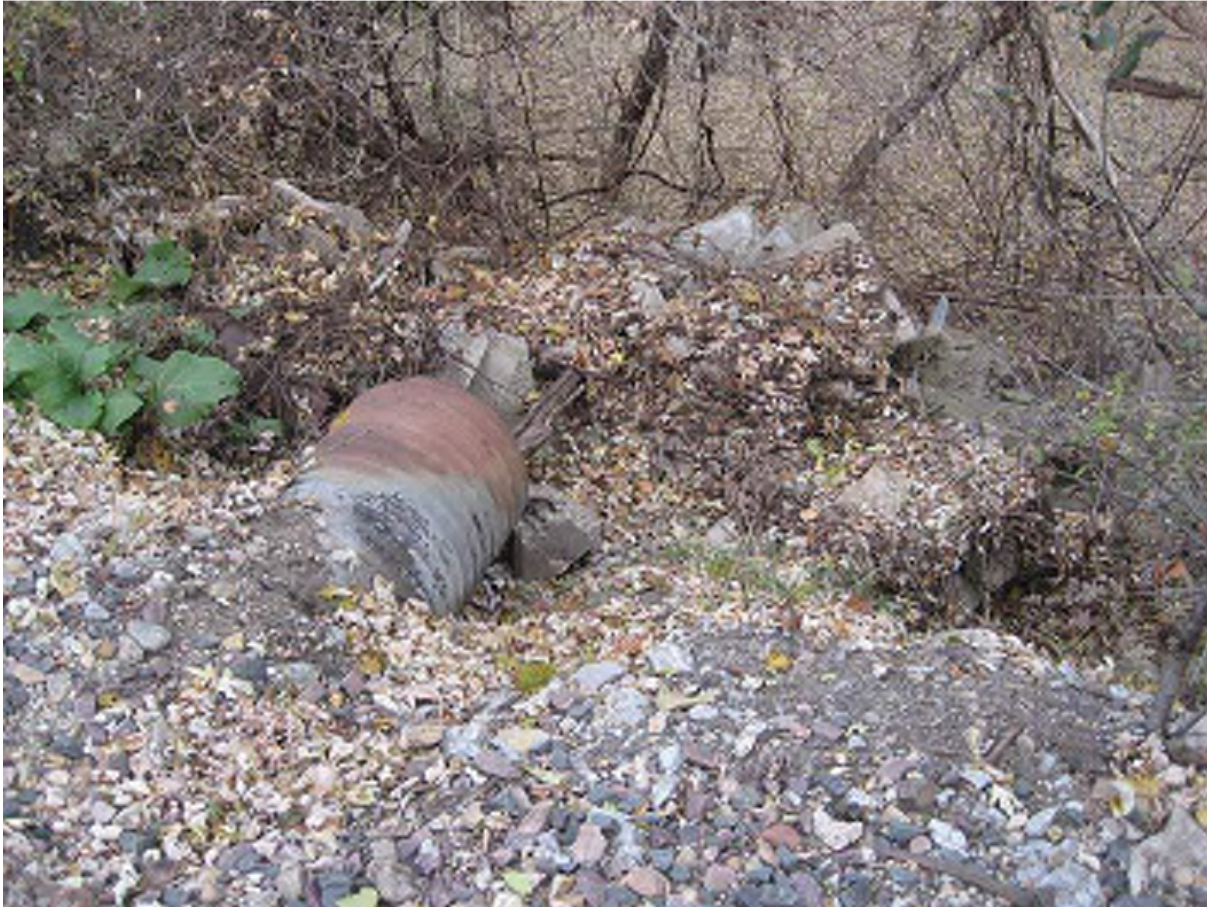
Waypoint 180A

Lower side of railroad tracks; culvert with lots of cement piled below culvert; minimal erosion.

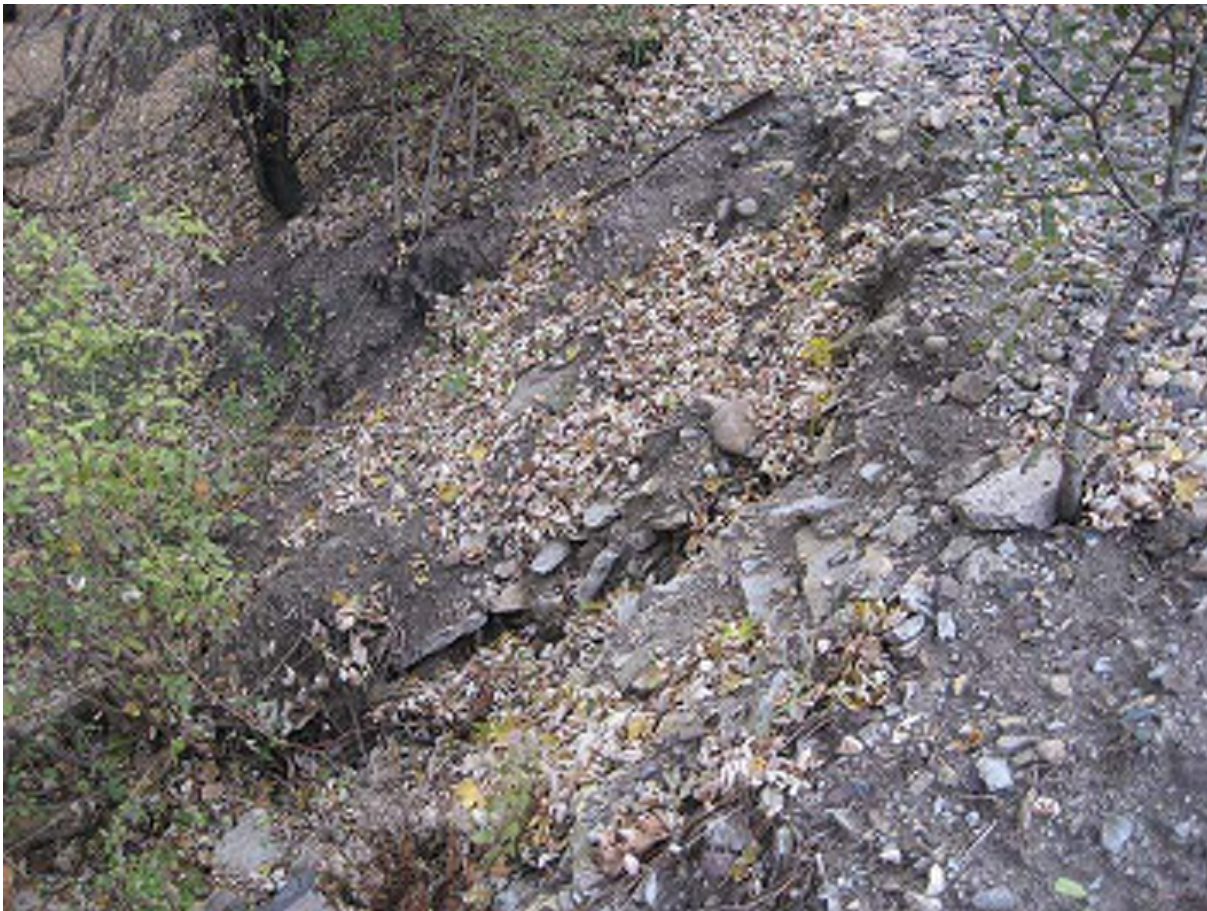
Lower side of railroad tracks; culvert with lots of cement piled below culvert; minimal erosion.

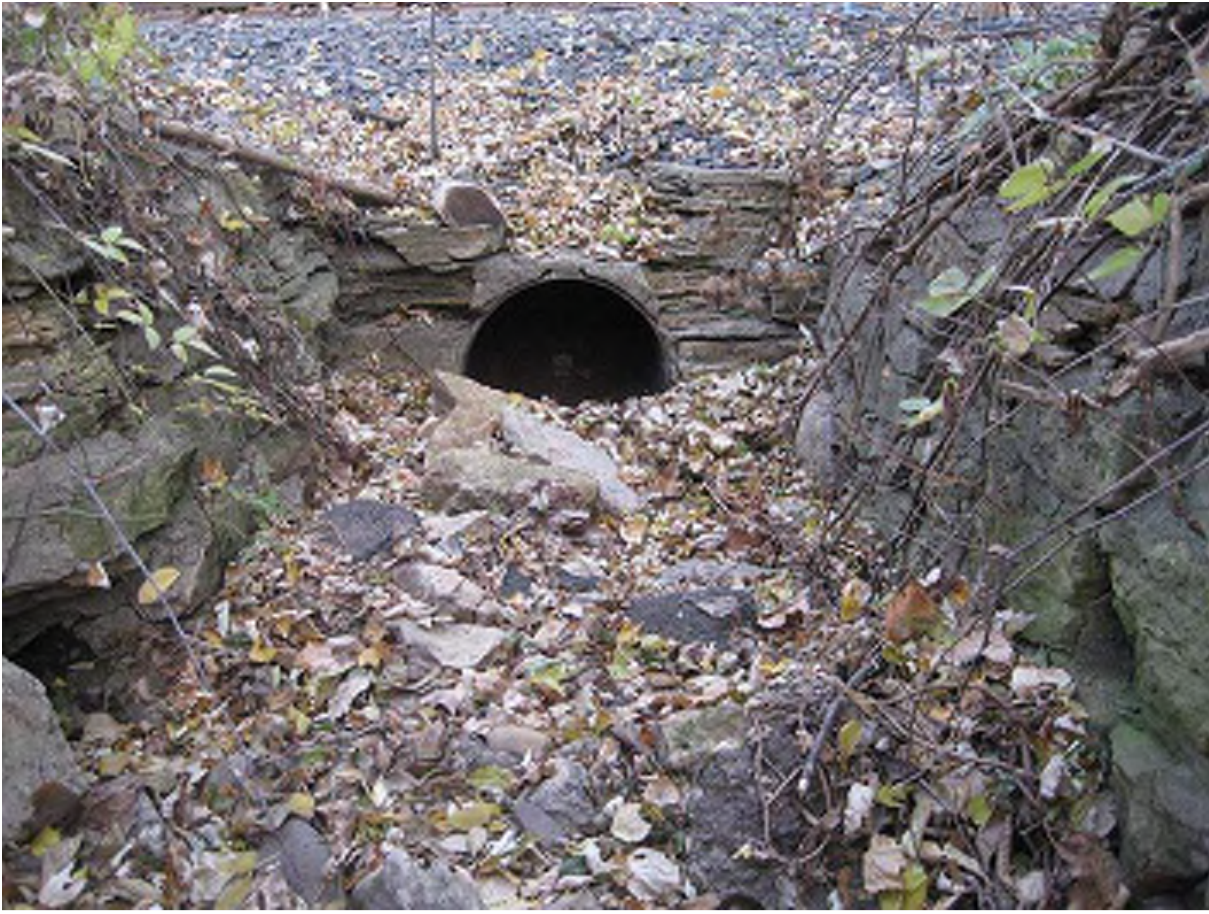
Upper side of culvert; lots of rock and debris.

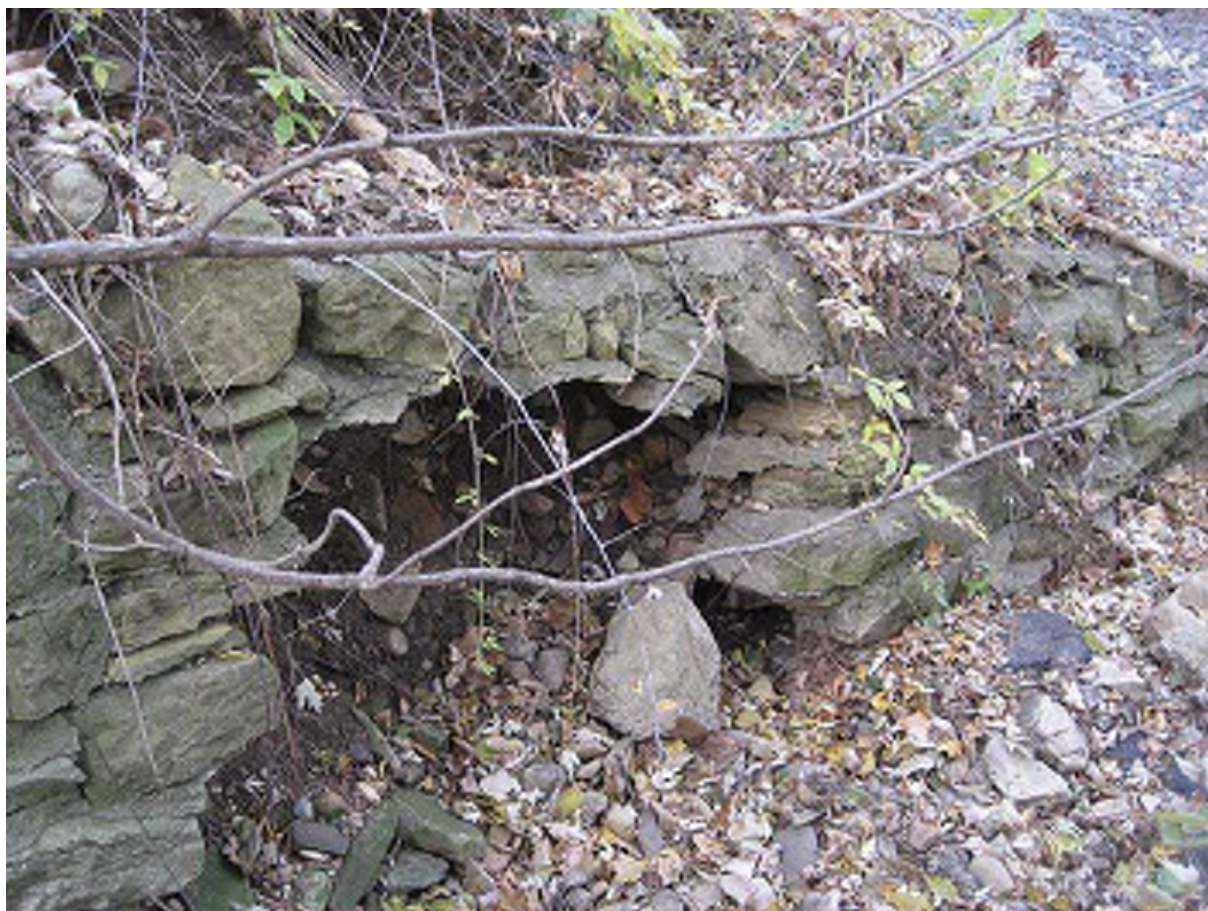
Side where water flows into culvert; rock and soil removed; moderate erosion.

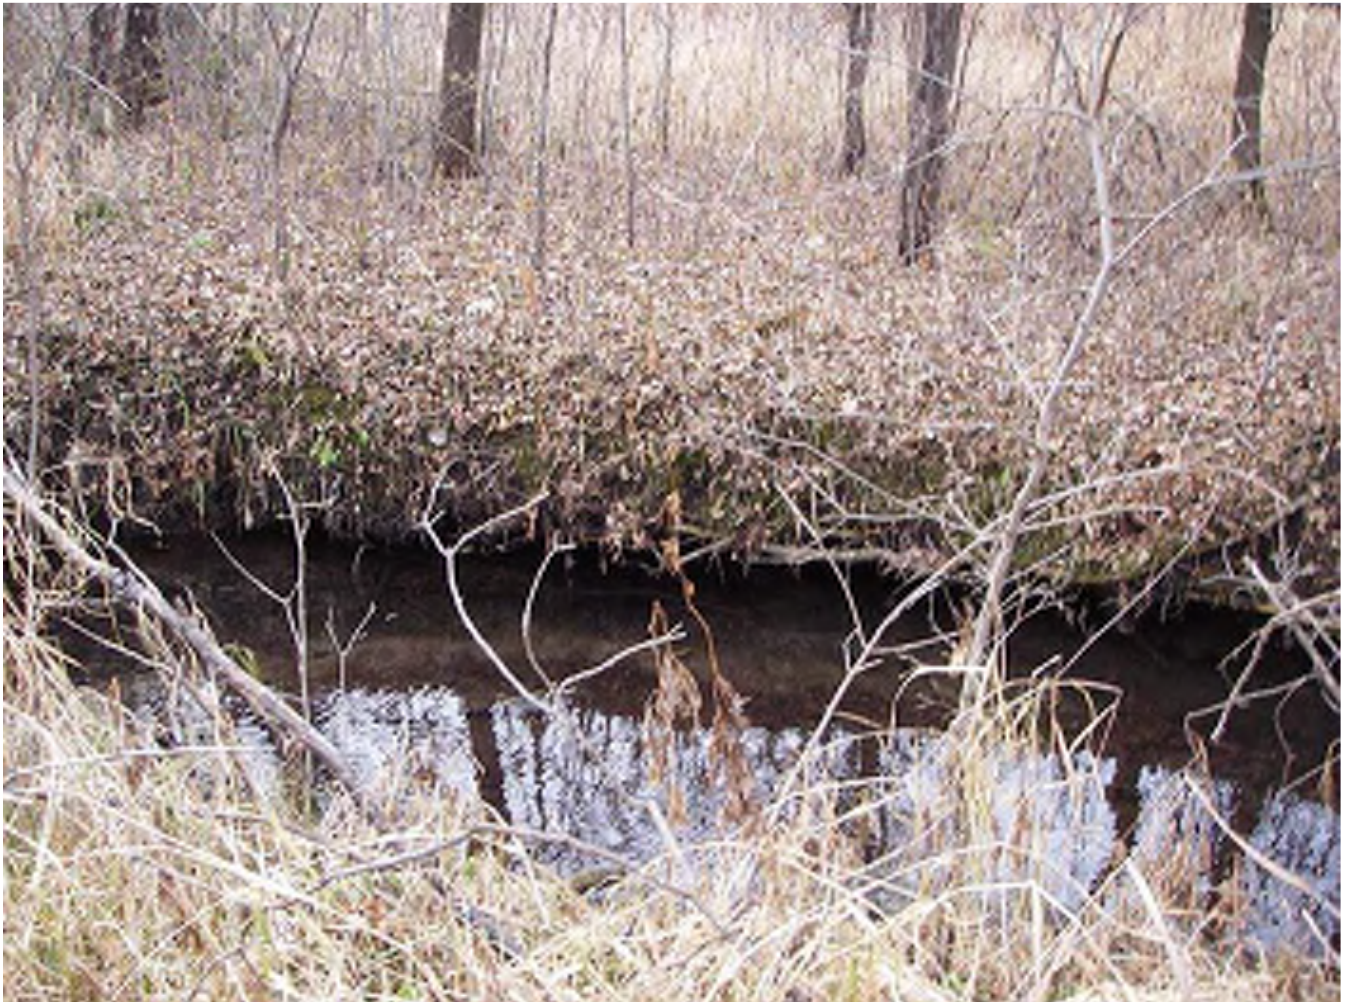
Waypoint 181

Branch

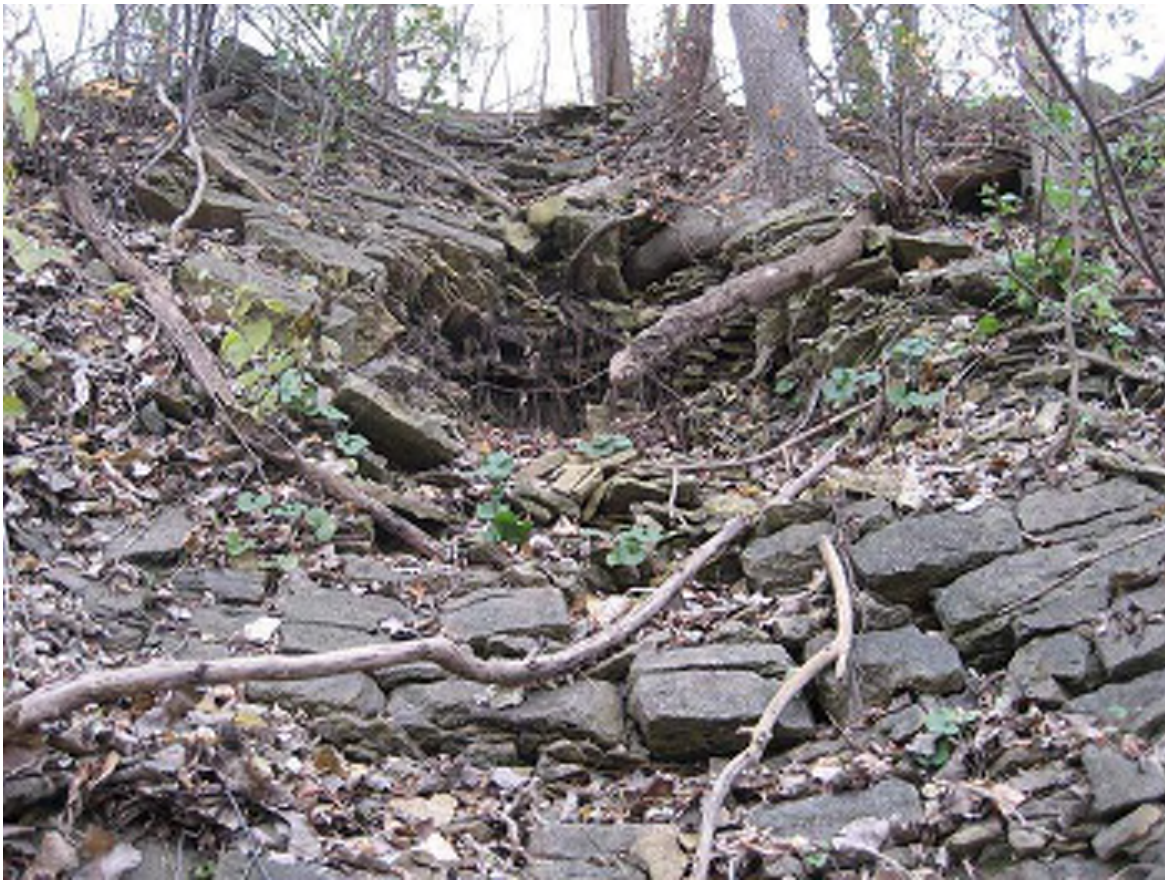
Looking up to where water comes down into culvert.

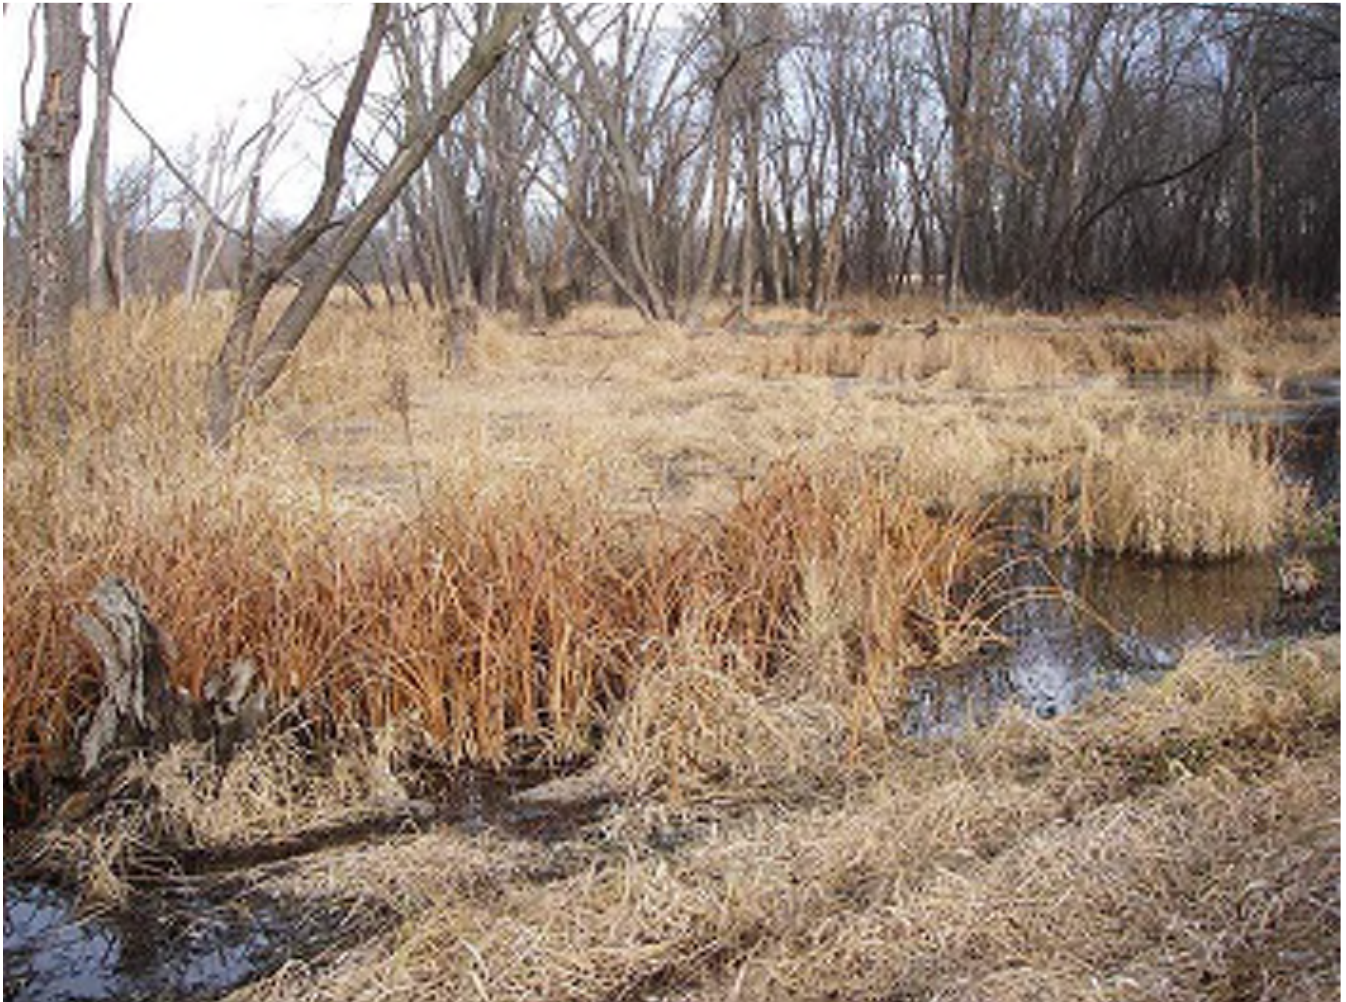
Waypoint 182

Erosion (undercutting)

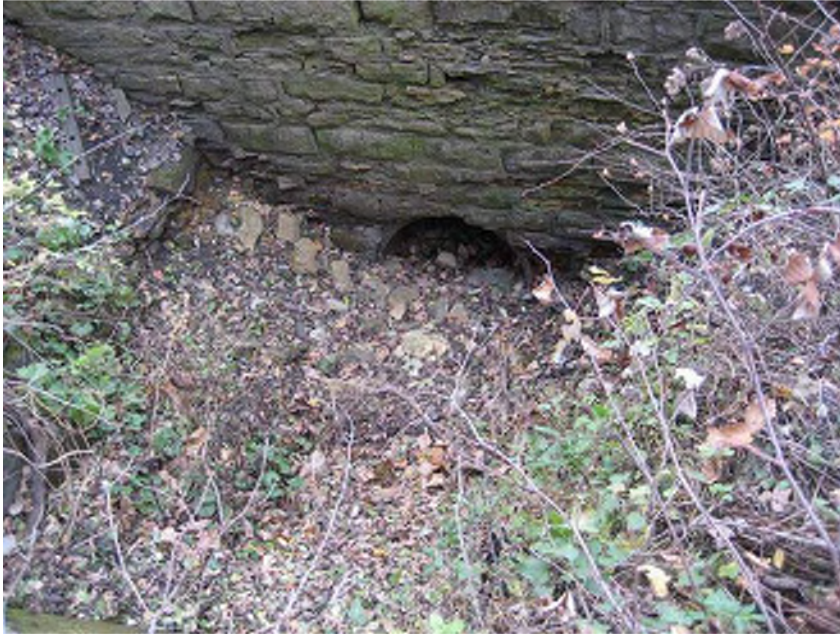
Waypoint 182A

Above railroad tracks, a chute leading water down through the culvert.

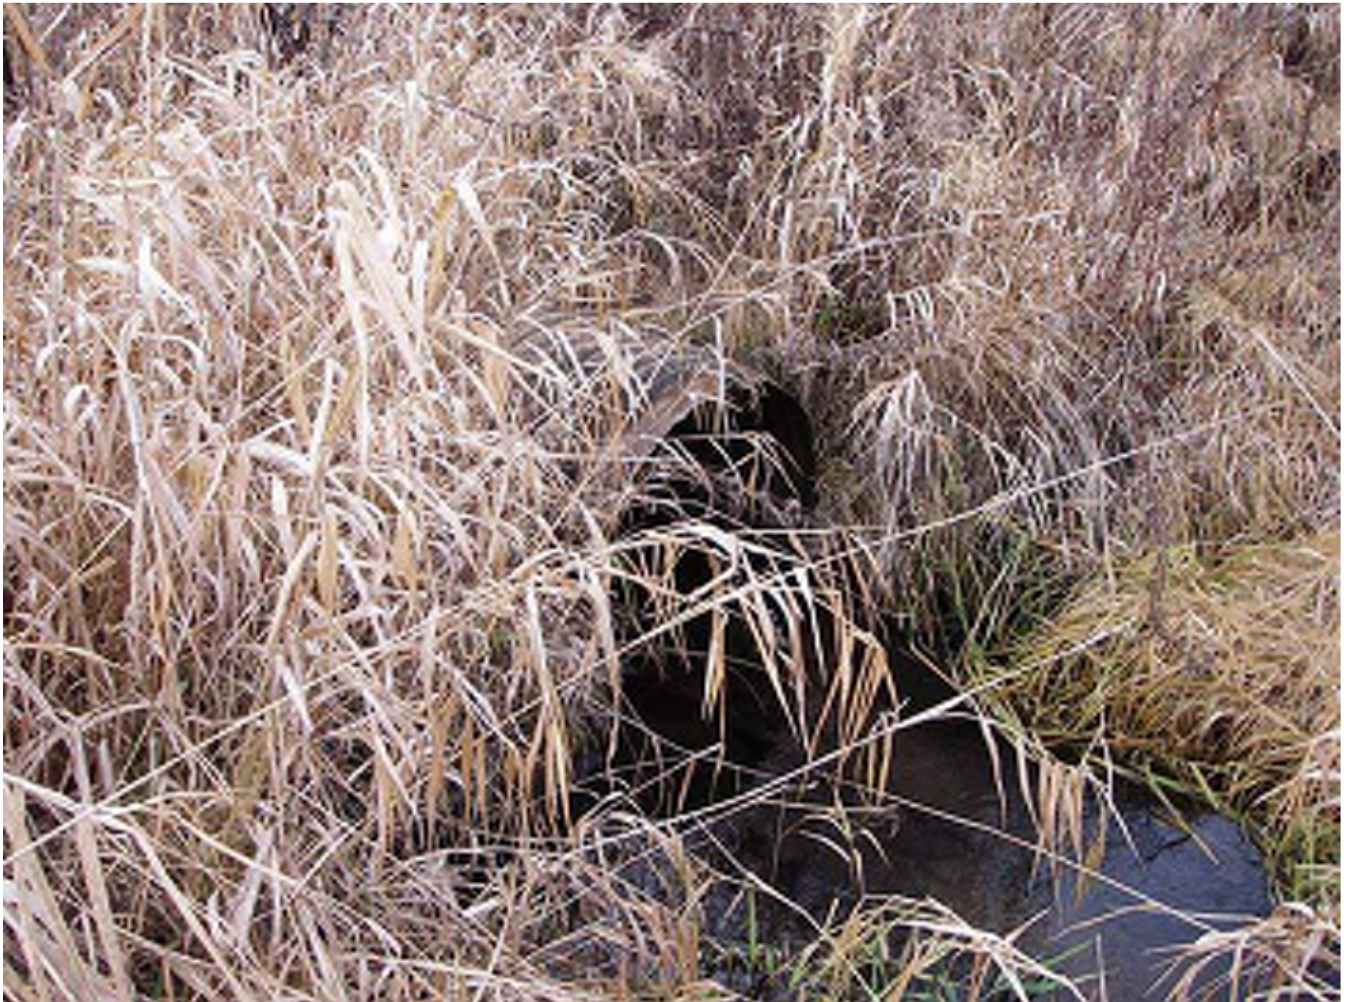
Waypoint 183

End

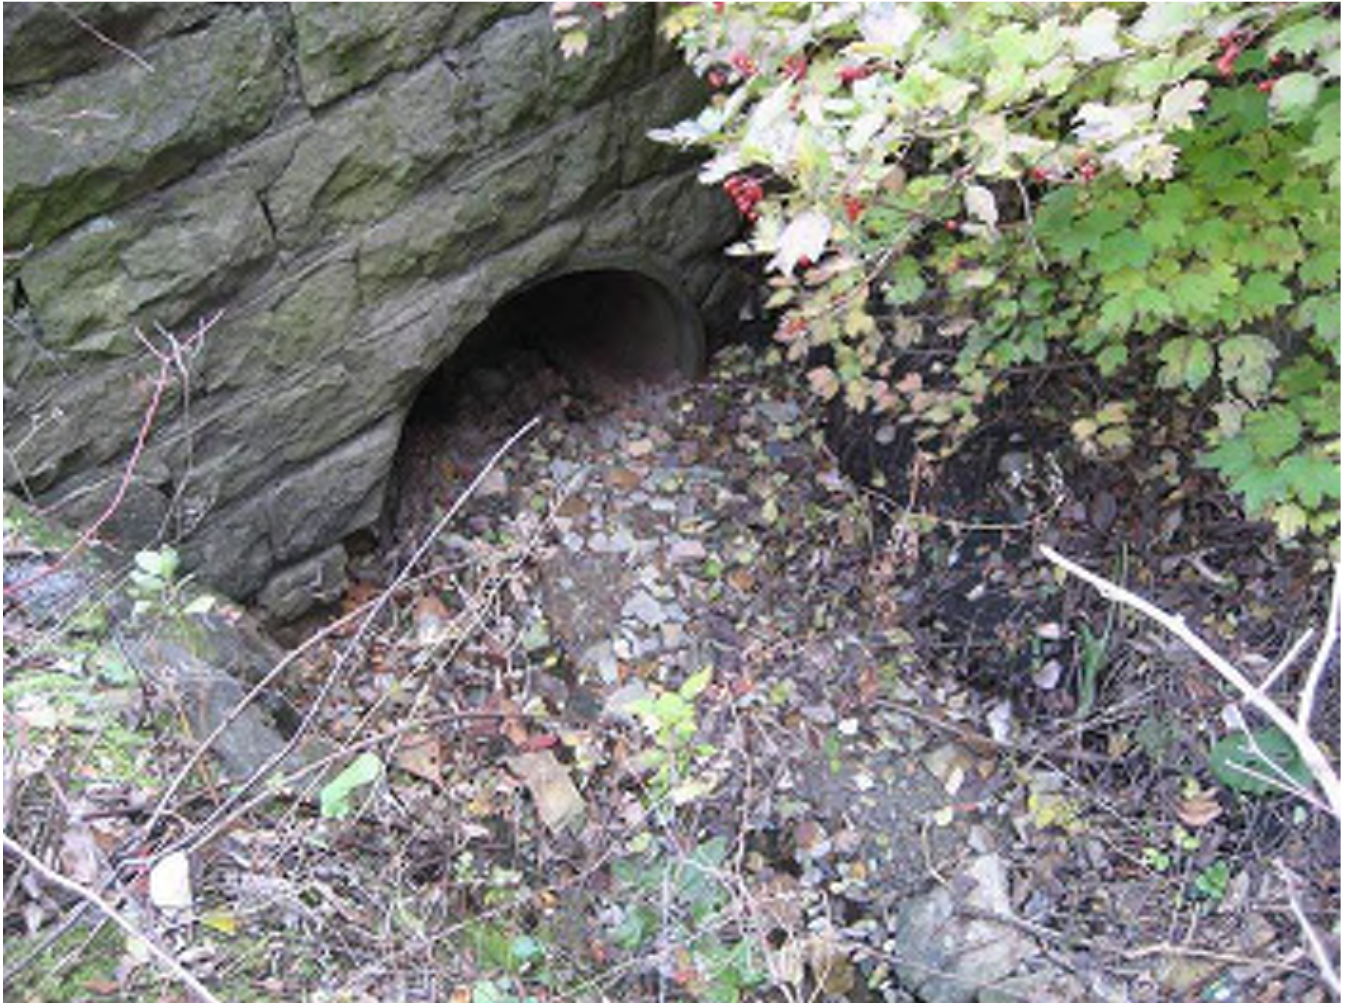
Waypoint 183A

Culvert on upper side of railroad.

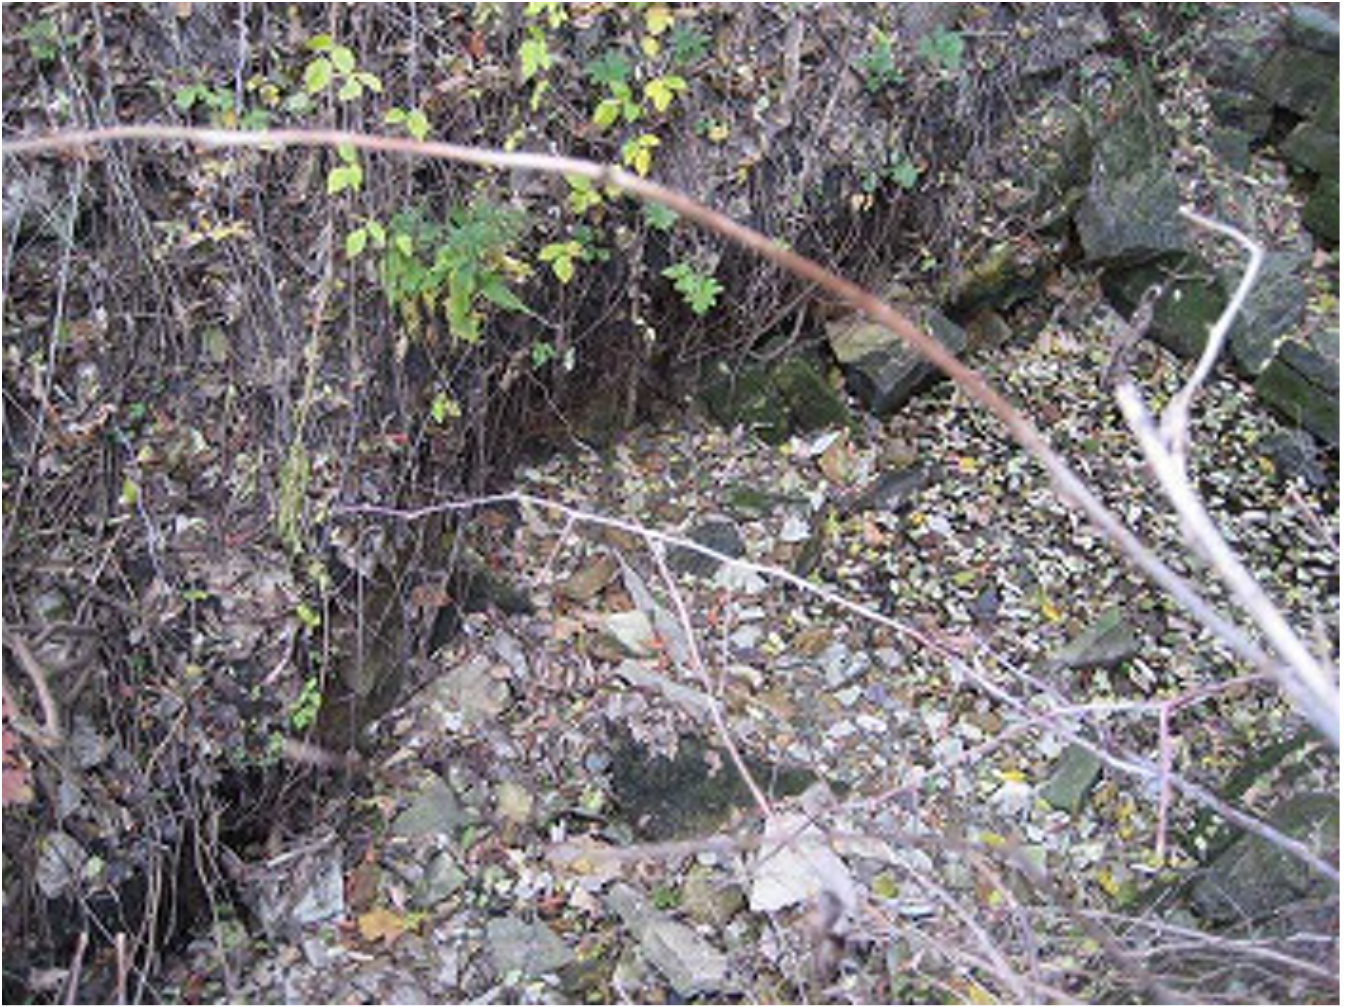
Moderate erosion.
