Appendix K: Lower Minnesota River Watershed District: Gully Inventory

Gully Inventory Map
 Area #1
 Lower Minnesota River Watershed District
 Watershed Management Plan

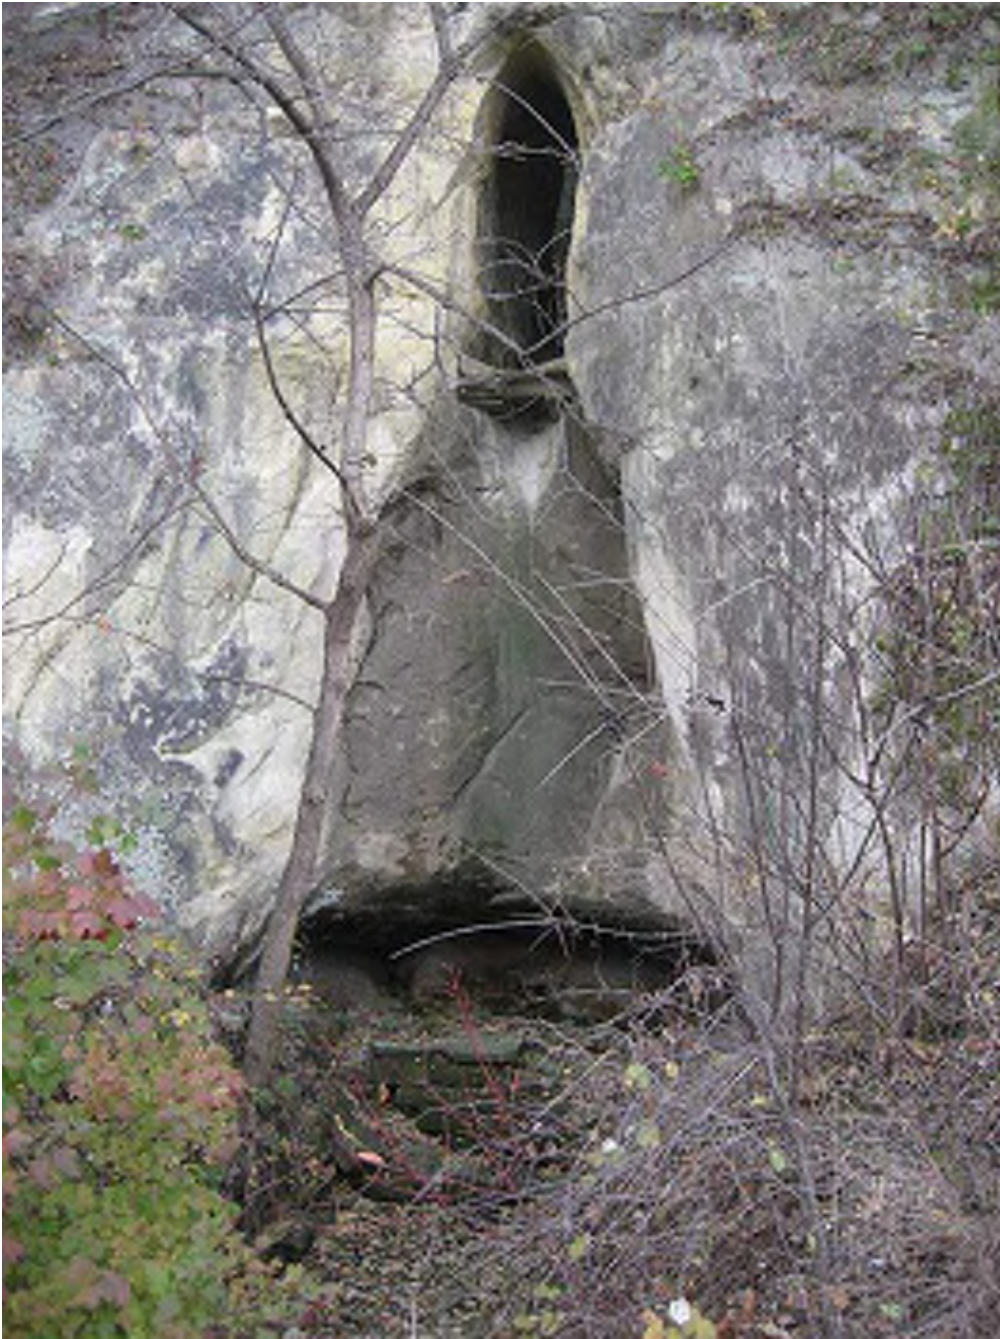
Part of bank beginning to cut under.

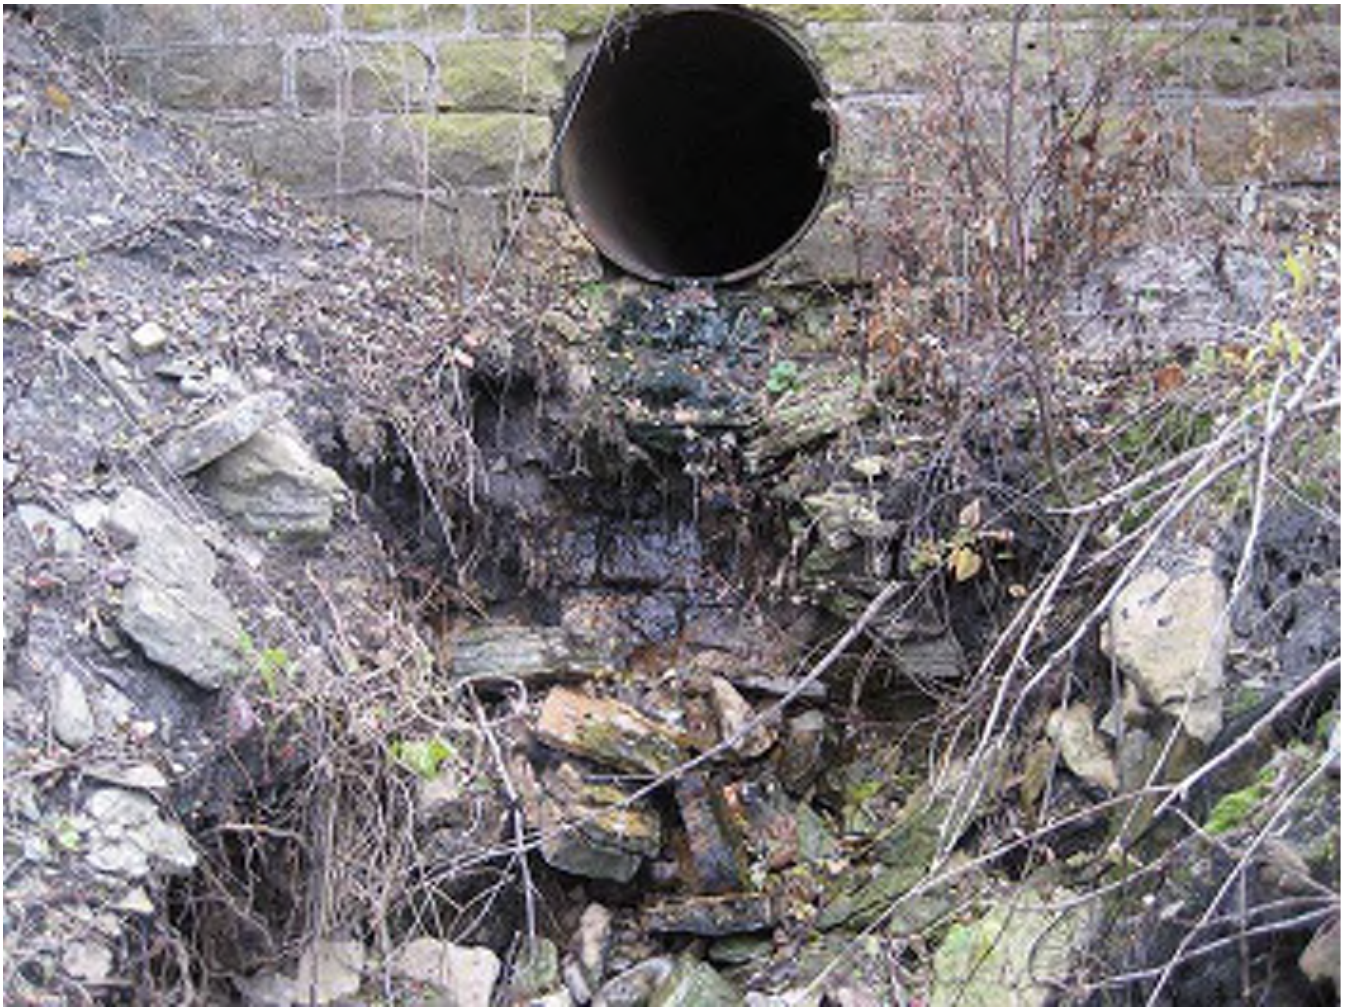
Major erosion on lower side of railroad tracks; undercutting bank.

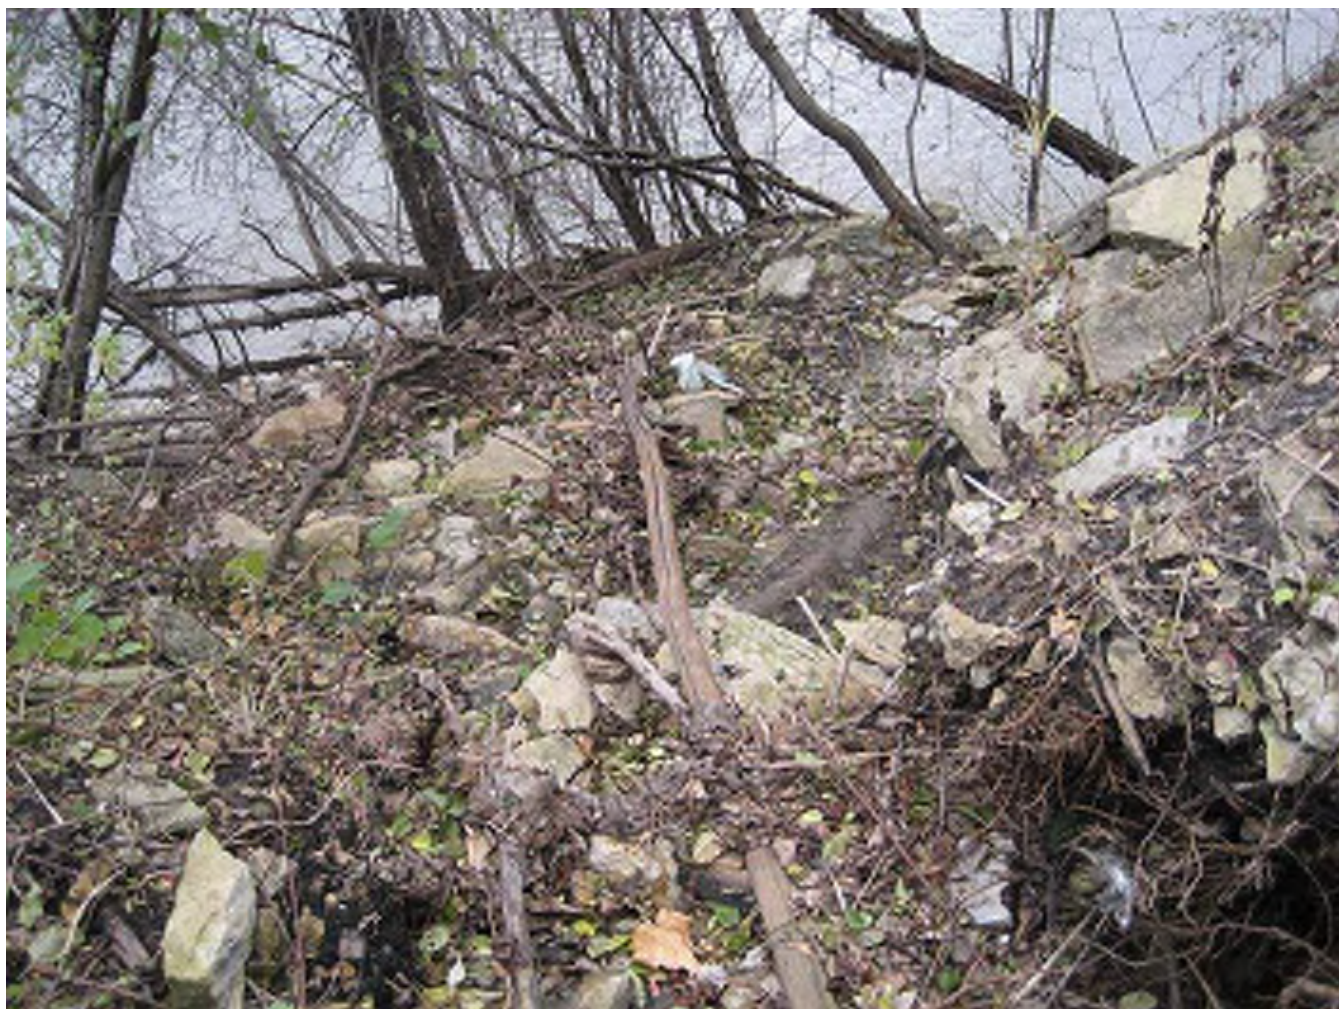
Lots of fallen rock; cutting out river bank.

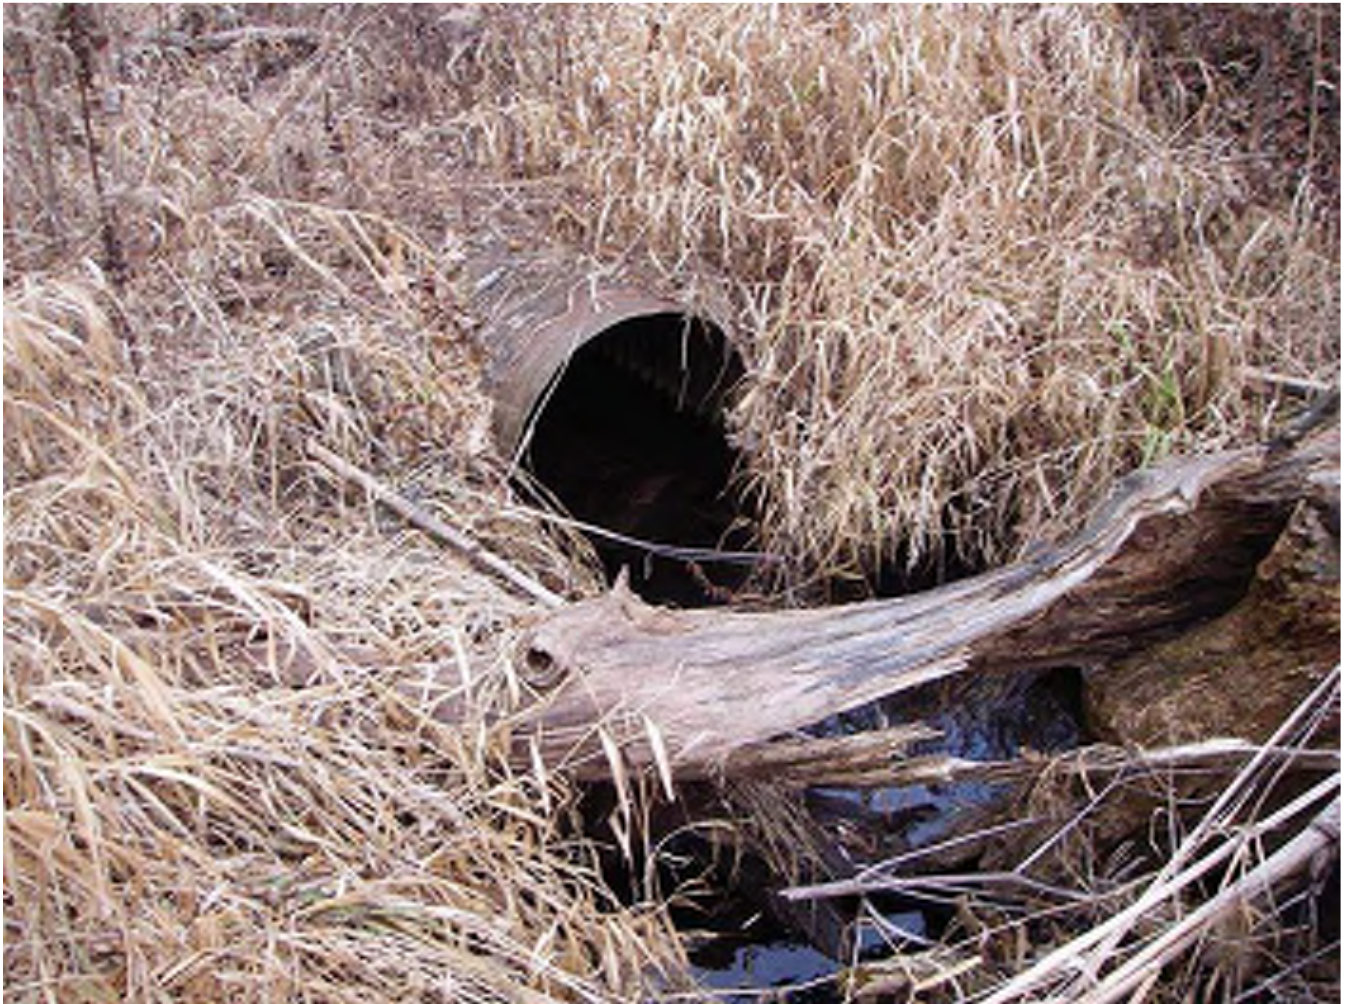
Waypoint 184

Drain pipe

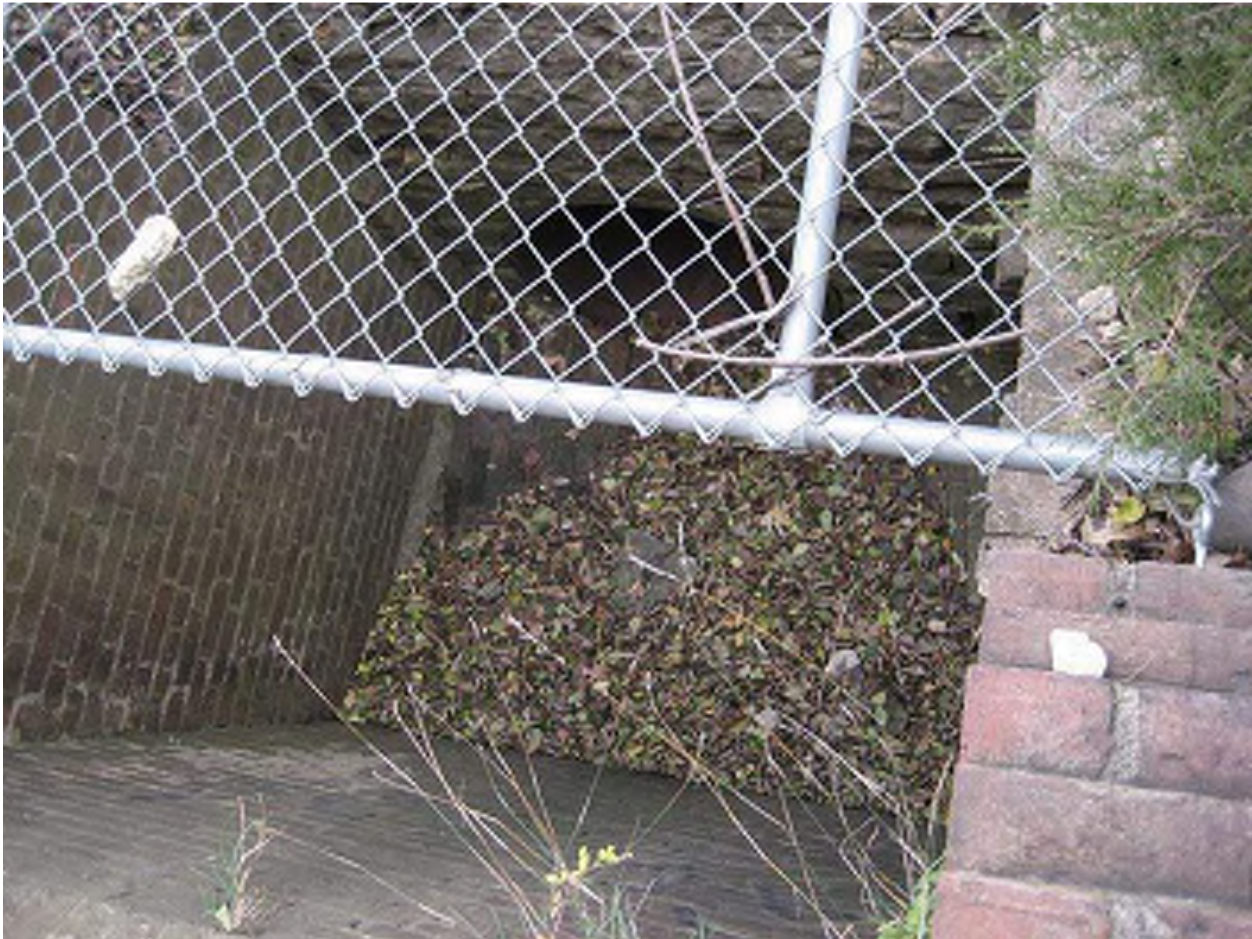
Waypoint 184A

Upper side of railroad tracks; culvert minimal erosion.

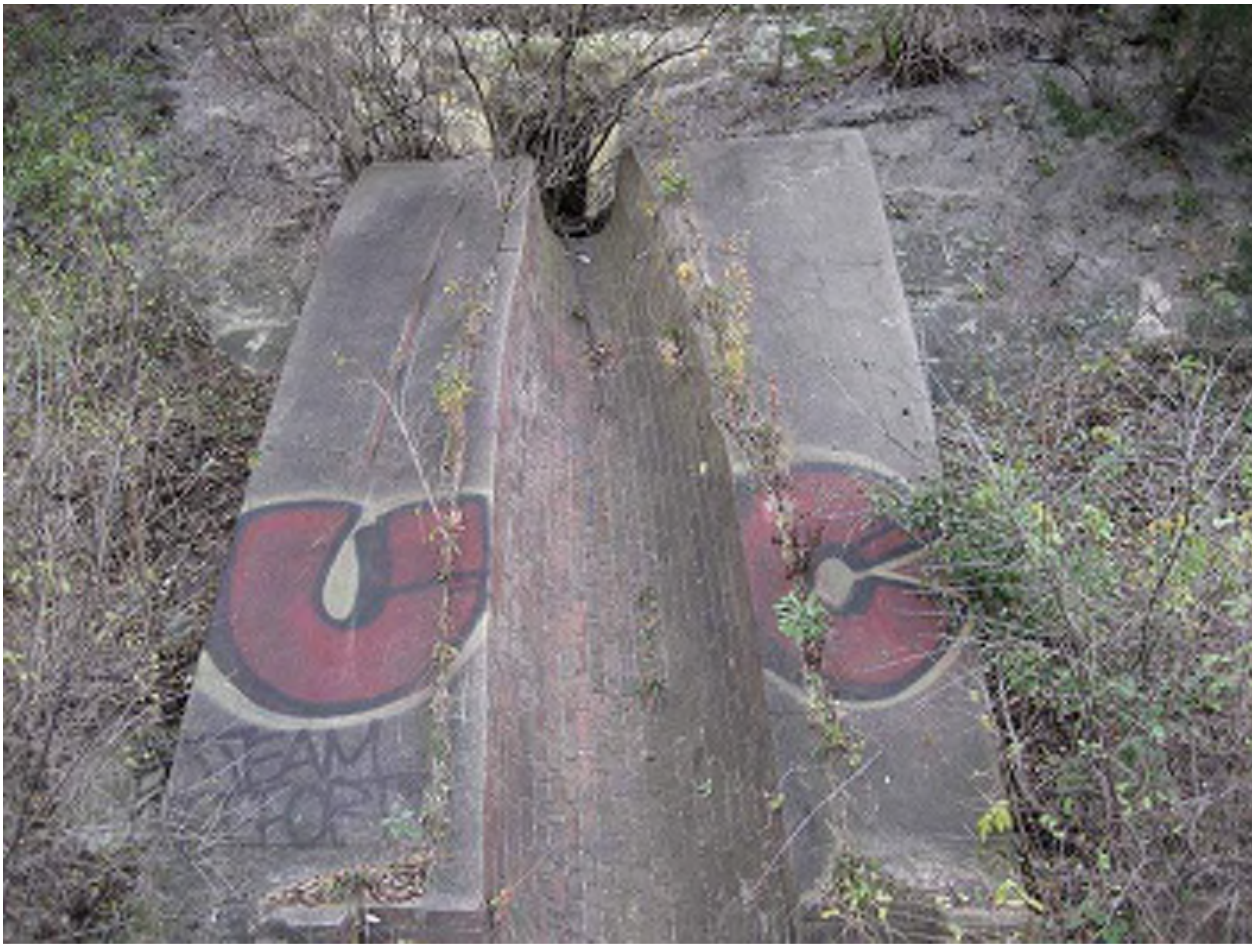
Upper side of railroad tracks; culvert minimal erosion.

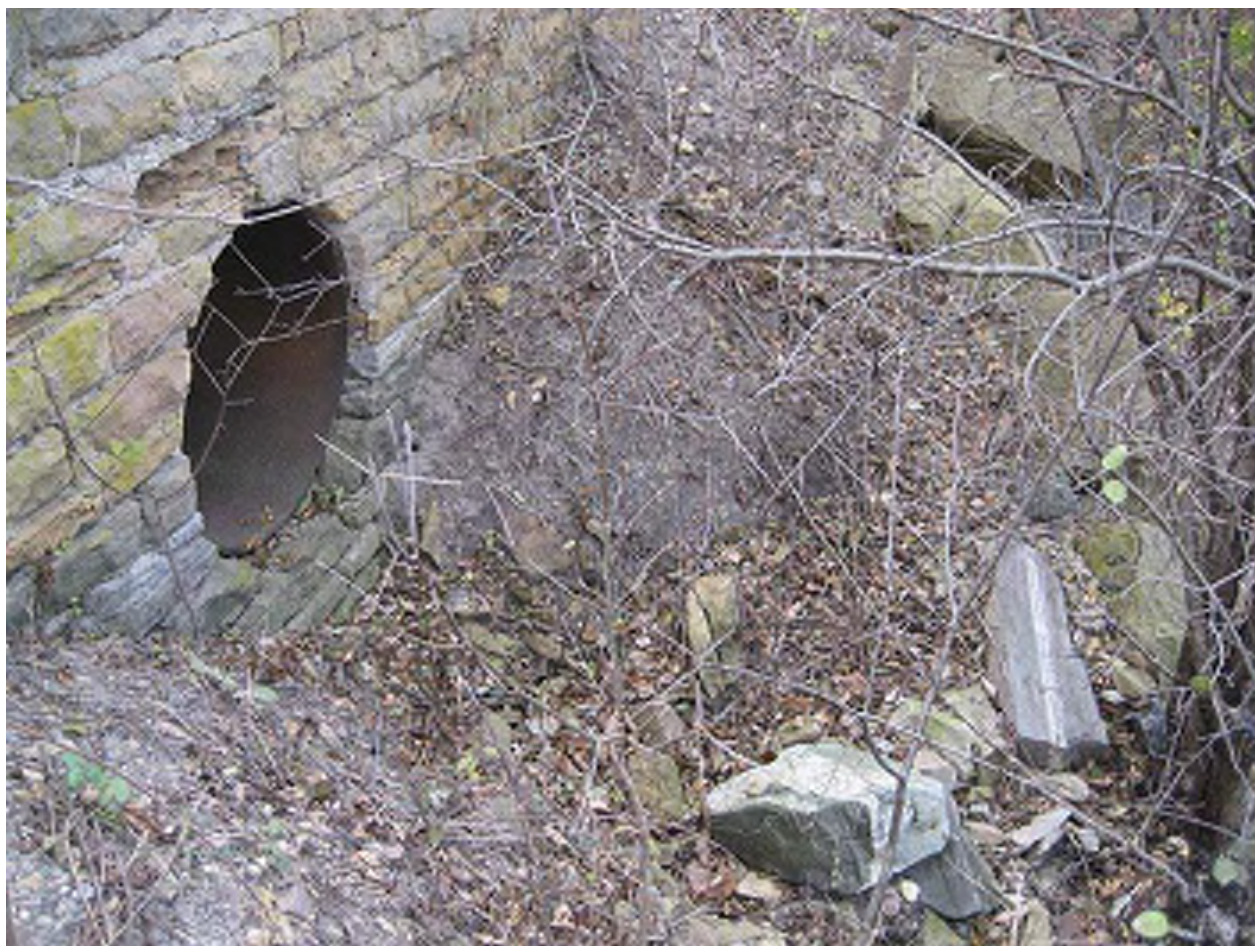
Lower side of culvert; lots of large rock and rip-rap protecting river bank; minimal erosion.

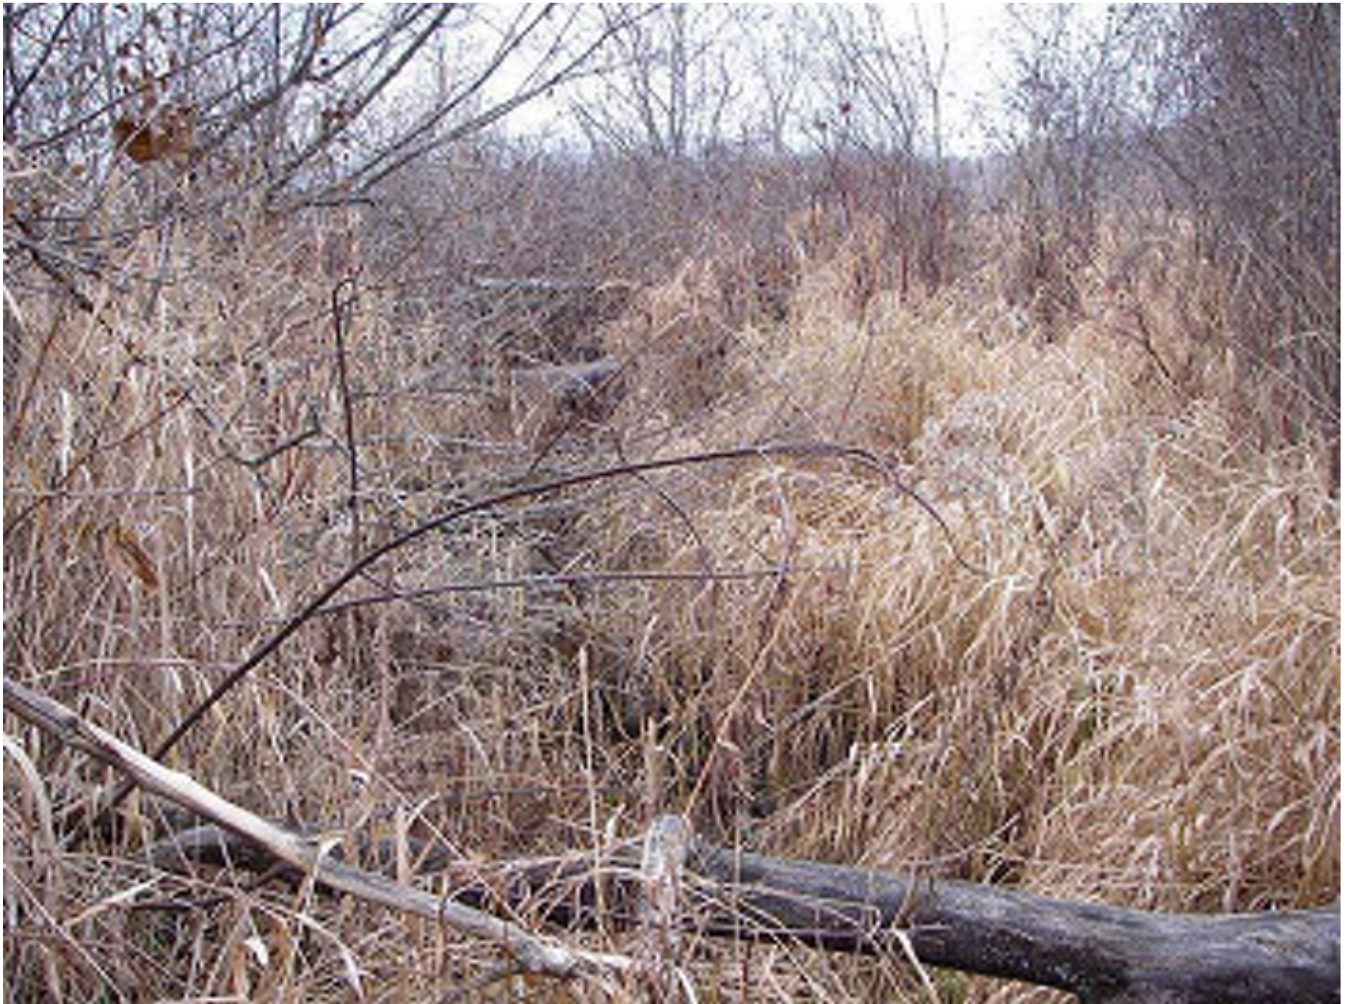
Waypoint 185

Drain pipe

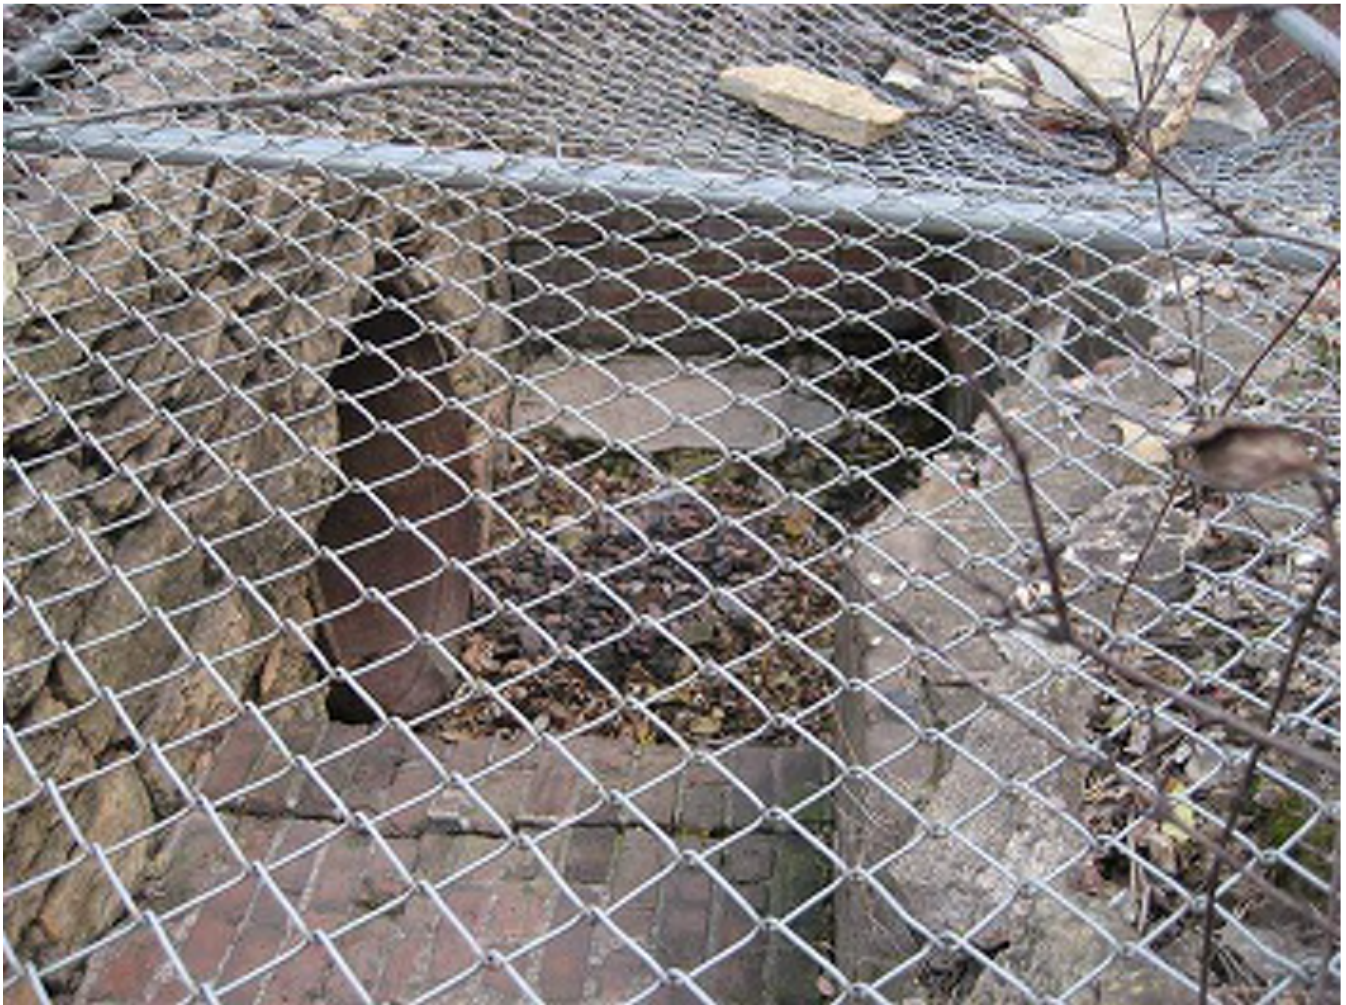
Waypoint 185A

Culvert on upper side of railroad tracks; minimal erosion.

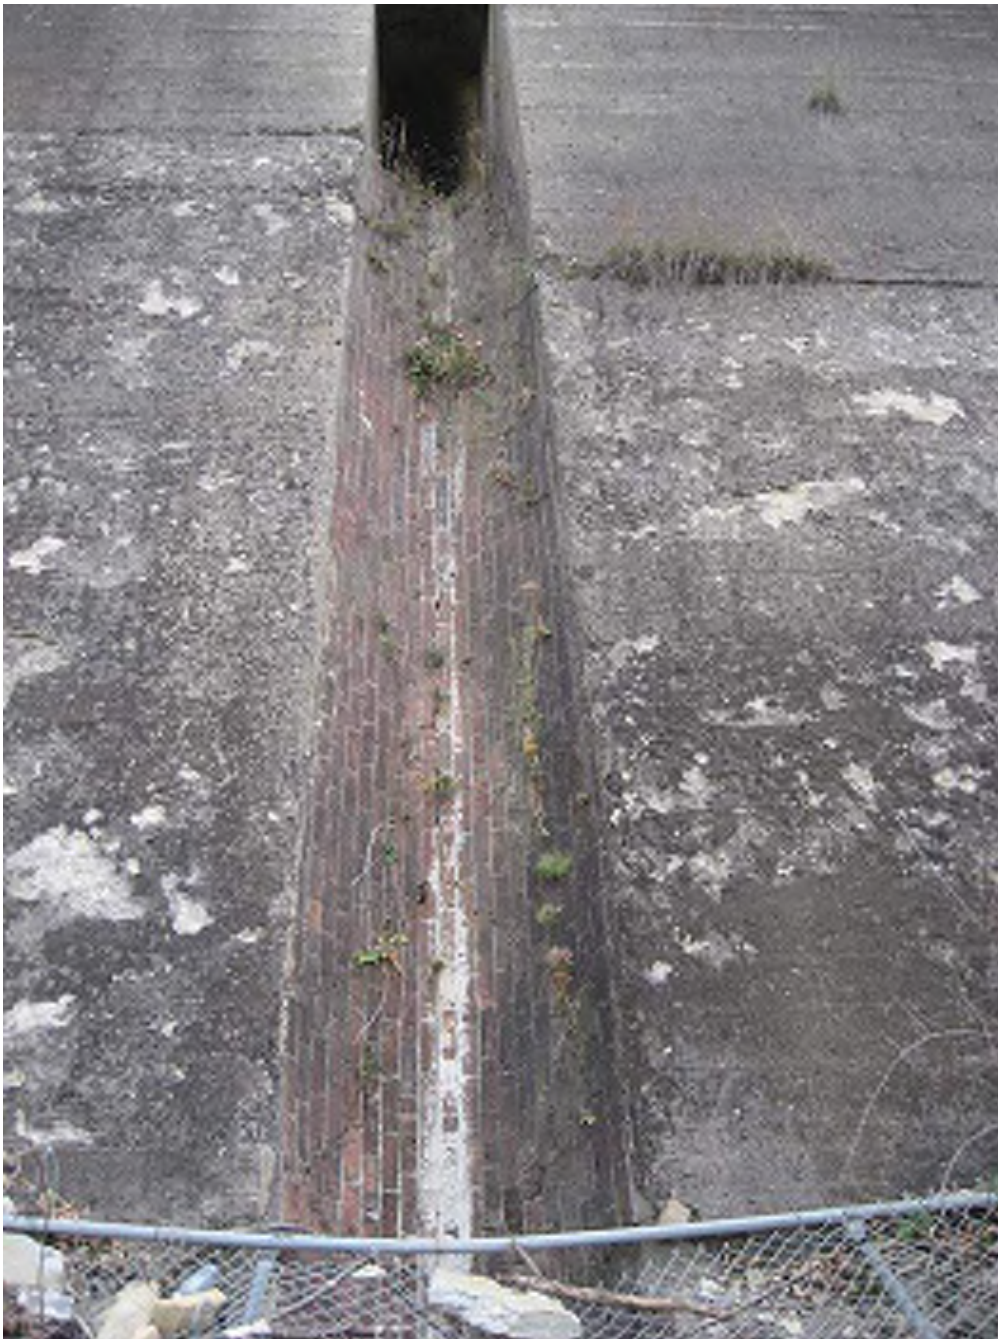
Culvert on upper side of railroad tracks; minimal erosion.

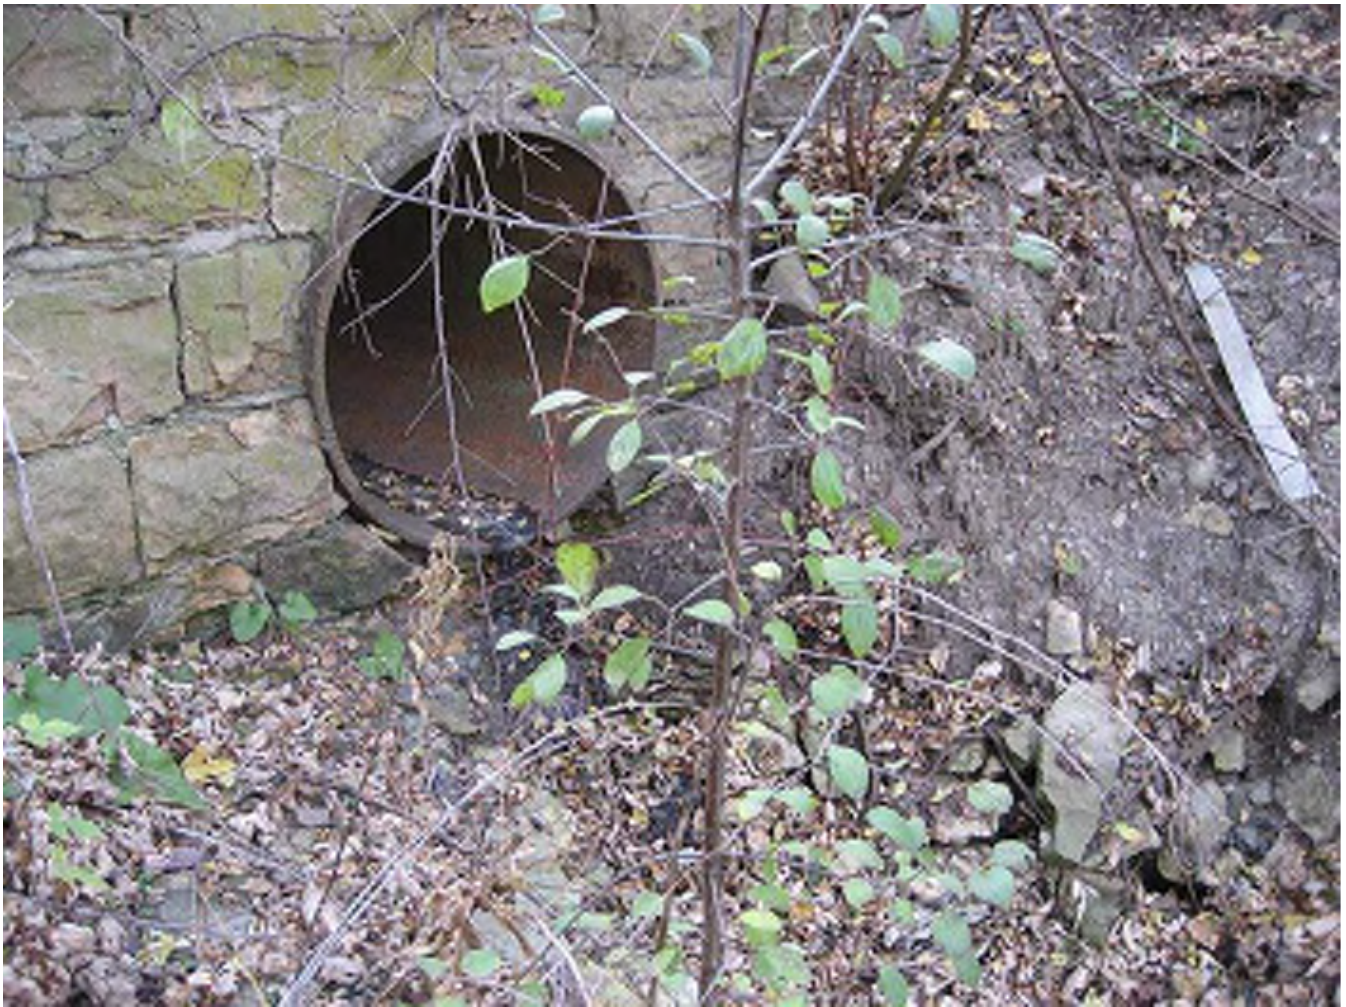
Lower side of culvert.

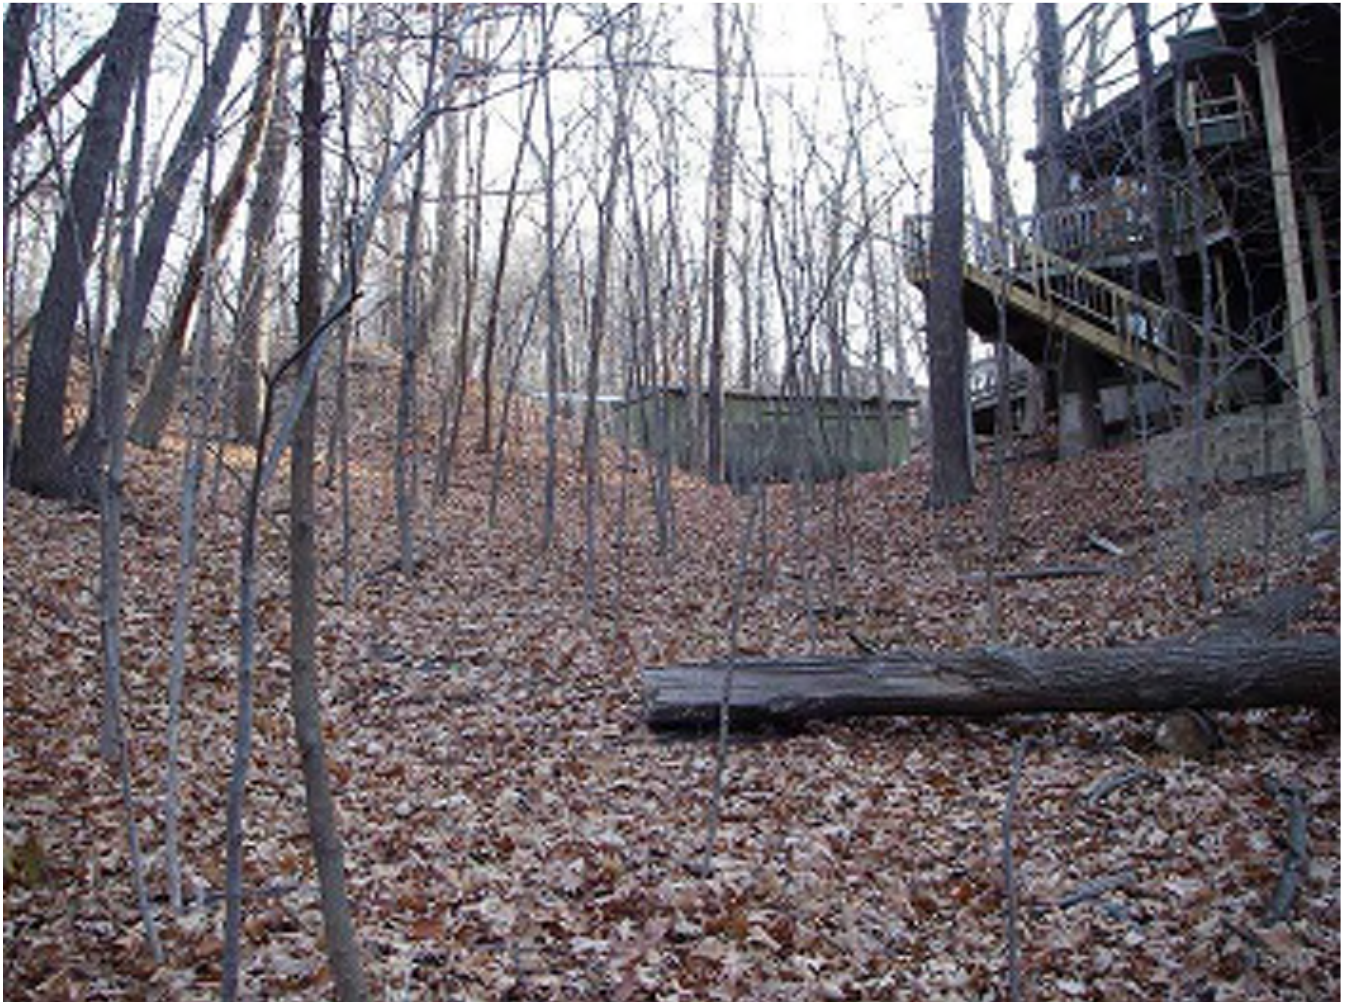
Waypoint 186

Branch

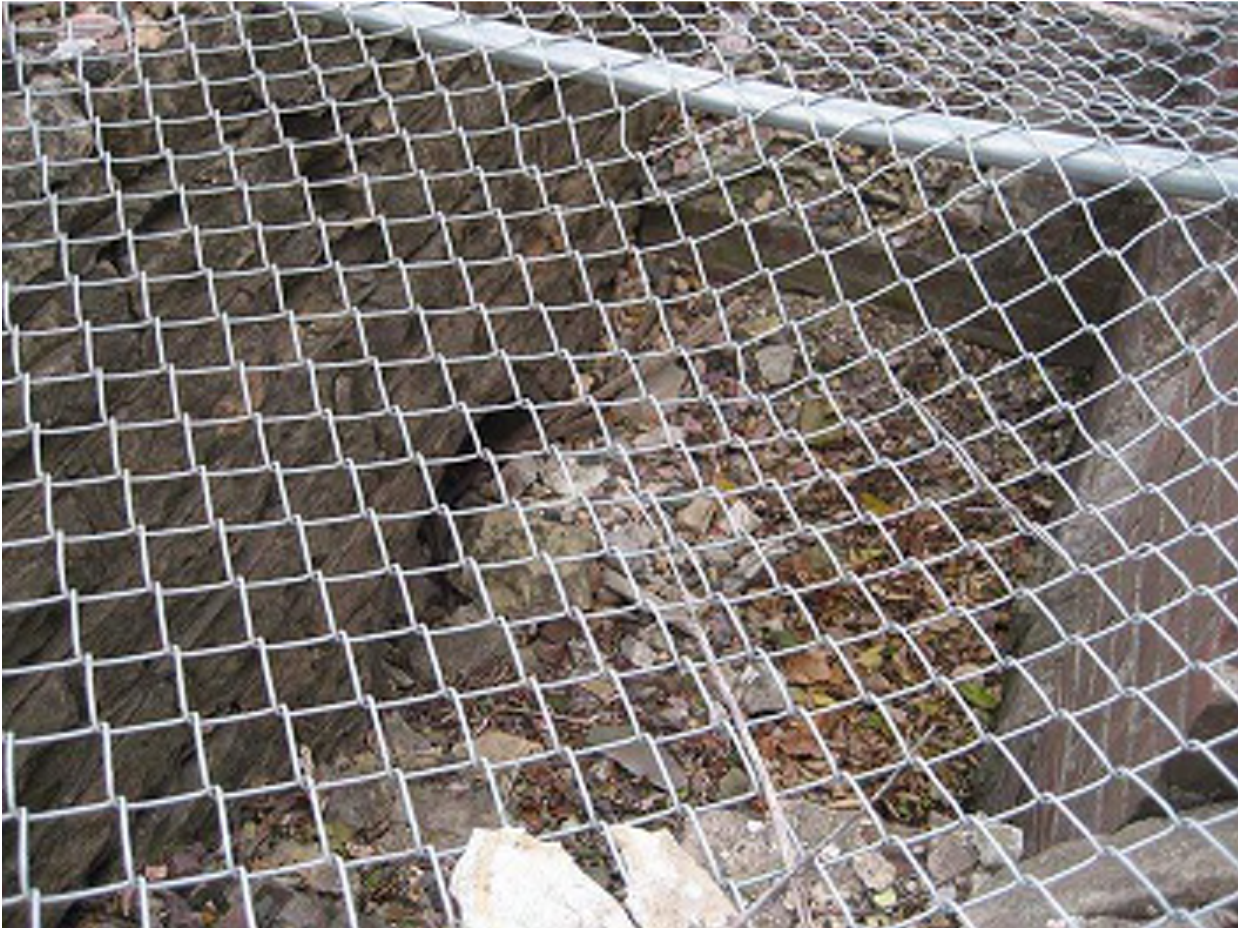
Waypoint 186A

Culvert on upper side of railroad tracks; minimal erosion.

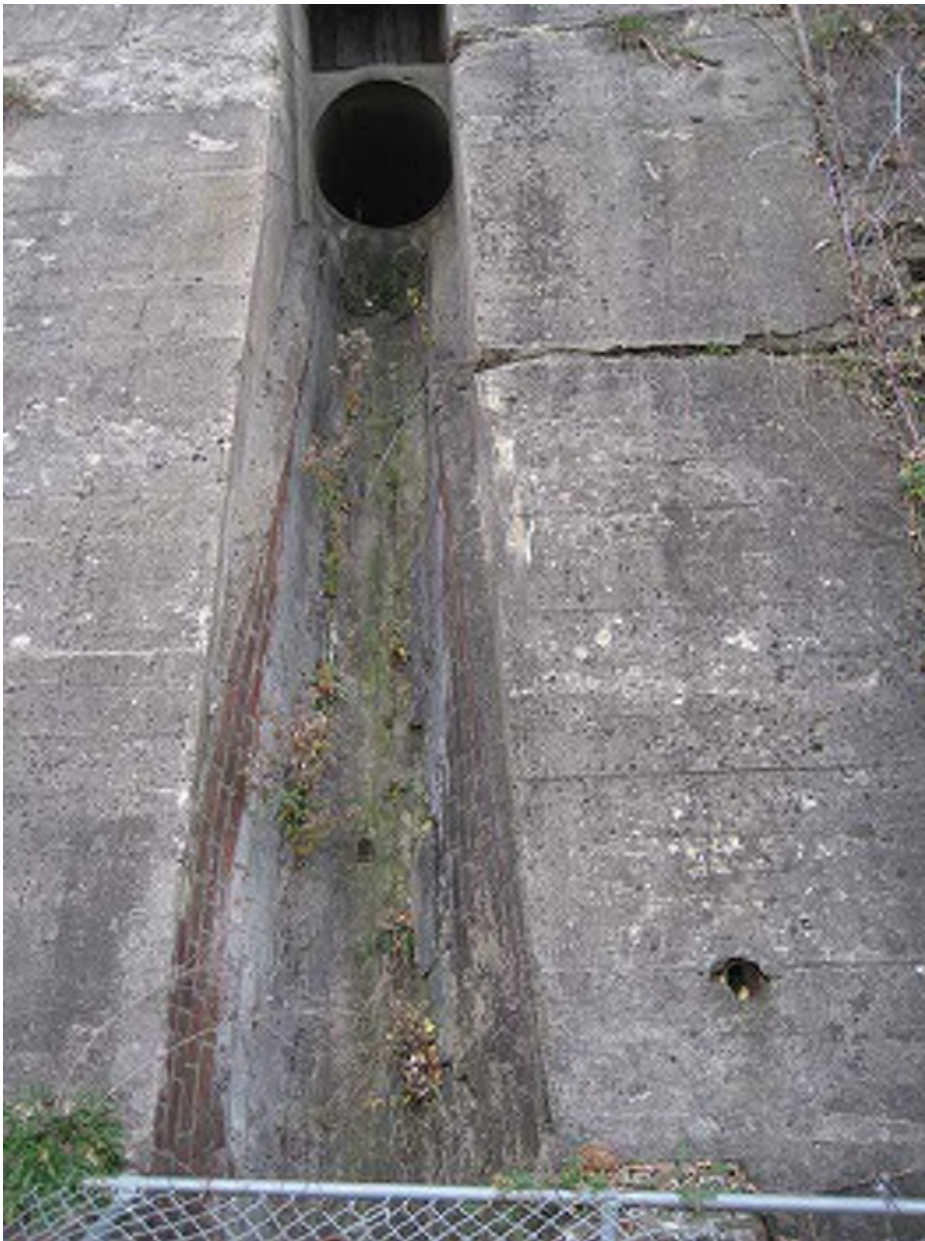
Culvert on upper side of railroad tracks; minimal erosion.

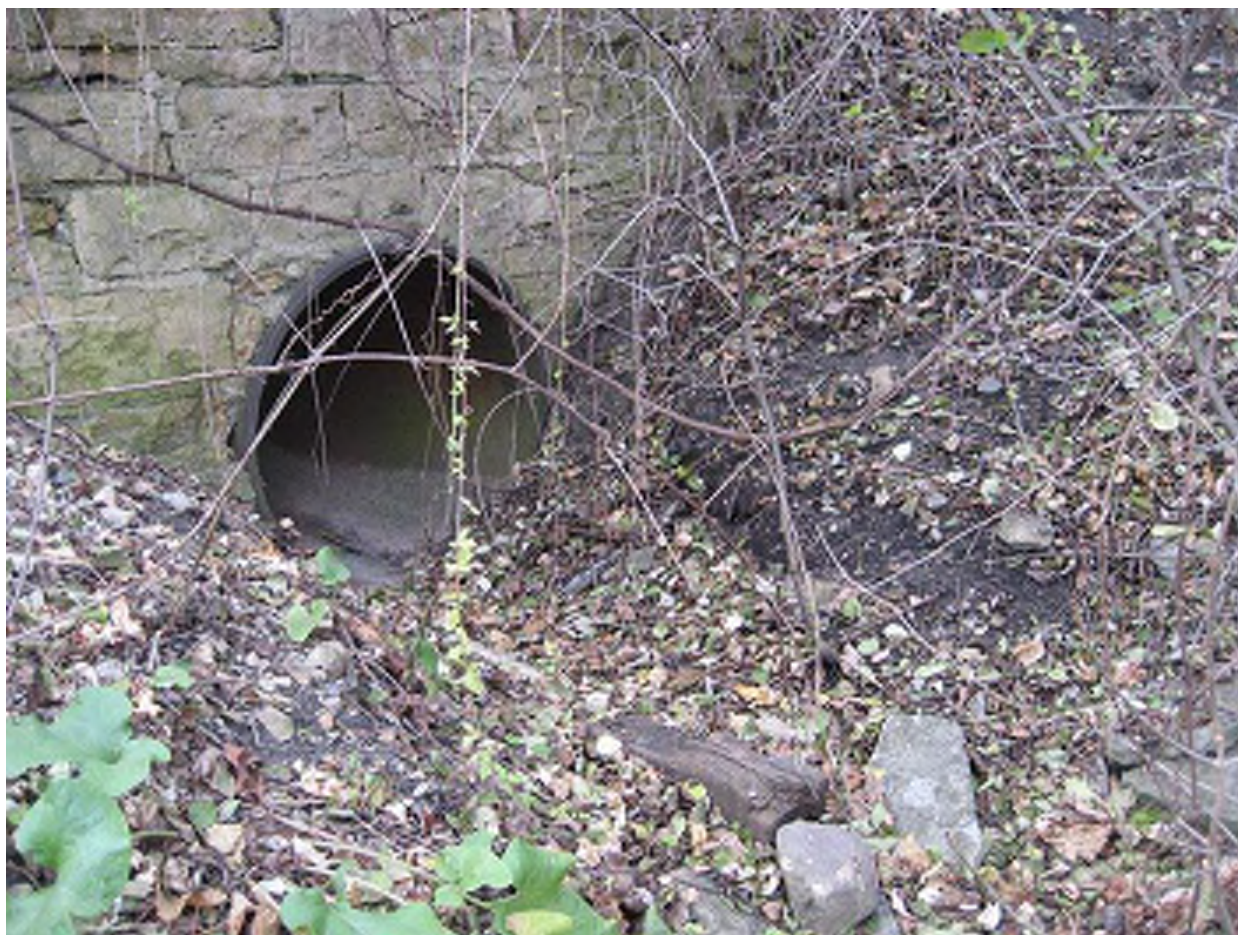
Culvert on lower side of railroad tracks; sides of culvert starting to erode; minimal erosion.

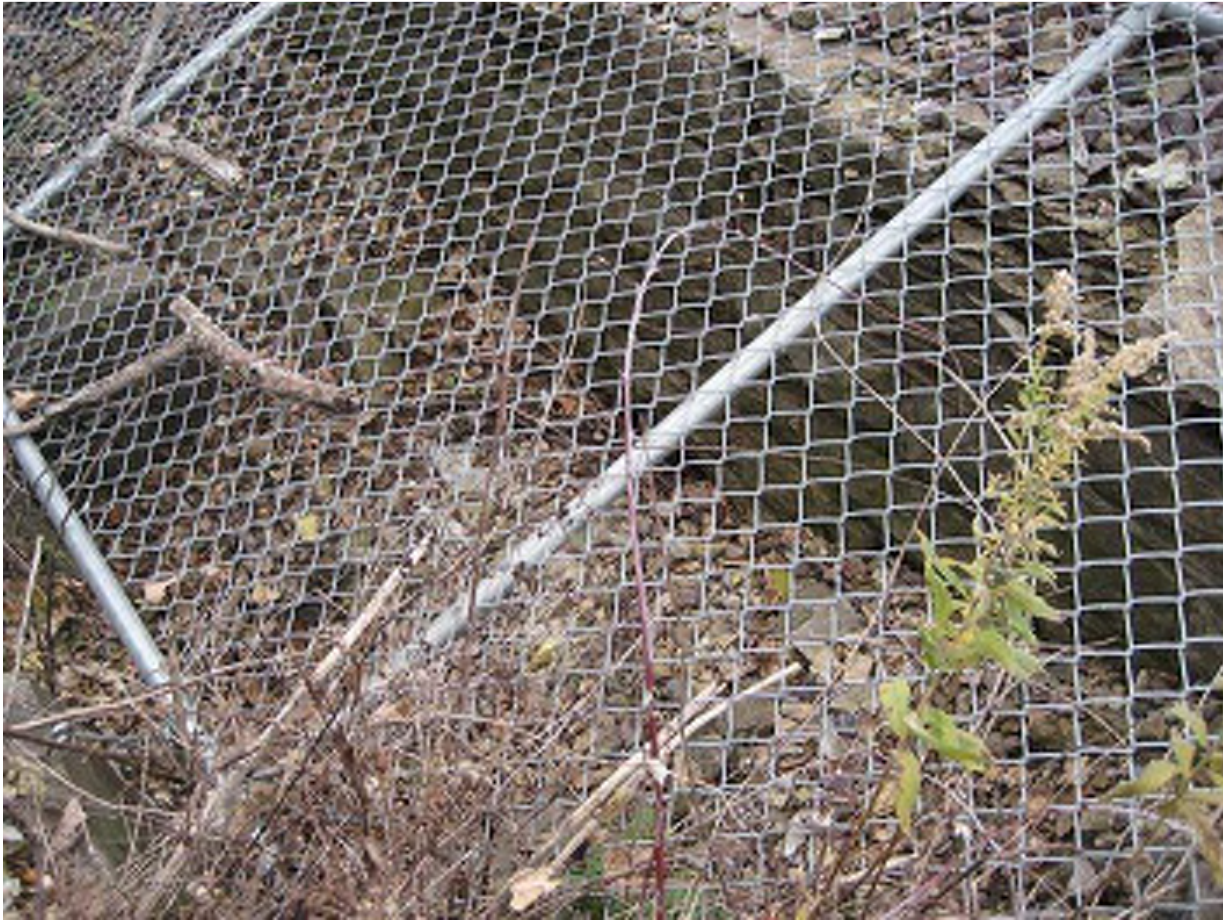
Waypoint 187A

Lots of rocks, sticks and leaves covering culvert; minimal erosion.

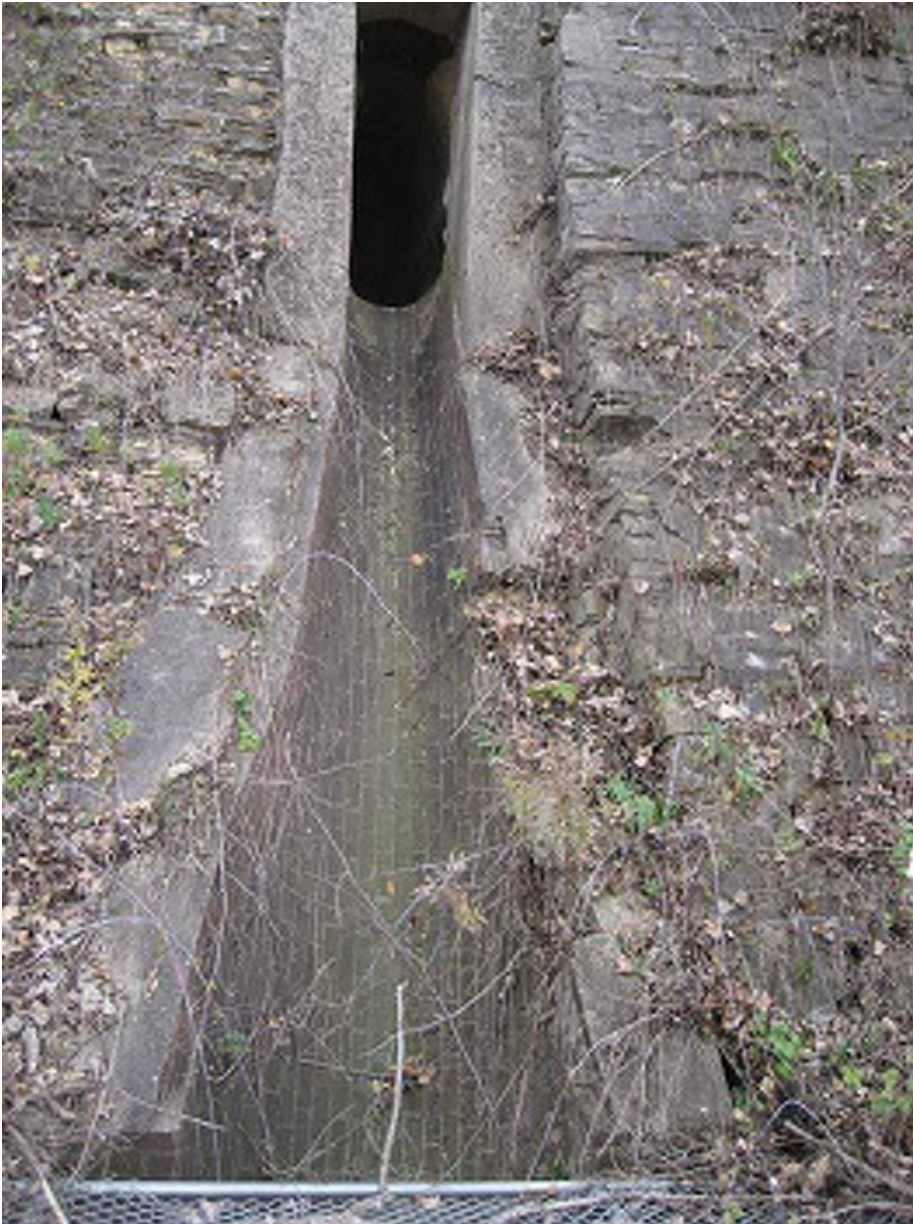
Culvert on upper side of railroad tracks.

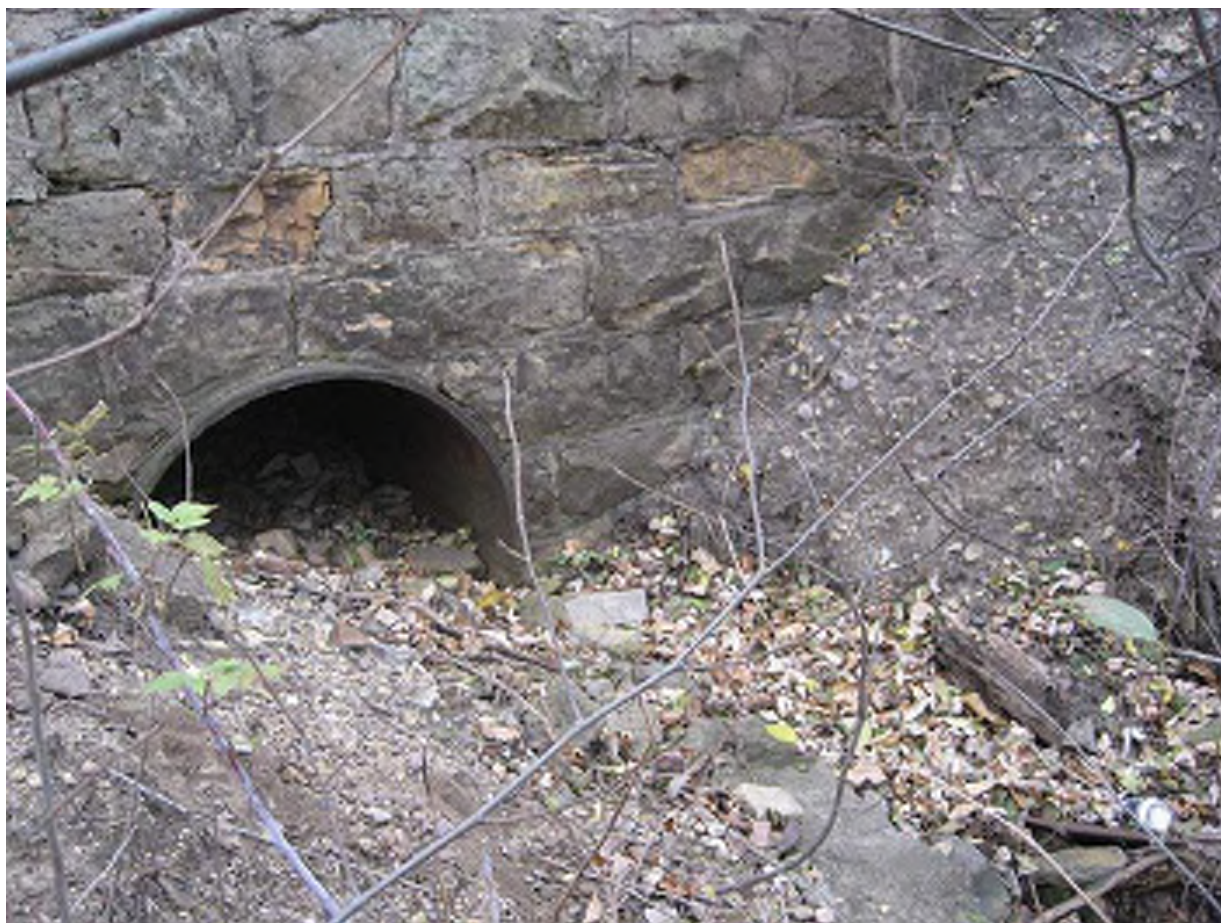
Lower side of railroad tracks; sides of culvert starting to erode; minimal to moderate erosion.
