Appendix K: Lower Minnesota River Watershed District: Gully Inventory

Gully Inventory Map
 Area #1
 Lower Minnesota River Watershed District
 Watershed Management Plan

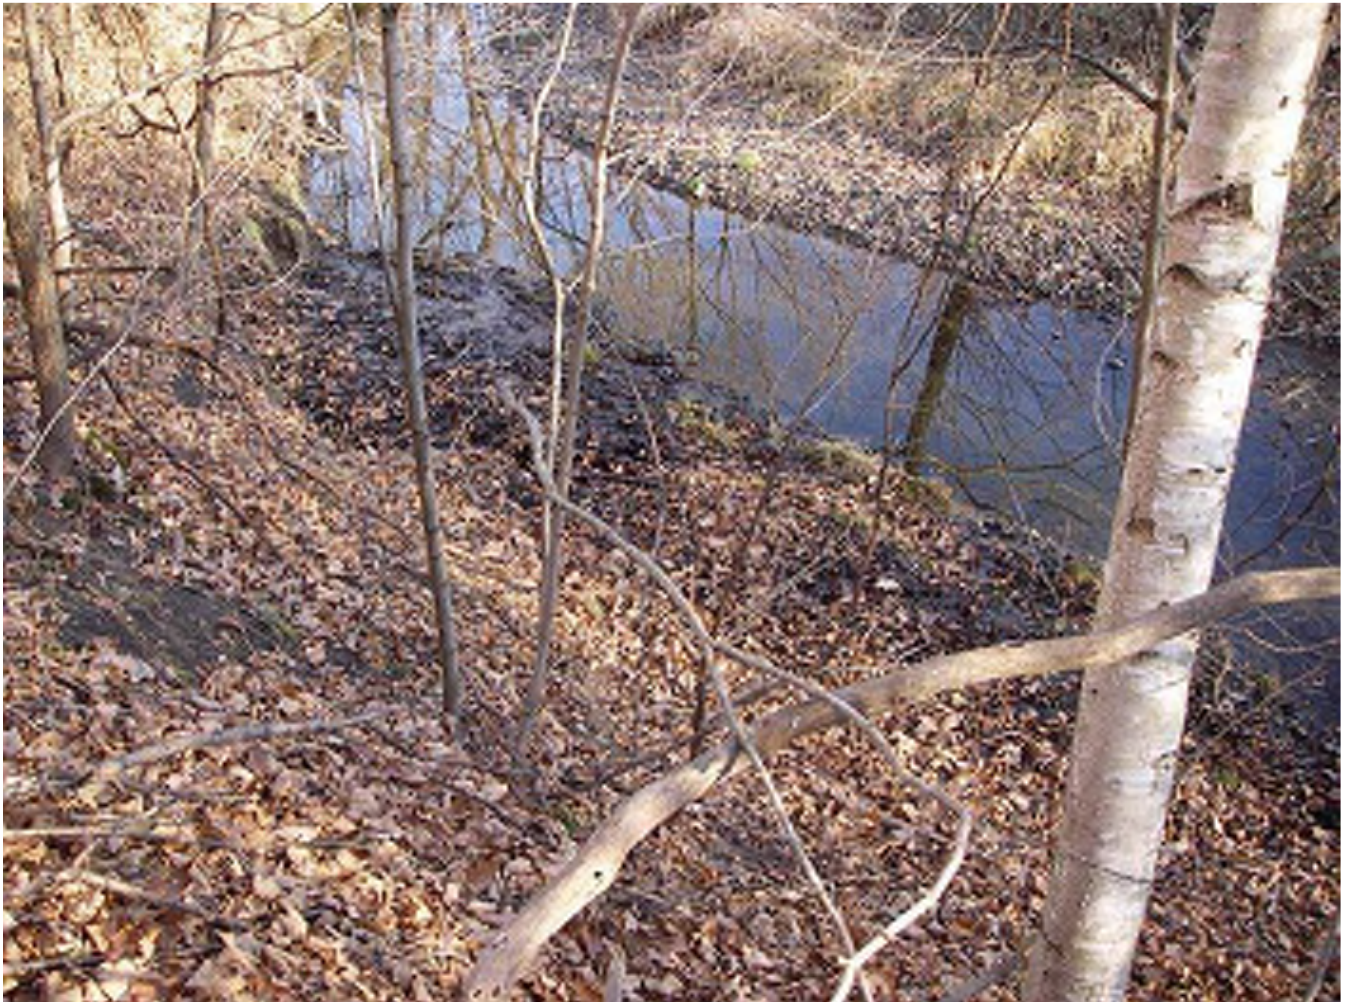
Waypoint 188

Erosion on side of creek, laying soil in the creek

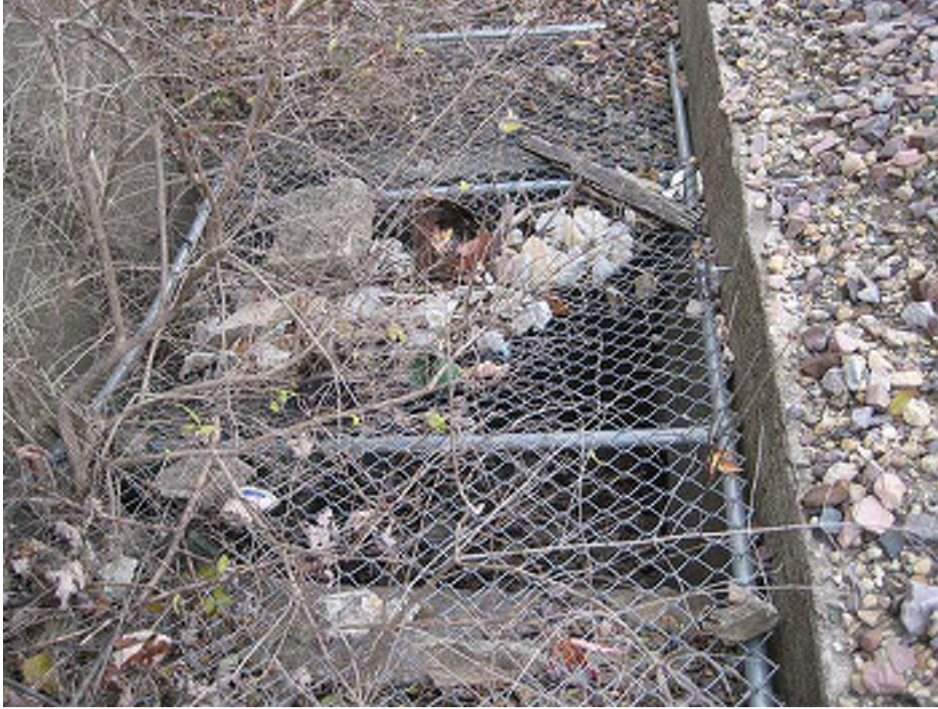
Waypoint 188A

Upper side of railroad tracks; lots of garbage and rock on top of fencing that is laid over top of culvert; minimal erosion.

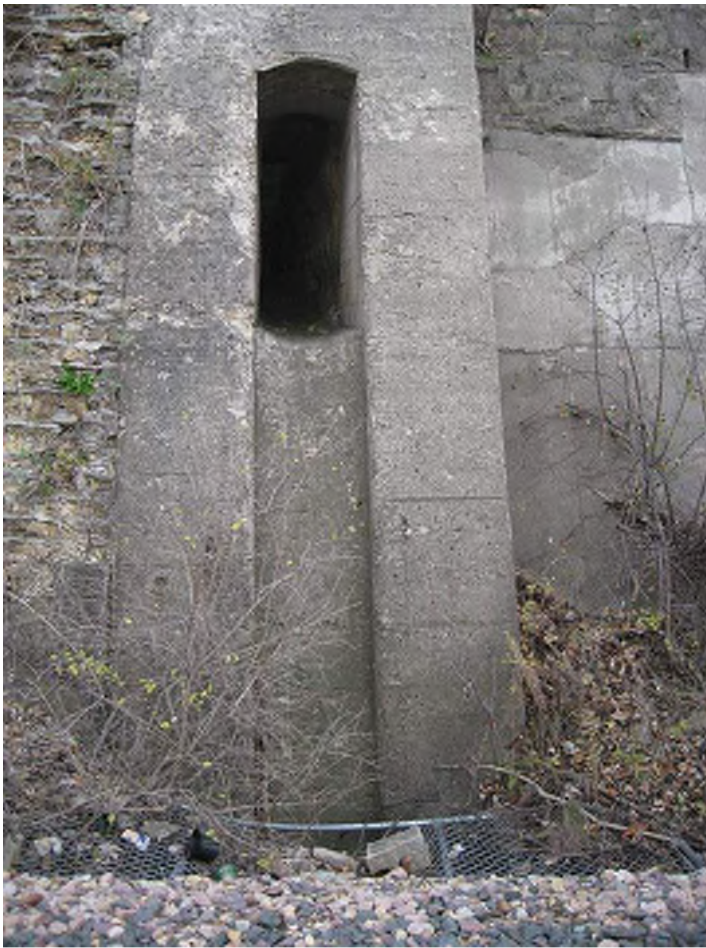
Upper side of railroad tracks; lots of garbage and rock on top of fencing that is laid over top of culvert; minimal erosion.

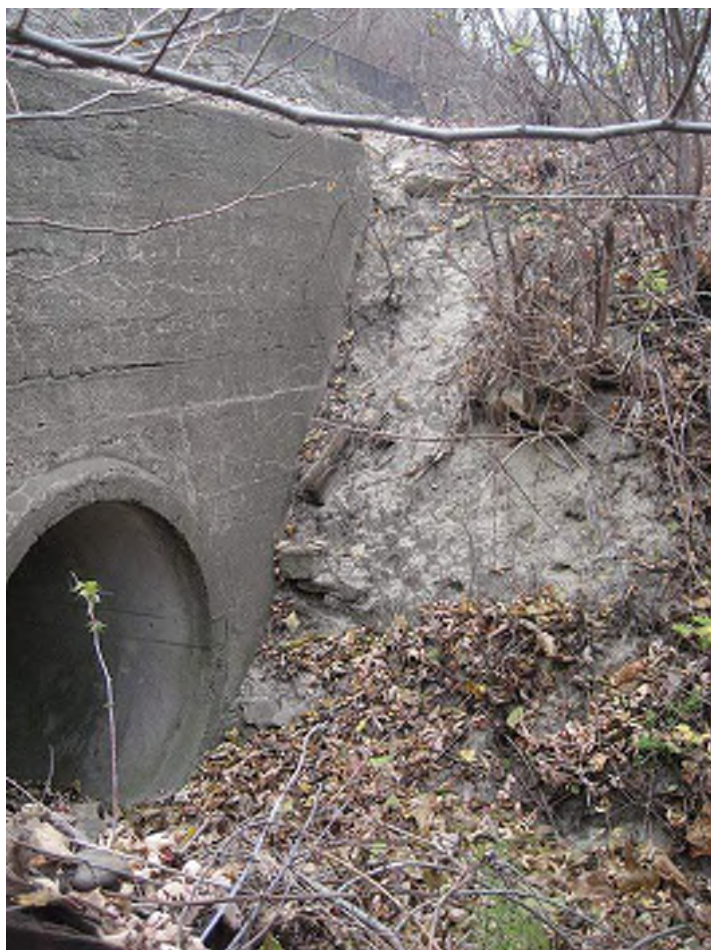
Lower side of railroad tracks; culvert had lots of rip-rap; sides starting to erode; moderate erosion.

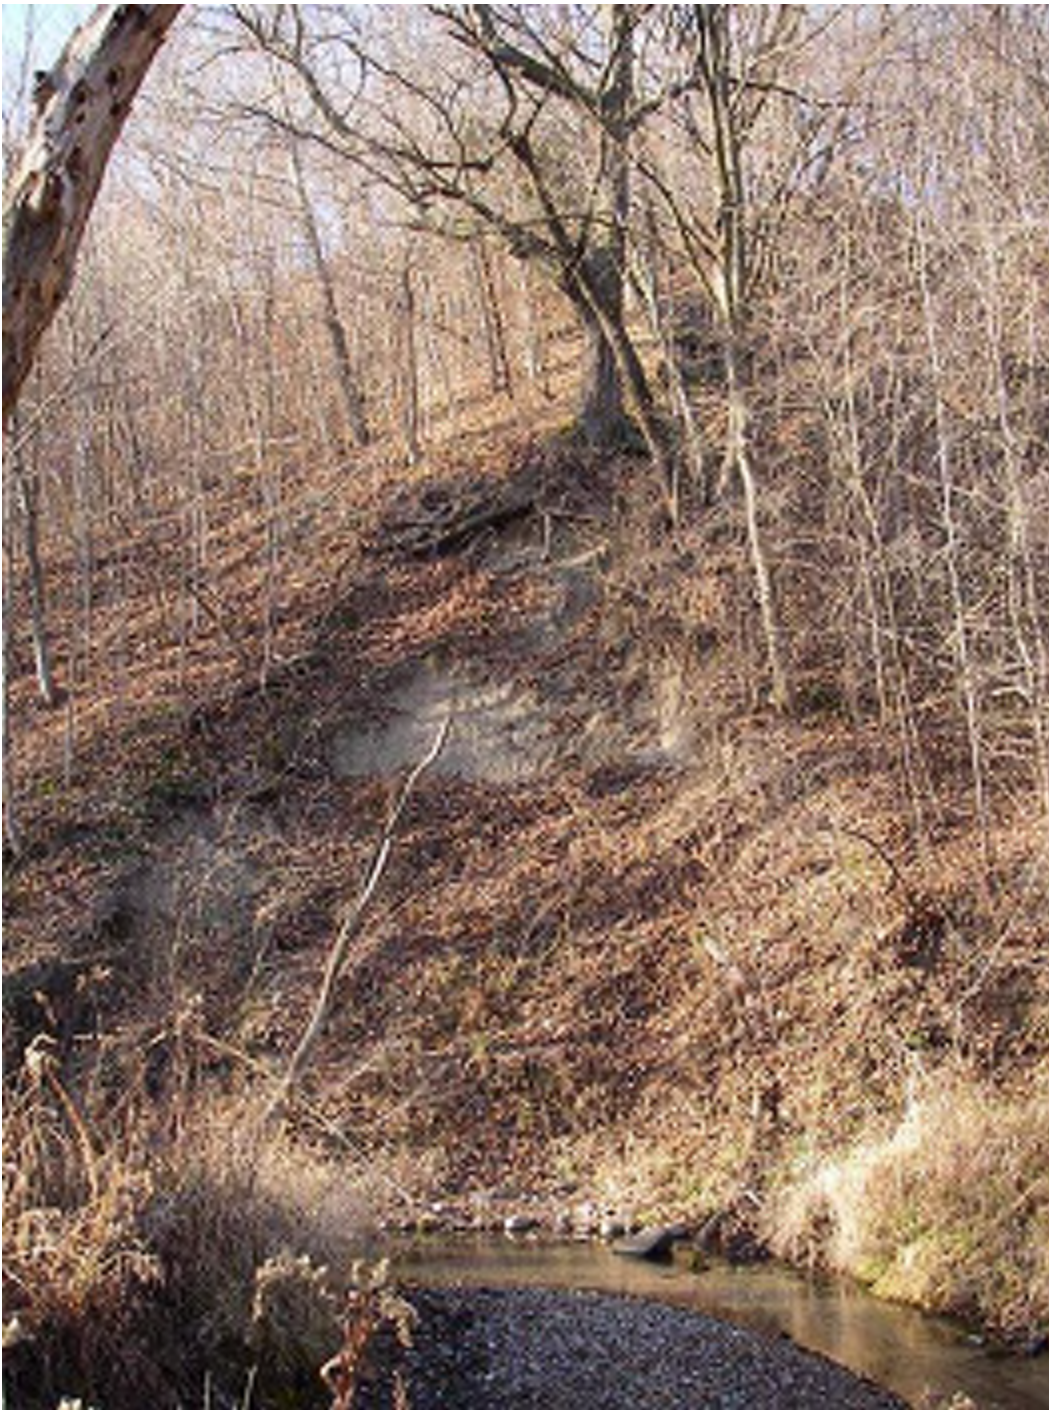
Waypoint 189

Steep erosion into creek

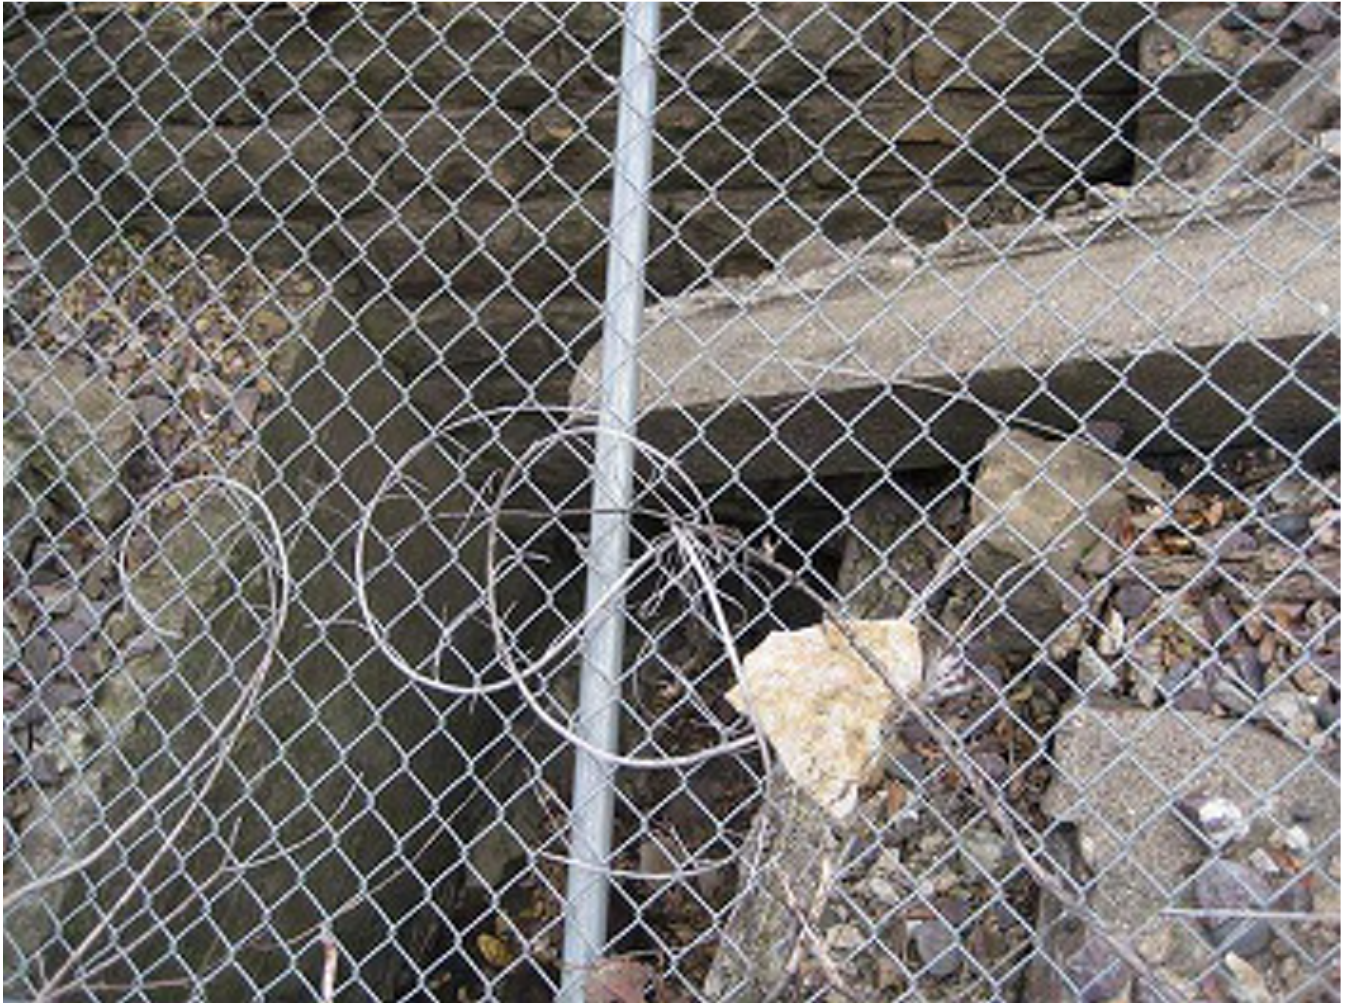
Waypoint 189A

Large cement culvert going under railroad tracks and into river.

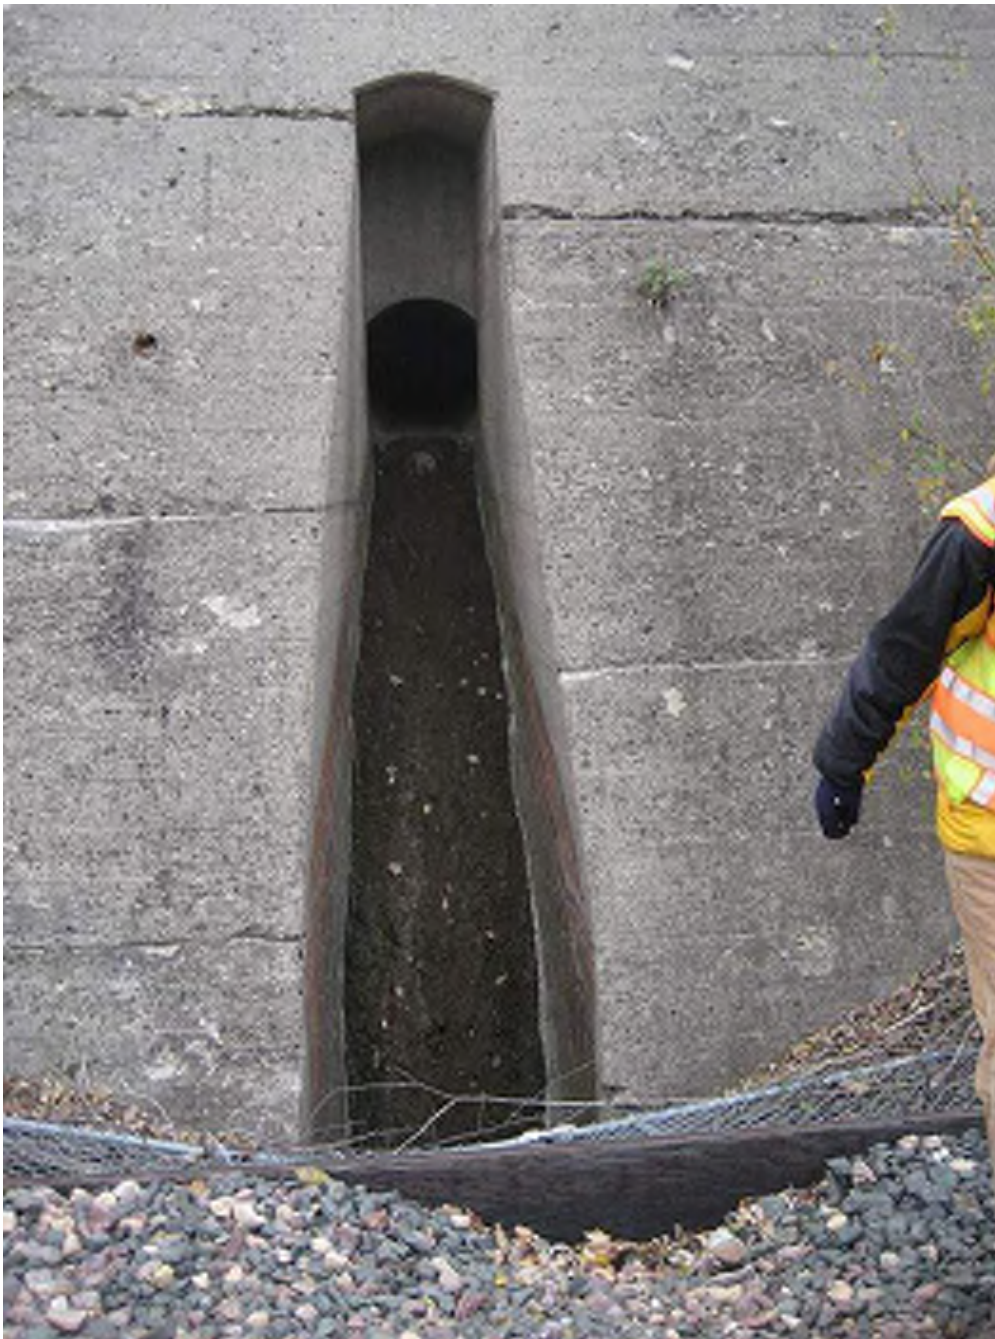
Large cement culvert going under railroad tracks and into river.

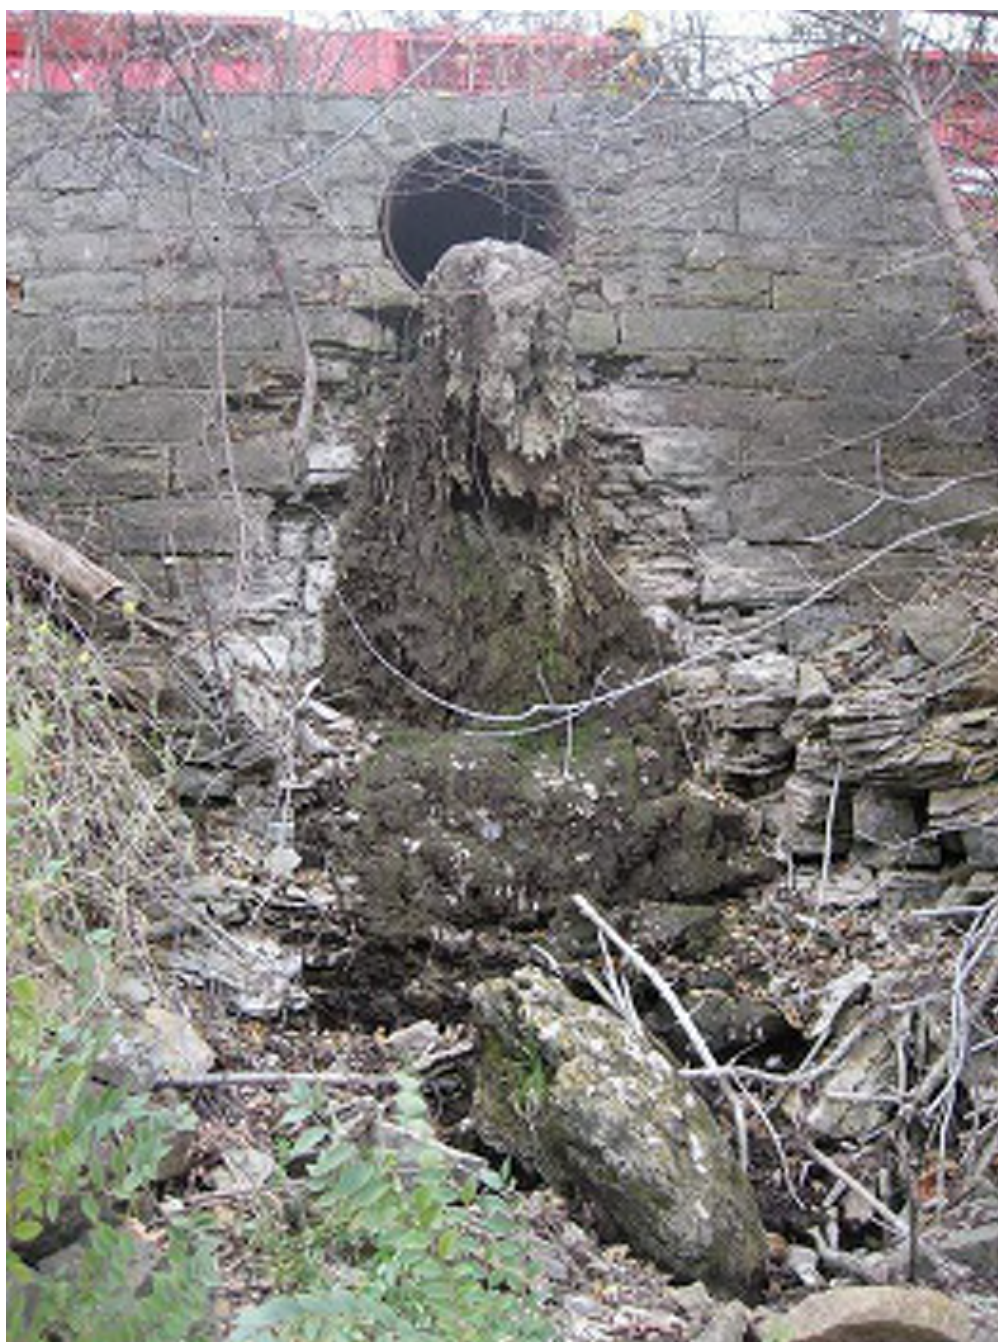
Lower side of culvert; minimal erosion; lots of rock surrounding the culvert.

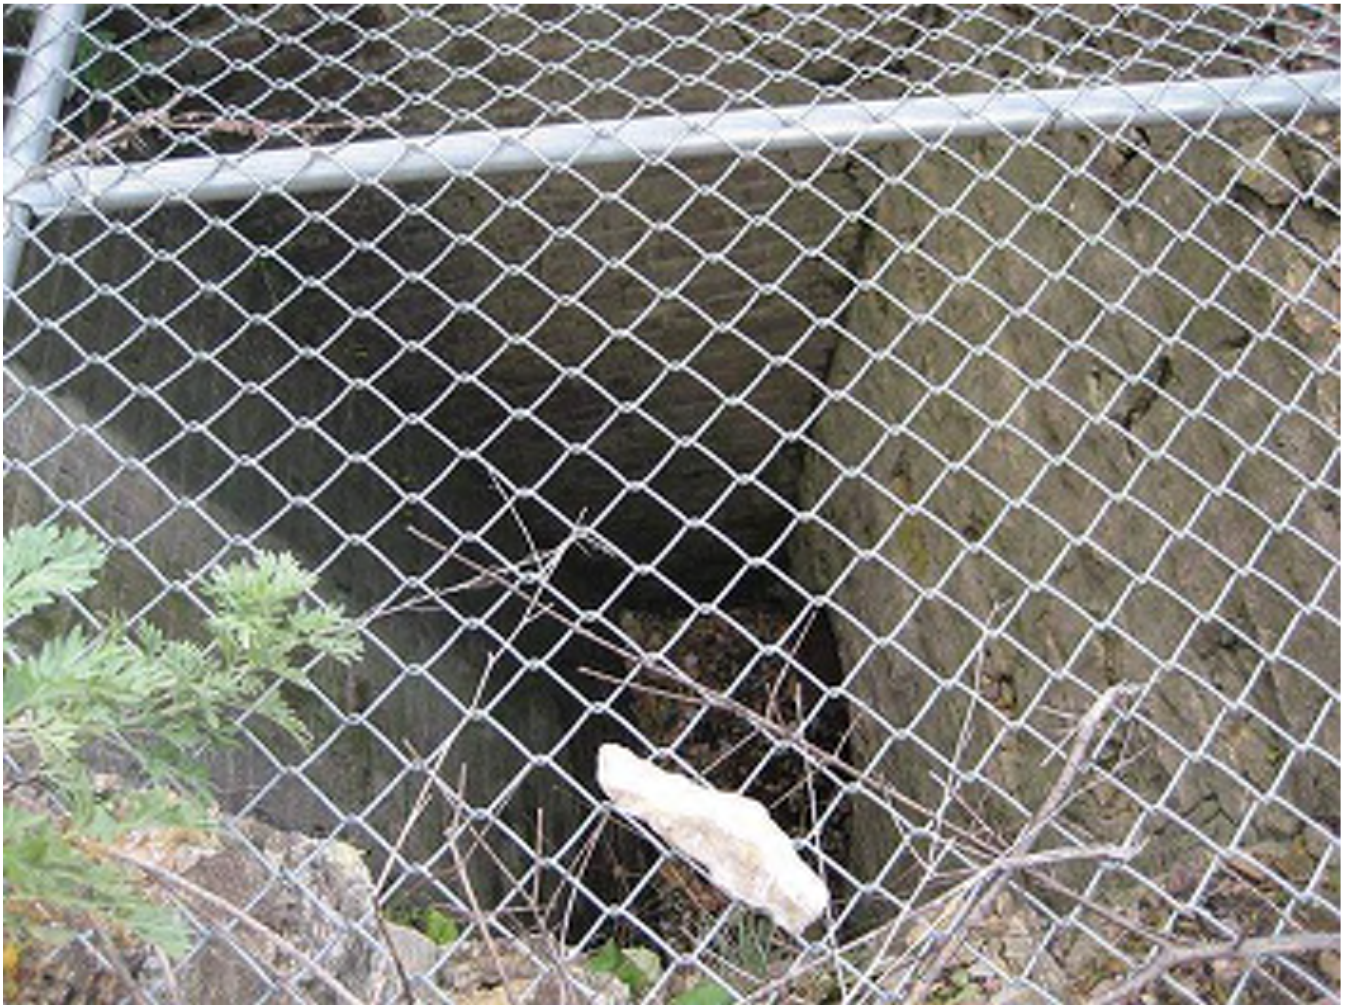
Waypoint 190A

Culvert at upper side of railroad tracks; minimal erosion.

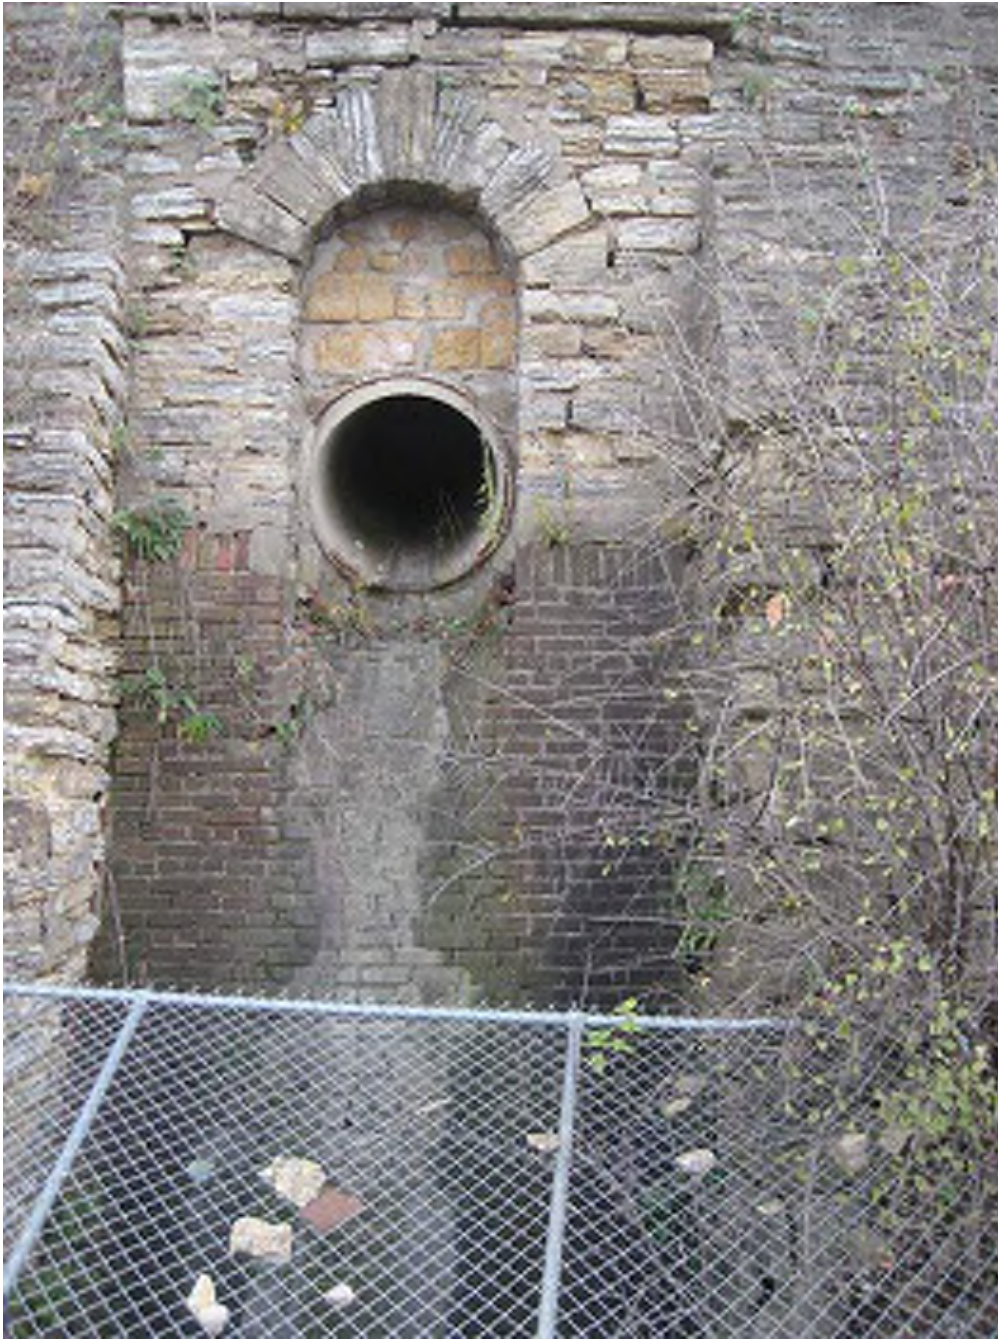
Culvert at upper side of railroad tracks; minimal erosion.

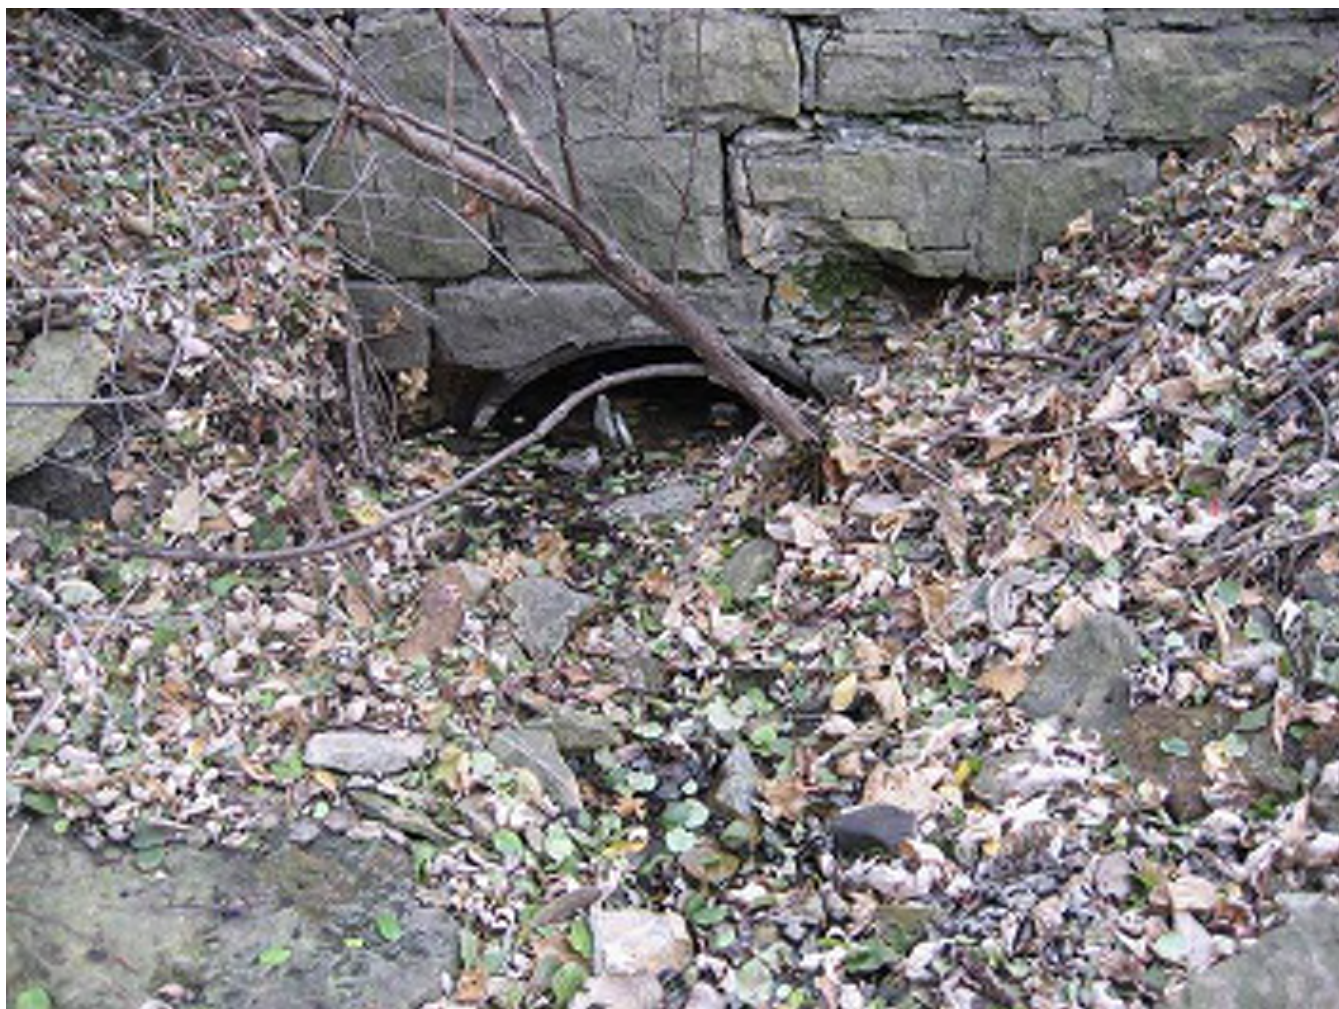
Lower side of culvert; full of rock and sand; water pooling at outlet; minimal erosion.

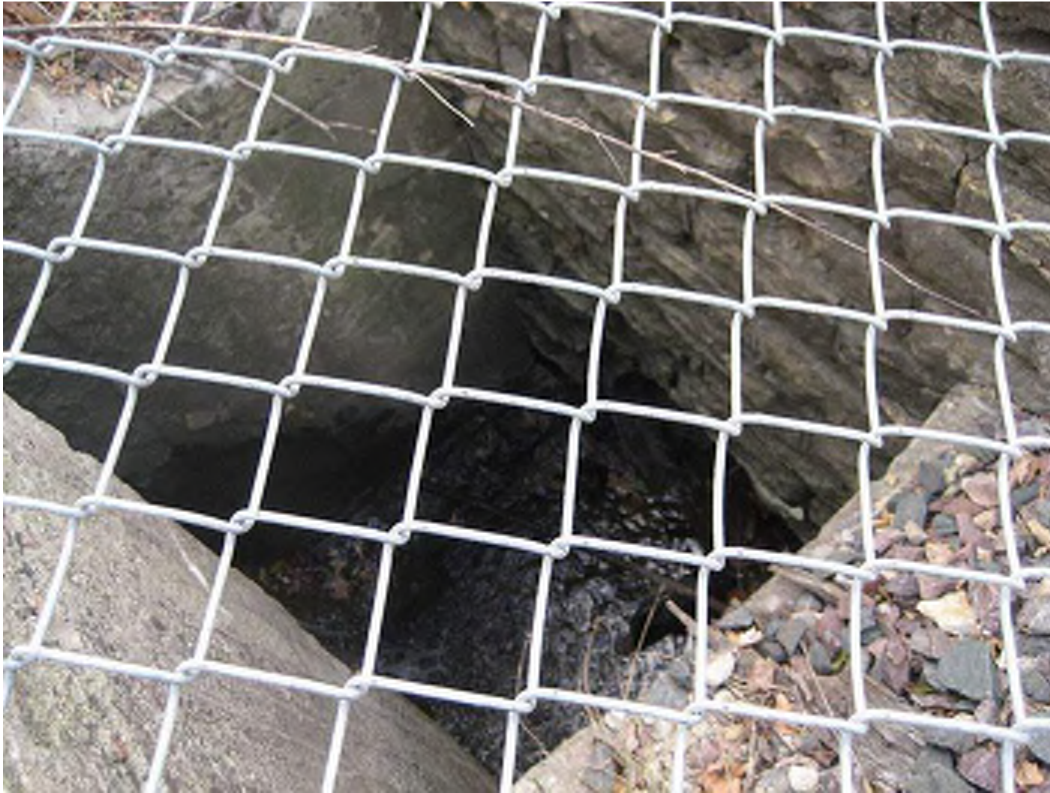
Waypoint 191A

Culvert on upper side of railroad tracks; water coming down through culvert; minimal erosion.

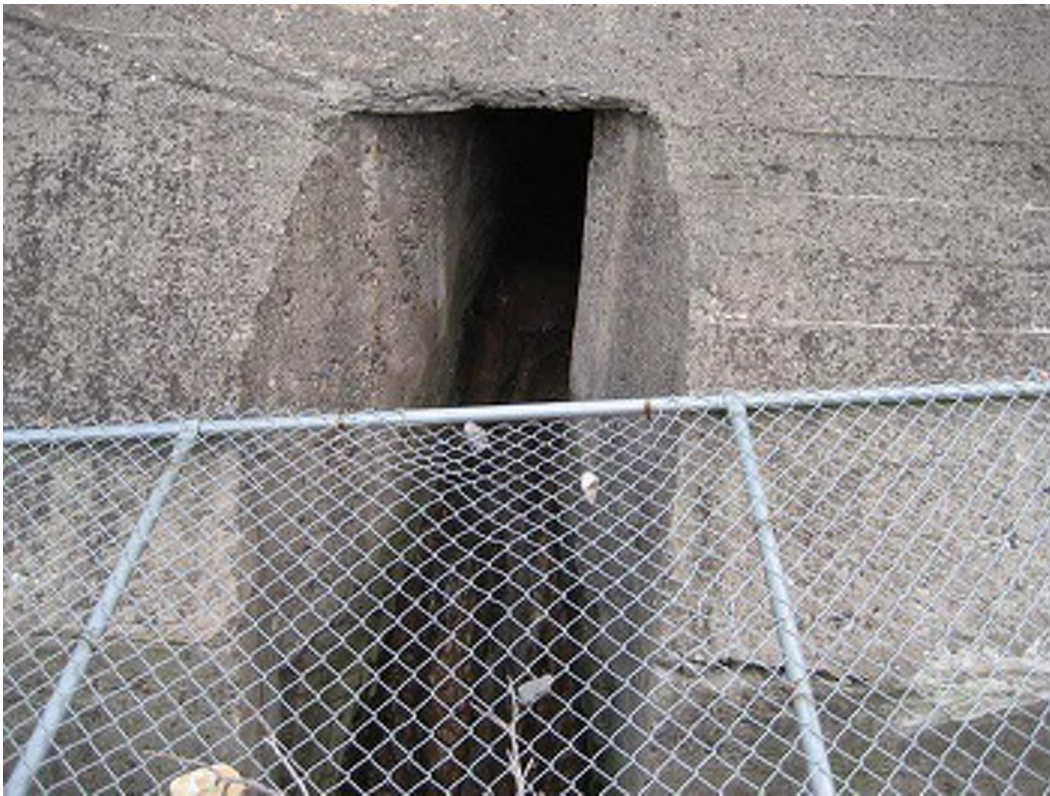
Culvert on upper side of railroad tracks; water coming down through culvert; minimal erosion.

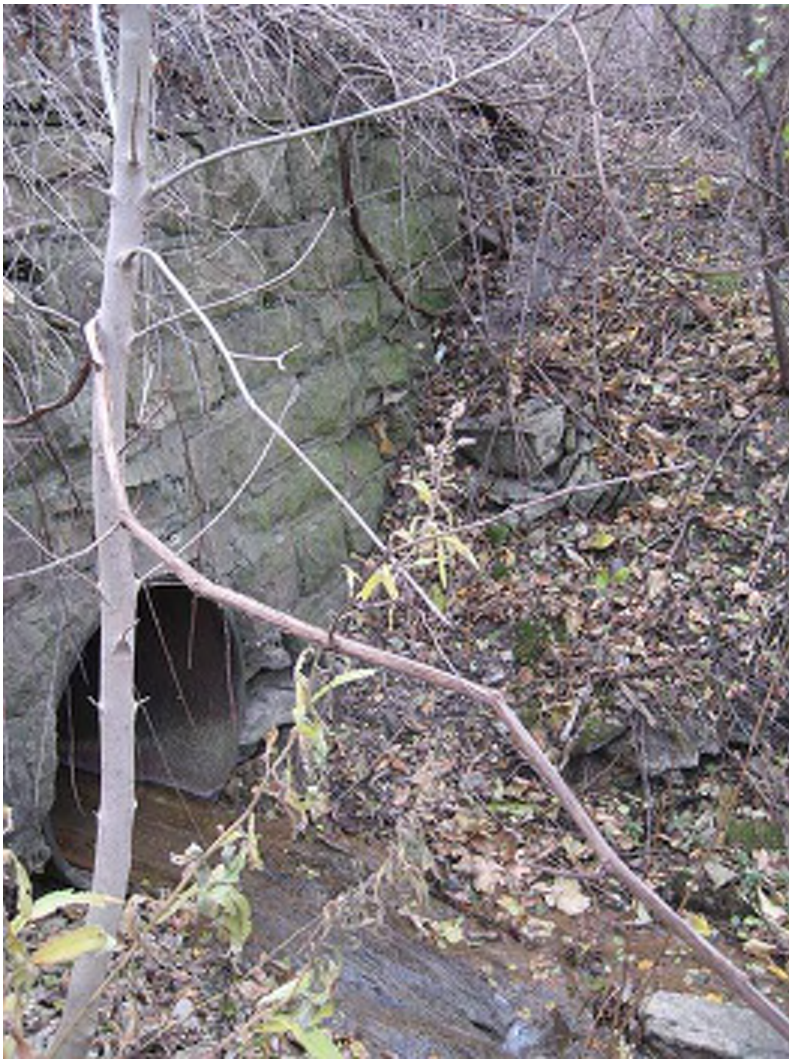
Culvert on lower side of railroad tracks.

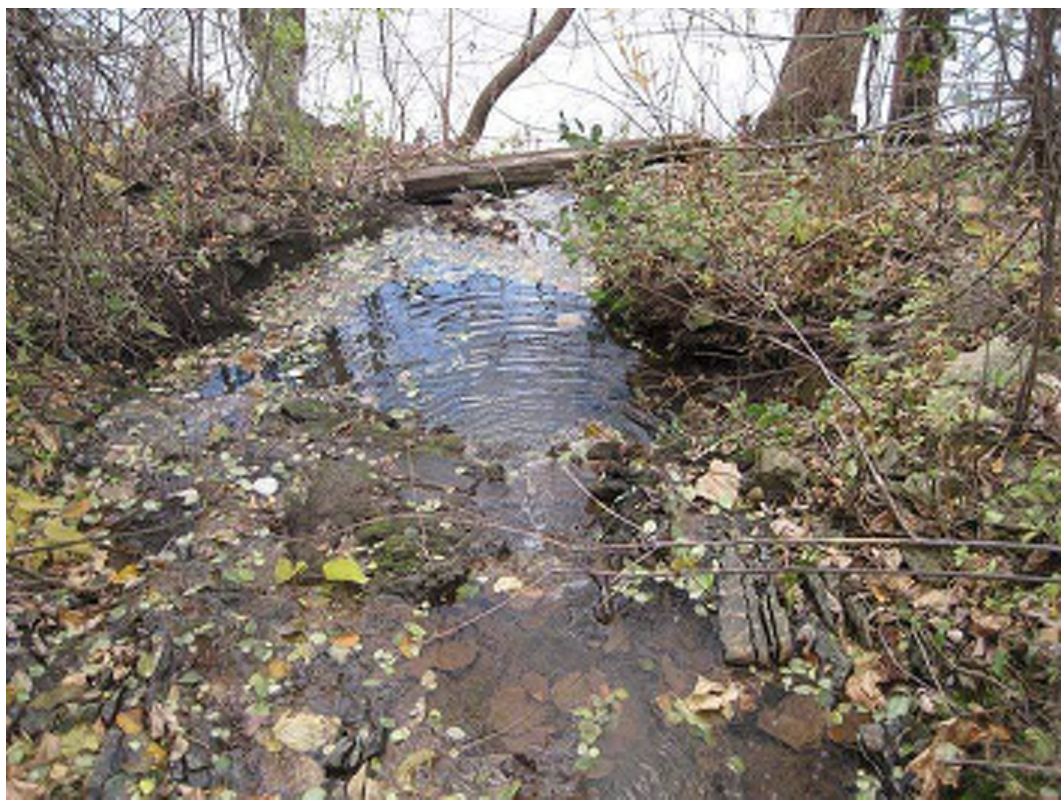
Water coming out of culvert and going through 2 large pools of water before going into river; moderate erosion.

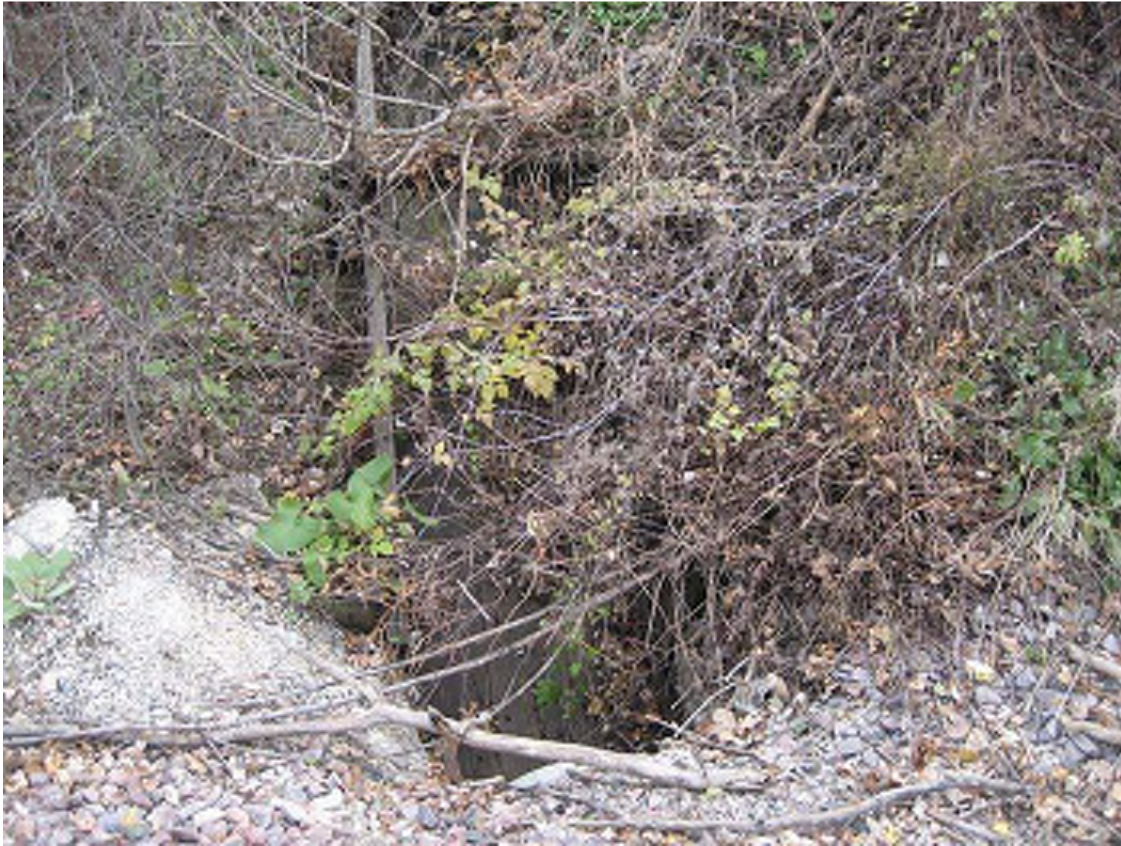
Waypoint 192A

Culvert going under railroad tracks

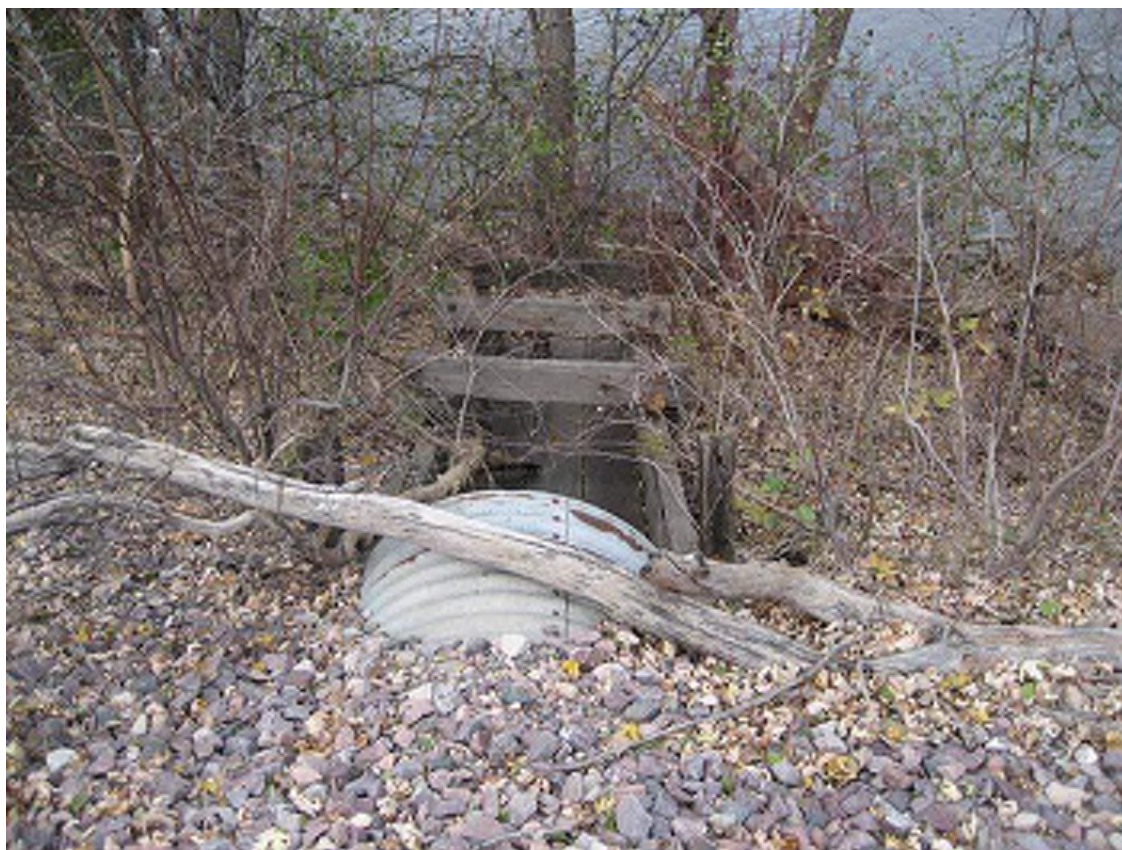
Upper side has wooden track to bring water down through the culvert to the other side and to the river.

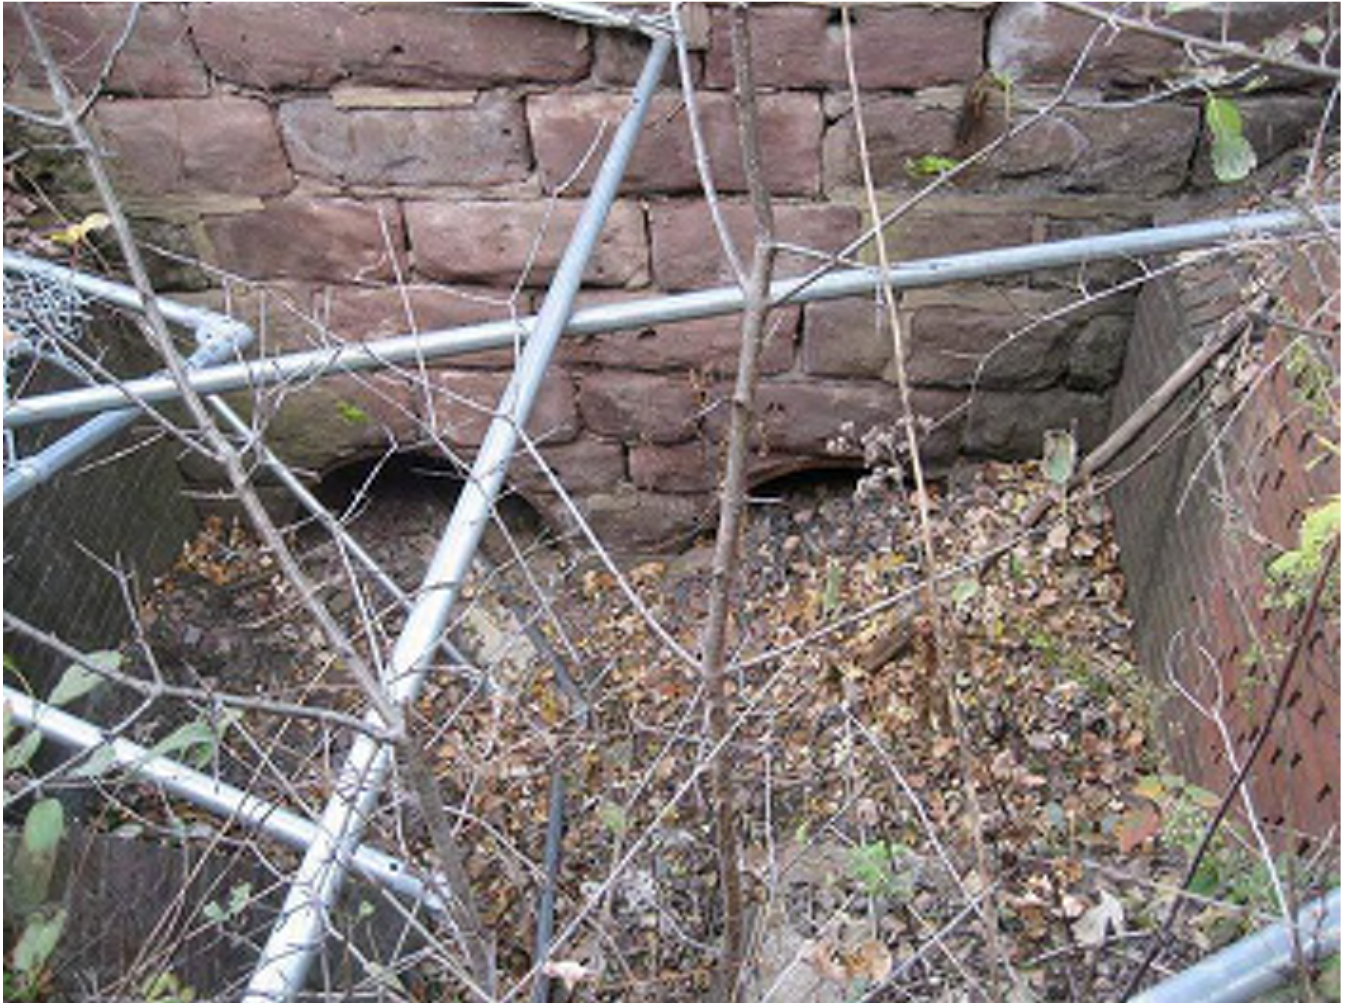
Waypoint 193A

Two culverts on upper side of railroad tracks going under tracks.

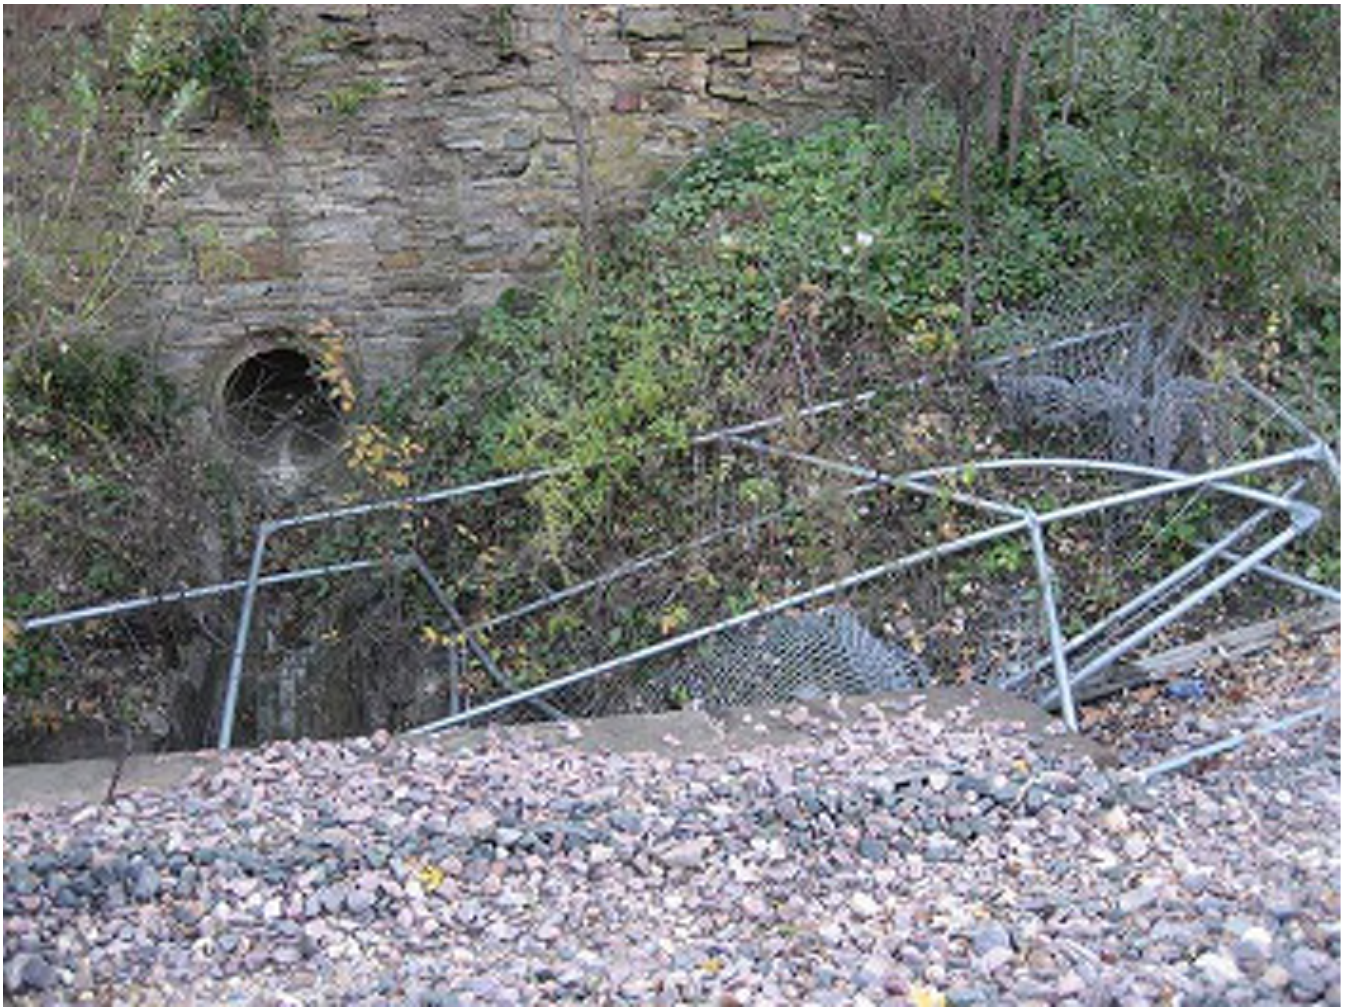
Fencing covering top of culverts is completely smashed and torn apart.

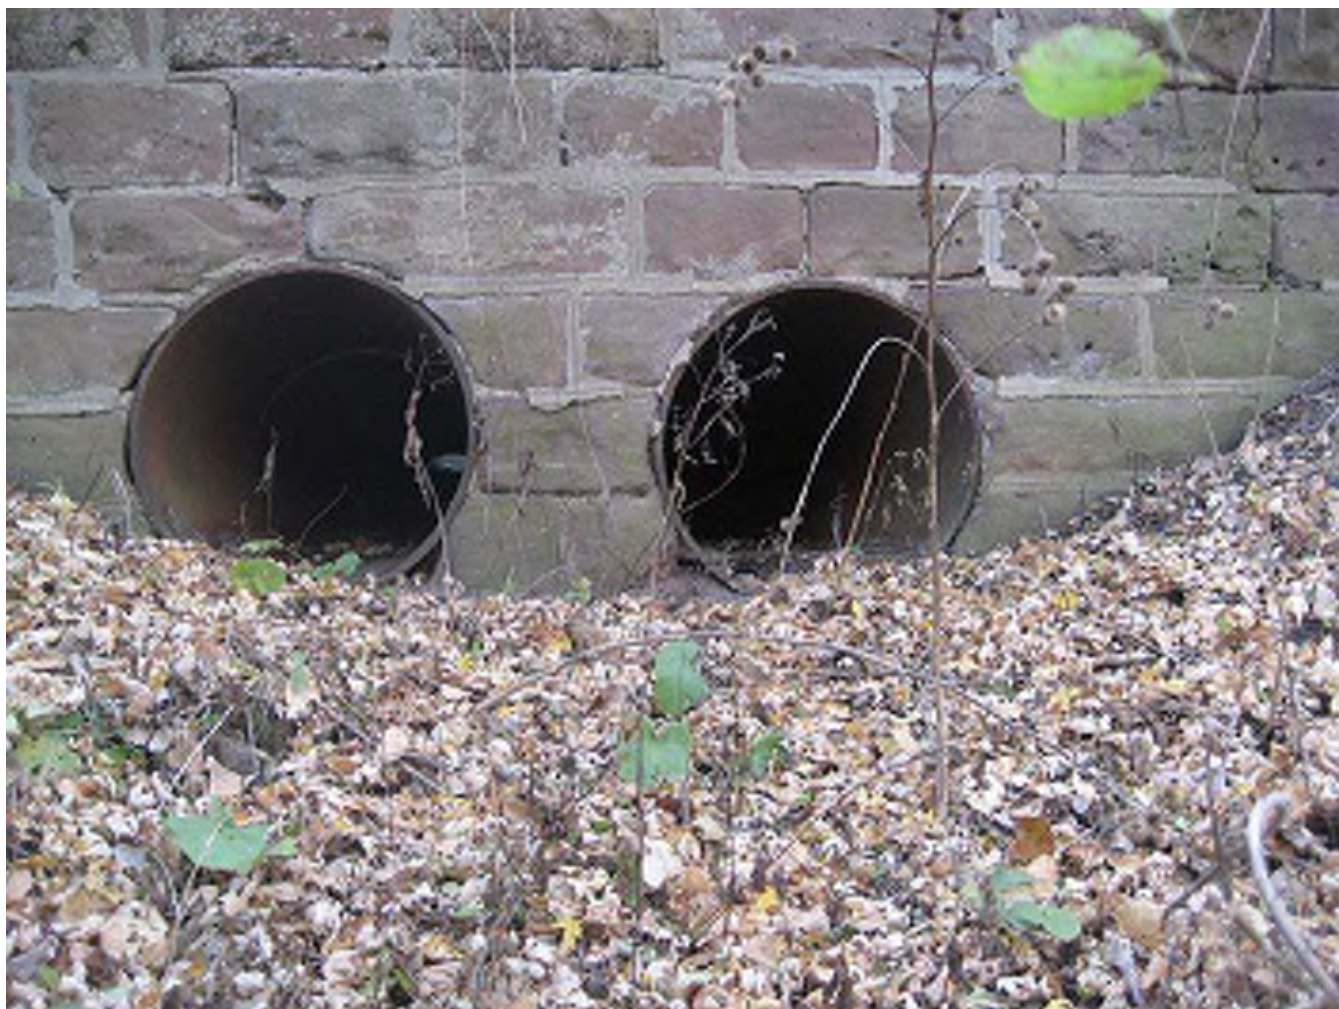
Lower side of culvert; minimal erosion.

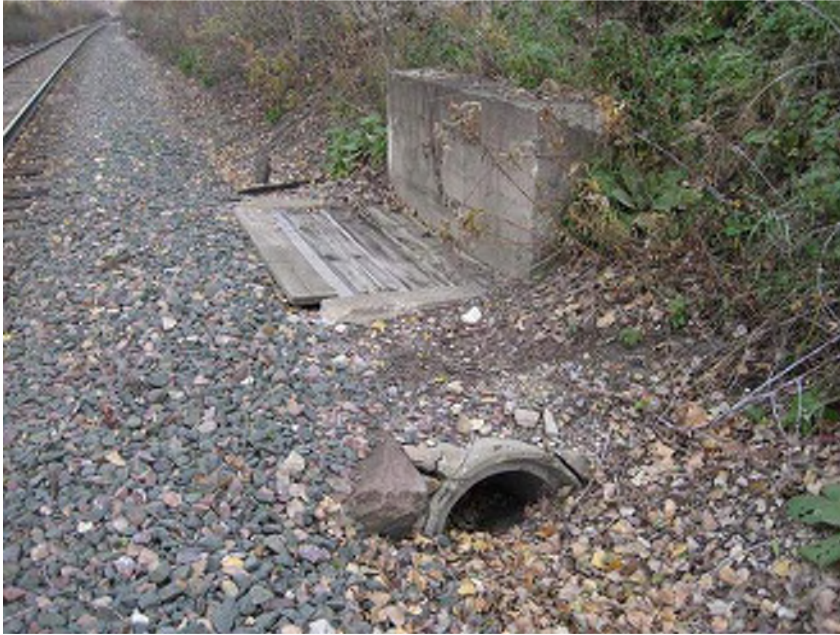
Waypoint 194A

Culvert of upper side of railroad tracks; minimal erosion.
