Appendix K: Lower Minnesota River Watershed District: Gully Inventory

Gully Inventory Map
 Area #1
 Lower Minnesota River Watershed District
 Watershed Management Plan

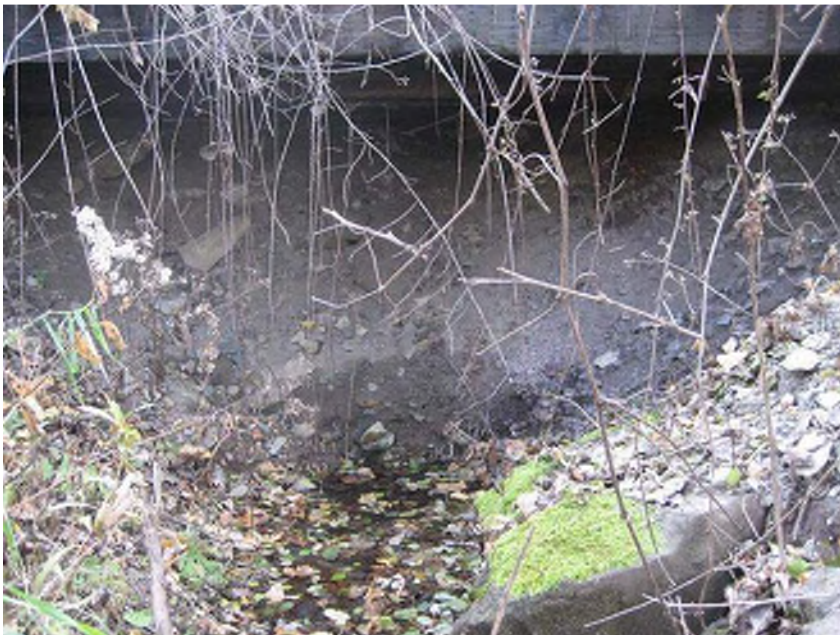
Large chunks of concrete on lower side of culvert; moderate erosion; no actual culvert but it looks like there used to be one and then it ma

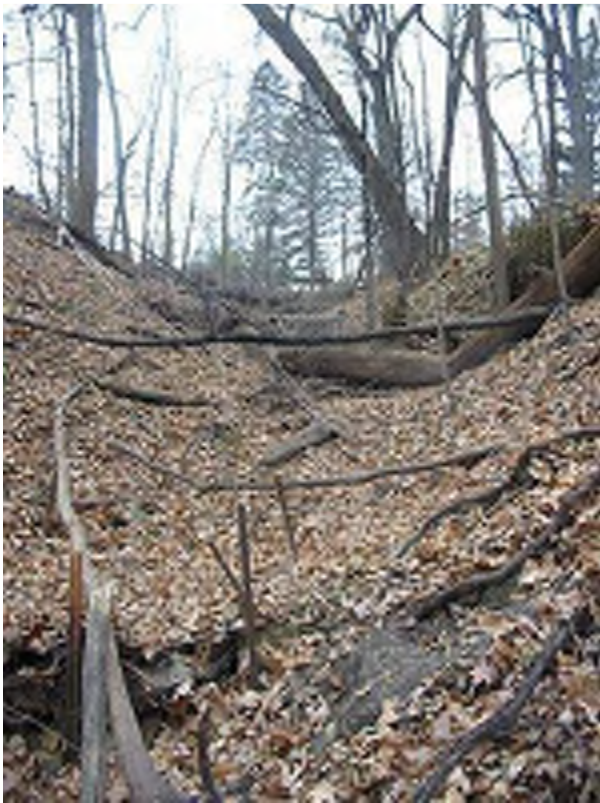
Waypoint 1001

overall looks good

Cement block erosion control, leaf and mulch dumping; overall looks good

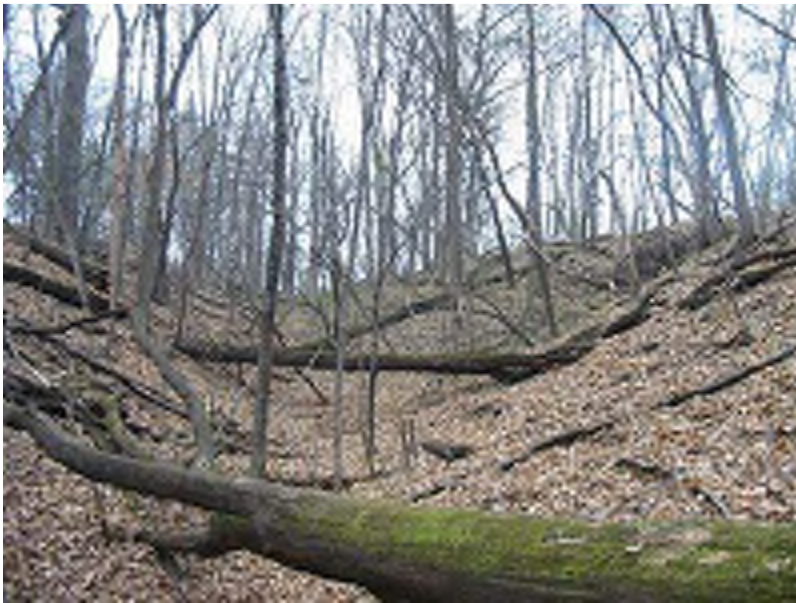
Waypoint 1002

overall looks good

Trash manhole dumping

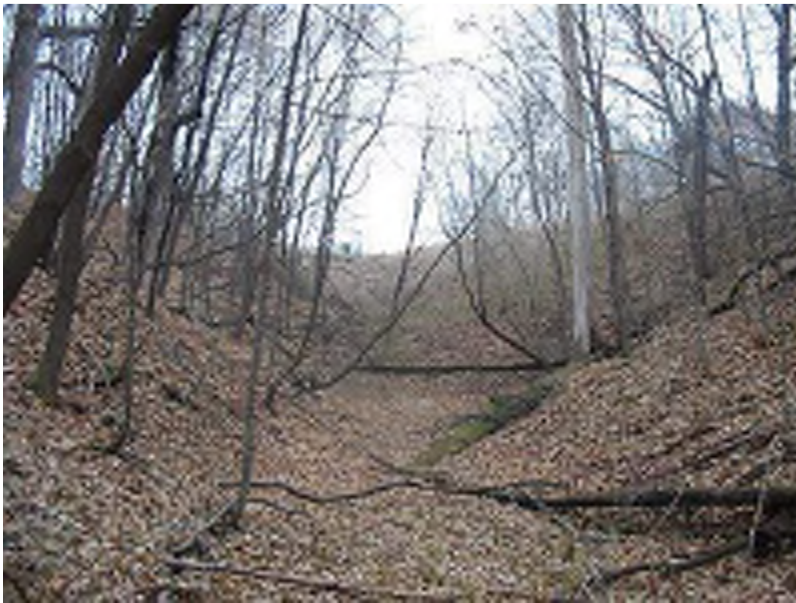
Waypoint 1003

overall looks good

Overall looks good.

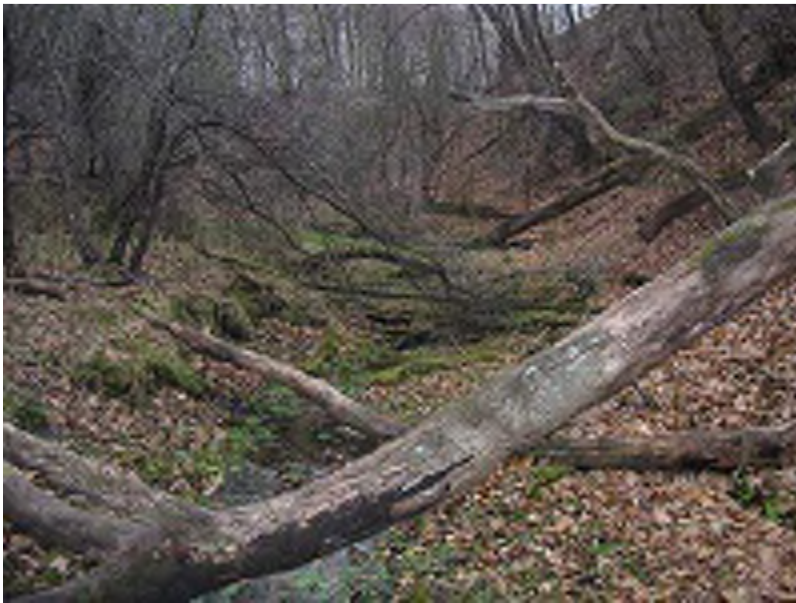
Waypoint 1004

overall looks good

Groundwater discharge; overall looks good

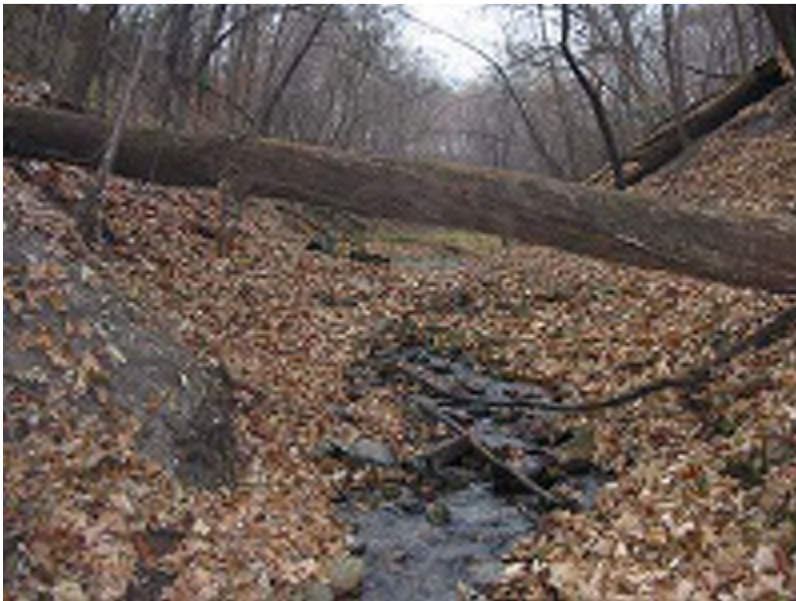
Waypoint 1005

overall looks good

Man made road barrier/bridge

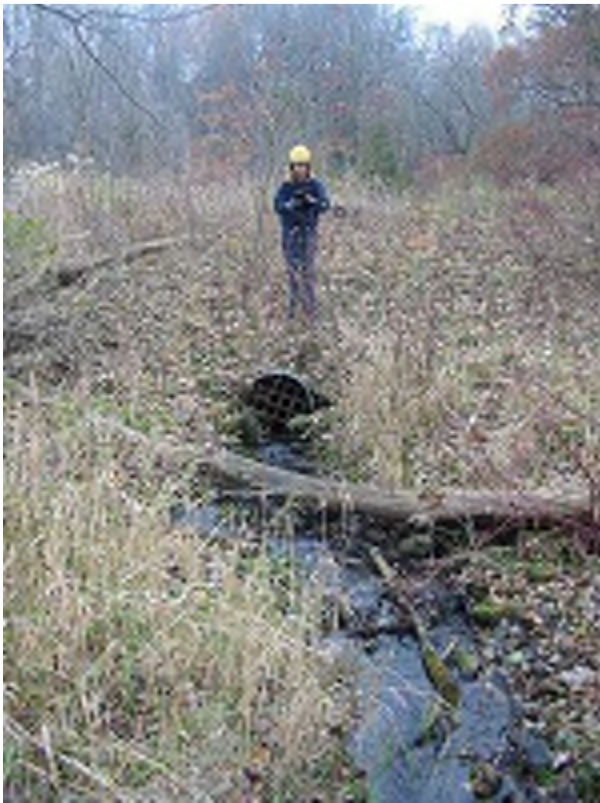
Waypoint 1006

overall looks good

Pond outlet 1; overall looks good

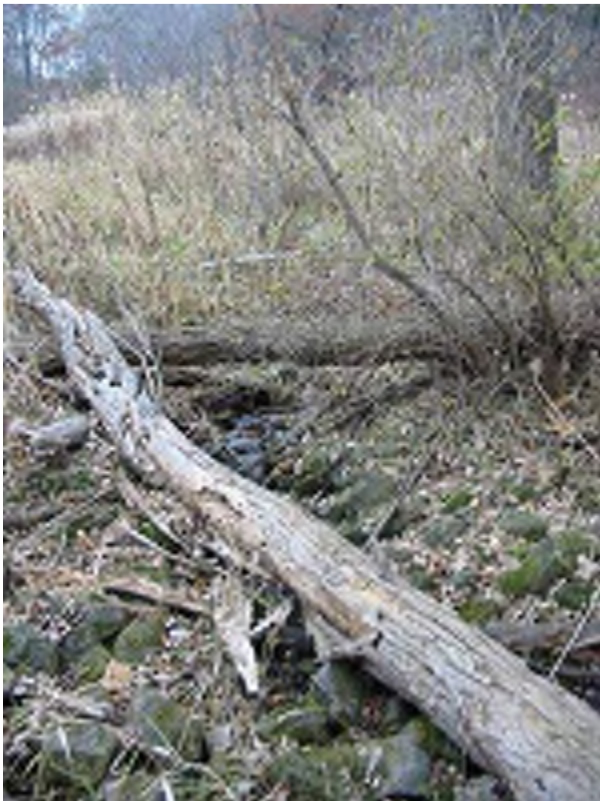
Waypoint 1007

overall looks good

Pond outlet 2; overall looks good

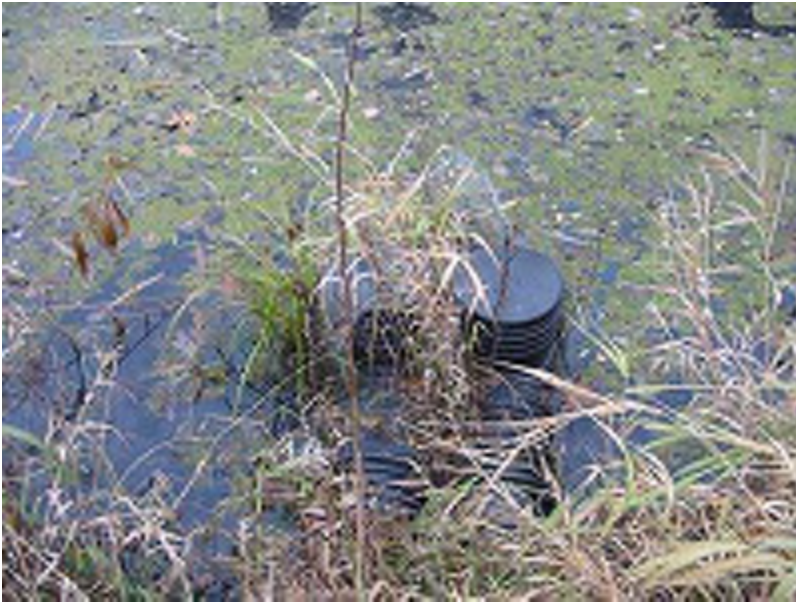
Pond drain 2

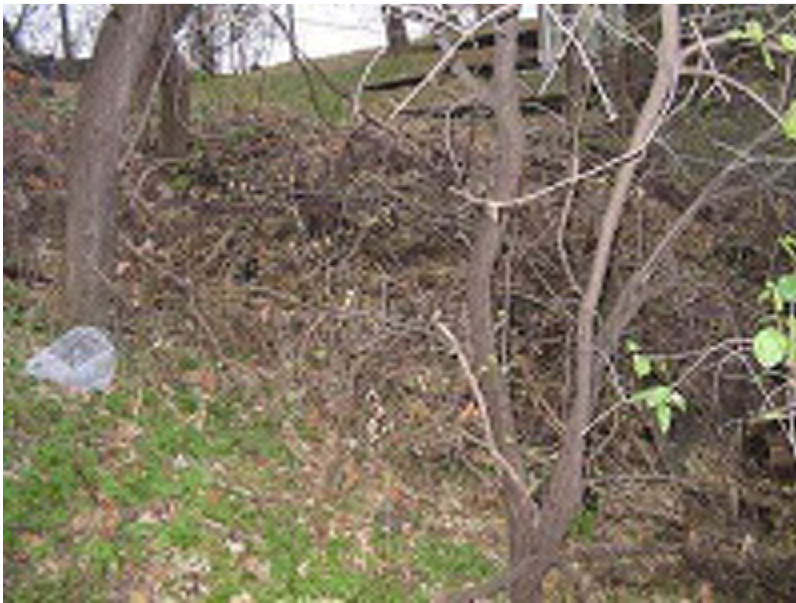
Waypoint 1008

not much erosion, lots of buckthorn/garlic mustard

Logs and brush at top of gully; not much erosion, lots of buckthorn/garlic mustard.

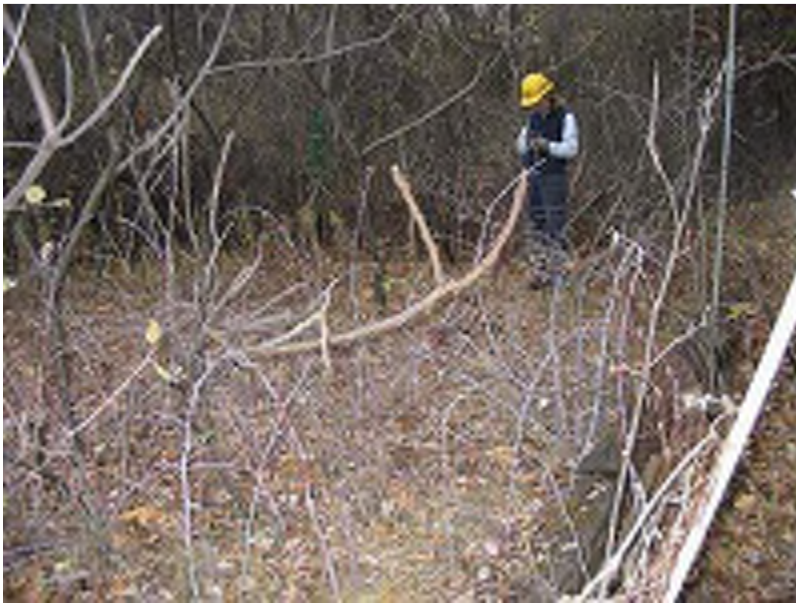
Waypoint 1009

not much erosion, lots of buckthorn/garlic mustard

Abandoned garden; not much erosion, lots of buckthorn/garlic mustard.

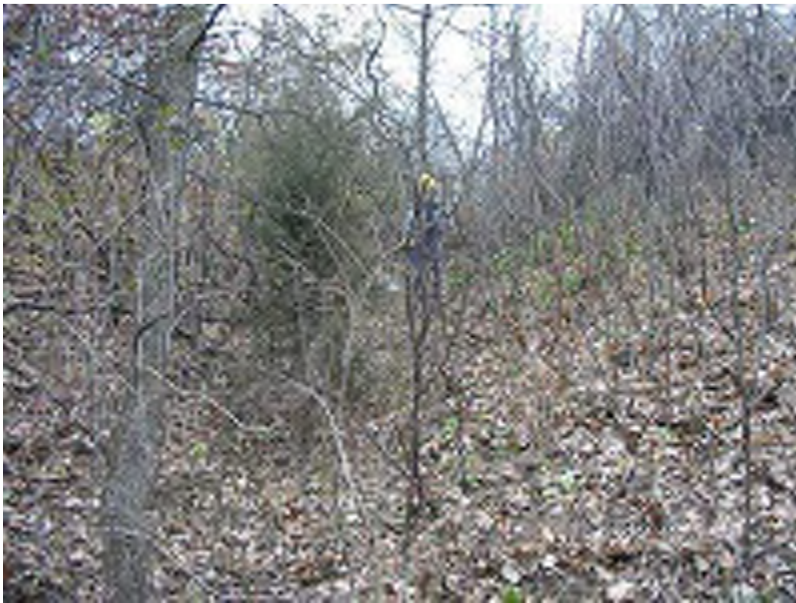
Waypoint 1010

not much erosion, lots of buckthorn/garlic mustard

Cut brush along top of gully; not much erosion, lots of buckthorn/garlic mustard

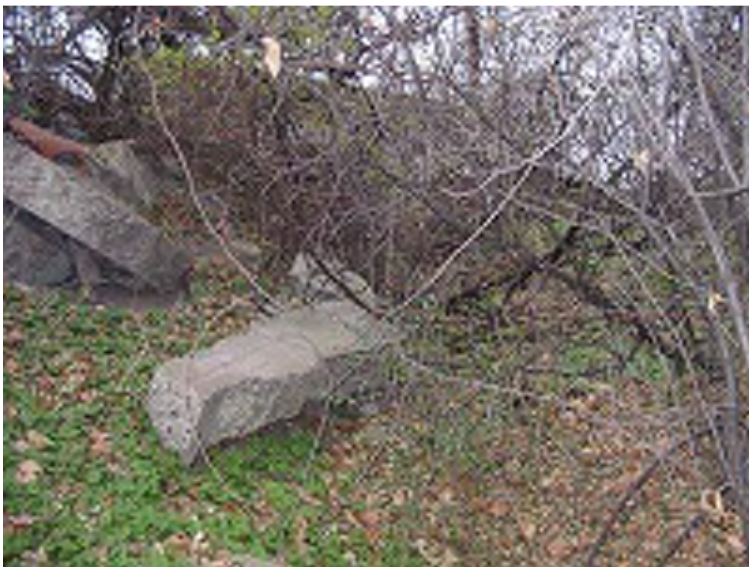
Waypoint 1011

Cement blocks erosion right up to yard; much erosion, lots of buckthorn/garlic mustard.

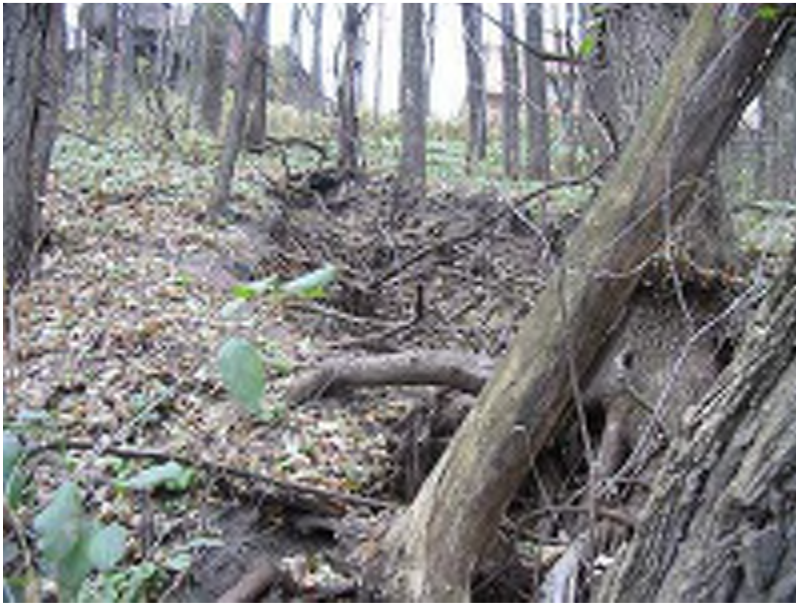
Waypoint 1012

Small gully-just getting started

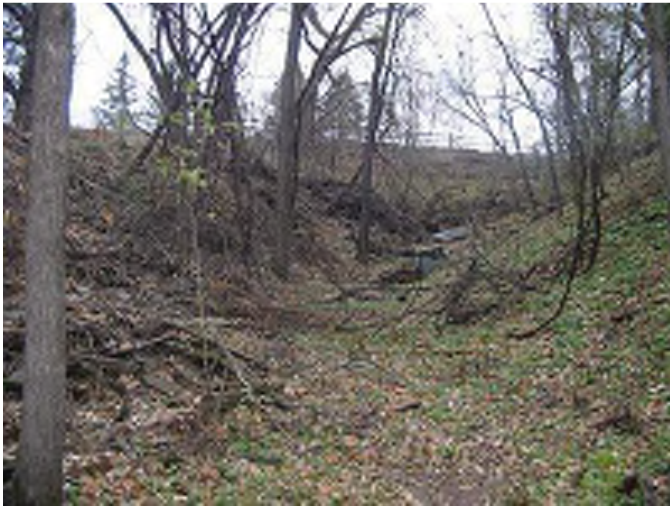
Waypoint 1013

Metal scraps, one tile line/drainage erosion not much of an issue, lots of garlic mustard/buckthorn

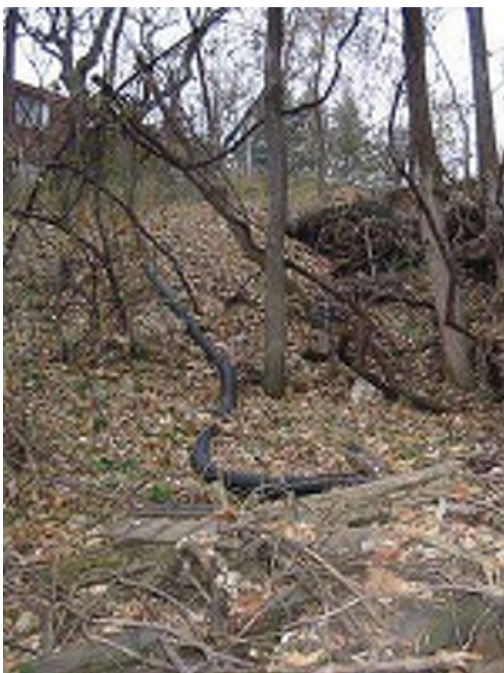
Metal scraps, one tile line/drainage erosion not much of an issue, lots of garlic mustard/buckthorn

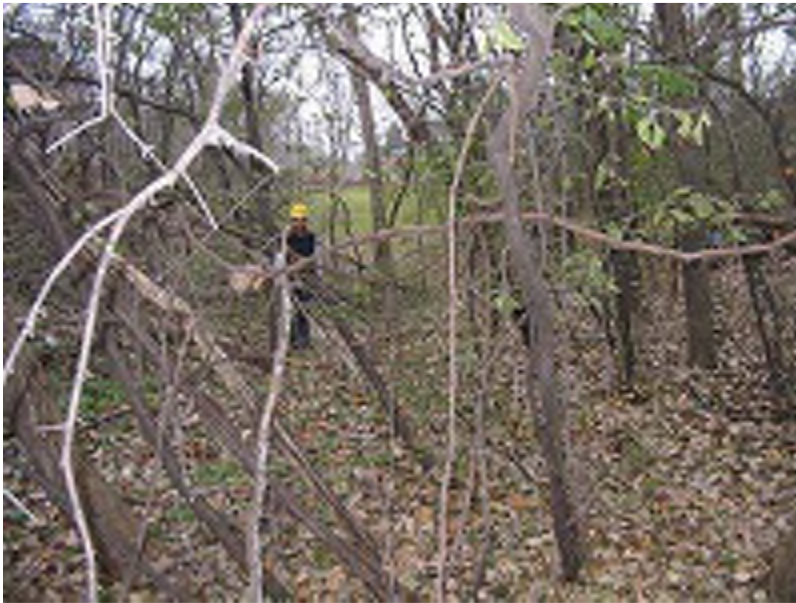
Waypoint 1014

Some groundwater seepage at bottom

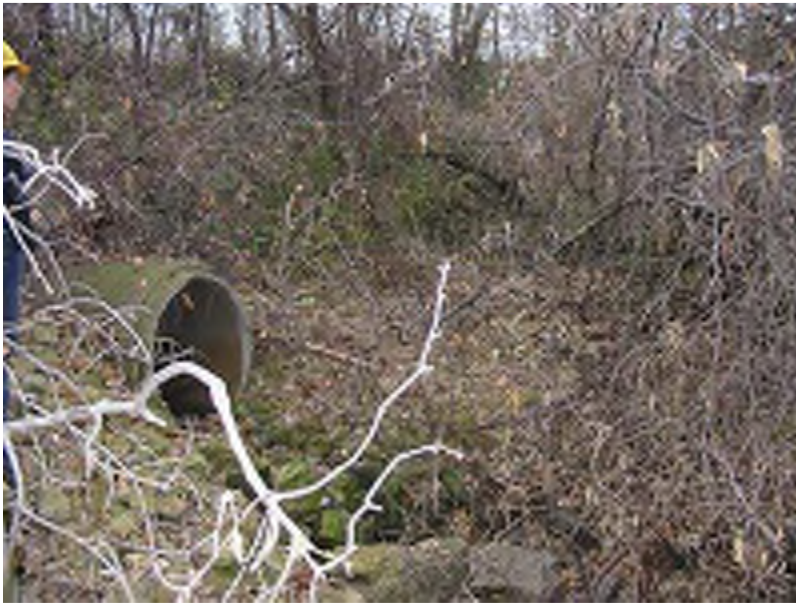
Large cement pipe w/riprap

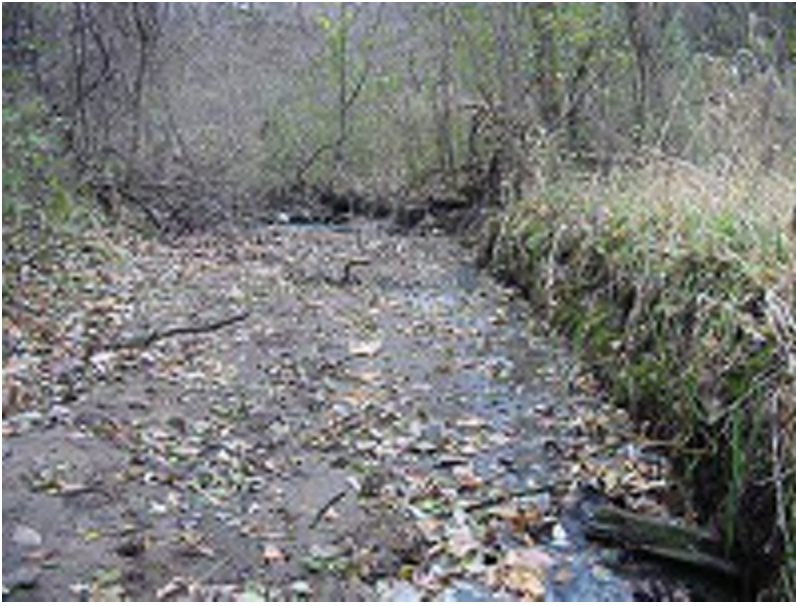
Erosion below riprap

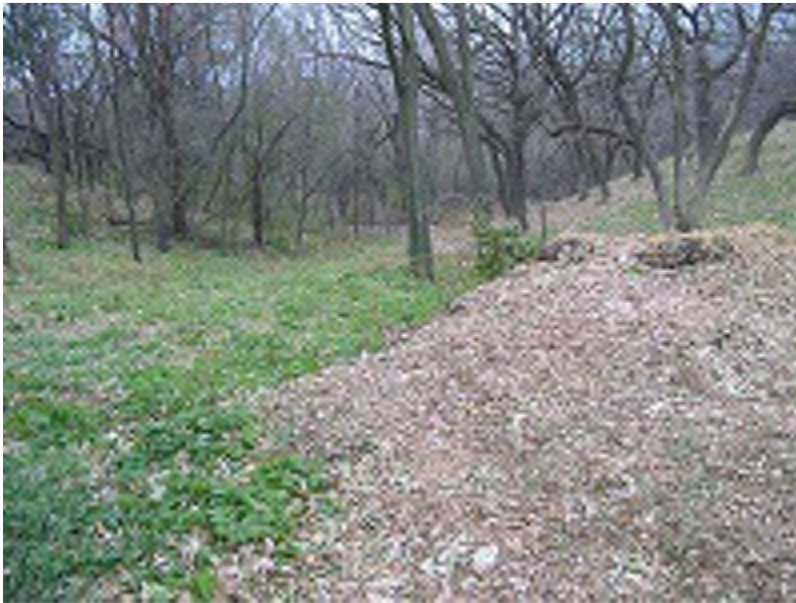
Waypoint 1016

large pile of mulch at top, 4-wheeler tracks down gully

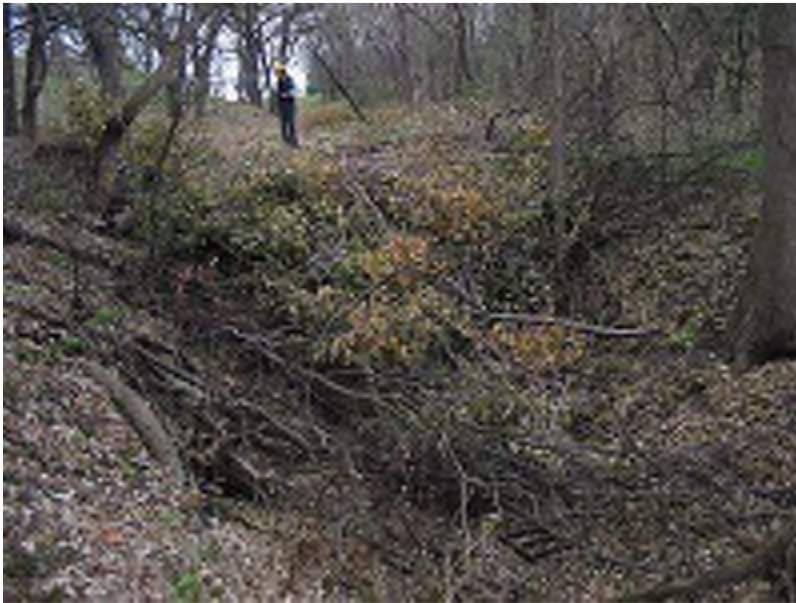
Waypoint 1017

Large amount of brush & dirt when gully gets steeper, some bank erosion

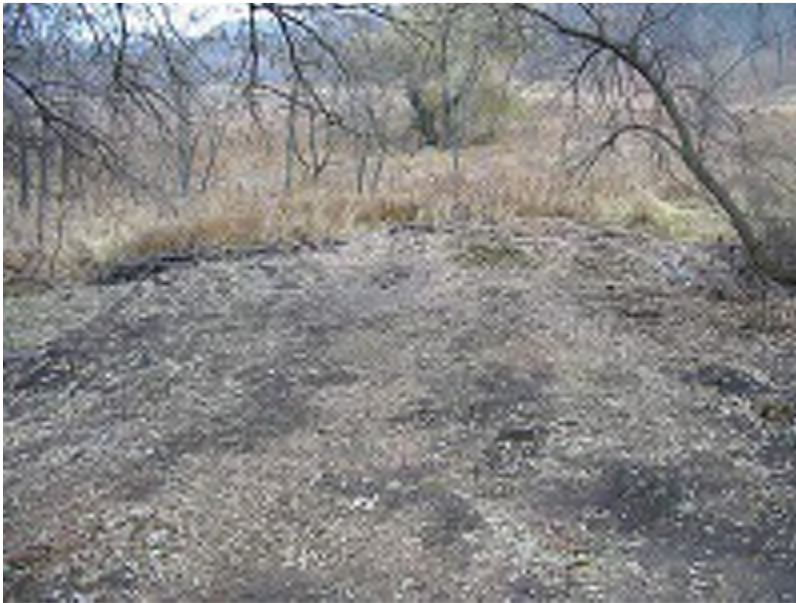
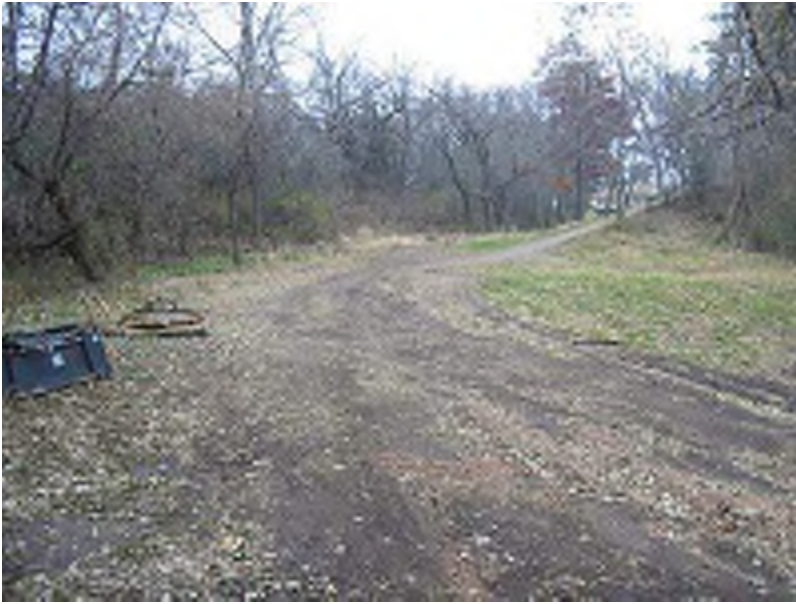
Waypoint 1018

Pushed dirt and brush at bottom of gully

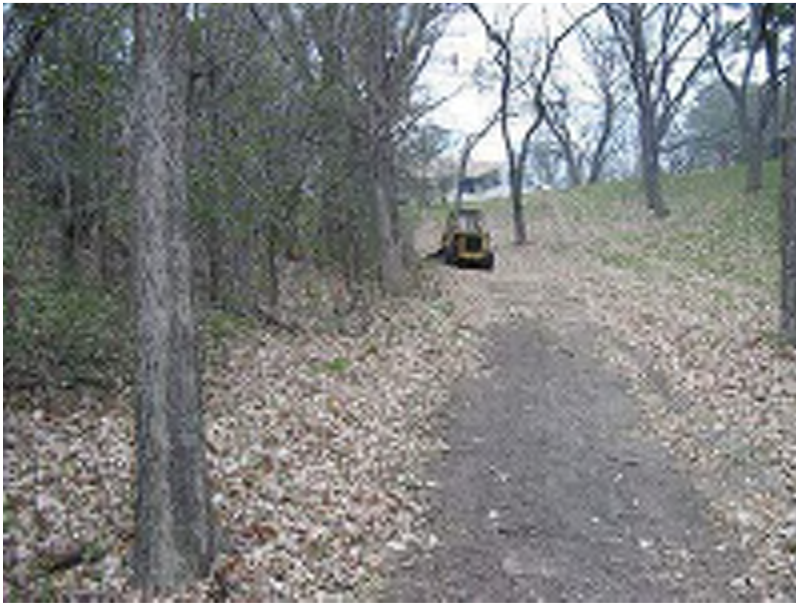
Waypoint 1019

Top of gully

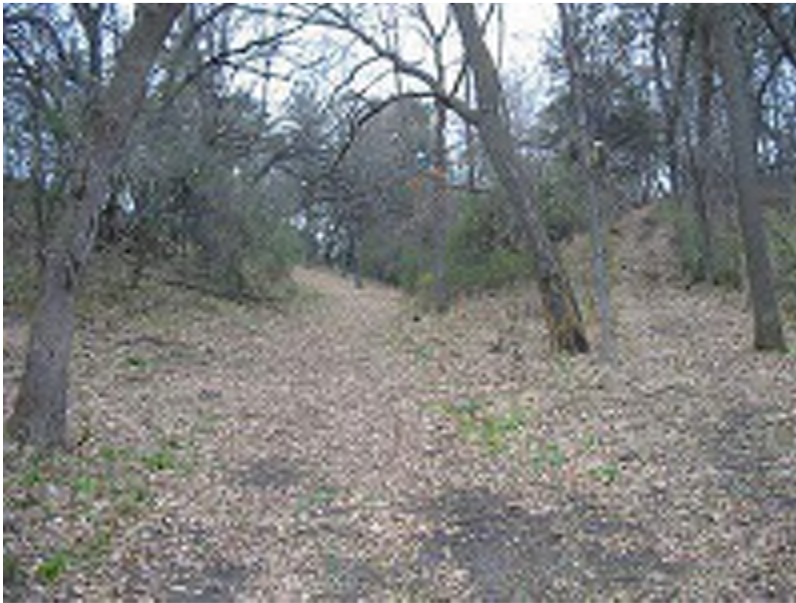
Waypoint 1020

Landscaped road

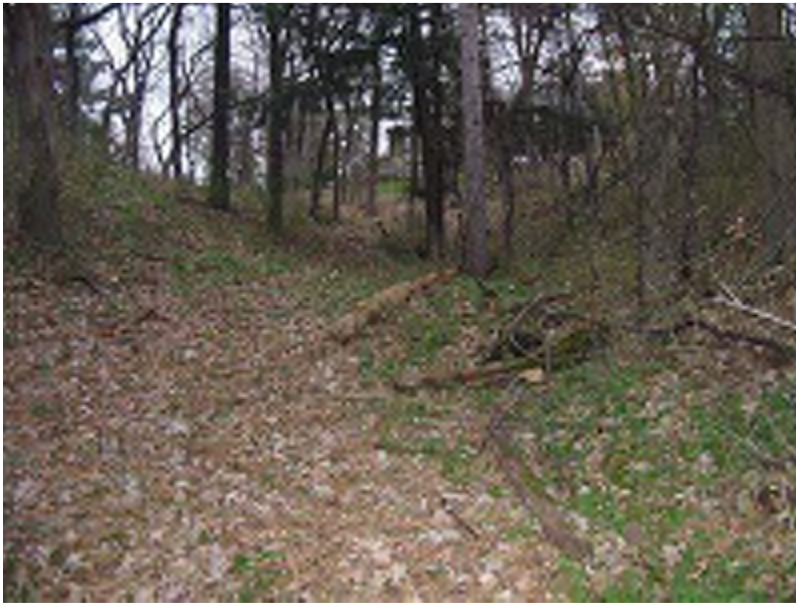
Waypoint 1021

Top of gully

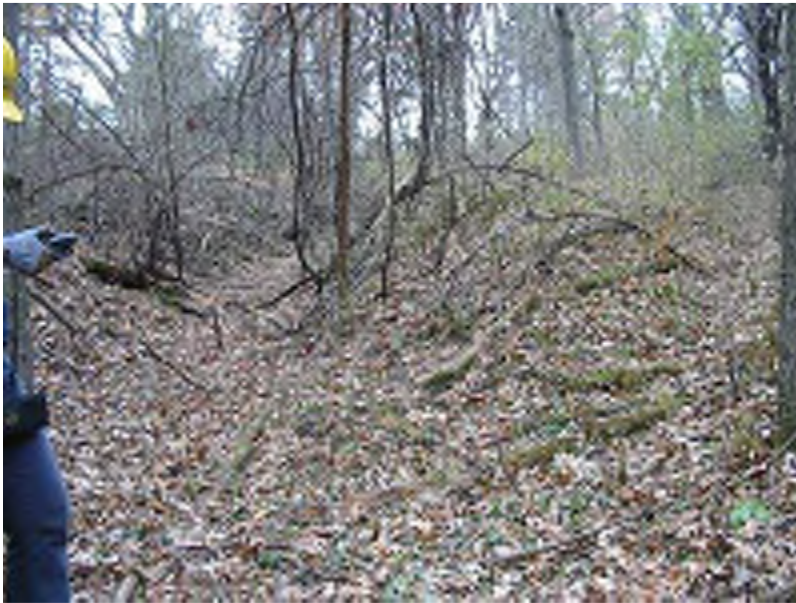
Waypoint 1022

Some cat brush at top, no real concerns

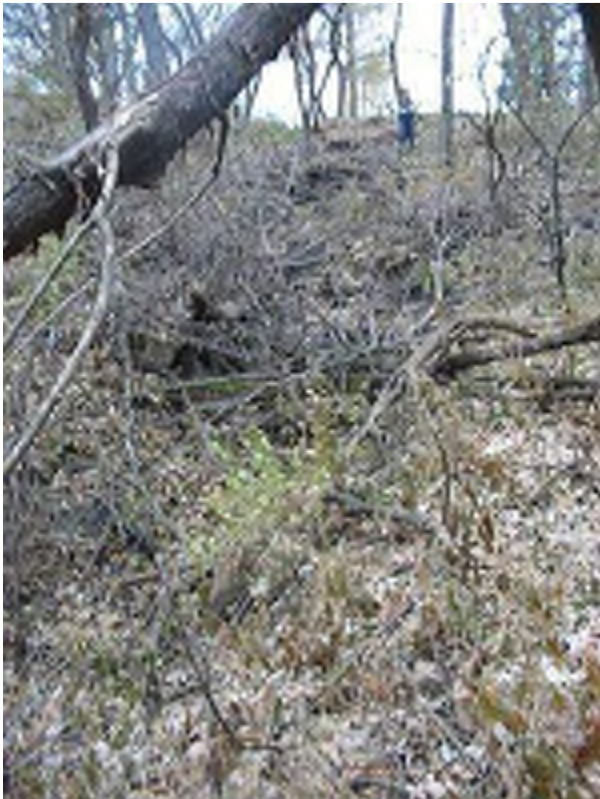
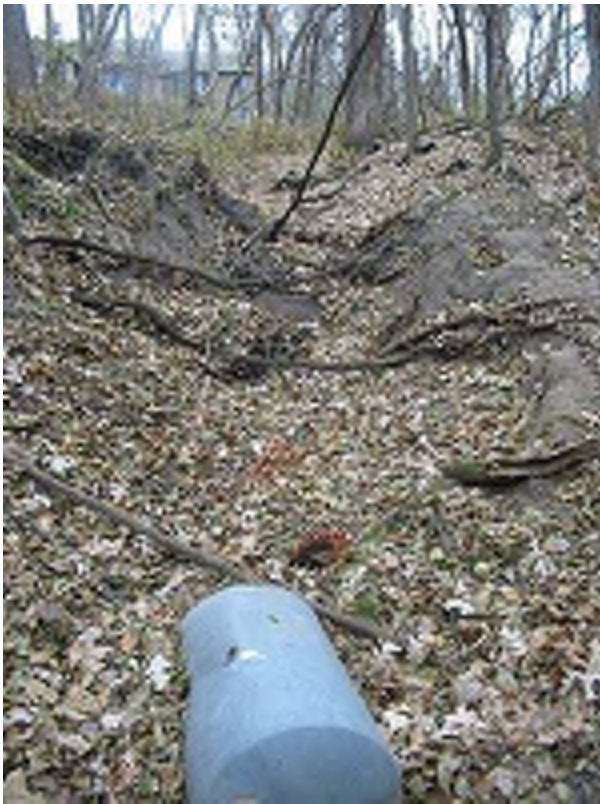
Waypoint 1023

Gully in hillside - drops into 4463

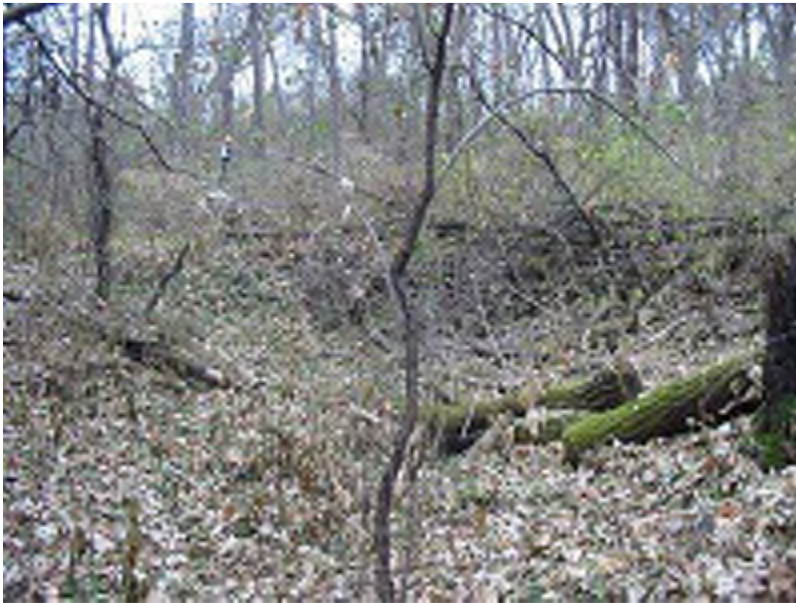
Waypoint 1024

Top of gully

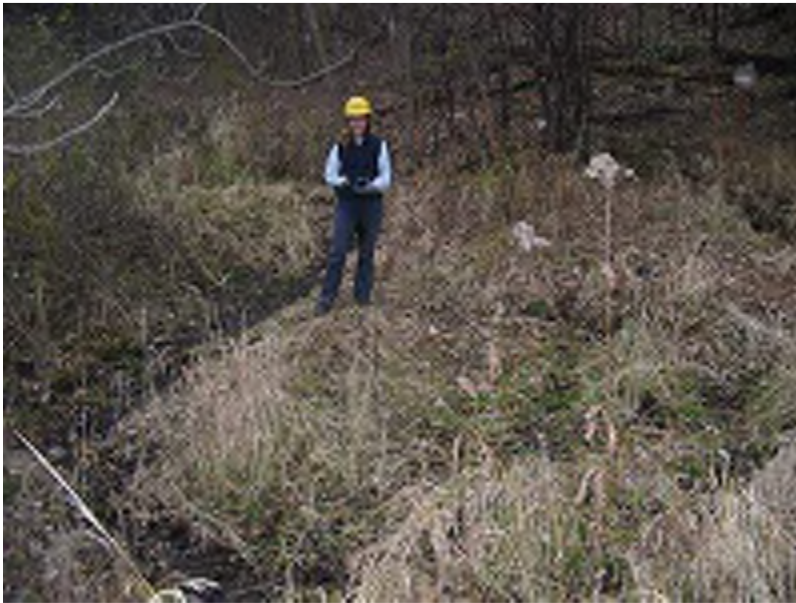
Waypoint 1025

Groundwater seepage, no real flow

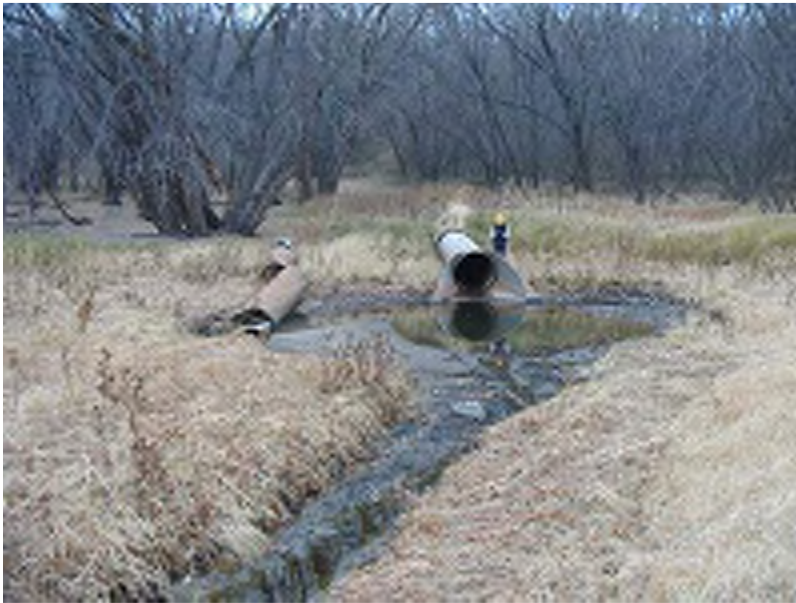
Waypoint 1026

Pipe outlet

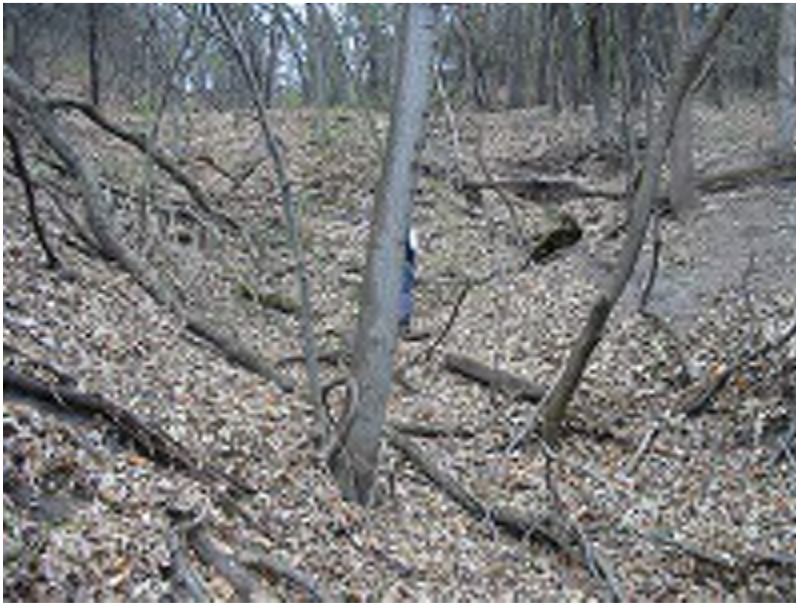
Waypoint 1027

Eroding gully with some old woven wire fence

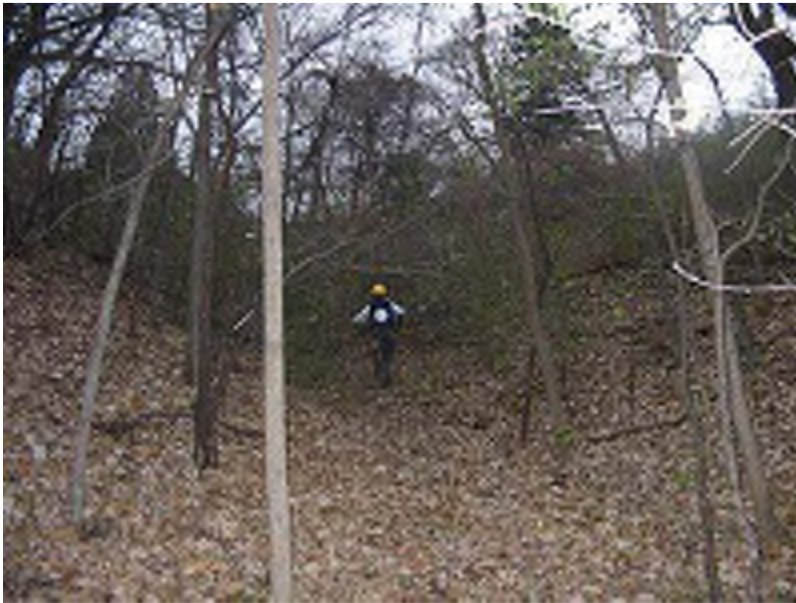
Waypoint 1028

Top of gully

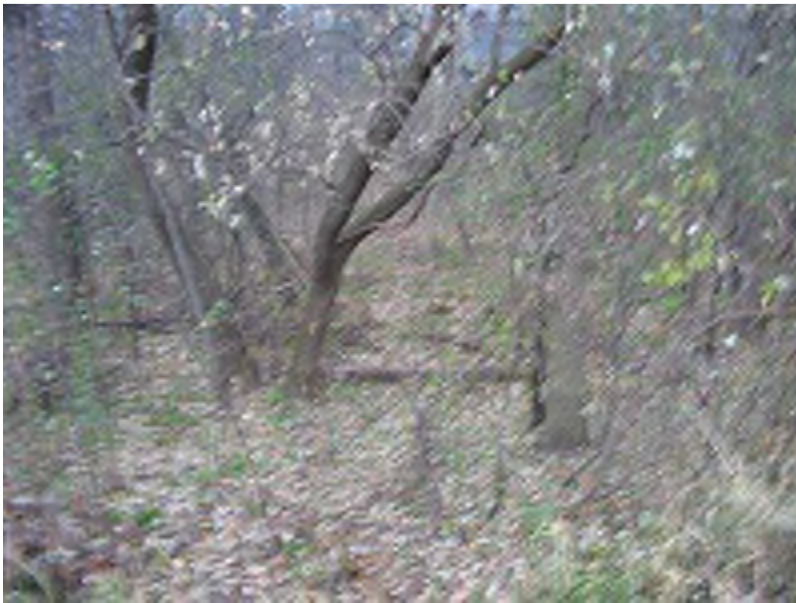
Waypoint 1029

random deeper cut gullies throughout the drain

Looks fine at top; random deeper cut gullies throughout the drain

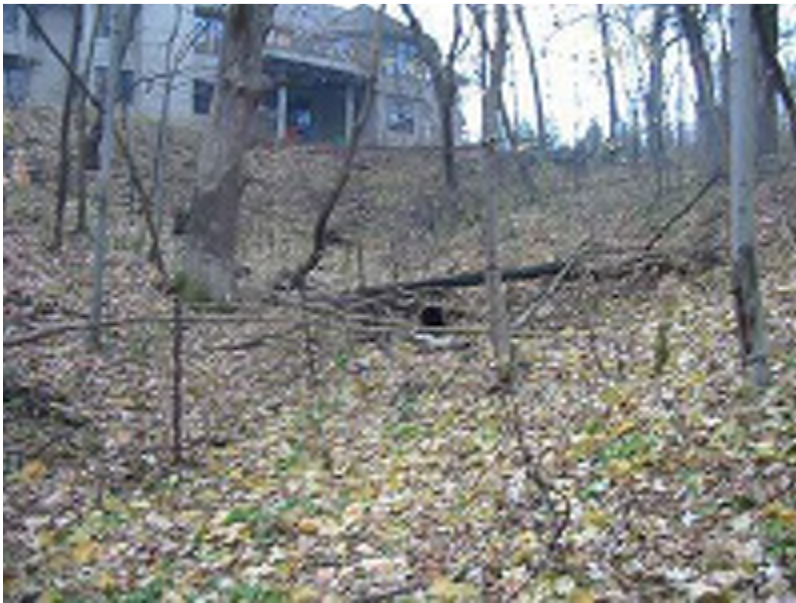
Waypoint 1030

random deeper cut gullies throughout the drain

Gully top drainage pipe; random deeper cut gullies throughout the drain

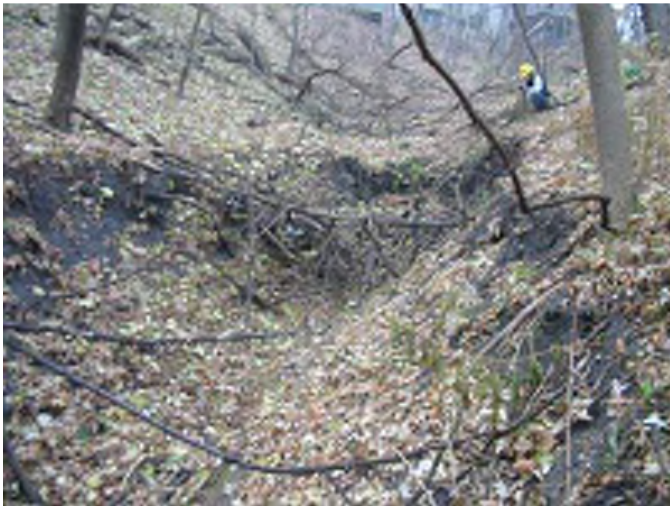
Waypoint 1031

random deeper cut gullies throughout the drain

Deep cut gully below 4469-about 60 yards in length; random deeper cut gullies throughout the drain.

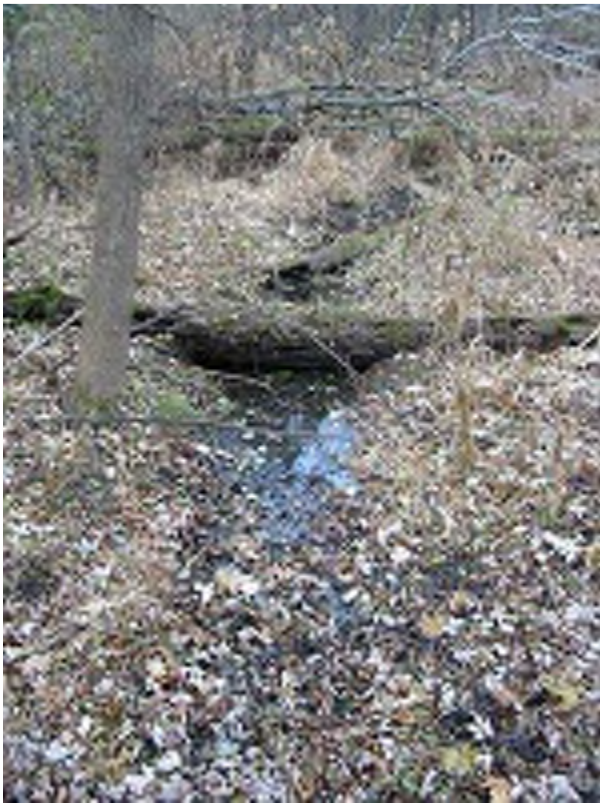
Waypoint 1032

random deeper cut gullies throughout the drain

Springs that disappear; random deeper cut gullies throughout the drain

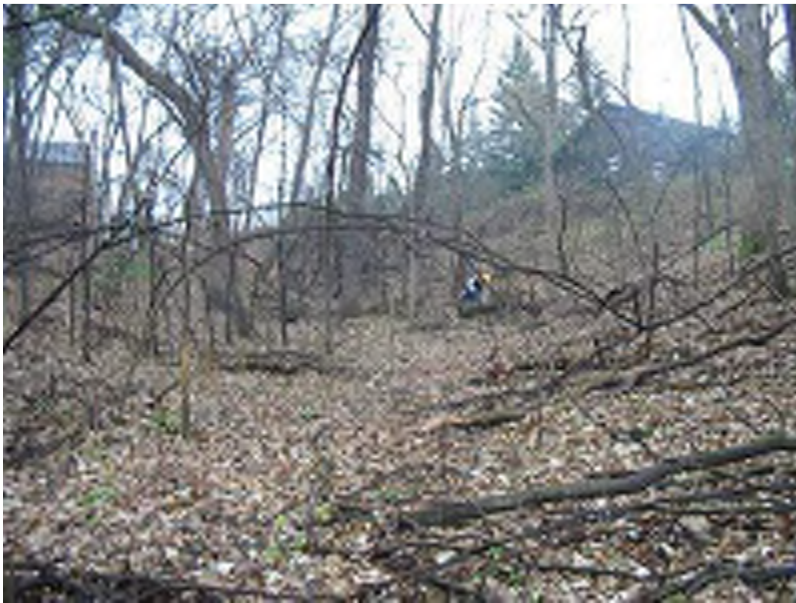
Waypoint 1033

random deeper cut gullies throughout the drain

Top of gully; random deeper cut gullies throughout the drainage.

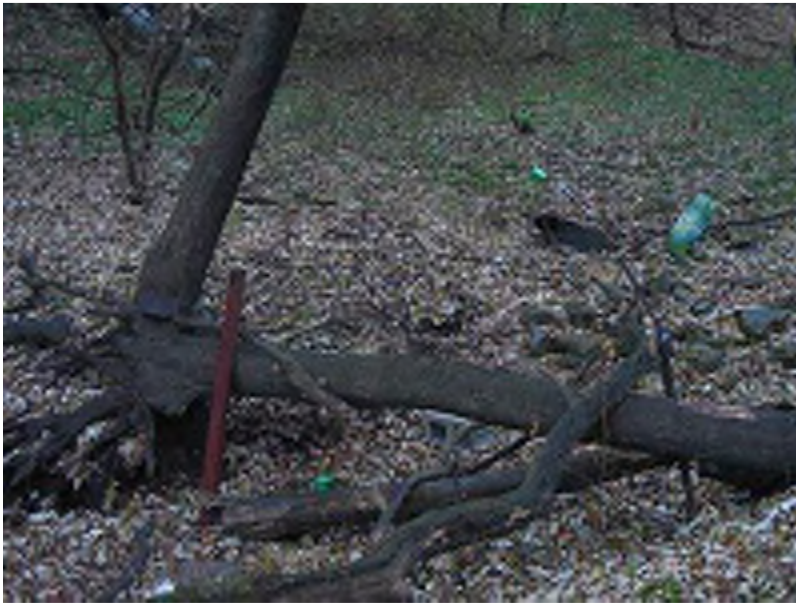
Waypoint 1034

Storm water pipe outlet

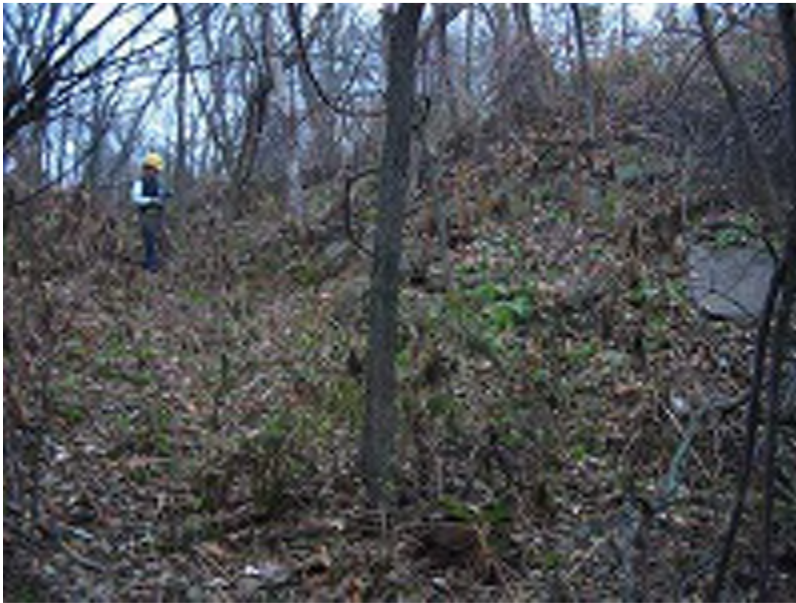
Waypoint 1035

Top of gully, lots of cement chunks, no real erosion problems

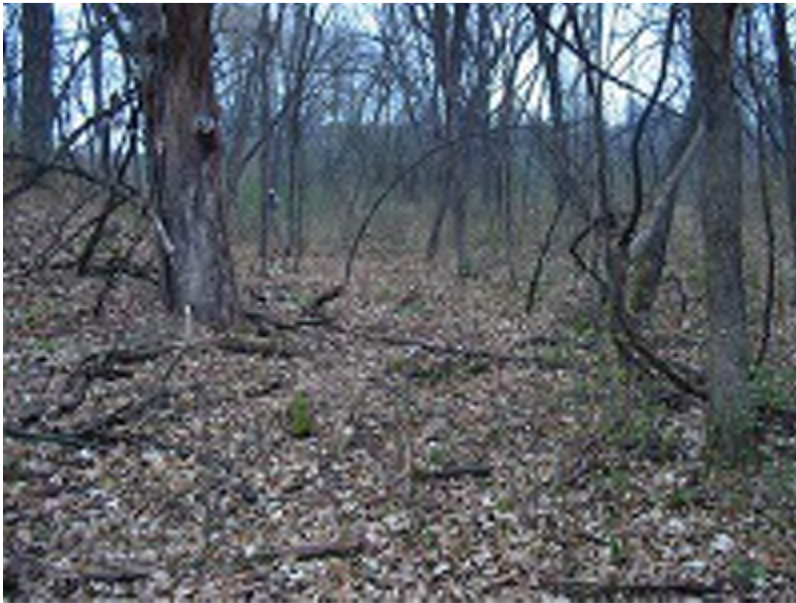
Waypoint 1036

Top of gully, no erosion problems

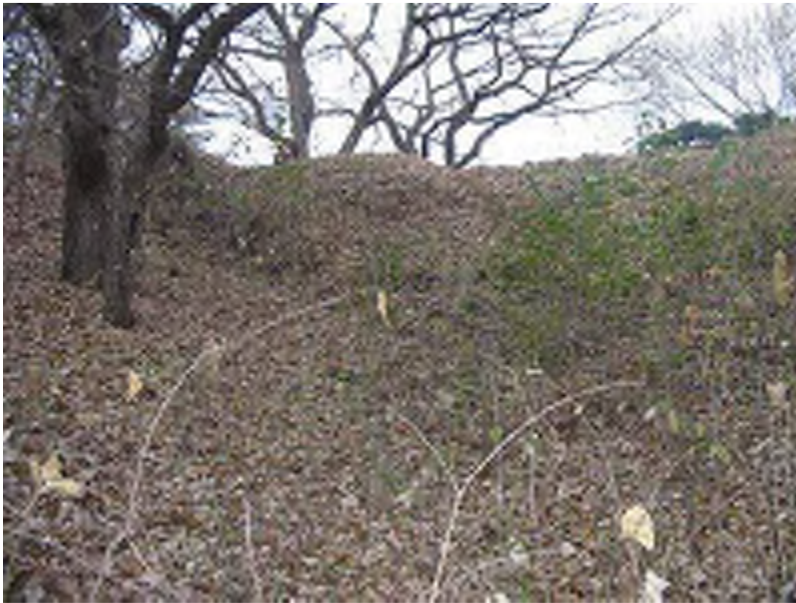
Waypoint 1037

Leaves and mulch piled at top, looks fine otherwise

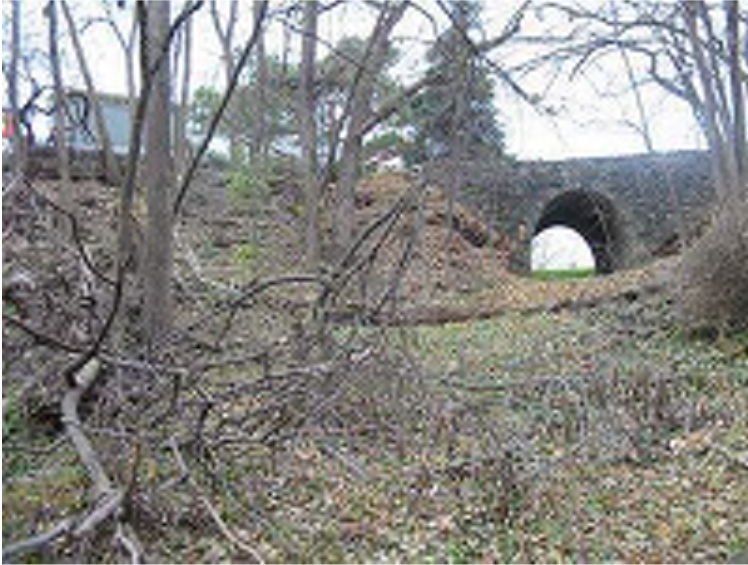
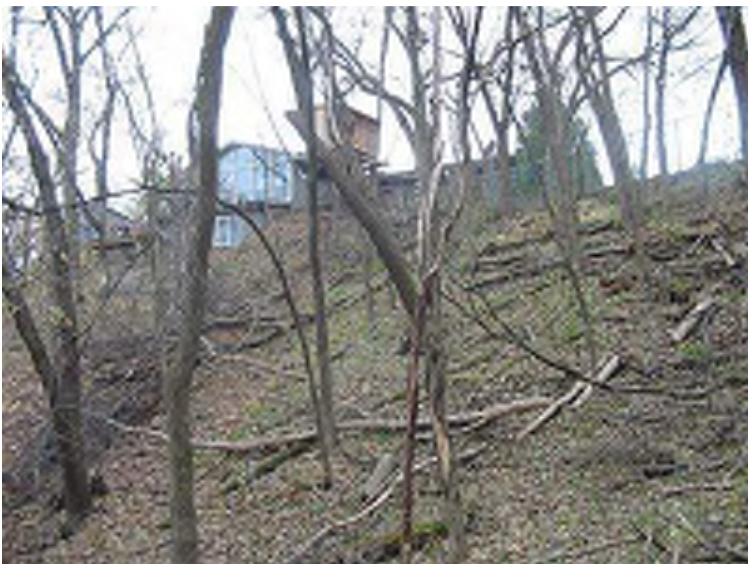
Waypoint 1038

Top of gully, some bare dirt behind house, dumped mulch, some erosion halfway down gully

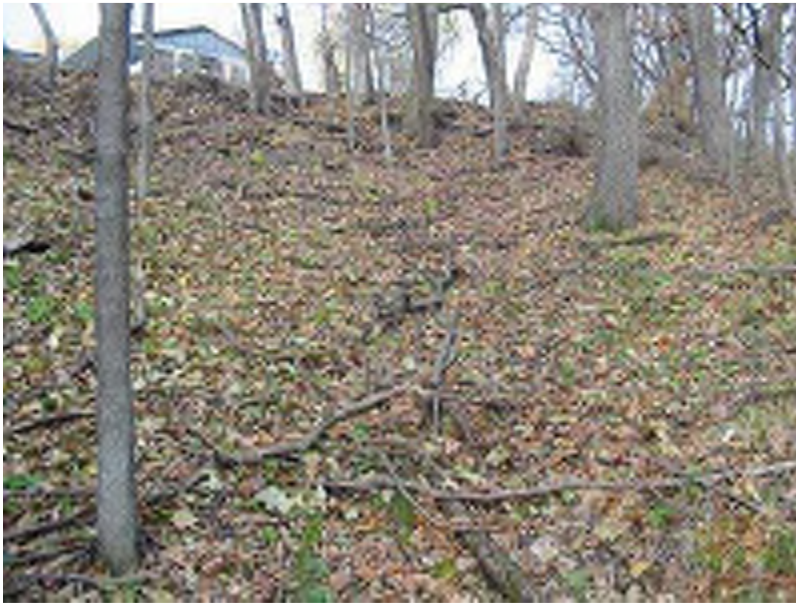
Waypoint 1039

Looks fine

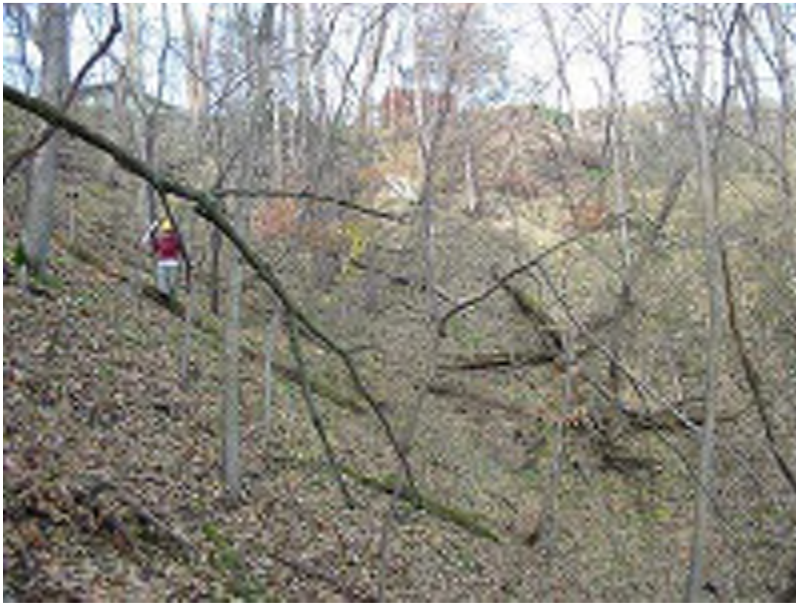
Waypoint 1040

Some mulch and brush dumping, no erosion problems, but steep
