Appendix K: Lower Minnesota River Watershed District: Gully Inventory

Gully Inventory Map
 Area #1
 Lower Minnesota River Watershed District
 Watershed Management Plan

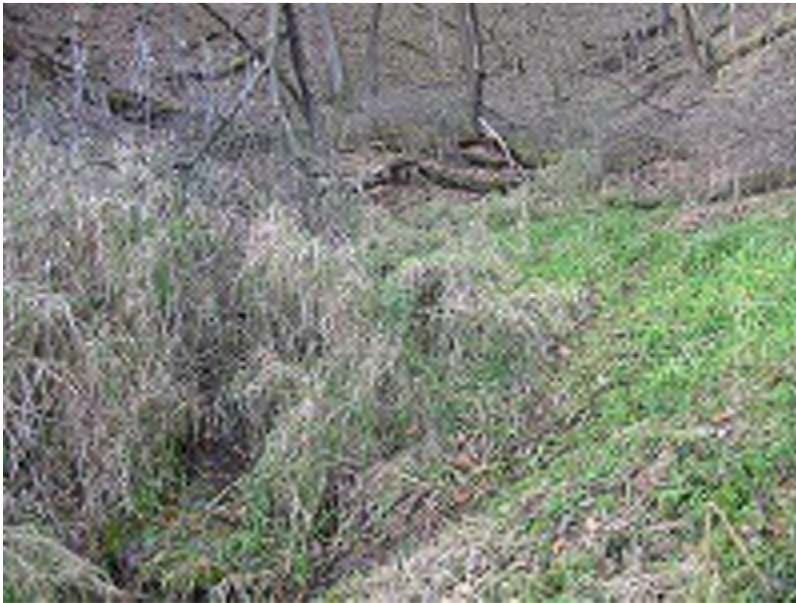
Waypoint 1041

Spring

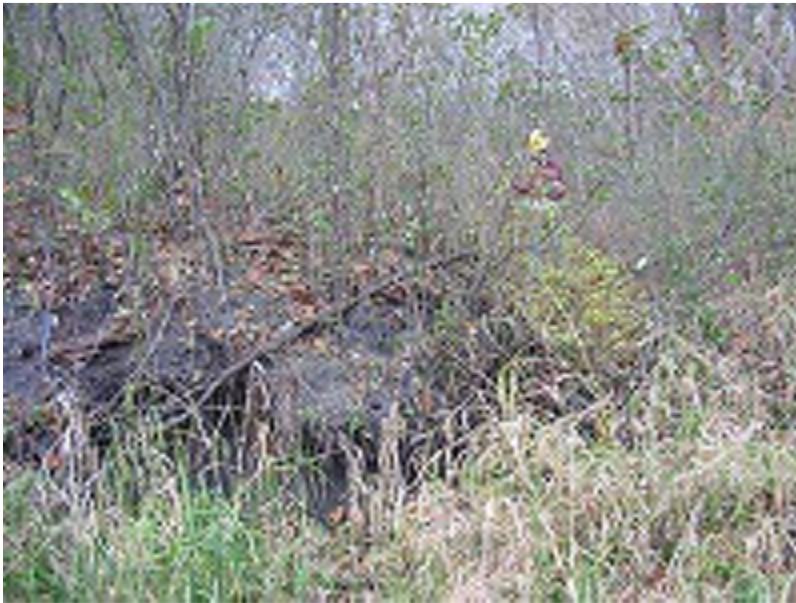
Waypoint 1042

Spring empties into creek, unvegetated, undercut banks

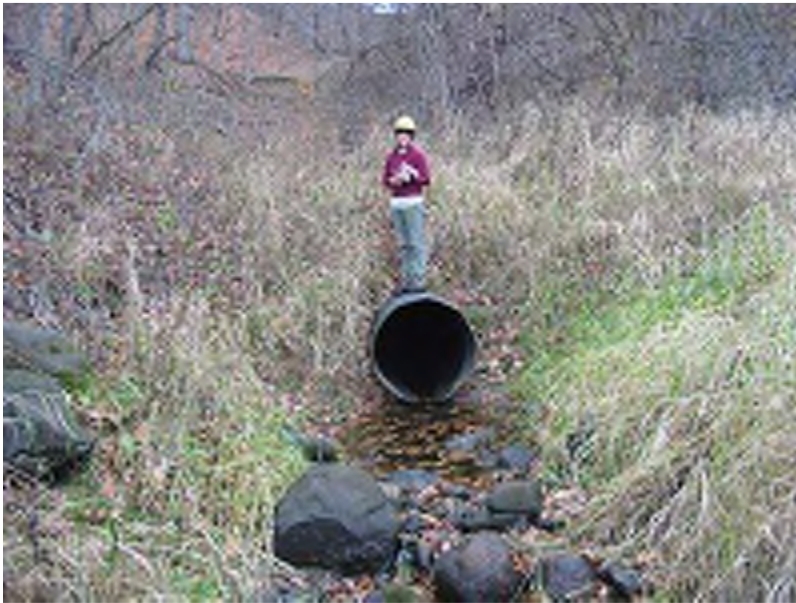
Waypoint 1043

Storm water pipe

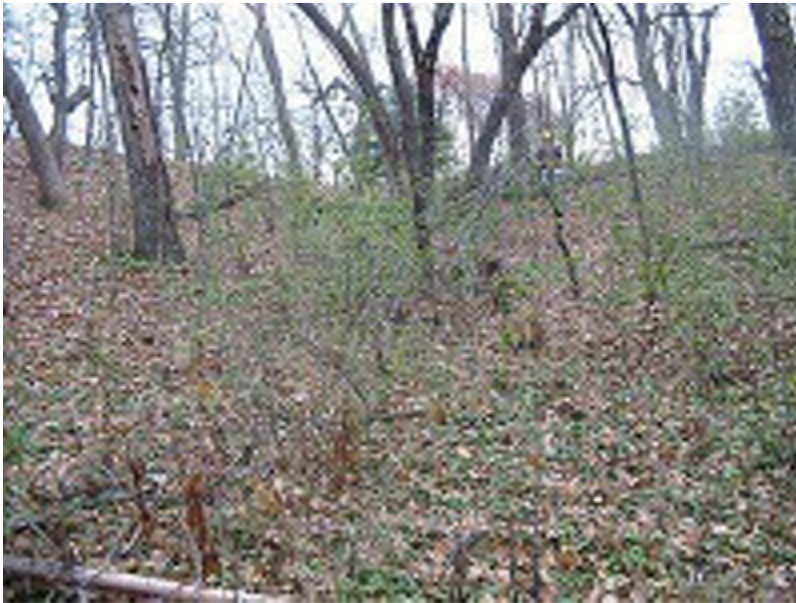
Waypoint 1044

Looks good

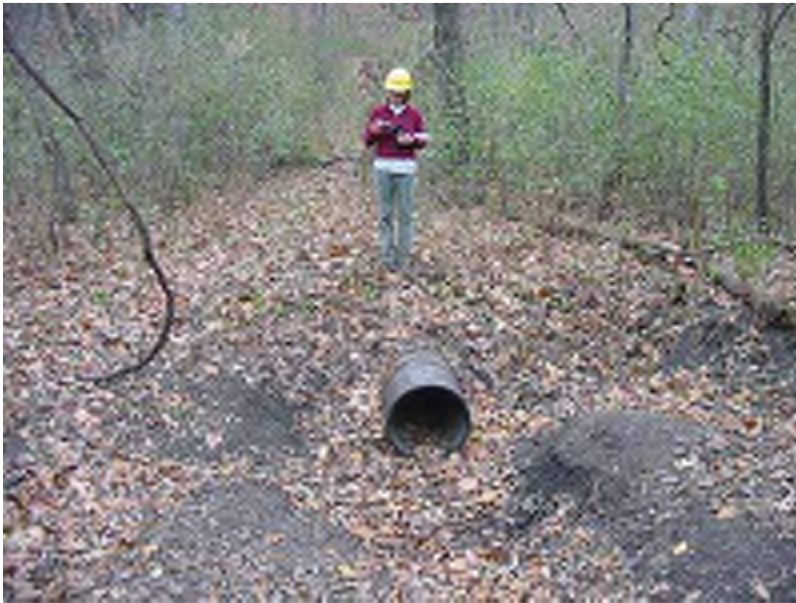
Waypoint 1045

Pipe with depress/erosion hole

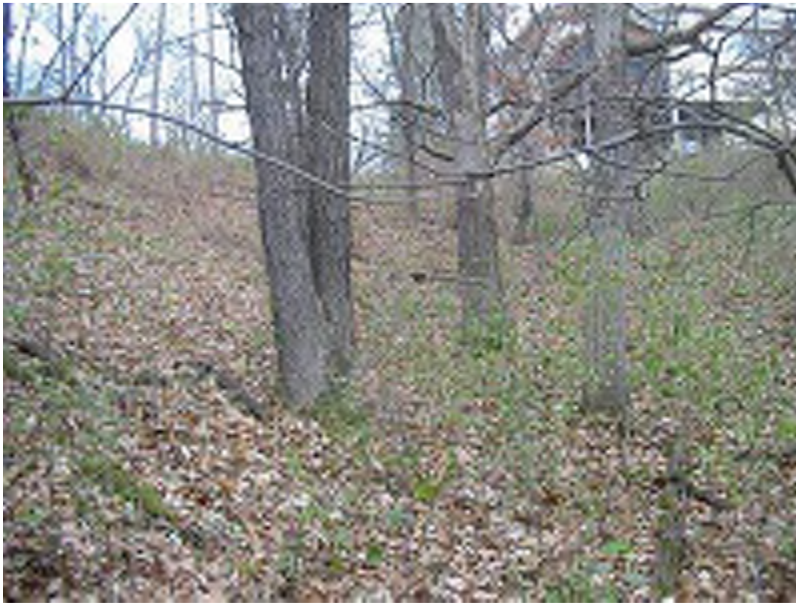
Waypoint 1046

Looks good

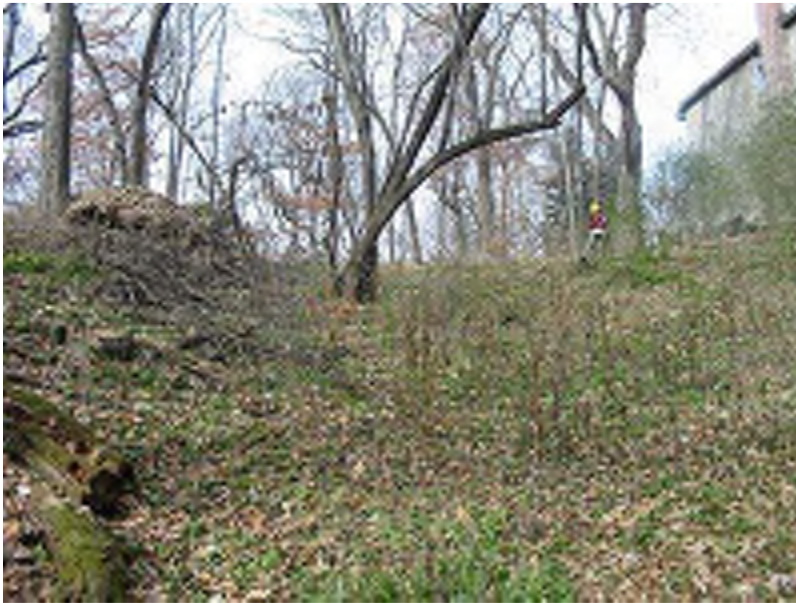
Waypoint 1047

Looks good

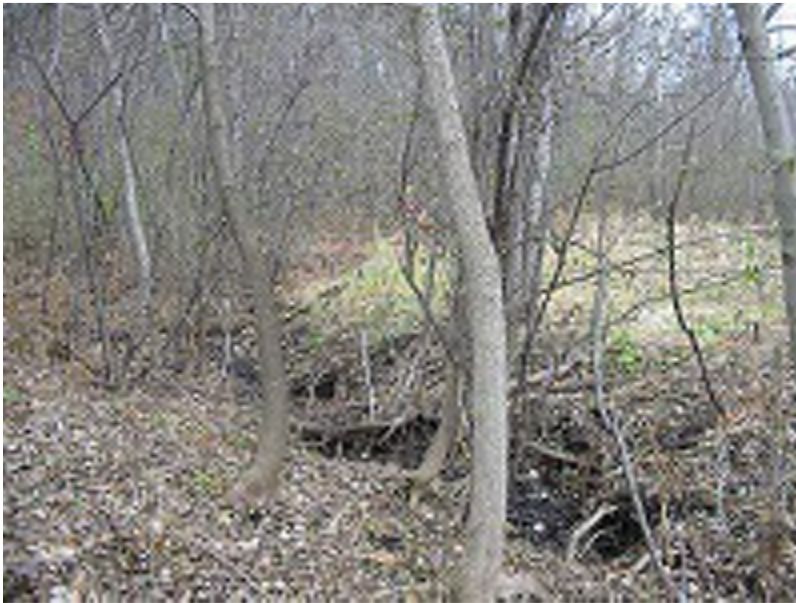
Waypoint 1049

Spring

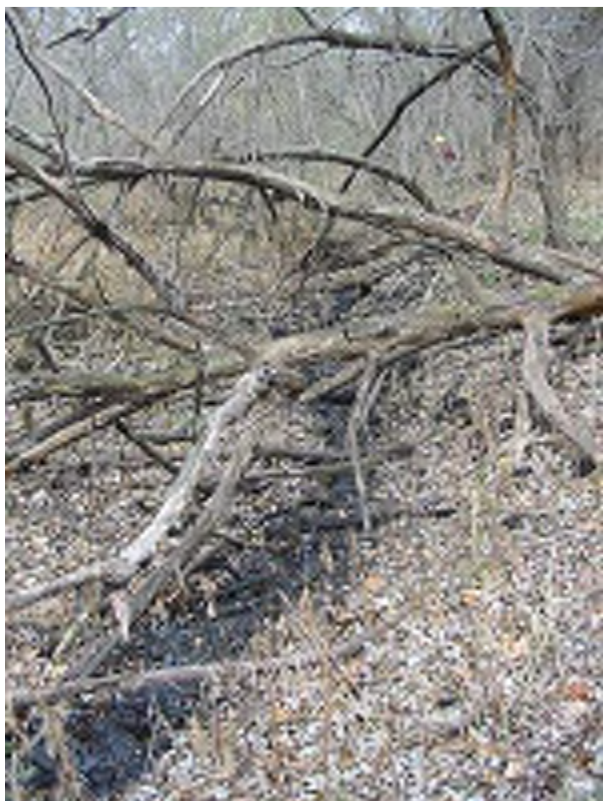
Waypoint 1050

Spring

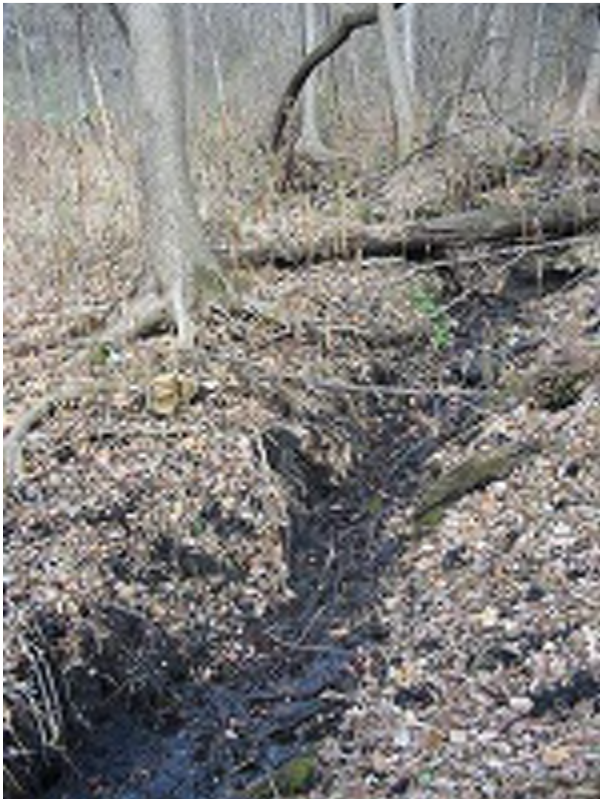
Spring

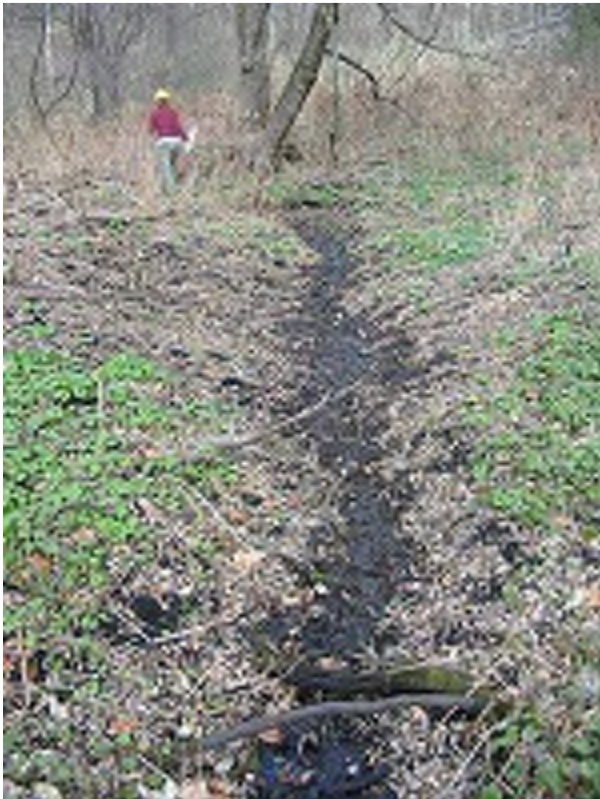
Waypoint 1052

Spring

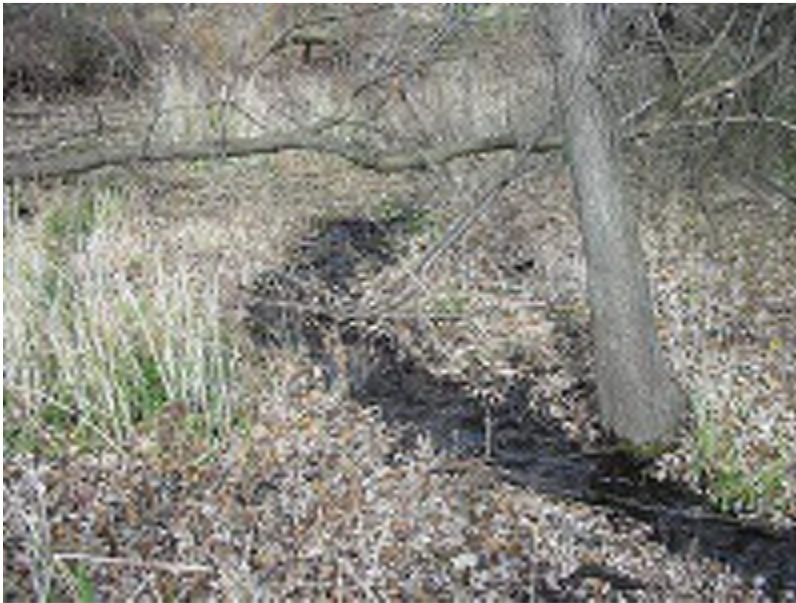
Waypoint 1053

Spring

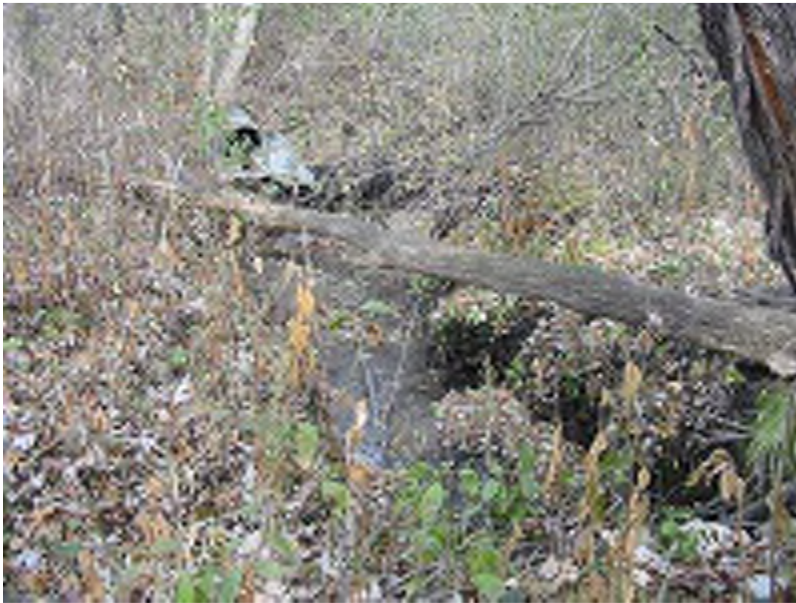
Waypoint 1054

Stormwater pipe, some water flow, undercut bank

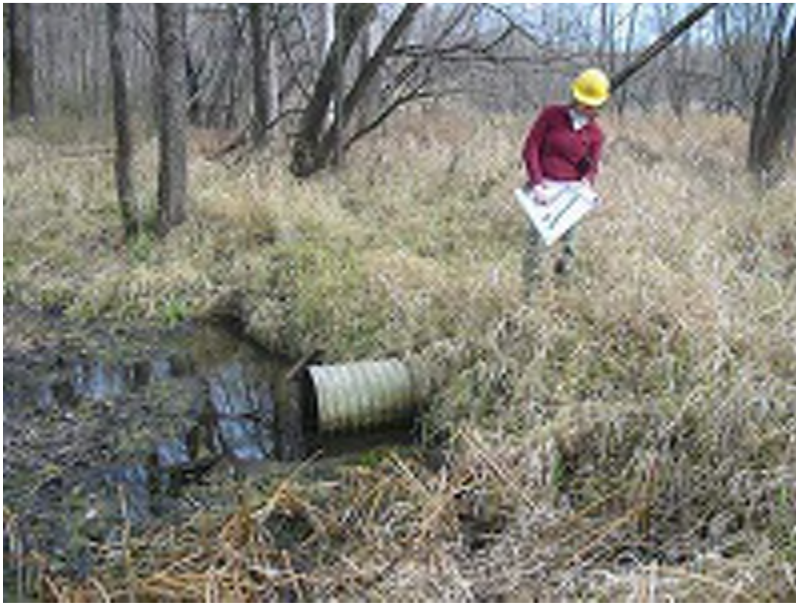
Waypoint 1055

Culvert under land bridge, drains where the pond appears to be located

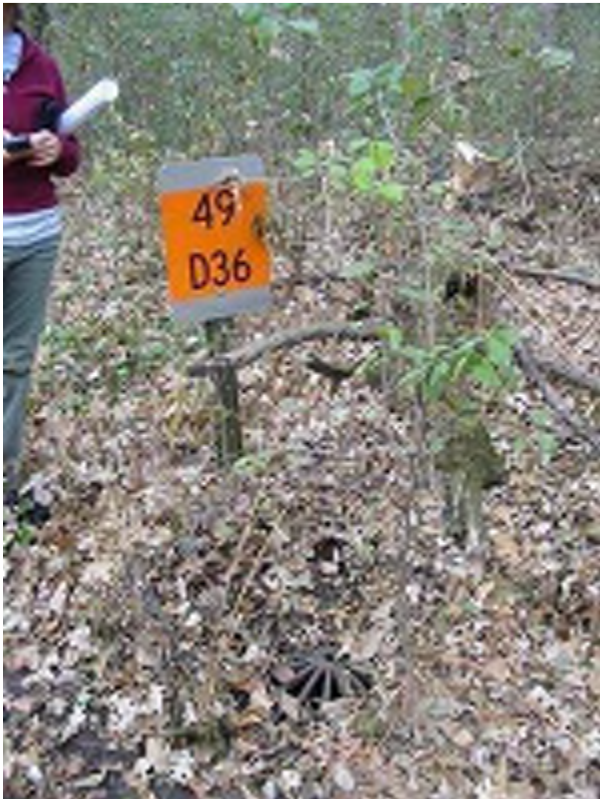
Waypoint 1056

Storm water grate

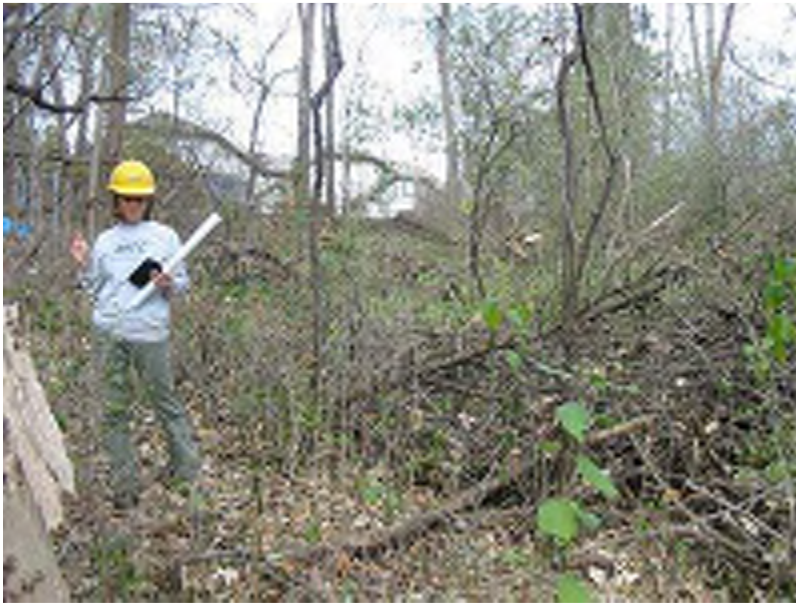
Waypoint 1057

Top of gully - looks good

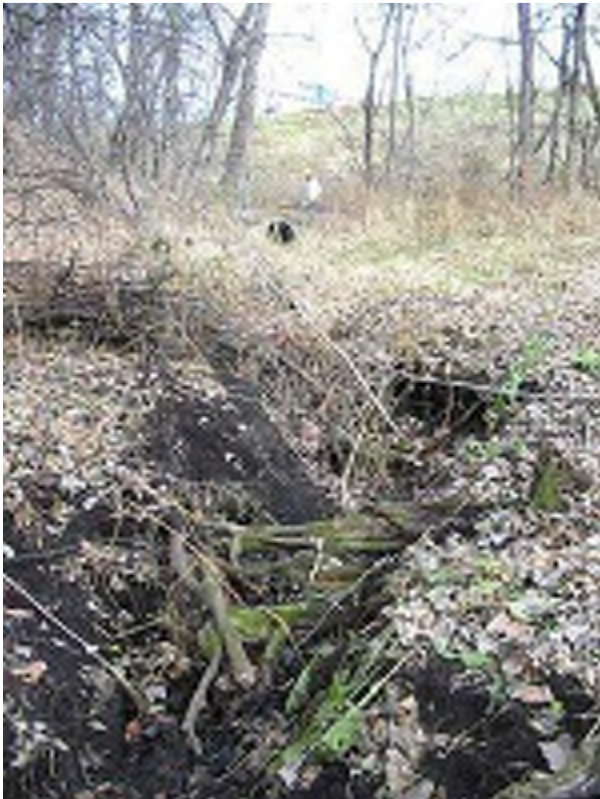
Waypoint 1058

Culvert w/ cut gully below

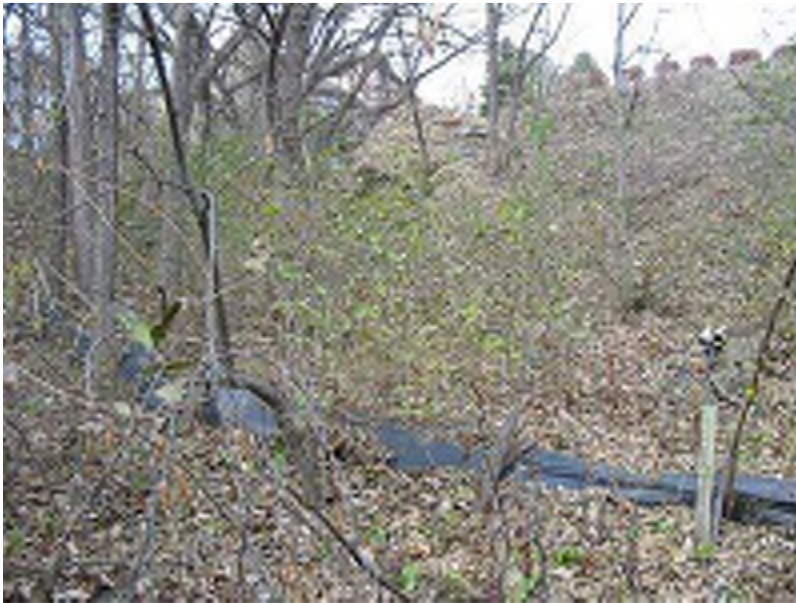
Waypoint 1059

Top of gully, 2 small storm water pipes, leaves pushed into gully

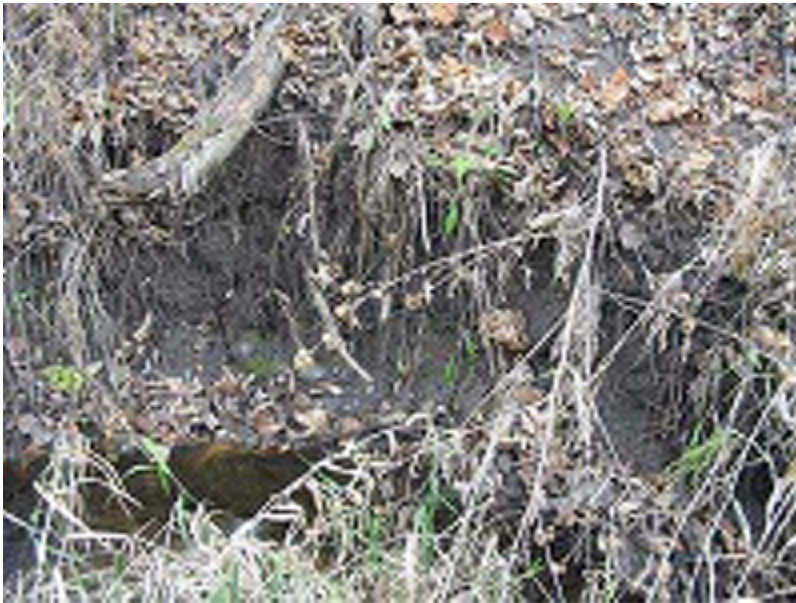
Waypoint 1060

Bank erosion on active stream

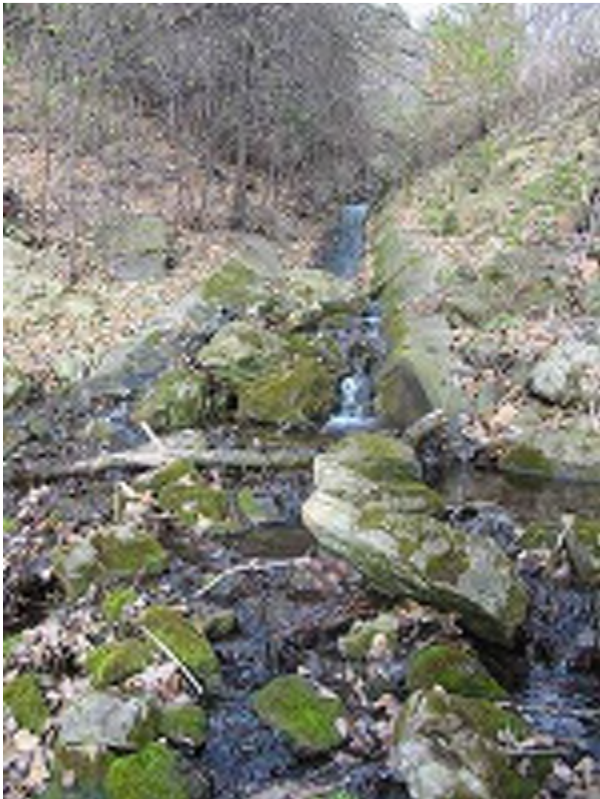
Waypoint 1061

Culvert empties into cement channel onto rocks

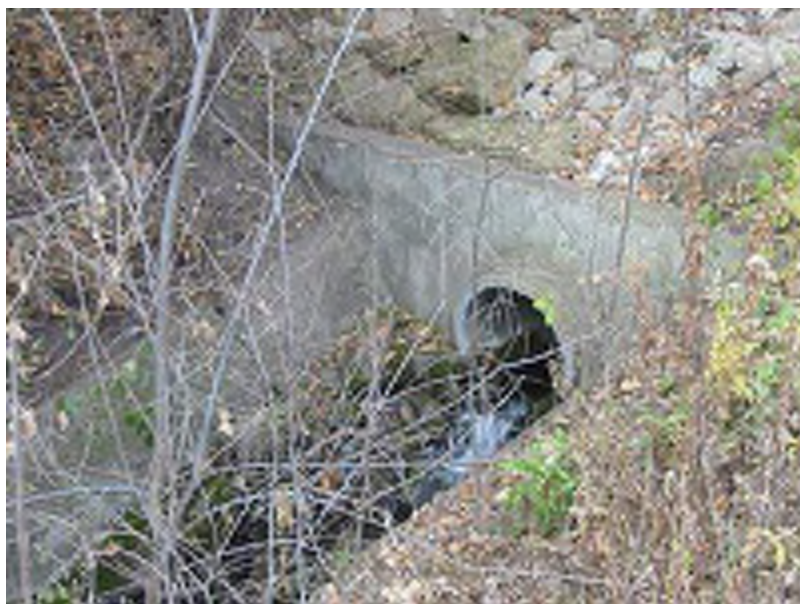
Same culvert close up

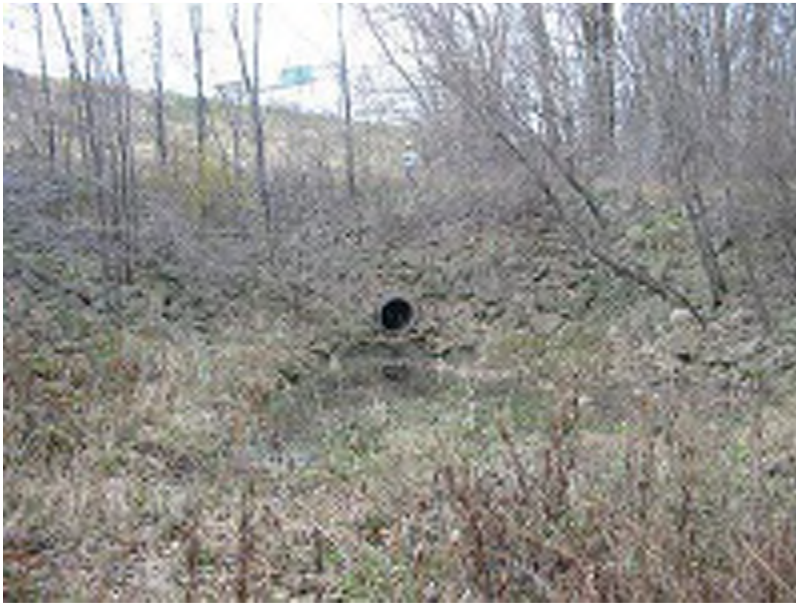
Waypoint 1062

Stormier culvert from under 35W

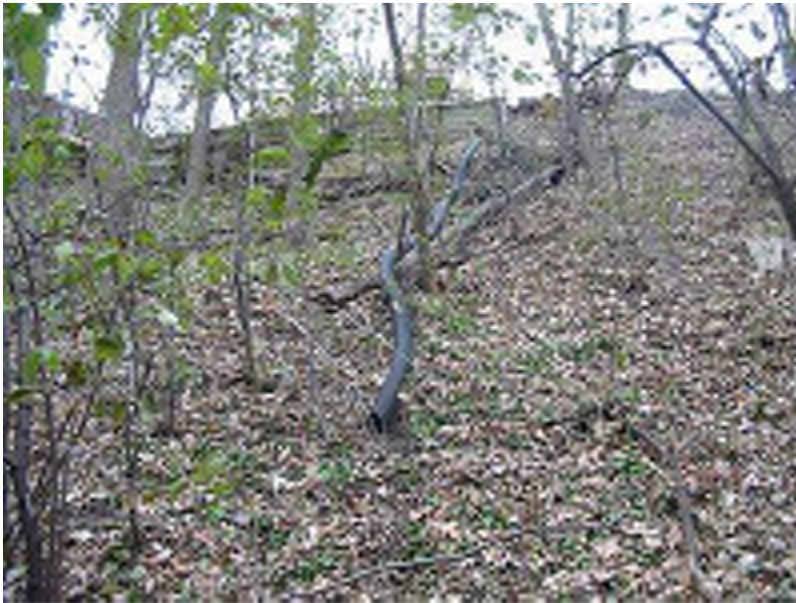
Waypoint 1066

House drainage pipe/tube

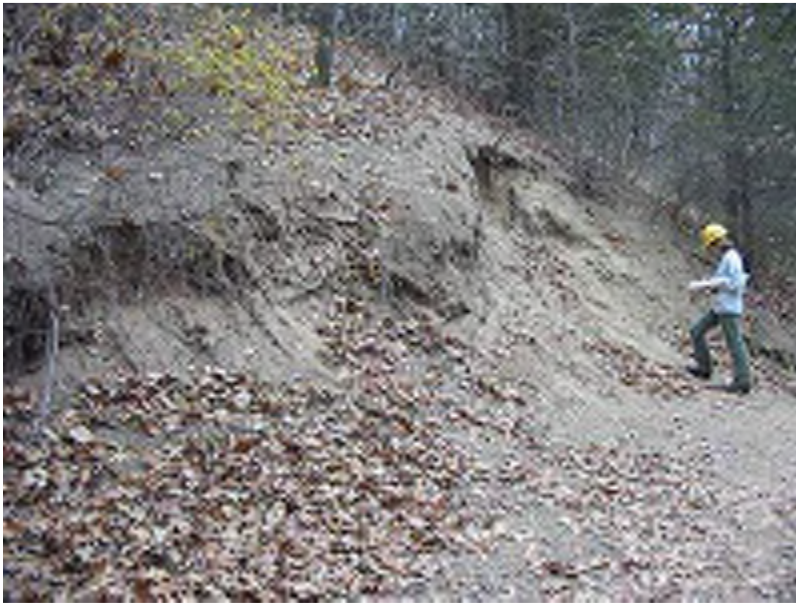
Waypoint 1068

Erosion on bike path in between 161 & 201

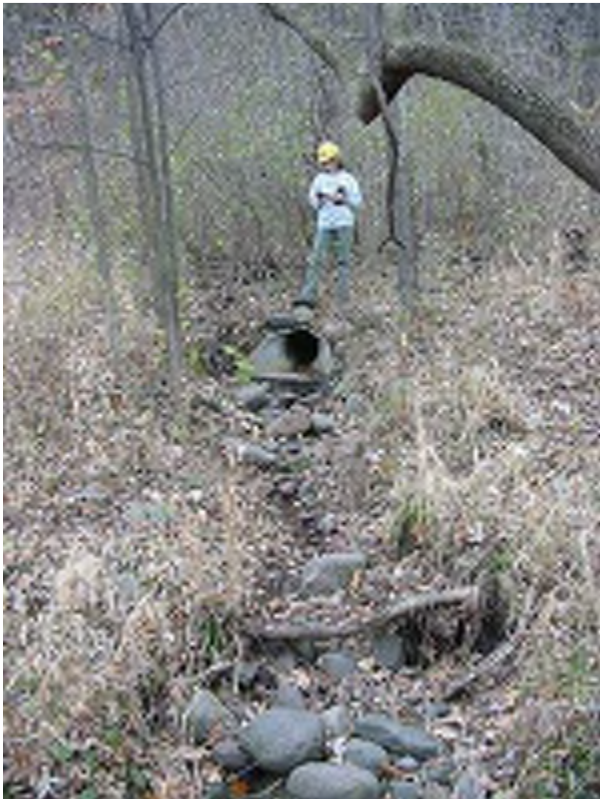
Waypoint 1069

Storm water outlet

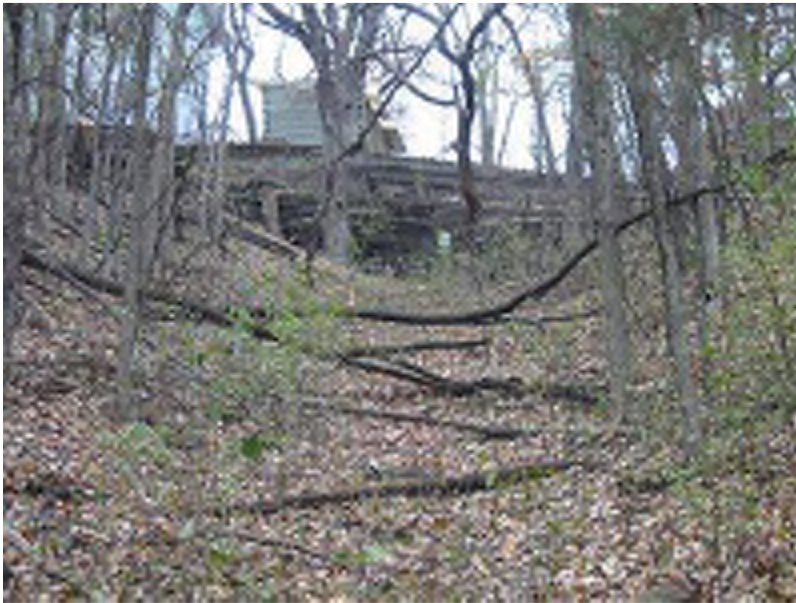
Waypoint 1070

Top of gully w/retaining wall & small drainage pipe

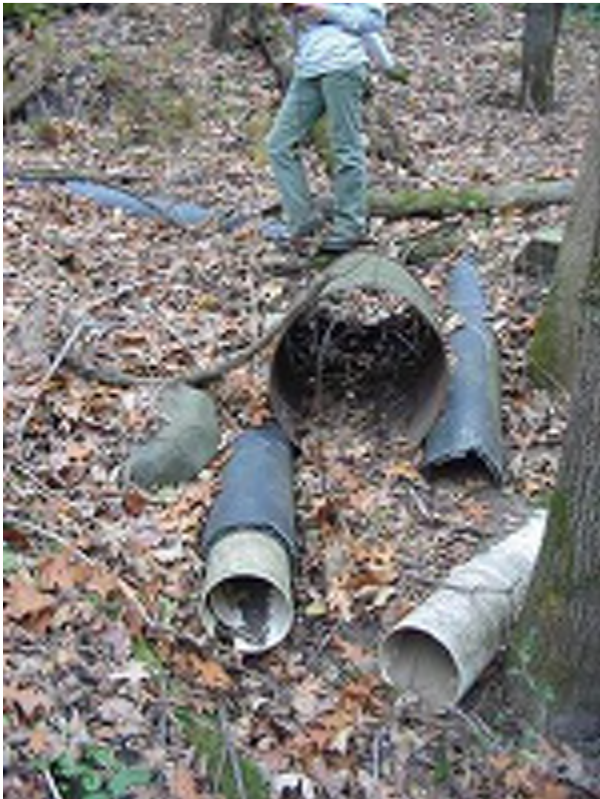
Waypoint 1075

Pipes - active drainage?

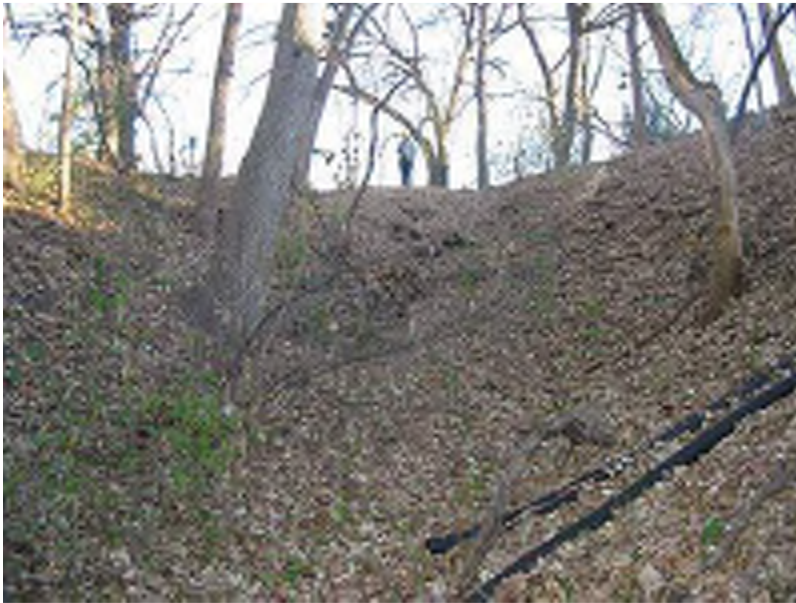
Waypoint 1079

Leaves/mulch at top-drainage pipe but not connected

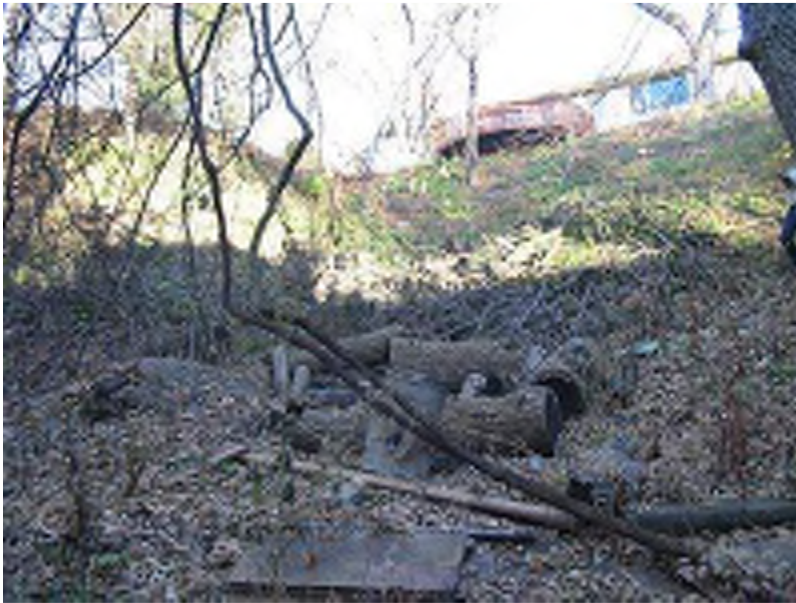
Waypoint 1080

Finger of gully-lots of brush and ??? Chunks

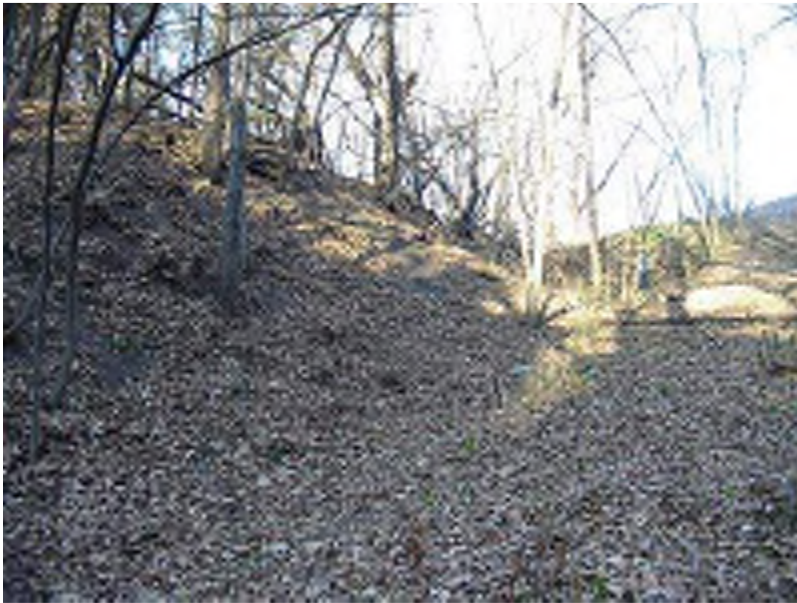
Waypoint 1081

Finger of gully-lots of brush and ??? Chunks

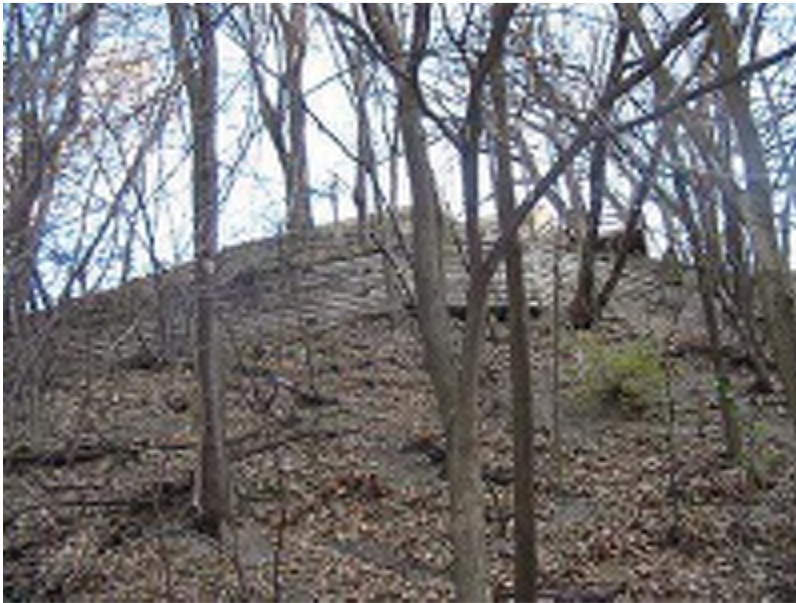
Waypoint 1082

Retaining wall above spring/4526 is spring

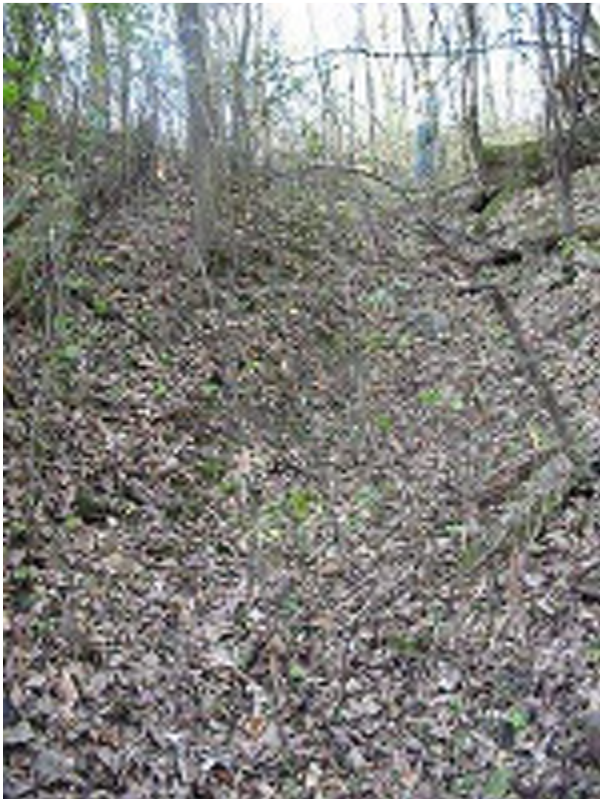
Waypoint 1084

Finger - moderate erosion in gully

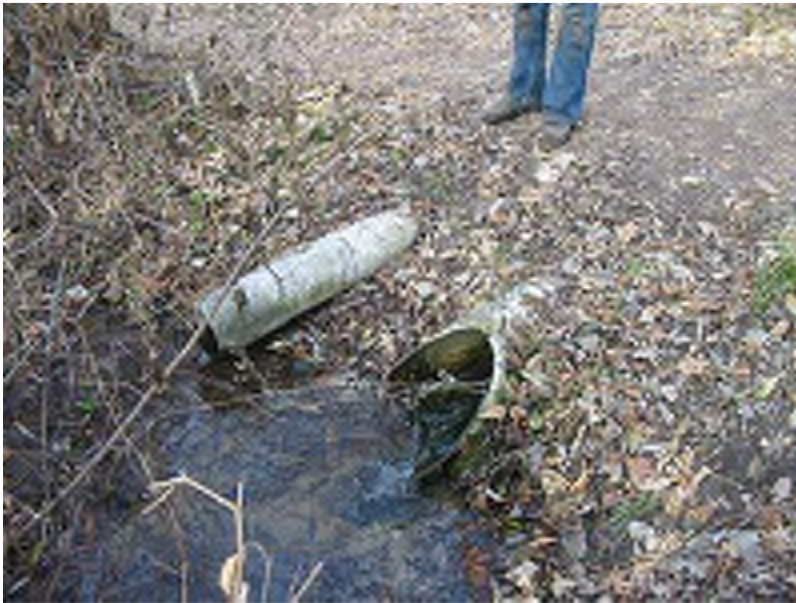
Waypoint 1085

Culvert under walking path

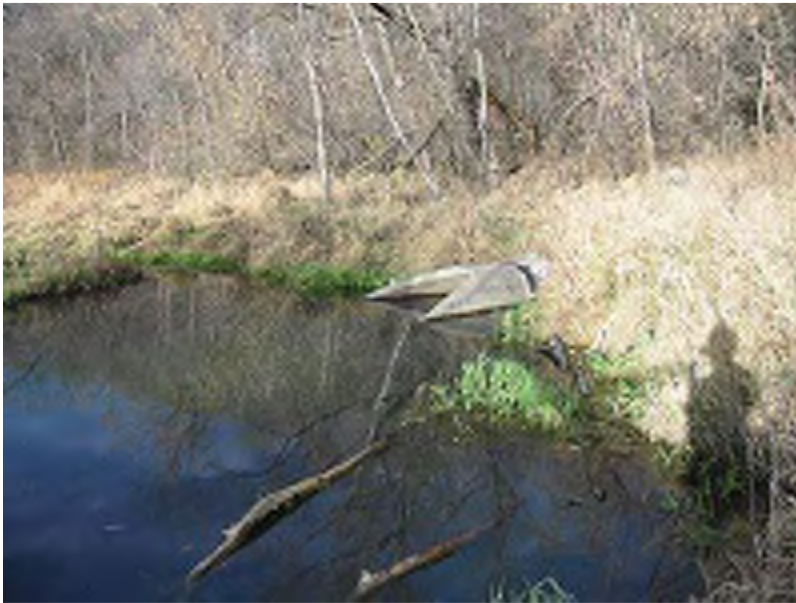
Waypoint 1086

Storm water outlet

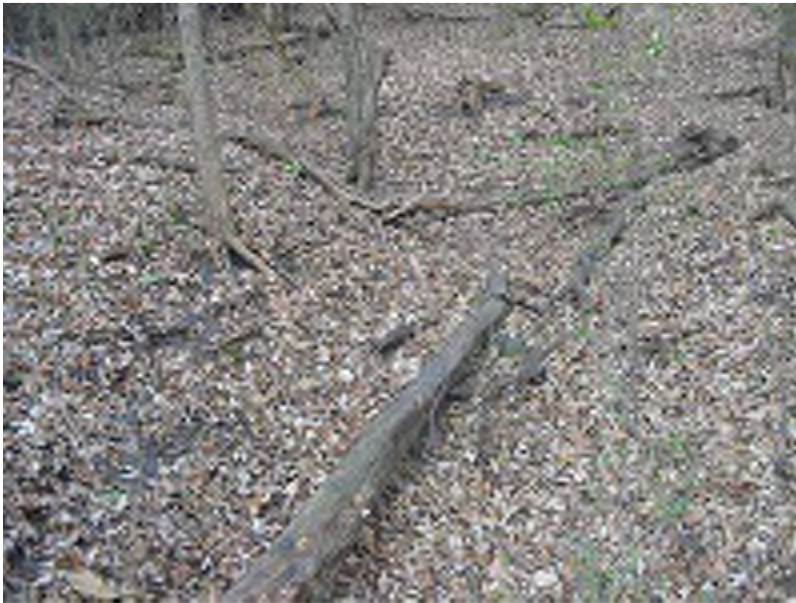
Waypoint 1087

"V" cut erosion gully - not too bad

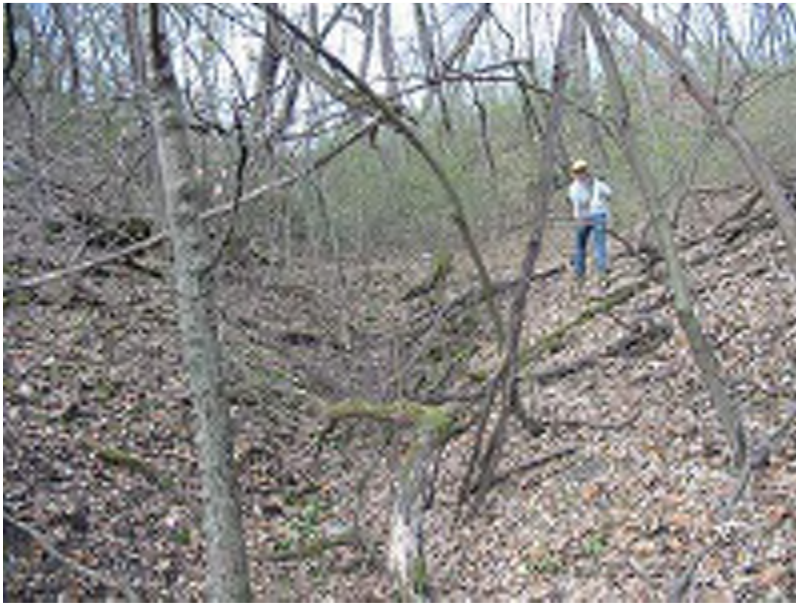
Waypoint 1088

Top of gully, some bare banks - looks just o.k.

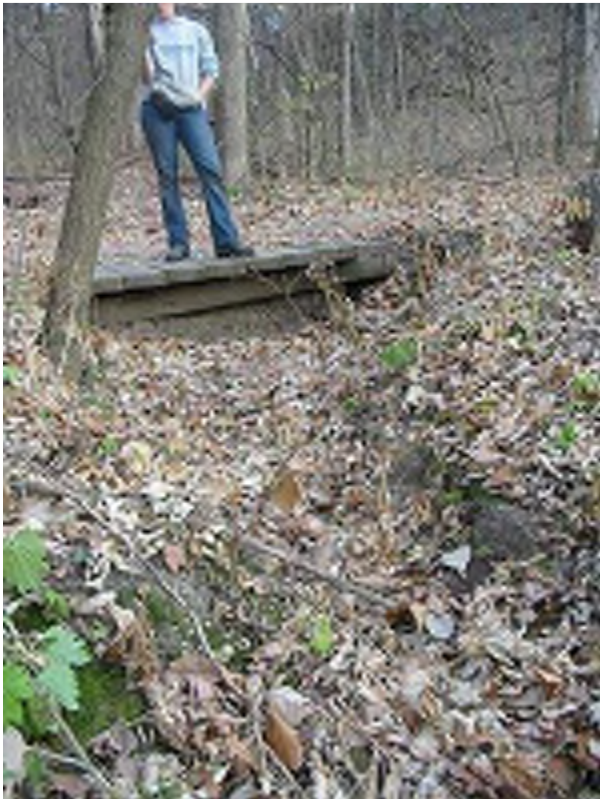
Waypoint 1089

Walking path bridge erosional storm water stream underneath

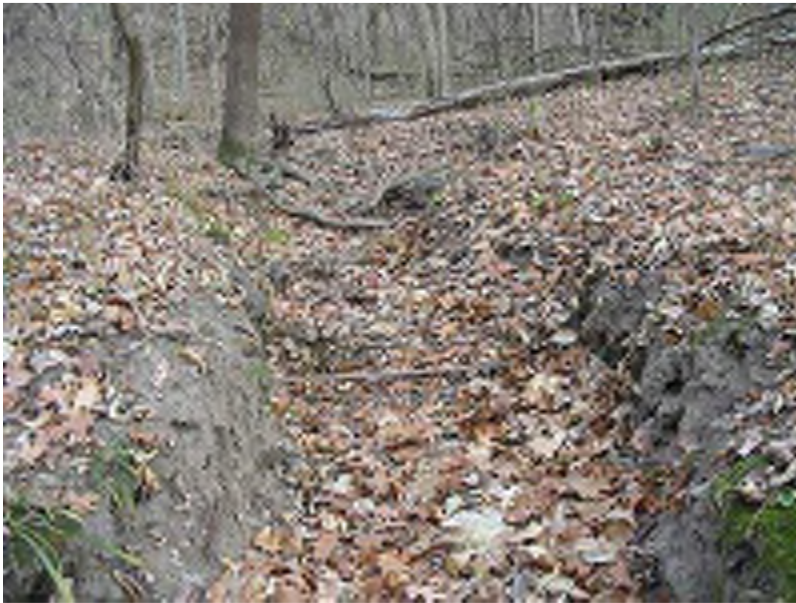
Down cut stream bed

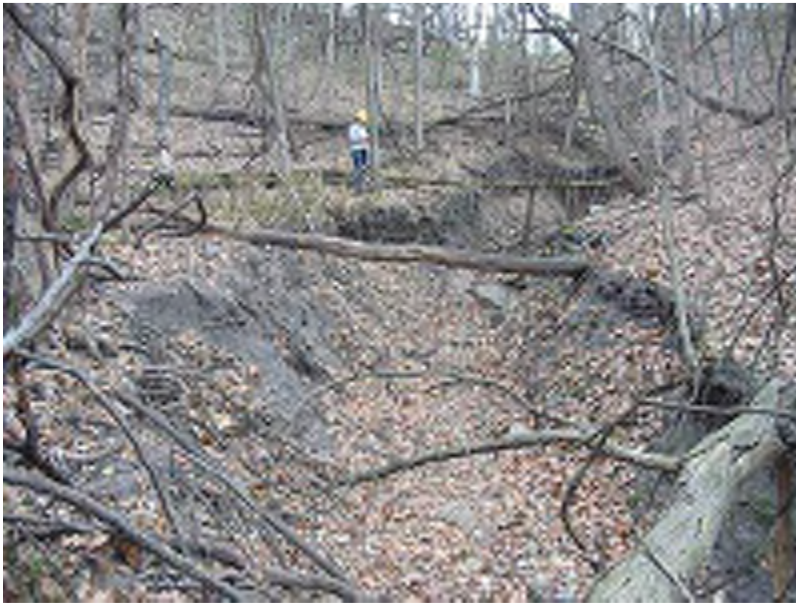
Waypoint 1091

Deeply cut stream bed-bad bank erosion

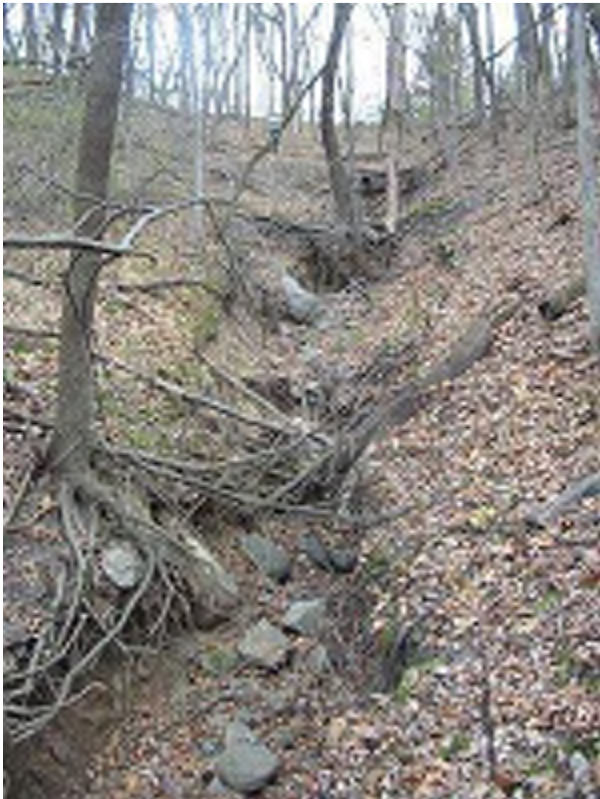
Waypoint 1092

Top of gully, stormwater drain, deeply cut, bad erosion from points 1089-1092

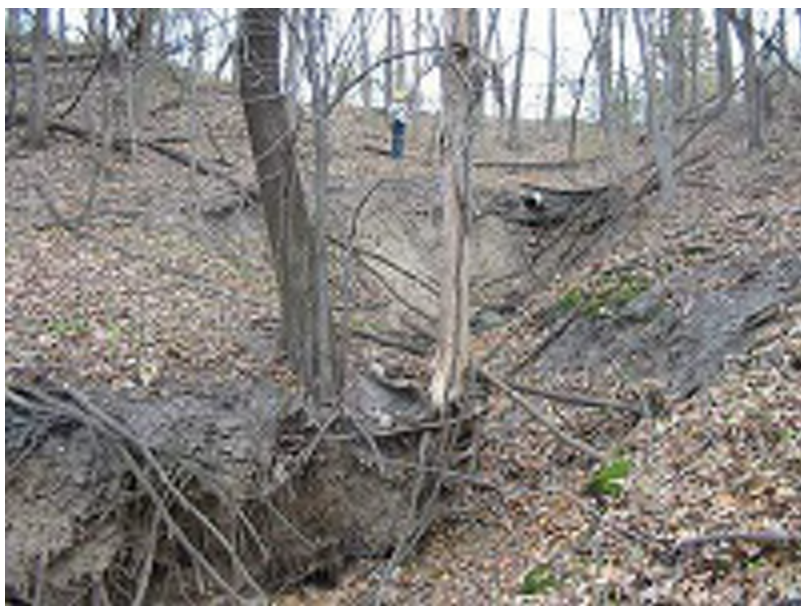
Top of gully, stormwater drain, deeply cut, bad erosion from points 1089-1092

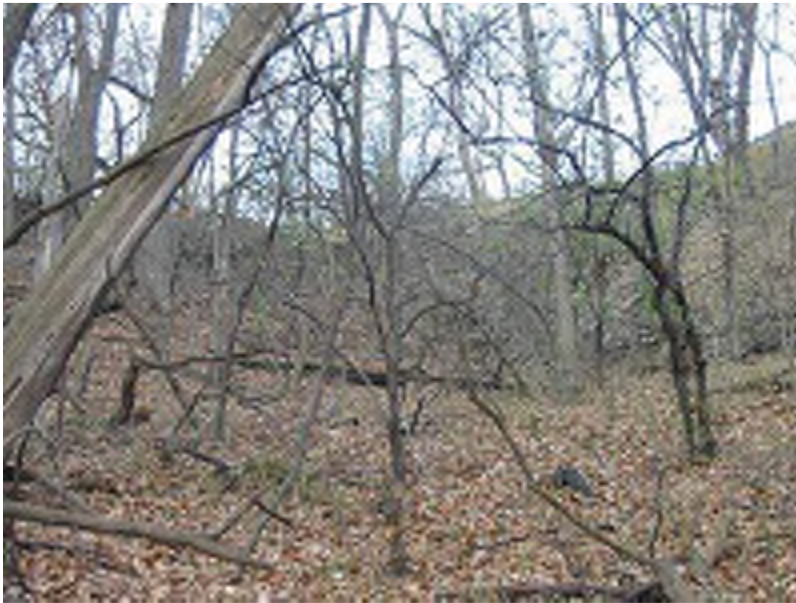
Waypoint 1093

Top of gully looks fine, retaining wall, some dumping of lumber

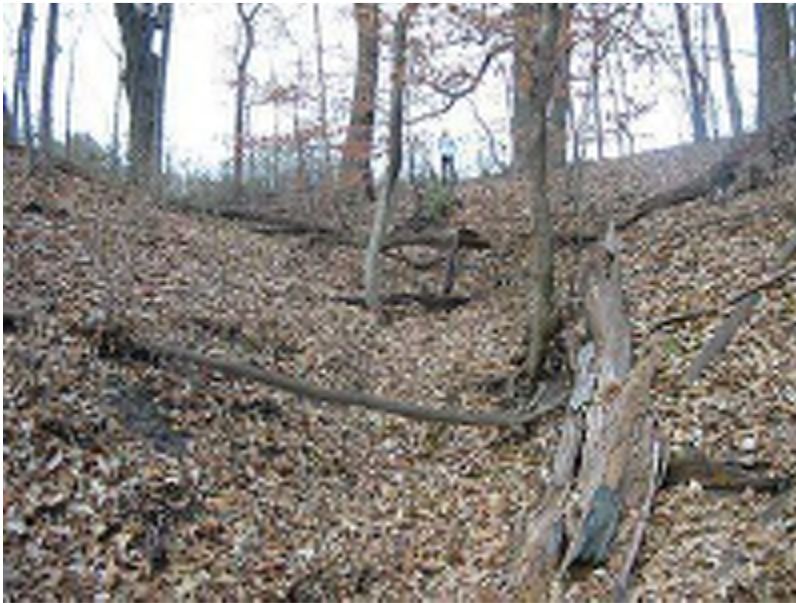
Waypoint 1094

Top of gully

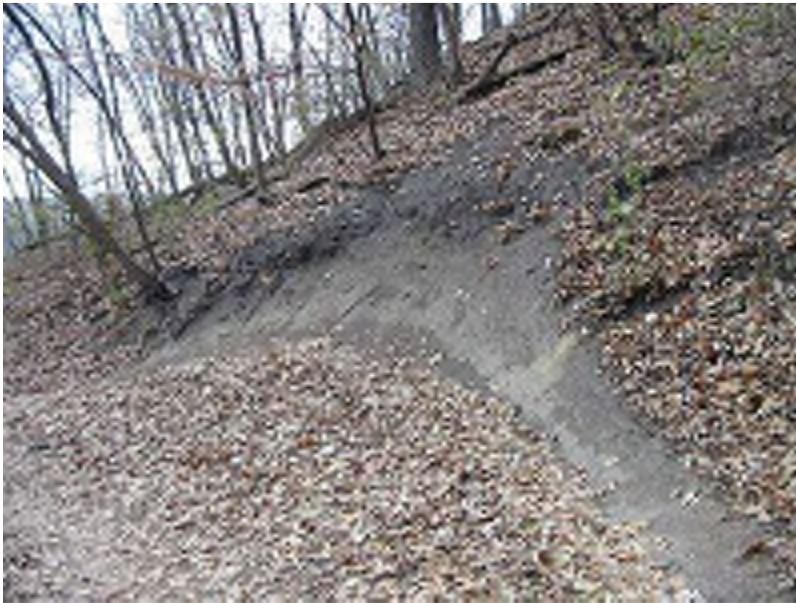
Waypoint 1095

Trail/bike erosion on bank

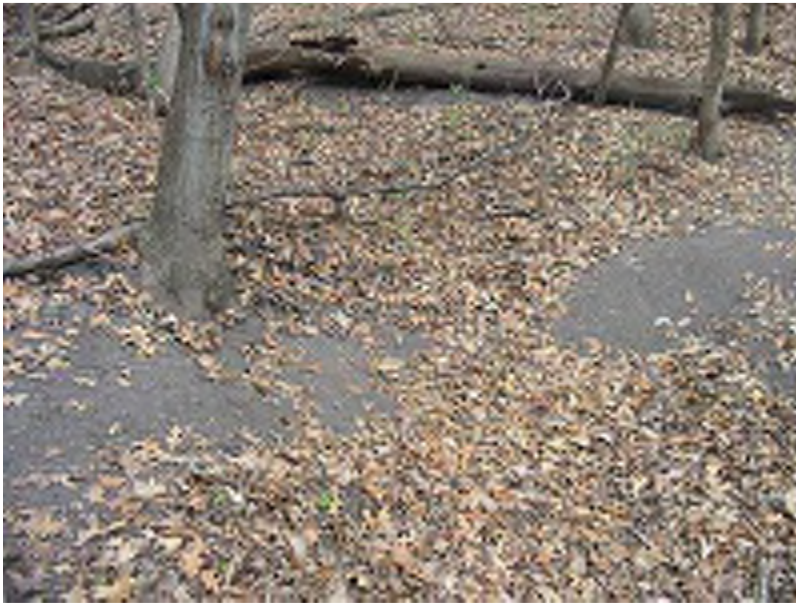
Waypoint 1096

Trail crossing dry stream bed-bank erosion

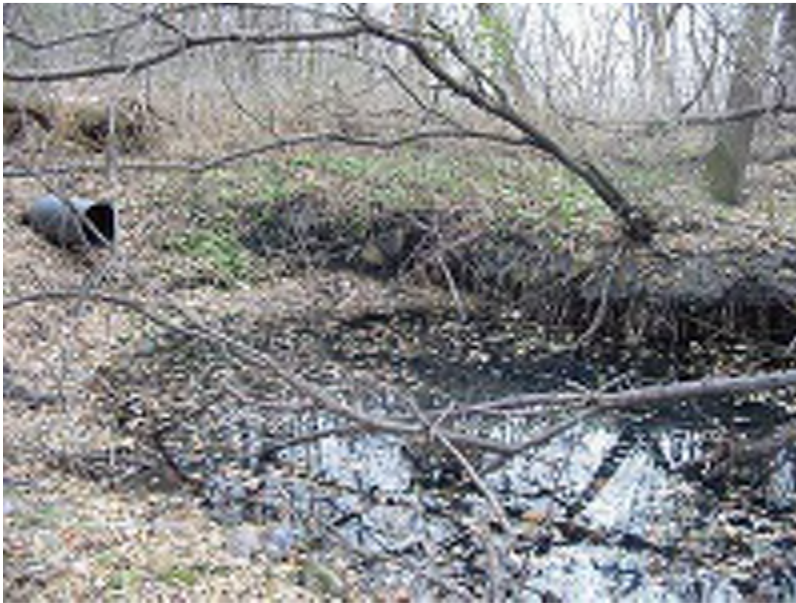
Waypoint 1097

Pipe outfall w/bank erosion, some riprap in place

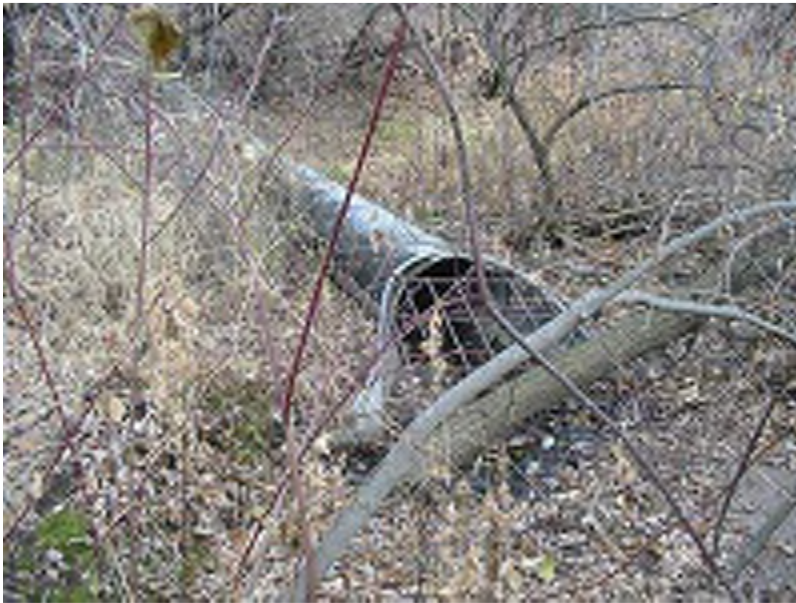
Waypoint 1098

Pipe outfall, minimal erosion
