Appendix K: Lower Minnesota River Watershed District: Gully Inventory

Gully Inventory Map
 Area #1
 Lower Minnesota River Watershed District
 Watershed Management Plan

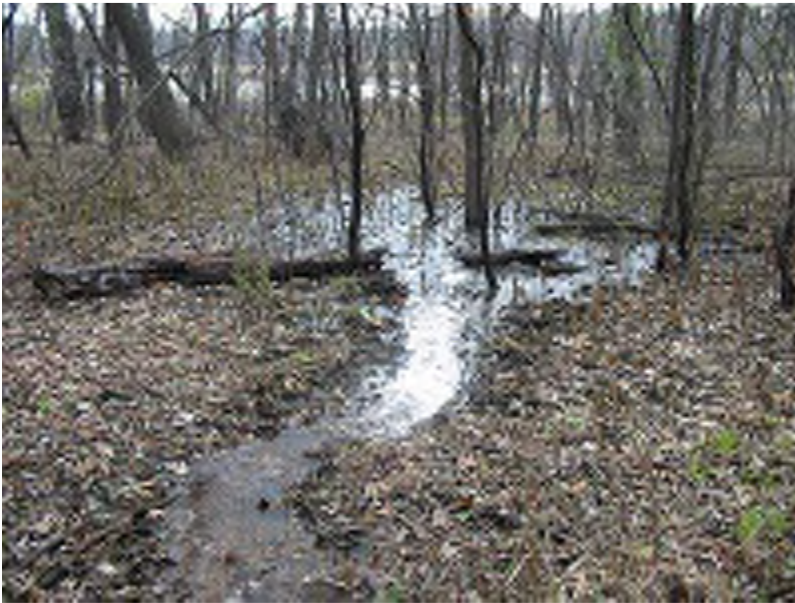
Waypoint 1099

Stream alluvial fan - looks like some re-charge

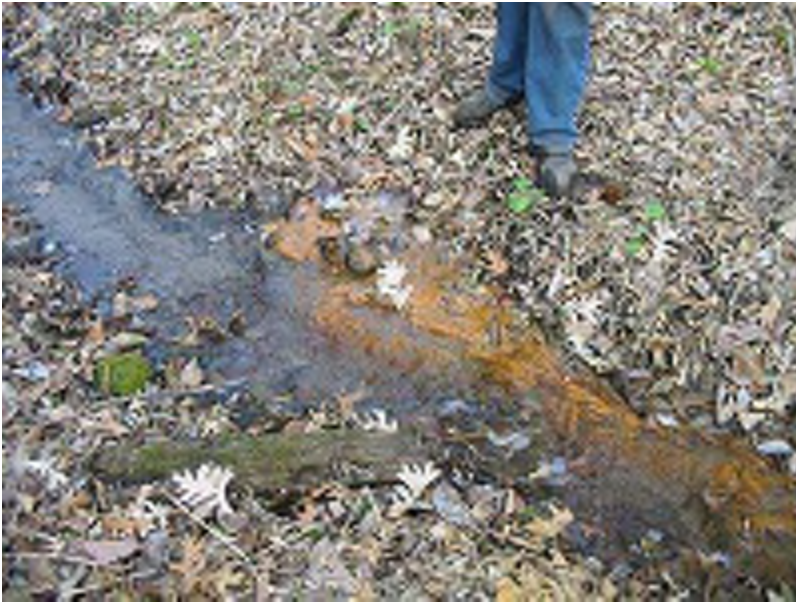
Water looks iron rich, orange "goo" buildup

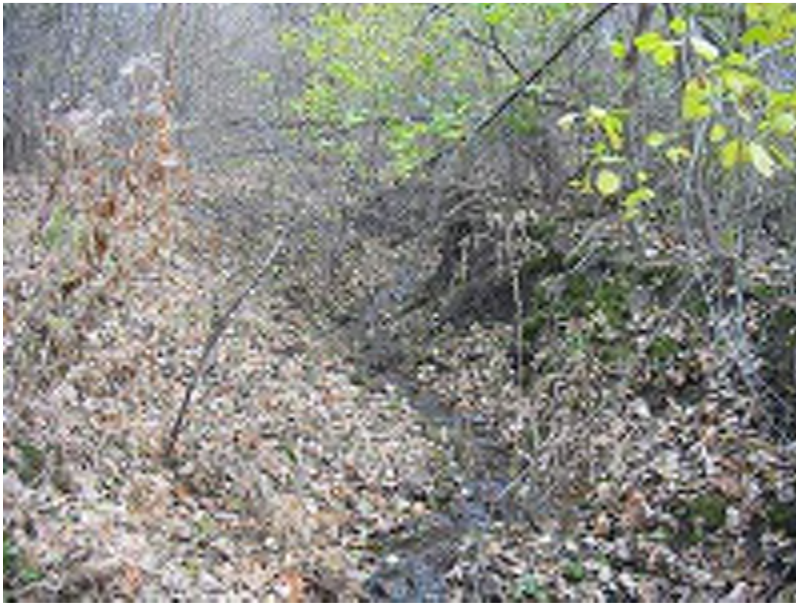
Waypoint 1100

Stream confluence, bank erosion on east shore

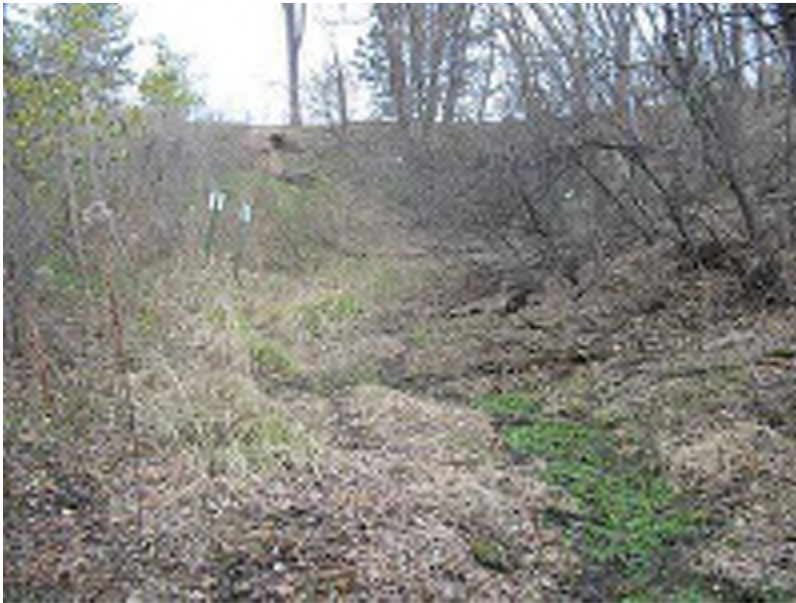
Waypoint 1101

Top of gully/spring

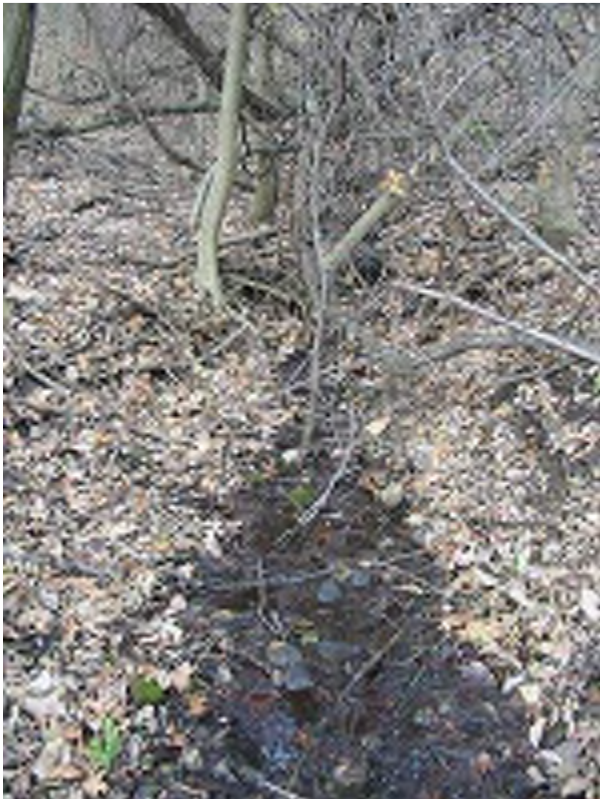
Waypoint 1102

Spring

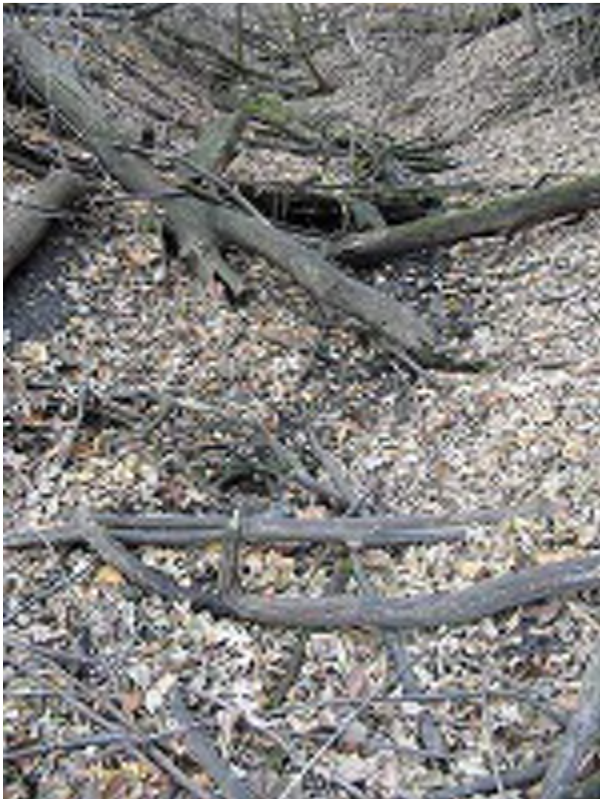
Waypoint 1103

Spring that appears to recharge

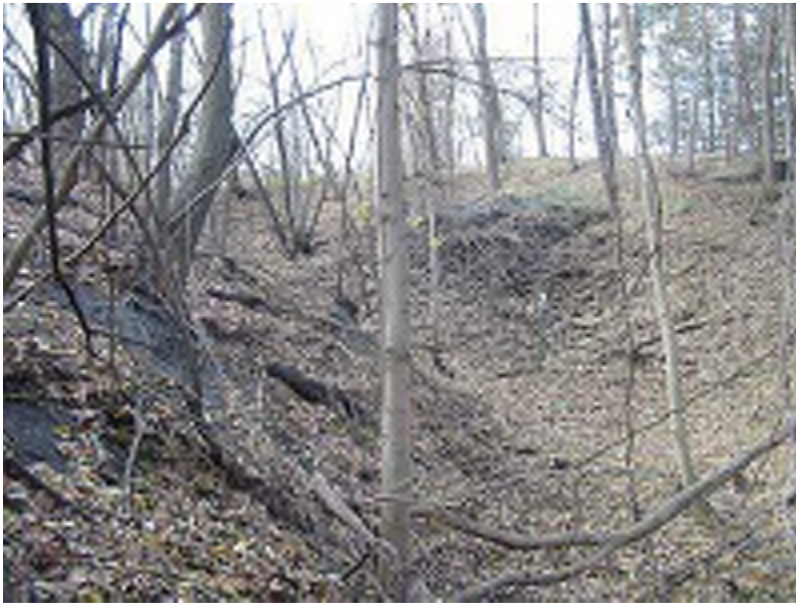
Waypoint 1104

Top of gully, pretty steep banks, but looks o.k.

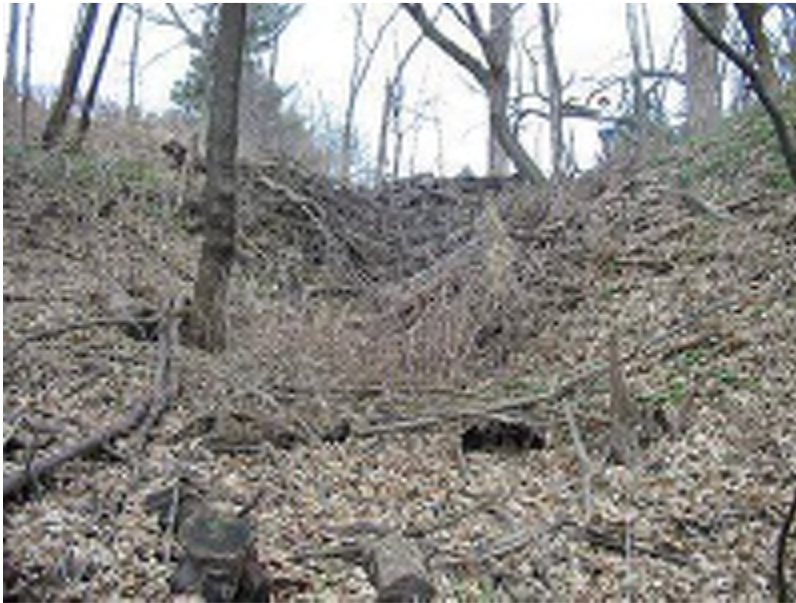
Waypoint 1105

Top of gully, lots of brush and brush piled up

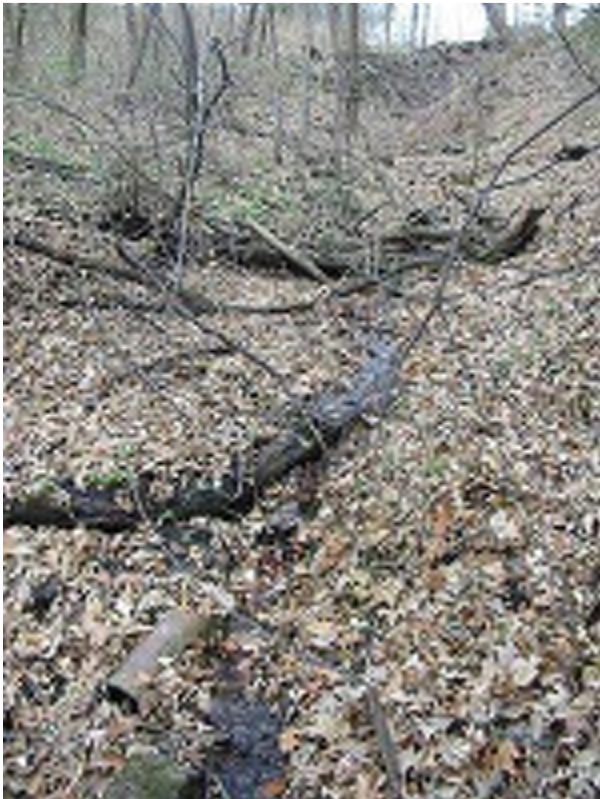
Waypoint 1106

Springs with eroding banks

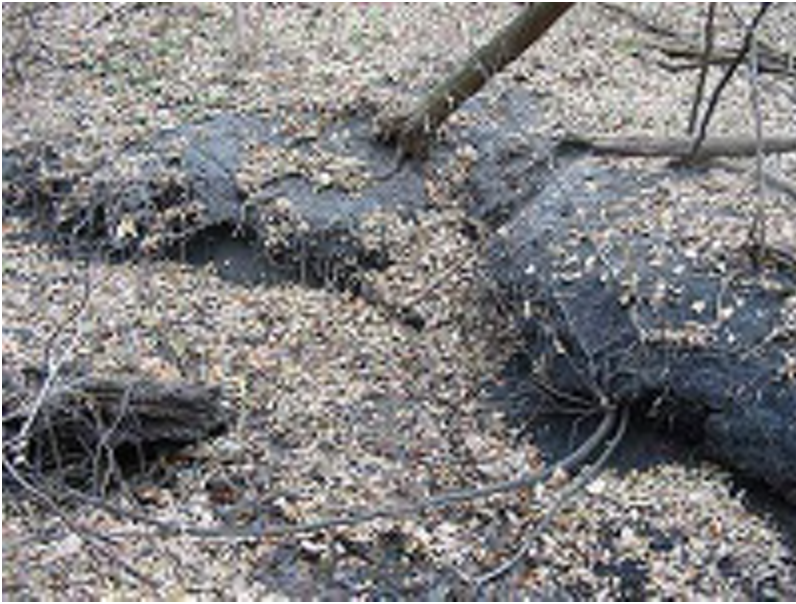
Springs with eroding banks

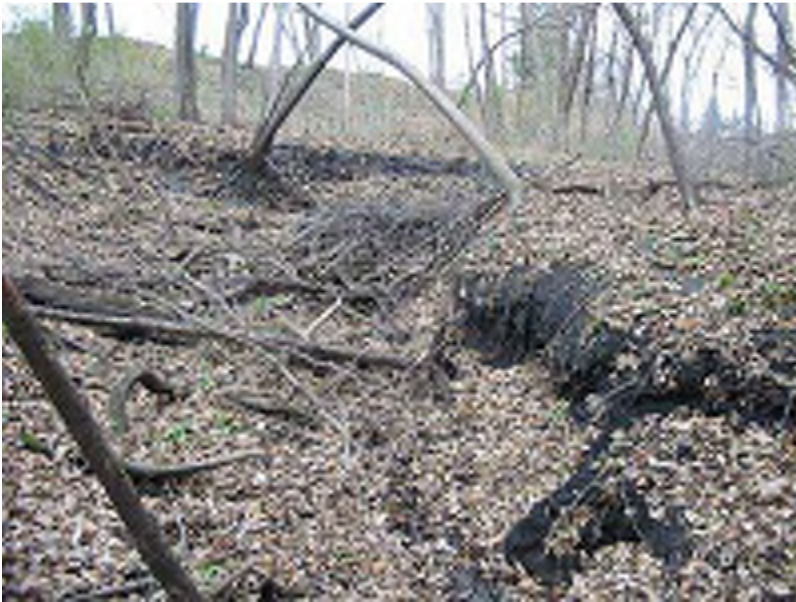
Springs with eroding banks

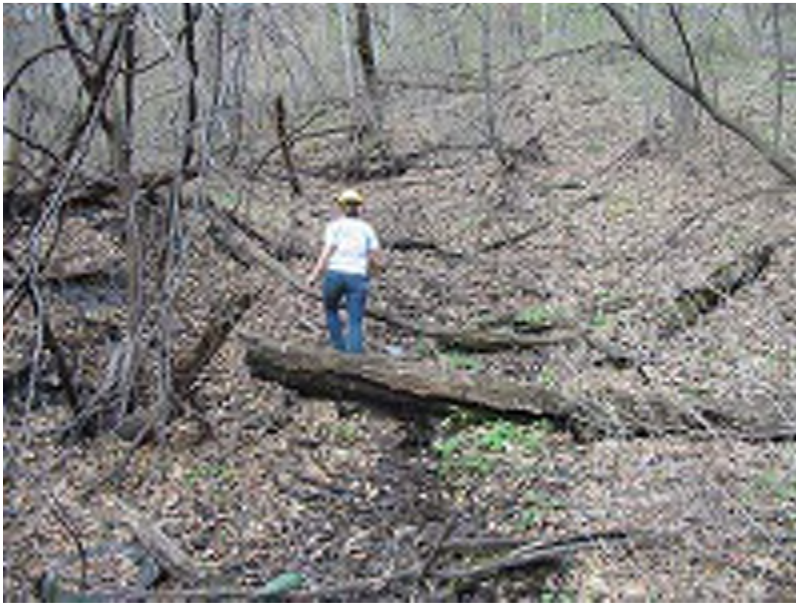
Waypoint 1107

Spring

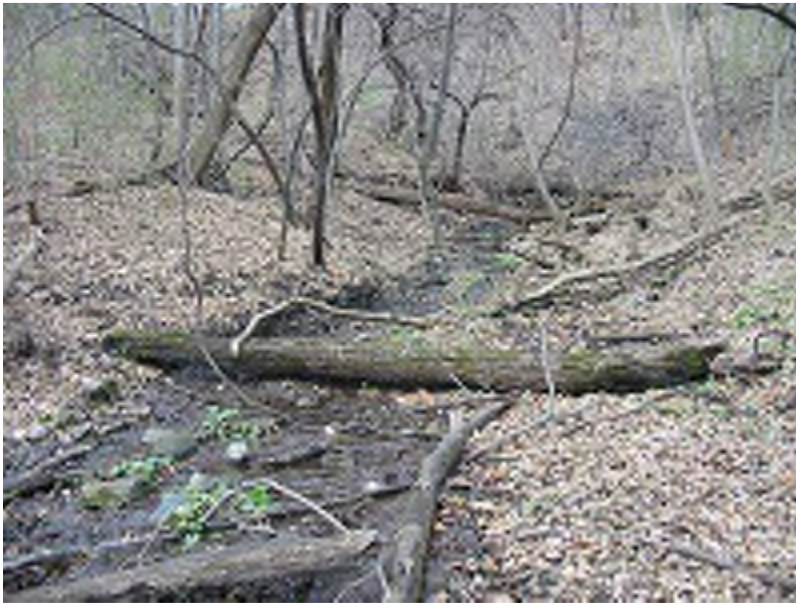
Waypoint 1108

Spring

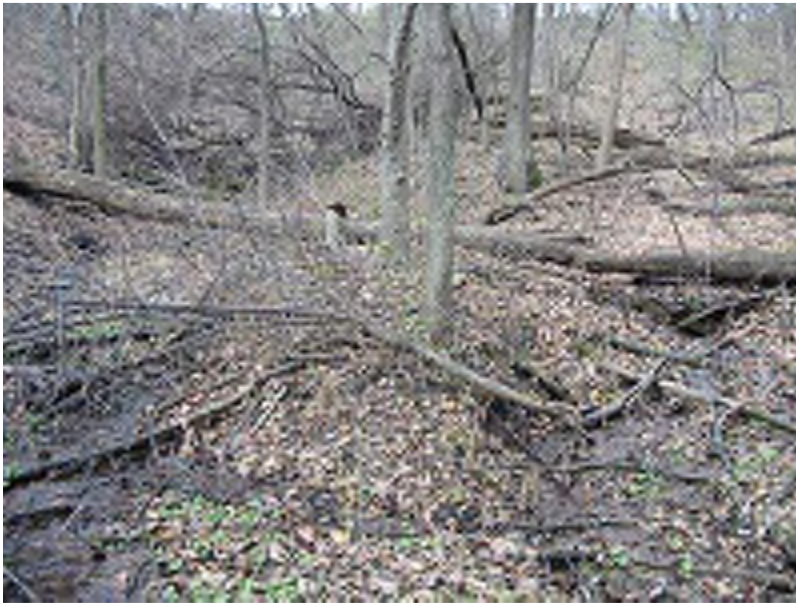
Waypoint 1109

More springs-top of gully huge complex of springs/grndwatr.

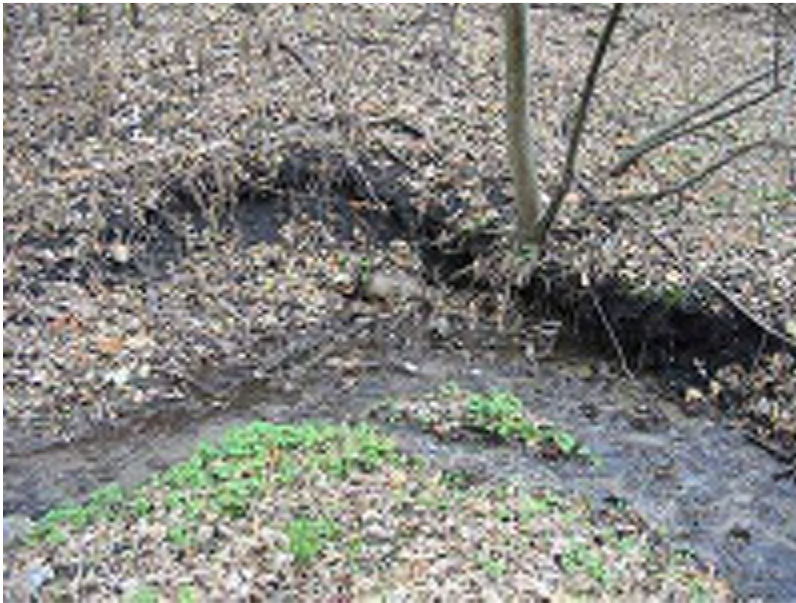
Waypoint 1110

Bank erosion along stream seepage

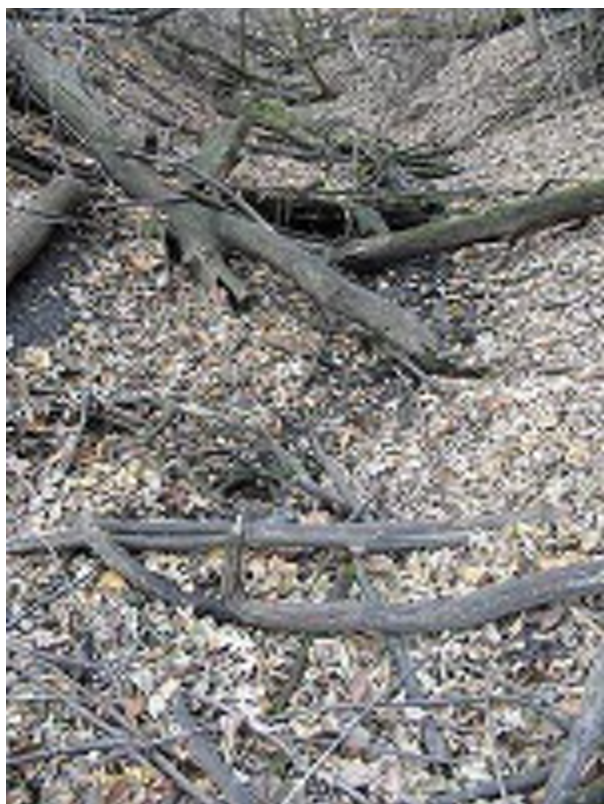
Steep gully side w/exposed roots and soil, spring flowing at base

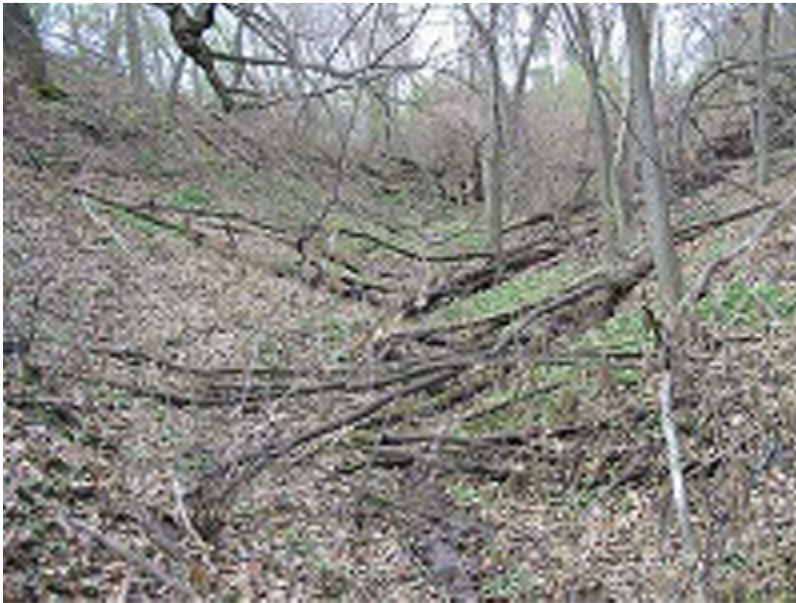
Waypoint 1111

Finger gully with spring

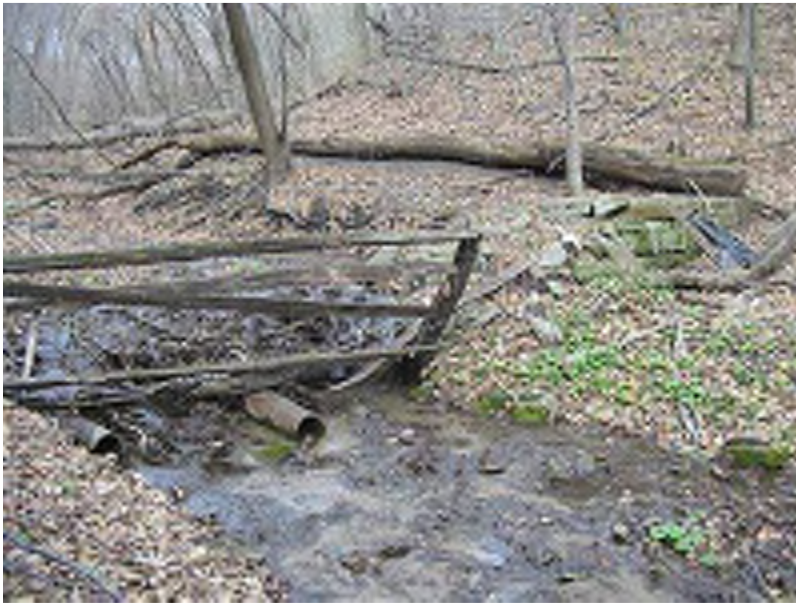
Waypoint 1112

Old pipes and concrete structure w/old fence

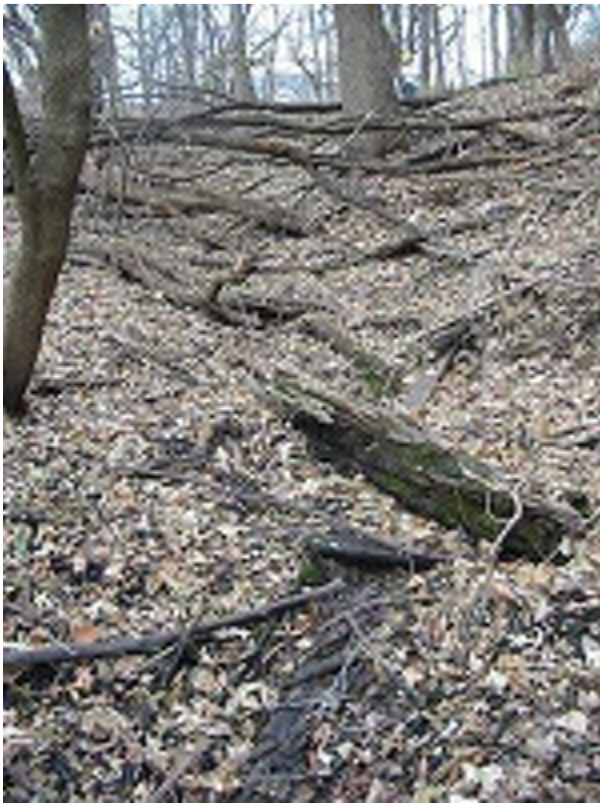
Waypoint 1113

pretty steep banks along west side

Top of gully and spring; pretty steep banks along west side

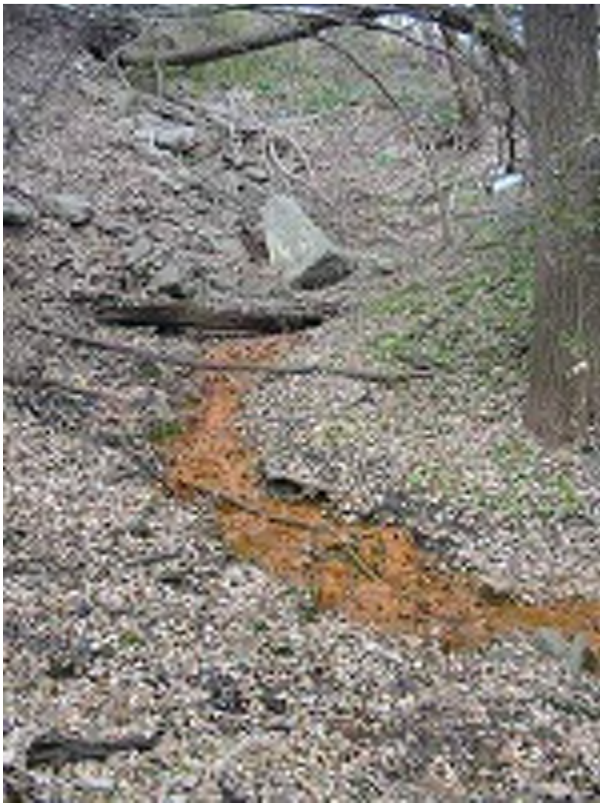
Waypoint 1114

pretty steep banks along west side

Spring, very orange, two old pipes; pretty steep banks along west side

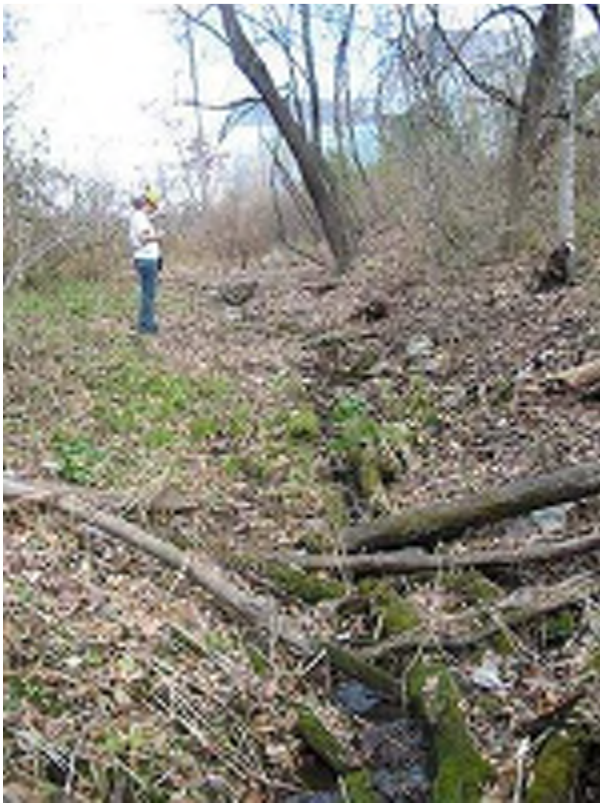
Waypoint 1115

pretty steep banks along west side

Top of gully with spring and bank erosion; steep banks along west side.

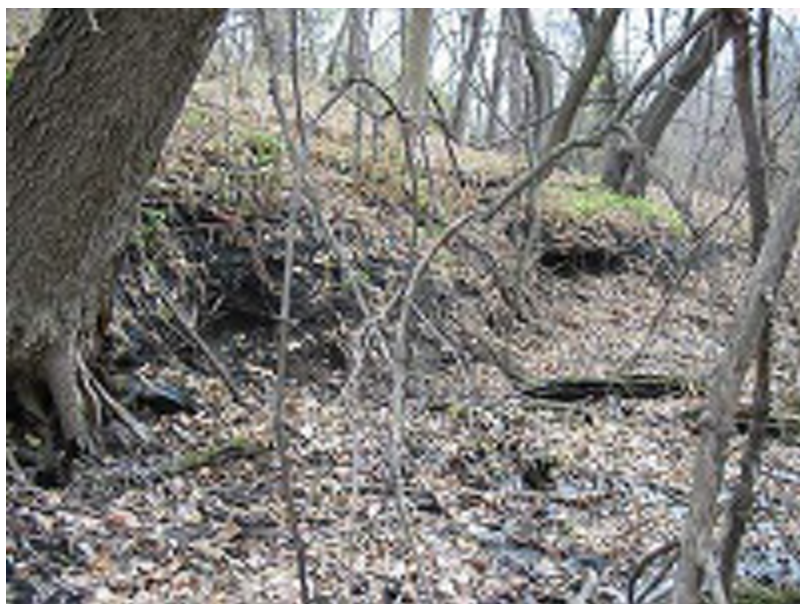
Top of gully with spring and bank erosion; steep banks along west side.

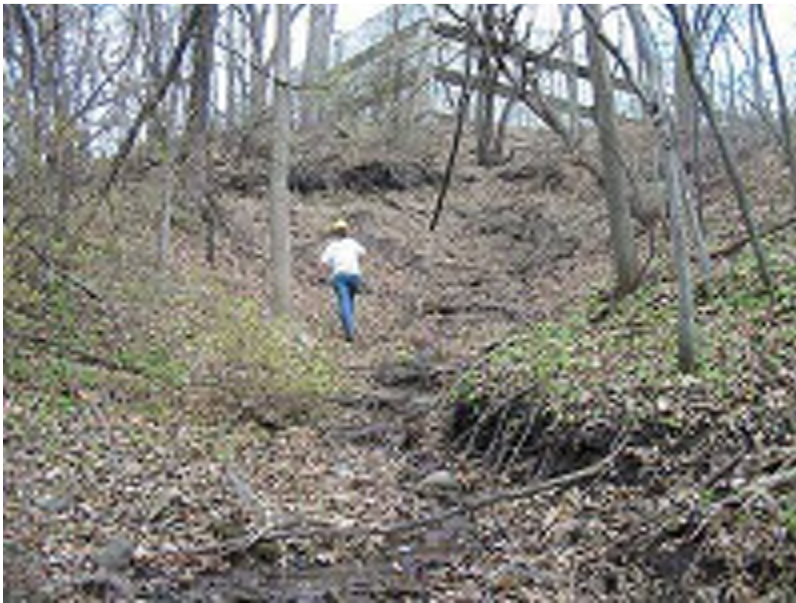
Waypoint 1116

pretty steep banks along west side

Spring with some bank erosion; pretty steep banks along west side

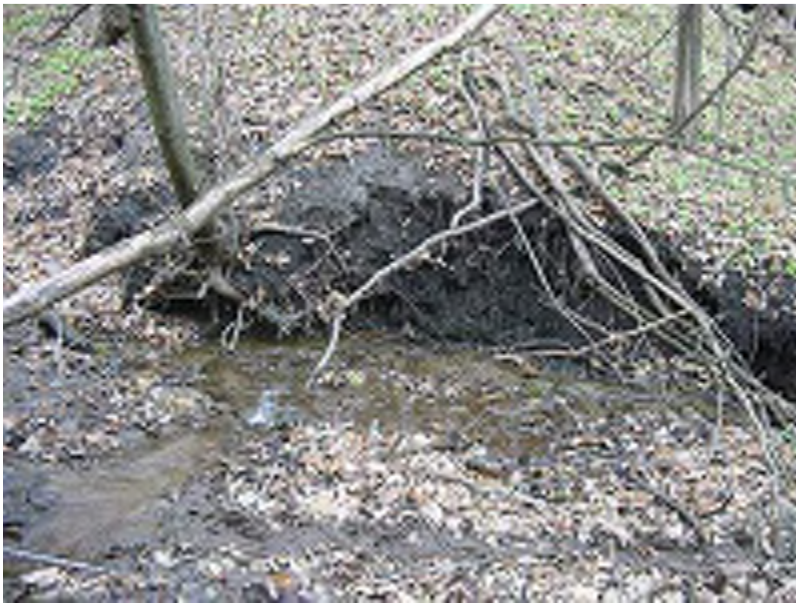
Waypoint 1117

pretty steep banks along west side

Bank erosion; pretty steep banks along west side.

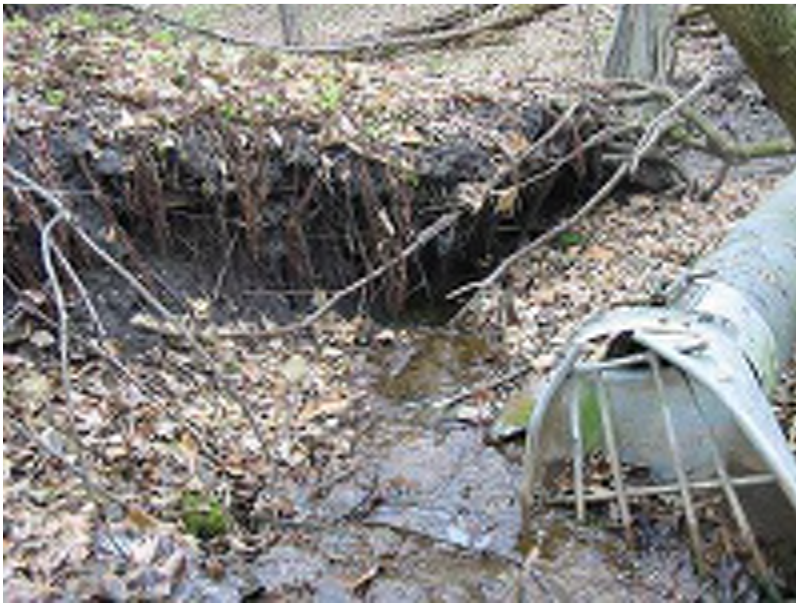
Waypoint 1118

pretty steep banks along west side

Pipe and bank erosion; pretty steep banks along west side.

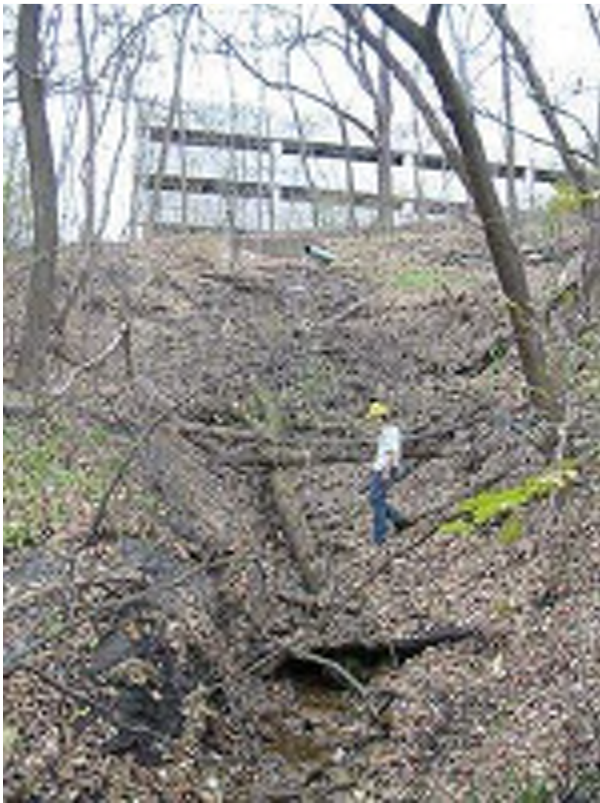
Waypoint 1119

pretty steep banks along west side

Pipe with active water flow, some bank erosion; pretty steep banks along west side.

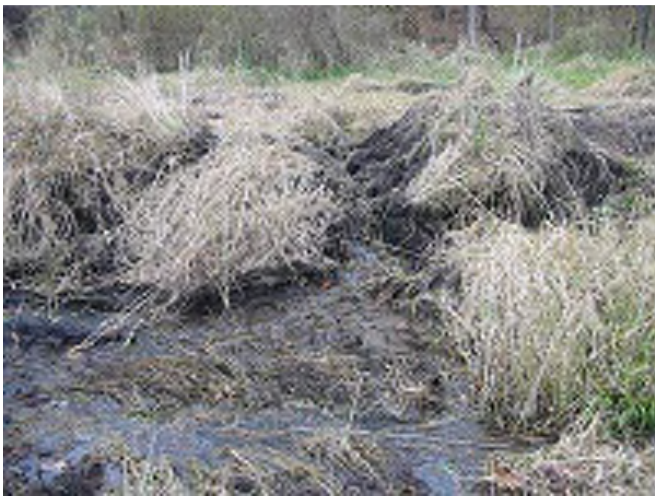
Waypoint 1120

pretty steep banks along west side

Exposed dirt, looks like its from machinery next to walking path; pretty steep banks along west side.

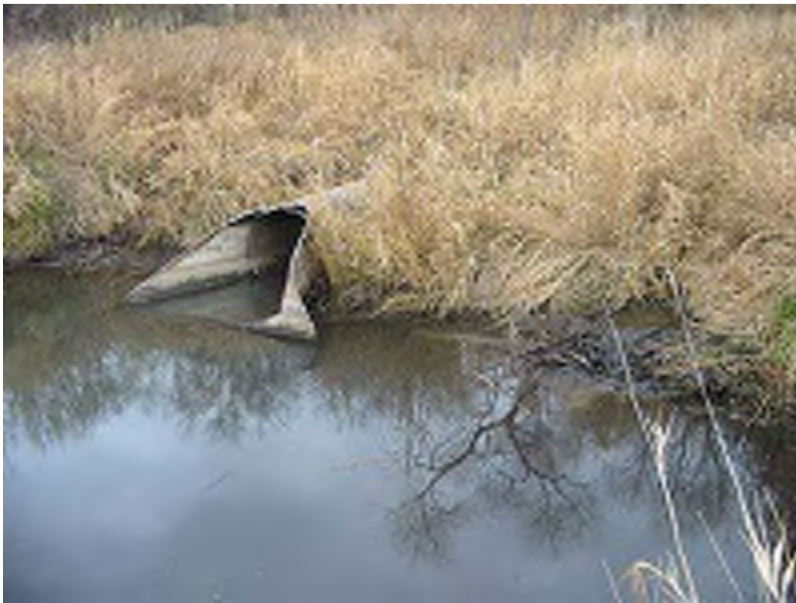
Waypoint 1121

pretty steep banks along west side

Storm water outlet w/adjacent stream outlet; pretty steep banks along west side

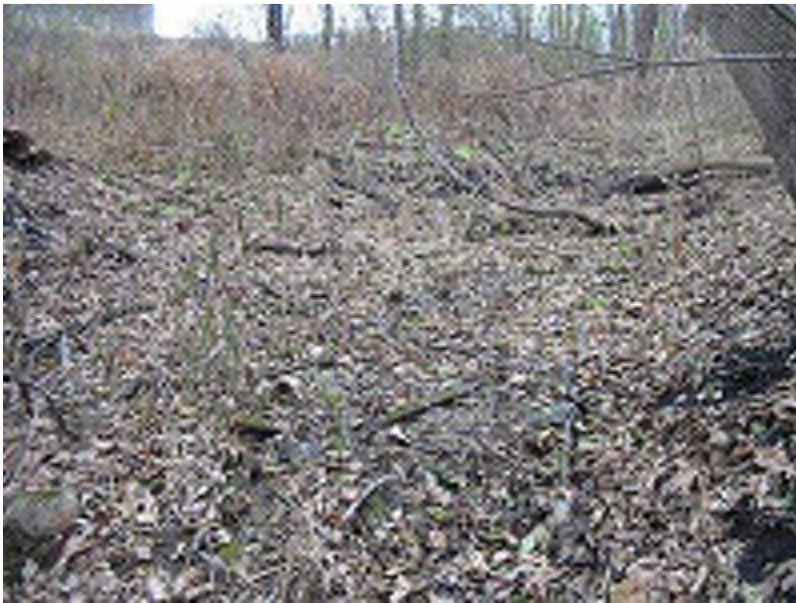
Waypoint 1122

pretty steep banks along west side

Gully/spring - slight bank erosion; pretty steep banks along west side

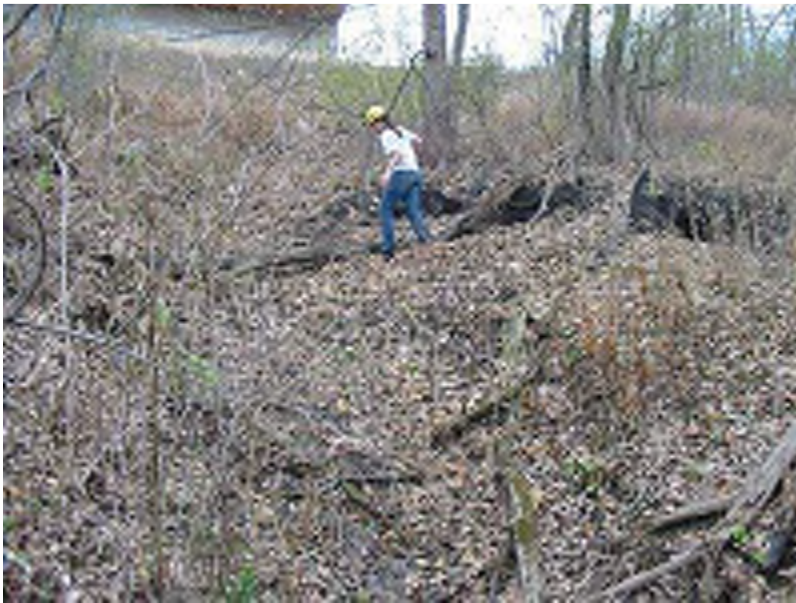
Waypoint 1123

pretty steep banks along west side

Gully/spring - slight bank erosion; pretty steep banks along west side

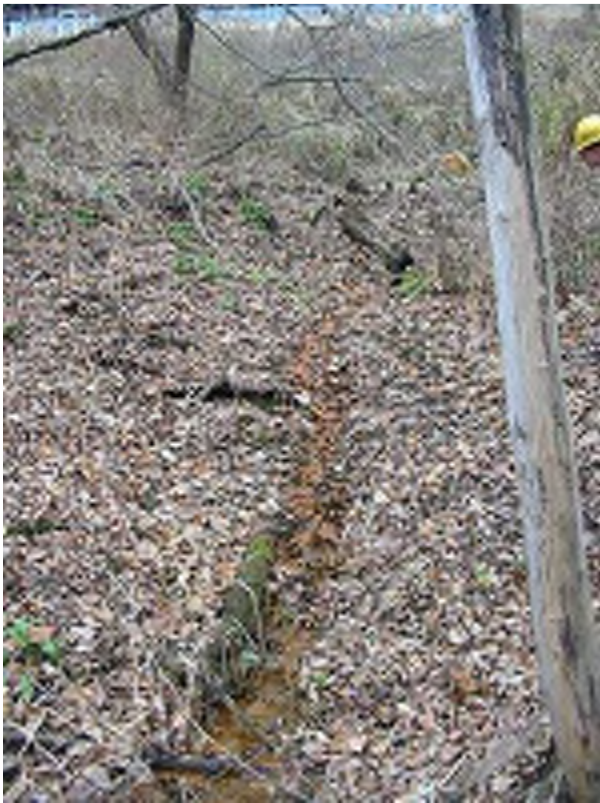
Waypoint 1125

Gully/spring; pretty steep banks along west side

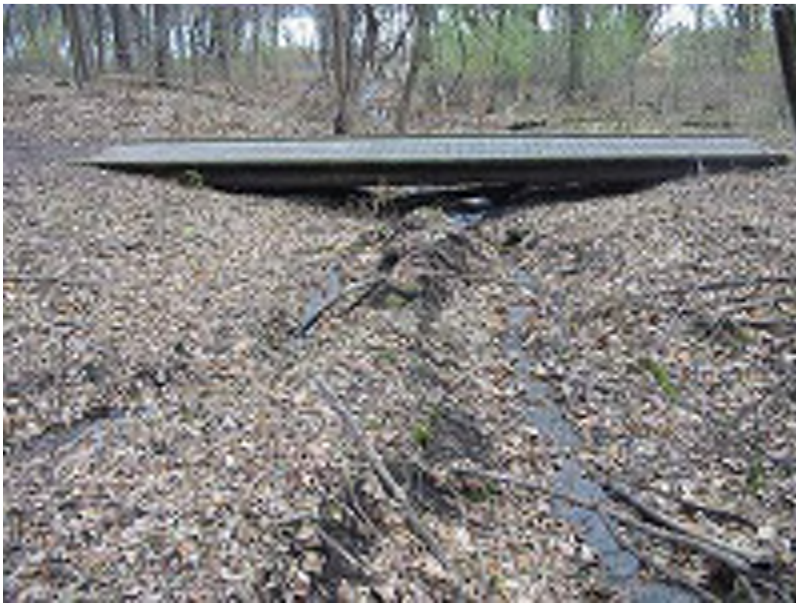
Waypoint 1128

Walking path bridge - eroding bank above

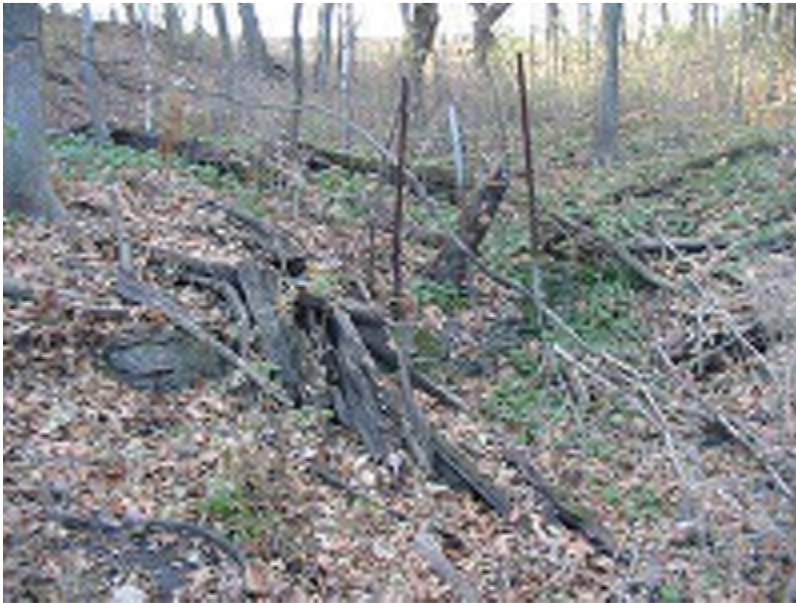
Waypoint 1130

Old foundation

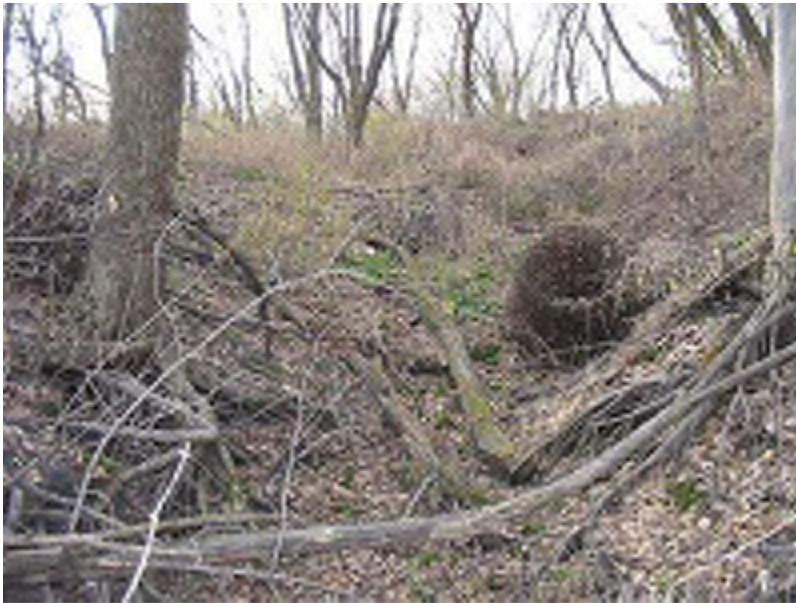
Waypoint 1131

Top of gully, exposed tree roots, some bank erosion

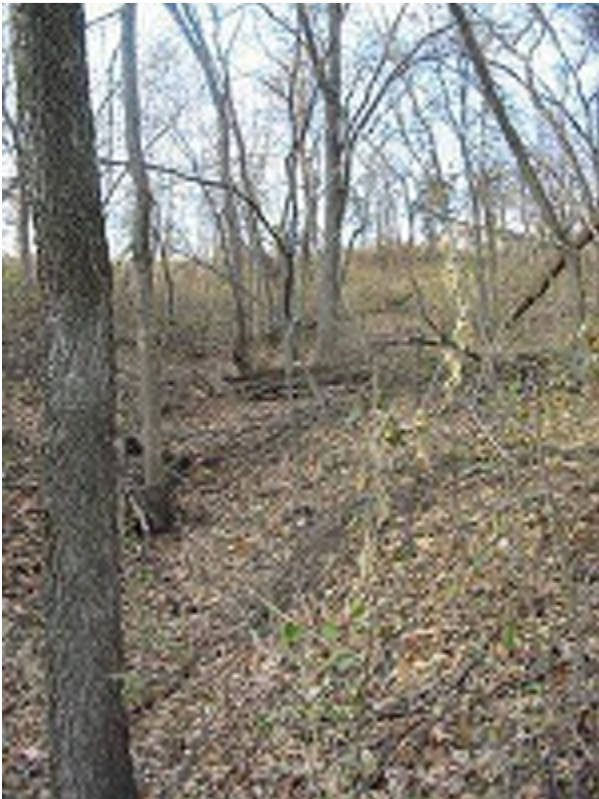
Waypoint 1132

Top of gully, fairly steep banks, not too bad

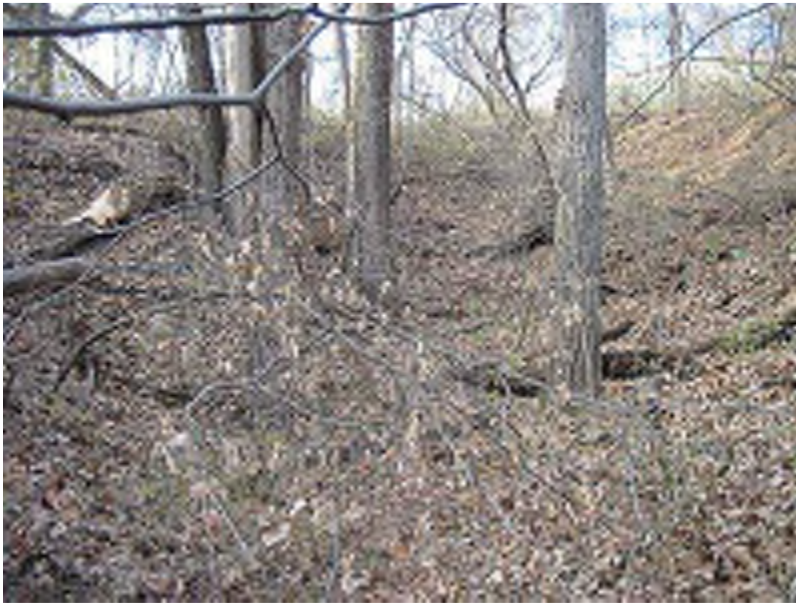
Waypoint 1133

Top of gully, fairly steep banks, not too bad

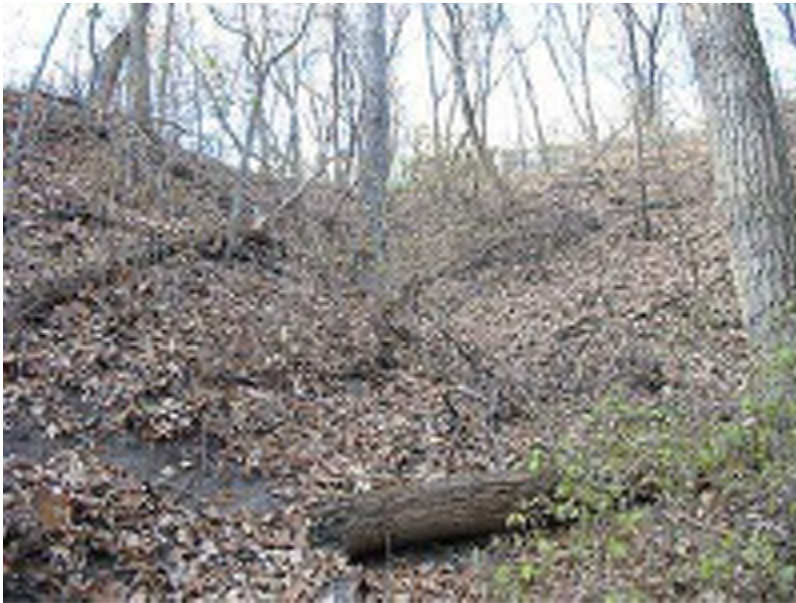
Waypoint 1134

Top of gully, fairly steep banks, not too bad

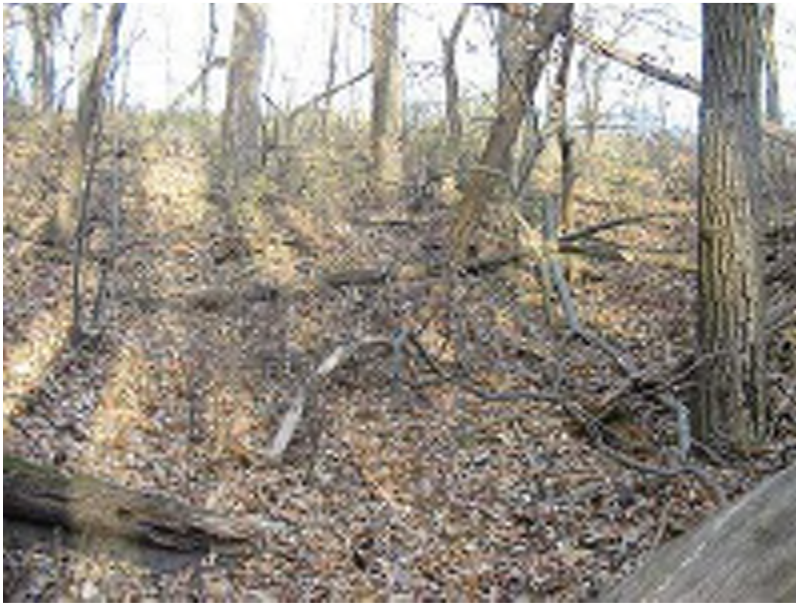
Waypoint 1135

Top of gully, fairly steep banks, not too bad

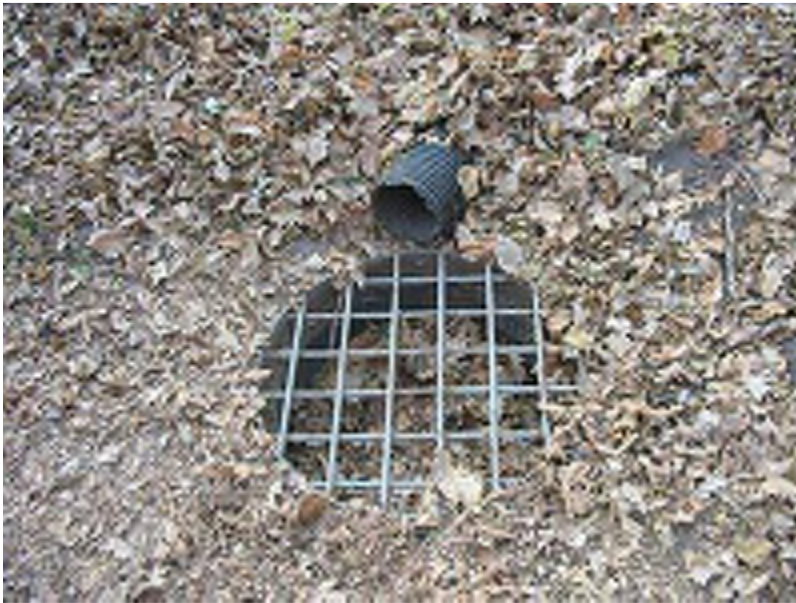
Waypoint 1136

Storm water grate?

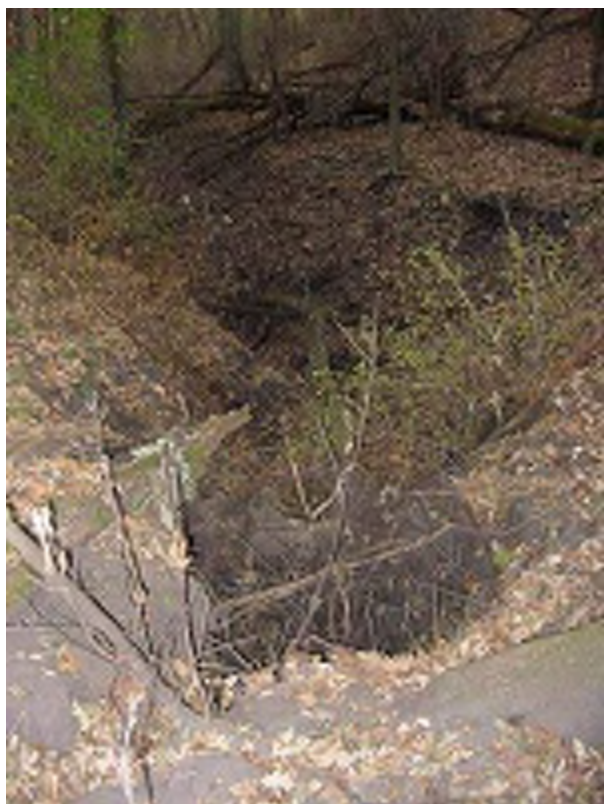
Erosion cut

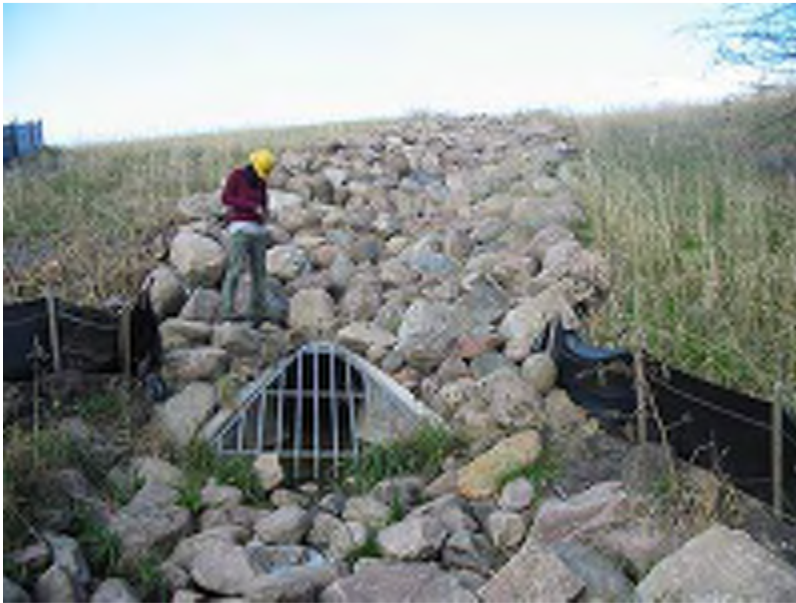
Waypoint 1138

Storm water outlet from catchment pond in new development-top of gully

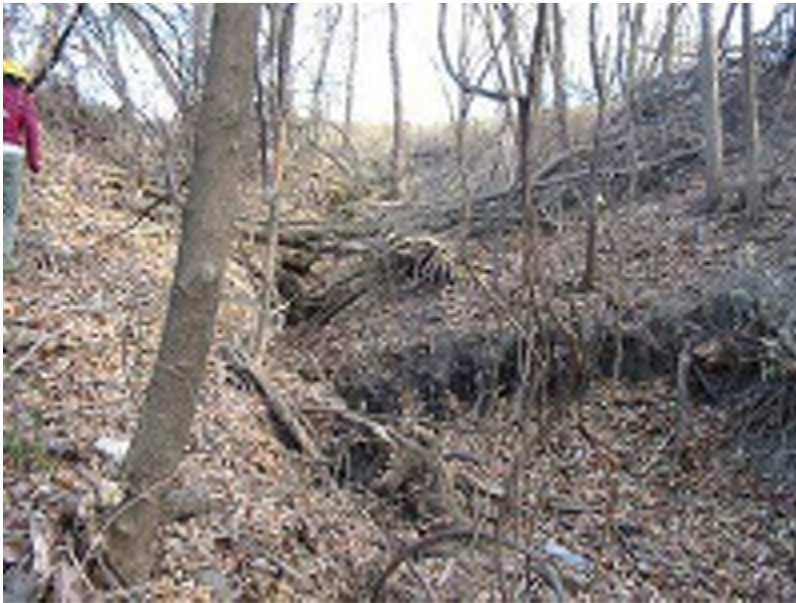
Waypoint 1139

Finger, bad down cut and bank erosion, a little water wash, brush and mulch

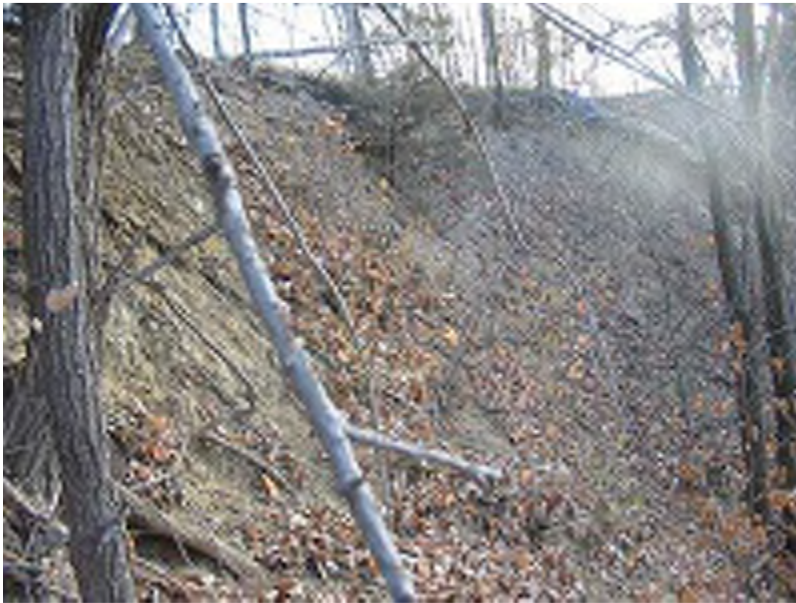
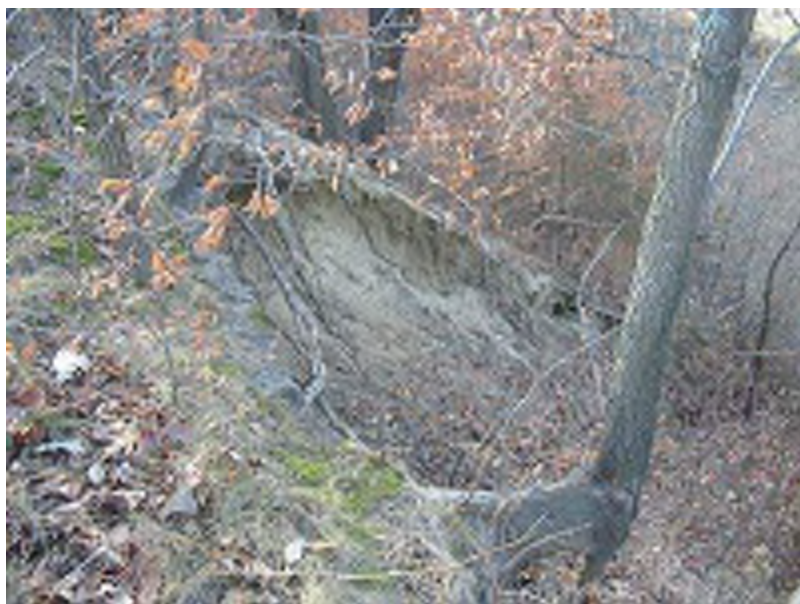
Bank erosion, slump/slide

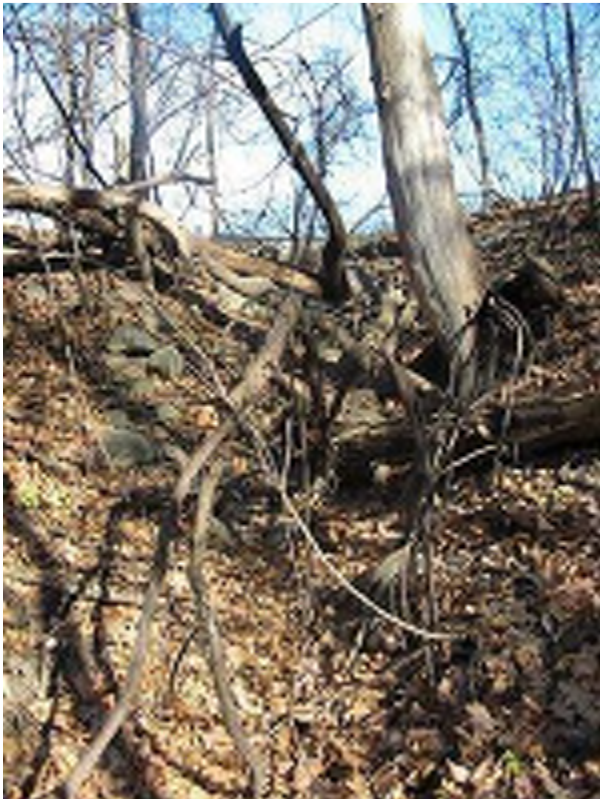
Waypoint 1141

Finger, down cut at top, pretty bad

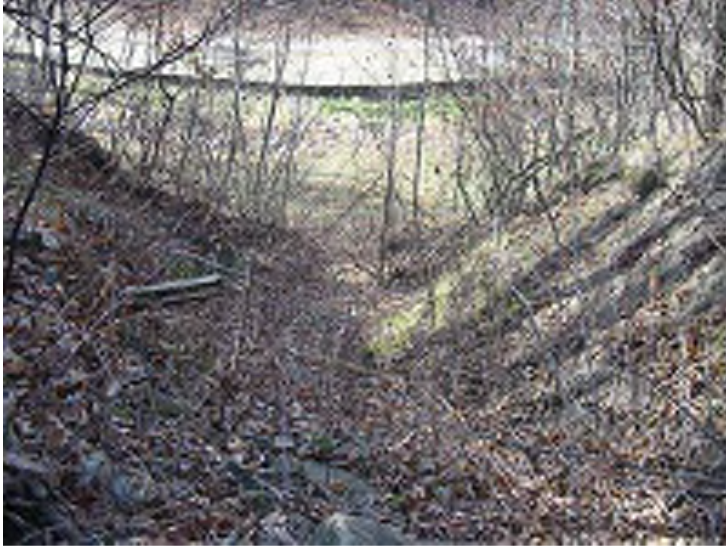
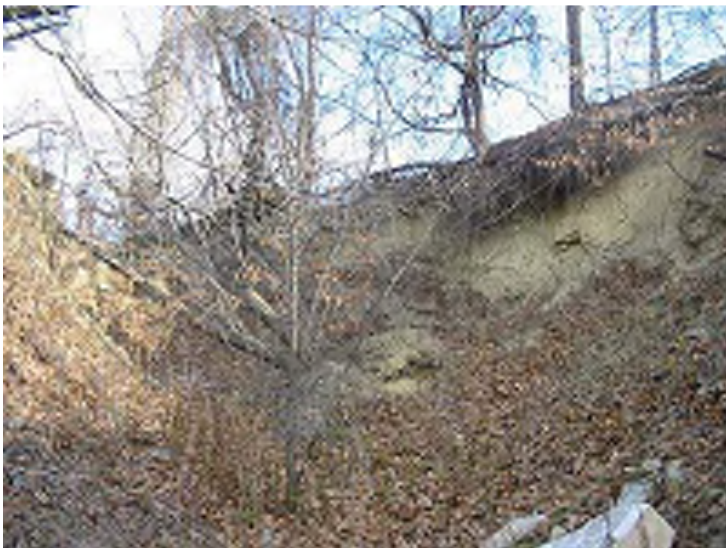
Finger, undercut banks, exposed roots, real bad, looks like an old path that channels water
