Appendix K: Lower Minnesota River Watershed District: Gully Inventory

Gully Inventory Map
 Area #1
 Lower Minnesota River Watershed District
 Watershed Management Plan

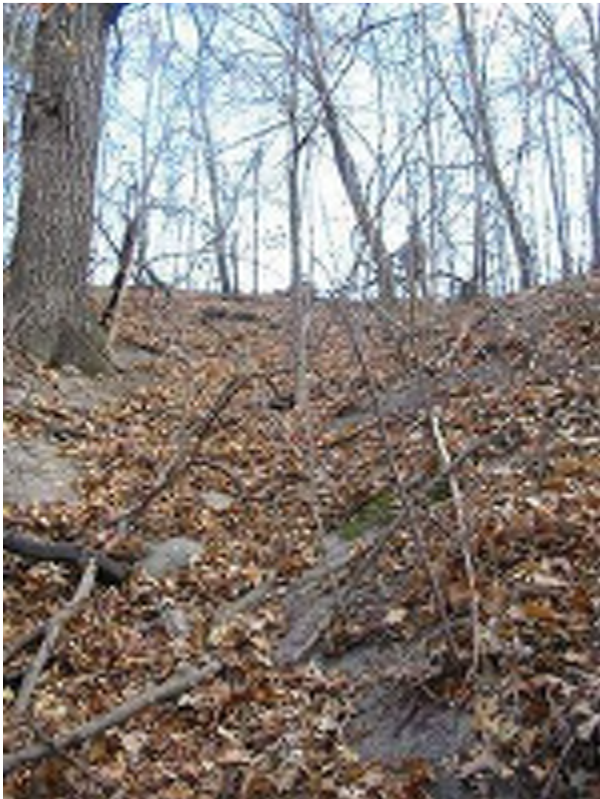
Waypoint 1143

Finger, looks fine

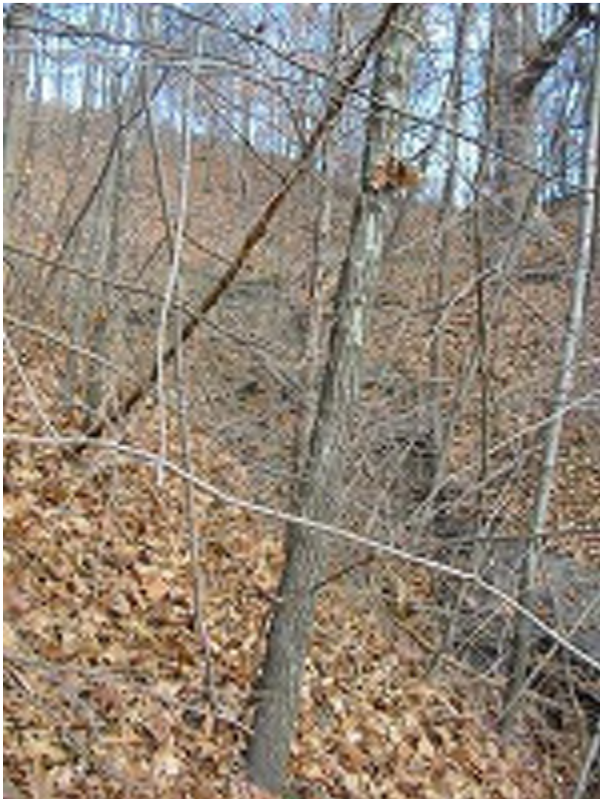
Waypoint 1144

Top of gully/4596 cut deep with bad bank erosion

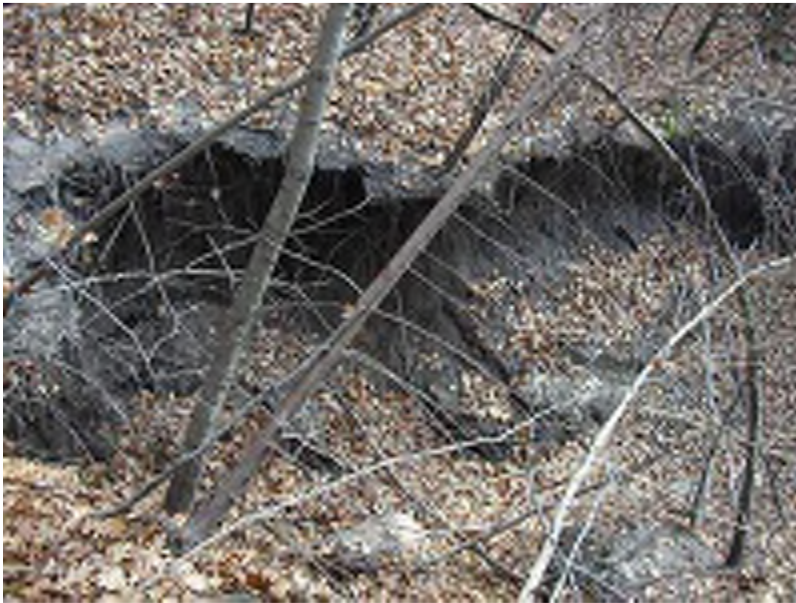
Waypoint 1145

Half-way down to creek/4597 cut deep with bad erosion

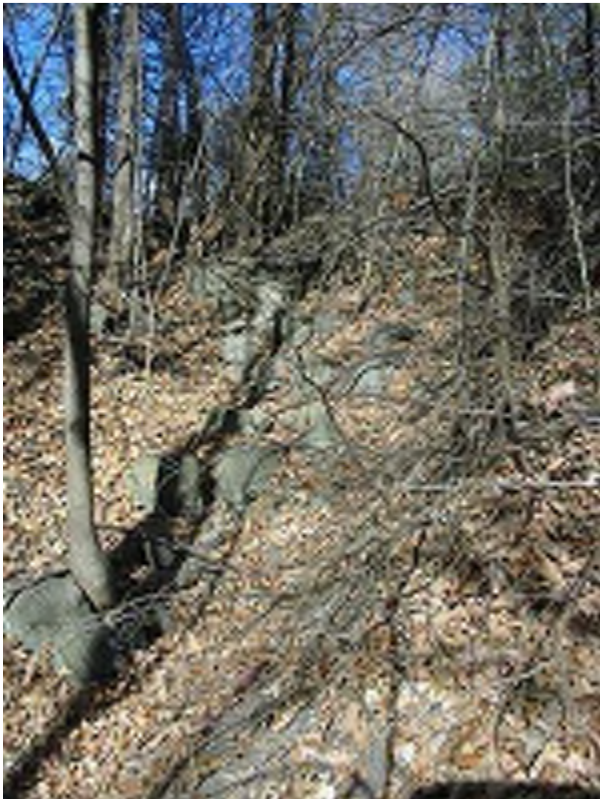
Waypoint 1146

Finger, looks pretty good

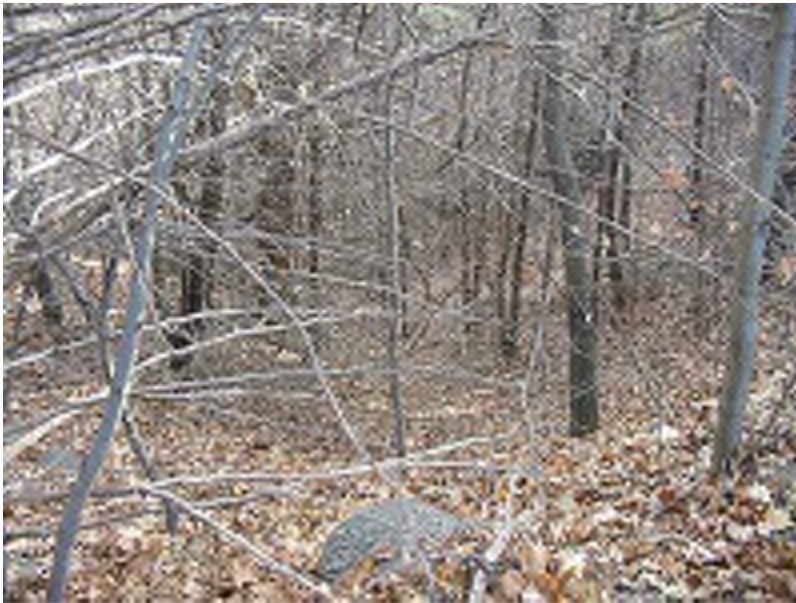
Waypoint 1147

Finger, looks good

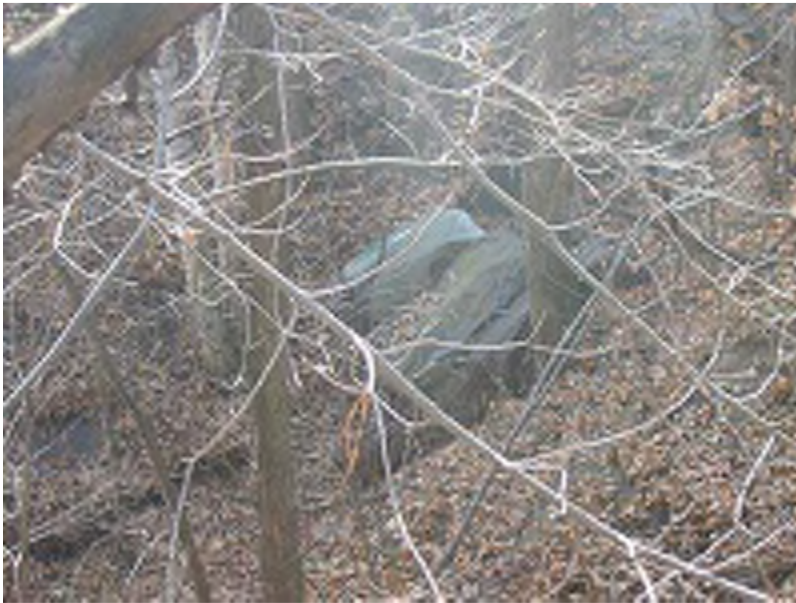
Waypoint 1148

Finger, car frame, steep banks with bare soil

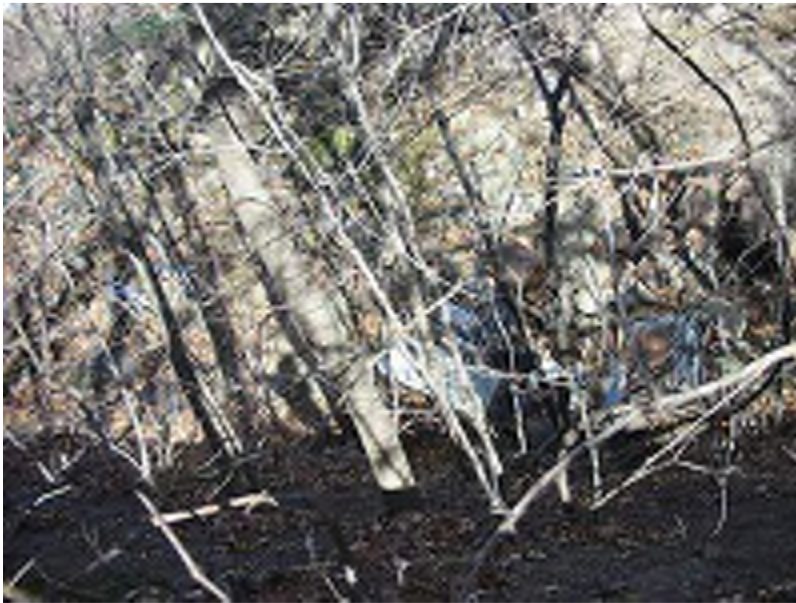
Waypoint 1149

Finger, metal junk

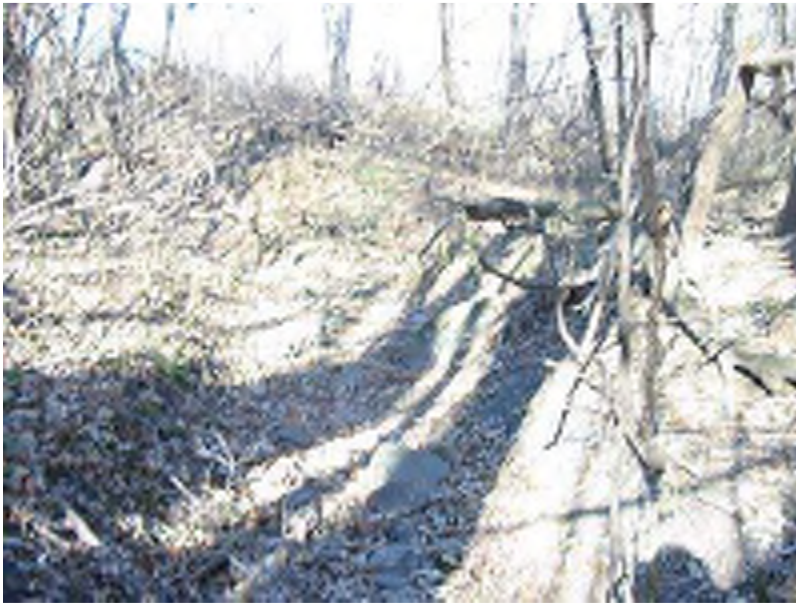
Waypoint 1150

End of big finger, some garbage, looks pretty sad

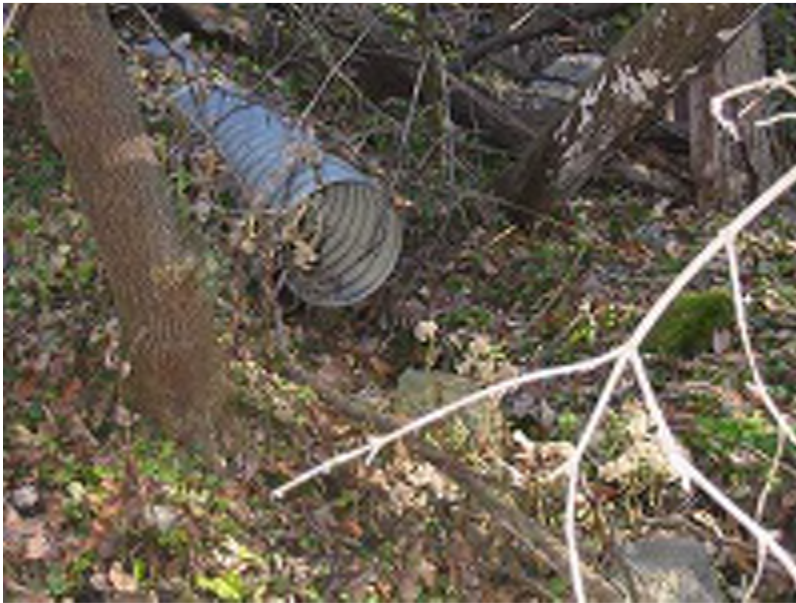
Waypoint 1151

Drainage pipe, no flow

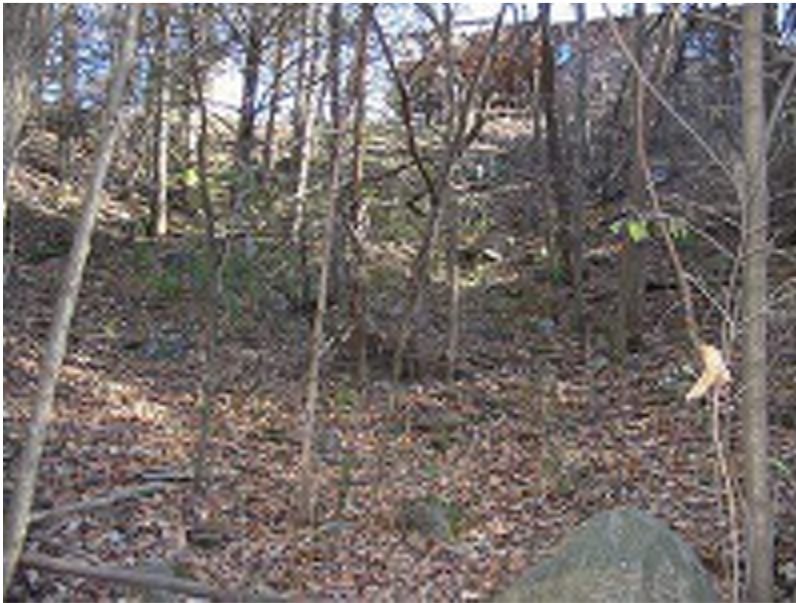
Waypoint 1152

Resident confront about washout issues

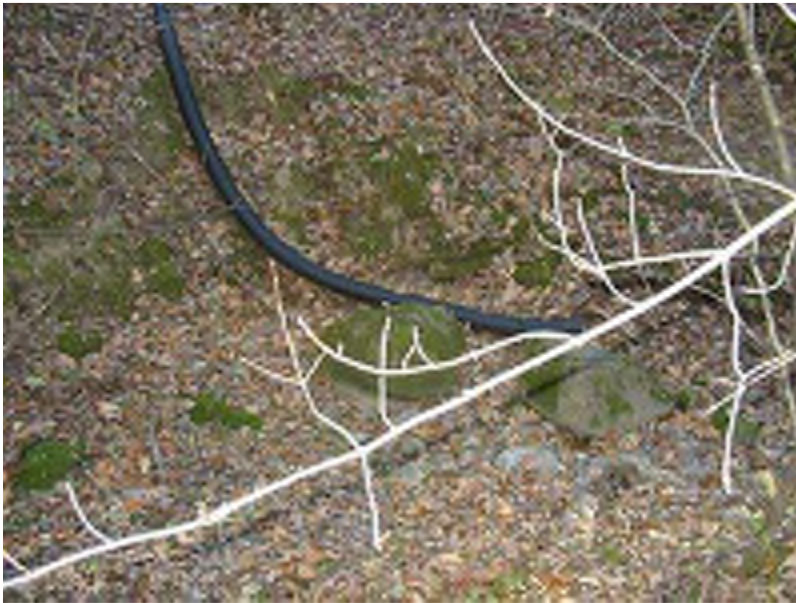
Waypoint 1153

House runoff tile

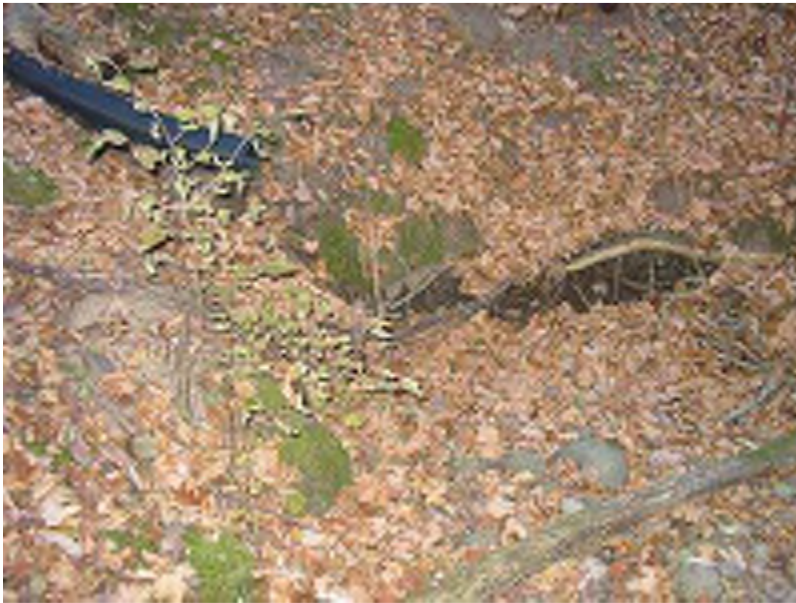
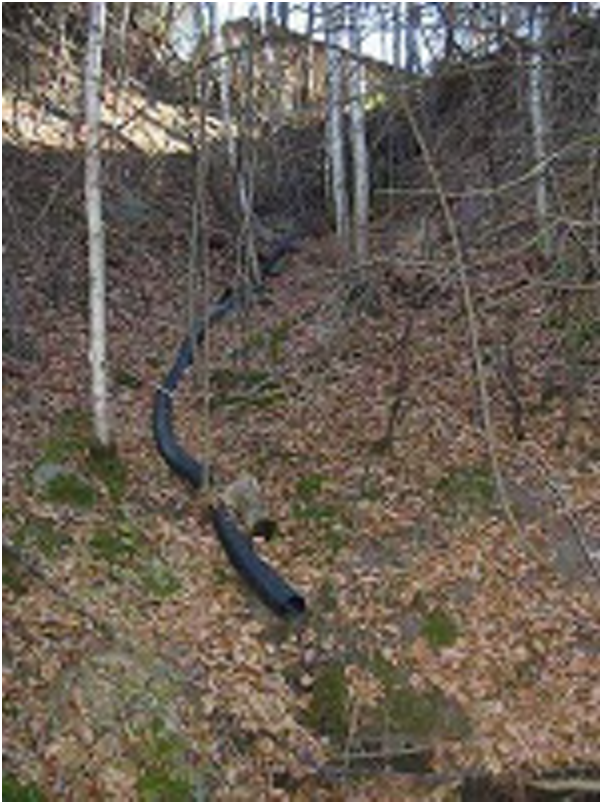
House runoff tile

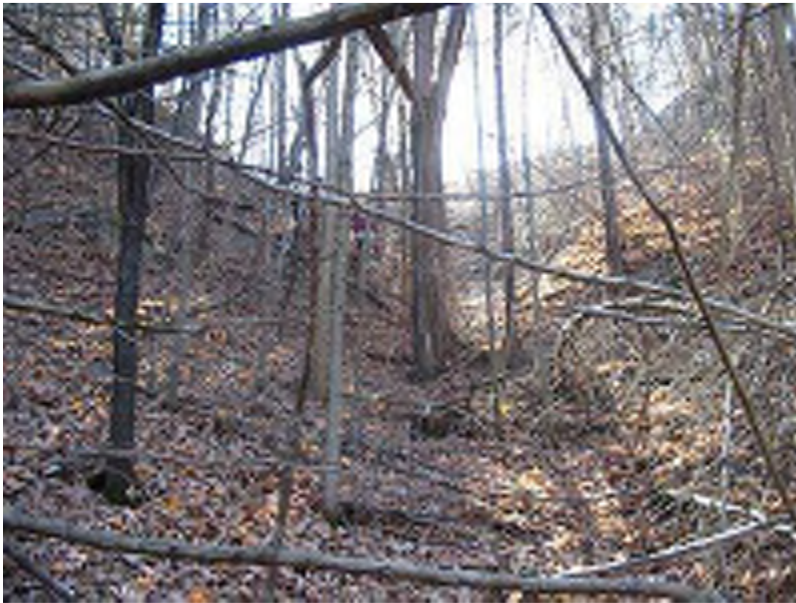
Waypoint 1155

Finger, moderate erosion

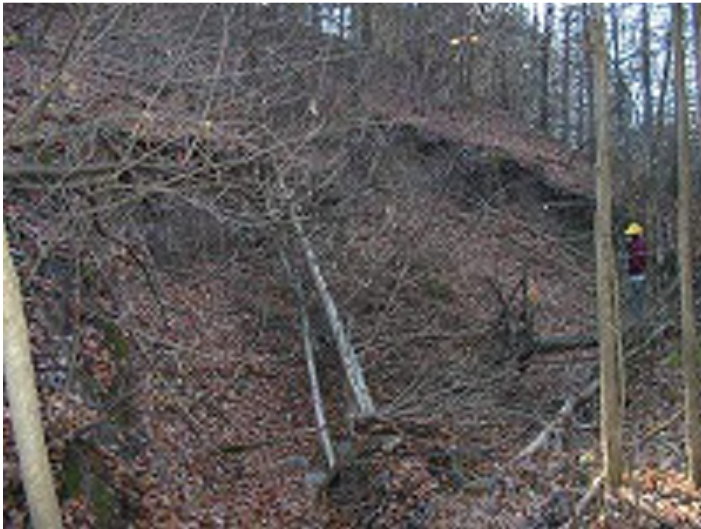
Waypoint 1156

Bank erosion pretty bad; groundwater seepage starting here, seepage disappears just downstream

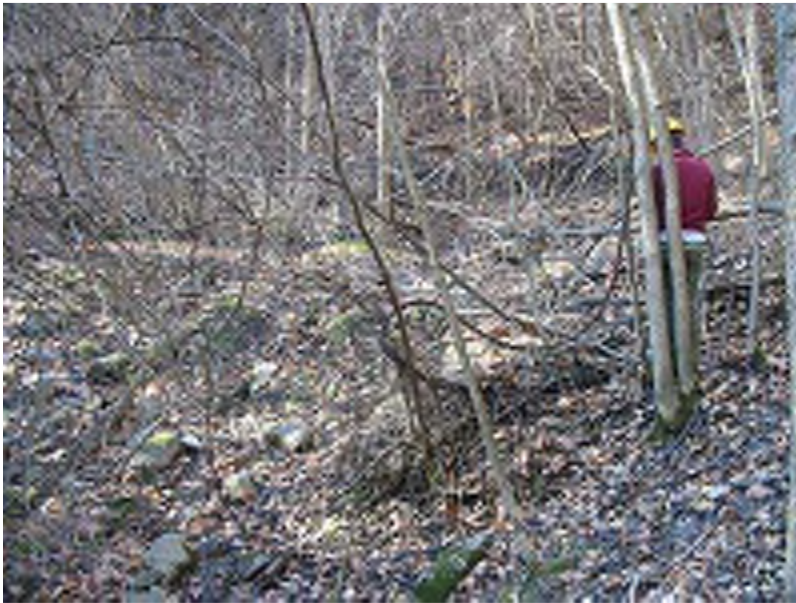
Waypoint 1157

Spring w/solid flow - below 1146

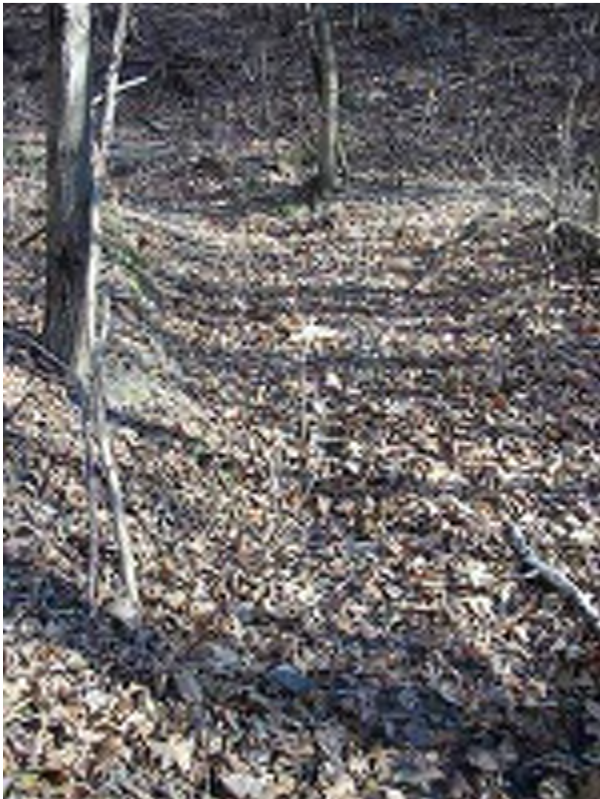
Waypoint 1158

Both flows from water stop by house, spring water disappears right before house

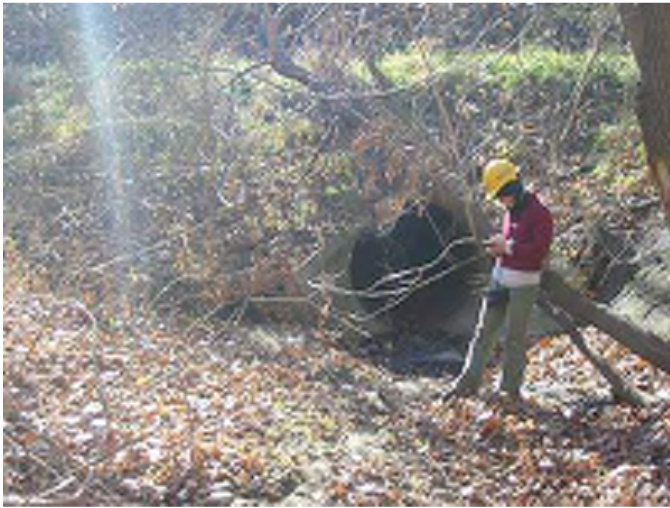
Waypoint 1159

Culvert under driveway by house, finger to 212 NE, quite a bit of bank erosion along extent finger

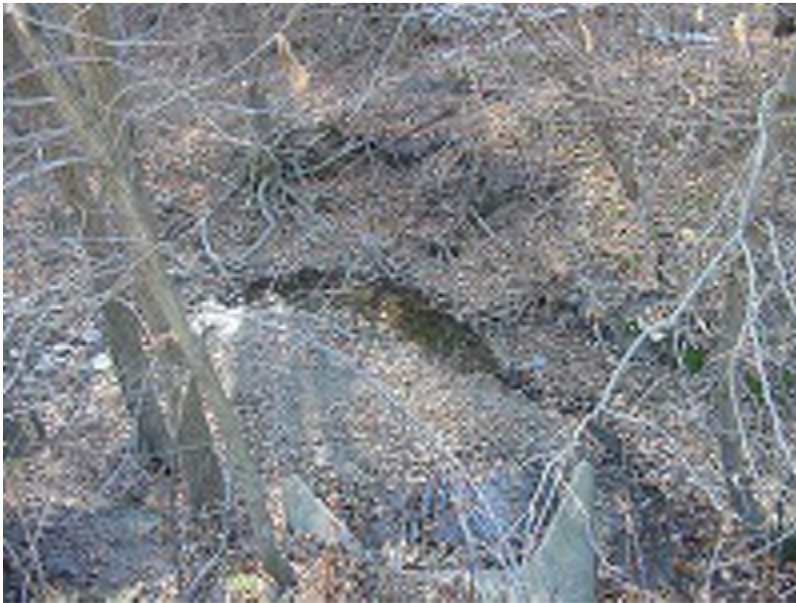
Waypoint 1160

Other sides of culvert, erosion on bank directly adjacent

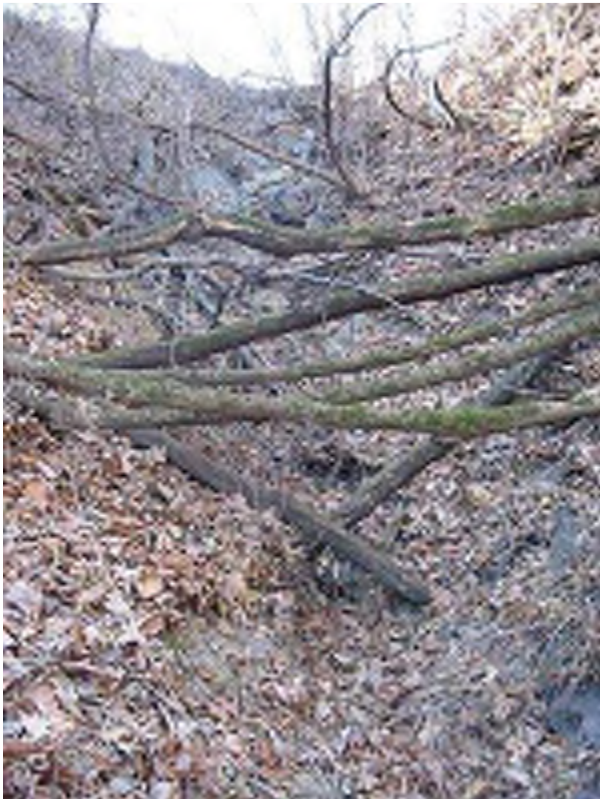
Waypoint 1161

Water seepage and erosion

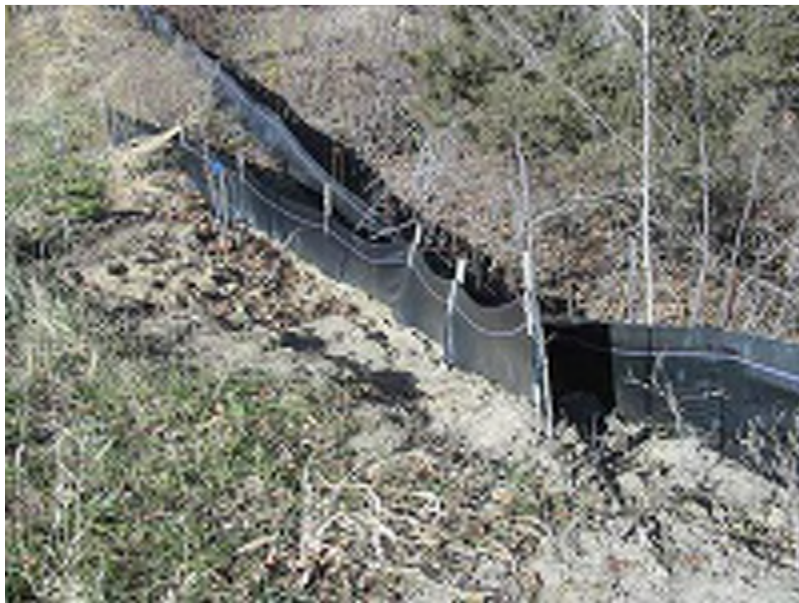
Waypoint 1162

Top of gully erosion/construction erosion prevention

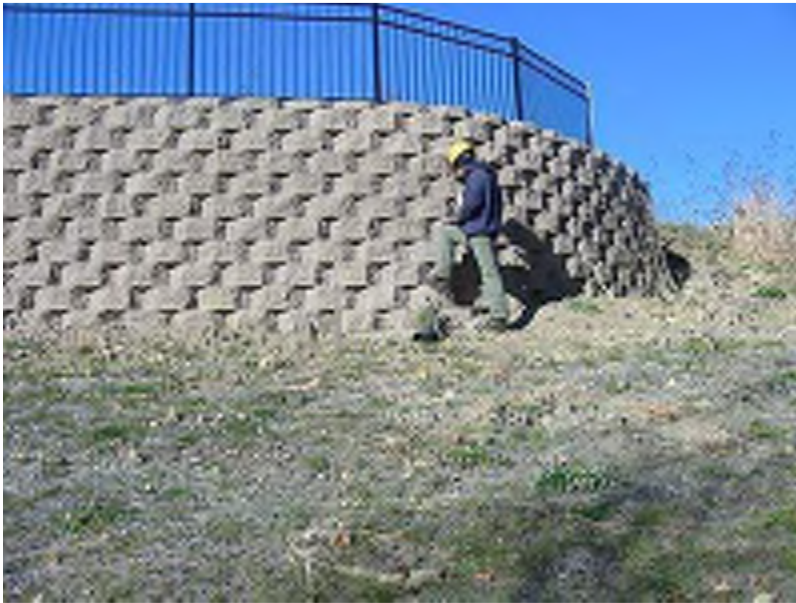
Waypoint 1163

Runoff tile from construction

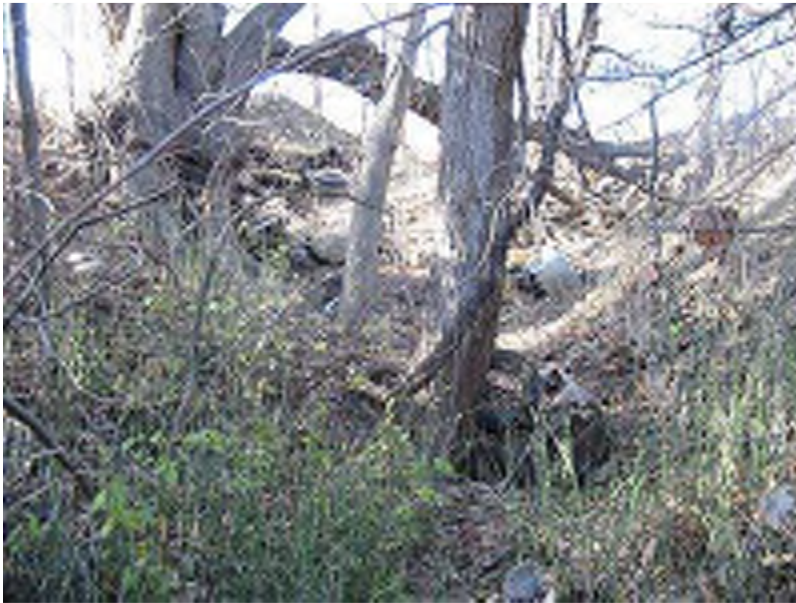
Waypoint 1164

Finger gully top and garbage pile

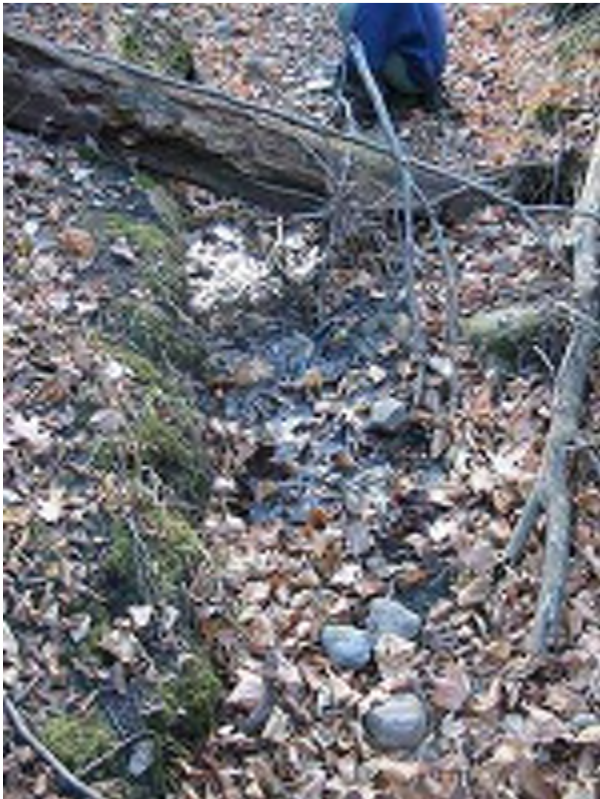
Waypoint 1165

Culvert and finger gully tip and tile line

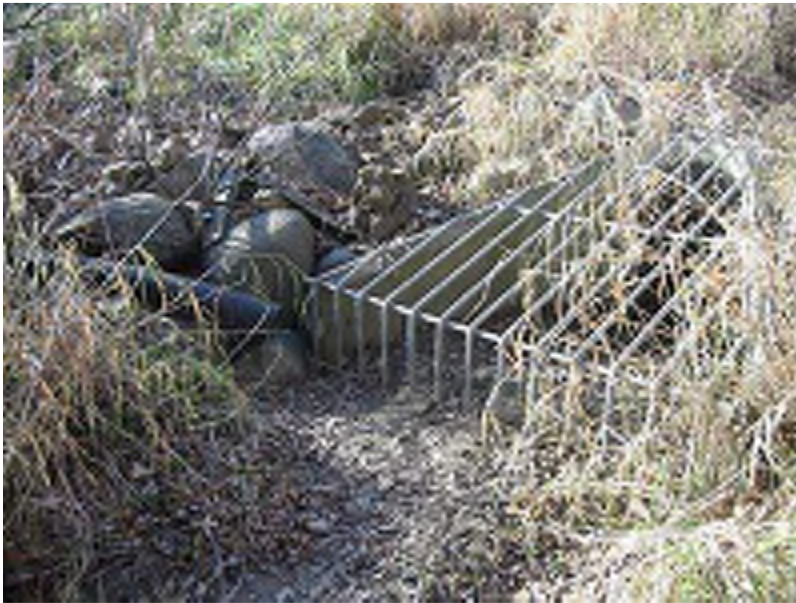
Waypoint 1166

Extensive erosion

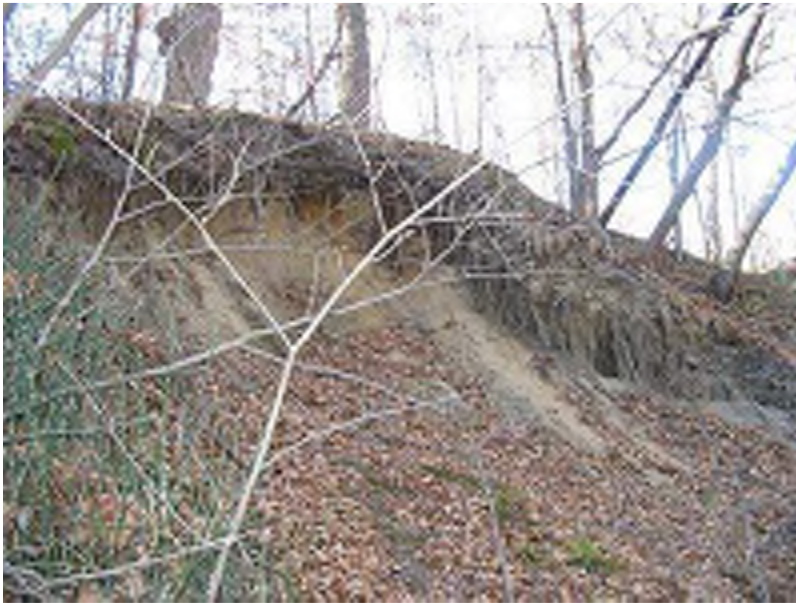
Waypoint 1167

Steady water flow and extensive erosion

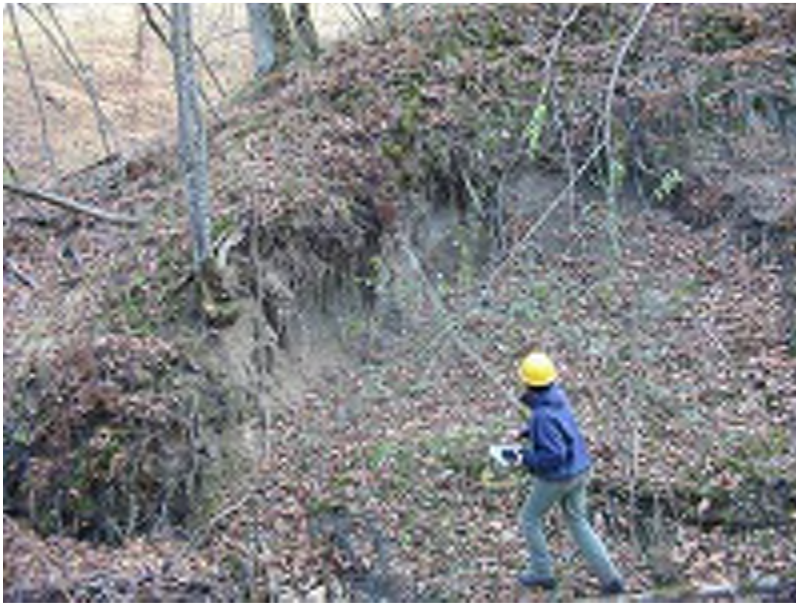
Waypoint 1168

Spring water

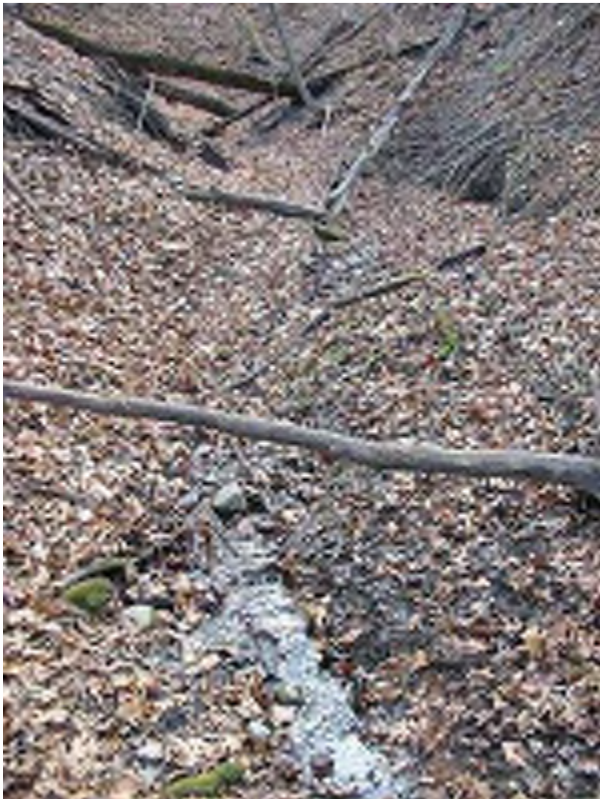
Waypoint 1169

Entrance to finger erosion

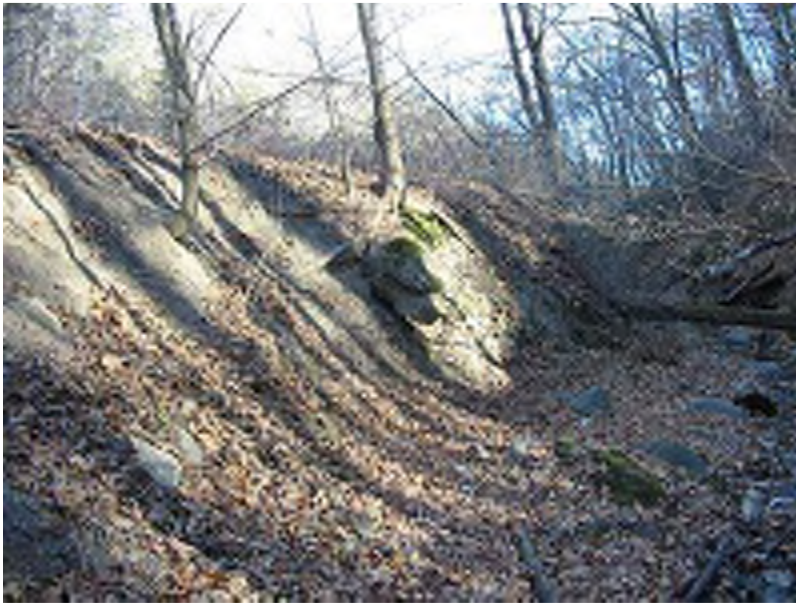
Waypoint 1170

Extensive erosion

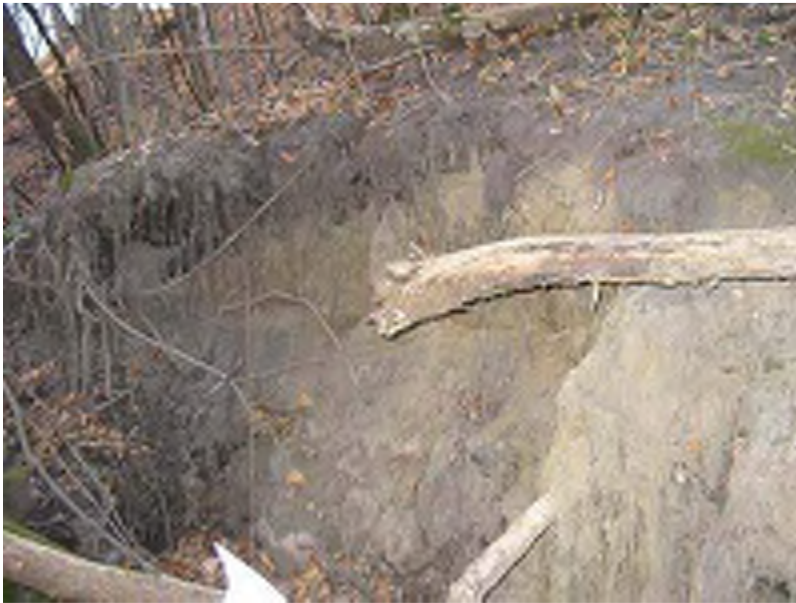
Waypoint 1171

Extensive erosion on southern gully

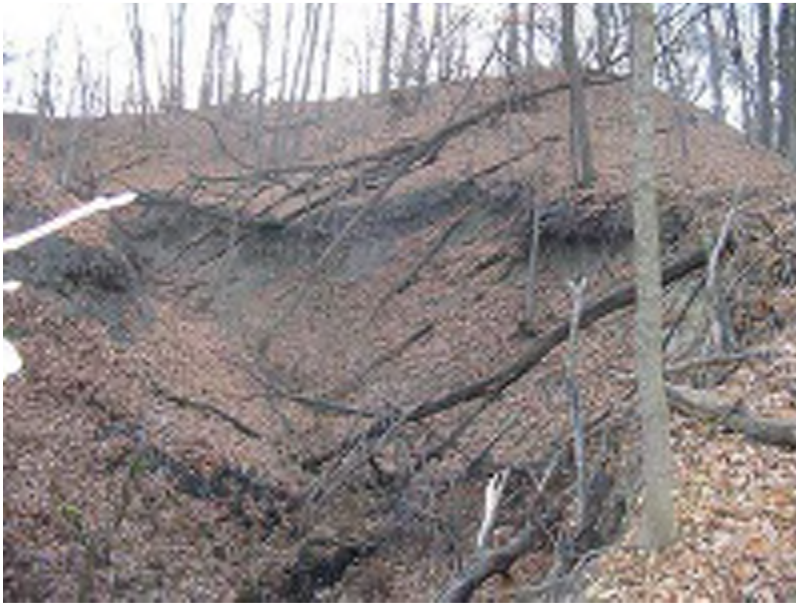
Waypoint 1172

Extensive and deep erosion

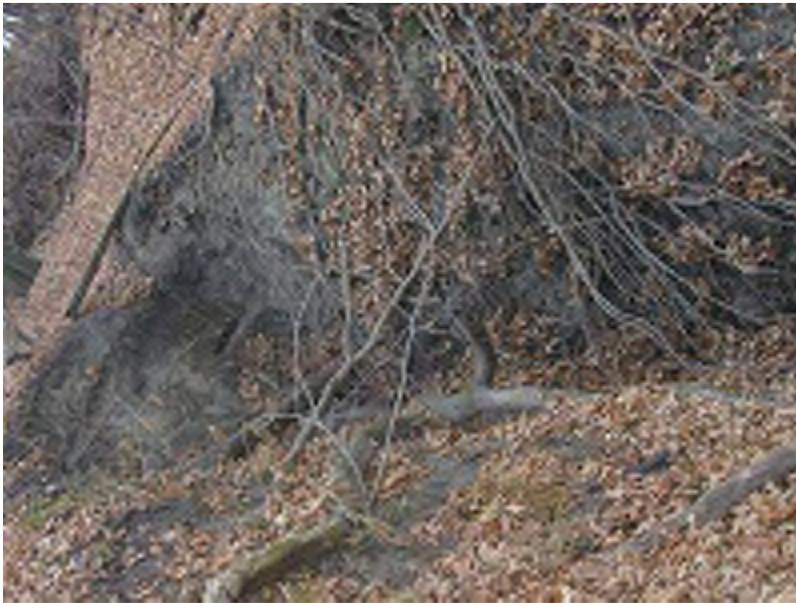
Waypoint 1173

Extensive erosion

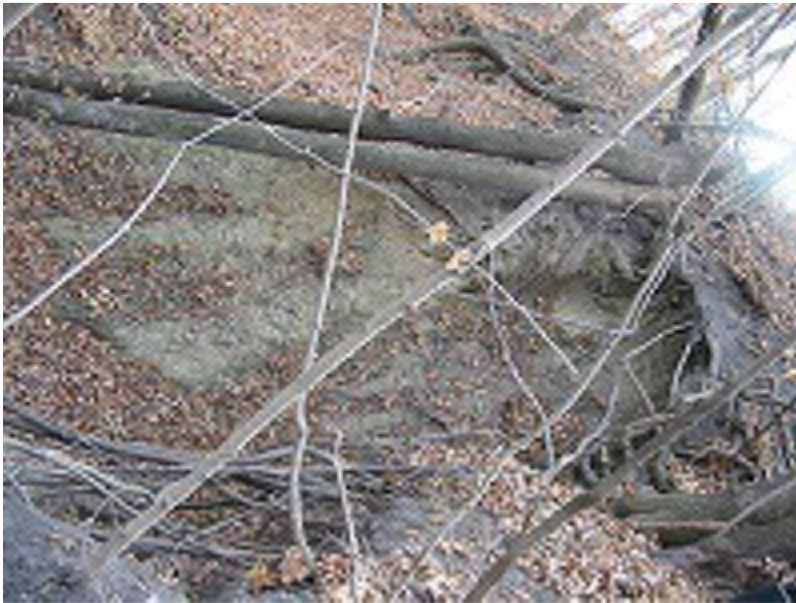
Waypoint 1174

Finger tip and tile line w/mild erosion

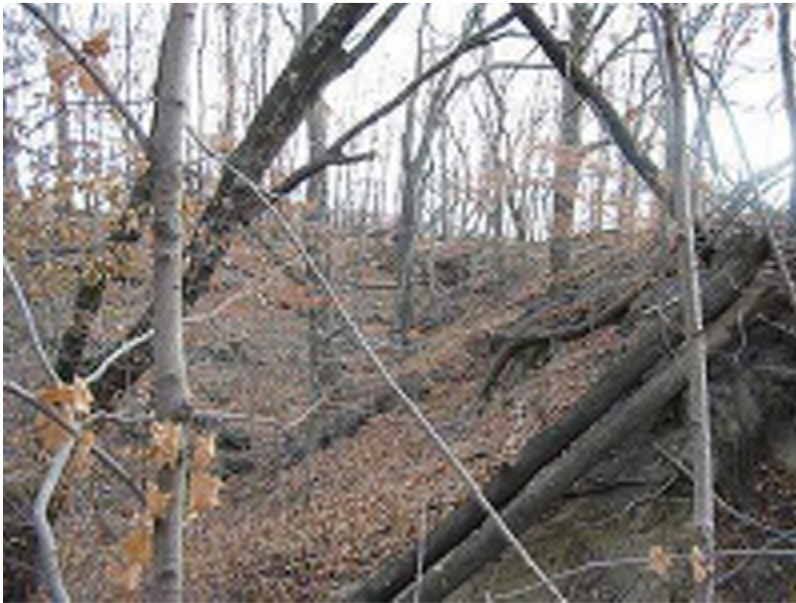
Waypoint 1175

Erosion encroachment to llama fence

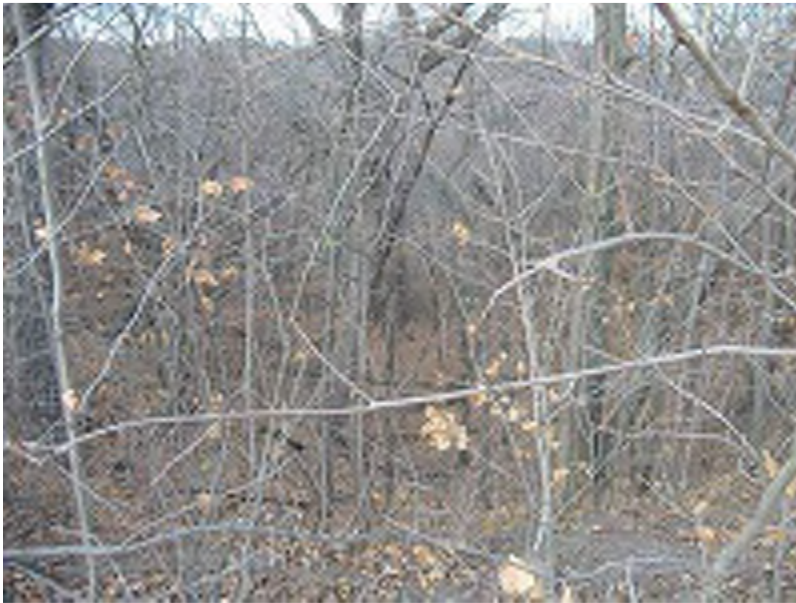
Waypoint 1181

Deep cut erosion under trees and all up hillside, small finger

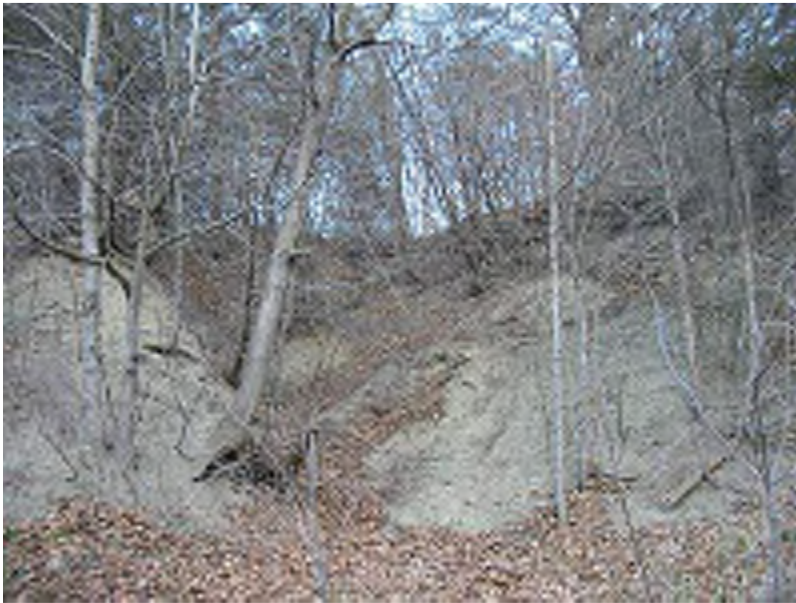
Waypoint 1182

Deep cut erosion on finger

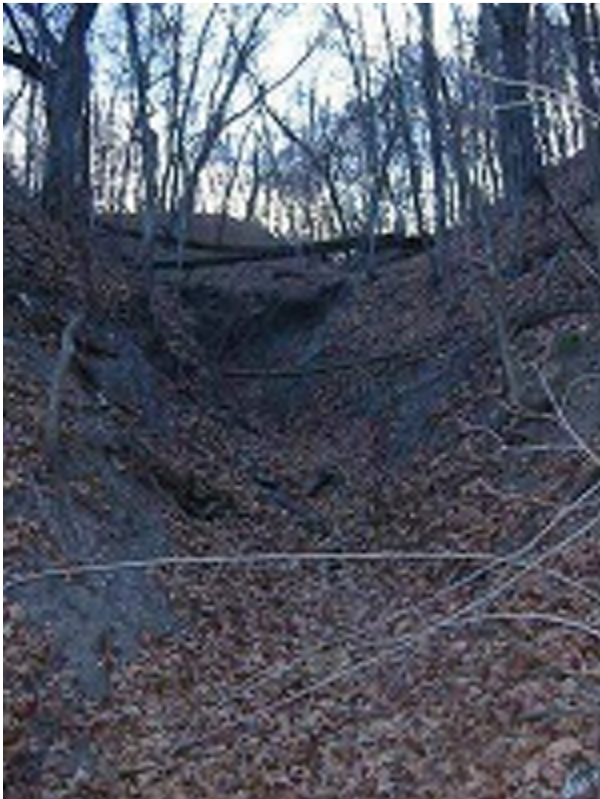
Waypoint 1183

Finger tip, sizeable erosion whole finger

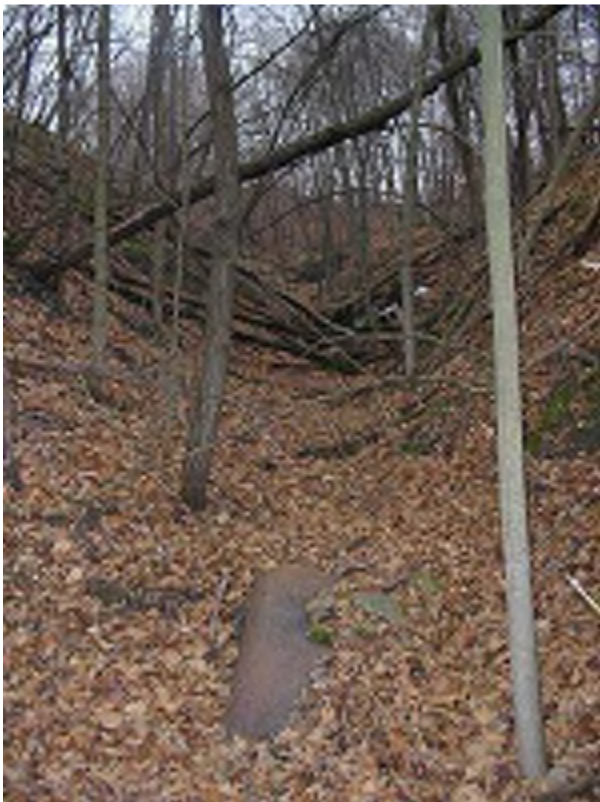
Waypoint 1185

Deep channel outlet w/trash/significant

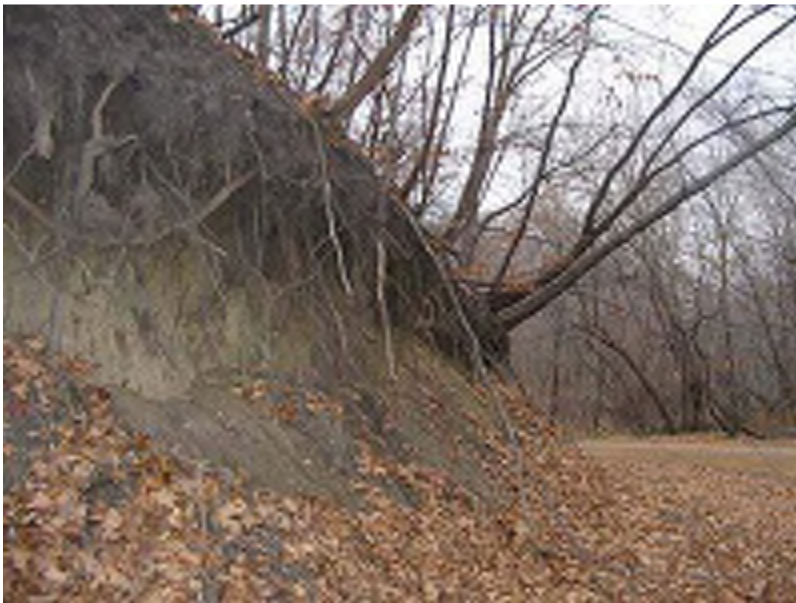
Waypoint 1187

Under cut bank/erosion problem along entire driveway

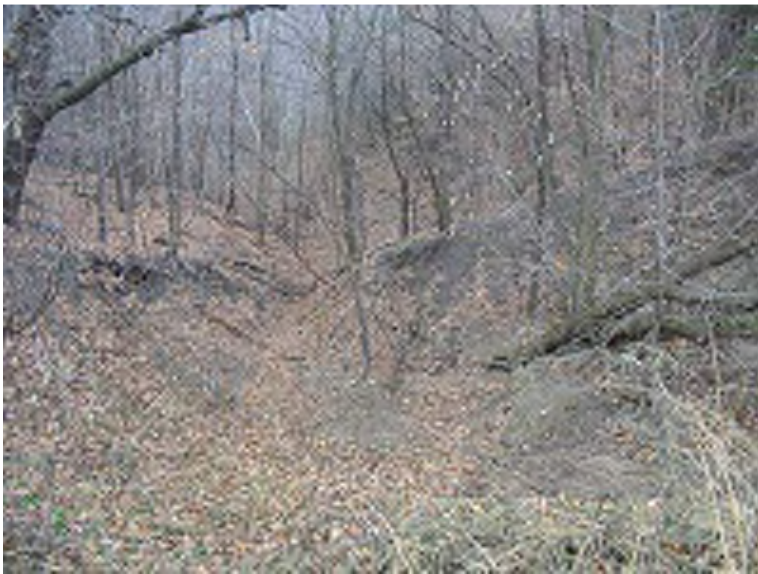
Waypoint 1189

Deep cut channel, severe erosion/large amount of llama feces in channel from llama farm

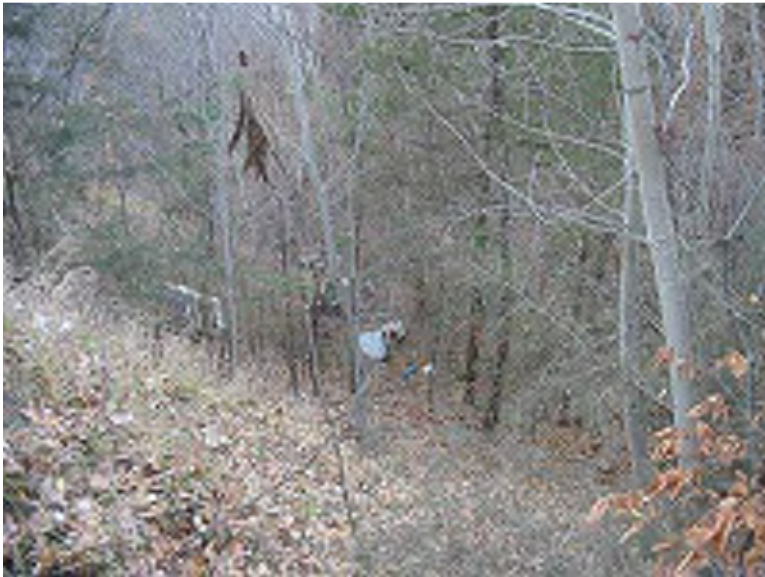
Waypoint 1190

Deep channel w/severe erosion and copious amounts of feces/straw on hillside and trash

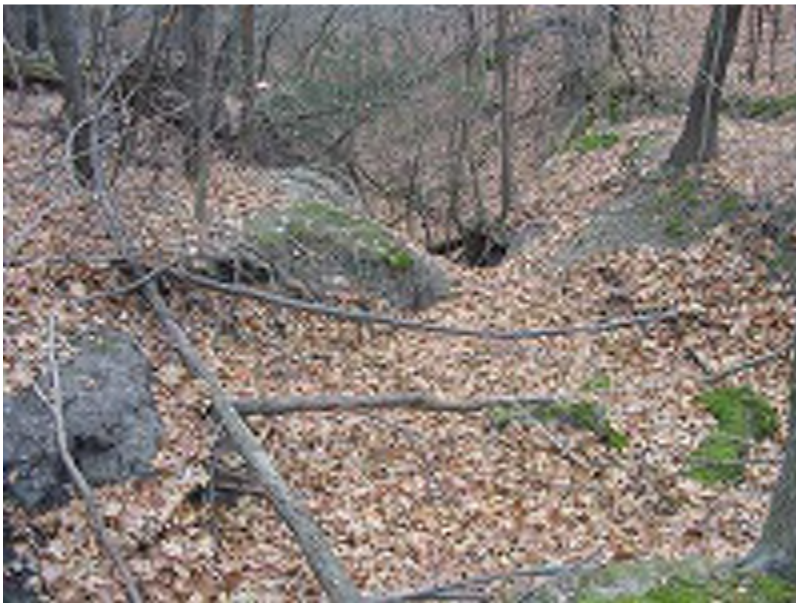
Waypoint 1191

Deeply eroded finger

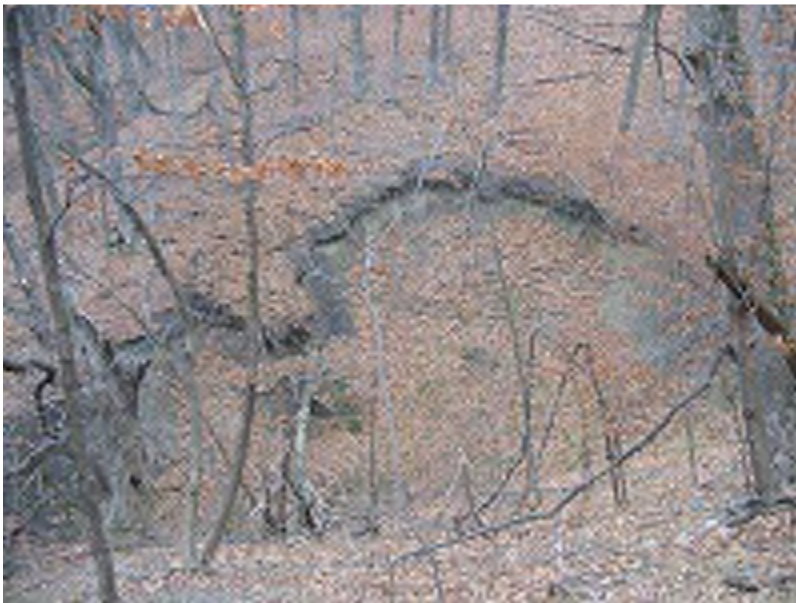
Waypoint 1192

Eroded bank

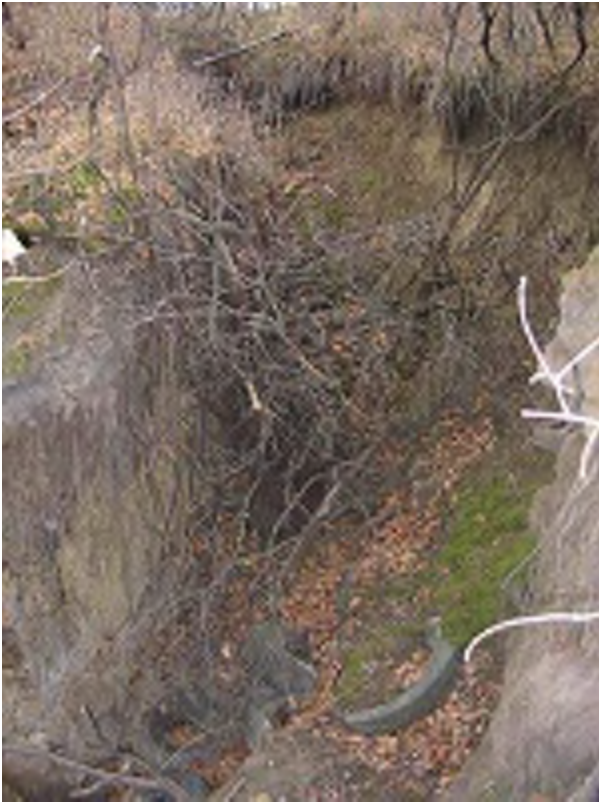
Extreme channel tires piled up in gully

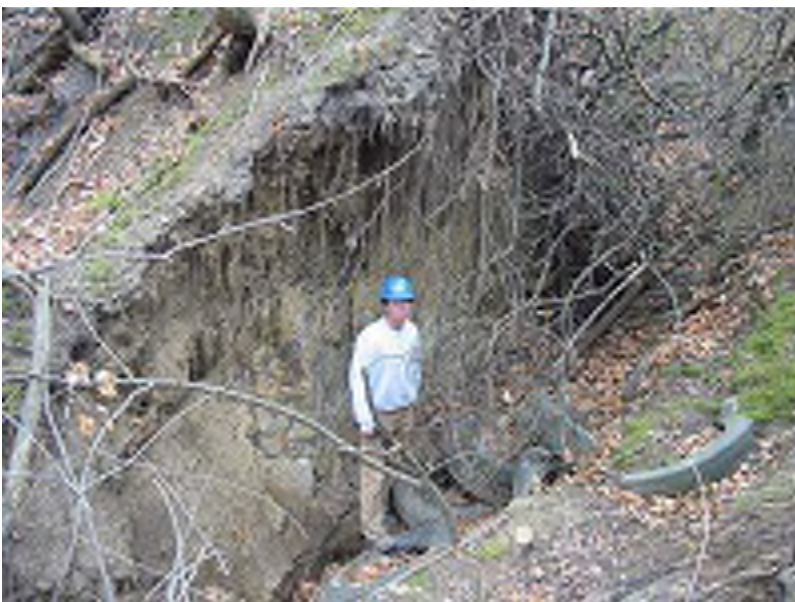
Extreme channel tires piled up in gully

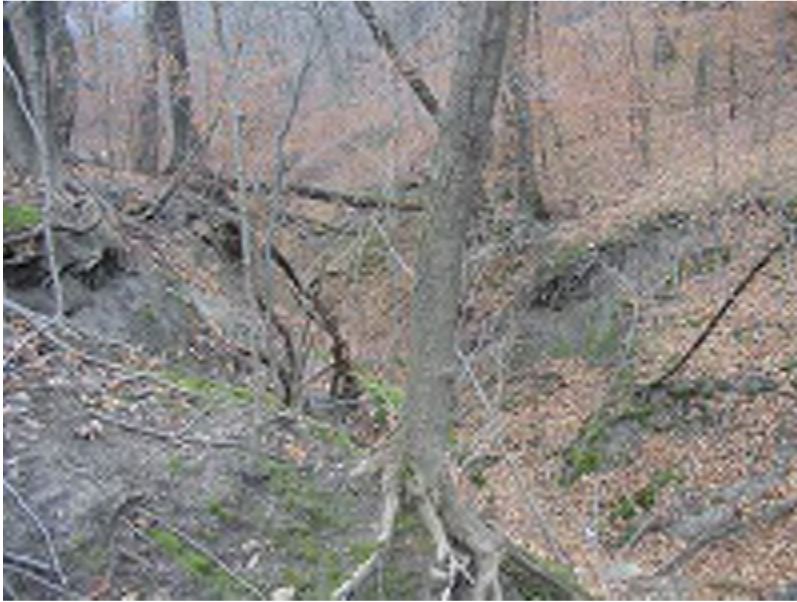
Eroded channel view from WP1192

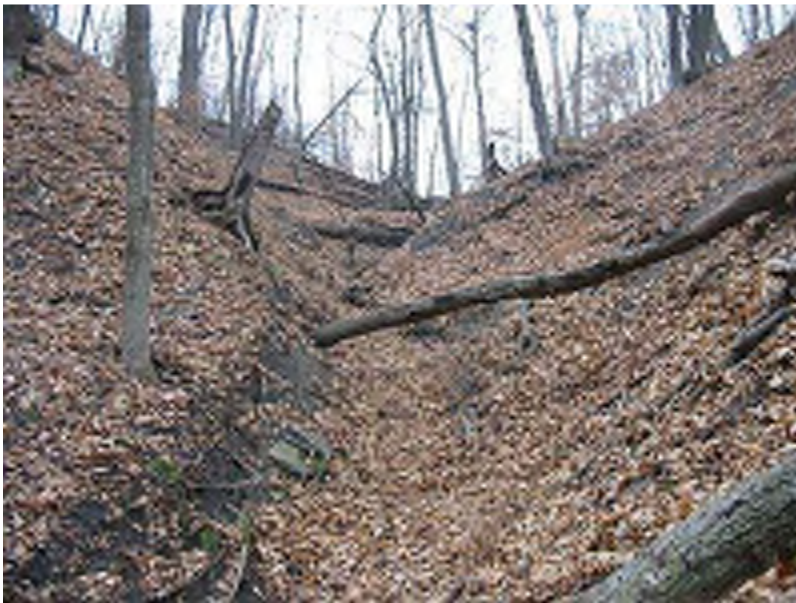
Waypoint 1193

Some erosion along finger
