Appendix K: Lower Minnesota River Watershed District: Gully Inventory

Gully Inventory Map
 Area #1
 Lower Minnesota River Watershed District
 Watershed Management Plan

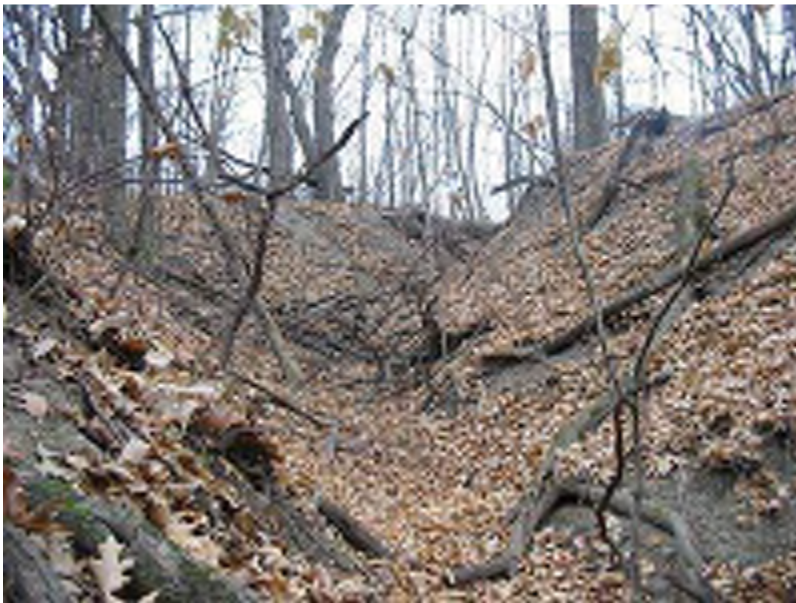
Waypoint 1194

Finger strongly eroded banks

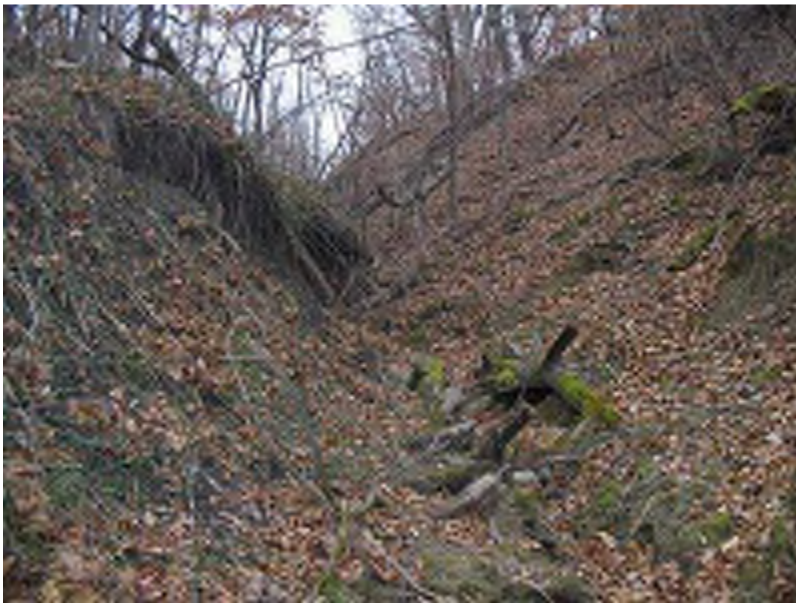
Waypoint 1199

End of extremely eroded channel w/tires on top

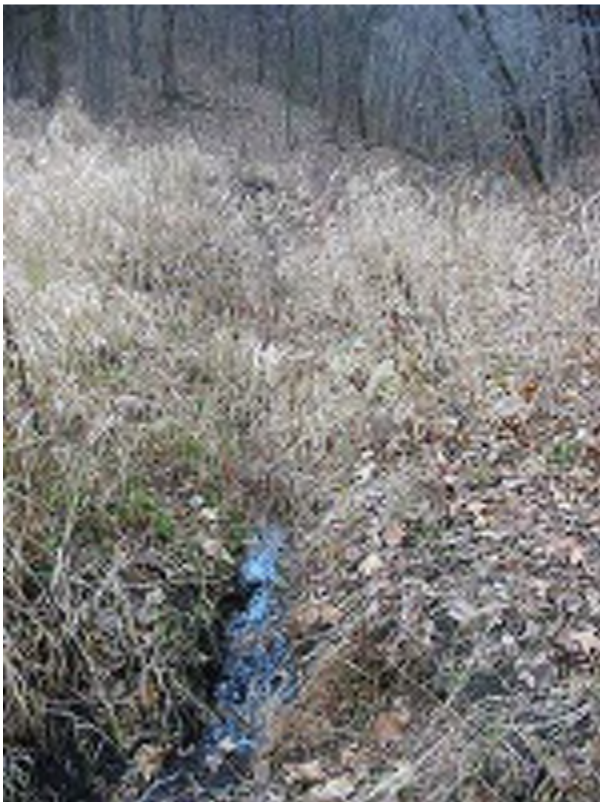
Spring at end of marsh

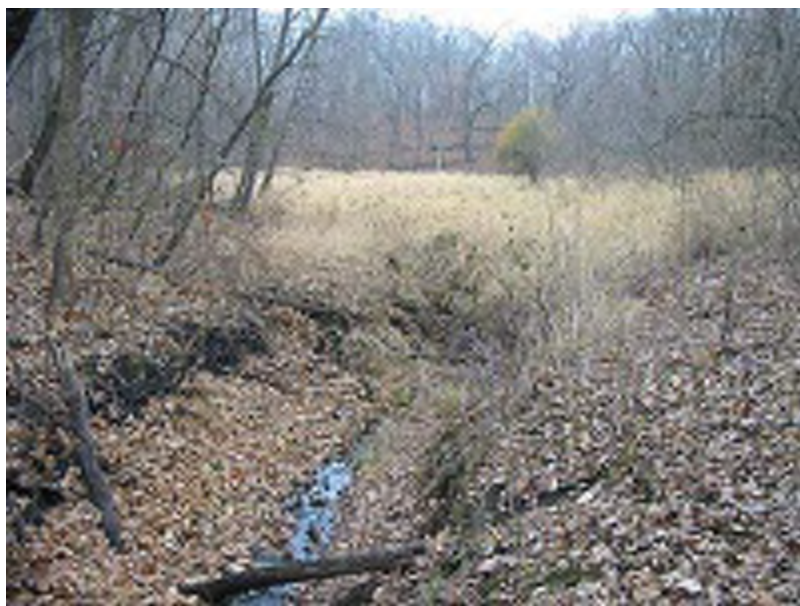
Spring at end of marsh

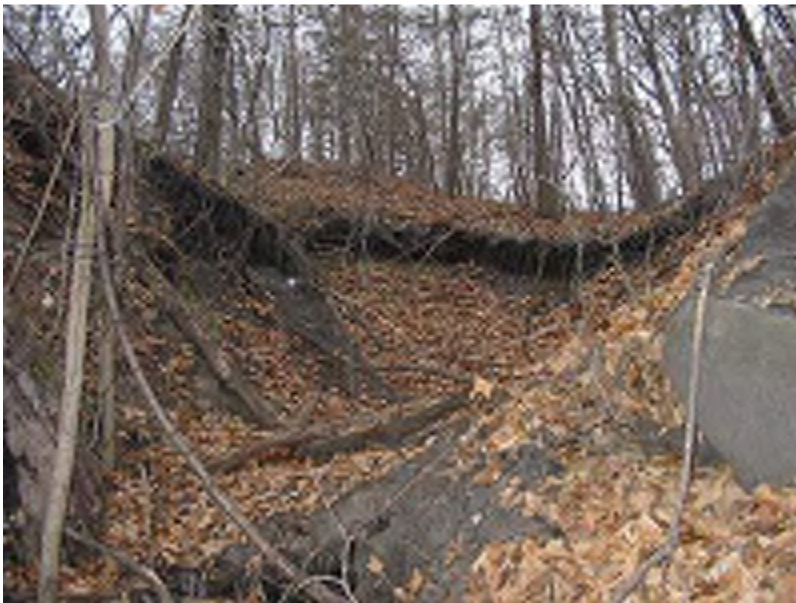
Waypoint 1201

Severely undercut stream bank

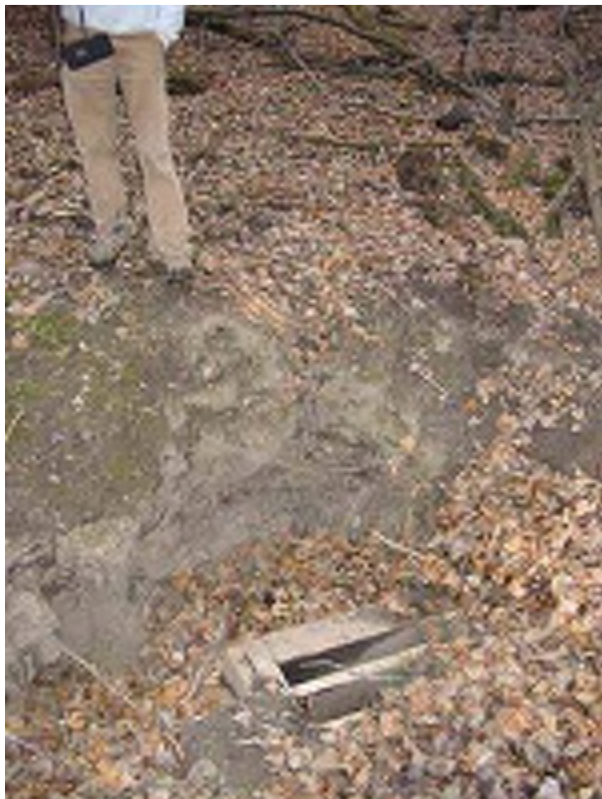
Waypoint 1202

End of huge channel system/box culvert

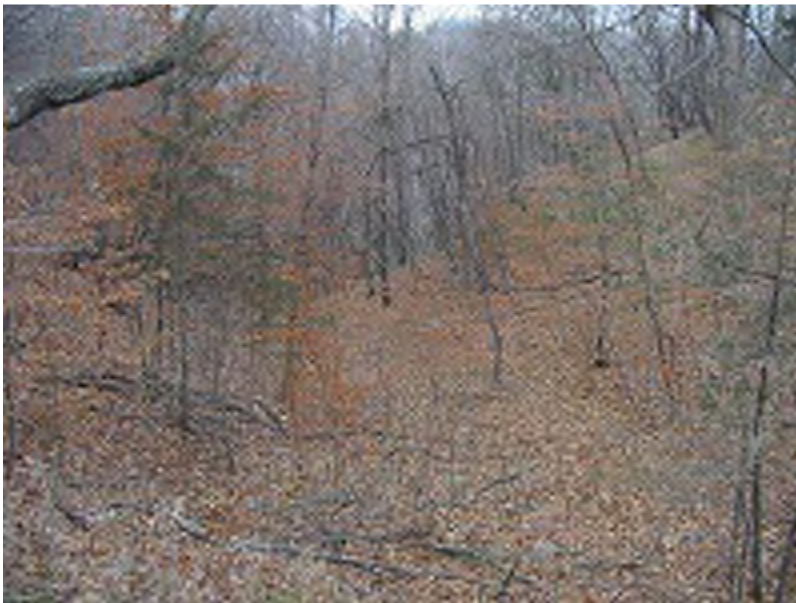
Waypoint 1203

Gully with minor erosion

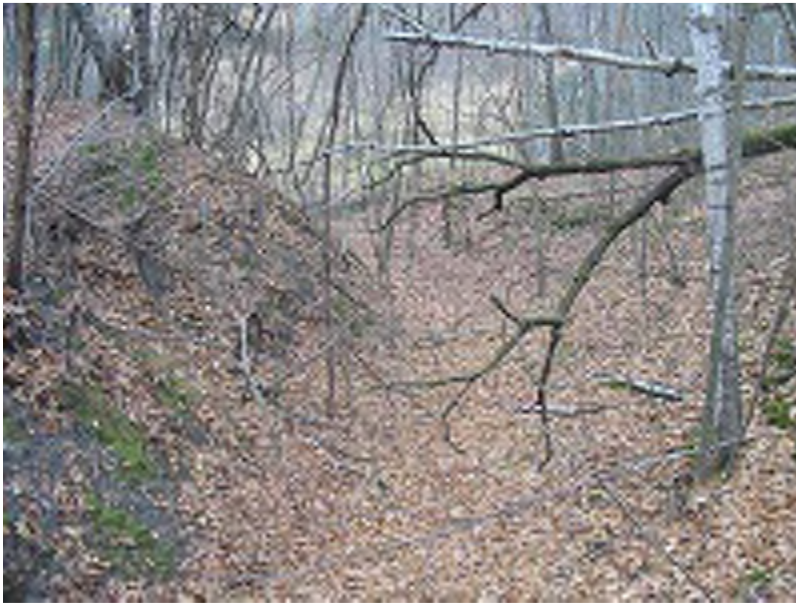
Waypoint 1204

Start of severe erosion in gully

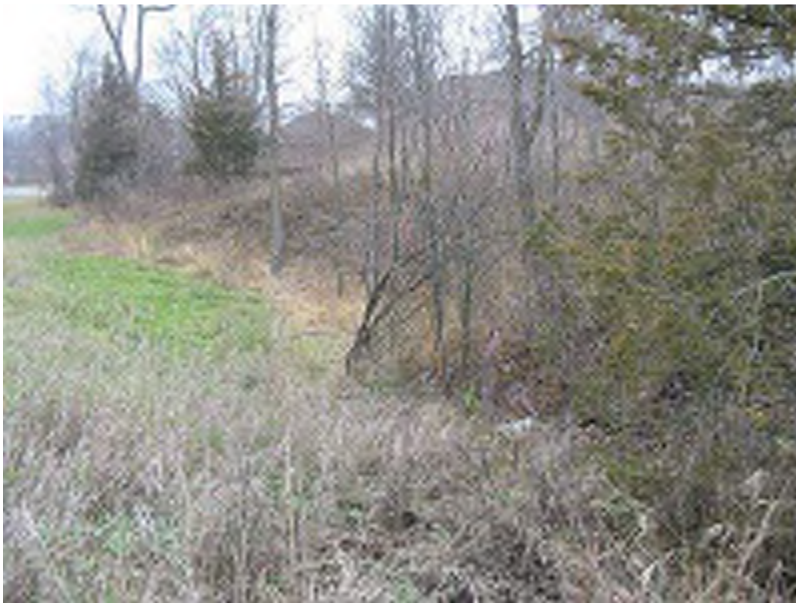
Waypoint 1206

Old gully

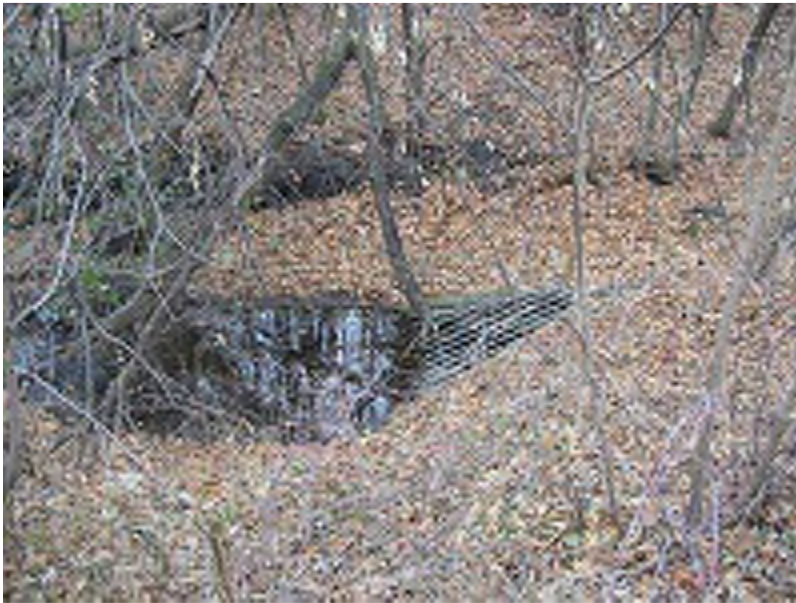
Waypoint 1207

Culvert on side of road

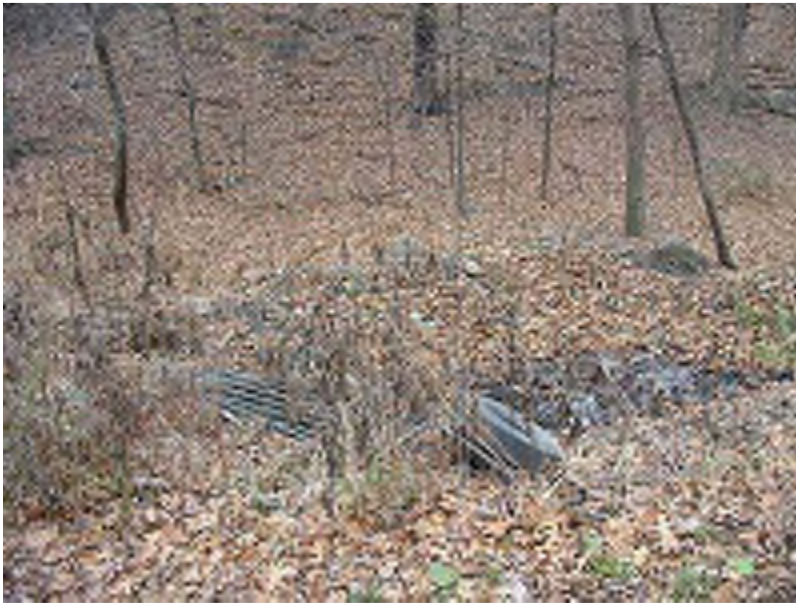
Waypoint 1208

Culvert entrance on side of road

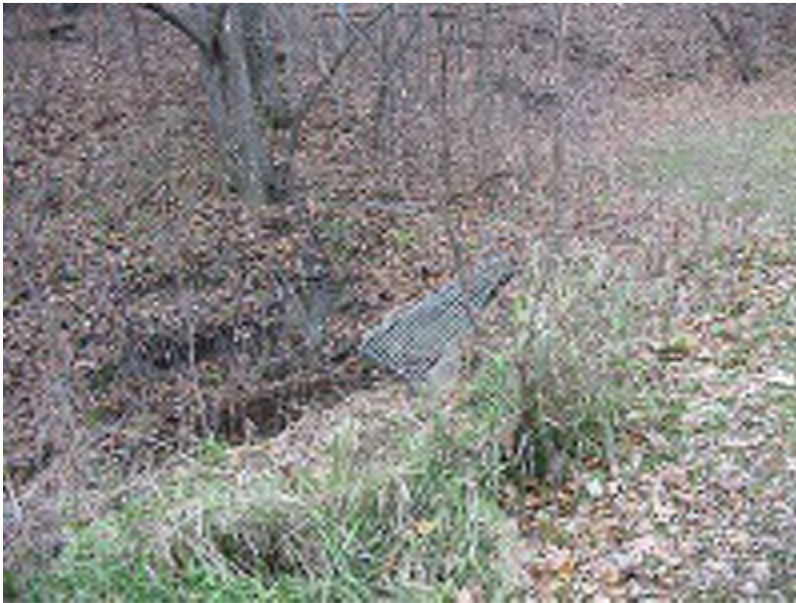
Waypoint 1209

Culvert exit

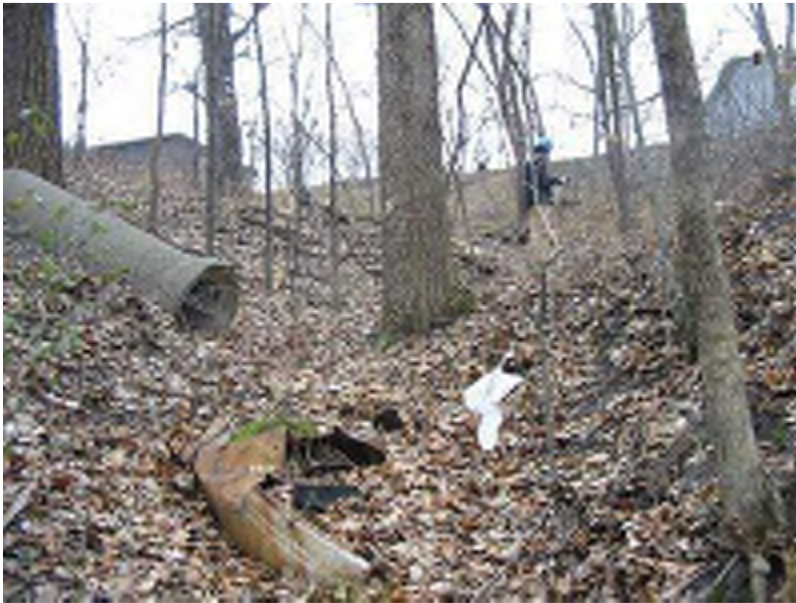
Waypoint 1210

Gully w/minor erosion/trash

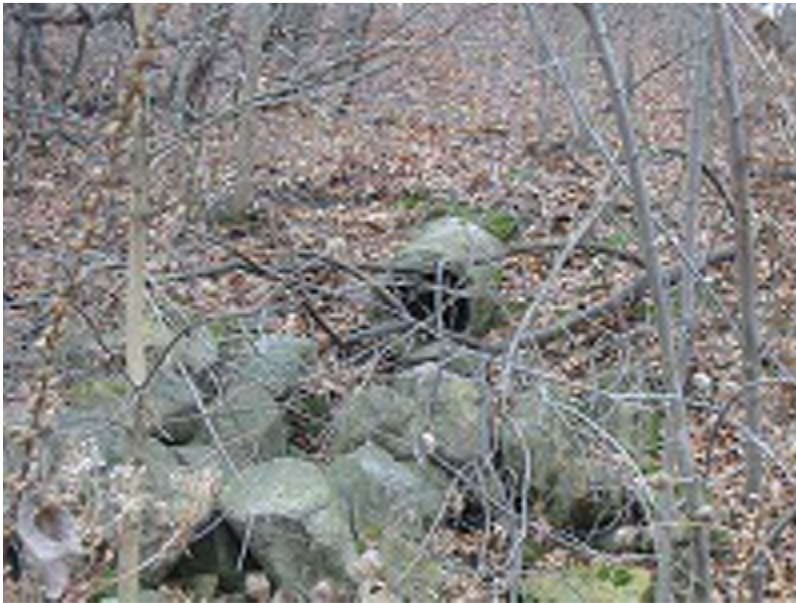
Waypoint 1211

Drain pipe exit

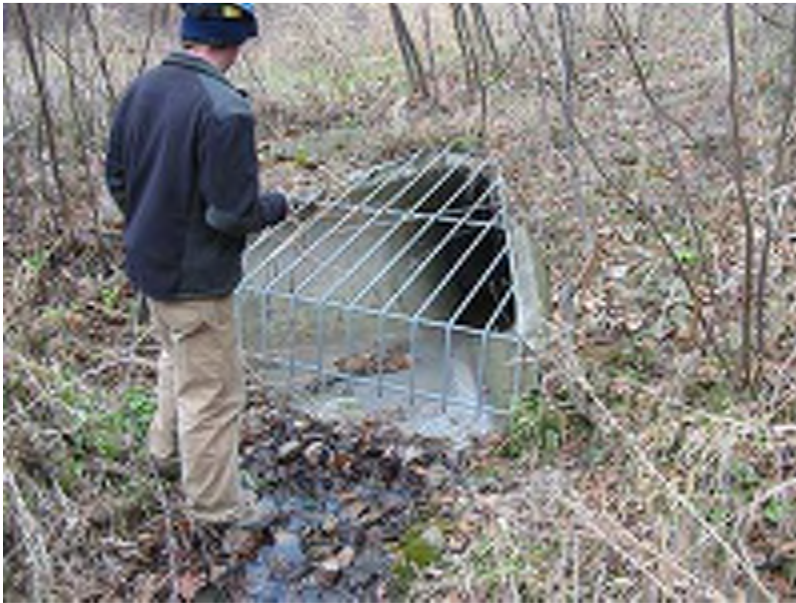
Waypoint 1212

Culvert entrance on side of road

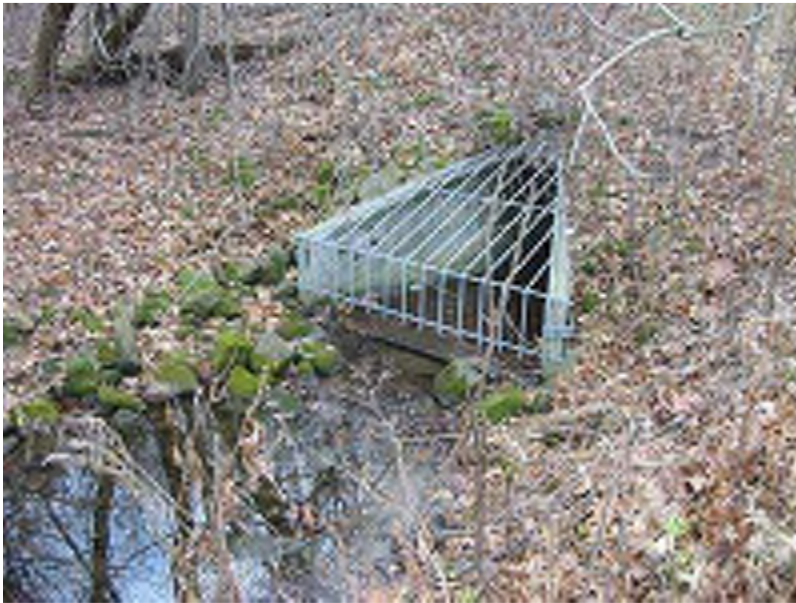
Waypoint 1213

Culvert exit

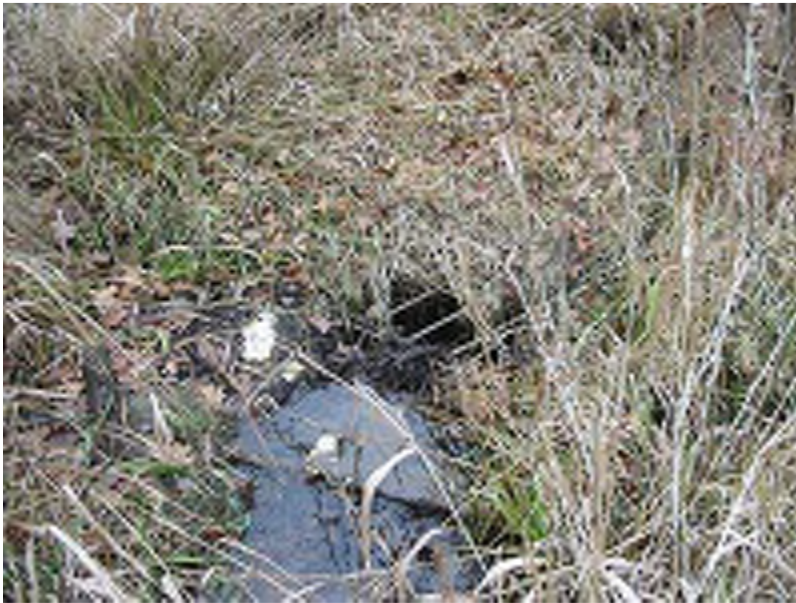
Waypoint 1214

Culvert entrance on side of road

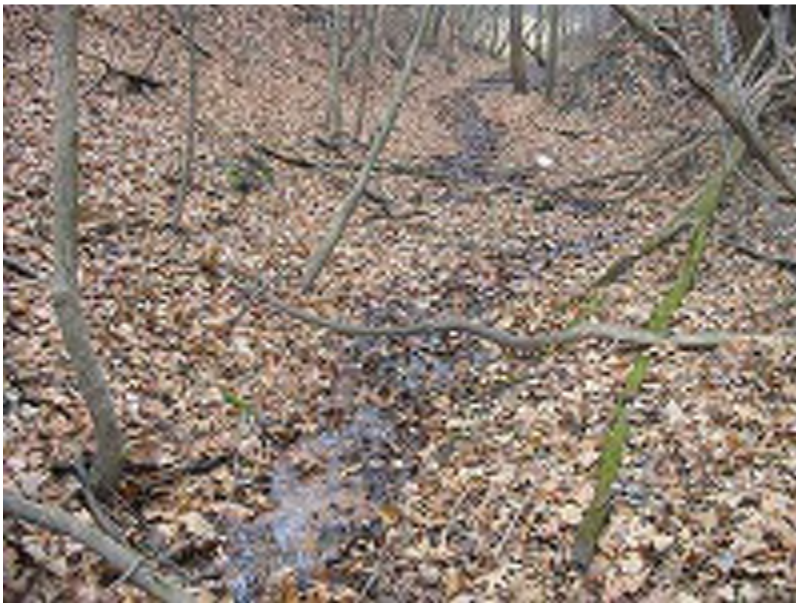
Waypoint 1215

Spring at end of marsh

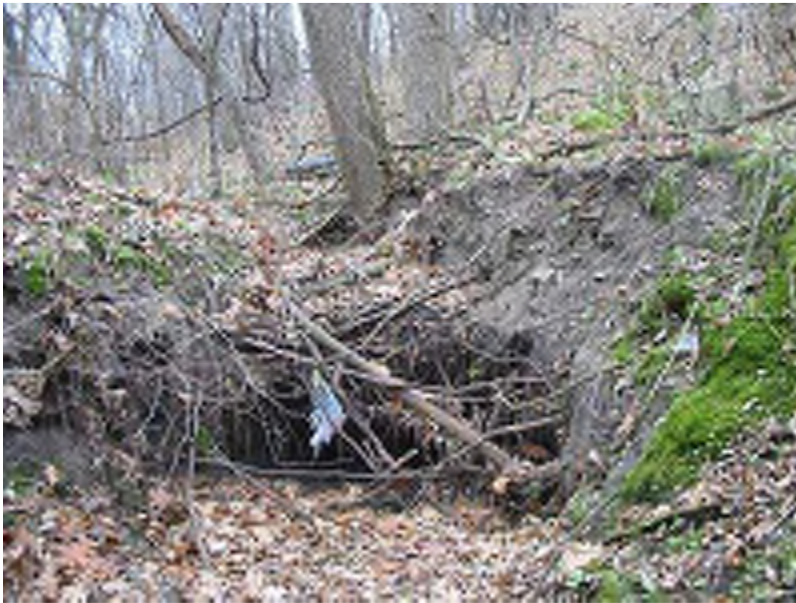
Waypoint 1216

Washout area w/trash, tires, cans, etc.

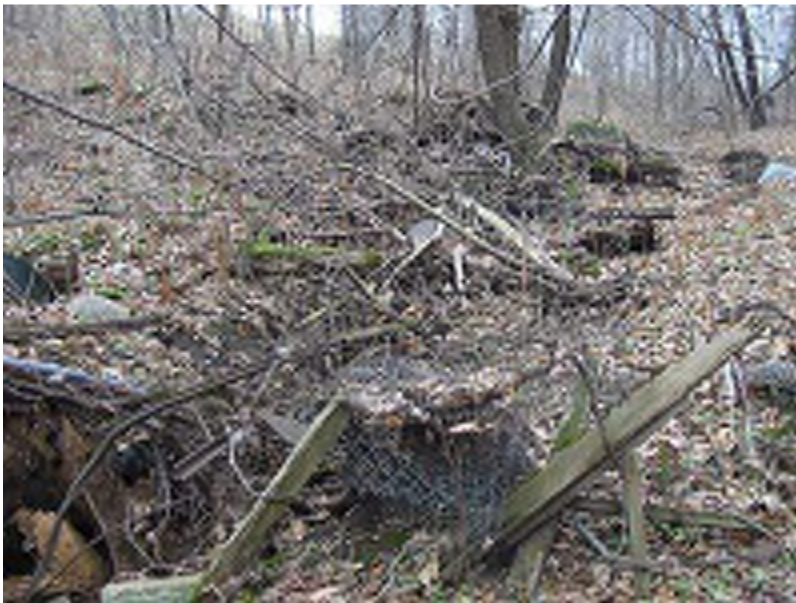
Waypoint 1217

Scrap metal/trash

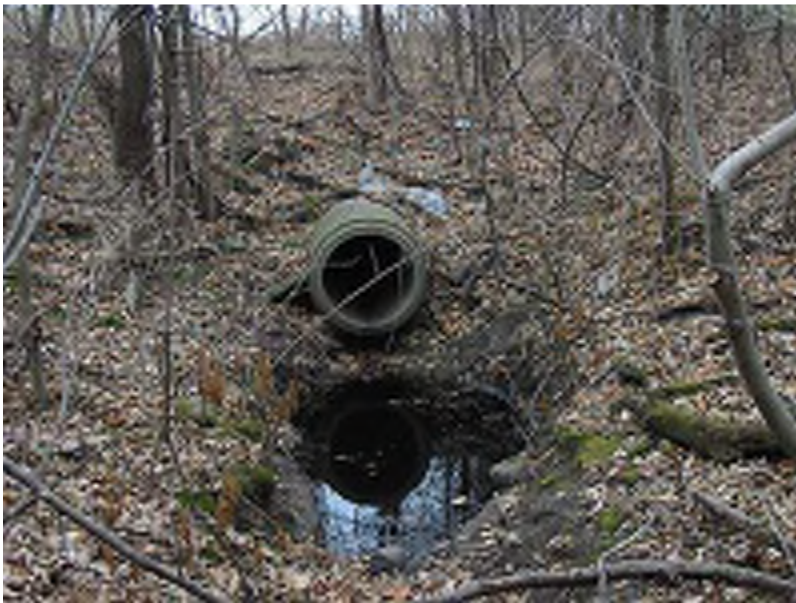
Waypoint 1218

Drain pipe w/horribly black water/top of gully

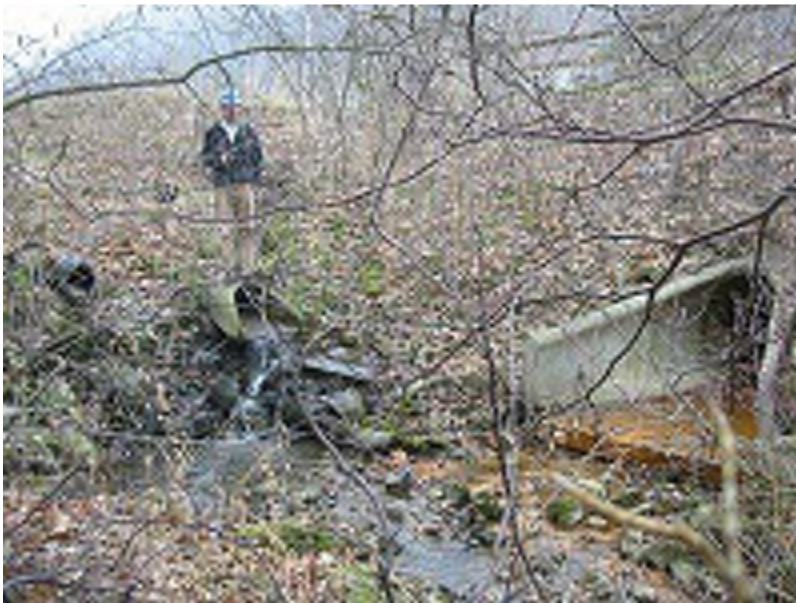
Waypoint 1219

4 pipe outlets, lots of iron deposits

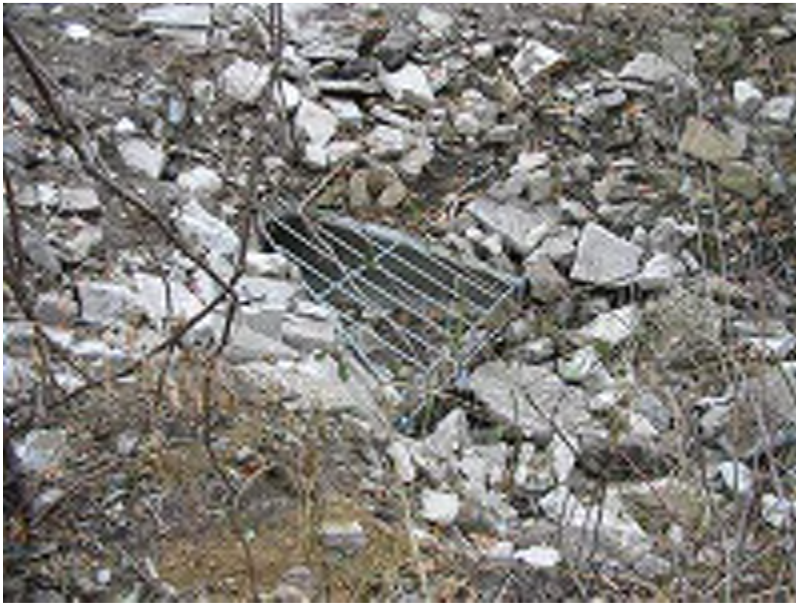
Waypoint 1220

Culvert exit

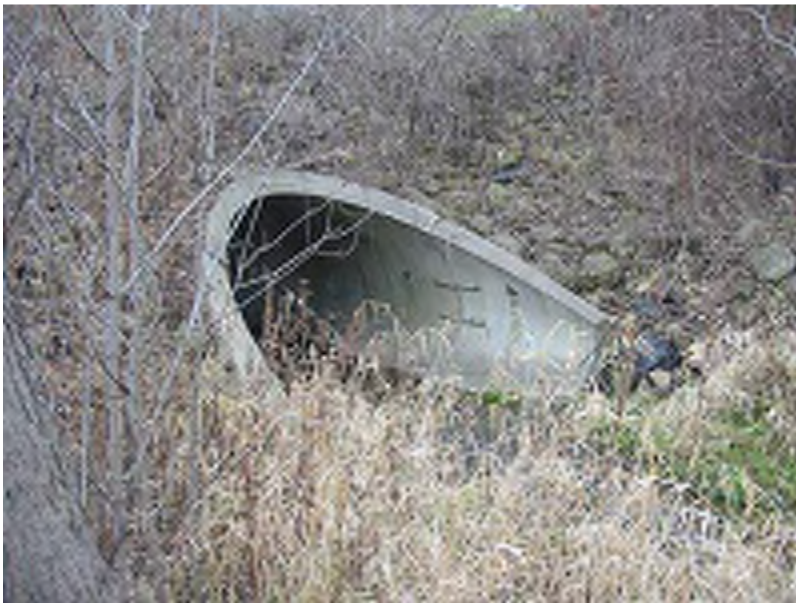
Waypoint 1221

Entrance bridge tunnel

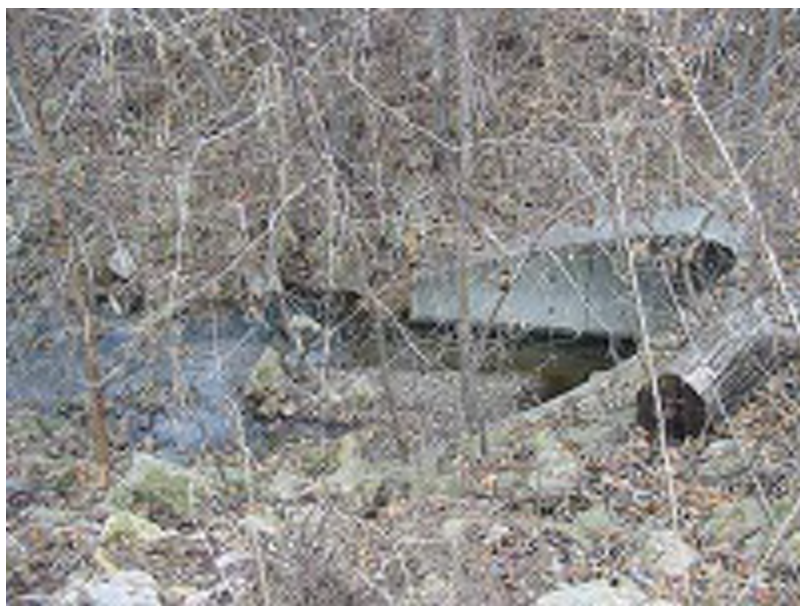
Exit

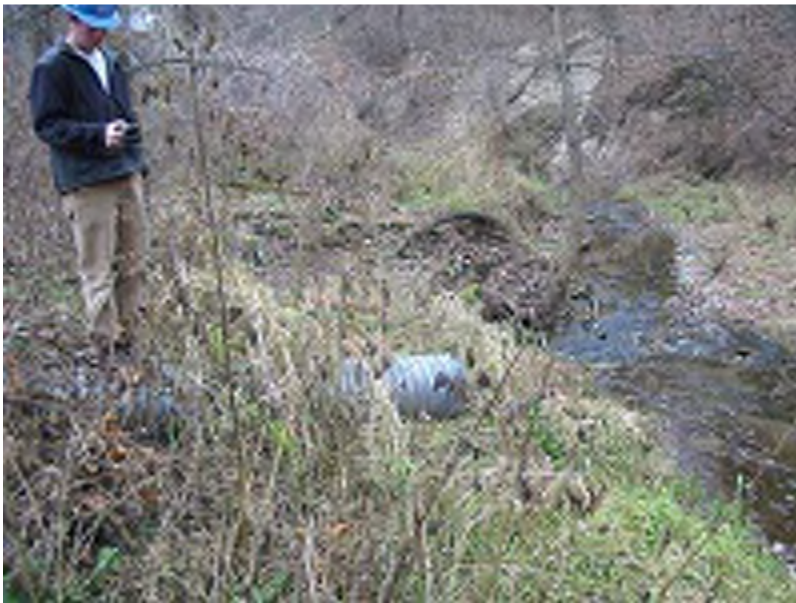
Waypoint 1222

Drain pipe

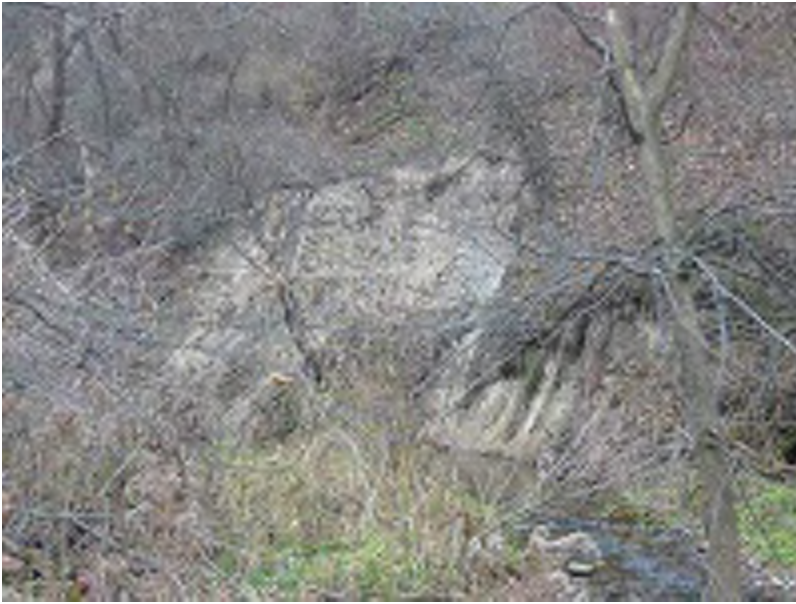
Eroded bank

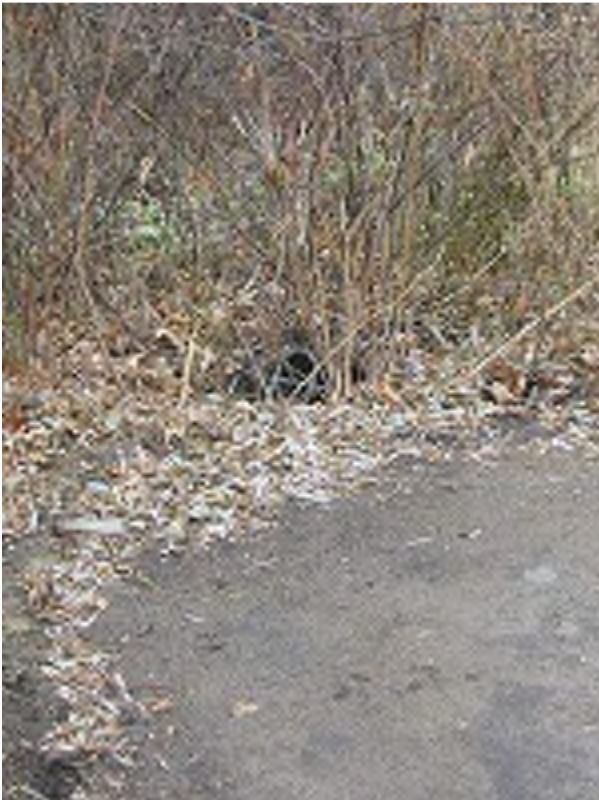
Drain pipe entrance at end of driveway

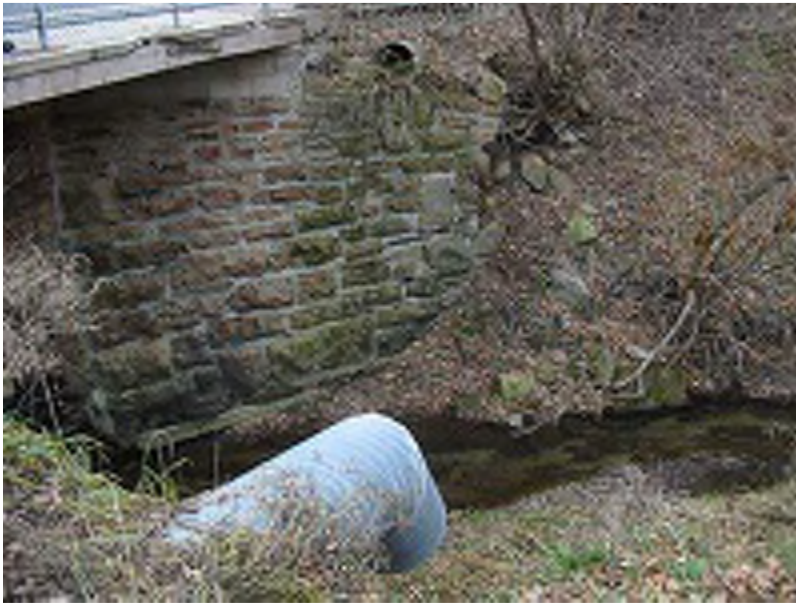
Waypoint 1223

2 pipes draining from street into river

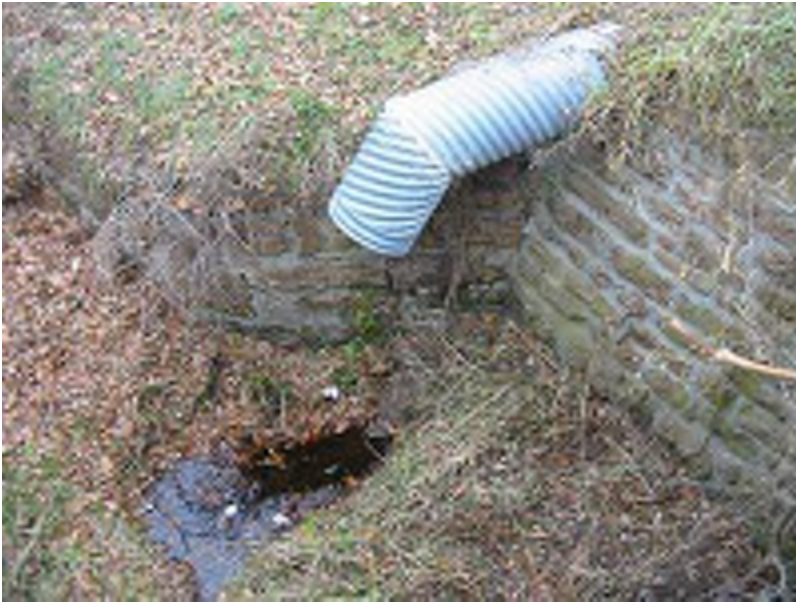
View of pipe from above

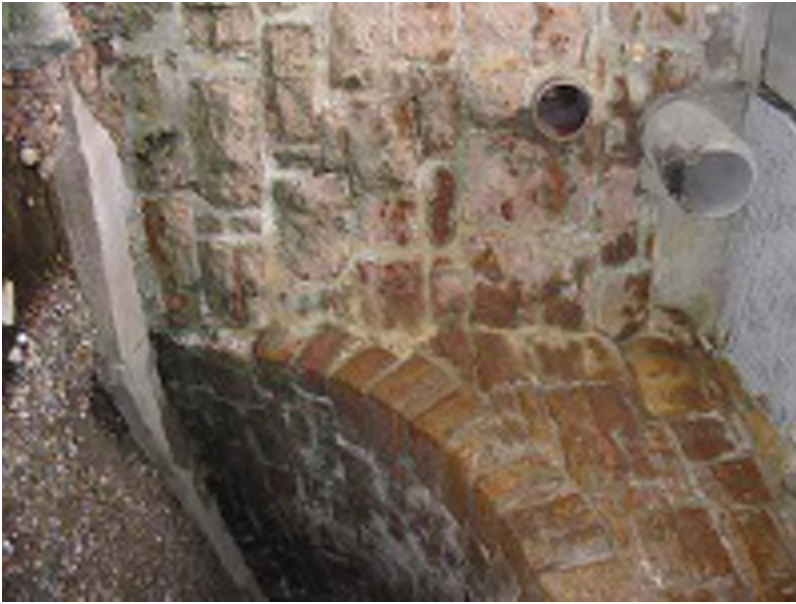
2 pipes draining into stream

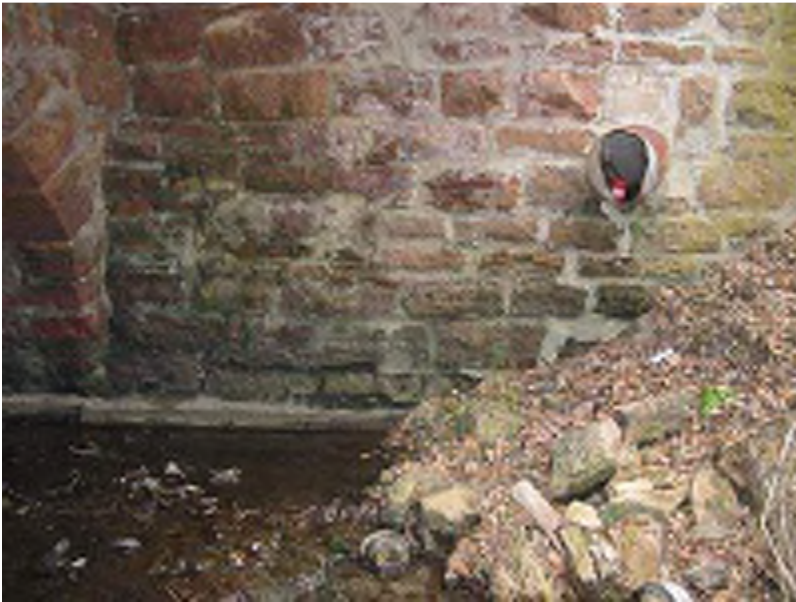
1 pipe draining into stream

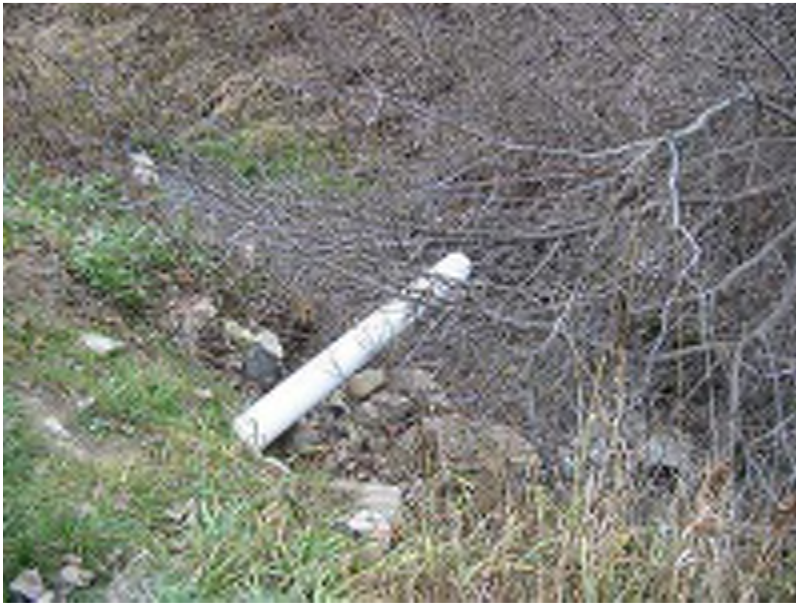
Waypoint 1224

Runoff from roof drains onto ground going into this pipe

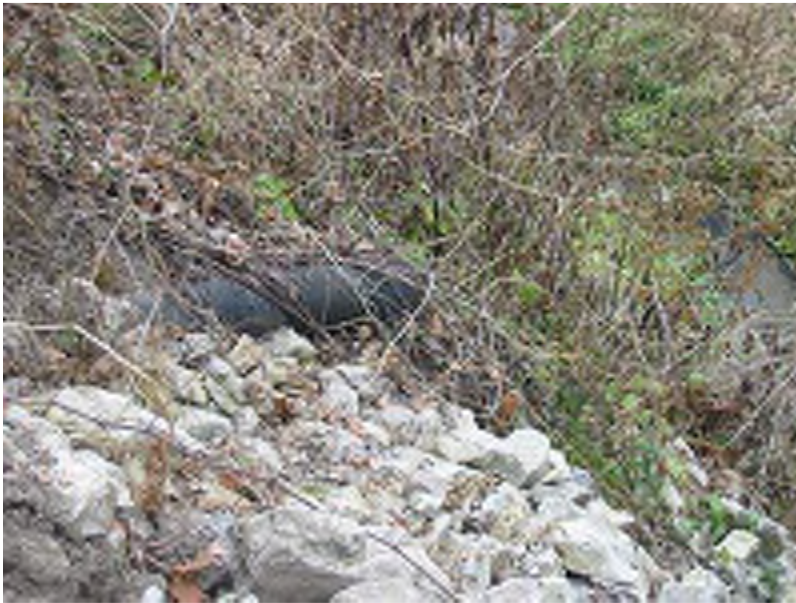
Waypoint 1225

Pipe draining into stream

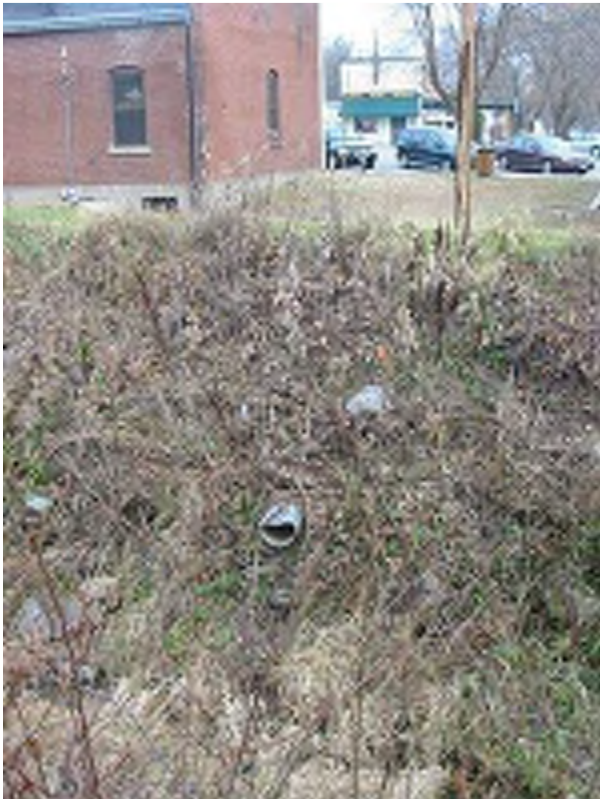
Waypoint 1226

Pipe draining into stream

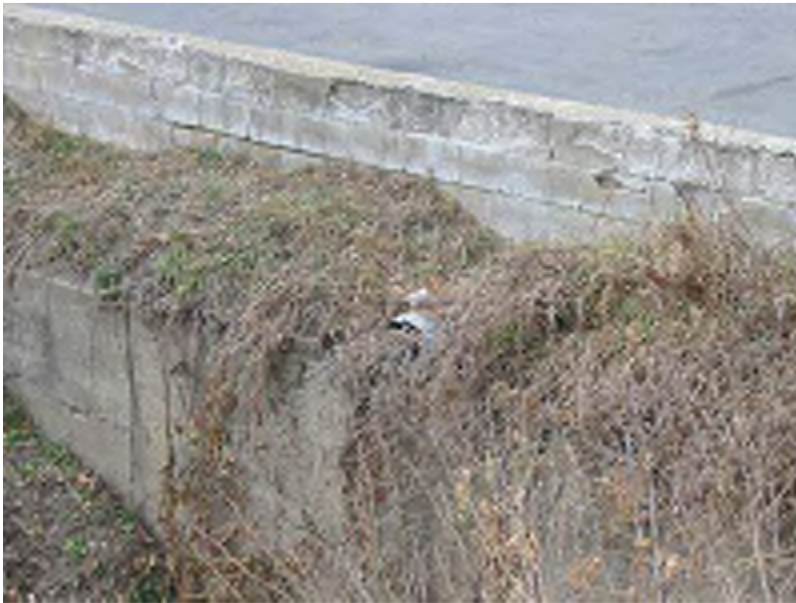
Waypoint 1227

Pipe from street into disposal

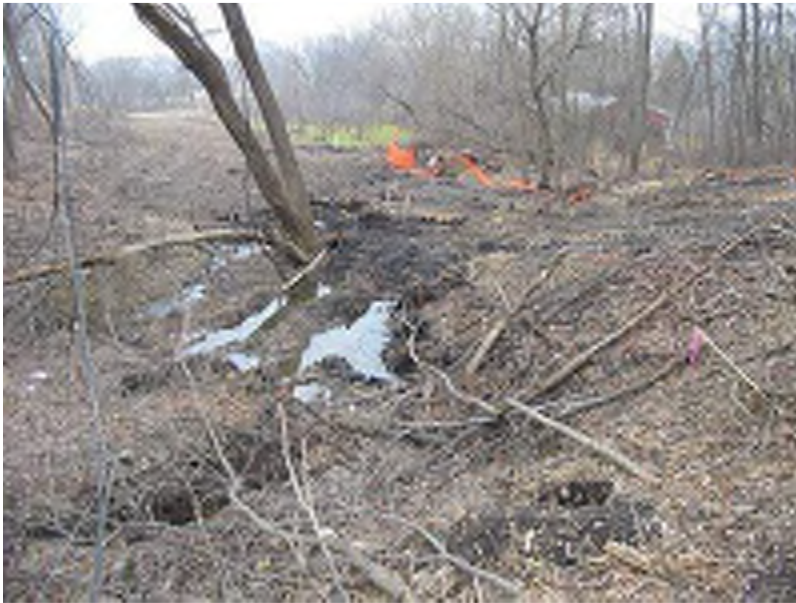
Waypoint 1228

Pipe outlet/groundwater seepage

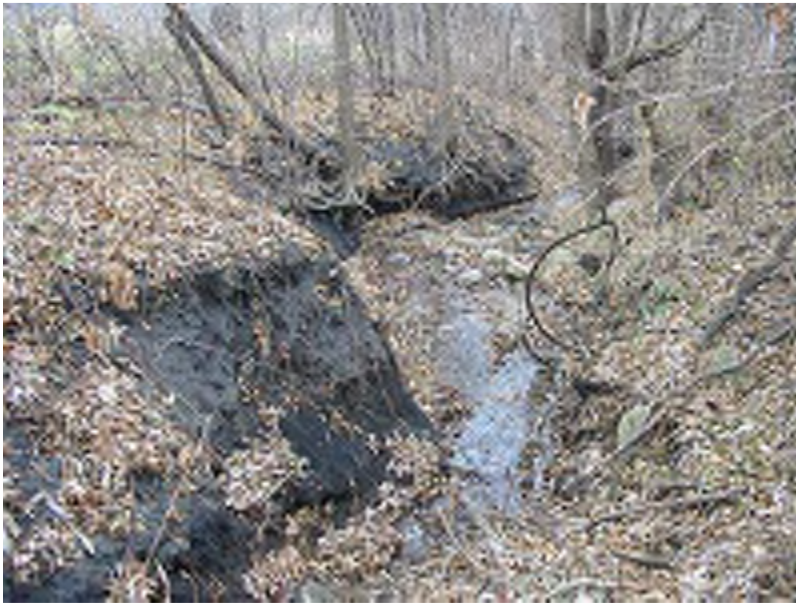
Waypoint 1229

Stream bank erosion

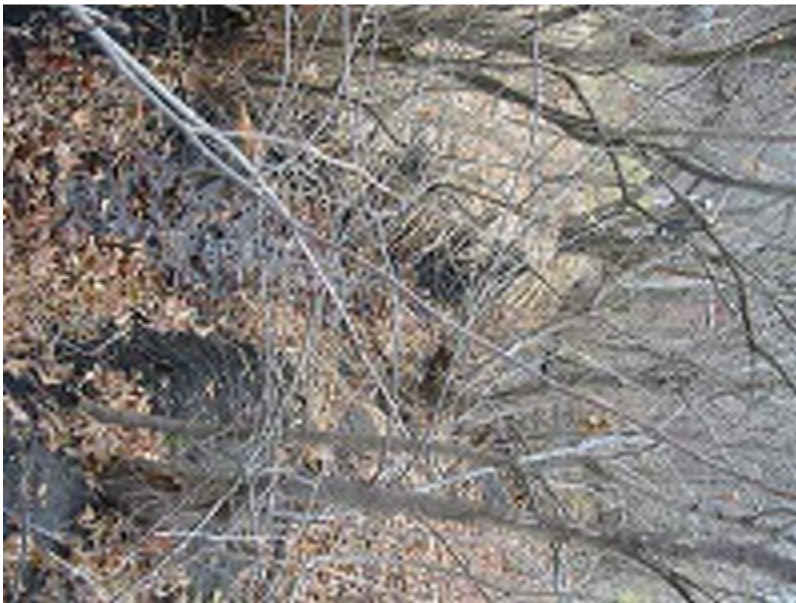
Waypoint 1230

End of water in stream/banks lined w/honeysuckle/buckthorn, easily removable

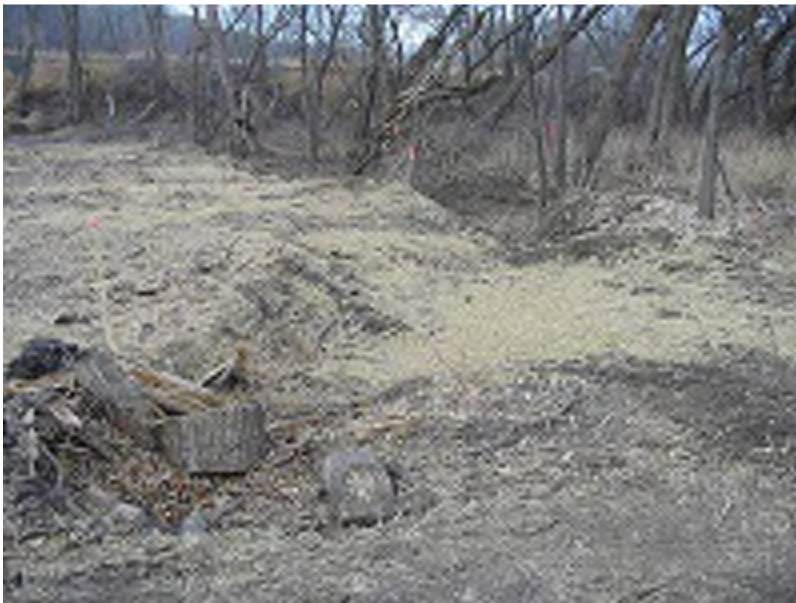
Waypoint 1231

Gully filled in with soil from construction

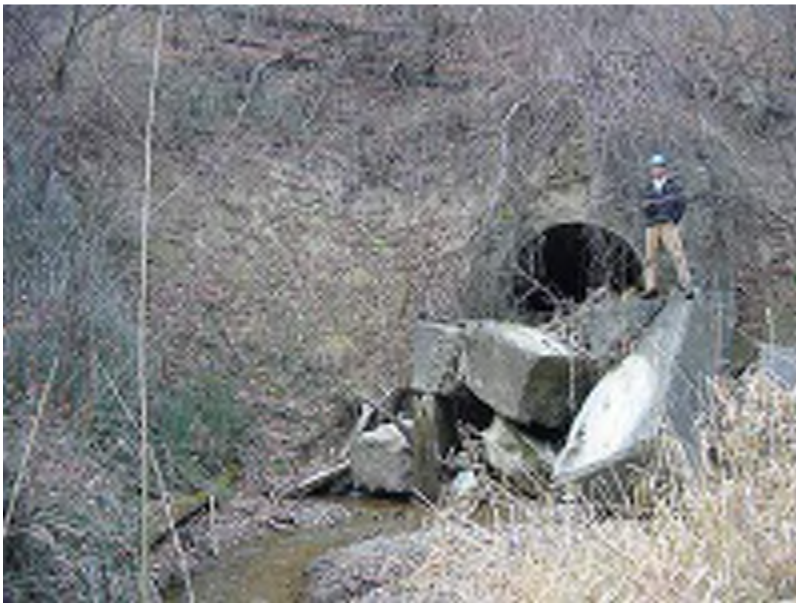
Waypoint 1232

Culvert exit w/erosion on bank

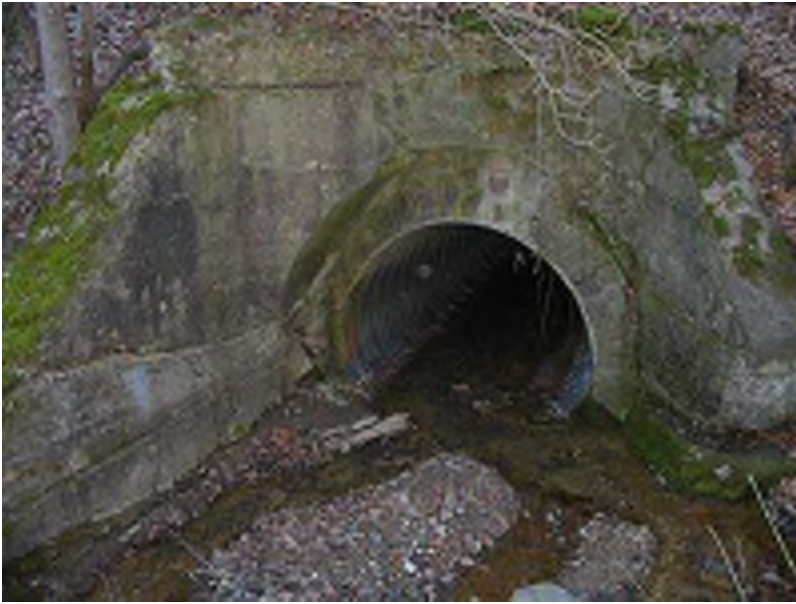
Culvert entrance

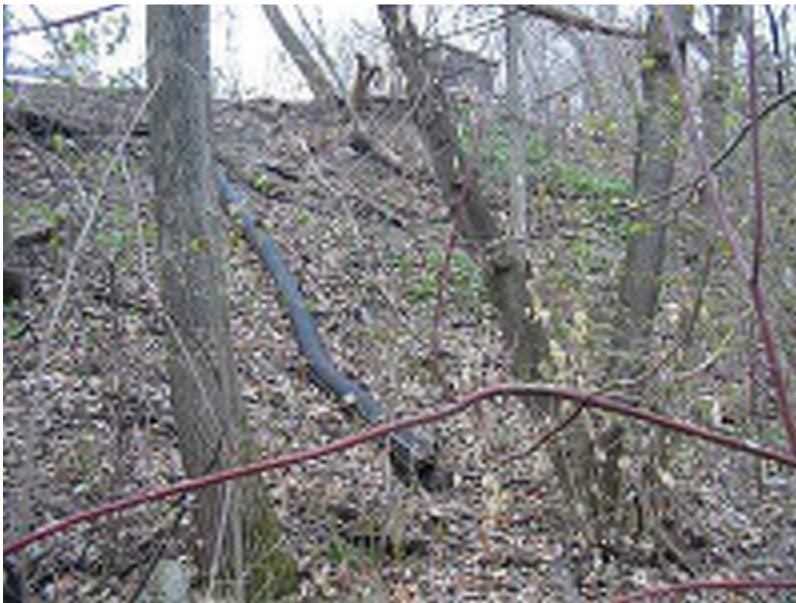
Waypoint 1233

Drain pipe

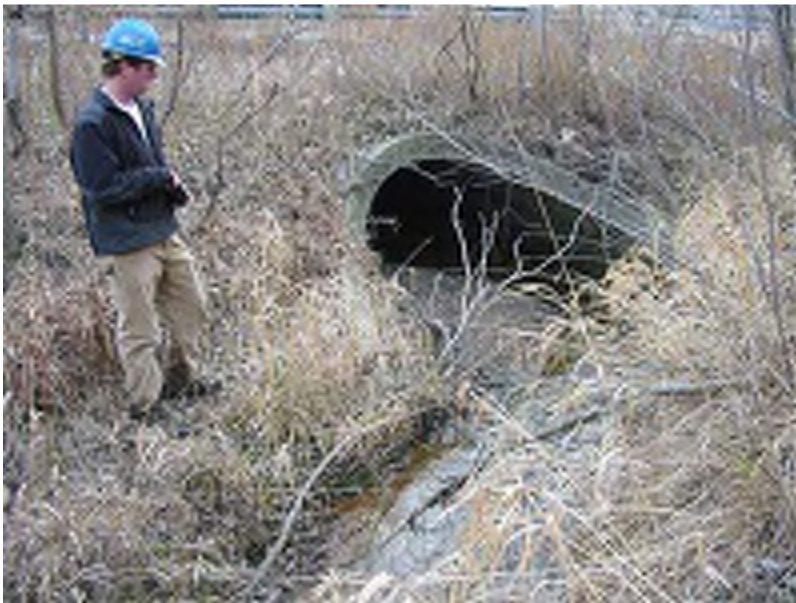
Waypoint 1234

Culvert under #212

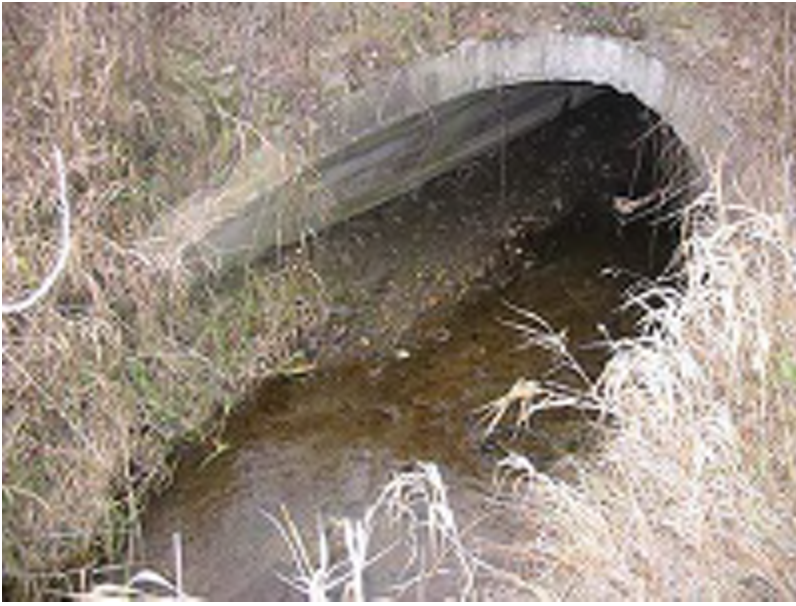
Culvert outlet under #212

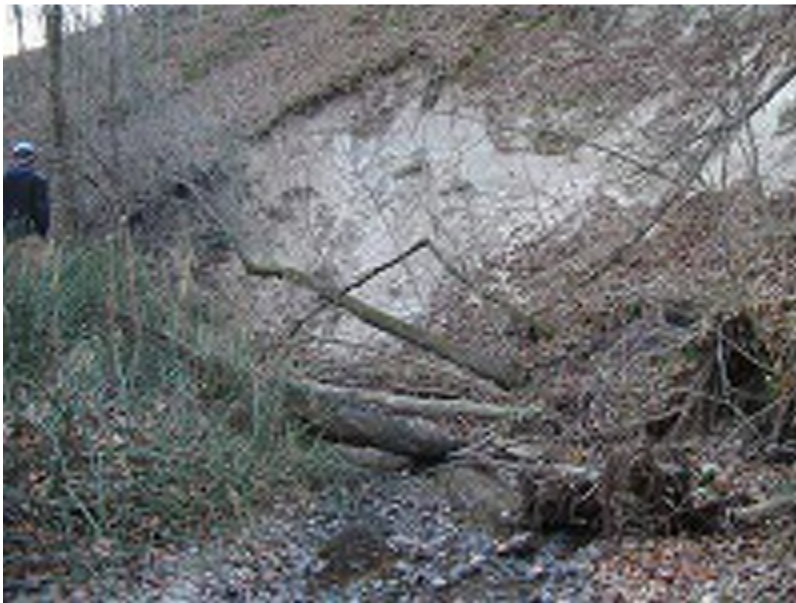
Waypoint 1235

Eroded bank very sandy

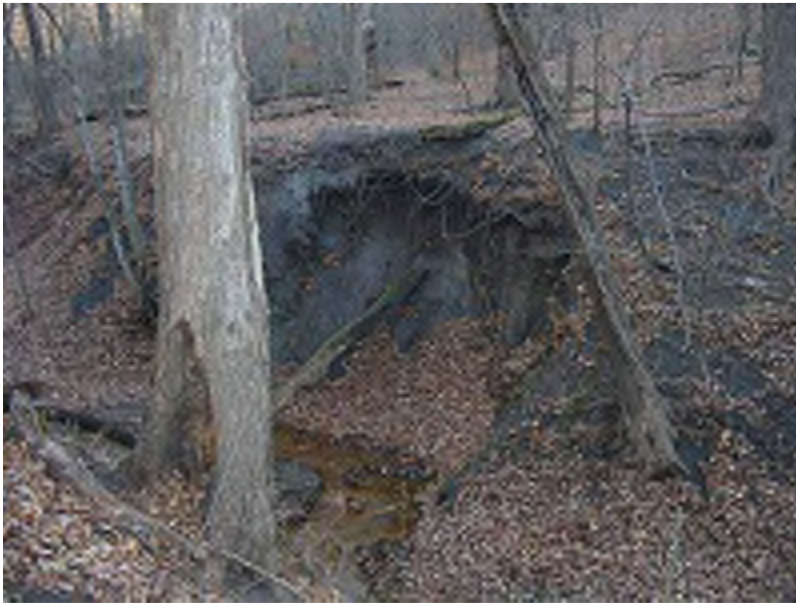
Waypoint 1236

Eroded stream bank/very ferrous stream
