Appendix K: Lower Minnesota River Watershed District: Gully Inventory

Gully Inventory Map
 Area #1
 Lower Minnesota River Watershed District
 Watershed Management Plan

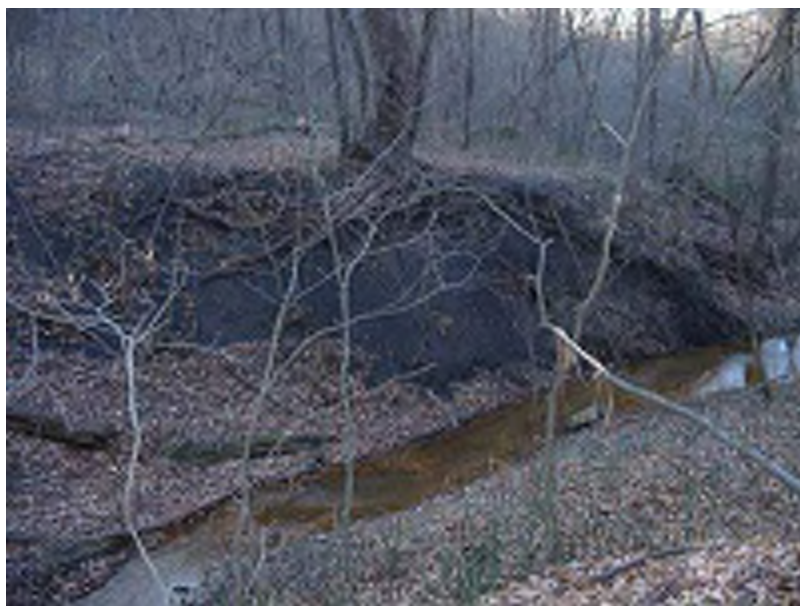
Eroded stream bank/very ferrous stream

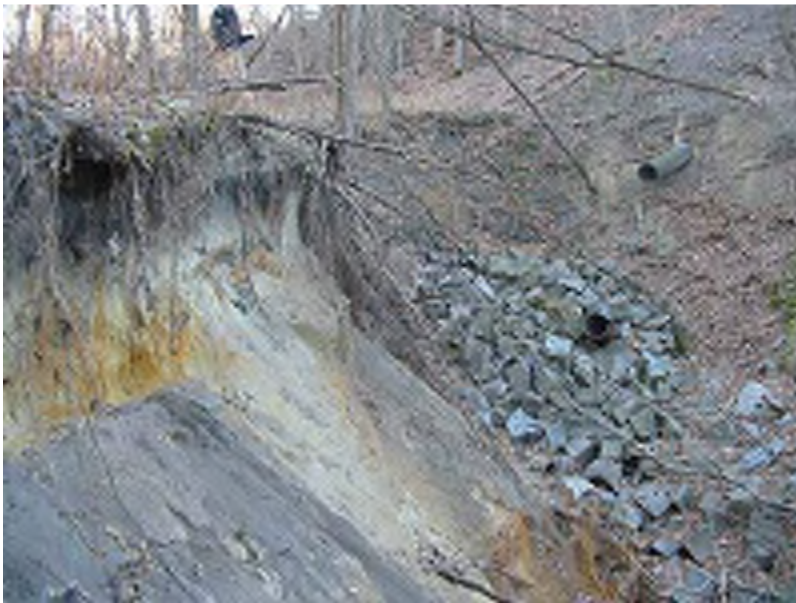
Waypoint 1237

Outlet pipe/severe erosion

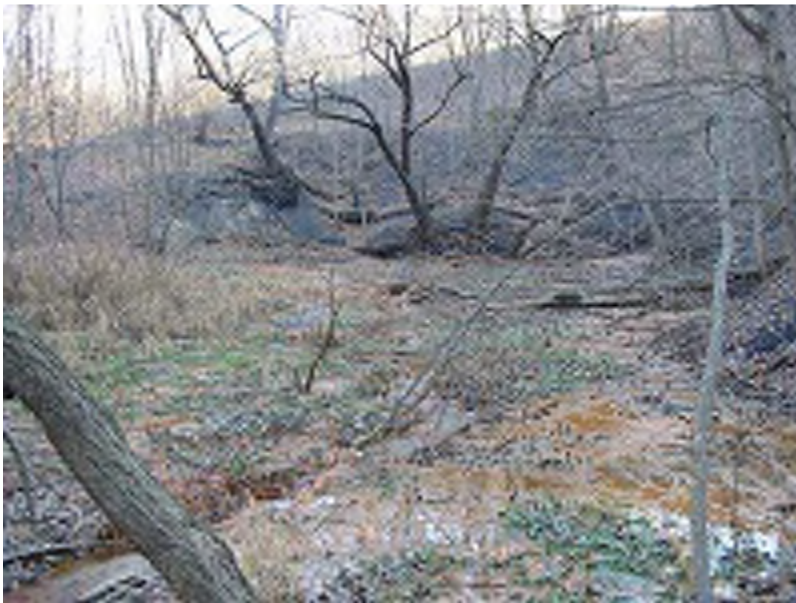
Waypoint 1238

Spring of ferrous stream

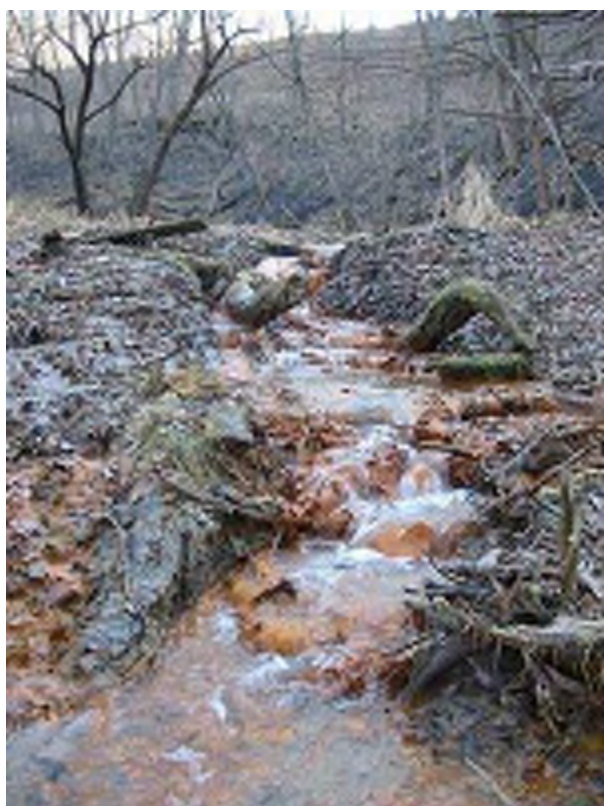
Sulfur smell

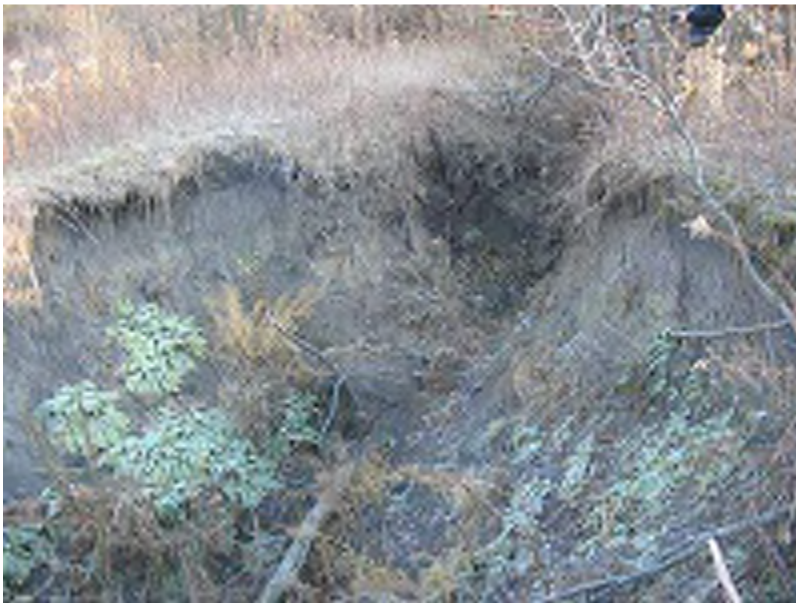
Waypoint 1239

Gully extreme erosion

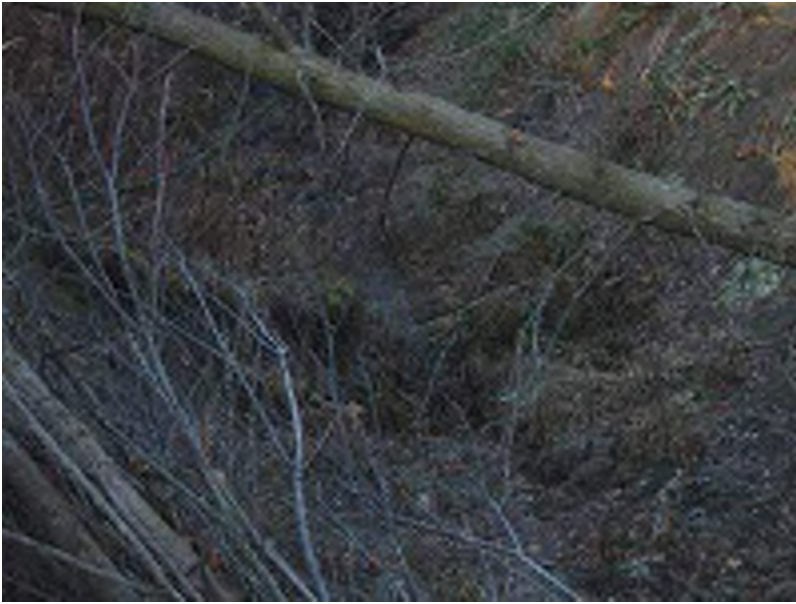
Spring

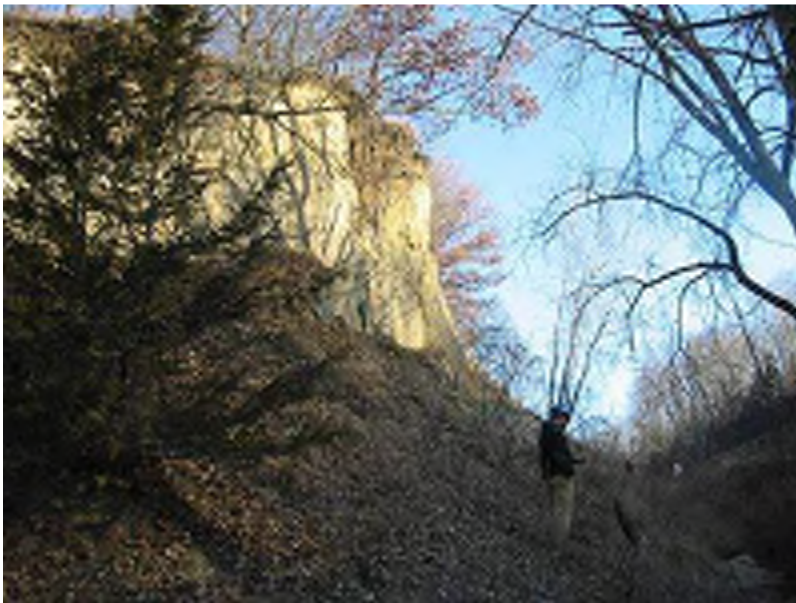
Waypoint 1240

Eroded hillside glacial fill along trail severe

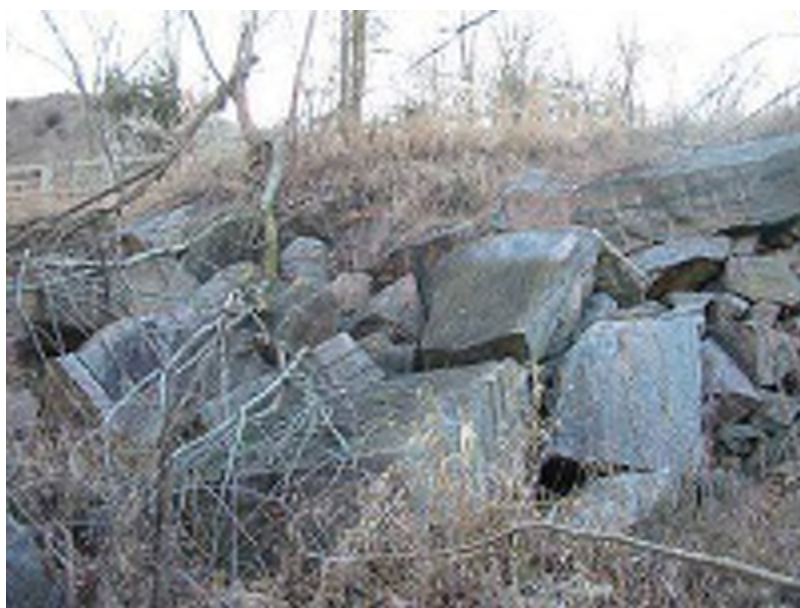
large boulders (from quarry?) to prevent erosion, beginning of gully

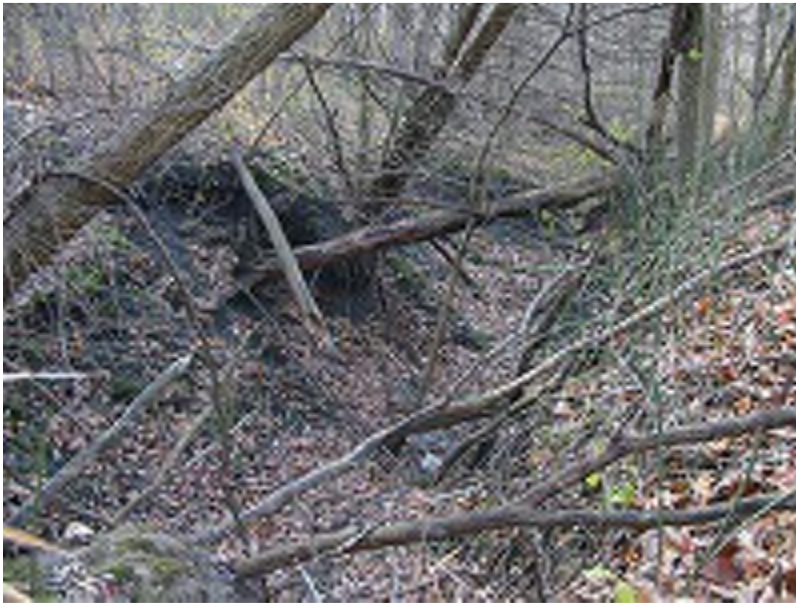
Waypoint 1241

Eroded gully/small spring

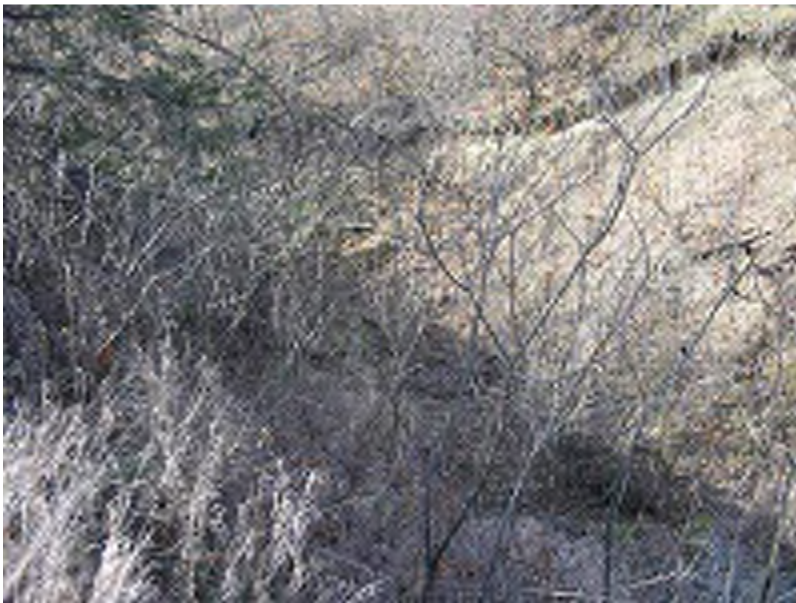
Waypoint 1242

Eroded gully beginning at house

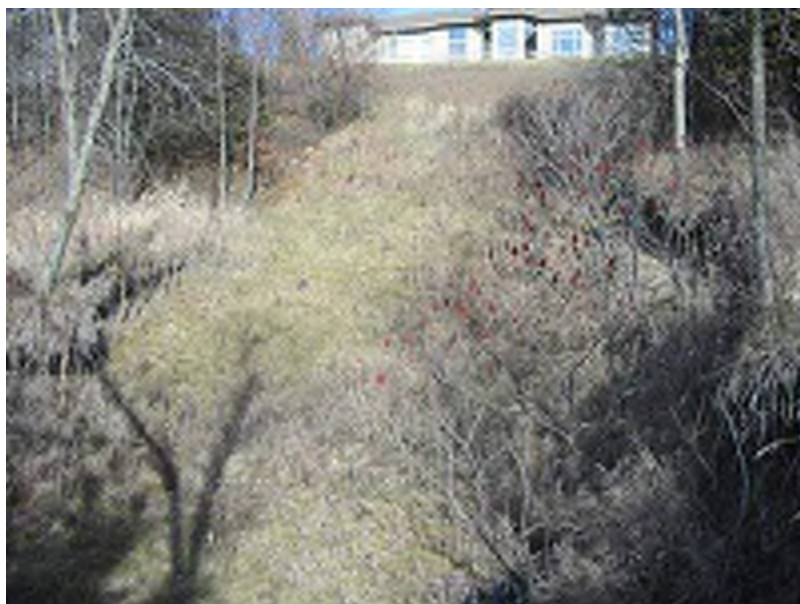
Some small erosion control-ineffective

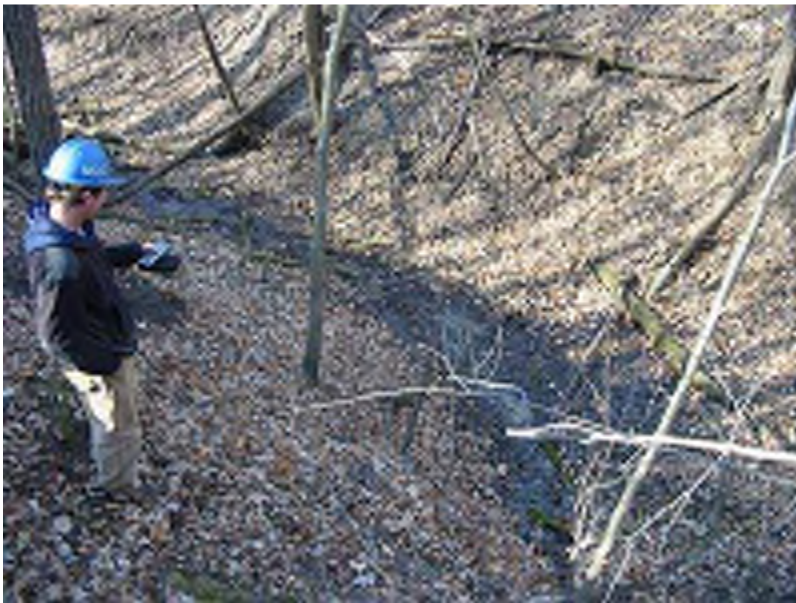
Waypoint 1243

Spring

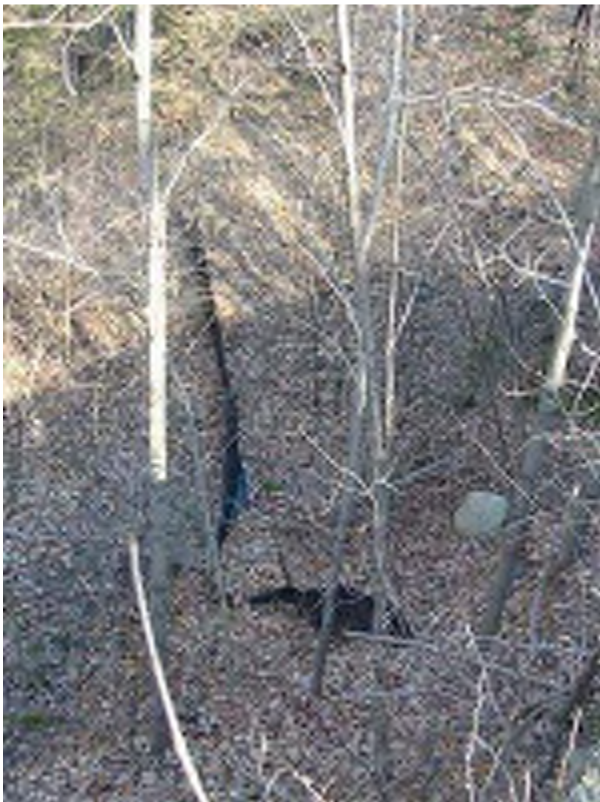
Waypoint 1244

Erosion control like WP1242

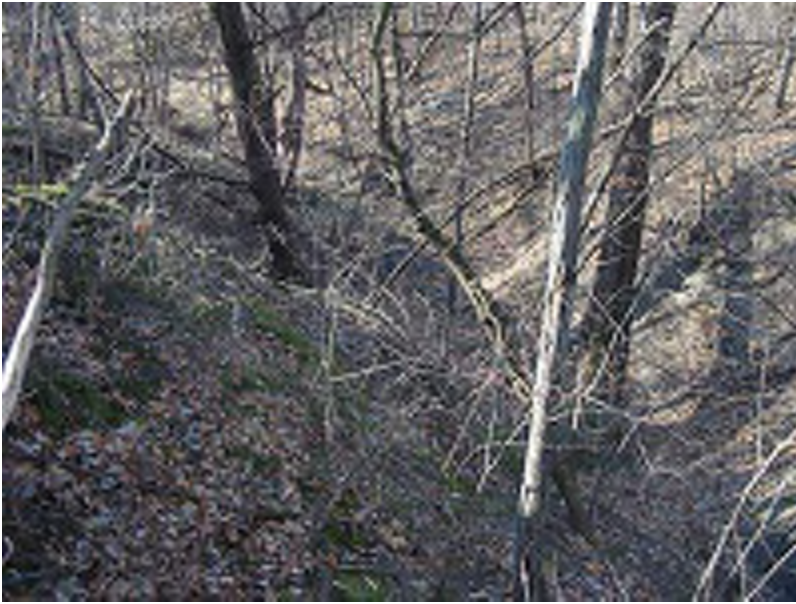
Beginning of gully/severe erosion by residential development

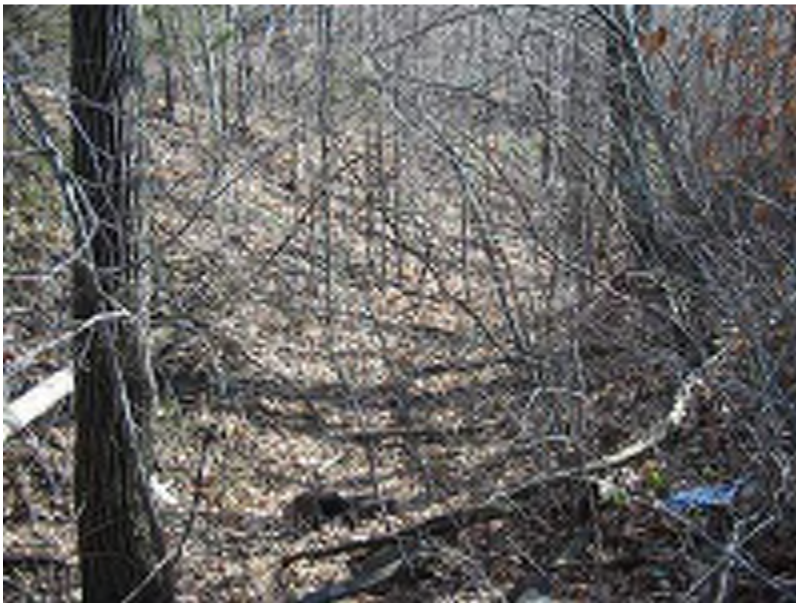
Waypoint 1245

Strong erosion present

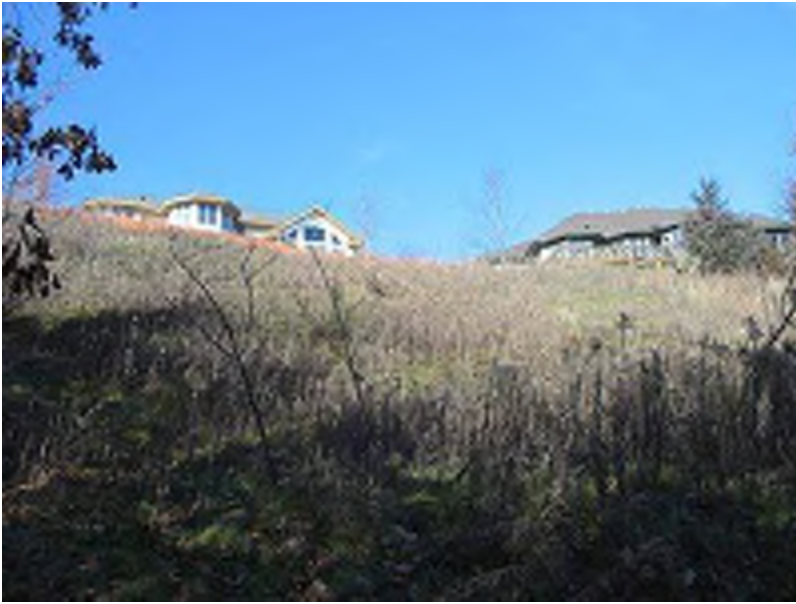
Beginning of gully on edge of residential development

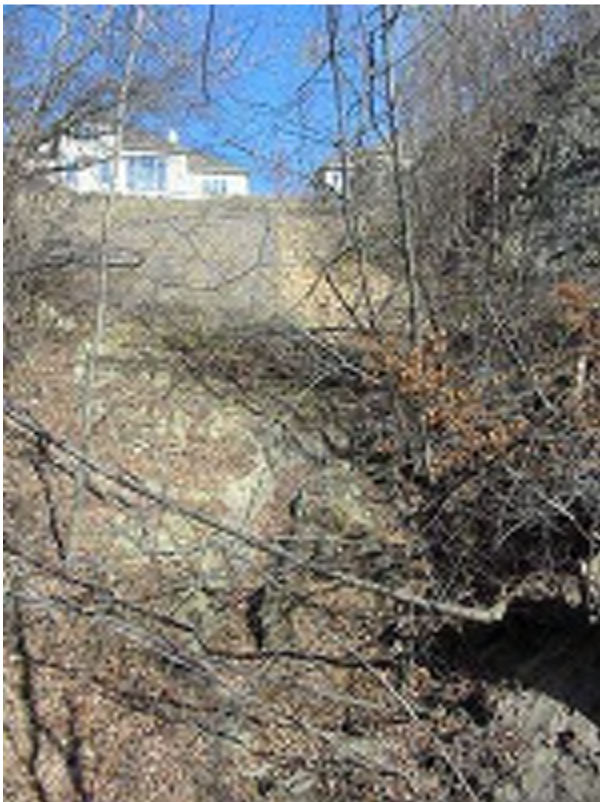
Waypoint 1246

Erosion matting and drain field

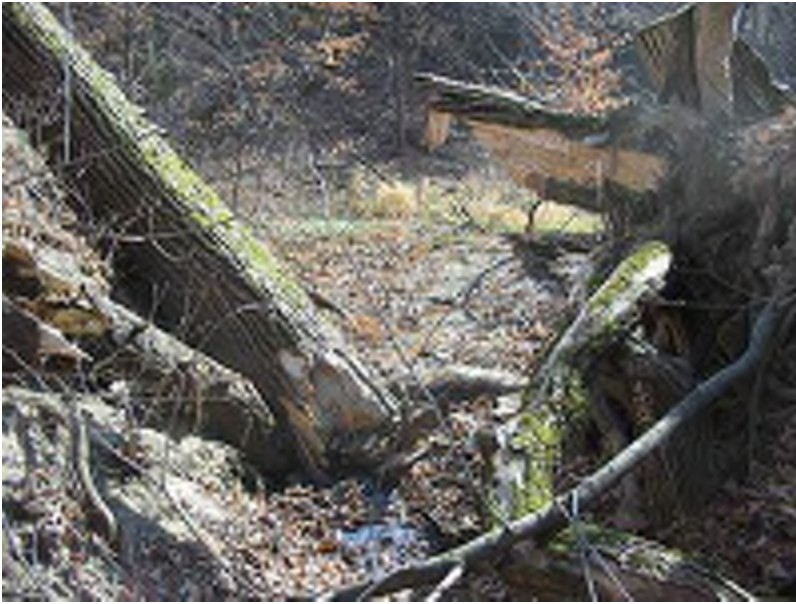
Spring/very ferrous, severe erosion, watercress

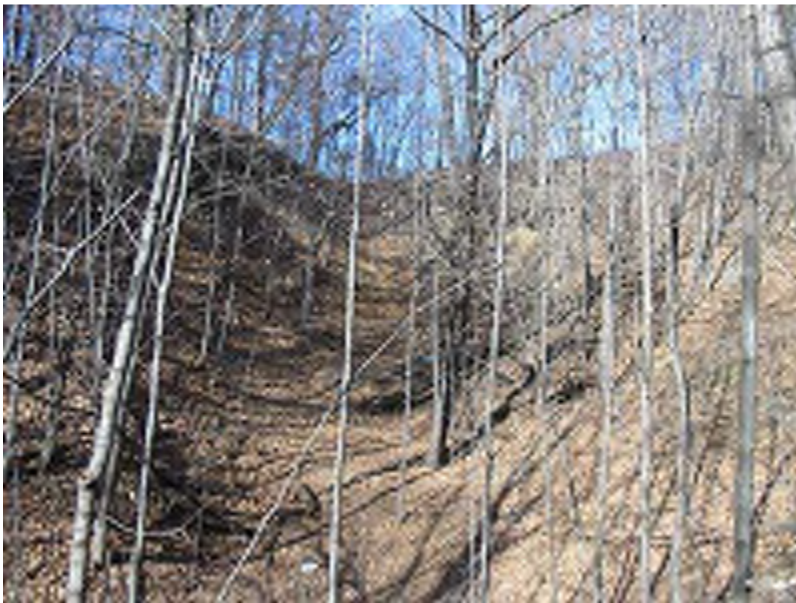
Waypoint 1247

Beginning of gully

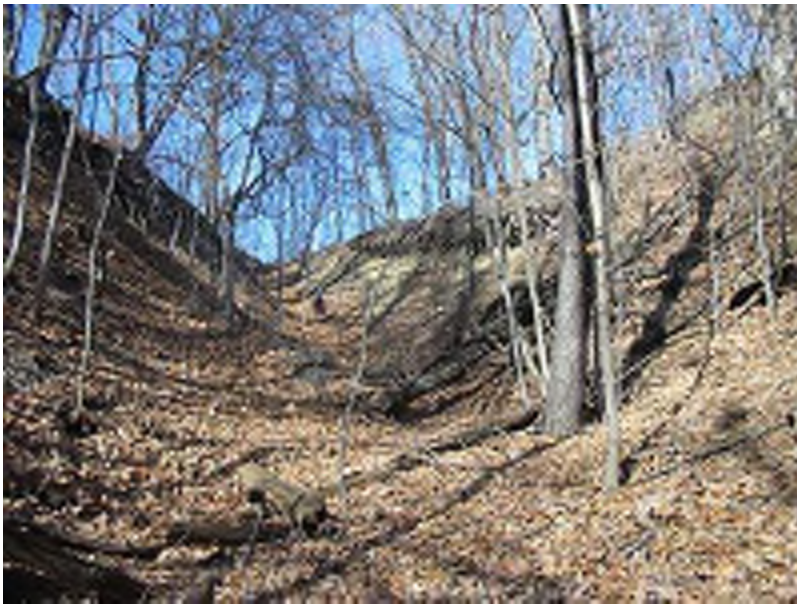
Severe erosion

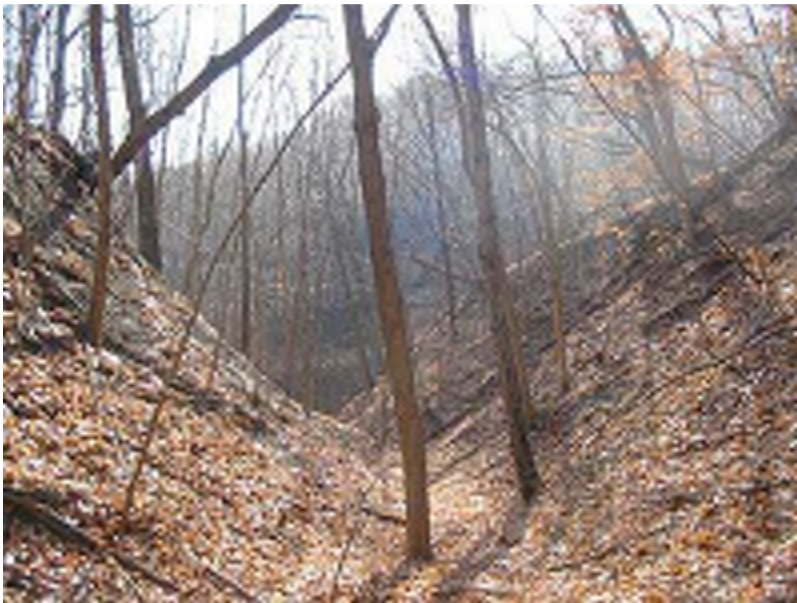
Erosion on rest of finger

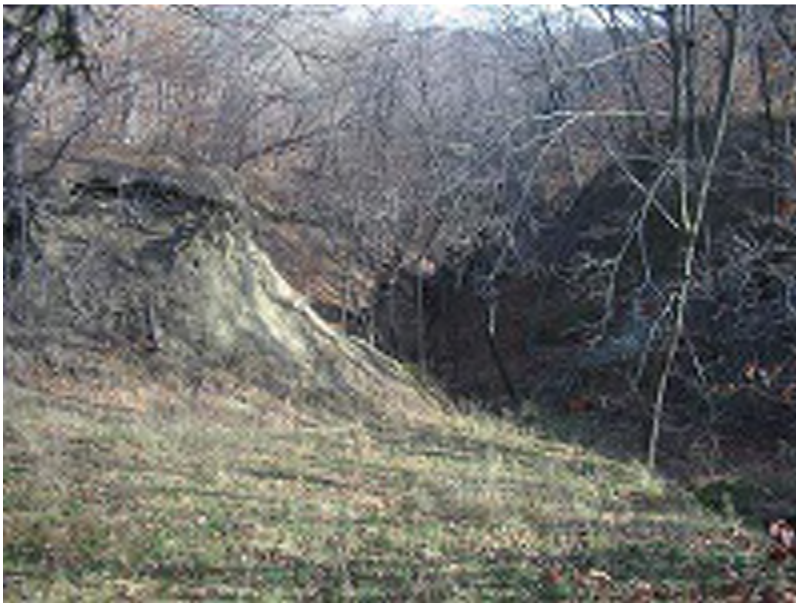
Waypoint 1248

Extreme erosion next to development

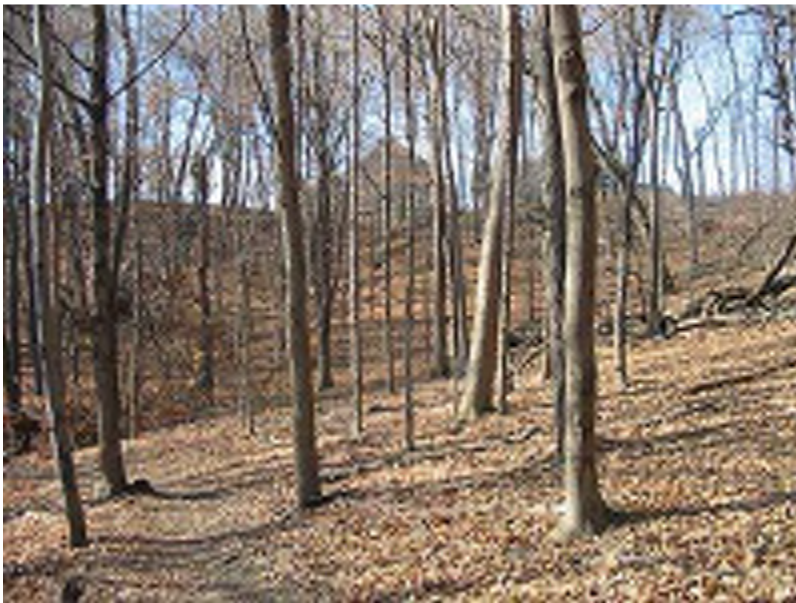
Waypoint 1249

Little erosion/beginning of gully

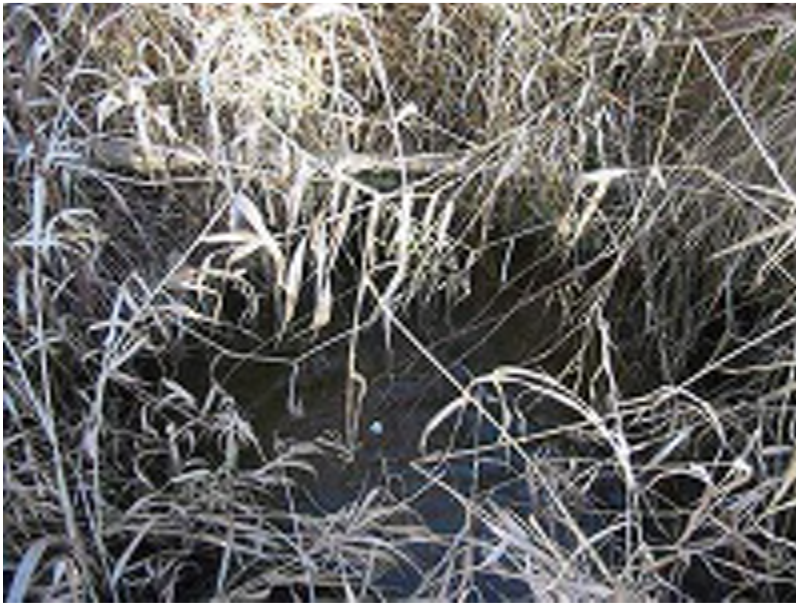
Waypoint 1250

Culvert

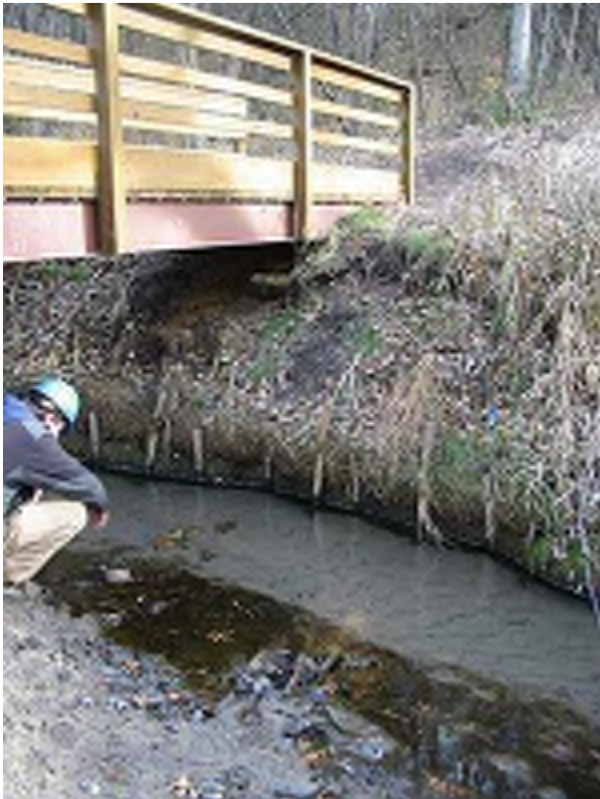
Waypoint 1251

Biologs underneath new bridge @ Fred Miller spring

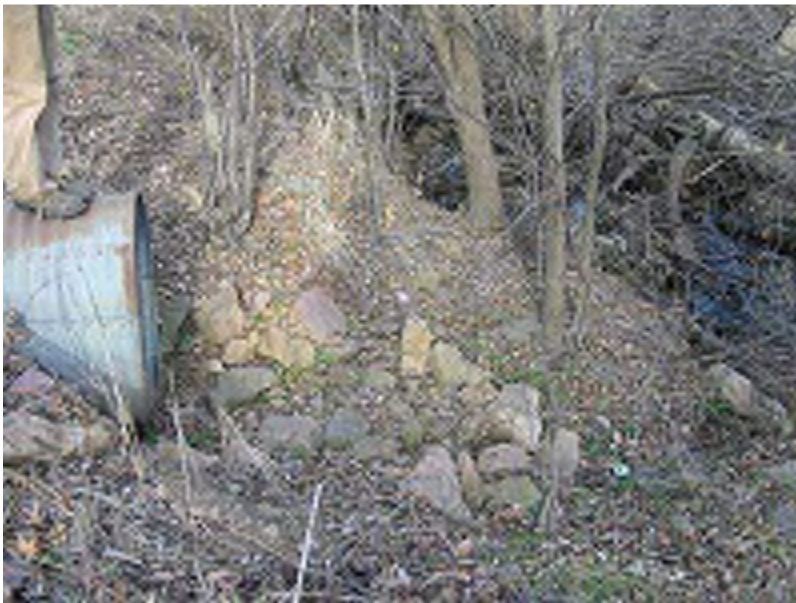
Waypoint 1252

Exit culvert

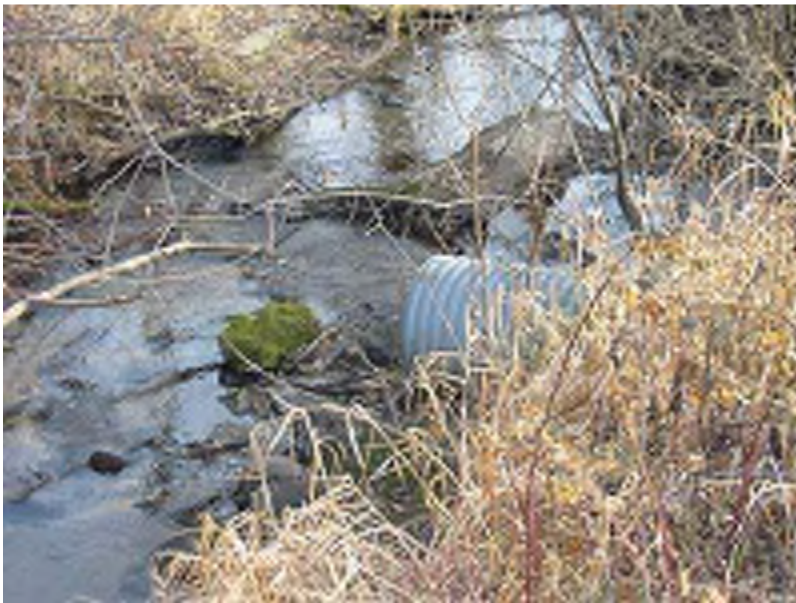
Waypoint 1253

Exit culvert

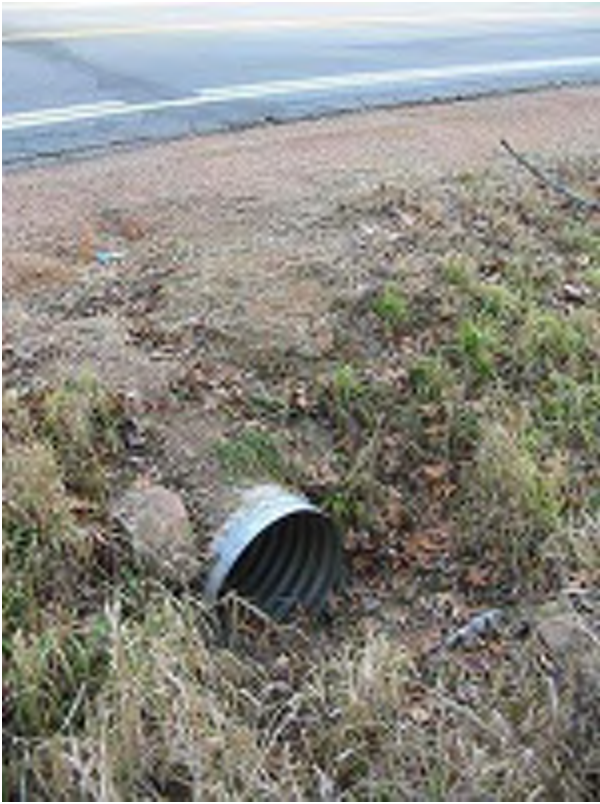
Entrance

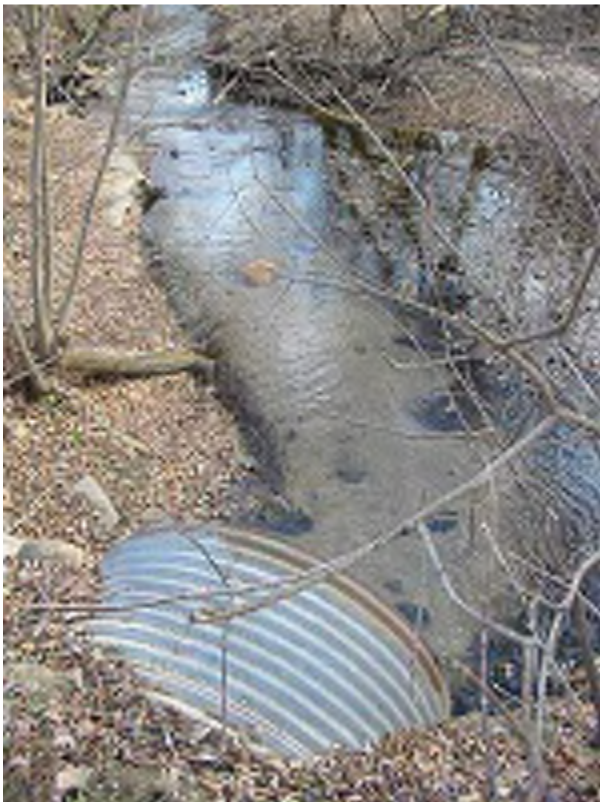
Waypoint 1254

Exit culvert

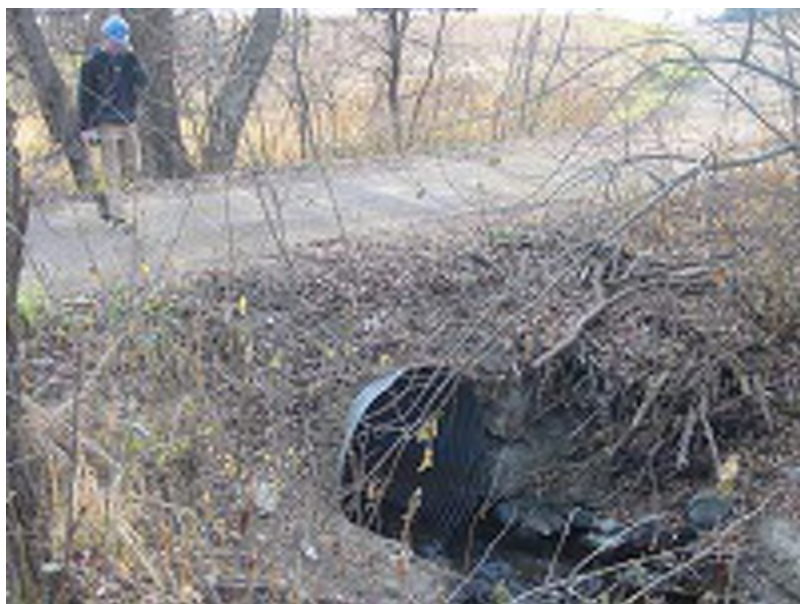
Entrance

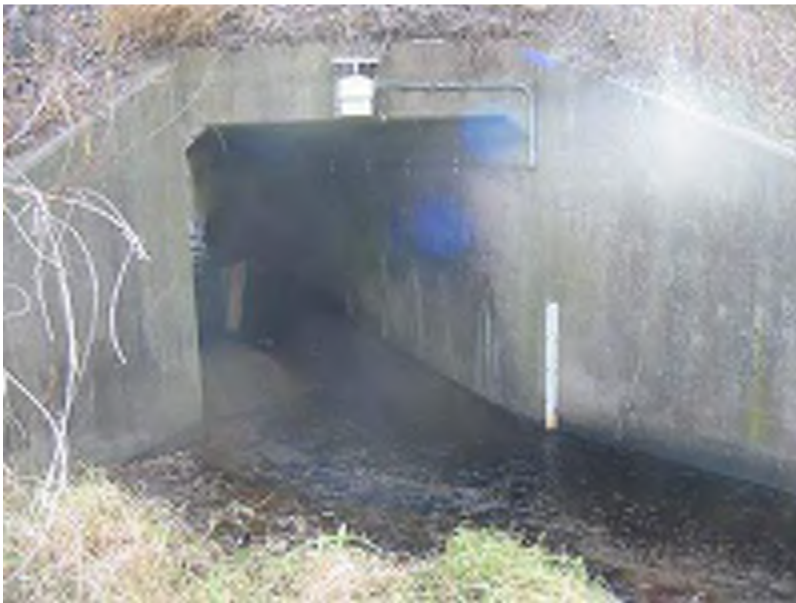
Waypoint 1255

Entrance culvert

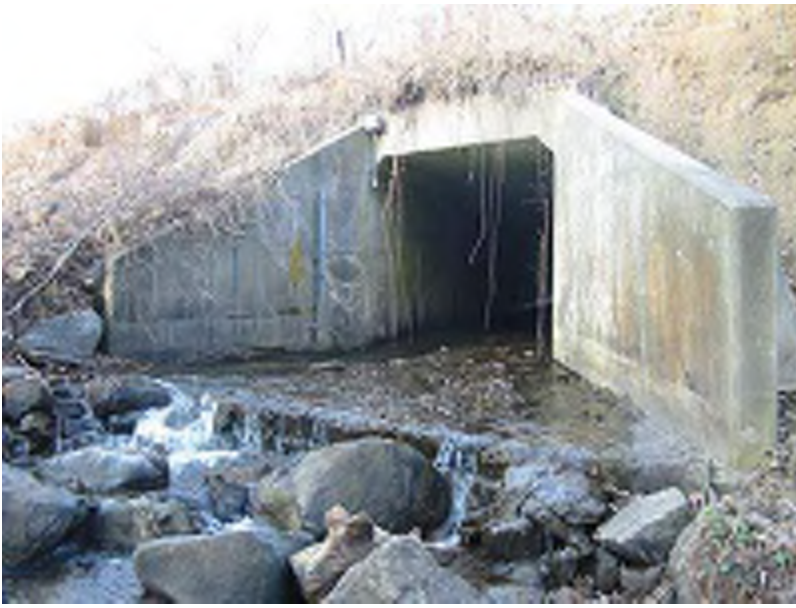
Exit

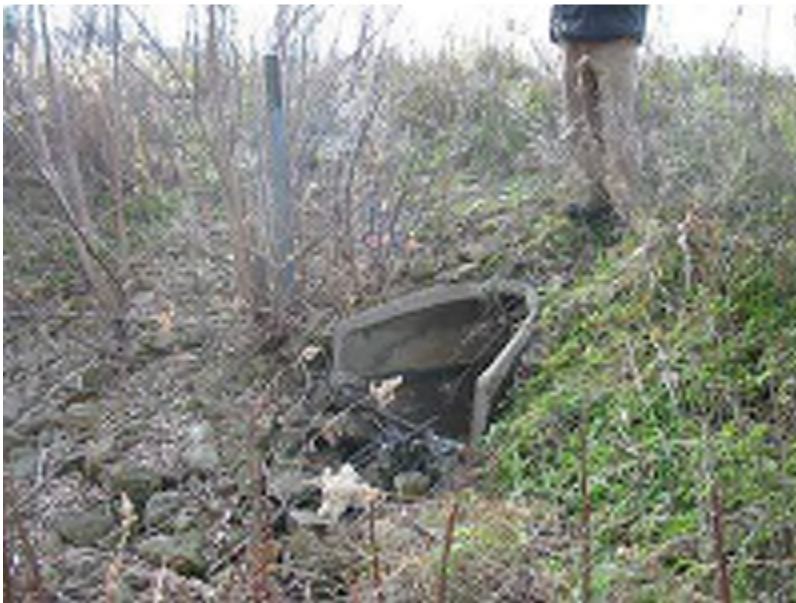
Waypoint 1256

Culvert

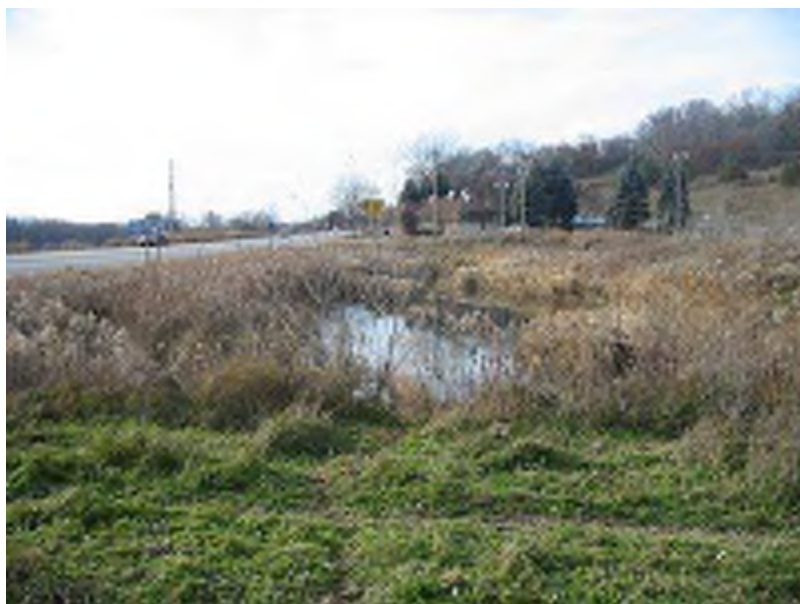
Waypoint 1257

Rain catchment area feeding culvert

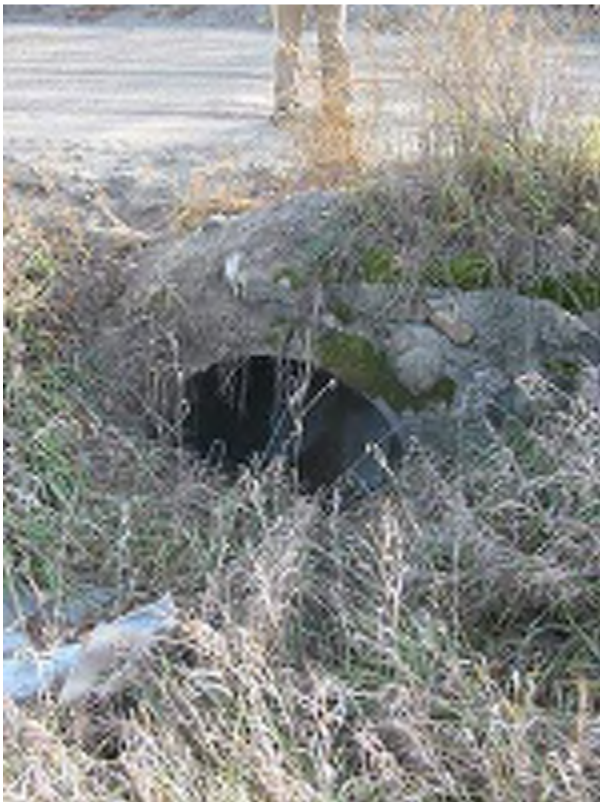
Entrance culvert

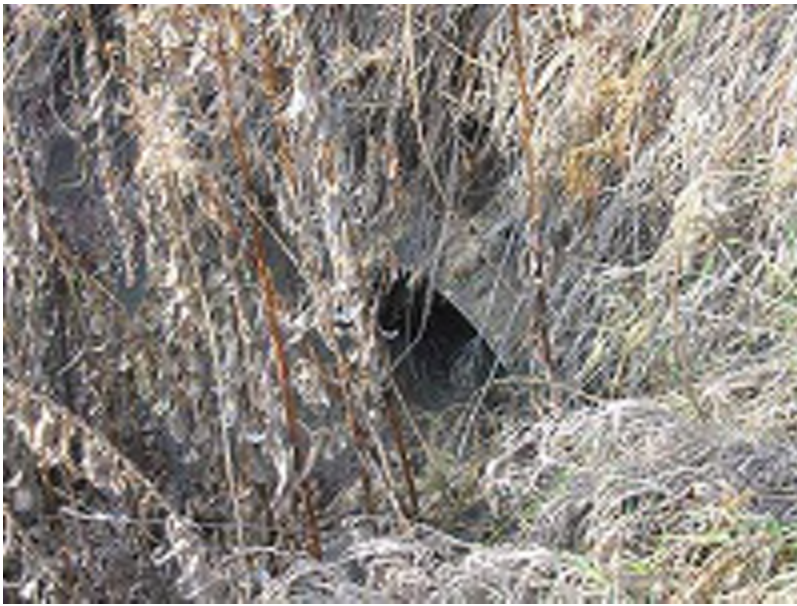
Exit culvert

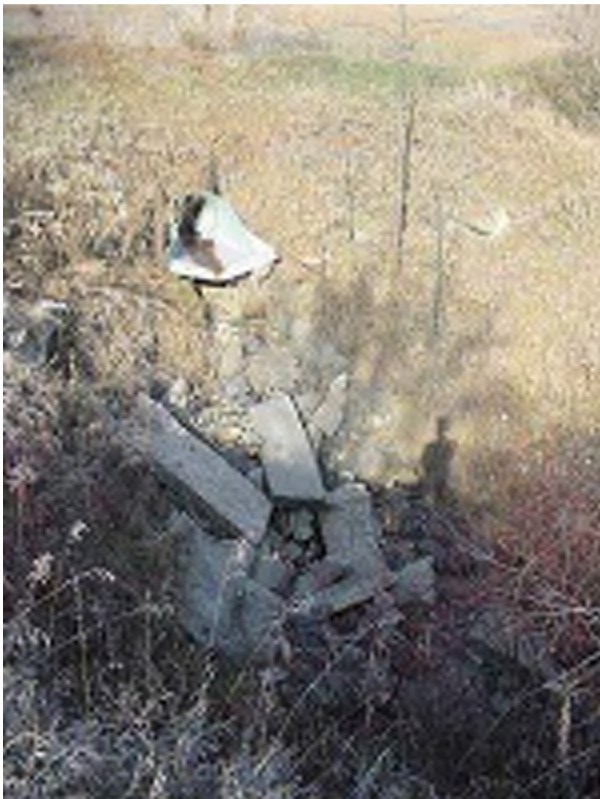
Culvert - big

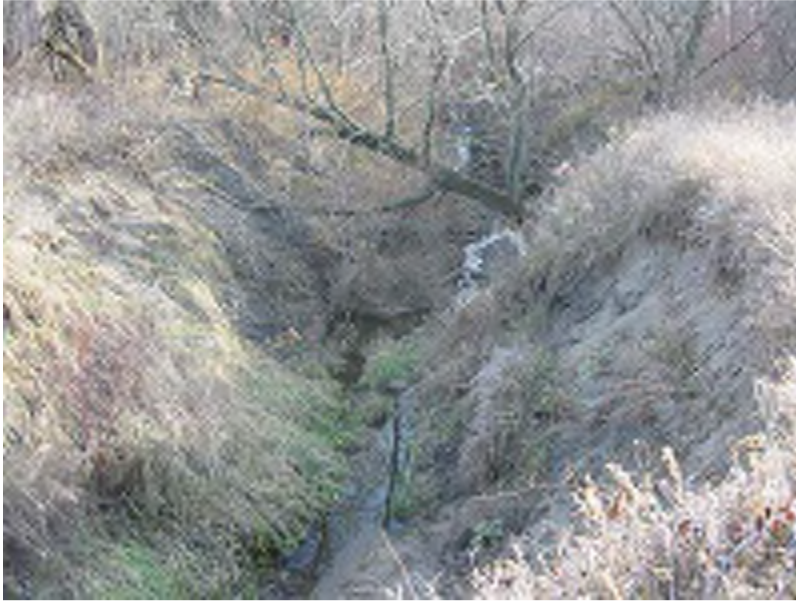
Severe erosion on banks after culvert

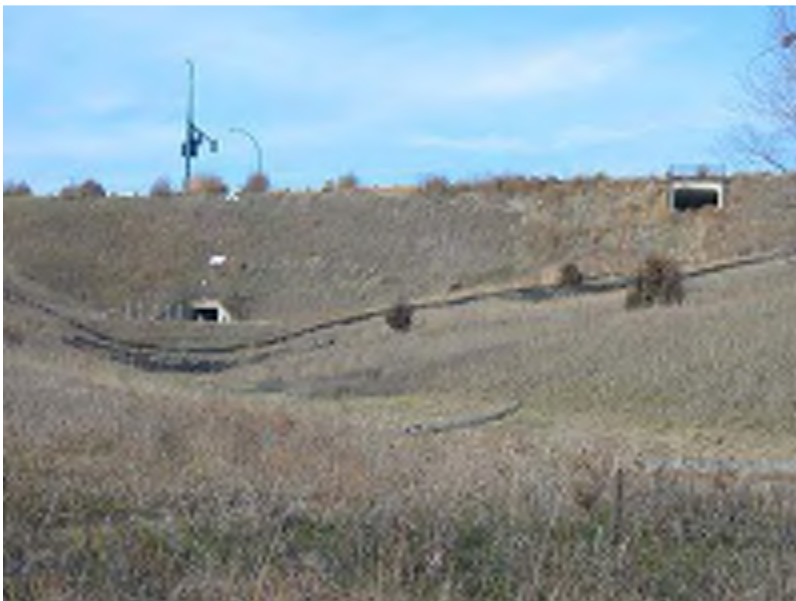
Culvert complex from #212/erosion control in place

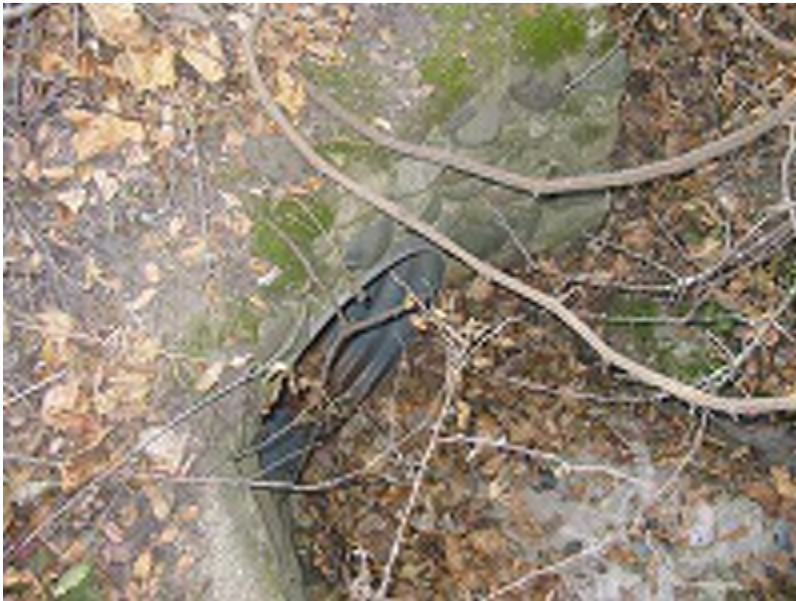
Waypoint 1258

Entrance culvert, minor erosion in gully

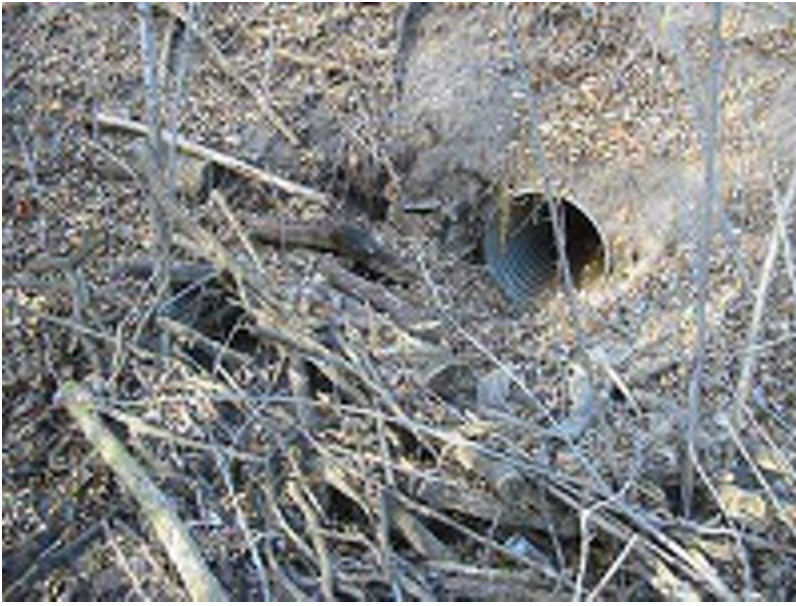
Exit

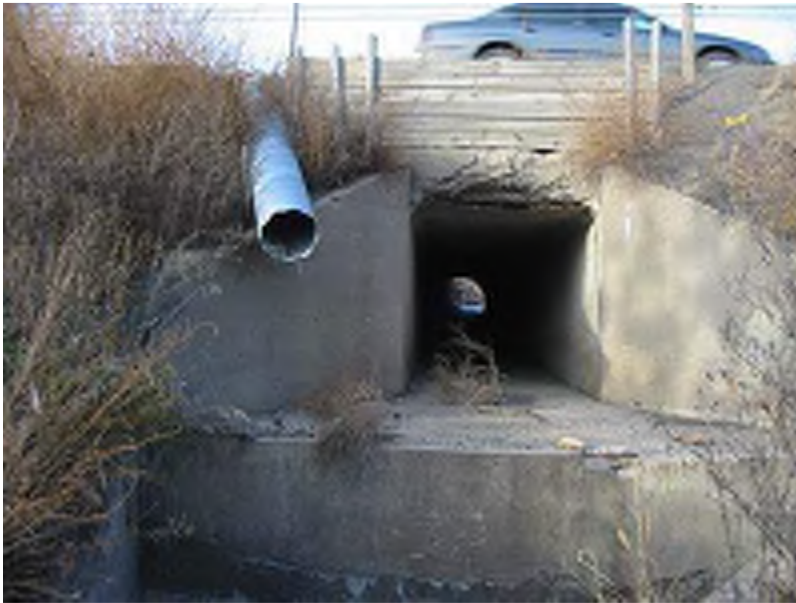
Waypoint 1259

Culvert exit/culvert from #212 & culvert continues

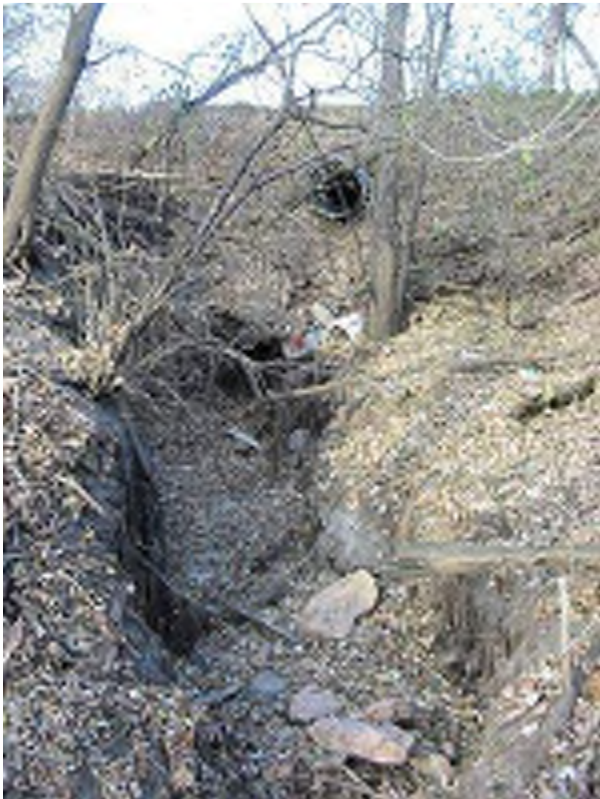
Waypoint 1260

Culvert exit from WP1259, severe erosion & trash

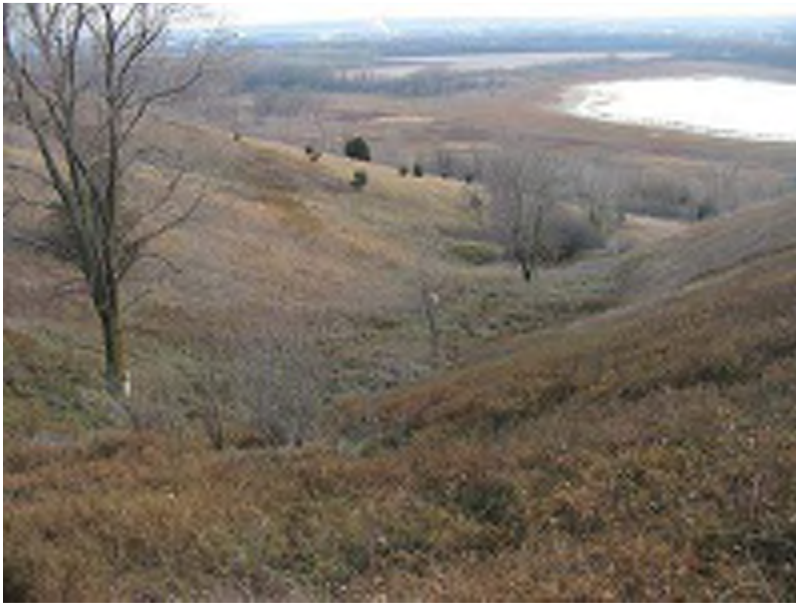
Waypoint 1261

Gully, no erosion

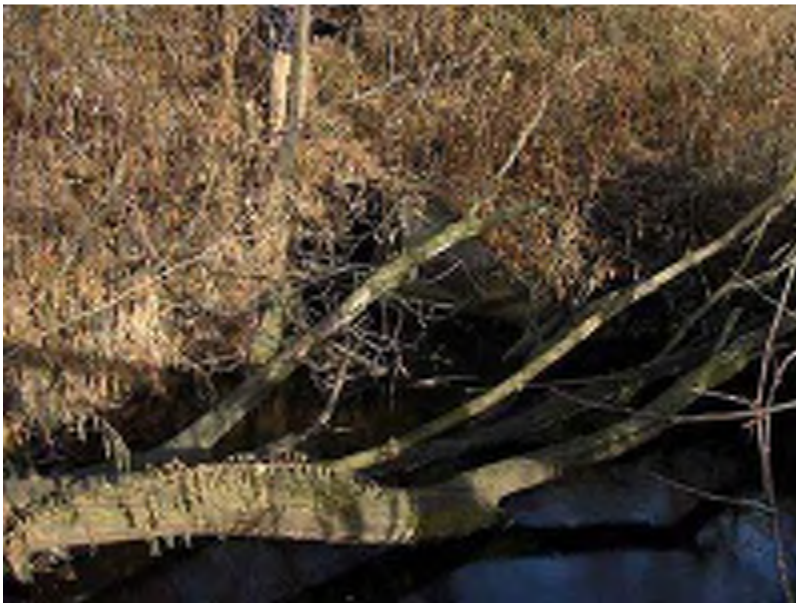
Waypoint 1262

Culvert exit

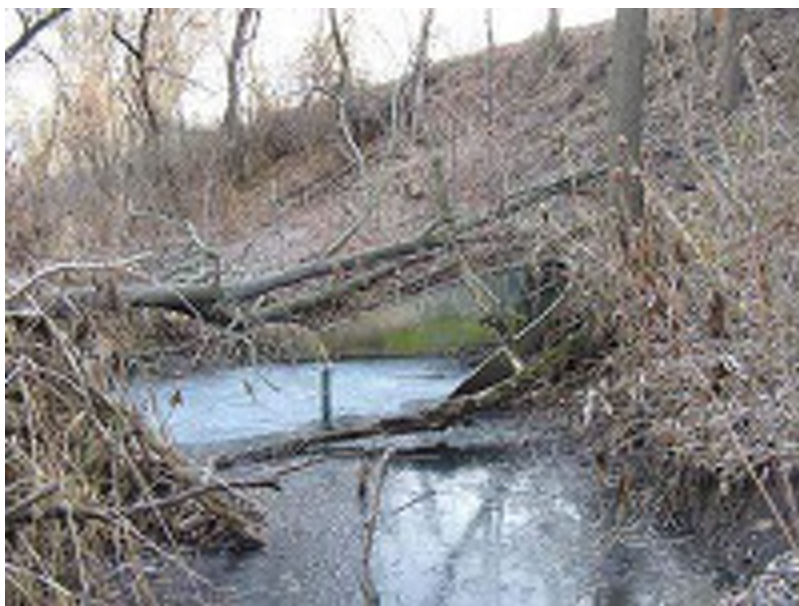
Culvert entrance

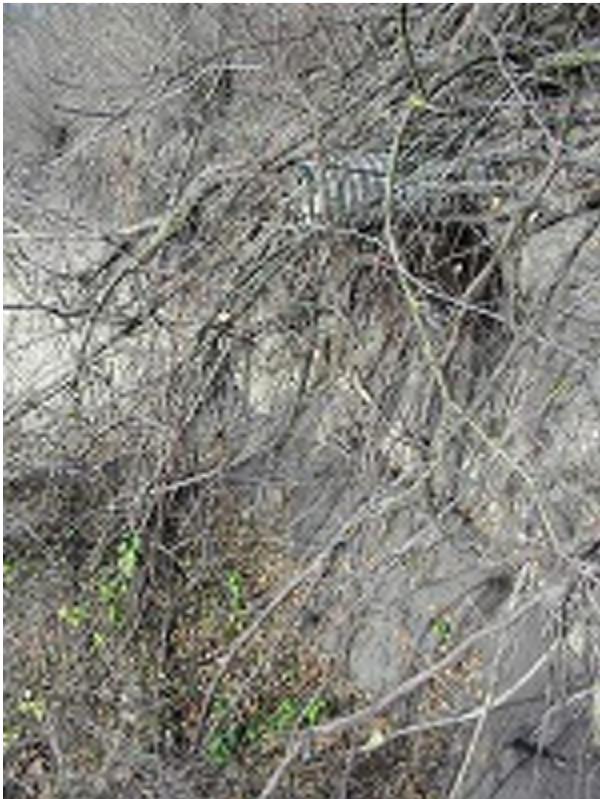
Waypoint 1263

Pipe outlet along MN River/severe erosion
