Appendix K: Lower Minnesota River Watershed District: Gully Inventory

Gully Inventory Map
 Area #1
 Lower Minnesota River Watershed District
 Watershed Management Plan

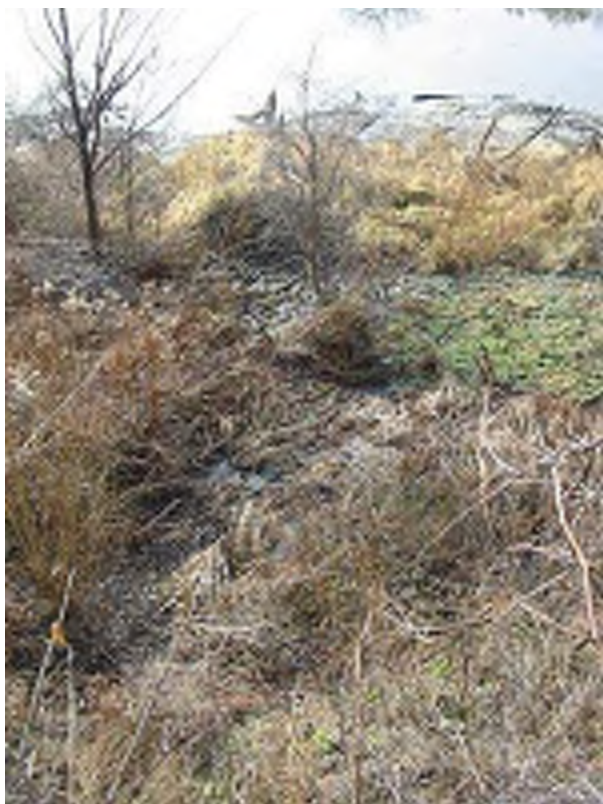
Spring 40 ft from river edge

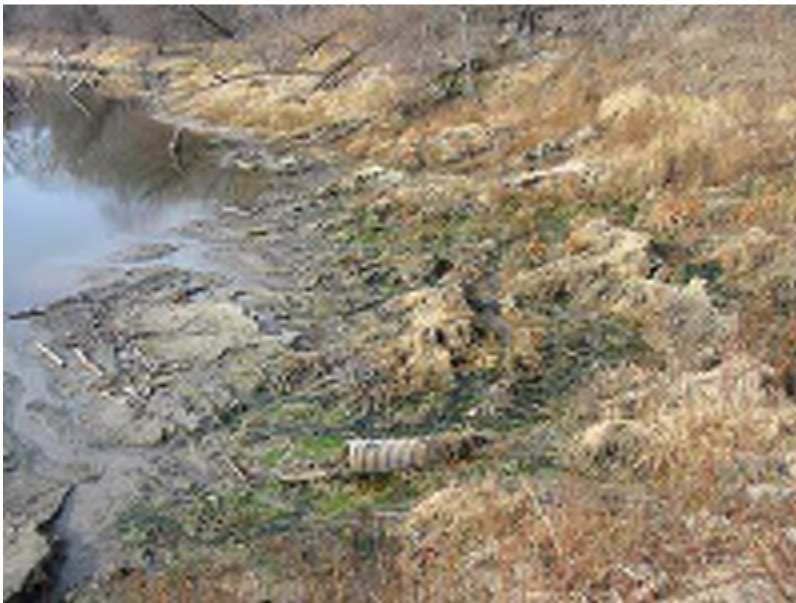
Waypoint 1264

Pipe outlet/spring/pipe outlet plugged up with dirt

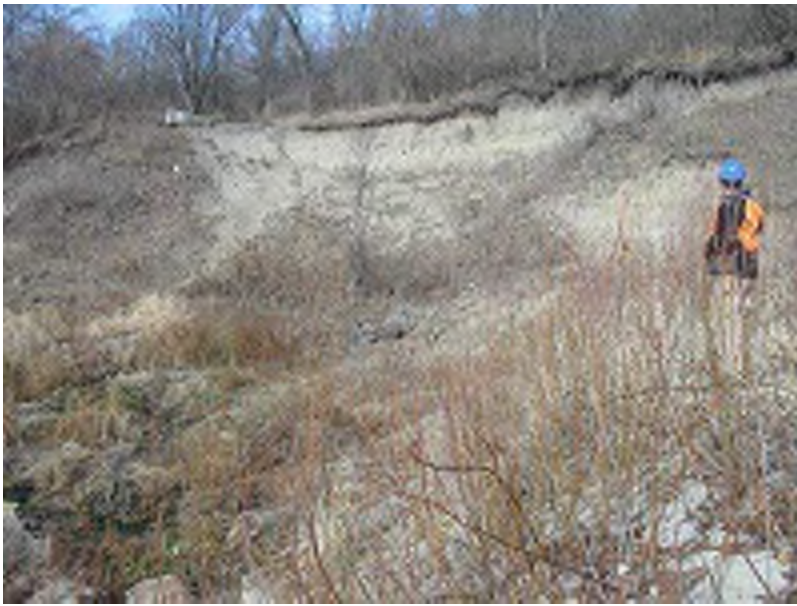
Erosion/severe on edge of river

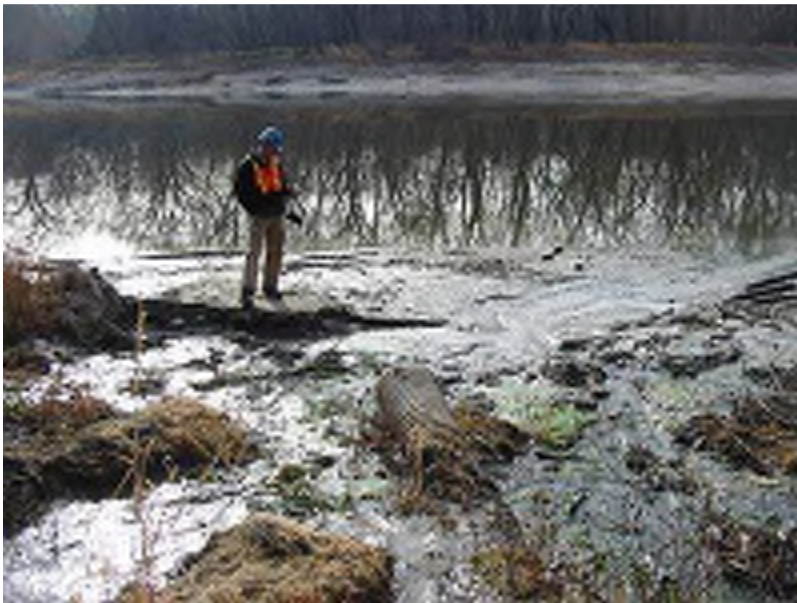
Shot of outlet facing river

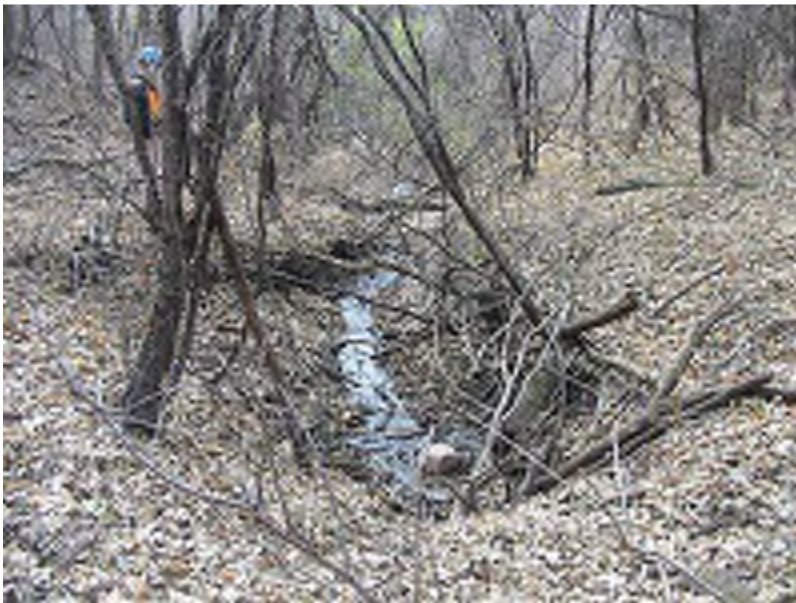
Waypoint 1265

Spring/minor erosion

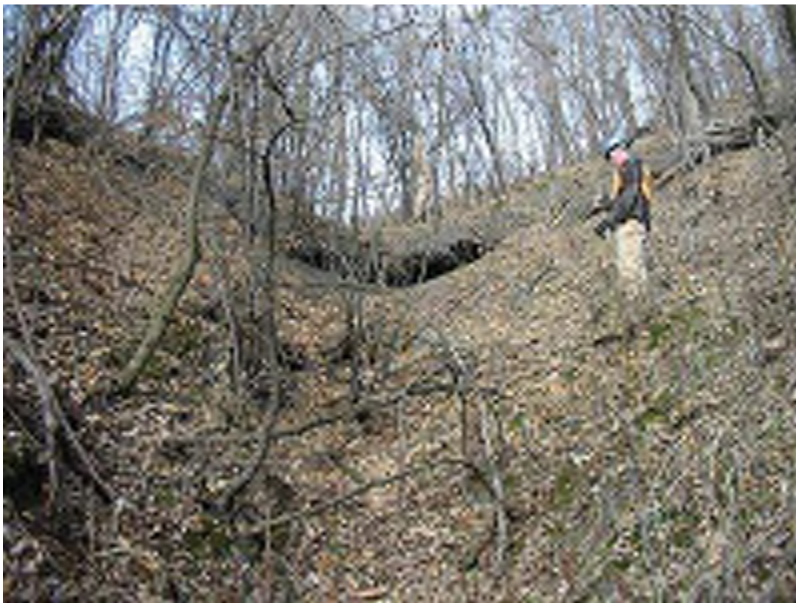
Waypoint 1266

Beginning of gully/strong erosion

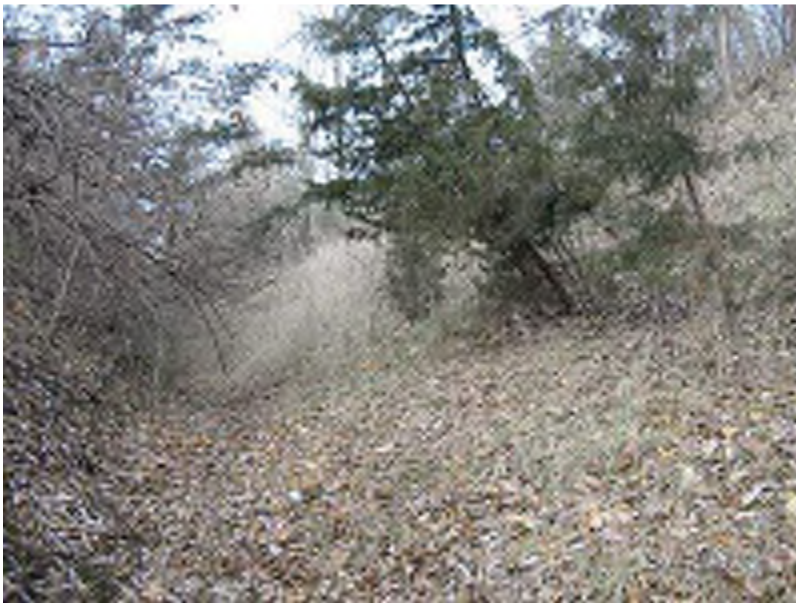
Waypoint 1267

Gully w/some exposed soil on banks

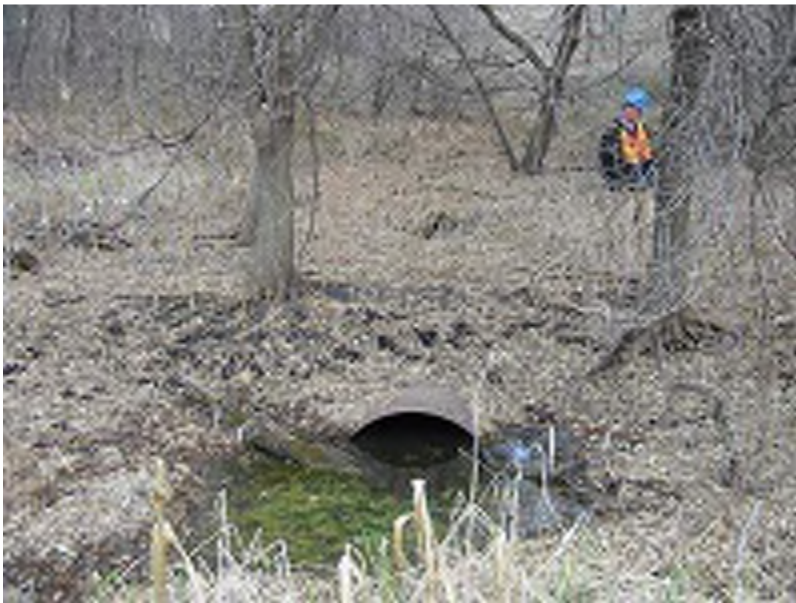
Waypoint 1268

Culvert w/open manhole 20 ft. behind it; outlet from development straight above?

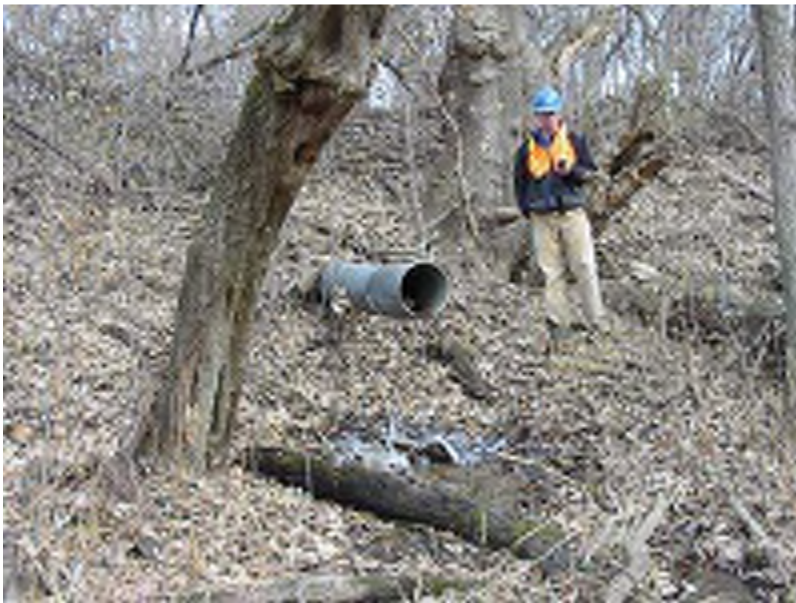
Waypoint 1269

Drain pipe outlet

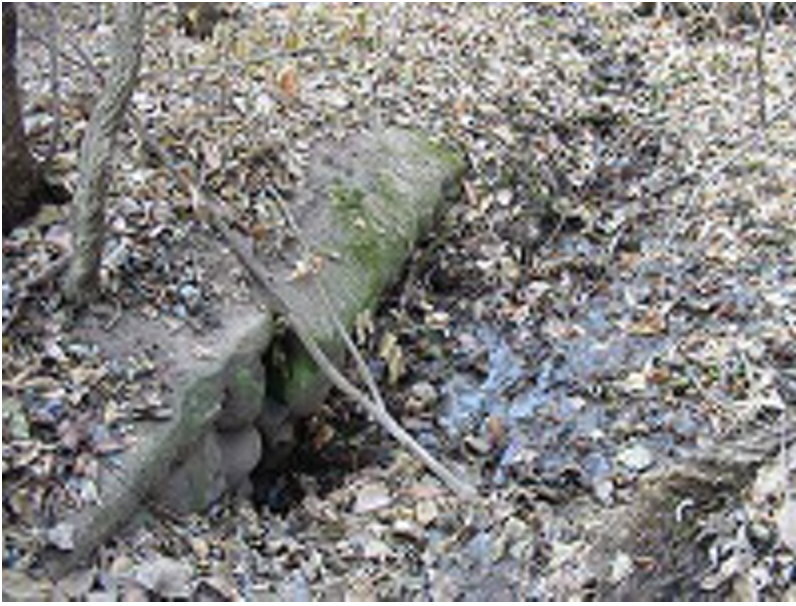
Drain pipe entrance

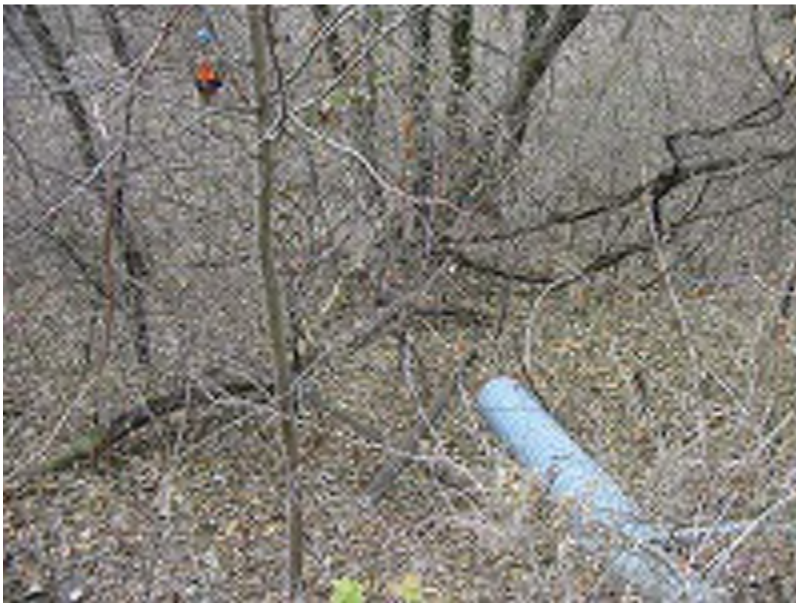
Waypoint 1270

Drain pipe outlet

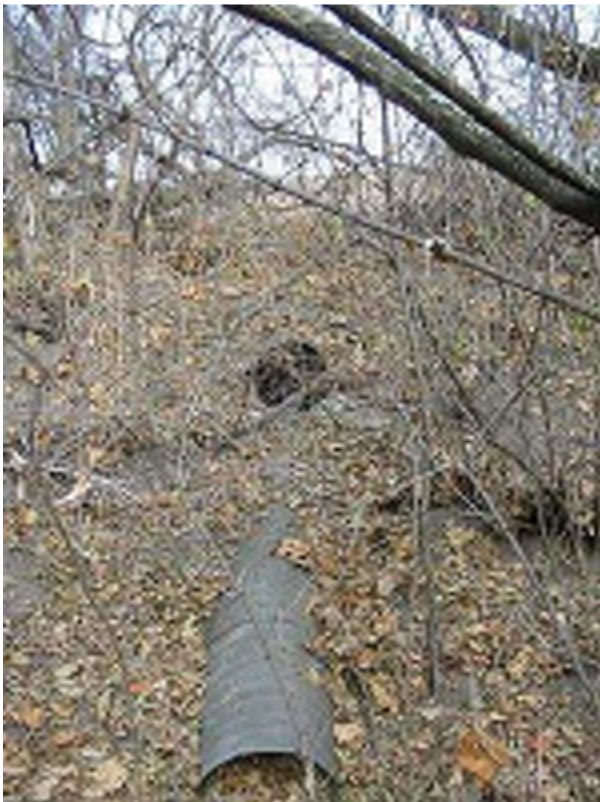
Waypoint 1271

Culvert outlet

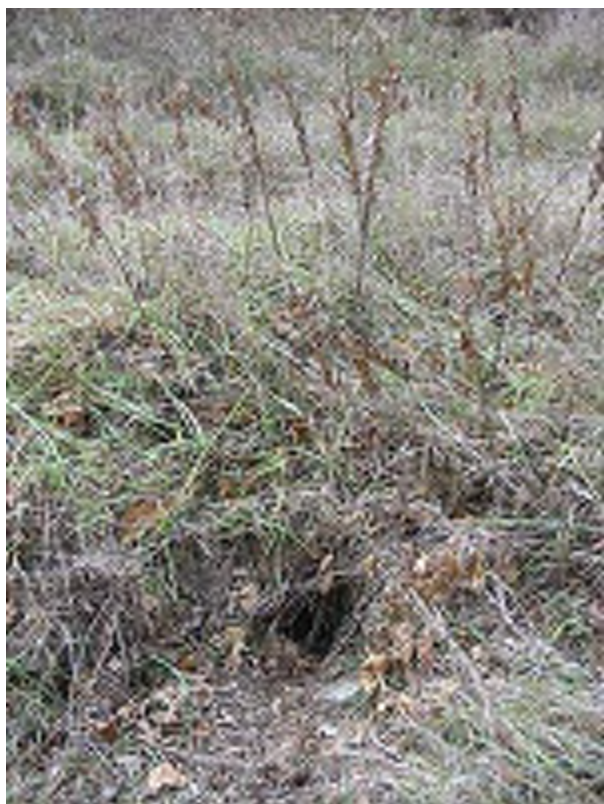
Culvert inlet

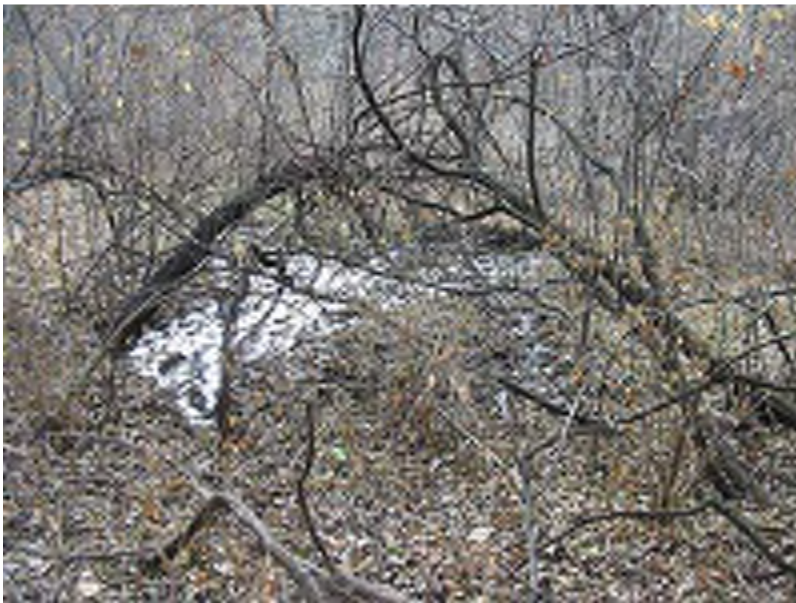
Waypoint 1272

Spring

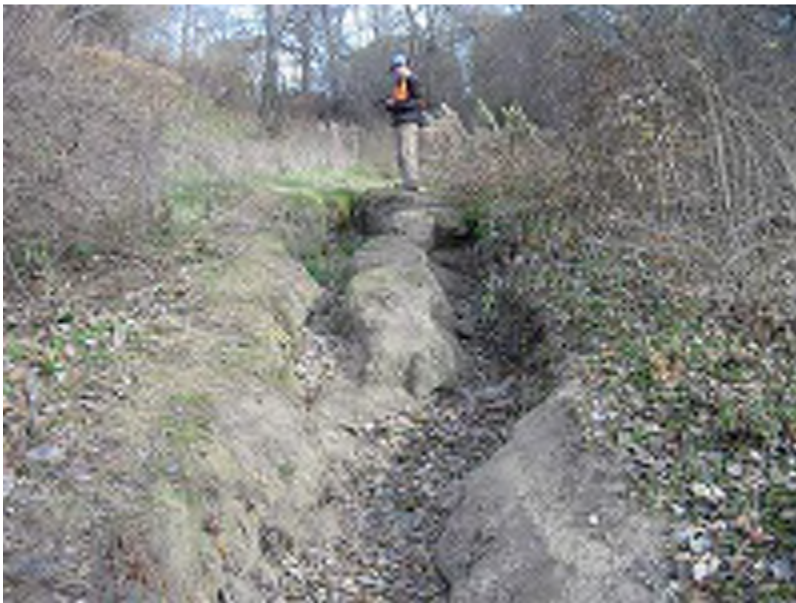
Waypoint 1273

Eroded path/severe 100 yards from gate to w.p.

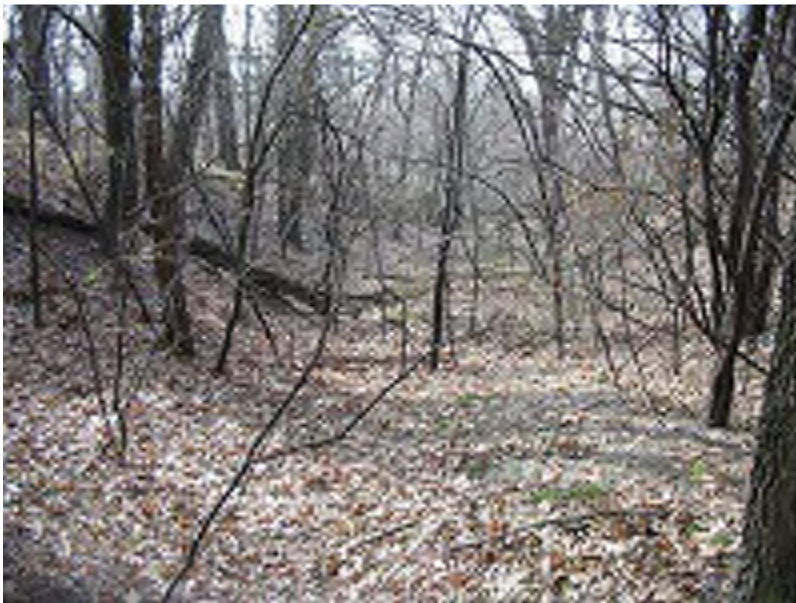
Waypoint 1274

Top of gully/some erosion apparent

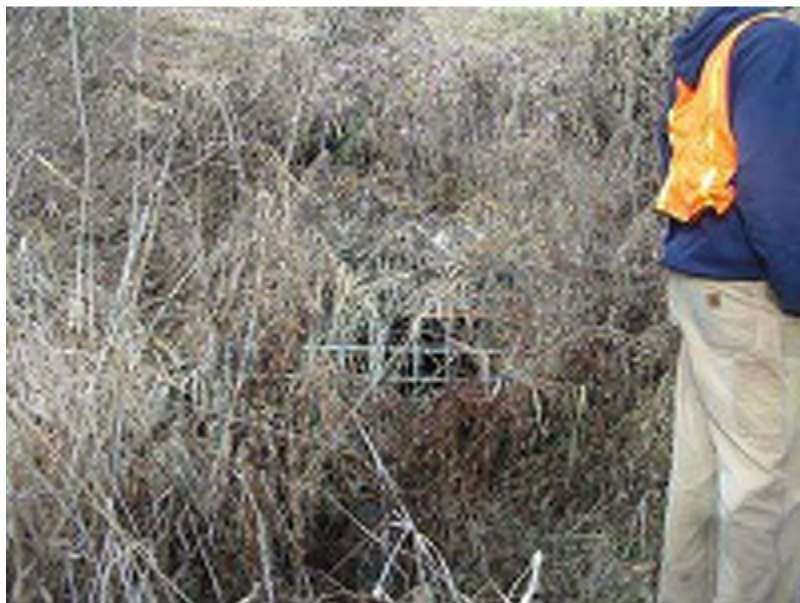
Waypoint 1275

Culvert exit /spring

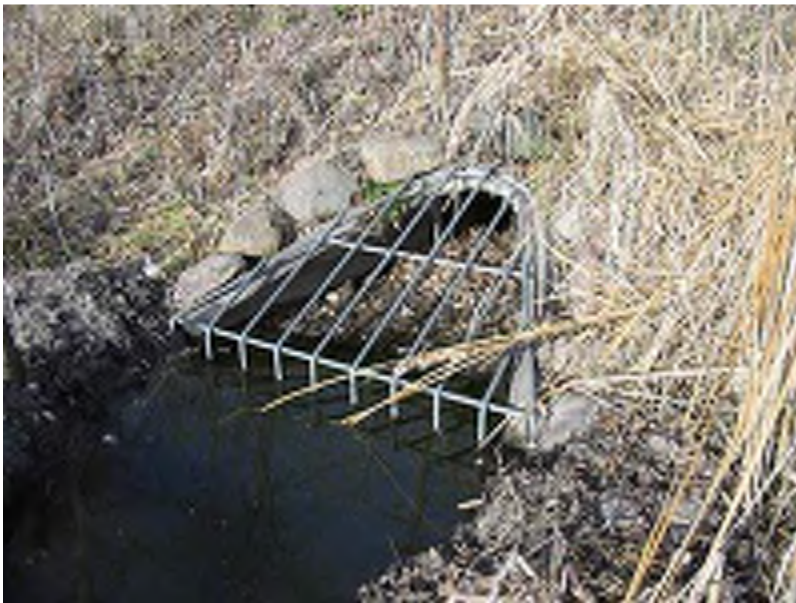
Waypoint 1276

Culvert outlet

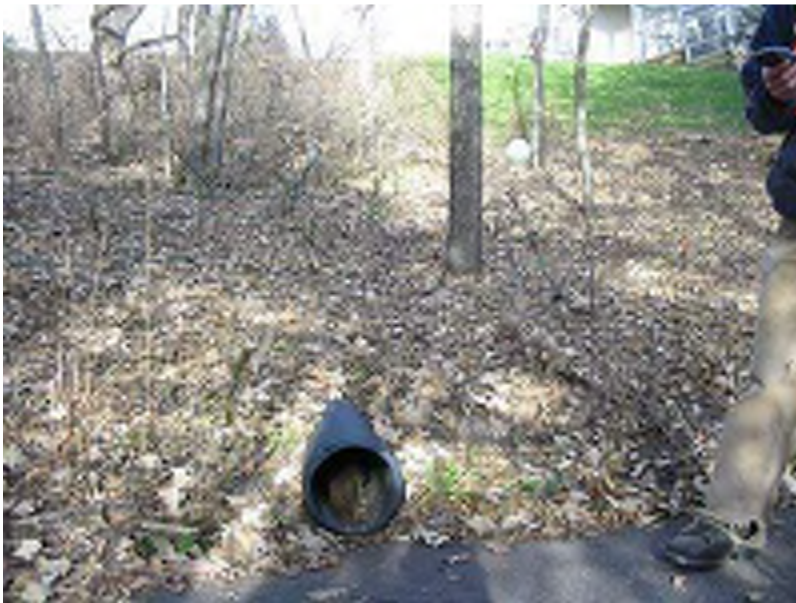
Waypoint 1277

Residential pipe outlet

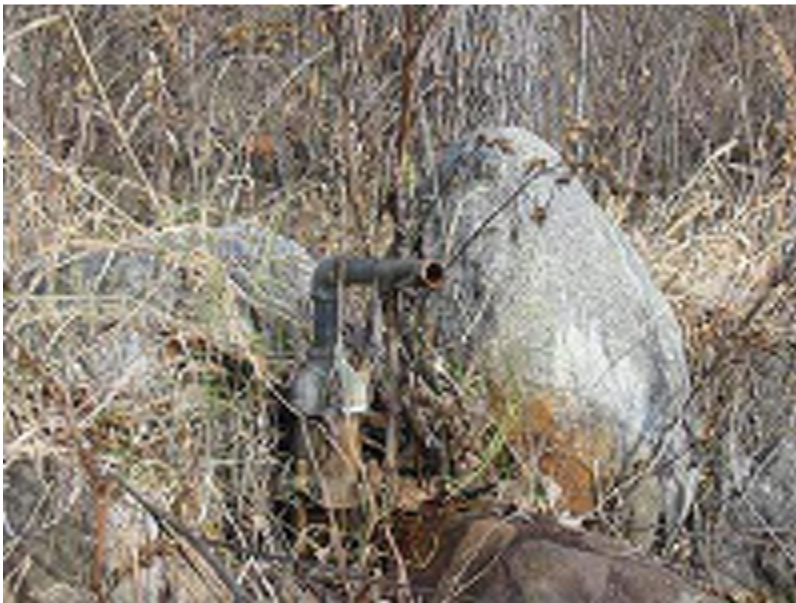
Waypoint 1278

Small pipe outlet into pond

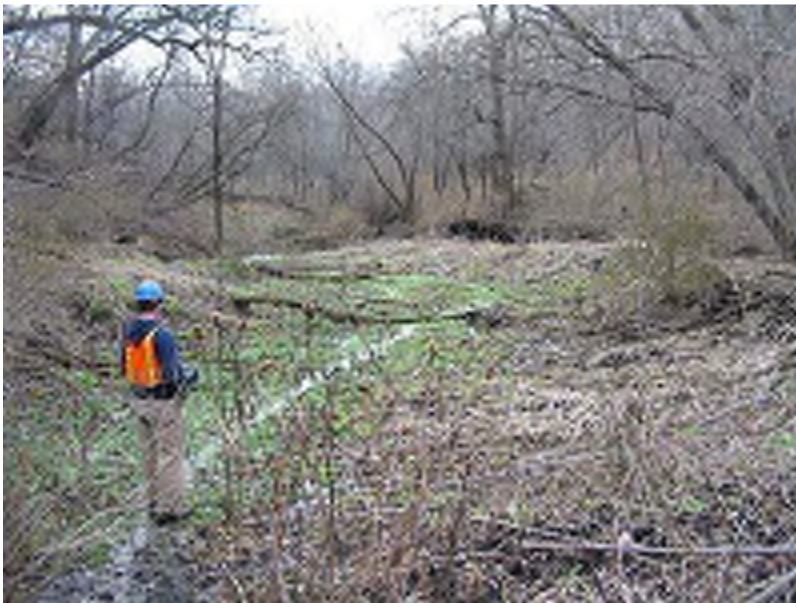
Waypoint 1279

Large spring

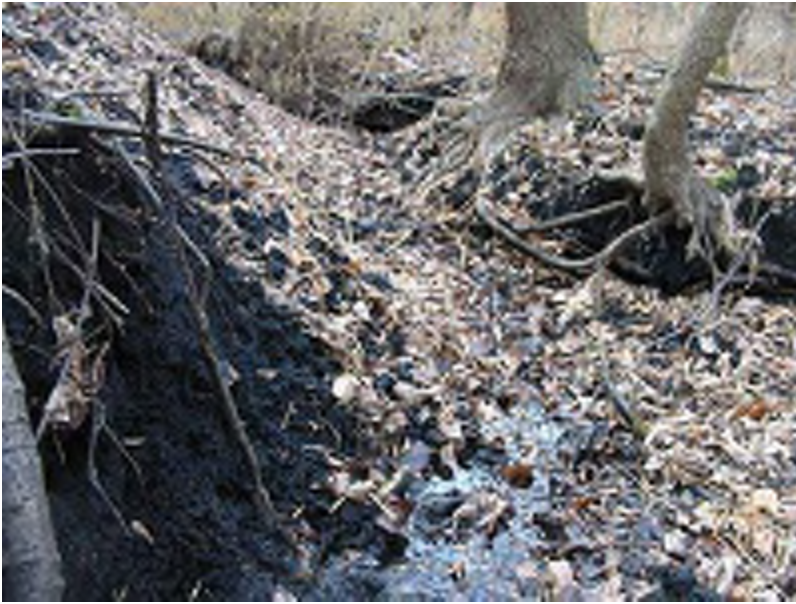
Small gully erosion

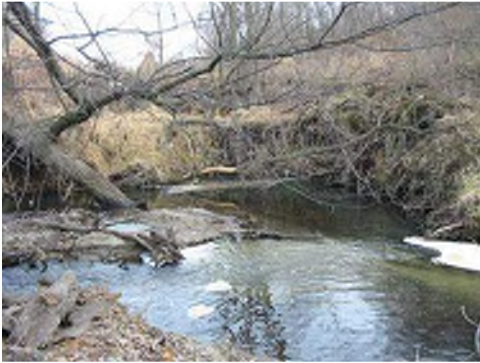
Waypoint 1280

Tim Marpe pointed out this eroded stream bank as being very close to pond. Bank is very water-logged between pond & stream. Believe there is

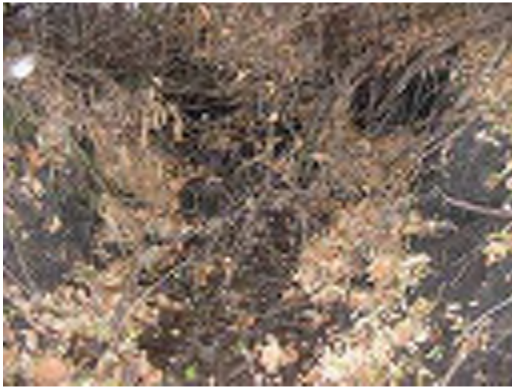
Waypoint 1281

Spring which feeds into Purgatory/minor erosion

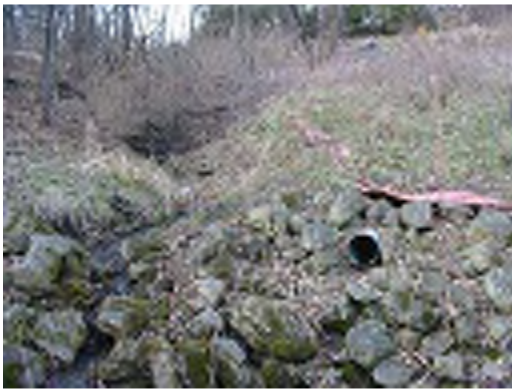
Waypoint 1282

Culvert on right/spring on left/ some erosion control

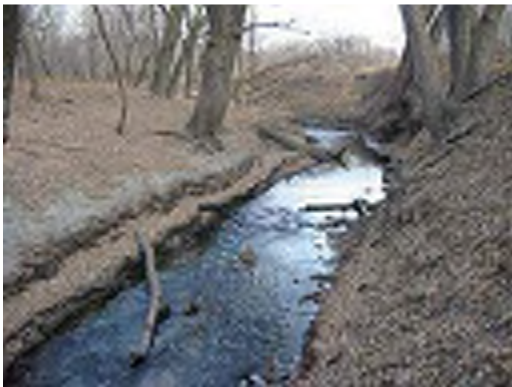
Waypoint 1283

Purgatory near outlet into Minnesota/typical erosion

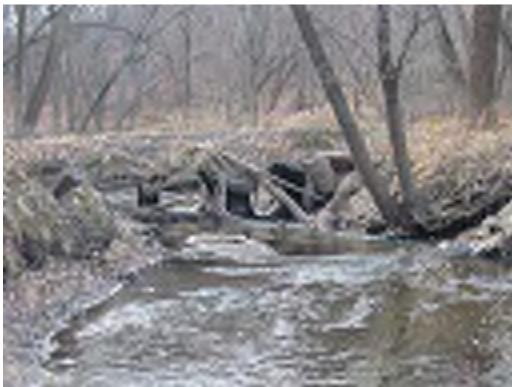
Waypoint 1285

2 culvert exits by River View Road

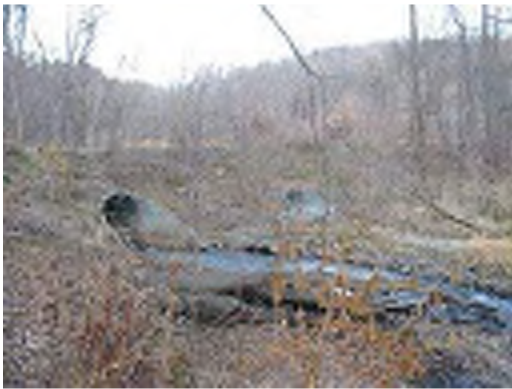
Waypoint 1286

Huge tunnel exit

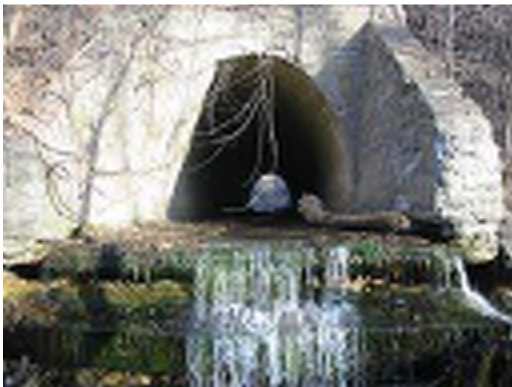
Severely eroded stream bank adjacent to tunnel

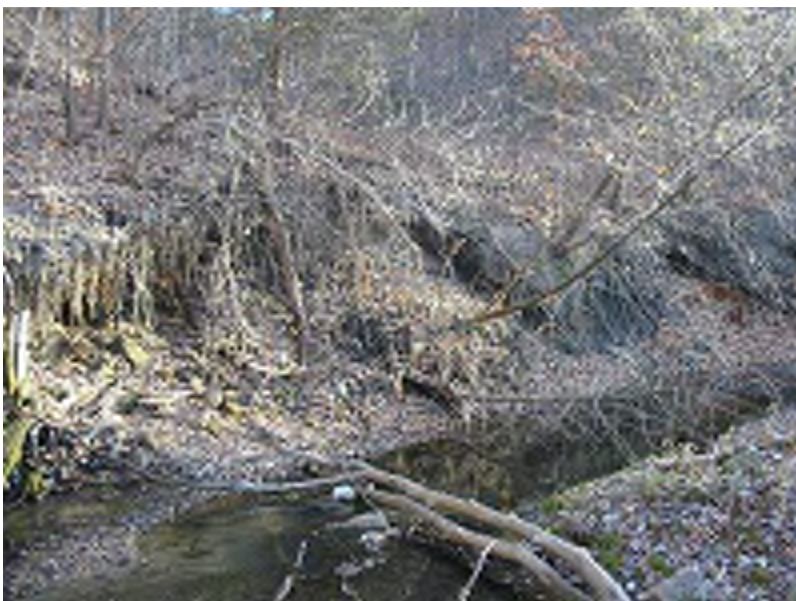
Waypoint 1287

Culvert exit

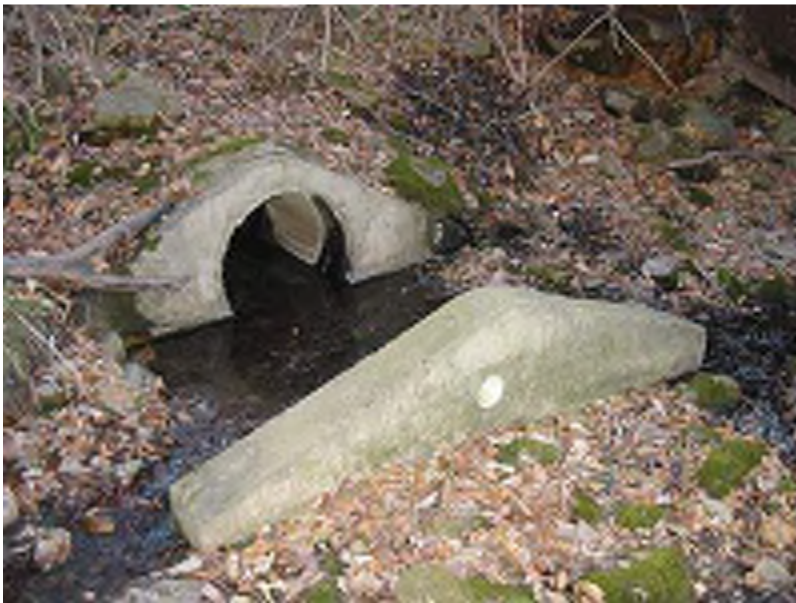
Waypoint 1288

Caged riprap erosion control

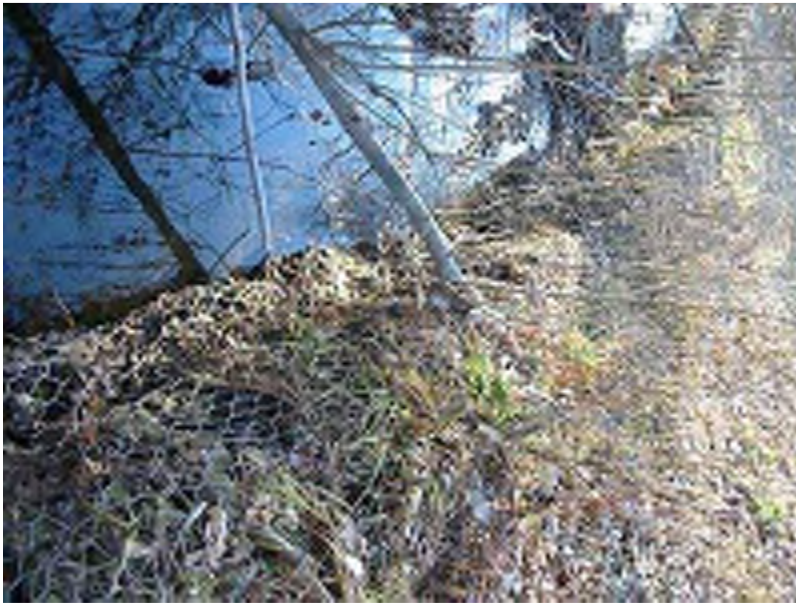
Waypoint 1289

Culvert entrance

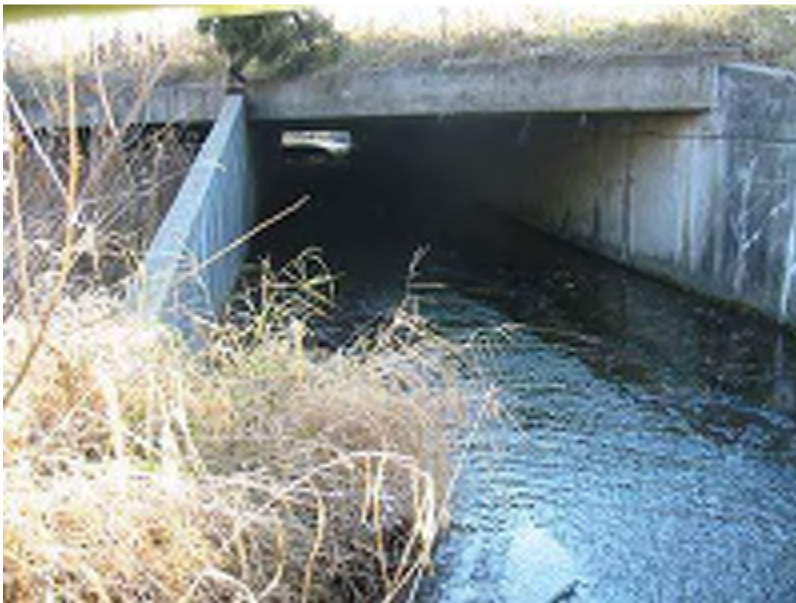
Culvert exit

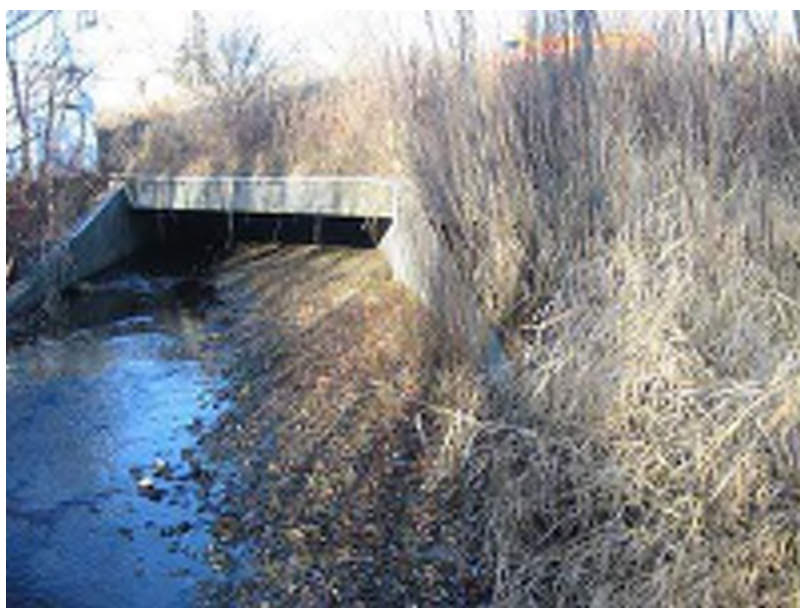
Waypoint 1290

Culvert entrance

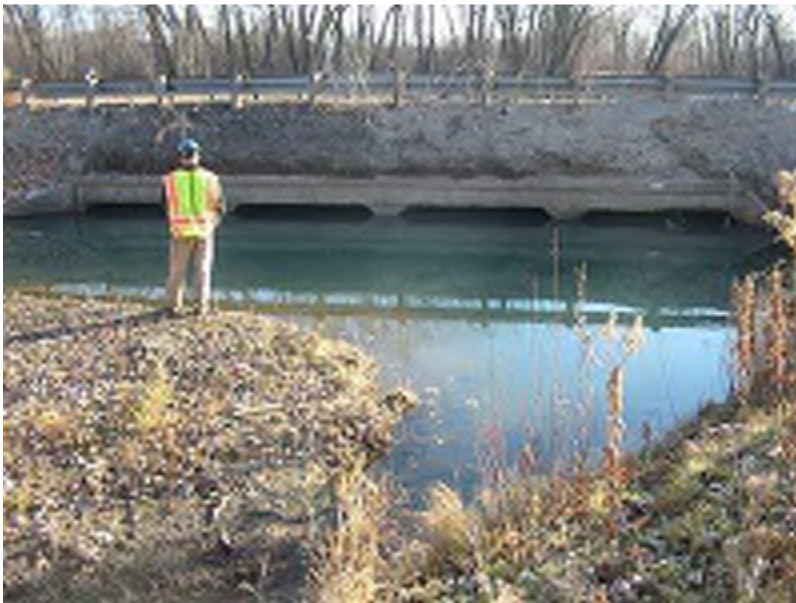
Culvert exit
